# CORROSION TESTS OF FLAME-SPRAYED COATED STEEL

## 19-YEAR REPORT

Prepared by  
AWS Committee on Thermal Spraying

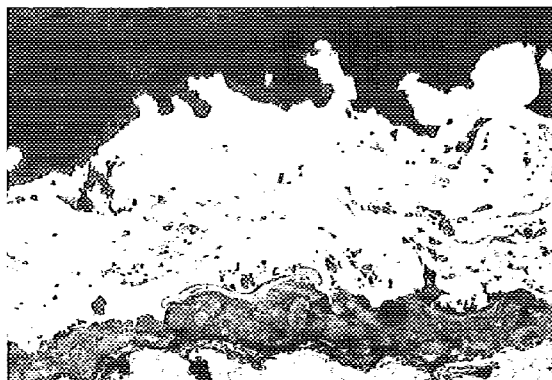
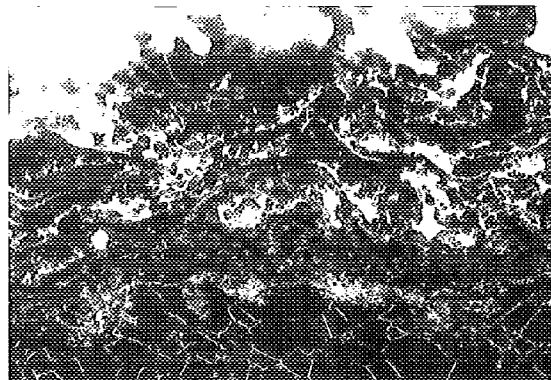
Fig. 1a—Flame-sprayed aluminum coating 0.006 in. (0.15 mm) thick, no sealer, over a flash coat of carbon steel. This photomicrograph illustrates the condition of the aluminum coating after exposure for 18 years at Wrightsville Beach, N.C. in sea water at mean tide level. 250X Nital etch. (Reduced 22% in reproduction.)

Fig. 1b—Same area, as shown in Fig. 1a, but under polarized light to show the amount of coating that has converted to aluminum corrosion product (white) and remaining aluminum (black). (Reduced 22% in reproduction.)

**Aluminum-Sprayed Panels (Figs. 1a, 1b, 2a-2d).** Unsealed aluminum-sprayed panels at this site show a few blisters which originate at the coating-steel interface. The heavier the coating, the larger the blisters (as large as 5/16 in. [8.0 mm] diam, in some cases). In those cases where a blister had broken open, the exposed steel was relatively free of corrosion. A layer of iron oxide was present, but no measurable loss of steel was evident. While the aluminum surrounding these broken blisters probably contributed to the protection of the steel, there was no significant evidence of aluminum corrosion. See Figs. 2c and 2d for the typical structure of aluminum. Scraping the aluminum surface results in a bright, metallic lustre.

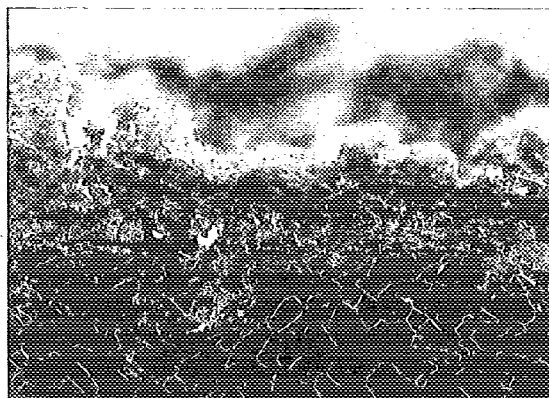
Fig. 2a—Flame-sprayed aluminum coating 0.003 in. (0.08 mm) thick plus one coat of primer and two coats of vinyl. This photomicrograph illustrates the overall condition of the aluminum coating after exposure for 18 years below low tide at Wrightsville Beach, N.C. 250X. Nital etch. (Reduced 22% in reproduction.)

Fig. 2b—This photomicrograph shows the same area as in Fig. 2a, but under polarized light to illustrate the relatively small amount of aluminum corrosion. (Reduced 22% in reproduction.)

Fig. 2c—Same coating as in Fig. 2a, but Nital etched on a reserve panel which was never exposed. (Reduced 22% in reproduction.)

Fig. 2d—Unexposed aluminum. Compare with Fig. 2b. (Reduced 22% in reproduction.)

All vinyl-sealed panels were in excellent condition—including those which were coated with only 0.003 in. (0.08 mm) of aluminum. A few small blisters were present on some of the sealed panels but were considerably smaller than those on the unsealed aluminum panels. When opened, these blisters reveal typical voluminous aluminum corrosion products and a thin layer of rust on the steel. No measurable loss of steel was evident. This is also true where the coatings were mechanically damaged at the edges by the ceramic mountings insulators. Areas as large as 1/2 in. (12.7 mm) x 1/8 in. (3.2 mm) of exposed steel showed no significant loss of steel. No progressive corrosion of the aluminum surrounding these areas was evident.

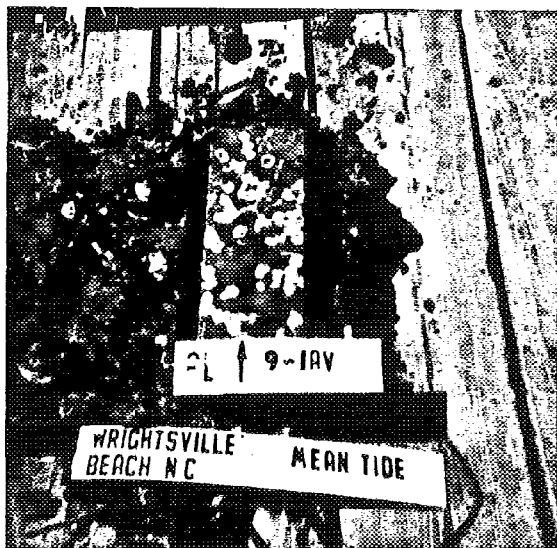
Fig. 5a—Flame-sprayed aluminum-coated steel panels, with foulants removed, after 19 years in sea water.

Fig. 5b—A closer view of one of the panels in Fig. 5a. This panel has 0.009 in. (0.23 mm) of flame-sprayed aluminum, wash primer, and one vinyl seal coat. The white markings are the remains of some of the tightly adherent foulants.

**Aluminum-Sprayed Panels (Figs. 4, 5a, 5b).** Unsealed aluminum coatings at this site appeared to blister slightly more than those at the mean-tide level. The steel was still being protected, even where the blisters had broken open, as in the case of the aluminum-sprayed panels exposed at the mean-tide level.

The vinyl-sealed panels were in excellent condition, showing only a few, small, unbroken blisters. The coatings on these panels were in a condition similar to aluminum-sealed panels exposed at the mean-tide level.

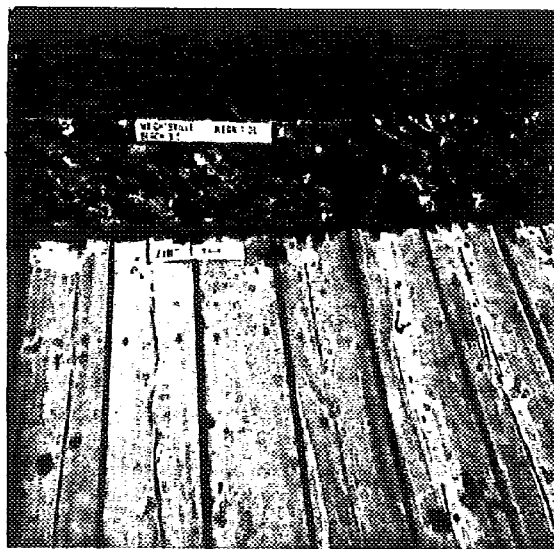
Fig. 6—Test rack of flame-sprayed zinc-coated panels immediately after removal from the mean tide site after 19 years exposure. Foulants have not been removed.

Sealed and unsealed zinc coatings of less than 0.012 in. (0.30 mm) thick had failed. Zinc coatings of 0.012 in. (0.30 mm), 0.015 in. (0.38 mm), and 0.018 in. (0.46 mm), sealed and unsealed, had protected the base metal, but the zinc had been converted to corrosion products. This tightly adherent mixture of white rust and foulants appeared to be providing corrosion protection to the base metal. All panels that failed were very deeply pitted.

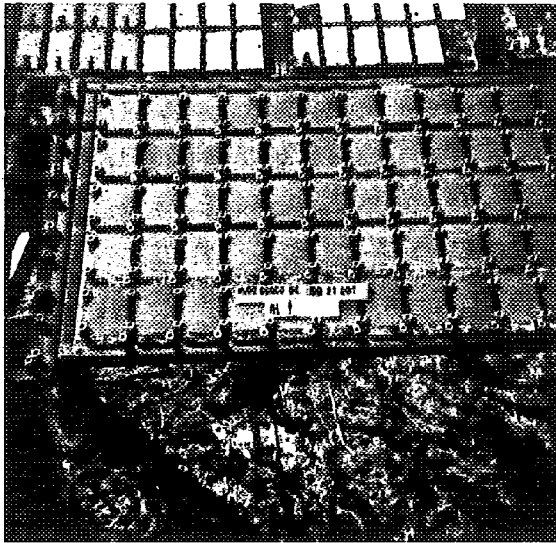
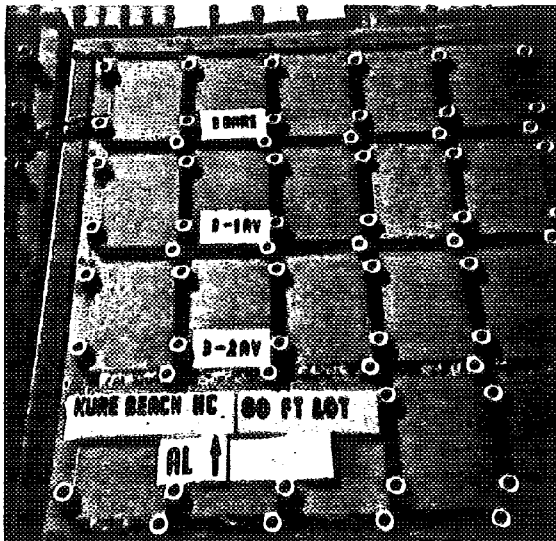
Fig. 7a—Flame-sprayed aluminum with and without sealers after exposure for 19 years, 80 ft (24 m) from the normal mean tide level, facing the surf.

Fig. 7c—A closer view of some of the panels in Fig. 7a (above). The top row, left three panels have 0.003 in. (0.08 mm) aluminum without a sealer. The upper second row, left three panels have 0.003 in. (0.08 mm) aluminum, a wash primer, and one coat of aluminum vinyl. The third row (from the top), left three panels are the same except for two coats of aluminum vinyl. The remaining unidentified panels are 0.006 in. (0.15 mm) and 0.009 in. (0.23 mm) aluminum with and without sealers.

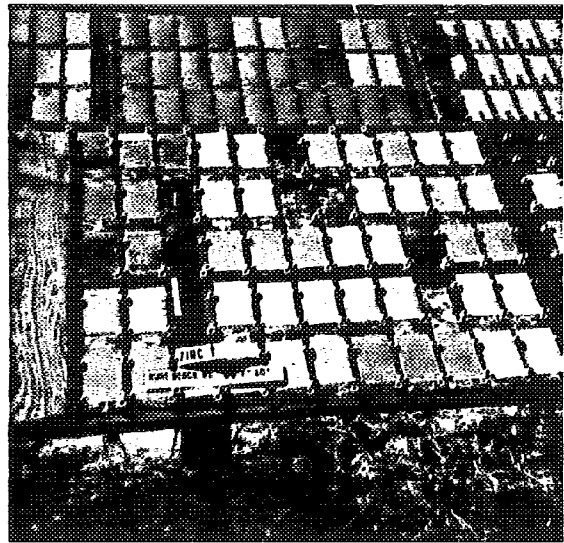
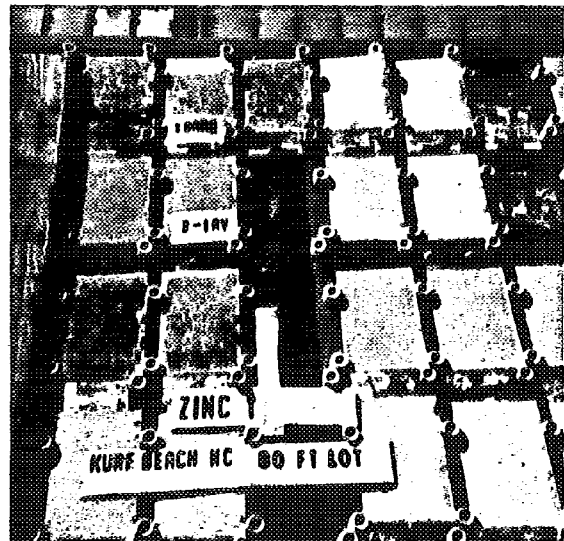
Fig. 7b—Flame-sprayed zinc with and without sealers after exposure for 19 years, 80 ft (24 m) from the normal mean tide level, facing the surf.

Fig. 7d—A closer view of some of the panels in Fig. 7b (above). The top row, left three panels show the condition of 0.003 in. zinc panels without a sealer. The upper second row, left two panels have 0.003 in. zinc, a wash primer, and one coat of aluminum vinyl. The third row (from the top), left two panels have 0.003 in. zinc with chlorinated rubber sealer. The top row, right two panels have 0.006 in. zinc with a chlorinated rubber sealer. The remaining panels are 0.009 in. zinc with and without sealers.

**Zinc-Sprayed Panels (Figs. 7c, 7d).** Unsealed zinc coatings of 0.003 in. (0.08 mm) exhibited heavy rusting of the base metal, as shown in Fig. 7d.

Aluminum vinyl sealer had completely deteriorated on the 0.003 in. (0.08 mm) zinc, with rusting of the base at the edges encroaching on the faces. Both skyward and groundward surfaces were covered with white rust. Unsealed 0.006 in. (0.15 mm) zinc exhibited rusting of the base metal at the edges; the flat surfaces were covered with small nodes of heavy white rust.

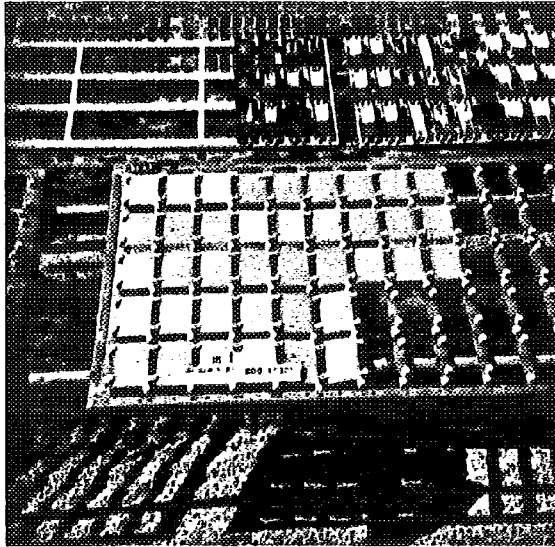
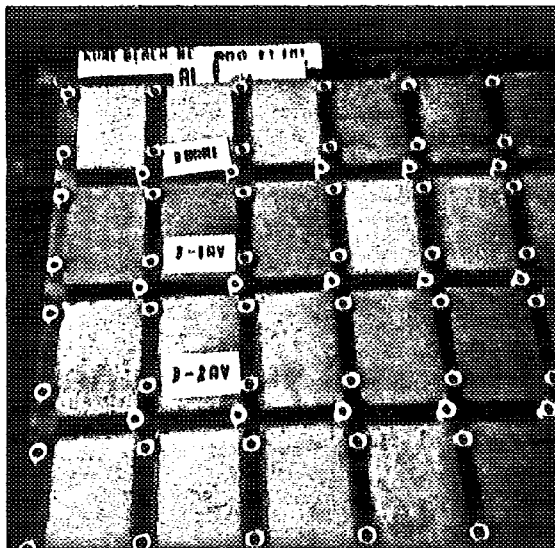
**Aluminum-Sprayed Panels (Figs. 8a, 8b).** As shown in Figs. 8a and 8b, all panels were in excellent condition at this site. Unsealed aluminum panels 0.003 in. (0.08 mm) thick were light gray in color on the skyward surface with a slightly darker

Fig. 8a—Flame-sprayed aluminum with and without sealers after exposure for 19 years, 800 ft (244 m) from the normal mean tide level.

Fig. 8c—A closer view of some of the panels in Fig. 8a (above). The top row, left three panels have 0.003 in. (0.08 mm) aluminum without a sealer. The upper second row, left three panels have 0.003 in. (0.08 mm) aluminum, a wash primer, and one coat of aluminum vinyl. The third row (from the top), left three panels have 0.003 in. (0.08 mm) aluminum, a wash primer, and two coats of aluminum vinyl.

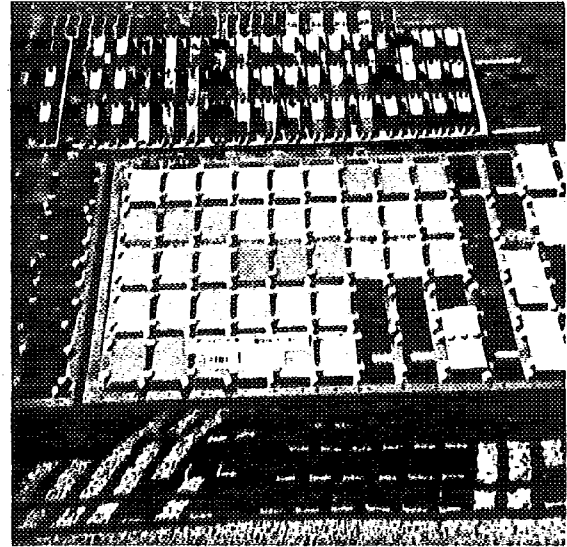
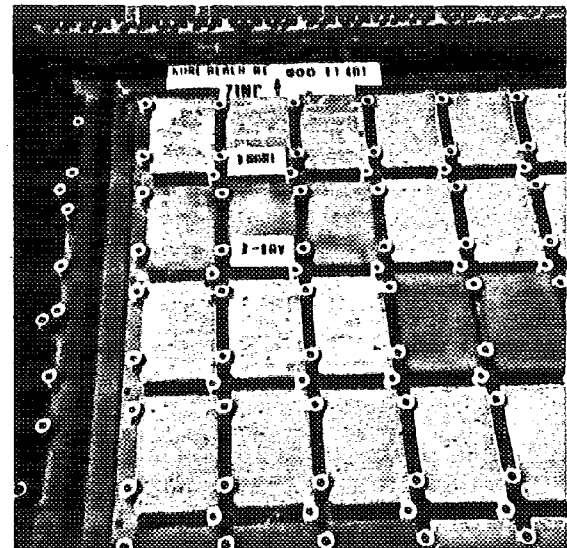
Fig. 8b—Flame-sprayed zinc, with and without sealers, after exposure for 19 years, 800 ft (244 m) from the normal mean tide level.

Fig. 8d—A closer view of some of the panels in Fig. 8b (above). The top row, left three panels have 0.003 in. (0.08 mm) zinc without a sealer. The upper second row, left three panels have 0.003 in. (0.08 mm) zinc, a wash primer, and one coat of aluminum vinyl. The bottom row, left three panels have 0.006 in. (0.15 mm) zinc, without a sealer.

**Zinc-Sprayed Panels (Figs. 8c, 8d).** The 0.003 in. (0.08 mm) thick unsealed zinc panels were dark blue with horizontal stripes of white rust that appeared to conform to the spray pattern (see Figs. 8c and 8d). This condition was apparent on both surfaces, with the groundward surface having a slightly darker blue color.

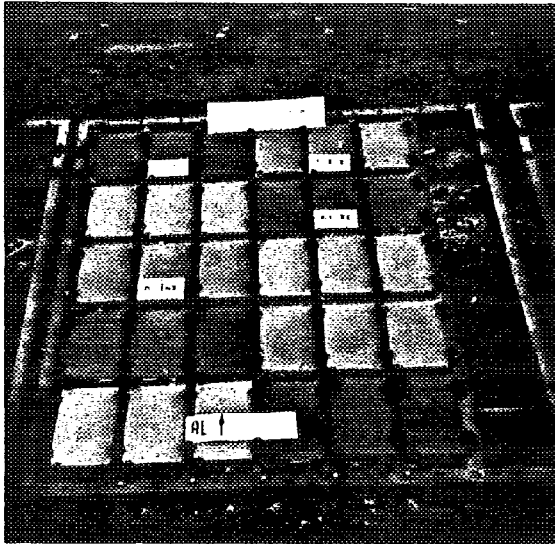
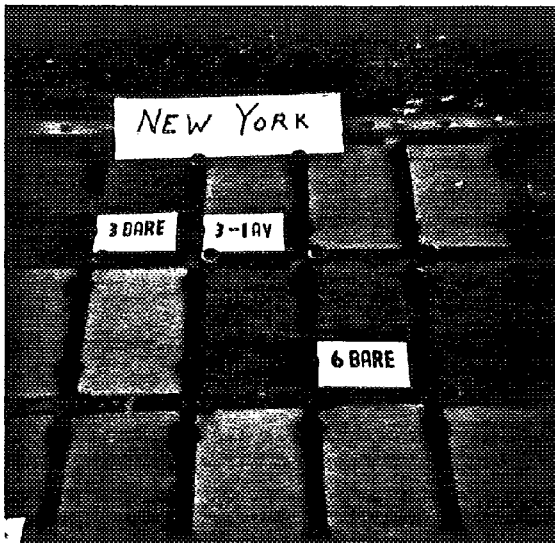
Fig. 9a—Flame-sprayed aluminum with and without sealers after exposure for 19 years.

Fig. 9c—A closer view of some of the panels in Fig. 9a (above). The top row, left two panels have 0.003 in. (0.08 mm) aluminum, with no sealer. The top row, right three panels have 0.003 in. (0.08 mm) aluminum, wash primer, and one coat of aluminum vinyl. The center row, right three panels have 0.006 in. (0.15 mm) aluminum with no sealer.

**Aluminum-Sprayed Panels (Figs. 9a, 9b).** Unsealed 0.003 in. (0.08 mm) thick aluminum coatings showed, on the skyward surface, many black nodes of corrosion due to retained contamination. The groundward surface was gray to black in color with some indication of nodular corrosion. No rusting of the base metal was evident.

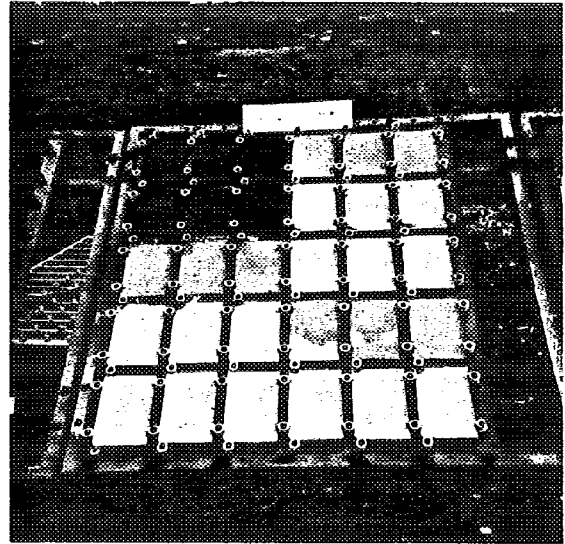
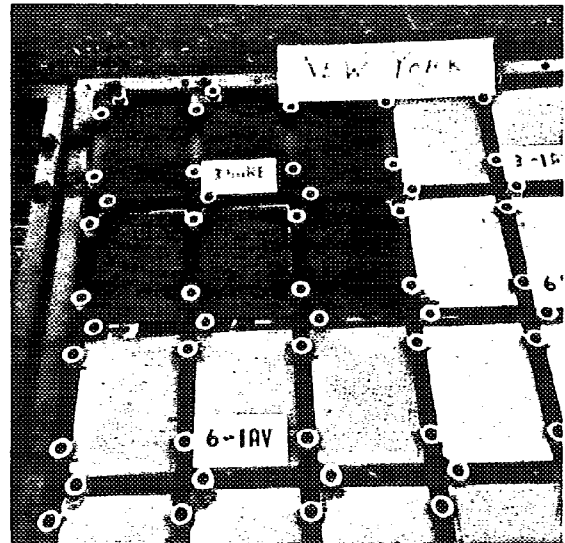
Fig. 9b—Flame-sprayed zinc with and without sealers after exposure for 19 years.

Fig. 9d—A closer view of some of the panels in Fig. 9b (above). The top row, left three panels show that the 0.003 in. zinc is gone and the steel is rusting. The upper second row, left three panels show that the 0.003 in. zinc and chlorinated rubber sealer are gone and the steel is rusting. The third row (from the top), left three panels have 0.006 in. zinc, wash primer, and one coat of aluminum vinyl.

**Zinc-Sprayed Panels (Figs. 9c, 9d).** Unsealed 0.003 in. (0.08 mm) thick zinc coatings failed completely on the skyward surface and on approximately 75% of the groundward surface. The 0.003 in. (0.08 mm) zinc coatings sealed with chlorinated rubber also failed completely on the skyward surface and about 10% on the groundward surface. Zinc coatings 0.003 in. (0.08 mm) thick sealed with aluminum vinyl were in excellent condition and were brighter and cleaner than aluminum with an equivalent amount of sealer. It is interesting to note that the vinyl sealer was in better condition on the 0.003 in. (0.08 mm) thick coatings than on the heavier zinc coatings where, in some cases, it had deteriorated 10-30%. This is probable because 0.003 in. (0.08 mm) thick coatings are smoother and do not absorb as much sealer as the heavier coatings.

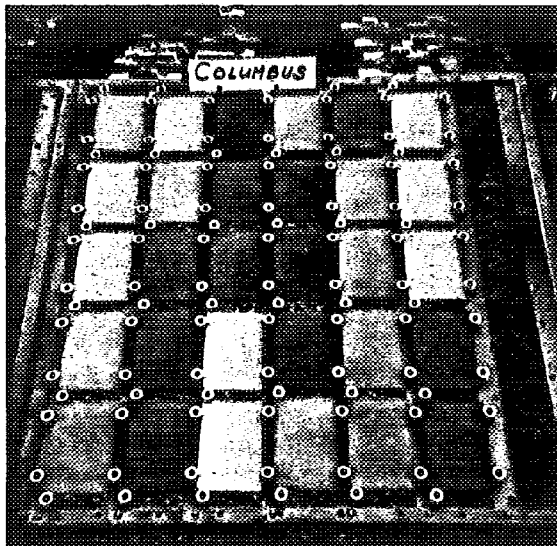
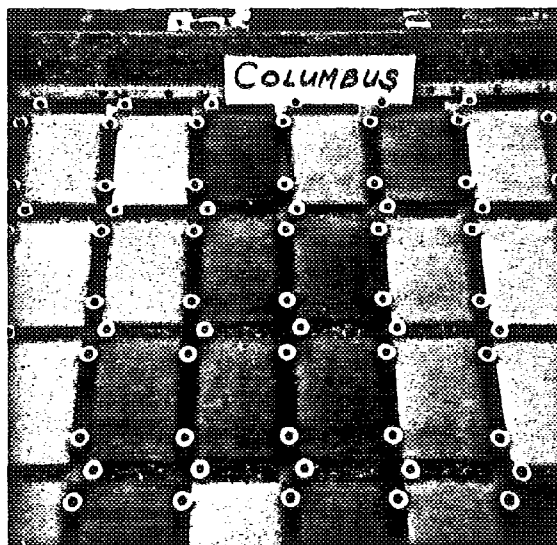
Fig. 10a—Flame-sprayed aluminum with and without sealers after exposure for 19 years.

Fig. 10c—A closer view of some of the panels in Fig. 10a (above). The three dark panels in the third column from the left are 0.003 in. (0.08 mm) aluminum without a sealer. The second panel from the left in the top row is 0.003 in. (0.08 mm) aluminum with a wash primer and two coats of aluminum vinyl. The panel directly below that in the second row is the same except that it has only one coat of aluminum vinyl.

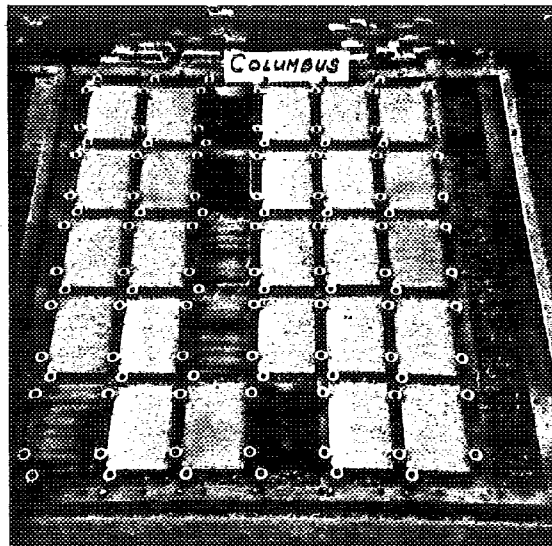
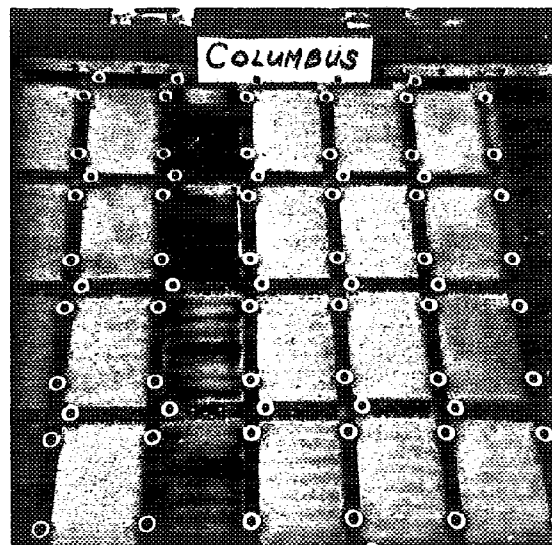
Fig. 10b—Flame-sprayed zinc with and without sealers after exposure for 19 years.

Fig. 10d—A closer view of some of the panels in Fig. 10b (above). The upper two panels in the third column from the left show the condition of 0.003 in. (0.08 mm) zinc without a sealer. The two panels below them were 0.003 in. (0.08 mm) zinc with chlorinated rubber sealer. The upper right column of three panels is 0.003 in. (0.08 mm) zinc, wash primer, and one coat of aluminum vinyl.

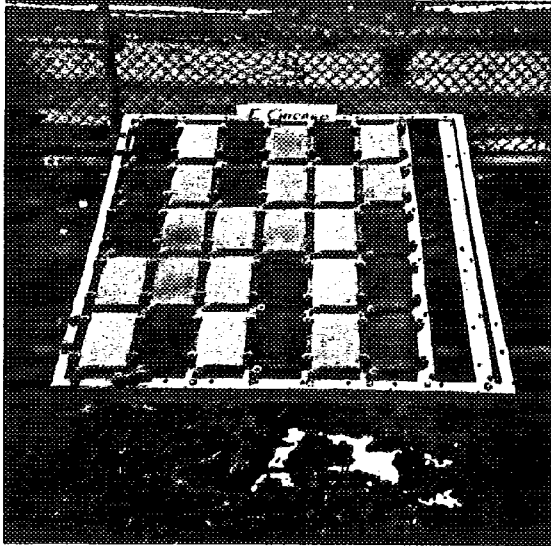
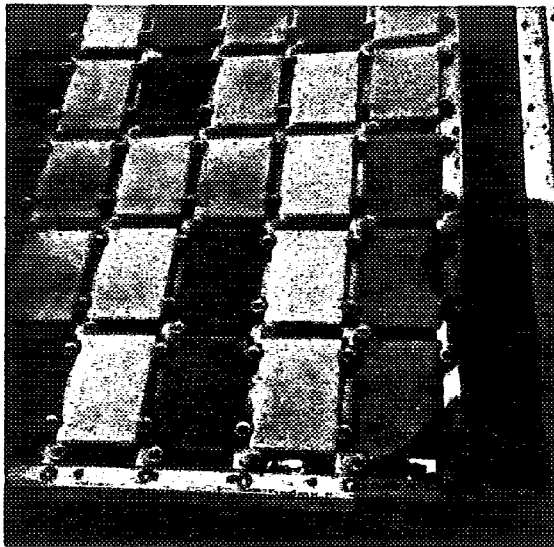
Fig. 11a—Flame-sprayed aluminum with and without sealers after exposure for 19 years.

Fig. 11c—A closer view of some of the panels in Fig. 11a (above). The dark panels are unsealed flame-sprayed aluminum, of various thicknesses, discolored by pollutants in the atmosphere. The lighter panels are flame-sprayed aluminum of various thicknesses with a wash primer and one or two coats of aluminum vinyl.

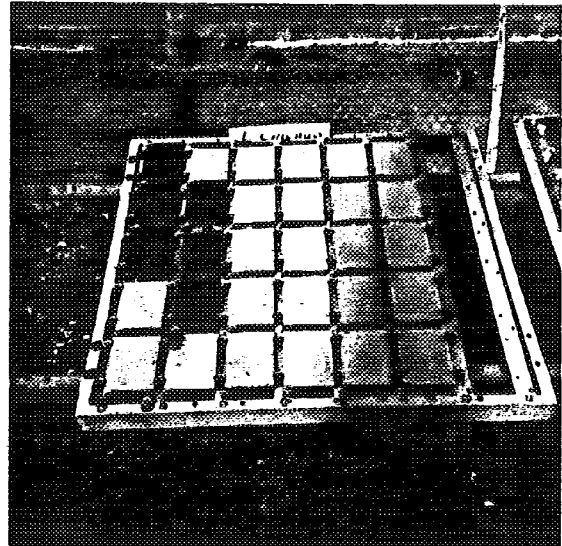
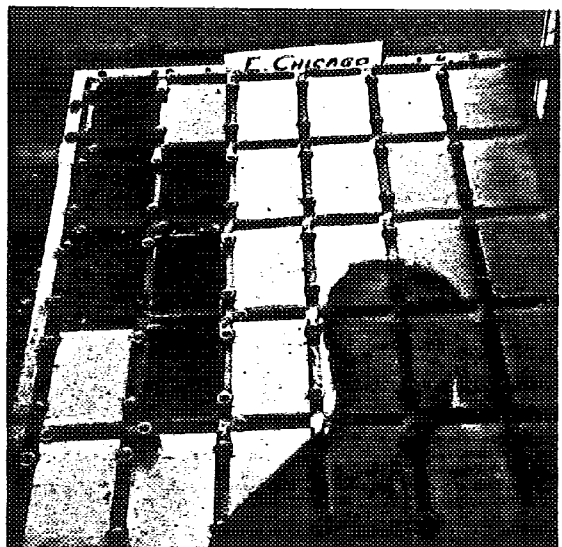
Fig. 11b—Flame-sprayed zinc with and without sealers after exposure for 19 years.

Fig. 11d—A closer view of the panels in Fig. 11b (above). The upper three panels in the first column show that the 0.003 in. (0.08 mm) zinc is gone and the steel is rusting. The three center panels in the second column were 0.003 in. (0.08 mm) zinc sealed with chlorinated rubber. The lower two panels in the first column have 0.003 in. (0.08 mm) of zinc, a wash primer, and one coat of aluminum vinyl.
