# COATING FAILURES: CONSEQUENCES AND CASE STUDIES

## 8

## Case Studies of Coating Failure

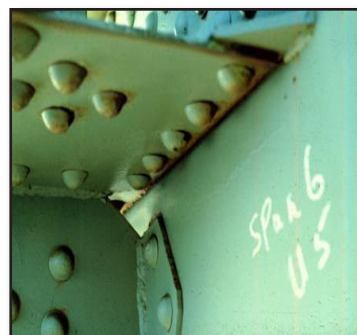
### Case Study Failure 1

corrosion was observed as illustrated in the photograph.

Corrosion products remained on the back side of the rivets that were not subjected to direct impact by the abrasive stream during blast cleaning. The coating was also applied from one direction, causing thin areas on the back side of the rivets and the adjacent flat areas of the steel plate. Inadequate attention was given to the coating along the edges.

The repair recommendation included power tool cleaning of corroded areas and subsequent touch-up. Abrasive blast cleaning may cause damage to the surrounding coating that remains in good condition.

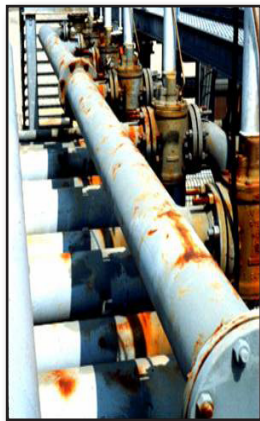
**Case Study Failure 2**

pinpoint rusting and rust-through. A closer examination of the pipe (second photo) shows one of the rusted areas, with the edge of a repair area also shown (top left). As illustrated, the repair area is performing well, but the surrounding area is exhibiting rusting.

When repairing damaged areas, the laborer failed to start and stop the flow of abrasive from the blast nozzle when moving from one damaged area to another. Instead, the blast nozzle was moved to the next location while the abrasive was still flowing at maximum pressure, which caused considerable damage to the coating. This is apparent in the second photo, where a round patch of coating had been effectively removed

by the abrasive impact, with the surrounding area nicked by the abrasive. Since the zinc primer is essentially the same color as the steel, the damage went unnoticed until the electrolyte (water) contacted the surface and caused the formation of corrosion.

The repair recommendation included cleaning the pipe by pressure washing and the rusted areas repaired by hand or power tool cleaning per SSPC SP2/SP3. Application of a full overcoat to all piping will help prevent formation of additional corrosion products.

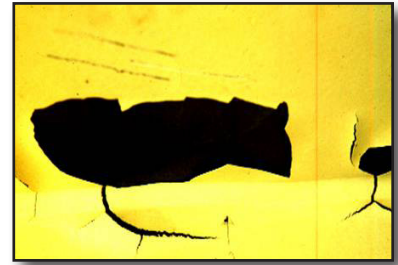
### Case Study Failure 3

The project specification required abrasive blast cleaning (to achieve a near-white blast per SSPC-SP10) and the application of an inorganic zinc primer to structural steel I Beams in the fabrication shop. Application of the intermediate coat was also performed in the shop, while the topcoat was scheduled for application in the field after erection and bolting of the steel. The fabricator's quality control specialist kept documentation revealing that they had conformed to the thickness and recoat times recommended by the coating manufacturer's technical representative, who visited the shop during coating application activities. The steel was loaded onto trucks and shipped to the site. Spontaneous cracking of the coating along the fillet weld (where the web and flange are joined) was evident, as illustrated by the photograph.

The second photo illustrates the spontaneous cracking and lifting along the fillet, and the poor adhesion of the coating system on the web. Examination of a disbonded coating chip revealed the presence of zinc primer on the back side of the chip and on the steel surface, indicating that the location of break was cohesive within the zinc primer.

Ethyl silicate type inorganic zinc-rich primers require moisture to cure. In this case, an insufficient length of time was allowed before the application of the epoxy midcoat. Once the epoxy was applied, no more moisture could react with the primer, since it was effectively sealed off by the epoxy. The zinc primer remained in a dry, but uncured (and weakened state). The solvents from the epoxy midcoat penetrated the uncured primer, and the contractive curing stresses imparted by the epoxy caused the zinc primer to cohesively split. Since the web and flange are adjacent to one another, the thickness of the epoxy was slightly higher along the fillet weld area. The higher thickness exacerbated the problem and resulted in the cracking and detachment. When other areas were evaluated, it became evident that the entire system was at risk for failure.

The repair procedures can take either of two approaches. The areas exhibiting spontaneous failure can be repaired by hand or power tool cleaning (SSPC-SP2/SP3) followed by the application of the epoxy to the repair areas. This assumes that once the steel is erected and is left undisturbed, additional detachment will not occur. If this approach was selected, then maintenance painting work over the following few years would be necessary. The other approach is to totally remove and replace the existing coating system. The owner may exercise this option if he does not want to take a “wait and see” approach and face monitoring performance and the potential for maintenance painting work on the structure for several years to come (based on the rate of failure).

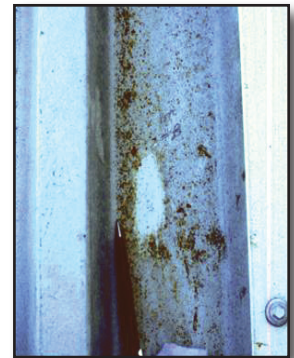
**Case Study Failure 6**

Galvanized and coil coated, corrugated white metal roofing was installed on a new low rise motel in the southeast. Within a few weeks of installation, excessive pinpoint rusting was visible. During the investigation, solvent was used to clean an area of the coated surface. Substantial rubbing of the coating with the solvent revealed a small area of bare galvanizing beneath the coil coating. The galvanized layer was in excellent condition, with no indication of red rusting.

This was not a coating failure at all. In fact, the coating itself was in good condition. The presence of pinpoint rusting was a surface phenomena caused by the presence of iron filings that had collected in the “troughs” of the roofing and rusted when contacted by moisture. The iron filings were generated

Since there is nothing wrong with the surface preparation or the coating, the roof can be thoroughly scrubbed to remove the rust staining.

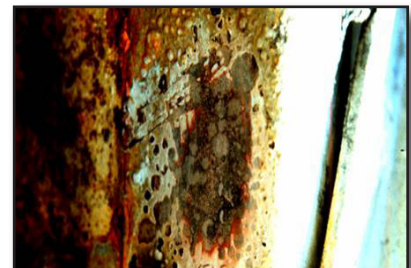
**Case Study Failure 7**

40°F), but within the allowable range stated on the PDS. The tank was placed back into service within 24 hours, in the event that a fire quenching water was required. The interior of the tank was examined a few months later and extensive blistering was evident. Blister caps were removed, revealing properly prepared steel beneath the blisters.

While vinyl coatings can be applied in cooler temperatures, they require an extended dry time to allow ample time for the solvents to evaporate from the film. Most vinyl coatings are formulated with 60% or more solvent. In this case, residual solvent in the coating film (which was water soluble) pulled water through the coating film (by osmotic forces) causing a build-up of water and pressure beneath the coating, resulting in blistering of the lining.

The entire coating system inside the fire water tank had to be removed by abrasive blast cleaning and replaced. In some cases, blistered areas can be repaired. However, the blistering in this tank was too extensive for repair. By putting the tank back into service too quickly, the tank was actually out of service much longer due to the failure investigation and the rework required. Costs also escalated much higher than budgeted for the project because of the rework.

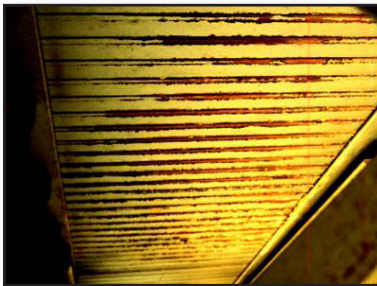
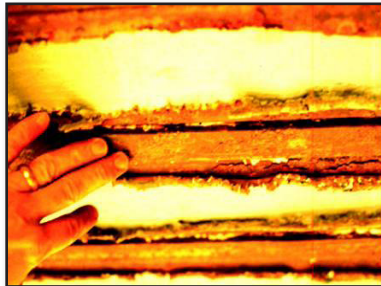
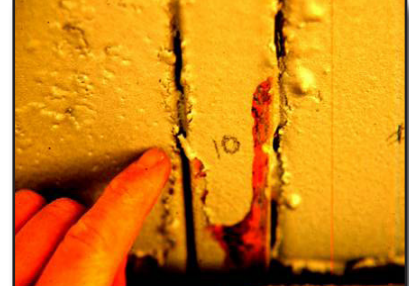
## Case Study Failure 8

The underside of a viaduct containing an aged lead alkyd coating (first photo) was brush-off abrasive blast cleaned to remove loosely adhering corrosion and paint (according to SSPC-SP7/NACE No. 4), followed by the application of an epoxy mastic overcoat. The second photo illustrates the condition of the coating prior to abrasive blast cleaning. The third photo illustrates lifting of the old alkyd by the epoxy mastic overcoat. The number “10” is written on the coating in an area where the epoxy mastic was applied directly to the steel, rather than the aged lead alkyd. Directly beneath that area is an area where the mastic had lifted the alkyd, and was removed by scraping during the failure investigation. The area beneath the hand in the same photo represents epoxy mastic applied over the aged lead alkyd. This area was not probed during the investigation.

The aged lead alkyd coating was in poor condition, as illustrated by the second photo. While brush-off abrasive blast cleaning removed the loosely adhering materials, the impact of the abrasive on the “intact” alkyd weakened (fractured) it, but did not affect it sufficiently that it would be considered “loose.” Application of the epoxy mastic imparted curing stresses that proceeded to weaken the cohesive strength of the aged lead alkyd, causing it to lift and disbond from the surface.

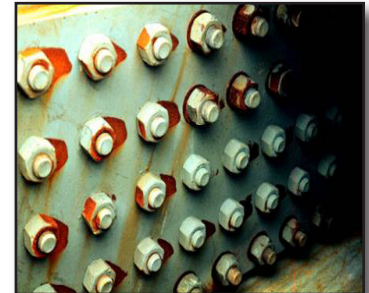
**Case Study Failure 9**

observed as illustrated in the photograph. The pattern of the failure is erratic. At first glance, it appears as if the coating was applied from one direction. However upon closer examination, this may not be accurate, since the failure on the side of the nut does not correlate to the failure on the plate (it is on the opposite side). For example, the first nut in the second row does not show failure on the left side, but failure is evident to the right of the nut. In contrast, the third nut shows failure on the left side of the nut and to the right of the nut.

The coating was in fact applied from one direction (left to right). The nut shadowed the application to the plate, leaving bare steel on the plate, which was not discovered until the rusting was evident, since the blast cleaned steel and the

gray epoxy mastic were similar in color. The erratic failure pattern was caused by tightening of the nuts after the coating was applied. Stripe coating of the nuts, bolt ends and areas between the nuts would have provided additional protection. It is unknown whether stripe coating was specified, but may be considered good painting practice for this type of configuration.

Since the failure is localized, the repair recommendation included power tool cleaning of corroded areas and subsequent touch-up with the epoxy mastic coating. If the failure was widespread, then abrasive blast cleaning and recoating all surfaces may be more efficient.
