# ***FAILURE ANALYSIS CASE STUDIES II***

A sourcebook of case studies selected from the pages of  
*Engineering Failure Analysis* 1997-1999

**D.R.H. JONES**

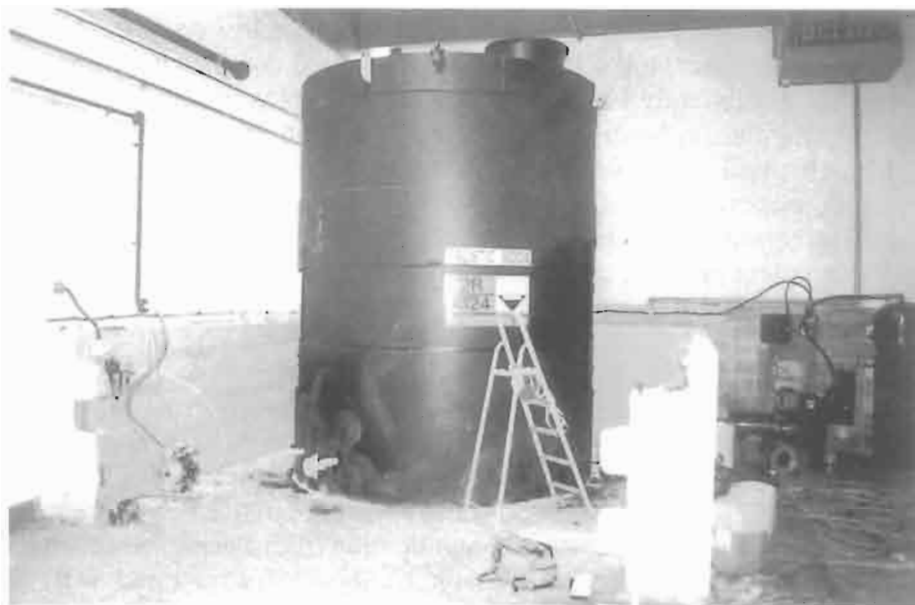
Fig. 2. Failed plastic tank, showing the bund wall in section (the front part was removed by the Fire Brigade). The jet of caustic soda flew from the tank wall near the right-hand edge in the figure, just above the top of the bund wall. It rose upward from a small crack in the weld, and landed some 4–5 m away from the exit point.

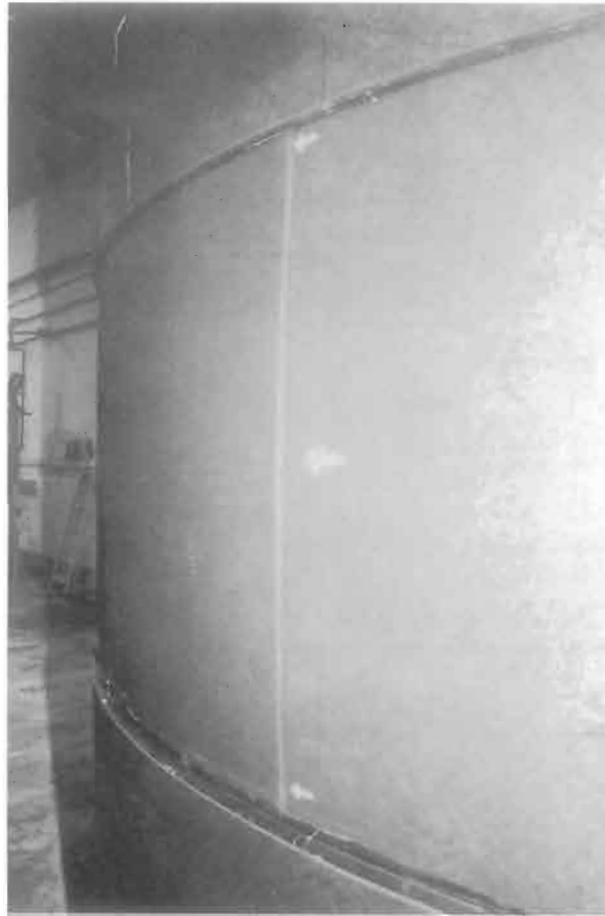
Fig. 3. Face view of the failed weld in the plastic panels of the tank. The large white arrow indicates the position of the crack initiation point in the centre of the weld, the crack eventually widening to the points shown by the two smaller arrows. The surface surrounding the failed weld is pristine and totally undamaged, with no abrasive wear or traces of impact damage.

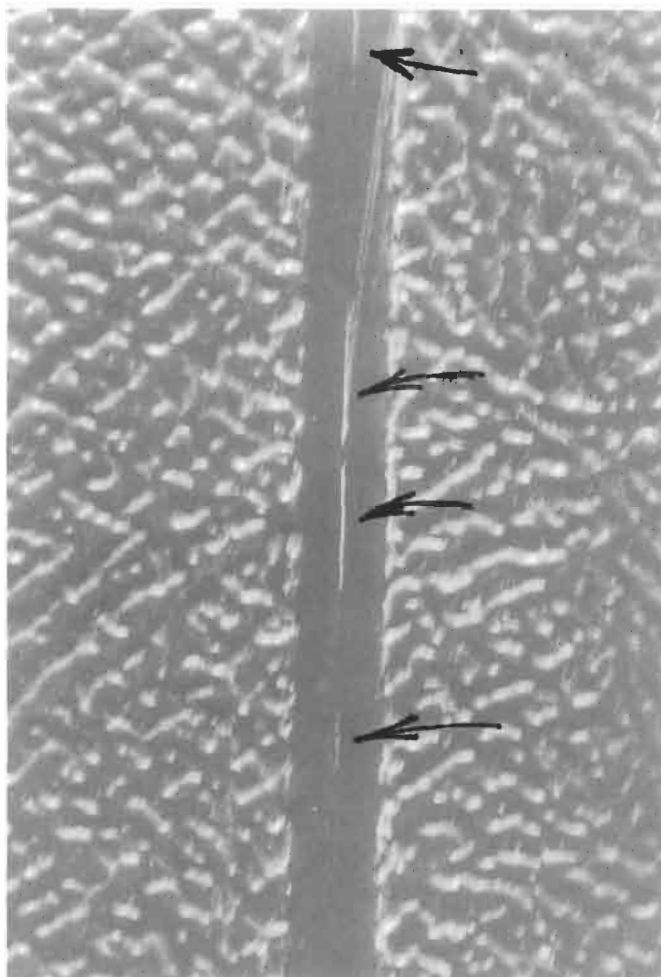
Fig. 7. Close-up of hairline subcritical cracks (arrows) in another vertical weld of the failed tank. The weld was adjacent to that which failed, occurring about the same height, towards the centre of the panel. The cracks were found during re-inspection of the tank, by dusting the welds with fine talcum powder, and represent sub-critical cracks formed during loading the tank with caustic soda. The weld itself is about 2.5 mm wide.

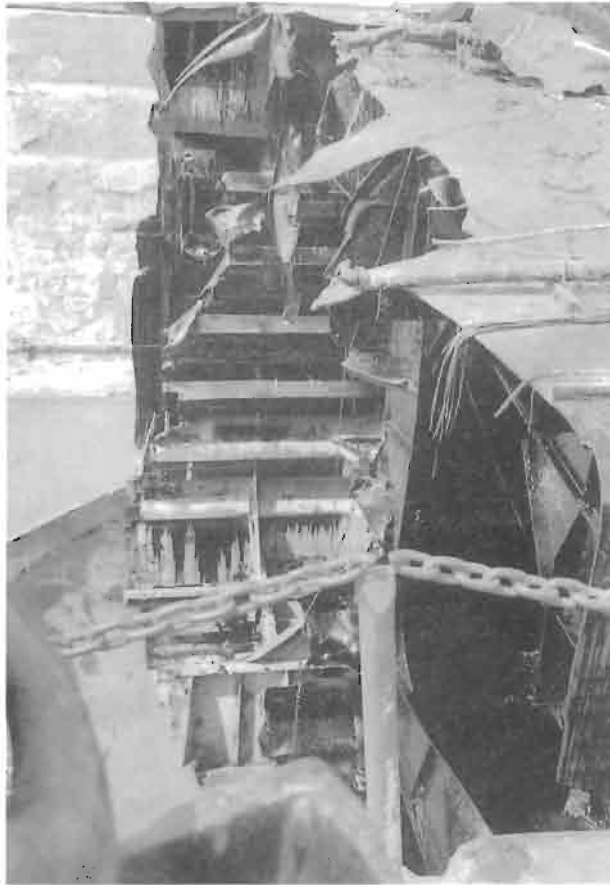
Fig. 7. Side view from port showing fractures to bulkheads, port gunwhale and deck plating.

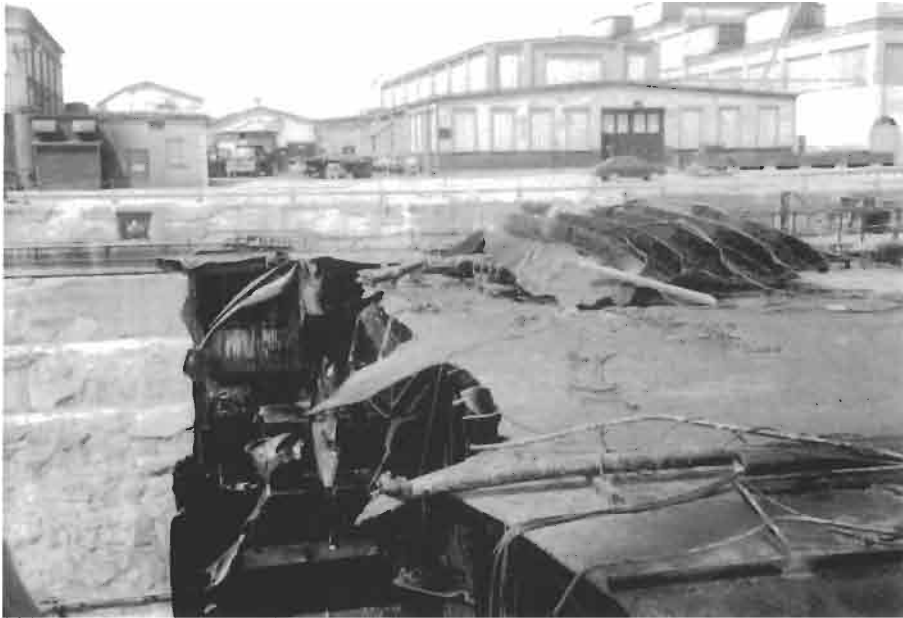
Fig. 12. View of the deck plate fracture: part of the deck and longitudinal ripped out during final fracture is also shown.

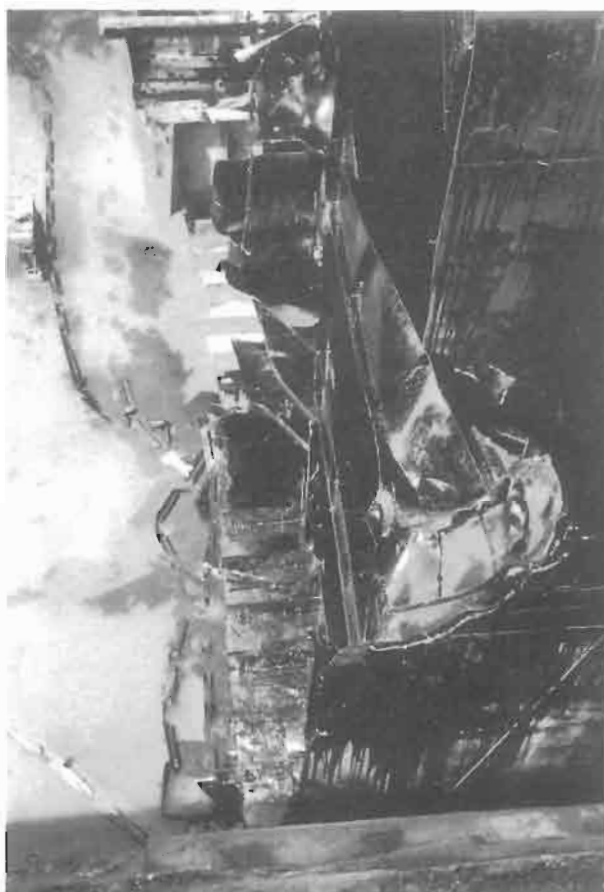
Fig. 13. Port hull plates and longitudinal bulkhead fractures: deformation to the web frame on the port side is also visible.

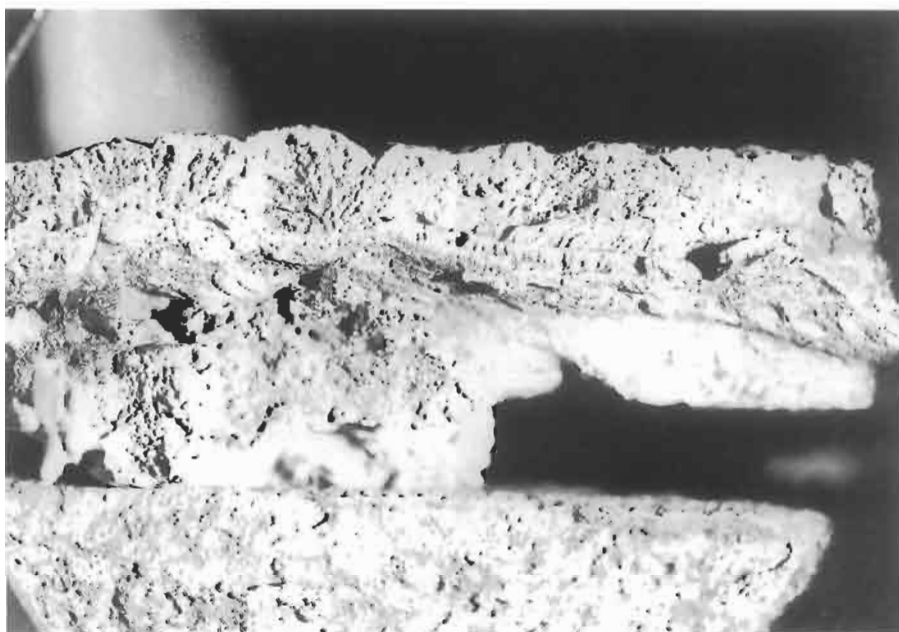
Fig. 19. Fracture surface of ground bar butt weld in sample 1 in single-sided region, close to outboard edge of ground bar. Note smoother fracture surface in weld root, from which some chevron patterns (arrowed) emerge.  $\times 4$ .

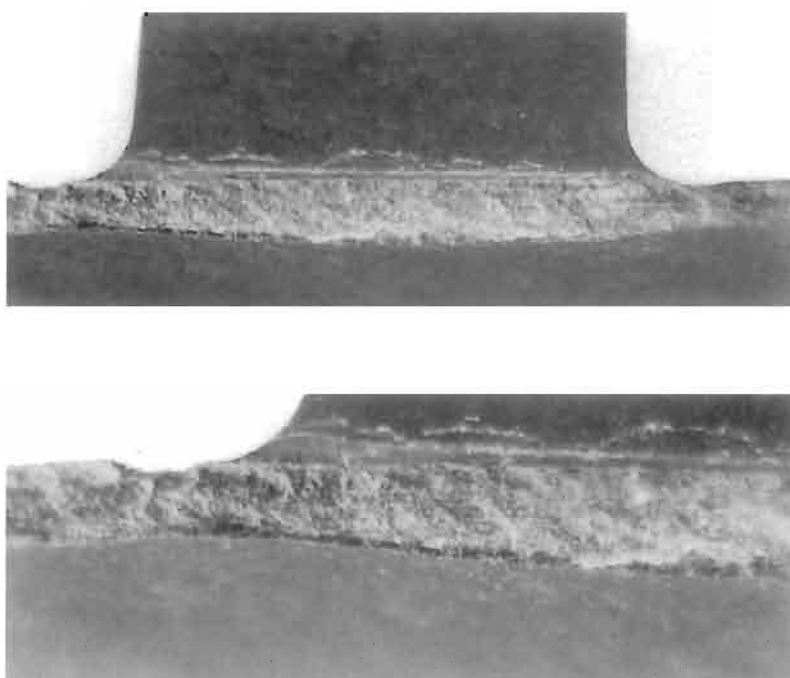
Fig. 10. Close-ups of main crack near buttress corner. Note lower edge shows what appears to be a weld line running into the bulk material.

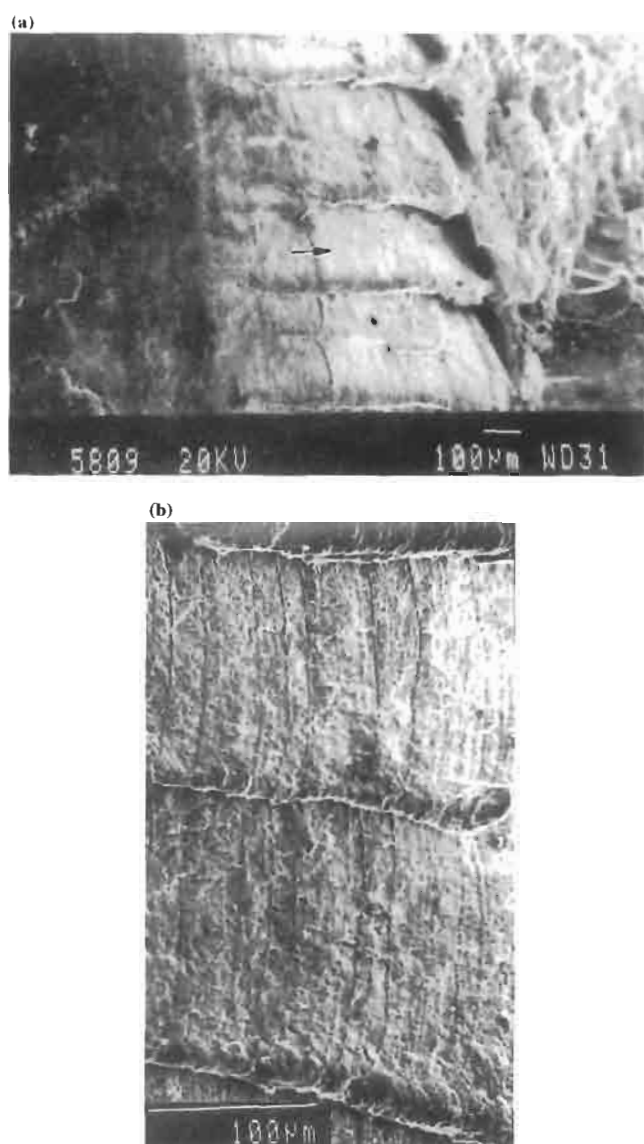
Fig. 5. (a) Enlarged area marked as 'C' in Fig. 4(c); (b) magnified portion of (a) revealing fatigue striations and ratchet markings. Arrow indicates the crack growth direction.

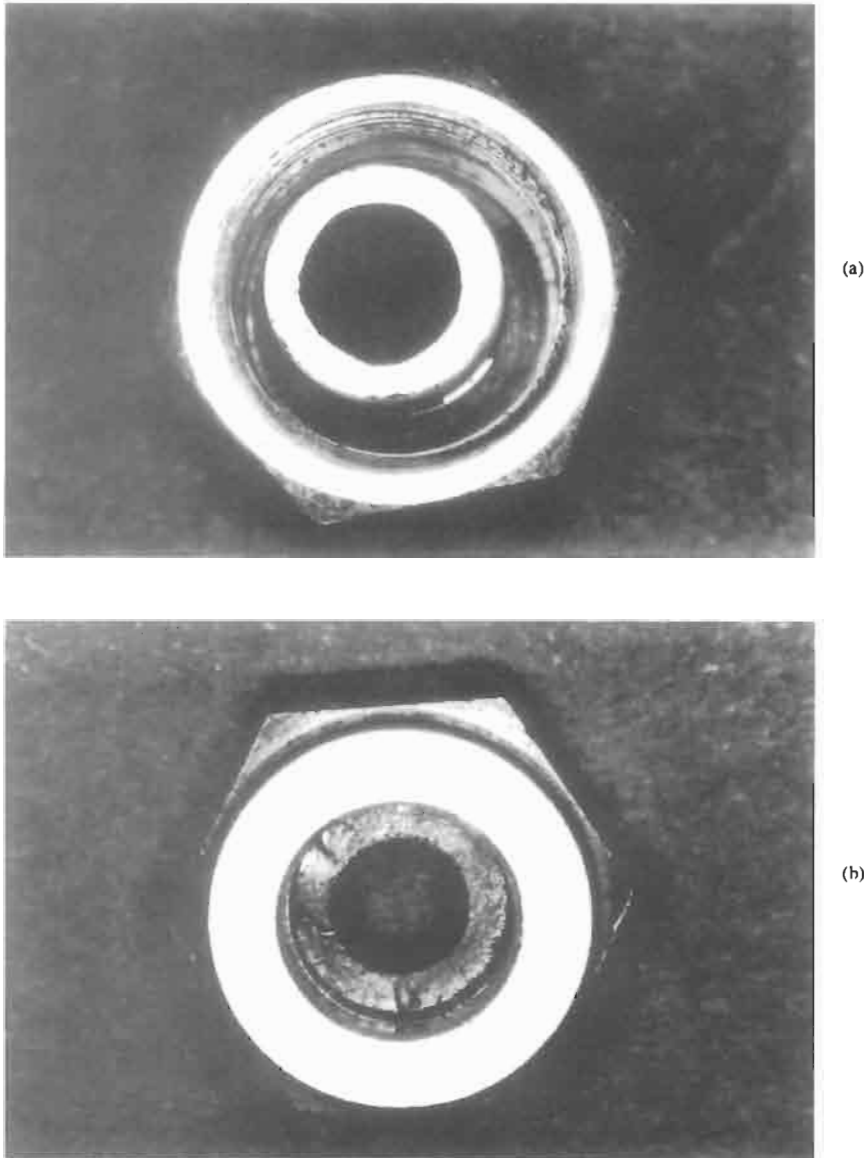
Fig. 3. End connector with the fractured piece jammed inside the nut.

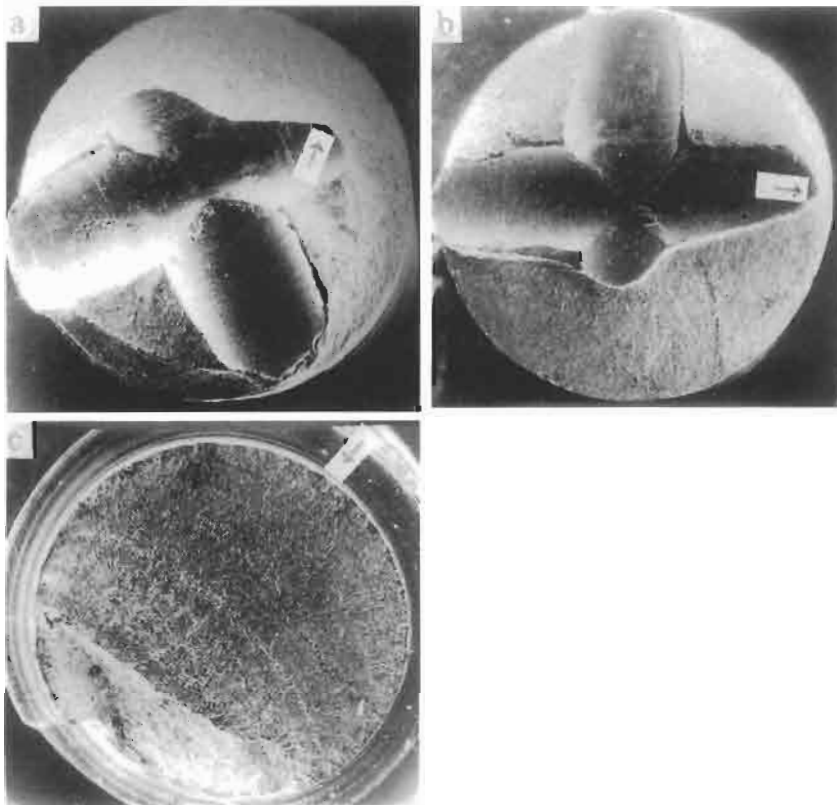
Fig. 2. Fracture surfaces of bolts. (a) 1#; (b) 2#; (c) 3#. Fracture origins are marked with an arrow.

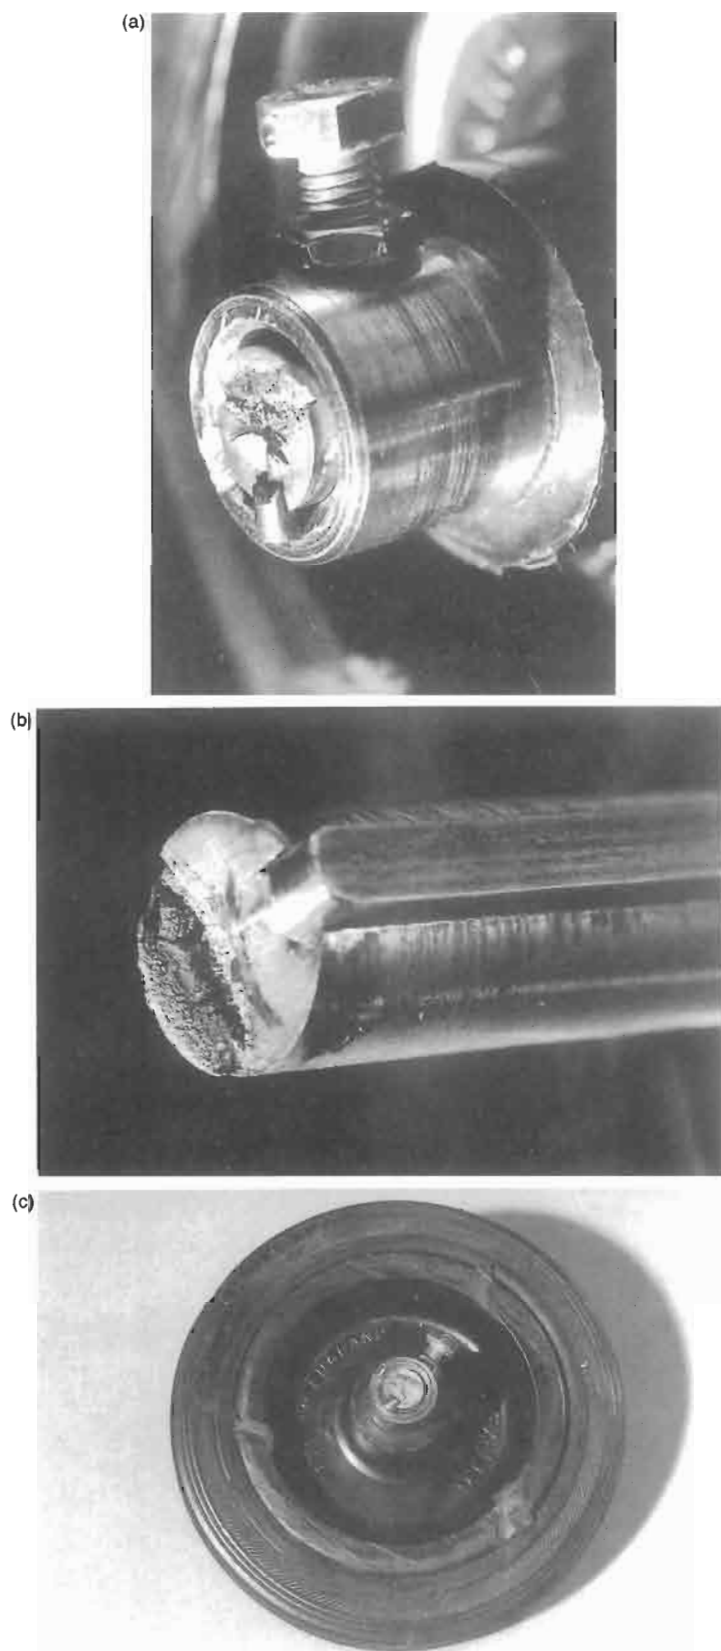
Fig. 3. The failed wheel shaft. (a) and (b) close examination of fracture; (c) failed hub portion and wheel.

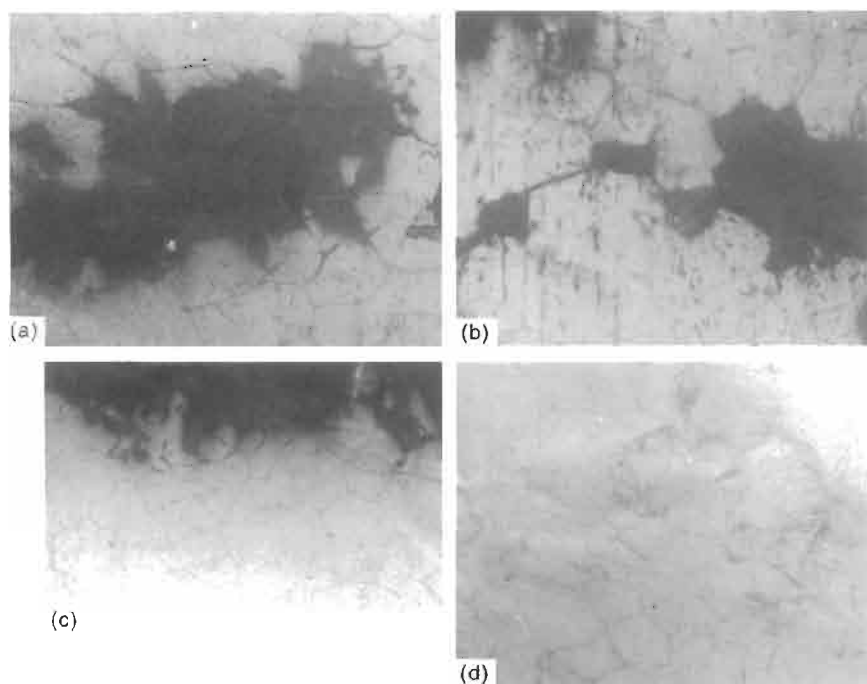
Fig. 3. Optical micrographs of the failed pipe-to-flange joint. (a) Microstructure near the crack, showing equiaxed austenite grains with slip bands, and the absence of annealing twins (circumferential side). (b) and (c) Microstructure of through-thickness section, showing intergranular fracture. (d) Microstructure away from the cracked region, showing equiaxed austenite grains with slip bands (note the absence of twins). All  $\times 200$ .

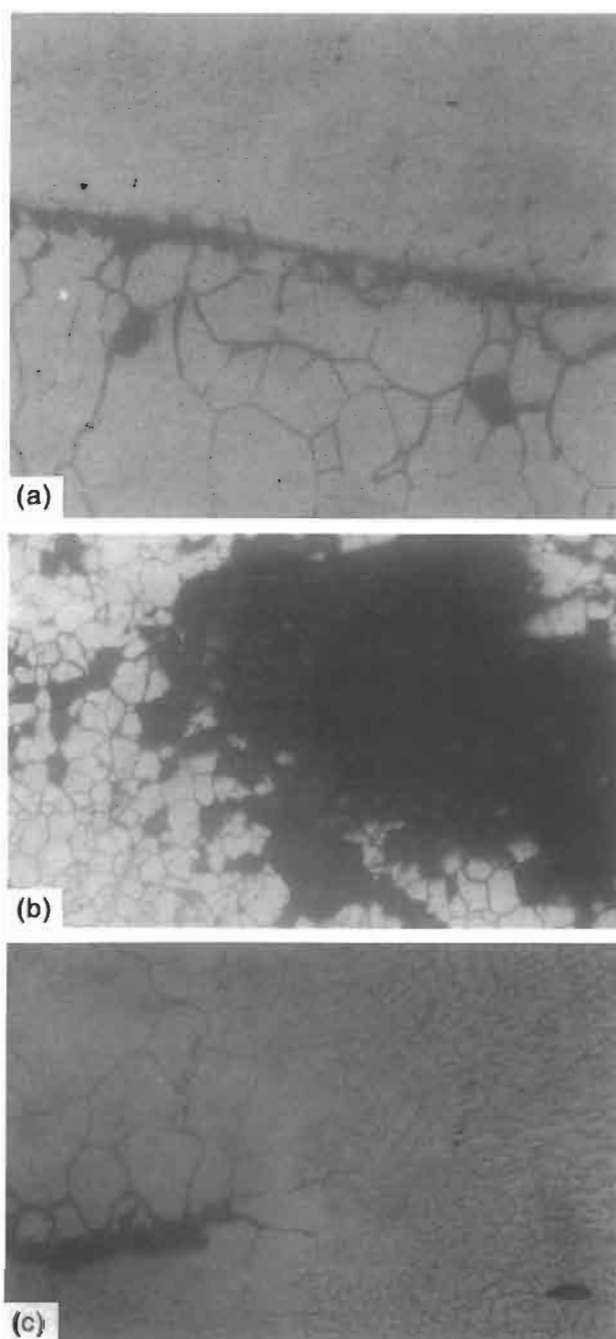
Fig. 7. Optical micrographs of sight port flange. (a) Interface between flange and pipe portion, showing corrosion attack on the interface and propagation intergranularly.  $\times 120$ . (b) Cracked area in the flange portion, showing individual grain dissolution.  $\times 80$ . (c) Weld region (dendritic type), flange (left top) and pipe (left bottom), showing corrosion attack in flange only.  $\times 120$ .

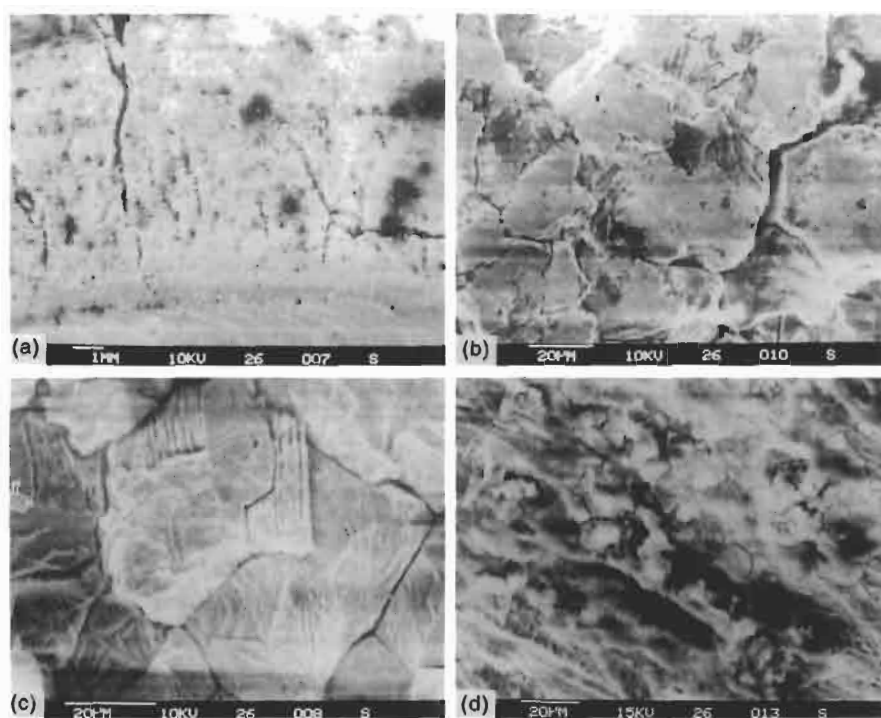
Fig. 8. SEM fractographs of failed sight port flange. (a) Radial cracks starting from the pipe-to-flange interface. (b) Intergranular cracks with grain dissolution. (c) Intergranular cracks with preferential attack along slip bands. (d) Corrosion product ( $\text{Fe}_2\text{O}_3$ ).

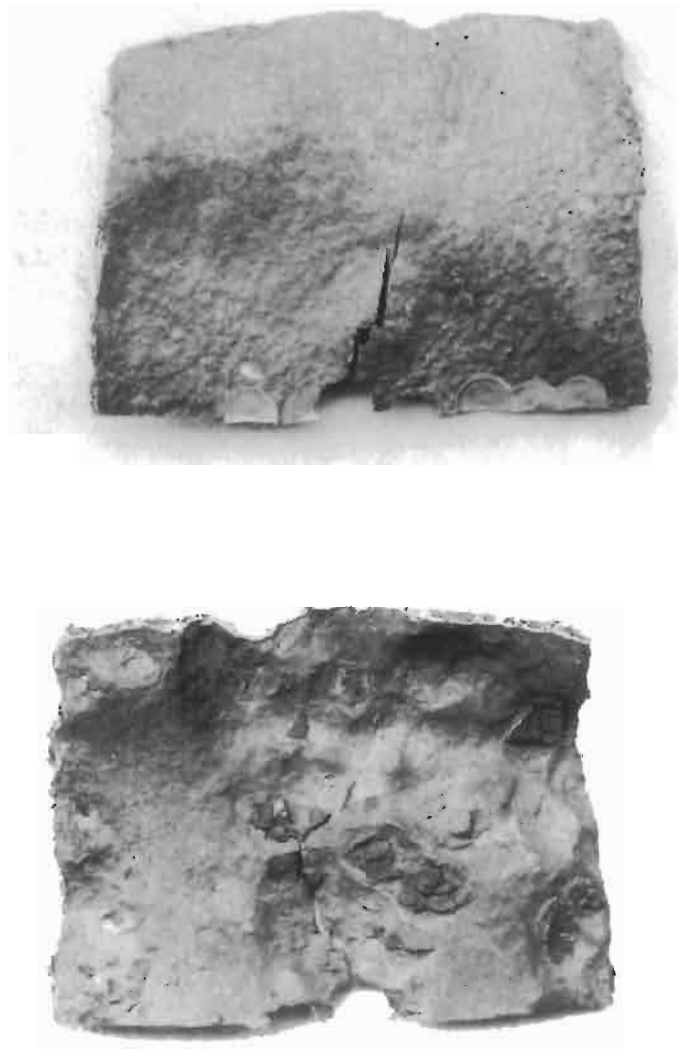
Fig. 3. Appearance of internal and external surfaces of the cracked tube specimen D<sub>2</sub>.

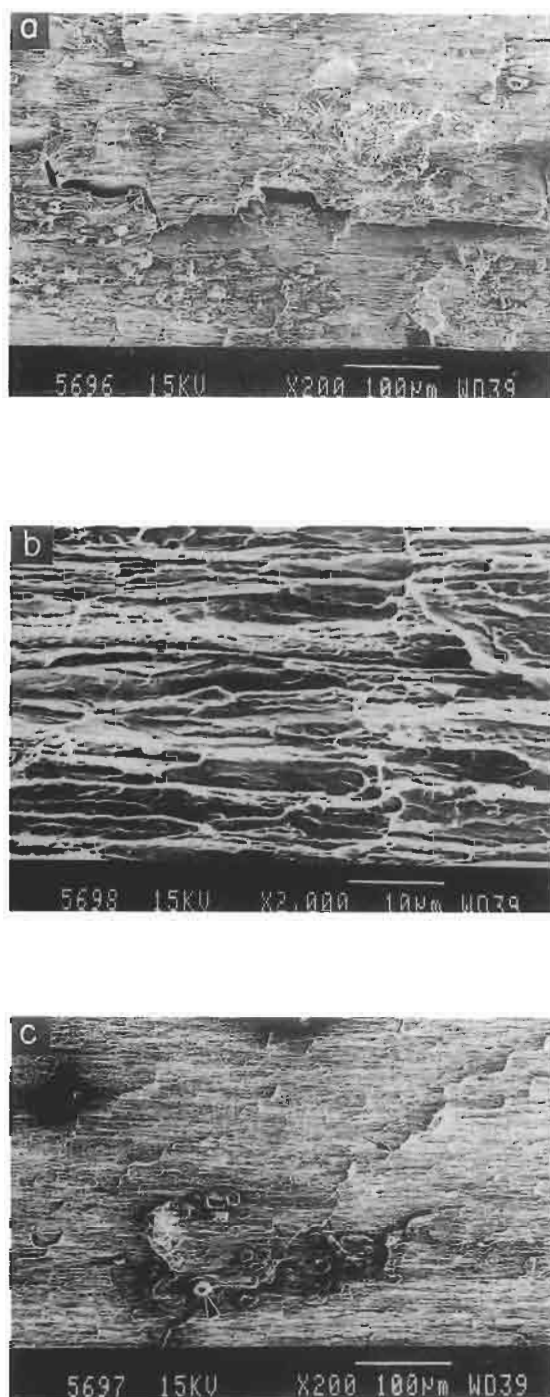
Fig. 5. SEM fractographs of the failed wire samples. (a) Subsurface secondary cracks indicative of hydrogen damage; (b) the fracture features at high magnification appear to correlate well with interlamellar spacing; (c) globule shaped cementite particles segregated in a colony.

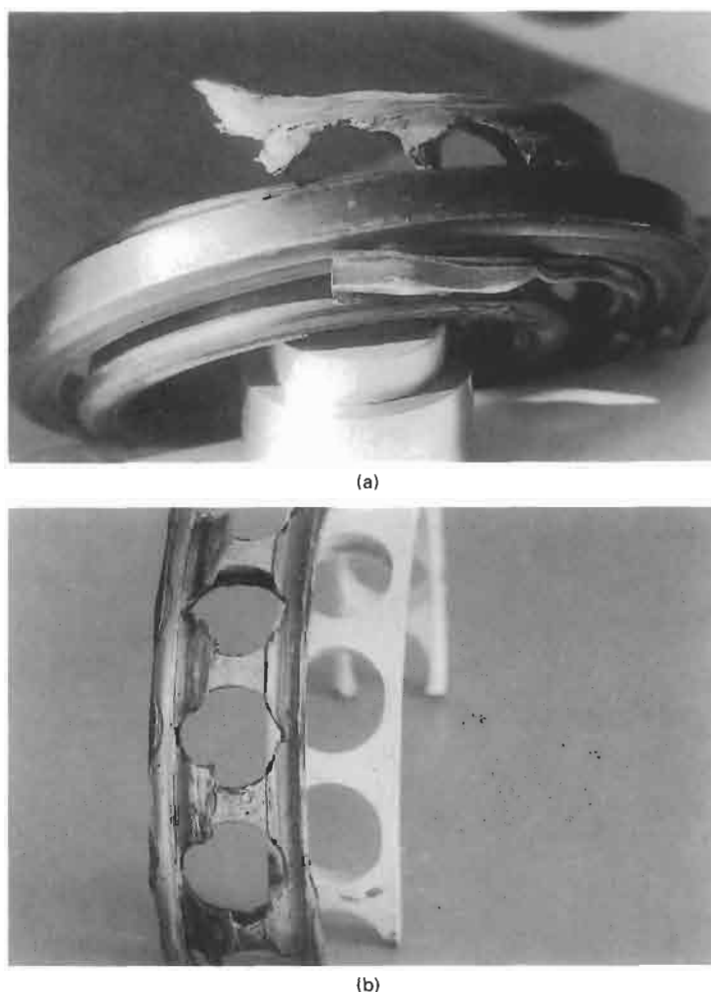
Fig. 3. (a) Probable configuration of bearing components after mishap. (b) Retrieved cage compared with the new one.

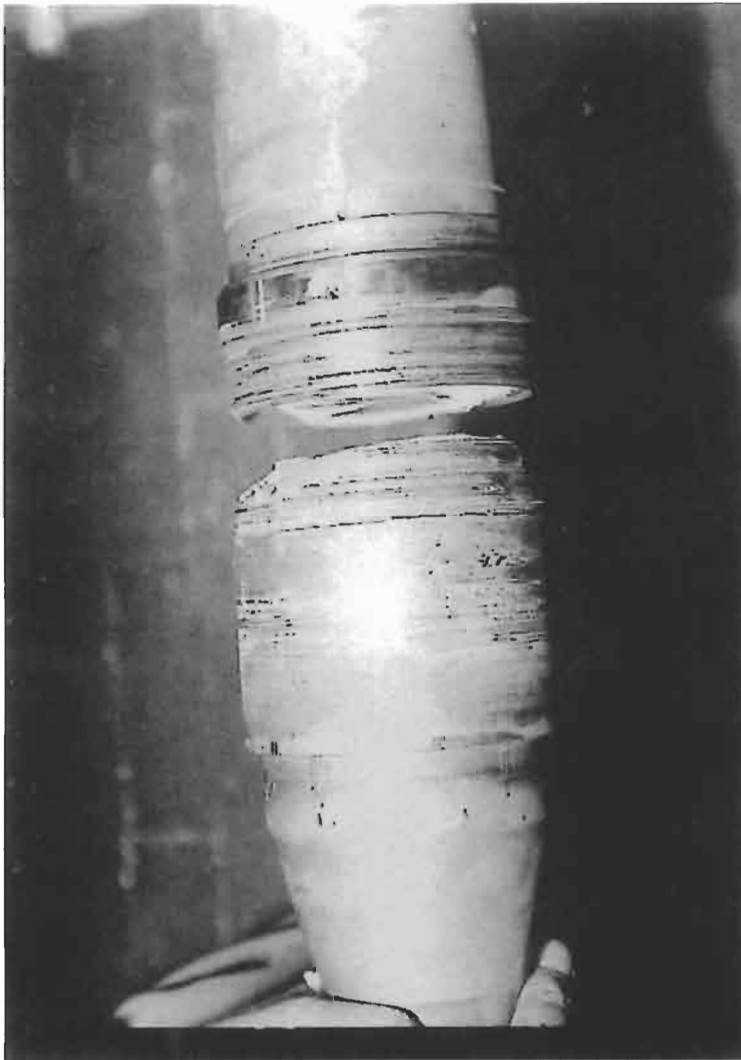
Fig. 2. Photograph of the failed shaft and chromium-plated sleeve.
