# Failures Related to Hot Forming Processes

Dick Douglas, Forging Consultant  
Charles V. White, Kettering University  
Tim McHenry, Collins Aerospace

## Introduction to Failures Related to Hot Forming Processes

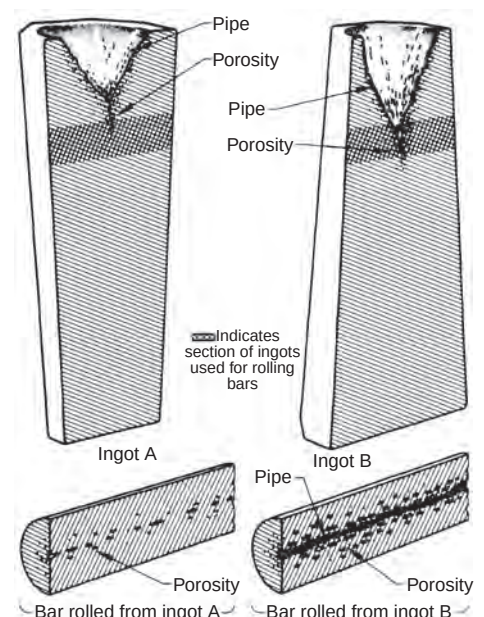
Subsurface and core discontinuities may also occur. Subsurface flaws often (but not always) originate from the as-cast ingot due to shrinkage, voids, and porosity that form during solidification. Figure 1 illustrates how rolled bar may contain porosity and pipe imperfections carried over from the cast ingot. These imperfections can serve as sites for crack initiation during fabrication or in service.

**Fig. 1** Longitudinal sections of two types of ingots showing typical pipe and porosity. When the ingots are rolled into bars, these flaws become elongated throughout the center of the bars.

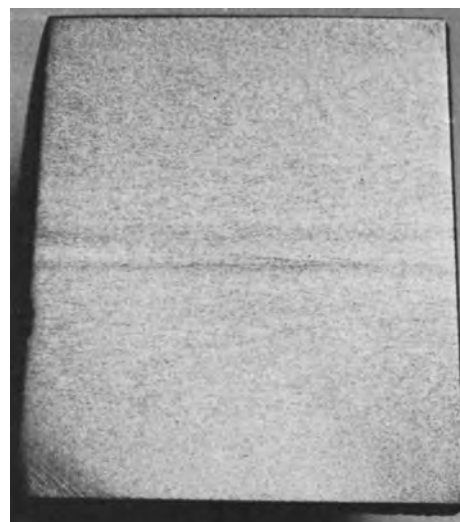
A certain degree of alloy segregation exists in all wrought products, and hot working can alleviate some of the inhomogeneity. However, if the ingot is badly segregated, hot working just tends to alter the shape of the segregation region into a banded structure. Figure 2 shows banding from a carbon-rich

**Fig. 2** Longitudinal section through a hot rolled 1041 steel bar showing a carbon-rich centerline (dark horizontal bands) that resulted from segregation in the ingot. Picral etch. Original magnification: 3 $\times$ . Courtesy of J.R. Kilpatrick

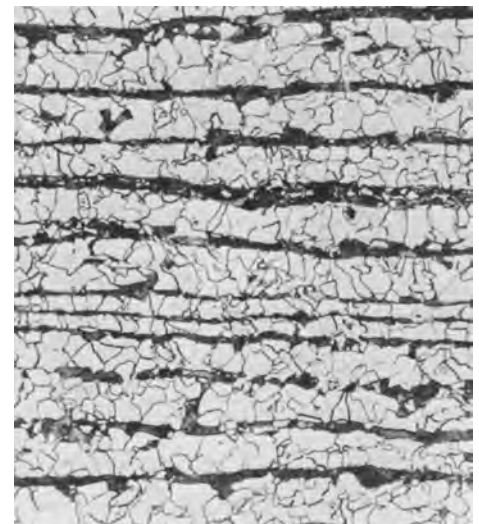
centerline condition in a hot rolled 1041 steel. Figure 3 shows an extreme example of banding in a hot rolled plain carbon steel (1022) in which alternate layers of ferrite and pearlite have formed along the rolling direction. The relationship between increasing percentages of reduction by hot rolling and the intensity of banding in type 430 stainless steel is demonstrated by Fig. 4.

**Fig. 3** Hot rolled 1022 steel showing severe banding. Bands of pearlite (dark) and ferrite were caused by segregation of carbon and other elements during solidification and later decomposition of austenite. Nital etch. Original magnification: 250 $\times$ . Courtesy of J.R. Kilpatrick

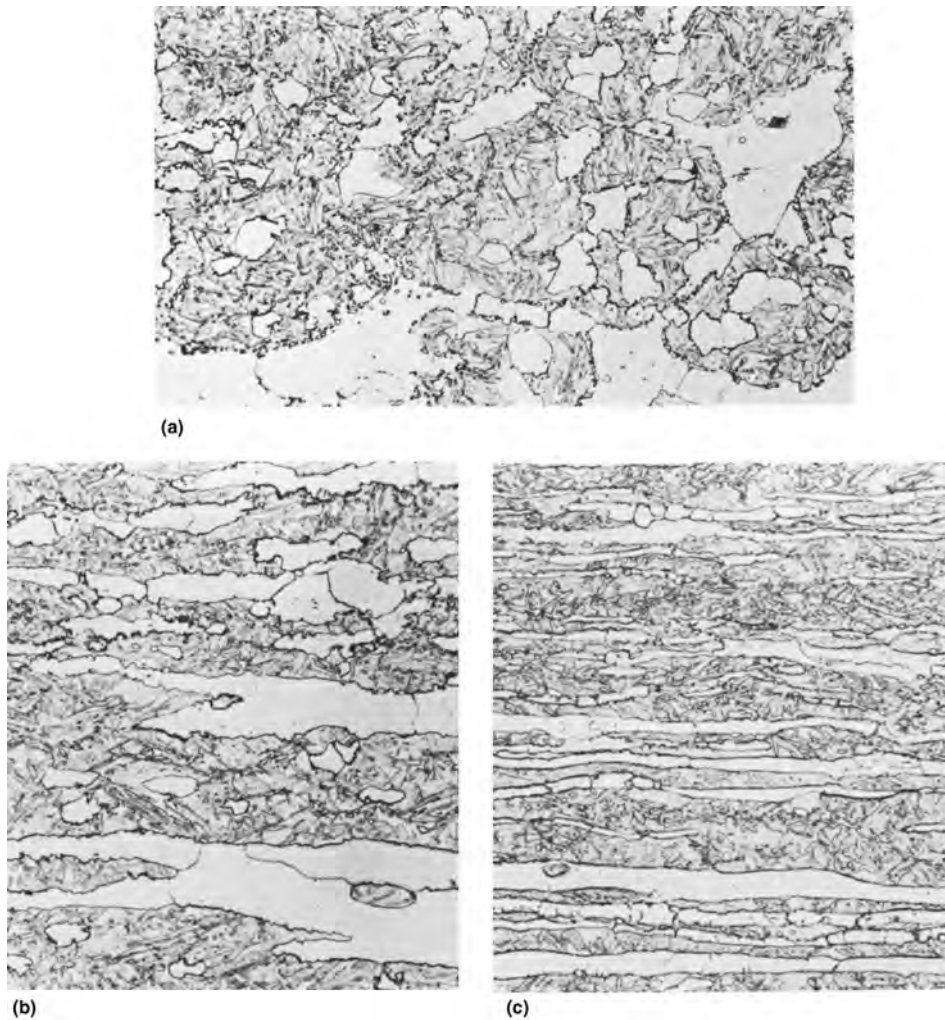
**Fig. 4** Type 430 stainless steel hot rolled to various percentages of reduction showing development of a banded structure consisting of alternate layers of ferrite (light) and martensite (dark) as the amount of hot work is increased. (a) 63% reduction. (b) 81% reduction. (c) 94% reduction. Etched with 55 mL 35% HCl, 1 to 2 g potassium metabisulfite, 275 mL H<sub>2</sub>O (Beraha's tint reagent No. 2). Original magnification: 500×

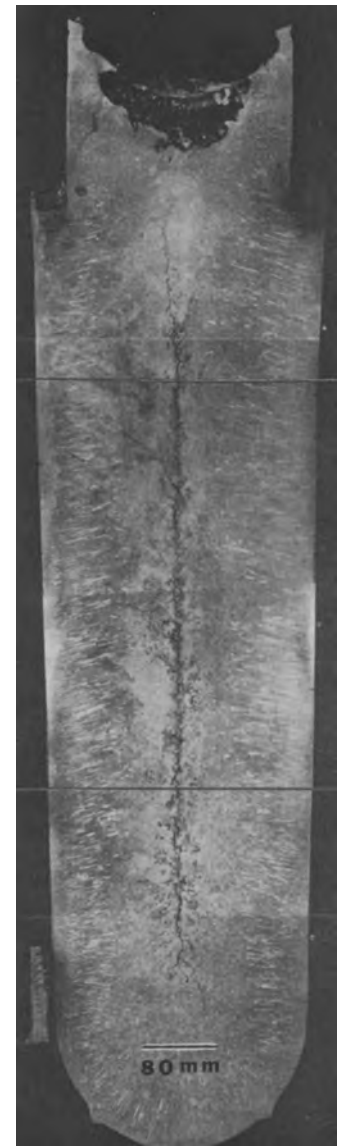
In addition to the primary pipe near the top of the ingot, secondary regions of piping and centerline shrinkage may extend deeper into an ingot (Fig. 5). Primary piping is generally an economic concern, but if it extends sufficiently deep into the ingot body and goes undetected, it can eventually result in a defective product. Detection of the pipe can be obscured in some cases if bridging has occurred.

**Fig. 5** Longitudinal section through an ingot showing extensive centerline shrinkage

Piping can be reduced by pouring ingots with the big end up, providing risers in the ingot top, and applying sufficient hot-top material (insulating refractories or exothermic materials) immediately after pouring. These techniques extend the time that the metal in the top regions of the ingot remains liquid, thereby minimizing the shrinkage cavity produced in this portion of the ingot. Secondary piping and centerline shrinkage can be very detrimental because they are harder to detect in the mill and may subsequently produce centerline defects in bar and wrought products. Such a material condition may indeed provide the flaw or stress concentrator for a forging burst in some later processing operation or for a future product failure.

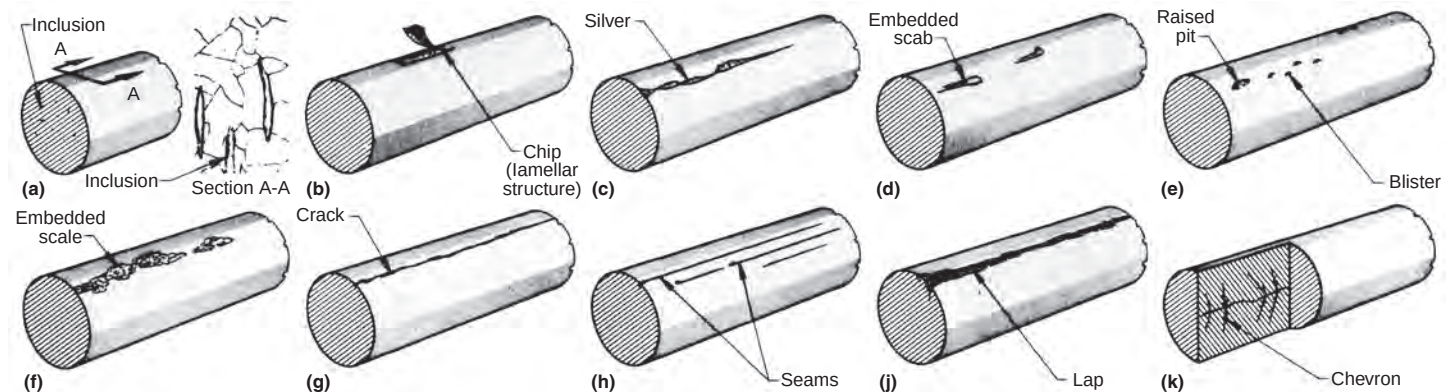
are found with seams. Slivers usually have raised edges, as shown in Fig. 8(c).

Gaseous pockets in the ingot often become pits or blisters on the surface or slightly below the surface of bar products. Pits may also be caused by overpickling to remove scale or rust. Pits and blisters are both illustrated in Fig. 8(e). Embedded scale may result from the rolling or drawing of bars that have become excessively scaled during the prior heating operations. The pattern illustrated in Fig. 8(f) is typical.

Cracks and seams are often confused with each other. Cracks with little or no oxide present on their edges may occur when the metal cools in the mold, setting up highly stressed areas. Seams develop from these cracks during rolling as the reheated outer skin of the billet becomes heavily oxidized, transforms into scale, and flakes off the part during further rolling operations. Cracks also result from highly stressed planes in cold-drawn bars or from improper quenching during heat treatment. Cracks created from these latter two causes show no evidence of oxidized surfaces. A typical crack in a bar is shown in Fig. 8(g).

**Fig. 8** Ten different types of flaws that may be found in rolled bars. (a) Inclusions. (b) Laminations from spatter (entrapped splashes) during the pouring. (c) Slivers. (d) Scabs are caused by splashing liquid metal in the mold. (e) Pits and blisters caused by gaseous pockets in the ingot. (f) Embedded scaled from excessive scaling during prior heating operations. (g) Cracks with little or no oxide present on their edges when the metal cools in the mold, setting up highly stressed areas. (h) Seams that develop from elongated trapped-gas pockets or from cracks during working. (i) Laps when excessive material is squeezed out and turned back into the material. (k) Chevron or internal bursts. See text for additional discussions.

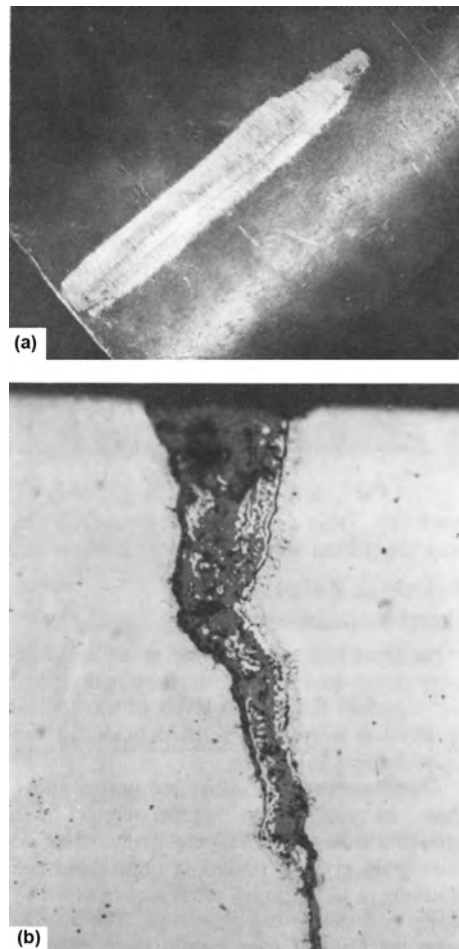
**Fig. 9** Seam in rolled 4130 steel bar. (a) Closeup of seam. Note the linear characteristics of this flaw. (b) Micrograph showing cross section of the bar. Seam is normal to the surface and filled with oxide. Original magnification: 30×

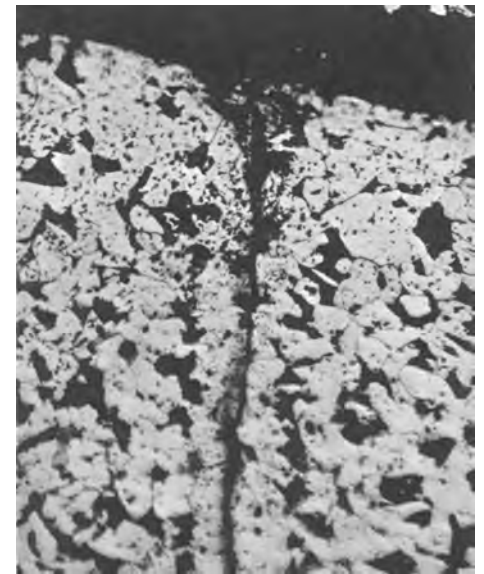
**Fig. 13** Micrograph of a seam in a cross section of a 19 mm (0.75 in.) diameter medium-carbon steel bar showing oxide and decarburization in the seam. Original magnification: 350×

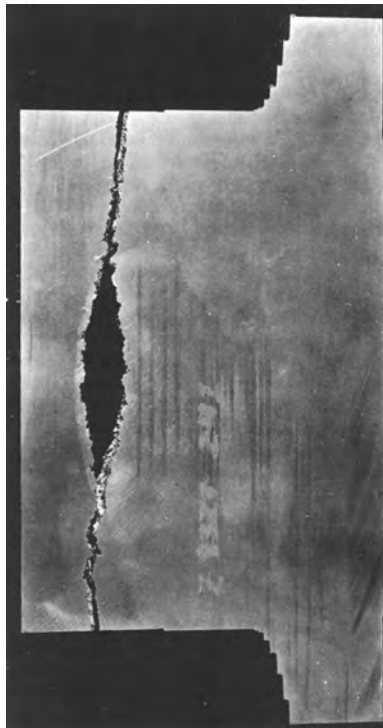
**Fig. 15** Section through a heat-resistant alloy forging showing a central discontinuity that resulted from insufficient homogenization during conversion. Step machining was used to reveal the location of the rupture; original diameter is at right.

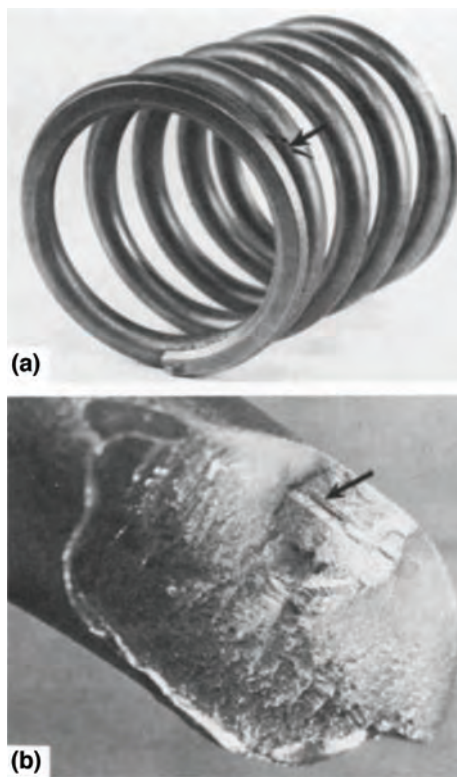
**Fig. 1** Valve-spring failure due to residual shrinkage during solidification. (a) Macrograph showing fracture, as indicated by arrow. (b) Fracture surface; pipe is indicated by arrow. Source: Ref 4

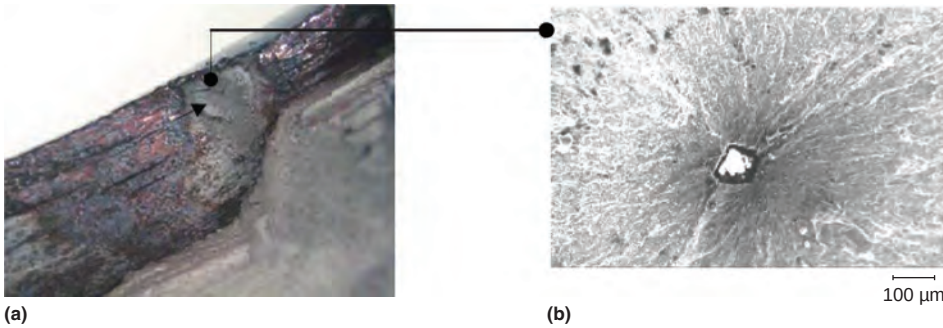
**Fig. 2** (a) Fatigue fracture surface of a coil spring that failed prematurely due to a subsurface inclusion; (b) as shown with SEM imaging

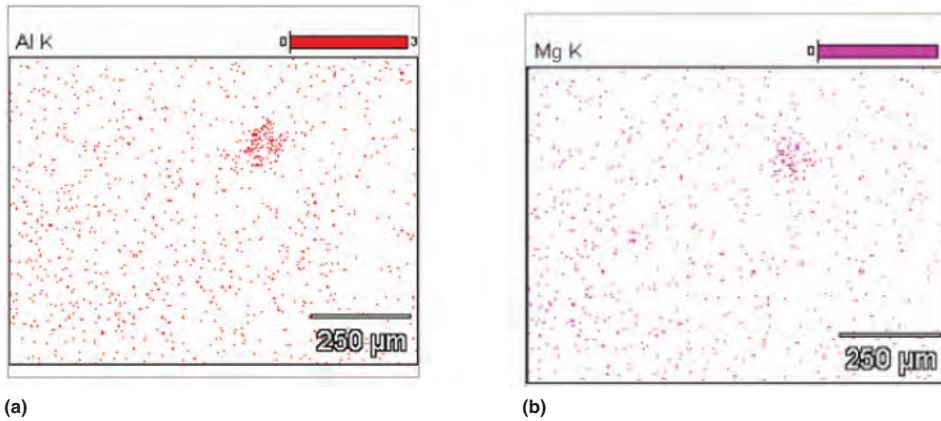
**Fig. 3** EDS results showing the inclusion is comprised of (a) aluminum and (b) magnesium. Scan was taken from the image in Fig. 2(b)

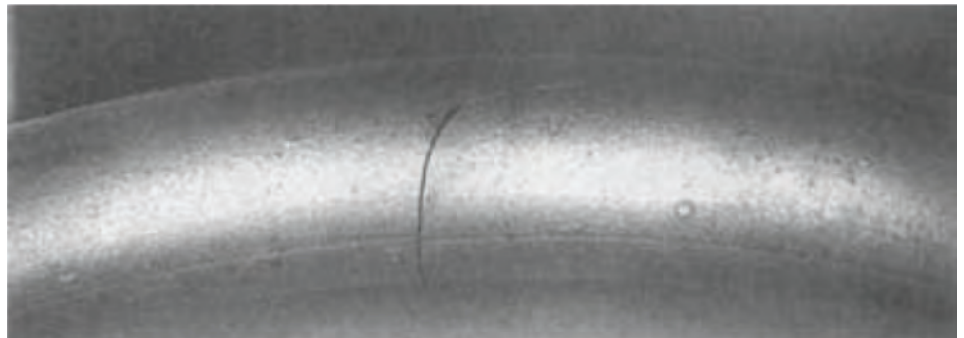
**Fig. 10** A fatigue crack on a second helical spring at a similar location as shown in Fig. 9

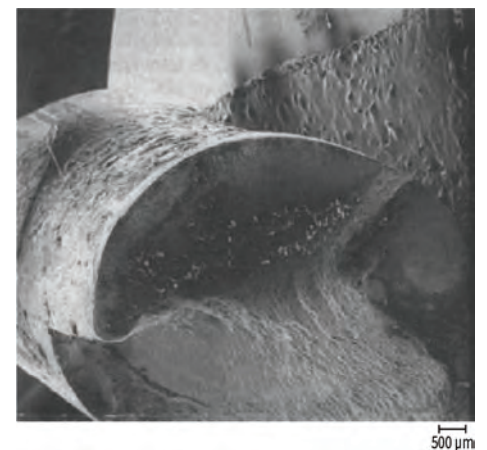
**Fig. 11** The fatigue crack area (top) and overload location (below) with some minor corrosion residue

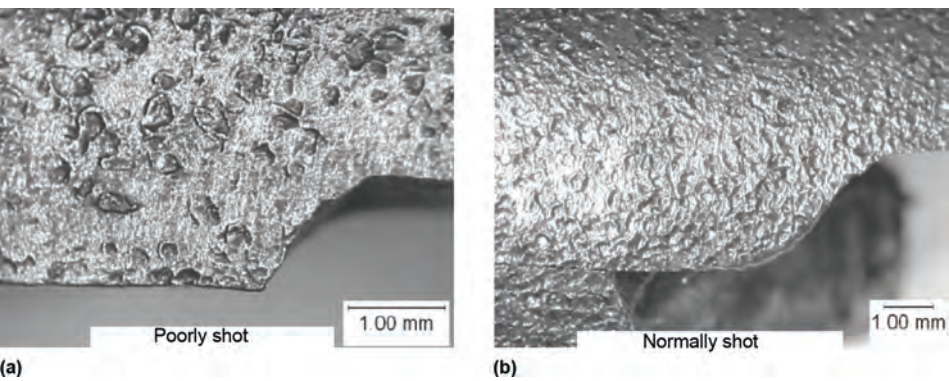
Fig. 12 Surface imperfections caused by (a) poor shot peening conditions that resulted in deep imperfections compared with (b) normal peening conditions

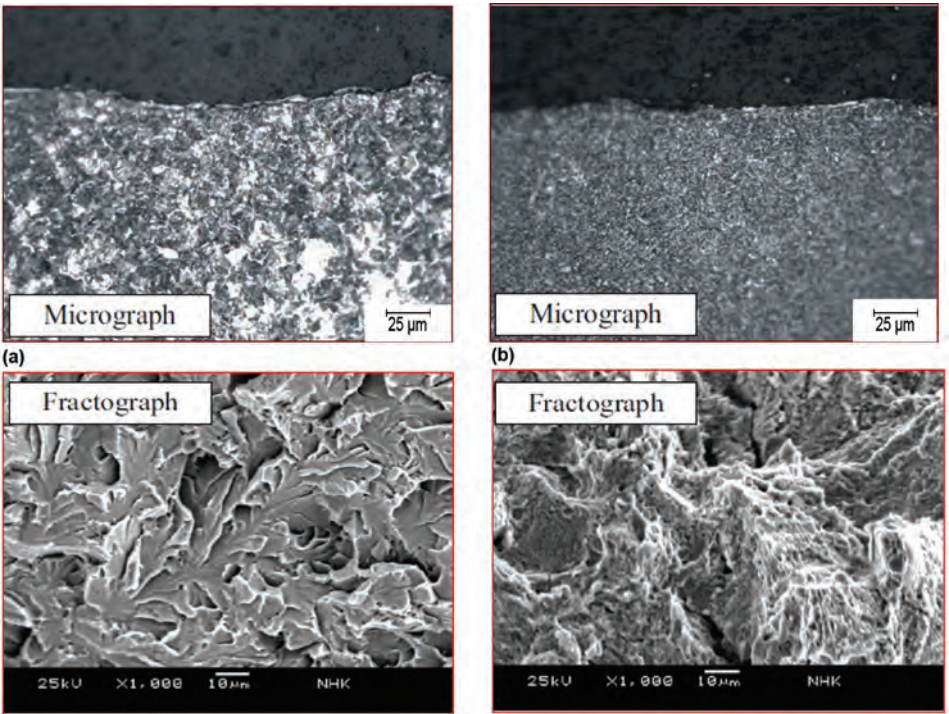
Fig. 13 (a) Improperly heat treated spring vs. (b) properly heat treated spring (tempered martensite) and the resulting fracture surface morphologies

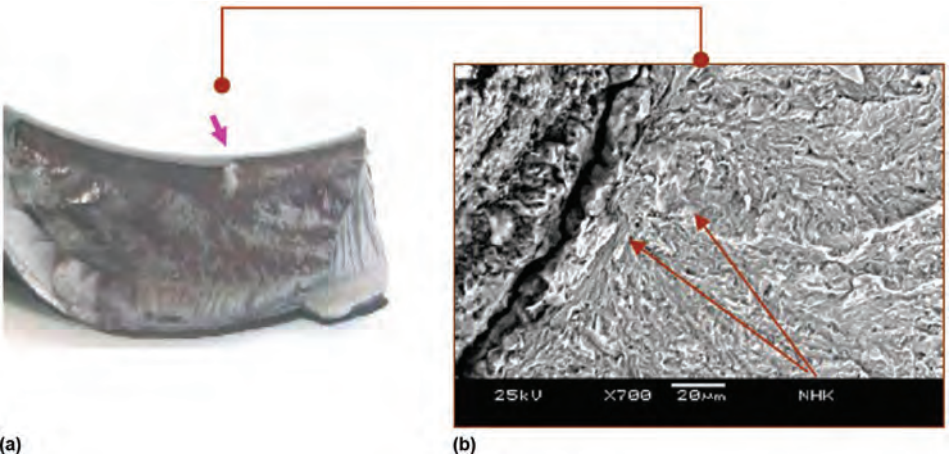
Fig. 14 (a) Fracture surface and (b) SEM fractography of a coil that failed due to excessive decarburization

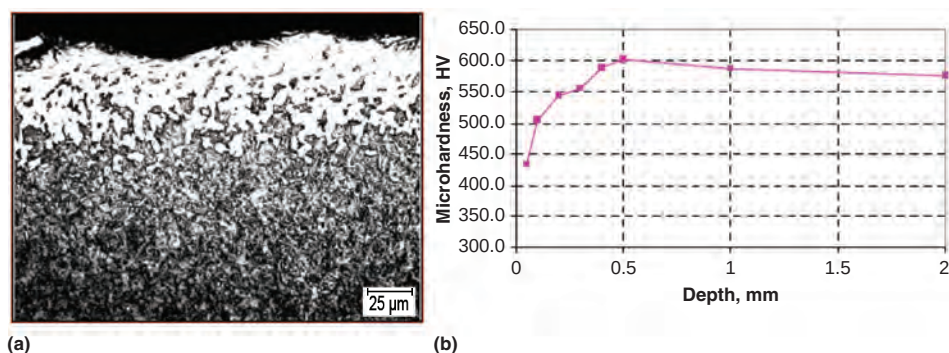
Fig. 15 Cross-sectional metallographic image of the (a) fractured coil and (b) microhardness profile near the surface

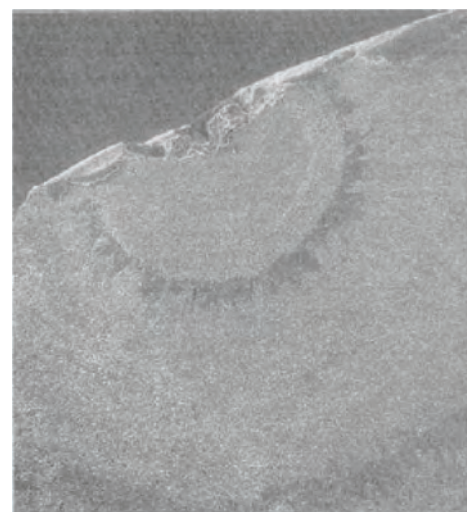
Fig. 16 Optical photograph of the fatigue region of a stainless steel compression spring that failed due to corrosion fatigue. Note beach marks on the fracture

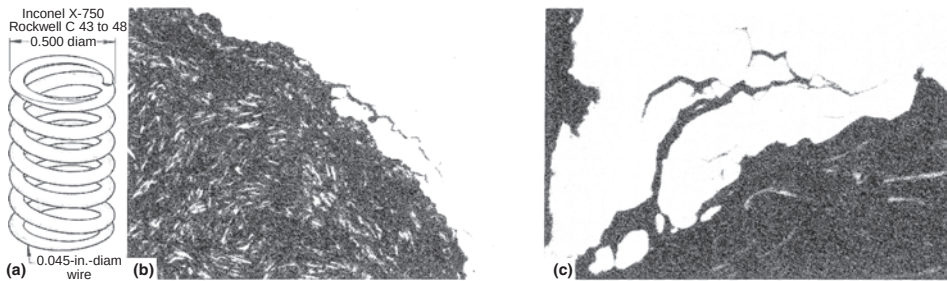
**Fig. 17** Inconel X-750 spring that failed by stress-corrosion cracking. (a) Configuration and dimensions (given in inches) of the spring. (b) and (c) Unetched longitudinal sections showing intergranular cracking. Magnification: 100× and 500×, respectively

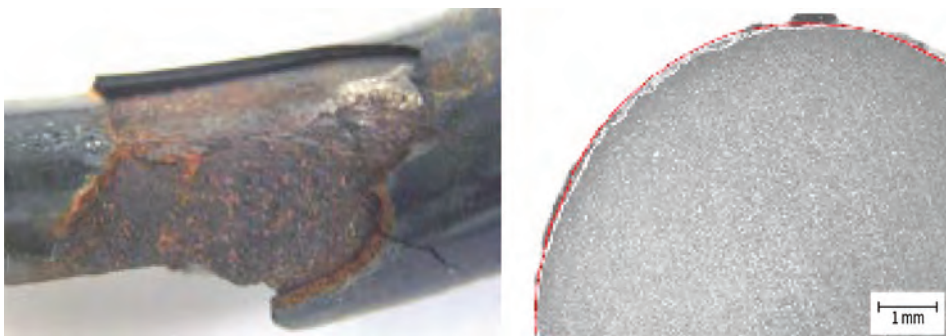
**Fig. 18** Automotive coil spring that fractured due to corrosion

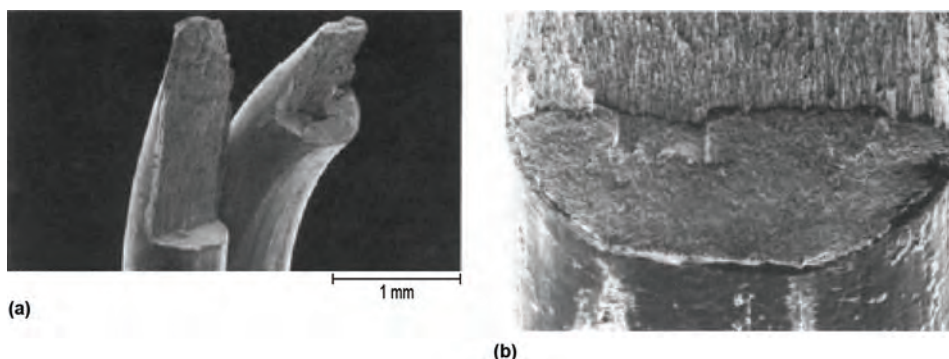
Fig. 20 SEM micrographs showing a rub mark at the fatigue origin, magnification 30×

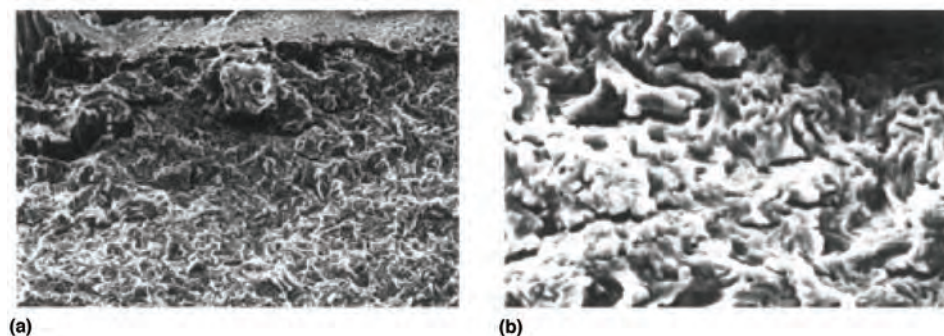
Fig. 22 SEM micrographs showing the fatigue portion of the fracture surface

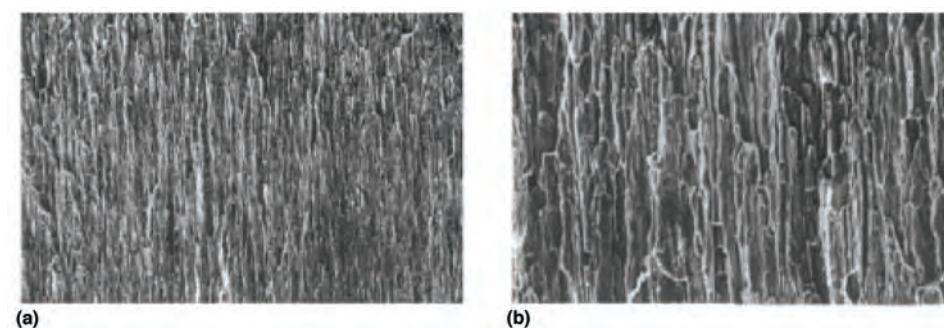
Fig. 23 SEM micrographs of the overload fracture showing a typical woody fracture appearance

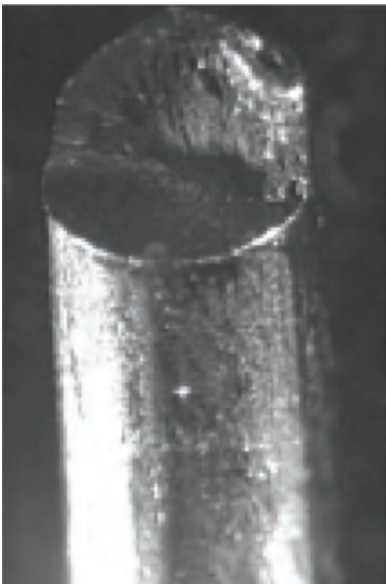
**Fig. 24** Photograph of helical compressor spring failure that occurred three active turns from the bottom. The failure origin was on the inside diameter of the spring

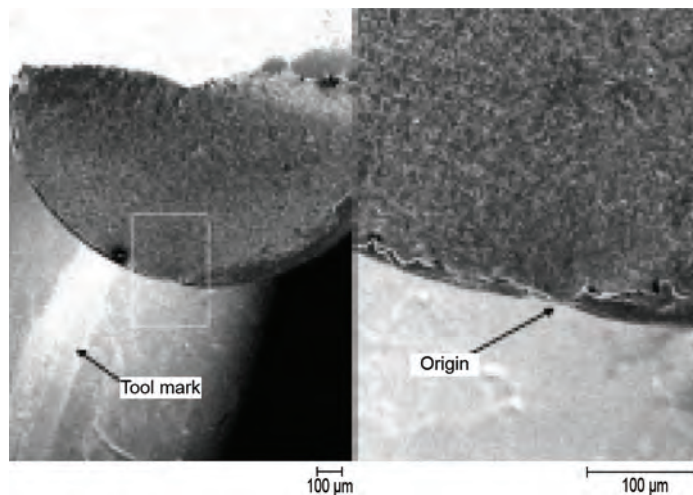
**Fig. 25** Scanning electron photograph showing the failure origin relative to the tool mark as a result of forming the spring. No internal material defect was found near the failure origin

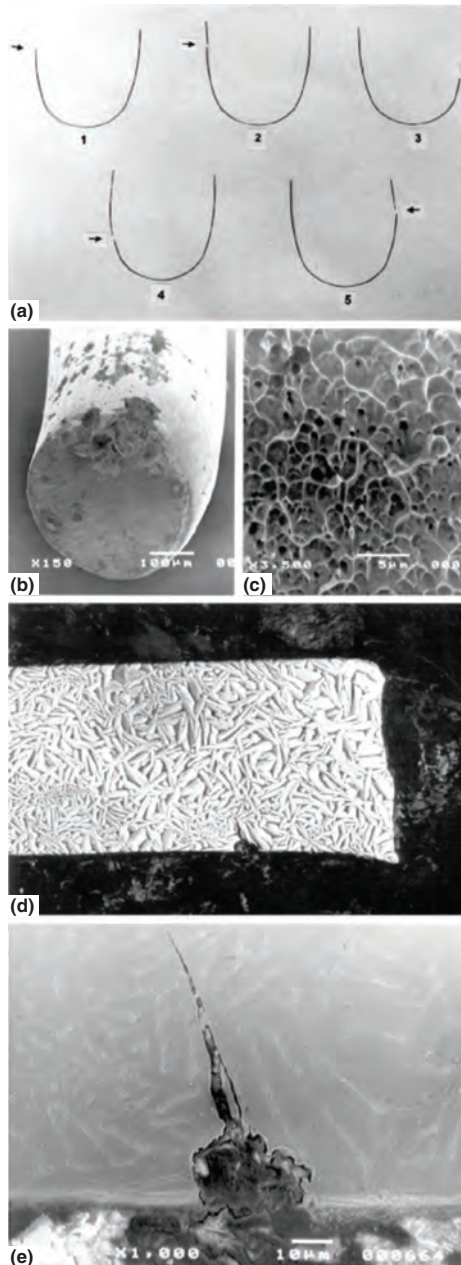
**Fig. 26** (a) Nitinol wires. (b) General view of the fracture surface showing surface defects and massive corrosion, magnification 150 $\times$ . (c) Detail of the fracture surface showing a ductile fracture, magnification 3500 $\times$ . (d) Acicular microstructure and the progression of lateral cracking. (e) Detail of the lateral cracking, magnification 1000 $\times$

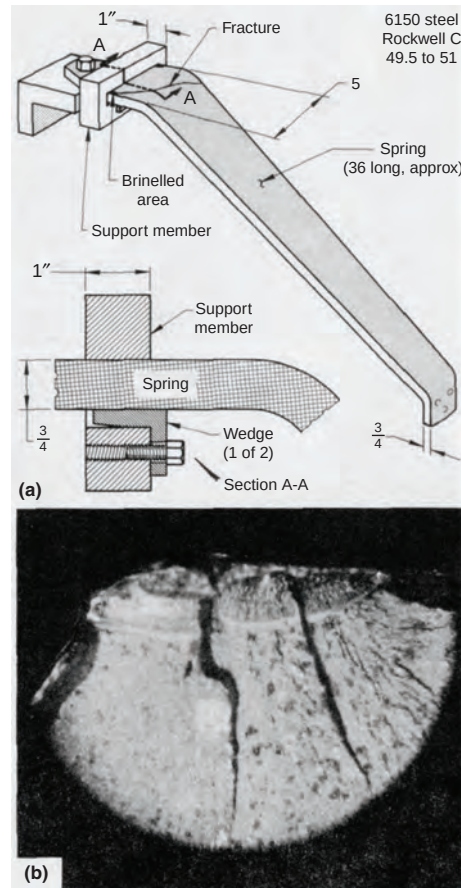
**Fig. 35** Landing-gear spring, 6150 steel, that broke during a hard landing. (a) Configuration and dimensions (given in inches) of the spring. (b) Fractograph showing fatigue crack that initiated the brittle fracture; magnification, 7 $\times$

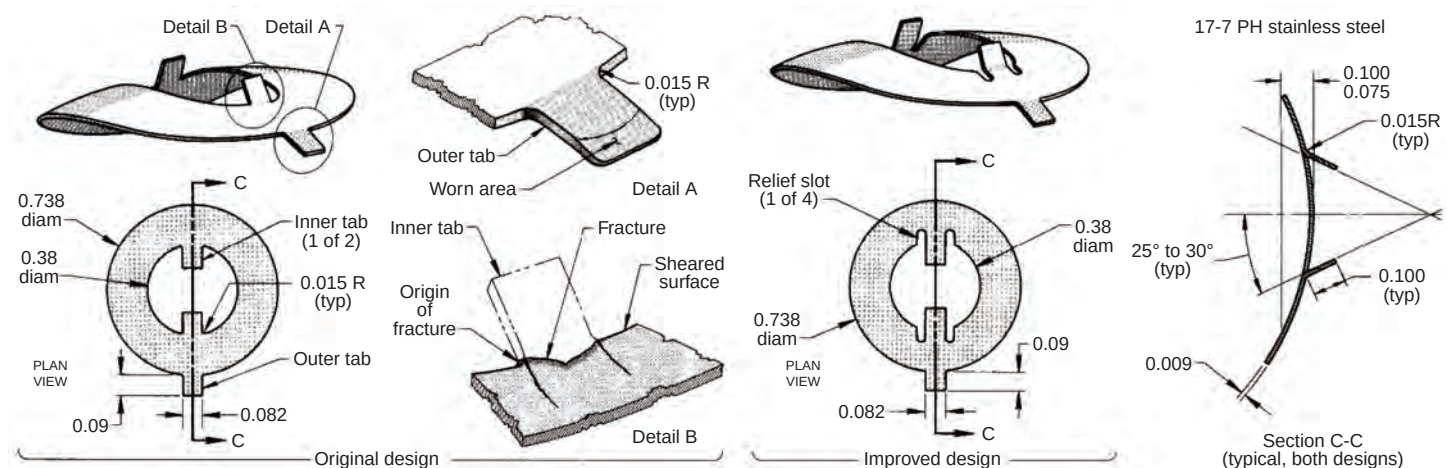
**Fig. 36** Original and improved designs of a 17-7 PH stainless steel valve-seat retainer spring. As originally designed, the inner tabs on the spring broke off as a result of fatigue, and the outer tab exhibited wear

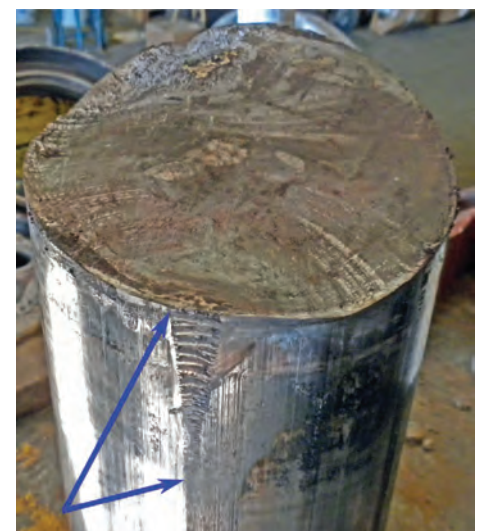
**Fig. 3** Initiation site of fracture surface is indicated by larger blue arrow. Beginning of galling damage is indicated by smaller blue arrow

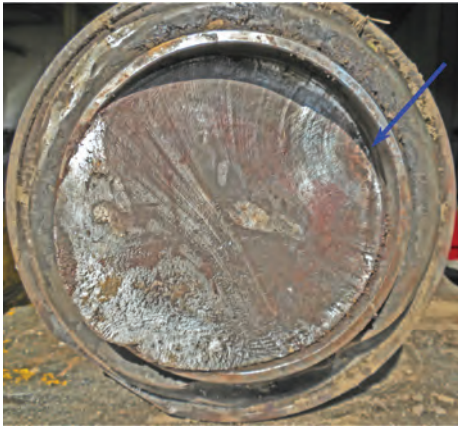
**Fig. 4** Initiation site of axle 1, indicated by blue arrow, bearing side of journal

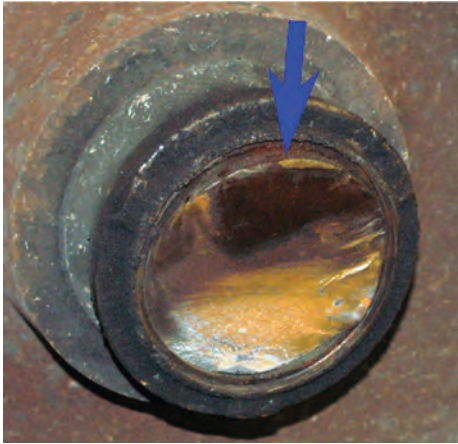
**Fig. 5** Axle 1 wheel and backing ring in place. Arrow indicates fracture-initiation site

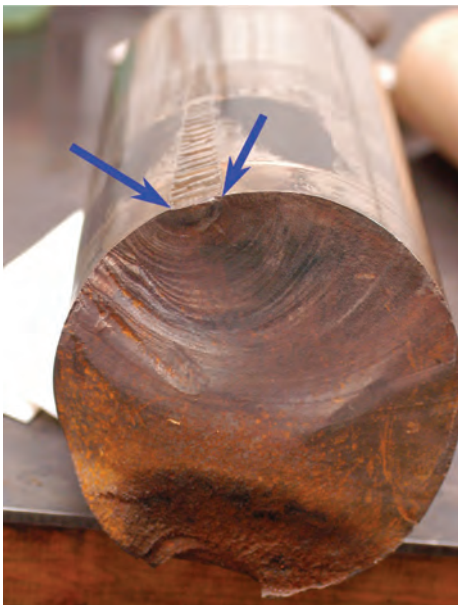
**Fig. 6** Derailment 2. Arrows indicate boundary of galling damage and fracture-initiation location

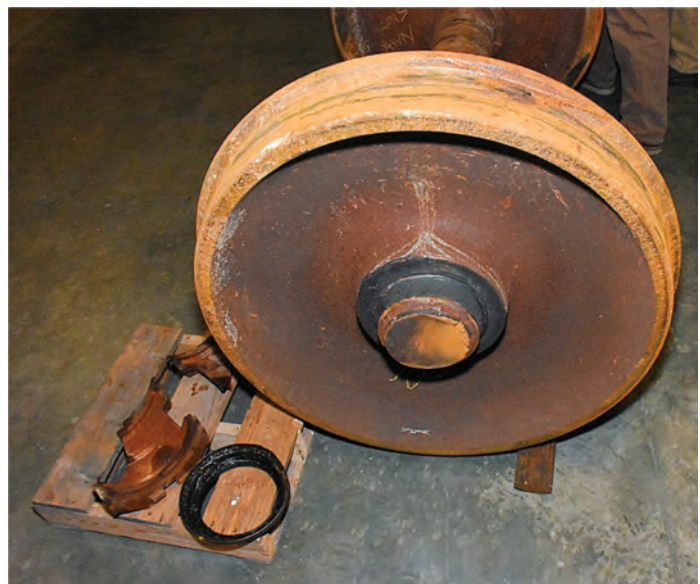
Fig. 11 As-received axle showing fracture surface

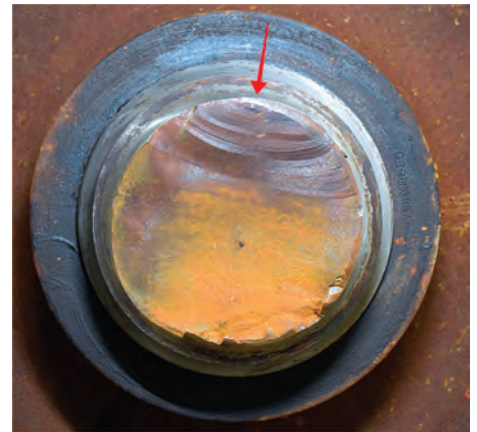
**Fig. 14** Fracture surface of subject journal, axle side (arrow indicates initiation location)

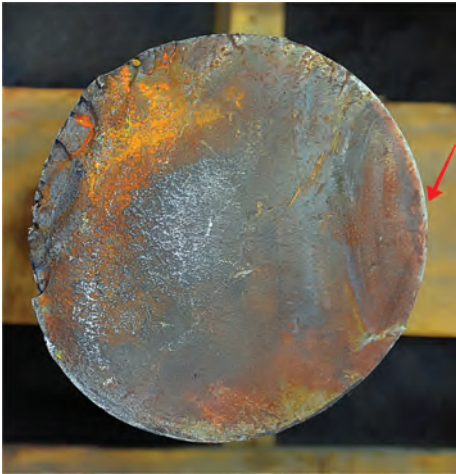
**Fig. 15** Fracture surface of subject journal, bearing side (arrow indicates initiation location)

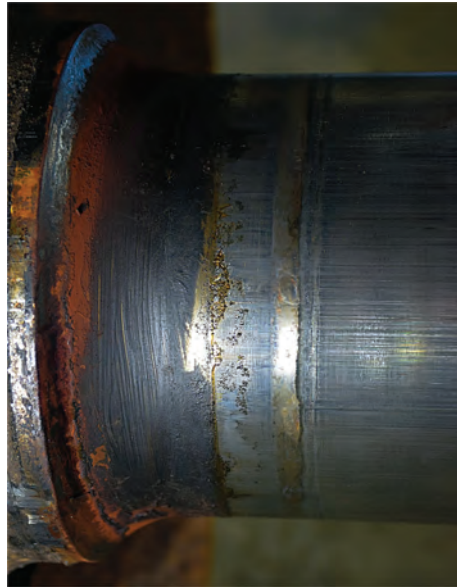
**Fig. 17** Close-up view of mate journal. Left side of image is dust guard, then Tectyl-covered fillet, transitioning to seal wear ring area. Corrosion pits visible on journal diameter onto fillet

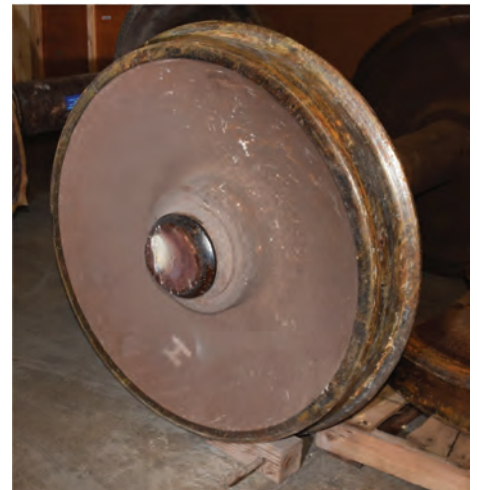
**Fig. 27** Overall view of failed axle journal. The locking plate data are stamped on both bearings to provide information to the bearing installer as to whether the bearing is new or reconditioned, including the month and year of installation. In this case, it was found that the bearing had been installed in new condition in December 1990 by Trinity 54 in Dallas, Texas. These notations are shown in Fig. 31

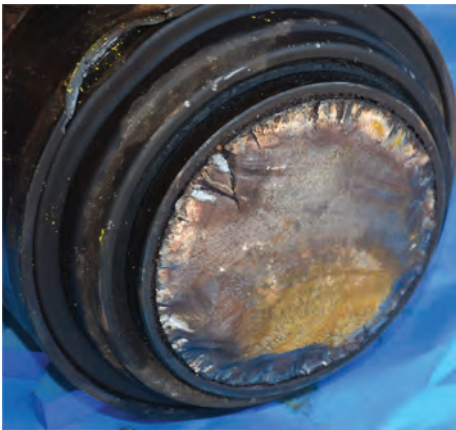
**Fig. 30** Fractured axle journal within bearing. The end cap was removed from the failed side. A noticeable amount of red rust was present on the interior of the end cap, as seen in Fig. 32. The journal stub was pressed out of the bearing. Present on the end of the journal was the axle fabrication data, shown in Fig. 33. The axle was manufactured by Standard Forged Products, McKees Rocks Forgings of McKees Rocks, Pennsylvania, in June 1990

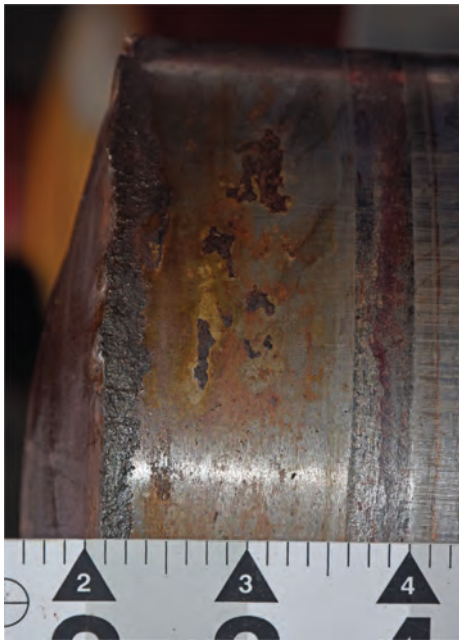
**Fig. 35** Side view of axle stub, with fracture on left, showing heavy buildup and groove from seal wear ring

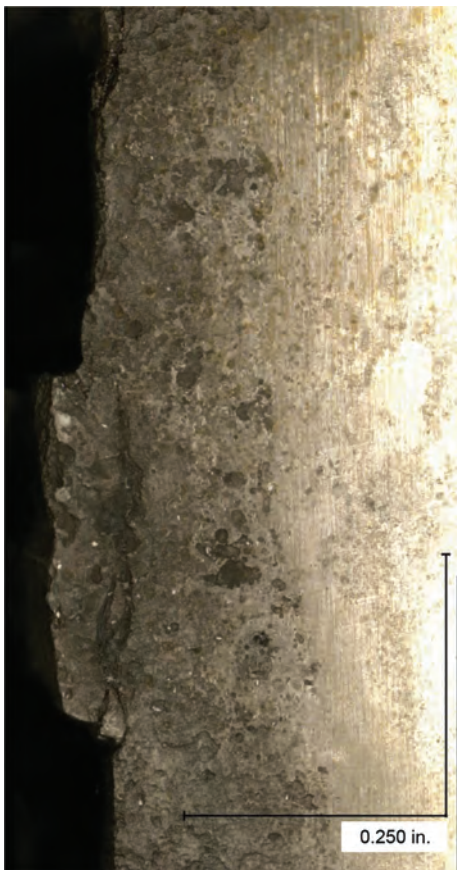
**Fig. 36** Overall view of pitting near fracture surface

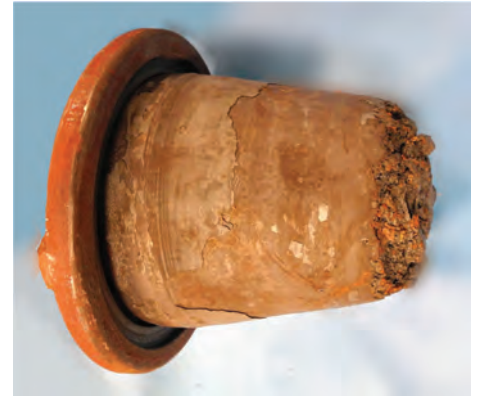
**Fig. 41** Burned-off journal stub. The short, rough stub indicates high heat over a short time period and is associated with an inner cone failure

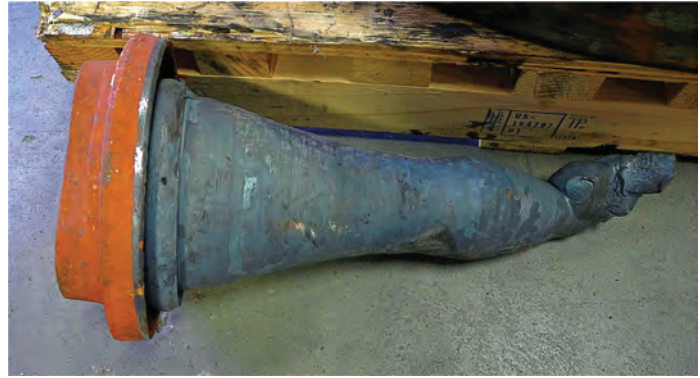
**Fig. 42** Burned-off journal stub. The long, thinned-out journal indicates that the bearing was hot over a long time period and is associated with an outer cone failure

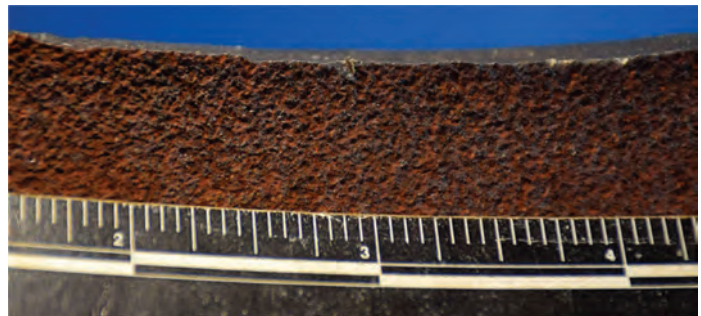
**Fig. 55** Plate surface condition around the fracture-initiation locations. No evidence of a plate strike was present

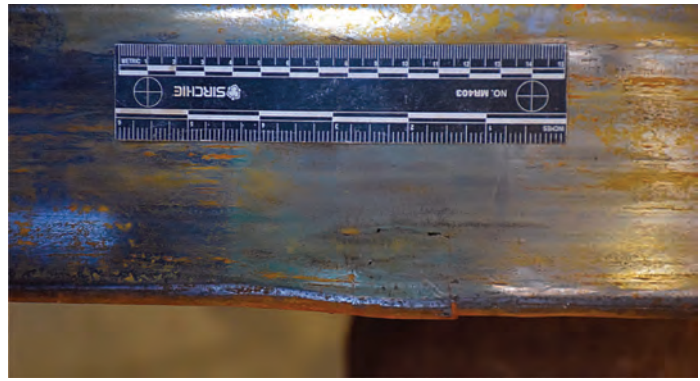
**Fig. 65** Top view of damage to area 1 from Fig. 63

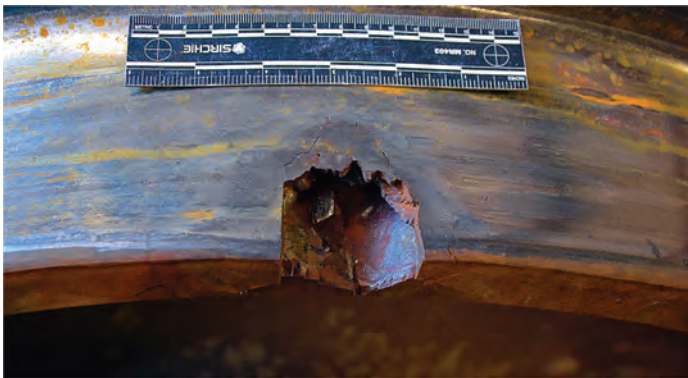
**Fig. 66** Top isometric view of damage to area 2 from Fig. 63

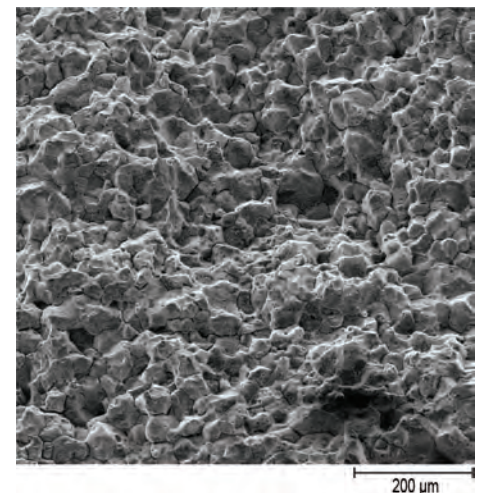
**Fig. 84** Intergranular cracking indicative of thermal cracking. Original magnification: 200×

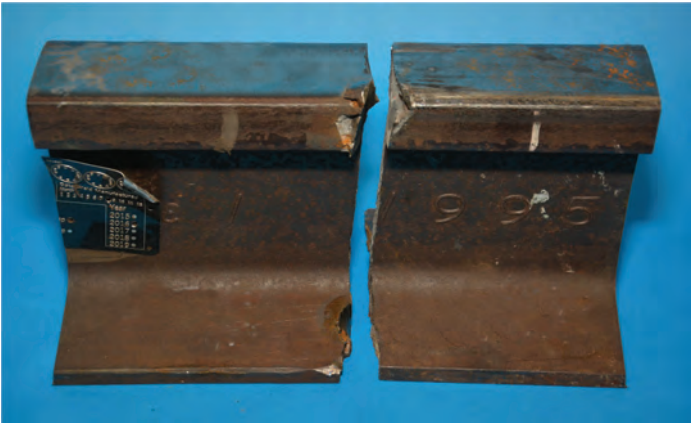
Fig. 93 Mating fracture surfaces with thumbnail fatigue fracture from field-side corner of rail head. Black tag is a partial record of rail weld not included

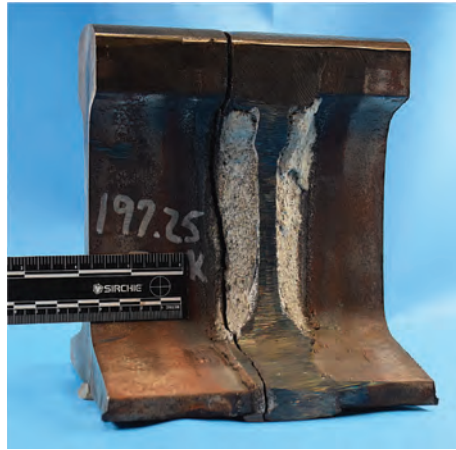
**Fig. 97** Overall view of failed weld in the as-received condition

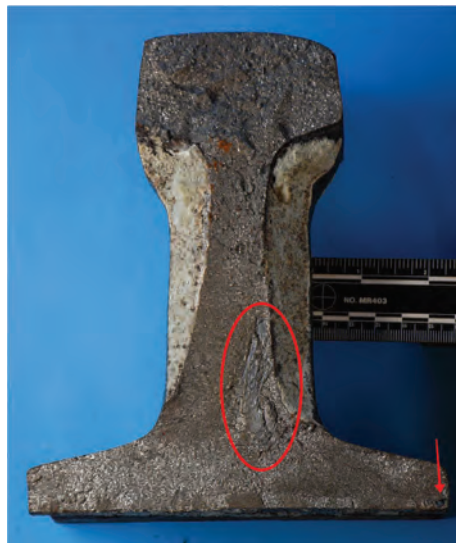
**Fig. 99** Rail fracture surface. Circle indicates fracture initiation, and arrow indicates void

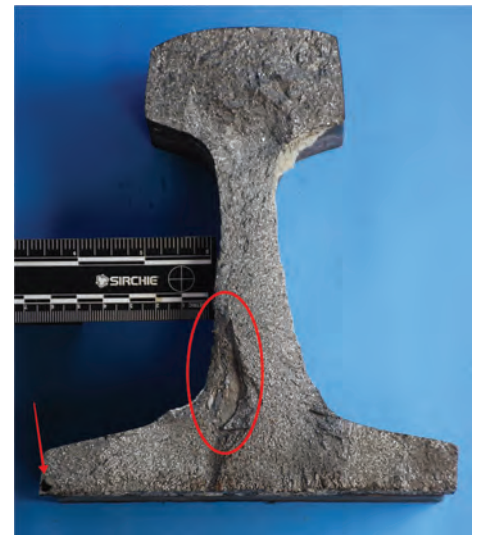
**Fig. 100** Mate fracture surface. Circle indicates fracture initiation, and arrow indicates void

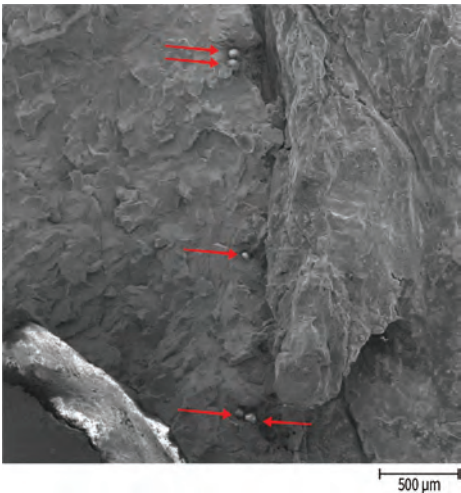
**Fig. 104** Scanning electron micrograph. Arrows indicate the presence of round inclusions. Original magnification: 55×

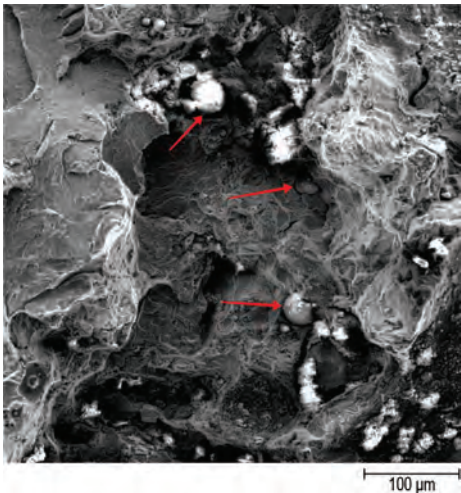
**Fig. 105** Closeup of fracture-surface defect. Arrows indicate spherical inclusions. Original magnification: 300×

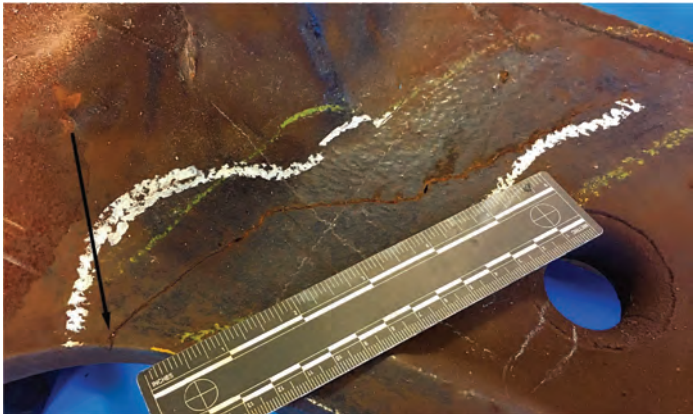
**Fig. 114** Closer view of crack in beam. Arrow indicates the general area of initiation

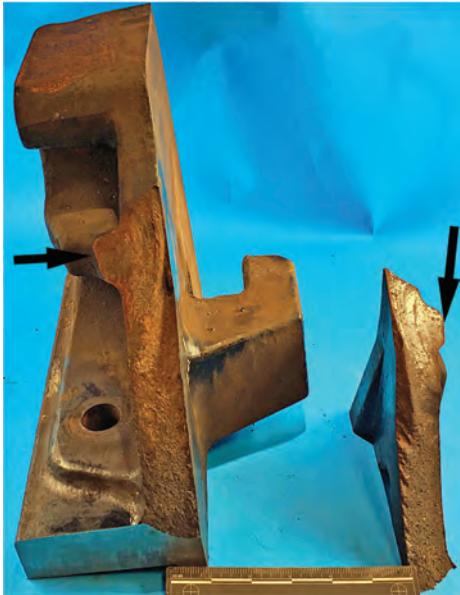
**Fig. 115** Fracture surface opened. Black arrows correspond to crack-initiation sites on the mating fracture surfaces
