# Failure Case Studies

## Steel Structures

Forensic Engineering Division

the Forensic Engineering Division of the  
American Society of Civil Engineers

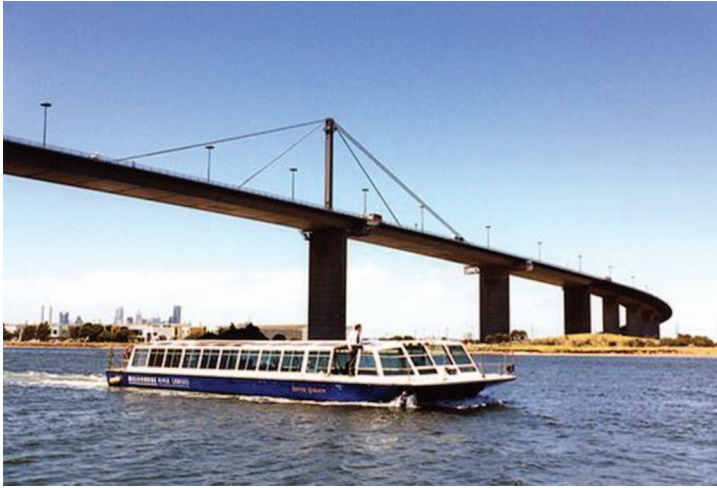
The collapse occurred on October 15, 1970, while the bridge was still under construction. A half-span of the bridge had been assembled on the ground. When it was raised into position, it was discovered that the camber of the new half-span was about 114 mm (4.5 in.) out of alignment compared to the camber of the previous half-span to which it was to be attached ([West Gate Bridge Royal Commission 1971](#)). To force the camber to match and allow the new span to be attached, seven 8-ton concrete blocks, known as kentledge, were used to load down the new half-span and remove the camber difference. This large load caused one of the inner upper panels of the bridge to buckle, and an 88.9 mm (3.5 in)

*Figure 1-1. Photo of the West Gate Bridge, Melbourne, Australia, taken on February 15, 2006.*

The Royal Commission of Inquiry placed most of the blame for the collapse on the design engineer, but also found fault with the contractor. The design engineer was found to have failed to design the bridge to have a great enough margin of safety both during erection and when it was to be put into service. In addition, the design engineer did not properly check the safety of the erection proposals put forth by the contractor ([West Gate Bridge Royal Commission 1971](#)). The fact that the design engineer was located halfway around the world, in London, further complicated matters. The contractor was found to have not recognized the need to exercise special care required to implement its unusual erection plan for constructing the half-spans separately before attempting to connect them after raising them into position ([West Gate Bridge Royal Commission 1971](#)). The contractor at the time of the collapse came onto the project part

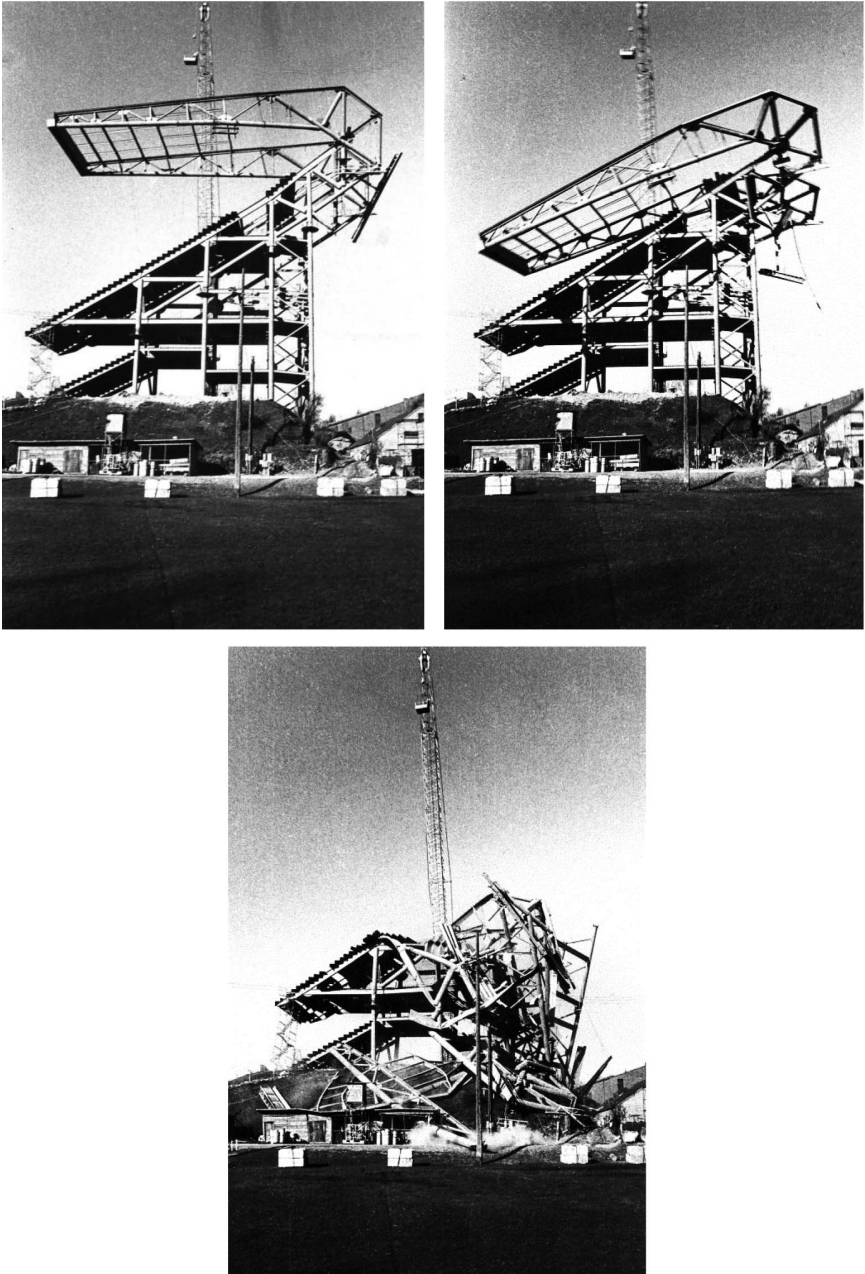
Fortunately, there was sufficient warning that this collapse was imminent. About an hour before the collapse, a construction worker observed that a structural steel member was beginning to buckle. If not for this report and the actions of an alert construction superintendent in clearing the construction site, there would certainly have been serious injuries and fatalities. The collapse sequence was recorded by an accomplished Seattle architectural photographer, John Stamets, who just happened to be in the vicinity at the time (Figure 2-1).

Inadequate temporary support was clearly the cause of this failure. There was no indication of either wind or seismic disturbance. However, lateral loads were not necessary to cause this collapse. Without bracing, a cantilevered structure of this configuration is unstable under gravity loads alone. Forensic investigations concluded that there was no evidence of design defect. Investigators blamed an incomplete system of temporary guying cables. Some stabilizing cables had reportedly been removed on the morning of the collapse to facilitate the progress of the steel erection.

*Figure 2-1. Collapse sequence recorded by John Stamets on February 25, 1987.*  
Source: University of Washington Libraries, Special Collections, John Stamets Photograph Collection.

During construction of structures of this type, temporary stability must be provided until the design features required for structural stability are in place. Stability-related failures during erection of steel, timber, and precast concrete assemblies are all too frequent. Provision of temporary support is typically the responsibility of the erection contractor. It is critical to have a detailed erection plan, along with on-site personnel qualified to implement the plan. The proper sequence of assembly and the provision of adequate temporary bracing for the incomplete structure are essential.

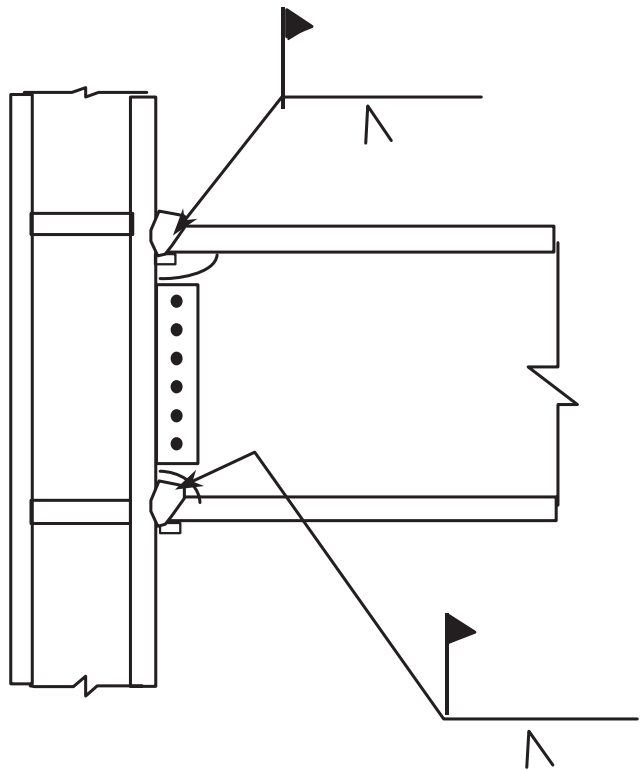
The observed damage to SMRFs was typically in the form of cracks in the complete joint penetration welds between the beam and column flanges. In some instances, the cracks propagated into the columns, resulting in column fracture; and in some cases, cracks were observed in beam flanges. Figure 3-1 depicts the typical detail of the web-bolted, flange-welded moment connection commonly used prior to the Northridge Earthquake, often referred to as Pre-Northridge connection. Figure 3-2 schematically illustrates the typical connection weld fracture observed after the Northridge Earthquake.

*Figure 3-1. Typical pre-Northridge flange-welded, web-bolted moment-resisting connection.*

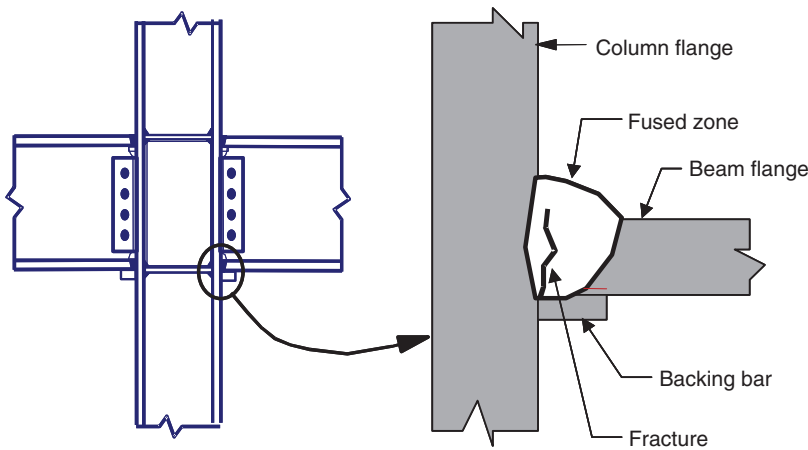
*Figure 3-2. Observed weld fracture in beam-column connections.*

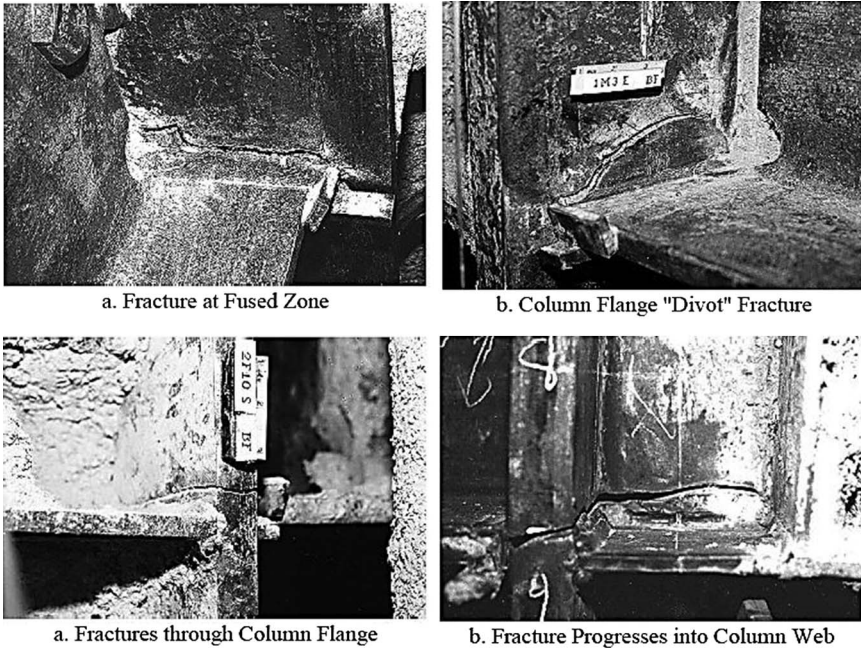
*Figure 3-3. Damage to beam-to-column connections.*

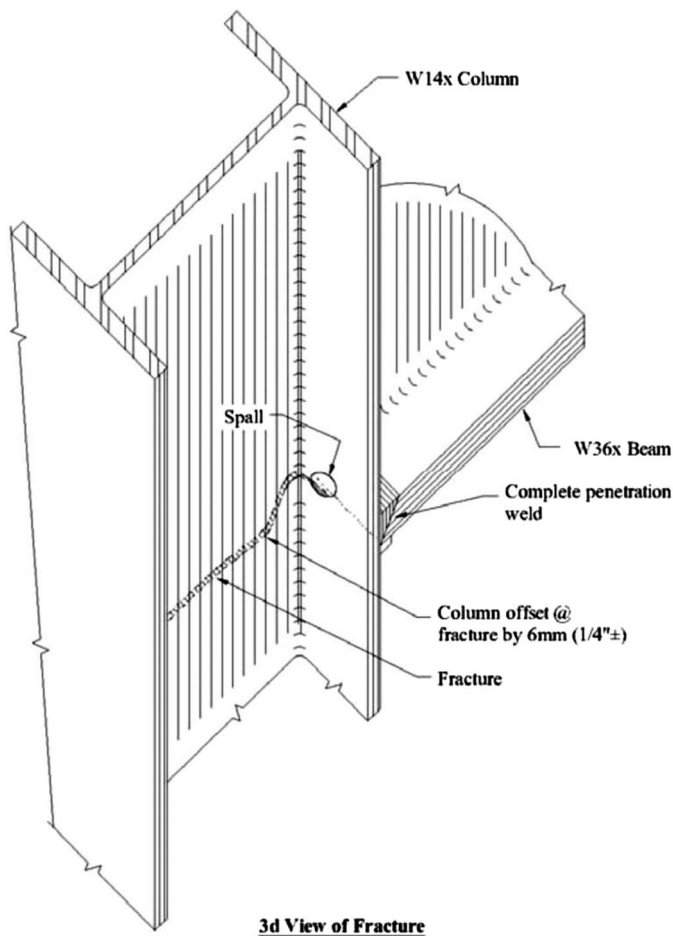
Figures 3-4 and 3-5 show examples of the documented instances of fracture in columns.

*Figure 3-4. Damage to a moment frame column at the beam–column connection of an 11-story building.*

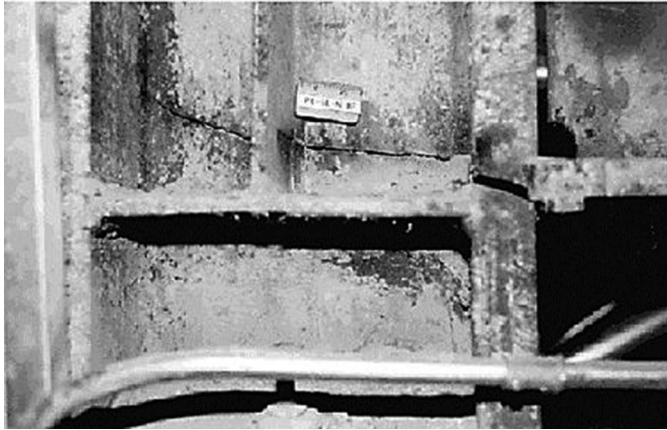
Figure 3-5. Brittle fracture observed after the Northridge Earthquake in a W14 steel column.

Findings and recommendations from the SAC Steel Project were incorporated into revised connection design and construction practices and became the basis for modern codes. New Post-Northridge connection details were developed and

tested, with a focus on weld quality and the geometry of the connection. The American Institute of Steel Construction (AISC) incorporated the recommendations in their seismic design provisions and prequalified connections, which were subsequently adopted by newer generations of building codes. Each earthquake demonstrates that our knowledge is limited, and new lessons about the material behavior and performance of structural systems help us advance the “state of the art” of our profession.

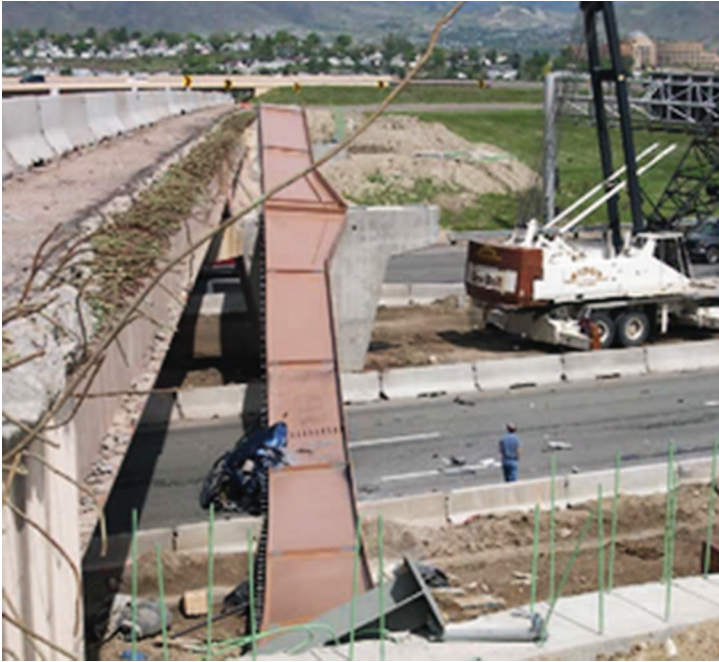
*Figure 4-1. Fallen girder and top portion of the accident vehicle on I-70 (looking north).*

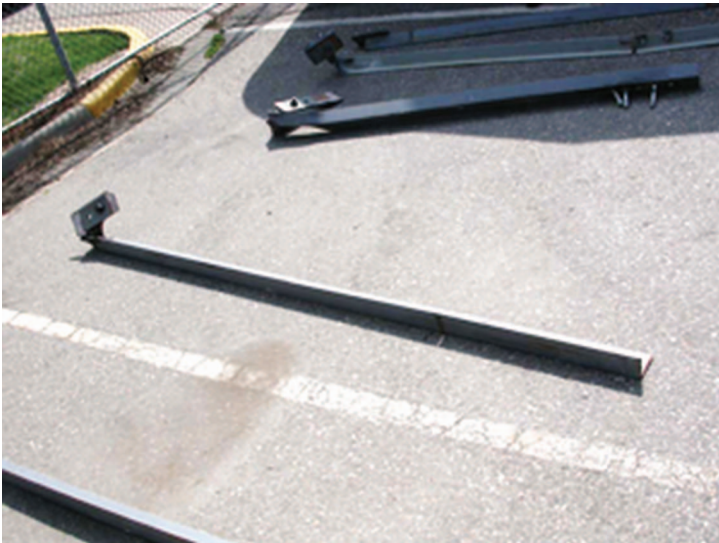
*Figure 4-2. Post-accident photograph of one of the angle-shaped steel braces used to brace the collapsed girder.*

- The five lateral braces were to be bolted flush with the existing bridge deck, but none of the braces were flush with the deck.
- The bolt hole diameters in the existing bridge deck measured 0.90 in., whereas the bolts were only 0.75 in. With these oversized holes, a horizontal load was required to maintain some pullout resistance.
- With the exception of one bolt, the bolts were not embedded in the concrete to the minimum required depth of 3.25 in. This improper installation of the expansion bolts prevented them from reaching their pull-out design capacity.
- Wind loads and lateral vibrations on the braces eventually led to the incorrectly installed expansion bolts pulling out of the concrete. Analysis showed that if brace number 2 failed, the collapse would occur.

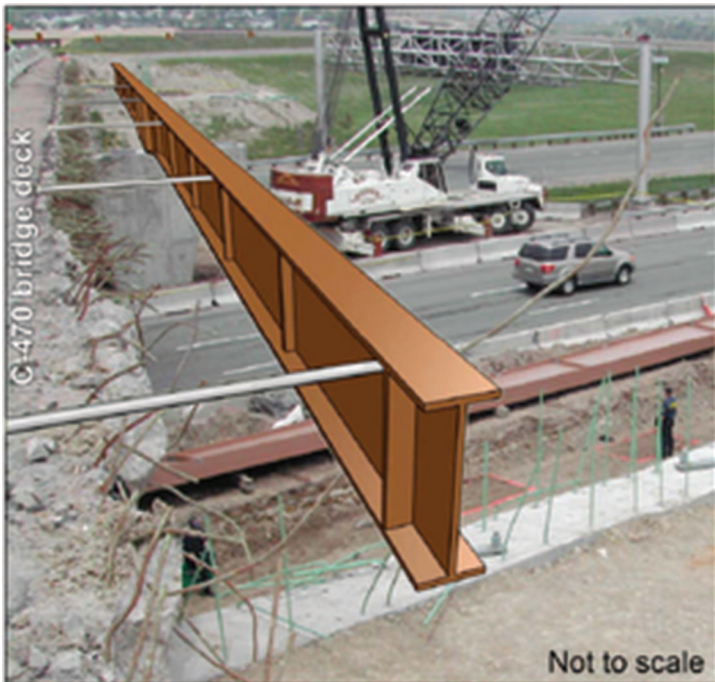
Figure 4-3. Diagram overlaid on photograph to show the girder that failed in its erected position along with the five braces in relation to the C-470 bridge deck.

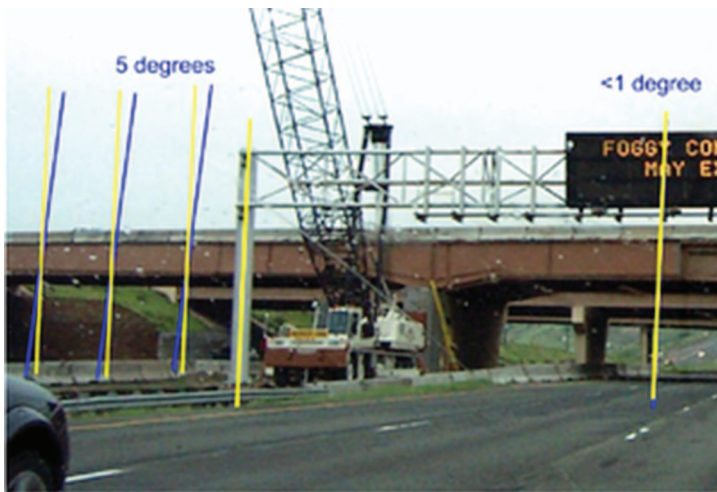
- The girder had not been installed plumb (Figure 4-4). It was installed 4.26 degrees out of plumb at the south abutment and 2.33 degrees out of plumb at the center bridge pier, leaning toward the existing bridge. The

Figure 4-4. Portion of the photograph taken by a driver on May 13, 2004, while the accident girder was in place over I-70.

Proper design of temporary bracing and construction for bridge projects is essential. Following this incident, recommendations were made by NTSB to FHWA, Occupational Safety and Health Administration (OSHA), and CDOT regarding the design and construction of falsework and formwork (NTSB 2006). Most notably, the designs must be prepared or approved by a Registered Professional Engineer. Also, erection subcontractors performing safety-critical work on highways must be prequalified. Although state DOT personnel should not supervise the subcontractor(s), they should intervene when a subcontractor exhibits a lack of competence. This case study also shows the need for redundancy in temporary as well as permanent structures.

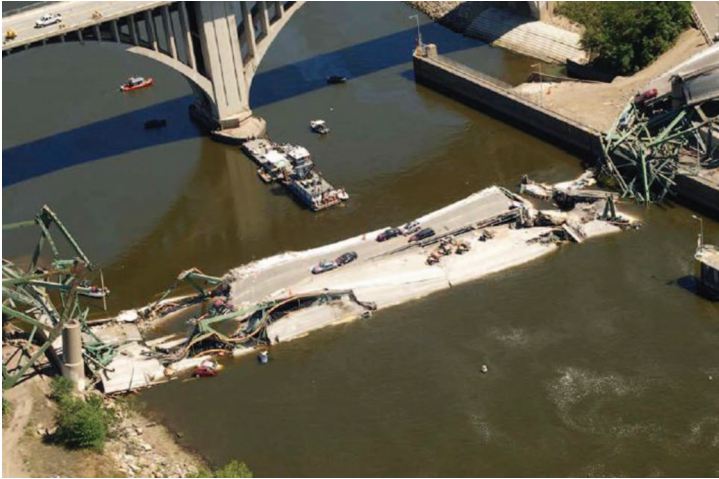
All possible collapse scenarios were investigated, including undetected fatigue cracks caused by cyclic load, strength reduction due to corrosion damage in gusset plates, settlement of the piers, capacity of steel trusses, pre-existing cracks in the bridge superstructure, temperature effects, and design of the gusset plates. The investigations concluded that the collapse was caused by inadequate capacity of gusset plate connections due to an error in the original design, manifested in the

*Figure 6-1. Collapsed bridge center section.*

bowing of the gusset plates. The substantial increases of dead load due to the 1977 and 1998 bridge modifications, along with the lateral shifting instability of the diagonal member connected to the U10 node due to concentrated loads and traffic load on the day of the accident, caused the fracture of the improperly designed gusset plates at the U10 node and the following collapse of the main deck truss.

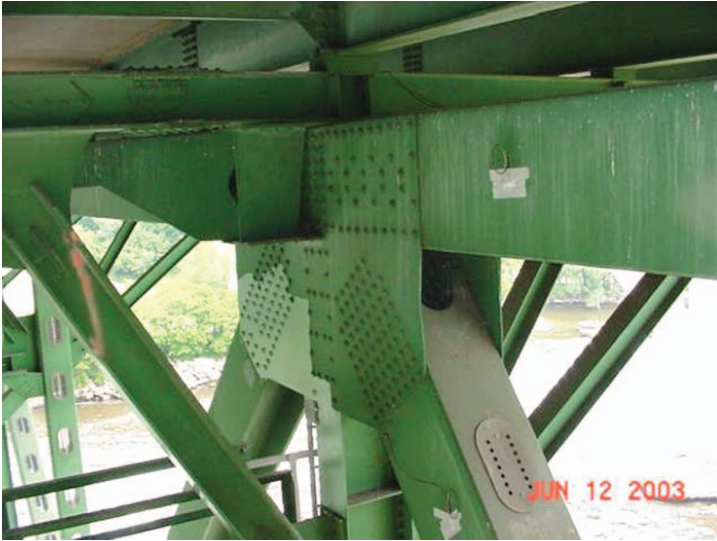
At the time of collapse, the concrete deck was under another major reconstruction, with construction materials and equipment concentrated in the center span above the upper 10th node (U10, numbered from the south—see Figure 6-3). The catastrophic failure of the main deck truss started from a lateral shifting instability of the upper end of a diagonal member connected to the U10 node on the west side, which caused the fracture of the bowing 12.7 mm (0.5 in.) thick gusset plates at the U10 nodes (Figure 6-4). As a result a 139 m (456 ft) long section of the main span of the bridge fell into the river. The collapse killed 13 people and injured 145. Fire and rescue units were notified of the accident immediately, and the rescue was coordinated well among different departments.

Figure 6-3. Node U10 West before collapse.

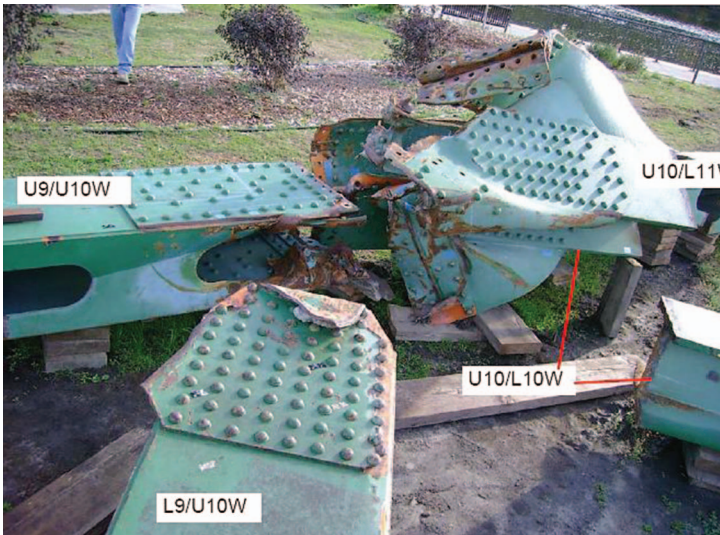
Figure 6-4. Node U10 West after collapse.

- “Require that bridge owners assess the truss bridges in their inventories to identify locations where visual inspections may not detect gusset plate corrosion and where, therefore, appropriate nondestructive evaluation technologies should be used to assess gusset plate condition . . .”.

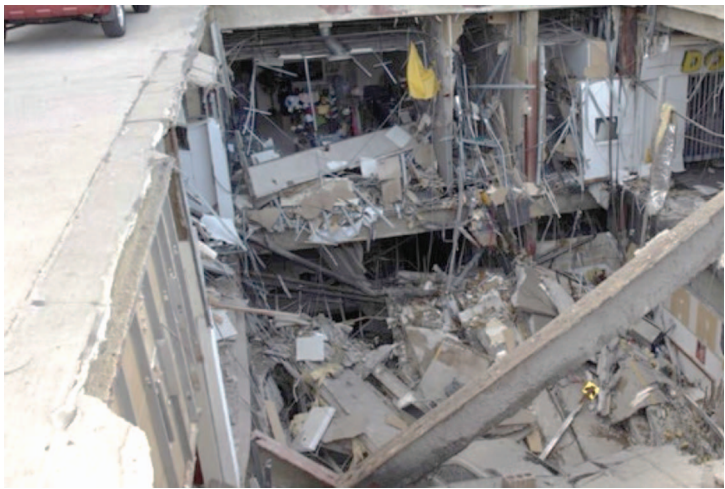
The roof collapse was directly caused by the failure of the unique, unprecedented, and untested waterproofing system, which was created by pouring concrete over hollow core slabs without a full waterproofing membrane. The

*Figure 7-1. Collapse of the rooftop.*  
Source: Figure 2.3.1 in [Elliot Lake Inquiry \(2014\)](#) © Queen’s Printer for Ontario, 2014.

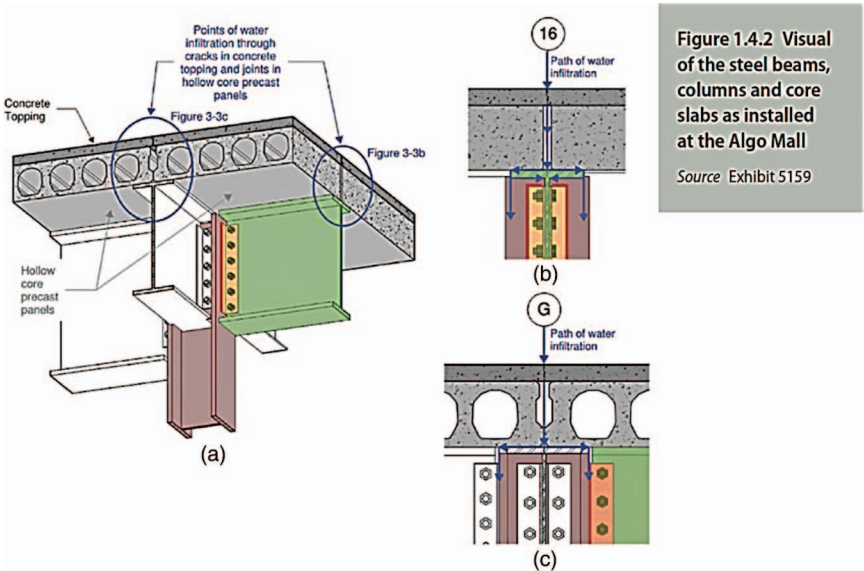
The sudden collapse occurred at a steel frame connection between a beam and a column, which was heavily corroded by salty slush due to rainwater leaking through the failed waterproofing of the parking deck for decades (Figures 7-3 and 7-4). Two people were killed and 19 were injured in this heartbreaking incident. The Elliot Lake Commission of Inquiry was established to investigate the cause of the collapse. It concluded that the collapse was “one of human, not material, failures. Many of those whose calling or occupation touched the Mall displayed failings—its designers and builders, its owners, some architects and engineers, as well as the municipal and provincial officials charged with the duty of protecting the public. Some of these failings were minor; some were not. They ranged from apathy, neglect, and indifference through mediocrity, ineptitude, and incompetence to outright greed, obfuscation, and duplicity . . .” (Elliot Lake Inquiry 2014).

*Figure 7-2. Connection of the steel beams, columns, and slabs.*  
Source: Figure 1.4.2 in [Elliot Lake Inquiry \(2014\)](#) © Queen’s Printer for Ontario, 2014.

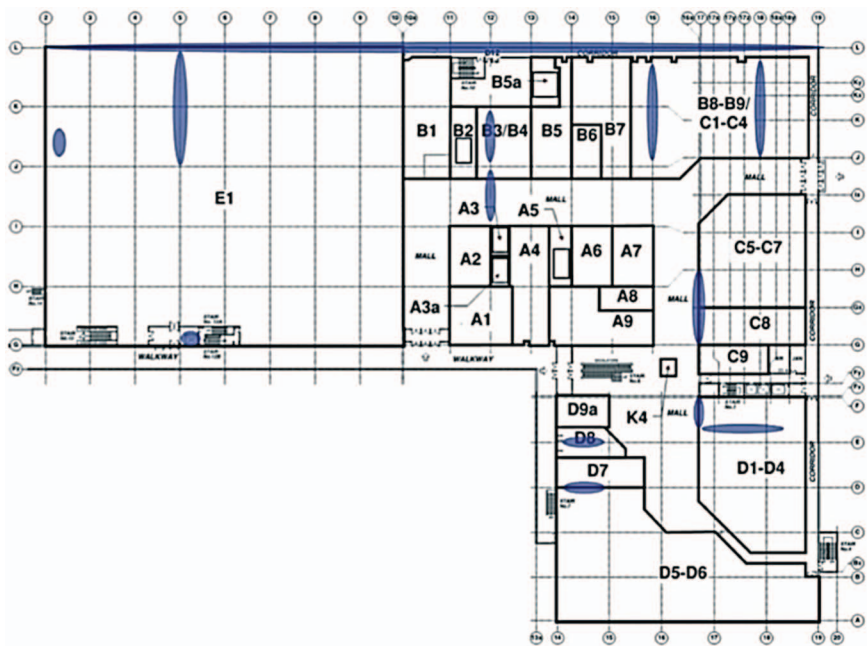
rooftop was poorly sloped, which resulted in water ponding in numerous locations on the deck. Crack-control joints were applied in the concrete topping above the grouted space along the long side of every third hollow core slab. Additional cracking where the hollow core panels abutted was expected to be limited due to

Figure 7-3. Mapping of the water leakage on the floor plan.  
Source: Figure 1.4.9 in *Elliot Lake Inquiry* (2014) © Queen’s Printer for Ontario, 2014.

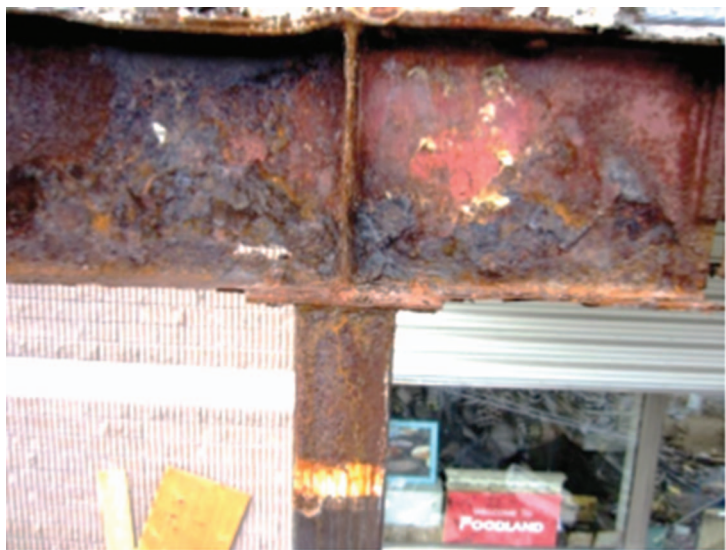
Figure 7-4. Severely corroded connection exposed after the roof collapse.  
Source: Figure 1.3.5 in *Elliot Lake Inquiry* (2014) © Queen’s Printer for Ontario, 2014.

During its lifetime, the property belonged to three owners. The commission criticized all three and found that they had missed numerous opportunities to fix the water-leak issue. The original owner did not hire a consultant to manage the entire design and construction, but hired a specialized firm to design and install the ineffective waterproofing system. After the roof leak was noticed, an engineering firm recommended that the owner install a full waterproofing membrane; otherwise the leaking would compromise the structural capacity of the roof system. However, the owner only patched and sealed the roof cracks and sold the problem to the second owner, who continued the repair that was “not working” ([Elliot Lake Inquiry 2014](#)). The third owner did not want to invest in the “black hole” ([Elliot Lake Inquiry 2014](#)) to fix the issue, but hired an engineer who performed only very cursory and incomplete inspections and incorrectly rated the structural condition of the mall as reasonable. Throughout the lifetime of the parking deck, none of the owners, architects, engineers, or public officials anticipated the severe corrosion of the steel framing below caused by decades of water leakage.

The commission recommended that buildings be inspected periodically by a qualified structural engineer according to minimum structural maintenance standards for buildings. The record of inspection, including condition rating and recommendation of repairs, should be easily accessible and understandable to the owners and be filed in a publically accessible registry. The local jurisdiction should have the power to require buildings that do not meet the minimum standards to be repaired or demolished for the protection of the public. From this sad incident, design professionals should learn that unusual and untested design features may have unexpected consequences. The redundancy, continuity, and robustness of the structural systems should be considered in the design of all buildings. Although a successful design is often a function of what is technically possible and what is economically feasible, in considering building maintenance, repair, and

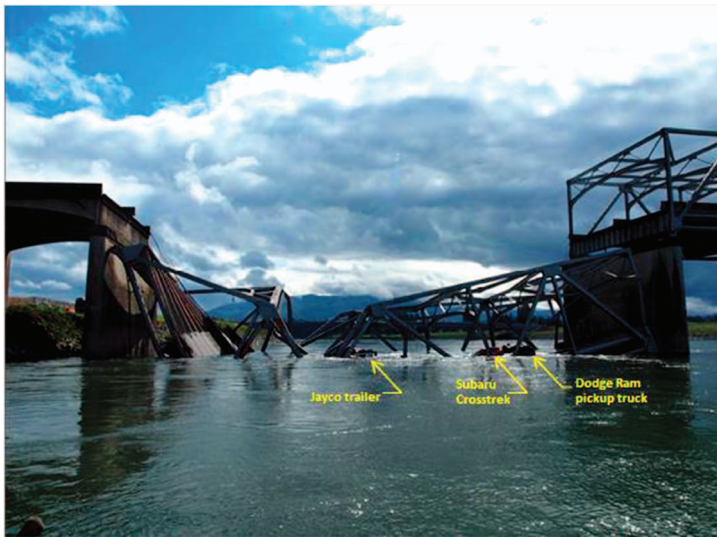
*Figure 8-2. Through-truss Span 8 collapsed into the Skagit River.*

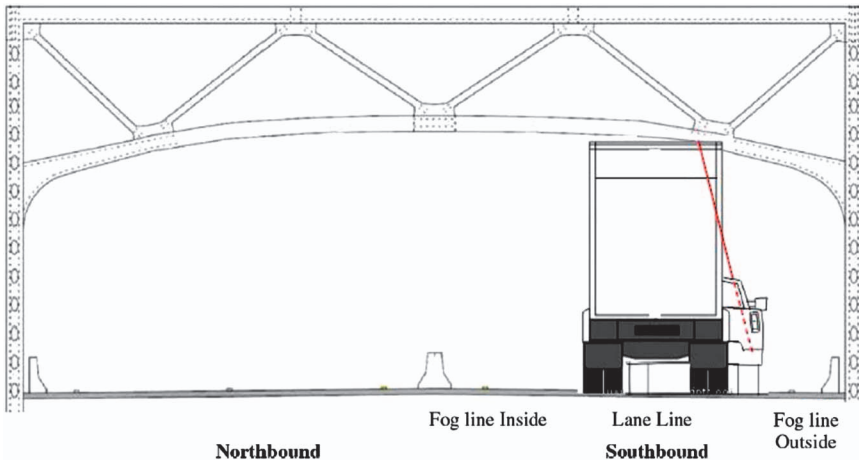
Along a permitted route, clearances can vary from lane to lane. The permitting process is discussed by [Stark et al. \(2016\)](#), who note that “Permitting of oversized vehicle routes is not federally regulated . . .”. States establish their own permit requirements, which vary from state to state. Online permitting is often available to trucking companies. Signage informing oversize-vehicle and escort-vehicle drivers of the vertical clearance of an upcoming structure is an important factor in preventing this type of incident. In this case, Washington State placed the responsibility for determining route clearance on the trucking company and allowed the permit to be issued online, without review by WSDOT personnel. Washington State had recorded clearance heights for the bridge that were available to the trucking company, but only the minimum and maximum clearances were recorded. These heights did not indicate that the lane where the truck struck the truss had a lower clearance than the adjacent lane, where the truck would have cleared.

*Figure 8-3. Section through bridge showing relationship of oversized vehicle height to portal frame clearance.*
