# **Fast and Ultimate Vibration Field Solution: From Problem Detection to Field Performance Validation**

**Giancarlo CICATELLI**  
Flowserve - Italy

***First Middle East Turbomachinery Symposium***

# Description of the problem

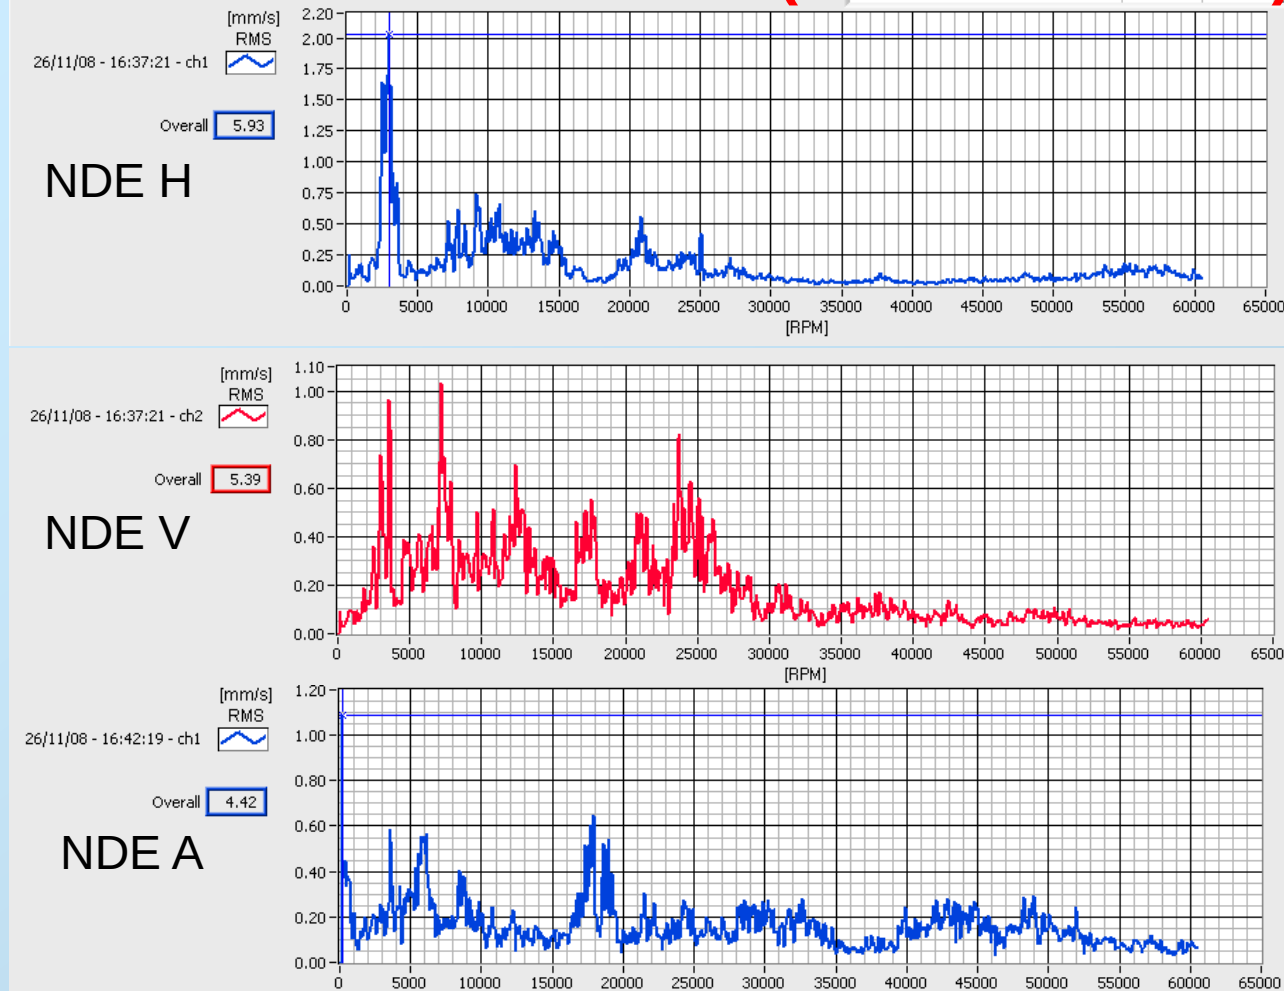
## NDE vibration spectra

N=3580 rpm

1x=3580 rpm

VPF= 7x=25060 rpm

Q=1700 m<sup>3</sup>/hr (7490 gpm)

Close to Normal duty

### Remarks:

- a) Low amplitude at VPF  
( < 1 mm/s = 0.04 ips )
- b) High activity mainly  
across a range up  
500 Hz ( 30000 rpm )

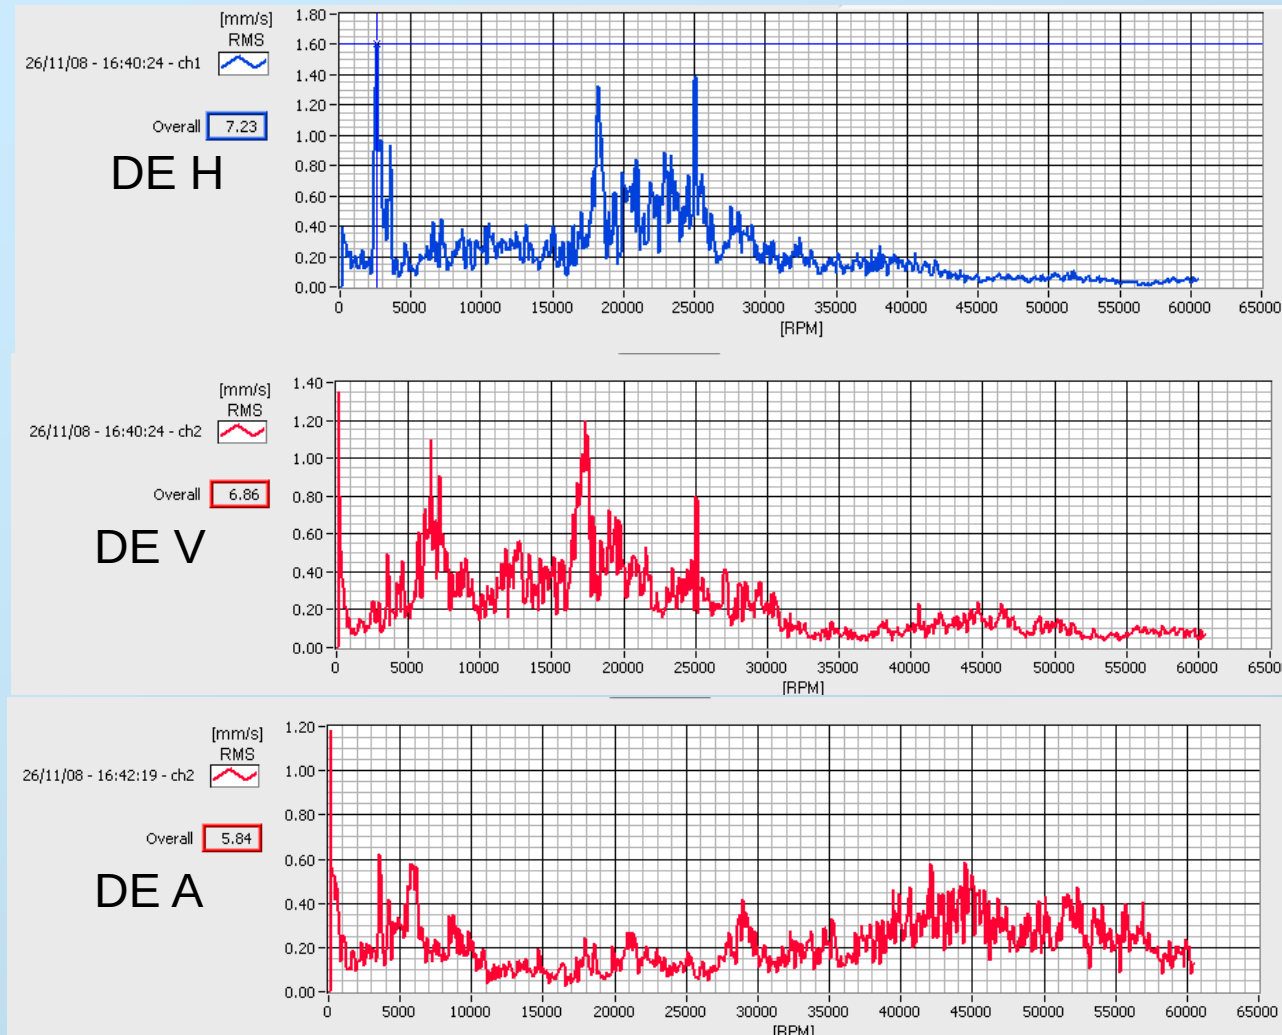
DE vibration spectra

Remarks :

a) Max amplitude at VPF

(1.4 mm/s = 0.06 ips )

b) High activity distributed

and dominant across

a range up 500 Hz

( 30000 rpm )

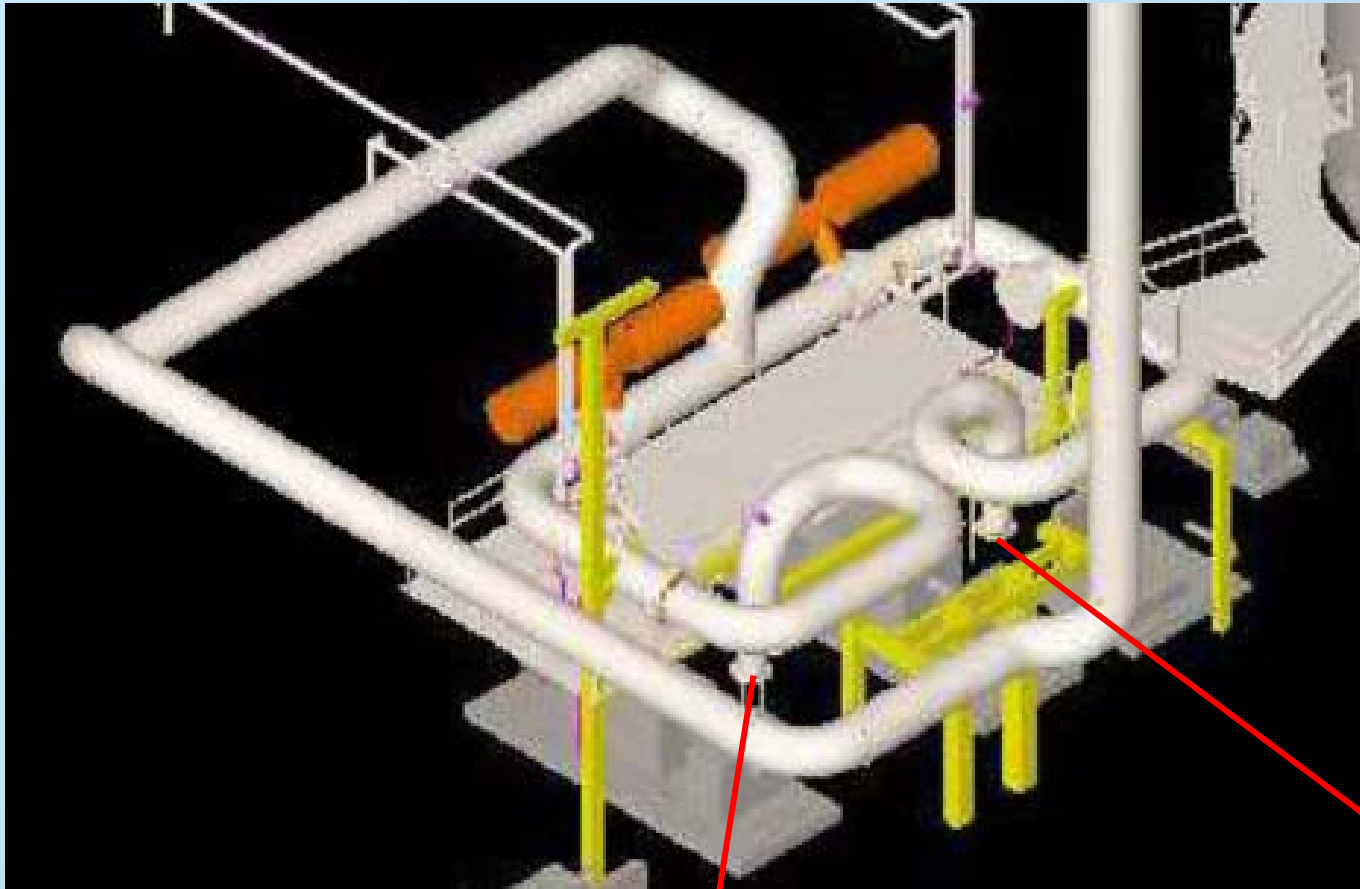
# Initial analysis – Suction piping

Pump A Suction flange

Pump B Suction flange

| POSSIBLE CAUSE | Why yes | Why not | Result |
|---|---|---|---|
| Fluid dynamics of the piping | Unsteady and random spectra with a broadband distribution of many peaks of low frequencies are indicative of intense turbulence.<br>Piping was not fully compliant with HI recommendations | Piping designed according to customer best practice | PROBABLE CAUSE |

- ❖ The customer modified the piping layout as to have it compliant to Hydraulic Institute recommendation.
- ❖ The results of the modification showed visible reduction in vibration level, though not within the required acceptance limits.

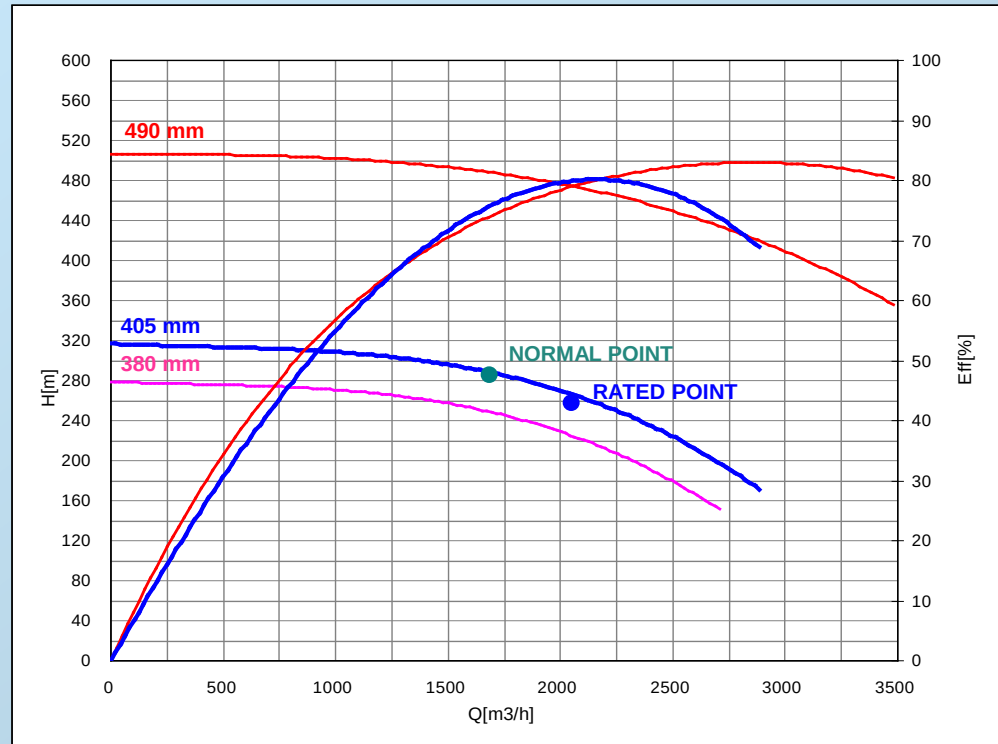
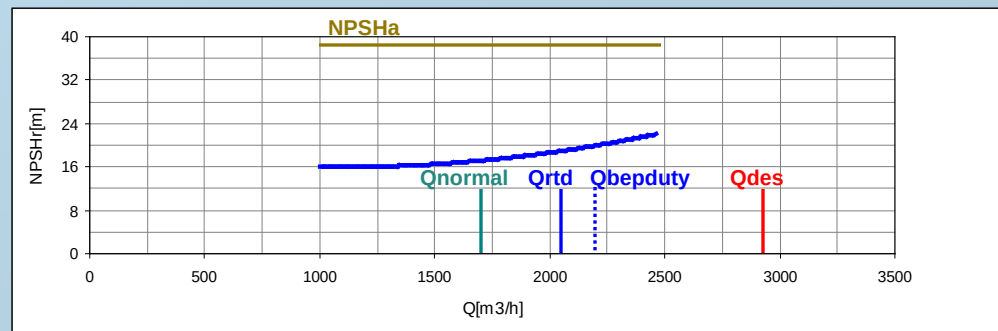
## Test Curves

$Q_{\text{normal}} / Q_{\text{rated}} = 0.83$

$Q_{\text{normal}} / Q_{\text{bepduty}} = 0.8$  (OK for API 610)

$Q_{\text{normal}} / Q_{\text{bepdes}} = 0.59$  (Too low)

$Q_{\text{normal}} / Q_{\text{sl}} = 0.54$  (Too low)

$Q_n = 59\% \text{ of } Q_{\text{des}} - \text{RED FLAG}$

$Q_{\text{normal}} / Q_{\text{s}} = 0.82$

Suction recirculation is root  
cause of vibrations

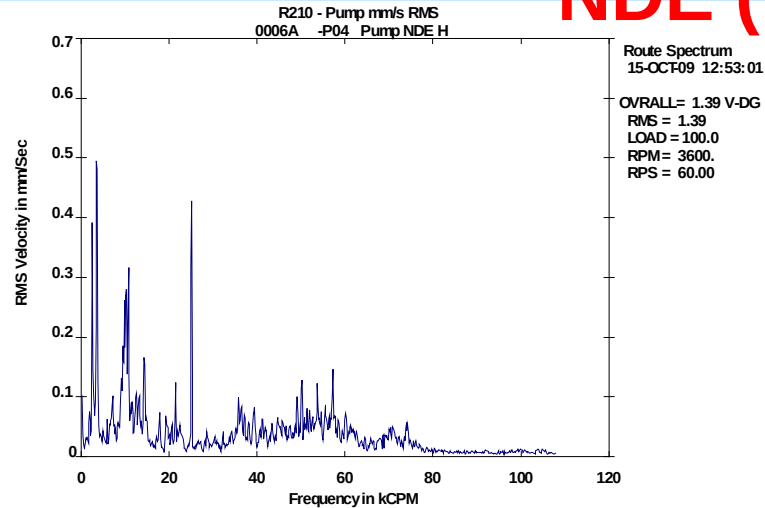
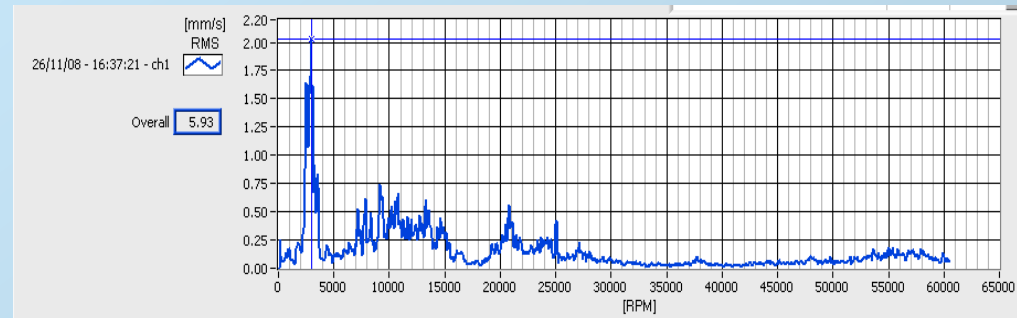
Initial field data with old impeller

| | Old | New |
| H mm/s(ips) | 5.93 (0.23) | 1.39 (0.05) |
| V mm/s(ips) | 5.39 (0.21) | 3.11 (0.12) |

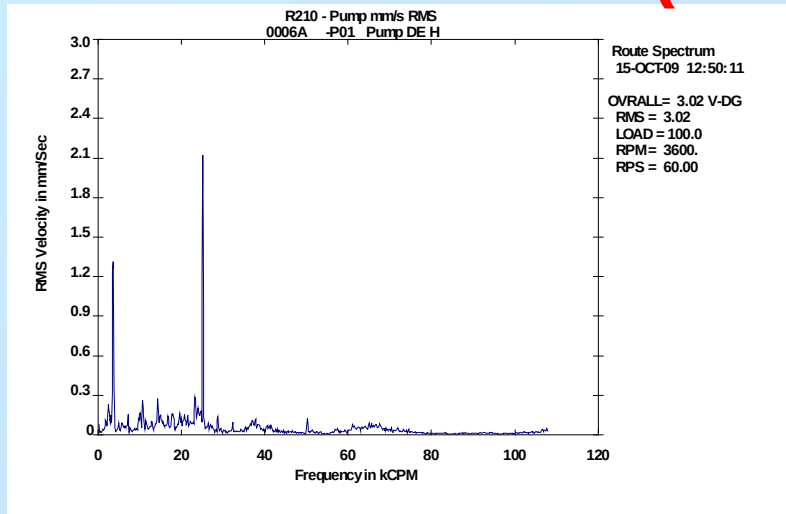
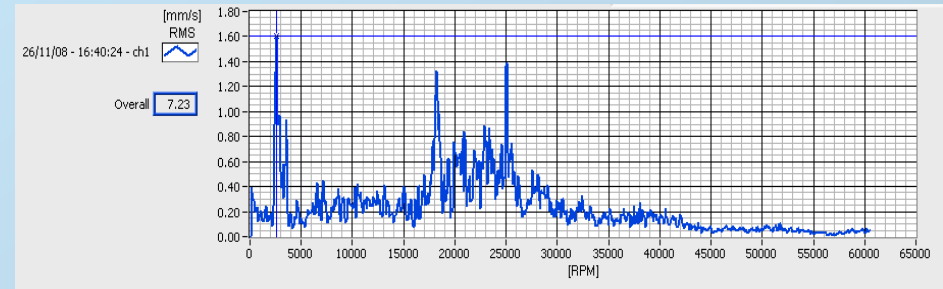
Initial field data with old impeller

| | Old | New |
| H mm/s(ips) | 7.23 (0.28) | 3.02 (0.12) |
| V mm/s(ips) | 6.86 (0.27) | 2.25 (0.09) |
