# **METALLURGICAL FAILURE ANALYSIS**

Techniques and Case Studies

KANNADI PALANKEEZHE BALAN

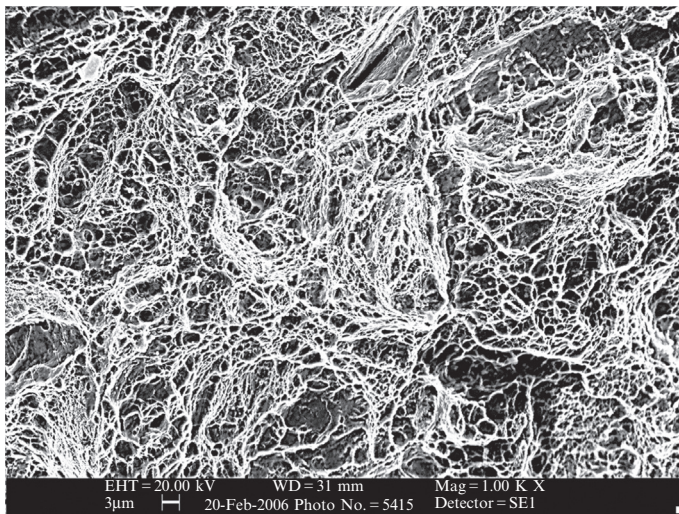
**Fig. 4.3.2** SEM fractograph from the fracture surface at position 'B' revealed predominantly dimpled rupture.

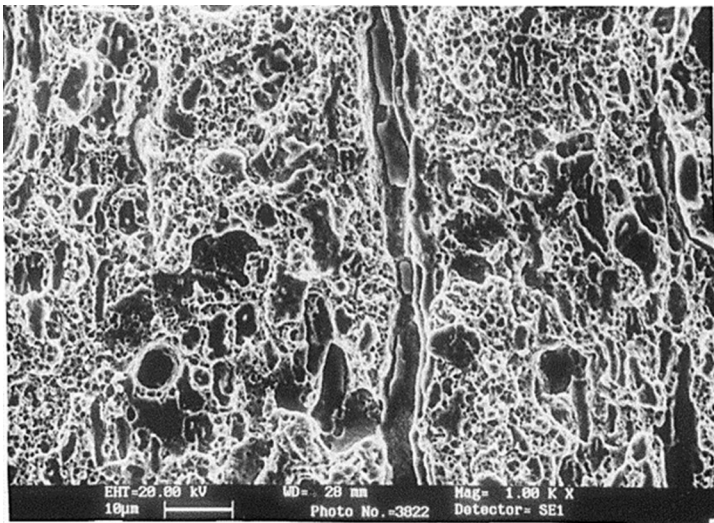
**Fig. 4.5.2** SEM fractograph of the fracture surface showing dimpled rupture and separation along stringers of inclusions.

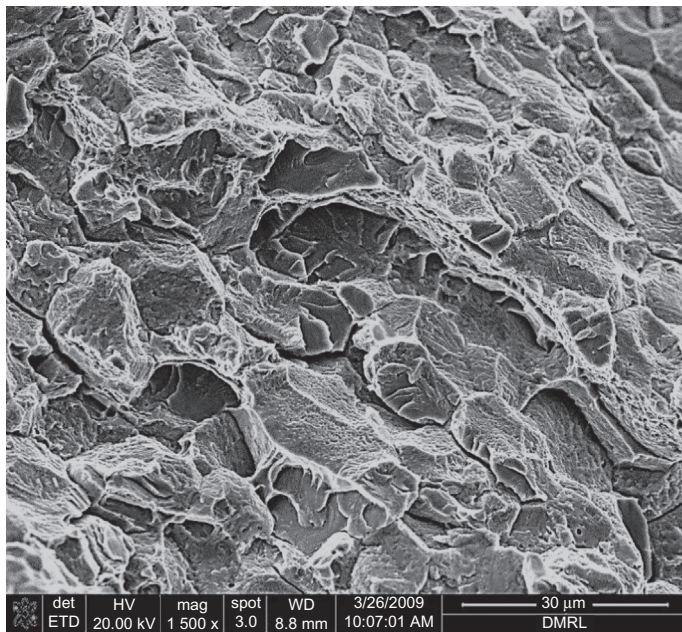
**Fig. 5.3.3** SEM fractograph of the fracture surface with granular appearance showing predominantly transgranular cleavage fracture.

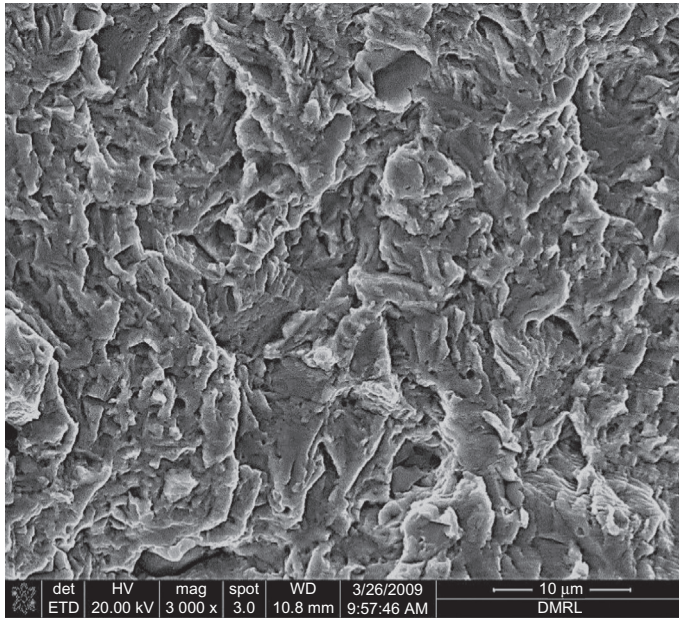
**Fig. 5.3.4** SEM fractograph of the smooth fracture region showing quasi-cleavage fracture.

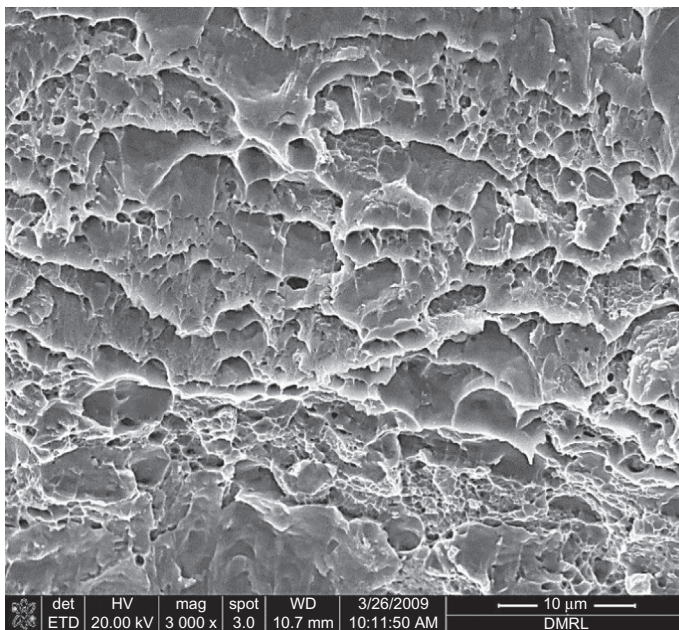
**Fig. 5.3.5** SEM fractograph of the final fracture region showing dimpled rupture.

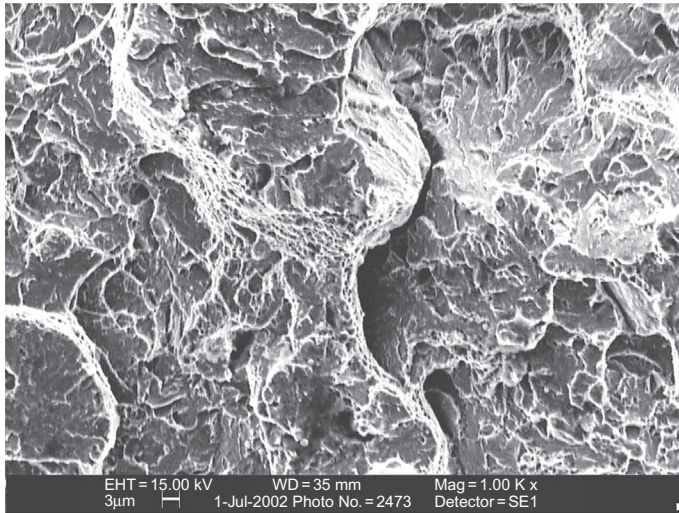
**Fig. 5.7.4** SEM fractograph of the fracture surface at location 'A' showing a quasi-cleavage fracture.

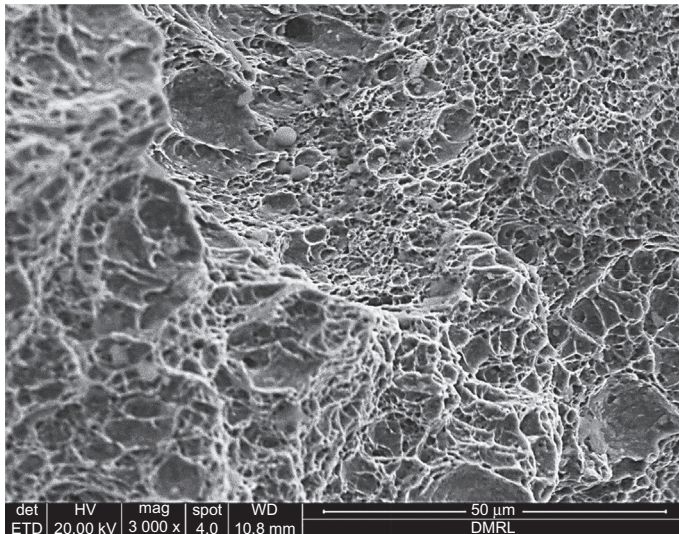
**Fig. 5.7.5** SEM fractograph of the fracture surface at location 'B' showing a dimpled rupture.

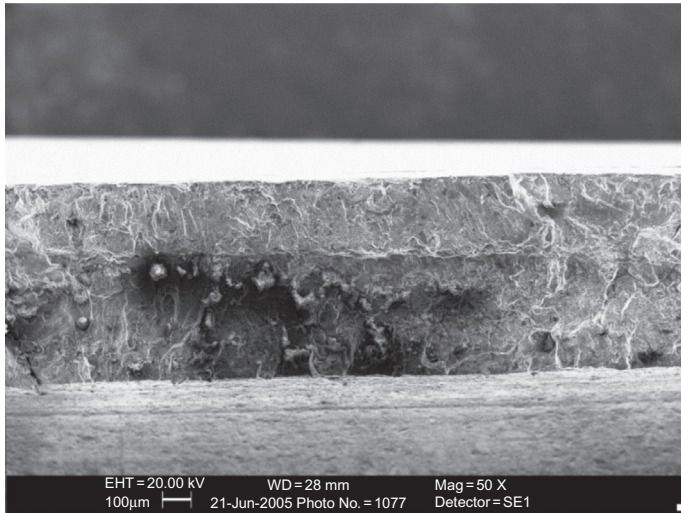
*Fractographic Examination:* The crack was cut open and cleaned ultrasonically in acetone and examined under SEM. About two-thirds of the section was coarse and crystalline with a number of cavities. The remaining one-

**Fig. 6.1.3** SEM fractograph of the fracture surface showing about two-third of the fracture being coarse with large cavities and inclusions, and almost smooth fracture of the remaining one-third portion.

third of the fracture surface showed a mixed mode of smooth and coarse fracture (Fig. 6.1.3). Large cavities with some inclusions were noticed in the coarse region of the fracture surface. One such cavity containing some inclusions is shown in Fig. 6.1.4. The inclusions at two different spots were

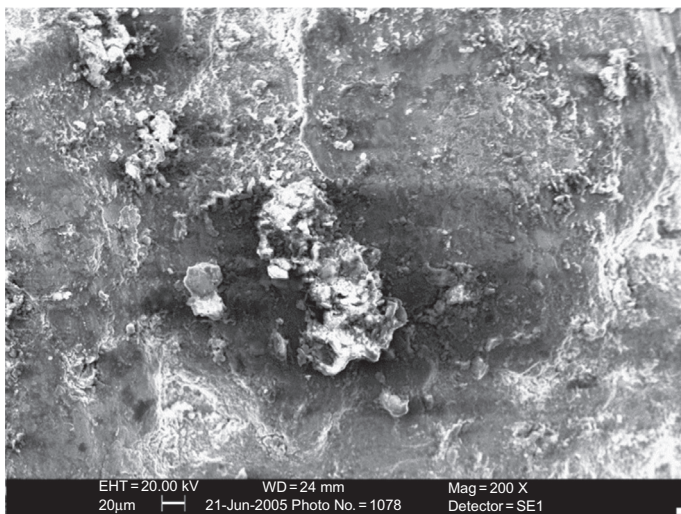
**Fig. 6.1.4** SEM fractograph of the fracture surface showing one of the cavities containing some inclusions.

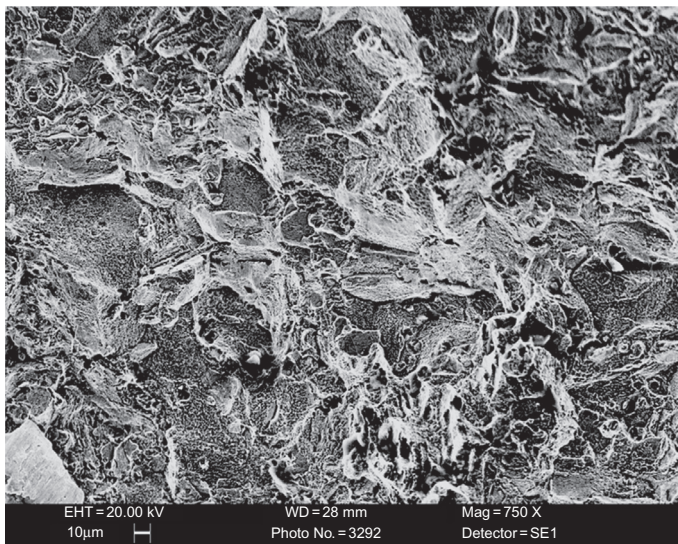
**Fig. 6.1.6** SEM fractograph of the coarse region of the fracture surface showing quasi-cleavage fracture.

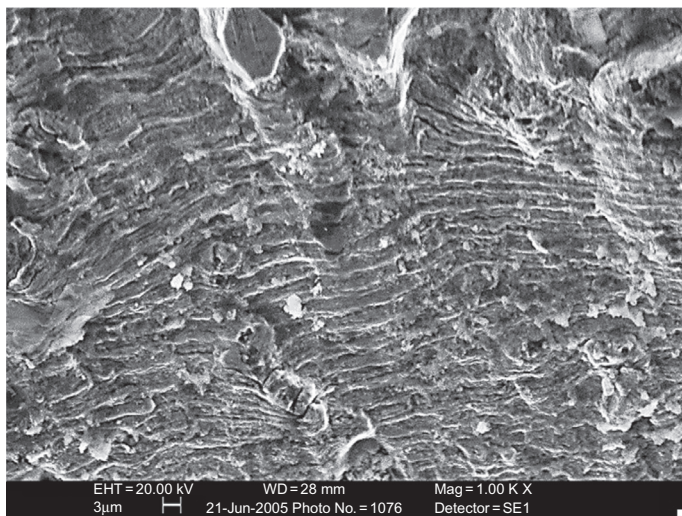
**Fig. 6.1.7** SEM fractograph of the smooth region of the fracture surface showing fatigue striations.

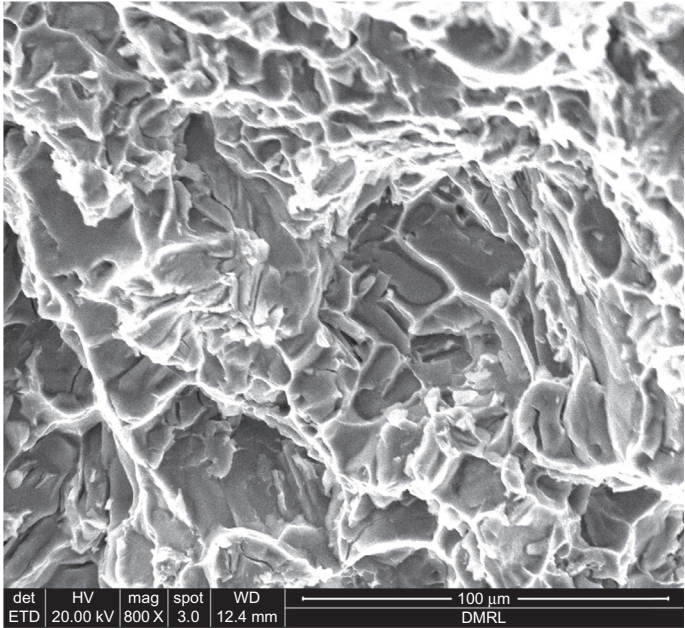
**Fig. 6.2.2** SEM fractograph of the fracture surface showing transgranular cleavage fracture in sample A.

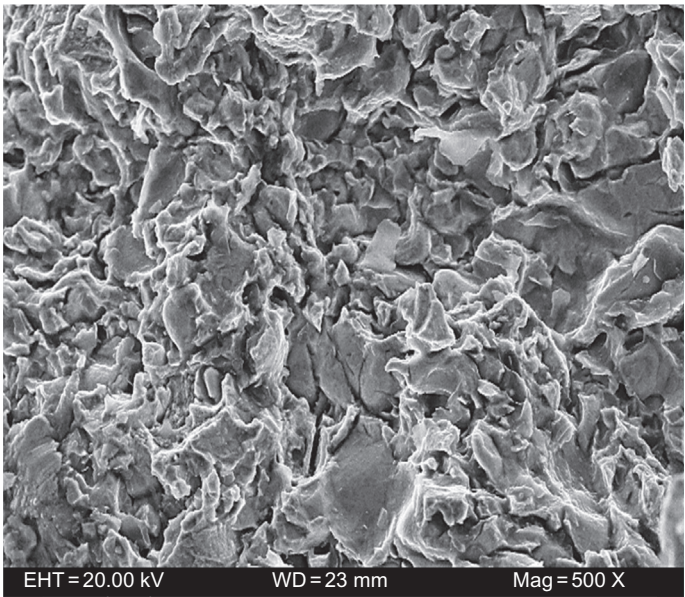
**Fig. 6.2.3** SEM fractograph of the fracture surface showing quasi-cleavage fracture in sample B.

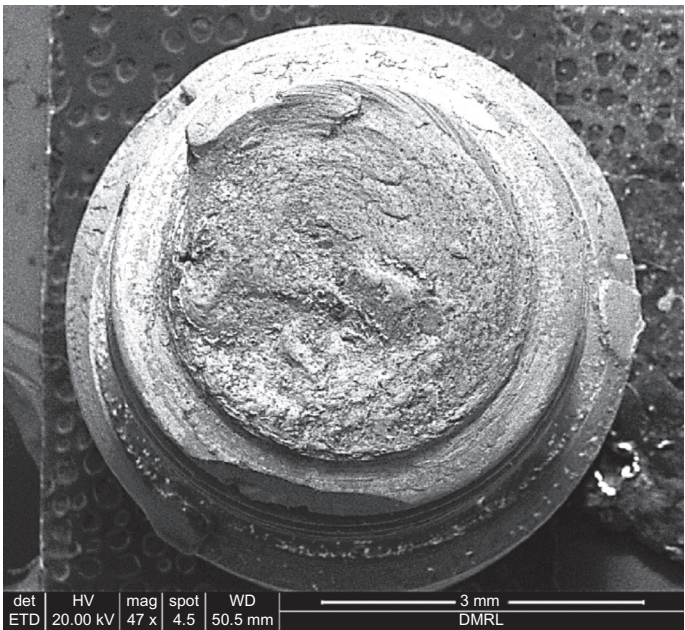
Fig. 7.1.3 Fracture surface of the bolt showing a fibrous fracture feature.

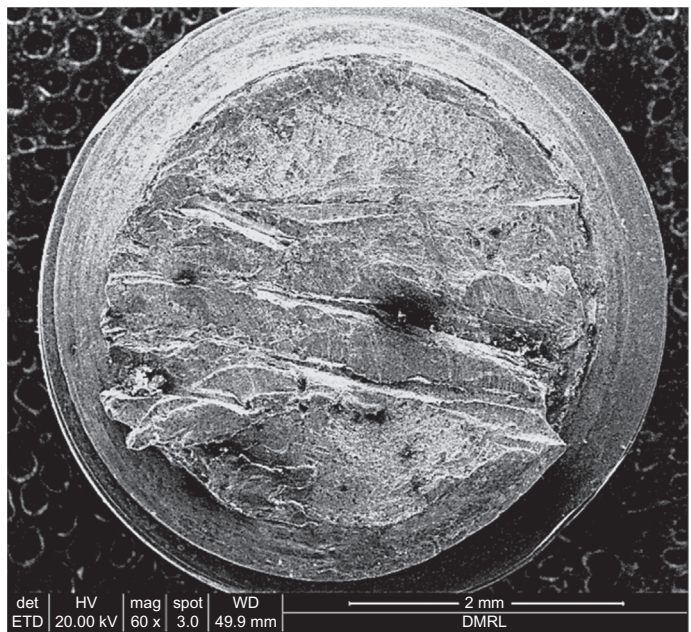
**Fig. 7.1.4** Another mating fracture surface of the bolt showing a fibrous fracture feature and severe rub marks.

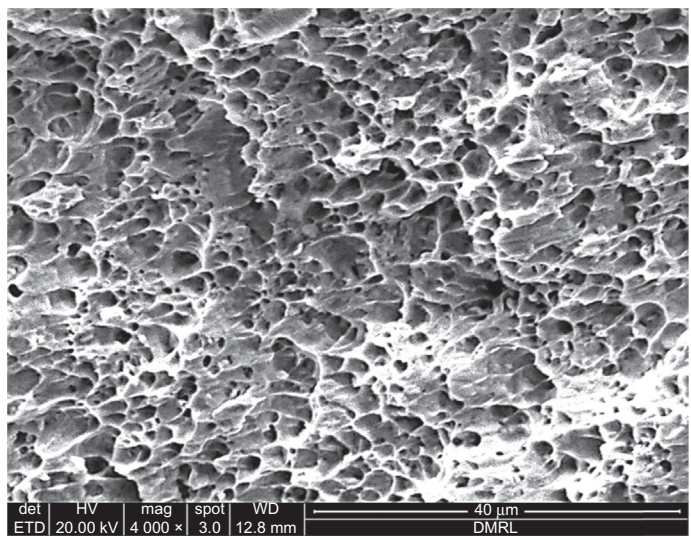
**Fig. 7.1.5** SEM fractograph of the fracture surface showing slightly elongated dimples.

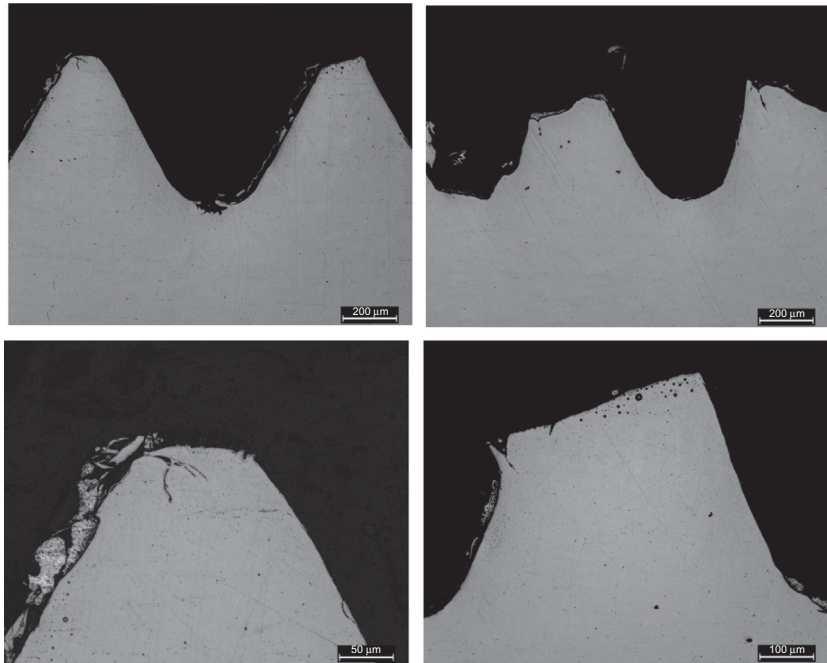
**Fig. 7.1.6** Micrographs of longitudinal section of the failed bolt showing cracks both at the crest and trough of the threads and deformation of the threaded region. Unetched.

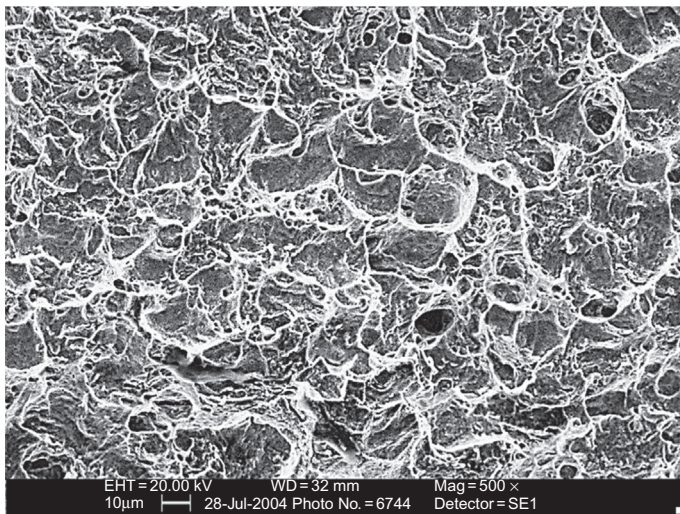
**Fig. 7.2.4** SEM fractograph of a typical fracture surface showing dimpled rupture.

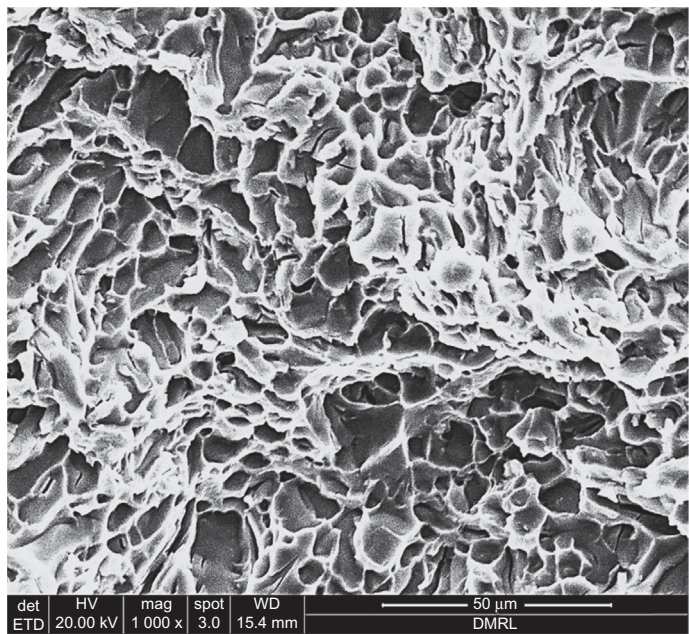
Fig. 7.3.4 SEM fractograph of the fracture surface showing region of dimpled rupture.

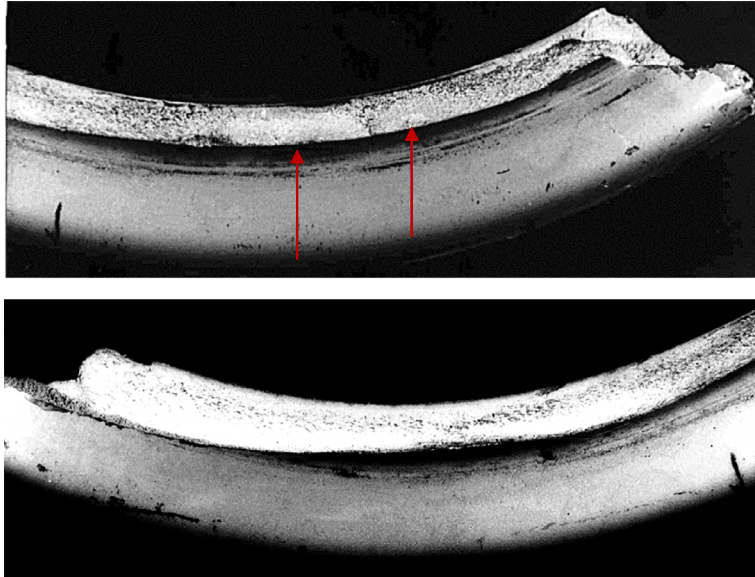
**Fig. 8.1.2** Close-up view of the fracture surface showing two origins 30mm apart (arrow heads).

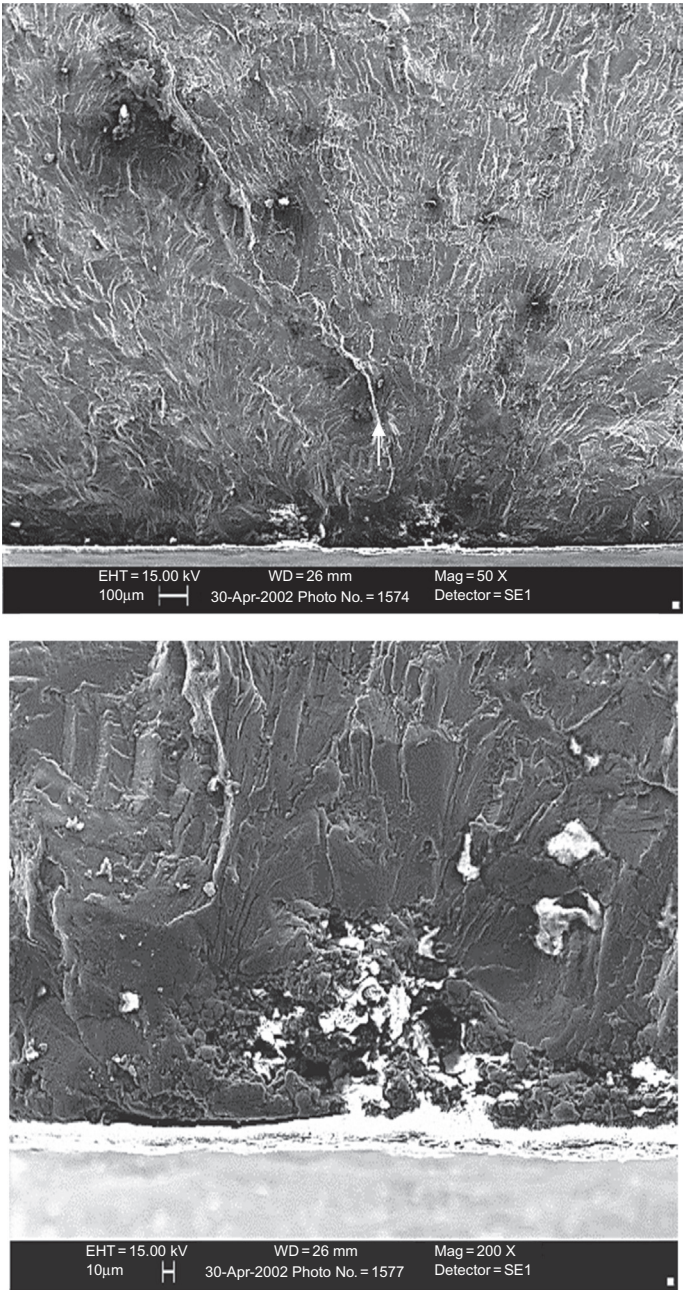
Fig. 8.1.3 SEM fractographs showing cluster of inclusions at the origin.

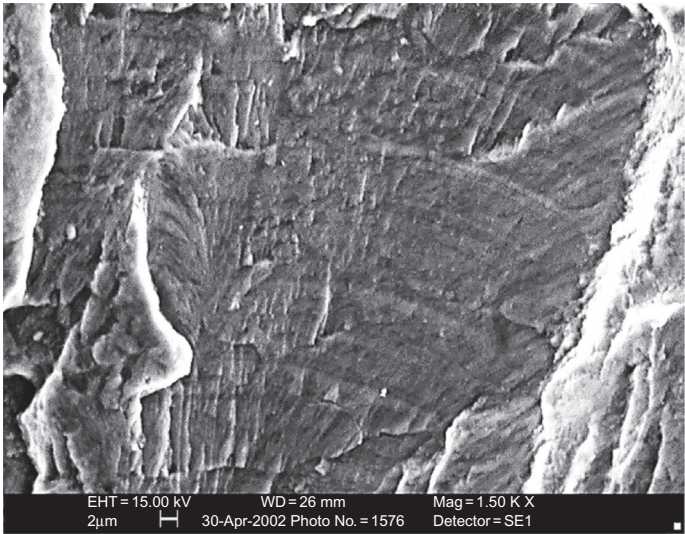
Fig. 8.1.5 SEM fractograph of the smooth fracture region showing fatigue striations.

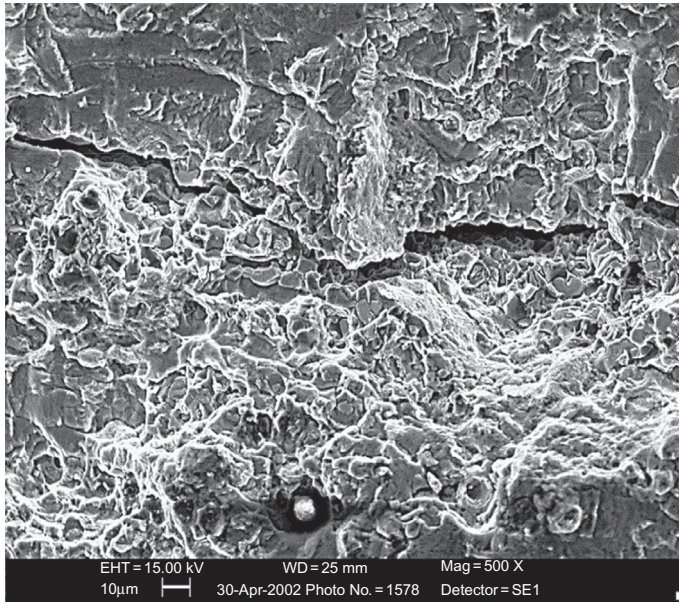
**Fig. 8.1.6** SEM fractograph of the remaining fracture surface showing quasi-cleavage fracture.

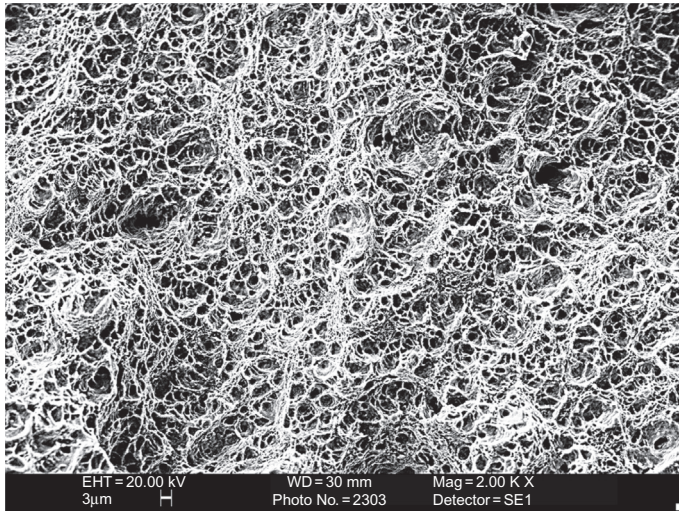
**Fig. 8.2.3** SEM fractograph of the final fracture region showing equiaxed dimples.

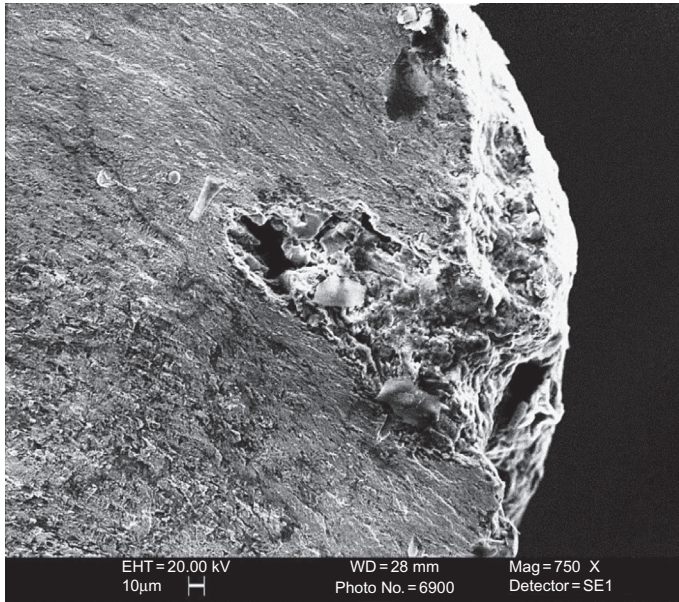
**Fig. 8.3.3** SEM fractograph of the fracture surface at higher magnification showing corrosion pit at the leading edge.

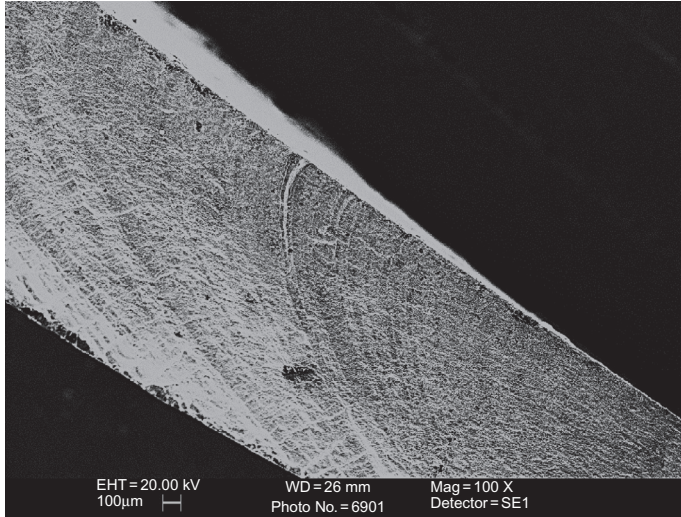
**Fig. 8.3.5** SEM fractograph of the fracture surface showing beach marks initiating near the corrosion pit at the leading edge and propagating toward the trailing edge.

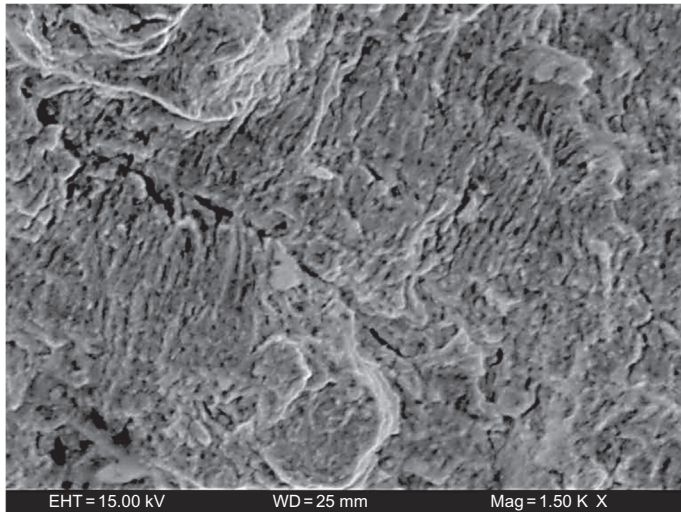
**Fig. 8.3.6** SEM fractograph of the fracture surface showing fatigue striations.

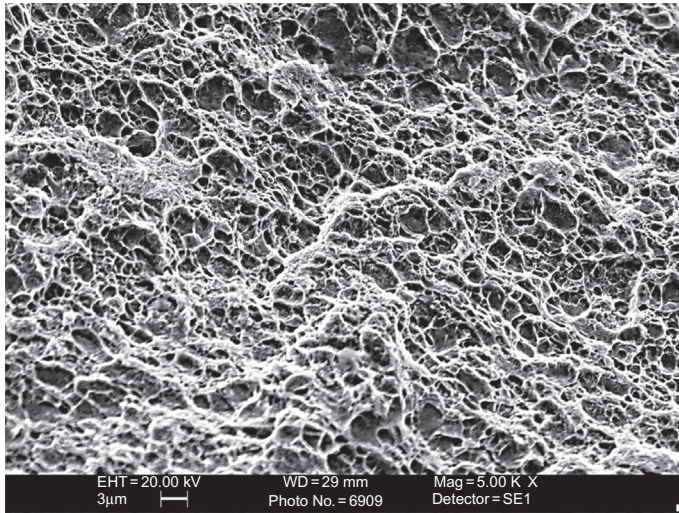
**Fig. 8.3.7** SEM fractograph of the fracture surface showing equiaxed dimples at the final fracture zone.

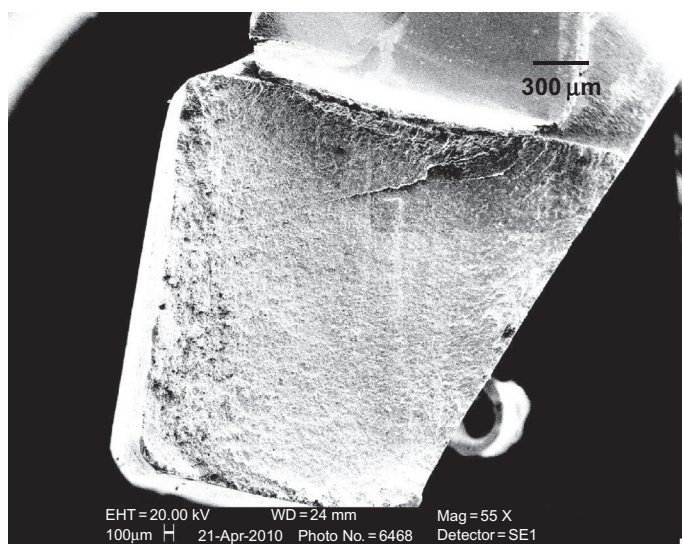
**Fig. 8.4.5** SEM fractograph of the straight fracture surface showing brittle smooth fracture over three-fourth of the region and fibrous fracture over the remaining region.

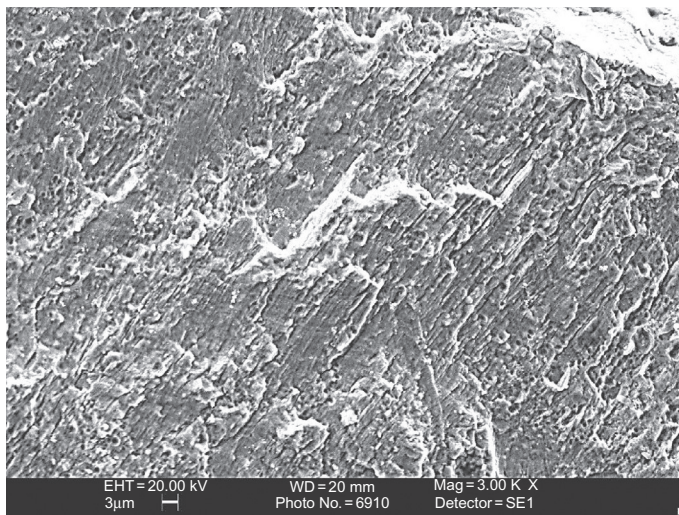
**Fig. 8.4.7** SEM fractograph of the smooth region of the fracture surface revealing fatigue striations.

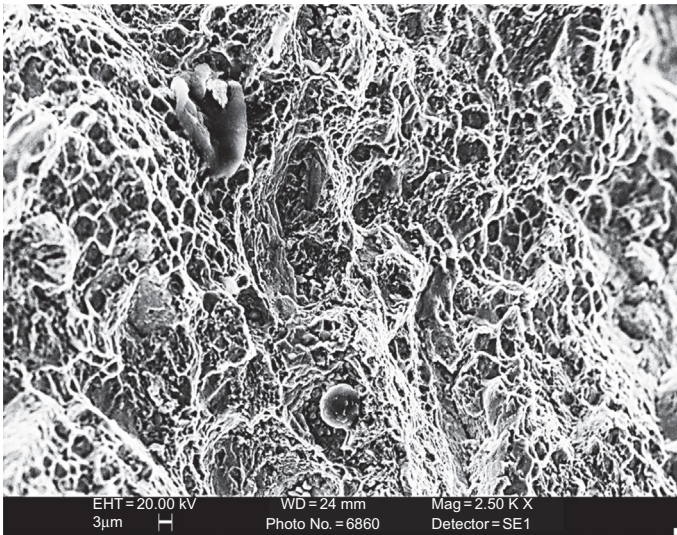
**Fig. 8.4.9** SEM fractograph of the fracture surface inclined at 45° revealing, essentially equiaxed dimples.

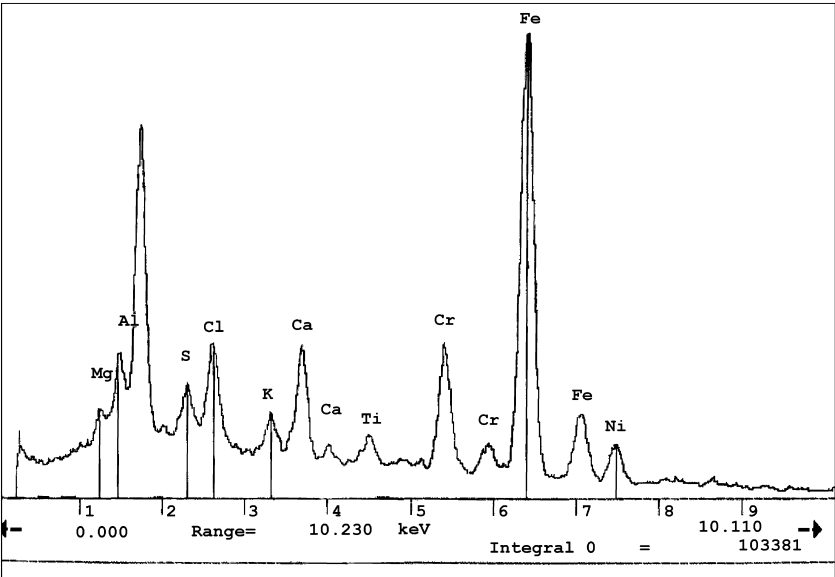
**Fig. 9.3.5** EDAX of pitted area showing the presence of sulfur, chlorine, potassium, calcium, and silicon in addition to elements of the parent stainless steel.

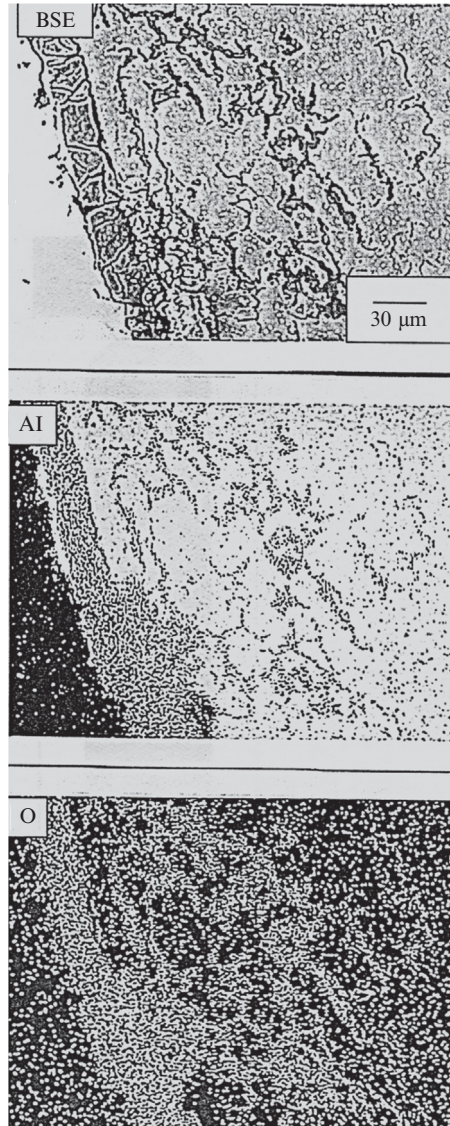
**Fig. 9.4.10** BSE image of the transverse section of the defective tube sample showing corroded outer surface and grain boundaries along with X-ray elemental mapping for Al and O.

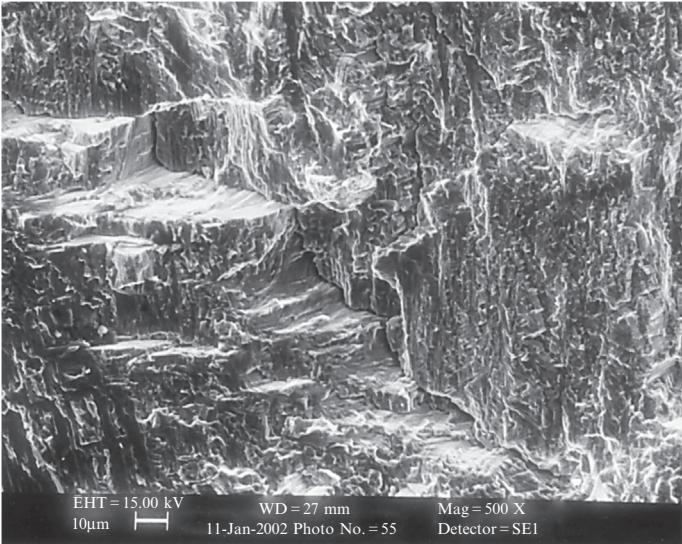
**Fig. 10.2.3** SEM fractograph of the fracture surface showing cleavage steps and transgranular secondary cracks.

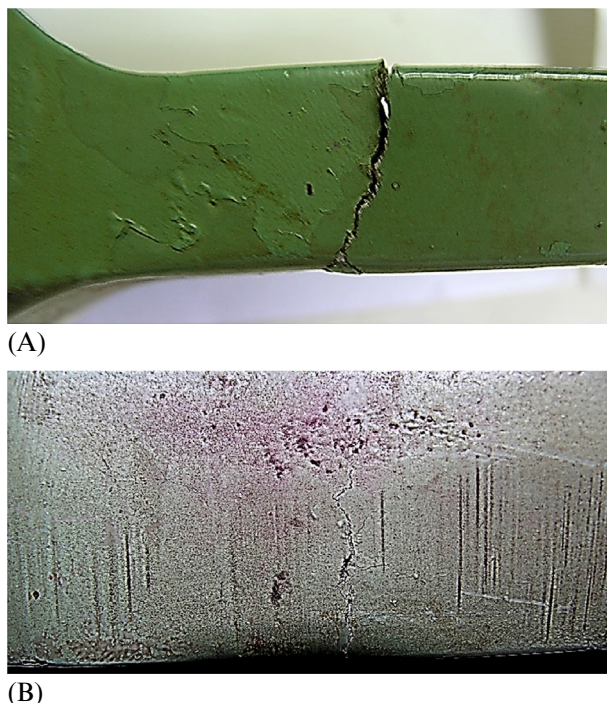
**Fig. 10.3.2** (A) Close-up view of the crack as mentioned in [Fig. 10.3.1](#). (B) Pits and deep grooves on the inner surface of the component.

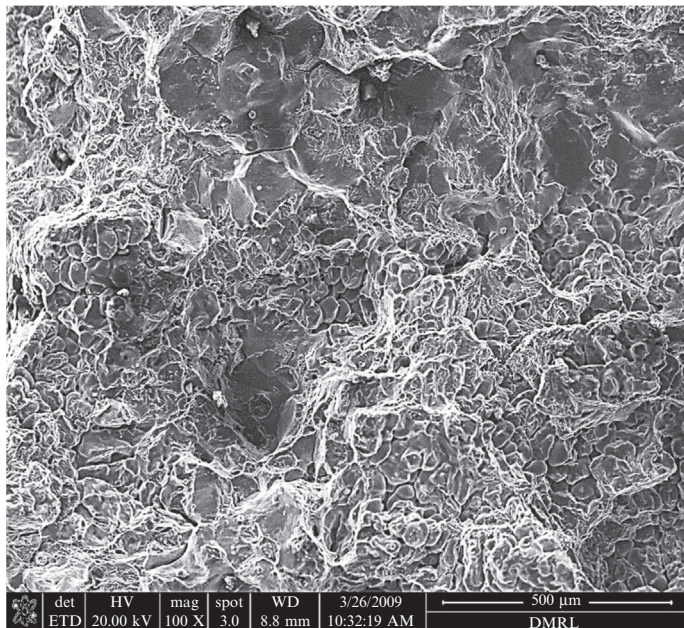
**Fig. 10.3.3** SEM fractograph of the fracture surface near the surface showing intergranular fracture features in pockets and also dendritic features.

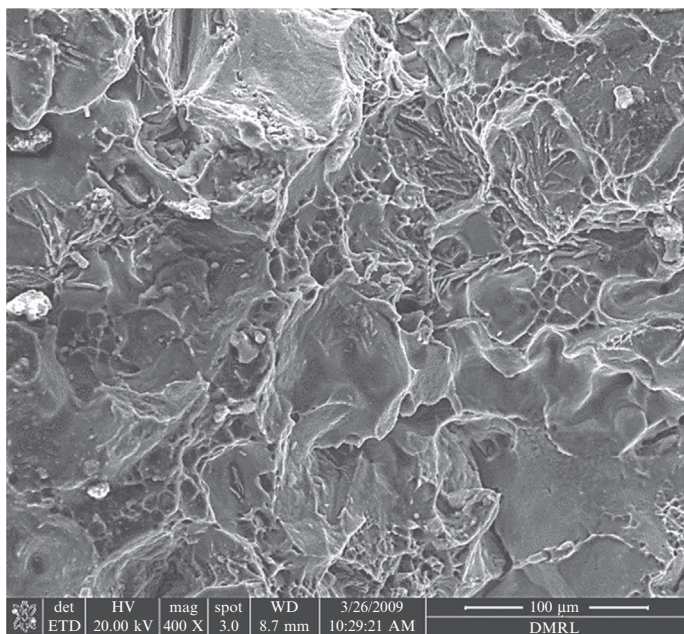
**Fig. 10.3.4** SEM fractograph of the fracture surface in the center showing quasi-cleavage fracture and pockets of dimpled rupture.

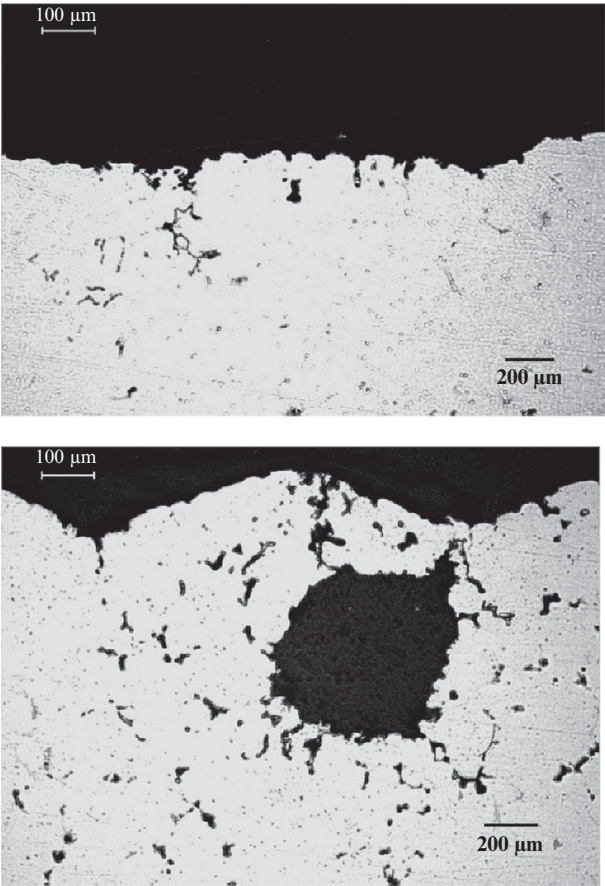
**Fig. 10.3.5** Micrograph of a section of the component showing pitting and intergranular corrosion near the surface. Unetched.

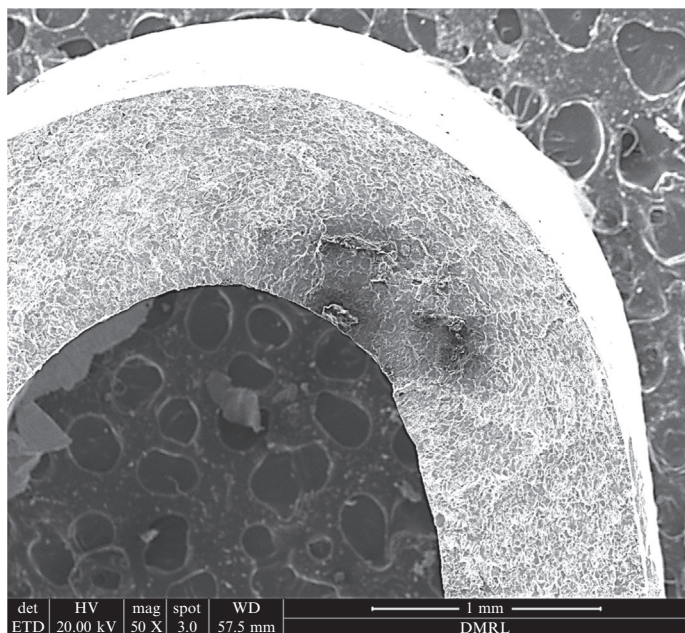
**Fig. 10.4.4** SEM fractograph of the fracture surface showing tarnished and discolored region near the inner surface of the 'U'-bend.

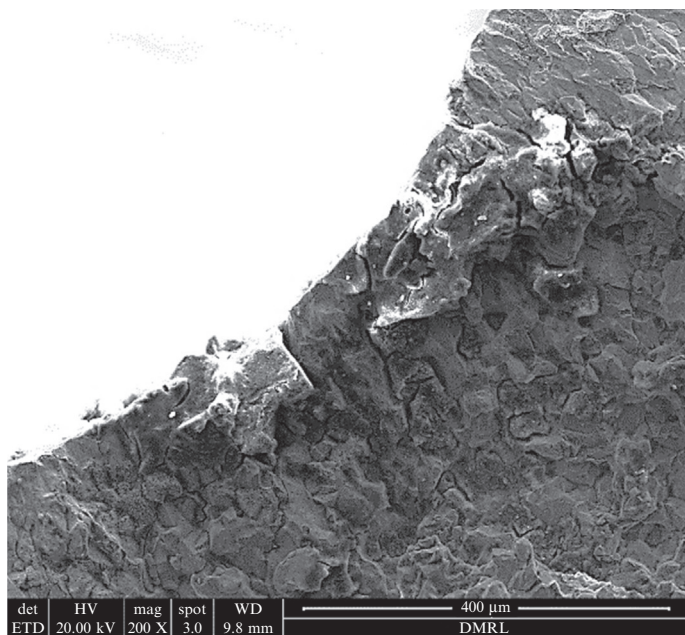
**Fig. 10.4.5** SEM fractograph of the fracture surface showing corrosion debris and mud cracks in the discolored region.

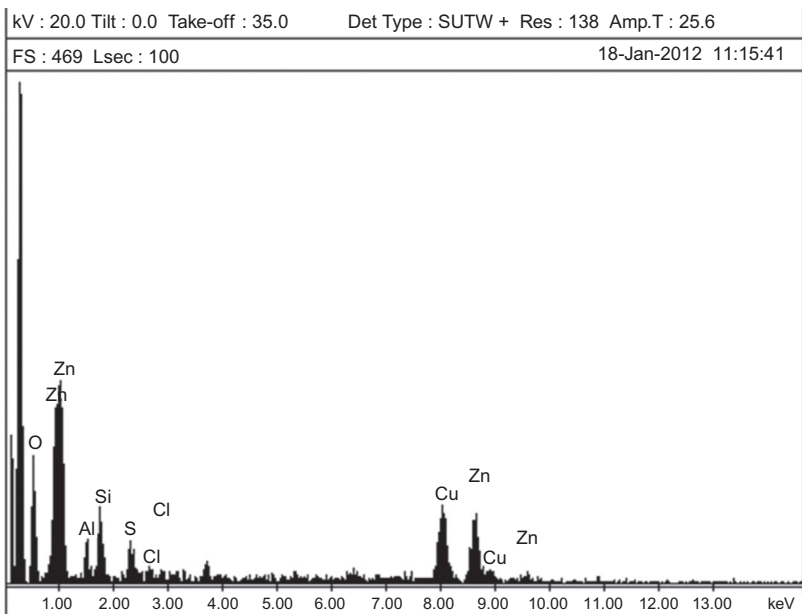
**Fig. 10.4.6** EDAX of the corrosion debris showing presence of sulfur in addition to the elements composing the brass cartridge, the rubber gasket, and the filler compound.

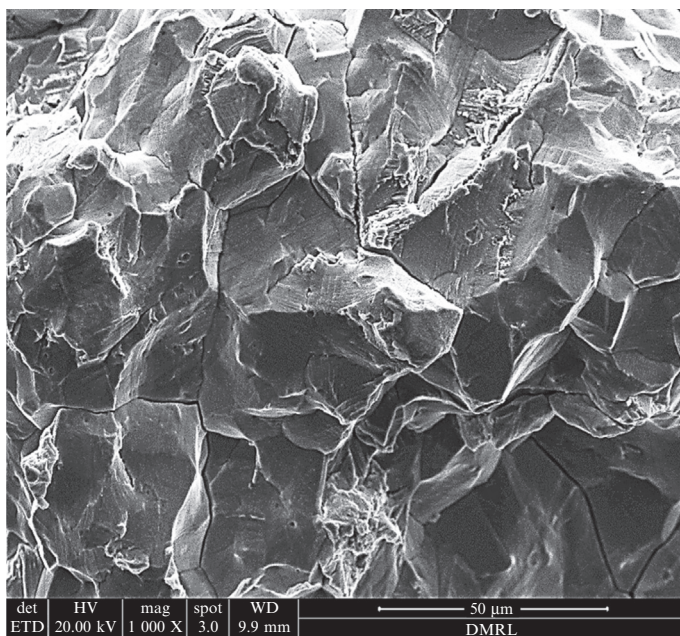
**Fig. 10.4.7** SEM fractograph of the fracture surface showing an intergranular fracture with secondary cracks.

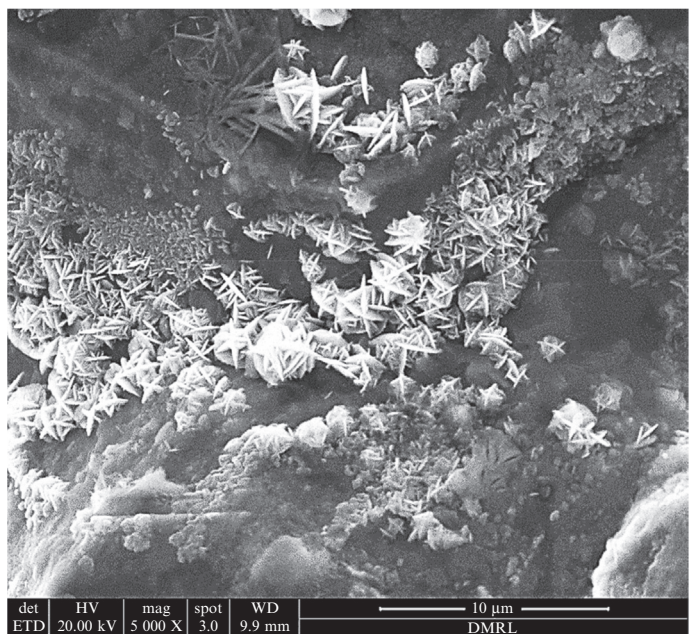
**Fig. 10.4.8** SEM fractograph of the fracture surface showing pockets of debris at higher magnification.

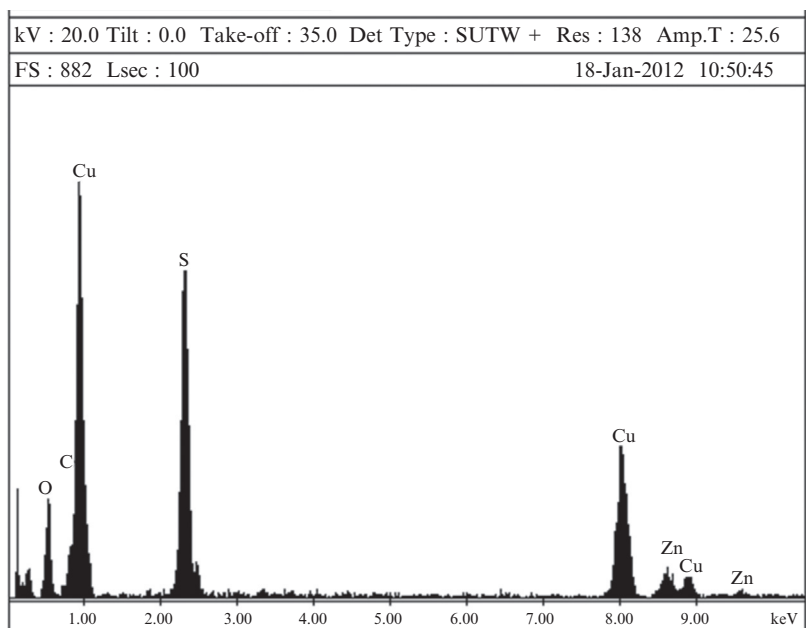
**Fig. 10.4.9** EDAX of the debris showing presence of large amount of sulfur in addition to the elements constituting the brass cartridge.

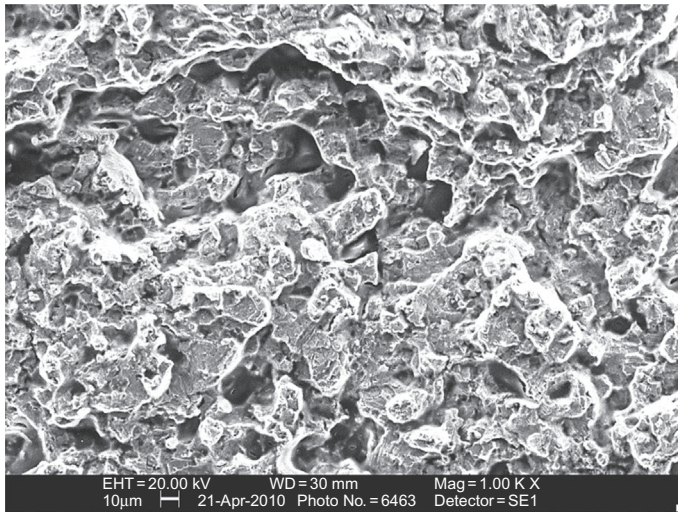
**Fig. 11.1.6** SEM fractograph of the fracture surface of the cage showing quasi-cleavage fracture feature.

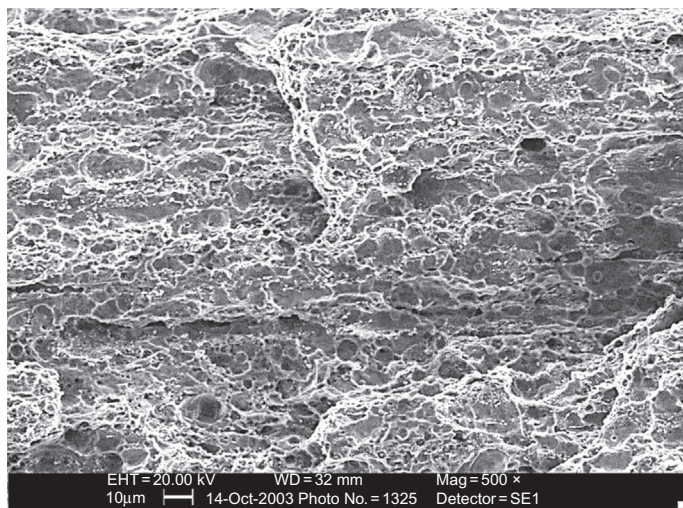
**Fig. 11.2.4** SEM fractograph of the fracture surface showing slightly elongated dimples.

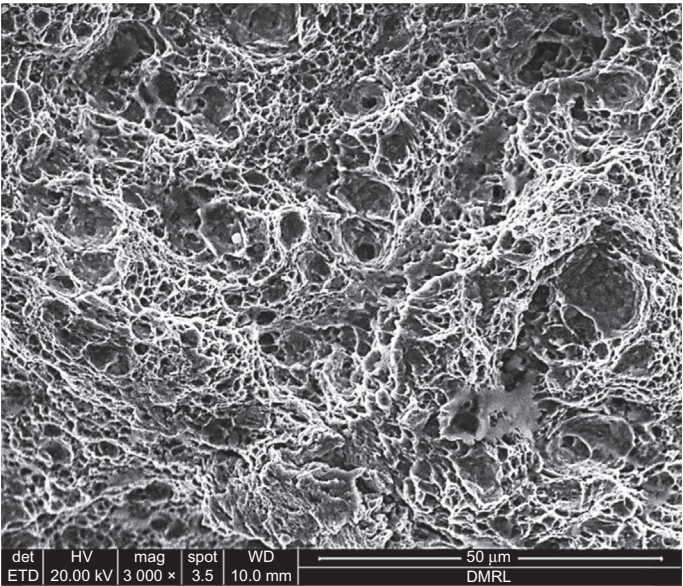
**Fig. 11.3.6** SEM fractograph of the fracture surface of the axle showing equiaxed dimpled rupture.

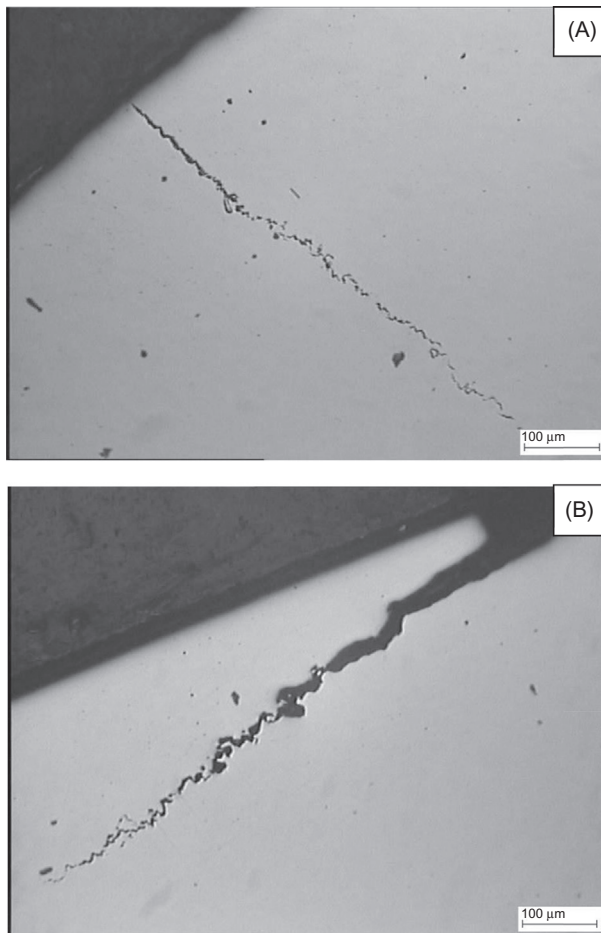
**Fig. 11.3.7** Micrograph of transverse section of the inner race sample showing cracks at the (A) inner and (B) the outer surfaces. Unetched

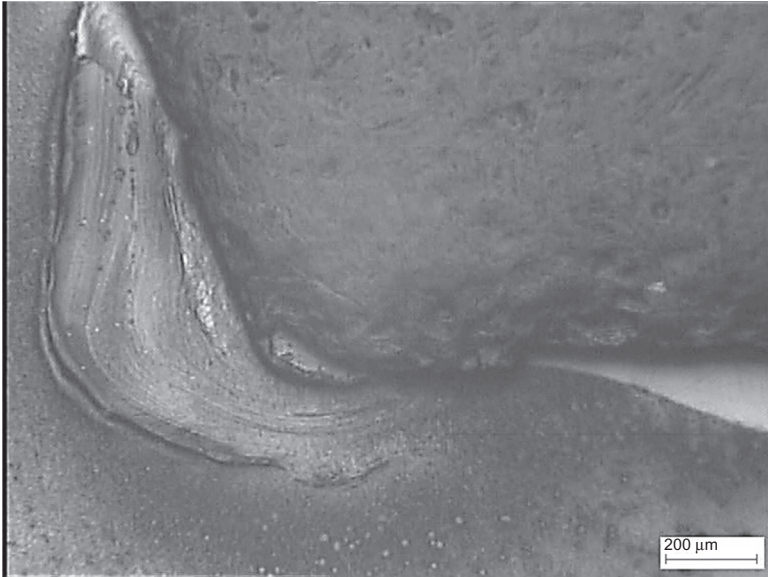
**Fig. 11.3.8** Micrograph of the transverse section of the inner race showing severe deformation and cracking at the elbow. Etchant: 2 % Nital.

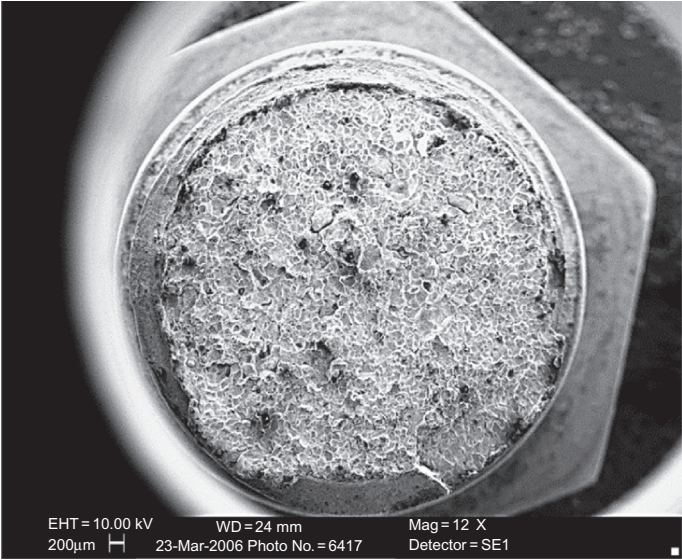
**Fig. 12.1.2** SEM fractograph of the fracture surface showing granular feature at low magnification.

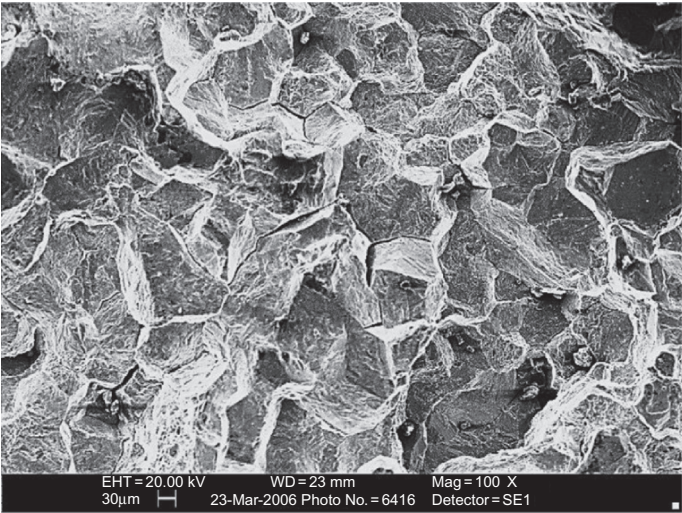
**Fig. 12.1.3** SEM fractograph of the fracture surface showing essentially intergranular fracture with secondary intergranular cracks at higher magnification.
