# **METALLURGICAL FAILURE ANALYSIS**

Techniques and Case Studies

KANNADI PALANKEEZHE BALAN

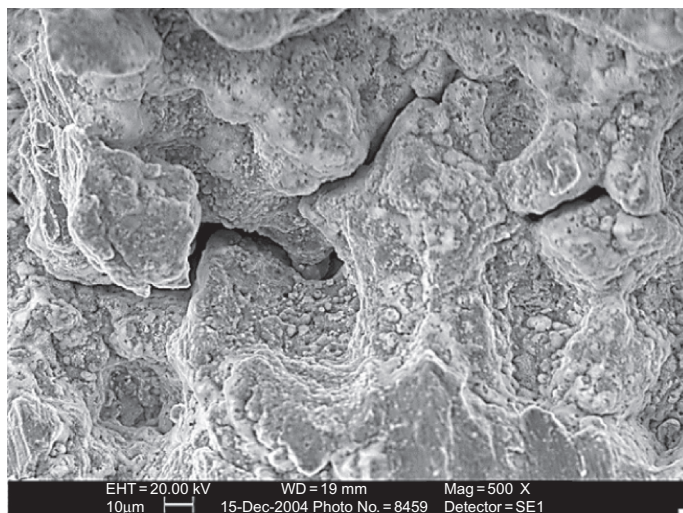
**Fig. 12.2.3** SEM fractograph showing intergranular fracture with secondary cracks and oxide scale on the fracture surface.

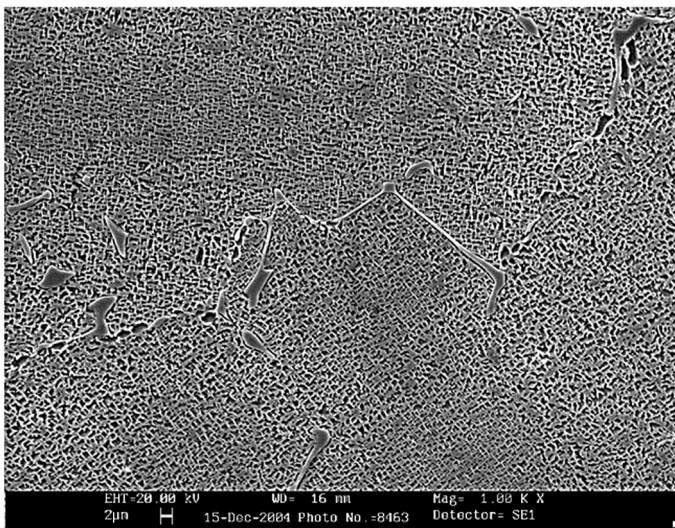
**Fig. 12.2.11** SEM micrograph of the vane sample showing predominantly continuous films of carbide along the grain boundary and gamma prime within the grains of gamma in the aerofoil. Etchant: Kalling's reagent.

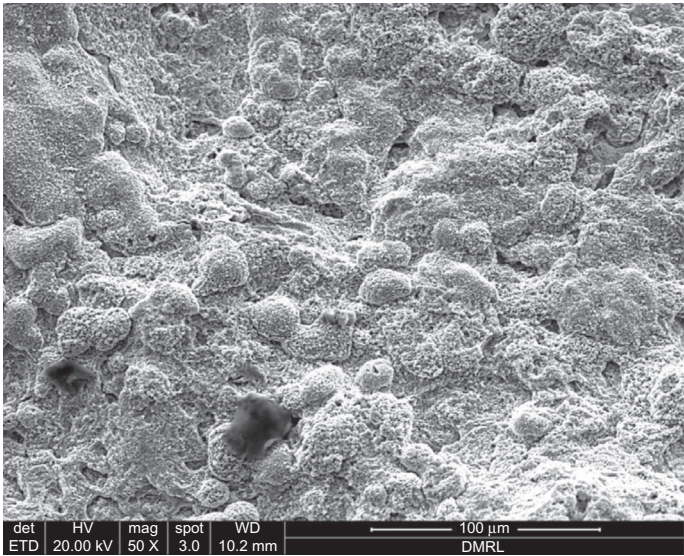
**Fig. 12.5.5** SEM fractograph of the fracture surface showing thick adherent oxide scale.

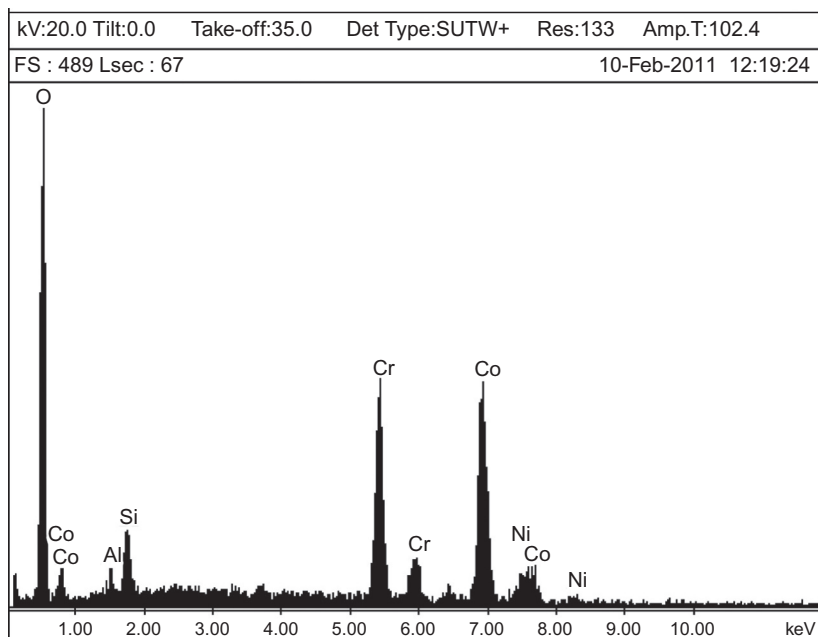
**Fig. 12.5.6** EDAX spectrum of the oxide scale found on the fracture surface.

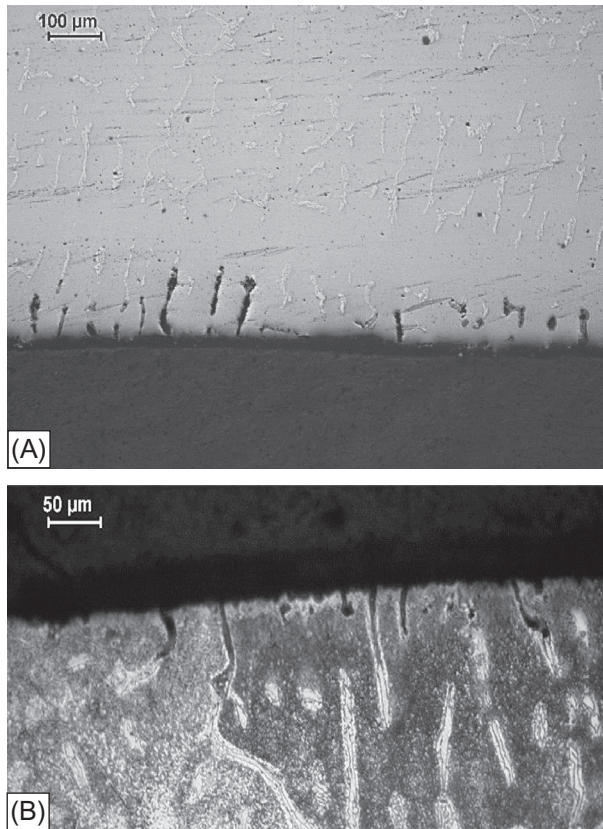
**Fig. 12.5.7** Micrograph of the longitudinal section from the aerofoil of a vane sample showing oxide-filled grain boundary cracks near the surface. (A) Unetched and (B) etched: Kalling's reagent.

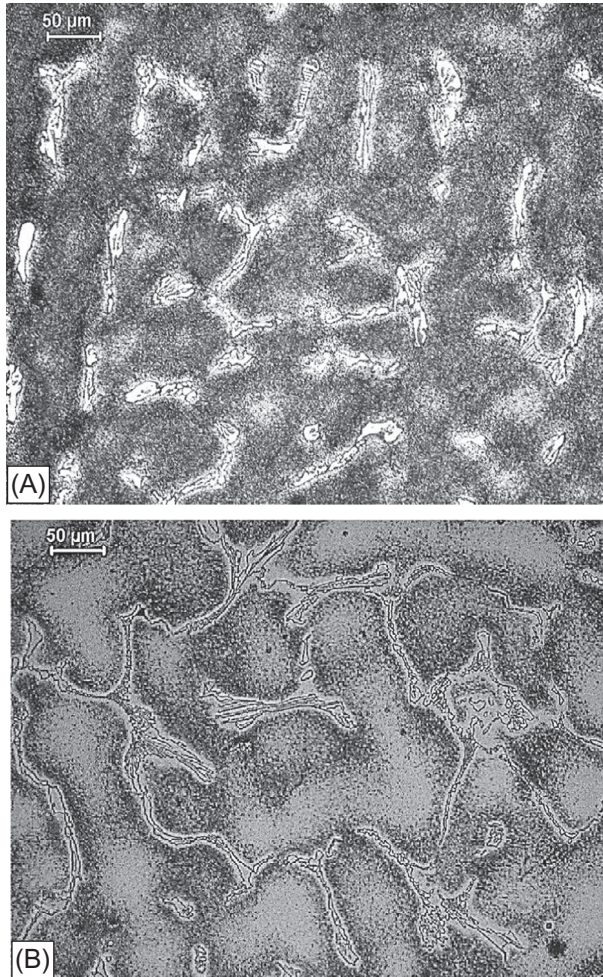
**Fig. 12.5.9** Micrograph of a section of the vane sample showing carbide particles and eutectic along the grain boundaries and mottled (fine spots) chromium-rich carbides in a matrix of solid solution of cobalt. (A) Aerofoil and (B) root. Etchant: Kalling's reagent.
