# METALLURGY OF FAILURE ANALYSIS

# Metallurgy of Failure Analysis

Formerly Manager (Design) Aircraft  
Design Bureau, Hindustan Aeronautics Limited  
Bangalore

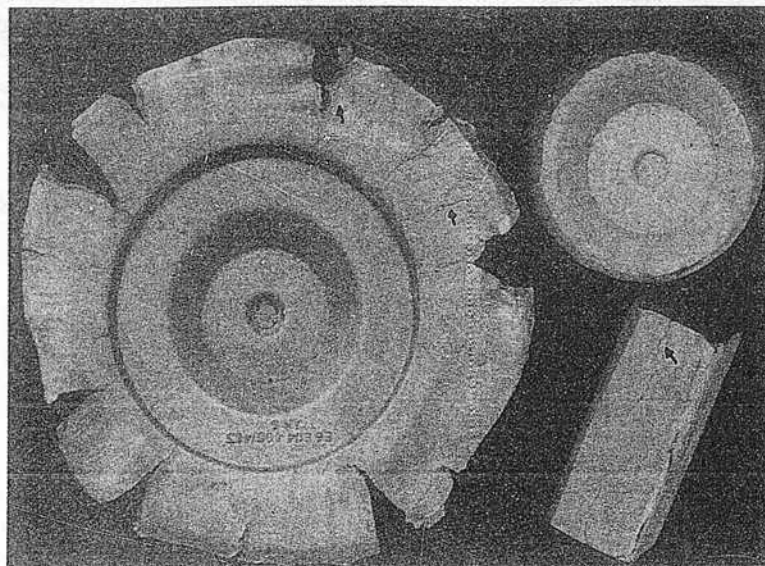
Fig. 7.1 Cracks and random bursting in pre and finished forging stages ( $\times 1/2$ )

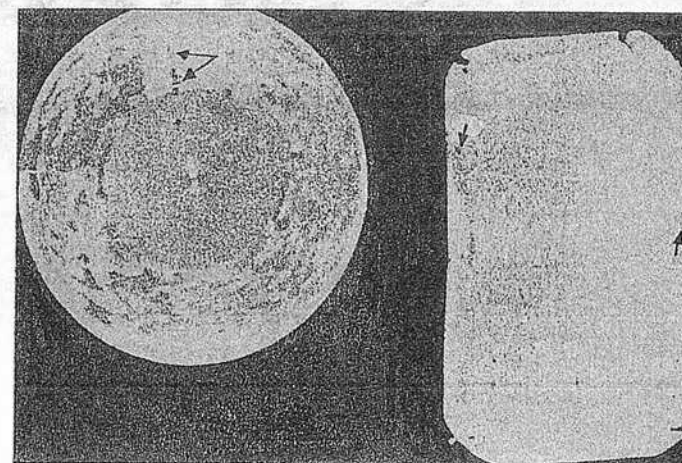
Fig. 7.2 Oxide film confined to coarse grain envelope ( $\times 1$ )

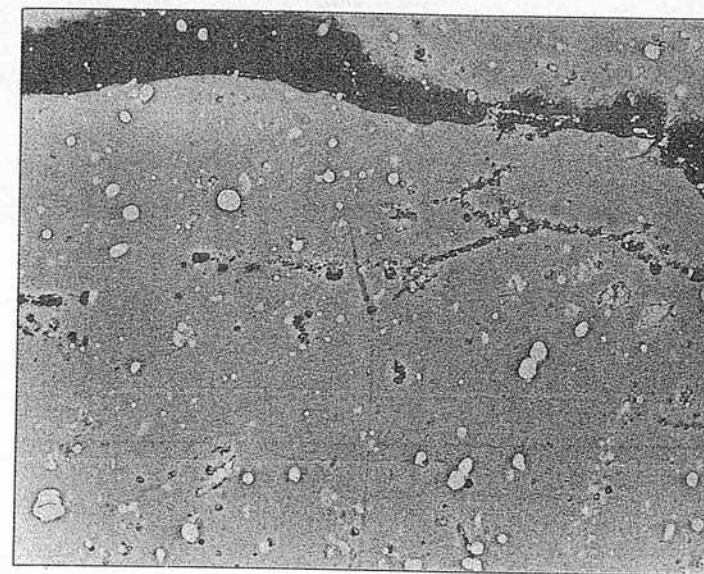
Fig. 7.5 Dark coloured particles as segregation along the path of cracking against white round particles of Cu $Al_2$  under the scanning electron microscope ( $\times 450$ )

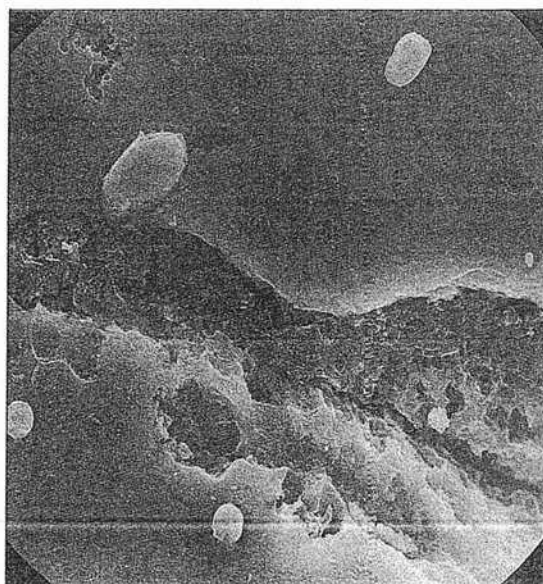
**Fig. 7.7** Segregated zones of copper base particles identified by elemental analysis using microprobe facility ( $\times 1000$ )

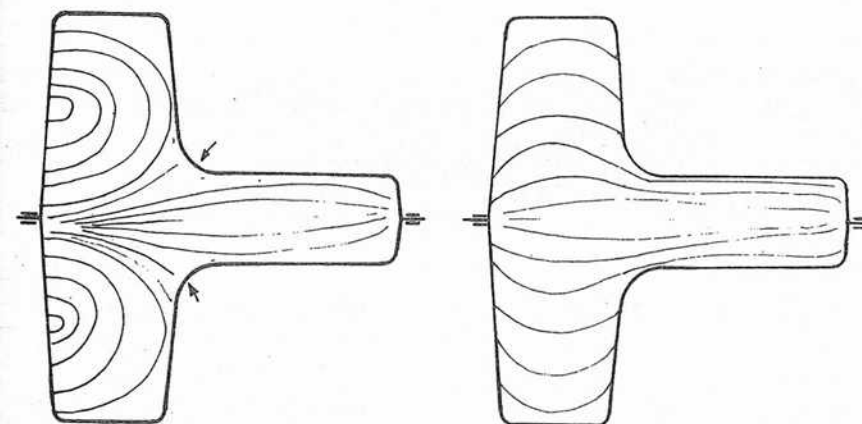
Fig. 7.13 Grain flow pattern as 'push through' defect in the failed part (left) along with desired type of grain flow pattern

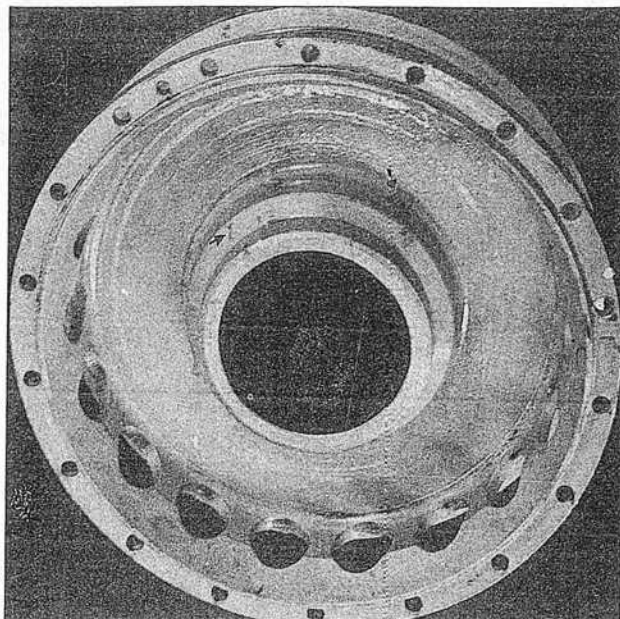
**Fig. 7.28** Several tiny crack like indications, mostly in the base fillet radius zones, on magnafluxing after chrome plating ( $\times 1$ )

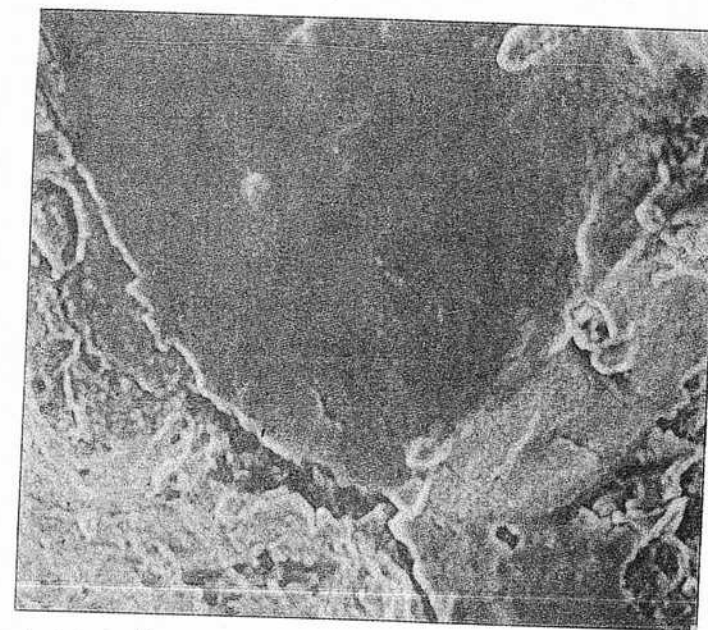
**Fig. 7.30** A mixture of heterogeneous structures including dimples, brittle facets, micropores and hair line crack under scanning electron microscope ( $\times 450$ )

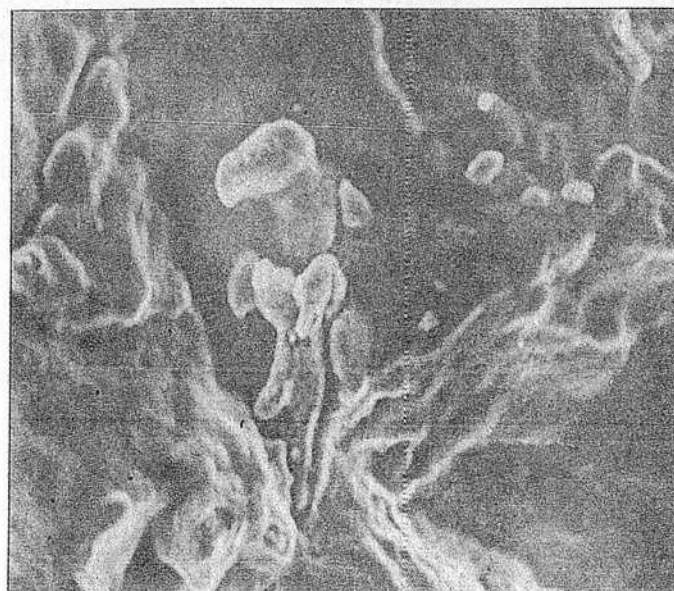
**Fig. 7.31** Presence of manganese sulphide inclusions in rod shaped form in the zone of tiny cracks ( $\times 450$ )

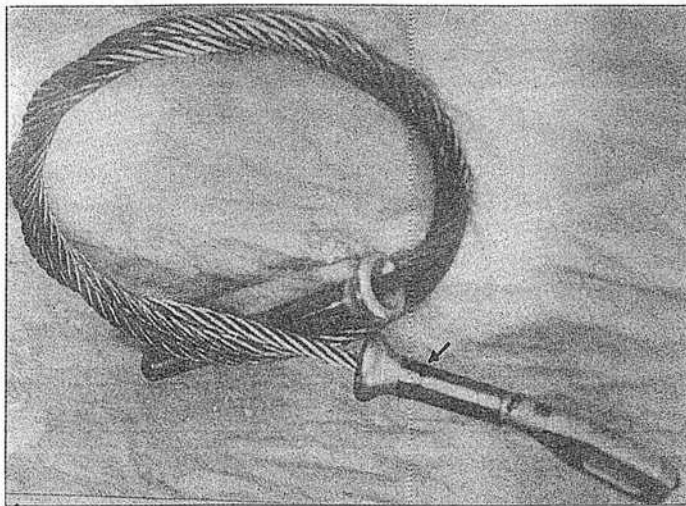
**Fig. 7.34** The swaged cable assembly with the steel link rod and its location of crack (x1)

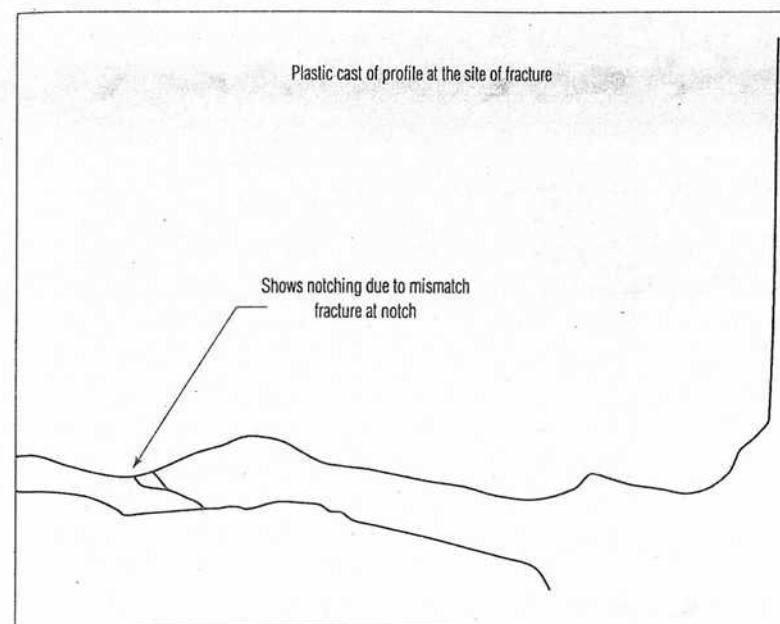
Fig. 7.41 Severe mismatch at the site of the fracture

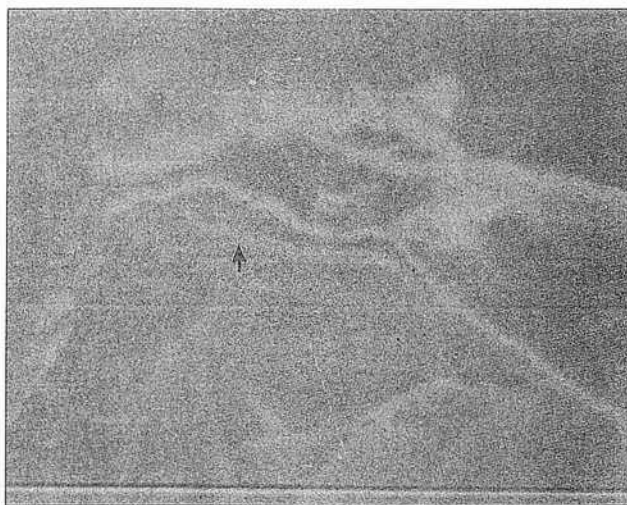
**Fig. 7.43** Secondary cracking and interface separation in the same zone in Fig.7.42, at high magnification, under the scanning electron microscope ( $\times 1500$ )

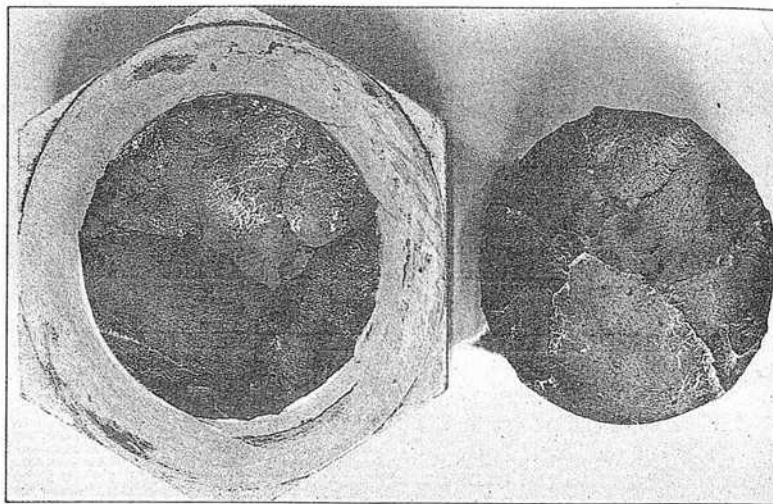
Fig. 8.4 Fractured surfaces of head and shank (kept side by side) ( $\times 2.5$ )

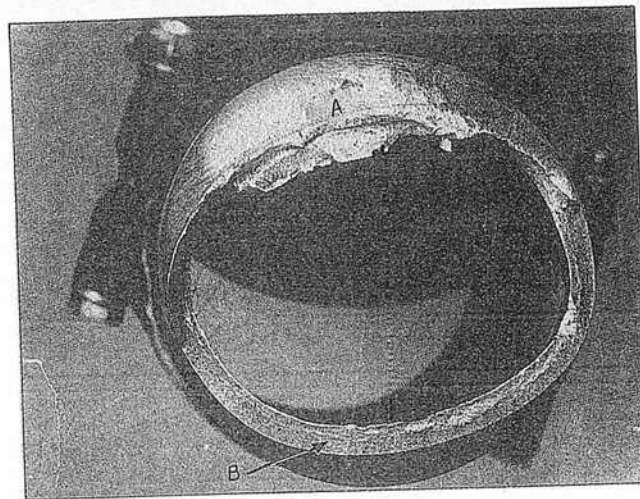
**Fig. 8.8** The cross-section of the broken tube at section 'AB' (with ovality) in Fig. 8.7 ( $\times 1/3$ )

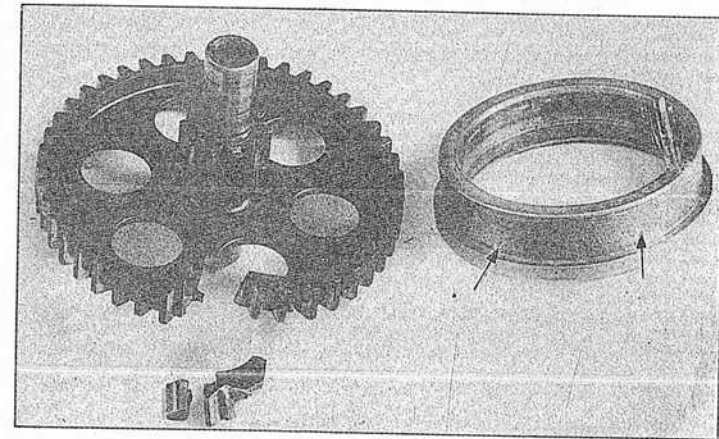
Fig. 8.21 Breakage of the gear with spalled bearing ( $\times 1/2$ )

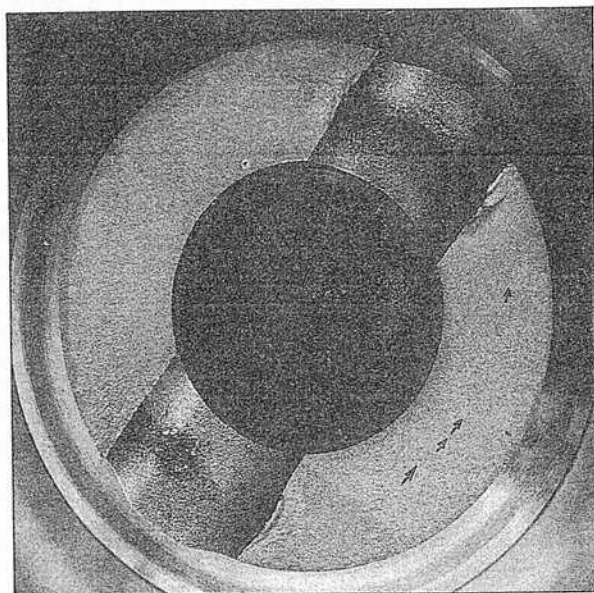
**Fig. 8.28** Smooth brittle fracture surface with burning effects and craters in the bore surface of the elongated hole. Fracture surface also shows faint arrest lines of crack propagation (marked by arrows) ( $\times 4$ )

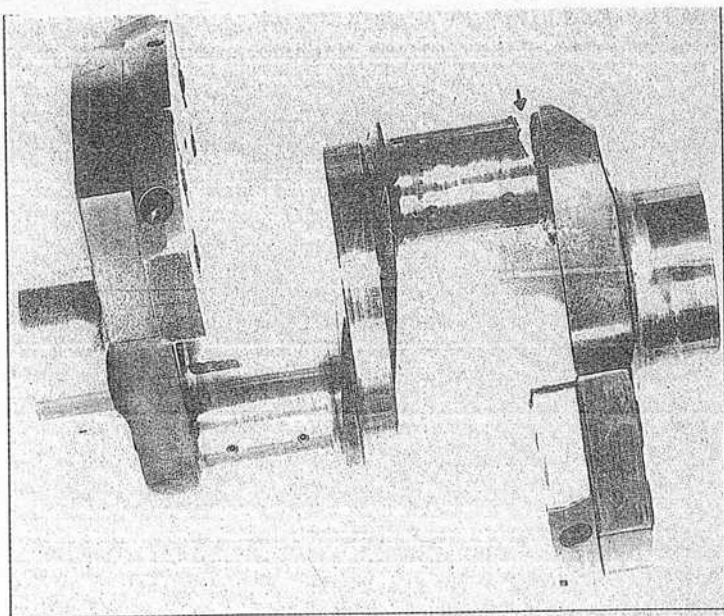
**Fig. 8.31** A close-up photograph of the broken crankshaft portion on assembling them together, showing breakage through the pin shoulder radius zone ( $\times 1/3$ )

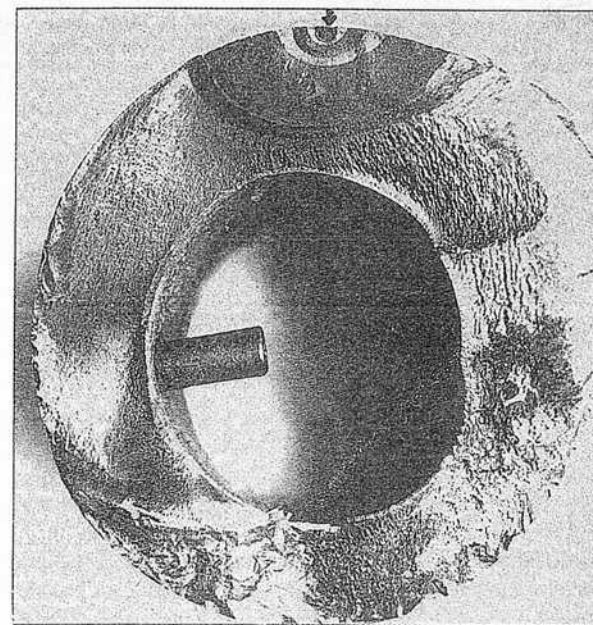
**Fig. 8.32** Smooth fracture zone of the undamaged portion of the broken crankshaft ( $\times 2$ )

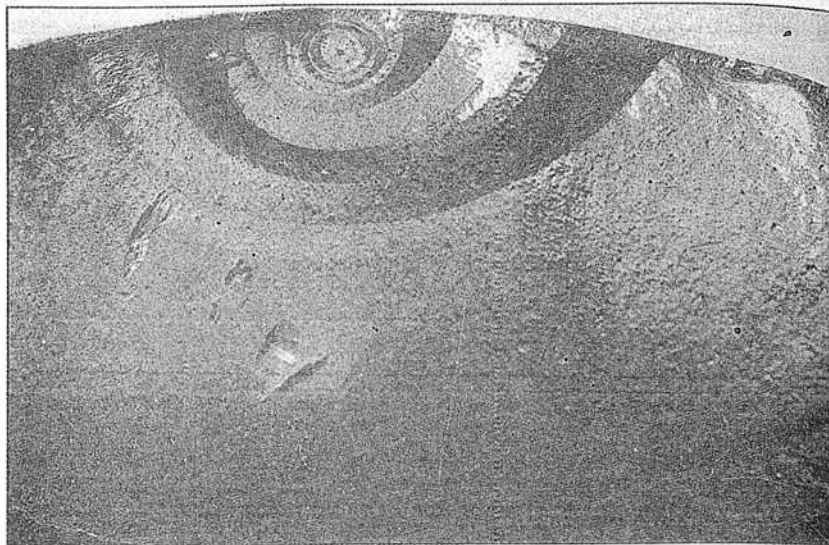
**Fig. 8.33** A 'distinct eye' zone formation by fatigue cracking with origin at a tiny sub-surface defect (black dot) ( $\times 8$ )

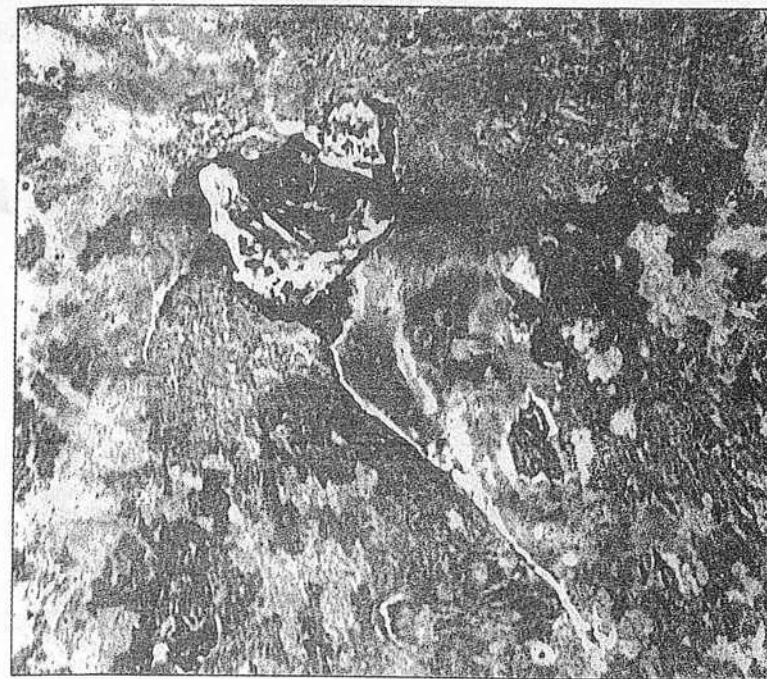
**Fig. 8.34** A hard refractory type inclusion enclosed by a non-metallic film inclusion, around which fatigue beach marks are clearly observed under scanning electron microscope ( $\times 450$ )

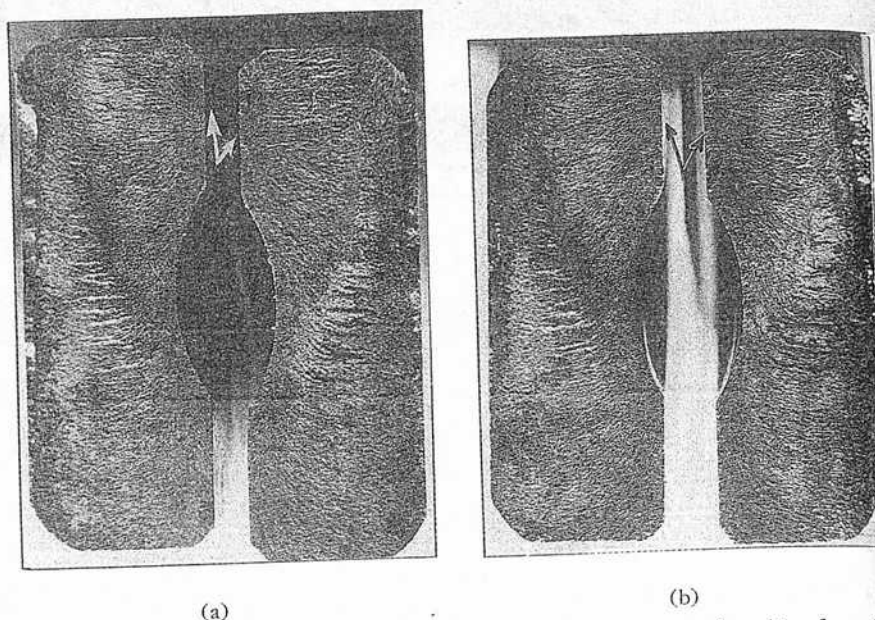
**Fig. 8.39** Small fatigue zone as fractured lines indicating the origin of cracking from the flat region between ID and groove (fractured surfaces kept side by side) ( $\times 10$ )

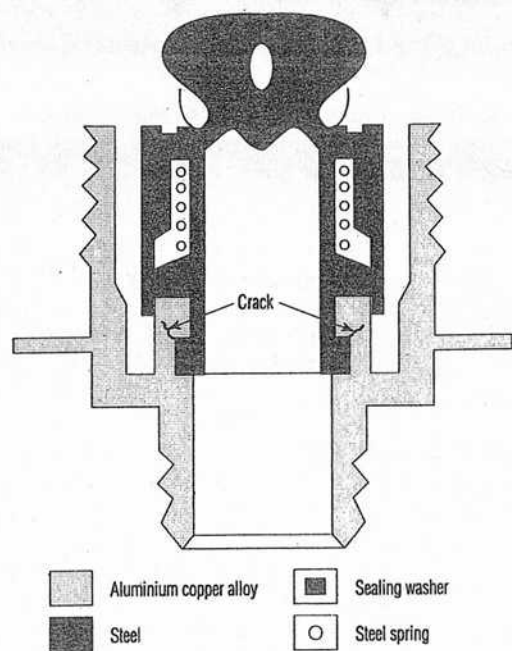
**Fig. 8.40** A schematic construction of the self sealing coupling half flange and the location of crack

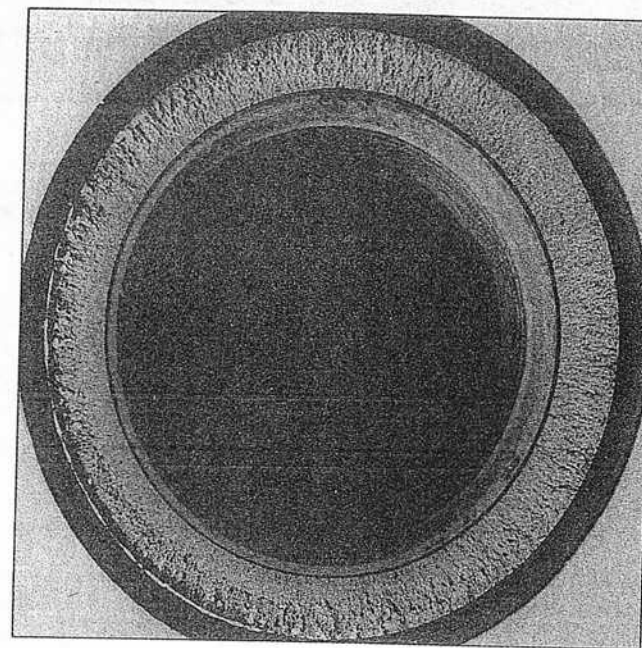
**Fig. 8.41** The fractured surface of the inner tube with fatigue originating from the inner radius ( $\times 5$ )

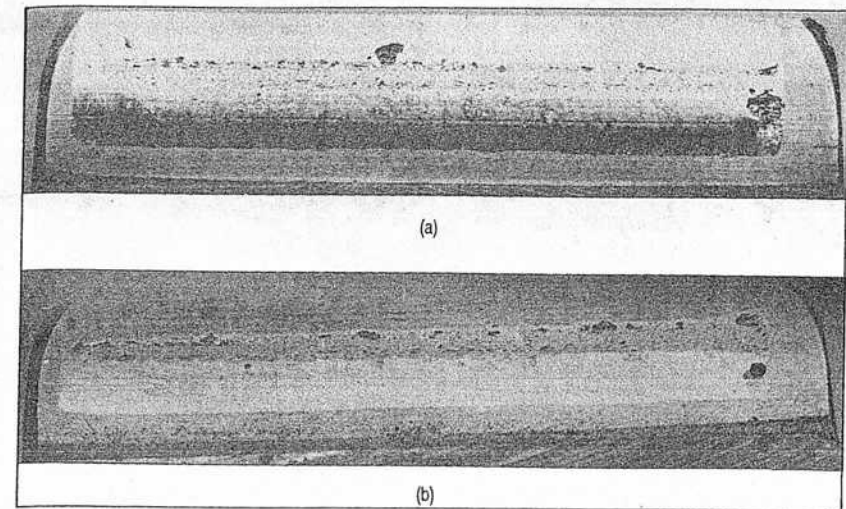
Fig. 8.43 Severe spalling on the driving face of the sun gear teeth ( $\times 8$ )

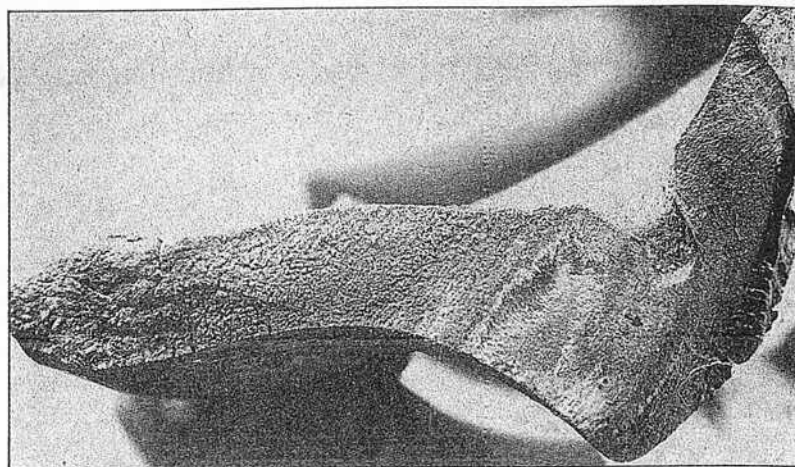
**Fig. 8.52** Fractured surface of radially cracked portion of the seat region showing beach marks with origin at the corrosion pits at the outer periphery of the rim (x5)

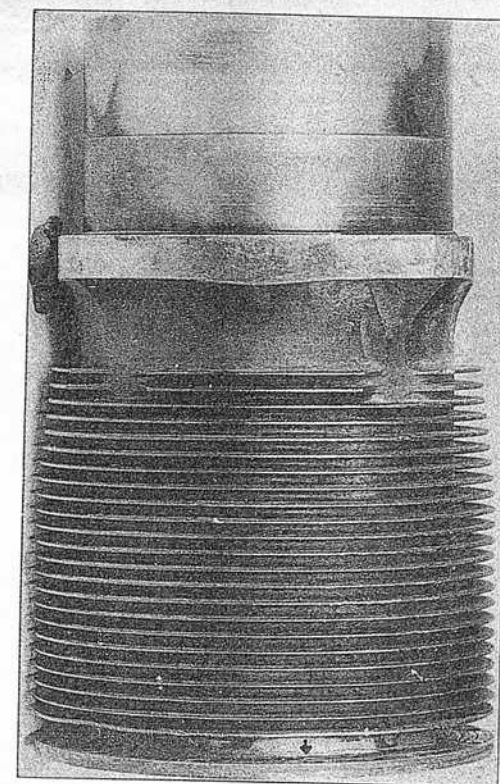
Fig. 8.55 Cylinder barrel cracked at the bottom groove radius ( $\times 1/3$ )

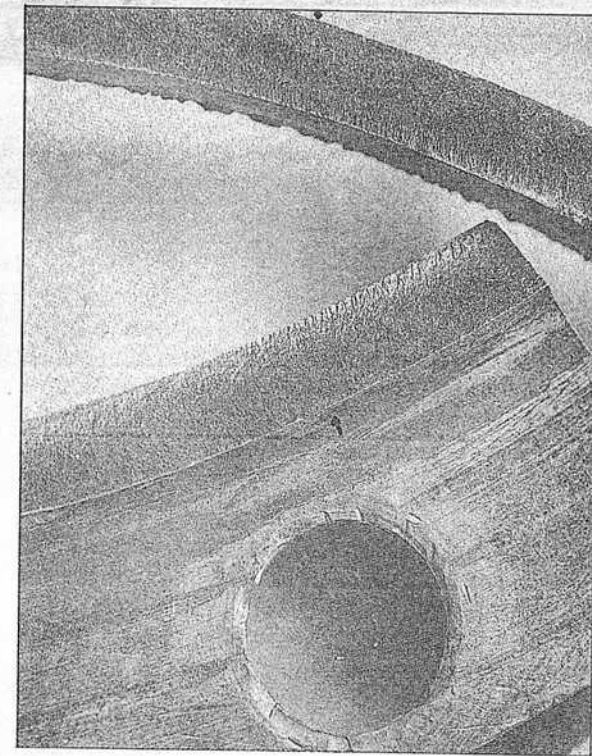
Fig. 8.58 Clear fatigue beach marks originating from the fouled radius zone marked by arrow ( $\times 6$ )

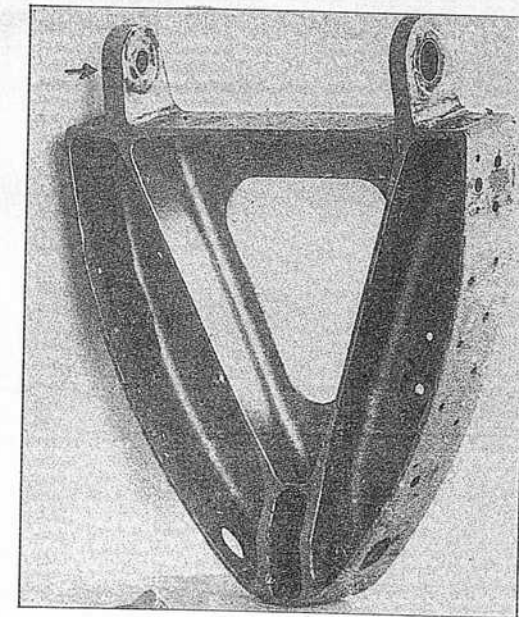
Fig. 8.72 Integral bracket showing crack in the lug ( $\times 1/3$ )

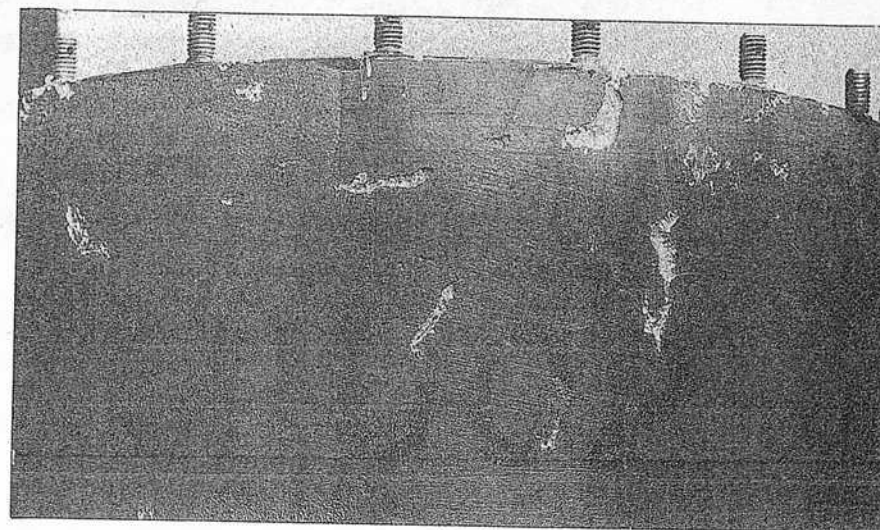
**Fig. 8.75** MGB housing outer surface showing furrows on cleaning off powdery deposits in localised zones ( $\times 1/2$ )

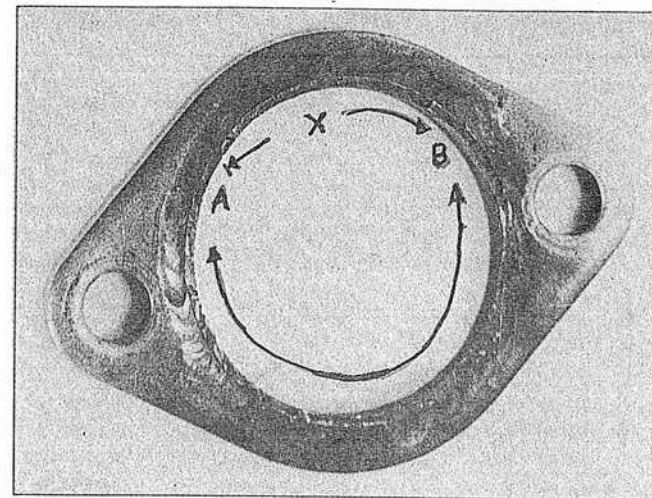
Fig. 8.79 The fractured surface of the cracked portion (A-B). Zone 'X' is fractured at the laboratory ( $\times 1$ )

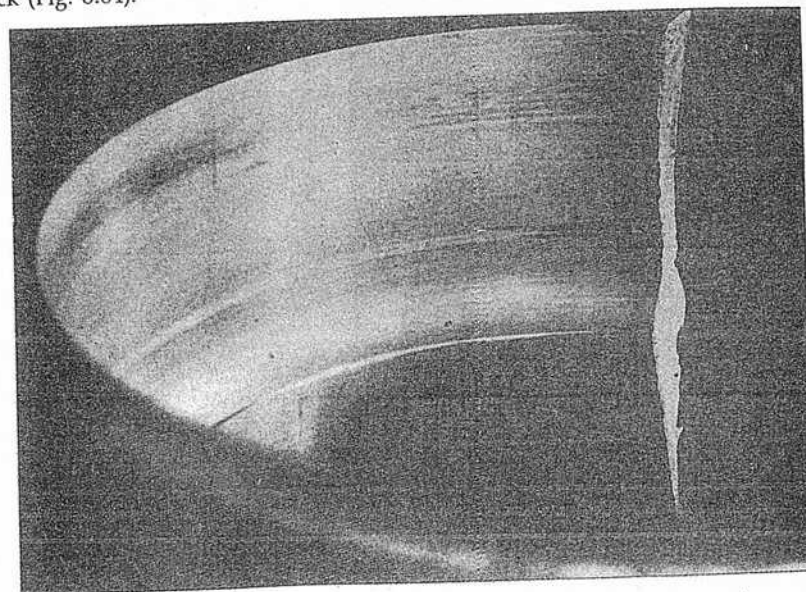
**Fig. 8.84** Bush insert showing deep circumferential scoring marks on the inner face ( $\times 1/2$ )

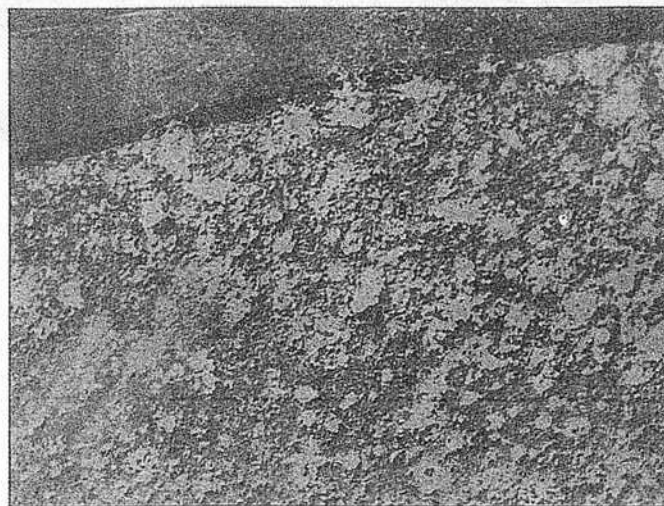
**Fig. 8.87** Severe corrosion attack on the surface of the propeller blade ( $\times 1$ )

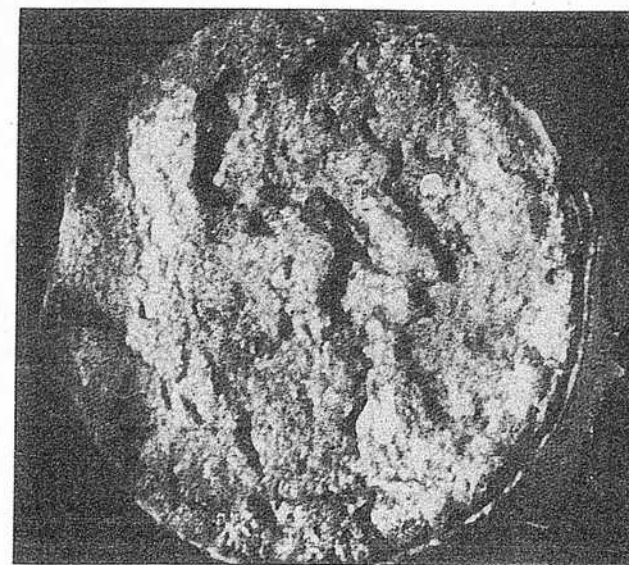
**Fig. 8.88** Brittle laterial fracture ( $\times 20$ )

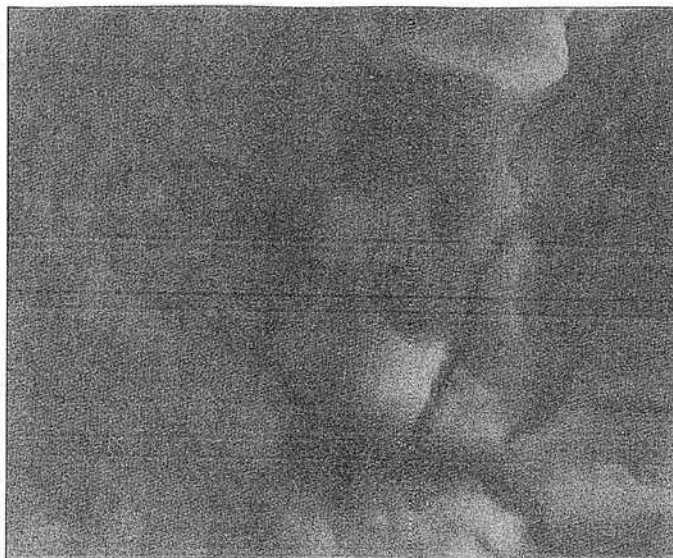
**Fig. 8.89** Intercrystalline mode of fracture under the scanning electron microscope ( $\times 1500$ )

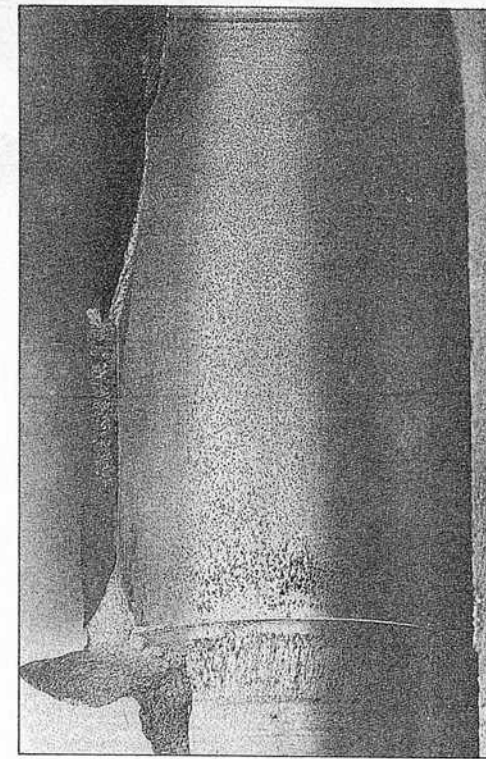
Fig. 8.93 The bore surface of the oleo head in the portion marked 'X' in Fig. 8.91 with numerous corrosion pits ( $\times 1/2$ )

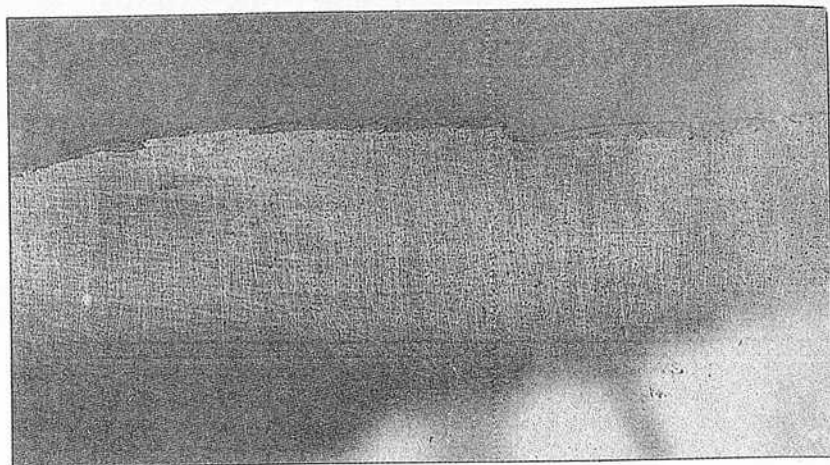
**Fig. 8.96** Origins of fracture from corrosion pits

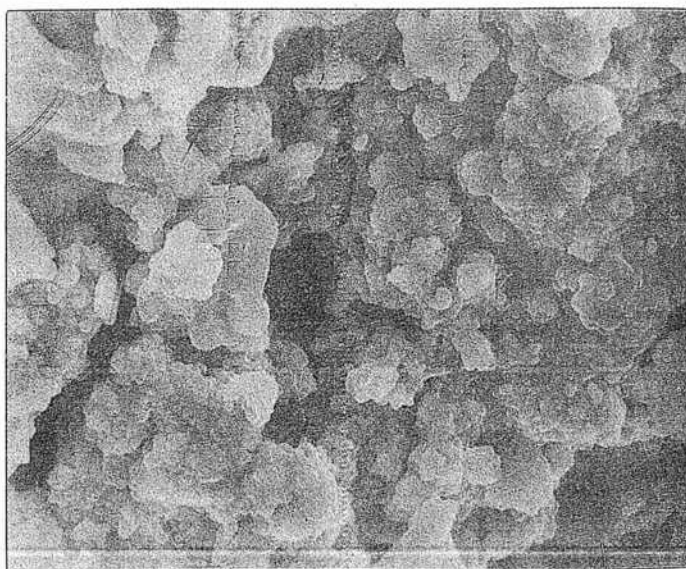
Fig. 8.113 Creep voids and cracks under SEM examination ( $\times 1500$ )
