AGARDograph No. 278

## AGARD Corrosion Handbook Volume 1 Aircraft Corrosion: Causes and Case Histories

W.Wallace  
Head, Structures and Materials Laboratory  
National Aeronautical Establishment  
National Research Council Canada  
Ottawa, Ontario, Canada

D.W.Hoeppner  
Cockburn Professor of Engineering Design  
Department of Mechanical Engineering  
University of Toronto  
Toronto, Ontario, Canada

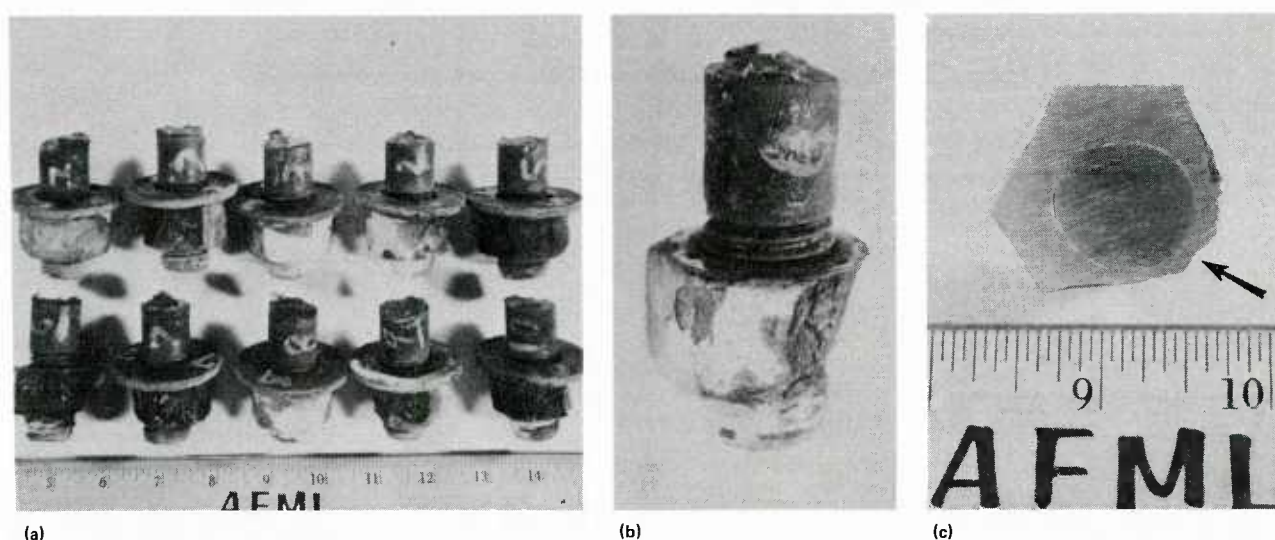
Visual and optical examination verified that considerable corrosion existed on all part surfaces. However, the most severely affected areas were found to be on the surfaces of the nuts, as shown in Figure 7-10(b). Cross-sections through the nuts and bolts revealed the severity of corrosion, and showed that nearly one-third of the cross-sectional area on all ten nuts had been lost to corrosion. The depth of corrosion, in some areas, extended almost to the bolt surface, as shown in Figure 7-10(c).

**Fig. 7-10 Corrosion of structural steel fasteners**

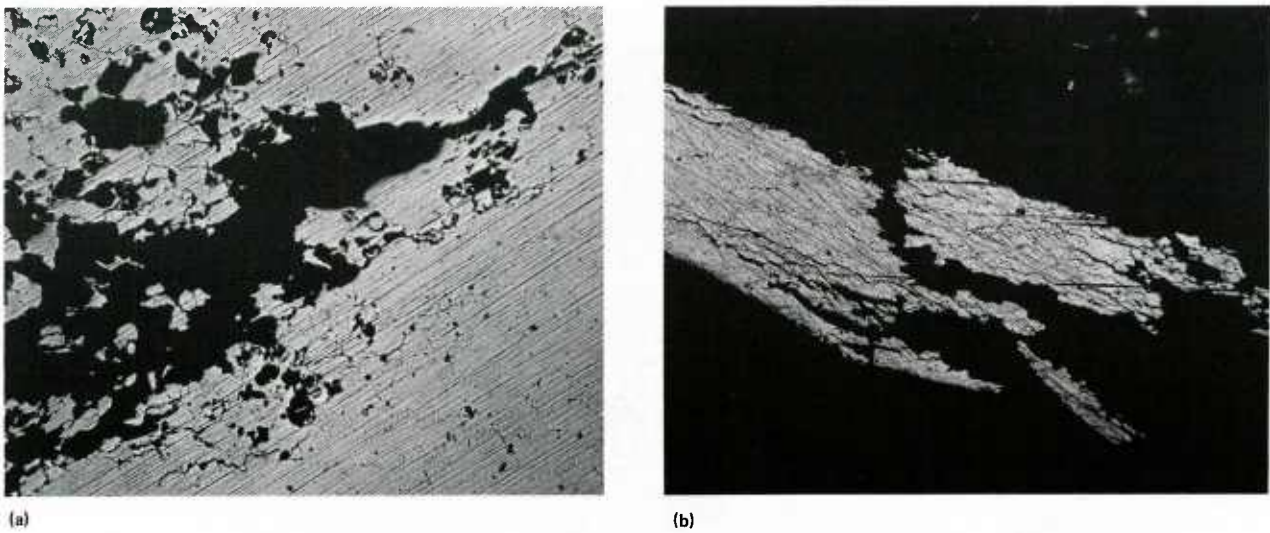
Fig. 8-6 Metallographic sections through the aluminium skin shown in Figures 8-4 and 8-5

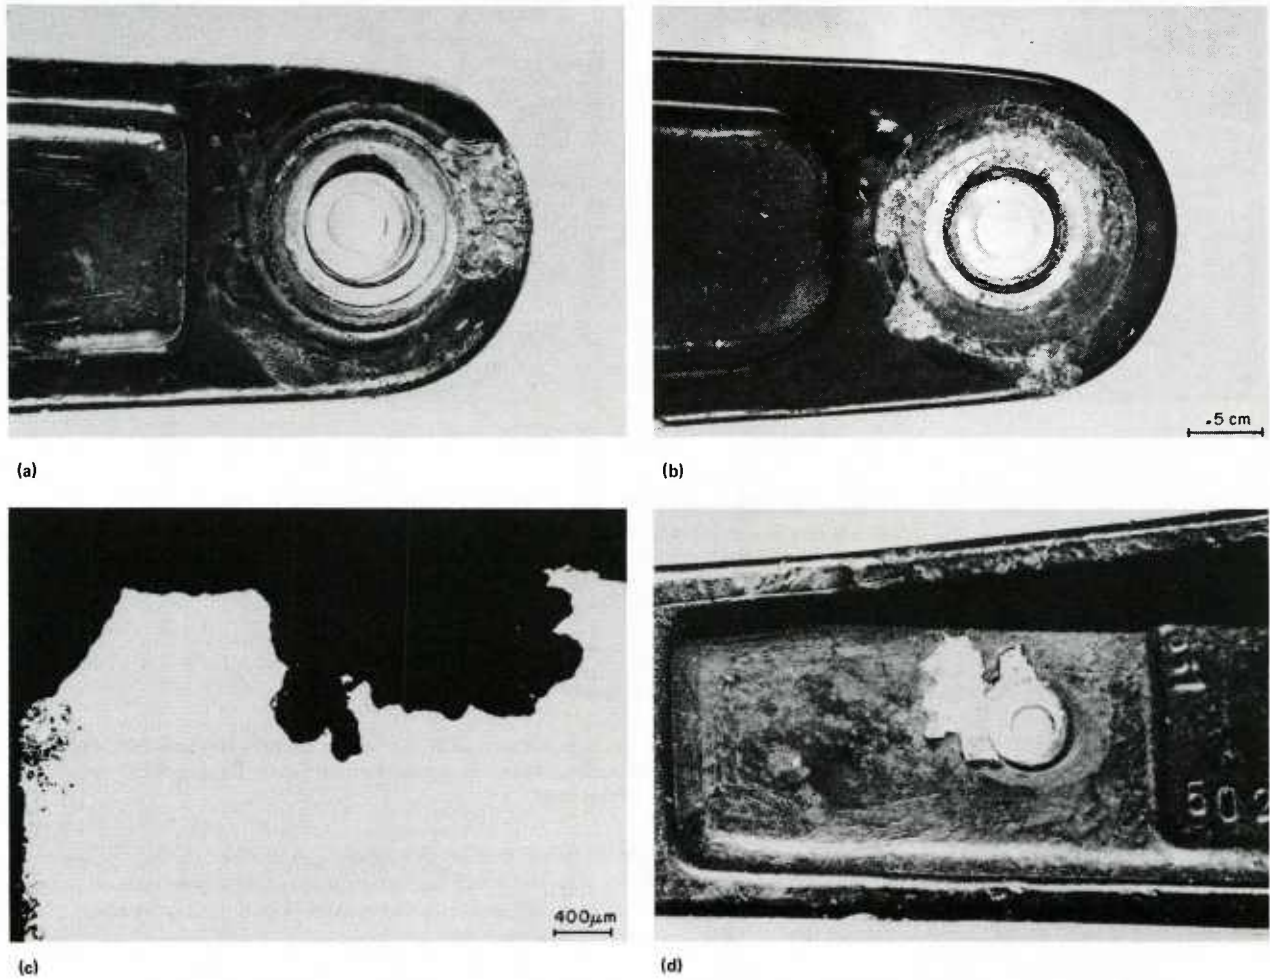
The control levers of a flap deflection mechanism of an aircraft were made from a magnesium casting alloy with a nominal composition Mg - 6%, Zn - 2%, Th - 0.75 Zr, similar to ZH62A. The levers were protected with a zinc-chromate primer and an epoxy top-coat. Galvanic corrosion was found in the levers in a socket where steel balls had been located. The ends of the lever arms are shown in Figures 8-10(a) and 8-10(b), which also show the corrosion damage. Figure 8-10(c) shows a cross-section through the lever arm in the corroded area and shows deep cavities due to this galvanic corrosion.

**Fig. 8-10 Galvanic corrosion in a cast magnesium alloy flap control lever arm**  
(a) and (b) End of the magnesium lever showing ball socket and corrosion. (Mag.  $\times 2$ )  
(c) Cross-section through the corroded region of Figure 8-10(a), showing deep pitting. (Mag.  $\times 25$ )  
(d) Galvanic corrosion in the magnesium lever around a press-fit aluminium bushing.

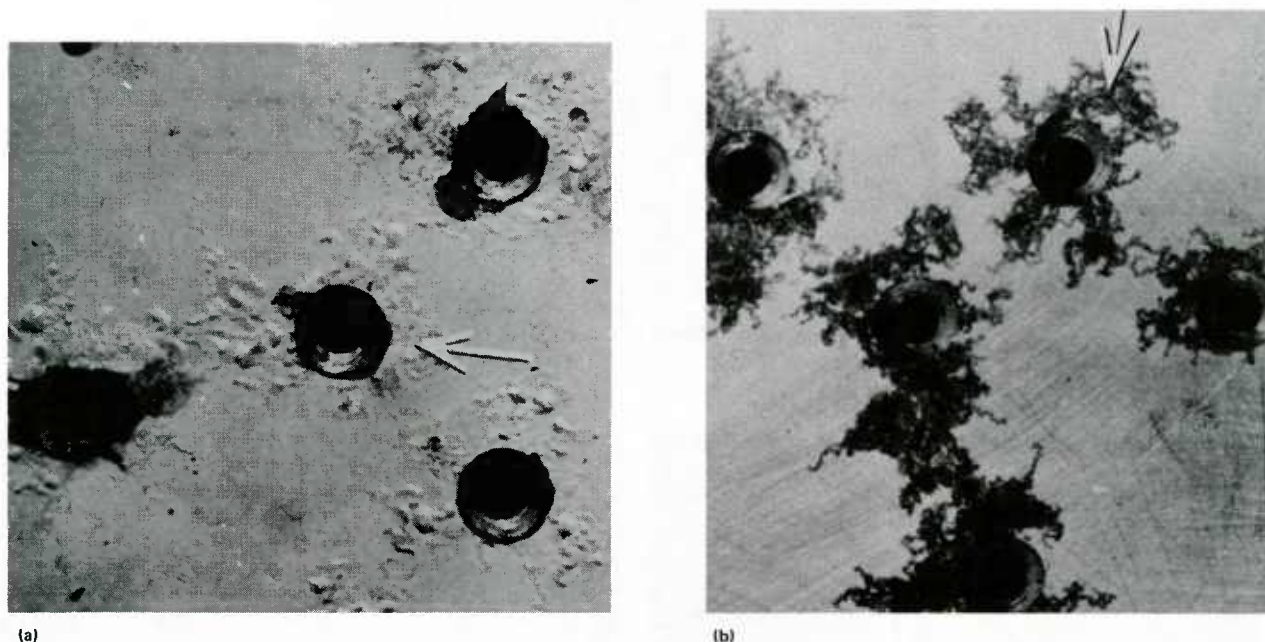
This form of corrosion may become quite severe before it is detected, since it will often be hidden by either cladding or paint, and in the latter case may be indicated by blistering. A typical example is shown in Figure 9-4(a), where the paint blistering is concentrated around the rivet holes in an aluminium alloy sheet. Figure 9-4(b) shows the same area after the paint has been removed, and the threadlike meanderings of the corrosion filaments can be seen. Filiform corrosion has been observed in magnesium, aluminium, steel and chromium-plated nickel.

Fig. 9-4 Filiform corrosion in an aluminium alloy sheet structure

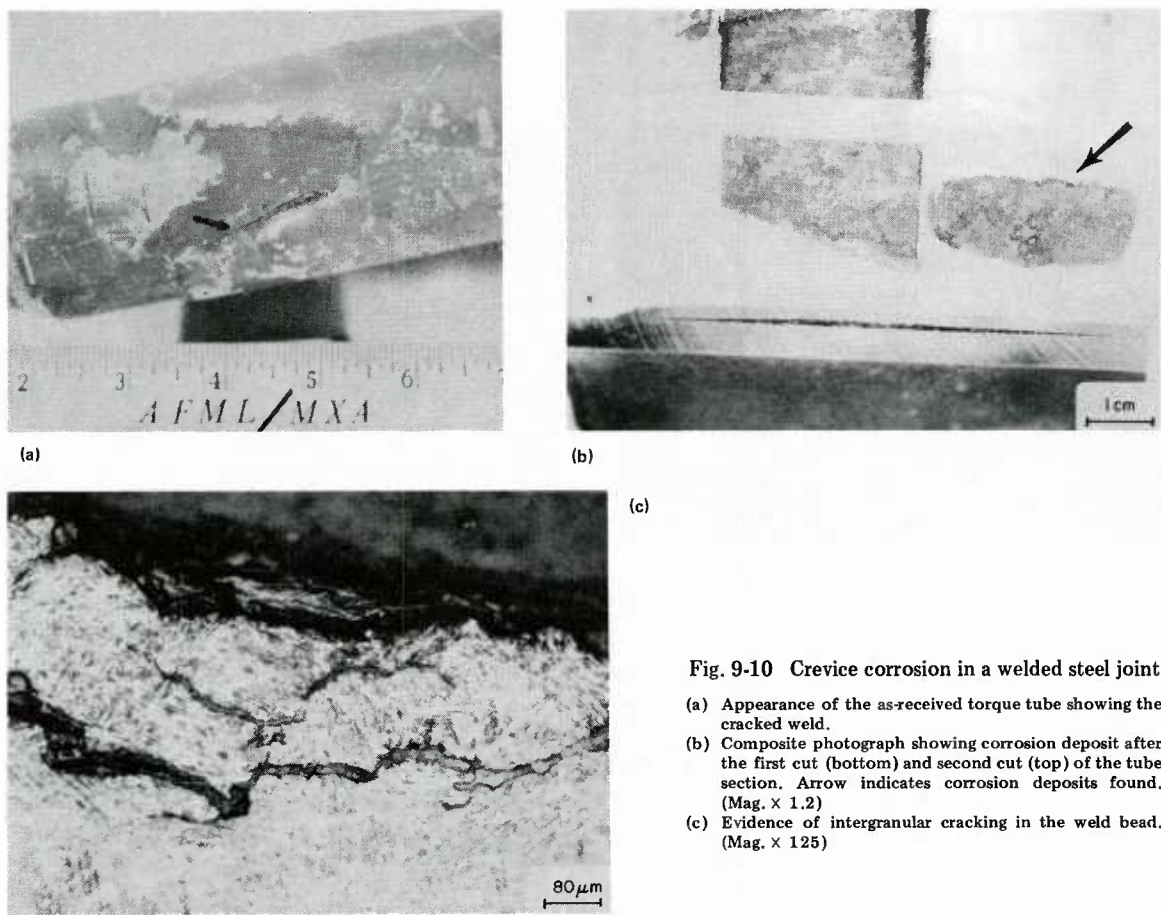
**Fig. 9-10 Crevice corrosion in a welded steel joint**

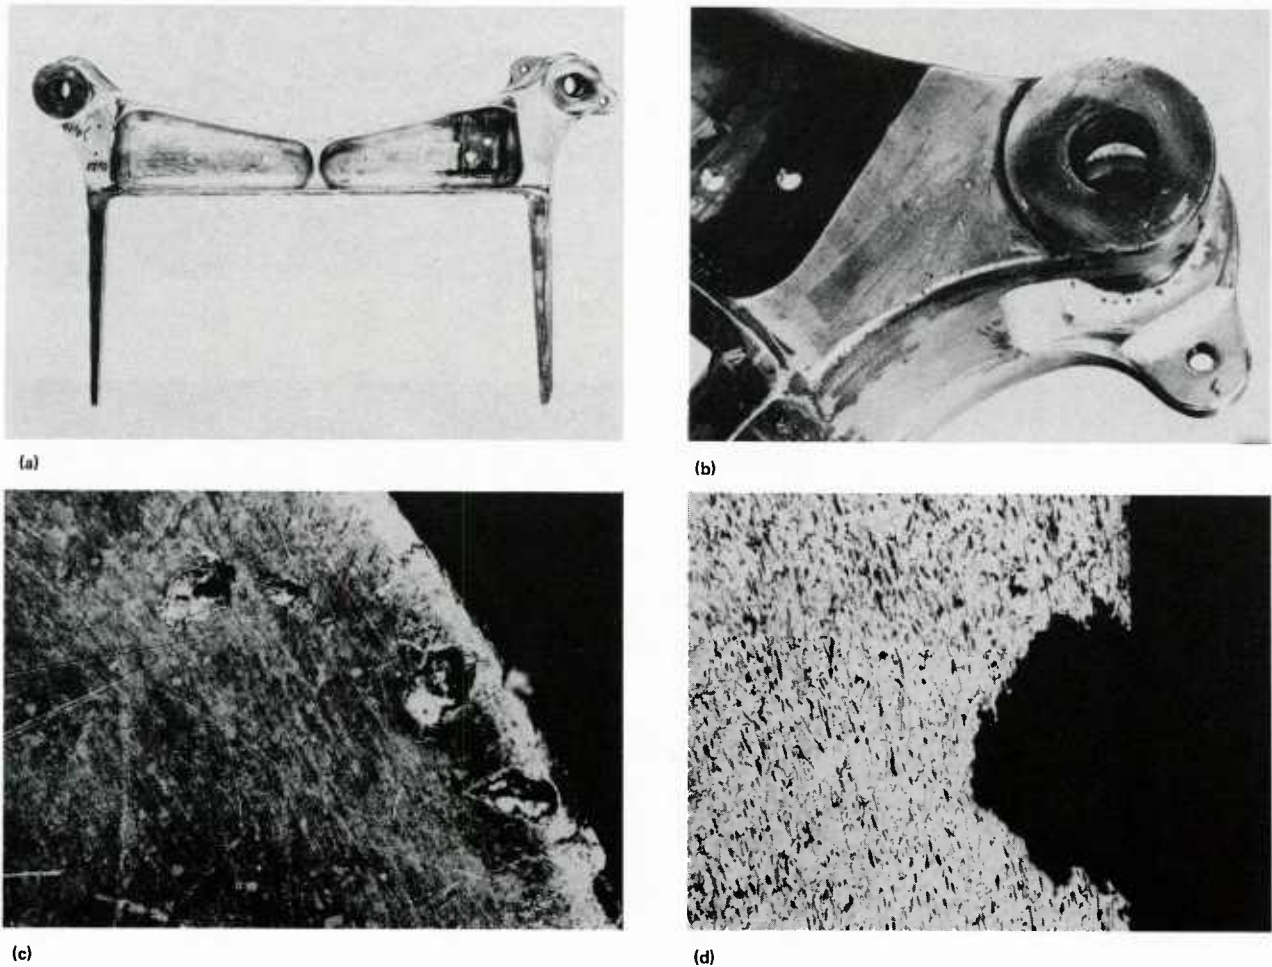
Fig. 9-12 Pitting corrosion of a 7075 aluminium tail cone fitting  
(a) General view of the tail cone fitting.  
(b) Close-up of the right lug.  
(c) Corrosion pits on the outer perimeter of the lug.  
(d) Cross-section through the lug showing corrosion penetration.

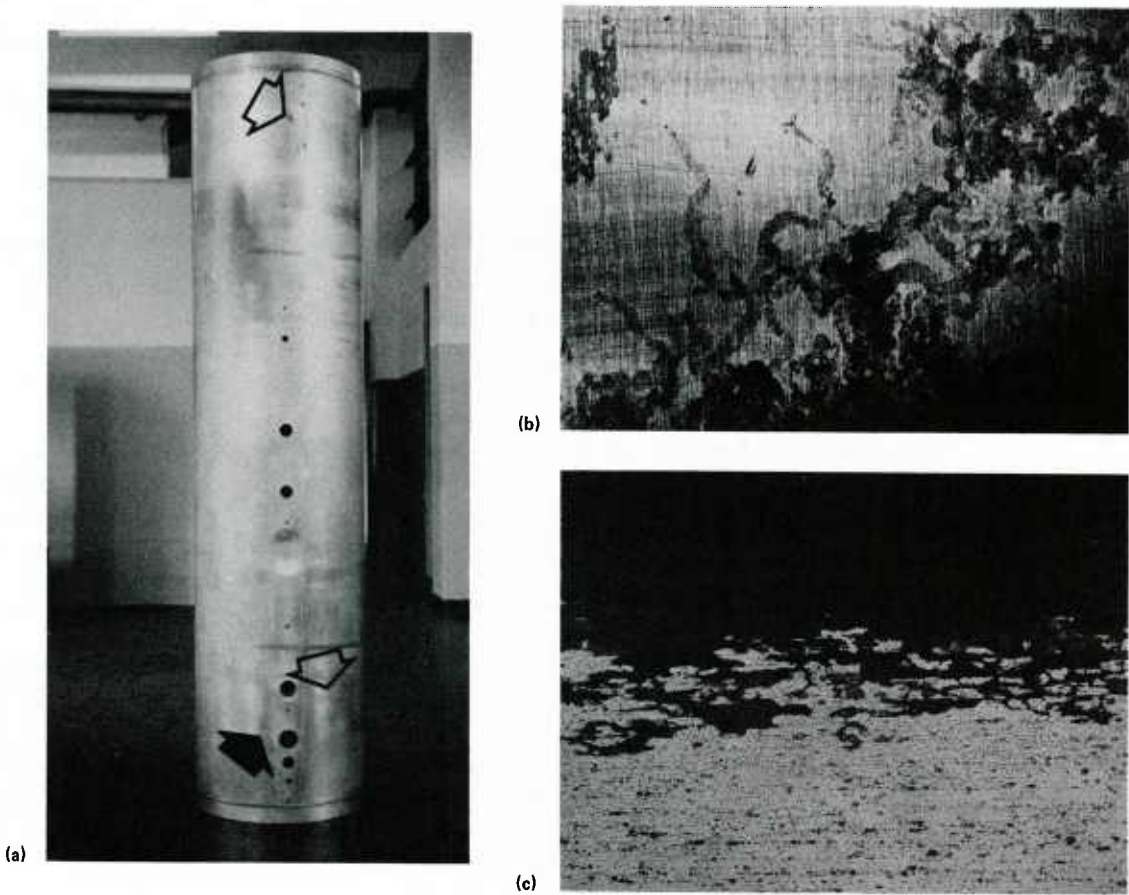
Fig. 9-13 Filiform corrosion in a fighter aircraft pylon tank

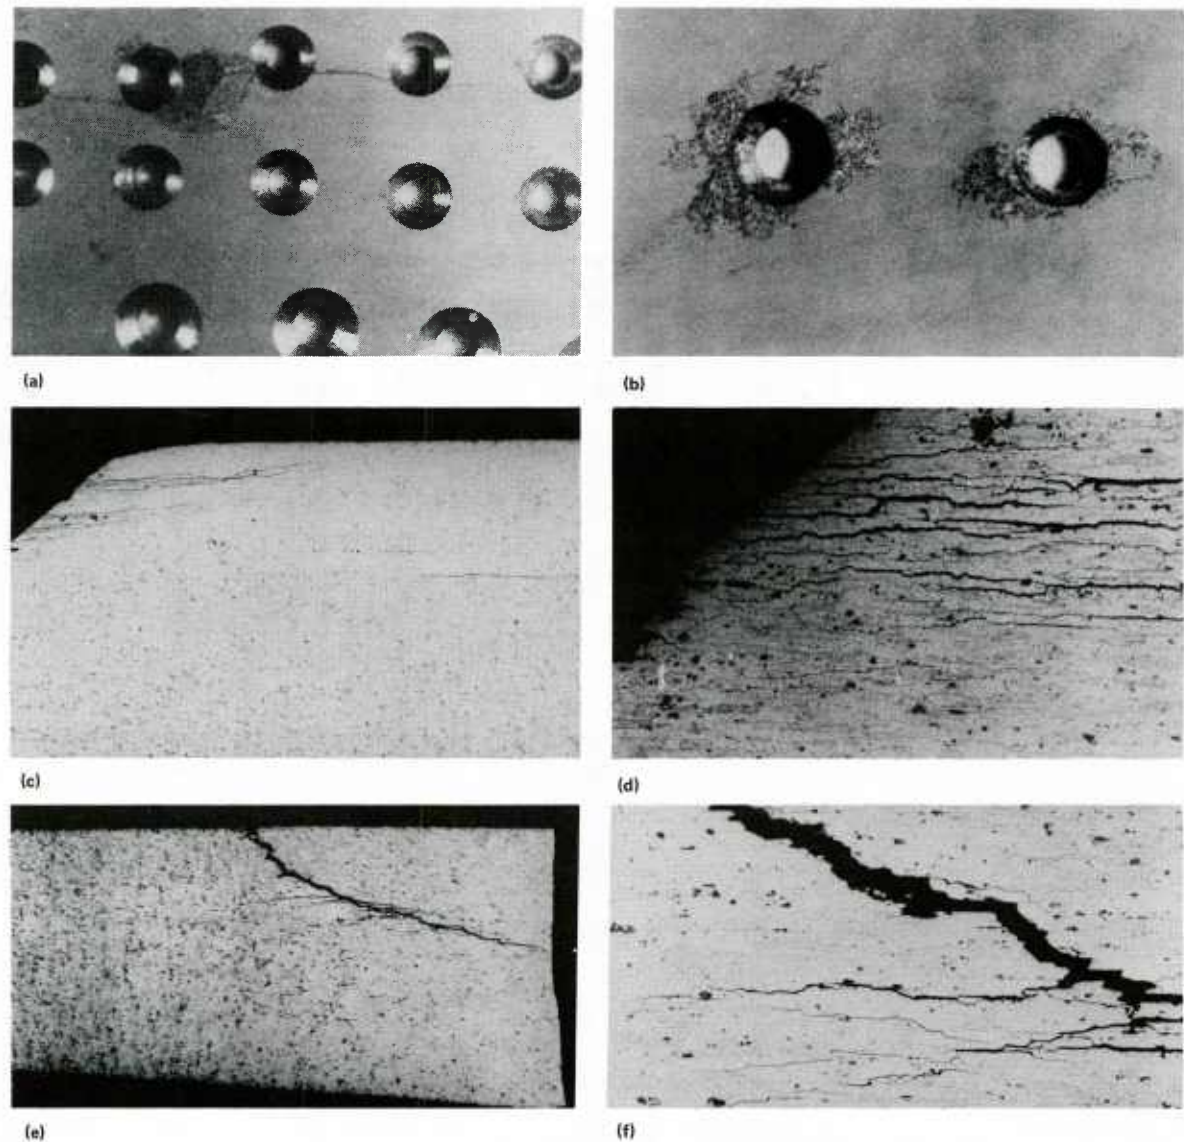
**Fig. 10-8 Intergranular corrosion and exfoliation of a 7075-T6 wing box lower panel**

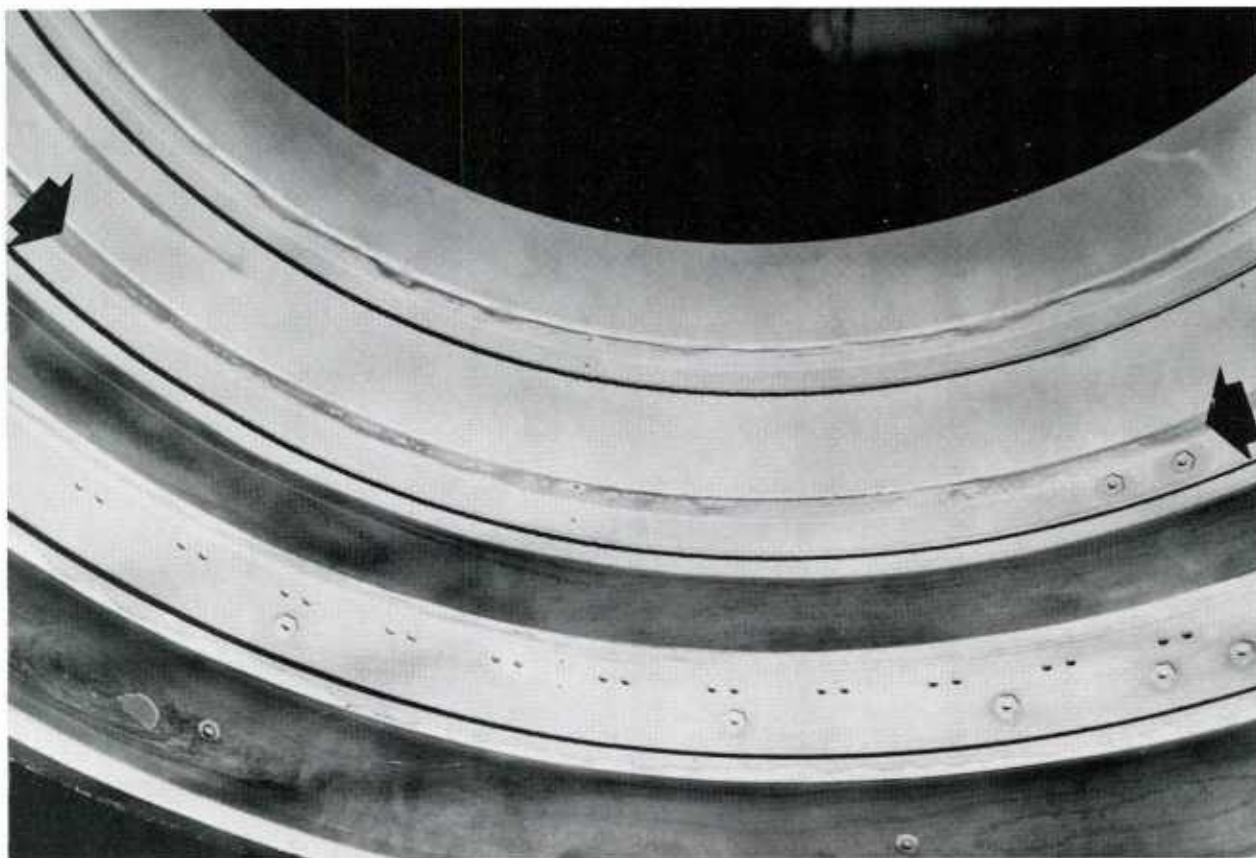
Fig. 11-2 Fretting corrosion in a magnesium alloy (EZ-33) compressor casing, indicated by arrows

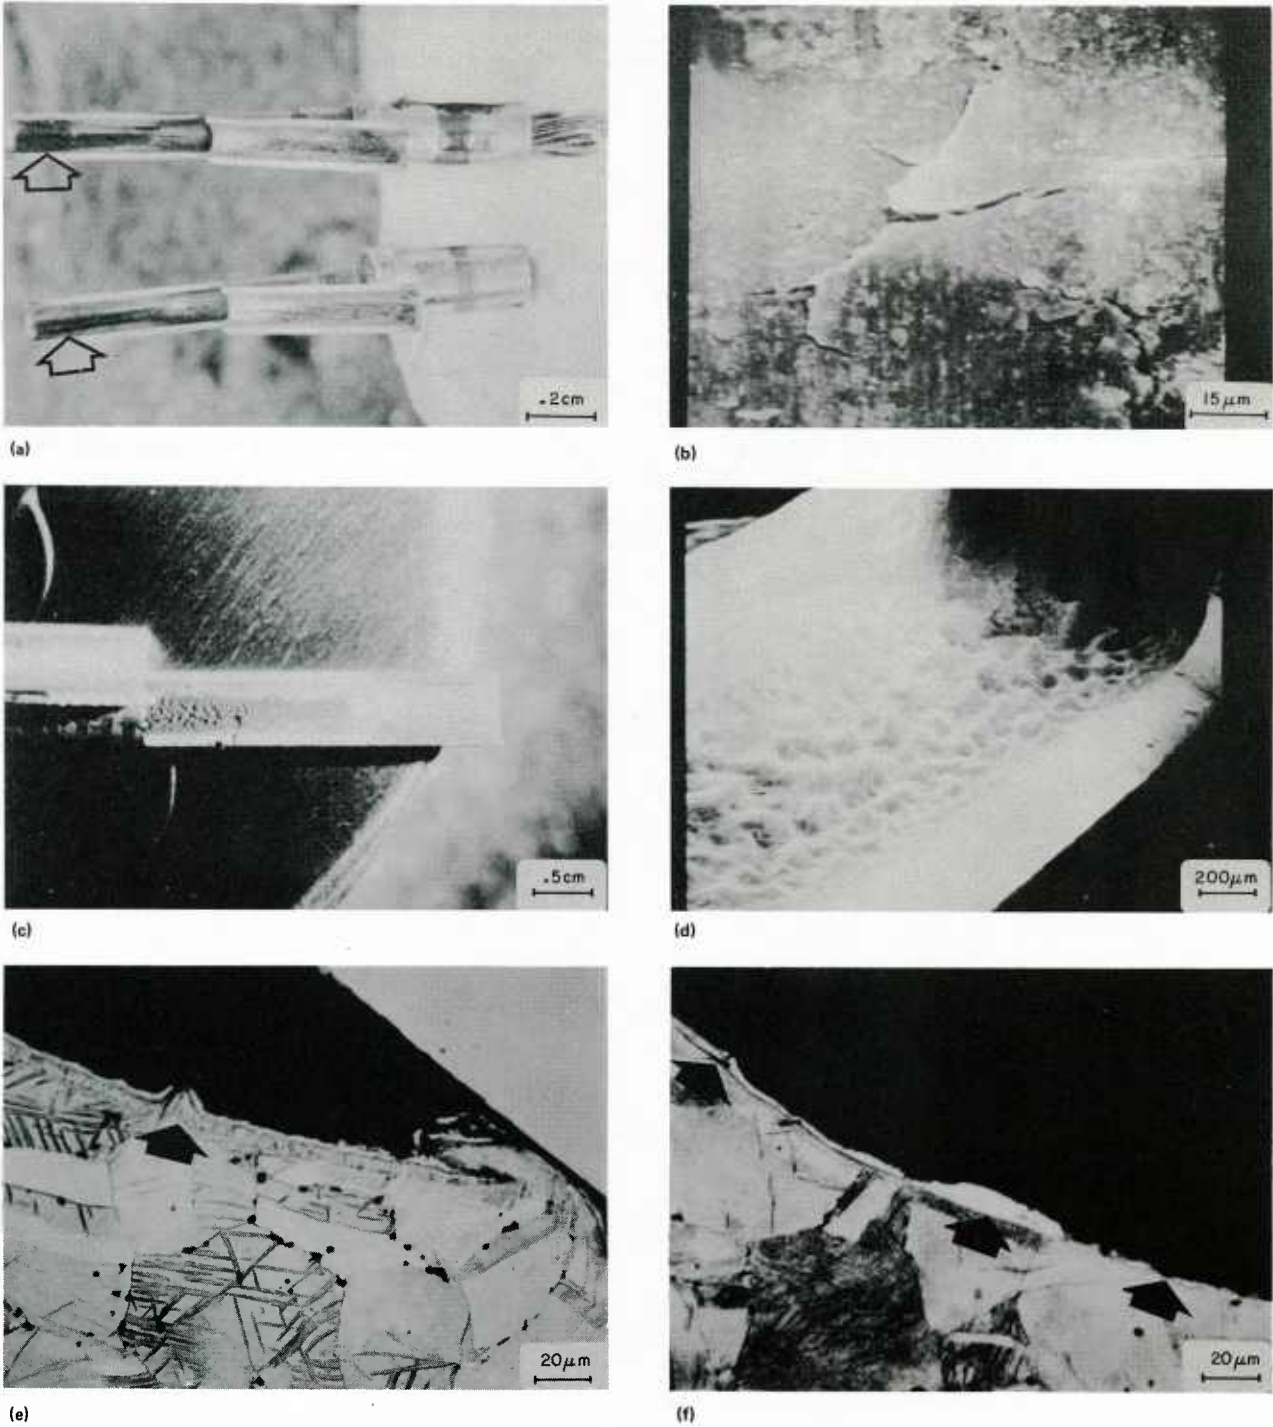
**Fig. 11-5 Fretting corrosion in electrical connectors**

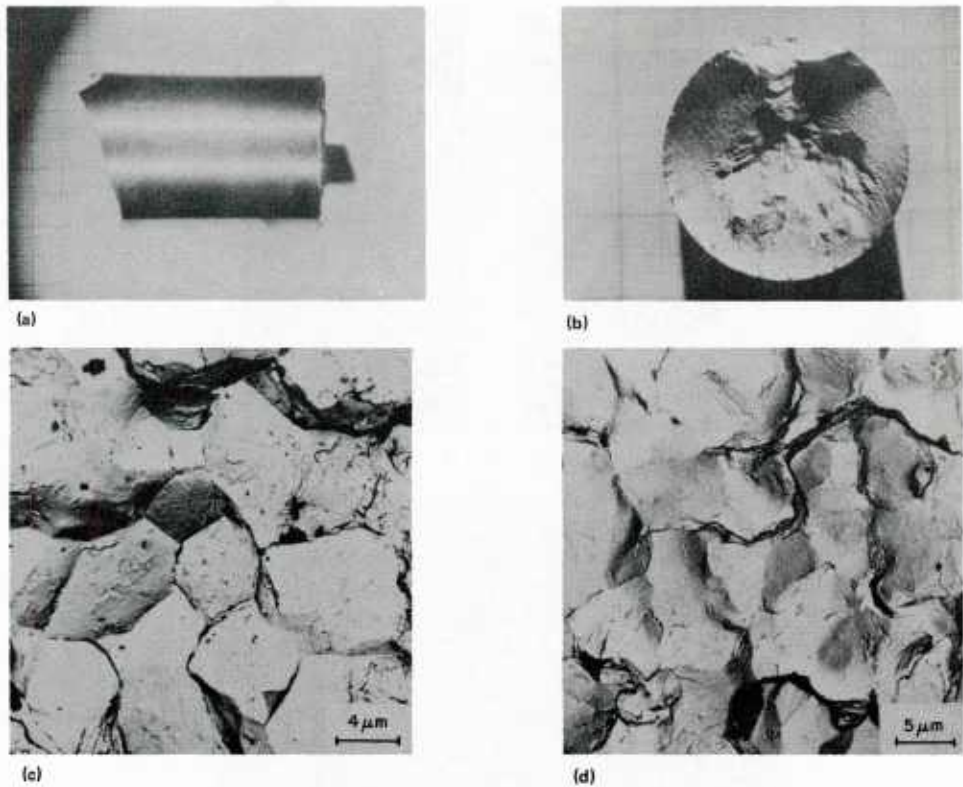
**Fig. 12-8 Hydrogen delayed cracking in a 4340 main landing gear pivot pin**  
(a) Central portion of the broken pivot pin.  
(b) One of two fracture surfaces on the piece shown in Figure 12-8(a).  
(c) Replica transmission electron microscope picture of an area from Figure 12-8(b). (Mag. X 2800)  
(d) Fracture surface of a specimen which failed during a sustained load test. (Mag. X 2200)

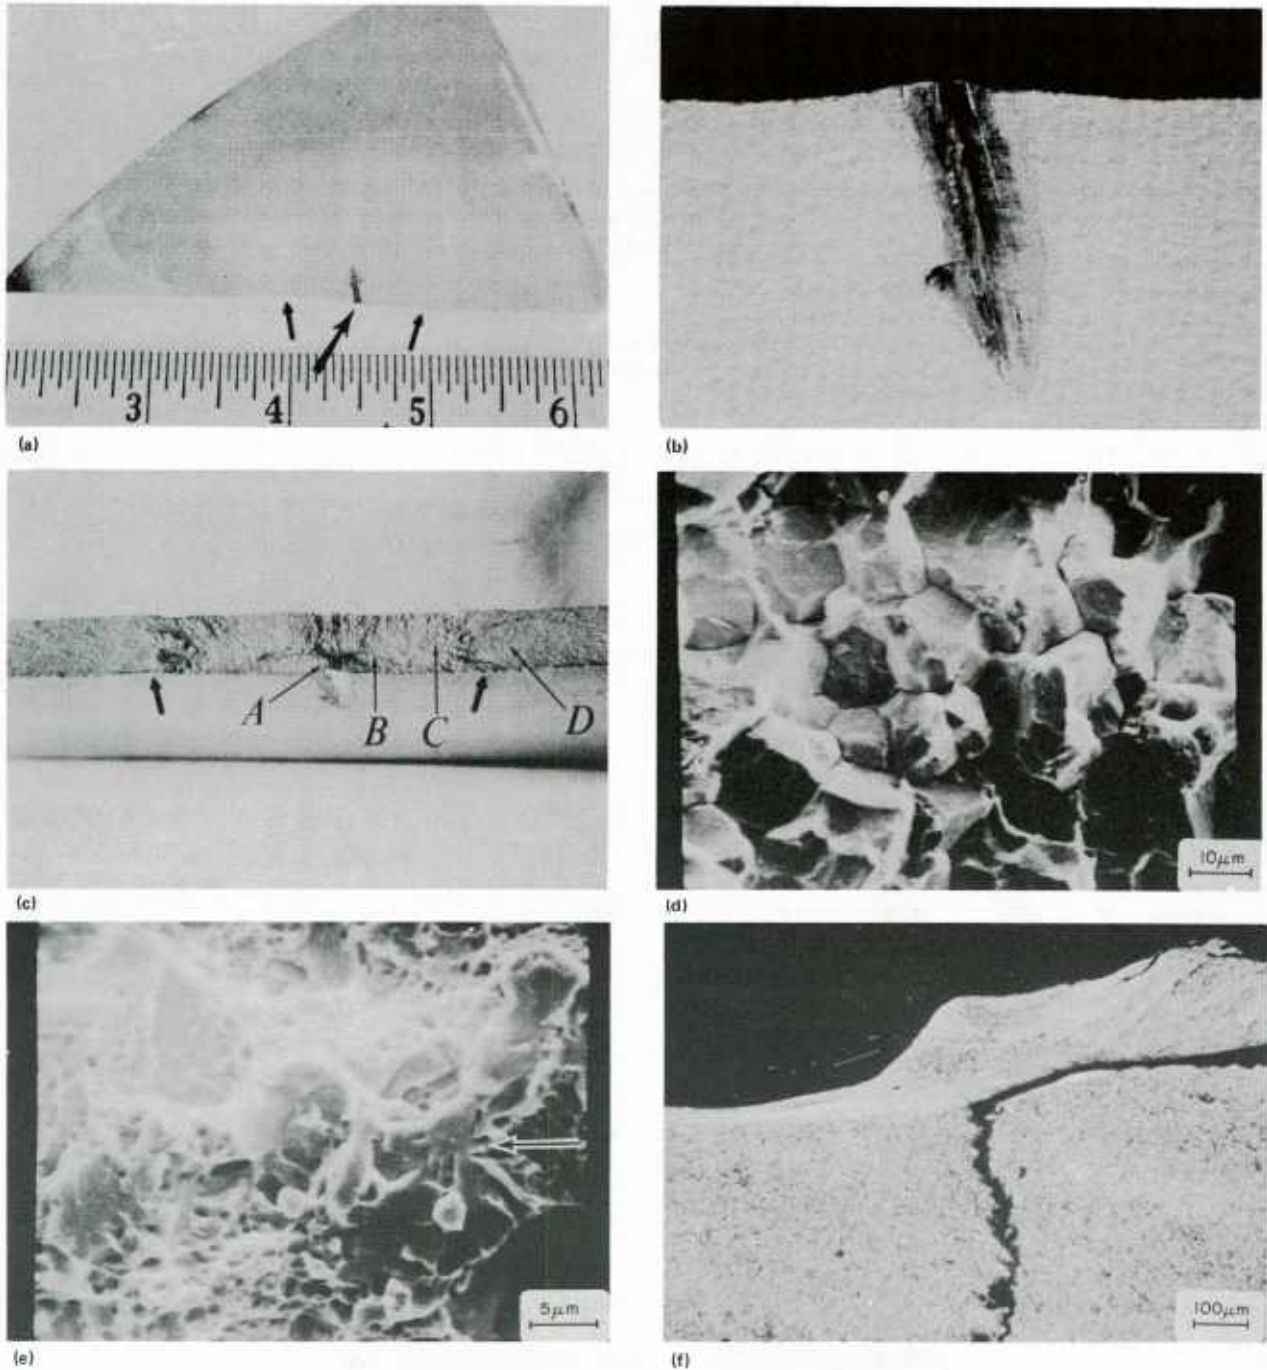
Fig. 12-13 Failure of a 4340 steel landing gear cylinder

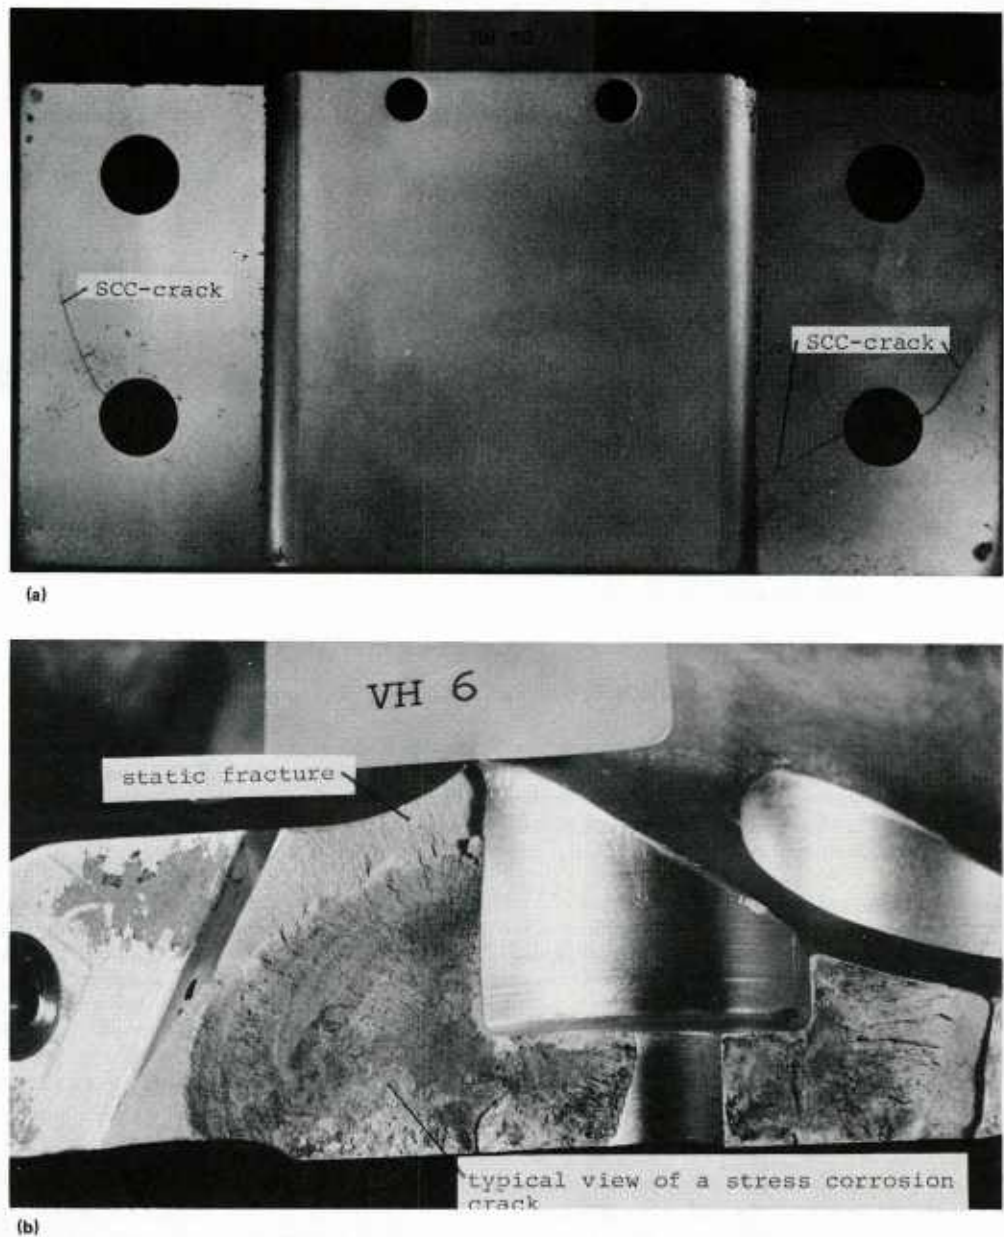
Fig. 13-28 Stress corrosion cracking in the 7079-T6 spars of a vertical fin, case history 13-2.

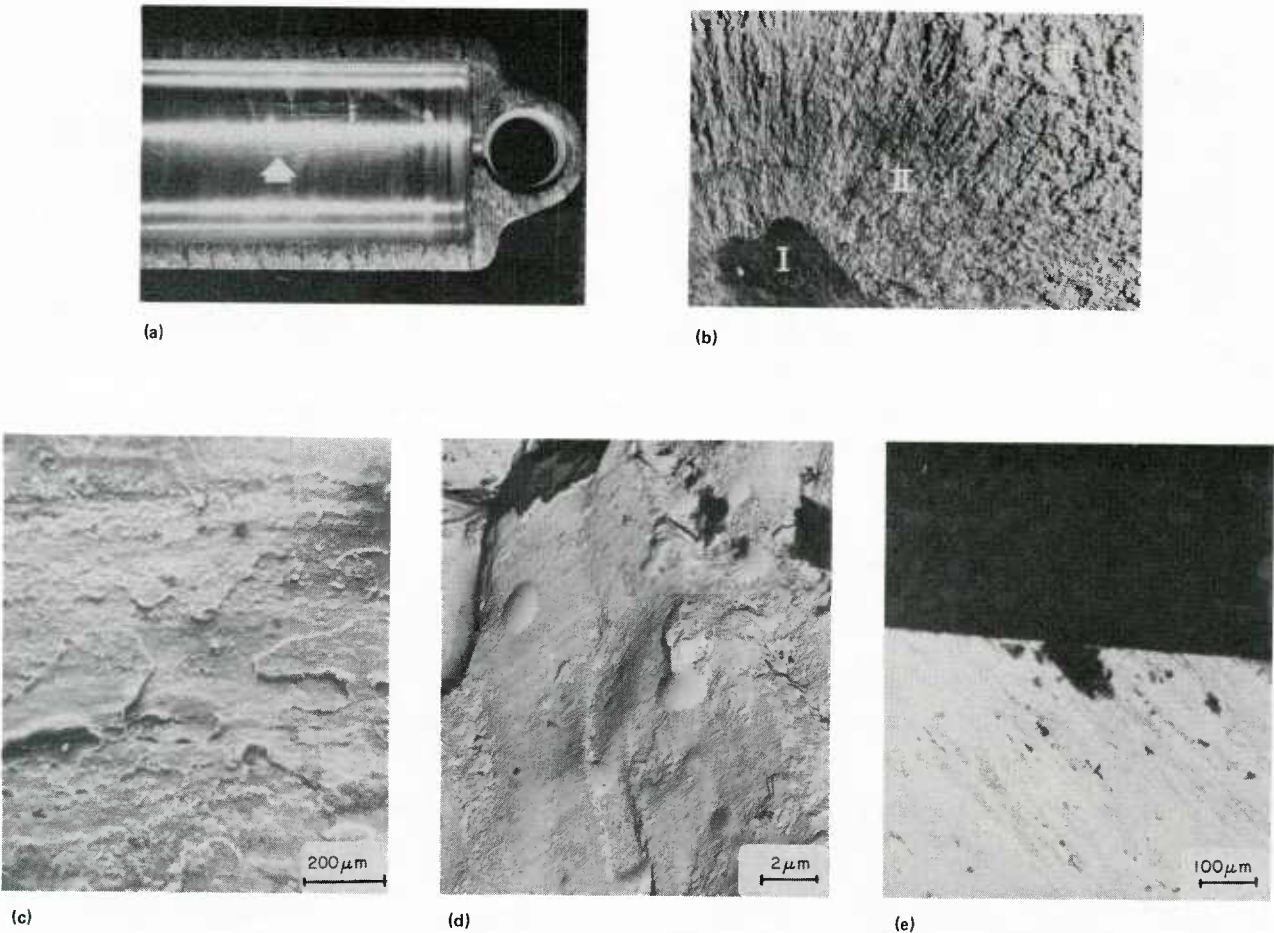
**Fig. 13-31 Stress corrosion cracking of a 7075-T6 hydraulic cylinder, case history 13-5.**

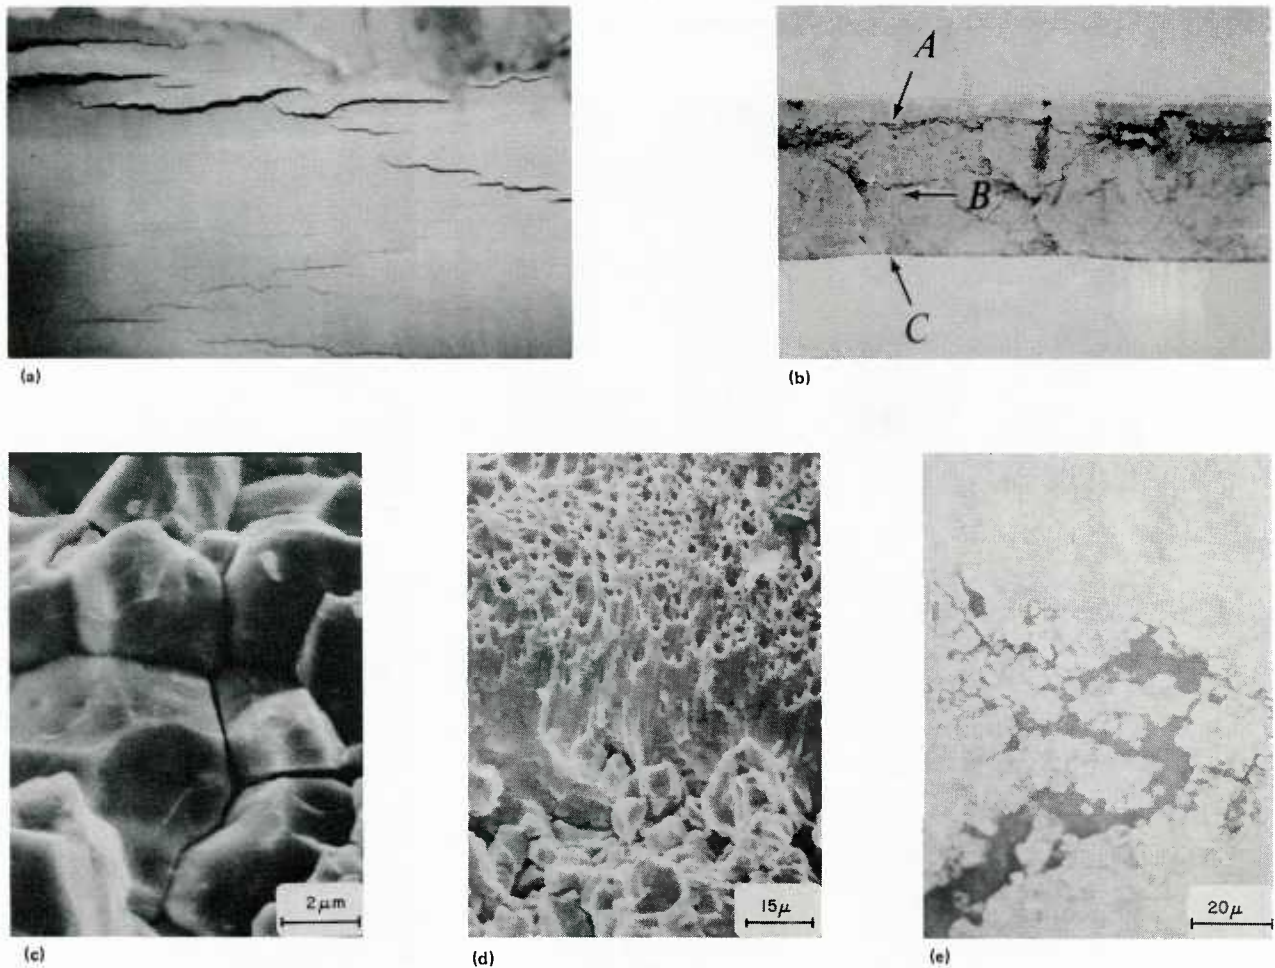
Fig. 13-50 Failure of a 18-Ni maraging steel pressure vessel, case history 13-15.

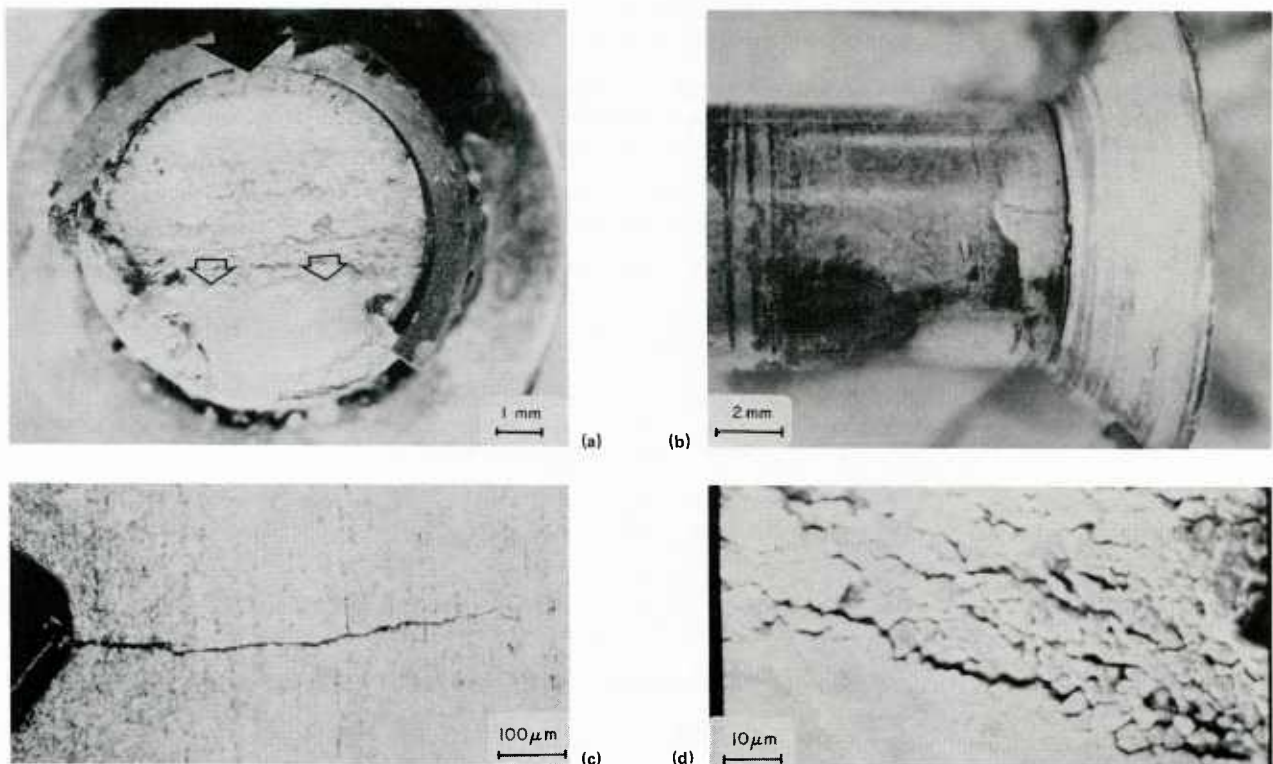
Fig. 13-52 Corrosion induced failure of a 1040 plain carbon steel bolt, case history 13-17.

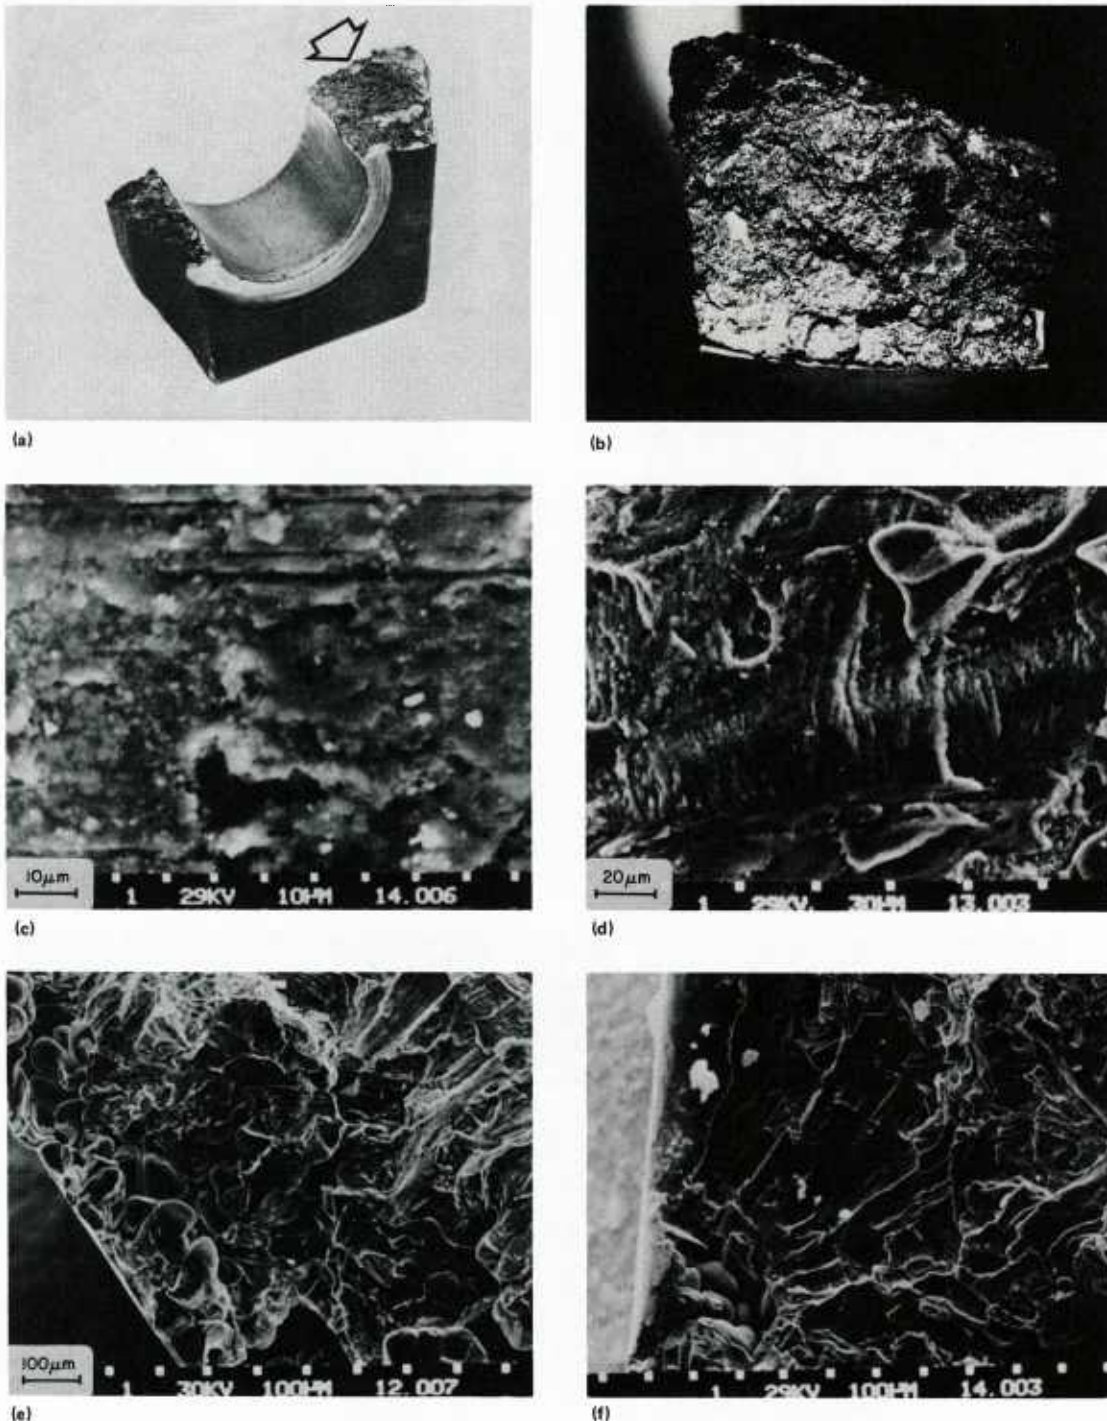
Fig. 14-11 Corrosion fatigue of a cast aluminium rocker arm journal bearing

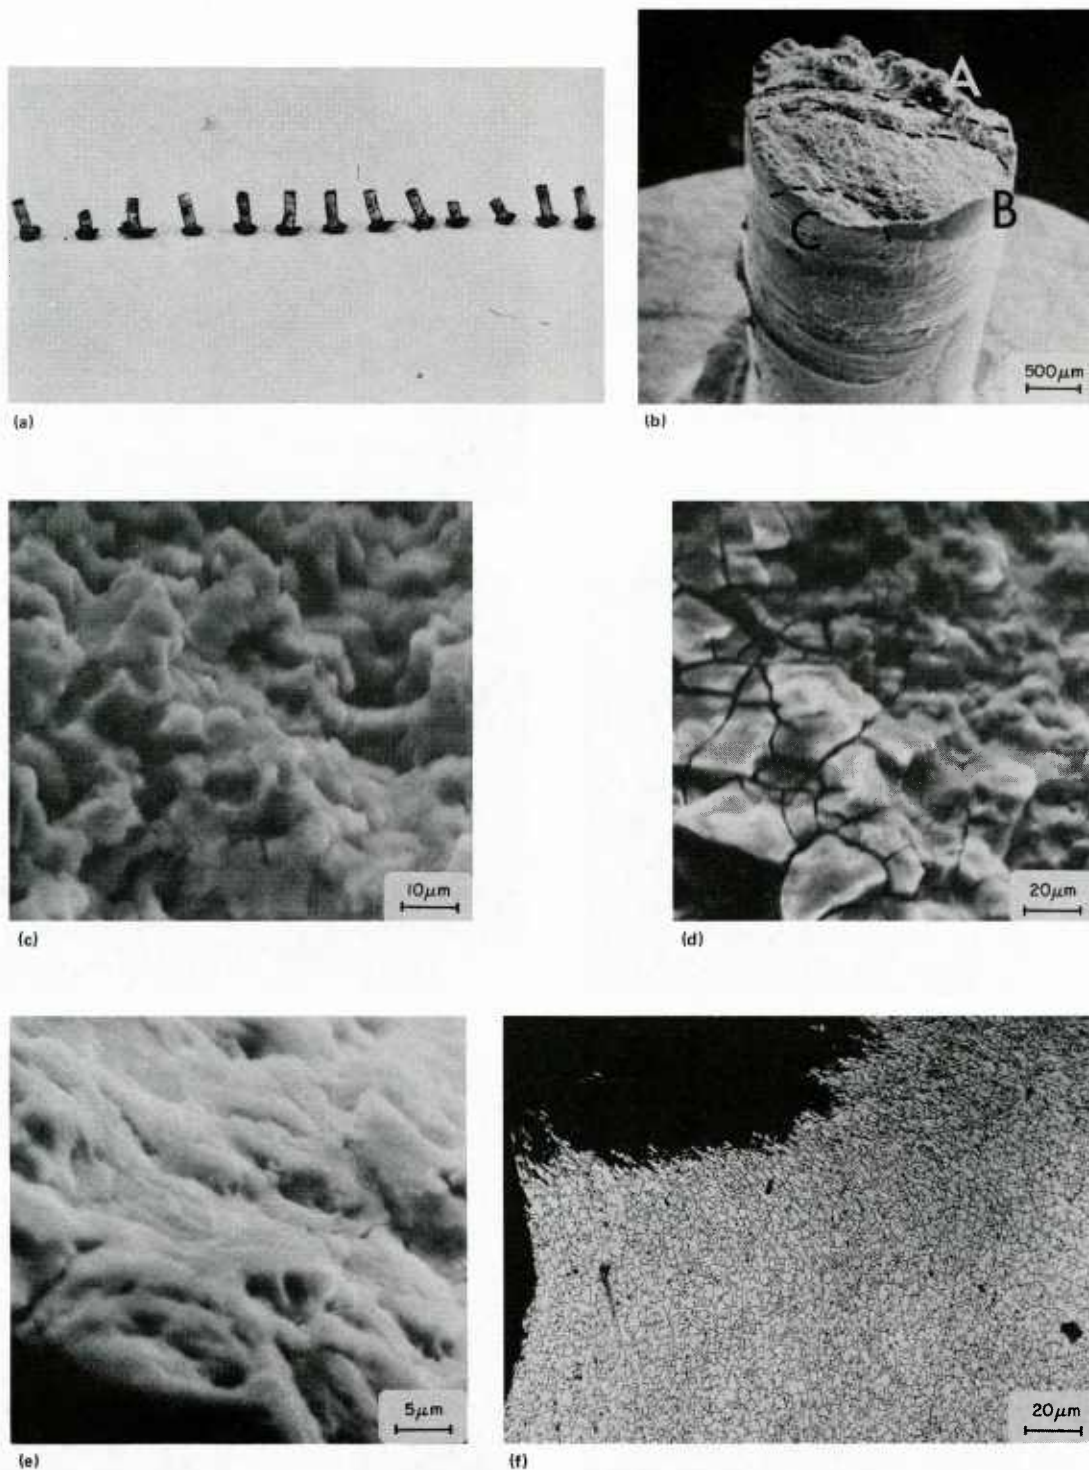
Fig. 14-12 Corrosion fatigue of 5052 aluminium alloy rivets
