AGARDograph No. 278

## AGARD Corrosion Handbook Volume 1 Aircraft Corrosion: Causes and Case Histories

W.Wallace  
Head, Structures and Materials Laboratory  
National Aeronautical Establishment  
National Research Council Canada  
Ottawa, Ontario, Canada

D.W.Hoeppner  
Cockburn Professor of Engineering Design  
Department of Mechanical Engineering  
University of Toronto  
Toronto, Ontario, Canada

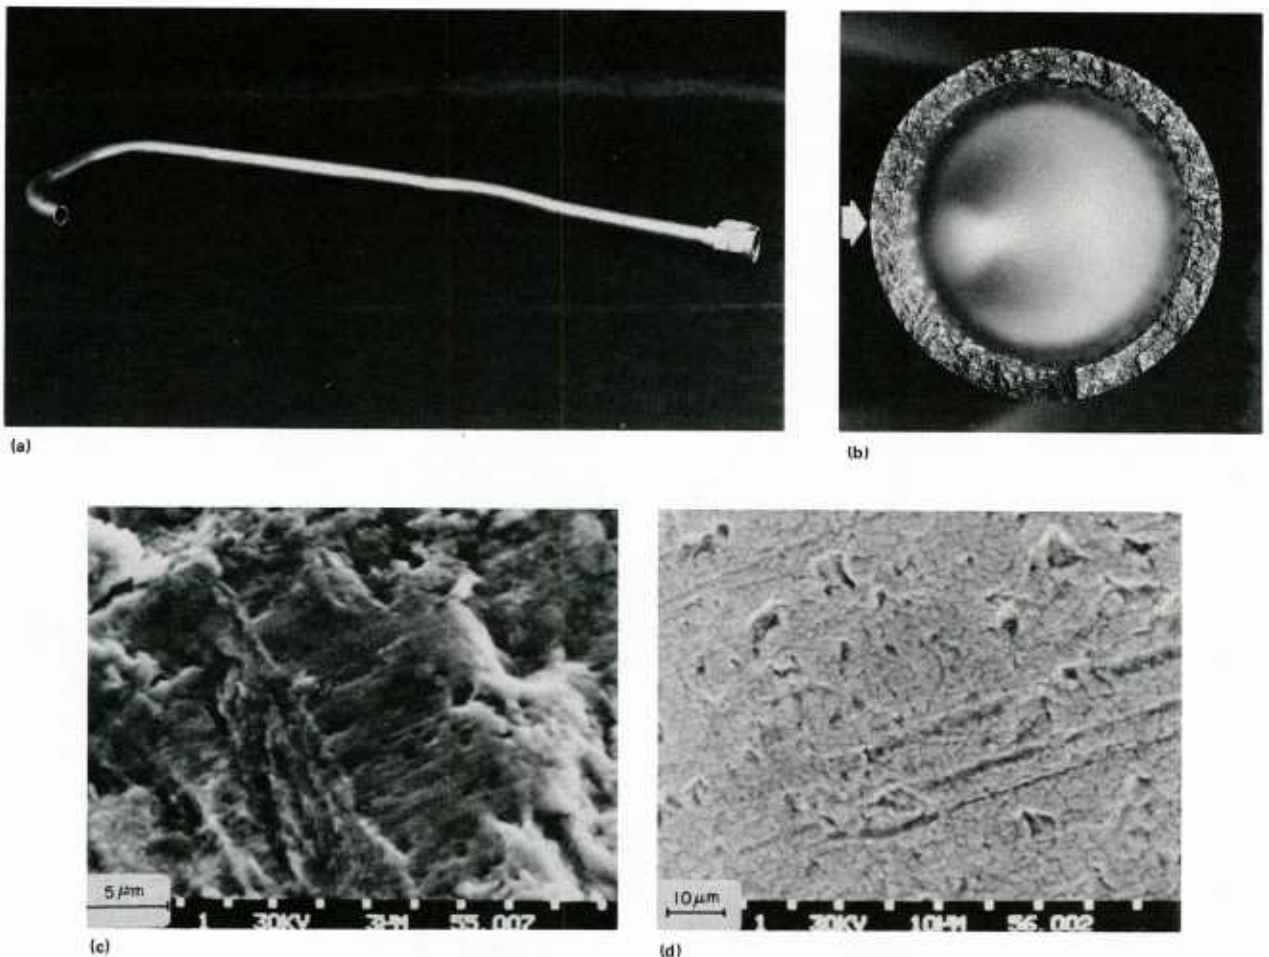
Fig. 14-14 Corrosion fatigue of a 321 stainless steel hose assembly

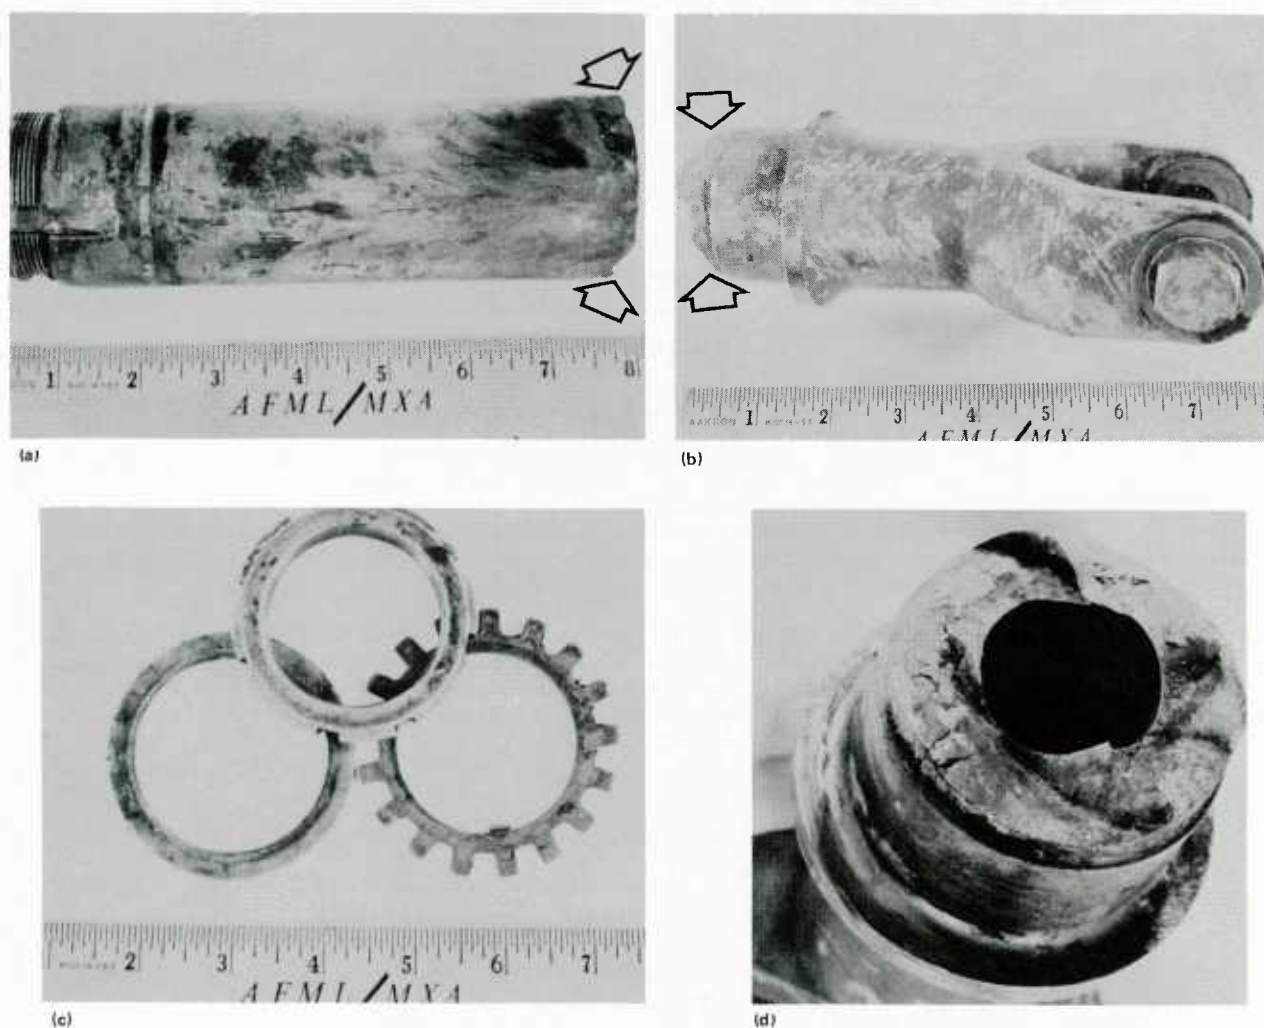
Fig. 14-15 Corrosion fatigue of a 4340 steel rotor attachment assembly

**Fig. 14-15 Corrosion fatigue of a 4340 steel rotor attachment assembly**  
 (e) Fracture face after cleaning, showing beach marks and crack plateaus in the initiation region. (Mag. × 2)  
 (f) Threaded end of the pin showing damaged threads.  
 (g) Outer circumference of the pin at the fracture showing secondary cracks and pits indicated by arrows. (Mag. × 2)  
 (h) Close-up of threads showing embedded thread at arrow. (Mag. × 2)
