**RELIANCE INDUSTRIES LIMITED**  
**HAZIRA**

## **TRAINING MODULE**

## **MECHANICAL SEALS** In Centrifugal Pumps

**Based On Failure Analysis Reports**

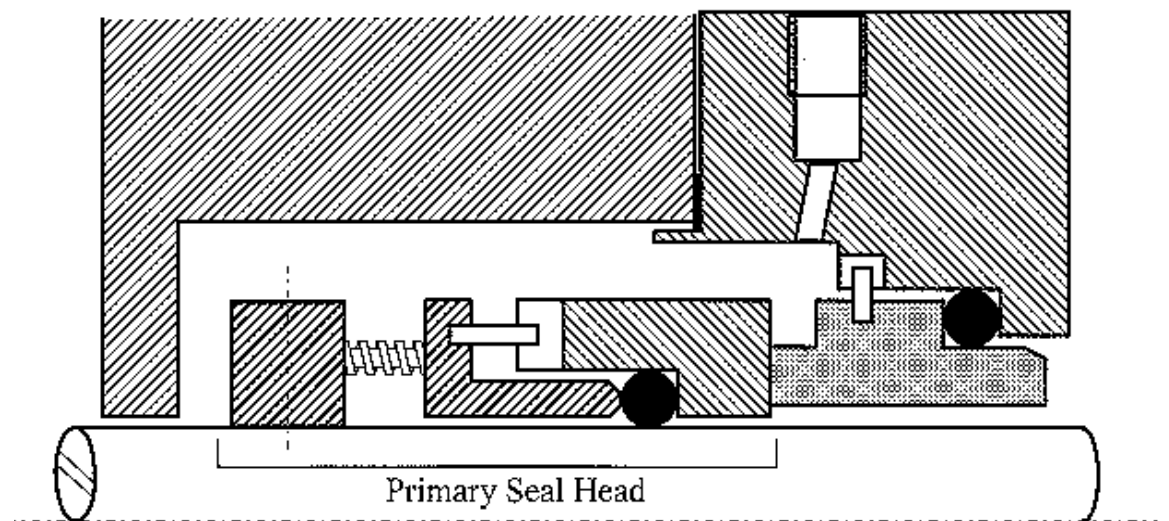
# Single Inside Mechanical Seal

**Figure 1** illustrates a single inside mechanical seal. The material of construction for the inside seal are selected to withstand corrosive liquids in the stuffing box. Inside seals requires a suitable stuffing box housing for installation and cannot be adjusted without dismantling the equipment unless they are cartridge mounted. In inside mounted seals the fluid under pressure acts with spring load to keep the seal faces in contact. Inside seals are easily modified to accommodate environmental controls and can be balanced to withstand high stuffing box pressures.

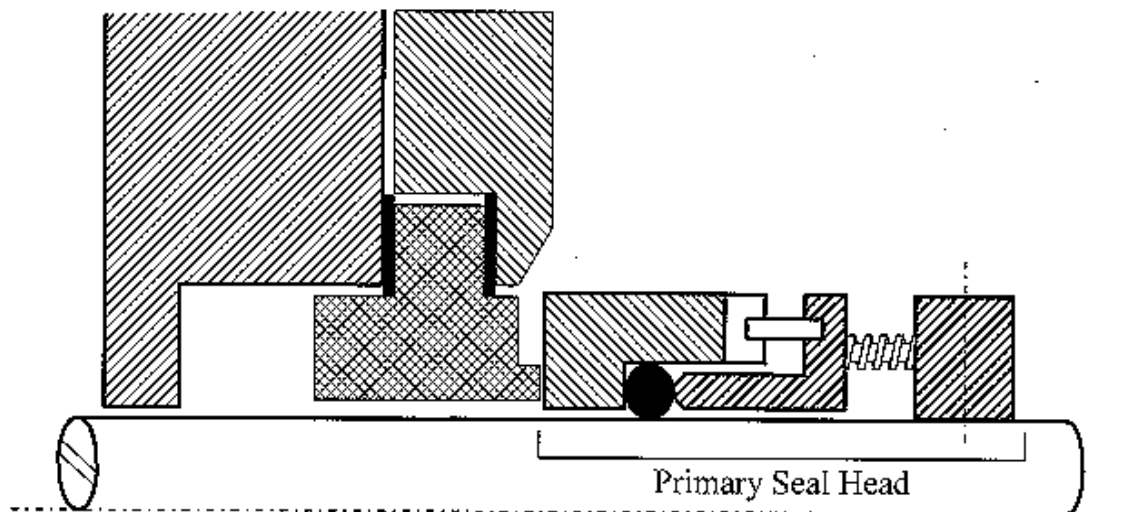
# Single Outside Mechanical Seal

If an extremely corrosive liquid has satisfactory lubricating properties, an outside seal offers an economical alternative to the expensive metallurgy's required for an inside seal to resist corrosion. Seals are mounted outside in little pumps that have no room inside for a seal. **Figure.2** shows a typical outside seal arrangement in which only the insert seal ring and secondary seals are exposed to the product. All these components can be non-metallic. The metallic rotary unit parts are exposed to the atmosphere.

The outside seals are easier to access for adjustment and trouble shooting. The disadvantages being, it is difficult to flush this seal. The service must be free

of solids which might collect under the seal. The hydraulic pressure in an unbalance outside seal tends to open, rather than to close the seal faces. All outside seals are limited to applications having moderate pressures.
