# 2800 Repairs

## Abstract

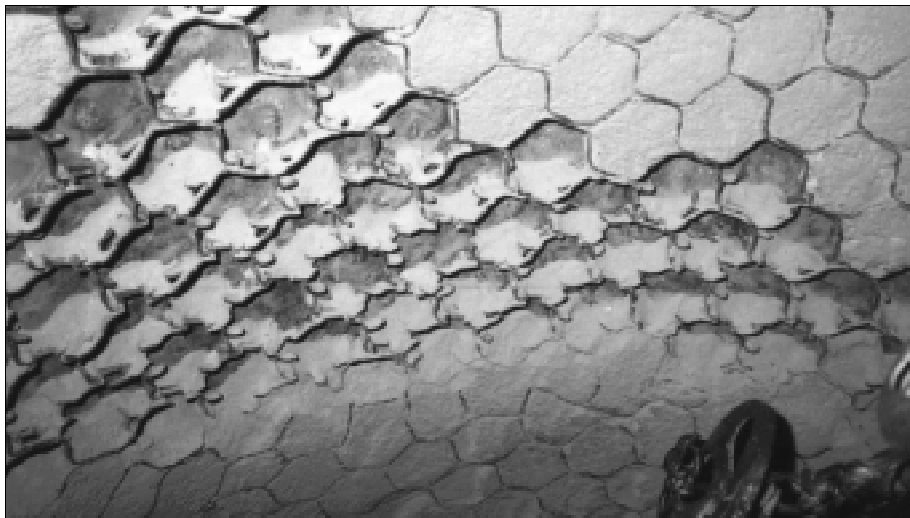
**Fig. 2800-2** FCCU Cyclone—*Refractory and hexmesh have washed out. Metal has eroded down to the lances and clinches. Replace both hexmesh and refractory.*

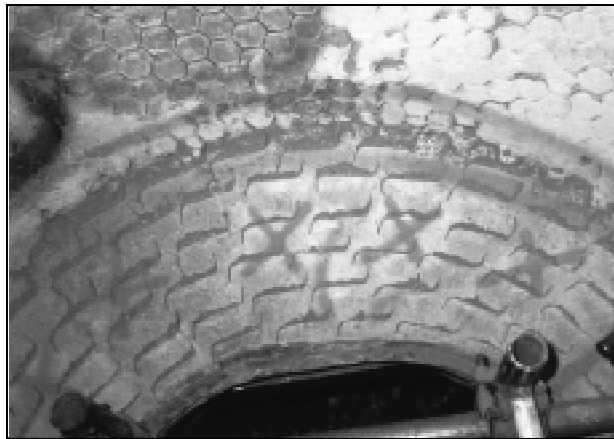
**Fig. 2800-3** FCCU Large Slide Valve—Approximately ½ of the hexmesh and S-bar anchorage is showing. Chop out and replace unsound refractory. Anchors do not need replacement.

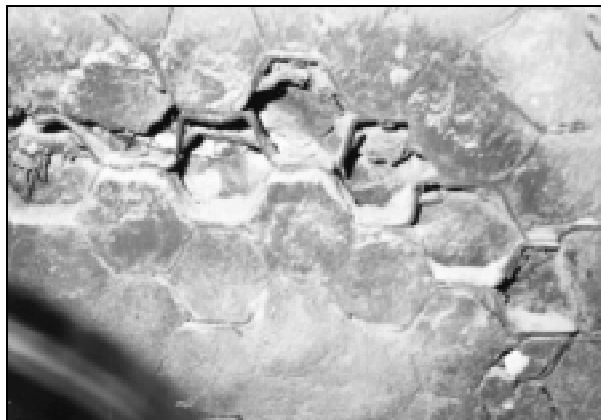
**Fig. 2800-4** Unidentified Area Showing Loose Refractory Biscuits—Hexmesh was incorrectly installed and formed narrow gaps which were impossible to pack properly. Replace both hexmesh and refractory.

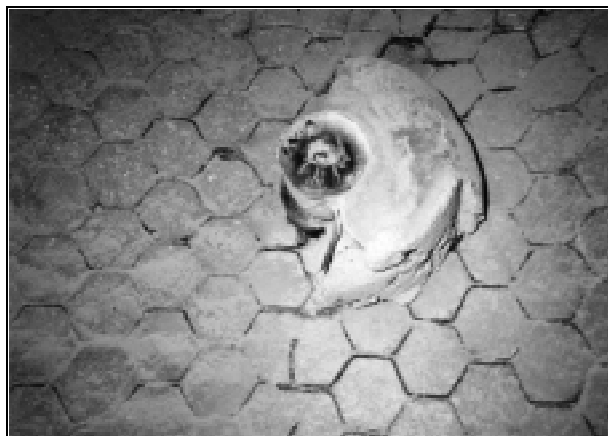
**Fig. 2800-5** FCCU Regenerator U-bend—Erosion of Aeration Nozzle—Chop out and replace nozzle refractory. Metal of surrounding hexmesh shows, but this is acceptable. No anchorage repair needed.

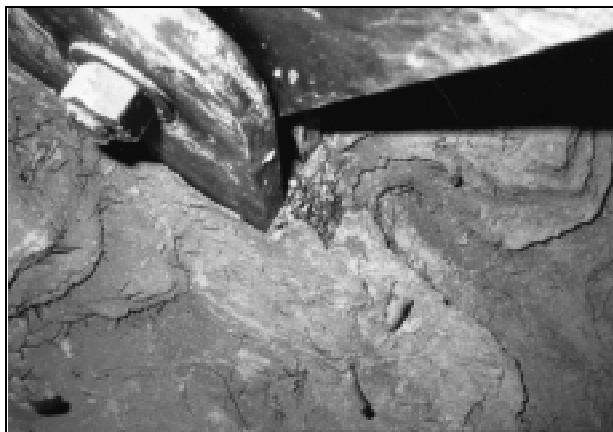
**Fig. 2800-6** FCCU Regenerator, Below Grid—*Laminated refractory and non-distributed metal fibers means poorly mixed material at installation time. Photo taken after 3 years of service. Replace both refractory and anchorage.*

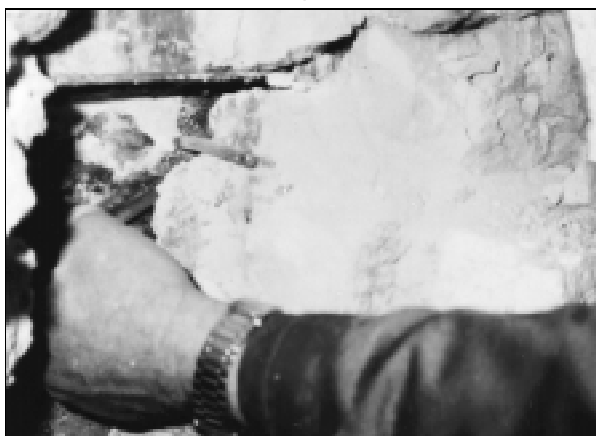
**Fig. 2800-7** Secondary Reformer Vessel—*Large void exposing back-up layer of two-component lining. Replace hot face and back-up layers and re-weld any anchors that come loose during refractory removal.*

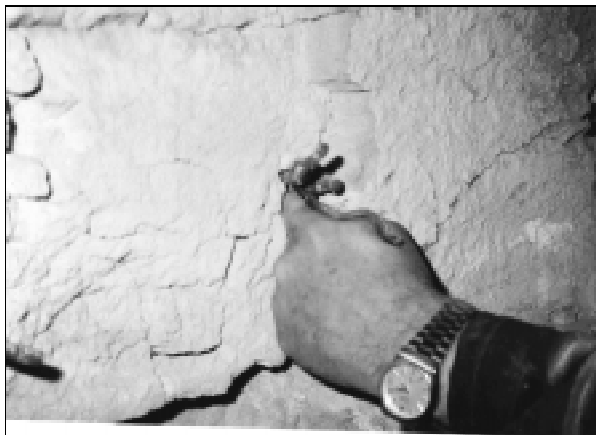
**Fig. 2800-8** Secondary Reformer Vessel—*Hot spot at anchor void just below vapor stop ring. Replace hot face and back-up layers and re-weld any anchors that come loose during refractory removal.*

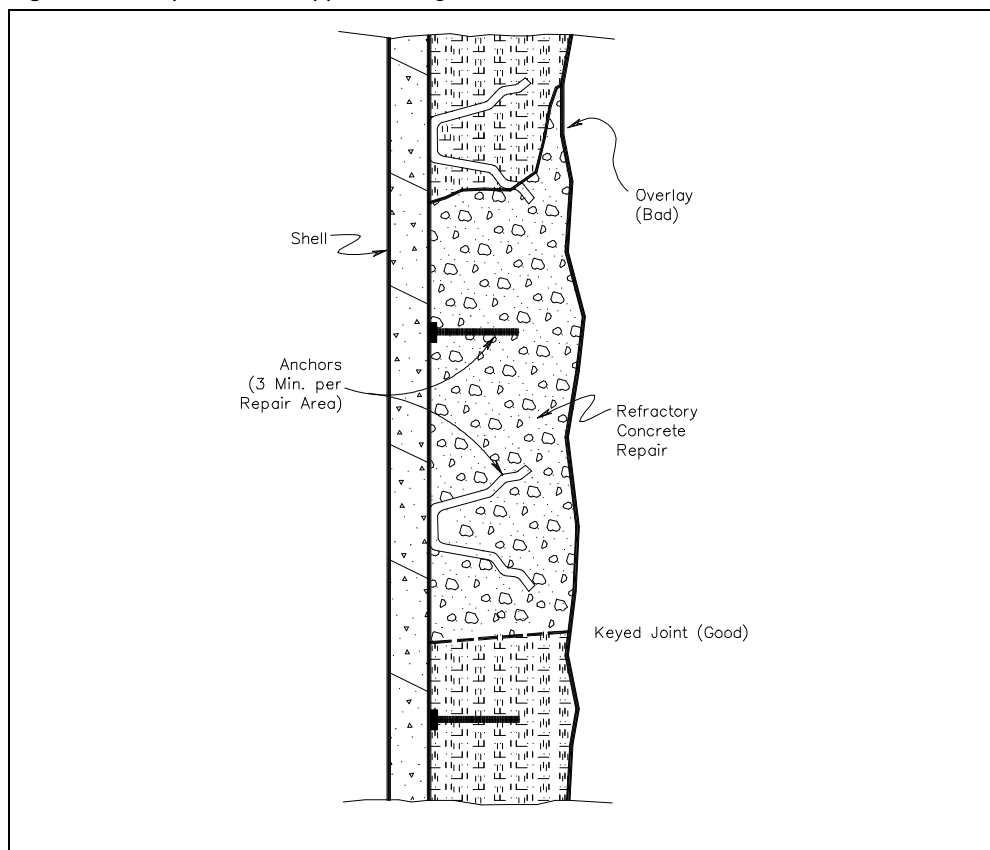
**Fig. 2800-9** Repair in Gun-Applied Lining

- Anchors or anchorage improperly installed
- Poor refractory workmanship
- Improper application of *gun-applied* castable linings (e.g., laminations and overlays. See Figure 2800-9.)
- Insufficient (ambient) curing
- Improper dryout (includes both too fast—which is rare—and too little)

Lining on the sidewall was deteriorating. Visual inspection and hammer testing defined areas to be replaced. This partial failure was the result of catalyst erosion, wear-and-tear, and not using a preferred castable during previous repair. The existing lining was cut back nearly perpendicular to the shell with a slight keyed taper where full 4-inch thickness of sound lining remained. A small jackhammer was used to remove the deteriorated refractory. The shell was abrasive blasted before the (new) 3-inch Type 304 wavy Vee anchors were welded in place. A 9-inch center-to-center, square pattern was used. The 83 pcf “one-shot” Type E castable was fiberized with 4% by weight of 1-inch long, Type 304 stainless steel (“melt-extraction”) metal fibers. After first wetting the entire repair area, the material was gun-applied. A colored membrane curing compound was sprayed on the repaired lining about one hour after installation. See Figure 2800-9 for details.

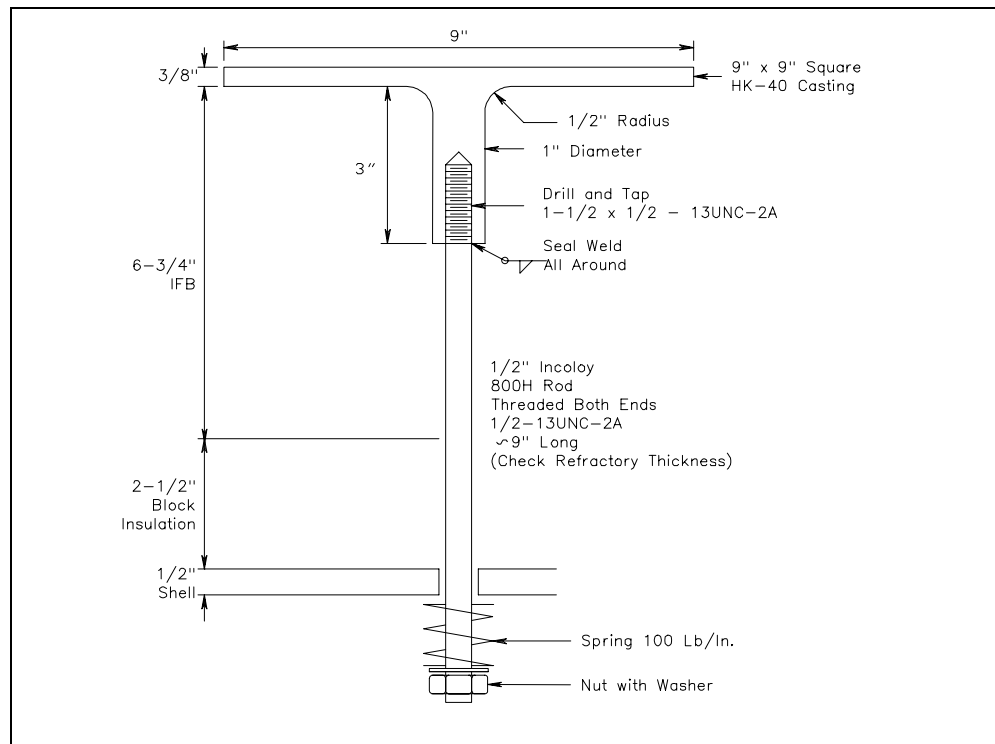
**Fig. 2800-10 Refractory Tie-back Anchor**

After many years of operation, the IFB and block insulation (back-up) walls in a primary reforming furnace were moving away from the shell—leaning inward. This was the result of ineffective anchors. The anchors were Type 304 stainless steel and suffered creep and oxidation. A through-bolt anchor system was fabricated to tie back the brick/block lining and prolong lining life an estimated 5 to 10 years. Figure 2800-10 shows this tie-back anchor system.

Several ½-inch diameter holes were drilled through the refractory and steel shell on appropriate spacings. The through-bolt anchor rods were inserted through these

holes and nuts were installed on the outside of the shell. Successive and systematic tightening of the nuts moved the sectionally supported wall back toward the shell.
