Fitness-For-Service Example Problem Manual

API 579-2/ASME FFS-2 2009

AUGUST 11, 2009

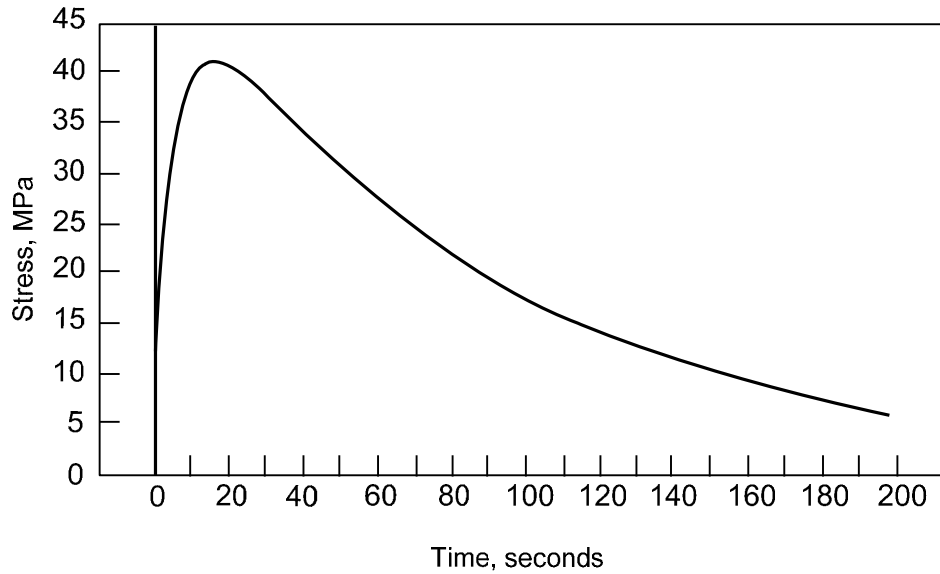
Figure E3.10-2
Transient Thermal Stress Computed From A Finite Element Stress Analysis

Transient Thermal Stresses – These stresses may be evaluated by using closed form solutions or a finite element analysis. In this example, a temperature excursion model consisting of a "cold front" of liquid is assumed to move down the tower. The liquid temperature in the cold front is defined by the process upset condition. The vessel wall is subsequently cooled from its pre-excursion steady-state temperature to the cold liquid temperature. Convective heat transfer from the cold fluid to the vessel shell is assumed to be instantaneous, and heat loss to the atmosphere is neglected. The stress versus time history at a point on the vessel wall computed using a finite element analysis is shown in Figure E3.10-2.

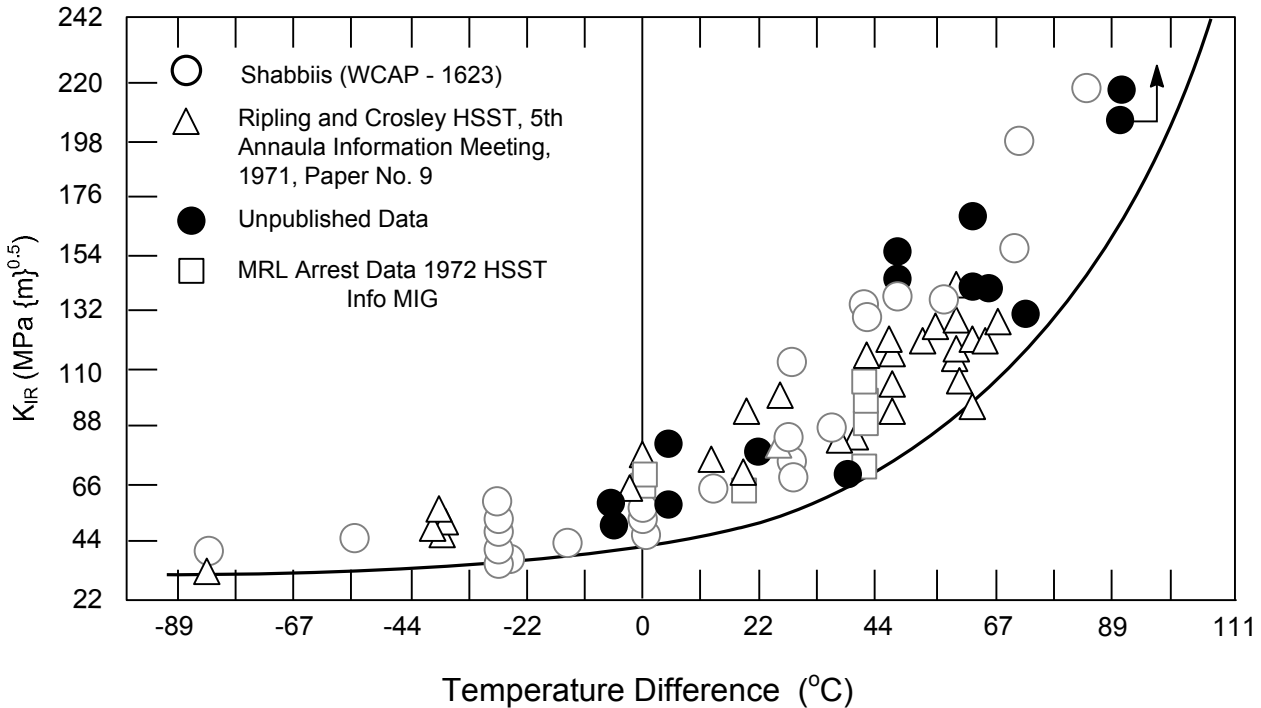
Actual fracture toughness data is not normally available for process equipment; therefore, it is necessary to adopt a lower bound approach to describe the variation of toughness with temperature. The most widely used lower bound is the K_{IR} curve from Figure F.3 in Annex F. This curve is shown in Figure E3.10-3. To use this curve it is necessary to estimate a reference temperature to position the temperature axis on an absolute scale. The reference temperature is typically taken as the Nil Ductility Temperature (NDT). In this example, the temperature at which a 40 Joules Charpy V-Notch energy is obtained from a longitudinal specimen is selected as the NDT. It should be noted that Annex F recommends the less conservative value of 20 J. The use of this value would shift the FTS curve shown in Figure E3.10-4 upward. When an impact temperature corresponding to 40 J is not available, actual values are extrapolated to give an effective 40 J test temperature using the relationship: $1.5 J/^\circ C$. For this assessment the lowest average Charpy value was used for determining the NDT as opposed to the lowest minimum. The use of actual values is illustrated in Figure E3.10-3.

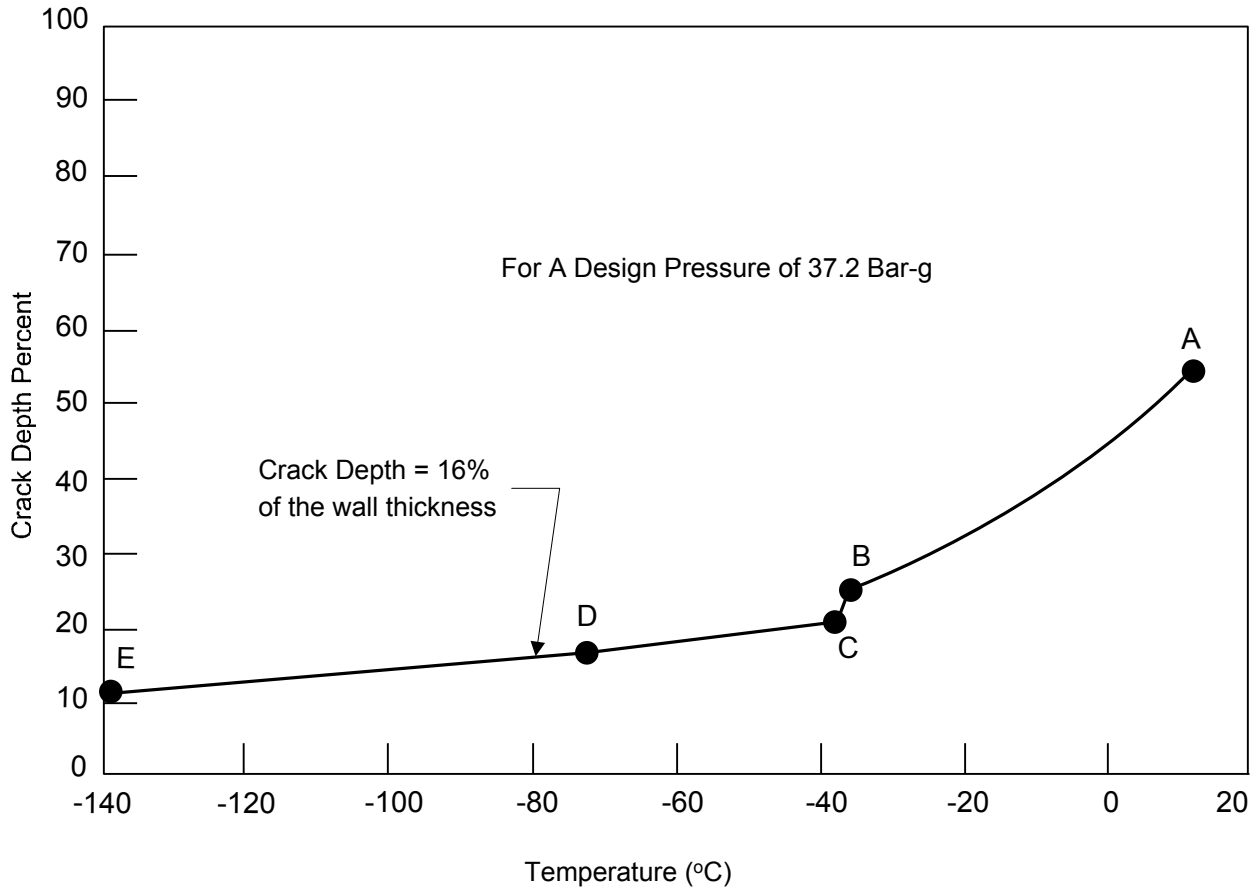
Figure E3.10-4
Fracture Tolerance Signature

The applied stress, material properties, and fracture toughness parameter defined above are used to create a plot of limiting flaw size versus temperature as illustrated in Figure E3.10-4. The critical flaw depth is in the through thickness direction and is expressed as a percentage of the wall thickness with a 6:1 aspect ratio maintained. The absolute factor of safety in the critical flaw size is undetermined, but is a function of the assumptions made with respect to lower bound toughness, stress, stress multiplier, and the NDT indexing temperature.

The flatness of the curve between points C and E makes limiting temperature predictions highly sensitive to the minimum flaw size. This in turn is greatly influenced by type and extent of inspection and factors such as probability of detection (*POD*) of flaws. While work still needs to be done to clarify *POD* issues, application of detailed NDE to a vessel should enable a minimum flaw size to be assumed with sufficient confidence to enable the *FTS* to be used to specify a minimum excursion temperature. Based on the *POD* curve shown in Figure E3.10-5, a flaw depth of 4.5 mm should be detectable using a magnetic particle examination technique (MT) with a confidence level greater than 90%. For the 6:1 aspect ratio assumed in developing the *FTS*, this equates to a crack of length 27 mm.

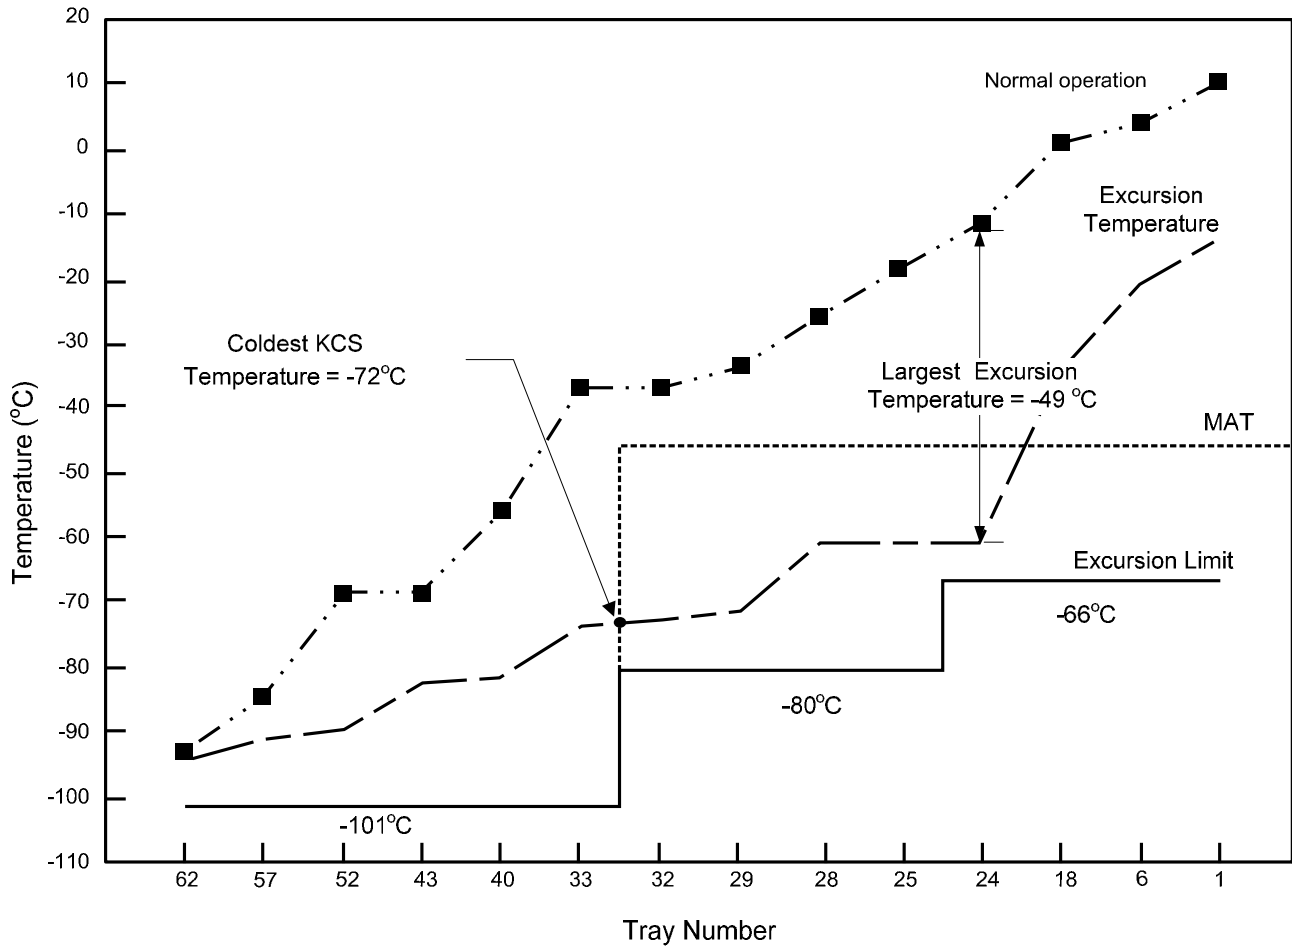
Figure E3.10-6
Demethanizer MAT Versus Location

- Case 1 – The lowest temperature in the carbon steel section is at tray 32 with a pre-excursion temperature of -35°C and an excursion delta of -37°C to -72°C.
- Case 2 – The largest delta of -49°C occurs from a steady state temperature of -12°C at tray 24 to give an excursion temperature of -61°C.

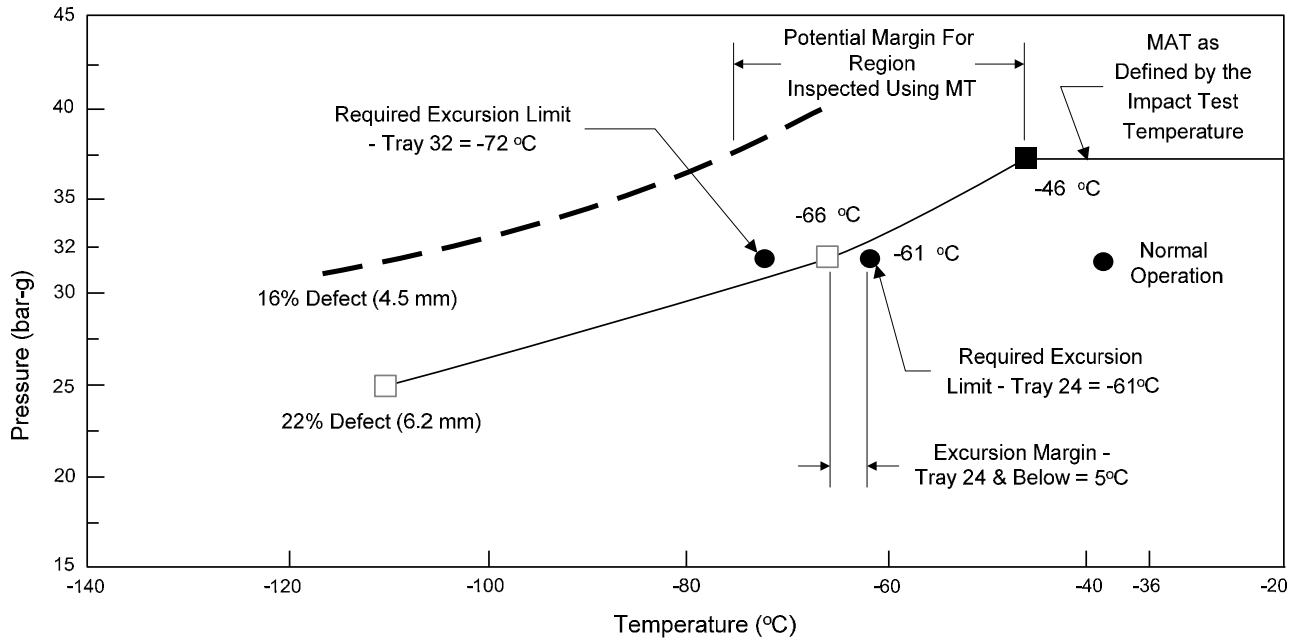
Figure E3.10-7
Pressure Temperature Relationship for Constant Defect Size - Killed Carbon Steel Section

The *MAT* approach for two constant flaw sizes is shown in Figure E3.10-7. One is 22% of the wall thickness, and was selected to pass through original design conditions. For clarity, the effect of the transient stress is ignored in Figure E3.10-7. The 22% curve illustrates that the excursion temperature at tray 24 of -61°C is within the acceptable *MAT* zone and, provided that additional transient stresses can be accommodated within the excursion margin, the *MAT* can be set at -66°C based on operating rather than design pressure. This check is made by evaluating the critical flaw size during the excursion, using an *FTS* for tray 24, and ensuring it is always above 22%. The check is made using tray 24 temperature and excursion conditions, with operating pressure applied rather than design. The check confirms that in this case -66°C is an acceptable excursion limit below tray 24.

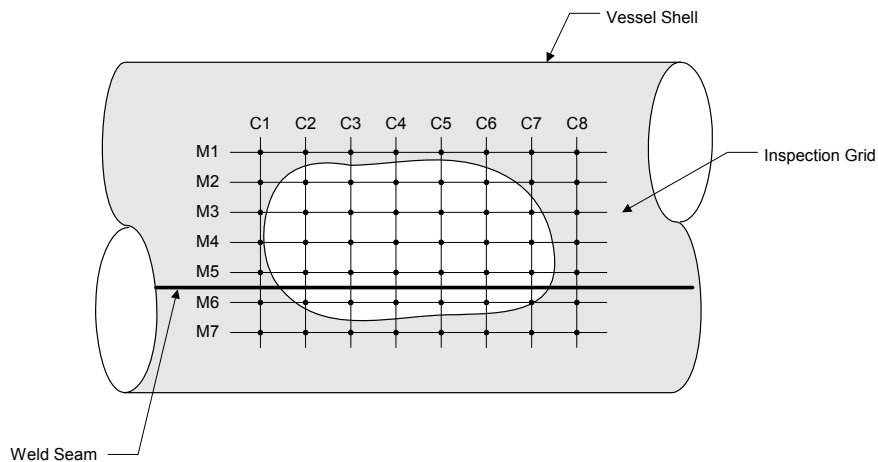
Figure E4.2-1 – Inspection Grid

The grid used for the inspection and the thickness readings are shown below. The grid spacing set by the Inspector in the circumferential and longitudinal directions is 1.5 in based on the corrosion profile.

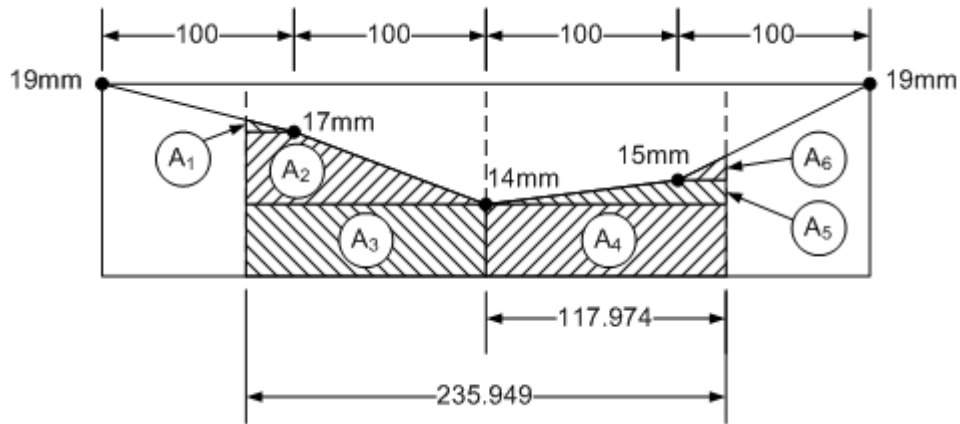
Figure E4.3-1 – Critical Thickness Profile

Circumferential Distance (mm)	Thickness Reading (mm)	Thickness – FCA (mm)
0	19	16
100	19	16
200	19	16
300	17	14
400	14	11
500	15	12
600	19	16
700	19	16

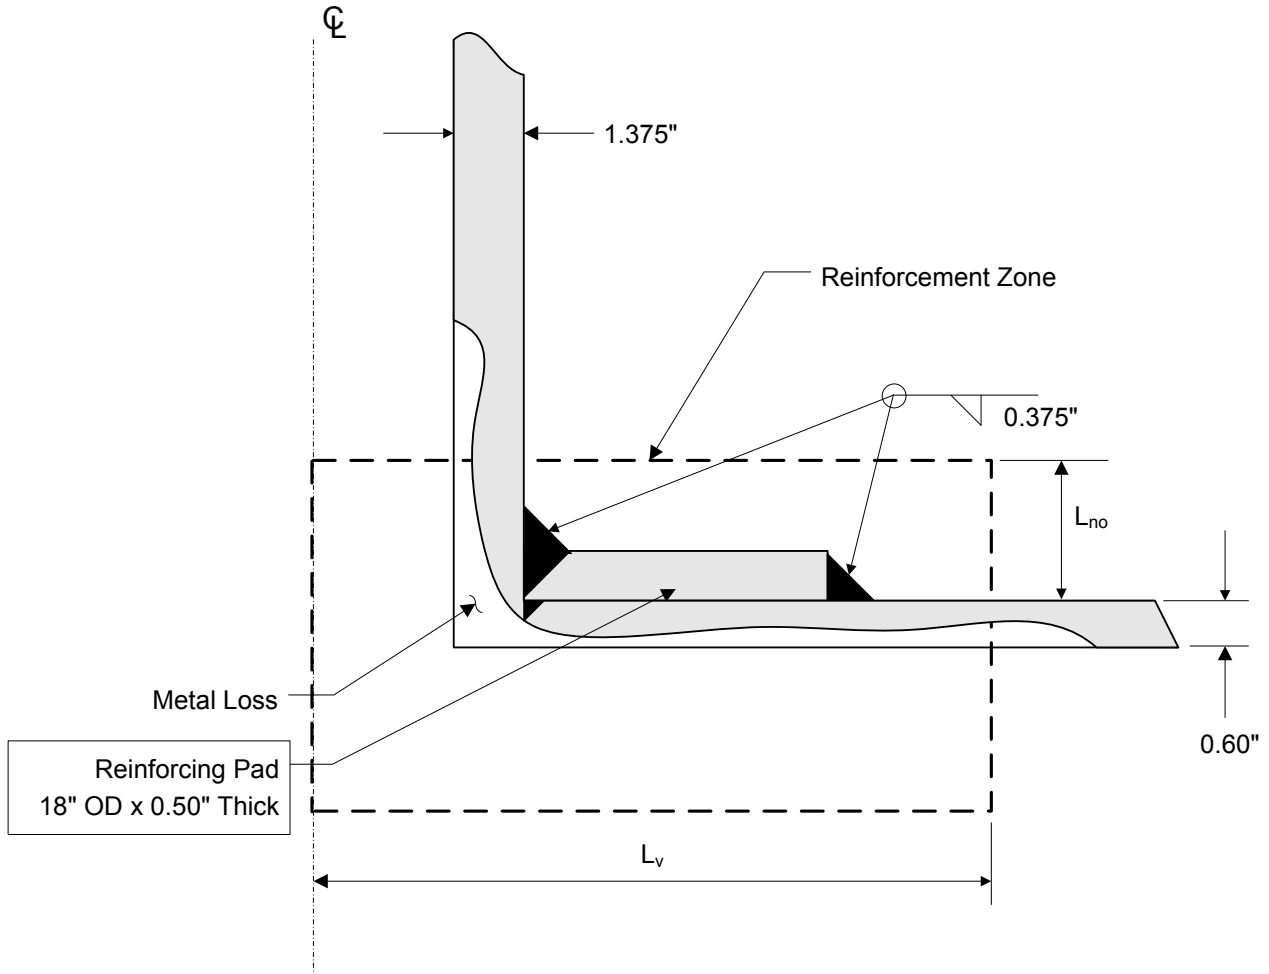
Figure E4.4-1 – Nozzle Metal Loss

A sketch of the nozzle and metal loss are shown below.

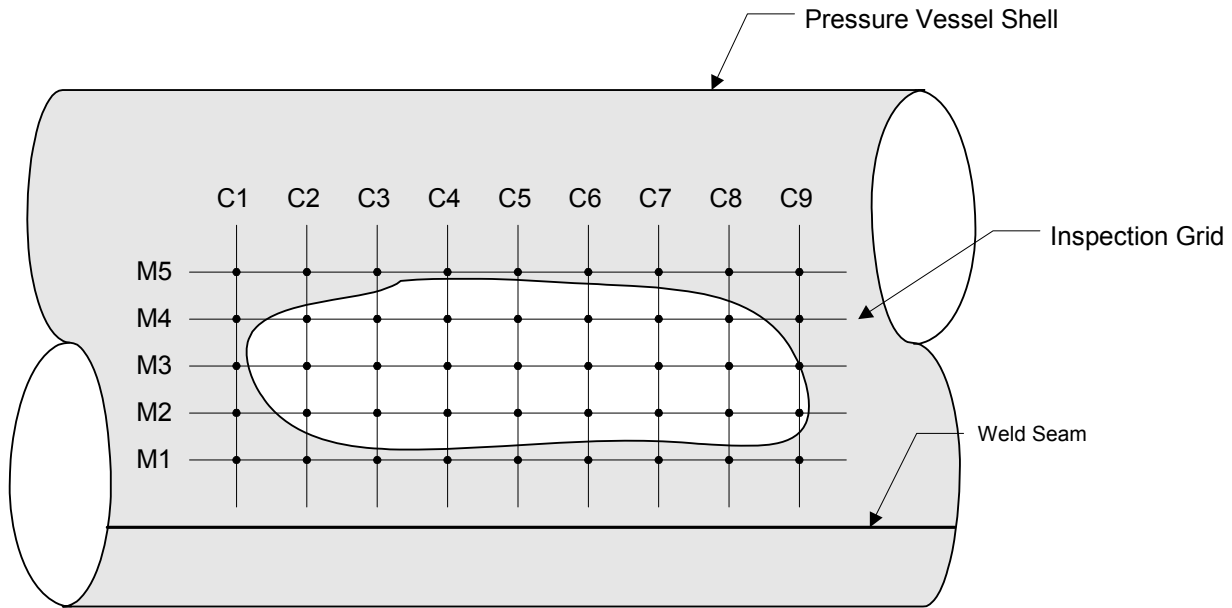
Figure E5.1-1

The thickness data and the grid used for the inspection are shown below. The distance from the region of local metal loss to the nearest structural discontinuity is 60 in. Another region of local metal loss with a smaller amount of metal loss is located 16 in from the region shown below.

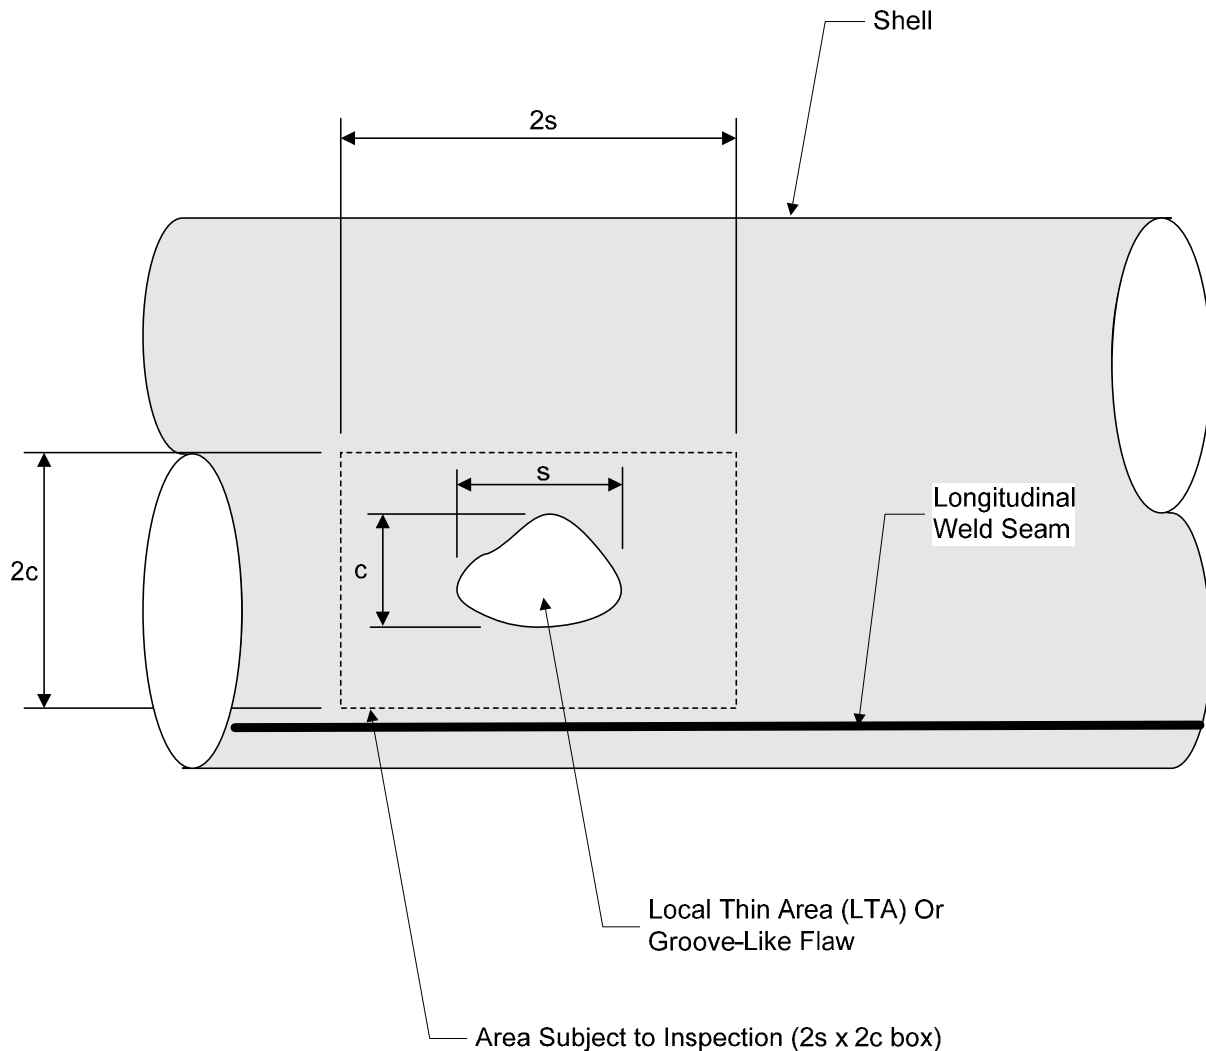
Figure E5.1-2

- c) STEP 3 – Determine the minimum measured thickness, t_{mm} , and the dimension, s , for the longitudinal CTP. The LTA being evaluated satisfies the spacing criteria in Part 4, paragraph 4.3.3.3.f.3; therefore, the dimensions of the LTA do not need to be adjusted (see Figure E5.1-2).

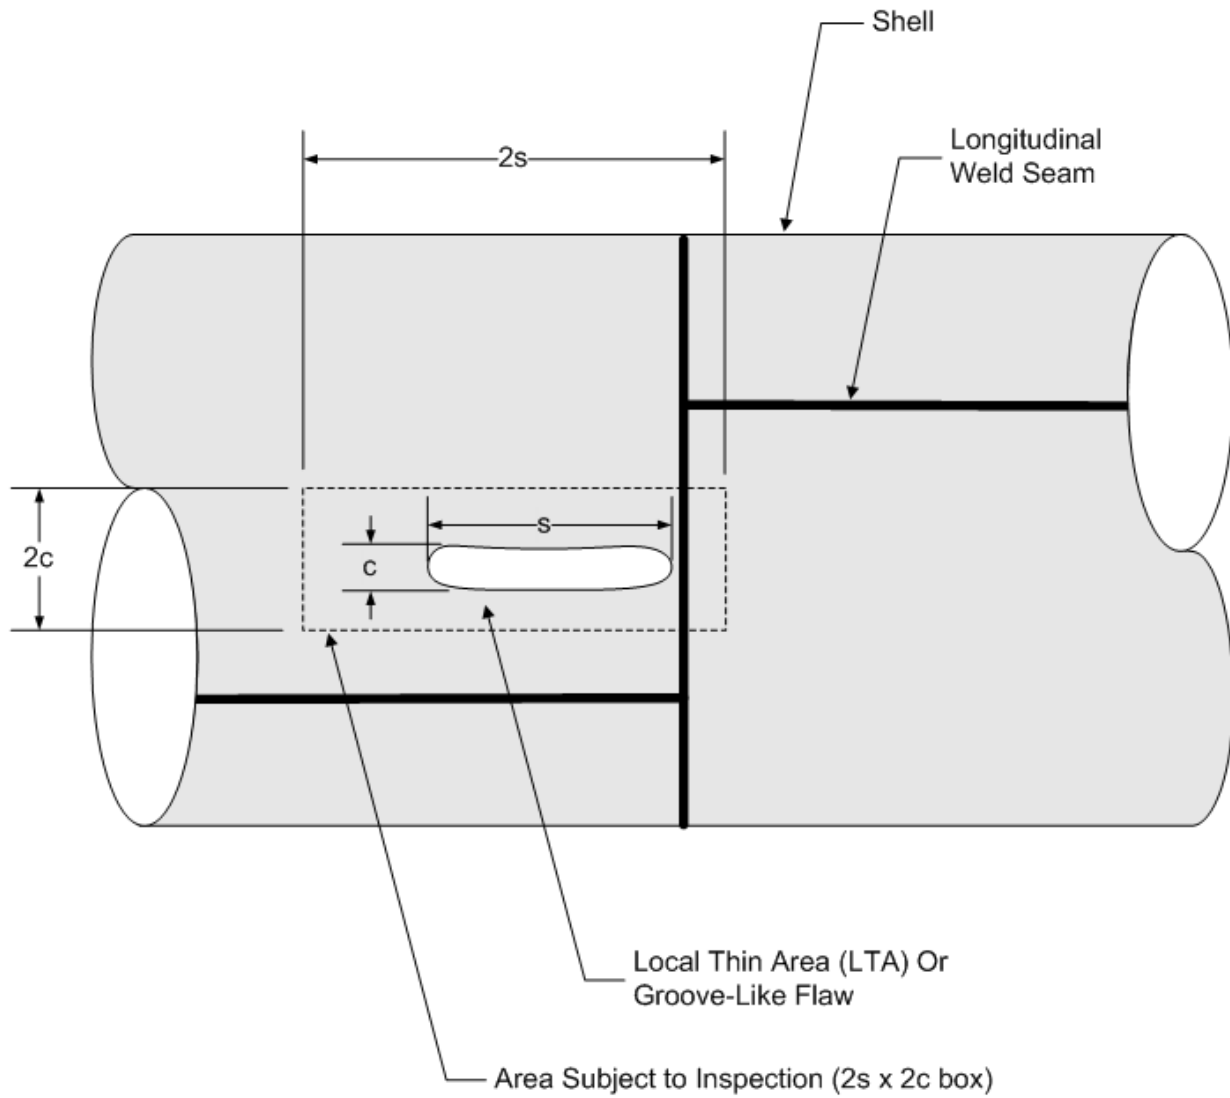
Figure E5.2-1

The groove-like flaw being evaluated satisfies the spacing criteria in Part 4, paragraph 4.3.3.3.f.3; therefore, the dimensions of the groove-like flaw do not need to be adjusted (see Figure E5.2-1).

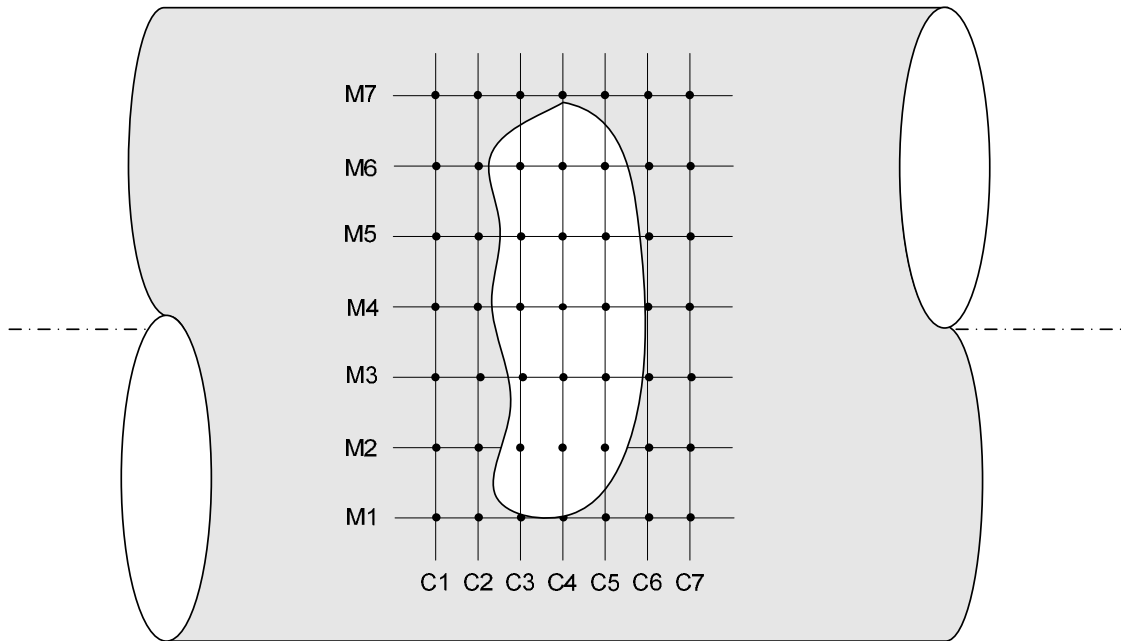
Figure E5.3-1

The thickness data and the grid used for the inspection are shown below. This is the only region of localized metal loss found on the vessel during the inspection. The distance from the region of local metal loss to the nearest structural discontinuity is 28 in.

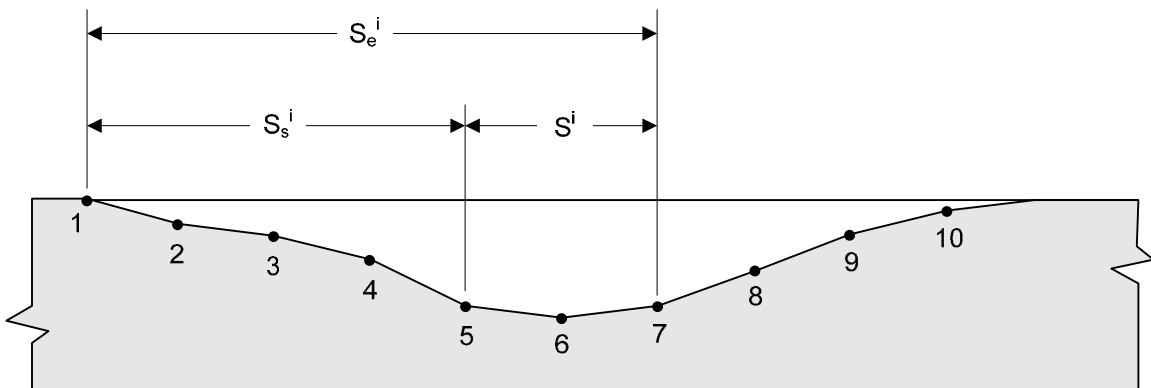
Figure E5.4-1 Thickness Profile

1. Starting location of metal loss region under consideration.
2. Ending location of metal loss region under consideration.
3. Length of metal loss for the region under consideration.
4. Shell parameter evaluated using Equation (5.6) integration with $s = s^i$.
5. Area of metal loss evaluated using a numerical procedure.
6. Original metal area evaluated using Equation (5.20).
7. Folias factor evaluated using Table 5.2 with $\lambda = \lambda^i$.
8. Remaining strength factor; evaluated using Equations (5.19).

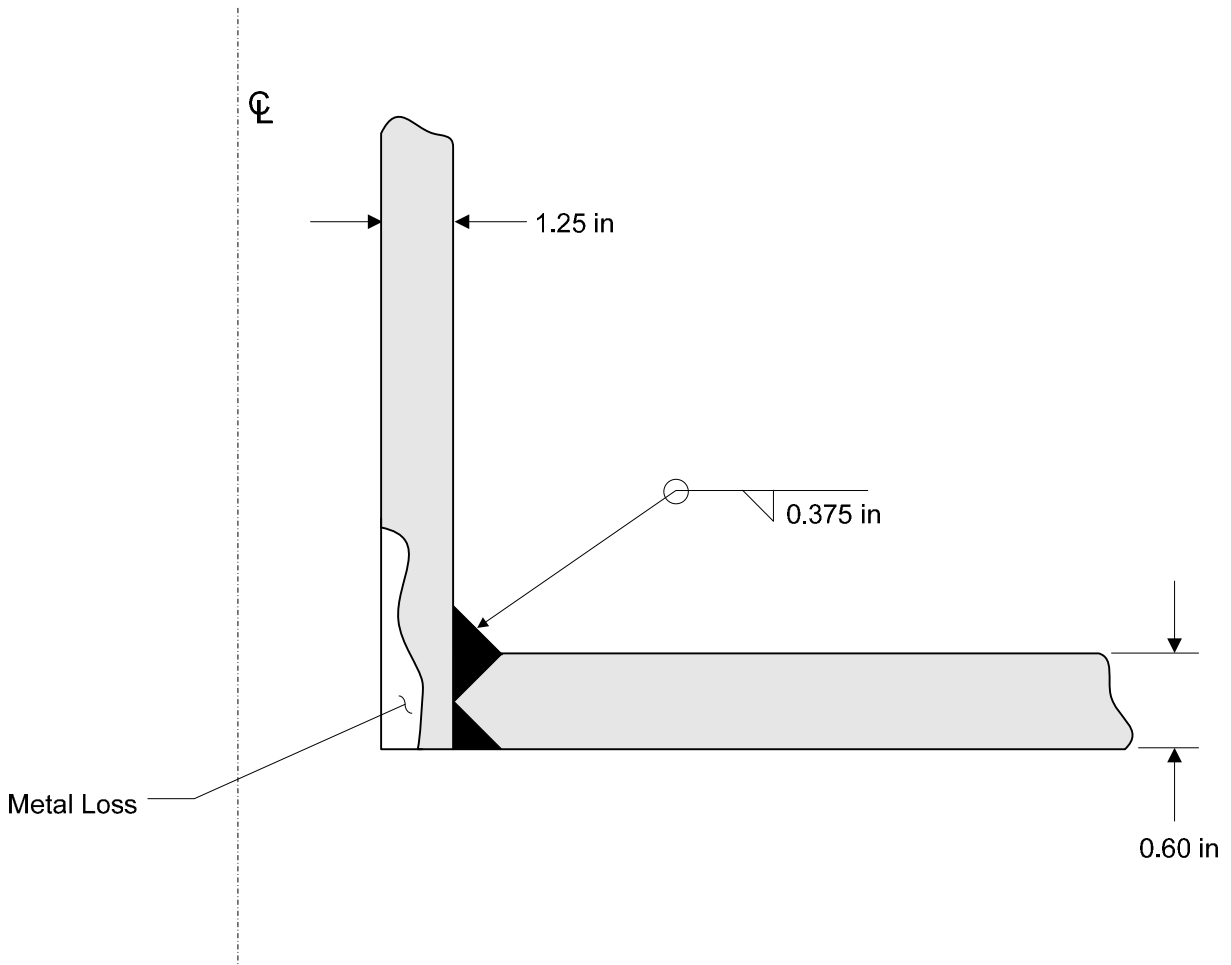
Figure E5.6-1

The region of localized metal loss is shown in the following figure. The opening is located 45 in from the nearest major structural discontinuity which is a NPS-12 nozzle.

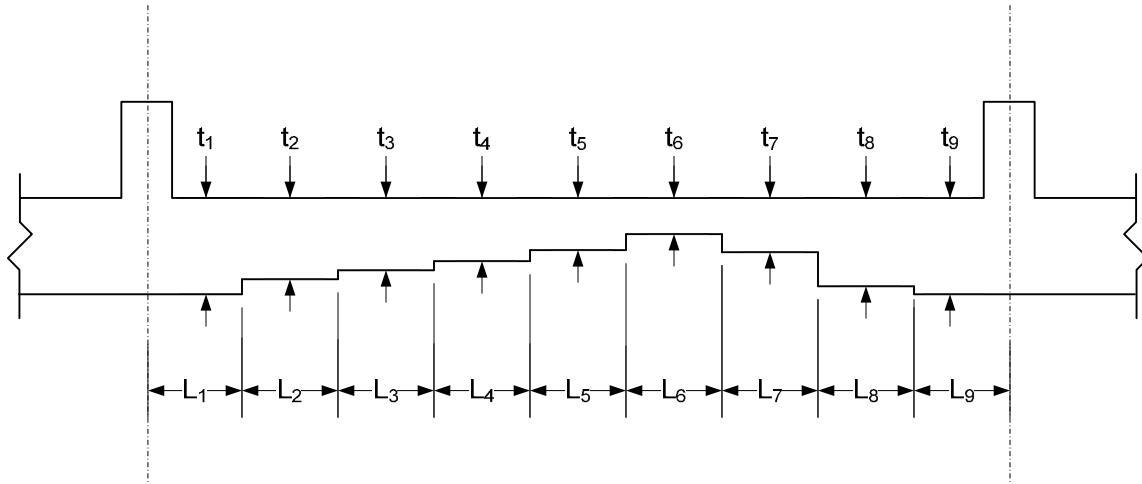
Figure E5.9-2 Thickness Profile

The distance from the edge of the metal loss to the nearest stiffening ring in the longitudinal direction is 310 in on one side and 580 in on another side.

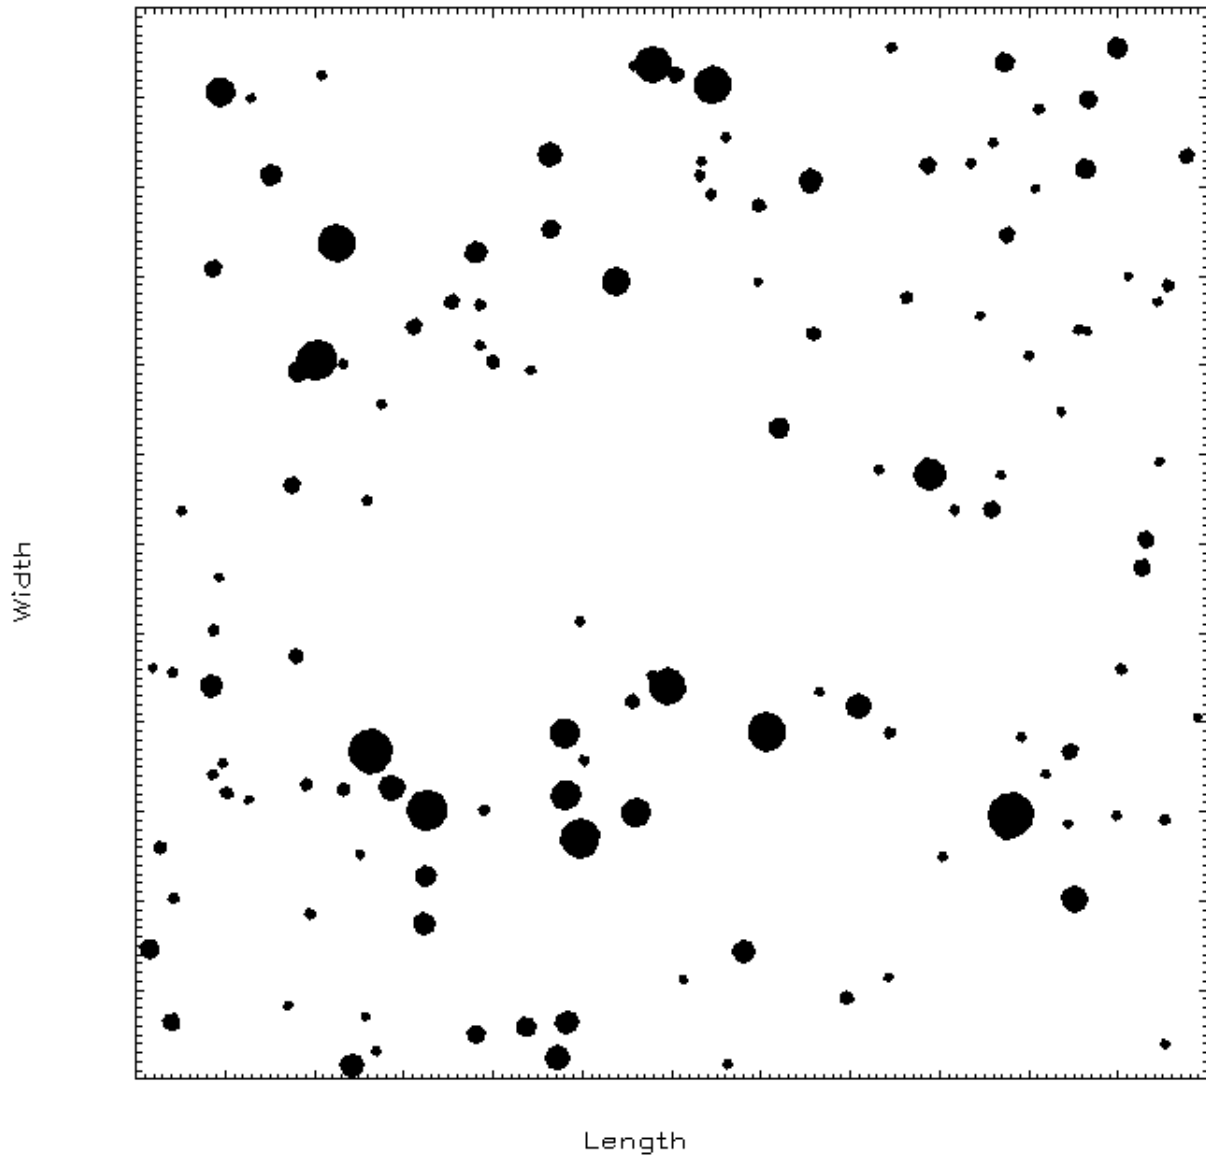
Based on the picture, the closest Level 1 pitting chart is Figure E6.1-2

Note: The scale of this figure is 150 mm by 150 mm (6 in by 6 in)

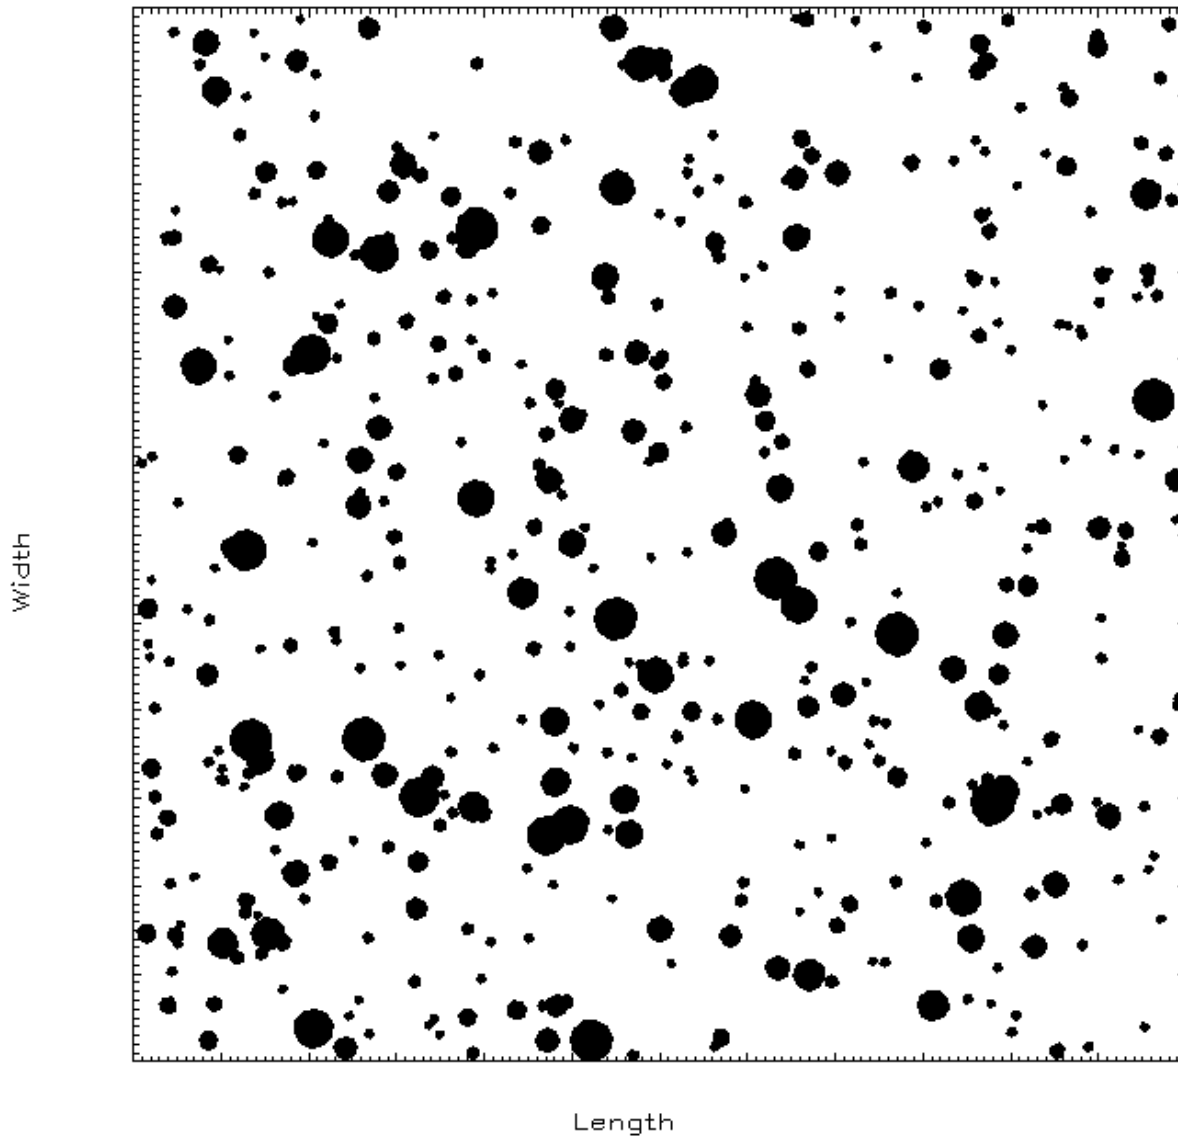
Based on the picture, the closest Level 1 pitting chart is Figure E6.2-2

Note: The scale of this figure is 150 mm by 150 mm (6 in by 6 in)

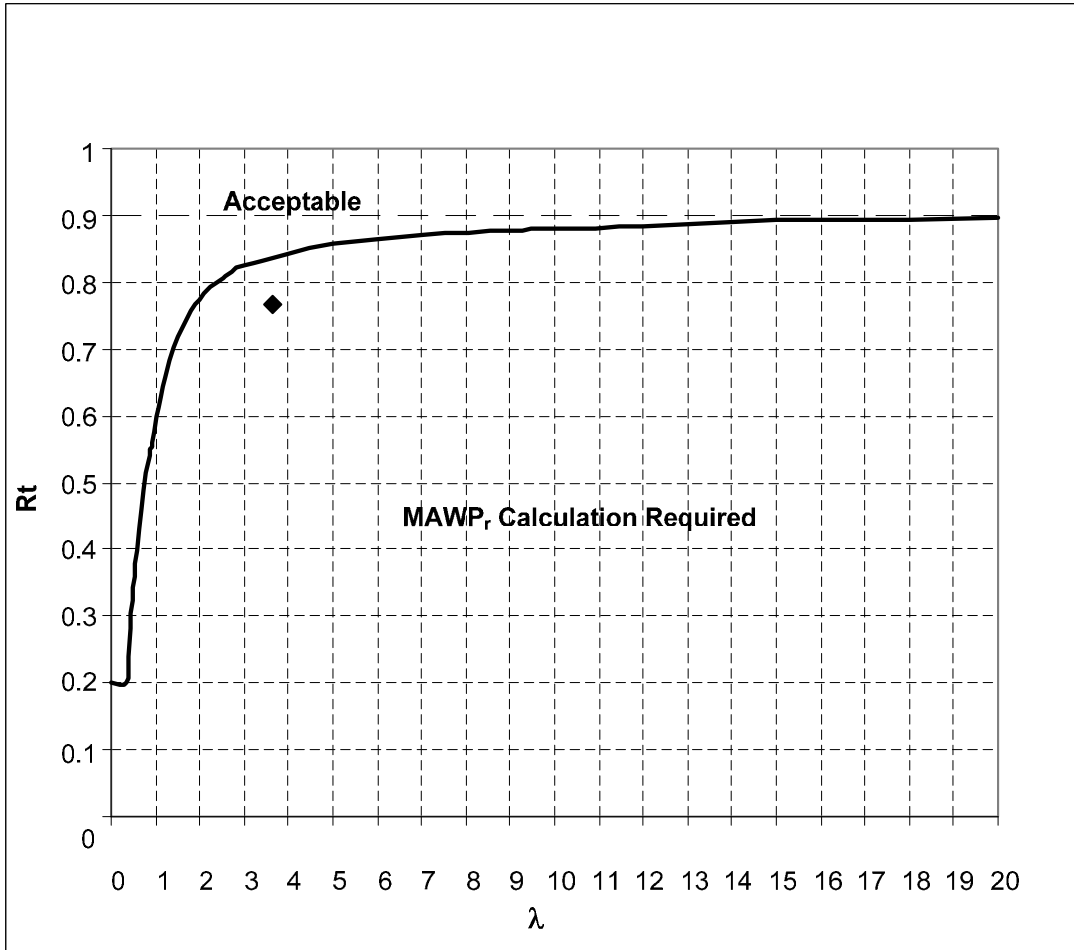
Figure E6.4-1 Level 1 Screening Curve (API 579 Figure 5.6)

- h) STEP 8 – Enter Figure 5.6 for a cylindrical shell or Figure 5.7 for a spherical shell with the calculated values of λ and R_t .

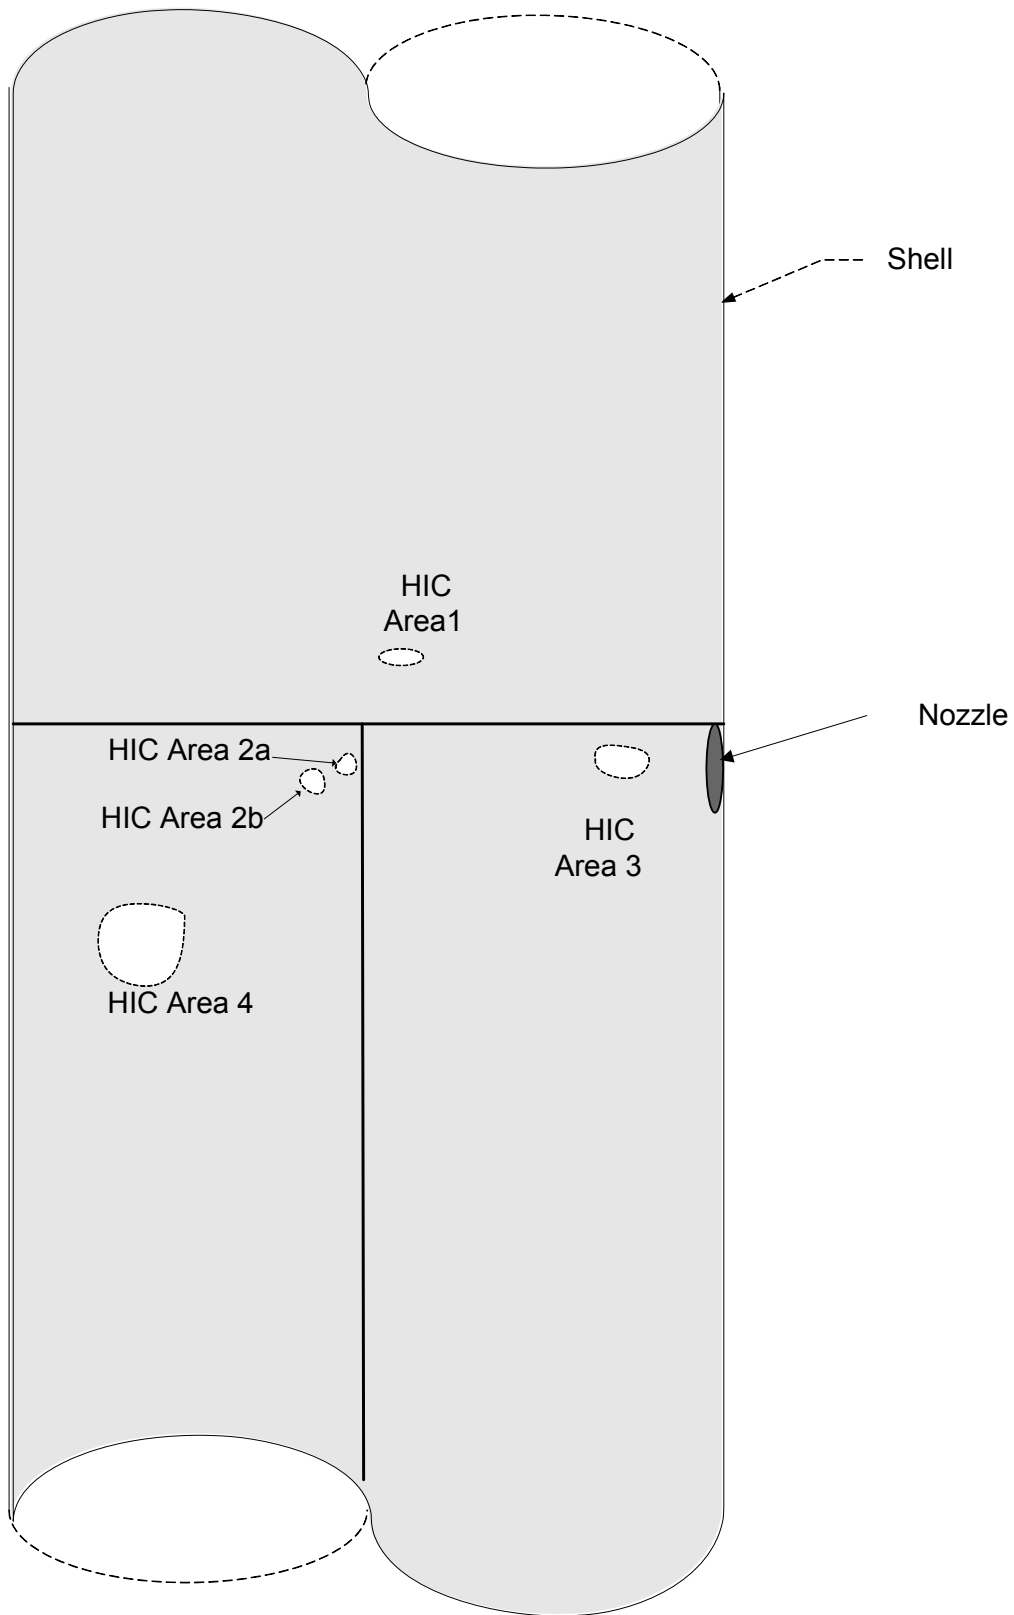
Figure E7.1-1 - HIC Damage

A schematic of a pressure vessel containing the HIC damage is shown in Figure E7.1-1. The inspection data for the HIC damage is in Table E7.1-1.

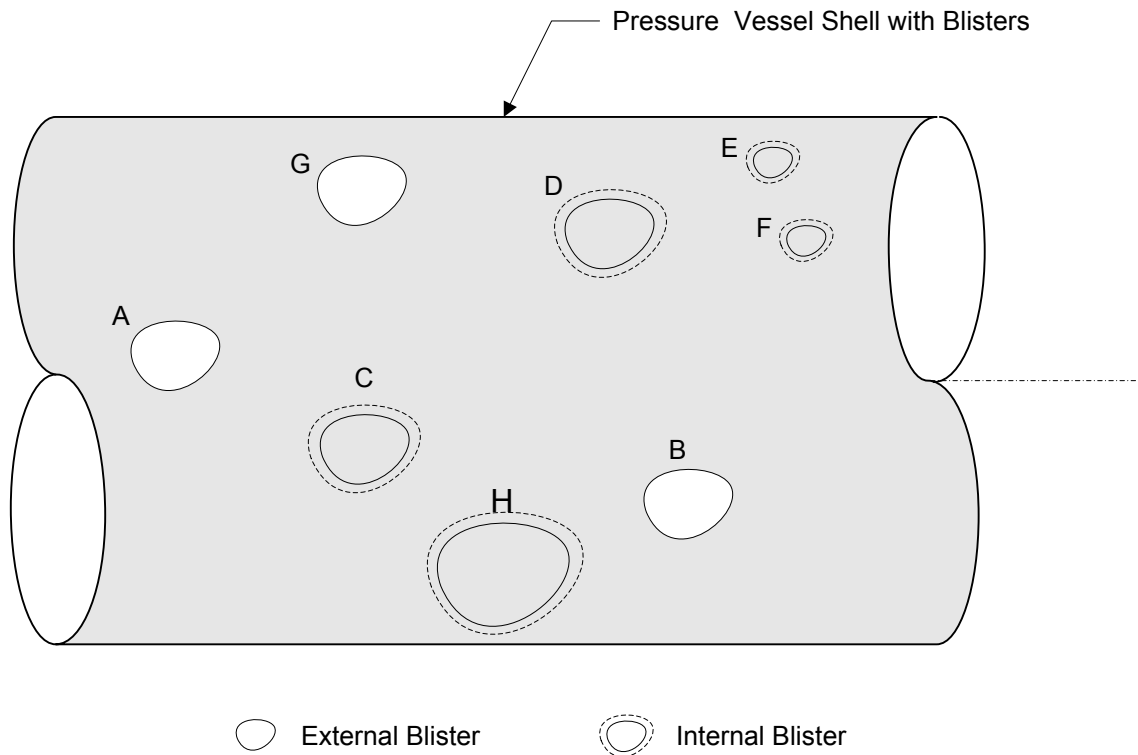
Figure E7.2-1 Blister Damage

The pressure vessel section containing the blisters is shown below. The inspection data for the blisters is shown in the following table.

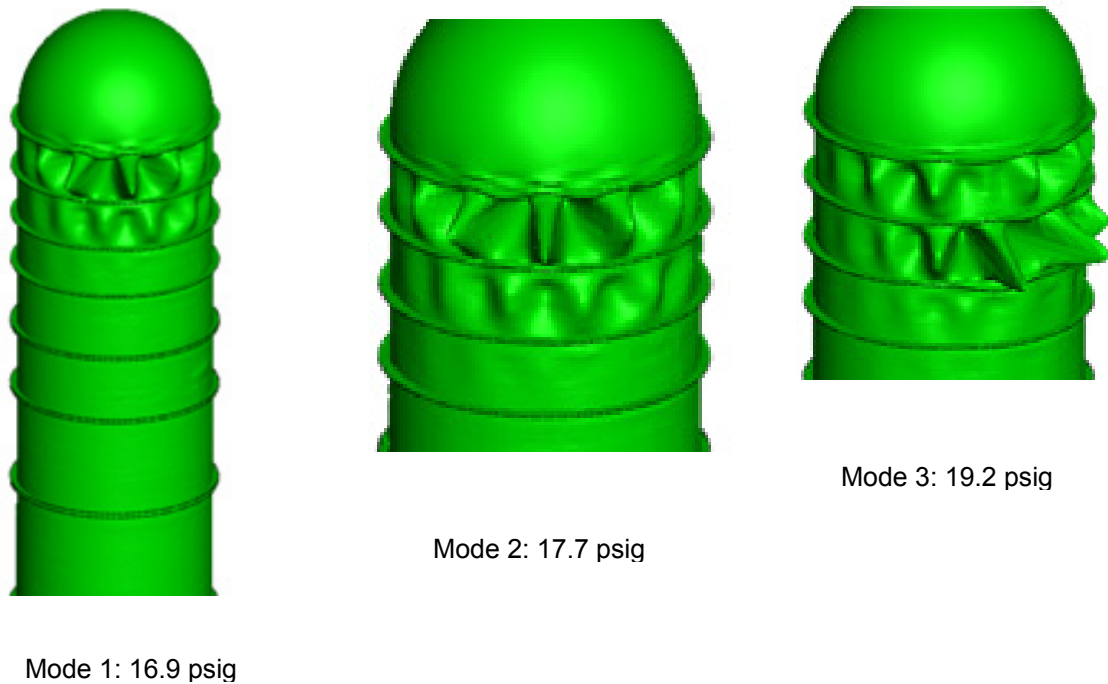
Figure E8.6-4 - Lowest Three Buckling Modes

Since the permissible external pressure P_{ext} exceeds the design external pressure of 5 psig, the deformed cylindrical shell is adequate for continued service.

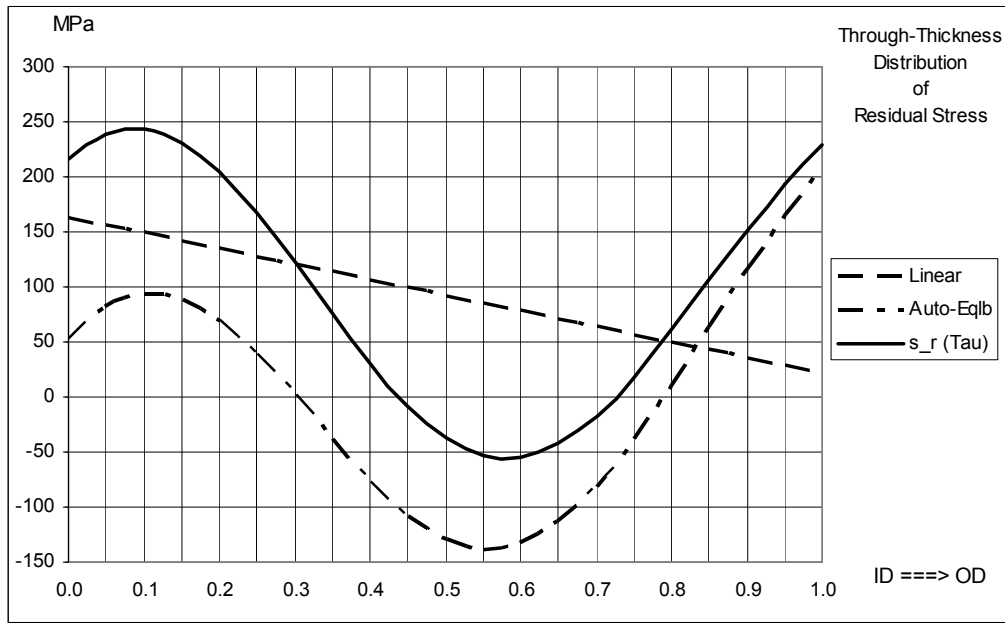
Figure E9.6-1 - Through-Thickness Distribution of Residual Stress per Annex E

ζ	A	B	D	E	$\sigma^R(\zeta)$	Linear	Auto-Eqlb
0.0	-0.2514	-0.4190	0.6972	0.6972	215.4324	163.6433	51.7892
0.1	-0.1287	-0.4318	0.7868	0.7868	243.1162	149.4546	93.6616
0.2	-0.0543	-0.2797	0.6632	0.6632	204.9168	135.2660	69.6509
0.3	-0.0161	-0.0208	0.3965	0.3965	122.5174	121.0773	1.4401
0.4	-0.0020	0.2461	0.0978	0.0978	30.2112	106.8887	-76.6774
0.5	0.0000	0.4190	-0.1190	-0.1190	-36.7730	92.7000	-129.4730
0.6	0.0020	0.4318	-0.1757	-0.1757	-54.3029	78.5113	-132.8142
0.7	0.0161	0.2797	-0.0555	-0.0555	-17.1361	64.3227	-81.4588
0.8	0.0543	0.0208	0.1958	0.1958	60.5019	50.1340	10.3678
0.9	0.1287	-0.2461	0.4912	0.4912	151.7754	35.9454	115.8300
1.0	0.2514	-0.4190	0.7408	0.7408	228.9135	21.7567	207.1567
