Fitness-For-Service Example Problem Manual

API 579-2/ASME FFS-2 2009

AUGUST 11, 2009

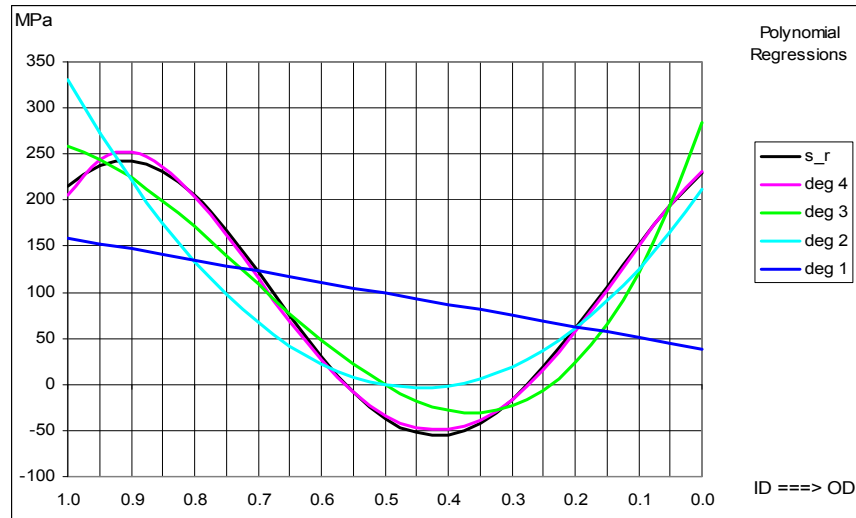
Figure E9.6-2 - Through-Thickness Distribution with Polynomial Trend Curves

Figure E9.6-2 shows the through-wall residual stress distribution as determined per Annex E (s_r) and the best-fit polynomial curves of different degrees (deg 1 to 4). This figure validates the use of a 4th order polynomial for the representation of the residual stress.

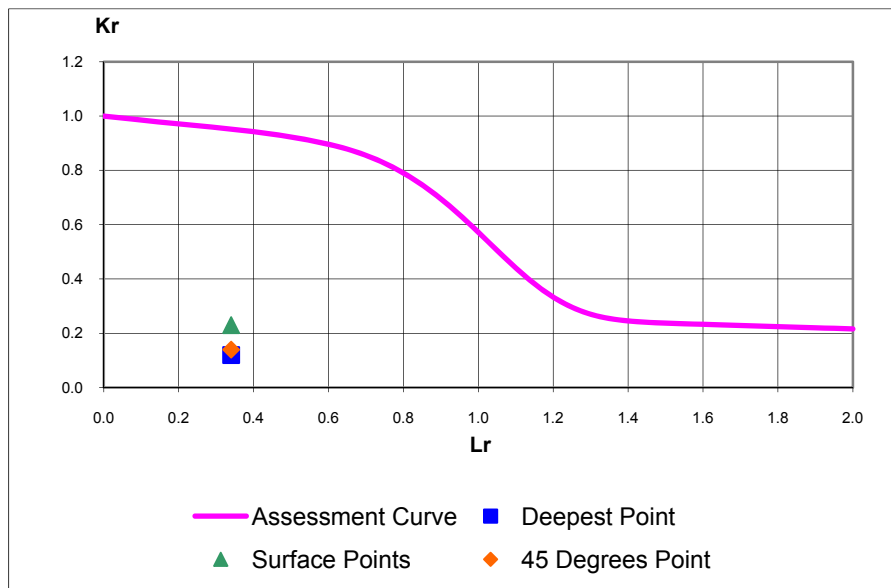
Figure E9.7-1 - FAD with Assessment Points

At 45 degrees on the crack front: $(L_r^P, K_r) = (0.342, 0.138)$; the point is inside the *FAD*

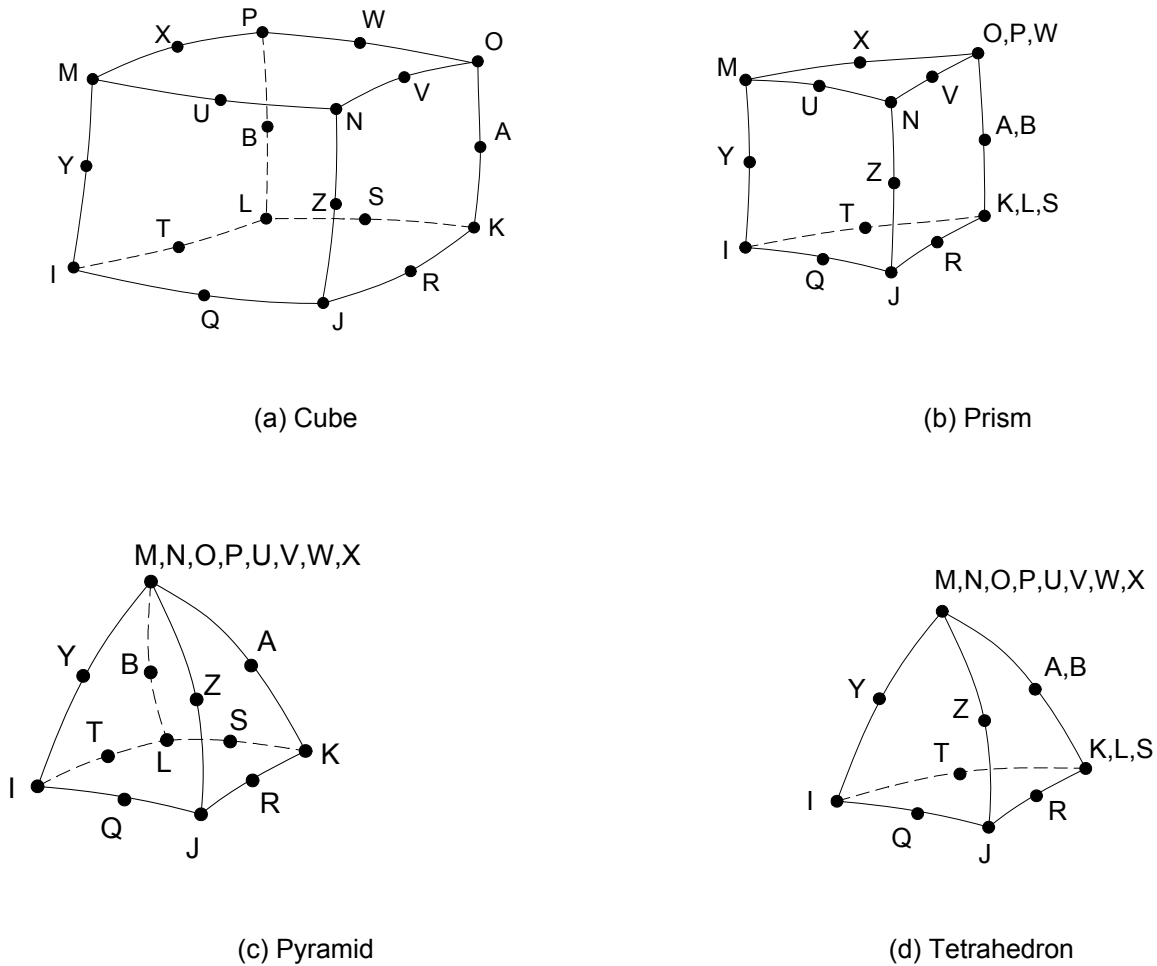
Figure E9.10-2 - 3D 20-Node Solid Elements used for Elastic-Plastic Analysis

Due to the 2 symmetries, only one quarter of the nozzle is modeled with SOLID186 elements. This is a 20-node brick element that degenerates into prism, pyramid or tetrahedron by merging nodes (see Figure E9.10-2). The length of modeled shell is 3000 mm, the length of nozzle is 1500 mm. The crack front itself is embedded in a torical region in order to ensure a regular spider mesh around it (see Figure E9.10-3). The size of the triangular faces next to the crack front is 0.5 mm.

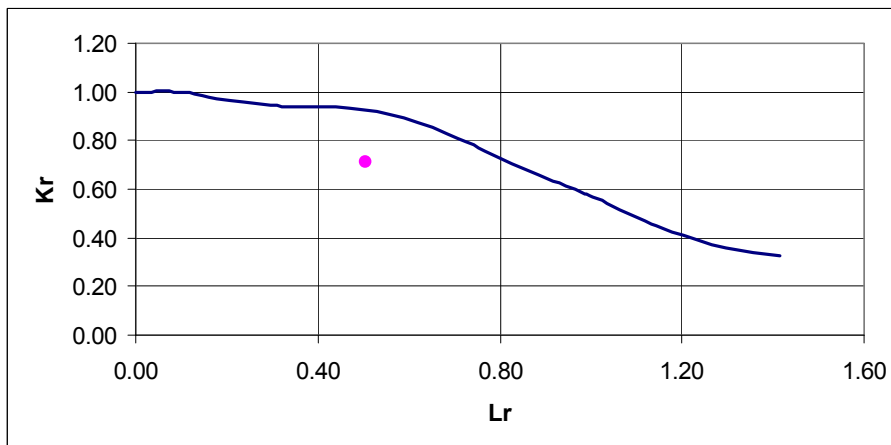
Figure E9.10-6 - FAD with Assessment Point

- h) STEP 8 - Plot the FAD curve K_r versus L_r - See Figure E9.10-6

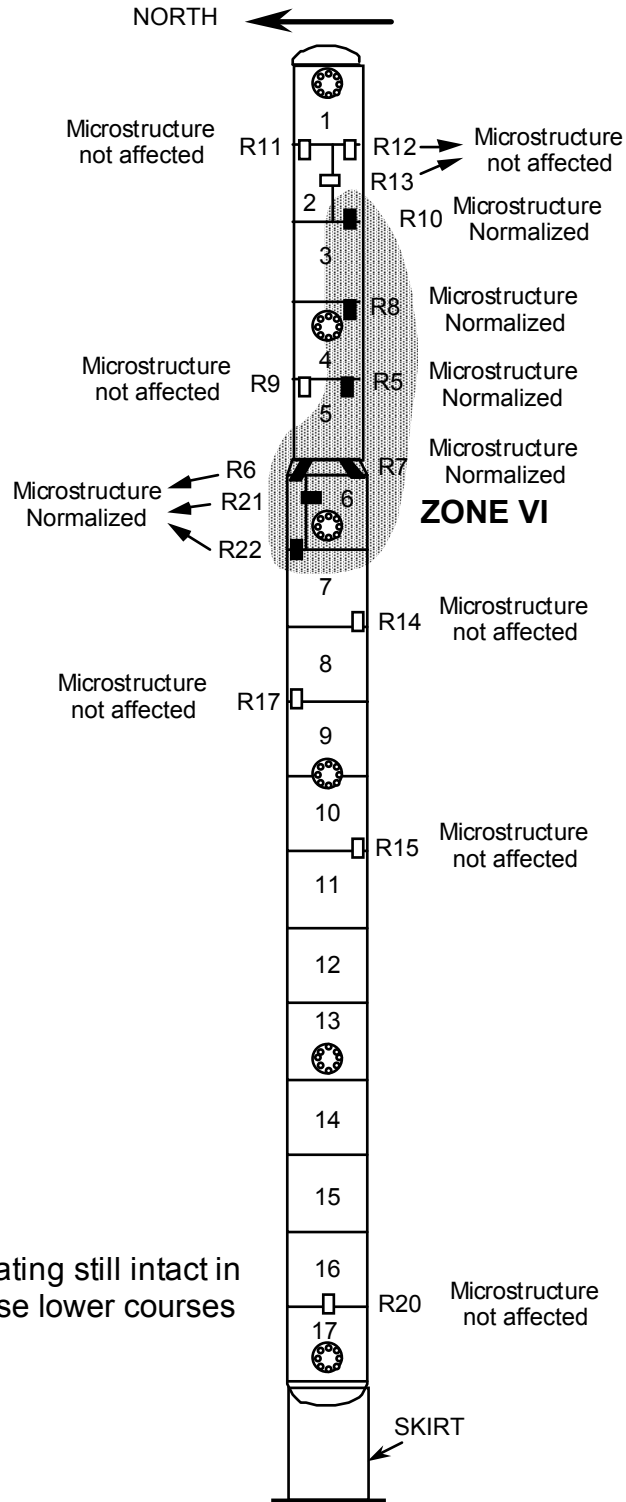
Figure E11.3-1 - Places Where In-Situ Field Metallography Was Performed. Heat Exposure Zone VI Was Defined Based On Metallographic Findings

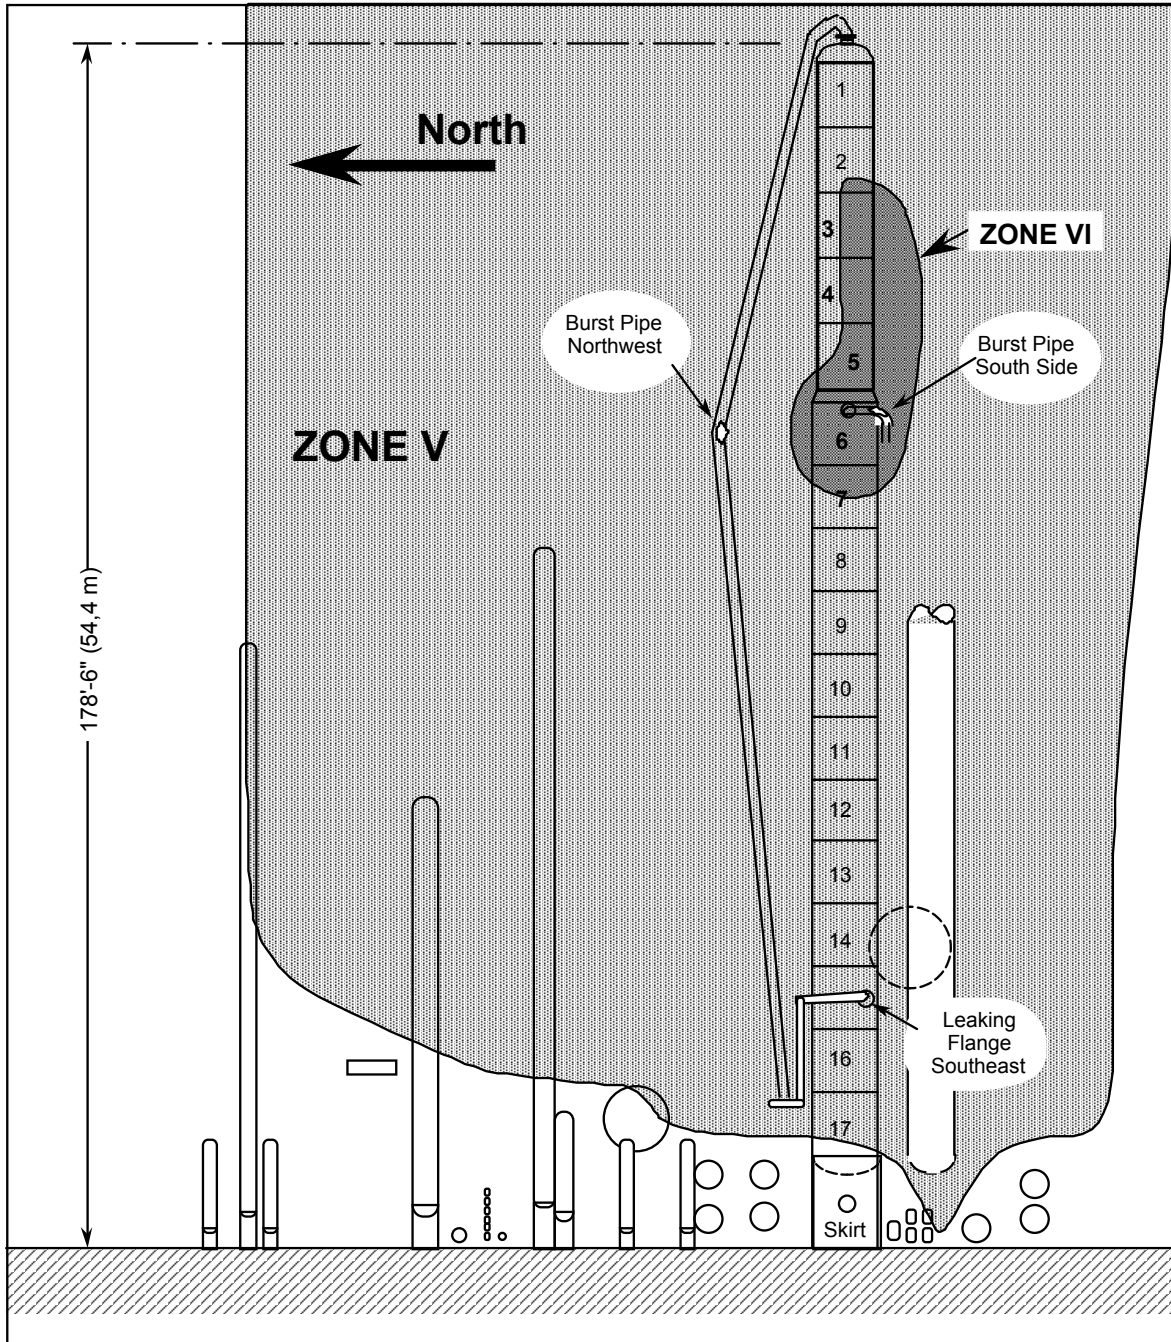
Figure E11.3-2 - Elevation View Showing Heat Exposure Zones V and VI, Looking Toward The East

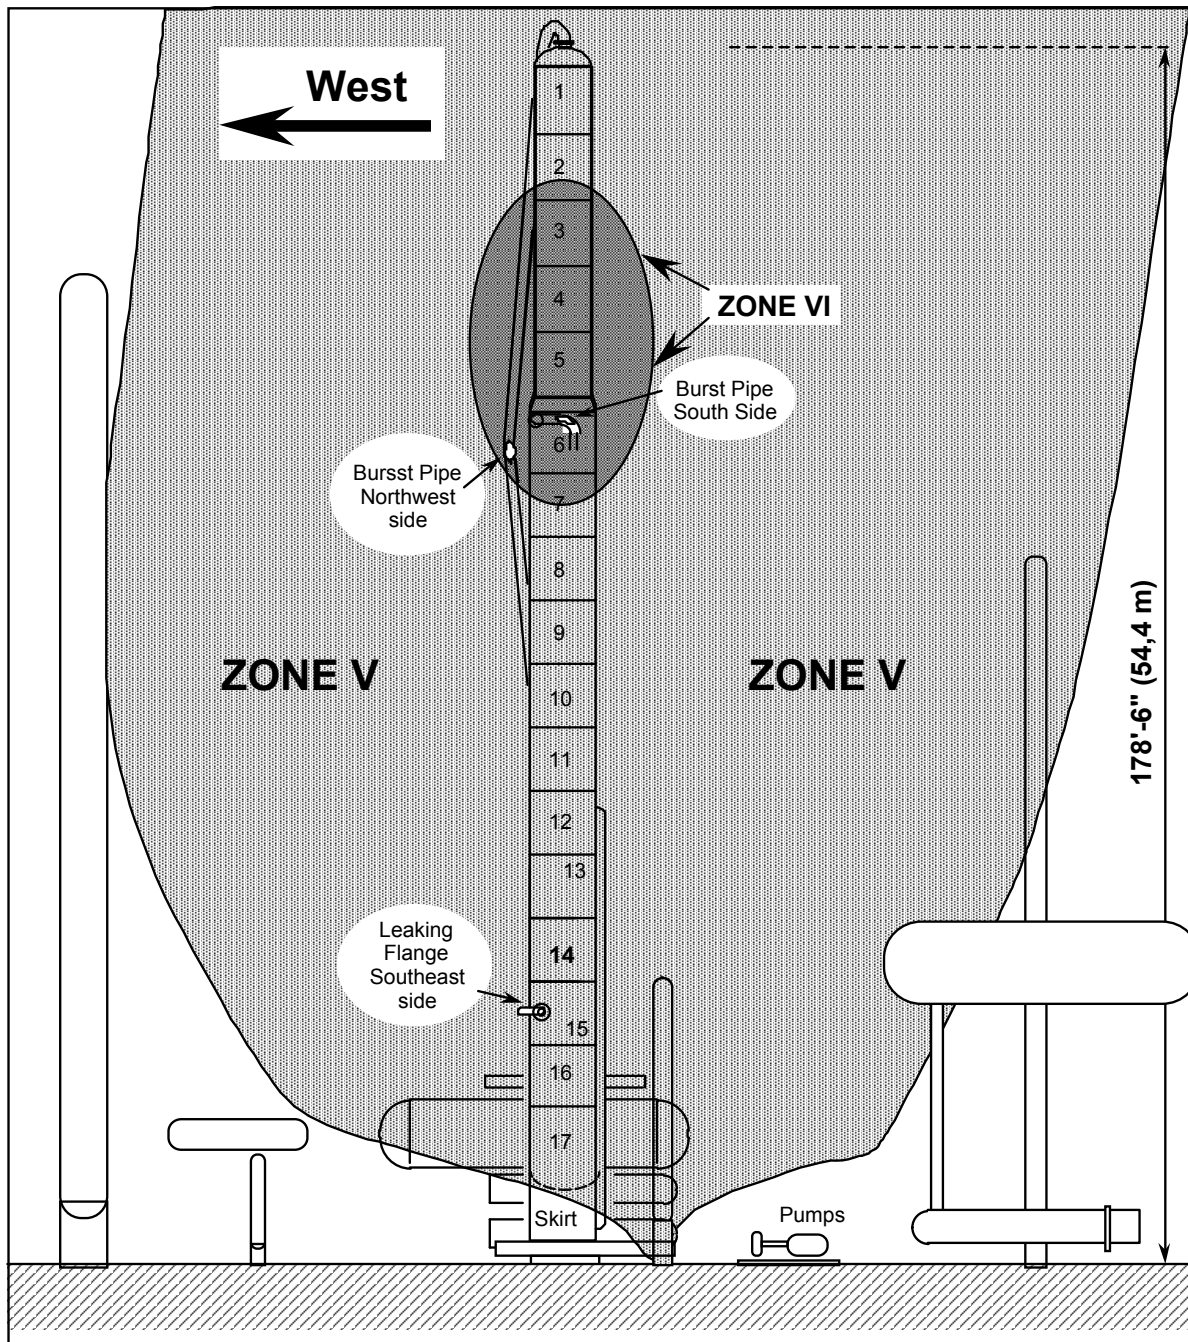
Figure E11.3-3 - Elevation View Showing Heat Exposure Zones V and VI, Looking Toward The North

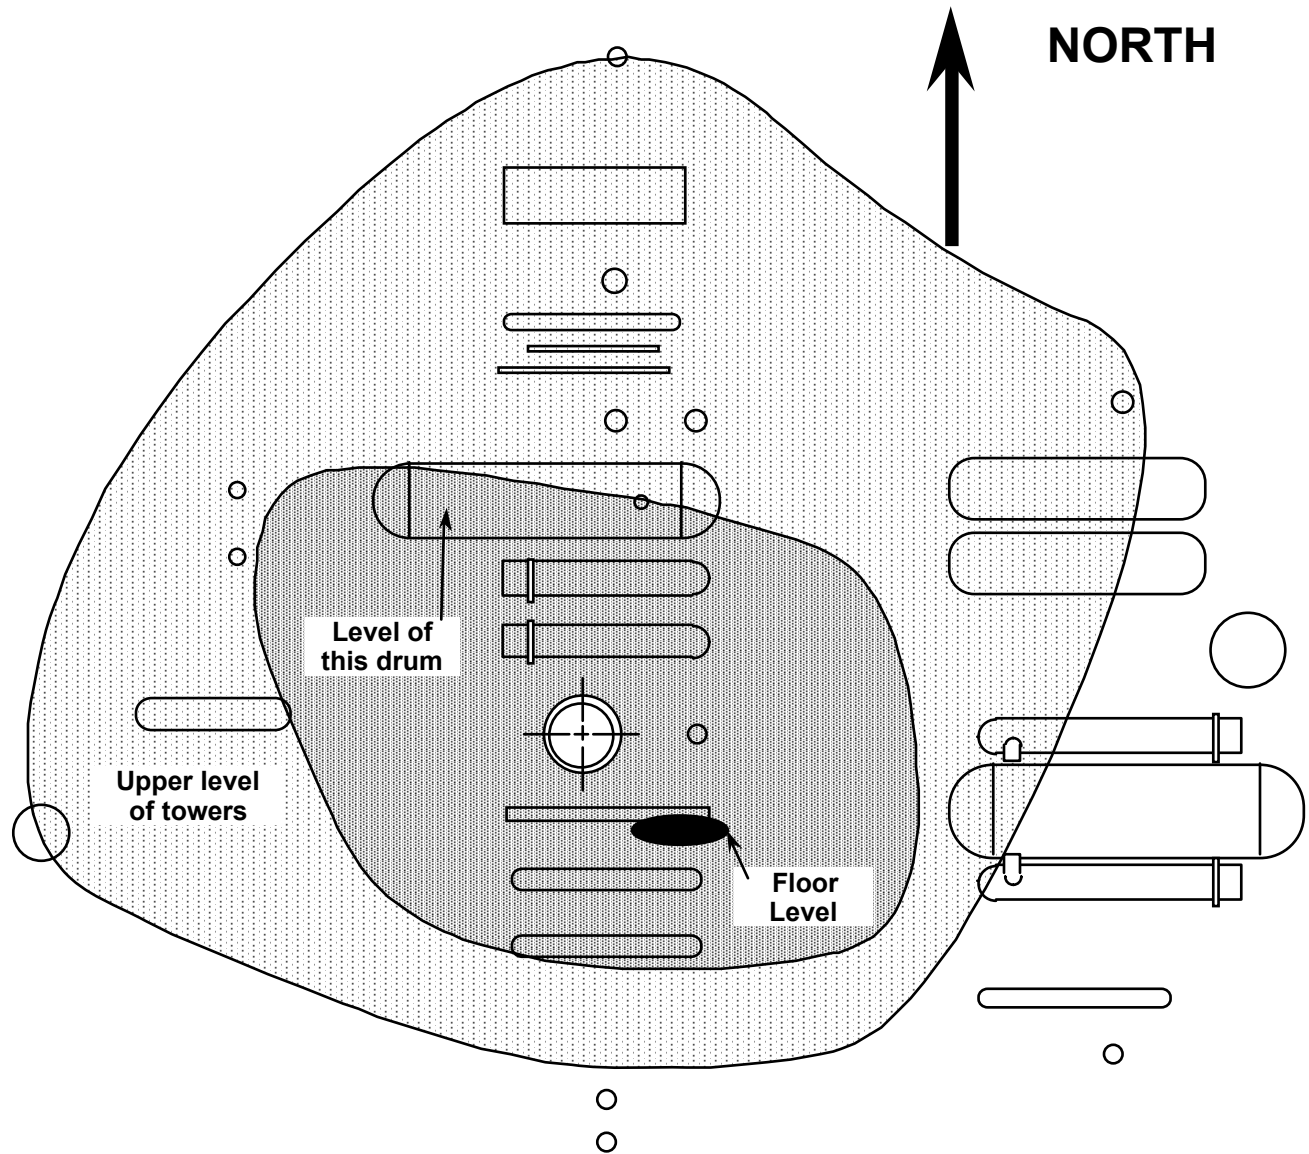
Figure E11.3-4 - Plan View Showing Heat Exposure Zone V

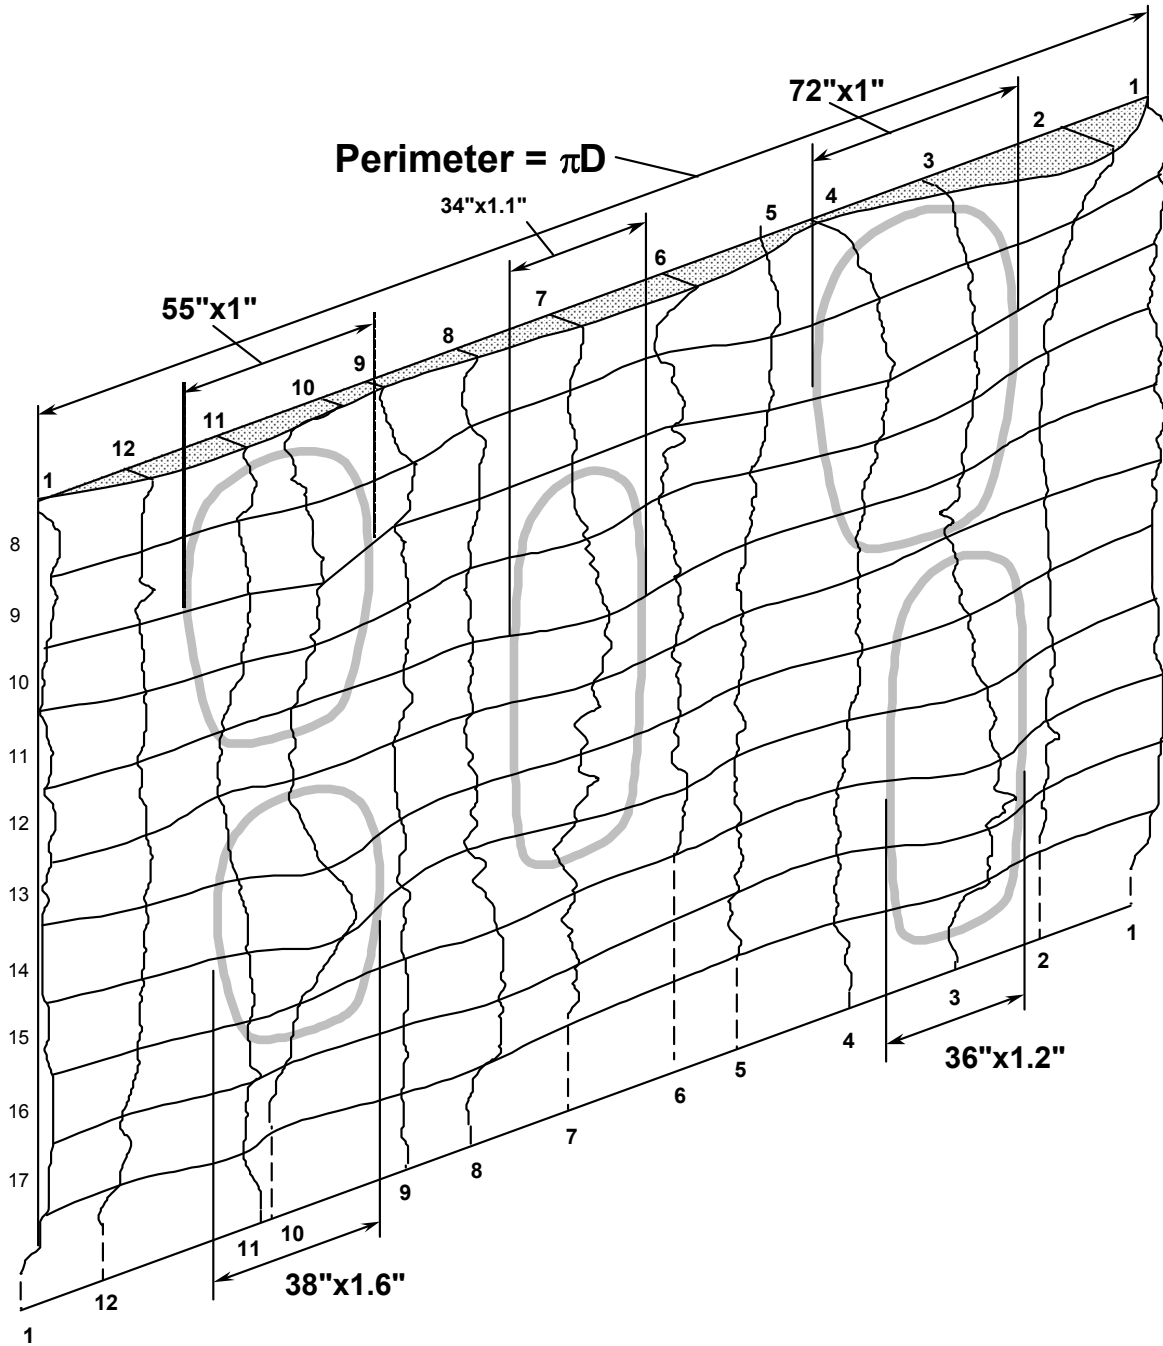
Figure E11.3-10 - Surface Contour Of The Lower Part Of The Tower Derived From The Profiles
