STRESS CORROSION CRACKING OF TITANIUM  
ALLOYS IN METHANOLIC AND OTHER MEDIA

AFML-TR-71-232

TECHNICAL REPORT AFML-TR-71-232

MARCH 1972

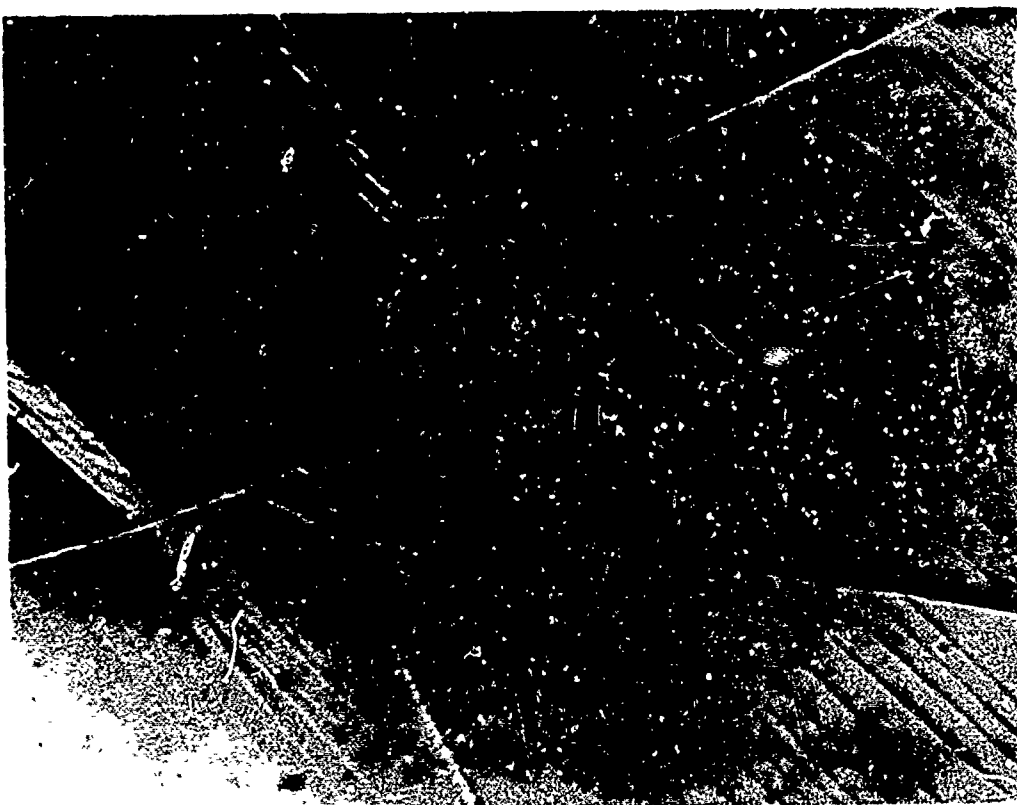
Figure 23. Transgranular Cracking of Highly Stressed  $\beta$ -III Alloy in Bromine-Methanol Solution (Note relationship of crack direction to slip lines caused by plastic deformation.)

intergranular when the bromine concentration is 0.5% or greater (Figure 21). At lower bromine concentrations the stress corrosion cracking appears to be largely transgranular, as illustrated in Figures 22 and 23. The stress corrosion cracking of heat-treated  $\beta$ -III is also mixed inter- and transgranular in methanol-hydrochloric acid-water mixtures as shown in Figure 24.
