EFFECTS OF HIGH SPEED MACHINING ON SURFACE TOPOGRAPHY OF
TITANIUM ALLOY (Ti6Al4V)

A THESIS PRESENTED TO THE GRADUATE SCHOOL
OF THE UNIVERSITY OF FLORIDA IN PARTIAL FULFILLMENT
OF THE REQUIREMENTS FOR THE DEGREE OF
MASTER OF SCIENCE

UNIVERSITY OF FLORIDA

2003

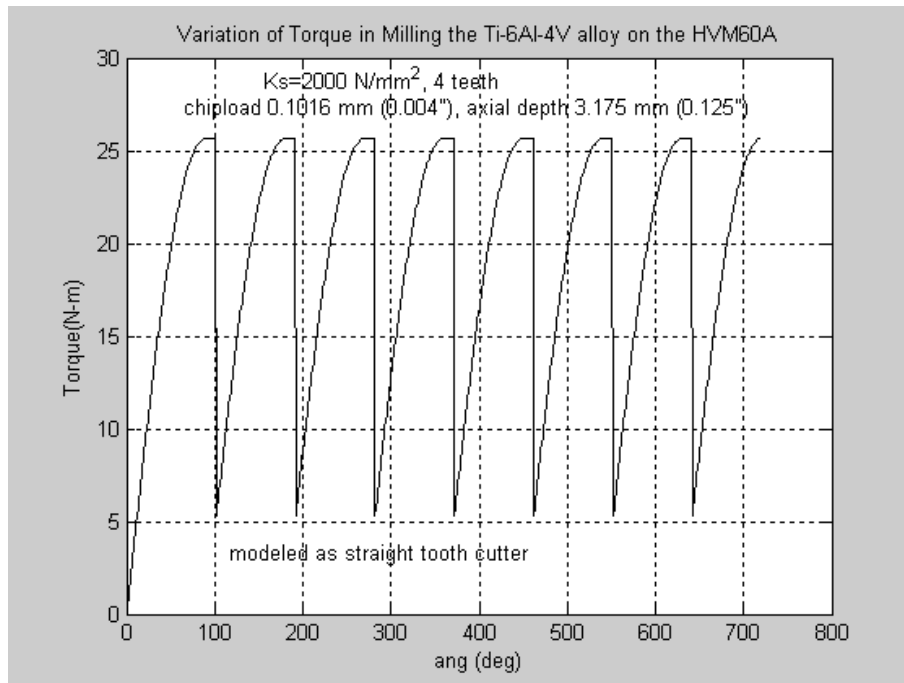
Figure 3-1 Variation of torque in milling Ti6Al4V alloy for 60% radial immersion

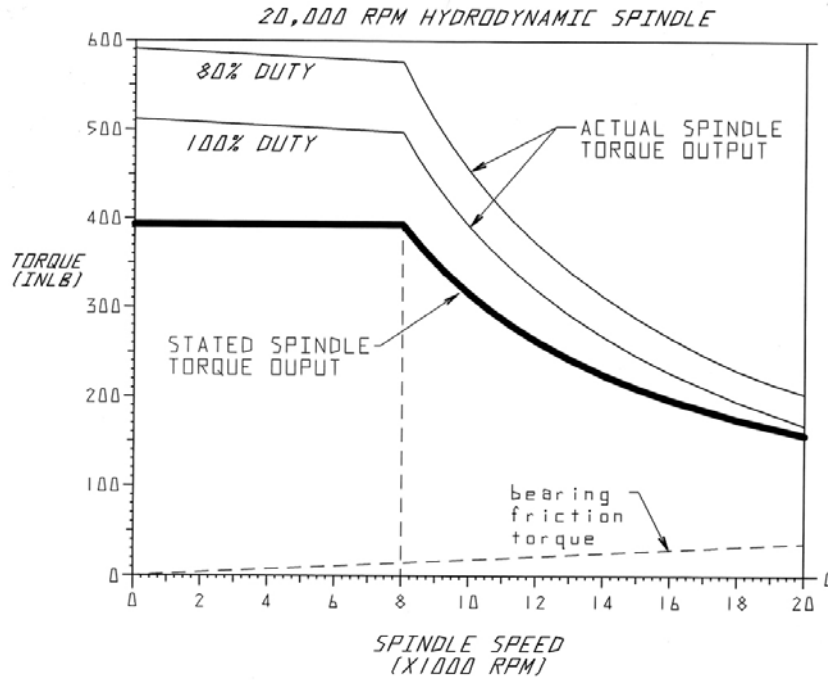
Figure 3-2 Torque-Speed characteristics of the Ingersoll HVMM [19]

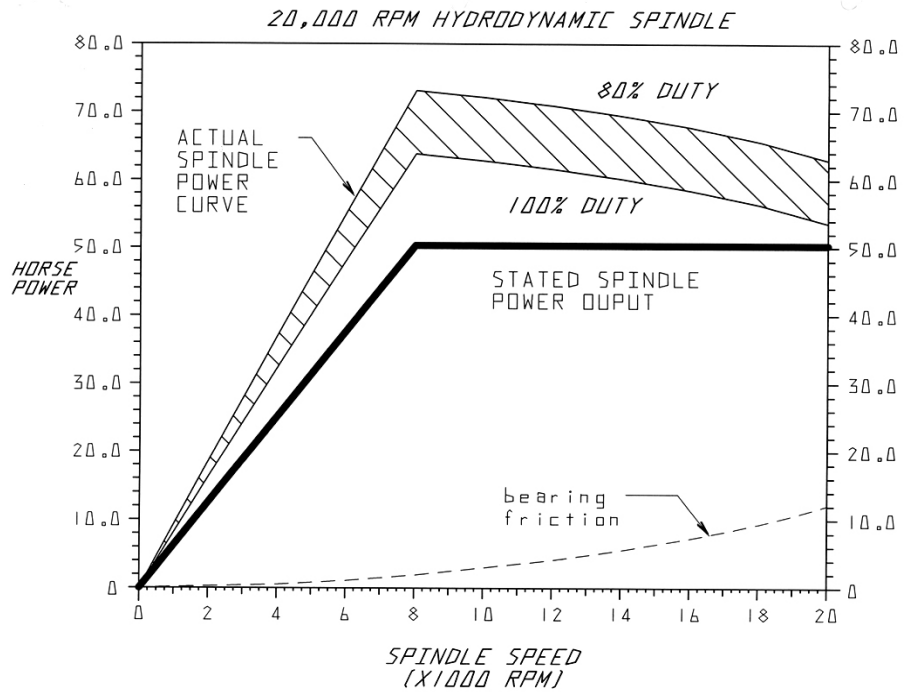
Figure 3-3 Power-Speed characteristics of the Ingersoll HVMM [19]

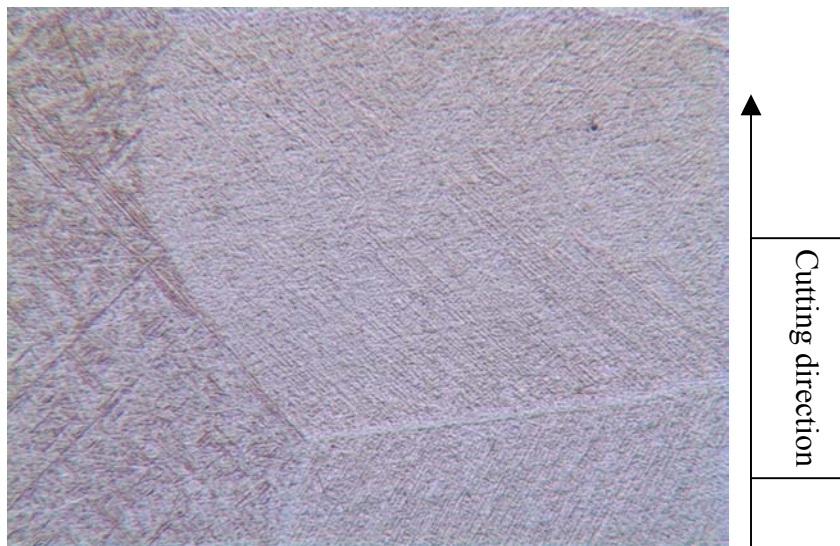
Figure 4-13 Microstructure of conventional machined process specimen #2 at magnification 120x

show the grains in the conventional machined specimen #2. at an arbitrary location on the surfaces while Figure 4-13 shows the grains in the microstructure of an advanced process specimen #7. The defects formed on the machined surfaces of specimen #2 and specimen #7, due to the different machining processes, were removed during the grinding, polishing and etching processes before taking the pictures shown in Figures 4-11, 4-12 and 4-13.

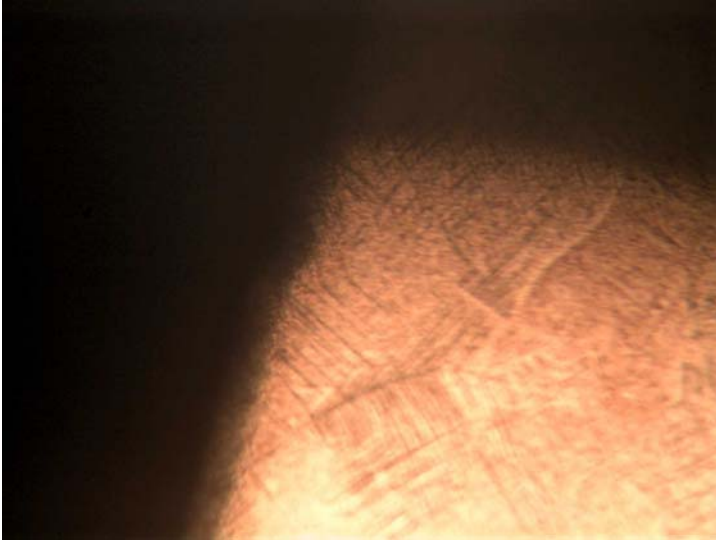
Figure 4-25 Microstructure of conventional speed machined specimen# 6 at 120x magnification showing the orientation of the grains

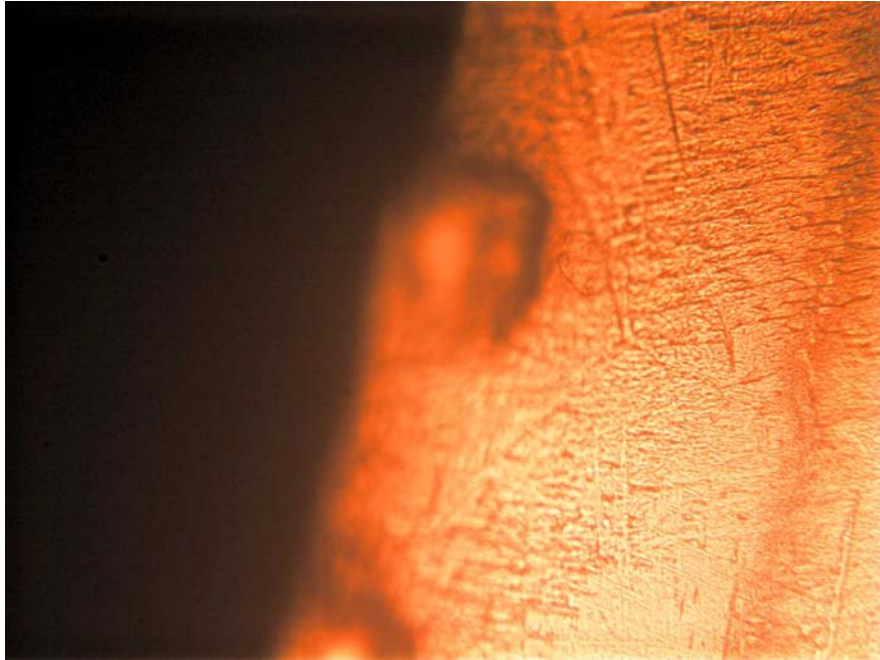
Figure 4-27 Microstructure of high speed machined etched specimen# 6 at 250x showing the surface defects at location #1

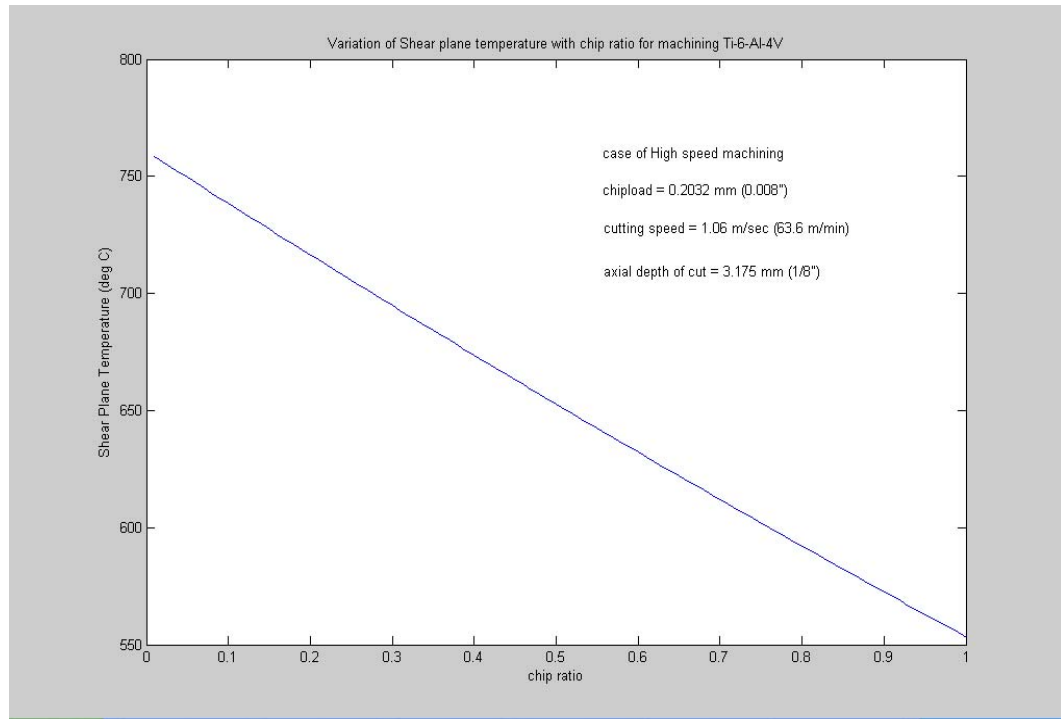
Figure 4-30 Variation of shear plane temperature with chip ratio

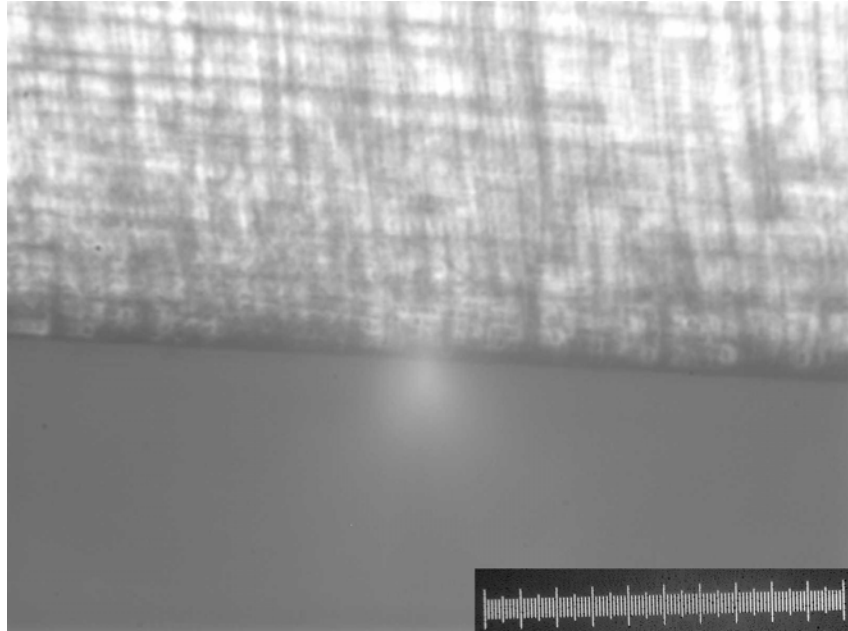
Figure 4-32 Microstructure of the advance speed machined specimen after the finish machining pass at location #2 at 100x magnification

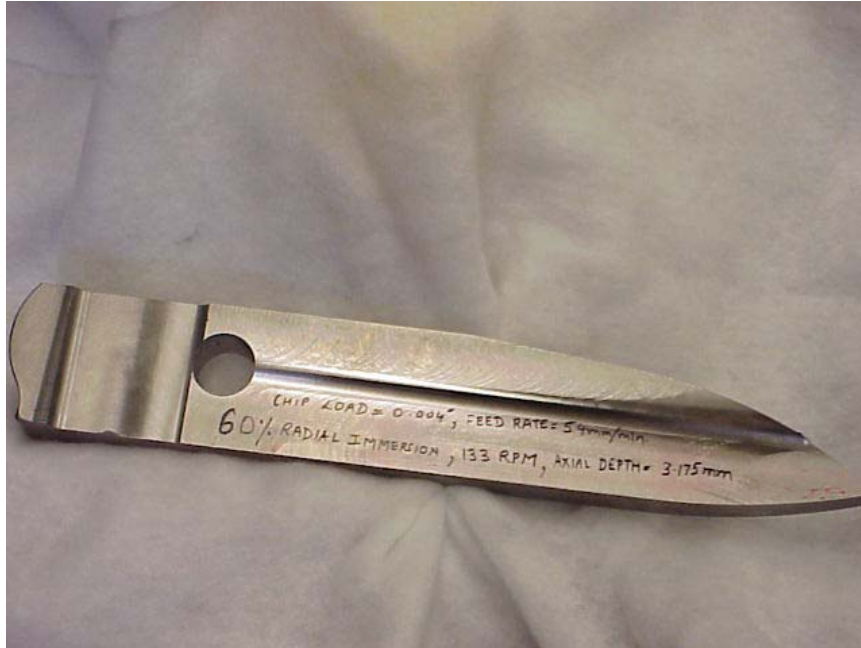
Figure 5-2 Workpiece used for cutting tests.

Specimens made of Ti6Al4V alloy were used as the workpiece for carrying out the cutting tests. Each of these specimens has dimensions of (19.5inch x 3.5inch x 1 inch).

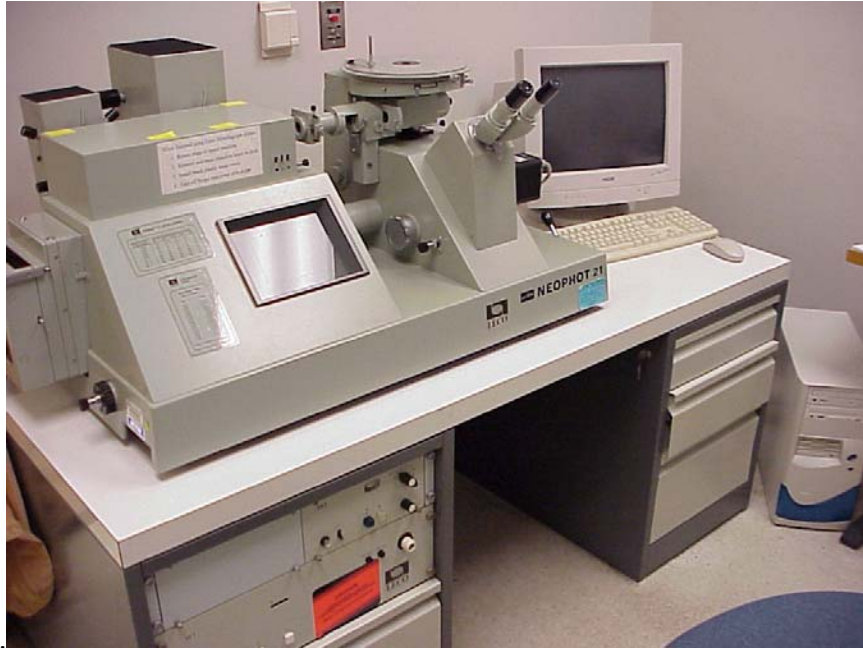
Figure 5-4 Optical Microscope

An optical microscope shown in Figure 5-4, available in the Material Science Department at the University of Florida, was used to carry out the metallographic study of the Ti6Al4V specimens

The components of the optical microscope shown in Figure 5-4 are:
