# Appendix 5 - AFNOR French Standard XP P 98-333 "Small Trenches"

## Roadways and ancillaries

### Small trenches

# Appendix 8 - Follow up of Micro Trenches

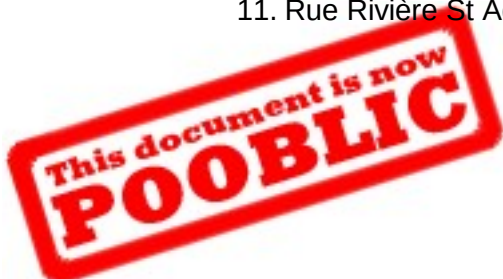
### 11. Rue Rivière St Agnan (280 m)

A few sinking areas have been recorded with a globally medium condition of the micro trench.

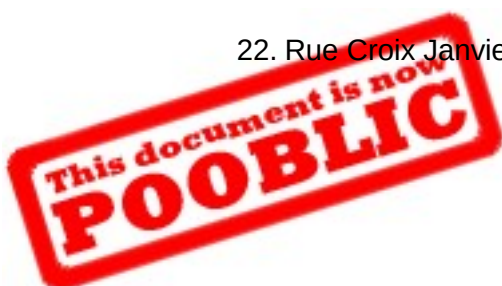
22. Rue Croix Janvier (240 m)

A few spalled areas have been recorded although the condition of the micro trench is globally good.

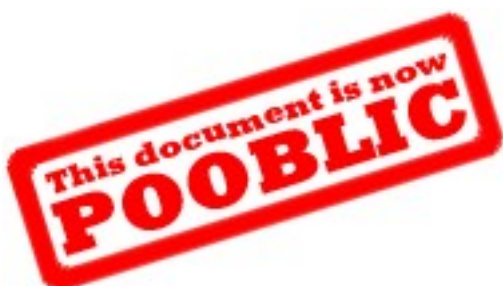
Synthesis map of the examination of micro trenches  
of the site of Cosne-Cours-sur-Loire
