# Damage Mechanisms Affecting Fixed Equipment in the Refining Industry

API RECOMMENDED PRACTICE 571  
SECOND EDITION, APRIL 2011

**Downstream Segment**

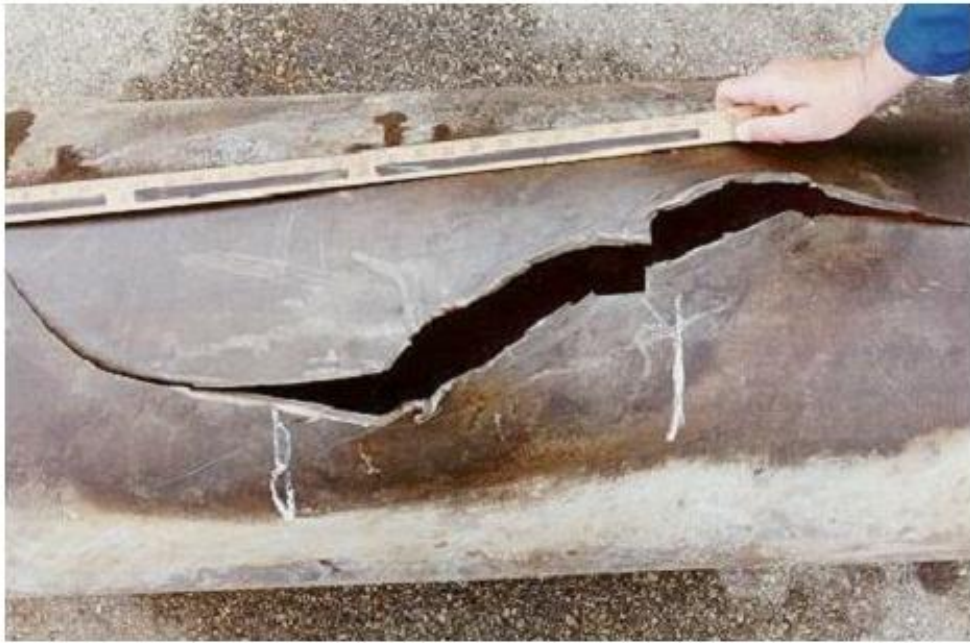
**Figure 4-12 – 20-inch carbon steel pipeline that failed during hydrotest at gouges on the O.D.**

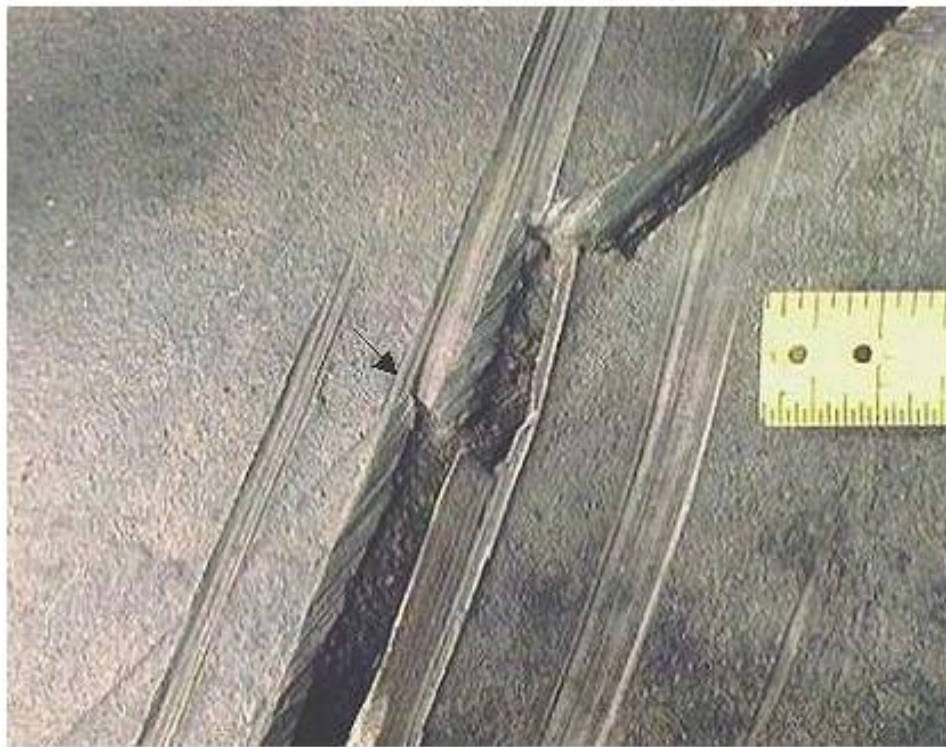
**Figure 4-13 – Close-up photograph showing the gouges and the fracture origin (arrow) in one of the gouges.**

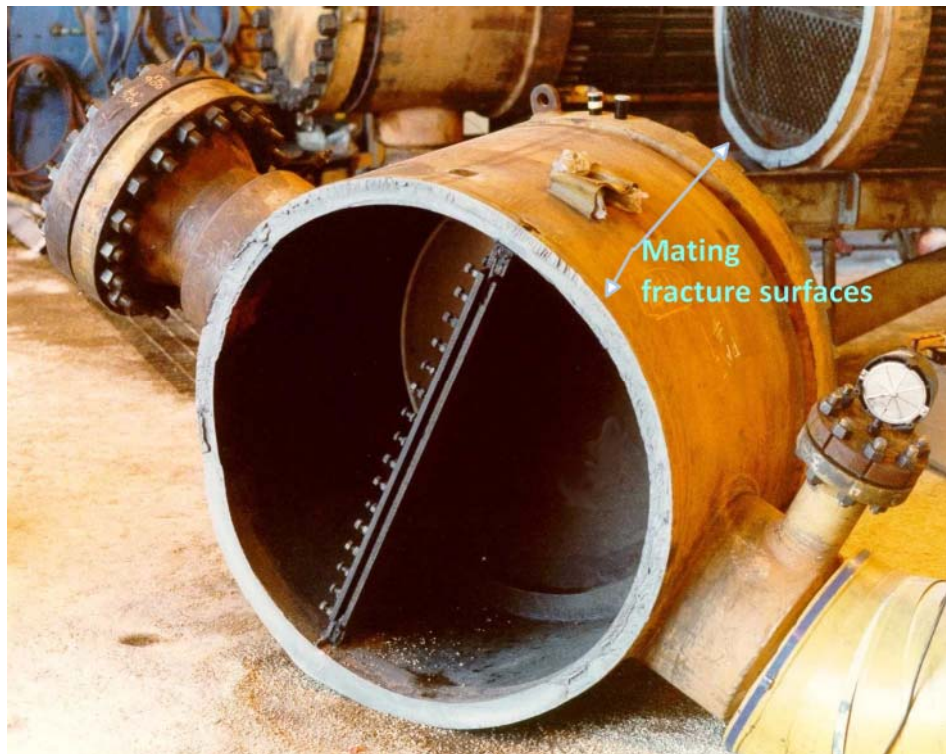
**Figure 4-14 – Brittle Fracture of 2.2 inch wall C-0.5Mo exchanger channel during hydrotest.**

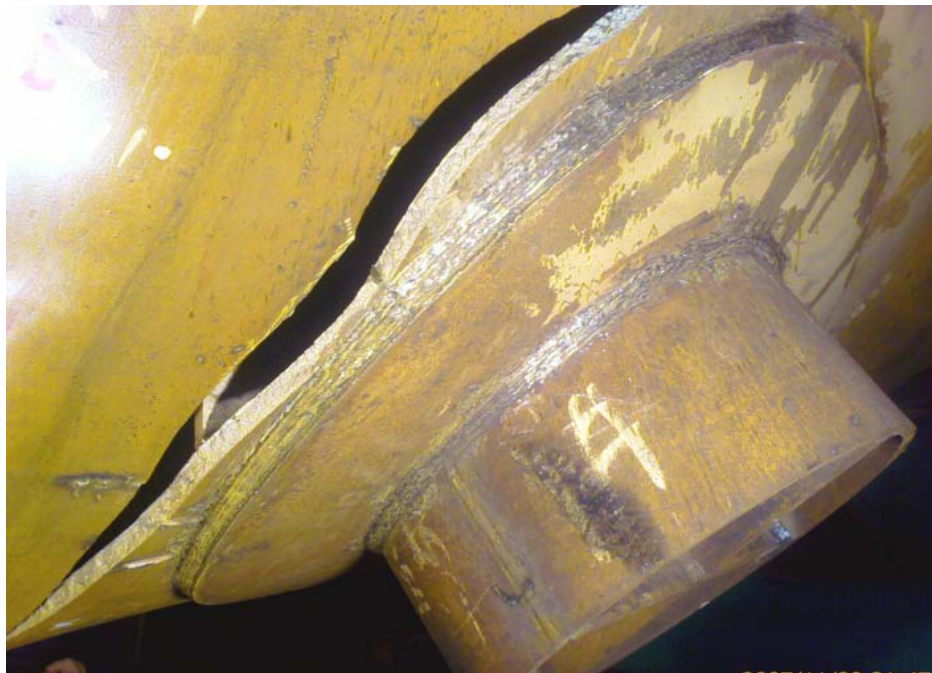
**Figure 4-15 – Brittle Fracture of vessel shell during hydrotest.**

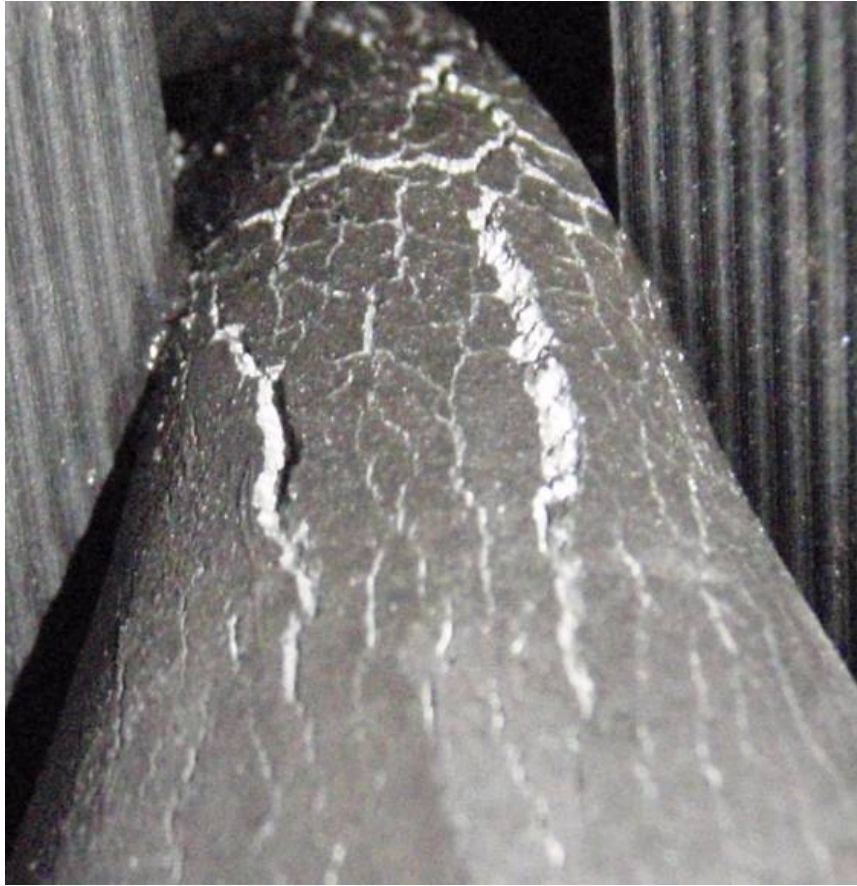
**Figure 4-17 – Pinched Alloy 800H pigtail opened up creep fissures on the surface.**

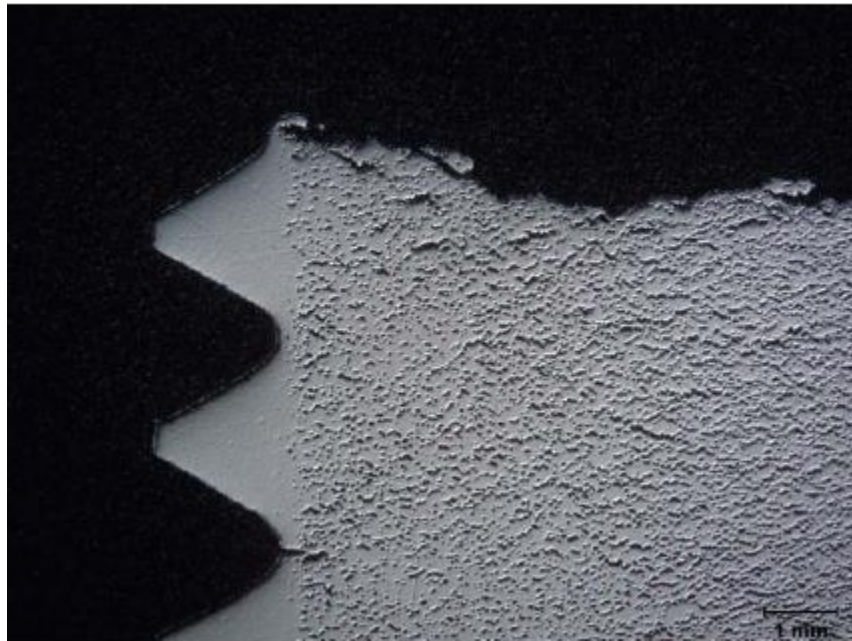
**Figure 4-19 – Creep Failure of 310 SS Heater Tube Guide Bolt after approximately 7 years service at 1400°F (760°C). a.) Cross-section at 10X, as-polished. b) Voids and intergranular separation characteristic of long term creep, 100X, etched.**

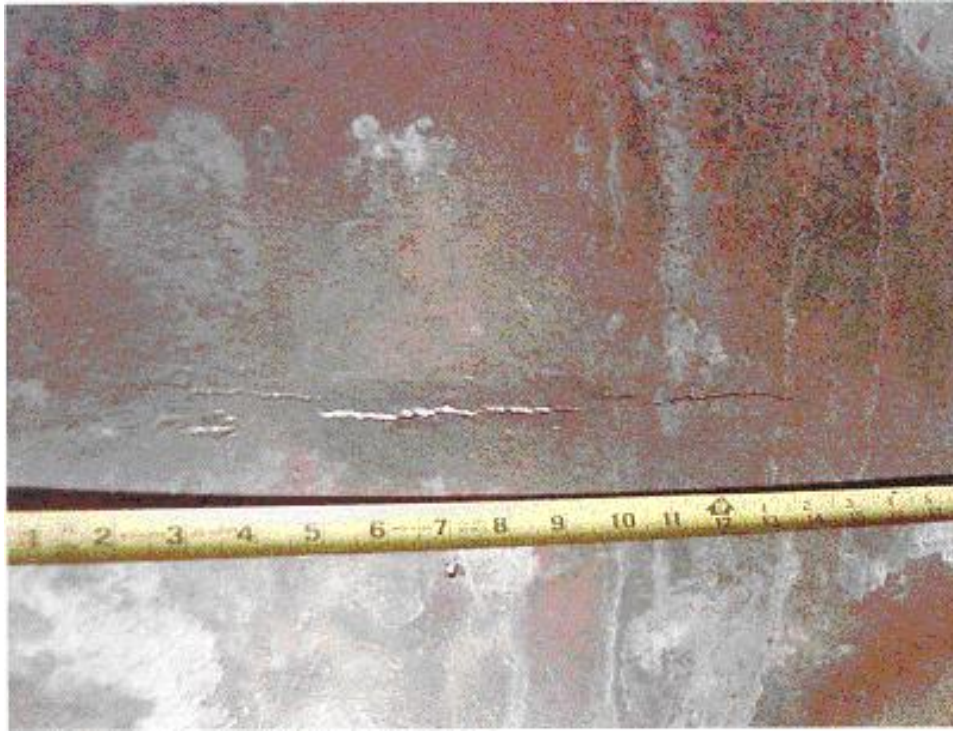
**Figure 4-22 –Thermal fatigue cracking associated with bulged skirt shown in Figure 4-21.**

- b) Thermal fatigue cracking has been a major problem in coke drum shells. Thermal fatigue can also occur on coke drum skirts where stresses are promoted by a variation in temperature between the drum and skirt (Figure 4-21 and Figure 4-22).

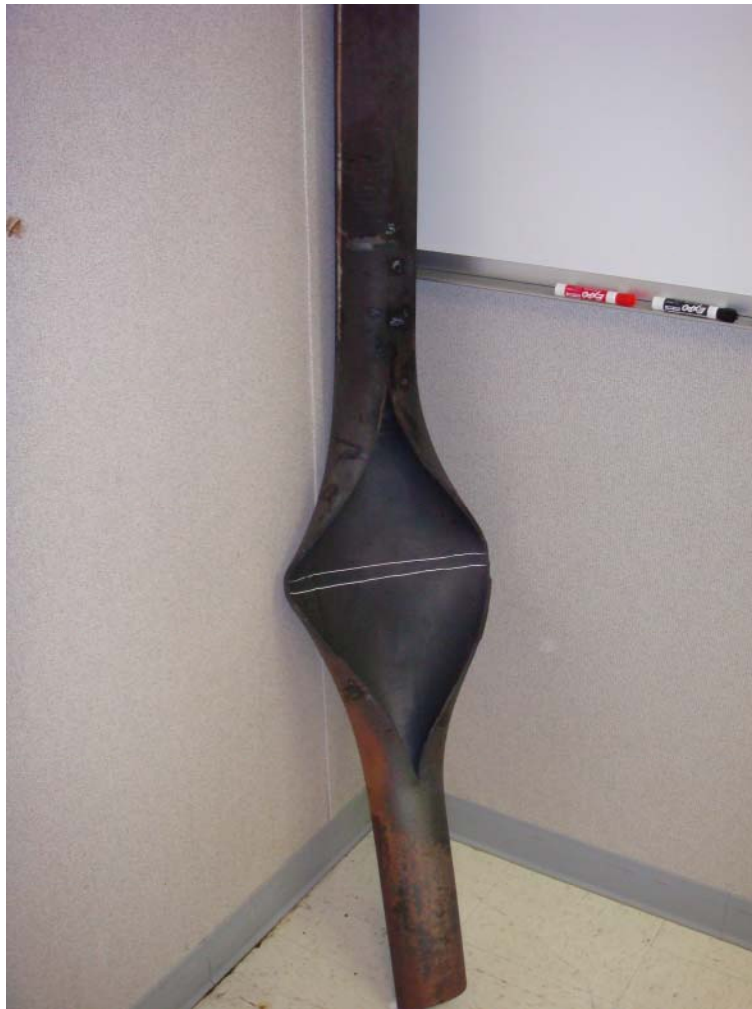
**Figure 4-28 – Short term overheating failure of a vertical 4.5-in. OD, Schedule 160 2.25Cr-1Mo (SA335-P2) hydrocracker radiant that was 21 years old. Failure occurred due process side starvation with burners running.**

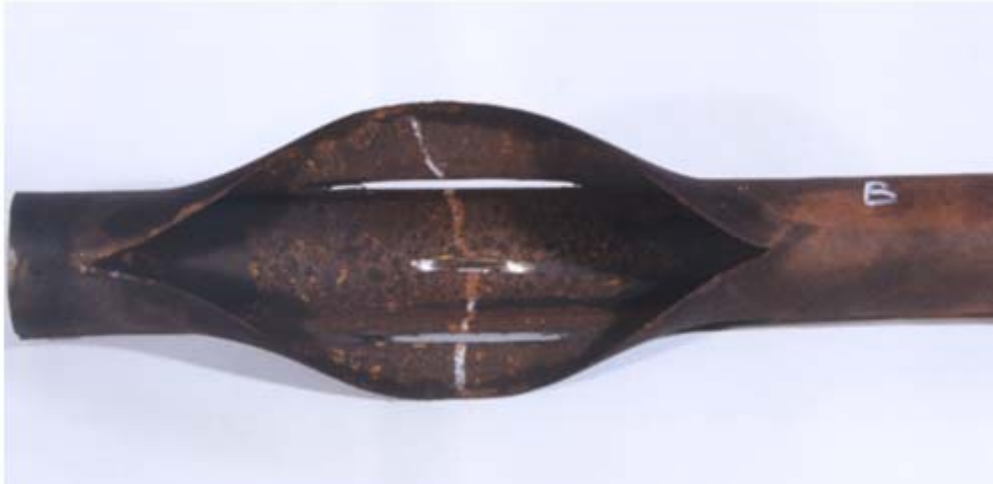
**Figure 4-29 – Short term overheating tube failed by bulging and rupture due to short term overheating at a temperature well over 1380°F (750°C).**

- a) Damage is typically characterized by localized deformation or bulging on the order of 3% to 10% or more, depending on the alloy, temperature and stress level.
- b) Ruptures are characterized by open “fishmouth” failures and are usually accompanied by thinning at the fracture surface (Figure 4-28 to 4-31).

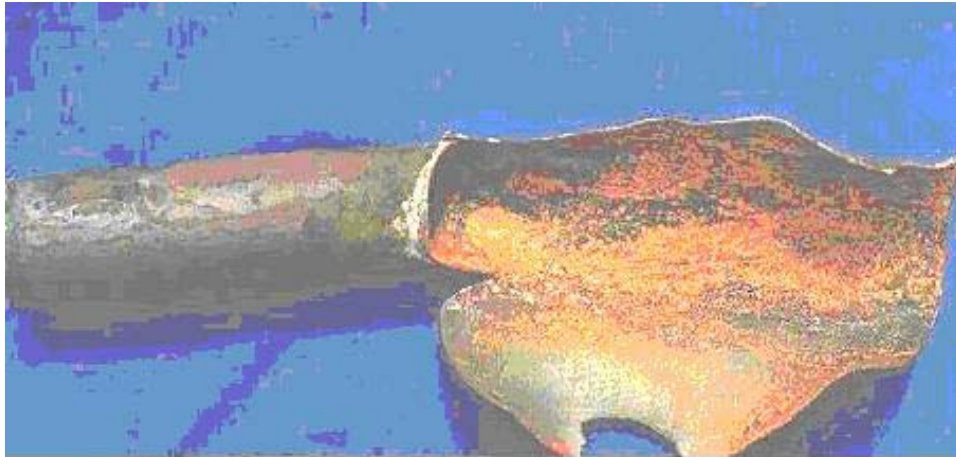
**Figure 4-30 – 1Cr-0.5Mo boiler superheater tube in 700 psig steam service that failed due to overheating.**

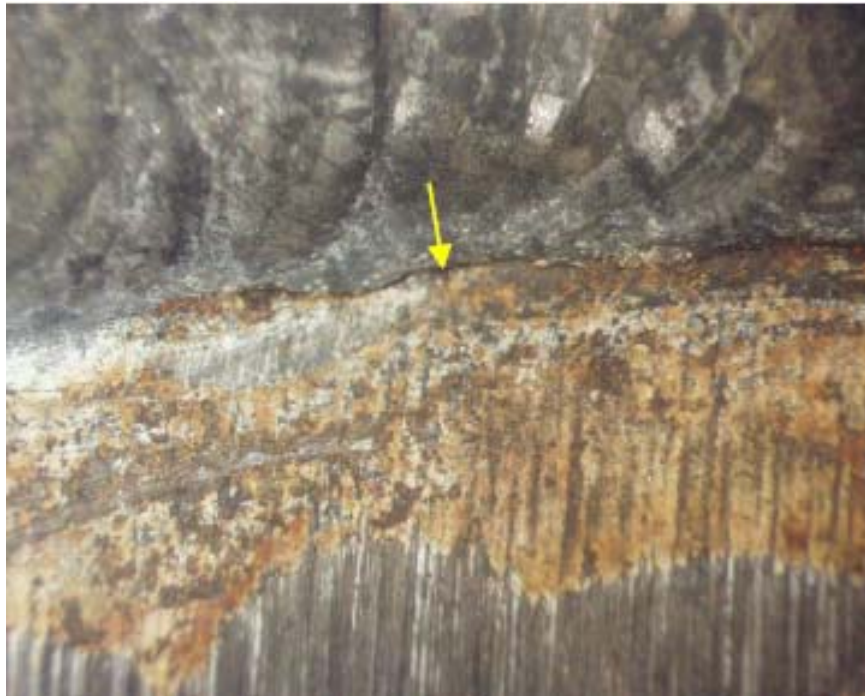
**Figure 4-36 – Weld detail used to join a carbon steel elbow (bottom) to a weld overlaid pipe section (top) in high pressure wet H<sub>2</sub>S service. Sulfide stress cracking (SSC) occurred along the toe of the weld (arrow), in a narrow zone of high hardness.**

- a) In most cases, the cracks form at the toe of the weld in the heat-affected zone of the ferritic material (Figure 4-36 to Figure 4-42).
- b) Welds joining tubes are the most common problem area, but support lugs or attachments of cast or wrought 300 Series SS to 400 Series SS are also affected.

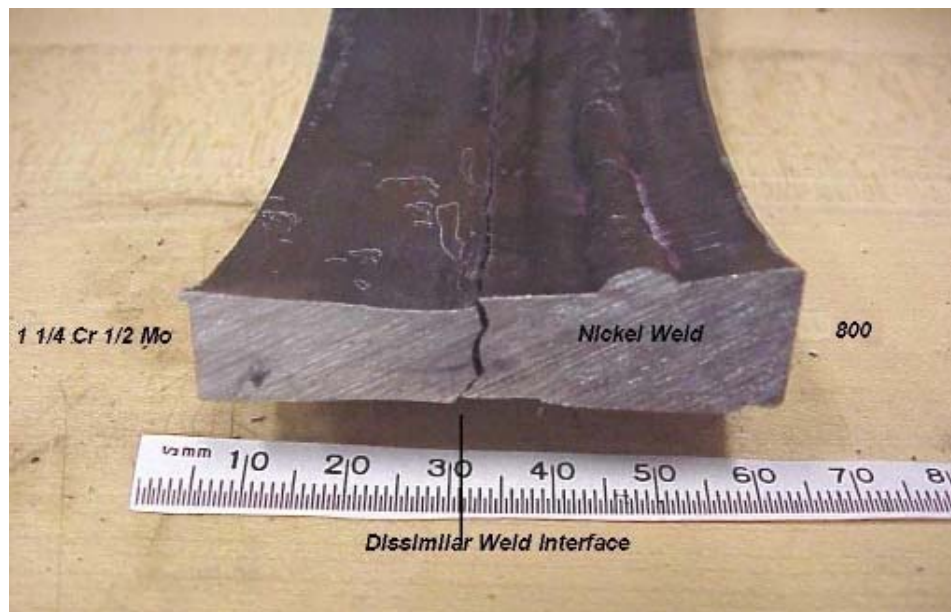
Figure 4-38 – Failure of DMW joining 1.25Cr-0.5Mo to Alloy 800H in a Hydro-dealkylation (HAD) Reactor Effluent Exchanger. Crack propagation due to stresses driven at high temperature of 875°F (468°C) and a hydrogen partial pressure of 280 psig (1.93 MPa).

- h) DMW's for high temperature service in hydrogen environments must be carefully designed and inspected to prevent hydrogen disbonding (Figures 4-38 to 4-41).

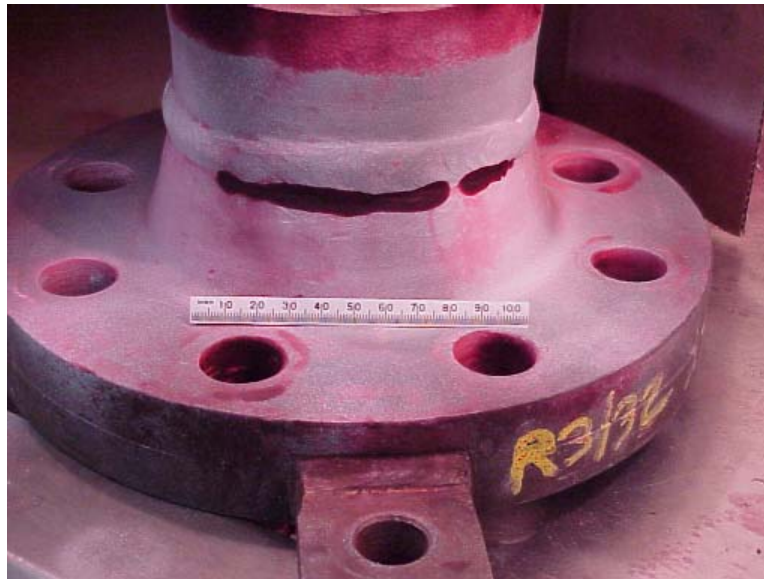
**Figure 4-41 – Failure of nickel alloy DMW joining HP40 (Nb modified) tube to 1.25Cr-0.5Mo flange in a Steam Methane Reformer due to cold hydrogen disbonding of the buttering layer. Process temperature 914°-941°F (490° to 505°C), Pressure (2.14 Mpa), H<sub>2</sub> content 10-20% (off-gas).**

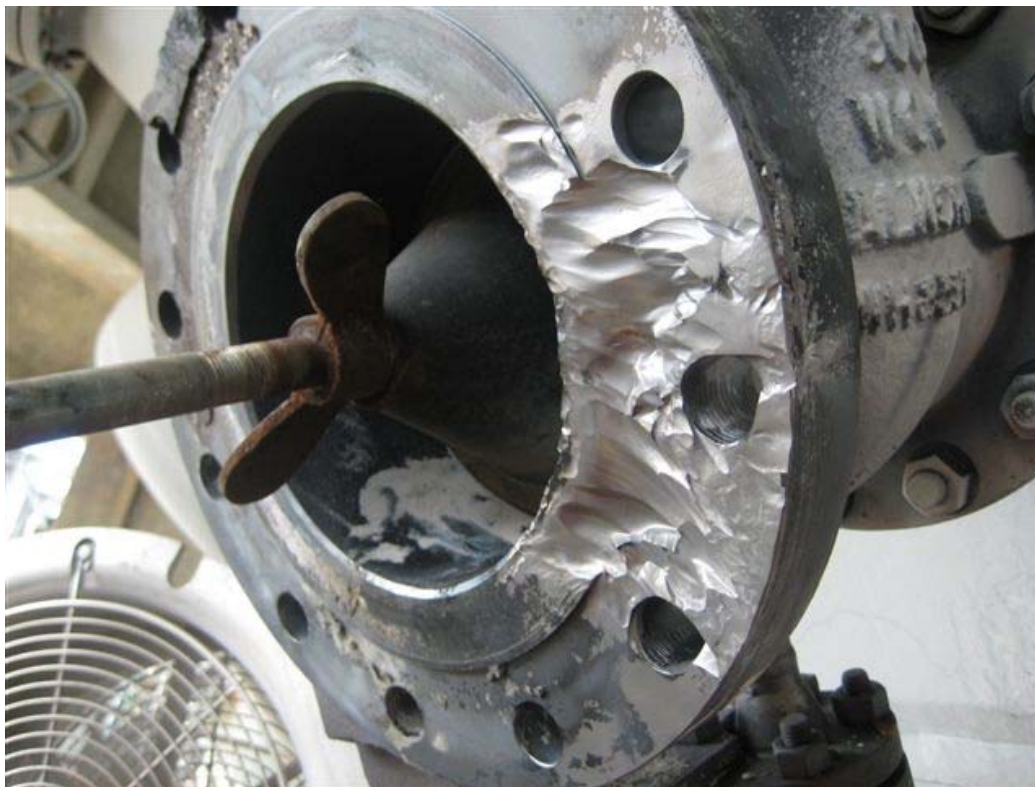
**Figure 4-43 – Erosion Corrosion of a 1.25Cr 300 # valve flange on an FCC Catalyst withdrawal line.**

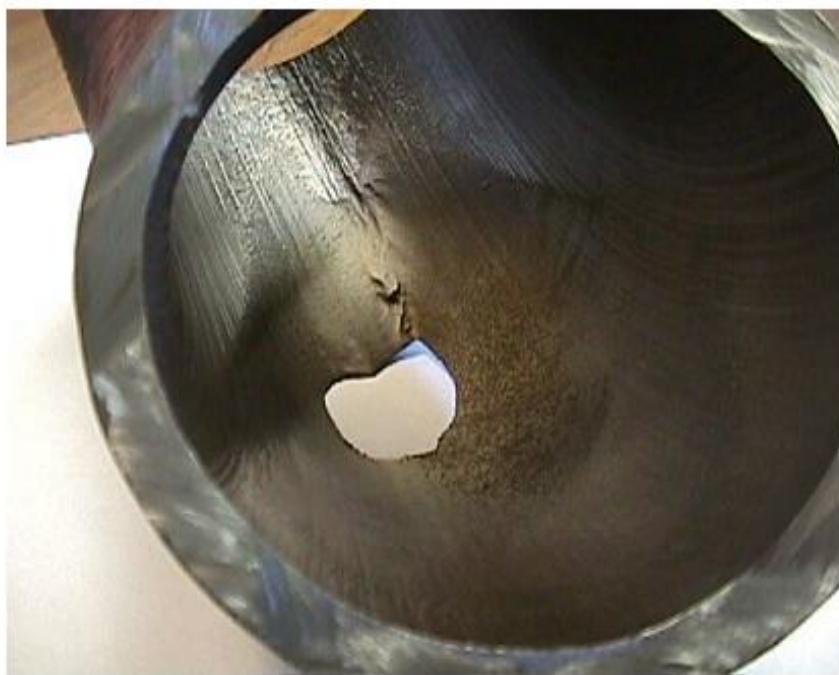
**Figure 4-44 – Erosion of a 9Cr-1Mo coker heater return bend.**

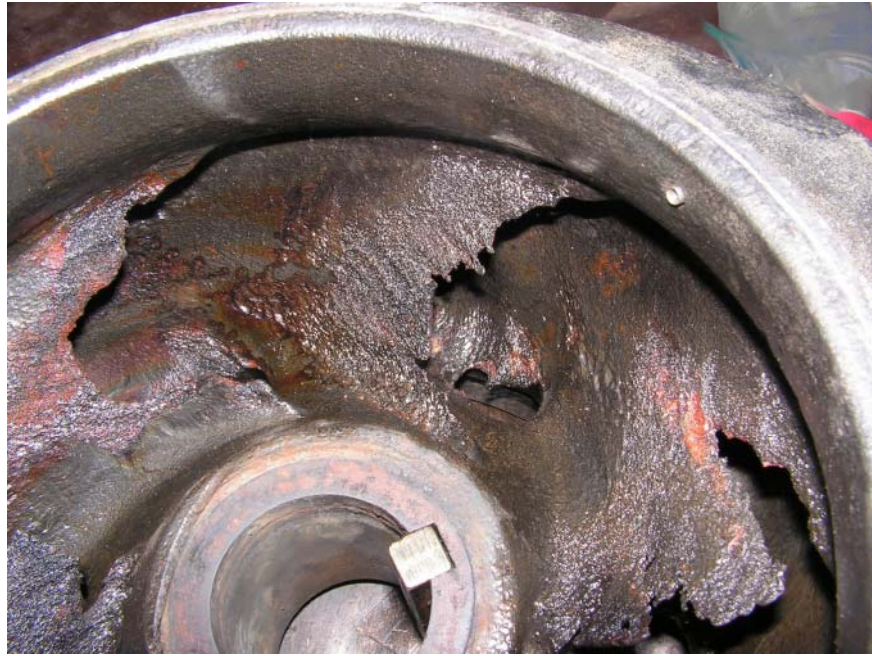
**Figure 4-45 – Erosion-Corrosion of is ASTM A48 Class 30 Cast Iron Impeller in recycle water pump.**

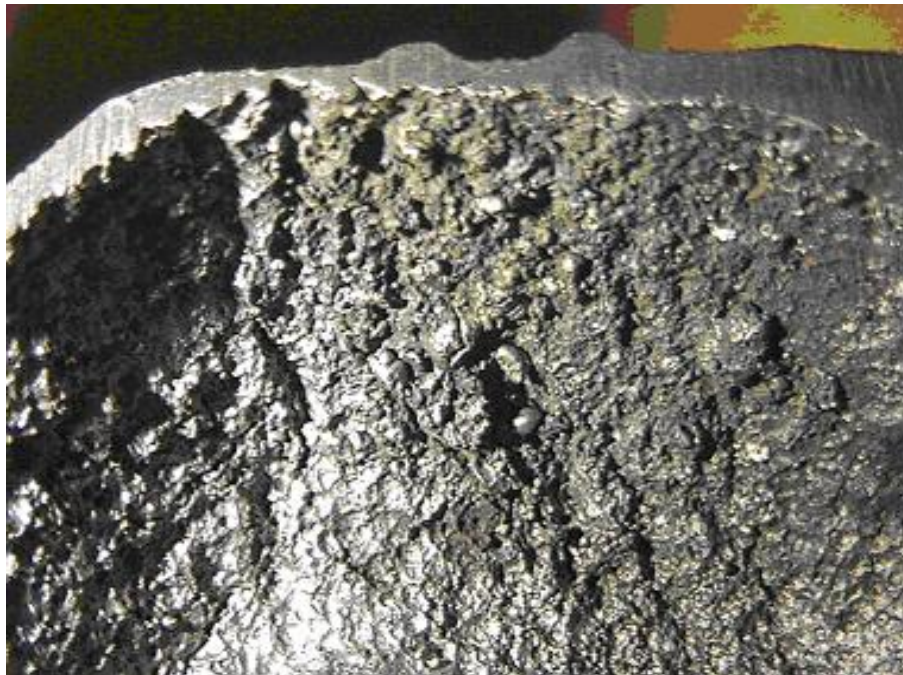
**Figure 4-47 – Closer view of damaged surface of butterfly valve.**

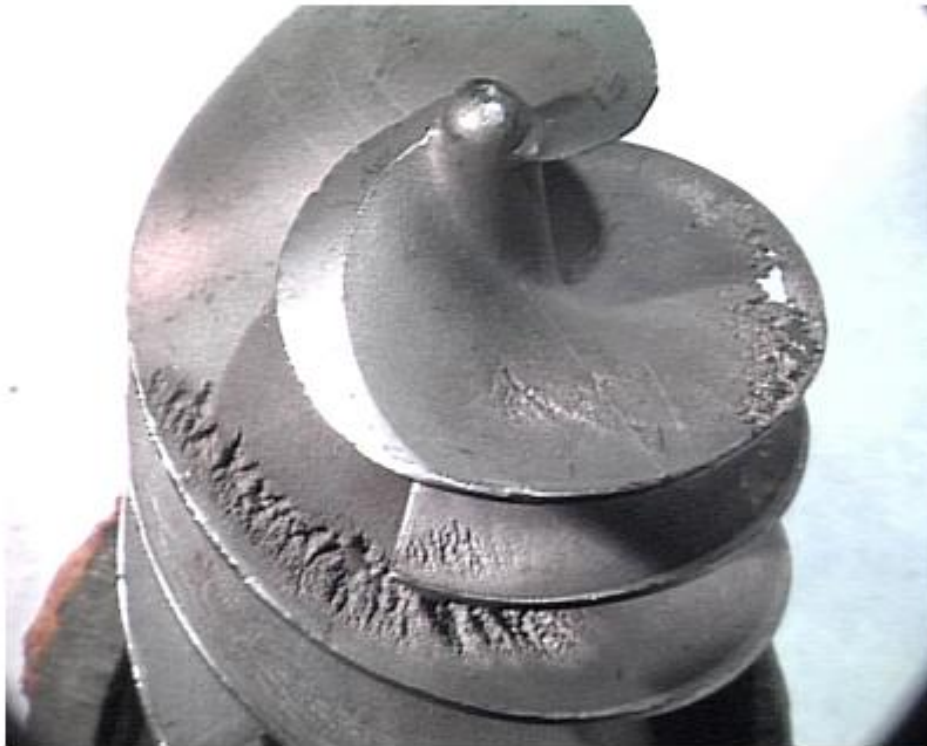
**Figure 4-48 – Cavitation pitting on the low-pressure side of a stainless steel pump impeller.**

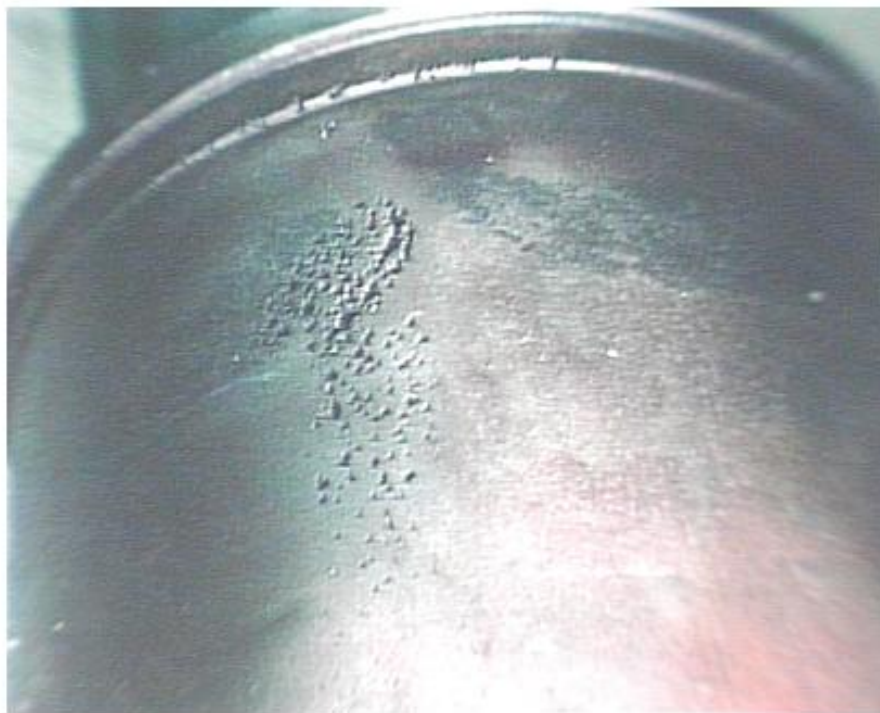
**Figure 4-49 – Cavitation pitting on the water side of a cast iron cylinder liner in a large engine.**

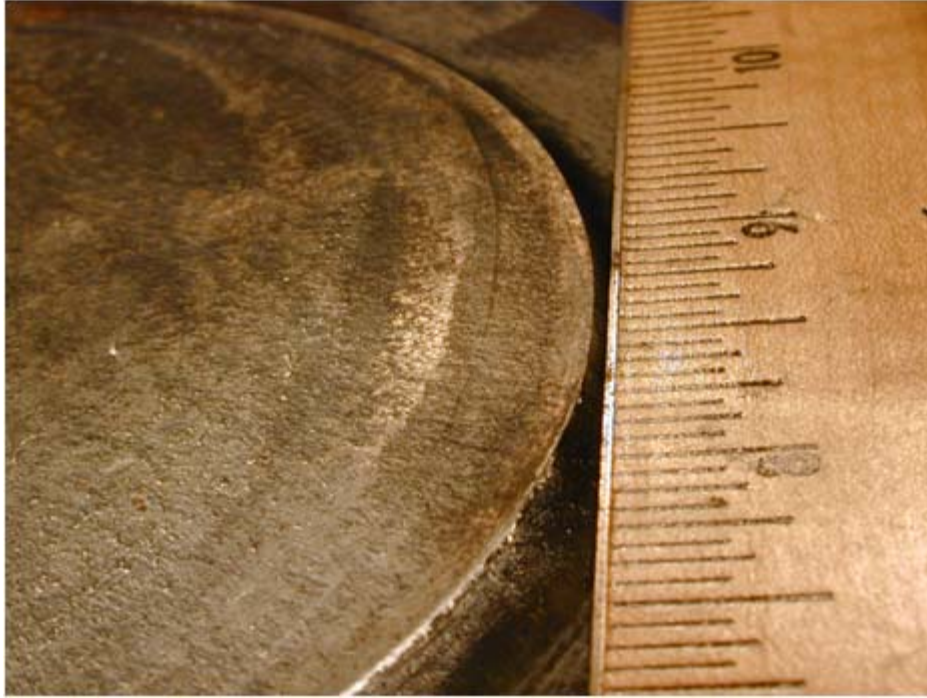
**Figure 4-52 – Higher magnification view of figure above showing “beach marks”.**

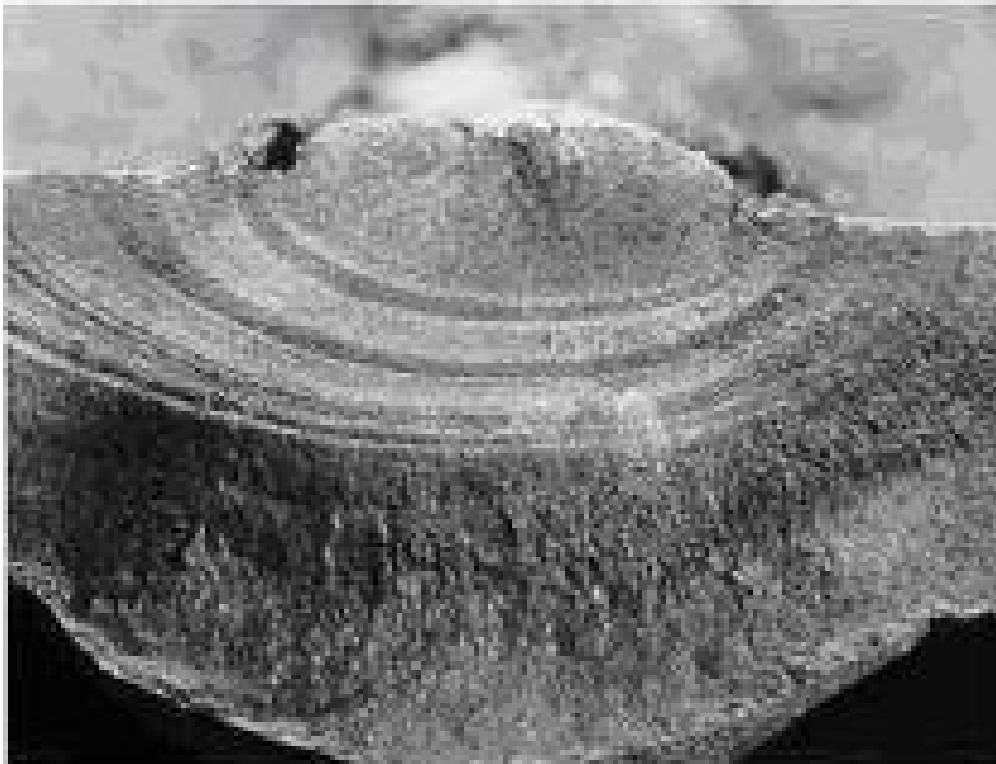
**Figure 4-53 – Fatigue fracture surface of a carbon steel pipe.**

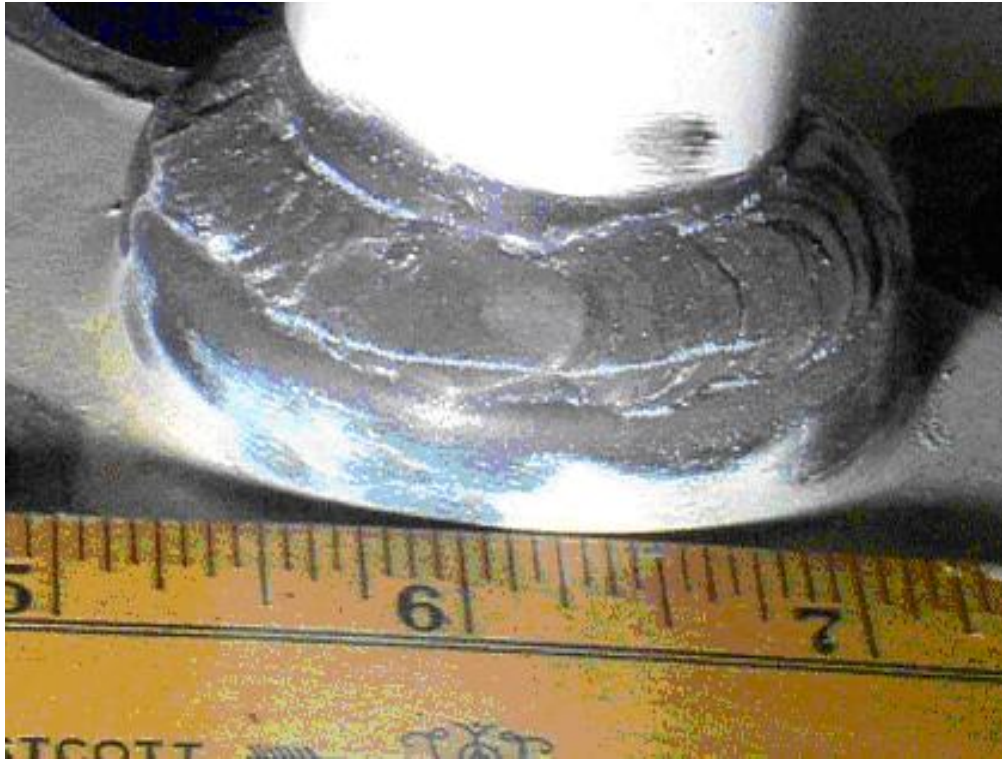
**Figure 4-57 – Vibration induced fatigue of a 1-inch socket weld flange in a thermal relief system shortly after startup.**

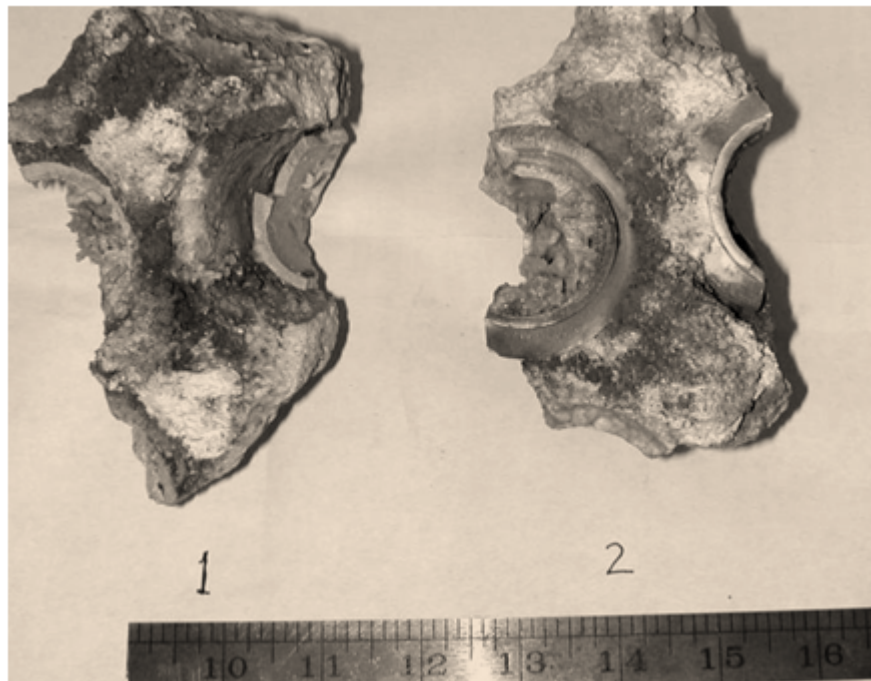
**Figure 4-59 – Damaged refractory and ferrules.**

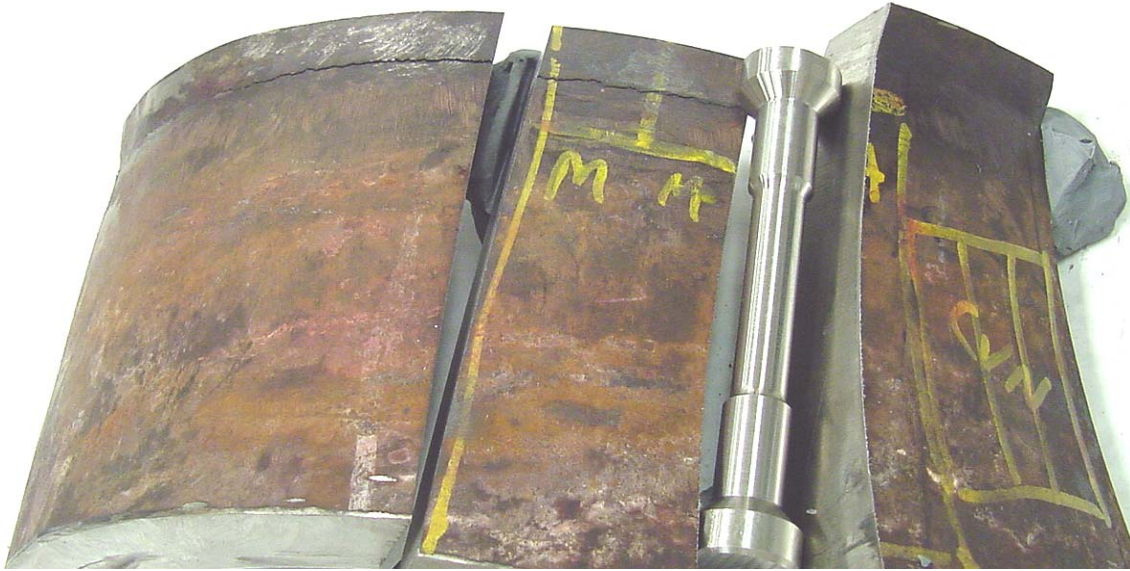
**Figure 4-60 – Samples removed from a cracked 12-inch NPS 321SS elbow in hot recycle H<sub>2</sub> line that operated at 985°F in hydrocracker.**

- a) Reheat cracking is intergranular and can be surface breaking or embedded depending on the state of stress and geometry. It is most frequently observed in coarse-grained sections of a weld heat-affected zone.
- b) In many cases, cracks are confined to the heat-affected zone, initiate at some type of stress concentration, and may act as an initiation site for fatigue. Figure 4-60 to 4-63.

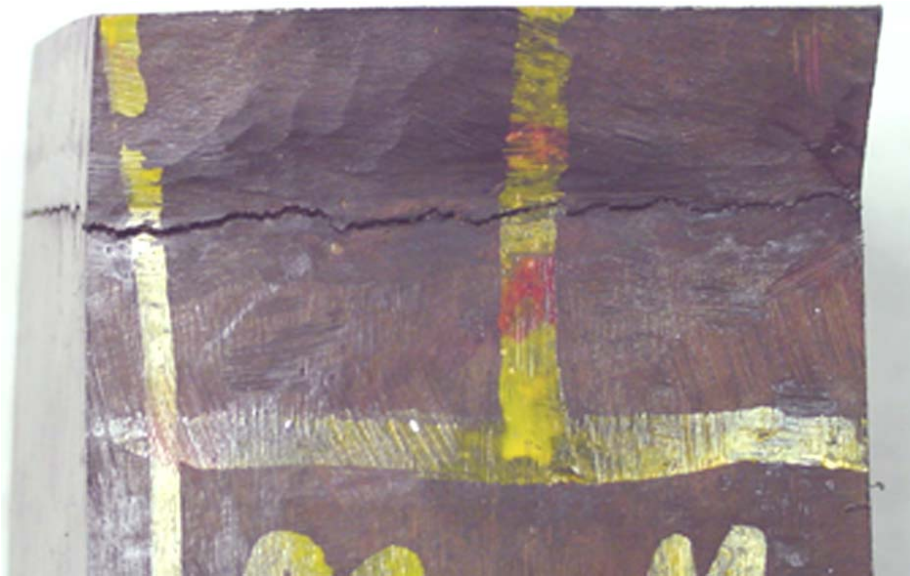
**Figure 4-61 – Crack at weld from SS321 elbow shown in the Figure 4-60.**

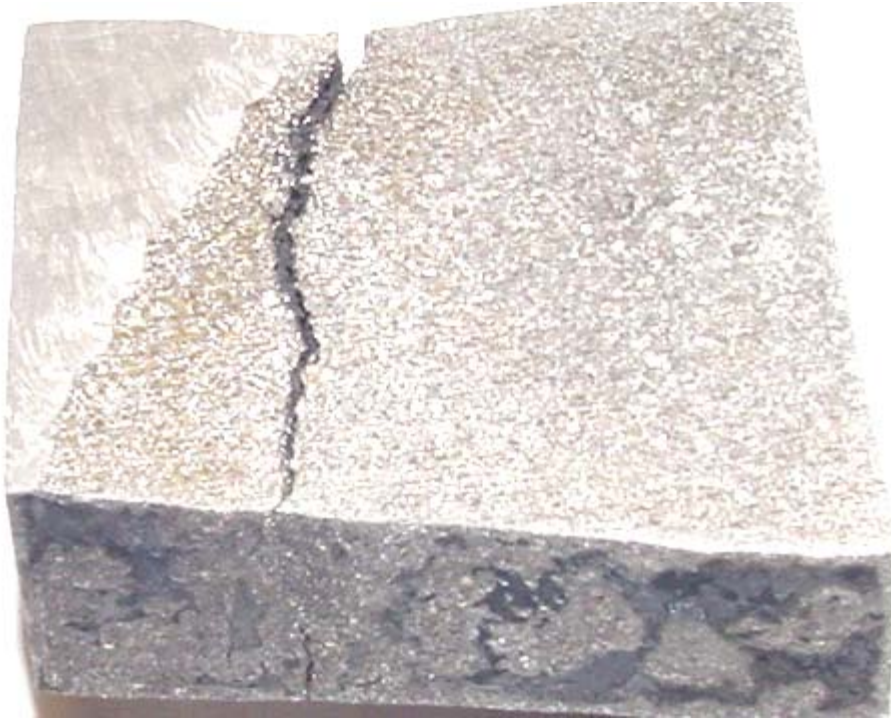
**Figure 4-62 – Cross-section through the weldment showing the crack in Figure 4-61.**

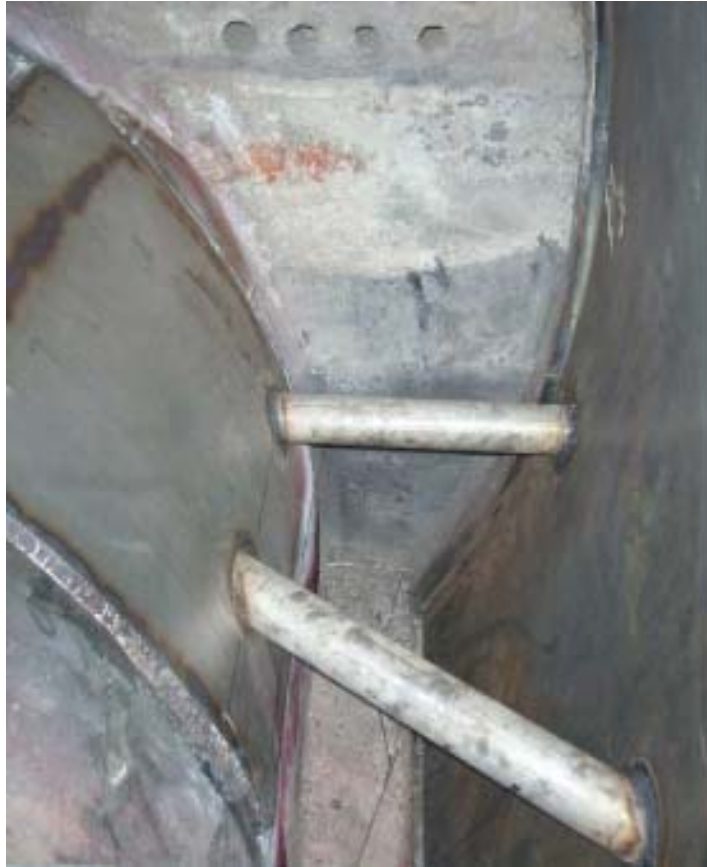
**Figure 4-64 – Thermal combustor on the front end of a reaction furnace on a sulfur recovery unit.**

- a) These guidelines apply to any unit that uses oxygen or enriched air for combustion or other process reasons.
- b) Oxygen is sometimes used in sulfur recovery units (SRU) and fluid catalytic cracking units (FCCU), Gasification, and Partial Oxidation (POX) units. [Figures 4-64 to 4-66](#).
- c) Oxygen piping systems especially valves, regulators, and other impingement areas are potentially vulnerable. Non-metals such as those used for seats and seals, are easier to ignite than metals ([Figure 4-69](#)).

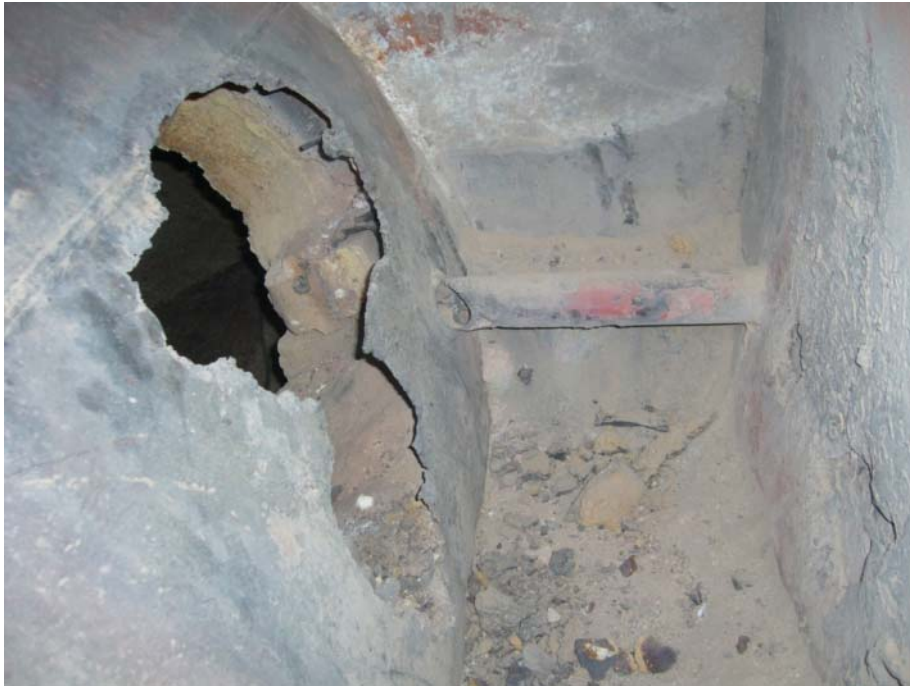
**Figure 4-65 – Same as figure above after damage due to oxygen combustion resulting from oxygen injection into the thermal combustor on the front end of the reaction furnace.**

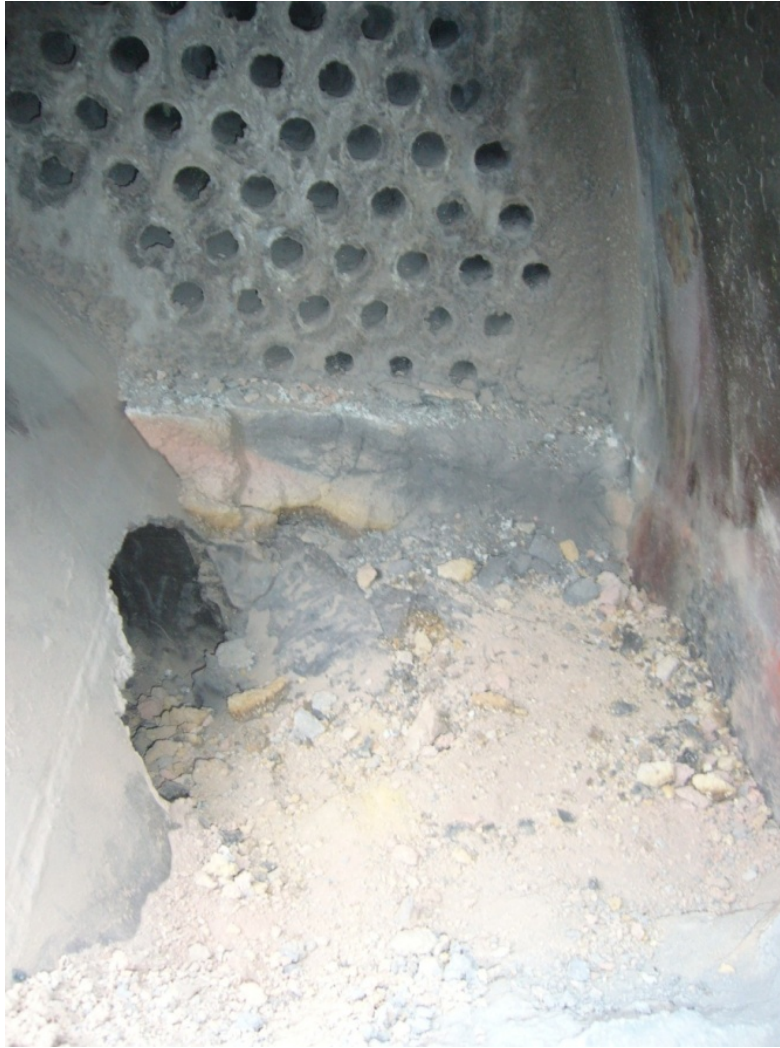
**Figure 4-66 – Same as figure above when viewed from a different angle.**

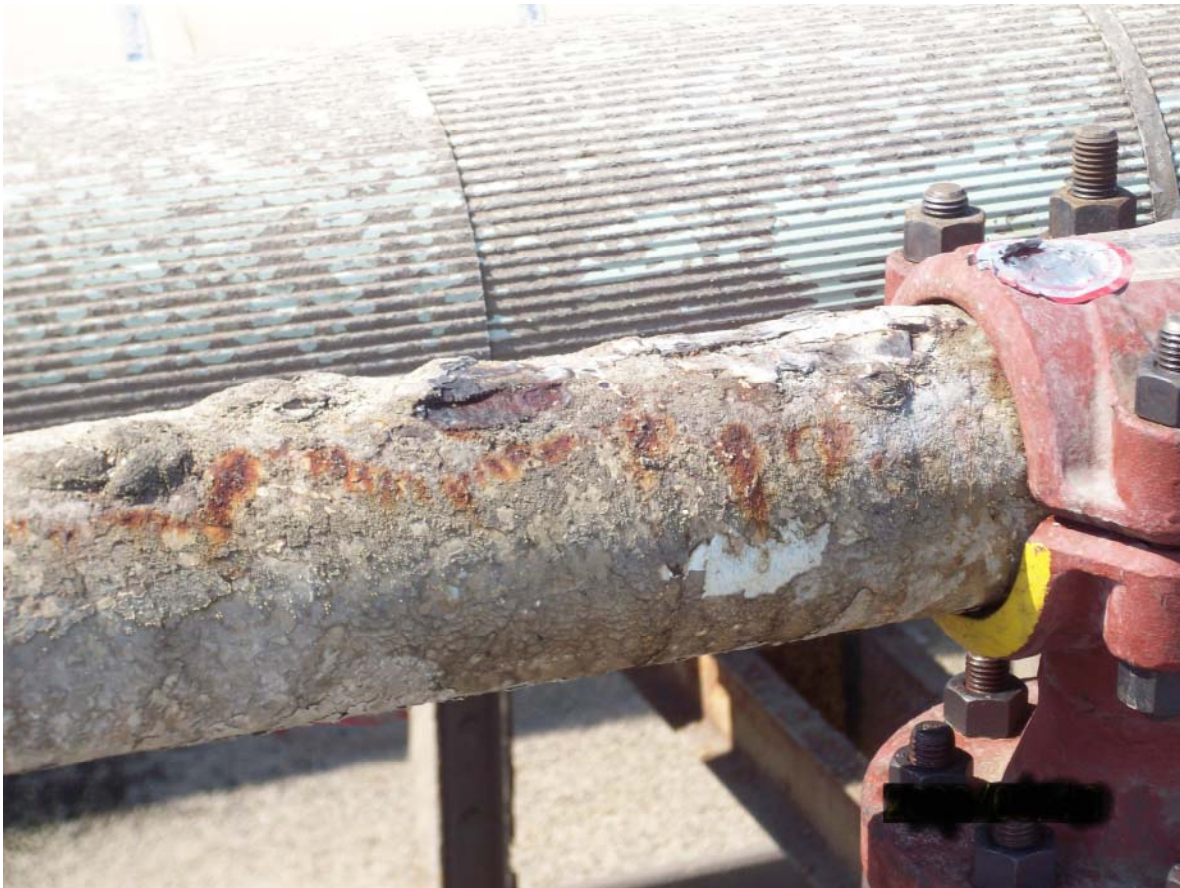
**Figure 4-72 – Atmospheric Corrosion of an LPG line in close proximity to a cooling tower.**

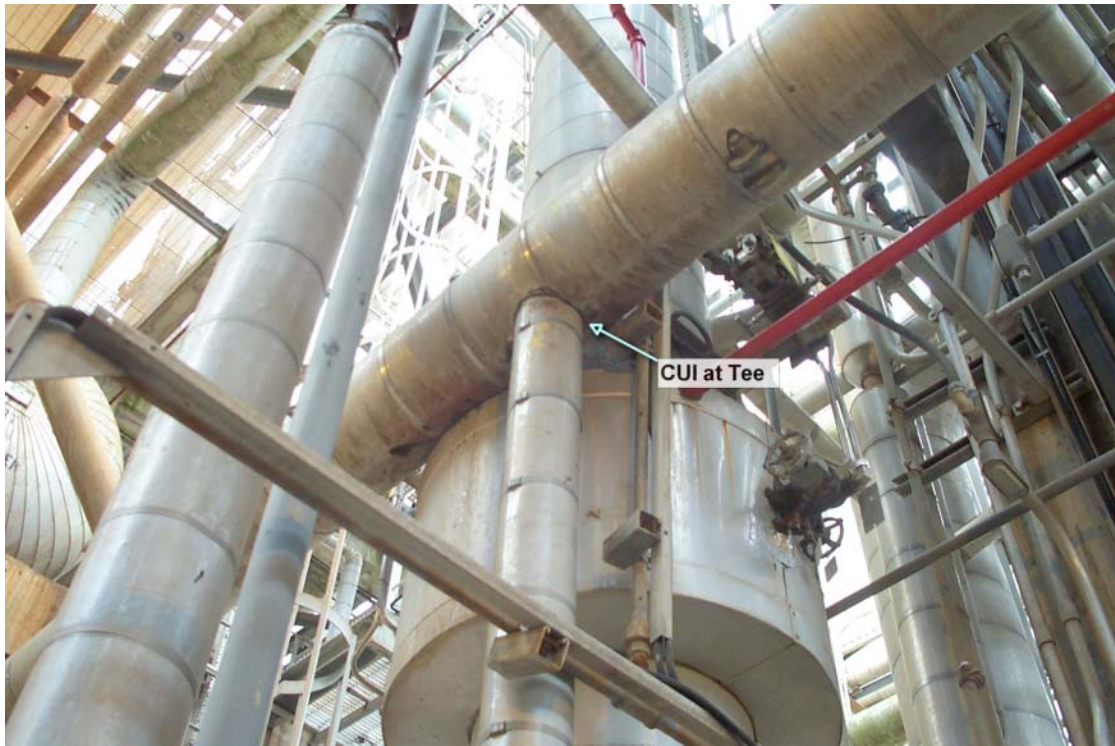
**Figure 4-73 – Tee in a 1000 psig ethylene line before insulation removal.**

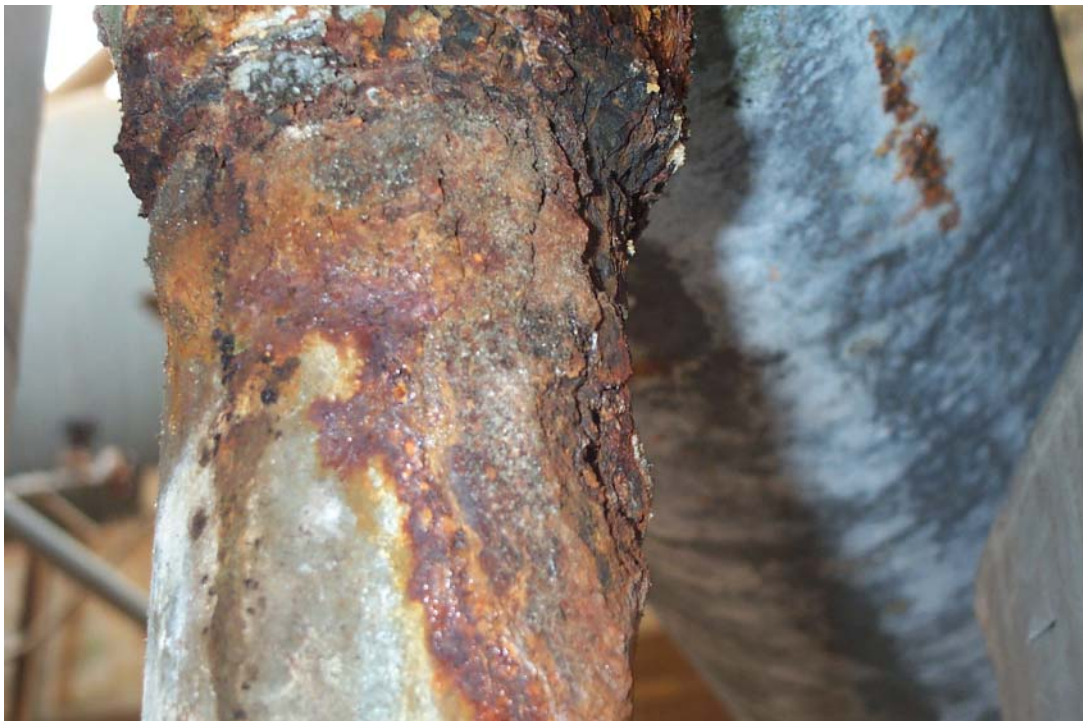
**Figure 4-74 – Close-up of Tee CUI of a Tee in Figure 4-73 after insulation removal.**

- d) After insulation is removed from carbon and low alloy steels, CUI damage often appears as loose, flaky scale covering the corroded component. Damage may be highly localized (Figure 4-73 to 4-79).
