# Damage Mechanisms Affecting Fixed Equipment in the Refining Industry

API RECOMMENDED PRACTICE 571  
SECOND EDITION, APRIL 2011

**Downstream Segment**

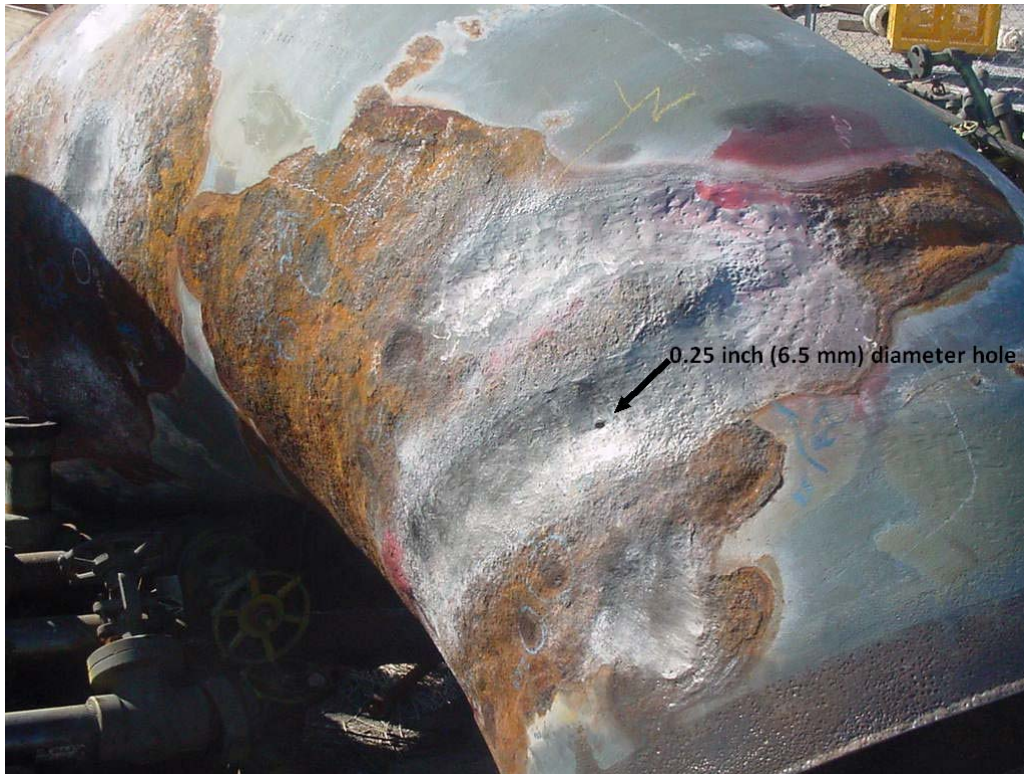
**Figure 4-75 – CUI of a 30 inch CS Butadiene line showing highly localized corrosion which could only be found by stripping the entire line. Note the 0.25 in (6.5 mm) diameter hole at arrow.**

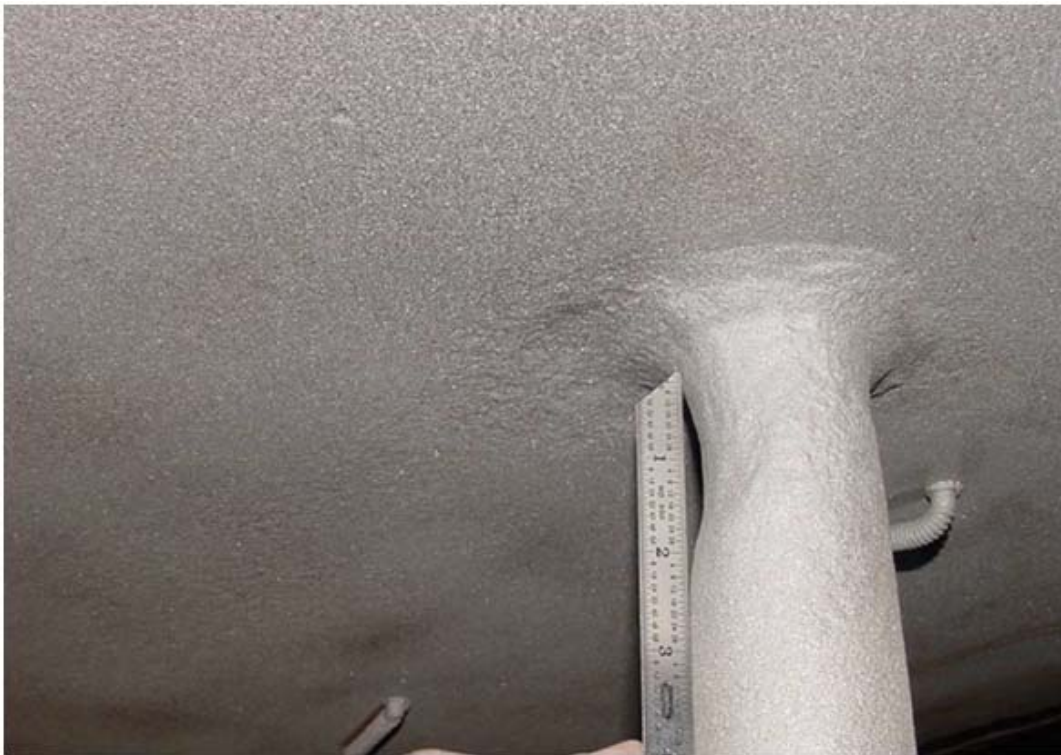
**Figure 4-76 – CUI of nozzle on a bottom head.**

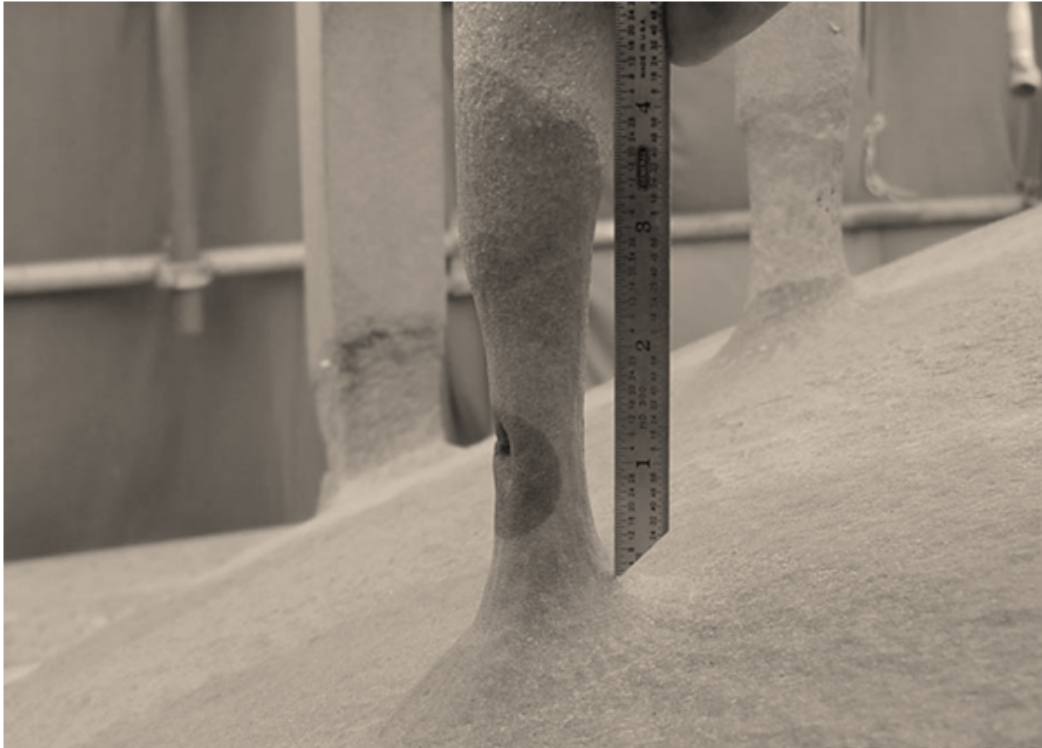
**Figure 4-77 – CUI of nozzle on a top head.**

- d) After insulation is removed from carbon and low alloy steels, CUI damage often appears as loose, flaky scale covering the corroded component. Damage may be highly localized (Figure 4-73 to 4-79).

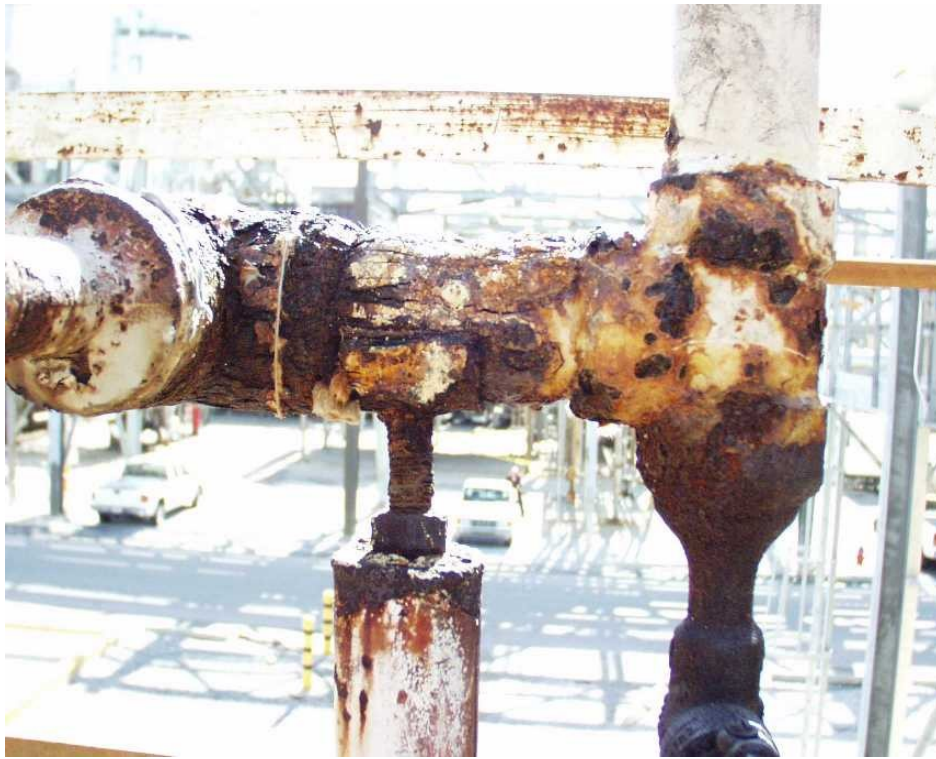
**Figure 4-80 – CUI of CS level bridge.**

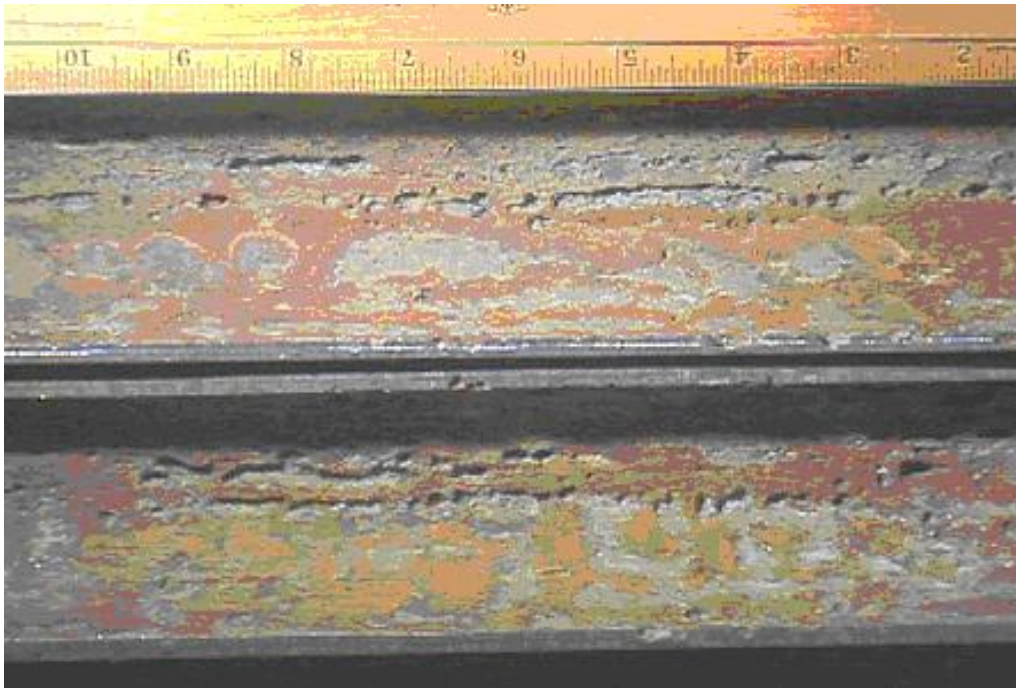
**Figure 4-85 – CO<sub>2</sub> corrosion of a carbon steel oil and gas production flow line.**

- a) Localized thinning and/or pitting corrosion of carbon steel (Figure 4-85, Figure 4-86 and Figure 4-87).
- b) Carbon steel may suffer deep pitting and grooving in areas of turbulence (Figure 4-88).
- c) Corrosion generally occurs in areas of turbulence and impingement and sometimes at the root of piping welds.

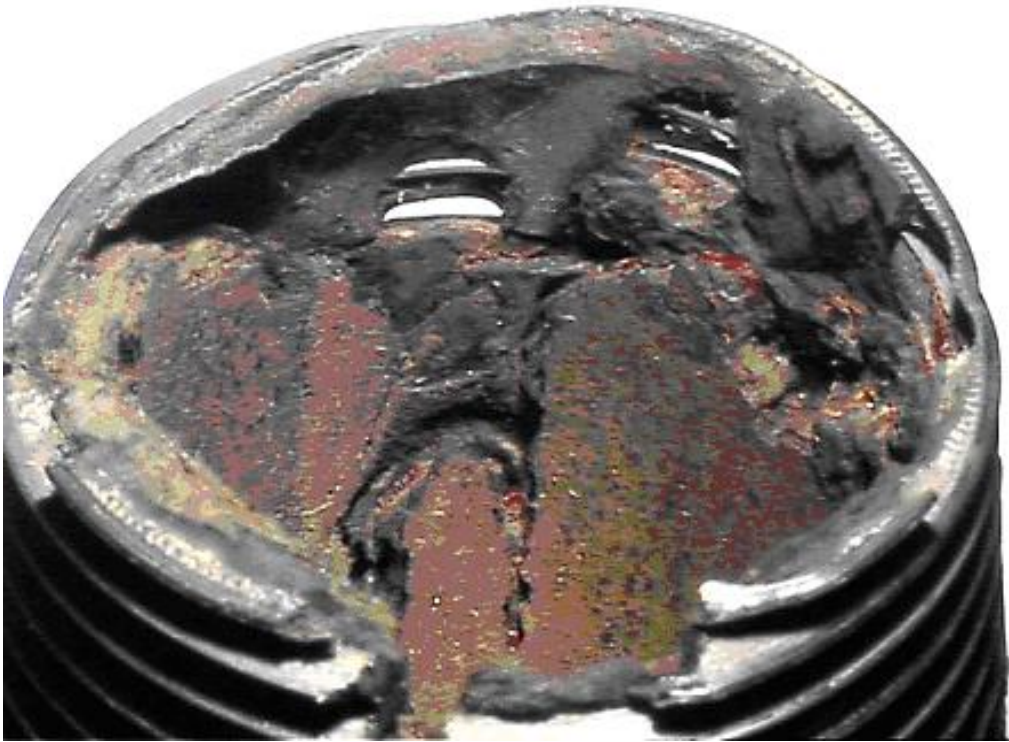
Figure 4-87 – CO<sub>2</sub> corrosion of CS pipe nipple in CO<sub>2</sub> contaminated water.

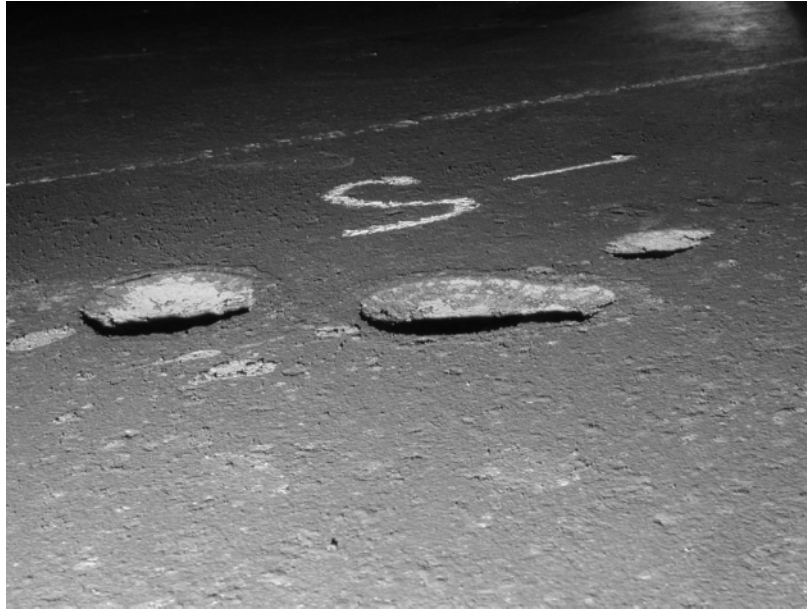
**Figure 4-89 – MIC of diesel tank bottom.**

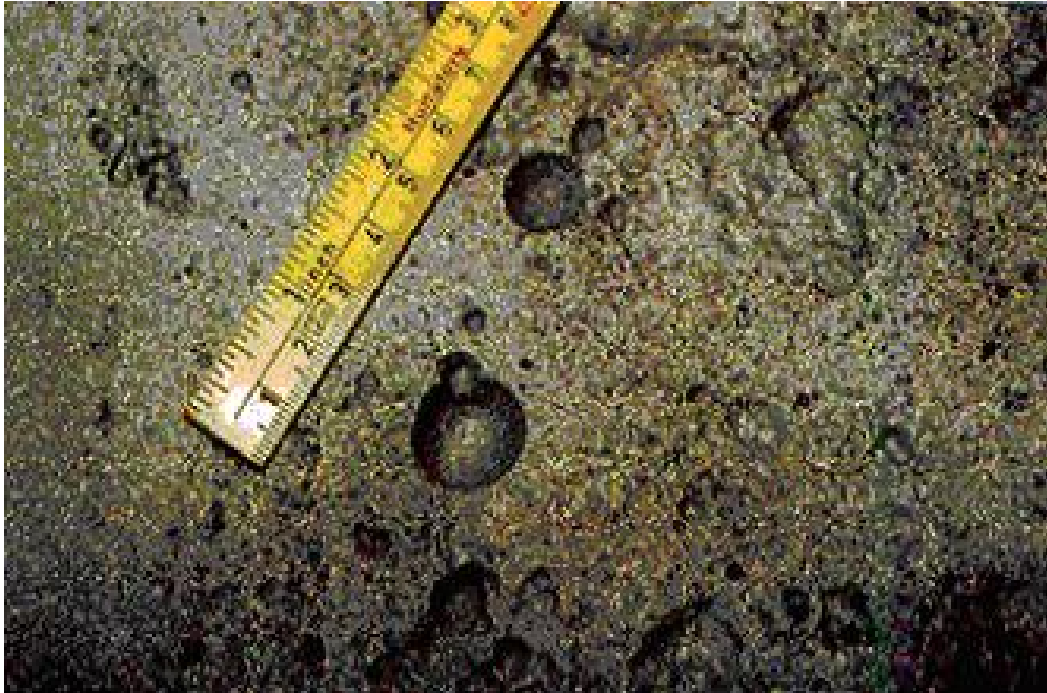
**Figure 4-93 – Same oil line as Figure 4-92. Hemispherical pitting typical of MIC can be seen after grit blasting to remove the scale.**

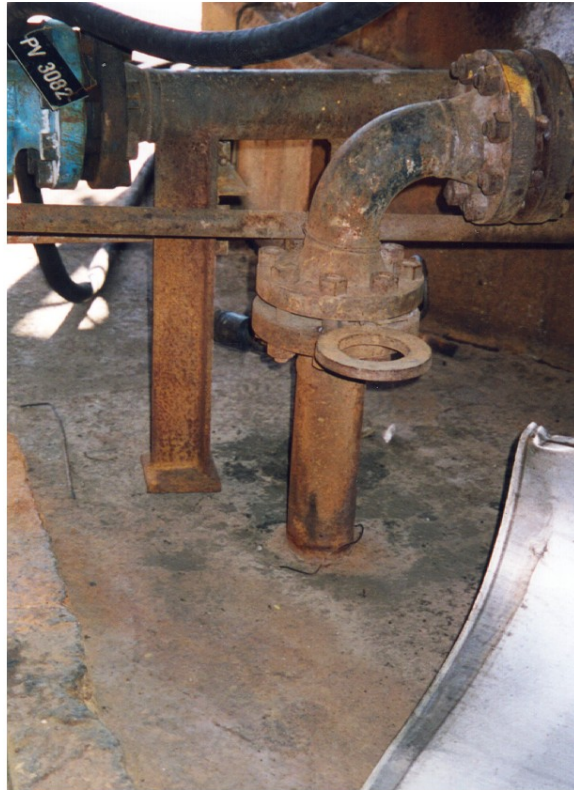
**Figure 4-96 – Corrosion of carbon steel pipe at the soil-air interface where the pipe emerges from underground.**

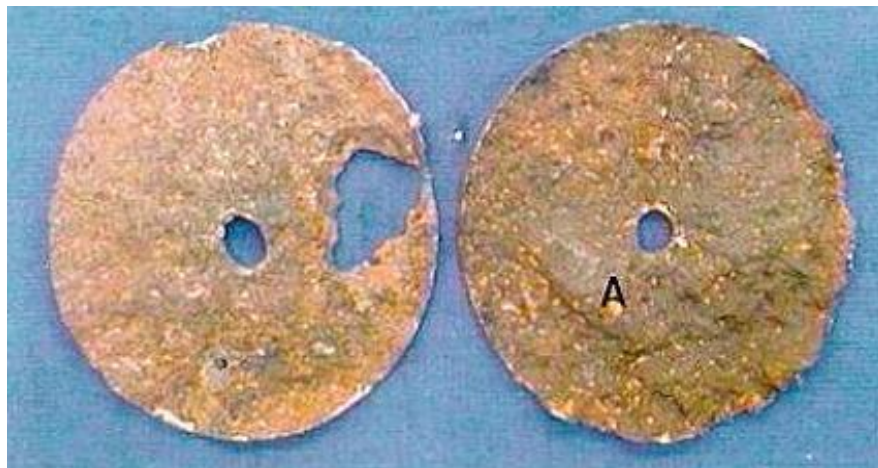
**Figure 4-97 – Coupons removed from the bottom of an unprotected steel condensate storage tank after 3 years of service. The external surface is shown.**

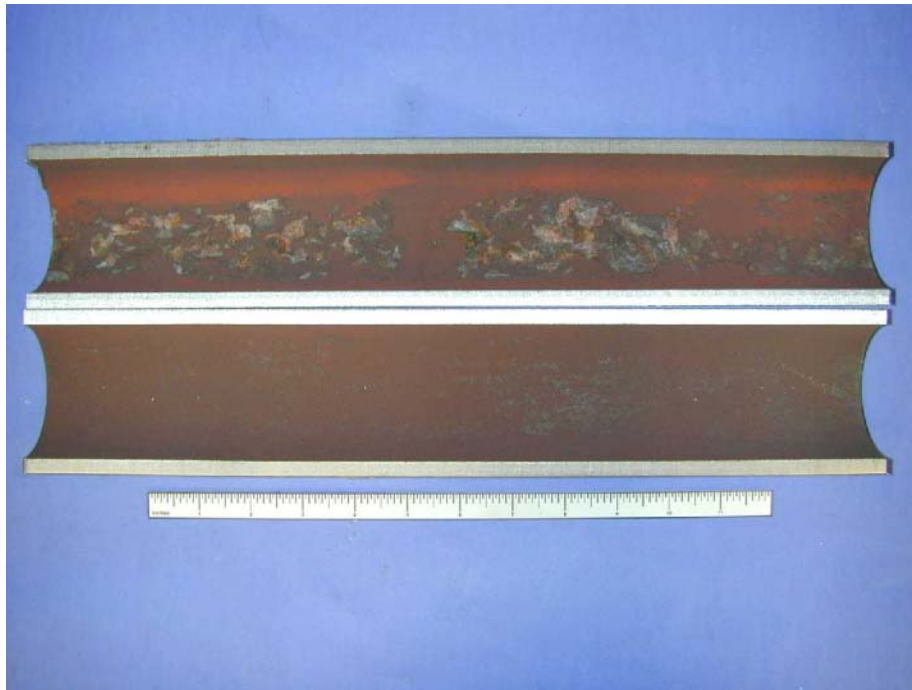
**Figure 4-99 – I.D. deposits on CS boiler tube with damage due to caustic corrosion.**

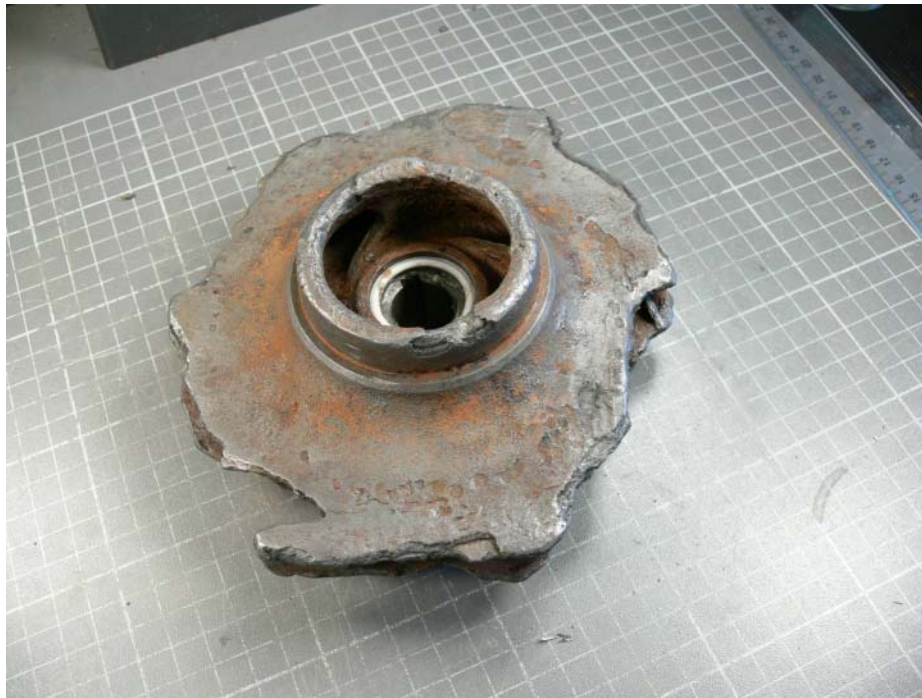
**Figure 4-103 – Graphitic Corrosion of cast iron impeller due to glycol acidification.**

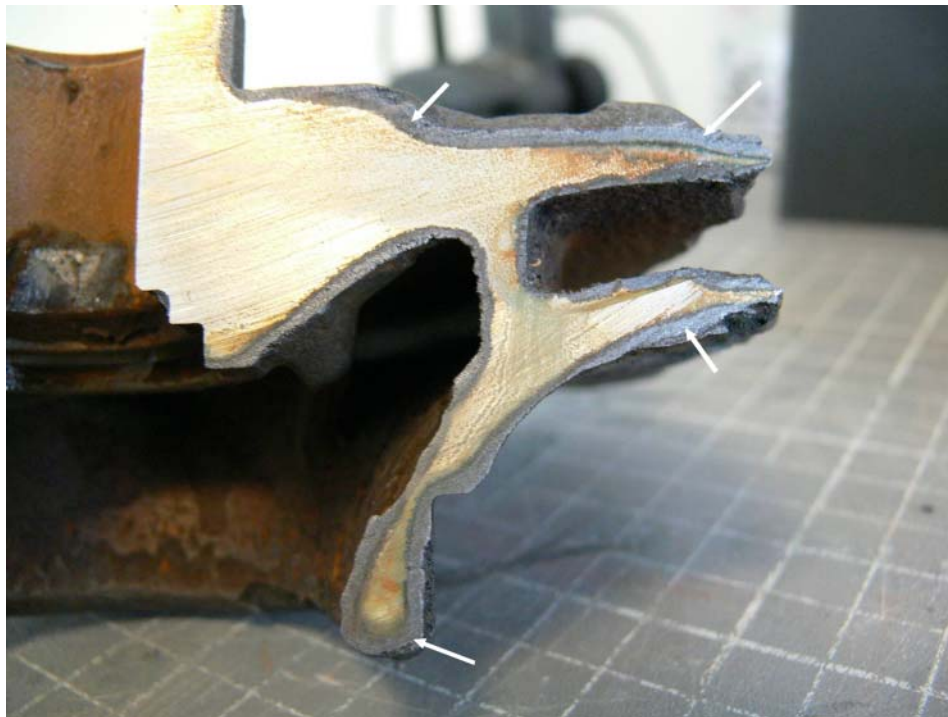
**Figure 4-104 – Cut away of cast iron impeller shown above. The dark phase around the outside perimeter (at arrows) is graphite which surround the unaffected metal in the middle.**

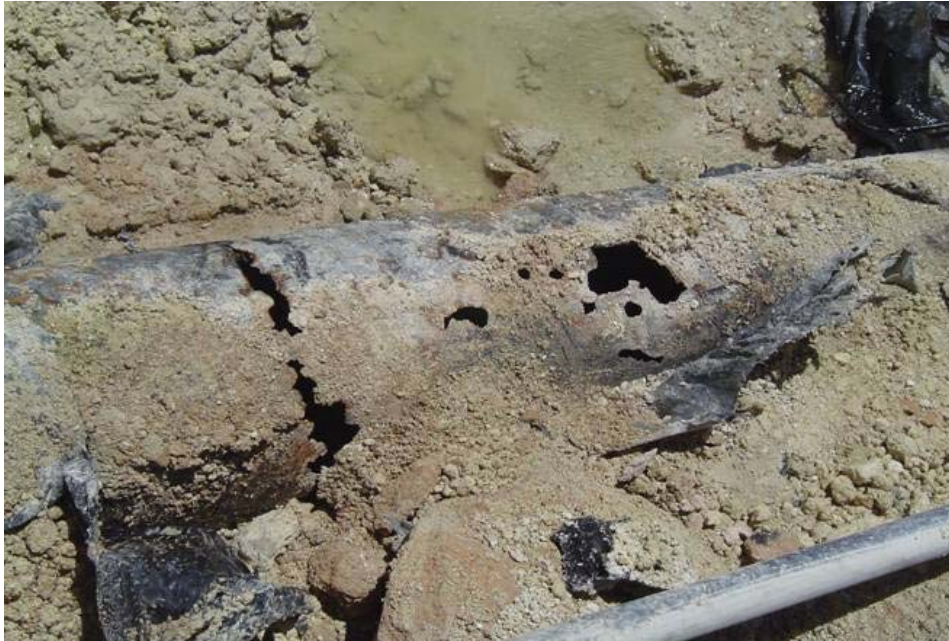
**Figure 4-105 – View of the outside of an underground concrete-lined salt water service line that failed from graphitic corrosion.**

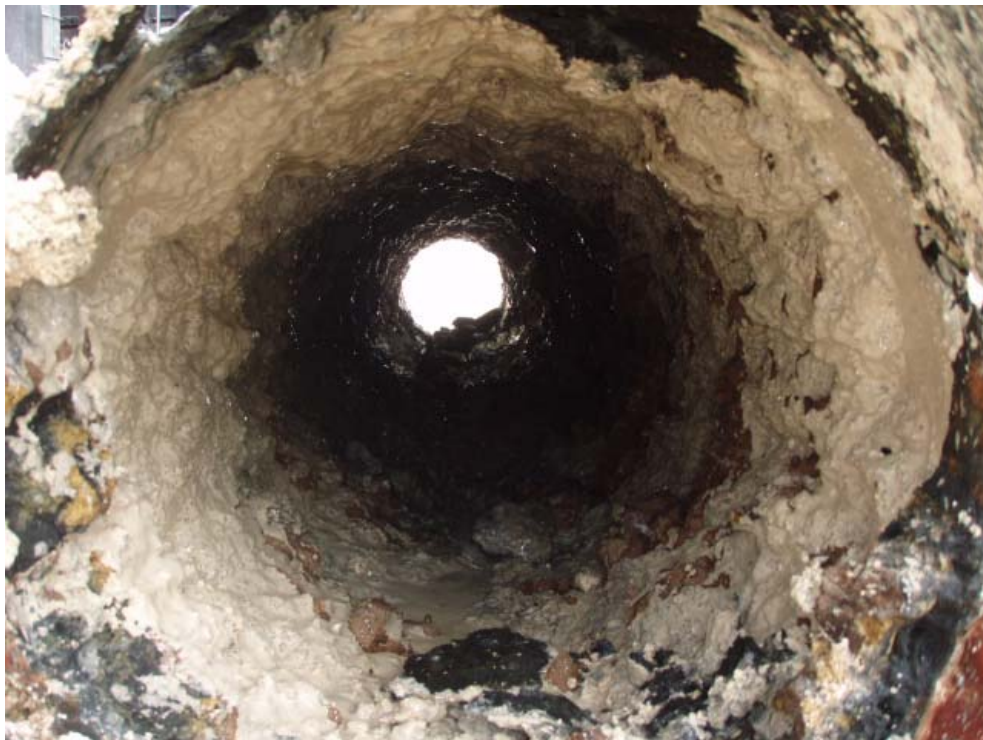
**Figure 4-106 – View of concrete lining inside the failed line shown in Figure 105.**

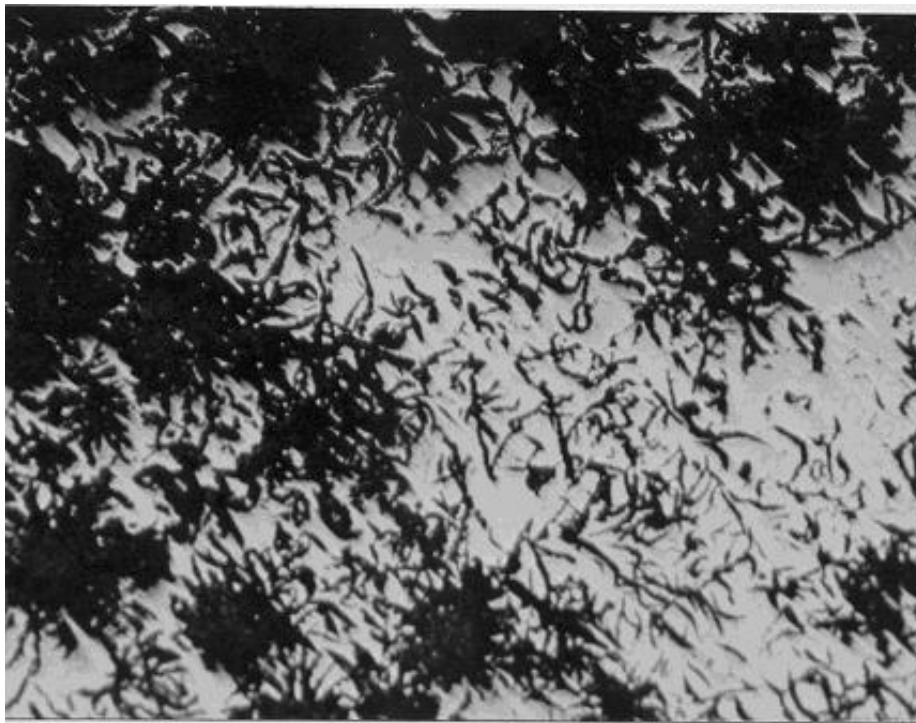
**Figure 4-110 – Higher magnification view of the damage from shown in 4-108 (area “B”).**

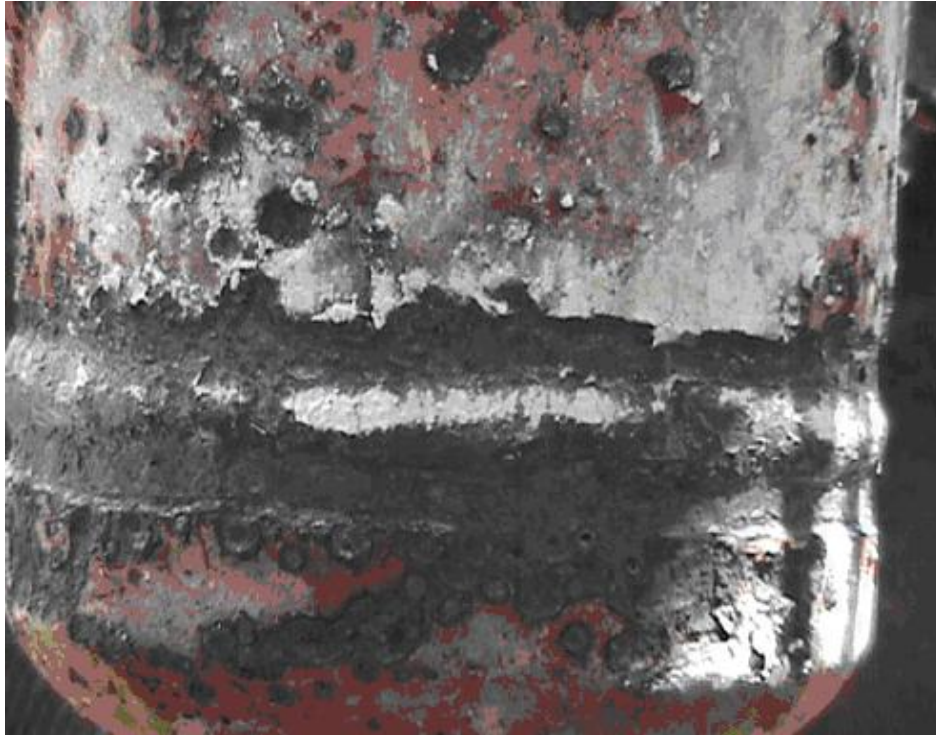
**Figure 4-113 – Oxidation of the O.D. of a carbon steel furnace transfer line.**

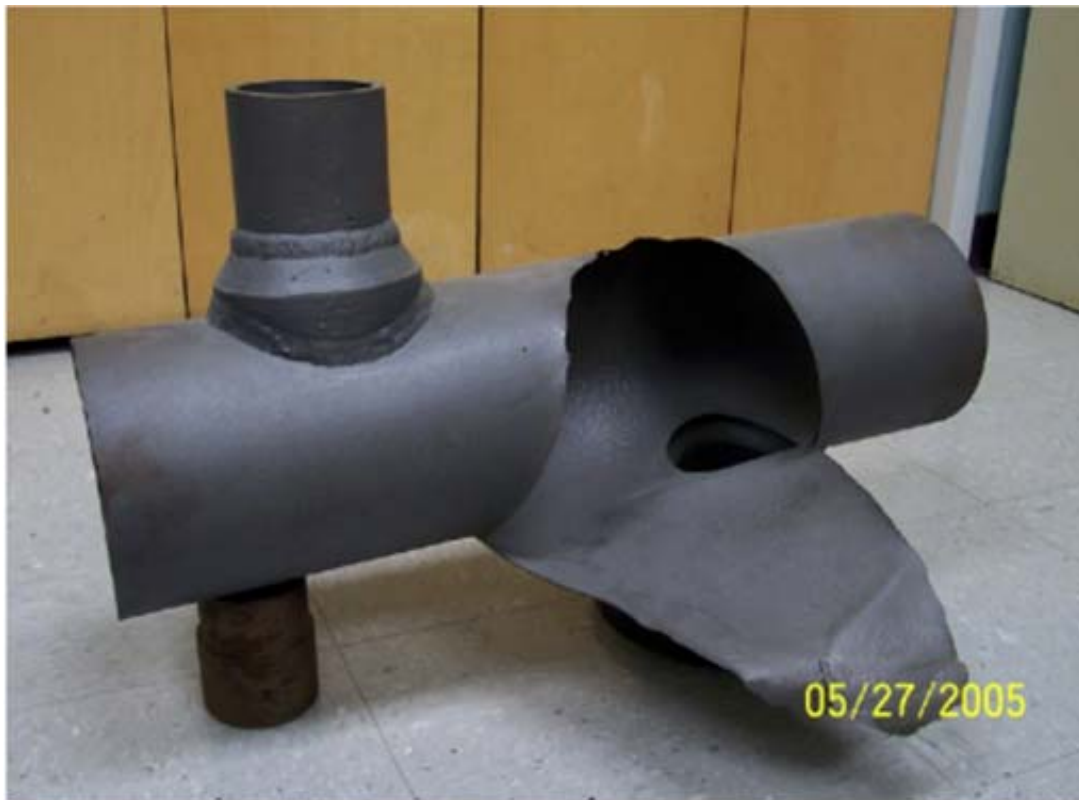
Figure 4-116 – Sulfidation failure of NPS 8 carbon steel pipe. Note the relatively uniform thinning that resulted in a sizeable rupture.

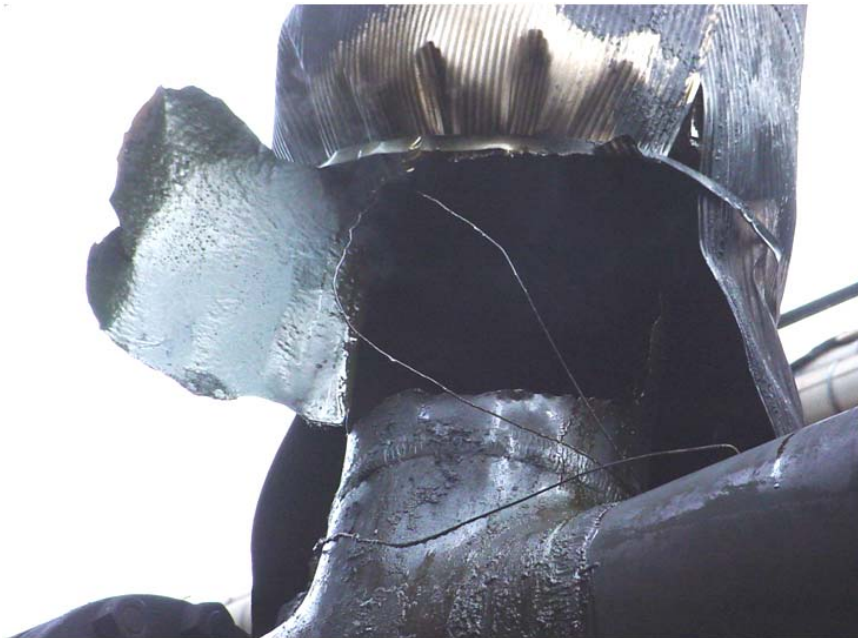
**Figure 4-117 – Sulfidation failure illustrating the effect of accelerated corrosion due to low silicon content. This 8 inch NPS pipe section in FCC bottoms piping was in service at 150 psig (1Mpa) at 650° to 700°F (340° to 370°C). The piping sketch in Figure 118 illustrates the difference in corrosion rate as compared to adjacent high-silicon components.**

- a) Depending on service conditions, corrosion is most often in the form of uniform thinning but can also occur as localized corrosion or high velocity erosion-corrosion damage (Figure 4-116 to 4-120).
- b) A sulfide scale will usually cover the surface of components. Deposits may be thick or thin depending on the alloy, corrosiveness of the stream, fluid velocities and presence of contaminants .

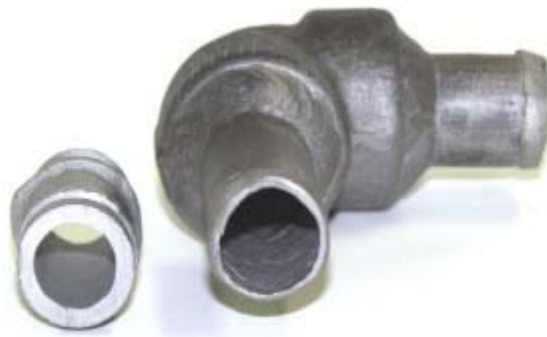
Figure 4-119 – Sulfidation failure of carbon steel sight glass nipple on the right after 2 years in crude unit. Original thickness is shown on left for comparison. Material was supposed to be 9Cr-1Mo.

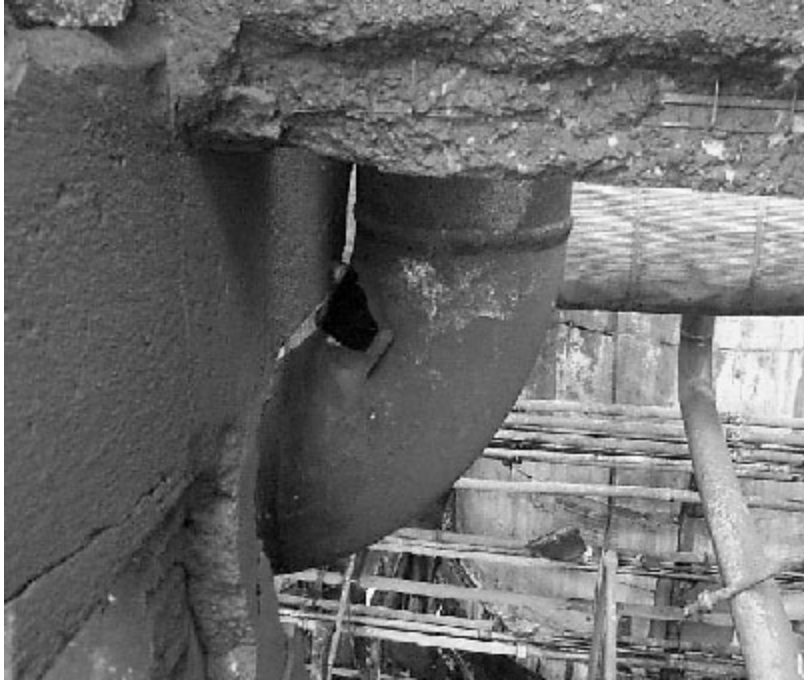
**Figure 4-120 – Sulfidation failure of piping elbow.**

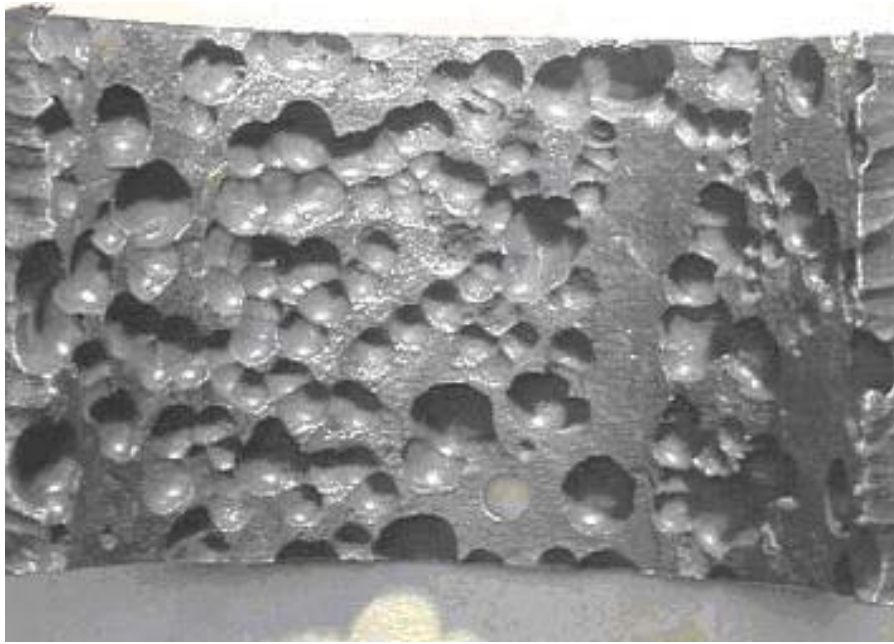
**Figure 4-125 – Metal dusting of a 304H stainless steel pipe.**

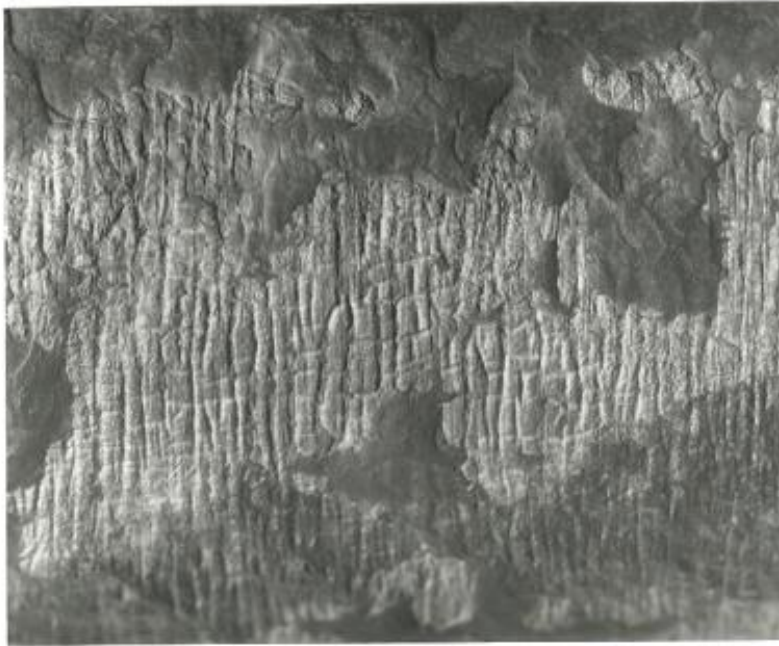
**Figure 4-127 – The “alligator hide” morphology of liquid coal-ash corrosion is evident when the dense, glassy deposit is removed. Mag. 2.4X**

- b) Metallographic examination and deposit-analysis techniques can be used to verify the presence of fuel ash corrosion.
- c) For oil ash corrosion of superheaters and reheaters, the appearance of the ash deposit will be in at least two distinct layers. The important deposit is adjacent to the component, which will have a dark gray or black appearance at room temperature. As the liquid sulfates sinter the corrosion debris to the surface, a hard, glassy, tenacious scale is formed. When removed, the surface of the steel will have an “alligator-hide” appearance (Figure 4-127 and Figure 4-128) as shallow grooves will have penetrated the steel in a cross-hatched pattern.

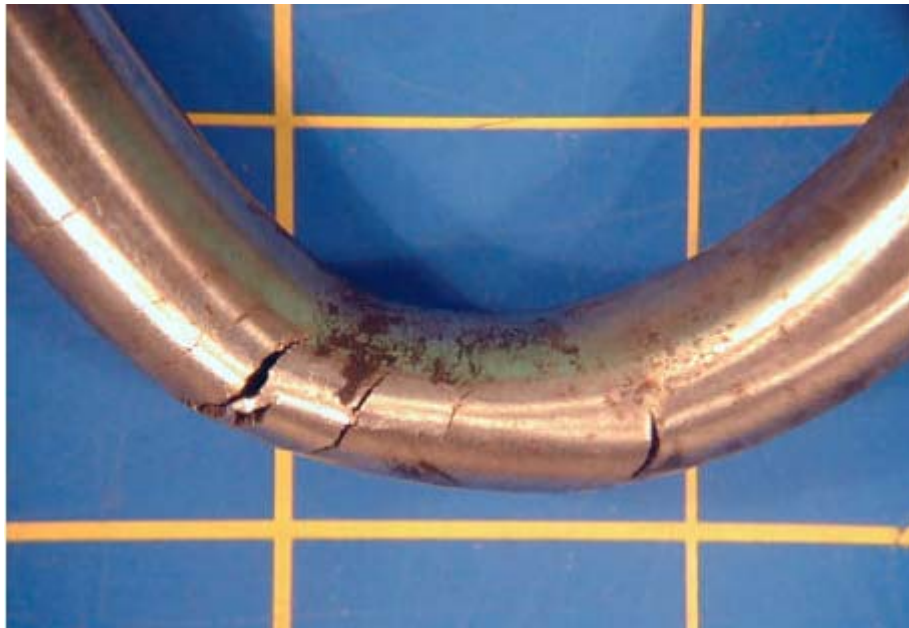
**Figure 4-133 – External cracking of Type 304SS instrument tubing under insulation.**

- a) Surface breaking cracks can occur from the process side or externally under insulation (Figures 4-133 to 4-134).
- b) The material usually shows no visible signs of corrosion.
- c) Characteristic stress corrosion cracks have many branches and may be visually detectable by a craze-cracked appearance of the surface (Figure 4-135 to Figure 4-136).
- d) Metallography of cracked samples typically shows branched transgranular cracks (Figure 4-137 to 4-139).
- e) Sometimes intergranular cracking of sensitized 300 Series SS may also be seen.
- f) Welds in 300 Series SS usually contain some ferrite, producing a duplex structure that is usually more resistant to CI-SCC.
- g) Corrosion-resistant nickel-based alloys are also susceptible to cracking under severe conditions (Figure 4-140).
- h) Fracture surfaces often have a brittle appearance.

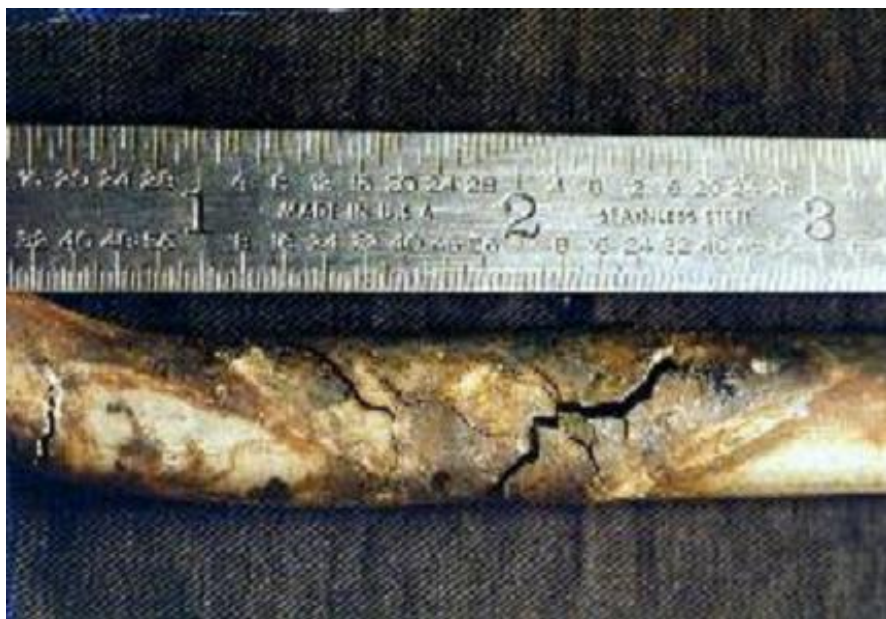
**Figure 4-134 – External cracking of Type 304SS instrument tubing under insulation.**

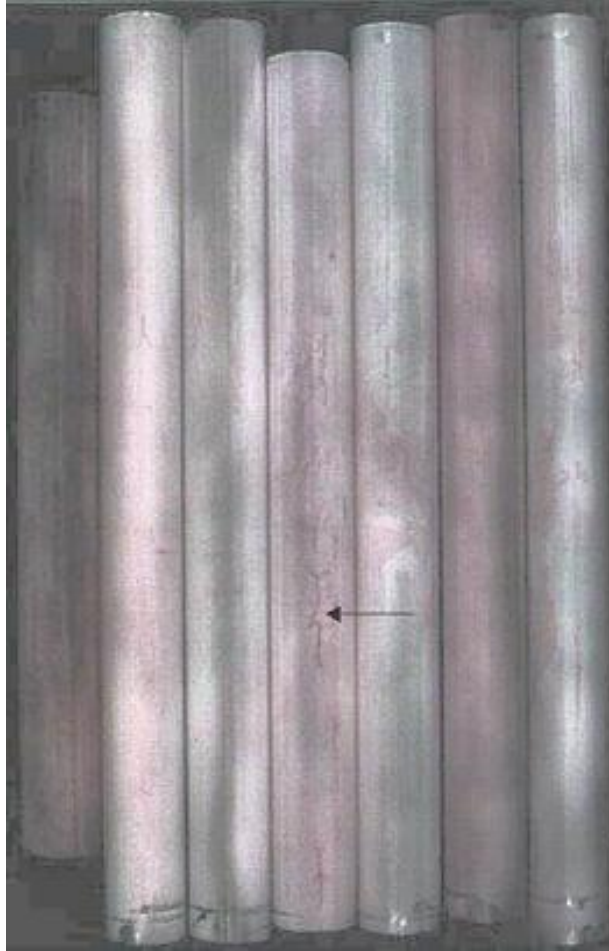
**Figure 4-135 – Cracking on the shell side of Type 316L SS tubes in steam service at 450°F (232°C), showing tubes after PT inspection. The cracks can be seen in the center tube (arrow).**

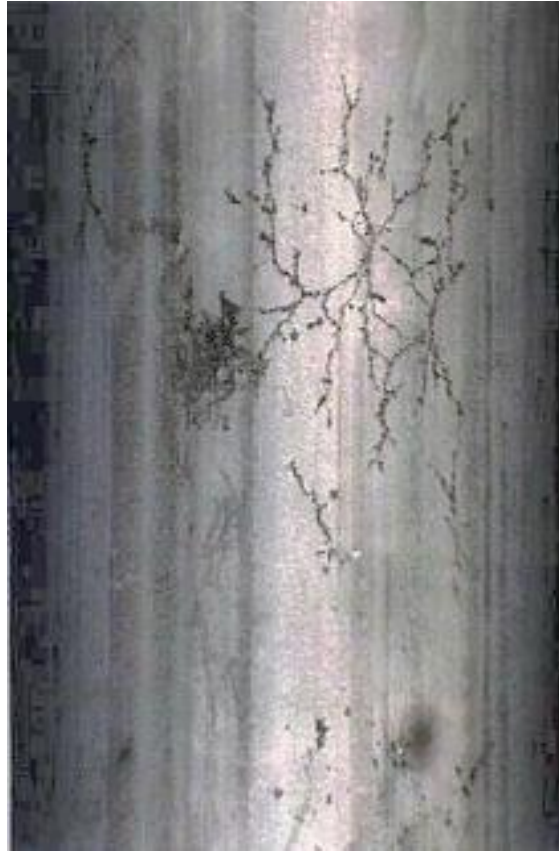
**Figure 4-136 – Close-up of the tube in Figure 4-135 showing tight cracks with a spider web appearance.**

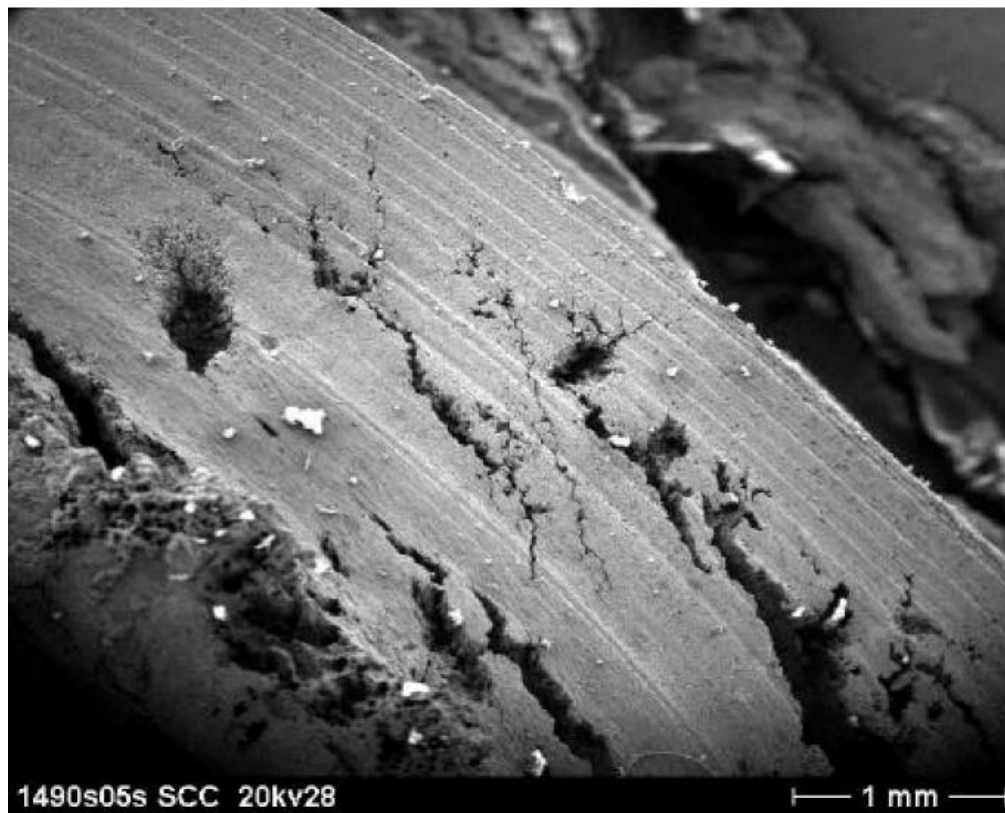
Figure 4-139 – Chloride SCC on the thread surface of a failed 303SS bolt.

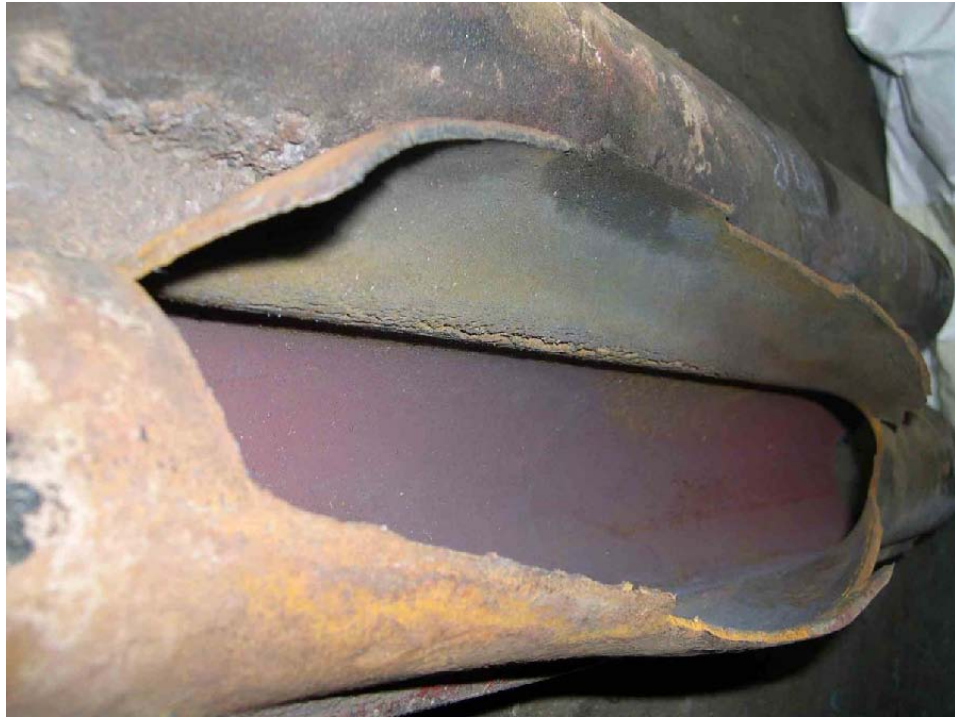
**Figure 4-141 – Corrosion fatigue failure of a boiler tube.**

- c) In cycling boilers, the damage usually appears first on the water side of buckstay (structural) attachments ([Figure 4-141](#)). The cracking pattern may be circular cracks surrounding the weld between the buckstay attachment and the waterwall tube. In cross-section, the cracks tend to be bulbous with numerous lobes ([Figure 4-142](#)). The crack tips themselves may be somewhat blunted but are oxide filled and transgranular [Figure 4-143 to 4-145](#)).

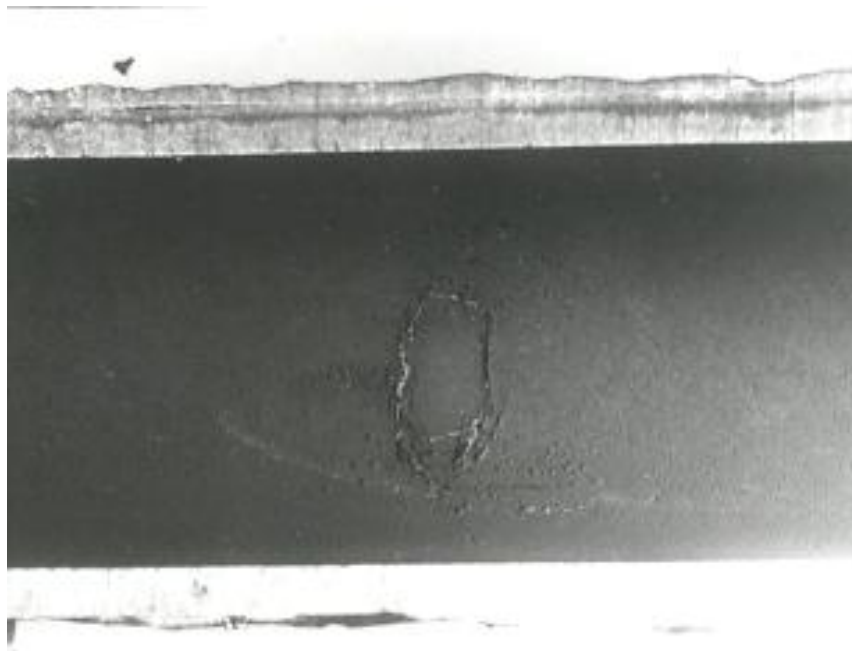
**Figure 4-144 – Photograph of a carbon steel boiler tube cut in half lengthwise. Corrosion fatigue cracks initiate at the I.D. of a tube, opposite a buckstay attachment on the O.D. (Mag. 1X)**

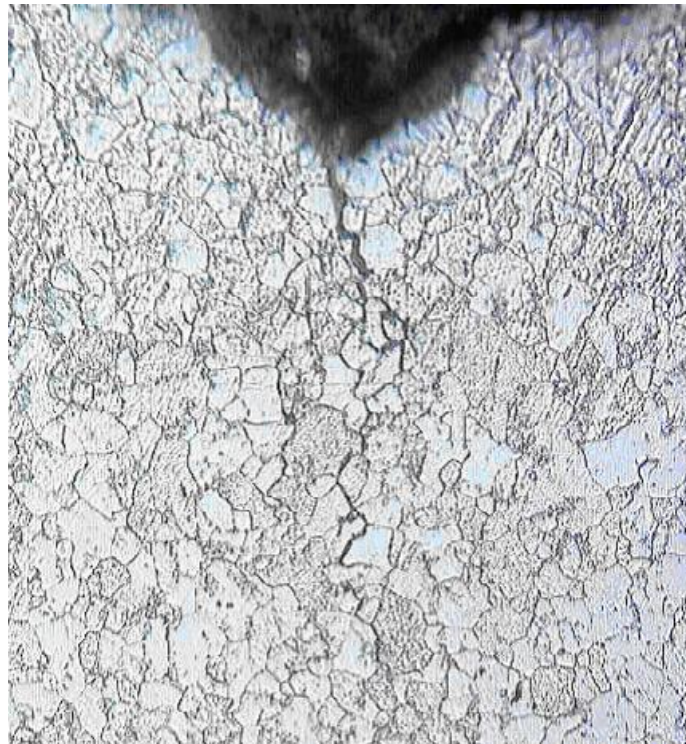
**Figure 4-148 – Photomicrograph of a crack in the tube shown in Figure 4-147.**

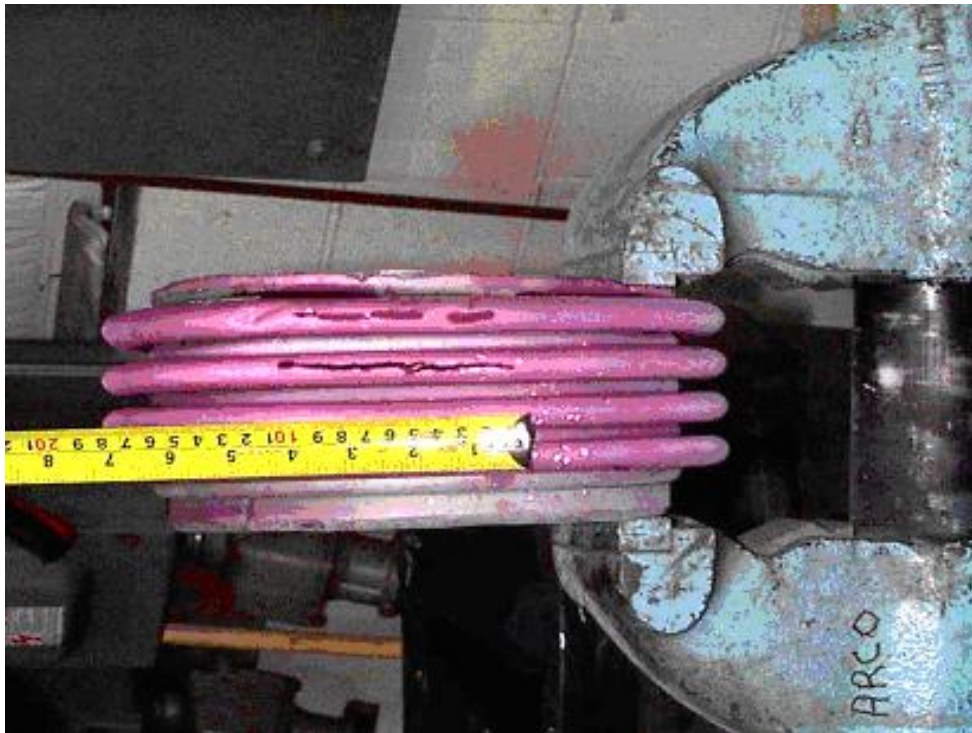
**Figure 4-153 – Stainless steel expansion bellows from a steam-driven turbine previously subjected to a caustic carryover upset condition.**

- b) The pattern of cracking observed on the steel surface is sometimes described as a spider web of small cracks which often initiate at or interconnect with weld-related flaws that serve as local stress raisers.
- c) Cracks can be confirmed through metallographic examination as surface breaking flaws that are predominantly intergranular. The cracking typically occurs in as-welded carbon steel fabrications as a network of very fine, oxide-filled cracks.
- d) Cracking in 300 Series SS is typically transgranular and is very difficult to distinguish from chloride stress corrosion cracking ([Figure 4-153](#)).

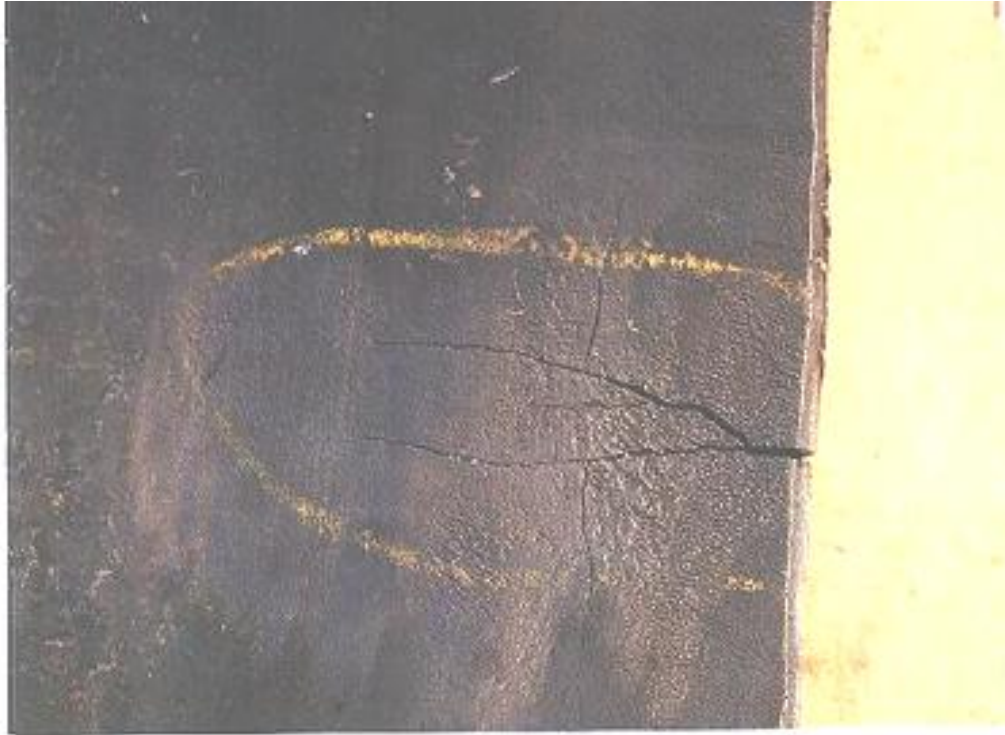
**Figure 4-159 – Liquid metal embrittlement of Monel caused by mercury in an FCC gas plant overhead drum.**
