# Damage Mechanisms Affecting Fixed Equipment in the Refining Industry

API RECOMMENDED PRACTICE 571  
SECOND EDITION, APRIL 2011

**Downstream Segment**

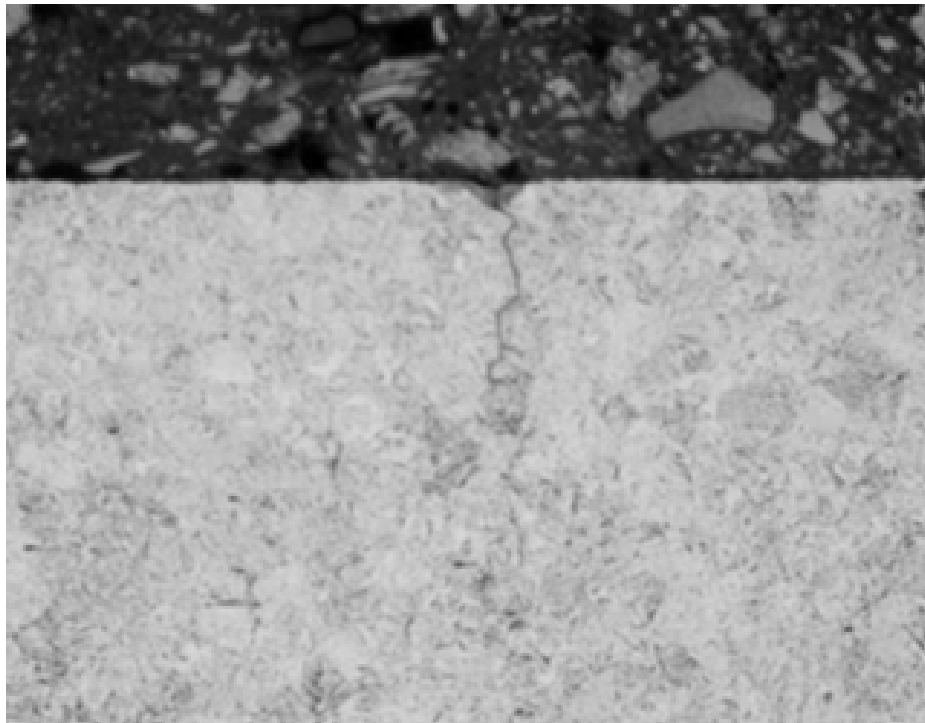
**Figure 4-160 – a.) Cracking due to hydrogen embrittlement of a carbon steel tube. b.) Intergranular crack emanating from surface in the tube.**

- a) Cracking due to HE can initiate sub-surface, but in most cases is surface breaking ([Figure 4-160 to 4-161](#)).
- b) HE occurs at locations of high residual or tri-axial stresses (notches, restraint) and where the microstructure is conducive, such as in weld HAZ's.
- c) On a macro-scale, there is often little evidence, although some materials will appear to have brittle fracture surfaces. On a microscale, the material will contain less ductile fracture surface, but must often be compared to a fracture without the presence of hydrogen.
- d) In higher strength steels, cracking is often intergranular.

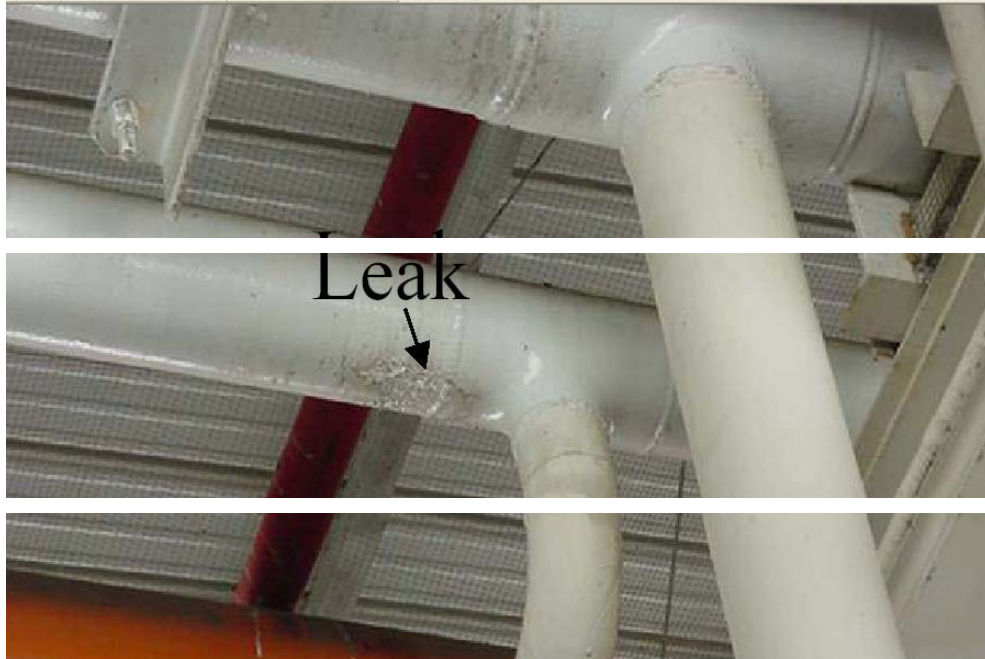
Figure 4-164 – A leak in piping resulting from an ethanol SCC adjacent to the weld.

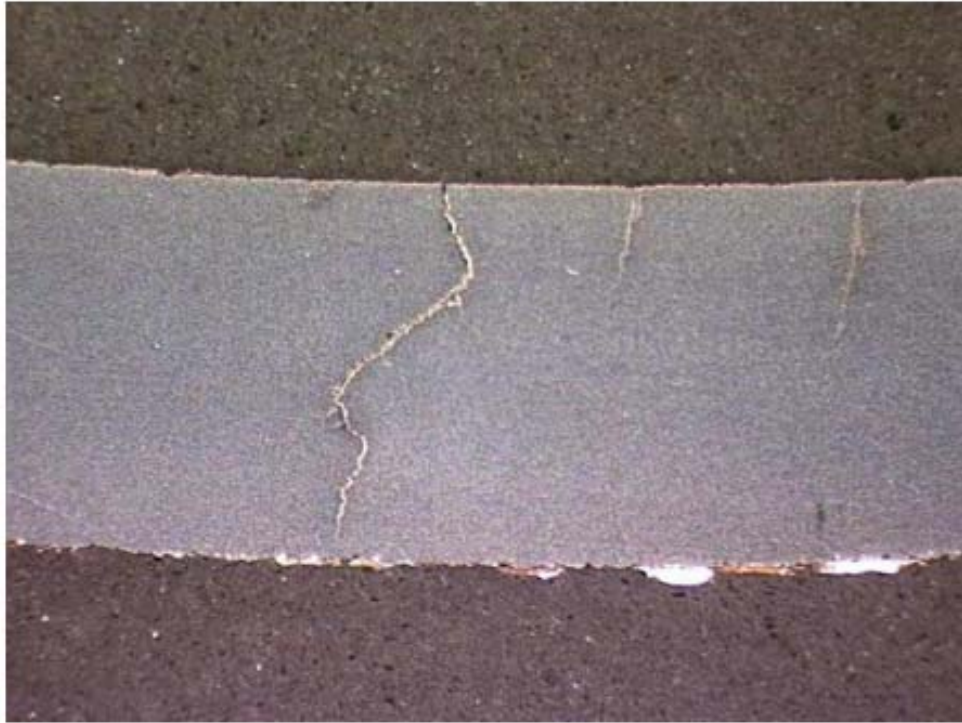
**Figure 4-168 – Transverse cross-section of a piping section exposed to fuel ethanol showing multiple crack initiation sites characteristic of SCC.**

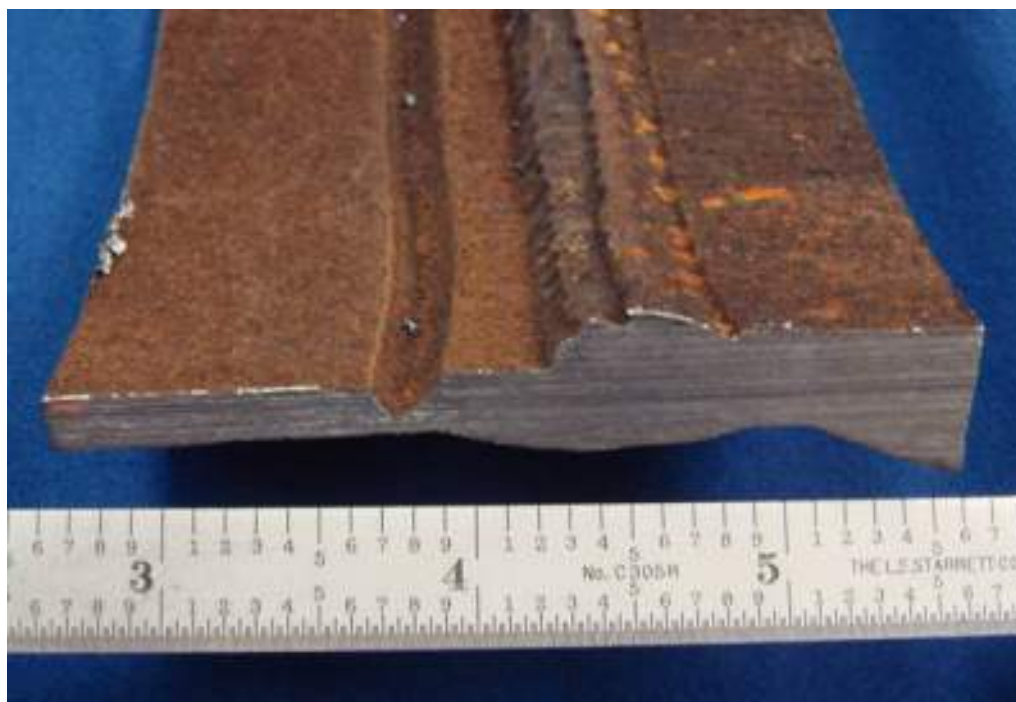
**Figure 5-2 – Hot Lean Amine Corrosion of Carbon Steel:**

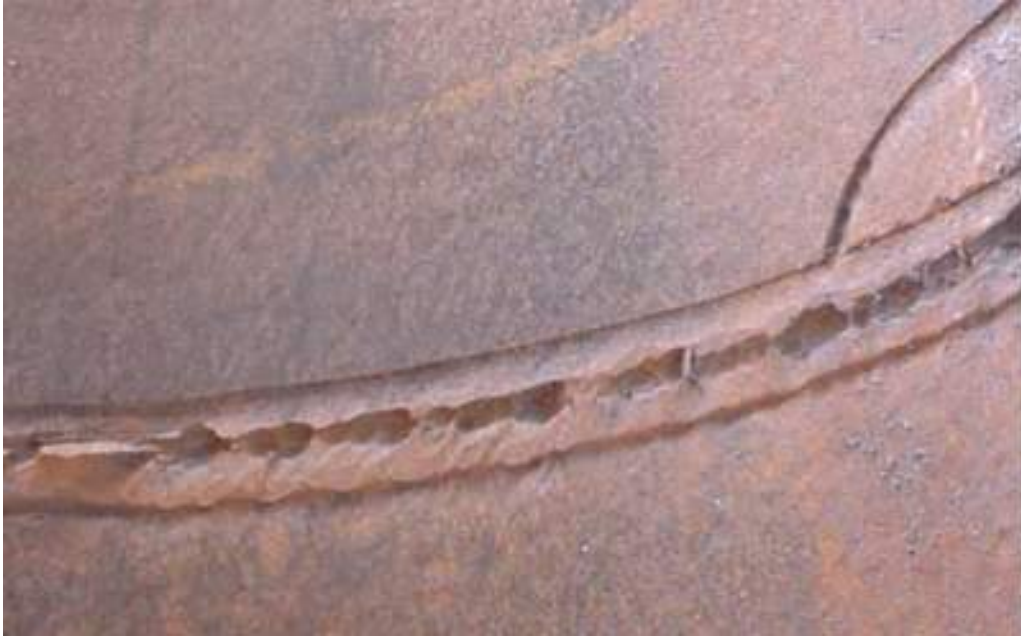
**Figure 5-3 – Preferential weld corrosion in lean amine (Reference 5)**

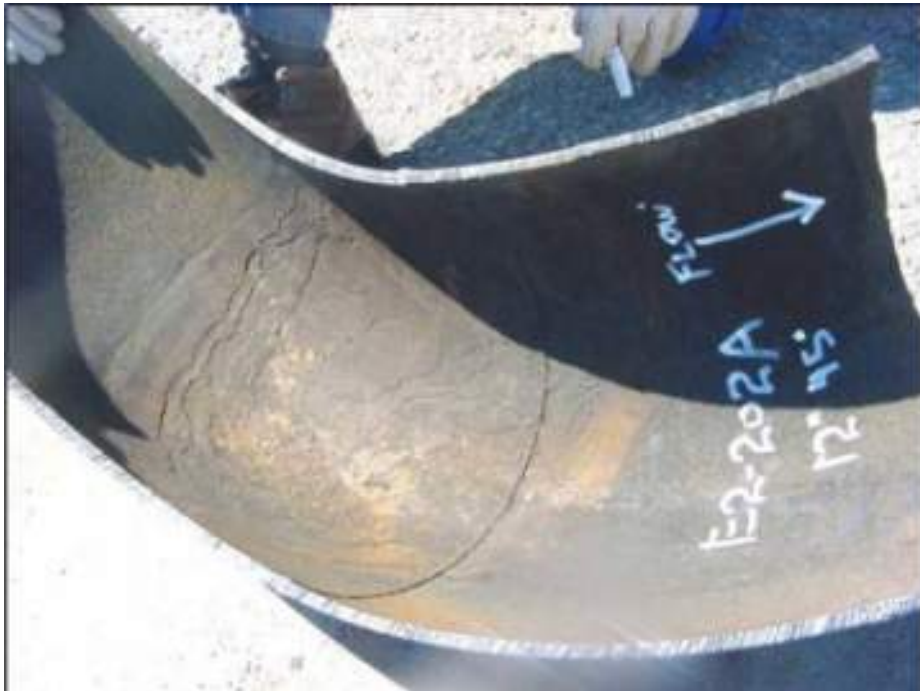
**Figure 5-4 – Preferential corrosion in amine regenerator reboiler return elbow (Reference 6).**

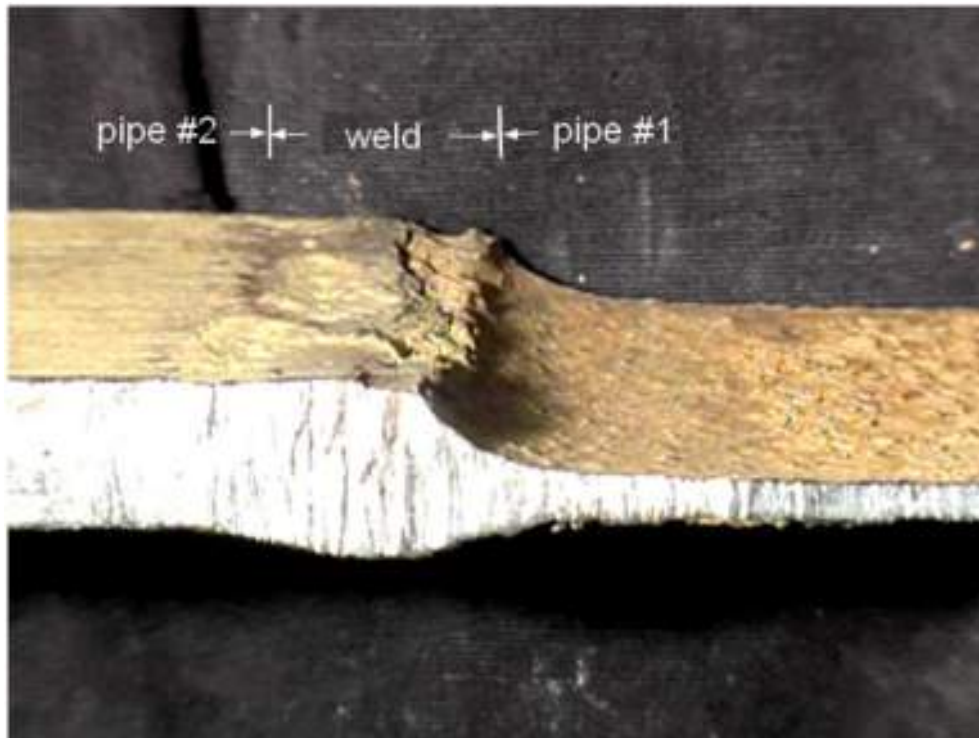
**Figure 5-12 – Cross-section of a carbon steel pipe showing preferential corrosion of the pipe with high residual element content on the right, as compared to the low residual pipe section to the left of the weld (Reference 3).**

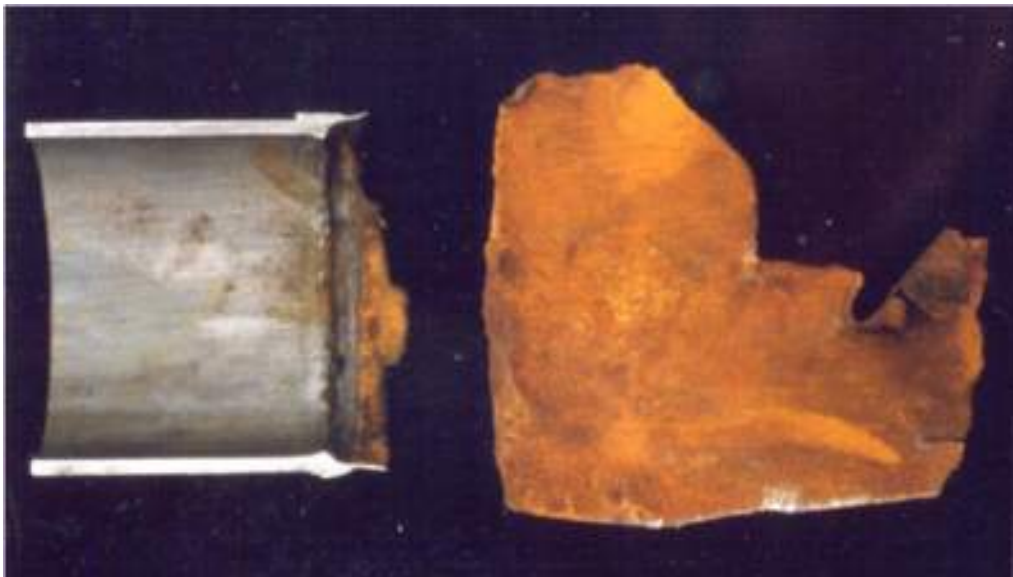
**Figure 5-13 – Ruptured NPS 3 Sch. 80 0.216 in (5.49 mm) Depropanizer Feed Line operating <120°F  
Residual element content is as follows:  
Both Base metals: %C > 0.18 & %Cu + %Ni < 0.15  
Weld Metal: %Cu + %Ni + %Cr < 0.15**

- a) Corrosion is in the form of localized general or severe thinning of carbon steel. Preferential corrosion may not always conform to behavior predicted by the RE guidelines in API RP 751 ([Figure 5-12 to 5-15](#)).
- b) Corrosion may be accompanied by cracking due to hydrogen stress cracking, blistering and/or HIC/SOHIC damage.
- c) Significant fouling due to iron fluoride scales may also accompany corrosion.
- d) Alloy 400 shows uniform loss in thickness but is not accompanied by significant scaling.
- e) Alloy 400 is susceptible to stress corrosion cracking when in contact with moist HF vapors in the presence of oxygen.

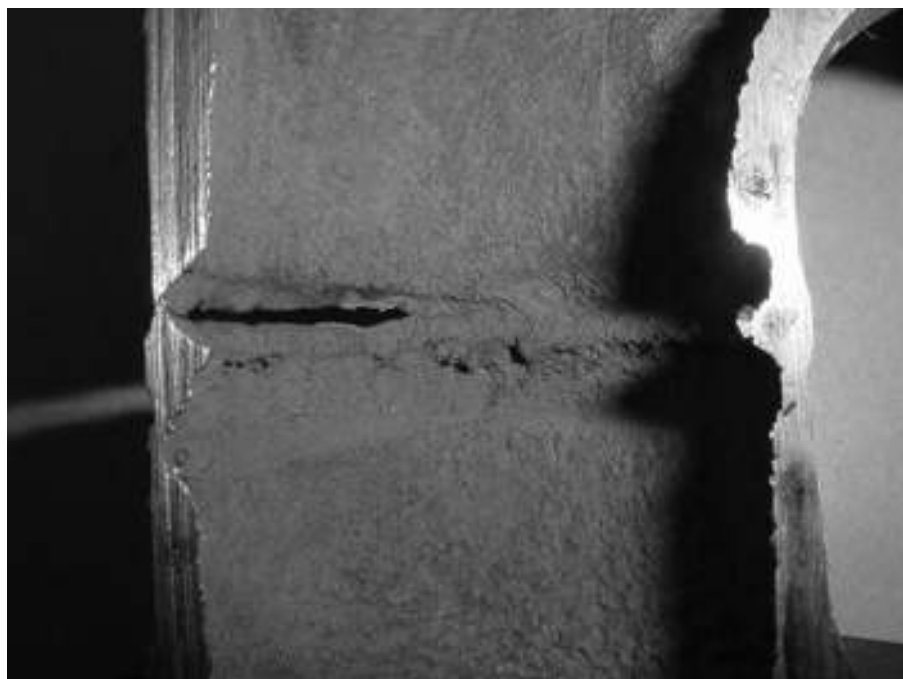
**Figure 5-15 – Accelerated corrosion in the heat affected zone of a carbon steel weldment.  
Residual element content is as follows (Reference 8):  
Both Base metals: %C > 0.18 wt. & %Cu + %Ni < 0.15  
Weld Metal: %Cu + %Ni + %Cr < 0.15**

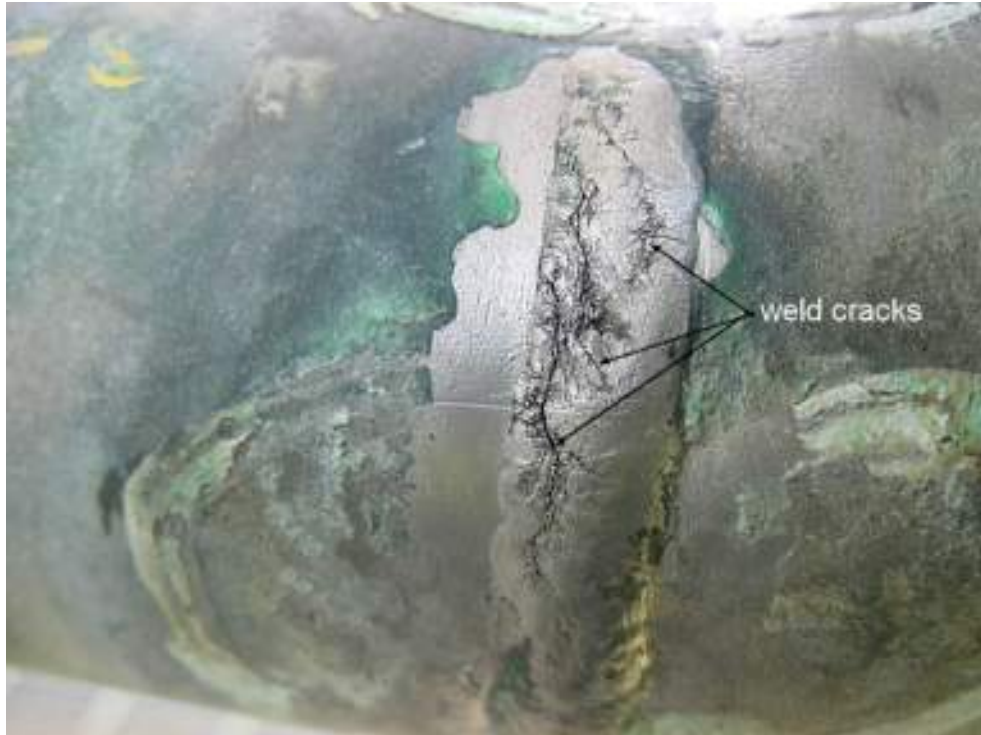
**Figure 5-16 – HF stress corrosion cracking of Alloy 400 vent line in an acid dump system (Reference 8).**

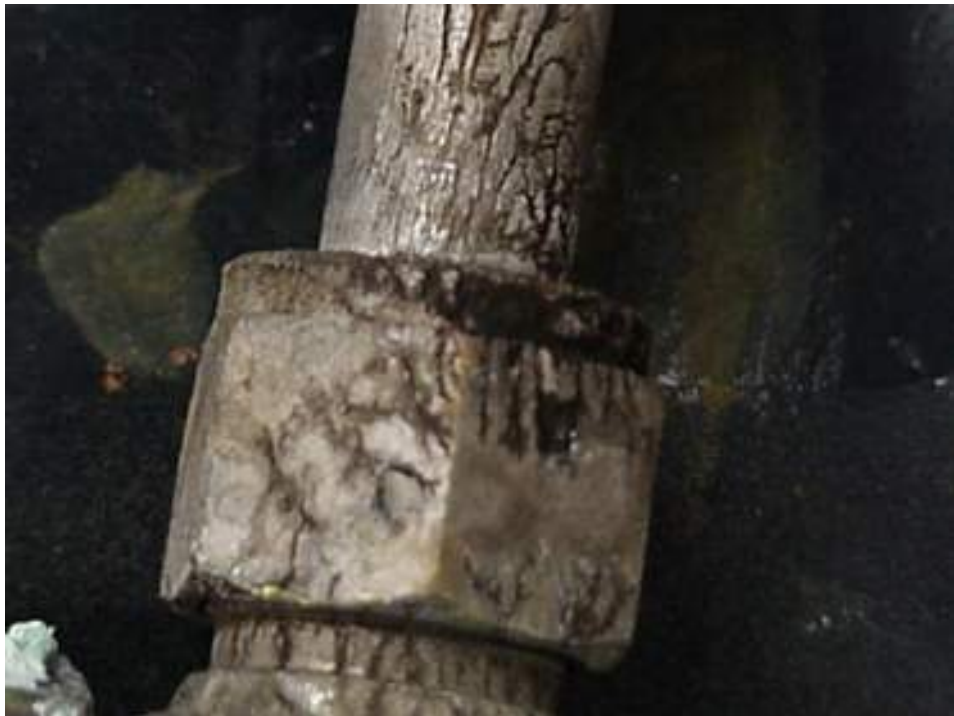
**Figure 5-17 – HF stress corrosion cracking of Alloy 400 instrument tubing (Reference 8).**

- a) Carbon steel operating above 150°F (66°C) should be closely monitored for loss in thickness and may need to be upgraded to Alloy 400.
- b) Corrosion can be prevented by careful operation of the unit to minimize water, oxygen, sulfur and other contaminants in the feed.
- c) Maintain strict controls on the water content of the circulating acid.
- d) Alloy 400 (solid or clad) can be used to eliminate the problems associated with blistering and HIC/SOHIC. A stress relieving heat treatment is required to help minimize, but not eliminate, the possibility of SCC ([Figure 5-16 to 5-18](#)).
- e) Alloy C276 has been used where there have been cracking problems with Alloy 400.

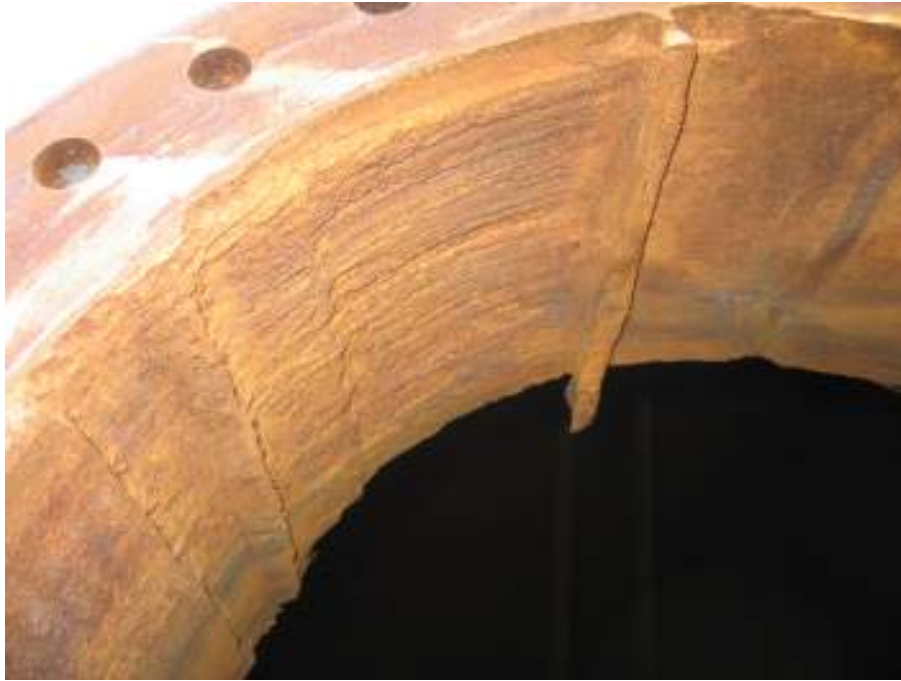
**Figure 5-18 – HF Corrosion at manway in HF acid storage service.**

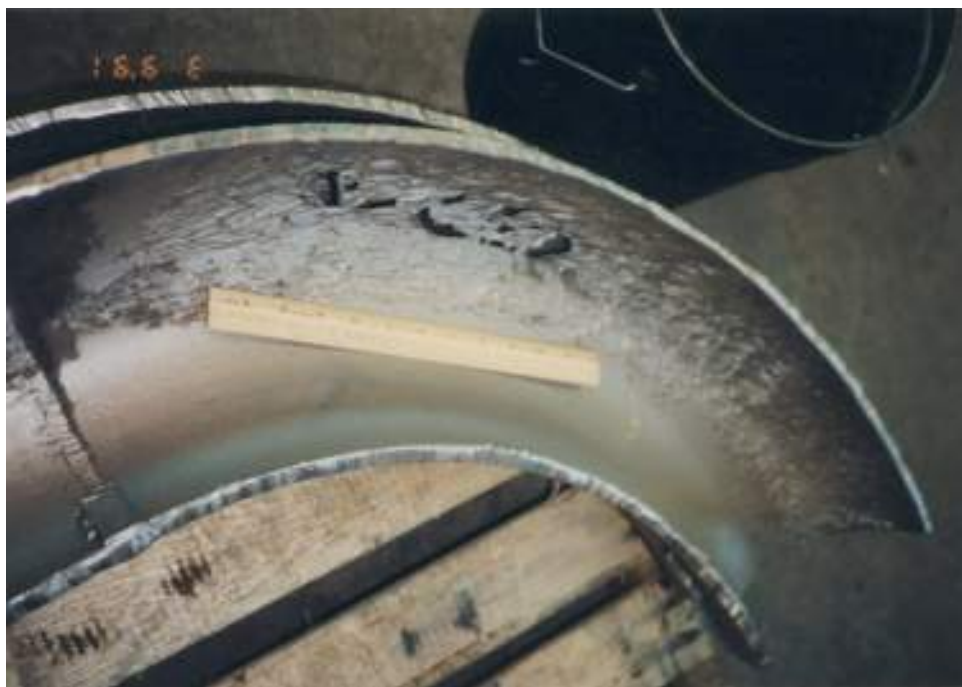
**Figure 5-19 – Erosion-corrosion damage due to NAC in a 10-inch 5Cr elbow in the outlet of a vacuum heater in a VDU.**

- a) NAC is characterized by localized corrosion, pitting corrosion, or flow induced grooving in high velocity areas (Figure 5-19 and Figure 5-20).
- b) In low velocity condensing conditions, many alloys including carbon steel, low alloy steels and 400 Series SS may show uniform loss in thickness and/or pitting.

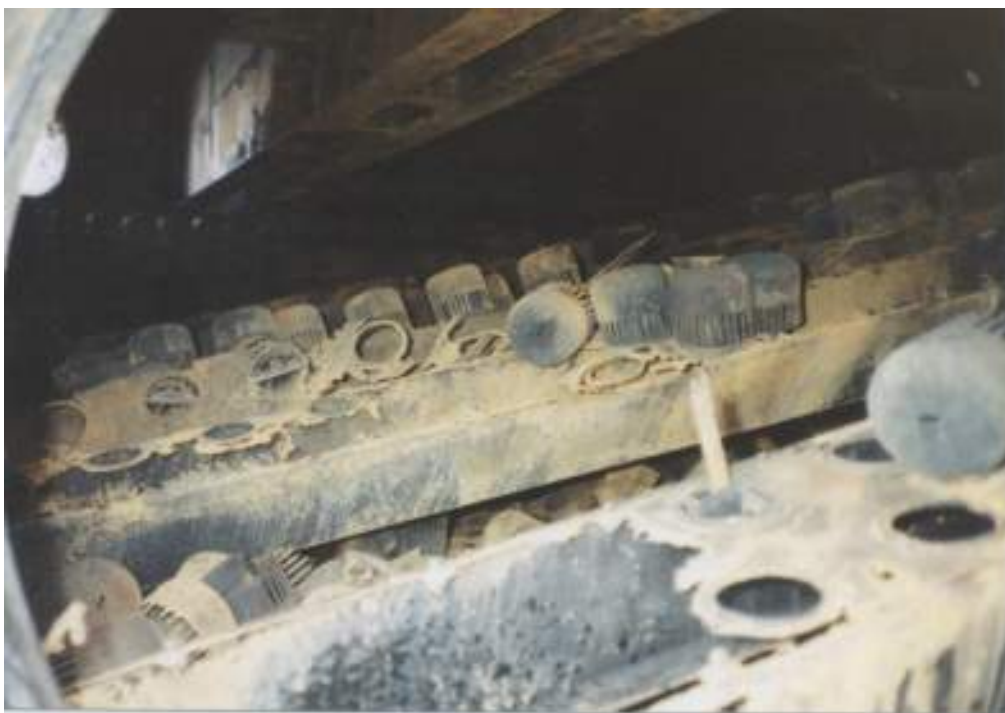
**Figure 5-20 – Severe NAC of 410 SS trays and bubble caps in the HVGO section of the vacuum tower fed by the vacuum heater in Figure 5-19.**

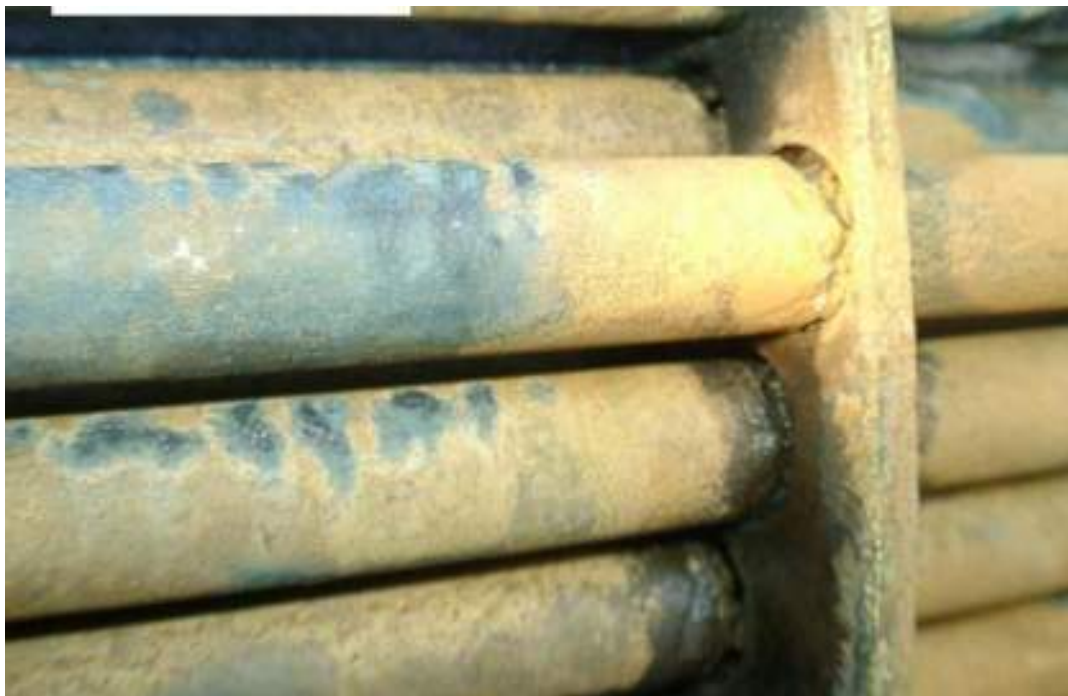
Figure 5-22 – Accelerated corrosion under a baffle.

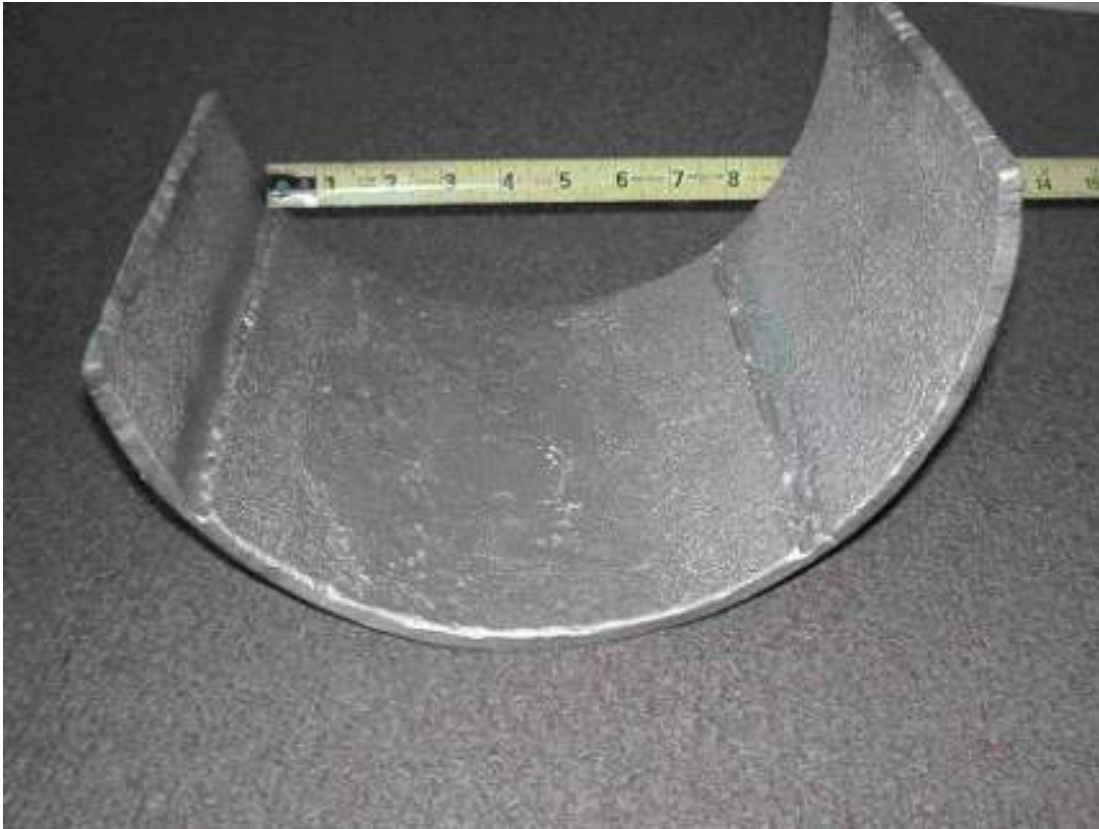
**Figure 5-23 – Grooving corrosion in the carbon steel vapor line from an alkaline water wash drum in a sulfuric acid alkylation unit.**

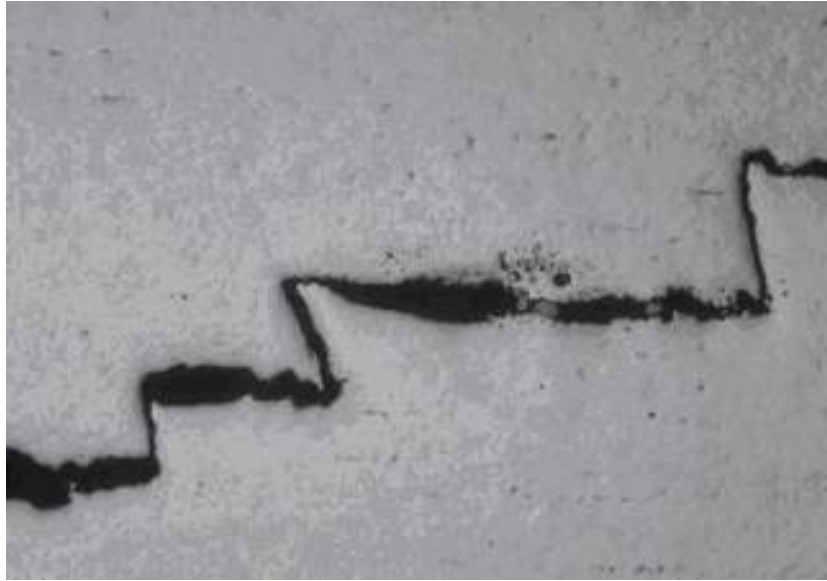
**Figure 5-38 – High magnification photomicrograph showing stepwise cracking nature of HIC damage.**

Hydrogen blisters can form at many different depths from the surface of the steel, in the middle of the plate or near a weld. In some cases, neighboring or adjacent blisters that are at slightly different depths (planes) may develop cracks that link them together. Interconnecting cracks between the blisters often have a stair step appearance, and so HIC is sometimes referred to as "stepwise cracking" (Figure 5-36, Figure 5-37 and Figure 5-38).

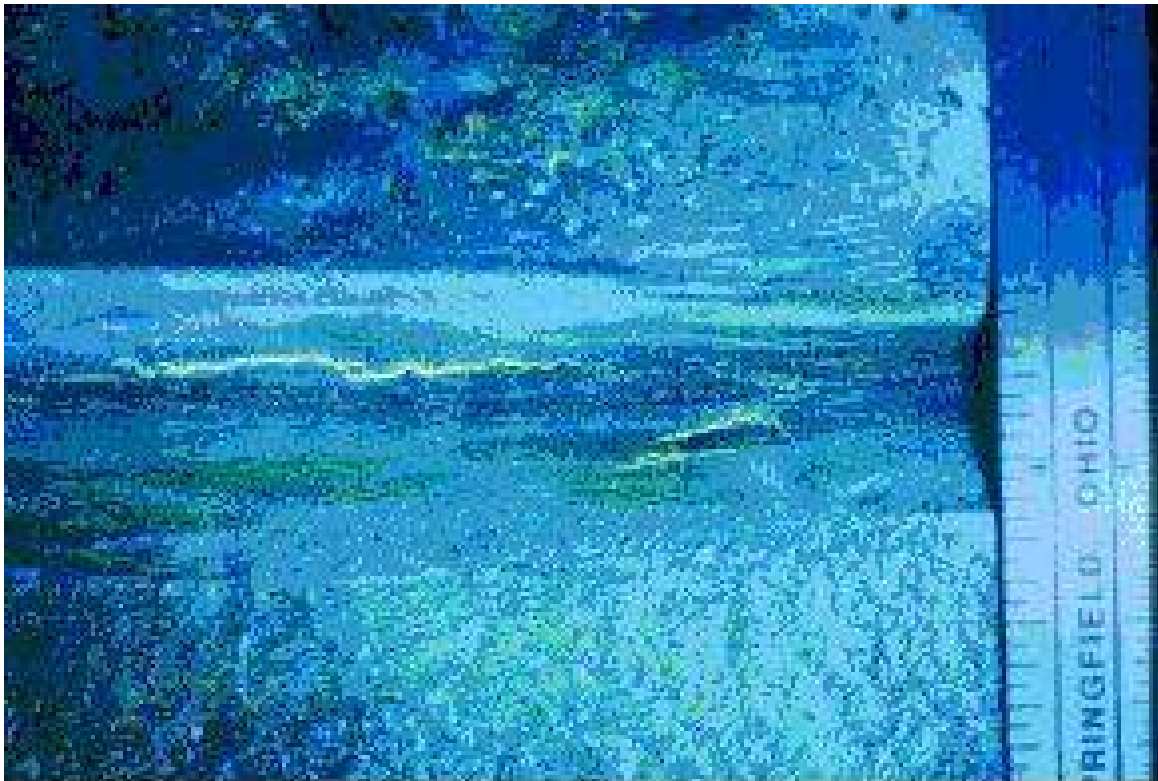
**Figure 5-41 – Photograph showing WFMT of SOHIC damage.**

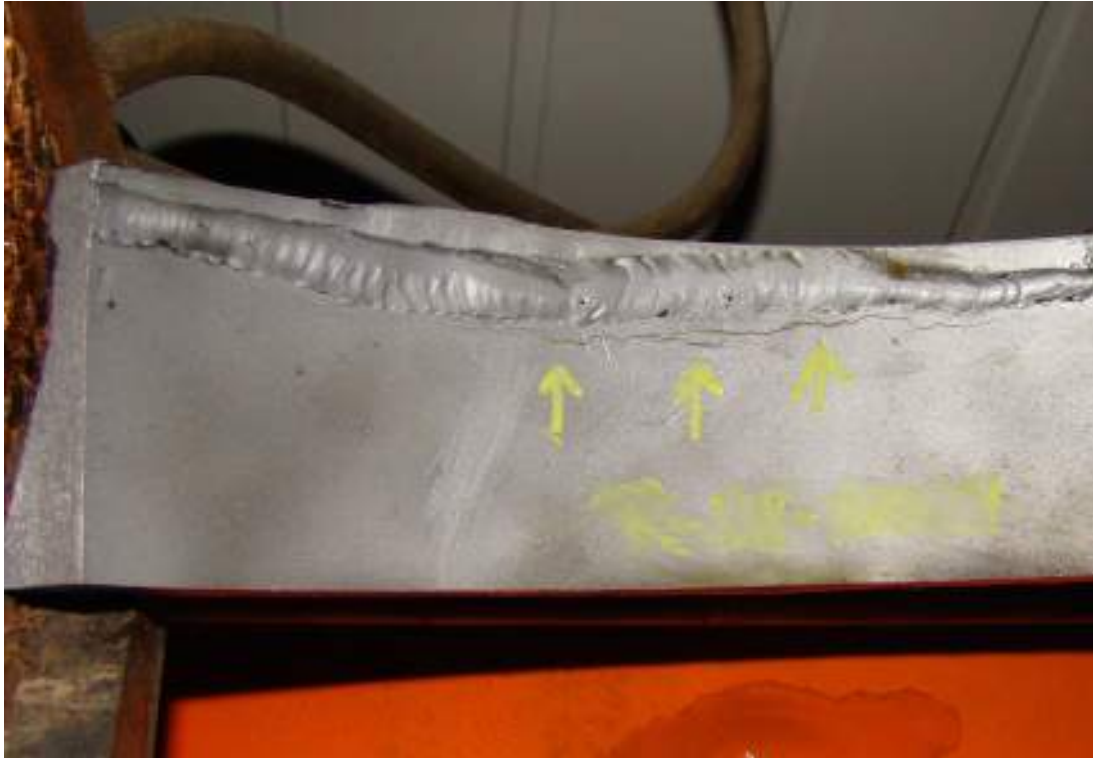
**Figure 5-46 – Overhead interstage knockout drum vapor outlet nozzle.**

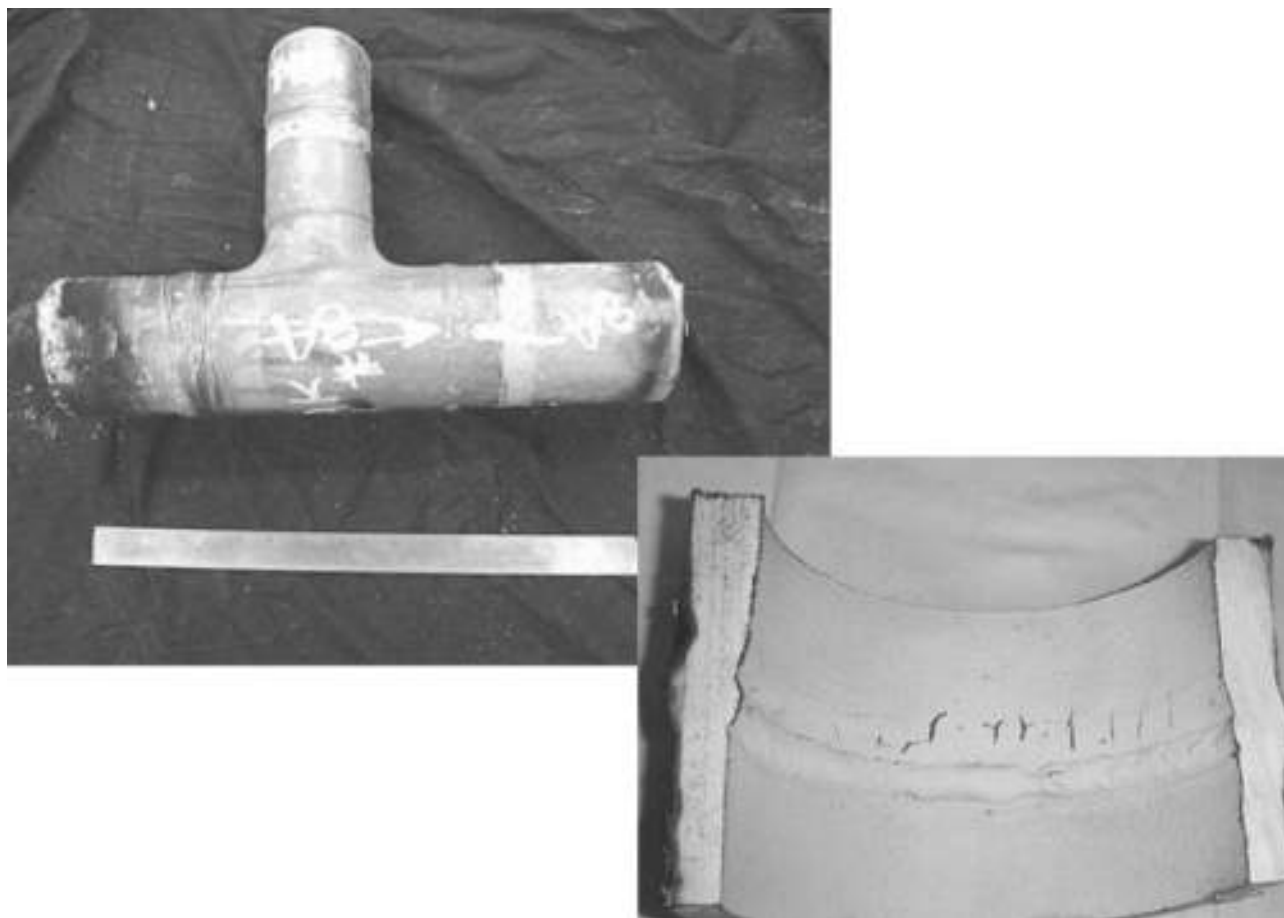
**Figure 5-55 – A 3 in x 4 in (76 mm x 100 mm) diameter tee in a hydrocarbon line off a water knockout pot in the FCC light ends recovery section. Cracking developed after 6 months service.**

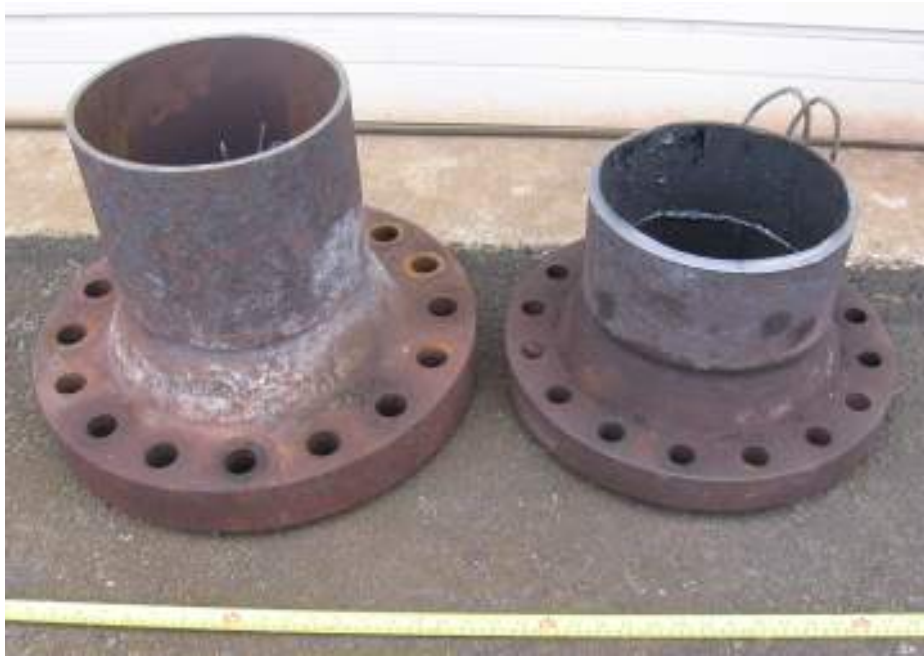
**Figure 5-57 – A pair of 10 inch Carbon-0.5Mo flanged pipe sections (SA335-P1 & SA234-WP1) from a hot bypass line in a catalytic reformer that was designed to remain closed but operated partially or fully open for unknown lengths of time. They were in service for ~34 years at temperatures up to 960°F (516°C) and a hydrogen partial pressure of 198 psig (1.37 MPa).**

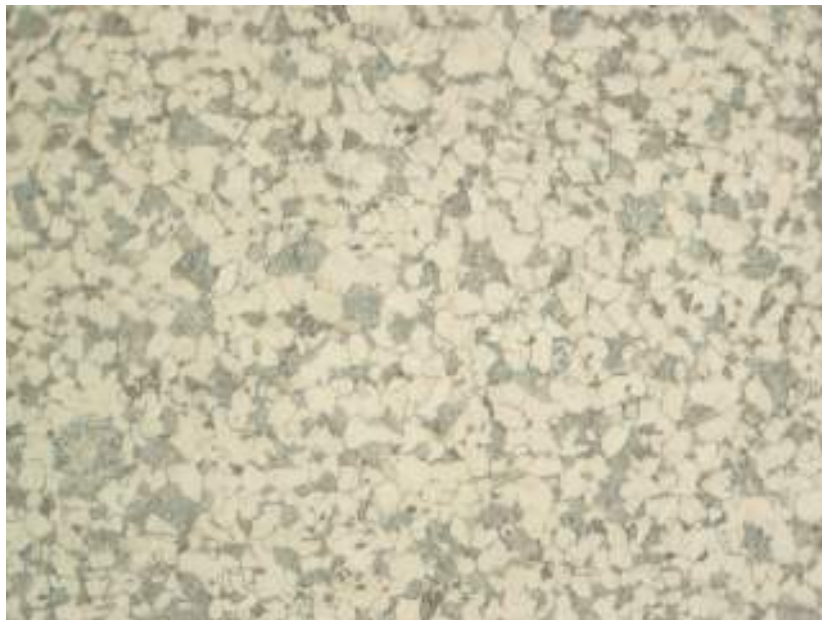
**Figure 5-58 – A photomicrograph of the outside surface of a pipe section, shown in the previous figure, exhibits a normal ferritic-pearlitic structure. Mag. 200X**

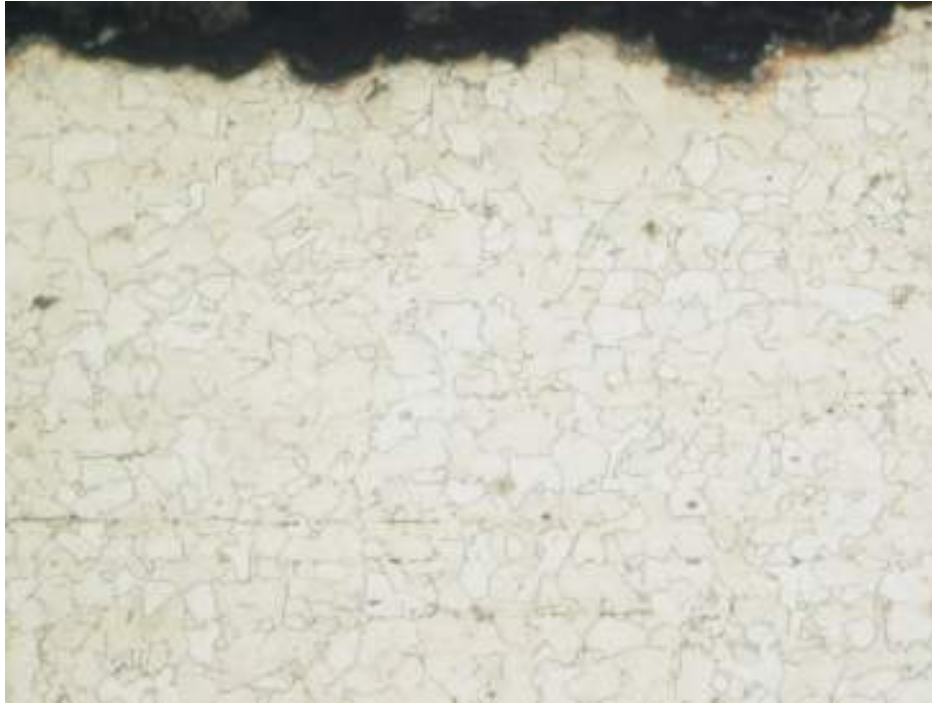
**Figure 5-59 – A photomicrograph at the pipe ID surface exhibiting of the pipe shown in the previous pictures, exhibiting complete decarburization of the original structure. Mag. 200X**

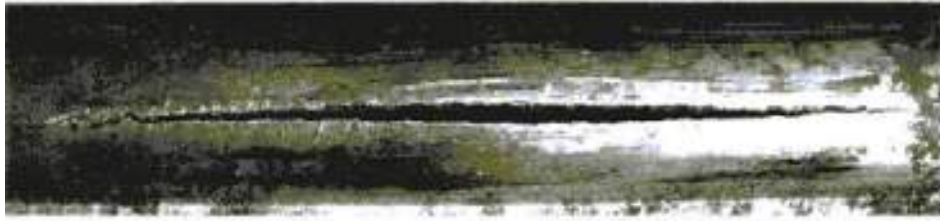
**Figure 5-62 – Titanium heat exchanger tube that failed from hydriding in a sour water cooler. The cooling medium is sea water.**

- a) Titanium hydriding is a metallurgical change that is not readily apparent, and can only be confirmed through metallurgical techniques ([Figure 5-62](#), [Figure 5-63](#) and [Figure 5-64](#)) or mechanical testing.
