# CORROSION FAILURES

**THEORY, CASE STUDIES,  
AND SOLUTIONS**

**K. ELAYAPERUMAL  
V. S. RAJA**

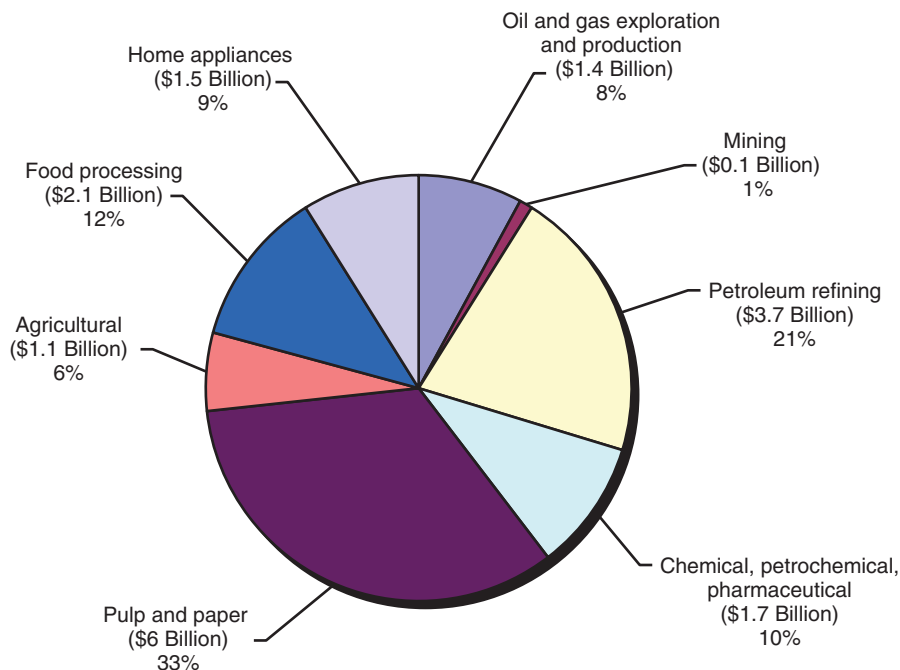
**Figure 1.1** Annual cost of corrosion in the production and manufacturing category in US (\$17.6 Billion). Koch et al. (2002) (courtesy Federal Highway Administration, USA.)

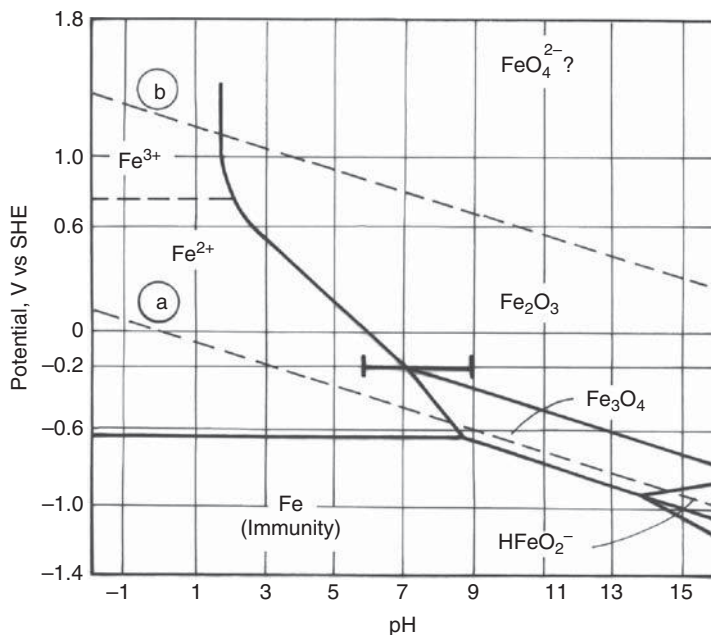
**Figure 2.3** Potential-pH diagram (Pourbaix) for iron in water at 25 °C (77 °F). A decrease in pH from 9 to 6 at potential of  $-0.2$  V, which shifts iron from a region of stability to one of active corrosion, is indicated by the solid bar (Pourbaix 1966) (Courtesy CEBELCOR).

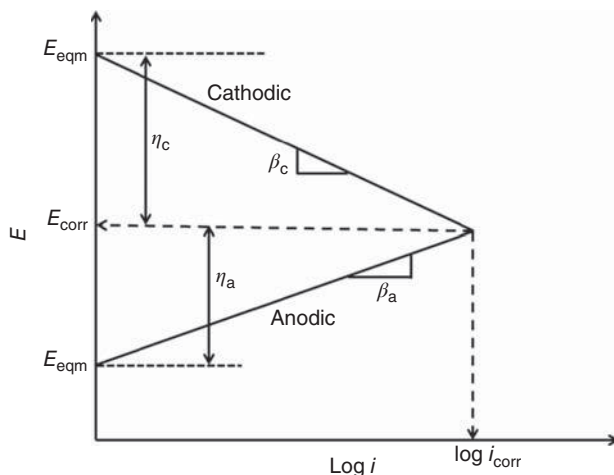
**Figure 2.6** Evans diagram illustrates various kinetic parameters that control corrosion rates.

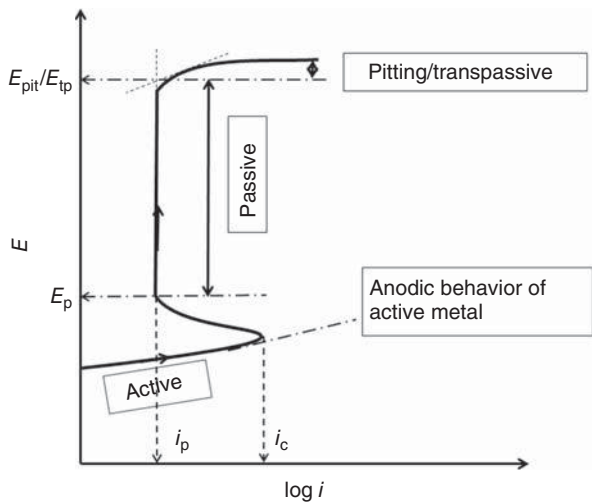
**Figure 2.7** Schematic of anodic polarization of a metal exhibiting active-passive-transpassive (pitting) regions. See the text for the parameters shown in the diagram.

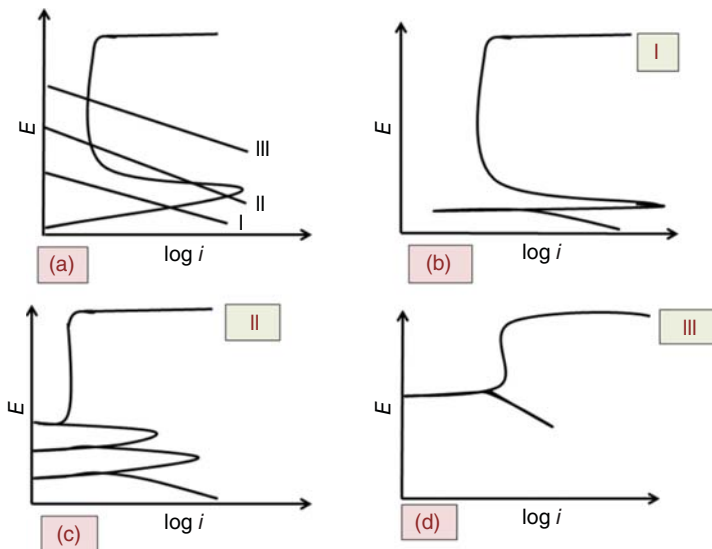
**Figure 2.8** (a) Types of cathodic reaction and the resultant polarization curves. Figures (b), (c), and (d) are polarization curves, respectively, for Types I, II, and III cathodic reactions.

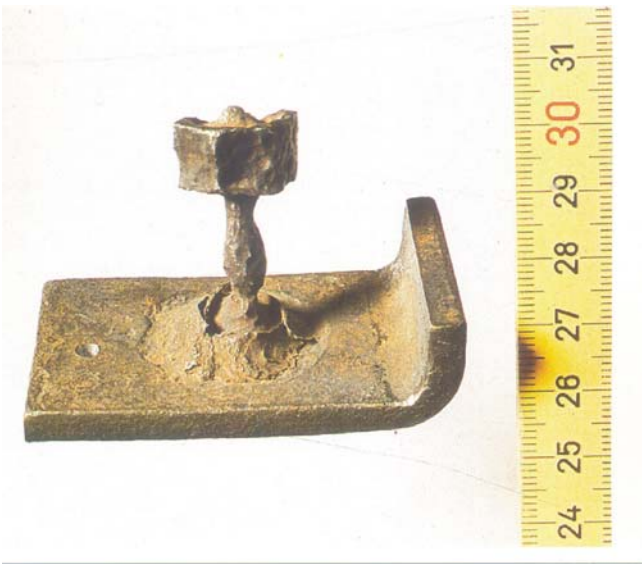
**Figure 3.1** Galvanic corrosion attack of carbon steel bolt in contact with 12% Cr steel (AISI 410) stainless steel plate in hydrocarbons contaminated with traces of salts. This is ray lamp of a distillation column. (Source: During (1988). Reproduced with permission of Elsevier.).

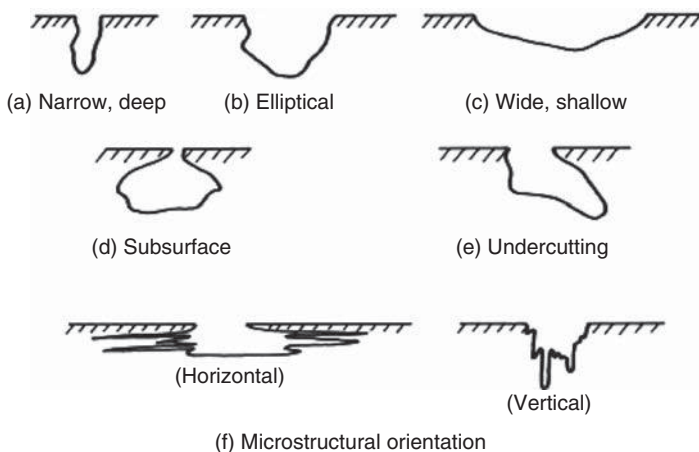
**Figure 3.4** Possible variations in the pit morphology, seen through sample cross-section, are shown. (Reprinted with permission from ASTM G46. Copyright ASTM International, 100 Barr Harbor Drive, West Conshohocken, PA 19428.)

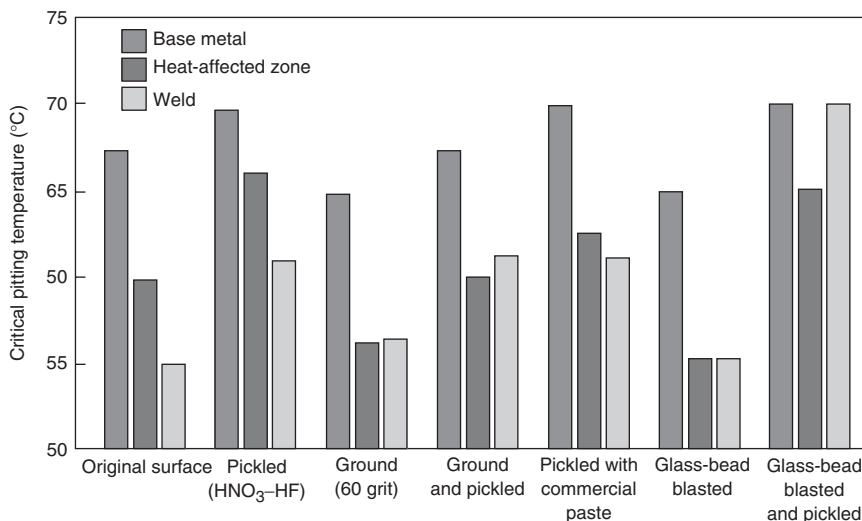
**Figure 3.5** Role of the surface condition on pitting is exemplified in this diagram. Pickling of stainless steel increases the critical pitting temperature in FeCl<sub>3</sub> in the base metal, heat-affected zone, and welds areas. Mechanical cleaning treatments that are performed without a subsequent pickling treatment decrease the critical pitting temperature. (Reprinted with permission of ASM International. All rights reserved [www.asminternational.org](http://www.asminternational.org).)

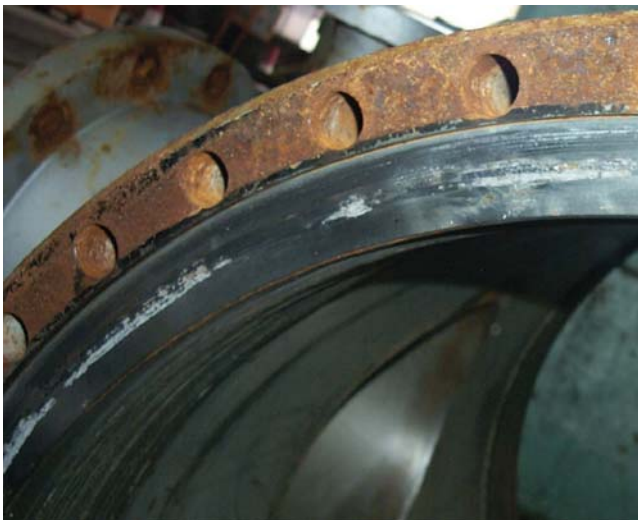
**Figure 3.6** Photograph of a part of heat-exchanger sheet affected by crevice corrosion. The carbon steel shell was weld-cladded with SAF 2507 alloy. Note, only the gasket area of the shell suffered from attack; shell side was exposed to seawater. (Source: Raja (2008). Reproduced with permission of Narosa Publishing House.)

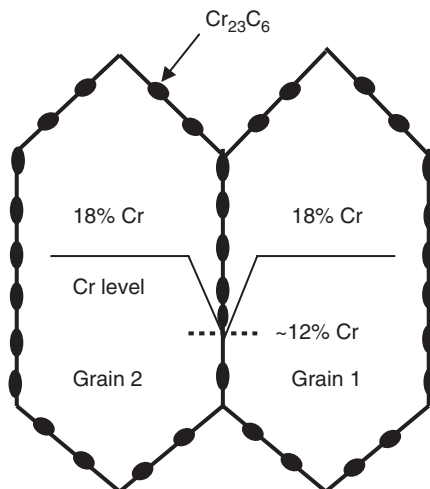
**Figure 3.7** Schematic diagram showing  $\text{Cr}_{23}\text{C}_6$  precipitations and chromium depletion at grain boundaries.

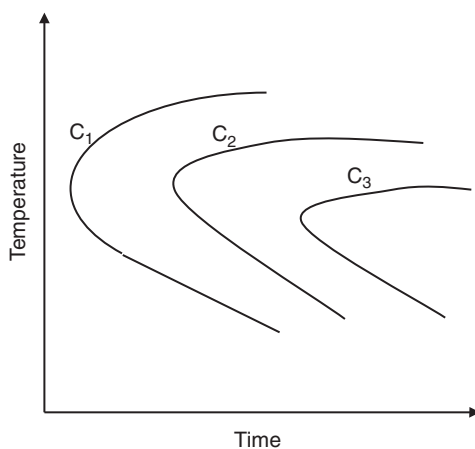
**Figure 3.9** Schematic of Time–temperature–sensitization diagram showing shift in the nose of the curves towards right with decreasing carbon content. The carbon content decreases in the order  $C_1 > C_2 > C_3$ .

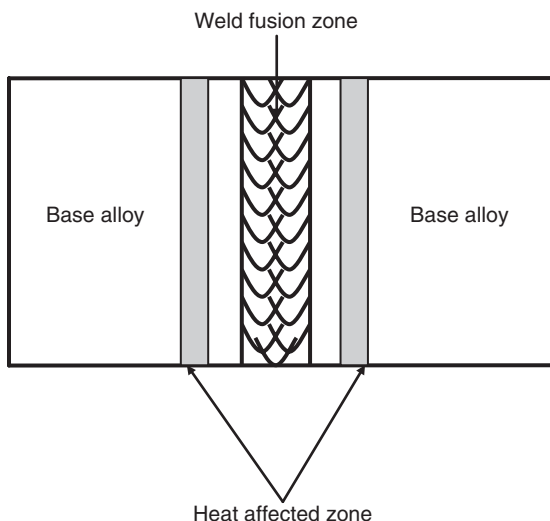
**Figure 3.10** Schematic of weldment showing weld-fusion zone, heat-affected zone, and base alloy. The long strip region of the base alloy located away on both the sides of the weld fusion zone, as well as lying parallel to it, suffers IGC.

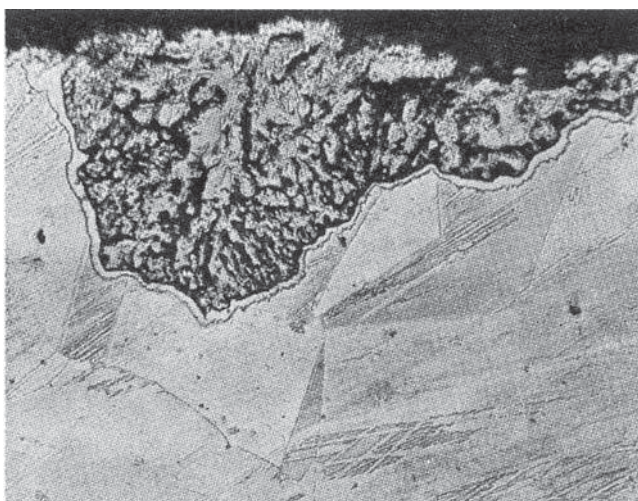
**Figure 3.11** Etched cross-section through dezincification plug (Source: Verink and Heidersbach (1972). Reprinted with permission from STP 516- Localised Corrosion- Cause for Metal Failure Copyright ASTM International.).

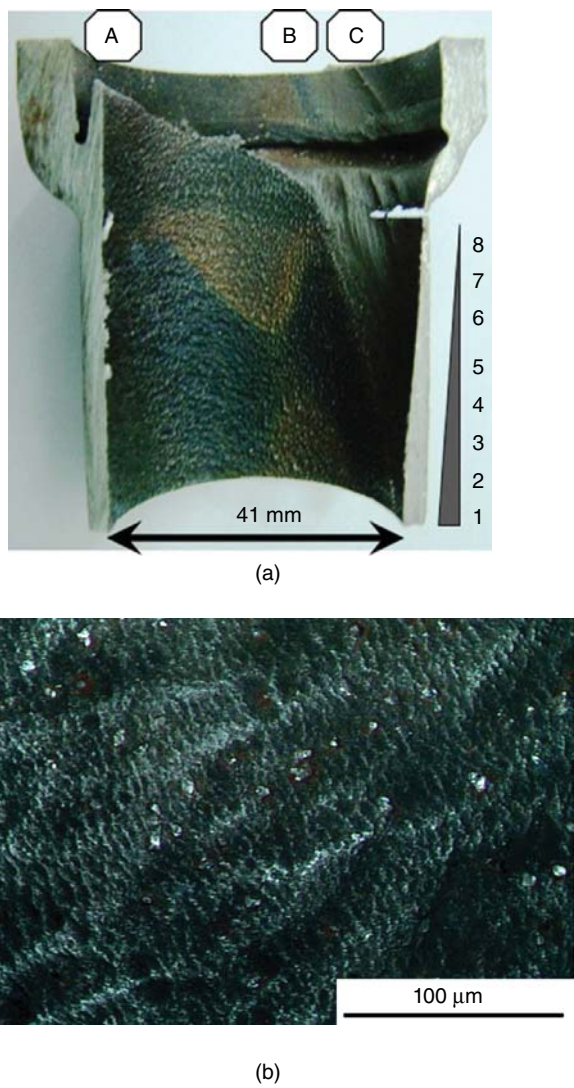
**Figure 3.13** (a) Heavy thickness reduction near the socket weld (at location 8) and lower thickness reduction as seen at a distance 40 mm away from the socket weld (location 1) due to flow-induced corrosion is shown. (b) Characteristic features (Tiger Strips) of flow-induced corrosion seen at high magnification is shown (Source: Kain et al.(2011). Reprinted with permission from Elsevier.).

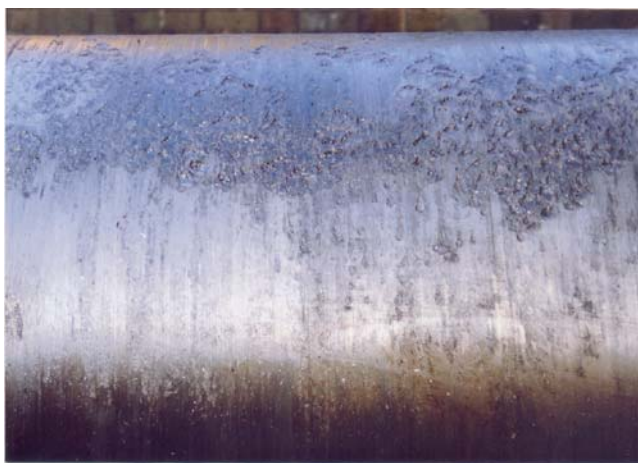
**Figure 3.15** Cavitation damage appearing as bright pits on a damaged propeller shaft of a ship. The alloy is beta brass.

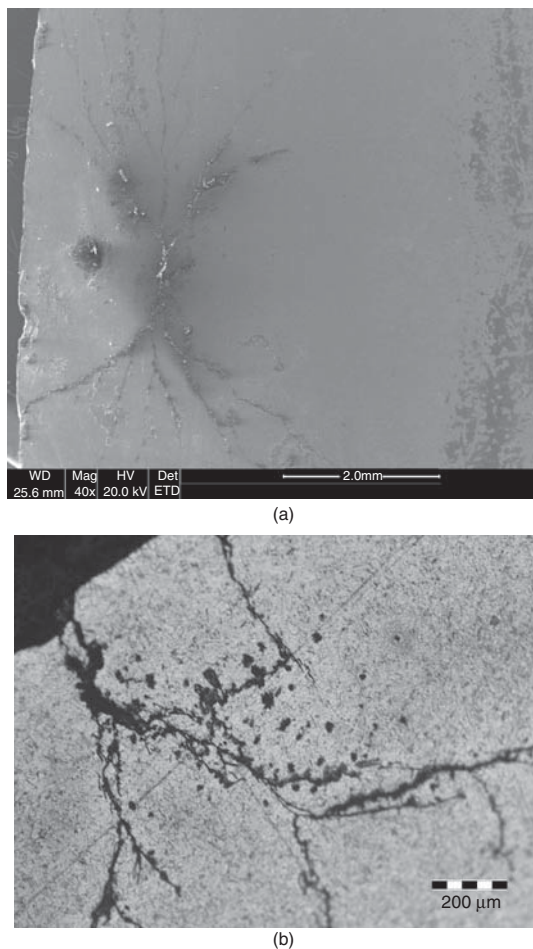
**Figure 3.16** (a) Stress corrosion cracks of type 304 L SS tube of a high-pressure heater of a boiler of a thermal power plant. The cracking occurred under a deposit. Note the SS tube was free from any corrosion except on the cracked region. (b) The cross-sectional image of the cracked area of the tube showed branching cracks, typical of stress corrosion cracking. (Source: Raja (2008). Reproduced with permission of Narosa Publishing House.).

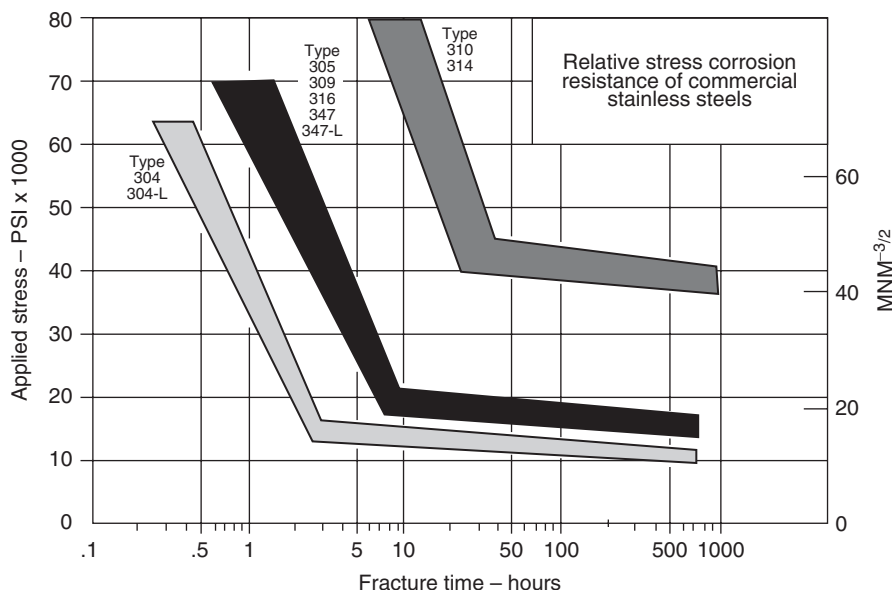
**Figure 3.18** Composite curves illustrating the relative stress corrosion cracking resistance for commercial stainless steels in boiling magnesium chloride. (© NACE International 1960.)

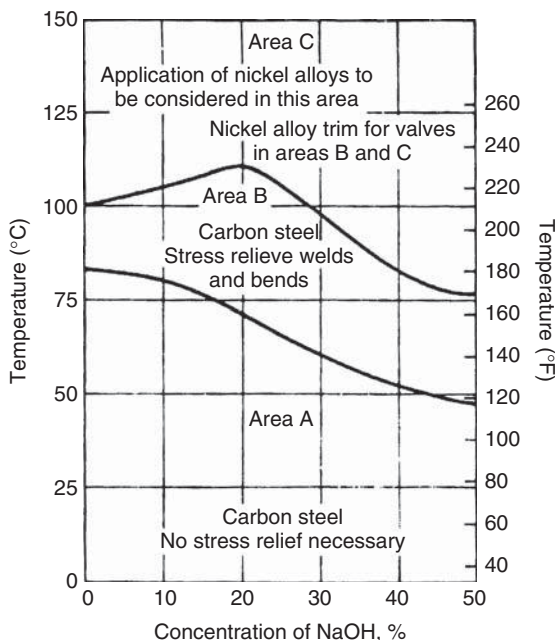
**Figure 3.19** Carbon steels: Temperature and concentration limits for stress-corrosion cracking in NaOH. (© NACE International 1974.)

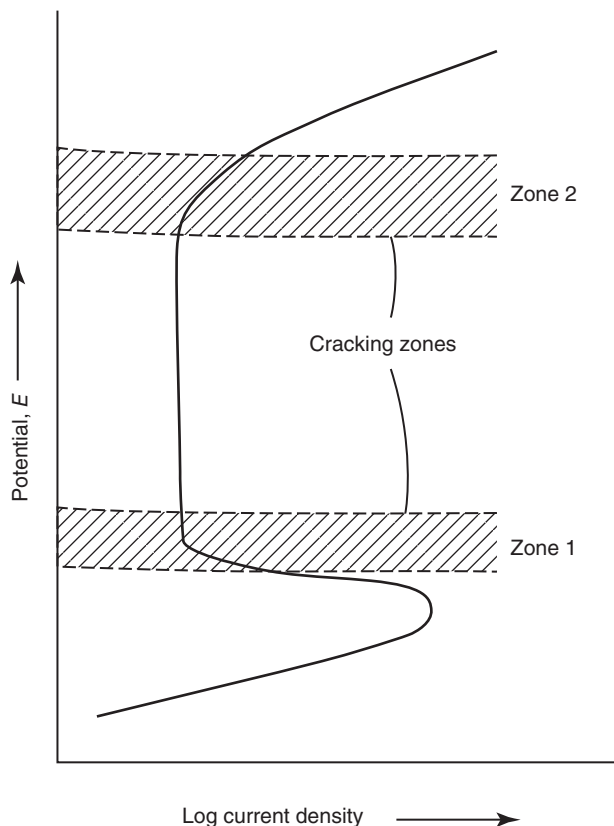
**Figure 3.20** Stress corrosion cracking susceptible areas with respect to anodic polarization curve exhibiting active-passive-transpassive transition.

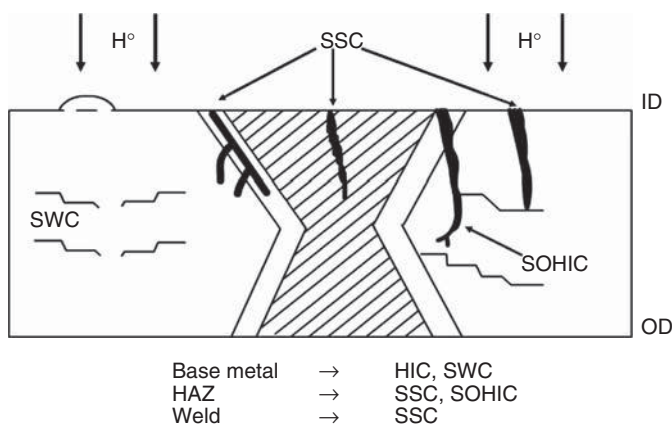
**Figure 3.21** Forms of hydrogen damage in  $H_2S$  service. See the text for the explanations of the abbreviations. (Source: Elboudjaini (2011). Reprinted with permission from John Wiley & Sons, Inc.)

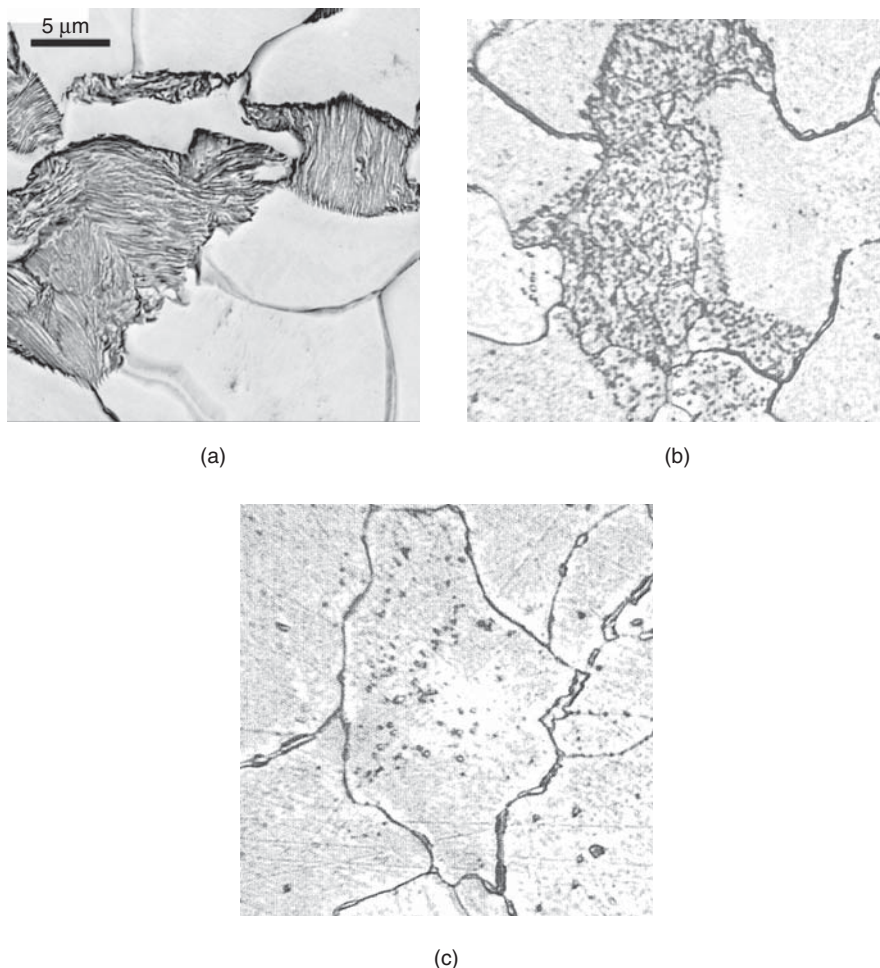
**Figure 3.23** Shows micrographs of 0.1C-1.1Cr-0.26Mo-0.17V steel that suffered severe high temperature hydrogen attack. (a) unexposed and depletion of carbides after (b) 110, 000 and (c) 190,000 h of exposure to steam conditions (Courtesy: Hryhorii Nykyforchyn).

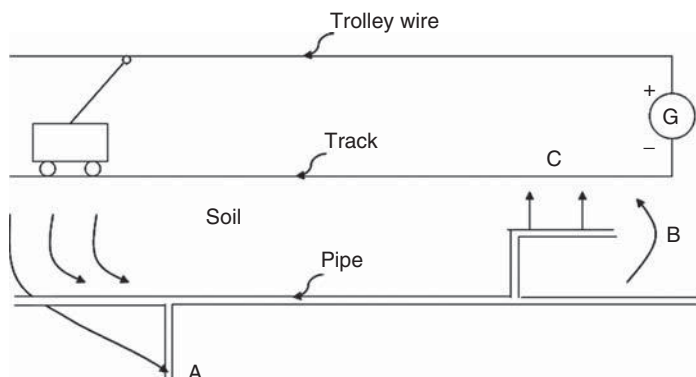
**Figure 3.24** Stray-current corrosion of buried pipe (Source: Revie W and Uhlig (2008). Reprinted with permission of Wiley.).

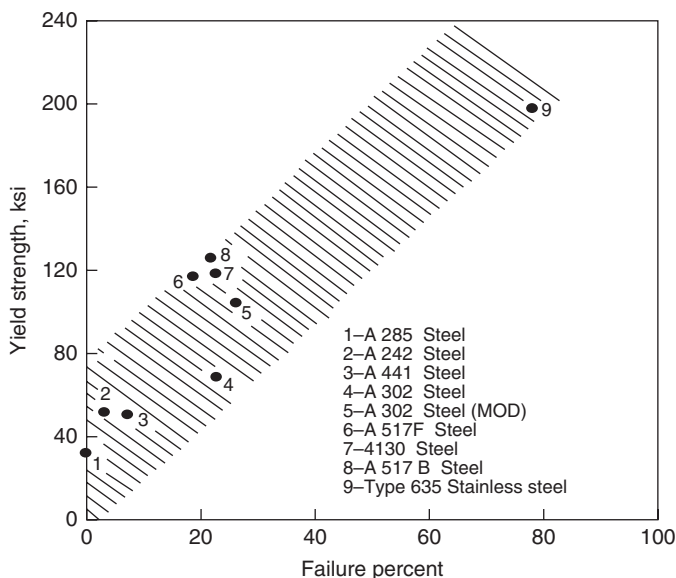
**Figure 4.1** Relation of fracture frequency to yield strength (© NACE International 1969).

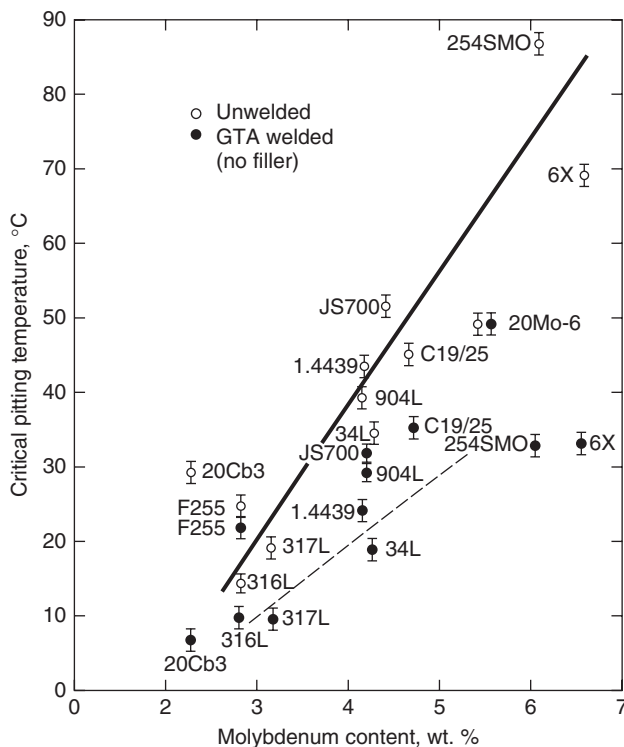
**Figure 4.2** Variation of the critical pitting temperature (determined from ferric chloride solution) with the molybdenum content of various stainless steels. (Source: Garner 1985, Welding Journal, Vol 62, No. 1.)

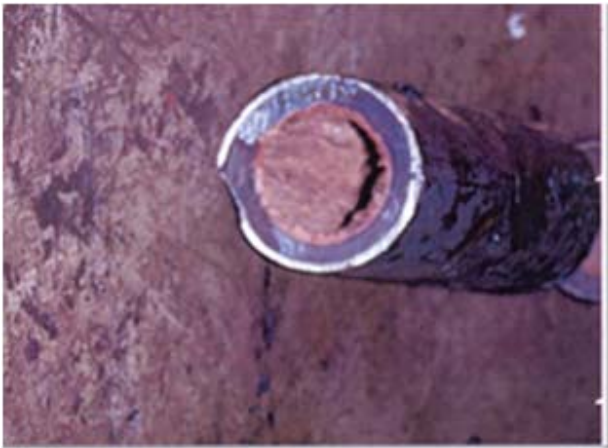
**Case 1**    Heavy corrosion and scaling in Monel-400 bromine preheater.  
(Courtesy: Elayaperumal, in “Corrosion Failures in Process Industries in India: Statistical Analysis and Case Studies” in Special Supplement 2009, Corrosion Reviews Special Issue: India, England: Freund Publications, 2009, p 51, case study 1.)

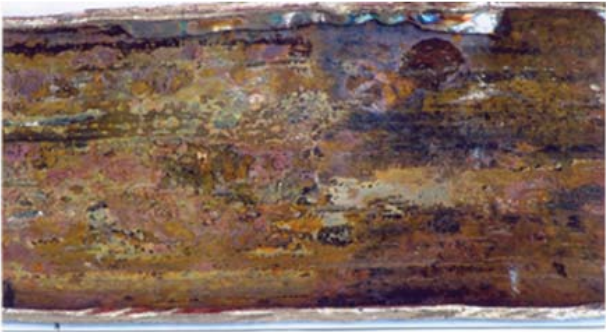
| CASE STUDY 3    Sea Water Cooler Tubes in an Oil Refinery | |
|---|---|
| <b>Case 3</b> Hot-wall effect corrosion by sea water on cupro-nickel cooler tube in an oil refinery. (Courtesy: Elayaperumal, in “Corrosion Failures in Process Industries in India: Statistical Analysis and Case Studies” in Special Supplement 2009, Corrosion Reviews Special Issue: India, England: Freund Publications, 2009, p 52, case study 3.) | |

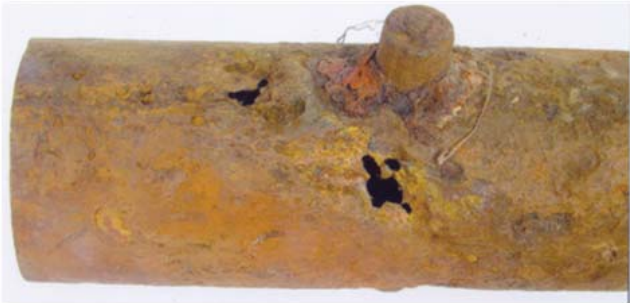
| CASE STUDY 4    Package Boiler Tube in an Organic Chemical Plant | |
|---|---|
| <p><b>Case 4</b>    Corrosion by fuel-ash deposit in a package boiler tube.<br/>(Courtesy: Elayaperumal, in “Corrosion Failures in Process Industries in India: Statistical Analysis and Case Studies” in Special Supplement 2009, Corrosion Reviews Special Issue: India, England: Freund Publications, 2009, p 53, case study 4.)</p> | |

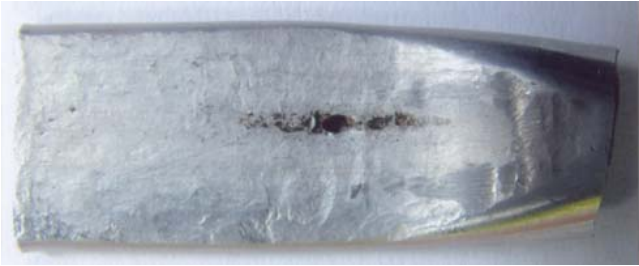
| <b>Case 6</b> Crevice corrosion in an off-shore platform stainless steel instrumentation tube.<br>(Courtesy: Elayaperumal, in “Corrosion Failures in Process Industries in India: Statistical Analysis and Case Studies” in Special Supplement 2009, Corrosion Reviews Special Issue: India, England: Freund Publications, 2009, p 55, case study 6.) | |

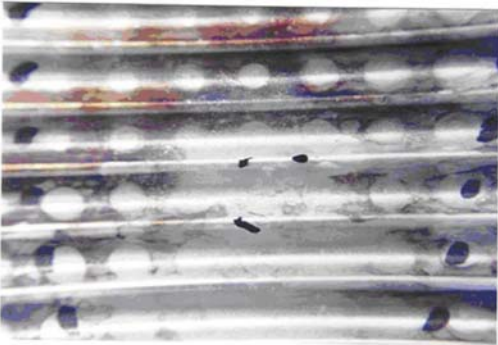
| <p><b>Case 7</b>    Microbial corrosion on Hastelloy C-276 plate- type heat exchanger/cooler (PHE) element in a sulfuric acid plant.</p> <p>(Courtesy: Elayaperumal, in “Corrosion Failures in Process Industries in India: Statistical Analysis and Case Studies” in Special Supplement 2009, Corrosion Reviews Special Issue: India, England: Freund Publications, 2009, p 57, case study 7.)</p> | |

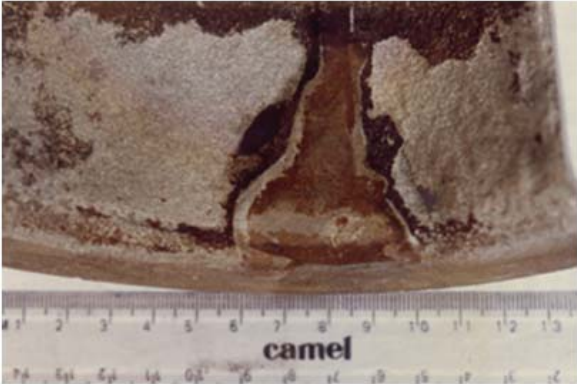
| <p><b>Case 8</b>    Galvanic corrosion on parent metal 304 stainless steel in contact with weld metal 316 stainless steel in an organic chemical plant.<br/>(Courtesy: Elayaperumal, in “Corrosion Failures in Process Industries in India: Statistical Analysis and Case Studies” in Special Supplement 2009, Corrosion Reviews Special Issue: India, England: Freund Publications, 2009, p 57, case study 8.)</p> | |

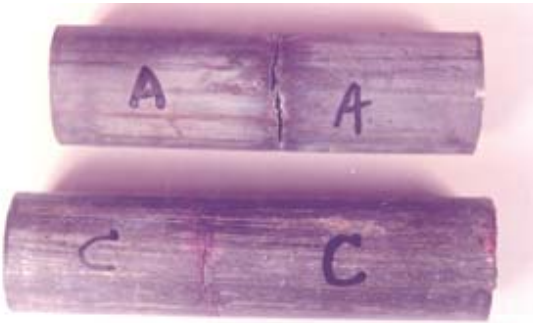
| <p><b>Case 9</b>    Caustic stress corrosion cracking in stainless steel digester pre-heater in a pulp and paper plant.</p> <p>(Courtesy: Elayaperumal, in “Corrosion Failures in Process Industries in India: Statistical Analysis and Case Studies” in Special Supplement 2009, Corrosion Reviews Special Issue: India, England: Freund Publications, 2009, p 58, case study 9.)</p> | |

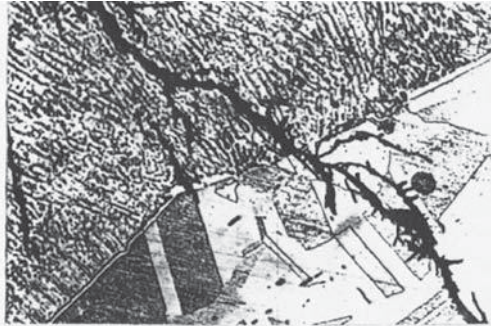
| <p><b>Case 10</b> Transgranular stress corrosion cracking by polythionic acid in a stainless steel esterification column in an organic chemical plant, microstructure across weld and parent metal, (200X).</p> <p>(Courtesy: Elayaperumal, in “Corrosion Failures in Process Industries in India: Statistical Analysis and Case Studies” in Special Supplement 2009, Corrosion Reviews Special Issue: India, England: Freund Publications, 2009, p 59, case study 10.)</p> | |

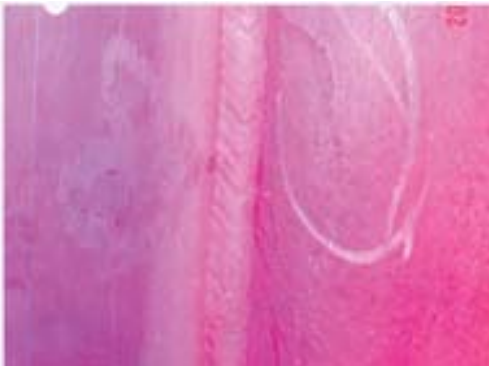
| <b>Case 11</b> Corrosion under insulation. Stress corrosion cracking of stainless steel half pipe limpet coil of a stirred reactor in an organic chemical plant.<br>(Courtesy: Elayaperumal, in “Corrosion Failures in Process Industries in India: Statistical Analysis and Case Studies” in Special Supplement 2009, Corrosion Reviews Special Issue: India, England: Freund Publications, 2009, p 60, case study 11.) | |

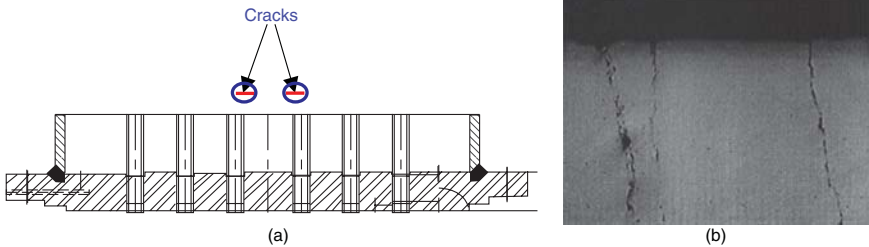
**Case 13** (a) Longitudinal sketch of the bottom portion of tubes and bottom tube-sheet showing the location of the circumferential cracks in alcohol vapor super-heater. (b) Microstructure of the longitudinal cross section of the inside surface of a failed tube of the alcohol vapor super heater showing multiple cracks initiating on localized pits, (50X).

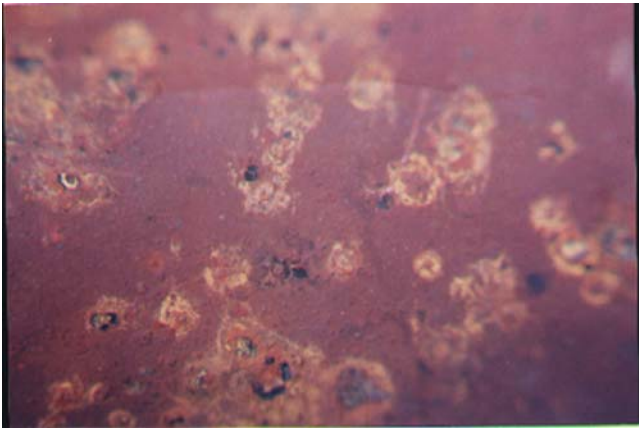
| <b>Case 14</b> Close-up view of the pits on the outside surface of one of the affected package boiler tubes. | |

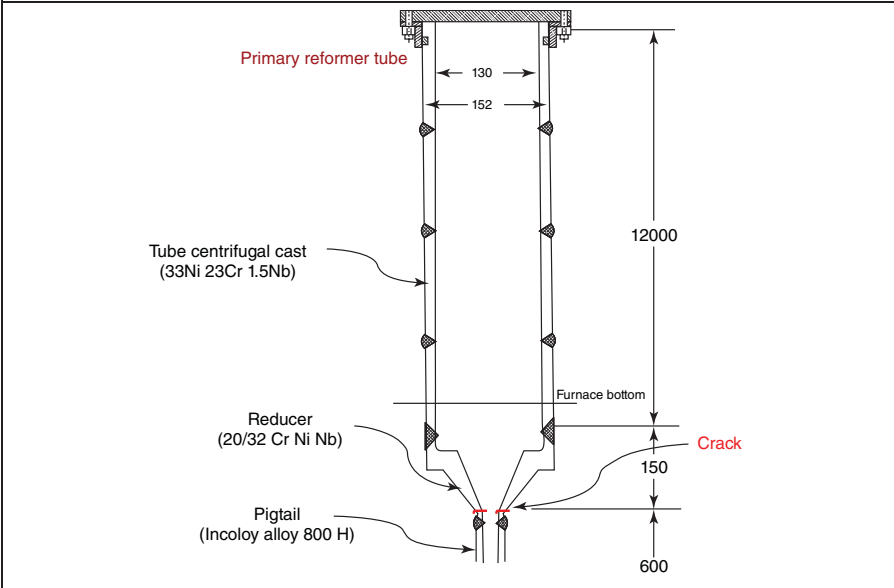
**Case 15**   Cross section of a reformer tube showing crack at the reducer at the bottom.

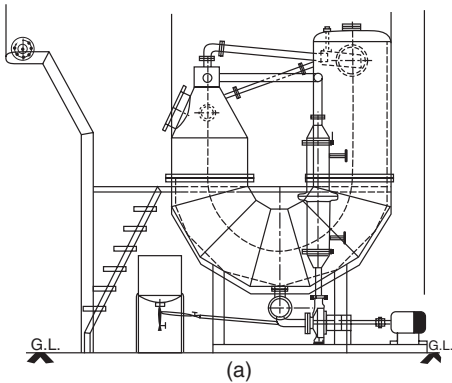
**Case 27**    (a) Elevation drawing of the U shape jet dyeing machine. (b) Localized sharp pitting corrosion marks on the inside surface of the perforated basket of jet dyeing machine.

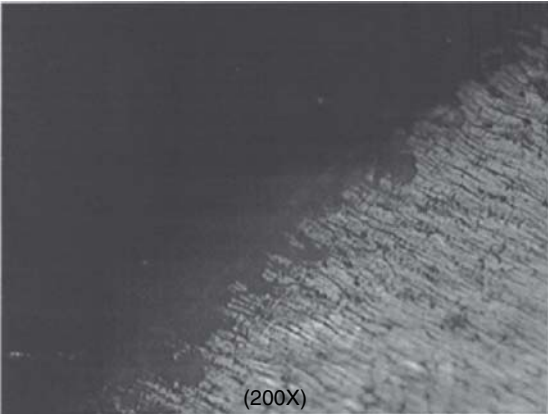
| CASE STUDY 29    Large Stainless Steel Pipeline in a Urea Plant of a Fertilizer Unit | |
|---|---|
| <div><div></div><div></div><div><div>(a)</div><div>(b)</div></div></div> <div><p><b>Case 29</b>    (a) The burst 316L SS welded pipe on location. (b) Optical micrograph of the longitudinal cross section across the split surface of the pipe showing crevice corrosion (200X).</p></div> | |
| SERVICE | 14'' NB 8.00 mm thick stainless steel pipeline transporting off-gas solution containing ammonia, carbon-dioxide, and ammonium carbamate at a pressure of 18 atm and at a temperature of 150°C |

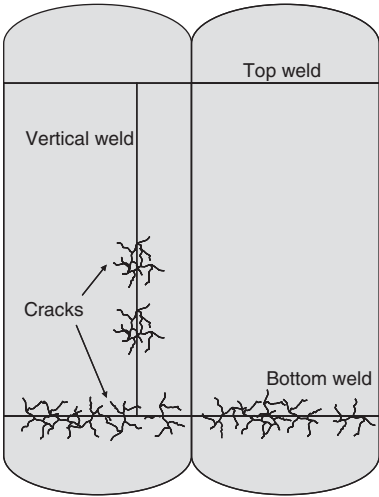
| CASE STUDY 33    Salt Evaporator | |
|---|---|
| Case 33 | (a) Sketch of the inside surface of the evaporator showing location of stress corrosion cracking in and around vertical and horizontal weld joints. (b) Photograph of a typical cluster of stress corrosion cracks around weld line on the inside surface. |

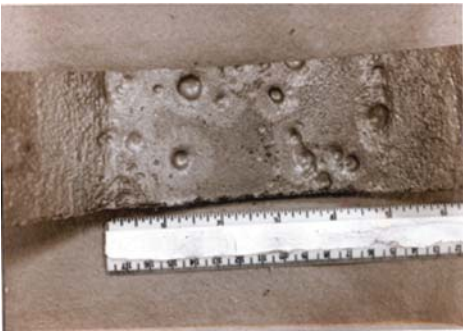
| CASE STUDY 38 Exhaust Gas Boiler in a Sugar Mill | |
|---|---|
| <div></div> <p><b>Case 38</b> Pitting corrosion due to dissolved oxygen in carbon steel boiler tube.</p> | |
| SERVICE | Waste heat boiler. Fuel: exhaust gas from burning of bagasse of a sugar mill along the outside surface of the tubes |

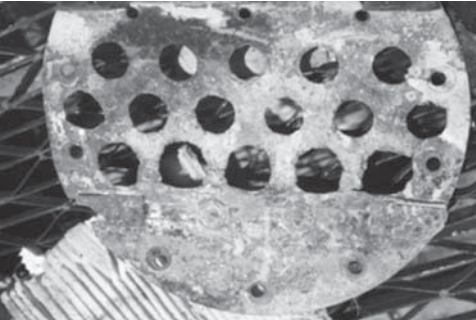
| CASE STUDY 44 Petrochemical Plant. Phosgene Absorption Column Internals | |
|---|---|
| SERVICE | Valve tray contact between gas mixture (phosgene + HCl) entering at the bottom with organic solvent coming from the top. Pressure 1.7 kg/cm <sup>2</sup> g, Temperatures: −8.0°C at the bottom and 35–40°C at the top |

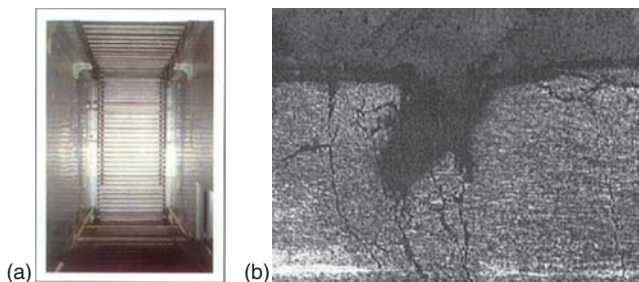
**Case 48** (a) Stainless steel inside surface of the loop steamer machine. (b) Pitting corrosion and stress corrosion cracking by chloride initiated on the inside surface of stainless steel chamber.

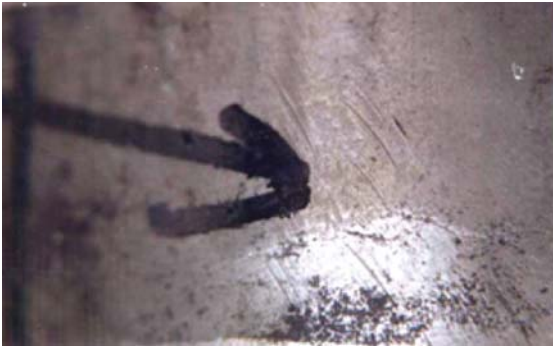
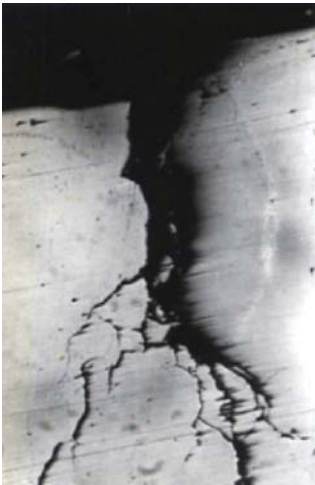
| CASE STUDY 61 Oil Refinery: 12 Inch Dia. Overhead Pipeline | |
|---|---|
| <div></div> <div></div> <div>(a) (b)</div> <p><b>Case 61</b> (a) Cracks as seen on the external, outside, surface of overhead pipeline of 304SS in an oil refinery. (b) External stress corrosion cracking (ESCC) due to chloride corrosion under insulation (CUI) on 304 SS pipe in an oil refinery 500X.</p> | |
| SERVICE | 12" NB 40 Sch. Pipe (4.36 mm WT). Pipeline from regenerator to overhead condenser transferring H <sub>2</sub> S-rich acid gas (80% H <sub>2</sub> S) at a pressure of 1 kg/cm <sup>2</sup> and at a temperature of 110°C |

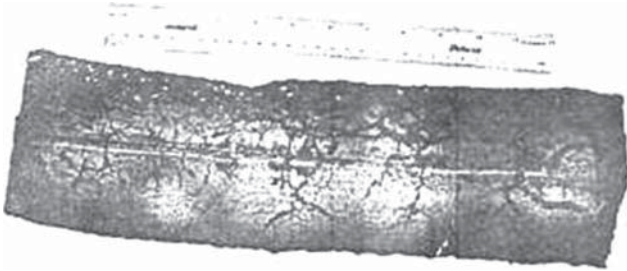
| <b>Case 70</b> Cracks as seen on the outside surface of \ pipeline along and across the weld line. | |

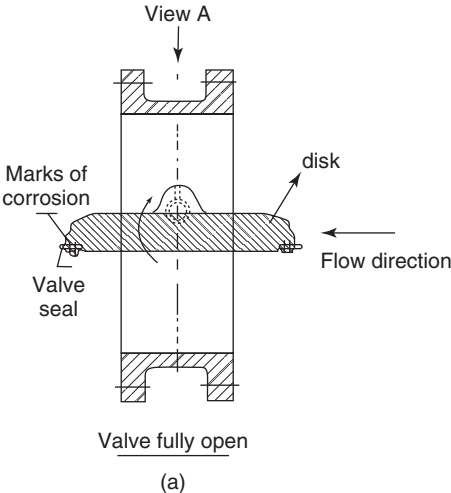
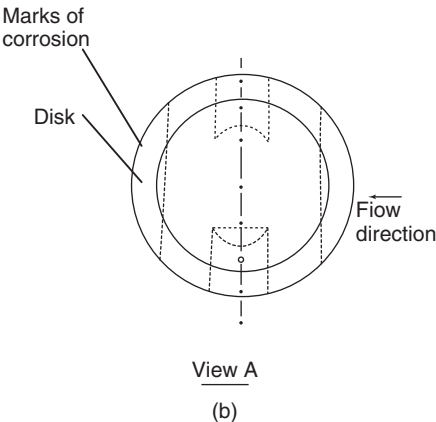
| CASE STUDY 72 Thermal Power Plant. Condenser Cooling Sea Water In-take Line. Butter Fly Valve | |
|---|---|
| <div><div><p>View A</p><p>Marks of corrosion</p><p>Valve seal</p><p>disk</p><p>Flow direction</p><p>Valve fully open</p><p>(a)</p></div><div><p>Marks of corrosion</p><p>Disk</p><p>Flow direction</p><p>View A</p><p>(b)</p></div></div> <p><b>Case 72</b> (a) Sketch of the condenser inlet valve. Longitudinal section with valve fully open. (b) Sketch of the cross section of the valve disc indicating the damage locations.</p> | |
| SERVICE | 2200 mm diameter butter fly valve in sea water in-take line |

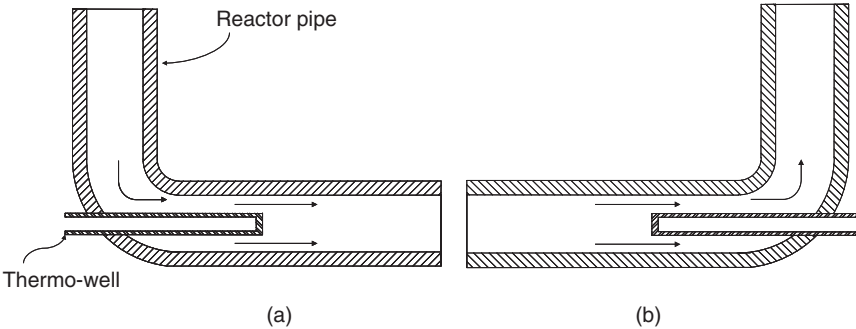
| CASE STUDY 76    Organic Chemicals Plant. Thermowells | |
|---|---|
| <div></div> <p><b>Case 76</b> (a) Sketch of the orientation of un-affected thermo-well with respect to flow of process fluid. (b) Sketch of the orientation of affected thermo-well with respect to flow of process fluid.</p> | |
| SERVICE | Thermowells inserted horizontally into a coiled reactor of several turns processing organic chlorides |

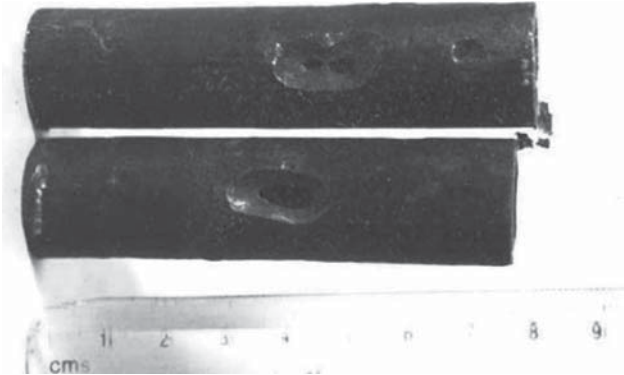
| CASE STUDY 78 Oil Refinery. Sulfolane Recovery Column Reboiler | |
|---|---|
| <div></div> <p><b>Case 78</b> Corrosion under sludge by sulfuric acid on carbon steel tubes.</p> | |
| SERVICE | U tube kettle type reboiler. Shell side: sulfolane water mixture boils at about 200 to 220°C. Tube side: hot oil entering at 220°C. Hot oil enters at the bottom half of the tubes and leaves at the top half |
