## **Weld Overlay of Waterwall Tubing, Alternative Filler**

**1001268**

Technical Review, March 2001

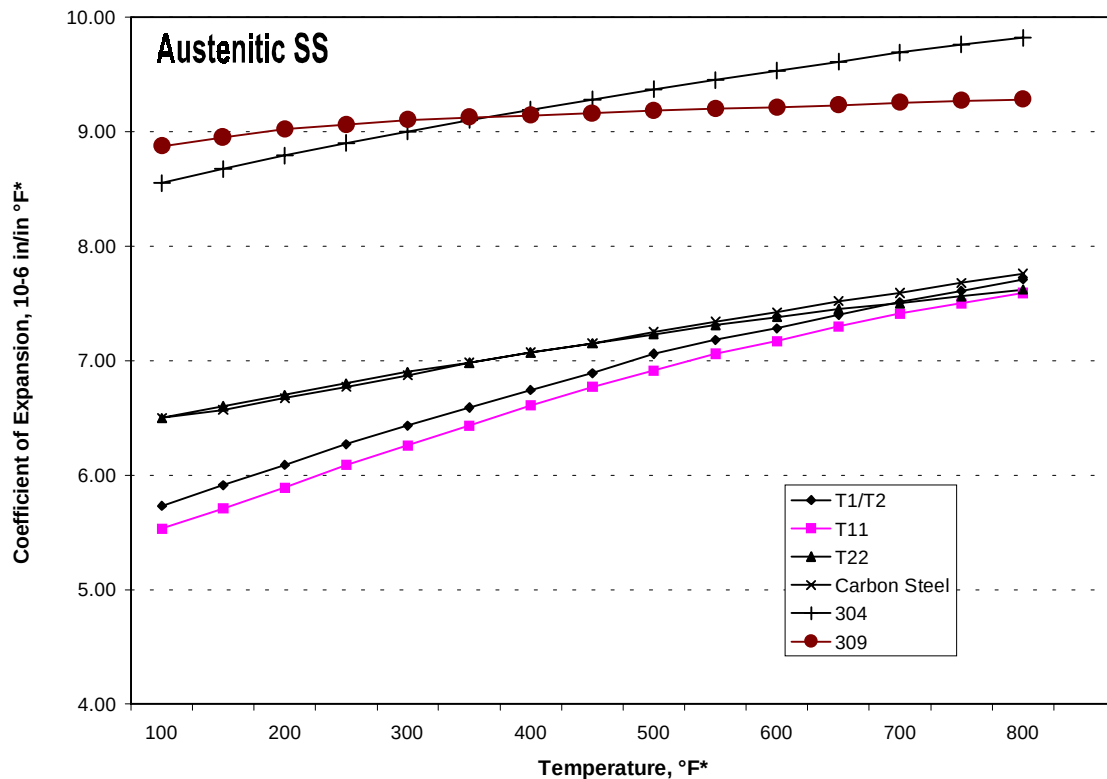
**Figure 3-1**  
**Thermal Expansion of Base Metals and 300 Series Austenitic SS from ASME Section II, Part D**  
*\* Conversion Factors — To convert inches to centimeters, multiply by 2.54. To convert Fahrenheit temperature to Celsius, subtract 32 and divide by 1.8.*

Various families (ferritic, austenitic, and duplex stainless steels) of alloys were considered solely from a thermal expansion standpoint. Several austenitic SS materials were plotted against the tubing alloys: T1/T2, T-11, T-22, and carbon steel. Two of the more common austenitic SS alloys, Types 304 and 309, are shown in Figure 3-1. As can be seen, the pure austenitic SS alloys do not match the tubing alloys very well in terms of thermal expansion characteristics. As mentioned above, it is important to note that Type 309 has seen some use as an overlay material.

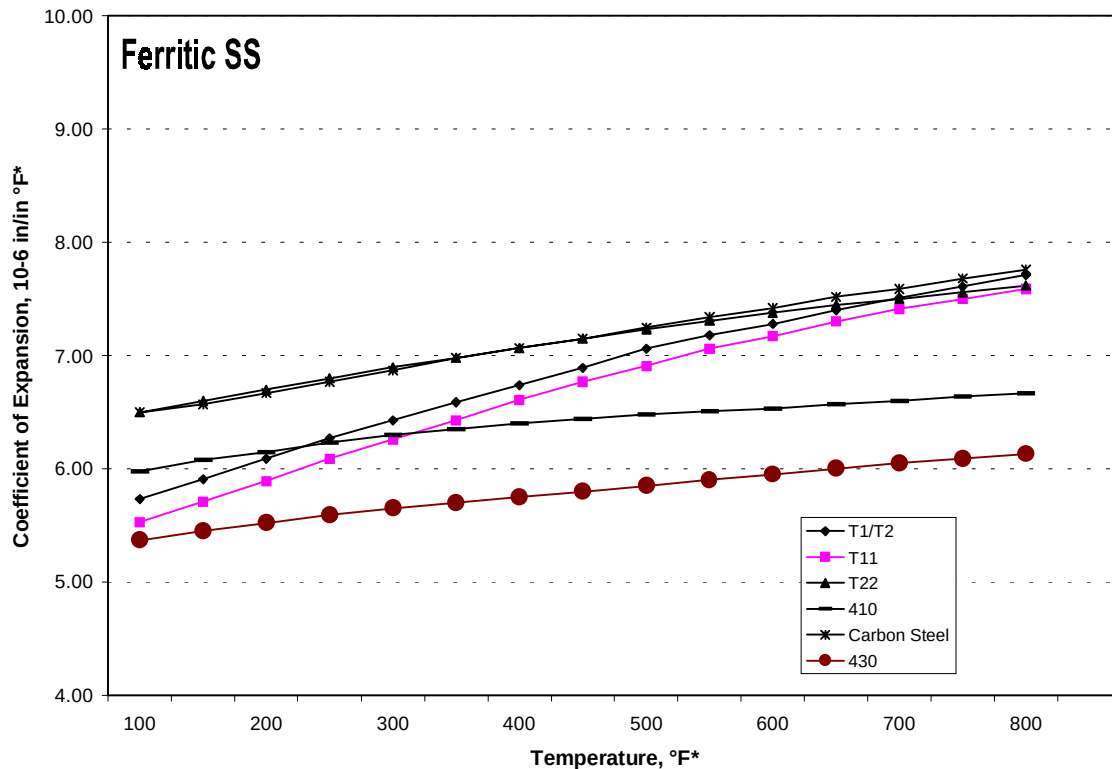
**Figure 3-2**  
**Thermal Expansion of Base Metals and 400 Series SS from ASME Section II, Part D**

Next, several ferritic SS alloys were plotted against the currently used tubing alloys. Two representative ferritic alloys are provided in Figure 3-2 for comparison. Again, as with the austenitic SS (though to a lesser degree), one can easily see that the ferritic SS alloys do not match the tubing alloys in terms of thermal expansion characteristics. Particularly at high temperatures, the ferritics tend to deviate from the tubing alloys by a rather wide margin.

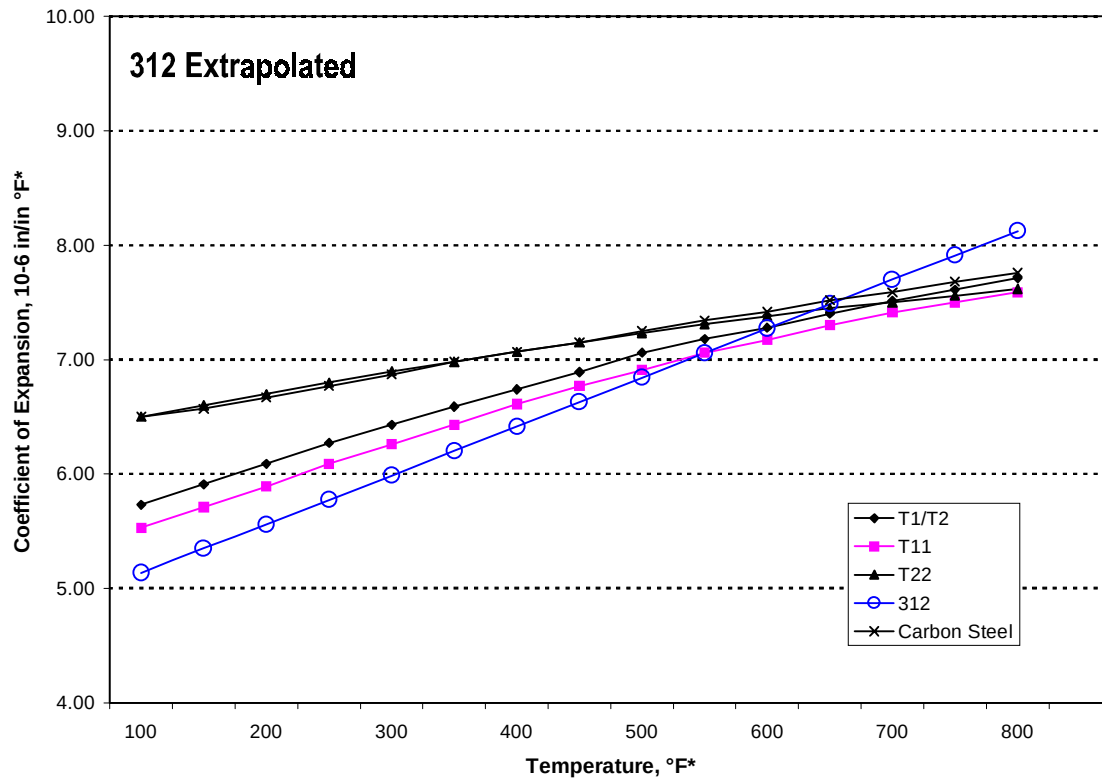
**Figure 3-3**  
**Thermal Expansion of Base Metals from ASME Section II, Part D and Type 312 SS**  
 (Type 312 SS properties were provided by Euroweld)

One of the duplex alloys that provided reasonably good thermal expansion characteristics was Type 312 SS. Only two data points for Type 312 SS were available from the filler-metal vendor. A straight-line curve was extrapolated from these two points. The alloy was then plotted versus the tubing alloys and is shown in Figure 3-3. At lower temperatures, the alloy matches the expansion characteristics of the T-11 and T-22 materials fairly well; however, it deviates from the T1/T2 and carbon steel by a sizable margin. Above 500°F (260°C) and up to 800°F (426.7°C), which is incidentally the operating temperature for waterwall panels, Type 312 SS corresponds quite well with all of the tubing materials currently used in boilers. As a result, further attention and investigation, which included actual thermal expansion testing to better define these curves, were targeted toward the Type 312 SS alloy. Discussion of the investigation is provided in the following subsections.

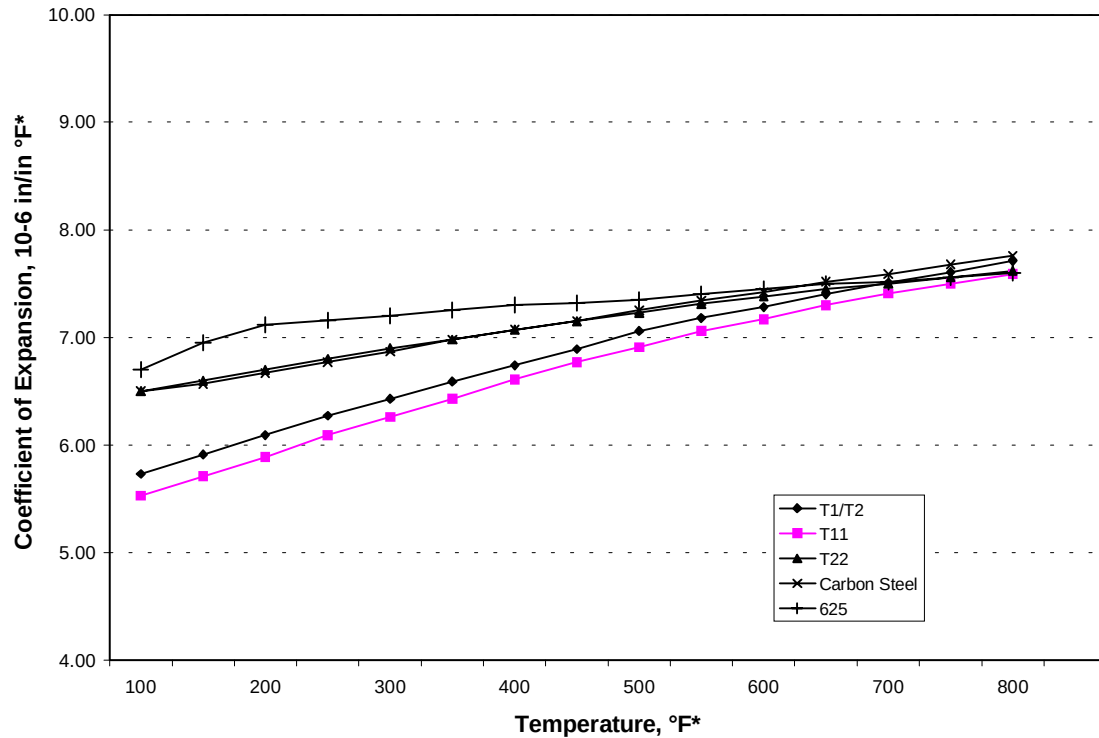
**Figure 3-4**

**Thermal Expansion of Base Metals and In 625 from ASME Section II, Part D**

One final plot (Figure 3-4) is provided here solely for informational purposes. The plot compares the currently used In 625 alloy with the tubing alloy materials. As shown, In 625 meets the expansion characteristics well over the entire range of temperatures from 100–800°F (38–427°C).

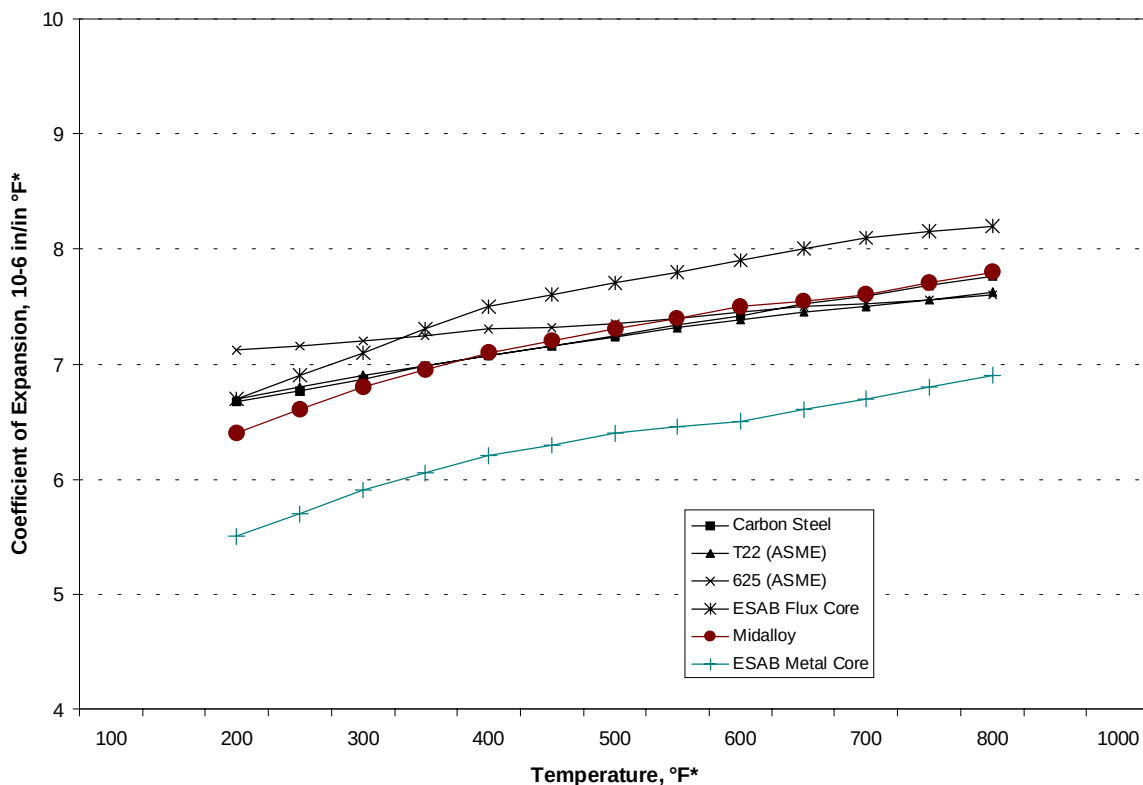
**Figure 3-10**

#### Thermal Expansion of Type 312 SS Filler Metals and Base Metals

Since there was no complete thermal expansion data for Type 312 SS in the ASME Code, samples were prepared for testing. The effect of ferrite on thermal expansion also needed to be investigated. All weld metal samples were prepared using the ESAB flux core, Midalloy, and ESAB metal core filler wires. These fillers were selected because of the different levels of delta ferrite they developed in the as deposited condition. The samples were sent to Materials Innovations, Inc., for testing. The samples were 1" (25.4 mm) long by 3/8" (9.5 mm) diameter. The results of this testing are plotted in Figure 3-10. **As can be seen from this figure, delta ferrite had a large influence on thermal expansion properties.** The Midalloy filler metal was found to have thermal expansion properties that closely match the carbon steel or T-22 base materials and was selected for further testing.

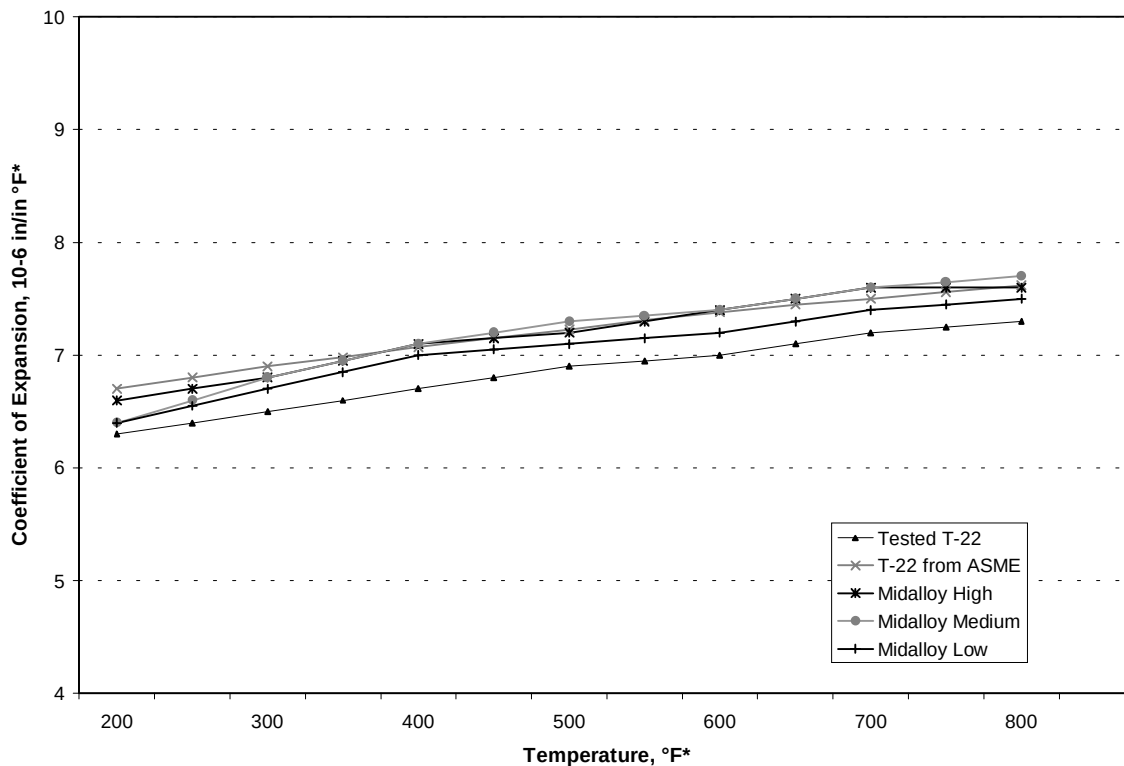
**Figure 3-11**  
**Heat Input Effect on Thermal Expansion, Type 312 SS**

The results are shown in Figure 3-11. Very little effect on thermal expansion rate was measured between the three samples. It is believed that the machine settings required to achieve sound welds limit the heat input to a range that has little effect on delta ferrite formation.

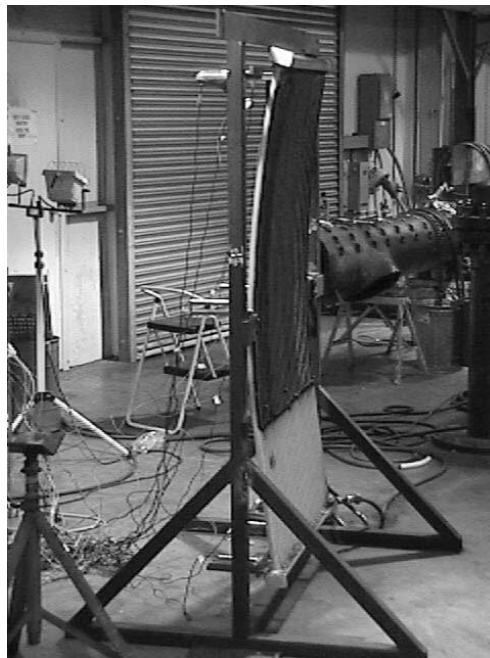
**Figure 4-3**  
**View of Panel as Welded**

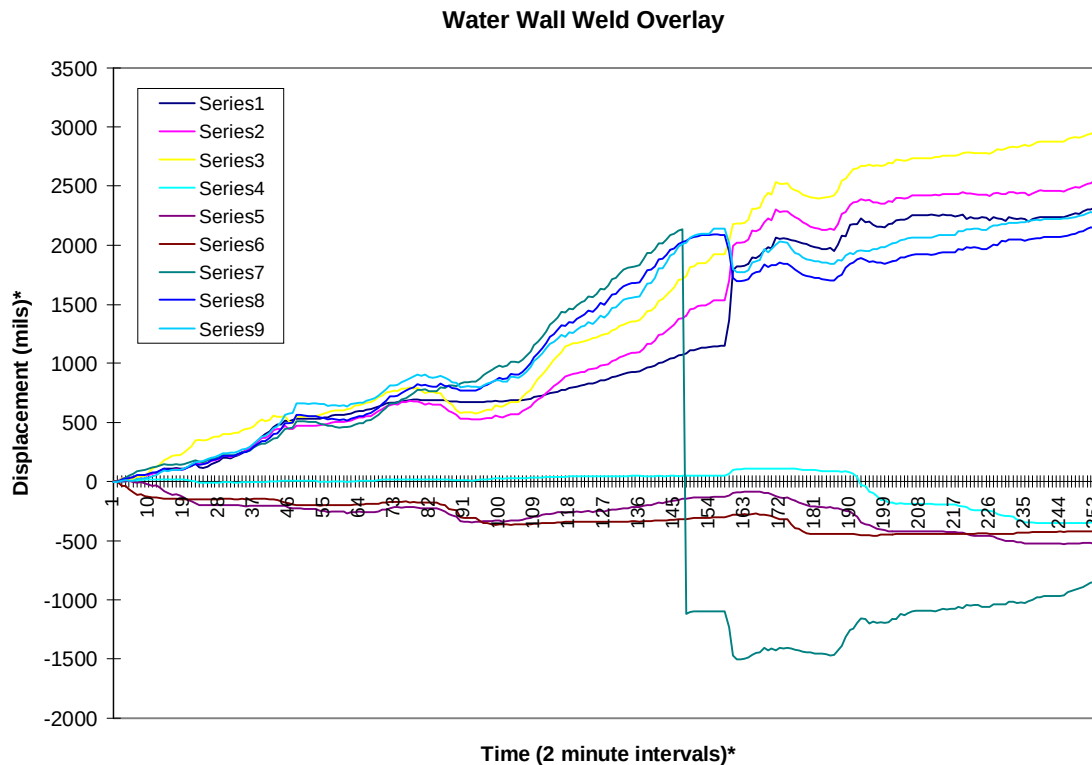
**Figure 4-4**  
**Typical Waterwall Distortion**

There is a tradeoff between welding speed and distortion. A welding contractor can slow down the welding process and decrease the distortion. There should be a balance between production and distortion. One typical distortion achieved by these tests can be seen in Figures 4-3 and 4-4. The jump in the graph in Figure 4-4 at the 160-minute range was caused by running out of travel on the LVDT's, which necessitated repositioning of the instrumentation before additional welding.

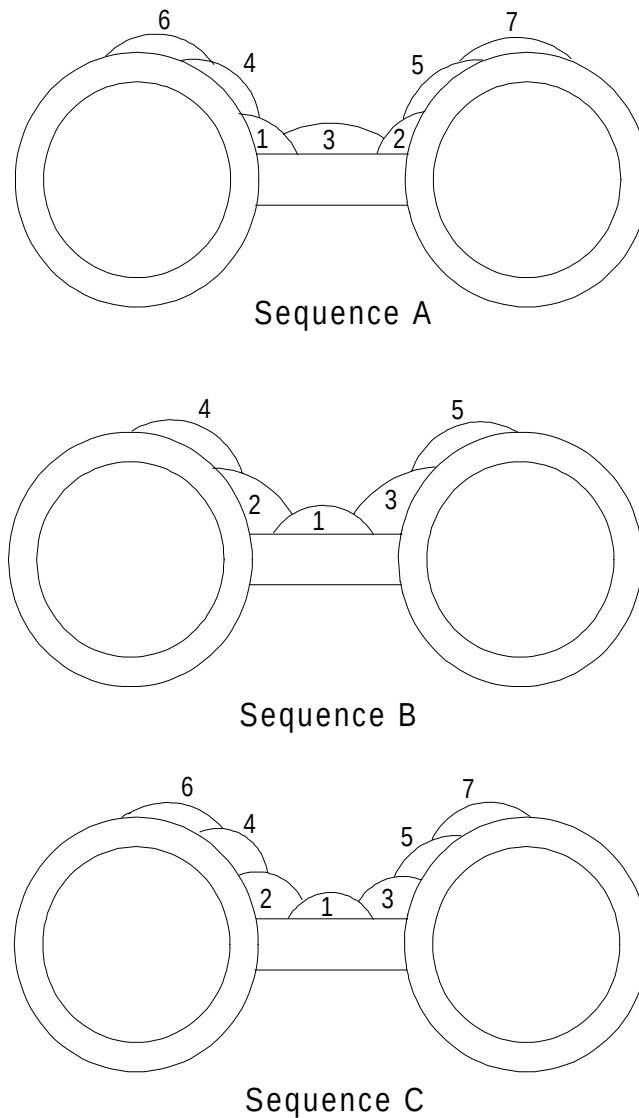
**Figure 4-5**  
**Weld Bead Placement Scenarios**

It was learned that the best results were achieved when the membrane areas of the panel were covered with weld metal first, as opposed to the tube. Some of the bead placement sequences that were experimented with are shown in Figure 4-5. Of these different scenarios, sequences B and C, which placed the first weld bead in the center of the membrane web, provided the best overall welding characteristics.

If the corners were welded first, as is shown in sequence A, lack of fusion was noted in the corners of the third bead. The stick-out changes of the filler metal during the welding process were also minimized by this bead placement, allowing better voltage and amperage control. It should also be noted that these are weld bead sequences for one pair of tubes. During the actual weld overlay operation, the welding head should be moved around on the waterwall to keep from curving the panels sideways.

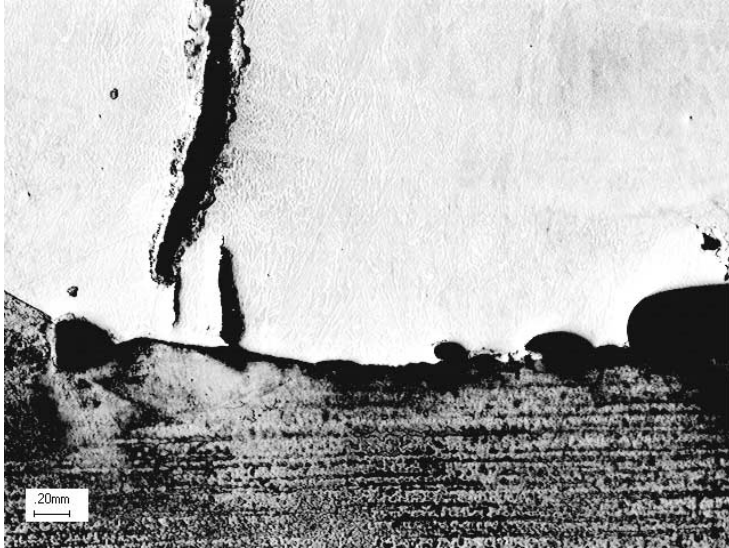
**Figure 5-2**  
**Photomicrograph of crack indication showing underbead deposits**

The overlayed panel containing the cracks was shipped to the EPRI Charlotte Facility for metallurgical evaluation. While the depressed delta ferrite content is thought to have been a contributing factor in the cracks, all of the cracks contained underbead deposits. Most were at the start or stop of an ER80S-B2 welding bead. No cleaning was performed between the weld buildup with the ER80S-B2 filler and application of the Type 312 SS filler. The underbead deposit could possibly have been caused from deposits on the tubing that were not originally

blasted off before repair welding with ER80S-B2 was performed that floated to the surface of the repair weld. When the Type 312 SS overlay was applied, the deposit acted to cause the cracking. No analysis was performed of the deposit chemistry. A typical crack and underbead deposit can be seen in Figure 5-2.

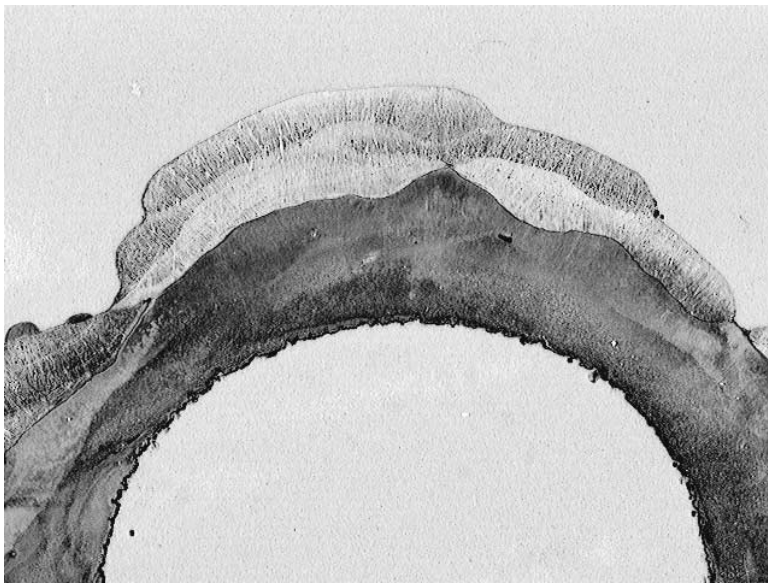
**Figure 5-3**  
**Cross section of overlaid tubing with incomplete coverage**

Additionally, some areas of tubing were found to have not been completely covered with Type 312 SS weld metal. This can be seen in Figure 5-3. Care must be performed during the welding and inspection stage of waterwall overlays. Any area that is not completely covered will result in a tube failure in a short duration.
