# FAILURE INVESTIGATION OF BOILER TUBES

A C O M P R E H E N S I V E   A P P R O A C H

PARESH HARIBHAKTI

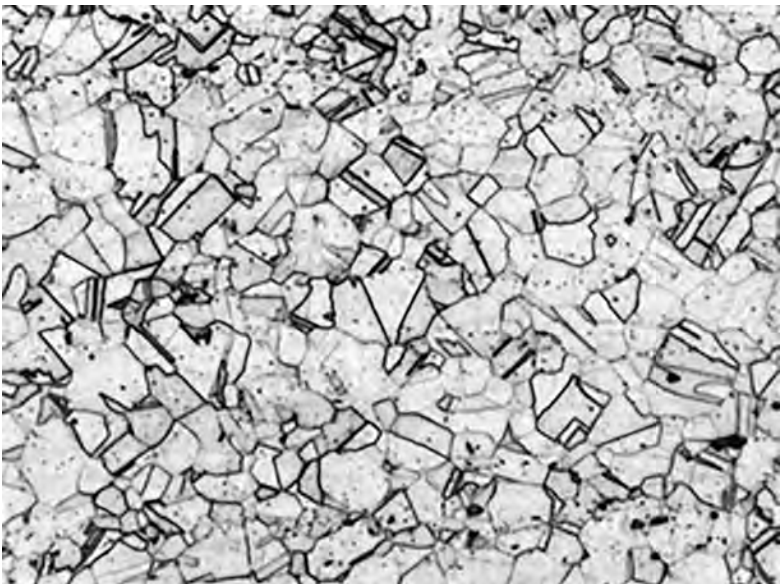
Fig. 3.18 Microstructure of austenitic stainless steel

Figure 3.18 shows the microstructure of austenitic stainless steel with grains of austenite separated by grain boundaries.

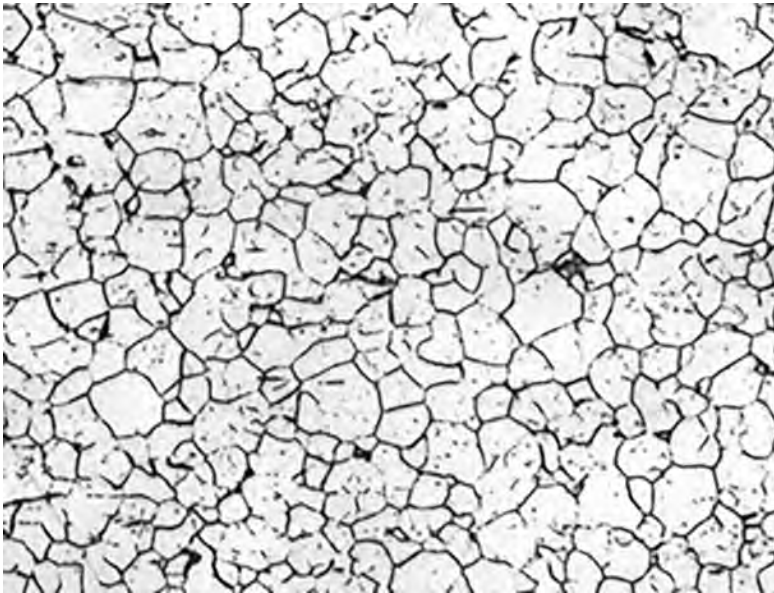
**Fig. 3.19** Microstructure of ferritic stainless steel

Ferritic stainless steels are composed of ferrite (bcc) as the stable phase at room temperature all the way up to the liquidus temperature. They are ferritic at all temperatures and do not transform to austenite; therefore,

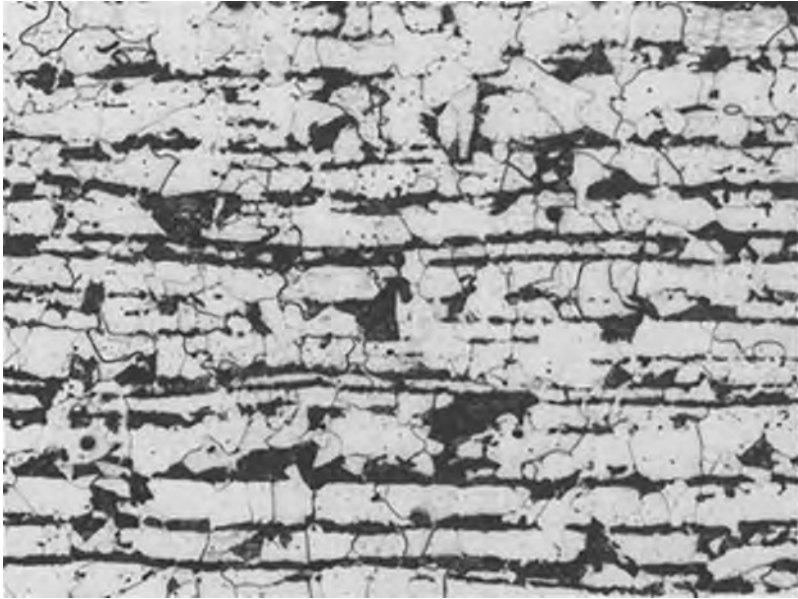
**Fig. 5.7** Microstructure of steel showing pearlite banding

Boiler tubes sometimes have a structure consisting of banded pearlite, as shown in Fig. 5.7. The microstructure of the steel in such a case shows

the colonies of pearlite aligned to form bands having alternate layers of ferrite and pearlite rather than a random orientation of pearlite in the microsection.

The root cause of this problem is the segregation of alloying elements during solidification of the molten alloy in the ingot mold. Areas of higher carbon concentration in austenite are developed as a result of segregation. The rolling of the ingot to form a sheet and the subsequent tube-making operation give rise to elongation of high-carbon areas in the forming direction that develop into pearlite banding. Such a structure is undesirable because a crack once initiated in this high-carbon area easily propagates through ferrite, leading to failure of the tube. Image analysis can be performed to study pearlite banding by using a specially developed software program. The method evolved is based on the measurement of the Feret diameter distributions in two directions, parallel and perpendicular to the rolling direction (Ref 5.8).

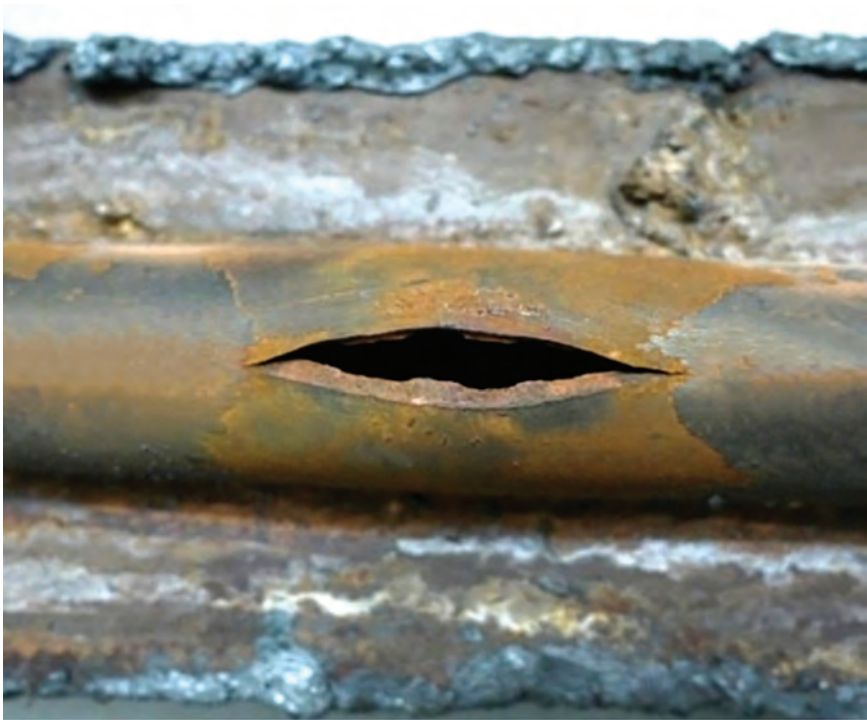
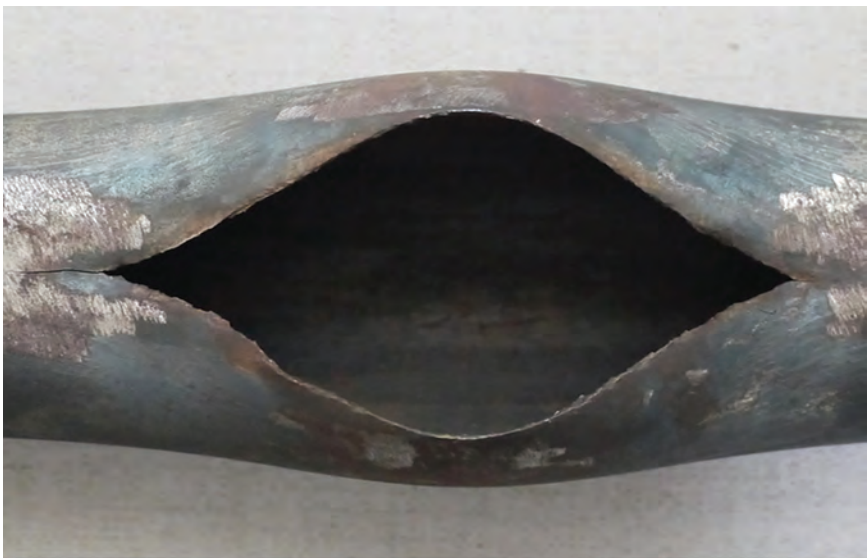
**Fig. 6.1** (a) Thick-lip rupture in a boiler tube due to long-term overheating. (b) Thin-lip rupture in a boiler due to short-term overheating

The waterwalls, superheater, and reheater tubes carrying water or steam in a boiler are all susceptible to overheating failure (Ref 6.1, 6.5). Fracture due to overheating generally takes place along the longitudinal axis of the tube, but at times it can be accompanied by fracture in the circumferential direction as well. The visual appearance of the fracture is like a *fish mouth*. Based on the degree of plastic deformation and the resultant thinning that the tube undergoes prior to fracture, it is called a *thick-lip* or *thin-lip fish-mouth* fracture. Depending on the time to which the tube has been exposed to high temperature prior to fracture, the failure is called *short-term overheating* (with exposure time as low as a few minutes) or *long-term overheating* (with exposure time of a few months to a few years). Figure 6.1 depicts thick-lip and thin-lip fractures.

Thick-lip fractures generally occur after long-term or prolonged overheating at a temperature slightly above the maximum safe working

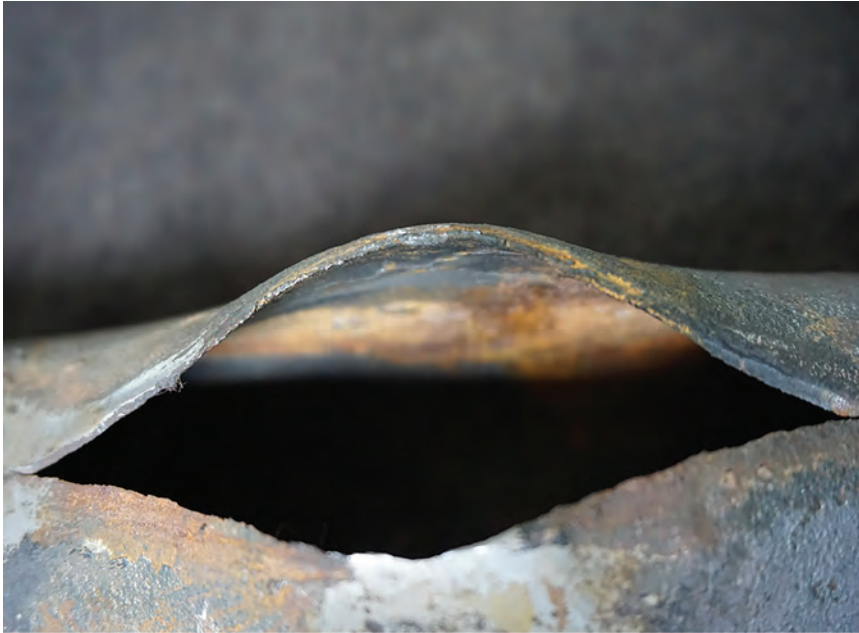
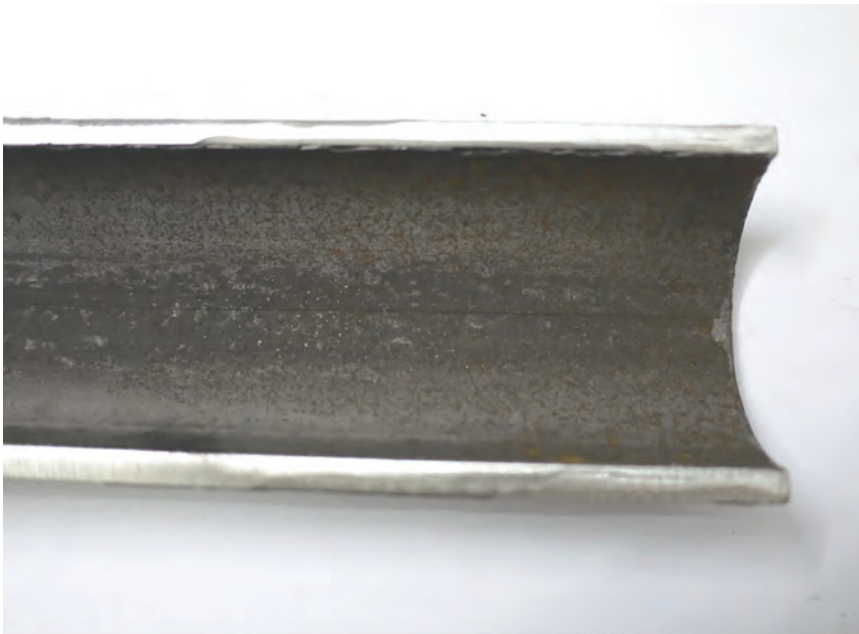
**Fig. 6.8** (a) Rupture opening with fine tips and (b) inner surface view after cutting the tube into two halves showing presence of grayish black scale

The tube sample was also subjected to scale thickness measurement. The average scale thickness at a location on the side facing the flue gas was 980  $\mu\text{m}$ . Excessive scale formation is indicative of a temperature rise beyond permissible design limits.

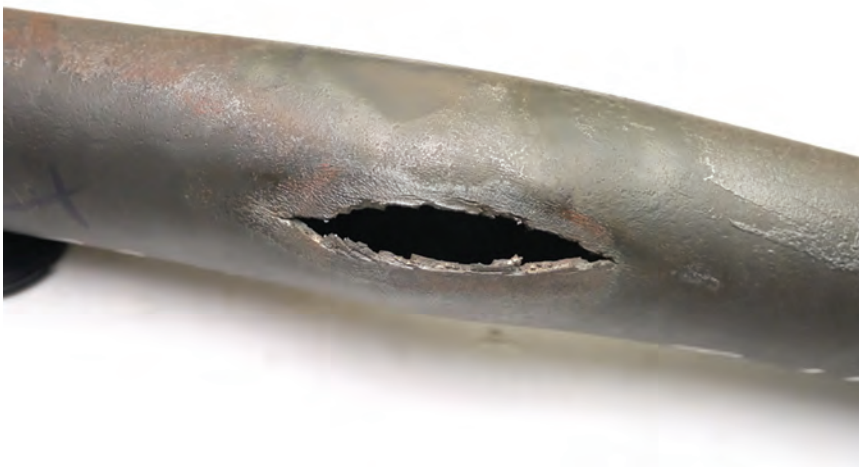
**Fig. 6.12** Reheater tube sample showing bulging and bending at failure location with thick-lip fish-mouth rupture

*Investigation and Findings* Visual examination was carried out on a tube sample received for investigation. This showed a rupture opening in the longitudinal direction, with fine lips at the failure location (Fig. 6.12). Dimensional measurements highlighted tube bulging across the failure location, and also showed bending of the tube near the failure location. A visual examination showed a thick-lip fish-mouth fracture. The thickness measurement survey indicated a minimum tube thickness equal to 4.0 mm (0.15 in.). The tube's outer surface had a thin adherent scale, grayish black in color. The inner surface of the tube, after it was cut into two halves, revealed patches of uneven but adherent scaling, grayish black in color (Fig. 6.13a). Figure 6.13(b) is an SEM image of the cross section of

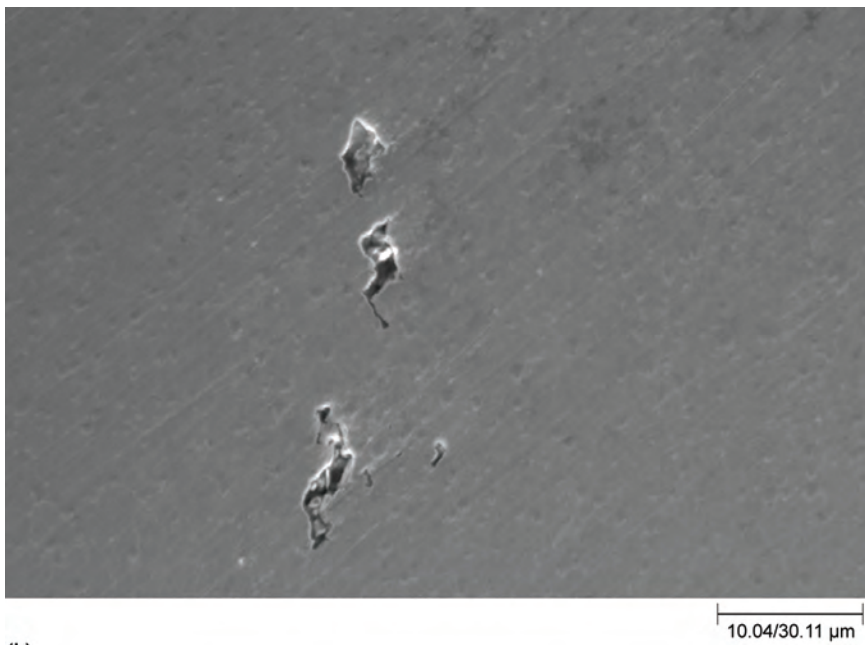
**Fig. 6.15** (a) SEM fractograph showing presence of creep voids on fracture lip surface, 500 $\times$ ; and (b) SEM image of as-polished sample after metallography showing scattered creep voids, 1000 $\times$

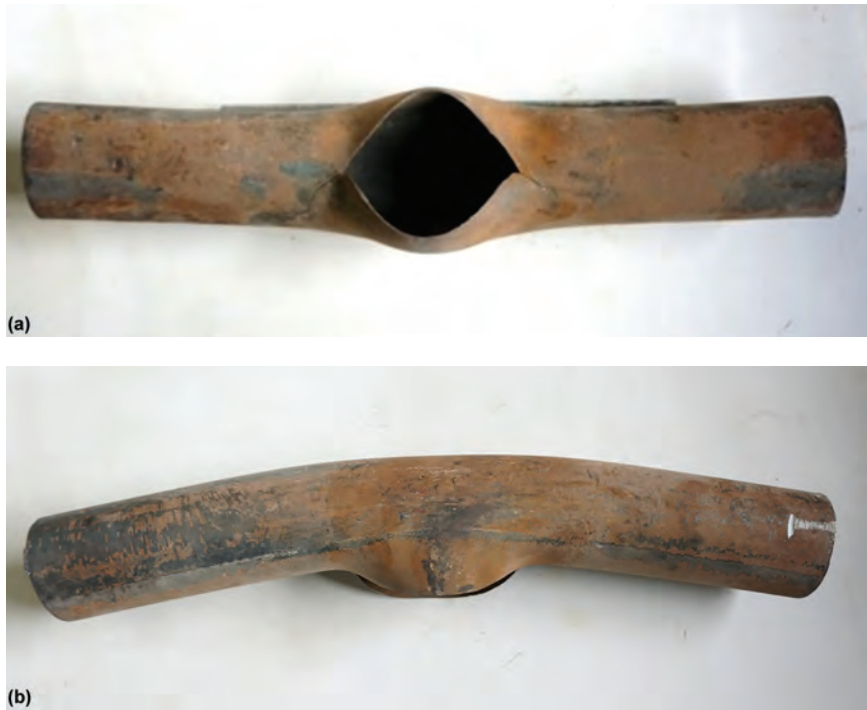
**Fig. 6.17** Close-up views of the failed screen tube showing (a) thin-lip fish-mouth fracture and (b) bulging and bending of the tube

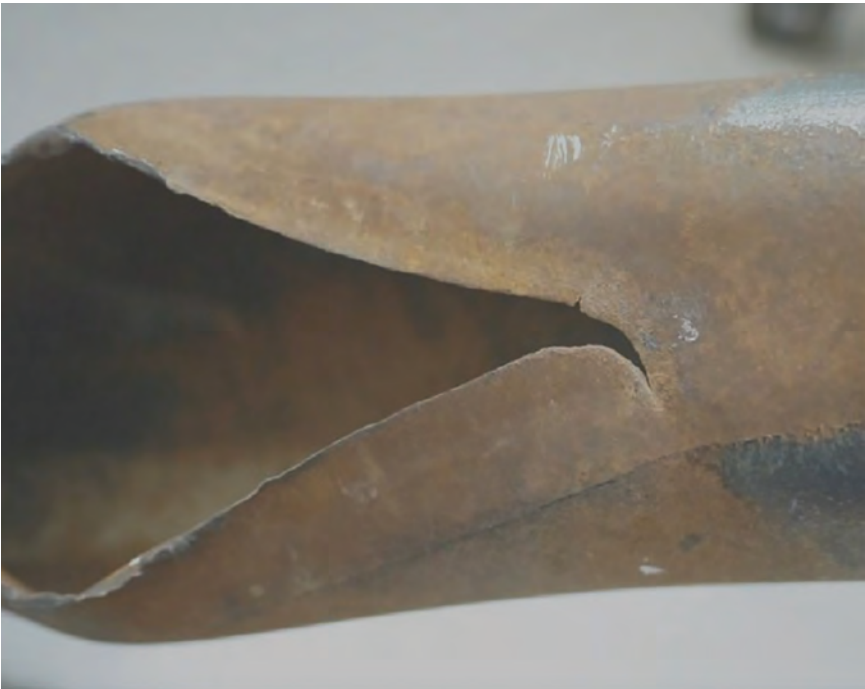
**Fig. 6.20** (a) Low-magnification view at the tip of the fish-mouth rupture, 250×; and (b) SEM micrograph showing typical short-term heat ruptured surface, 250×

Both visual (Fig. 6.19) and low magnification (Fig. 6.20a) views confirmed slight bulging at the failure location. A thickness measurement survey indicated reduction in wall thickness toward the failure location with a minimum wall thickness equal to 2.9 mm (0.1 in.). Wall thinning was observed on the fire side.

Scanning electron microscopy of the fractured lip indicated features resembling a typical short-term heated ruptured surface because cavities were joined to form the crack (Fig. 6.20b).

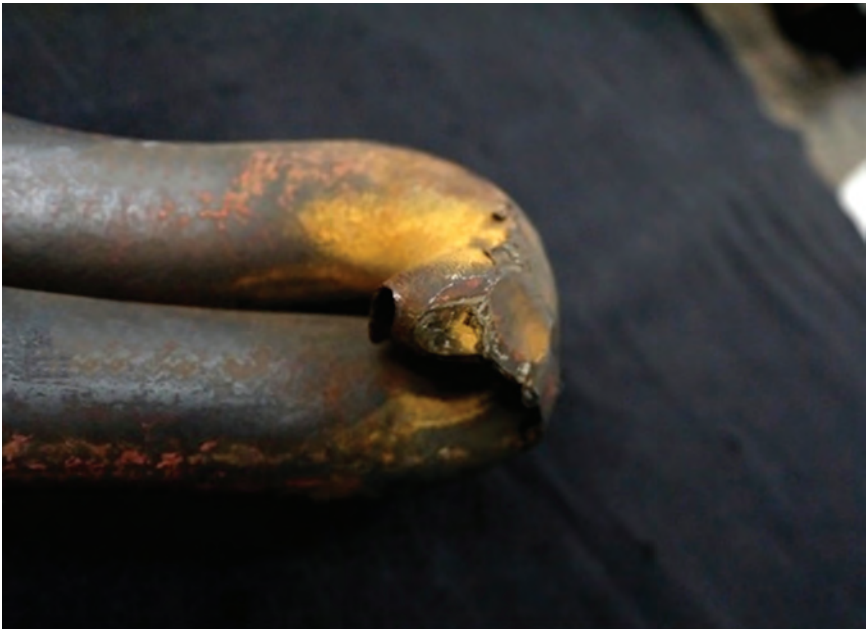
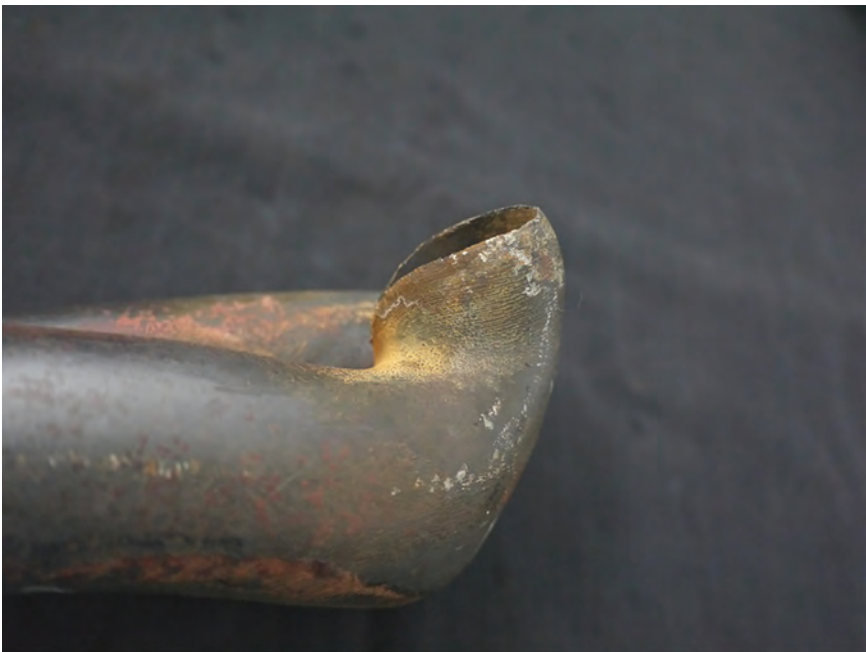
**Fig. 6.23** Failed superheater tube (a) showing 180° bending and (b) opposite end view showing a burst opening with disordered contours

The general microstructure did not undergo any phase transformation since the  $A_{c1}$  temperature for this material specification is about 800 °C (1470 °F). Calculations based on basic principles indicated that the temperature necessary to cause plastic deformation and resultant burst opening of the tube was 678 °C (1252 °F). This temperature limit could have been reached if steam starvation occurred.

*Conclusions* The failure of the superheater tube took place due to an instantaneous and localized temperature rise, which eventually led to burst failure due to steam starvation.

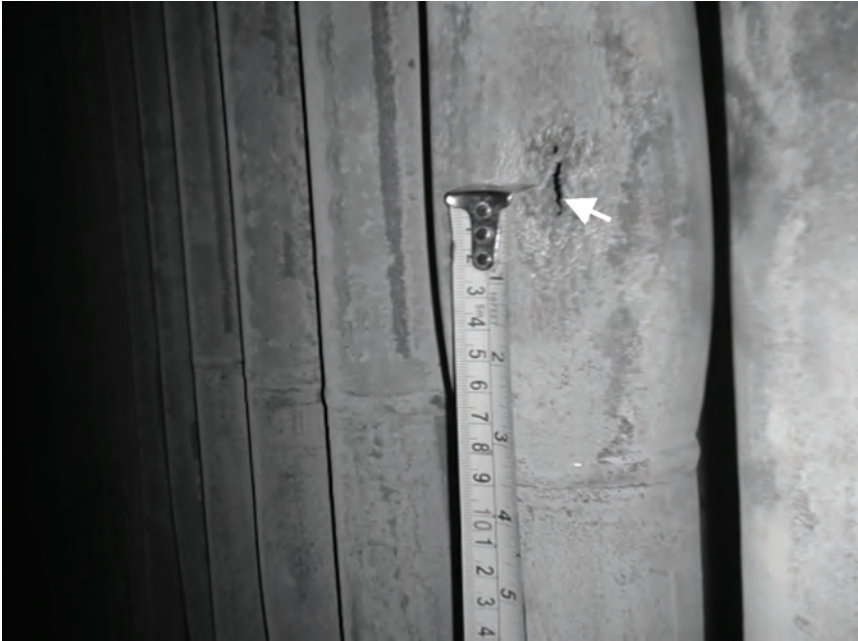
**Fig. 6.27** Longitudinal crack in a tube

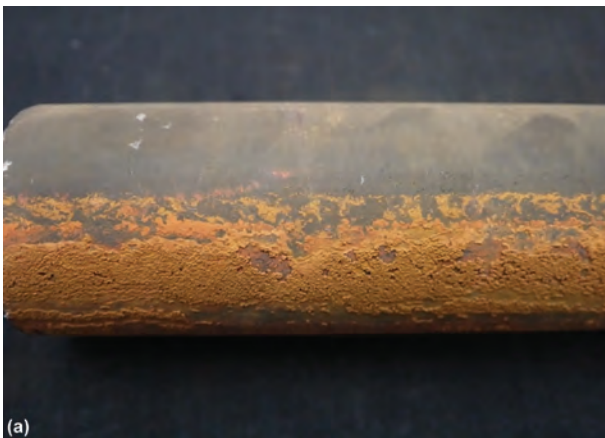
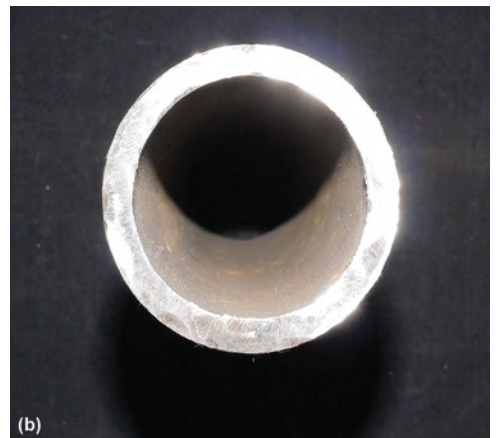
**Fig. 6.28** (a) Dark brown scale on OD surface. (b) Brownish black scale on the ID surface of a tube

The tube sample received for investigation showed oxide scales on both the OD and ID surfaces. Half of the OD surface had a thin scale, dark brown in color, whereas the ID surface of the tube appeared brownish black, as shown in Fig. 6.28.

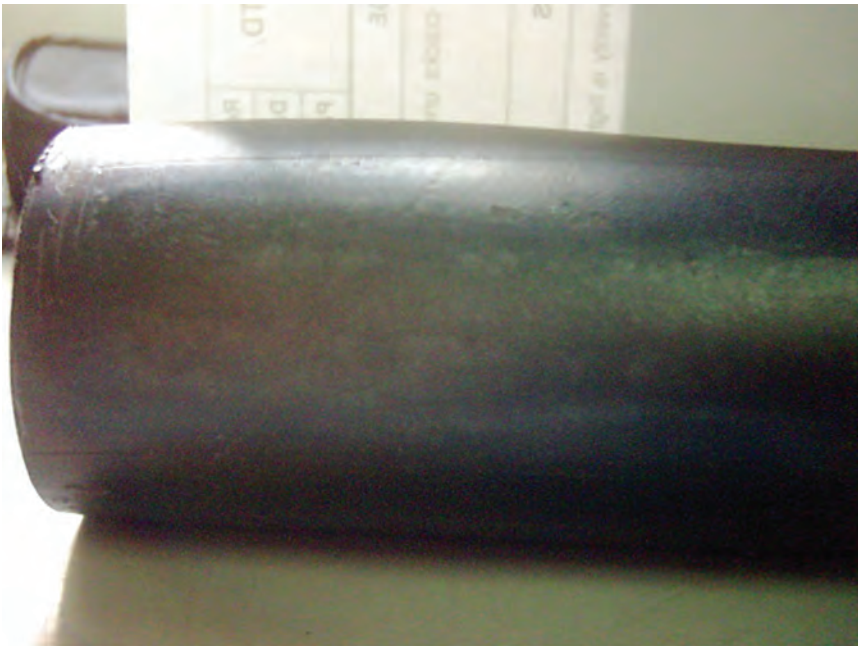
**Fig. 6.32** (a) Fish-mouth thick-lip failure of a PSH tube; (b) bulging on outer surface of the tube

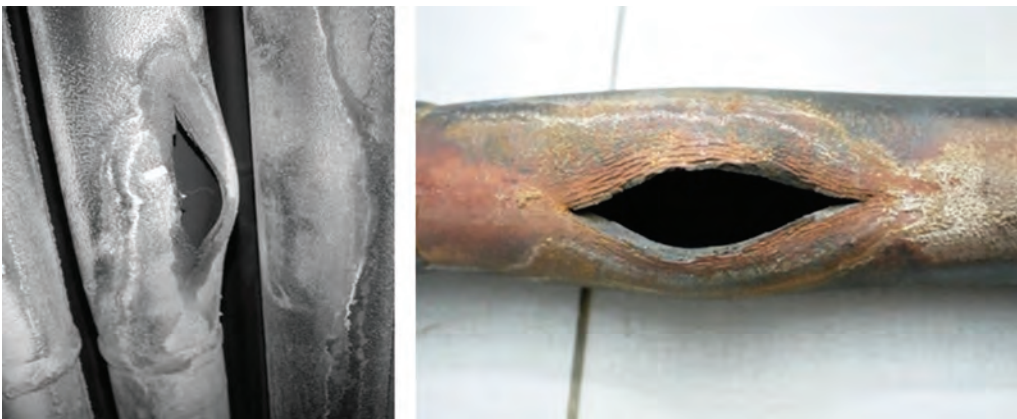
**Fig. 6.36** Close-up views of a superheater tube at the failure location

*Investigation and Findings* Figure 6.36 shows close-up views of the failed tube. Bulging of the tube was noticed surrounding the ruptured area. The rupture was in the form of a thick-lip fish-mouth opening. The rupture occurred at a distance of 40 to 50 mm (1.5 to 2 in.) from the welded joint. A craze pattern was observed on the outer surface near the burst.

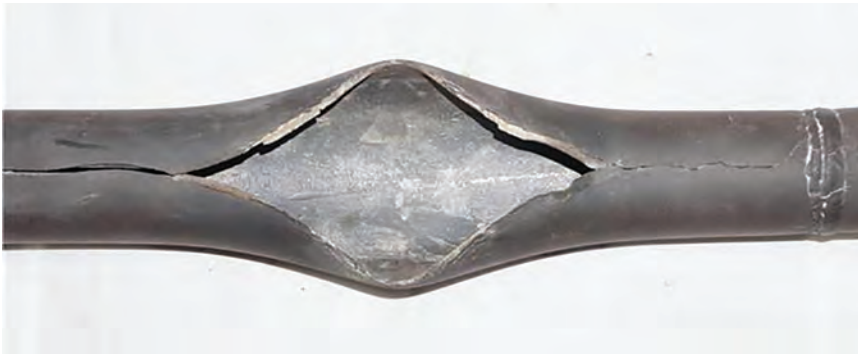
**Fig. 6.39** Close-up view at the failure location. The rupture is in the form of a fish-mouth opening. A crack extends in the longitudinal direction from one end of the rupture.

*Investigation and Findings* Visual examination of the failed tube sample revealed a rupture in the form of a fish-mouth opening. A crack extended in the longitudinal direction from one end of the rupture up to the weld region. Bulging of the tube was noticed surrounding the ruptured area. Figure 6.39 shows a close-up view of the failed tube.

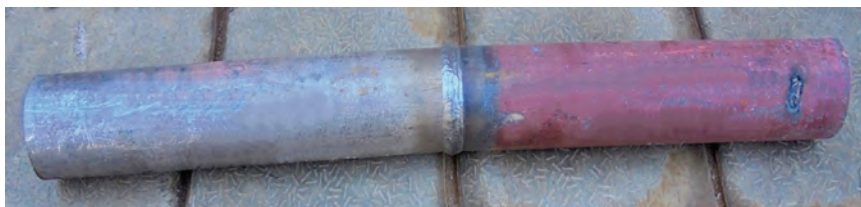
**Fig. 6.45** Typical dissimilar metal weld joint

Dissimilar metal welds account for some stress rupture failures of boiler tubes. For example, a butt joint between an austenitic stainless steel (SS 347) and a ferritic steel tube of SA 213 grade T91 material resulted in a circumferential rupture on the ferritic side of the joint along the weld fusion line (Fig. 6.45). Such failures were found in cases of dissimilar weld joints of tubes belonging to superheaters and reheaters. Figure 6.45 displays a typical case of failure due to dissimilar weld joints.

One reason for DMW-type failures is diffusion of carbon from the HAZ of the ferritic side to the austenite side of the weld metal. This forms a band of carbon-depleted low-alloy steel immediately adjacent to the weld interface. Such a band has much lower resistance to creep than average and gives rise to creep failure. Other reasons are the difference between the thermal expansion coefficients of the two grades of steel, resulting in a significant temperature-induced stress at the austenitic to ferritic weld interface; and the difference between the oxidation/corrosion resistance of the two grades, which leads to the formation of an oxide wedge on the ID and OD sides of the tube (Ref 6.8). Finally, the reduction in effective tube thickness reduces its load bearing capacity and causes failure through the stress rupture mode.

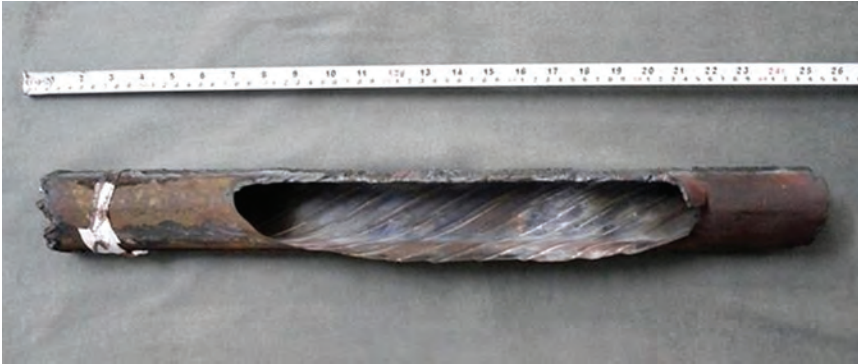
**Fig. 6.49** Window-type fracture in waterwall tube due to hydrogen damage

Whether it is due to accumulated hydrogen at the voids or trapped methane gas, as more and more microcracks are formed there is a marked reduction in the strength of the tube. A stage is reached when the pressure exerted by the internal fluid exceeds the strength of the tube, and the tube fails in a brittle catastrophic manner in the form of a thick-walled, longitudinal burst. A large, rectangular section of the wall is blown out, producing a rectangular *window-like* appearance (Ref 6.1), as shown in Fig. 6.49. Thus, it is a fracture that occurs violently and without any prior warning.

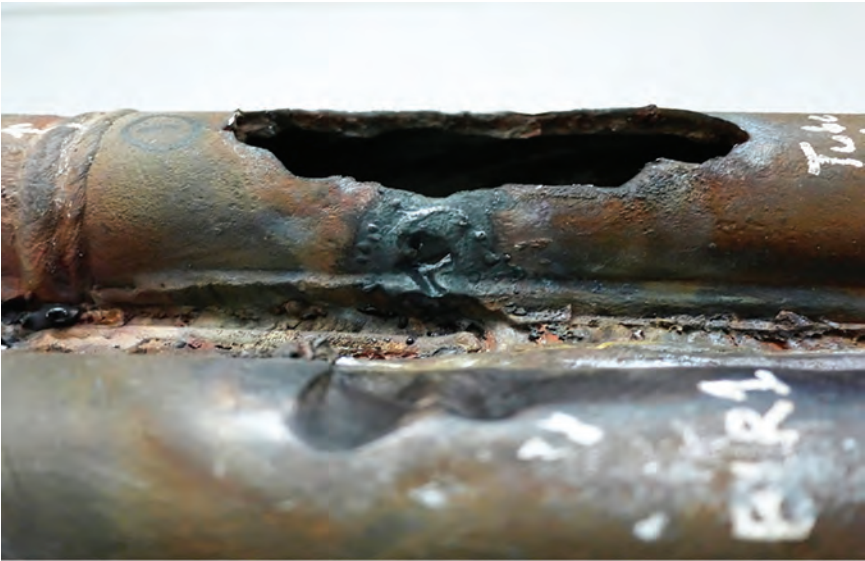
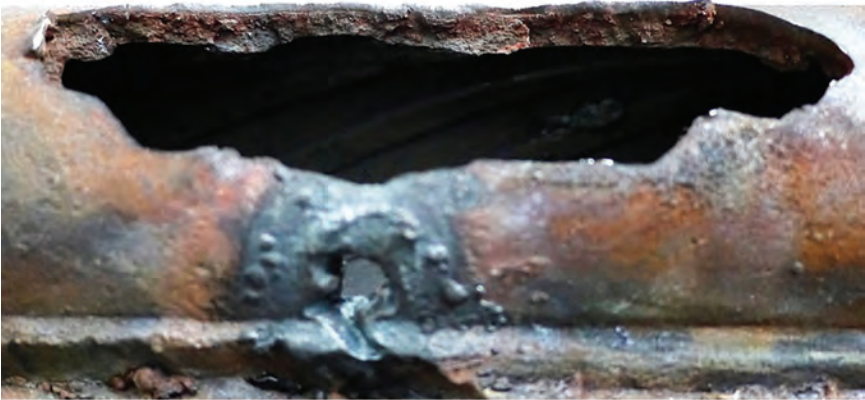
**Fig. 6.53** (a) Window-type fracture in riffler waterwall tube; and (b) close-up view at primary failure location

*Investigation and Findings* Visual examination highlighted a window-type rupture of the tube, elliptical in shape. The rupture contours were sharp but uneven and not deformed. Apparently, there was no reduction in wall thickness. The failure was away from the weld joint. The outer surface showed a thin adherent scale, brick red in color, while the inner surface showed a thin adherent magnetite scale, which was grayish black in color. Figure 6.53(a) shows the failed waterwall tube samples, and Fig. 6.53(b) shows a close-up view at the primary failure location.

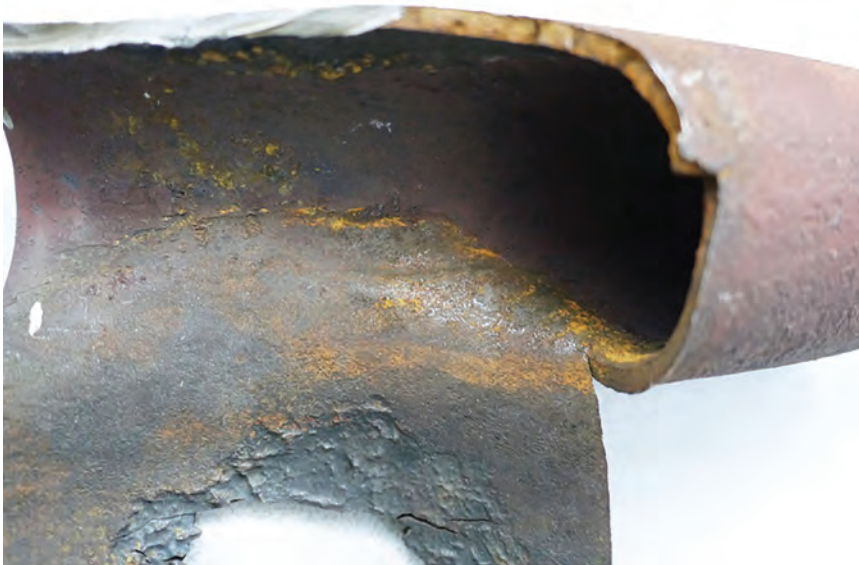
**Fig. 6.56** Failed waterwall tube with window opening at tube bend

**Background Details** The waterwall tube of an HRSG boiler failed during operation. The boiler tripped on *furnace pressure high* protection. It was noticed that one waterwall riser tube (goose neck) of the furnace east wall had a window opening at a 200 mm (8 in.) radius bend location (Fig. 6.56).

The opening was approximately 120 mm (4.5 in.) in length and 55 mm (2 in.) in width. The window opening was from the longer radius of the bend facing the burners.

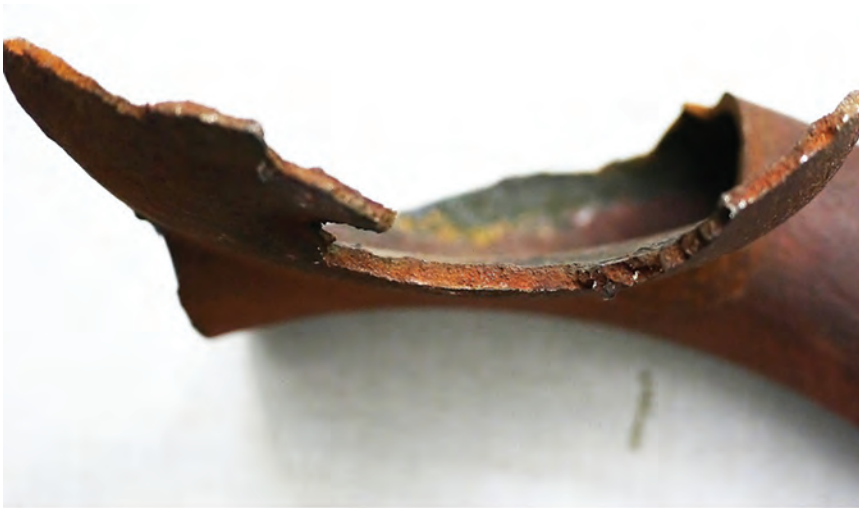
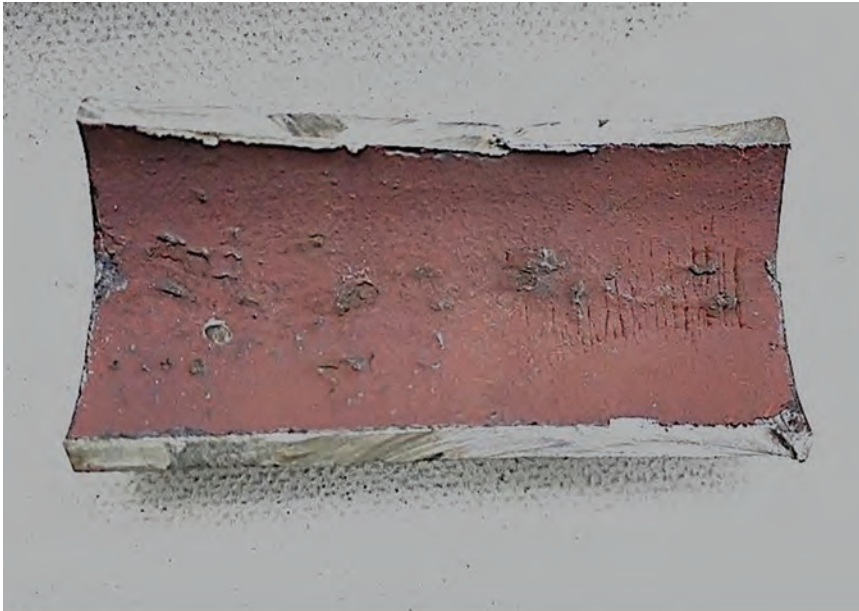
**Fig. 6.57** (a) Close-up view of the puncture portion of the failed waterwall tube.  
(b) Longitudinal cut section showing ID surface

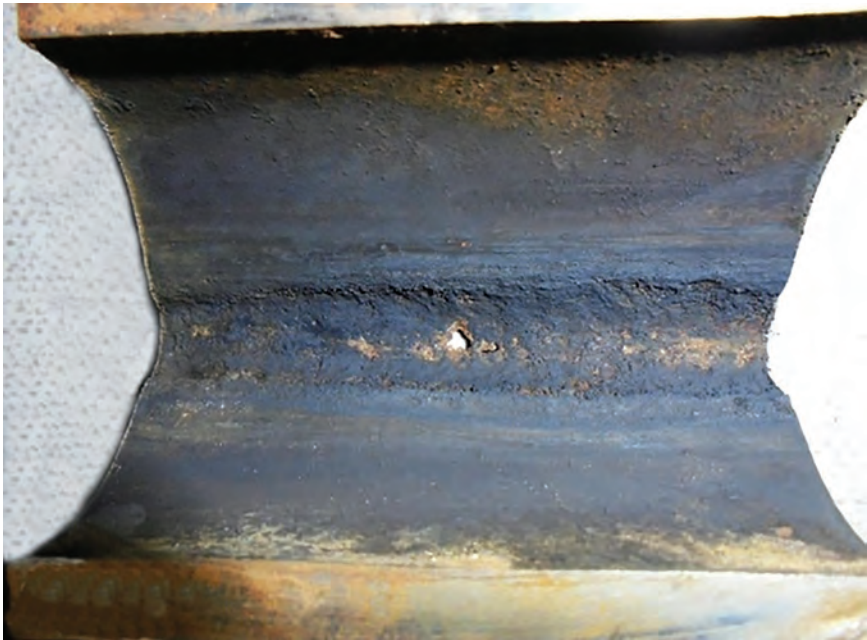
**Fig. 6.61** Deep caustic gouging below the insulating deposits on ID side of an economizer tube

Figure 6.61 shows a photograph of deep caustic gouging below the insulating deposits on the ID side of a tube.

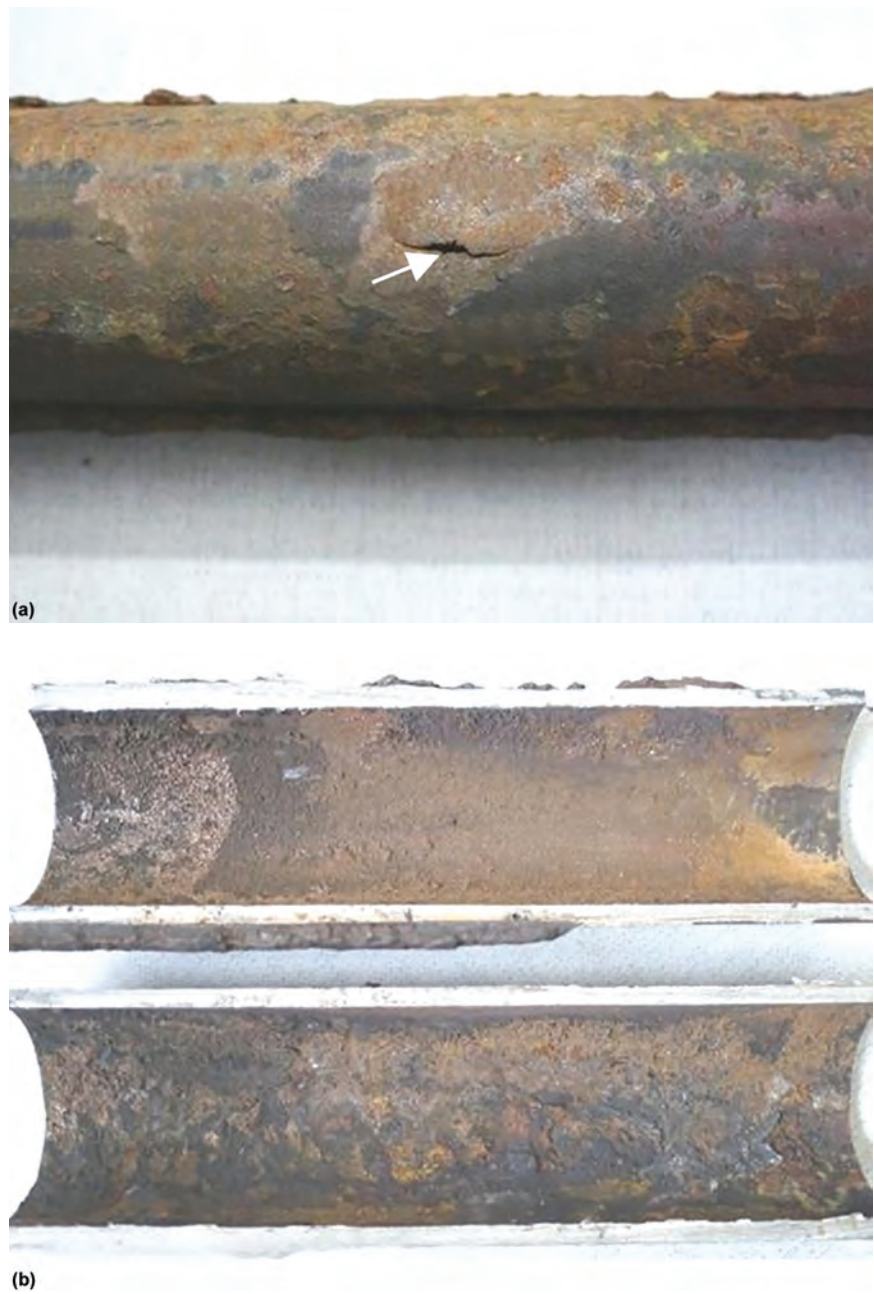
**Fig. 6.62** (a) Outer surface of a failed tube sample showing a linear crack. (b) Inner portion of the tube with grayish black scale

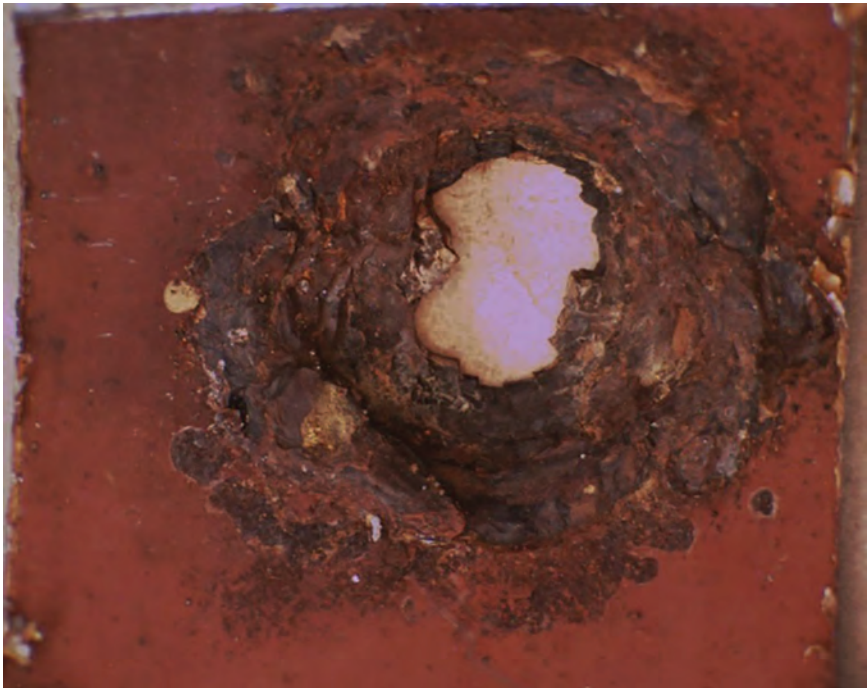
**Fig. 6.67** Rounded pit formed due to phosphate corrosion

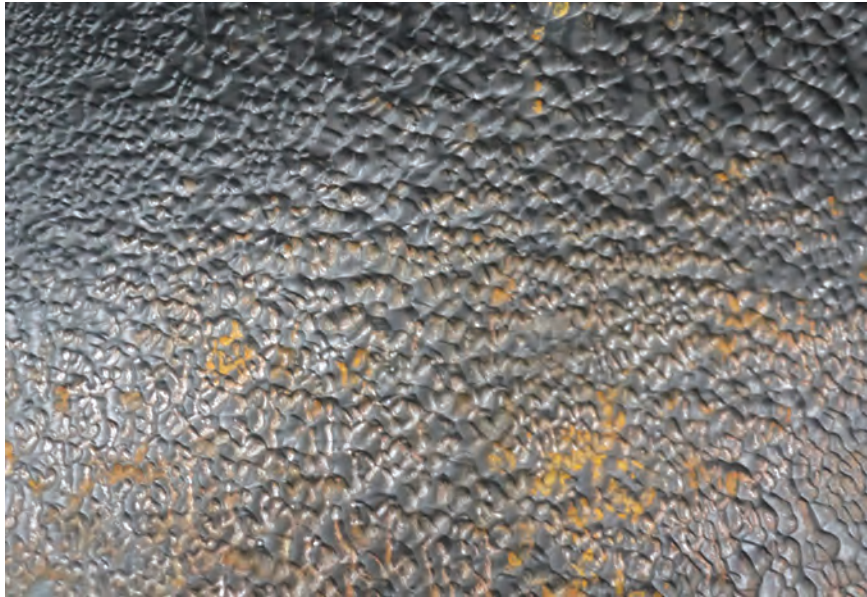
Flow-accelerated corrosion (FAC) is also known as *flow-assisted corrosion* or *flow-induced corrosion*. It is a damage to boiler tubes where thinning of the tube occurs due to complete or partial dissolution of the protective magnetite ( $\text{Fe}_3\text{O}_4$ ) layer (Ref 6.19, 6.20). If the protective film dissolves in a stream of flowing water, it is called single-phase FAC, whereas when the dissolution occurs in the presence of two fluids, namely water and steam (i.e., wet steam), the process is called two-phase FAC. Risk of failure due to FAC increases in a cycling operation involving frequent start-ups and low-load operations. Such conditions account for substantial transients in the chemistry of the BFW contributing to FAC. The most vulnerable areas prone to FAC are the auxiliary feedwater system, economizer tubes, condensers, moisture separation drains, reheater drains, bends in evaporators, and risers. In general, components such as elbows, bends, tees, reducers, and pipe entries are more susceptible to FAC. The eroded surface has, by and large, a shiny appearance without any corrosion products and has a structure like sand dunes, as shown in Fig. 6.71.

**Fig. 6.71** ID surface of a tube showing shiny metal surface with sand-dune-like appearance in the direction of flow due to FAC

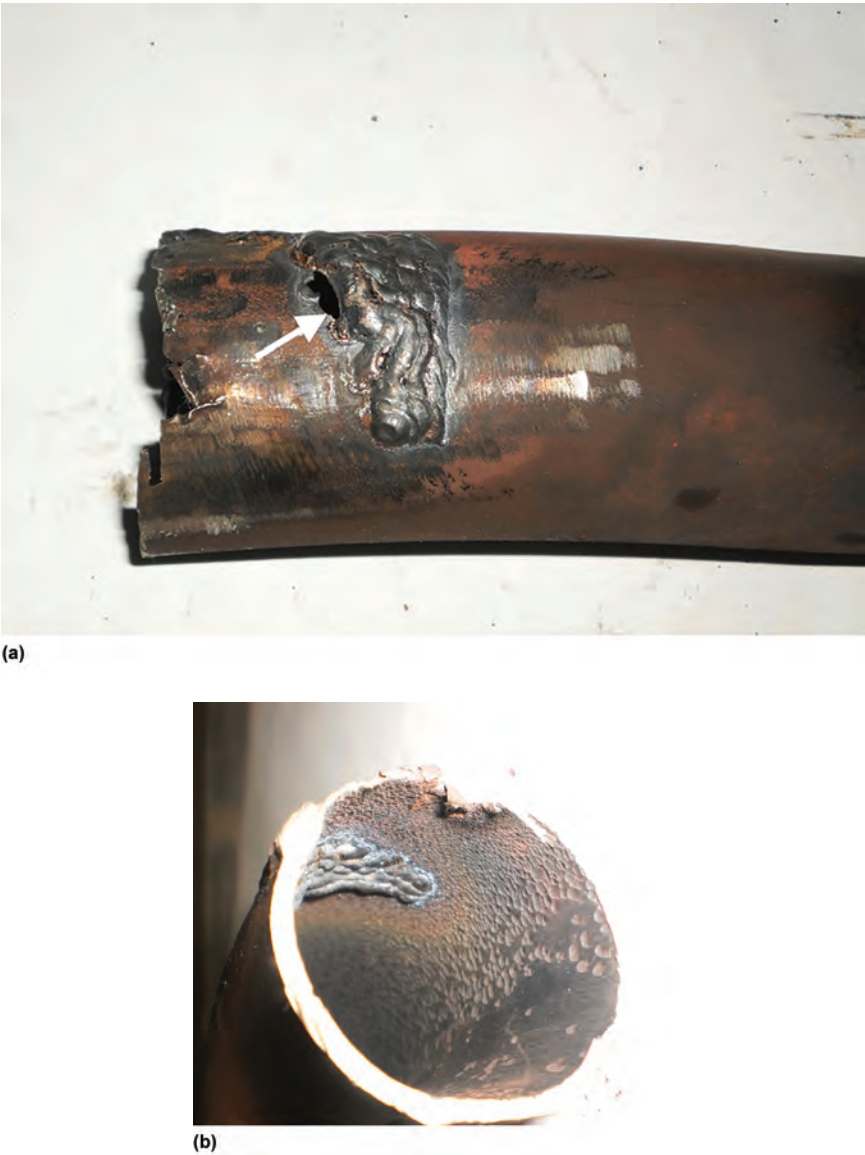
**Fig. 6.74** Close-up views of (a) OD side and (b) ID side of the tube bend showing puncture and repair weld area

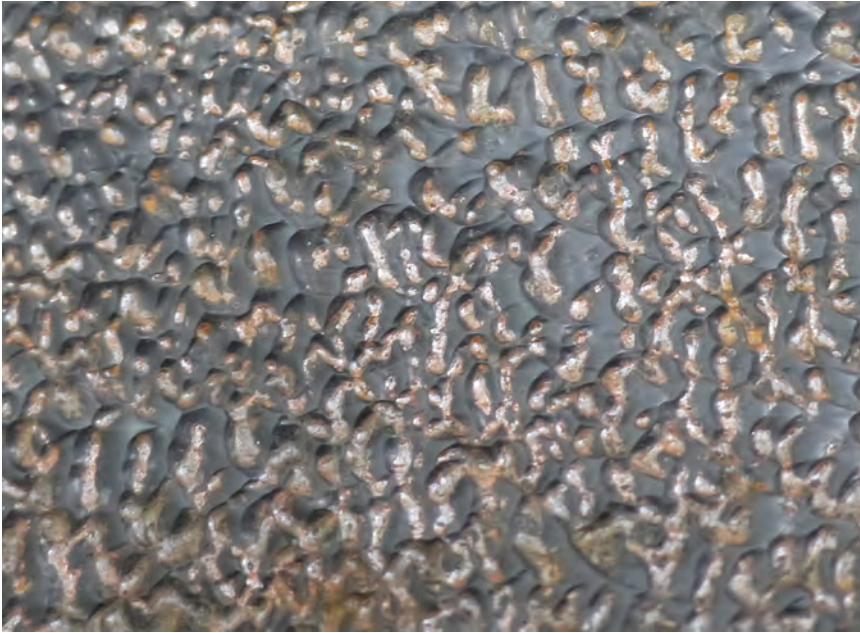
Upon close examination of the ID surface of the tube, horseshoe-shaped, scalloping corrosion marks were seen, especially on the outer curvature. Figure 6.75 shows a close-up view of the internal surface of the tube at the extrados portion at the low magnification of 11x.

**Fig. 6.75** Internal surface of a tube at extrados portion displaying scalloping marks at low magnification, 11×

In view of this, a wide fluctuation in the rate of flow was possible. These process conditions led to corrosion on the ID surface of the tube, with a scattered scalloped and horseshoe corrosion pattern. Both visual and low-magnification examination indicated such features that are typically found in case of an FAC failure. The signature of FAC was also seen in optical metallography. Thinning was noticed at the extrados portion of the tube. To rectify the situation, repair welding was attempted, but it had not proved successful.

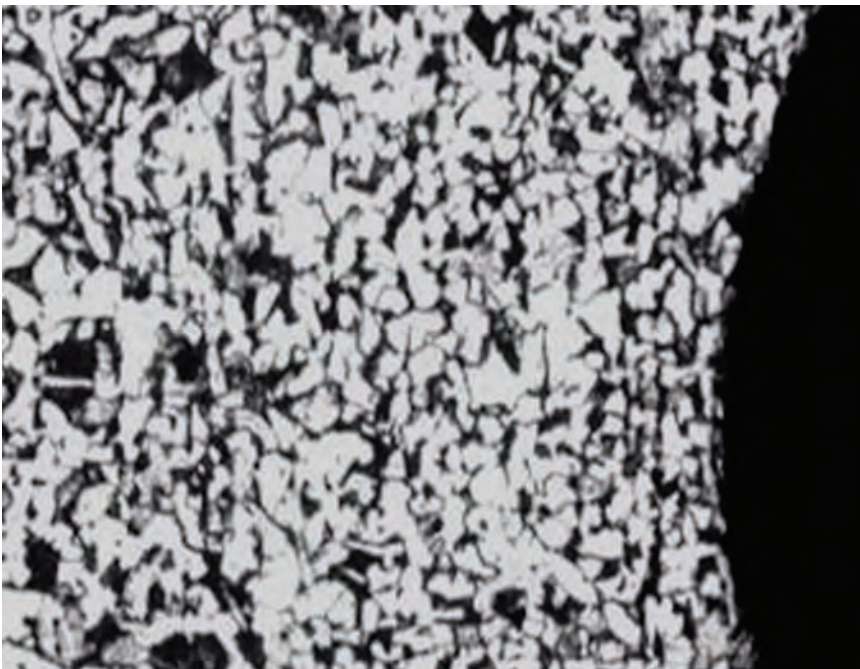
**Fig. 6.76** Microstructure of an ID-side bend sample, 200×

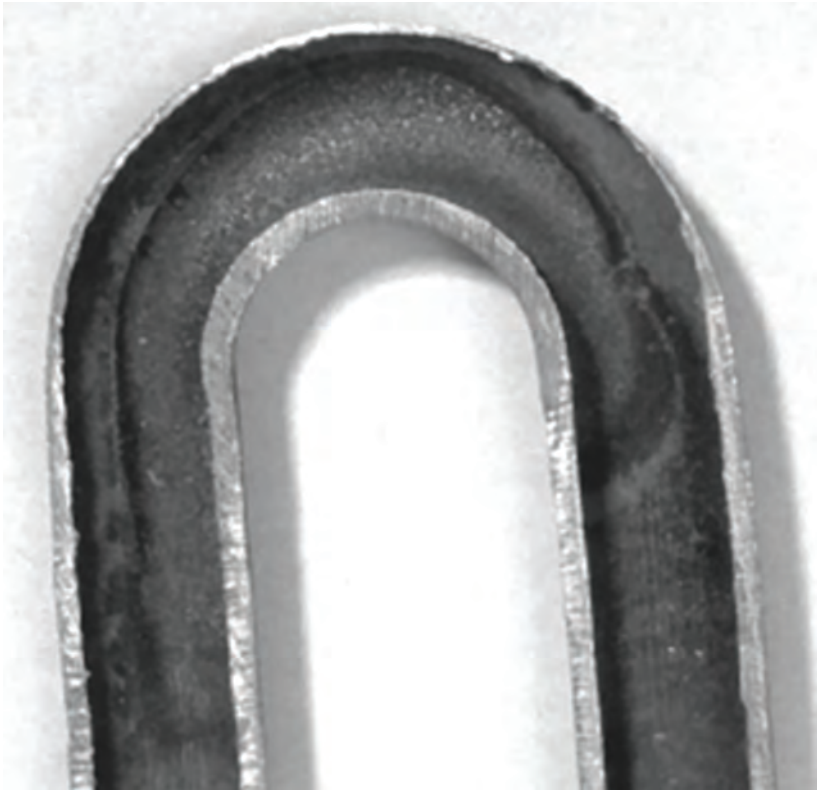
**Fig. 6.80** Erosion-corrosion damage of economizer tube bend

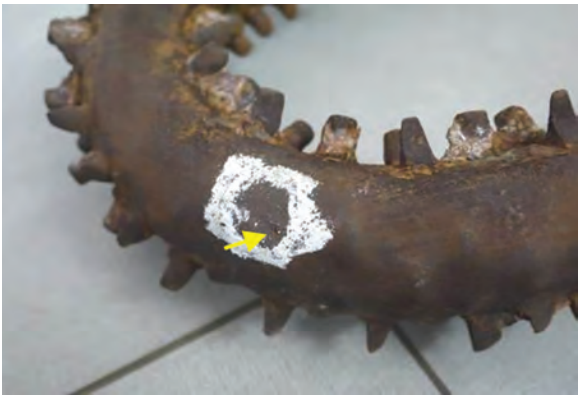
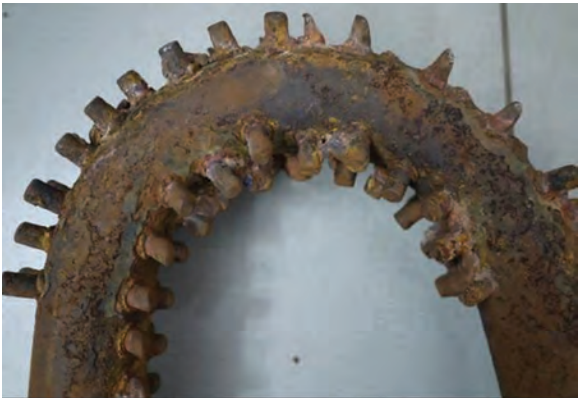
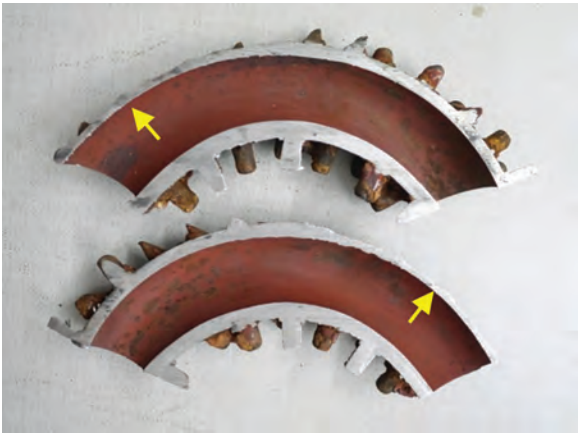
*Investigation and Findings* Visual examination of the failed sample revealed damage to the majority of studs on the outer surface, which were either completely or partly missing (Fig. 6.81a). Erosion marks in the form of smooth depressions were seen on the outer surface wherever the studs were completely missing. Leakage had taken place from a puncture that was in the form of a pinhole, and no studs were seen in the area surrounding the puncture. The number of studs on the outer surface at the bent location looked better. They were covered with a corrosion scale (Fig. 6.81b). The inner surface of the tube was smooth and brick red in color (Fig. 6.81c).

**Fig. 6.81** (a) Close-up view at leakage location with leakage in the form of tiny pinholes and smooth outer surface with erosion marks where the studs had worn out. (b) Bent location showing scale deposits. (c) Inner surface view brick red in color indicating absence of protective magnetite scale
