# FAILURE INVESTIGATION OF BOILER TUBES

A C O M P R E H E N S I V E   A P P R O A C H

PARESH HARIBHAKTI

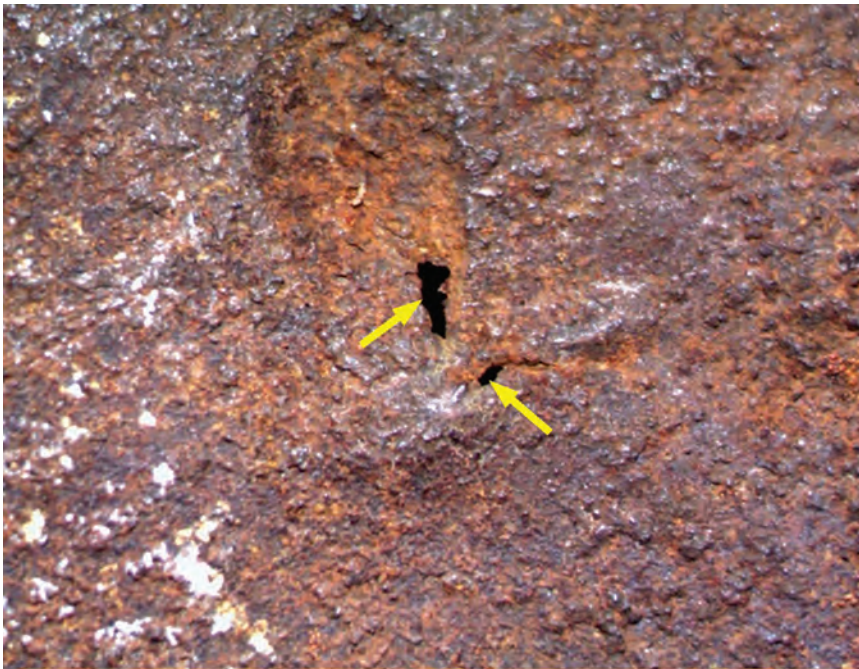
A low-magnification view revealed two punctures at the leakage location (Fig. 6.82). Erosion-corrosion damage was seen on the outer surface

**Fig. 6.82** Low-magnification views at outer surface showing erosion-corrosion damage surrounding two punctures, (a) 2 $\times$ , (b) 6 $\times$

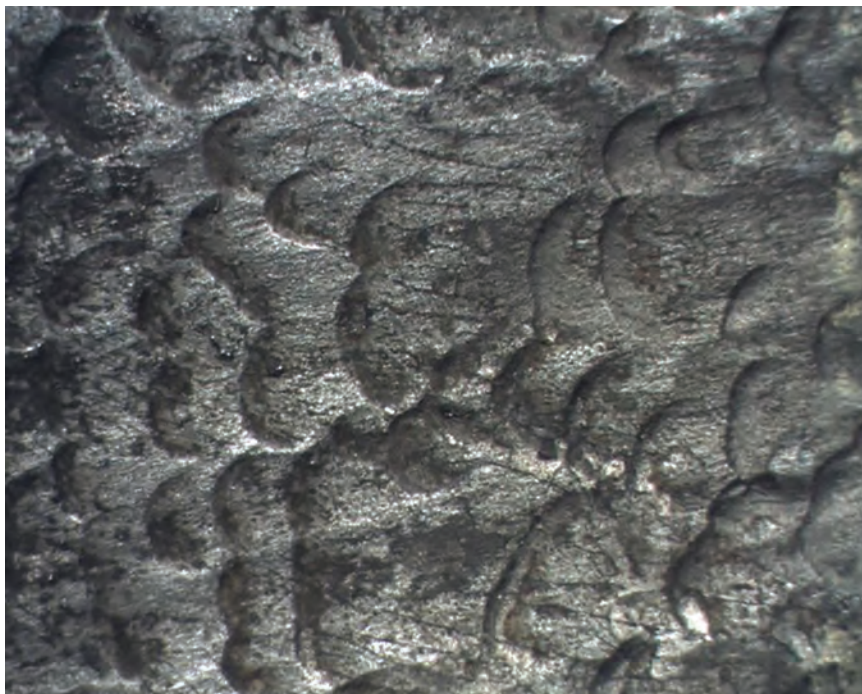
**Fig. 6.85** Cavitation damage in a boiler tube

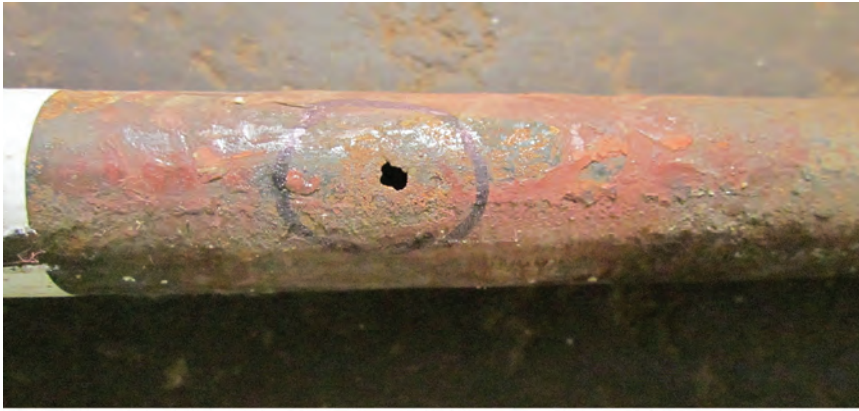
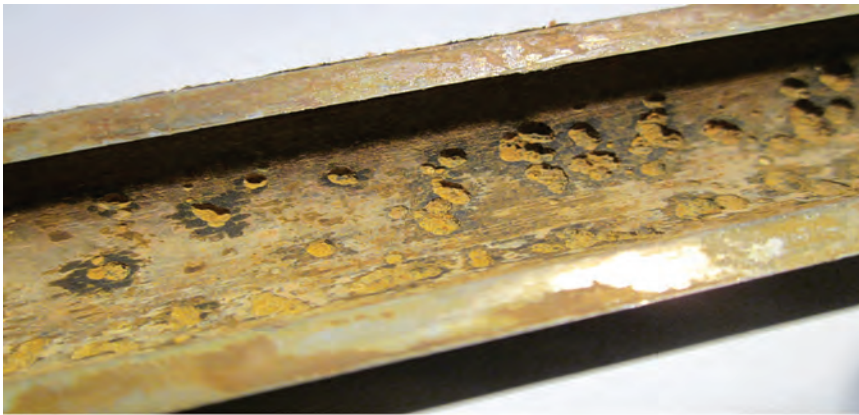
*Investigation and Findings* Visual examination showed that the tubes were straight with a light reddish brown appearance. No significant thinning or effect of corrosion was observed from the OD surface (Fig. 6.86a). The ID surface showed deep pits and grooving-type damage at the puncture, and the cavities were filled with corrosion products (Fig. 6.86b). The adjacent areas to the cavities were found free of any significant corrosion. More importantly, the opposite half of the ID surface with the cavities was found to be free from any such damage.

**Fig. 6.86** Close-up views of (a) OD surface at the puncture location; and (b) ID surface with deep cavities filled with orangish brown corrosion product

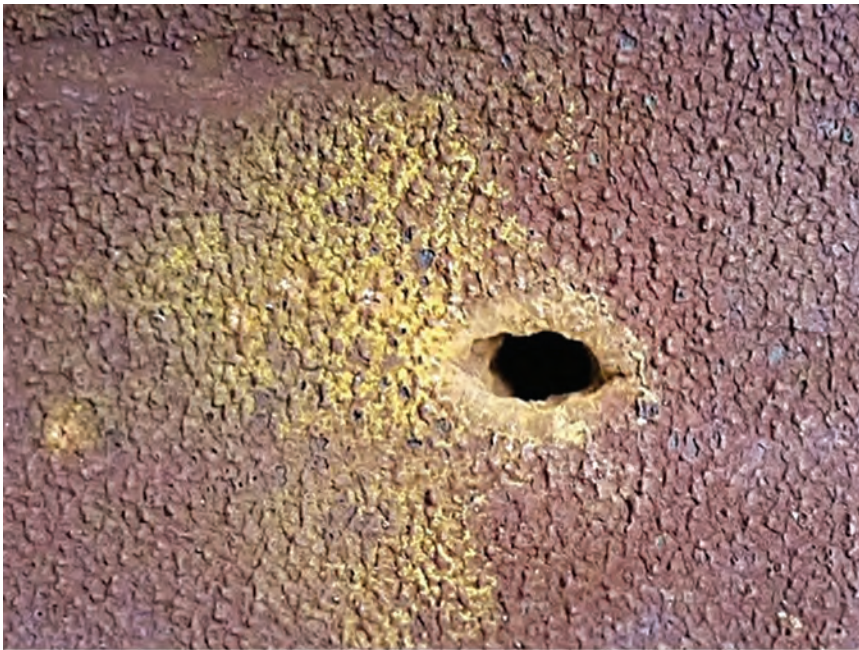
The tube ID surface was rough with dark brown coloration (Fig. 6.94a and b). A low-magnification view highlighted the elongated nature of the puncture on the ID surface (Fig. 6.95a). The entire ID surface was covered with shallow pits. The surface was dark brown in color. The punctured surface was quite smooth in nature, which characterizes erosion that appears as an aftermath to leakage. Scanning electron microscopy analysis highlighted shallow pitting corrosion in the ID surface (Fig. 6.95b). Energy dispersive spectroscopy analysis of the ID surface showed oxygen and iron; a scale on the ID surface showed the presence of oxygen, silicon, and manganese.

**Fig. 6.94** (a) ID surface view of a tube with pinhole-type puncture. (b) Close-up view at puncture location with ID surface showing dark brown adherent scale, 6×

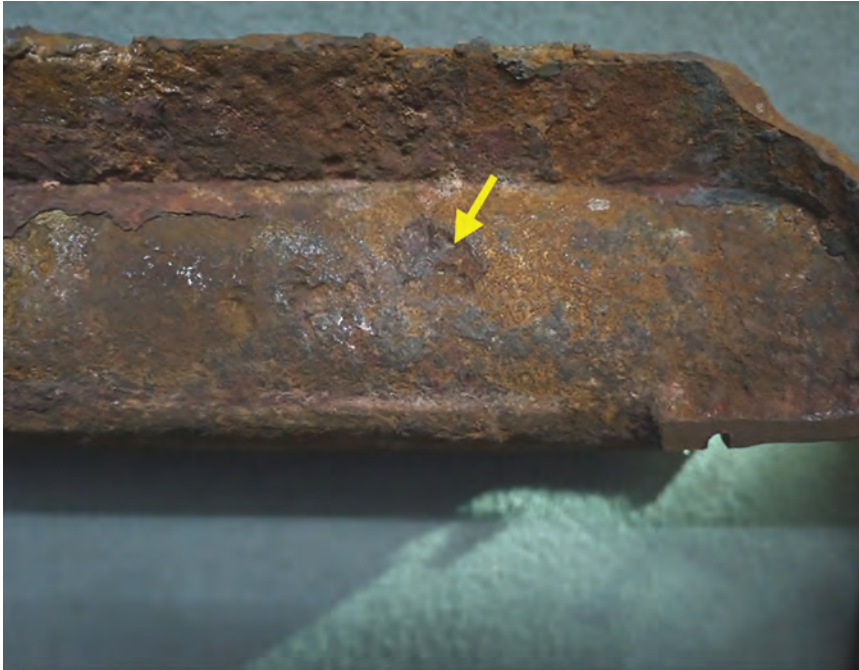
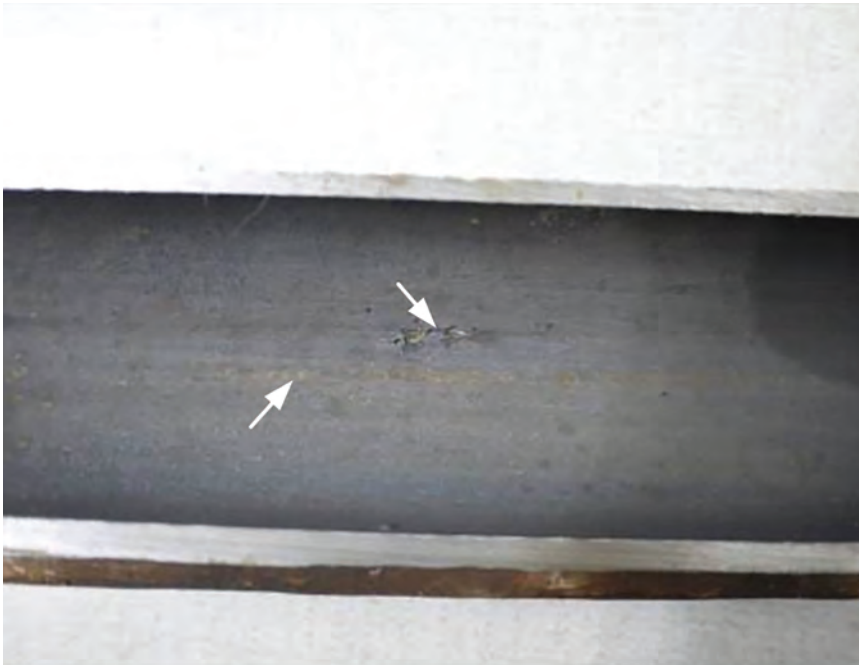
*Investigation and Findings* Visual examination highlighted a pinhole puncture on the outer surface, which was surrounded by erosion damage (Fig. 6.97a). The outer surface was reddish brown in color. The inner surface had thin adherent scale that was grayish black in color. Rough spots in the form of shallow grooves were noticed on the inner surface at the leakage location. There were scattered shallow pits on the inner surface (Fig. 6.97b).

**Fig. 6.97** (a) Close-up view at the leakage location on OD surface with leakage in the form of a pinhole. (b) ID surface indicating fine pits as well as groove-like metal wastage

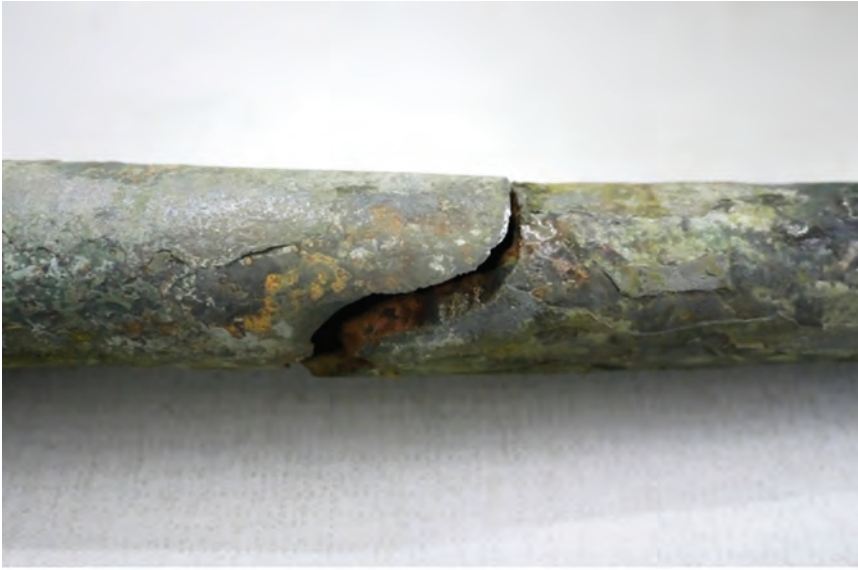
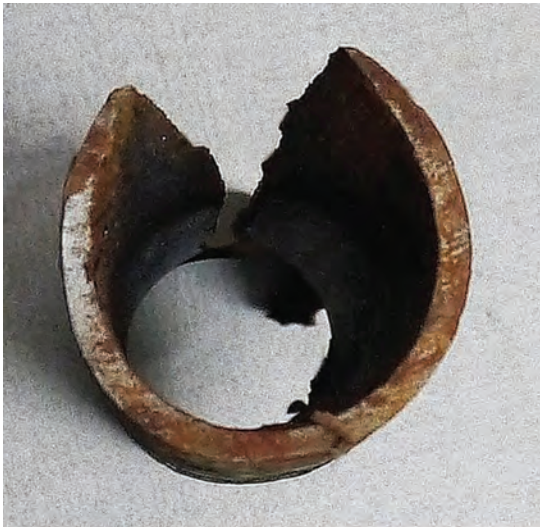
**Fig. 6.110** Oil-ash corrosion in low-alloy steel tube: (a) scale formation, (b) wall thinning

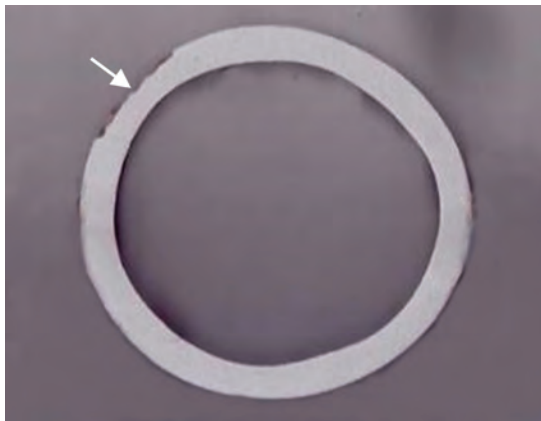
In order to determine the seamless nature of the tube, a sample was cut in a transverse direction followed by etching with 10% ammonium persulfate solution. Macrostructural examination confirmed the seamless nature of the tube, as shown in Fig. 6.115. It also showed metal wastage due to corrosion on the outer surface.

**Fig. 6.115** Transverse cross section of a tube in macroetched condition. It shows the seamless nature of the tube with metal wastage due to corrosion on outer surface.

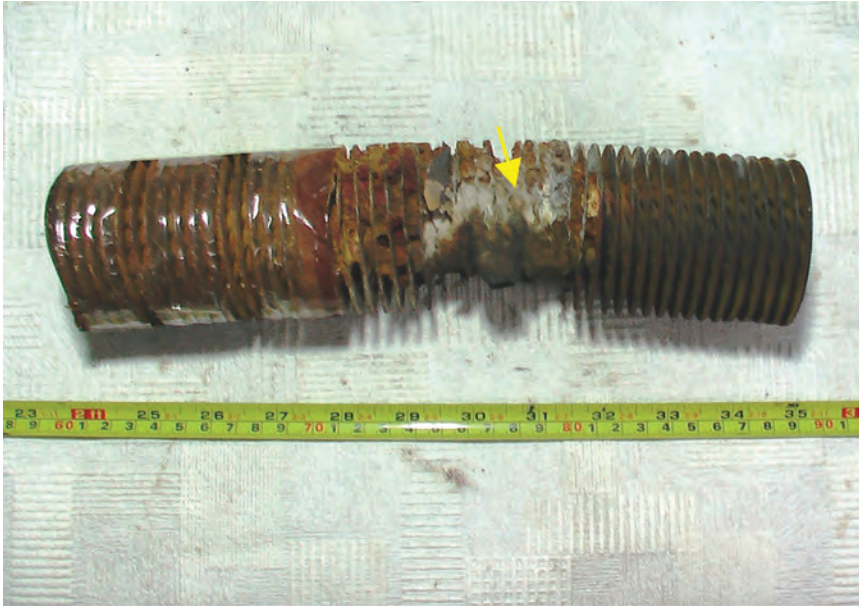
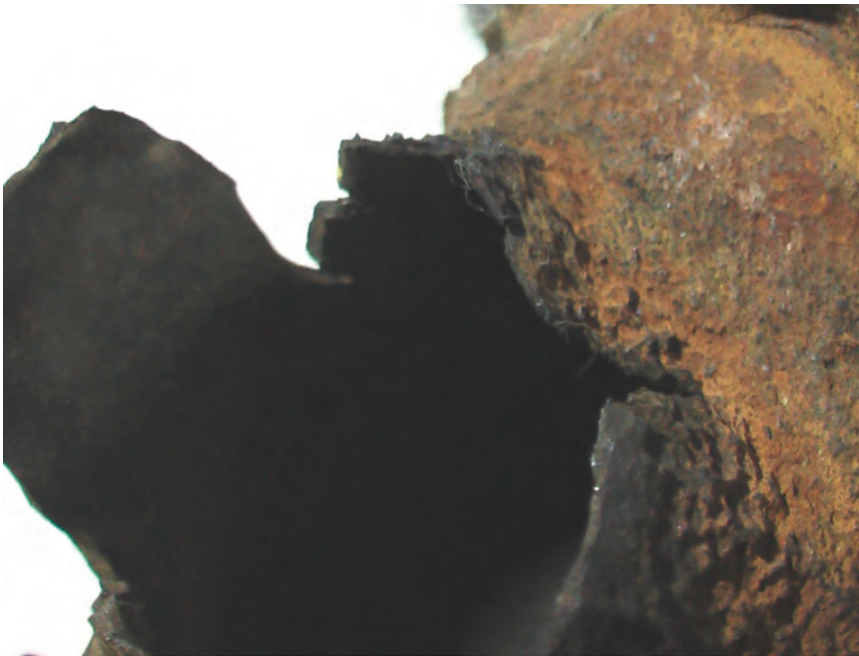
**Fig. 6.119** Failed tube showing (a) puncture location and surrounding area with damaged fins and (b) close-up view at puncture having thinned contours. Fins and area between the fins show scale deposits.

Investigation established that the failure was largely due to acidic corrosion. Energy dispersive spectroscopy analysis of the scale formed on the outer surface indicated a significant amount of sulfur as well as oxygen and iron. The flue gases produced on combustion of gaseous and liquid fuels proved to contain large amounts of moisture. An interaction between sulfur trioxide and moisture or water vapor present in the flue gases produced sulfuric acid in vapor form. When the prevalent surface temperatures of the tube metal decreased below the condensation temperature of the flue gases, the sulfuric acid vapor condensed as a white deposit on the tube surface. At certain locations, the sulfuric acid had eaten away the steel surface to such an extent that subsequent thinning of the tube resulted in failure of the tube in the form of a burst opening.

*Conclusions* The failure of the economizer tube in the form of a puncture was due to acid dew-point or cold-end corrosion. Moderate corrosion damage at the ID surface had assisted in the failure process. After a threshold

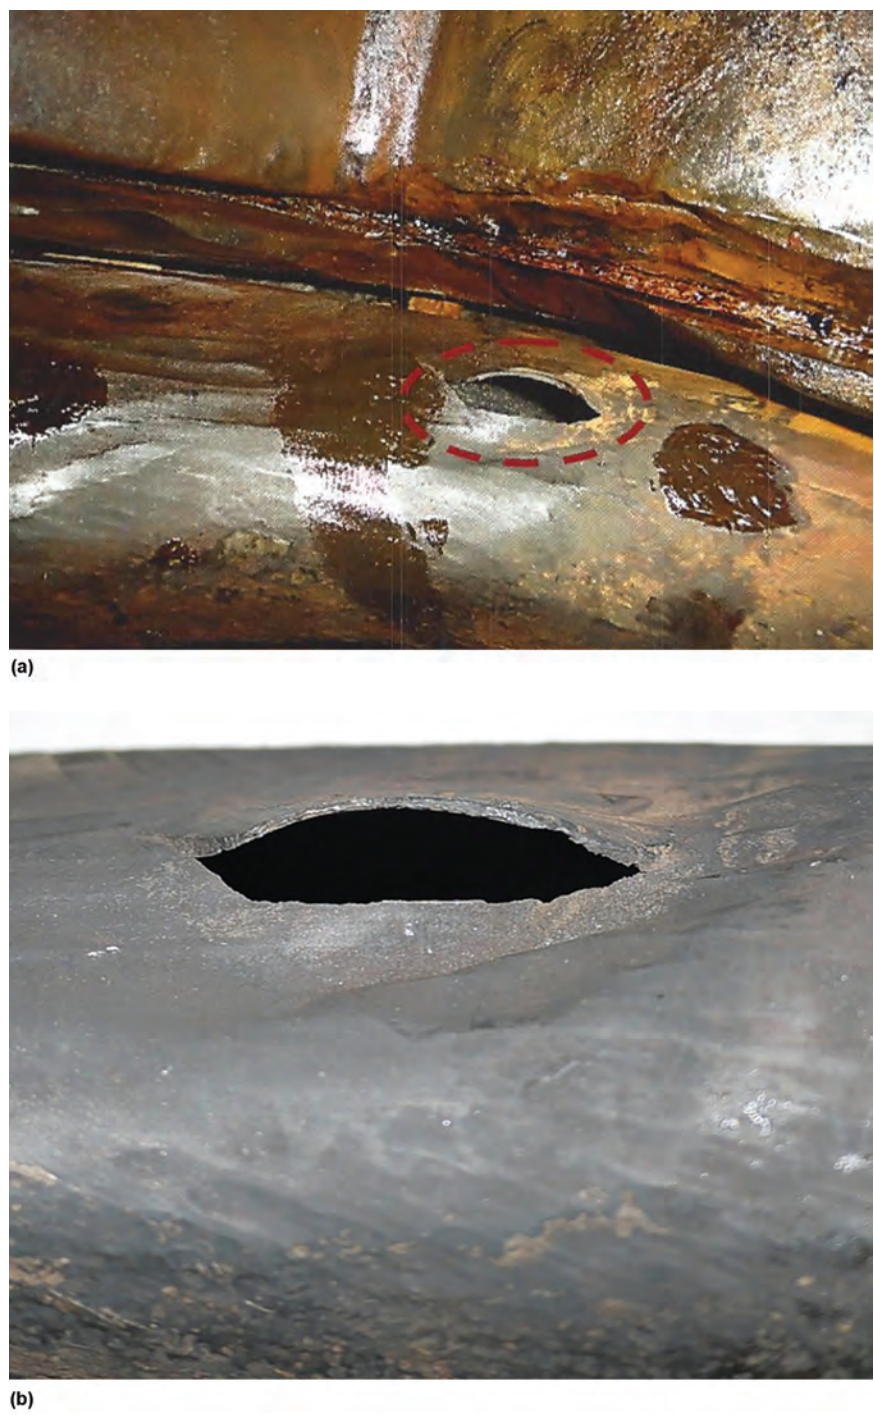
**Fig. 6.126** Erosion and longitudinal rupture of boiler tube due to misaligned soot blower

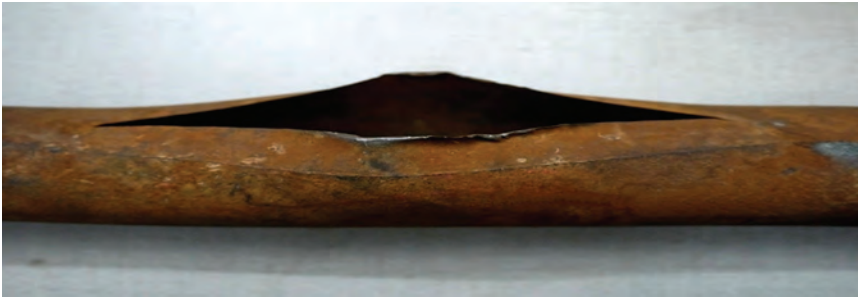
*Investigation and Findings* Visual examination showed a fish-mouth opening with sharp tips slightly away from the bend location (Fig. 6.128). The contours of the rupture lip were deformed outward. The area surrounding the contours on the outer surface was yellowish brown in color. The tube bulged slightly at the eroded area. The inner surface was partly

dark brown in color, indicating destruction of the protective magnetite scale in some places. The lip contours at the inner surface were dark brown in color.

**Fig. 6.128** Low-temperature reheater tube showing longitudinal rupture opening

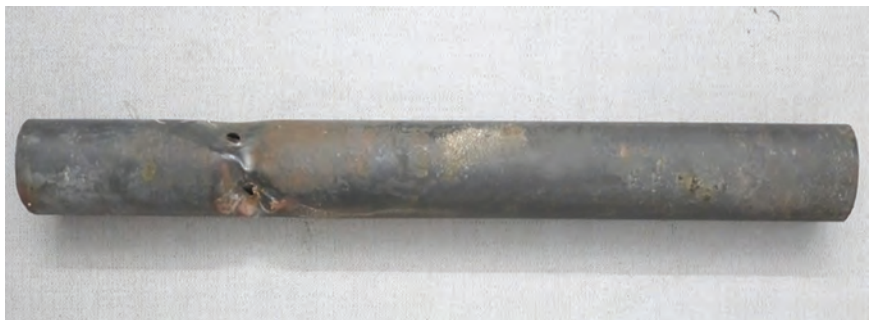
**Fig. 6.131** Superheater tube cut by steam leaking from an adjacent tube

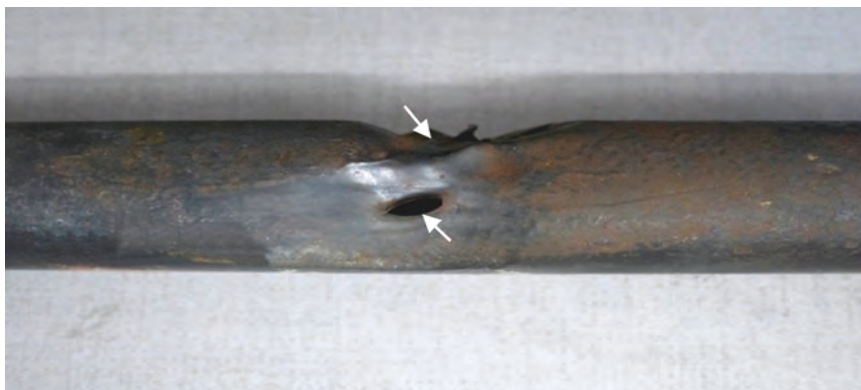
**Fig. 6.132** Failed tube showing brownish black scale and two punctures side by side, radially approximately 90° apart

*Investigation and Findings* Visual examination of the tube sample showed two punctures side by side, radially approximately 90° apart. The area surrounding the puncture had deformed inward and showed a smooth texture. The puncture contours were thinned down and projected outward (Fig. 6.132).

The extraneous nature of erosion on the outer surface was due to steam jet injections at the failure location, from the adjacent leaking superheater tube. This jetting promoted severe erosion, reducing the wall thickness at a localized spot on the outer surface of the failed tube. With reduced wall thickness, the tube could no longer sustain the internal prevailing pressure and burst open with its contours projecting outward.

*Conclusions* The failure of the superheater tube was of a secondary nature. It was caused by the external impingement of a steam jet that eroded the tube and also resulted in punctures at two locations.

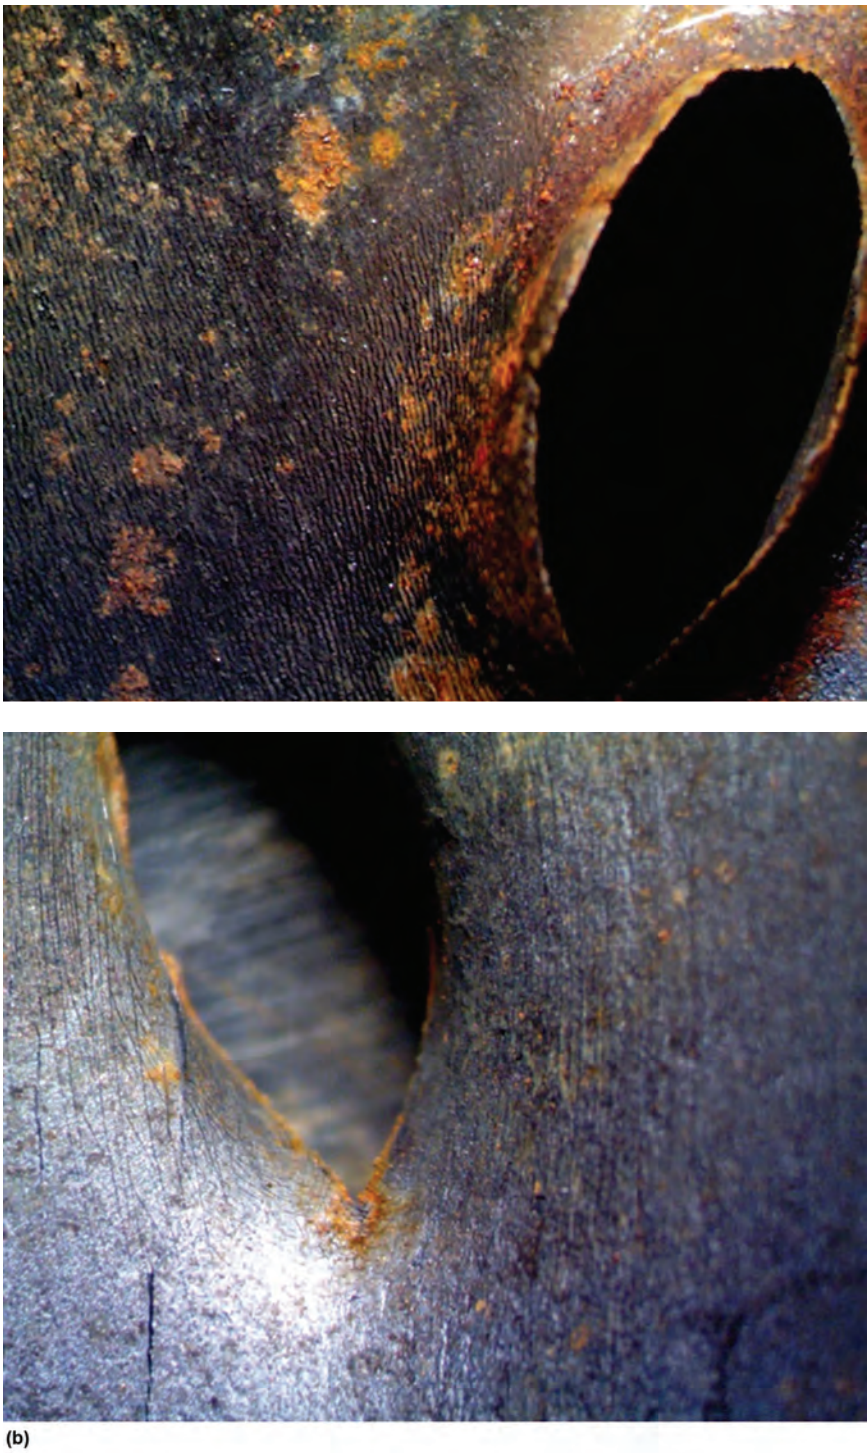
Low-magnification examination of the outer surface showed yellowish brown spots of corrosion surrounding the contour and erosion marks slightly away from the puncture location. The inner surface displayed a craze pattern surrounding the puncture. Thinning was noticed at the contours, which protruded outward (Fig. 6.133).

**Fig. 6.133** Low-magnification view of (a) outer surface indicating corrosion and erosion marks, 6×; and (b) inner surface surrounding the puncture with scale, 6×

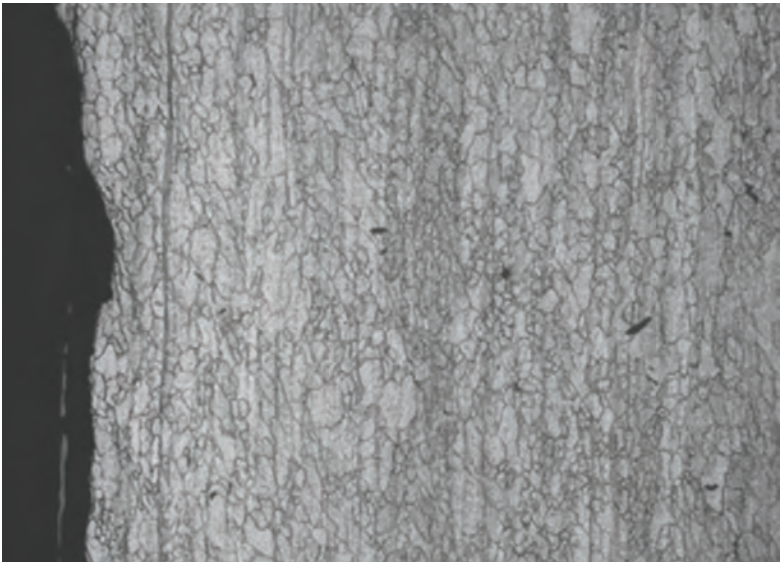
The outer-edge microstructure comprised ferrite, bainite, and carbides (Fig. 6.135b).

**Fig. 6.135** (a) Sample in as-mounted condition. (b) Outer edge microstructure of ferrite, bainite and carbides, 100×

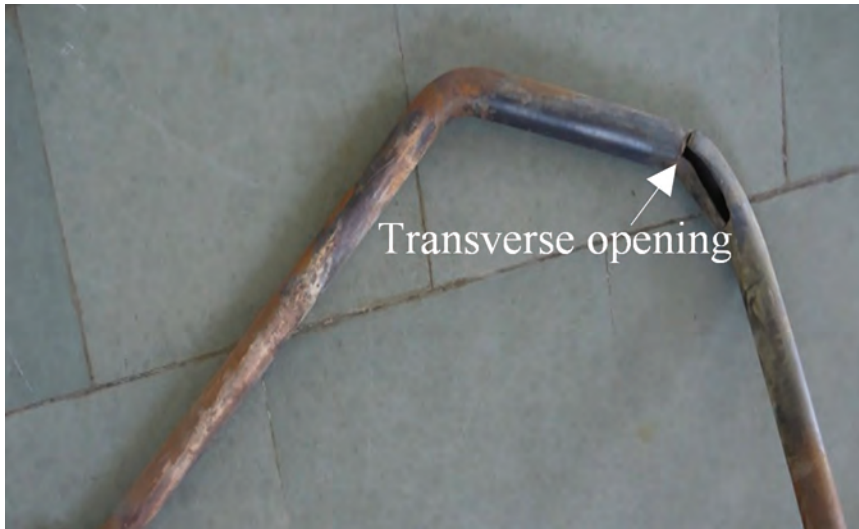
Bulging was noticed at the rupture location. The inner surface of the tube was smooth with a thin adherent magnetite scale that was grayish black in color.

**Fig. 6.137** Portion of a failed superheater tube showing failure location

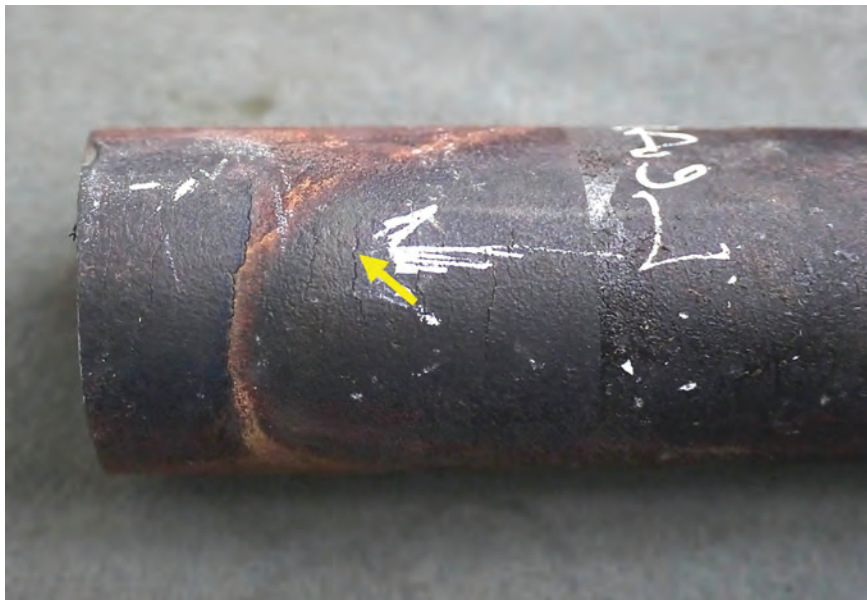
*Investigation and Findings* Visual examination of the failed tube sample revealed fine multiple and parallel cracks in the transverse (circumferential) direction. The outer surface of the tube was dark brown in color. Overall, the piece appeared straight and free from any visual abnormality with respect to distortion or bulging (Fig. 6.140).

**Fig. 6.140** Close-up view of a tube at leakage location revealing fine multiple and parallel cracks in transverse (circumferential) direction

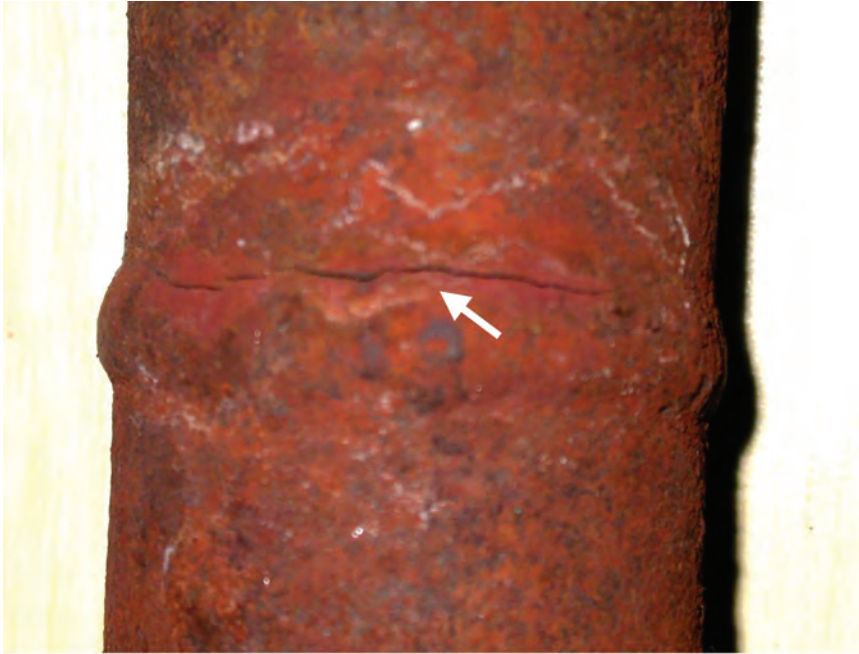
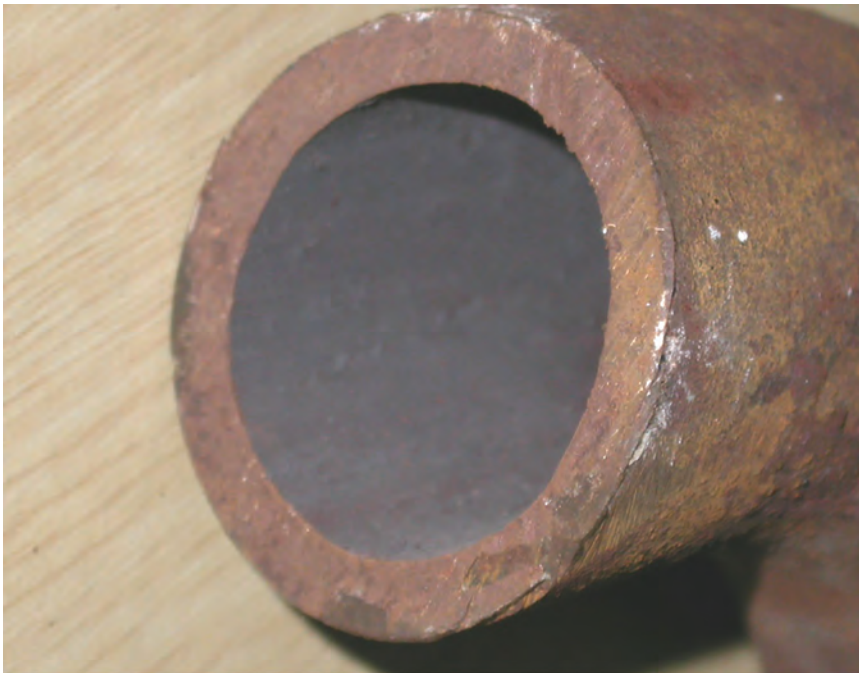
*Investigation and Findings* Visual examination of the tube showed the OD surface exhibiting a loosely adherent reddish brown scale. A crack of discontinuous nature in the transverse direction was seen at the weld joint between the tubes of two different wall thicknesses (Fig. 6.146). The ID side of the tube had a smooth black scale tightly adherent to the surface.

**Fig. 6.146** (a) Weld joint with a hairline crack on weldment. (b) ID surface view showing tightly adherent smooth black scale

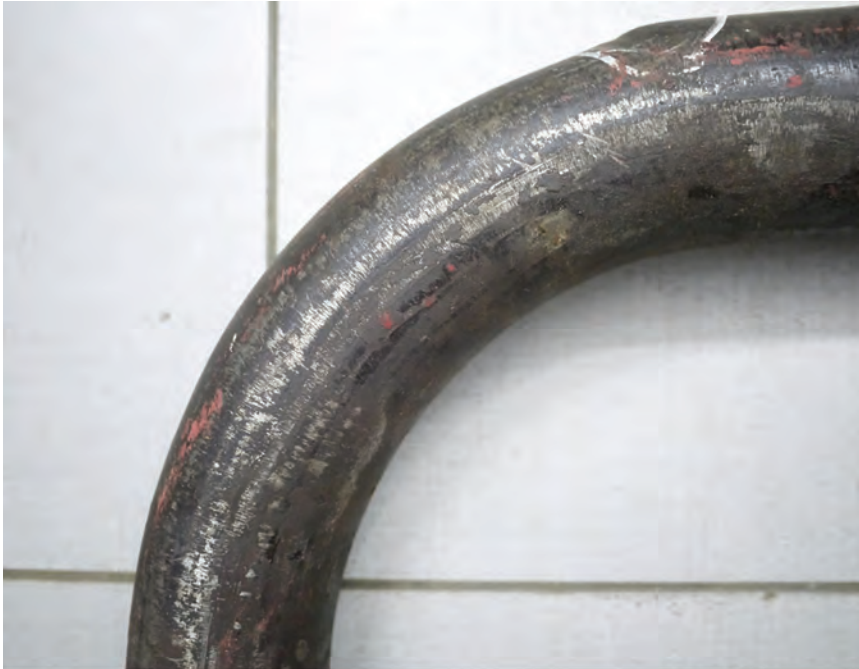
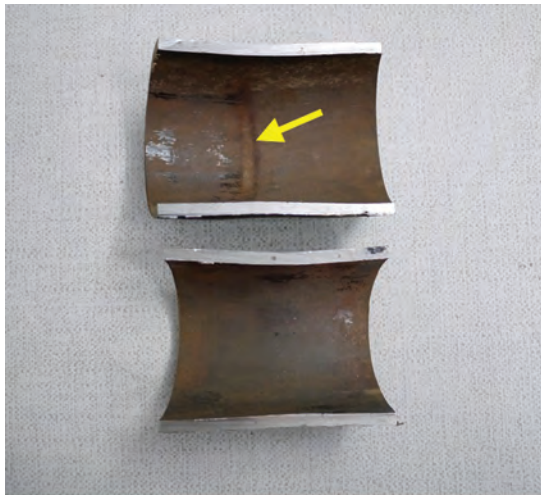
*Investigation and Findings* Visual examination revealed a smooth outer surface, with a few rubbing marks. No other defects were visible to the naked eye on the outer surface of the bend (Fig. 6.153a). The inner surface had a smooth texture with a thin adherent general form of corrosion. There was a small depression seen on the inner surface, marked by an arrow in Fig. 6.153(b).

**Fig. 6.153** Close-up views of the (a) outer surface of a tube bend and (b) inner surface with a small depression

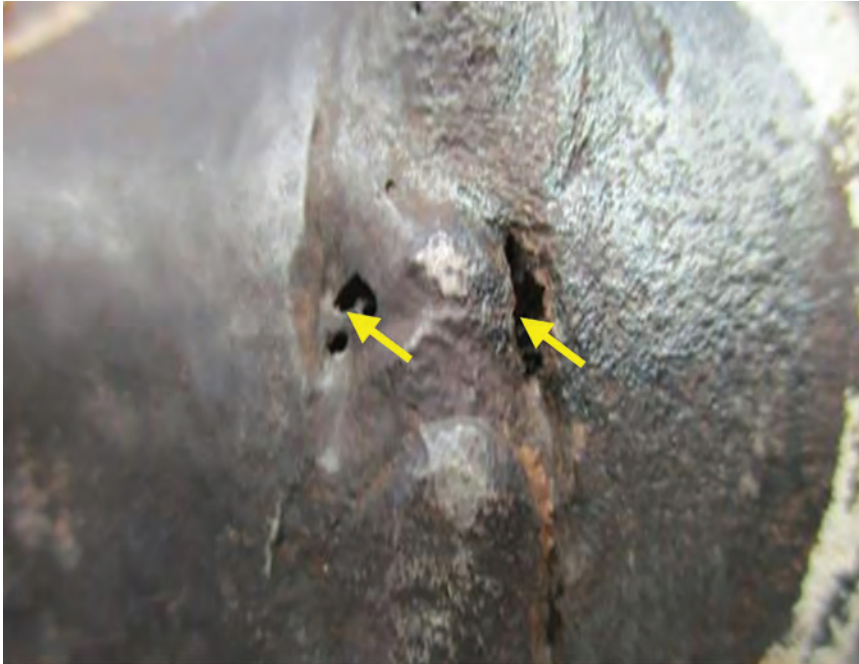
The tube sample was subjected to a low-magnification examination using a zoom stereo microscope. Leakage in the form of multiple punctures precisely from the weld location was clearly visible on the outer surface (Fig. 6.159a). The inner surface of the tube showed sharp ripples and deep undercuts, indicating the poor quality of the weld (Fig. 6.159b). The puncture contours on the outer surface were surrounded by erosion damage, which was due to water leakage after the failure.

**Fig. 6.159** Low-magnification views of the (a) outer surface of a tube with multiple punctures from where leakage had taken place and showing weld crown with nonuniform curvature, 8 $\times$ ; and (b) inner surface with sharp ripples and deep undercuts indicating poor quality of weld, 8 $\times$

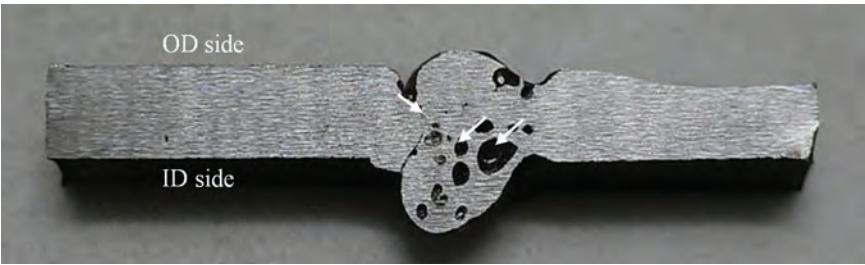
Macrostructural examination also confirmed the very poor quality of the welding; gross weld porosities and deep undercuts on either side were evident. A through and through crack joining the undercuts was seen, as marked by the arrow in Fig. 6.160. Uneven weld crown curvature as well as excessive weld penetration on the ID side was also visible.

**Fig. 6.160** Macrostructure showing longitudinal section view across the weld. The weld shows numerous porosities and through and through crack joining the undercuts from both sides.

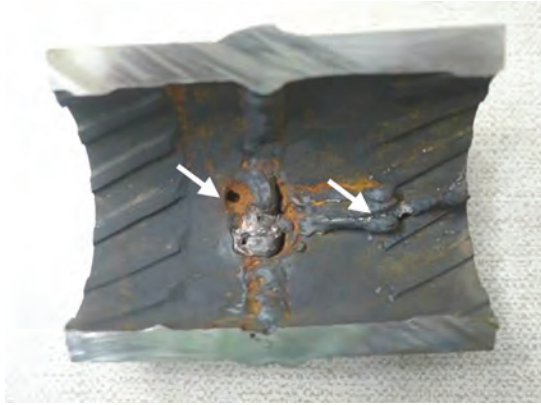
**Fig. 6.163** Close-up view of ID surfaces showing puncture located at fusion zone of the butt weld. Uneven weld penetration forming nonuniform ridges at the weld line are shown. The weld metal had excess penetration (as shown by arrow).

*Investigation and Findings* Upon visual examination of the ID surface of the tube, a puncture was seen at the fusion zone of the butt weld (Fig. 6.163). The weld metal had spilled out in the longitudinal direction of the tube, as shown by an arrow in Fig. 6.163. Dimensional measurements did not reveal any tube bulging.

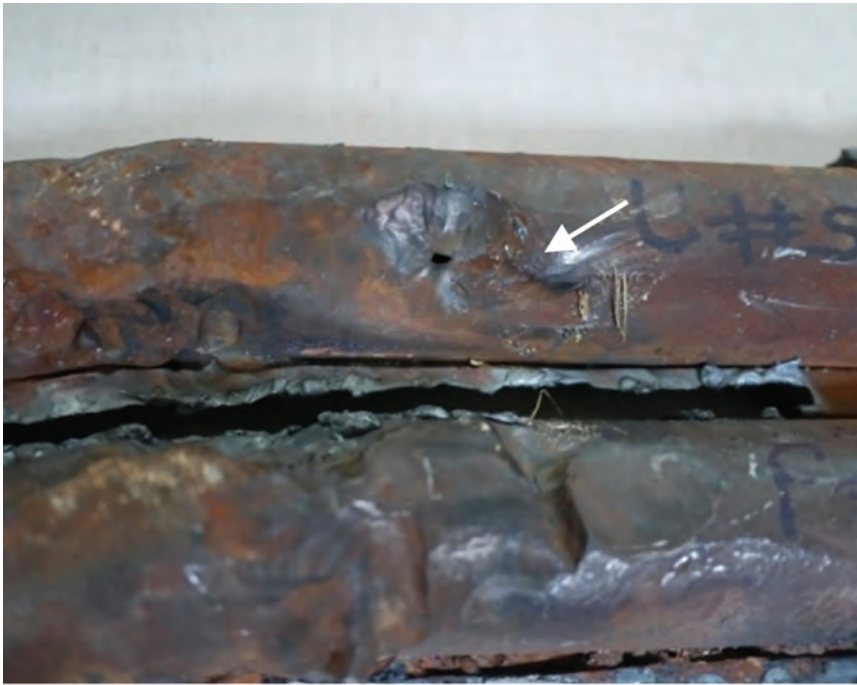
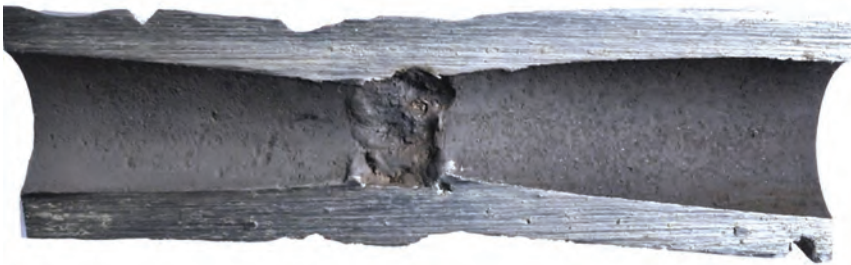
*Investigation and Findings* Visual examination of the failed sample highlighted a pinhole-type puncture at the tube-to-tube butt weld joint, as shown in Fig. 6.167(a). The area surrounding the puncture showed erosion damage on the outer surface due to water leakage. The inner surface of the tube showed a weld region with defects including lack of weld penetration and excessive weld penetration and porosity (Fig. 6.167b). The inner surface showed a rough texture, indicating metal wastage near the weld area.

**Fig. 6.167** (a) Close-up view of the tube indicating a pinhole-size puncture surrounded by the erosion damage. (b) Inner surface view of tube-to-tube butt weld joint with weld defects and surrounding area with shallow pits

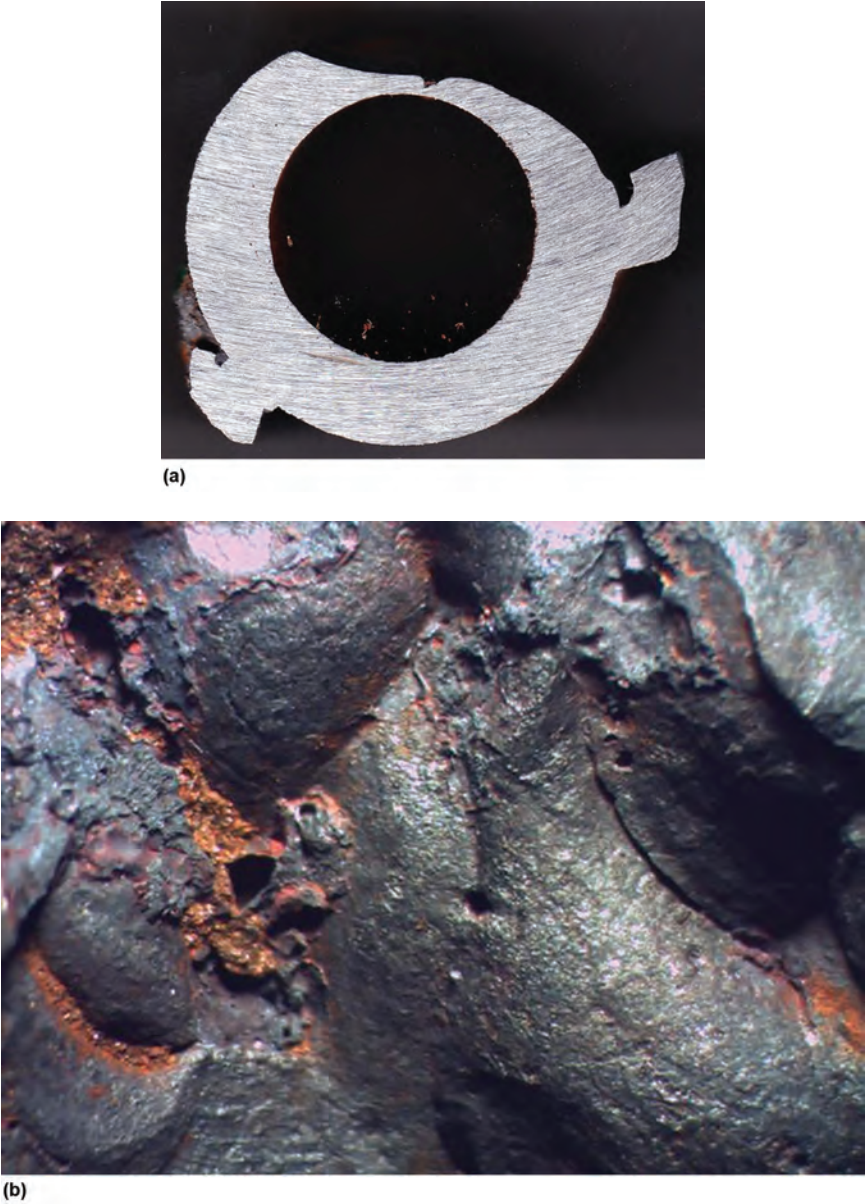
**Fig. 6.168** (a) Transverse cross section of a tube at a few millimeters distance from the leak indicating metal wastage on outer surface. (b) Poor quality of welding with porosities and deep ripples, 6×

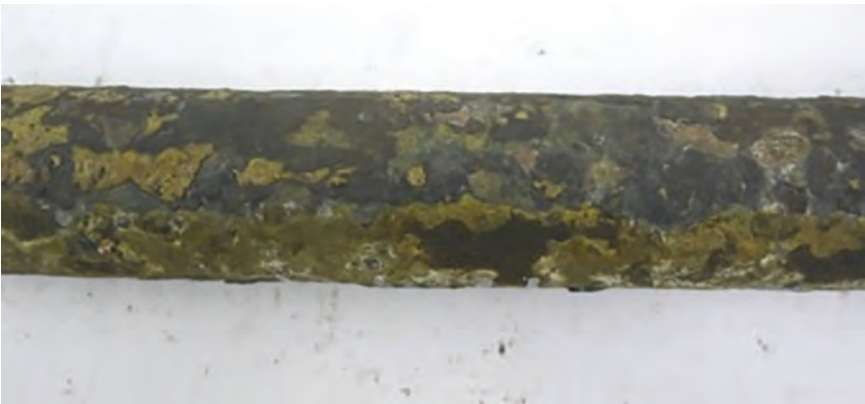
Visual examination of the tube revealed the presence of a greenish yellow scale on the external surface and an adherent blackish scale on the inner surface of the tube, as shown in Fig. 8.6 (a) and (b).
