# **The Corrosion of Copper and Its Alloys**

**A Practical Guide for Engineers**

**Roger Francis**

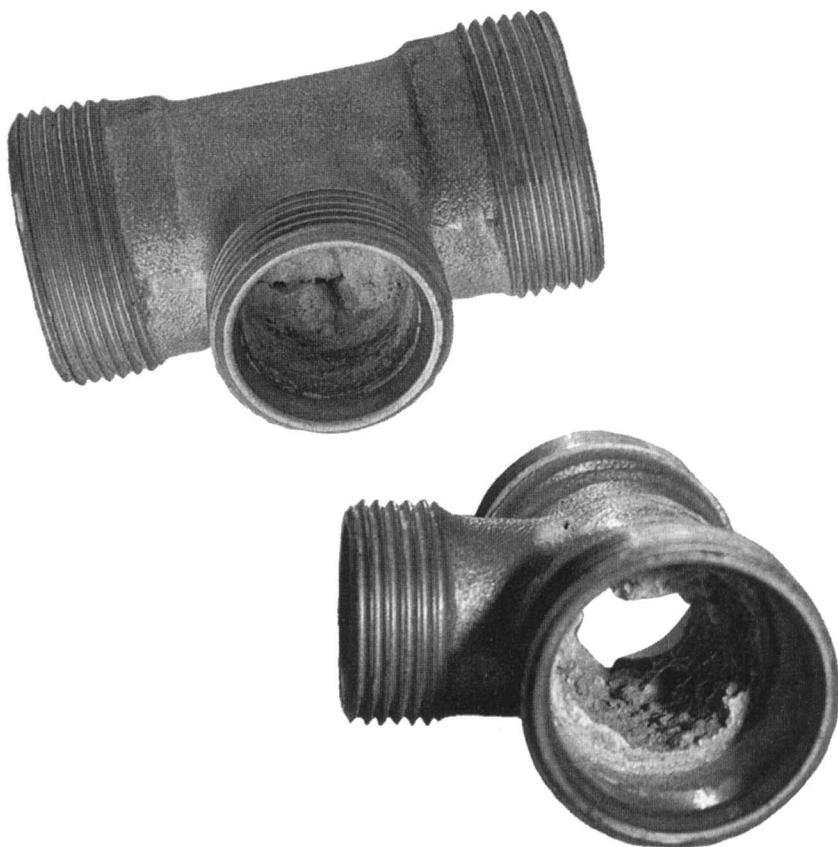
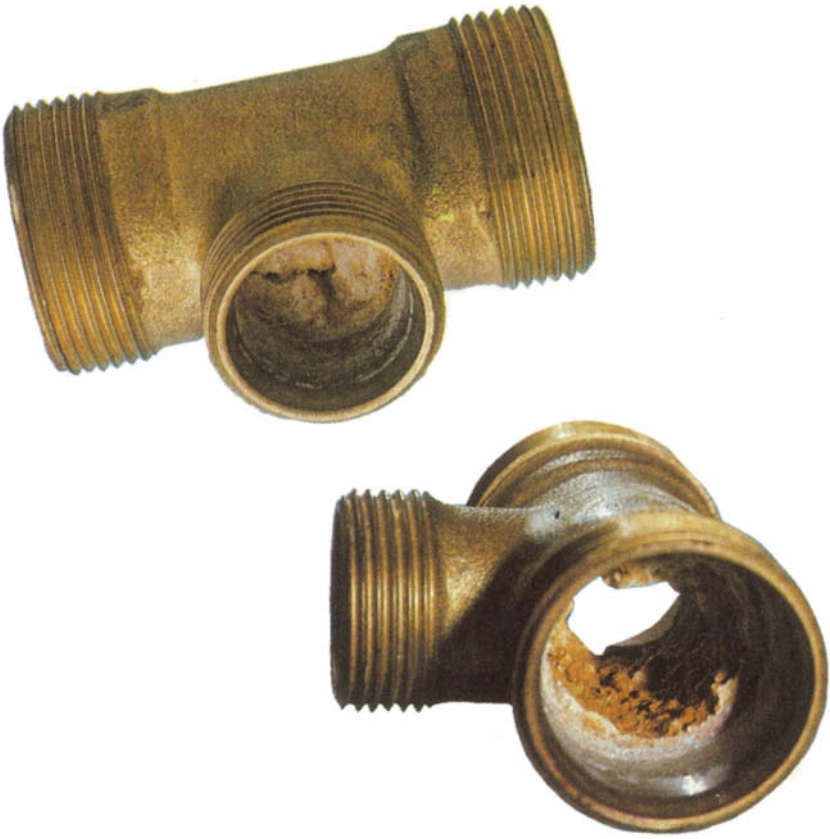
**FIGURE 9.1** Meringue dezincification blocking a duplex brass fitting. (Photograph courtesy of Copper Development Association U.K.) (See color section.)

**FIGURE 9.1** Meringue dezincification blocking a duplex brass fitting. (Photograph courtesy of Copper Development Association U.K.)

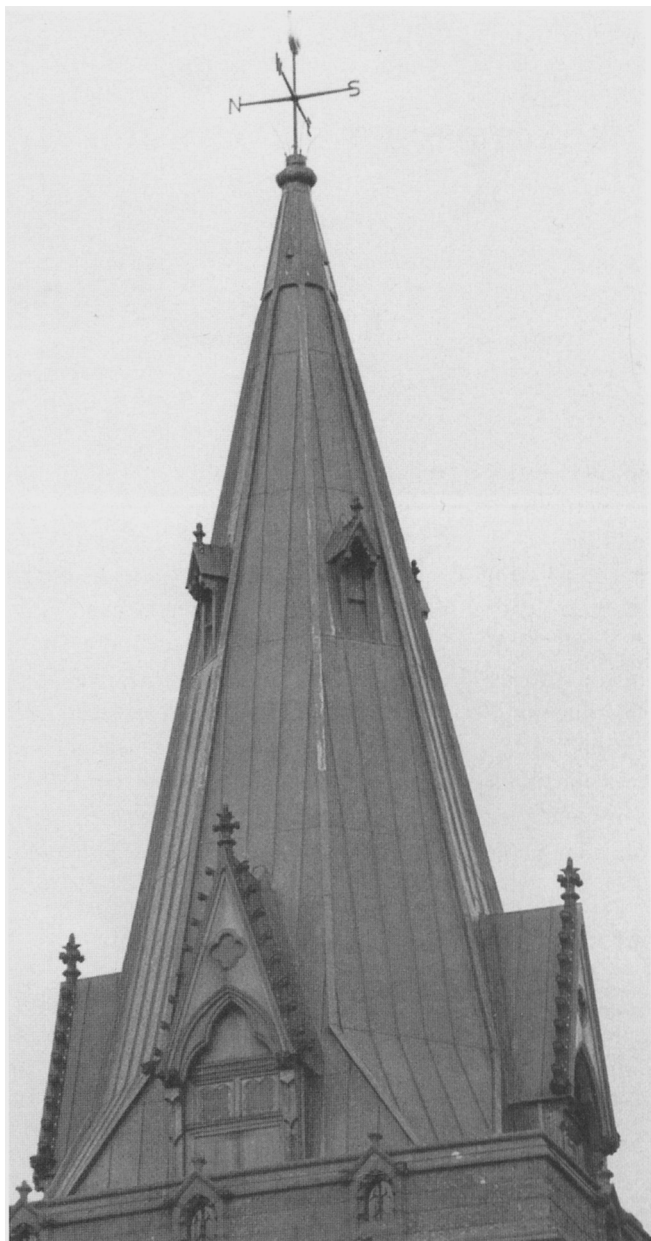
**FIGURE 16.1** Copper-covered spire on St. Magnus Cathedral, Kirkwall, Scotland. (Photograph courtesy of the Copper Development Association.) (See color section.)

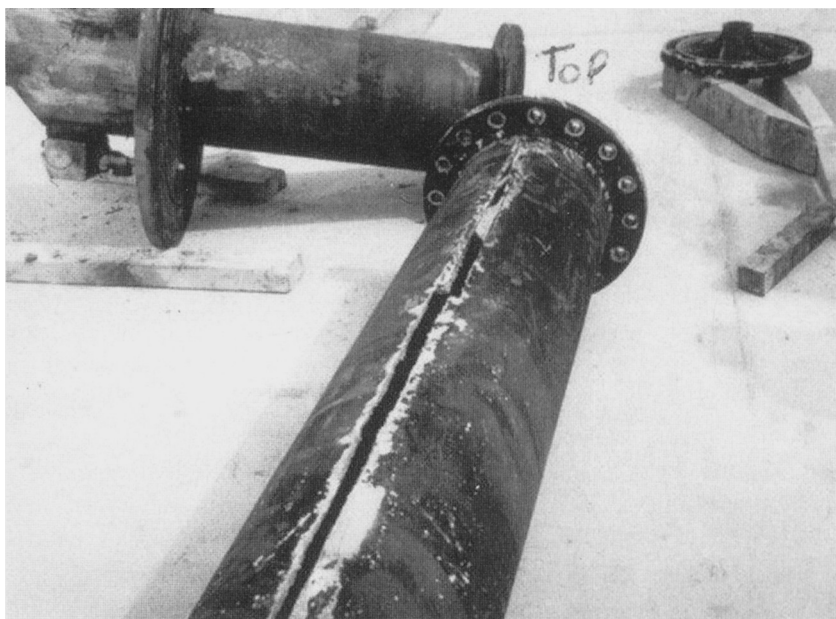
**FIGURE 18.1** Corrosion of the beta phase in an NAB seam-welded pipe that had not been postweld heat treated. (Photograph courtesy of the Nickel Institute.) (See color section.)

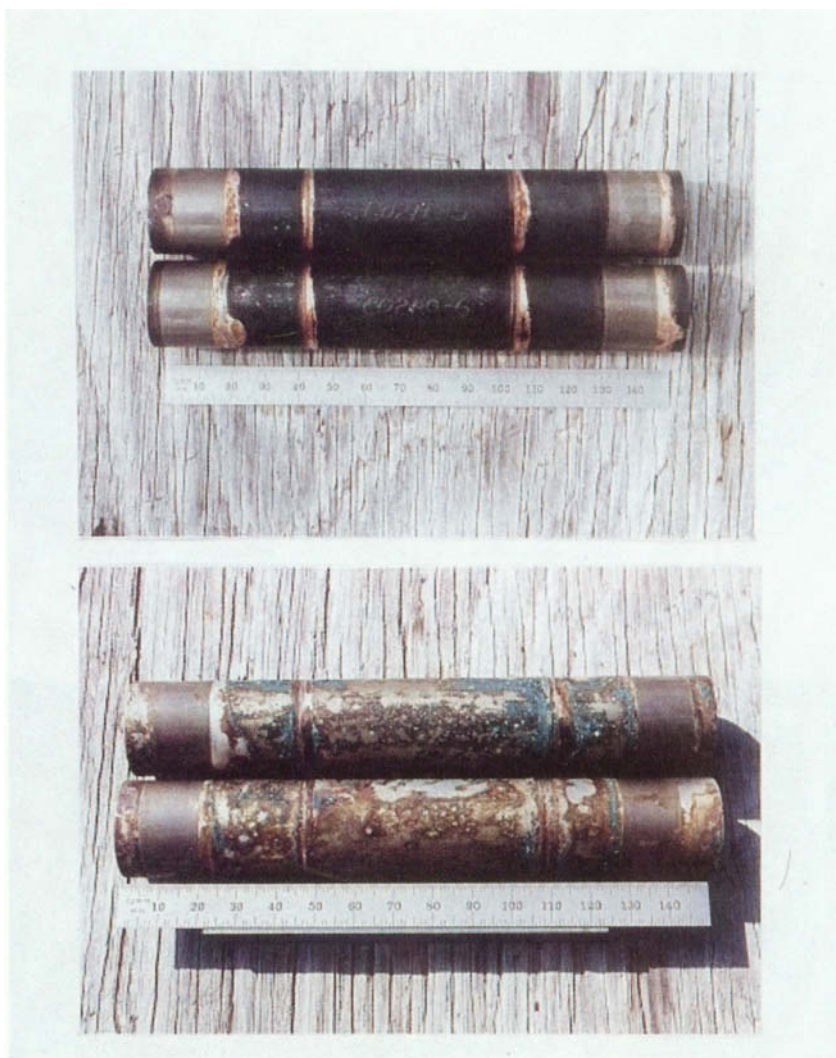
**FIGURE 6.2** Appearance of 70/30 copper-nickel tubes with O-ring crevices after one and three cycles of 500 hours in flowing seawater followed by 500 hours of stagnant seawater. (Photographs courtesy of R.M. Kain.) (See color section.)

**FIGURE 6.2** Appearance of 70/30 copper-nickel tubes with O-ring crevices after one and three cycles of 500 hours in flowing seawater followed by 500 hours of stagnant seawater. (Photographs courtesy of R.M. Kain.)

Kain and Weber examined the effects of lay-up conditions on the crevice corrosion resistance of 70/30 copper-nickel and Alloy 400 under RO conditions.<sup>14</sup> The samples were tubes and plates creviced as described earlier.<sup>13</sup> The exposure cycle was 500 hours of flowing seawater, followed by 500 hours in either stagnant, filtered seawater or stagnant lay-up solution, which consisted of 1% sodium metabisulfite in water containing 1,000 mg/L chloride. The samples were examined after one and three cycles of exposure, and Figure 6.2 shows the appearance of the 70/30 copper-nickel samples after one and three cycles. After the first cycle, the tube was largely covered in a black sulfide film, and the crevice corrosion where the O-rings were located is clearly visible. After three cycles, there were also some green and brown corrosion products, with the crevice attack at the O-rings again still clearly visible. The depths of attack are shown in Table 6.7.

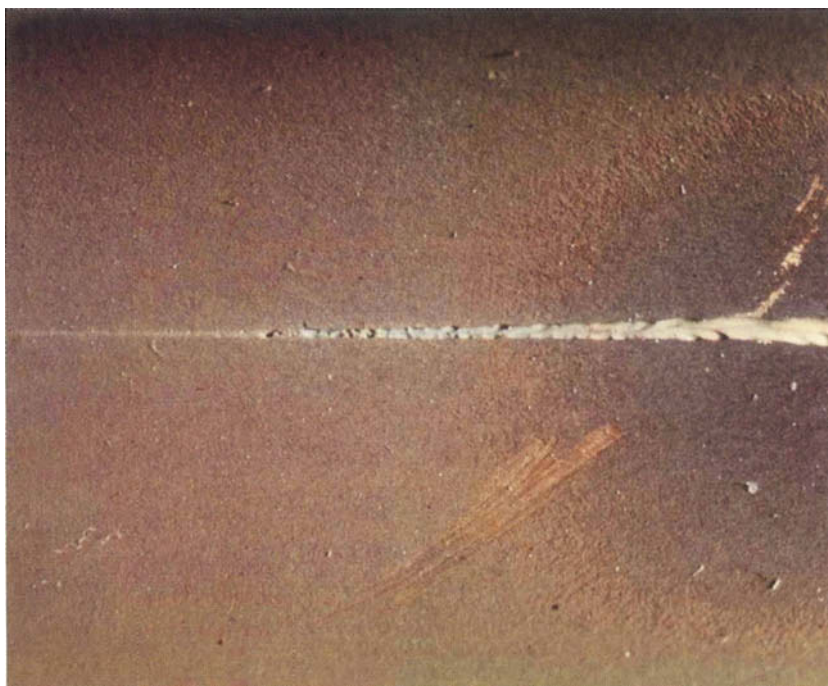
**FIGURE 7.23** Erosion corrosion at a scratch line on an aluminum brass tube, where repassivation did not occur due to overchlorination. (See color section.)

**FIGURE 7.23** Erosion corrosion at a scratch line on an aluminum brass tube, where repassivation did not occur due to overchlorination.

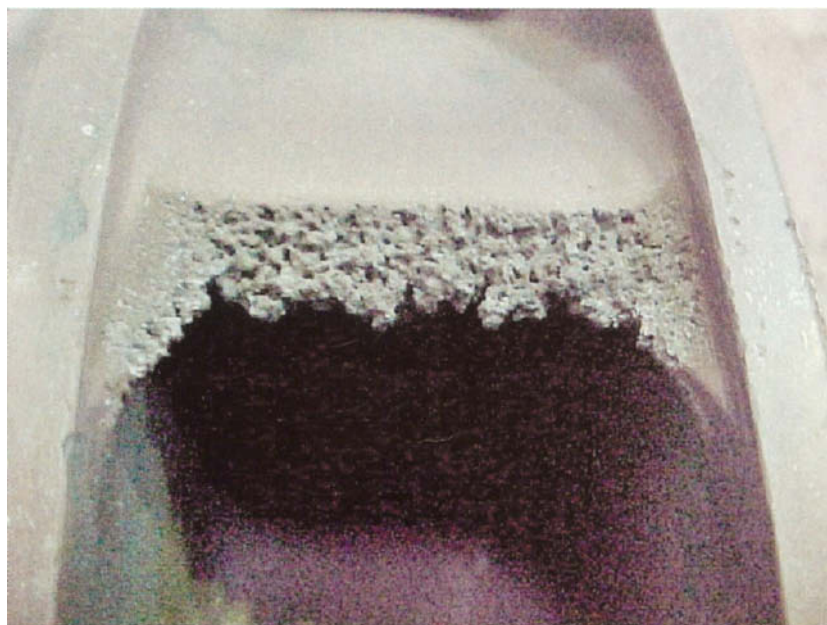
**FIGURE 8.1** Cavitation damage, showing typical jagged, honeycomb appearance. (See color section.)

**FIGURE 8.1** Cavitation damage, showing typical jagged, honeycomb appearance.
