# Handbook of Materials Failure Analysis

With Case Studies from the Electronic  
and Textile Industries

Edited by  
Abdel Salam Hamdy Makhlouf  
Mahmood Aliofkhazraei

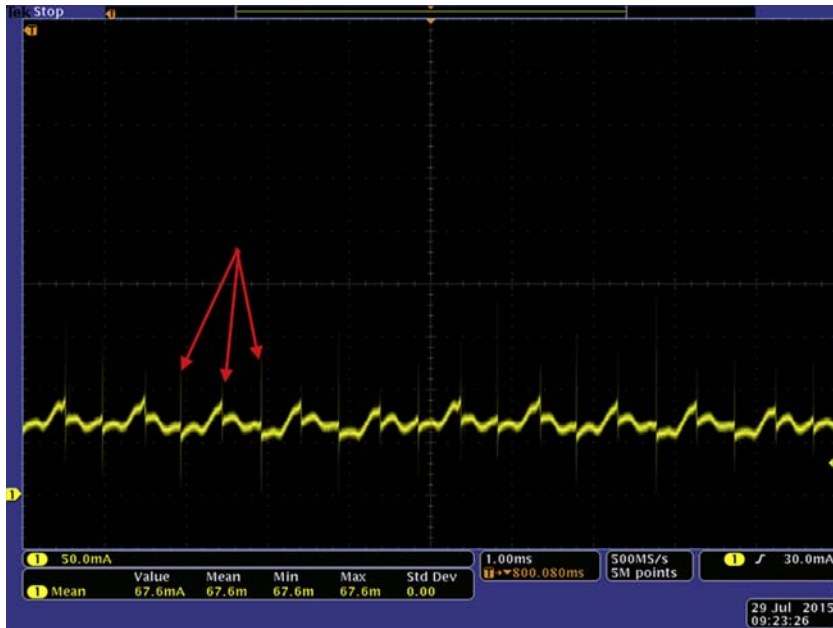
**FIGURE 6.2**

Oscilloscope capture displaying the commutation current through a stock motor over a period of approximately two revolutions. Commutation spikes are highlighted by the red arrows.

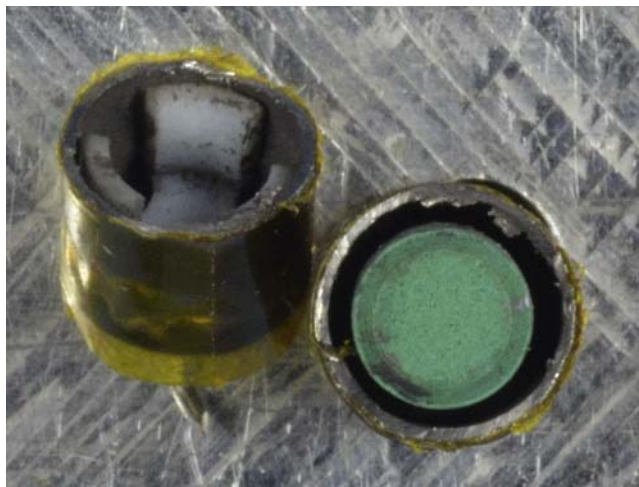
**FIGURE 6.20**

The inner electrolyte chamber was found to be dry.

In addition to these findings, the markings on the capacitor revealed that it was, in fact, a sulfuric acid electrolyte wet-tantalum capacitor. Additionally, as shown in Fig. 6.20, upon removal and disassembly, the inner chamber of the capacitor was found to be dry. Finally, upon analysis of a cross section of the capacitor end near the droplets found on the humid detector CCA, shown in Fig. 6.21, the leakage path was discovered. These findings allowed for unambiguous assignment of the source of the sulfuric acid that led to the residue formations.

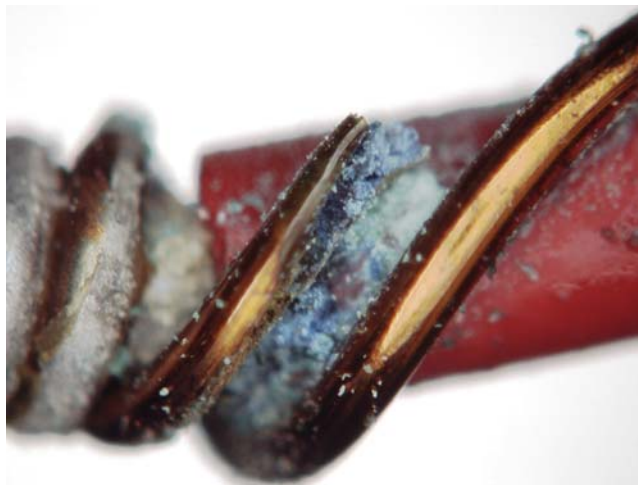
**FIGURE 6.22**

Corrosion of copper wire resulting from the presence of residual flux.

Fig. 6.22 displays corrosion at a copper mag wire with a polymer coating soldered to a lead. Residual water-soluble flux which was not rinsed off after application was shown to have led to the formation of the corrosion products. The wire in this area was completely consumed, causing an open circuit.

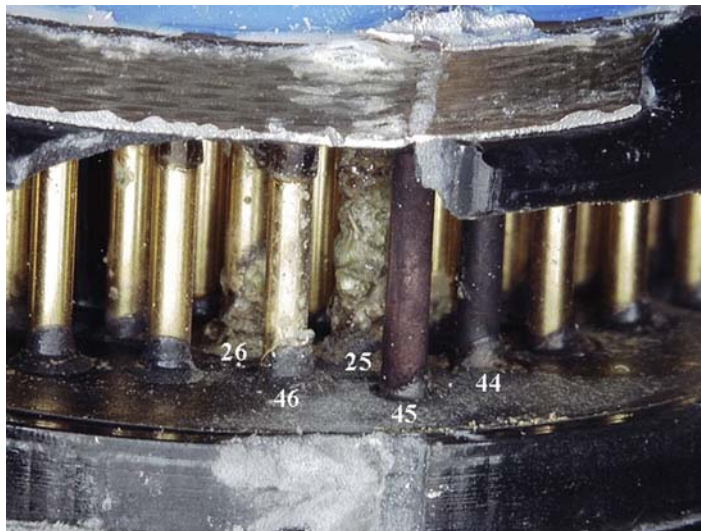
**FIGURE 6.23**

Electromigration of metals resulting from flux contamination.

Fig. 6.23 shows an example in which flux residue was found to have accelerated electromigration of metals associated with a connector. The pins labeled 44 and 45 have plated copper formations on the gold coating of the pins. The dull appearance of these pins results from the presence of copper and its oxides on the outermost gold pin plating layer. These materials identification as well as

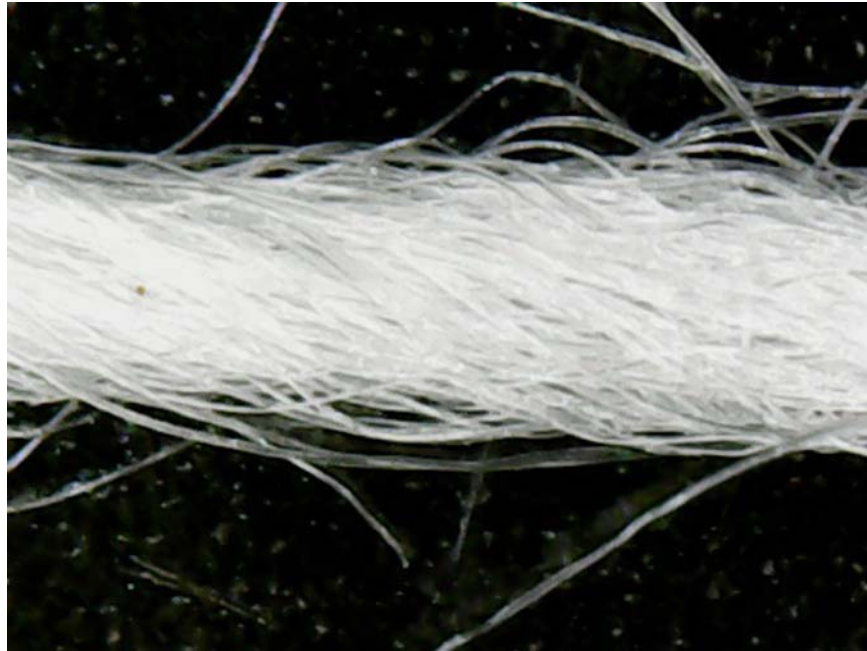
**FIGURE 10.1**

The helical structure of a ring spun yarn: microscopic view ( $\times 40$ ) of the longitudinal structure (cotton-polyester yarn, 15 tex).

Five spinning methods exist today that are used for industrial spinning of natural and man-made fibers: ring, rotor, friction, hollow-spindle, and air-jet. Only the ring spun yarns have a helical structure along their length, thus using to a maximum extent the strength of the fibers in the cross section (Fig. 10.1). The helical path of the fibers is visible. The same is the path of the single yarns, when they are twisted to form a twofold yarn (Fig. 10.2).

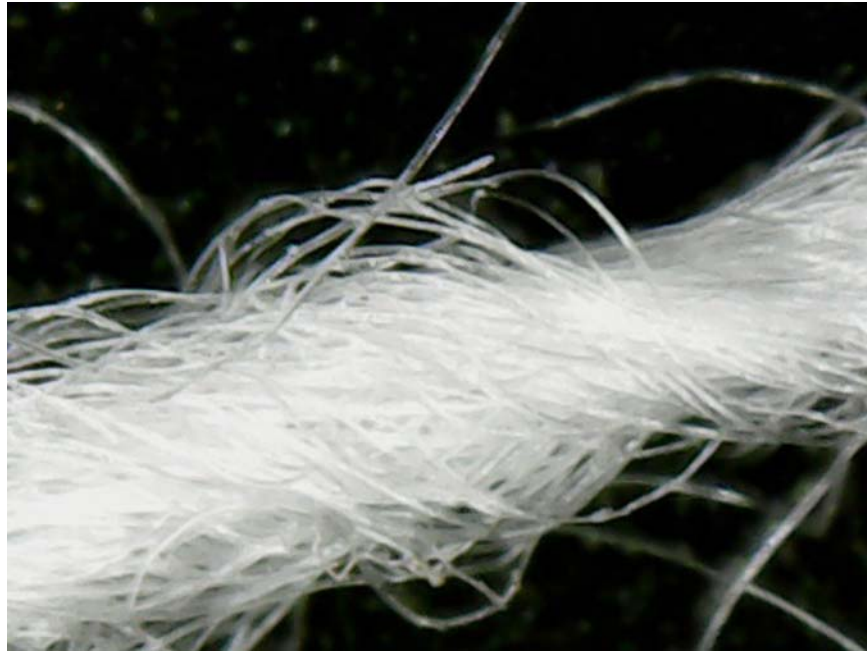
**FIGURE 10.3**

Rotor spun yarn: microscopic view ( $\times 40$ ) of the longitudinal structure (cotton-polyester, 20 tex).

Rotor spun yarns show core—sheath structure, where only the core possesses a helical twisting of the fibers, while the sheath is constituted of individual fibers or ribbons of fibers, wrapped around the core (Fig. 10.3). Air-jet spun yarns have a fasciated structure: a core of parallel fibers around which a small number of surface fibers are twisted [1] (Fig. 10.4).

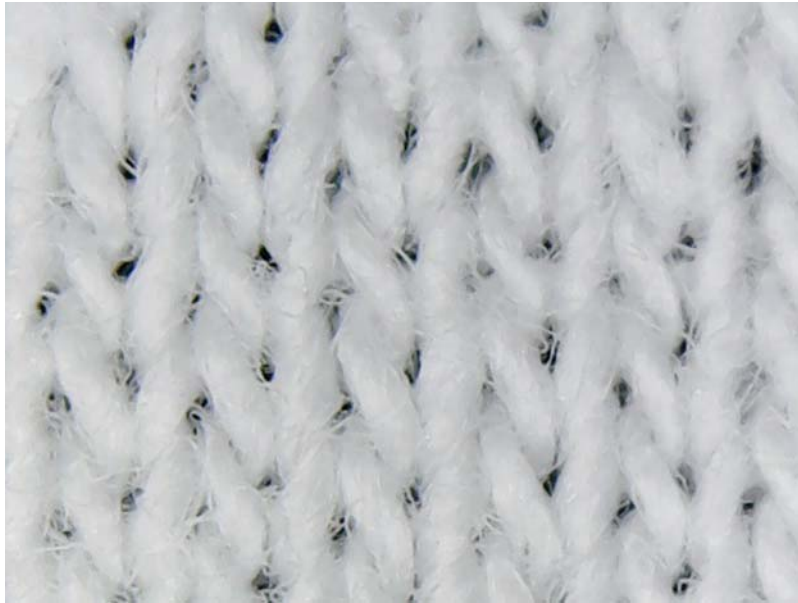
**FIGURE 10.13**

Microscopic view of a knitted macrostructure.

Most of the yarns are used for weaving or knitting of fabrics, representing the mesostructure of the woven (Fig. 10.12) or knitted (Fig. 10.13) macrostructures. The exploitation of the fabrics differs from the tests, applied to the compound yarns, including the tensile tests. During wearing, storing, and washing, textiles are subjects to specific mechanical stresses [24]: they can be exposed to strain forces of 20% or more [25], load of thousands of Newtons per meter [26], and forces that make them bend to radii of less than 1 mm [27].

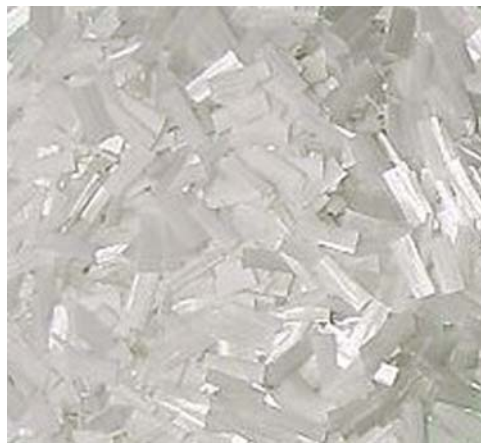
**FIGURE 10.15**

Fiberglass material.

Fiberglass is an example of the first modern human-made composite materials: the matrix is plastic, reinforced by the glass, formed as fine threads that are usually woven into a glass fabric (Fig. 10.14). Glass fibers, being made of brittle material (Fig. 10.15), would break without the protection of the matrix. On the other hand, the plastic binder increases its strength extremely, acting together with the glass fibers and using their very high sturdiness.

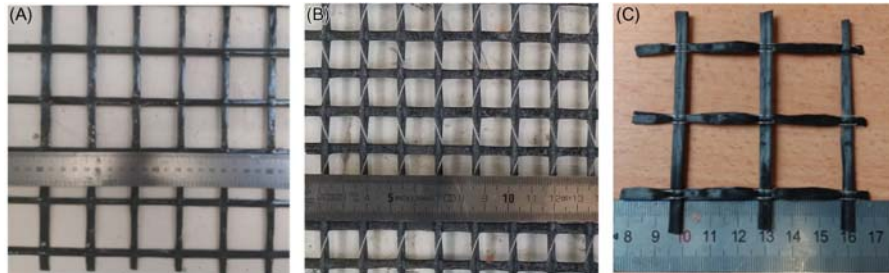
**FIGURE 12.4**

Images of three carbon textiles (GC1, GC2, GC3) used in the experimental study. (A) GC1 carbon textile; (B) GC2 carbon textile; and (C) GC3 carbon textile.

preimpregnated by epoxy resin with two different preimpregnation ratios, completely preimpregnated for the GC1 textile and a very low level for GC3 textile, whereas the GC2 textile was treated with a product of amorphous silica as a coating. They were also manufactured in grid form with different grid geometries (see Fig. 12.4). The properties of the three studied carbon textiles are summarized in Table 12.1.
