# Handbook of Materials Failure Analysis

With Case Studies from the Chemical,  
Concrete, and Power Industries

# Progressive failures of components in chemical process industry: Case history investigation and root-cause analysis

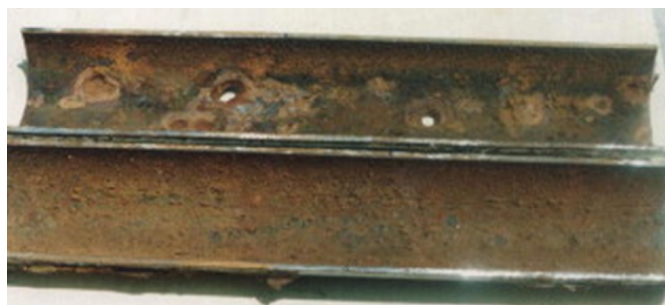
**FIGURE 2.4**

Through holes depicted due to pitting and deposition of corrosion product are present at the inner surface of line pipe.

The damaged portion of line pipe was selected and cut for visual examination from inside as shown in [Figure 2.4](#). The metallographic study was carried out to evaluate any variation in microstructure due to any metallurgical variation during manufacturing or operation. To investigate the cause of failure, the line pipe design and flow rate calculations were critically examined. The electrochemical behavior of line pipe material was determined by potentiostatic method to predict its corrosion tendency toward spent caustic solution.

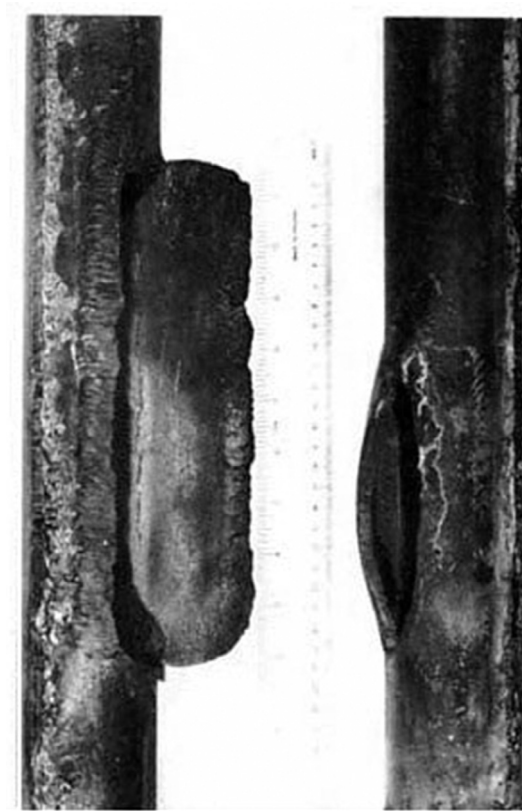
**FIGURE 3.5**

Hydrogen damage, “window opening” and “thick-edge spilt” type failure [3].

Boiler tube failure caused by hydrogen damage resulted from liberation of atomic hydrogen during corrosion process [13,14]. This hydrogen is capable of diffusing into the metal wall. It may pass through the wall into the furnace environment. If the atomic hydrogen reacts with carbide ( $\text{Fe}_3\text{C}$ ) phase of tube wall metal to form methane ( $\text{CH}_4$ ),  $4\text{H} + \text{Fe}_3\text{C} = \text{CH}_4 + 3\text{Fe}$ , the outward diffusion ceases and methane begins to accumulate within the tube wall. The accumulation sites for the  $\text{CH}_4$  are grain boundaries adjacent to colonies of pearlite, the  $\text{Fe}_3\text{C}$  containing constituent of the microstructure.  $\text{CH}_4$  gas pressure at the grain boundaries eventually exceeds the grain boundary strength, resulting in short, discontinuous, randomly oriented microcracks. Interlinkages of these microcracks diminish the load carrying cross-section of the tube wall metal. Eventually, a thick-walled rupture of the tube metal occurs. Figure 3.2 shows the locations of the boiler where hydrogen damage can occur and Figure 3.5 shows hydrogen damage, window opening, and thick-edge-type failure.

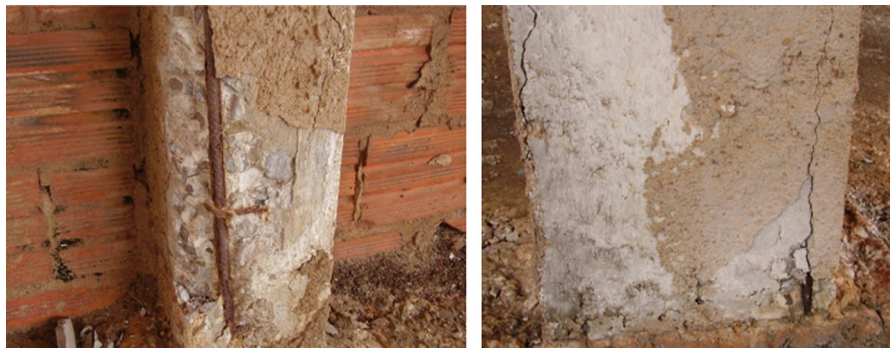
**FIGURE 5.1**

Columns damaged due to reinforcements corrosion effects. Author's personal picture.

In recent past decades, structural problems related to durability failure of reinforced concrete structures have increased drastically [5–7]. Figure 5.1 presents two columns mechanically damaged due to reinforcements corrosion effects. In this figure, crack growth and spalling phenomena are observed. In addition to economic and financial impacts due to repair costs, the durability problems also have industrial, environmental, and social consequences, due to the application of repair materials and the decrease of safety of these structures [8–10].

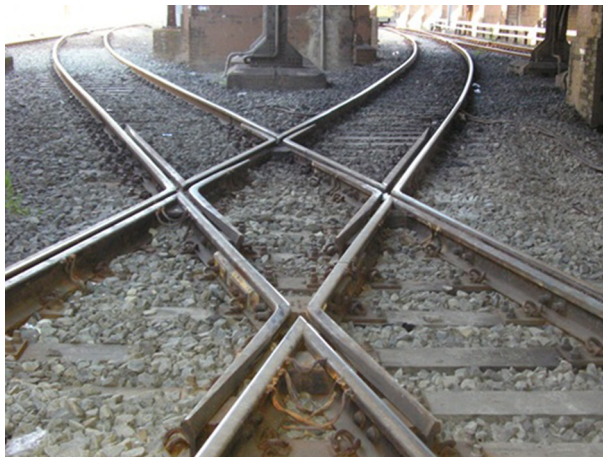
**FIGURE 6.2**

A typical railway turnout diamond (k crossings induce double impacts on the supporting bearers).

Recently, there have been several incidental cracks in concrete bearers in a turnout within an urban railway network in Australia. The concrete bearer cracked under a rail pad, the part which supports the rail, where the train wheels shift over a diamond formation. The purpose of this chapter is to demonstrate an engineering failure analysis of a complex structural system using a case study of turnout diamond (Figure 6.2), which is often found in railway network. The finite-element model

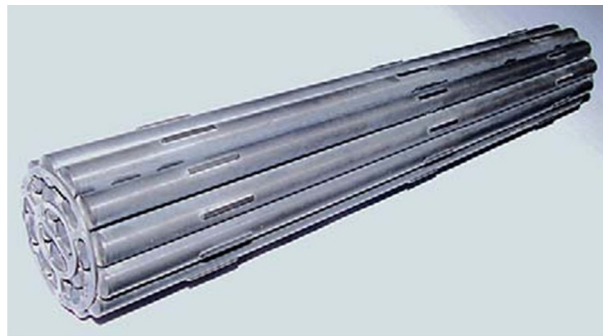
**FIGURE 7.1**

19-Pin fuel-bundle used in Indian PHWRs from which ring and axially cracked fuel-clad specimens are machined.

Several specimens in the shape of rings of 3 mm width approximately were machined from the unirradiated stress-relief annealed (SRA) Zircaloy-4 fuel pins of 220 MWe Indian PHWRs. The 19-element fuel-bundle used in PHWRs is shown in [Figure 7.1](#). The inner diameter of the fuel pin specimen is 14.42 mm and the thickness is 0.4 mm. A typical ring-tension specimen is shown in [Figure 7.2a](#). The loading fixture consists of two semi-cylindrical mandrels attached to a loading rod and it is shown in [Figure 7.2b](#). The ring has been loaded on the pair of split mandrels and the test setup has been presented in [Figure 7.2c](#). The specimens have been loaded in a displacement-controlled mode until fracture and the load-displacement response of the specimens have been obtained directly from the test. The displacement data as obtained directly from the machine has been corrected for the machine compliance following the standard practice. In order to determine the transverse mechanical properties of the fuel-cladding tubes, FE analysis of the above-mentioned

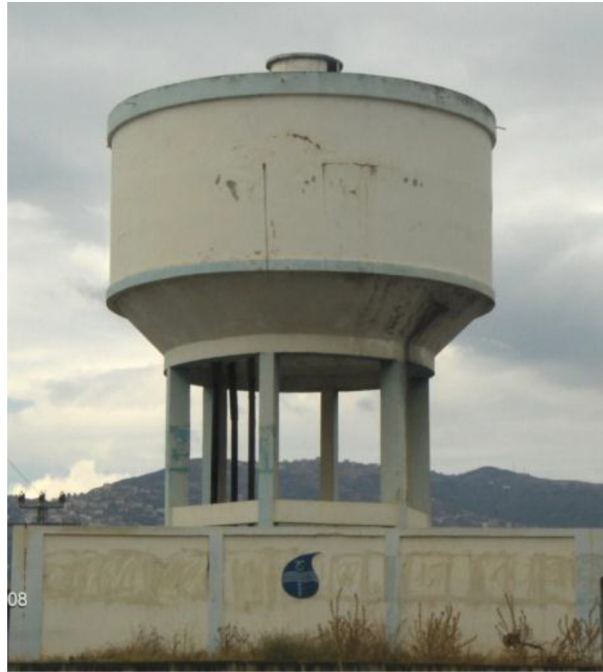
**FIGURE 8.1**

The general view of Sikh Oumedour tank.

As a practical application, we illustrate the method of vulnerability index in a water storage elevated tank of  $100 \text{ m}^3$  capacity and located in average seismicity zone in Algeria. This tank shown in [Figure 8.1](#) of frustoconical form has been made of reinforced concrete in 1986 and has been investigated and analyzed 28 years later. Several visits were made to the archives of the Hydraulic Administration of Tizi Ouzou. We were able to find the formwork drawings of our tank dating from 1986. No note of calculation has been found. A detailed review of these execution plans (see [Figure 8.2](#)) found in very good condition after 28 years of archiving have enabled us to evaluate the seismic load in [Section 5.3](#). The geometrical characteristics of the tank are given in [Table 8.4](#).

The bracing system of an elevated tank is constituted by the set of resistive elements ensuring its rigidity and stability to the horizontal forces caused by the earthquake. It constitutes one of the most important aspects of seismic design. The classification of this parameter is defined taking into account the capacity of energy dissipation to the seismic action and deformation. For this, there is currently interest to equip tanks with a regular structural mesh in order to avoid twisting of bracing elements. The tank studied is installed on a supporting system of pilings which is a structure that has a low rigidity distribution of mass and stiffness that changes from abrupt manner (see [Figures 8.1](#) and [8.2](#)). The parameter is classified as **class C**.

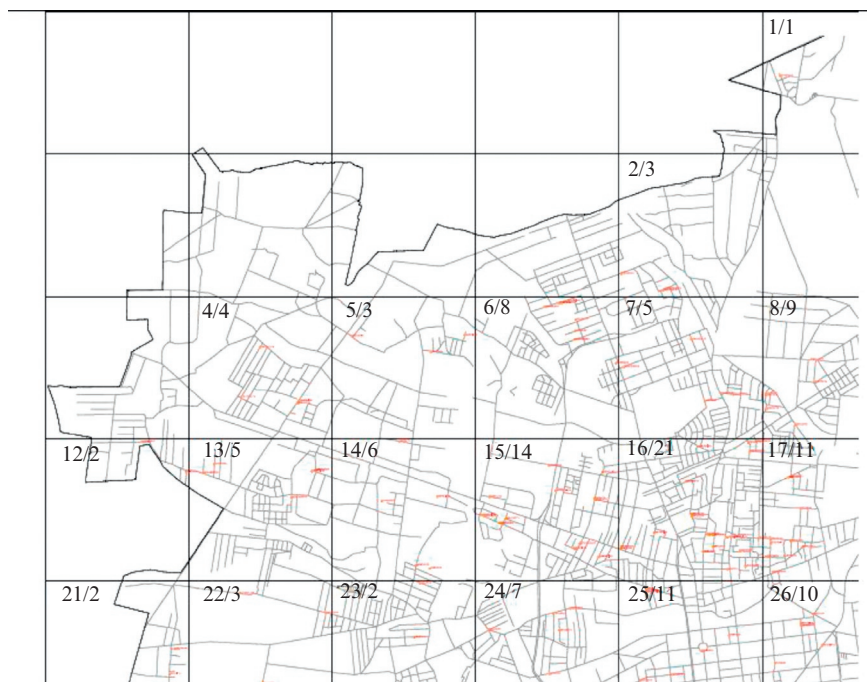
**FIGURE 9.9**

Map of spatial distribution of failures of the water supply network based on the last year of observation (2012).

For the purpose of analyzing susceptibility to failure, a spatial distribution of failures of the water supply network was prepared on the basis of the data collected in the last year under investigation (2012). In order to present the spatial distribution of the degree of susceptibility of the water supply network to failure, a grid of uniform fields with the surface area of  $4 \text{ km}^2$  ( $2 \times 2 \text{ km}^2$ ) was formed and failures were counted in each field. Figure 9.9 presents a fragment of the map of the water supply network with the superimposed grid of square fields and the numbers of failures corresponding to each field.

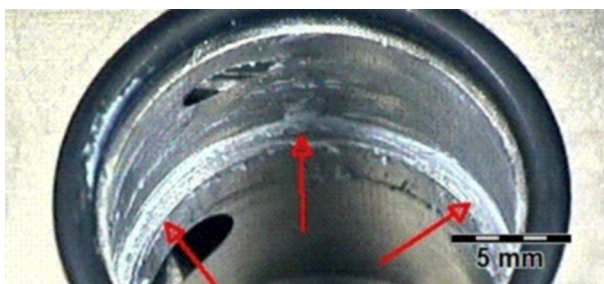
**FIGURE 17.17**

Residue on the surface of a valve block unit from the failed medical oxygen resuscitation device.

In the final failure analysis case, the cause of failure of a medical oxygen resuscitation apparatus was investigated. In the study of the components, a residue on the surface of a valve block unit from the device was observed (Figure 17.17). The residue was pyrolyzed at 700 °C. Figure 17.18 shows the pyrogram of the sample. The substances in pyrolyzate were identified using the mass spectral library *NIST 05*. Based on the thermal decomposition products showed in Figure 17.18, the examined residue was identified as a mixture of polytetrafluoroethylene (PTFE), silicone gum, polystyrene, and a large number of drugs, like oxazepam (peak 7, RT = 17.04 min), triazolam (peak 8, RT = 19.50 min), phenytoin (peak 10, RT = 26.58 min), clozapine (peak 11, RT = 27.47 min), nordazepam (peak 12, RT = 28.30 min), levomepromazine (peak 13, RT = 29.74 min), clomipramine (peak 15, RT = 34.93 min), and buprenorphine (peak 16, RT = 36.01 min). The peak of the monomer tetrafluoroethylene (peak 1, RT = 6.78 min) was assigned to PTFE, the peaks of hexamethylcyclotrisiloxane (peak 3, RT = 8.85 min) and octamethylcyclotetrasiloxane (peak 6,
