# Preparation, Installation, Analysis, and Interpretation of Corrosion Coupons in Hydrocarbon Operations

## NACE SP0775-2023

This standard practice was prepared to encourage the use of uniform and industry-proven methods to monitor mass-loss and pitting corrosion in hydrocarbon operations.

This standard outlines procedures for preparing, installing, and analyzing metallic corrosion coupons. Factors considered in the interpretation of results obtained from these corrosion coupons are also included for the use of oil, gas and service industry personnel.

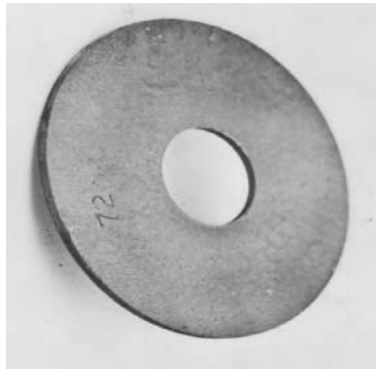
**Figure 1: Circular (Washer Type) Coupon and Typical Mounting in a Ring Joint Flange**

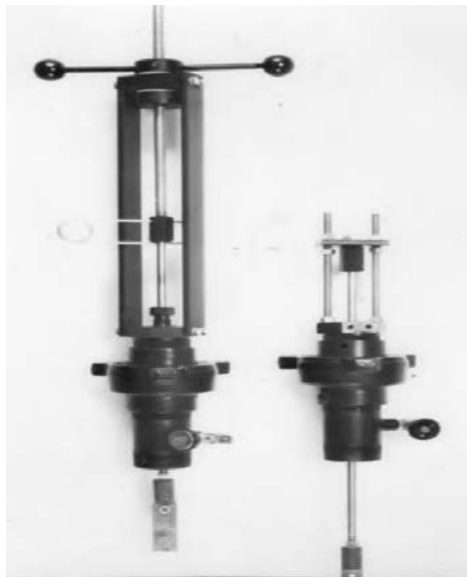
**Figure 5: Tool for Installing and Removing Coupons in Systems under Pressure. The Pipe Nipple Screws into an Existing Valve on the Line or Vessel. Complete Assembly is Shown on Left. After the Coupon has been Positioned, the Drive Unit is Removed and the Coupon Holder is Locked as Shown on the Right**

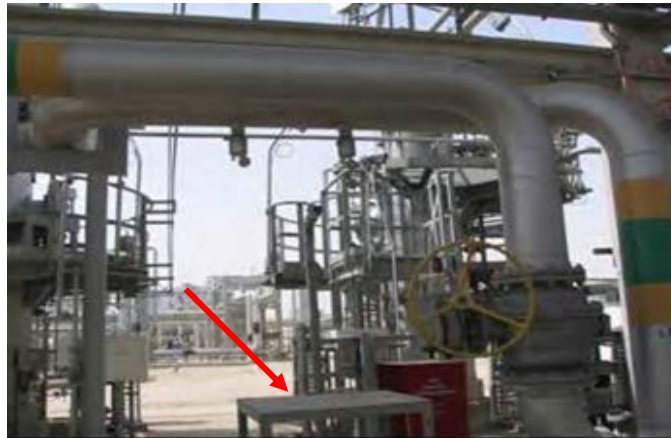
Figure 9A: Portable Hop-up/Stand (0.5 m to 1 m)

- 6.5** Accessibility considerations for corrosion monitoring stations shall be made (portable hop-ups/stands, access pits or permanent access platforms (as per company’s specifications or requirements), as they are essential for ensuring periodic servicing of corrosion monitoring access fittings (coupon retrieval and probe data collection) and should be taken into consideration/implemented for new or existing facilities. (Examples can be seen in Figures 9A, 9B, 9C and 9D).

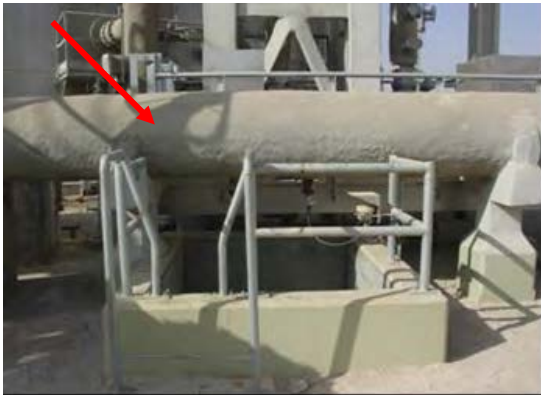
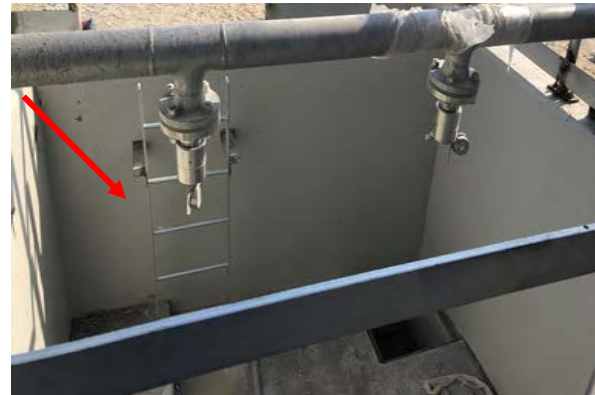
Figure 9B and 9C: Concrete Access Pits (1.8 m to 2 m height)

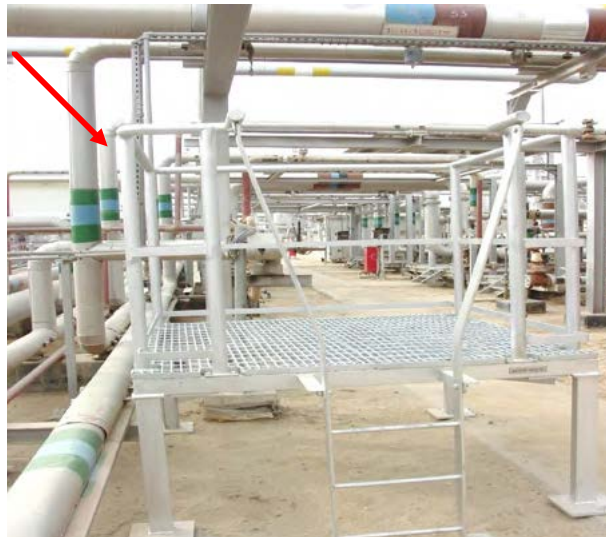
Figure 9D: Permanent Access Platform

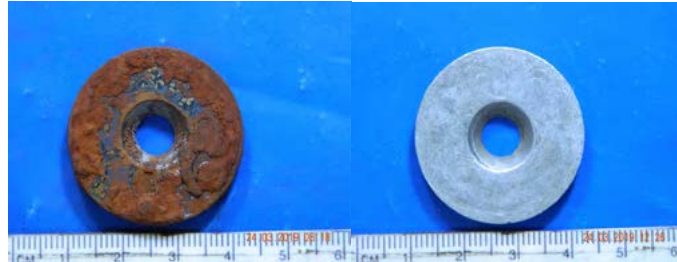
**Figure B4**

- B4)** Service: Brackish water to desalters  
Corrosion Rate: 4 mpy  
Pitting rate: 13 mpy  
Exposure Period: 87 days  
Findings: High chloride content, pH 6.8  
Conclusion: Typical uniform corrosion on coupons with moderate corrosion rate.

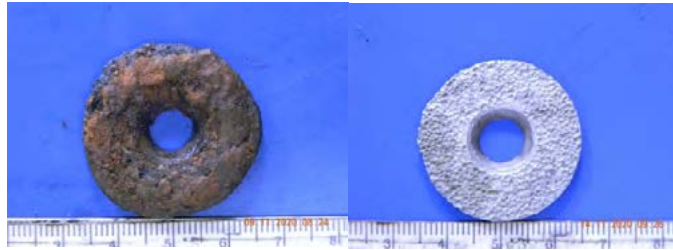
**Figure B8**

- B8)** Service: Brackish water to desalters  
Corrosion Rate: 20 mpy  
Pitting rate: 98 mpy  
Exposure Period: 473 days  
Findings: High chloride content, pH 6.8  
Conclusion: Extremely high corrosion & pitting rates due to long exposure period in the process environment.

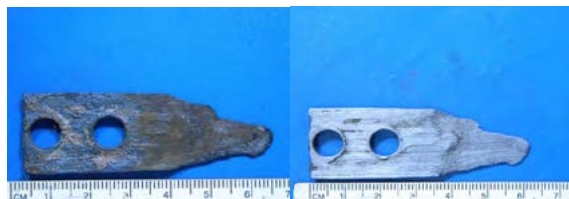
**Figure B12**

- B12)** Service: Effluent water outlet from wet tank  
Corrosion Rate: 246 mpy  
Pitting rate: 843 mpy  
Exposure Period: 55 days  
Findings: High chlorides & waters contents, pH 5.5, general anaerobic bacteria (GAnB) 1,700 counts/cm<sup>2</sup>, acidic environment  
Conclusion: MIC. Extremely high corrosion and pitting rates due to a highly acidic environment, influenced by presence of GAnB.

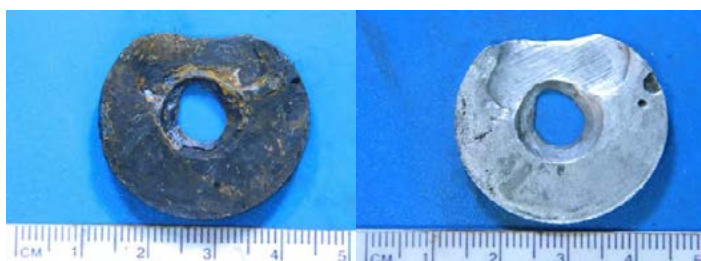
**Figure B17**

- B17)** Service: Effluent water outlet from 1st stage desalter  
Corrosion Rate: 74 mpy  
Pitting rate: 610 mpy  
Exposure Period: 76 days  
Findings: High chlorides, sulfates & water contents, pH 5.8, general anaerobic bacteria (GAnB) 1,000 counts/cm<sup>2</sup>, H<sub>2</sub>S 21 ppm, acidic environment  
Conclusion: MIC. Extremely high general corrosion and pitting rates due to the significant GAnB presence in an acidic environment. This is another photograph showing similar damage morphology to coupon # 12 and coupon #16 for possible GAnB damage pattern. Further, the high amount of sulfate and H<sub>2</sub>S contents could be a sign for sulfate reducing bacteria (SRB), which was not detected in the sessile analysis on the coupons or fluid analysis. However, SRB found upstream in the process could have influenced corrosion (in the form of isolated pitting), as can be seen in the photograph.

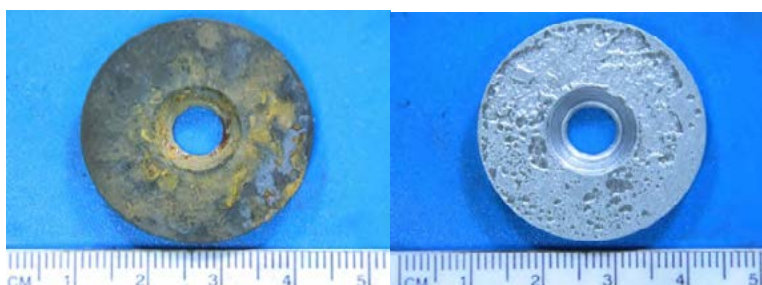
**Figure B20**

- B20)** Service: Gas outlet from compressor to dehydration unit  
Corrosion Rate: 8 mpy  
Pitting rate: 40 mpy  
Exposure Period: 127 days  
Findings: High chlorides, sulfates & water contents, pH 5.3, general aerobic bacteria (GAB) 380 counts/cm<sup>2</sup> and general anaerobic bacteria (GAnB) 3,800 counts/cm<sup>2</sup>, H<sub>2</sub>S 76 ppm, elemental sulfur (S<sub>8</sub>), acidic environment  
Conclusion: MIC. High general corrosion rate, extremely high pitting rates, due to the influence GAB & GAnB in an acidic environment containing elemental sulfur and long exposure period.

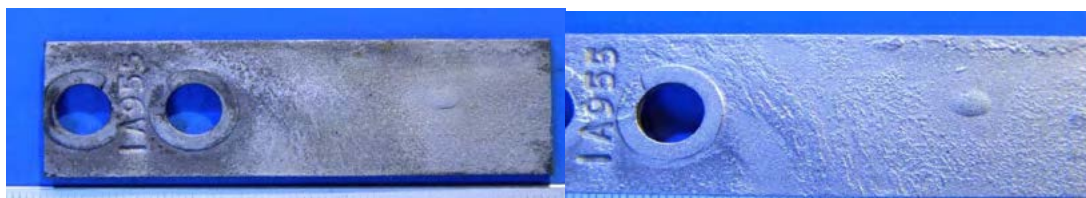
Figure B37

**B37) Hydrogen Blistering in Amine treatment unit - Rich Amine outlet from contactor (Example 3)**

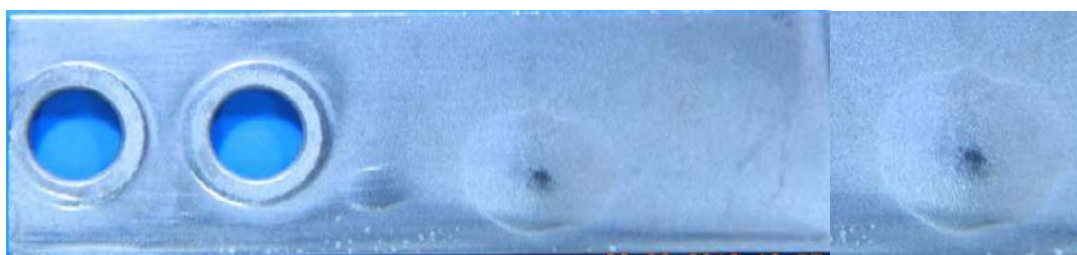
Figure B38

**B38) Hydrogen Blistering in Amine treatment unit - Rich Amine outlet from contactor (Example 4)**
