**STRESS CORROSION  
CRACKING OF METALS  
—A *STATE OF THE ART***

**STP 518**

A symposium  
presented at the  
American Society for Metals  
Metals Conference  
Detroit, Michigan, 18 October 1971

ASTM SPECIAL TECHNICAL PUBLICATION 518  
H. Lee Craig, Jr., symposium chairman

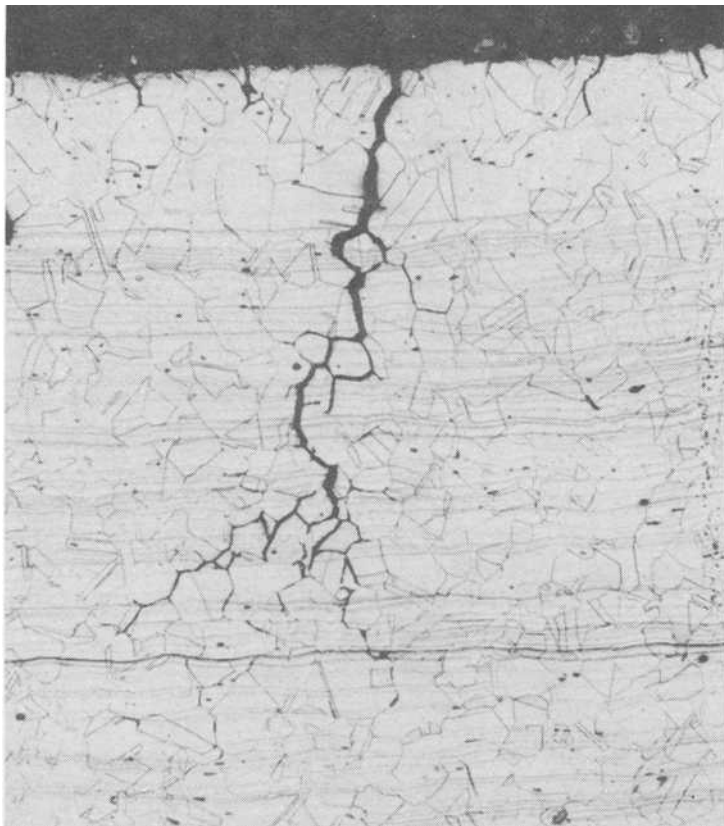
FIG. 2—Intergranular stress corrosion cracking of Monel 400 in steam ( $\times 100$ ).

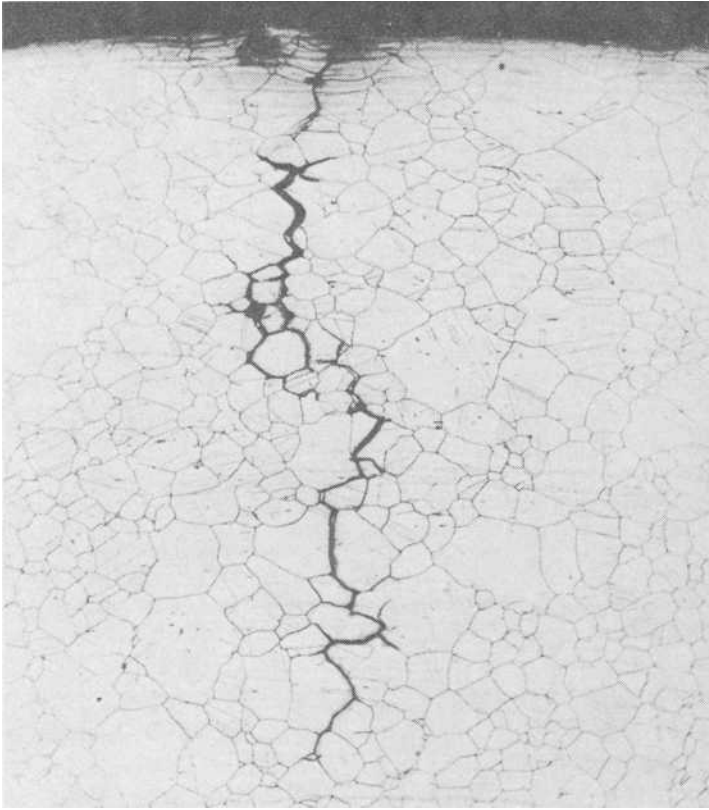
FIG. 3—*Intergranular stress corrosion cracking of Inconel 600 in high temperature water (X 70).*
