# ***FAILURE ANALYSIS CASE STUDIES II***

A sourcebook of case studies selected from the pages of  
*Engineering Failure Analysis* 1997-1999

**D.R.H. JONES**

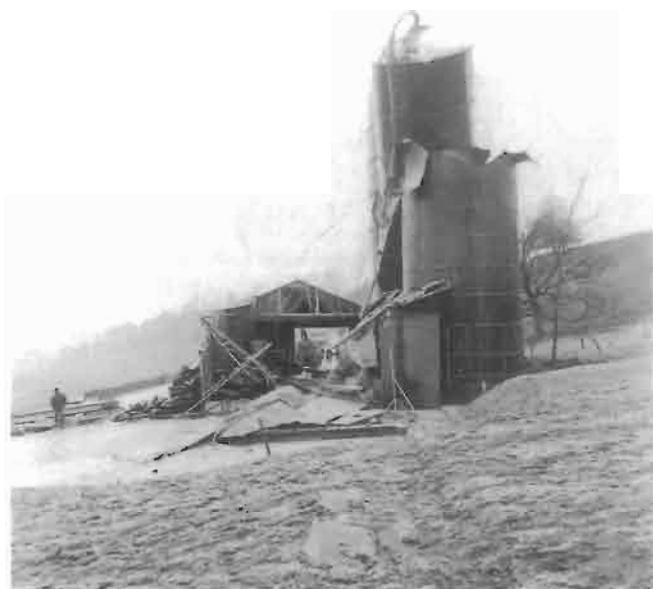
The detached rings were separated into several pieces, and were in some places still immersed in a pool of slurry, such that it was difficult to make out where the pieces had belonged. Failure had

Fig. 1. Damaged silos: view of the site.

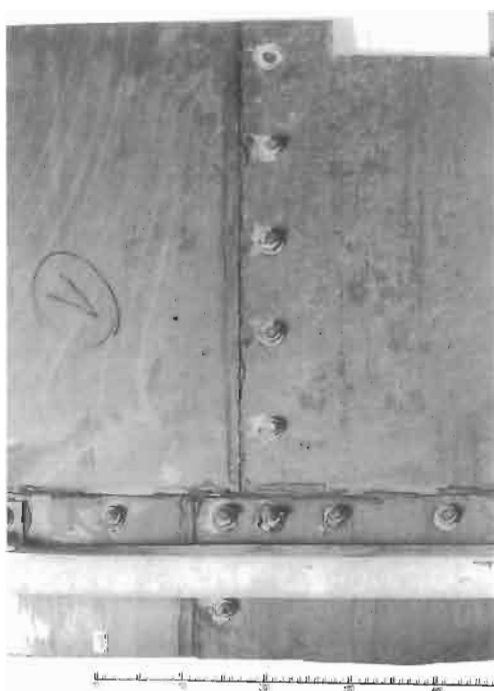
Fig. 2. Bolted joints of the sheets used for the silo. In the lower part, a reinforcement ring was attached.

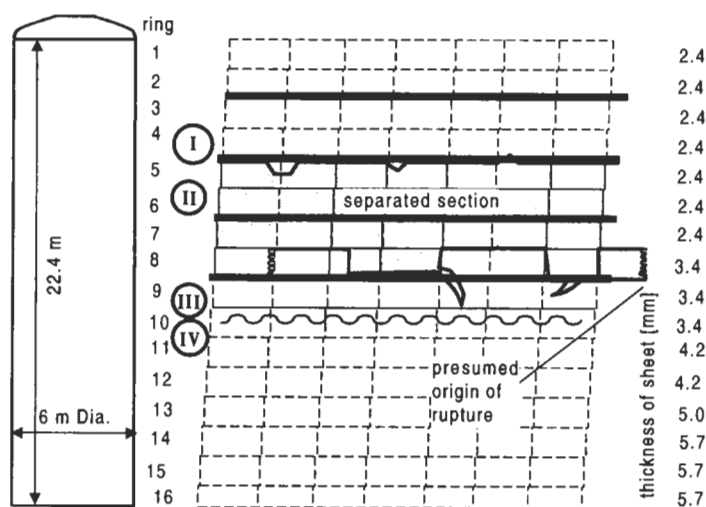
Fig. 3. Schematic drawing of the silo, showing the location of the rupture: (I) level theoretically necessary for bursting by hydrostatic pressure; (II) level for filling with 407 t; (III) permissible filling for density of  $1.05 \text{ kg l}^{-1}$ ; (IV) level after bursting.

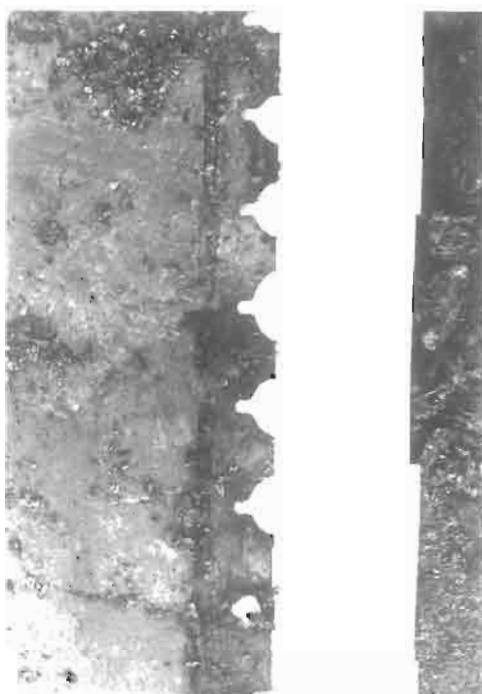
occurred by rupture of the boltholes of the vessel in circumferential and longitudinal directions (Fig. 4).

Fig. 4. Longitudinal bolted joint, presumably at location of start of rupture.

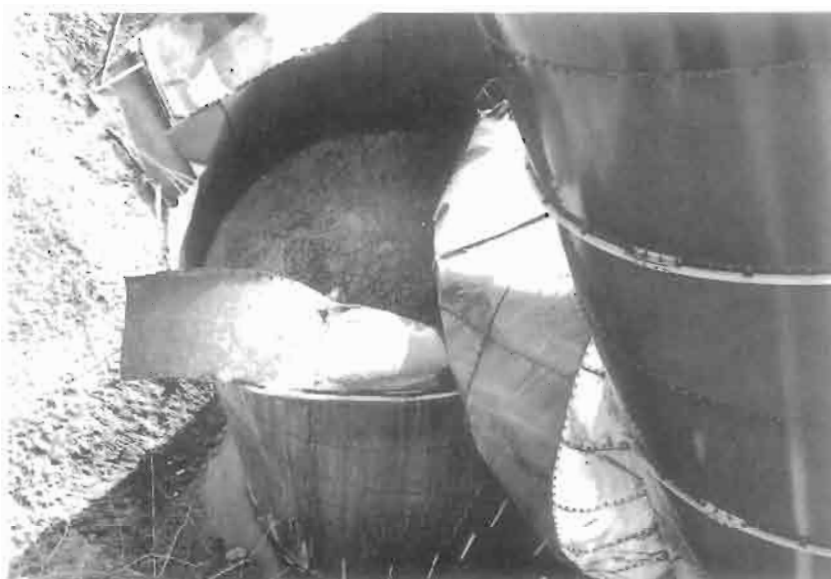
After the accident, the silo was still full up to the seventh ring (counted from the bottom), as can be seen from Fig. 5.

Fig. 5. Top view of failed silo, showing remaining filling level.

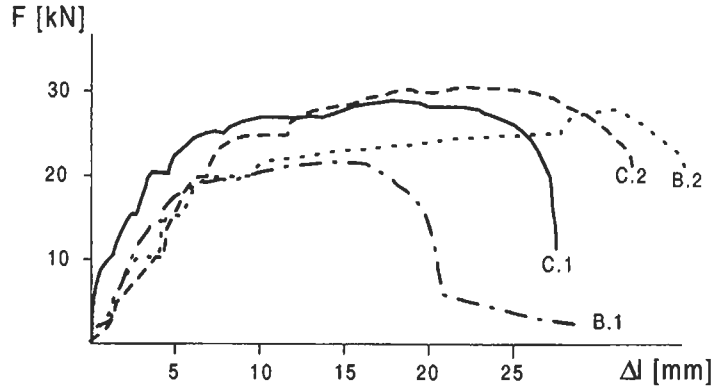
Fig. 7. Behaviour of bolted joints in tension tests.

Specimens B.1, B.2, C.1 and C.2 were tested for the strength of the bolted joints. From Fig. 7, it can be seen that they started to yield between loads of 15 and 25 kN, and that the deformation before fracture was in most cases more than 25 mm.

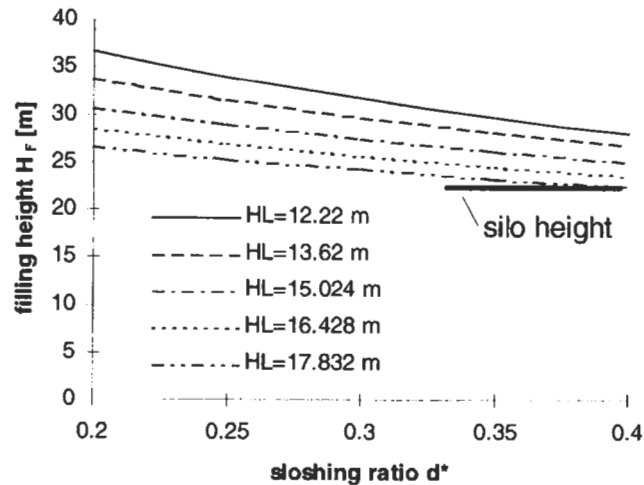
Fig. 9. Filling height of the silo necessary to produce the observed spurting distance, assuming different sloshing ratios  $d^*$  and different levels  $H_L$  for the initial leakage.

levels  $H_L$  for the first leak and different ratios of sloshing ( $d^* = \delta/D$ ) are assumed, it can be seen from Fig. 9 that the silo must have been filled to the top, and the liquid must have sloshed relatively far after hitting the ground to have produced the observed pattern on the site.

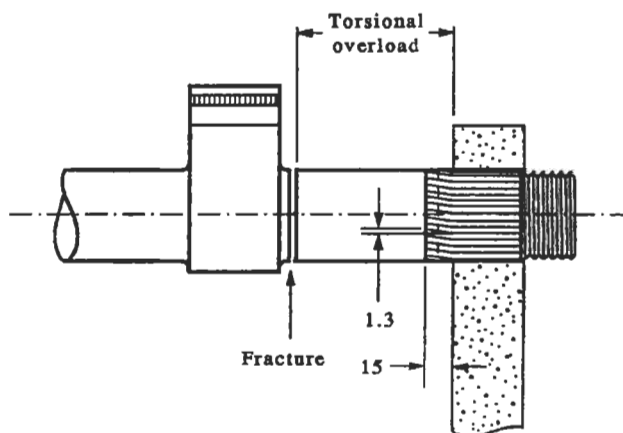
roller bearings. Between the bearings was a toothed sector, which was driven by a worm connected to the steering wheel. The steering arm, which transmitted movement to the track rods, was attached to the end of the shaft by a splined connection. As shown in Fig. 3, the steering shaft had been subjected to a torsional overload. As a consequence of the overload, the splined section of the shaft had been twisted permanently (the ends of the splines were offset by 1.3 mm), and the shaft had fractured where it met the toothed sector. The twisted splines are shown in Fig. 4, and the matching fracture surfaces are shown in Fig. 5. Most of the fracture surface was relatively flat and smooth, but there was a region near the centre which was comparatively rough. Figure 6 is a view taken in the scanning electron microscope of the flat part of the fracture surface, which shows the classic features of shear failure. Figure 7 is a scanning electron micrograph taken from the rough part of the fracture surface, which shows the classic features of fibrous tensile failure. There were no indications of prior defects on the fracture surface.

Fig. 3. Side view of the shaft, showing the plane of the fracture and the region of torsional overload. Dimensions in mm.

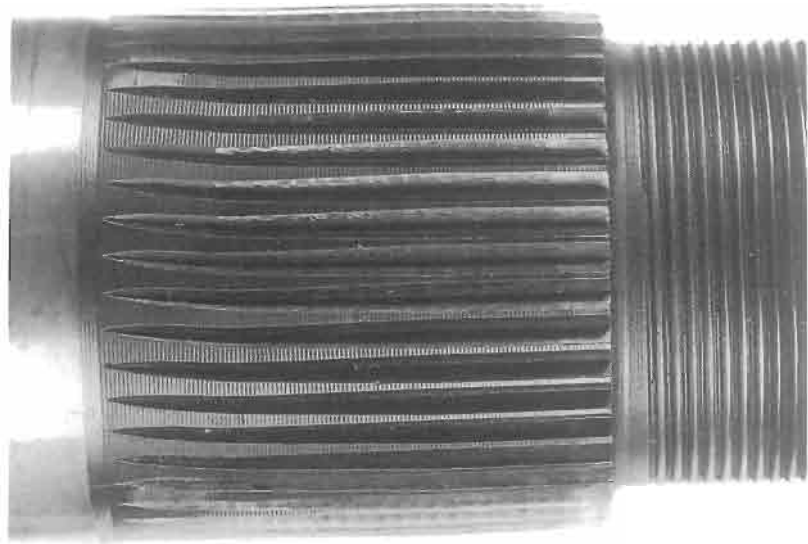
Fig. 4. Photograph of the splined section of the steering shaft, showing the twisted splines.

Table 2 shows that the hardness of the case (HV 880) is significantly higher than that specified (HV 680–780). However, there was no indication that this contributed to the failure. As shown in Figs 3 and 4, the splines were able to withstand a considerable shear strain even though they were case-hardened. The maximum engineering shear strain suffered by the splines was

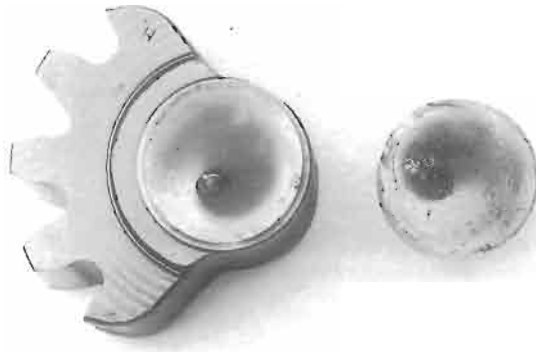
Fig. 5. Photograph of the matching fracture surfaces.

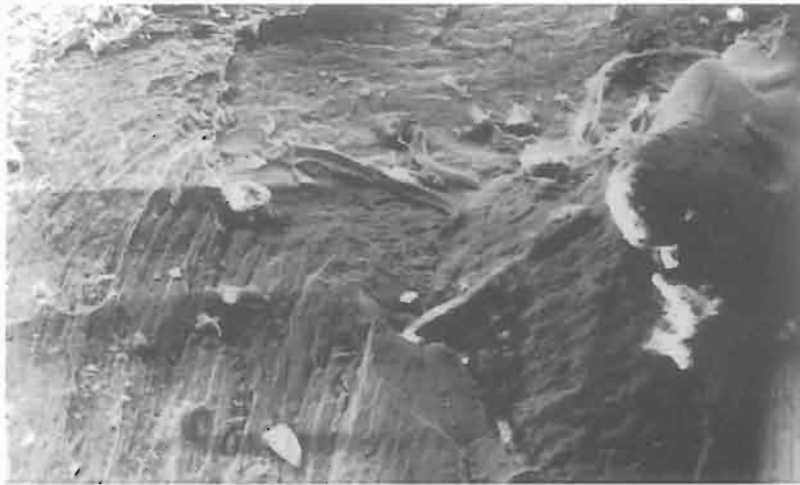
Fig. 6. Scanning electron micrograph taken from the shear part of the failure. Magnification: 153 times.

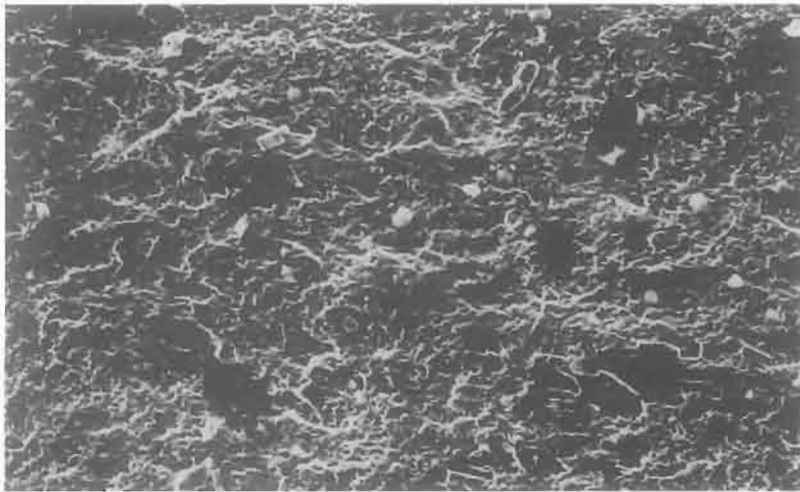
Fig. 7. Scanning electron micrograph taken from the fibrous part of the failure. Magnification: 292 times.

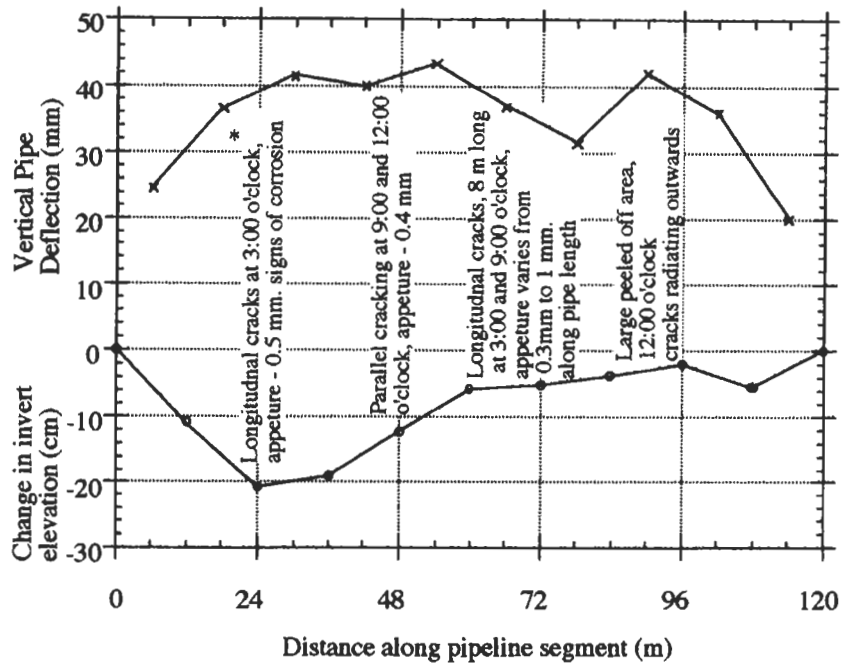
Results of the survey indicated that vertical pipe deflections greater than 3% (of the pipe diameter) were common over significant sections of the pipeline length. In places the deflections reached more than 8%. Severe cracking of the inner pipe liner was noted over substantial sections of the pipeline. Open cracks and peeling of the liner was observed at many locations. Longitudinal cracks with apertures greater than 0.35 mm were found in pipe sections which had undergone vertical deflections of 2.0% and less. Cracking of the internal pipe liner resulted in a substantial reduction in the protective capability of the concrete liner against corrosion of the steel pipe. Typical results pertaining to one 120 m pipe segment are shown in Fig. 2. The survey indicated significant deviations of the measured pipe invert level from the design elevation. Over significant portions of the pipeline length, the measured invert elevation was found to be as high as 25 cm below the design level. However, it must be noted that over several other segments along the pipeline length the surveyed invert level was found to be above the design elevation.

\* examples of damage description from along pipe segment AA11-AA12

Fig. 2. Typical data obtained from damage survey.

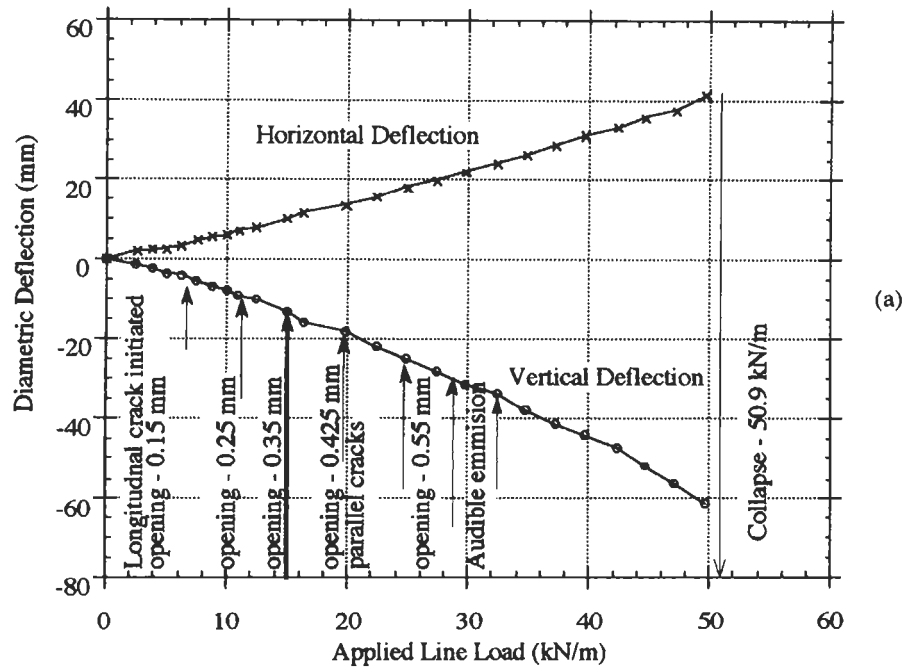
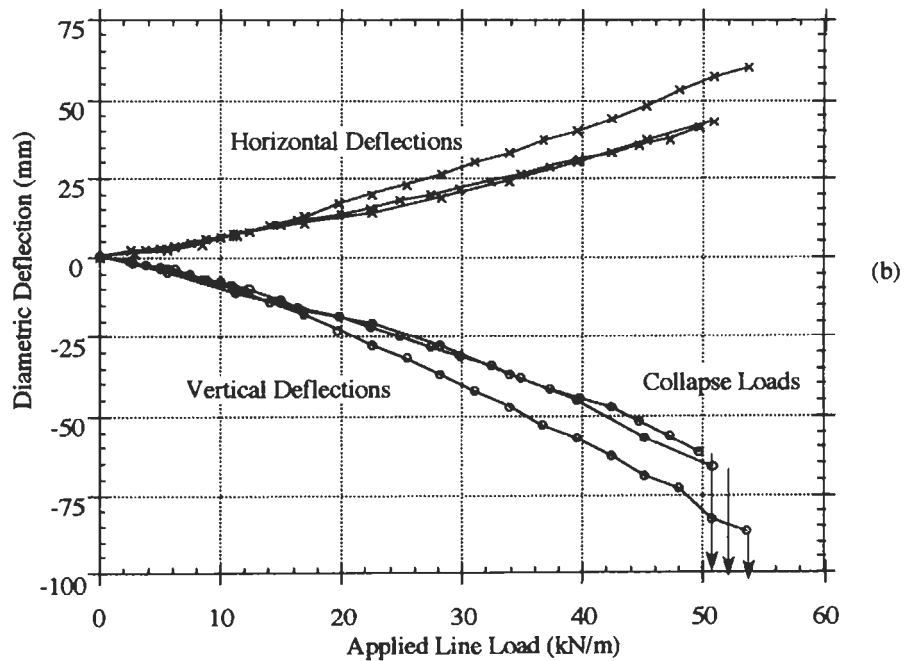
Fig. 3. Pipe load-deformation tests: (a) including damage observations, (b) comparison of results for three sections tested.

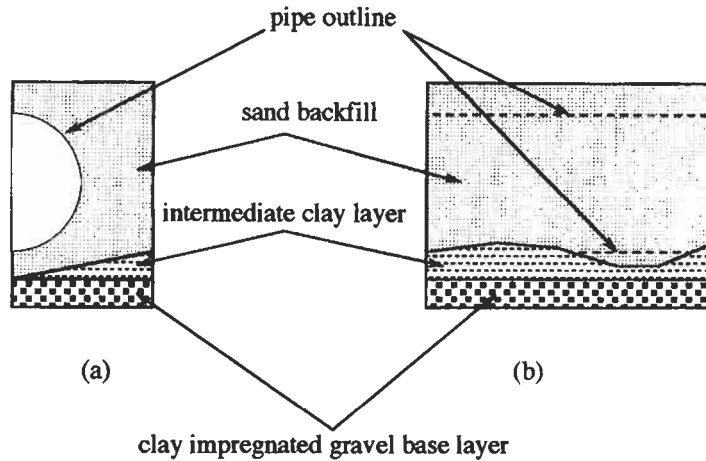
Fig. 6. Schematic of visual observations in test excavation: (a) cross-section, (b) longitudinal section.

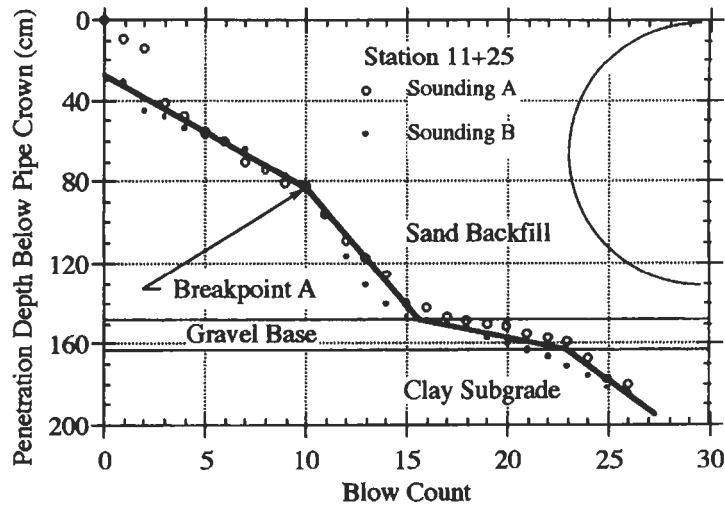
The large vertical deformation of the pipe and cracking of the pipe liner appear to be related to insufficient backfill stiffness as observed in the field investigation. The existing stiffness of the sand backfill may be inferred on the basis of the DCP tests performed alongside the pipe. Using empirical

Fig. 7. DCP sounding profile, excavation profile composite.

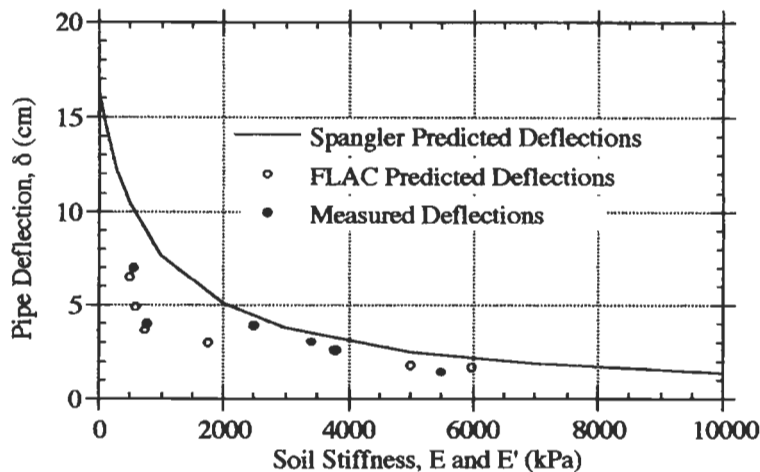
Fig. 8. Pipe deflection vs side backfill stiffness.

In order to test the suitability of the numerical system as a predictive tool a parametric study relating vertical pipe deflection to the stiffness of the sand backfill was performed. The results of these calculations are shown as the open symbols in Fig. 8. The numerical results compare very well with the field values. Both the numerical computations and the field values fall below the curve representing the Spangler model. Such an outcome is reasonable considering the fact that the Spangler formula is a design tool rather than a predictive one. It should be noted that the data shown in Fig. 8 involves three different "types" of elastic moduli, namely: modulus of soil reaction labeled as  $E'$  in the Spangler equation; conventional modulus of elasticity  $E$  as used in FLAC; and a stiffness modulus based on the DCP results.

Despite these differences in definition of the sand backfill stiffness, the correspondence of the data is quite remarkable. It is not clear whether this is a general phenomenon; or true only in this particular case.

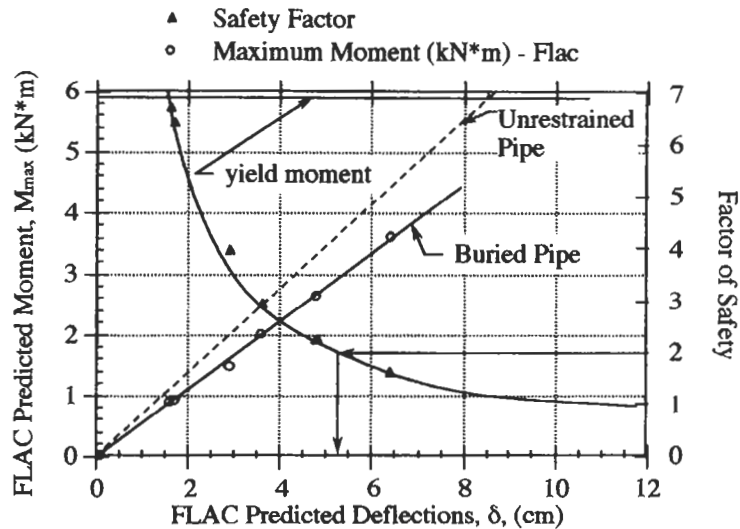
pipe section (laboratory conditions). The plot illustrates that for any given pipe deflection the maximum moment in an unrestrained pipe is greater than the maximum moment in a buried one. Including within Fig. 10 the definition of the safety factor (eqn (5)), it is possible to construct a safety factor-deflection relation, shown as the curve through the triangular points in the figure. This curve can be used to assess which pipe segments are sufficiently safe to be used as a structural shell. For example, assuming a required safety factor of 2, all pipe segments which have undergone deflections greater than approximately 5 cm would be considered unsuitable. The advantage of this approach is its simplicity. Pipe deflection is a simple parameter to measure, whereas moments in the pipe section are not.

Fig. 10. Maximum moment, safety factor, deflection plot.

considered. Careful control over the stiffness of the trench backfill material is of the utmost importance. In the particular case considered, deflection of the pipe was in places 6–7 times the deformation initiating severe damage.

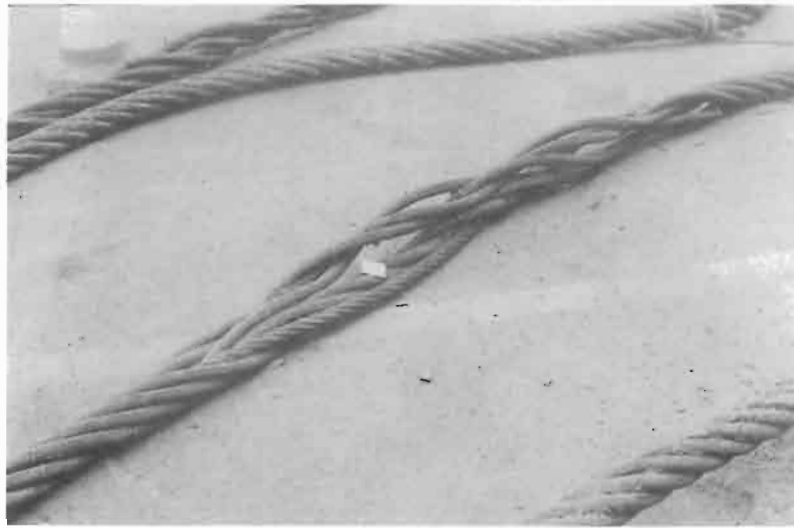
In a six stranded rope, untwisting whilst maintaining tensile load will eventually lead to local de-stranding of the rope (Fig. 4) which, when tension is relaxed, will allow the torque carried by the individual strands to cause local strand hockles (Fig. 5). If torque is imposed at low tension, whether untwisting or twisting up, then the whole rope will hockle. However, six strand ropes can sustain very severe torsional deformation, provided a minimum tension is maintained. Six strand Lang's lay mine hoist ropes have been reported [7] operating with lay length changes from  $-30\%$  to  $+70\%$  without any major compromise to service life.

Fig. 4. Destranding of a six strand mooring rope.

for potential dynamic resonances, but with very large structures and large masses these intuitions can be misleading. The torsional stiffness of wire rope mooring lines, as compared with equivalent solid bars, is so low that the period of natural torsion oscillation can be quite high, and there is reason to believe from observed mooring line failures, that such motions can sometimes be excited by the environmentally induced motions of floating structures. If the torsional amplitudes are large enough, and vessel motions such as to allow very low tensions to occur, then the kind of torsional instability described above can develop. Indeed, the destranding in the mooring rope illustrated in Fig. 4 is thought to have been induced by just such behaviour.

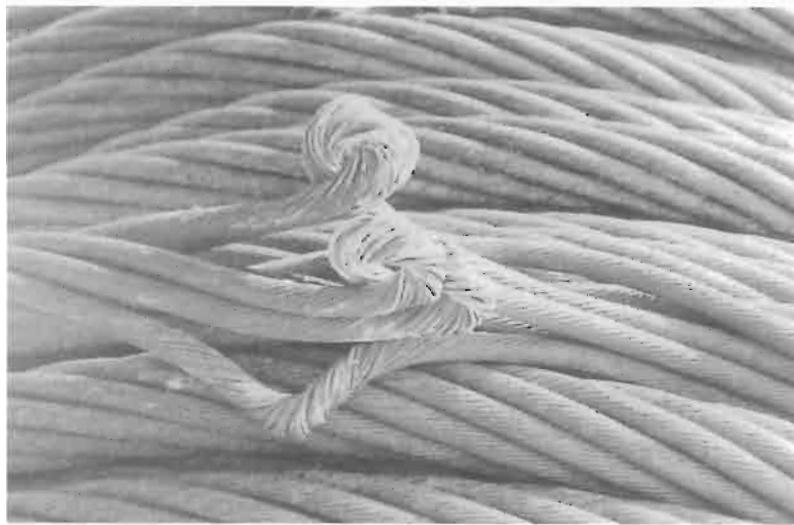
Fig. 5. Hockles formed in the individual strands of an eight strand work wire.

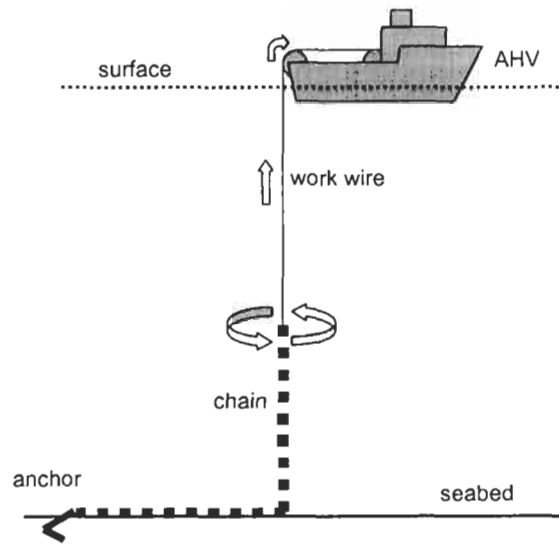
Fig. 7. Schematic representation of anchor handling vessel (AHV) lifting the anchor chain with six strand wire rope 'work wire'. The increasing tension as more chain is lifted causes rotation at the point of connection between rope and chain, the turns accumulating in the chain at zero tension on the seabed.

The chain is sized for the mooring application, but the rope is a work wire, and for this use has to support only the weight of the chain. At the start of this process all the chain is on the seabed and the rope is just supporting its own weight. As the rope is wound onto the winch the tension, which is always greatest at the surface, gradually increases as the heavy chain is raised. This increase in tension causes the rope to untwist since there is no torsional restraint from the slack chain on the seabed (see Fig. 7). As the chain is progressively lifted, the untwisted rope is wound onto the drum and the opposing twist transferred along the chain, accumulating in the final grounded section adjacent to the anchor. Once the end of the chain is on the deck of the AHV, the spiral strand is attached from a second AHV and the combination lowered back to the seabed as the spiral strand is paid out. The arrangement with the three components and two AHVs prevents further rotation. Finally the work wire is disconnected and the spiral strand tensioned. The increase in tension in the chain transforms its torsional stiffness, causing the accumulated twist to be transferred to the lower stiffness spiral strand. When the system is again relaxed to await hook up to the FPSO, the spiral strand can no longer sustain the imposed twist and forms kinks or hockles. When these hockles are pulled straight for final connection to the FPSO the rope is effectively destroyed, deforming as shown in Fig. 8.

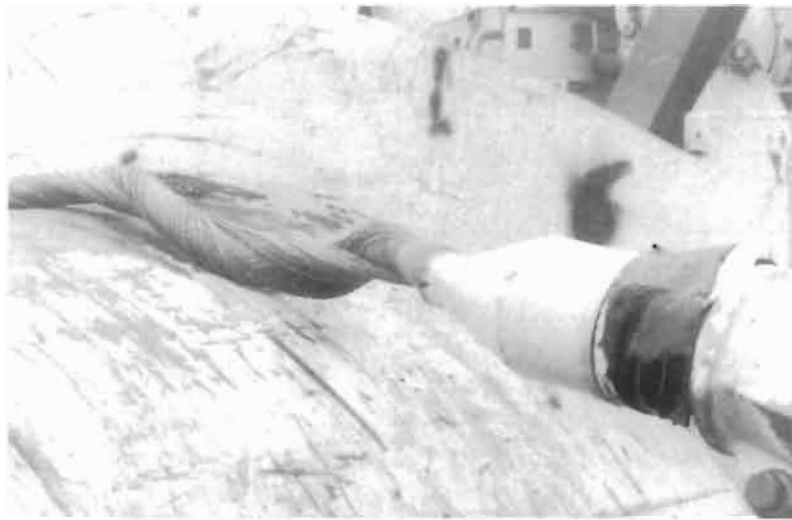
Fig. 8. Characteristic damage induced in spiral strand by pulling out a hockle or kink.

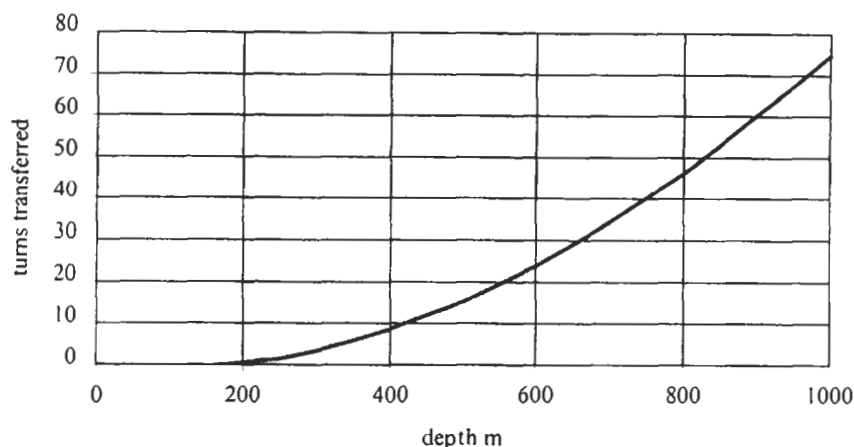
Fig. 9. Number of turns transferred from the chain when tensioned as a function of water depth.

Figure 9 shows how reduction in water depth reduces the number of turns transferred from the chain when tensioned, with the other parameters as specified initially. Figure 10 shows how using ropes of different diameter can influence the turns transferred, with results shown for two different water depths, 1000 and 700 m. In both figures, allowance has been made for an assumed capacity for the chain to accommodate  $3^\circ$  of rotation per link before adopting a high torsional stiffness. This capacity of chain to absorb induced turns can overcome the problem completely in shallower water (as seen by the effective cut-off in Fig. 9). It is evident from Fig. 10 that significant reductions in turns can be achieved from the use of rope with greater diameter and hence higher torsional

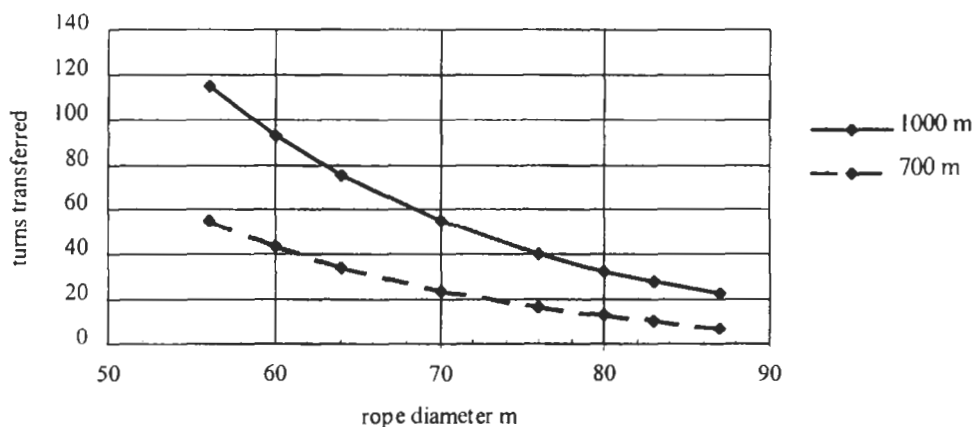
Fig. 10. Number of turns transferred from the chain when tensioned as a function of rope diameter, the upper line for 1000 m water depth and the lower for 700 m water depth.

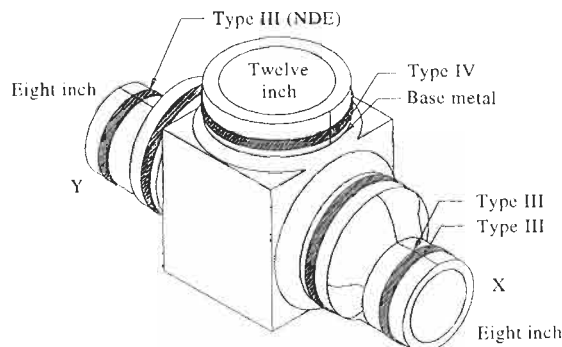
Fig. 2. At the forged tee, steam enters through the 12 in. line, and divides into two streams, along the 8 in. lines. Sites where creep cracking was found are labelled type III, base metal, or type IV, according to the sort of cracking found there.

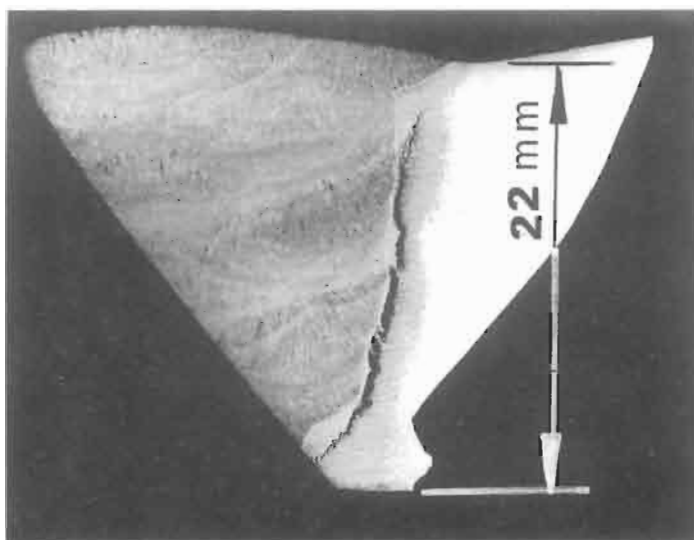
The metallographic examination of a section through the centre of the boat sample revealed a crack that extended from the weld root to within 2 mm of the outside surface of the pipe (Fig. 3). That is, cracking, unseen at the outside surface, was 90% through-wall. This cracking was entirely within the HAZ. It lay in the inner part of the HAZ, that is, in that part of the HAZ closest to the weld metal. The cracking sometimes came to within one or two grains of the fusion line, but it was never seen to touch the fusion line; also, it never strayed into the outer (intercritical) part of the HAZ. All of the cracking was intergranular. Grain boundary cavitation, varying in density, was associated with the cracking throughout. Both of these latter features are typical of long-time (low strain rate) creep cracking. Using the classification introduced by Schüler *et al.* [1], this cracking, in the inner HAZ, is termed type III creep cracking.

For most of its length, the crack had grown along the almost vertical wall formed by the fusion line. In the outer 1 or 2 mm, however, the last weld bead overhung the remainder of the fusion line, and the crack had not managed to grow around that overhanging bead (Fig. 3). The density of the

Fig. 3. Section through the cracking whose discovery prompted this investigation. It is in the 8 in. line on the X side of the tee. The cracking extended from the bore to a spot 90% through-wall. The cracking ran through the inner part of the HAZ. (Nital etch, bright field.)

The cracking did not consist of a single crack from the root to near the crown. There were many short overlapping cracks, in a band in the inner HAZ, and these had joined together. The widest cracks were in the mid-wall region. For this reason, it was believed that the cracking had probably initiated there, and had grown inwards to reach the pipe bore, and outwards towards the pipe's OD surface. The larger crack segments had faces coated with about  $60\text{ }\mu\text{m}$  of oxide.

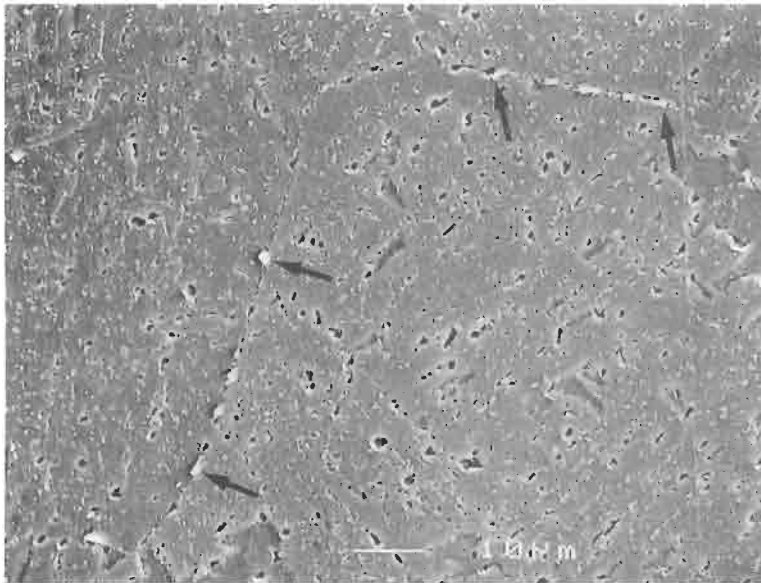
Fig. 4. Photomicrograph from a replica taken on the outside surface of the reducer to 8 in. pipe weld on the X side of the tee. It shows aligned voids along grain boundaries in the pipe side HAZ of the weld. This is the most advanced stage of creep damage that was seen on the outside surface of the 8 in. pipe. It is the stage that would immediately precede microcracking. (Nital etch, cellulose acetate replica, scanning electron micrograph.)

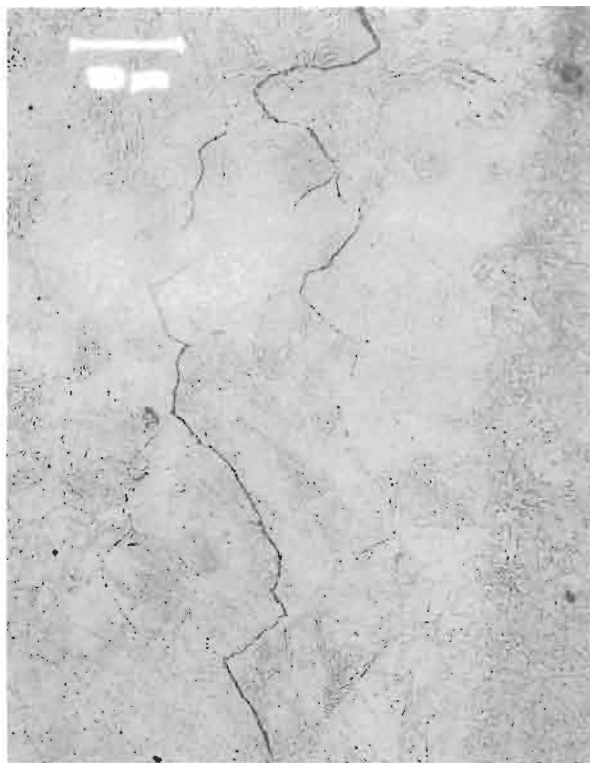
Fig. 5. Cracking on the 8 in. line side of the Y-side connection to the steam chest. The darker band to the right is weld metal. (Photomicrograph taken from a replica made in the cavity produced by removing a boat sample.) (Nital etch, bright field, cellulose acetate replica.)

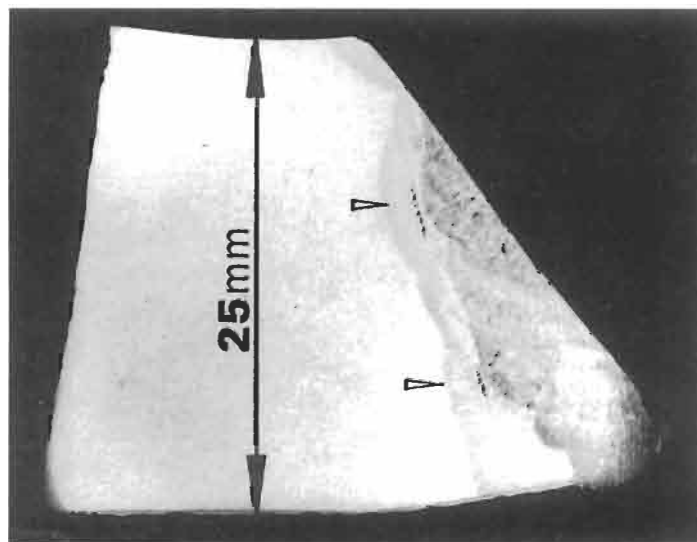
Fig. 6. Section through the X side of the reducer to pipe weld. The two arrows indicate small clusters of creep cracks. They are in coarse-grained parts of the HAZ. (In this case, the HAZ is the reducer HAZ. In Figs 3 and 5, the cracked HAZ was the 8 in. pipe HAZ.) (Nital etch, bright field.)

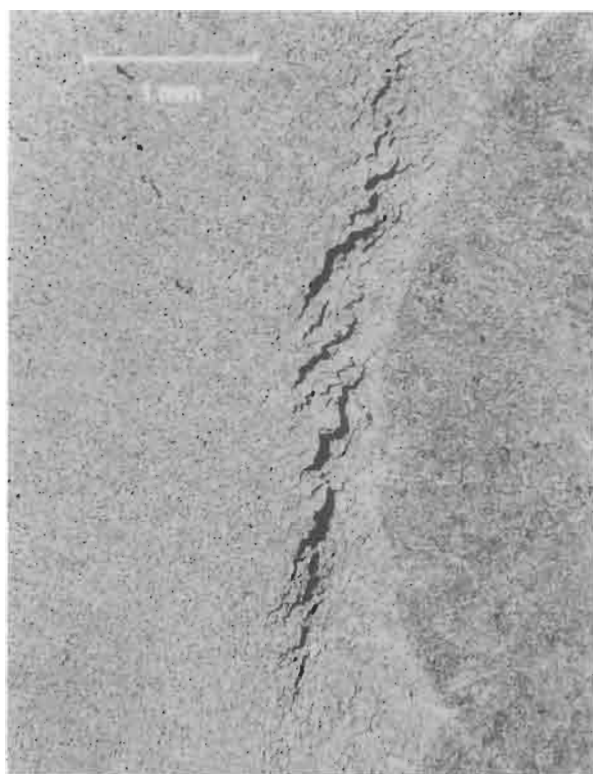
Fig. 7. One of the clusters of cracks in the HAZ on the reducer side of the weld joining the X-side reducer to the 8 in. pipe HAZ. The whole cluster is about 3.8 mm top to bottom.

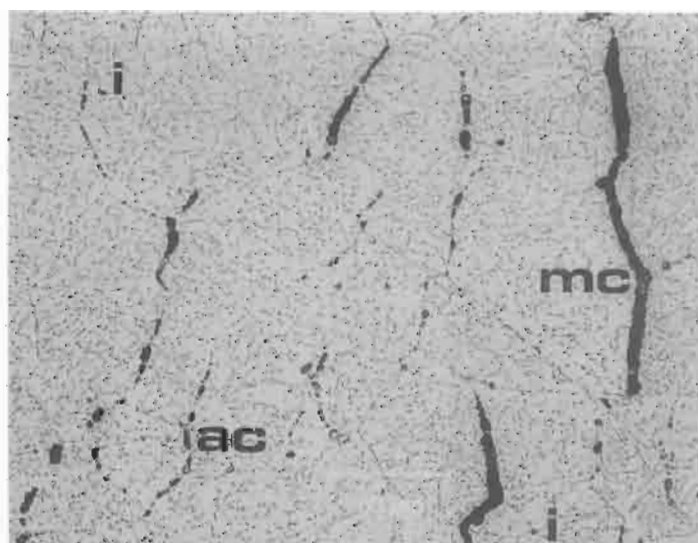
Fig. 8. This is close to one of the clusters of cracks in the reducer's HAZ. There are isolated grain boundary cavities, *i*, aligned groups of cavities, *ac*, and microcracks produced by the coalescence of aligned groups, *mc*. These are three stages in the progressive generation of creep cracks. (As in Figs 5–7, this is a coarse-grained region of the HAZ.) (Nital etch, bright field.)

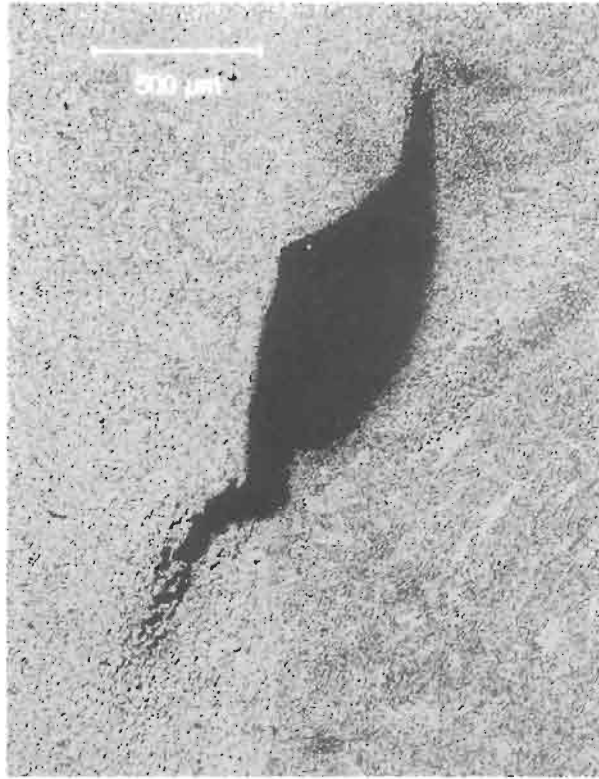
Fig. 9. This lack-of-fusion/slag flaw on the fusion line had extended about 500  $\mu\text{m}$  by creep. Where it grew into the HAZ, it grew into fine-grained material, and there was a very high density of creep rupture voids. (The darker material on the right is weld metal.) (Nital etch, bright field.)

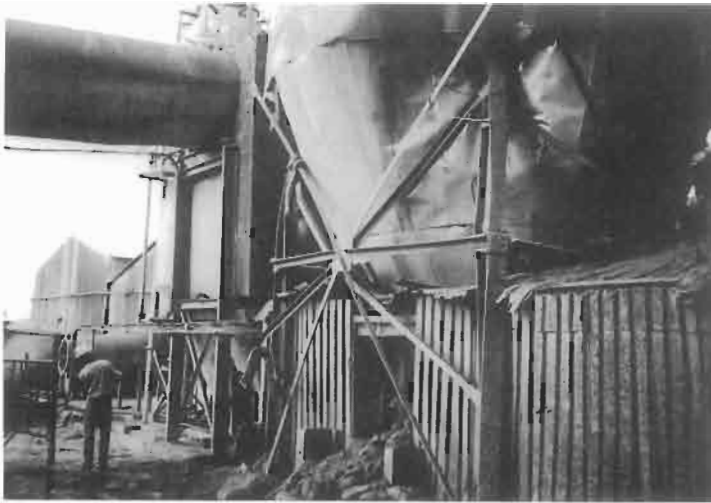
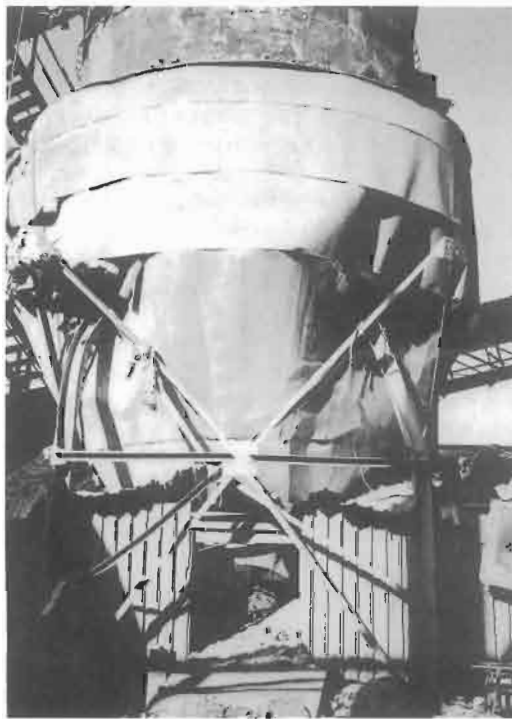
Fig. 1. View of base of collapsed drier.

There was clear evidence of a localised buckling deformation in columns and shells in the region of the welded column-shell joint. This was distinguishable from the damage associated with a collapse event itself.

To avoid a similar fate on other more recent (and stronger) spray driers, it was recommended that the lagging and cladding in the region of the annular gas duct and the column-shell joints, be removed.

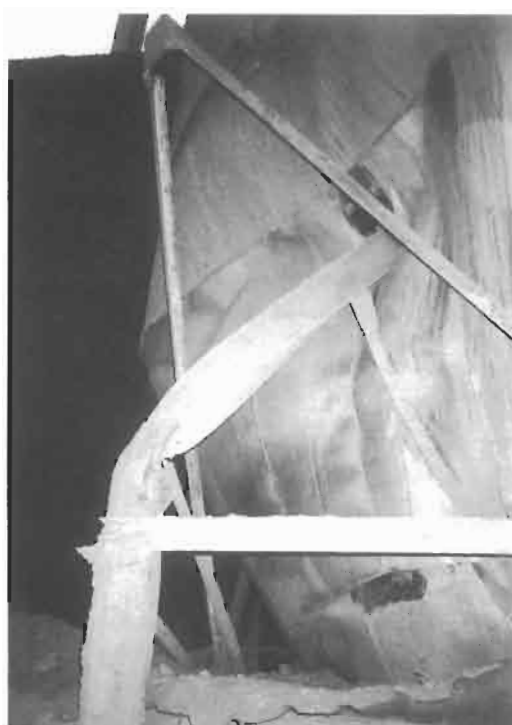
Fig. 3. View of buckled column.

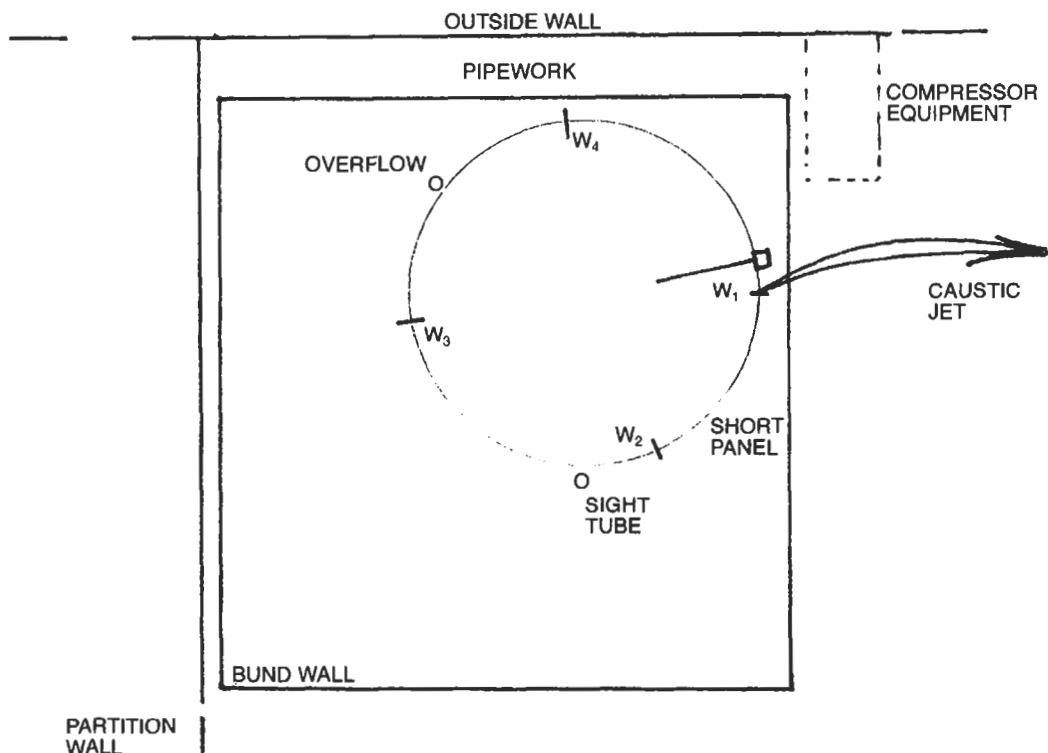
Fig. 1. Sketch plan of the caustic soda tank (diameter ca 2.7 m), showing four vertical welds (W1–4) and their position relative to the bund wall. Three of the four plastic panels had a contour length of ca 2.5 m, the fourth being shorter, at about 1.2 m. An internal heating element lay below the critical crack, but had apparently never been used. The sight and overflow tubes led to the top of the tank.

The jet of caustic soda could not be contained safely, since the fracture had occurred about 1.5 m from the floor of the tank (which itself was free standing on the factory floor), the jet projecting the liquid stream over the adjacent bund wall (Fig. 1). Since the initial fracture was only relatively small, the jet stream continued for several hours under hydrostatic pressure from the tank (which had only been filled that same morning by tanker) before the bund wall contained the liquid. The unconfined fluid spilled out over nearby equipment, and subsequently flowed into adjacent premises, which used specialised printing equipment. Severe damage ensued owing to the highly corrosive nature of the concentrated caustic soda, a fluid which degrades much organic and inorganic material very rapidly. Escape into local water streams could also have created a further hazard to animal and plant life as well as a potential danger to water supplies in the area, but was collected and safely disposed by the Fire Brigade and others. The tank apparently met the stringent conditions imposed by the only public standard available, the German Code of Practice DVS 2205 [3]. An English translation of the document only became available some time after onset of the investigation, and is discussed fully in Part II of this paper.

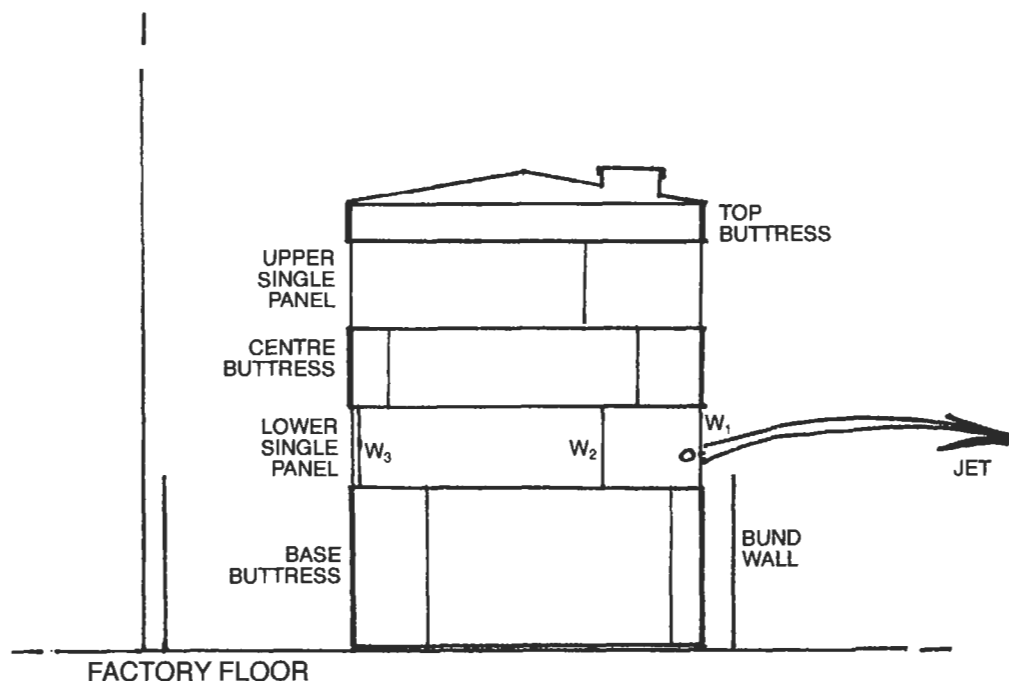
Fig. 4. Sketch section of the failed caustic soda tank, from the office side of the factory floor. It consisted of rectangular thermoplastic panels welded together, and reinforced with three extra horizontal buttresses (shown by the bold lines). The critical crack started (point O) in a vertical weld ( $W_1$ ) in the lower of the two unreinforced parts of the tank, and the jet rose in a gently curving arc above the bund wall.

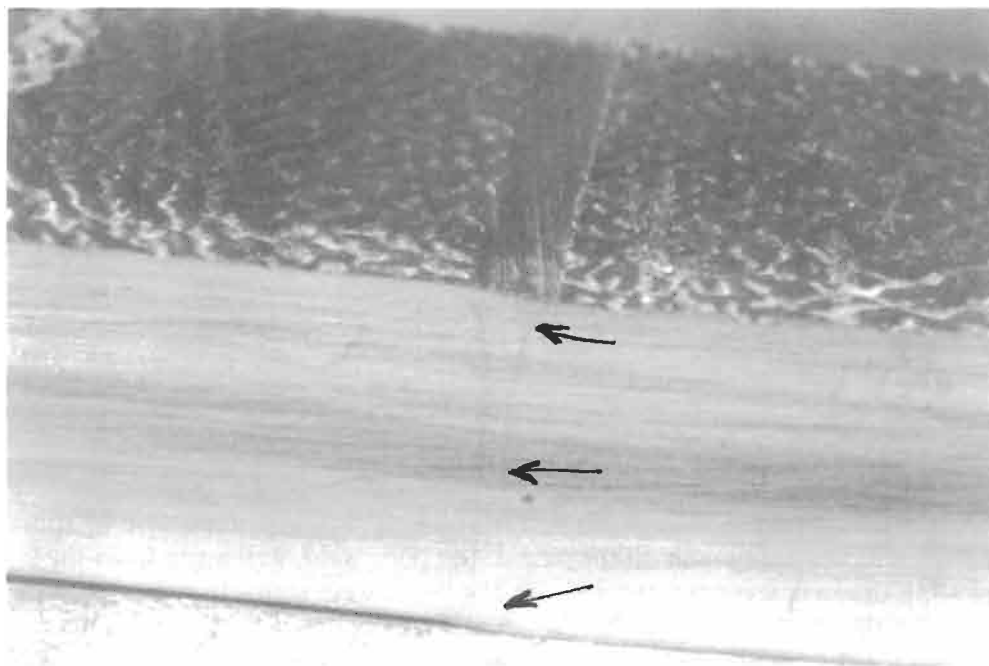
The etching revealed the internal structure of the form of the welds, both macrographs showing the weld to be wider at the external surfaces, and narrowing down to a reasonably uniform band of material within the bulk of the weld. Both samples also showed a centreline extending from bead to bead, which presumably represents the direct contact surface between the original panels when they were brought together during the thermal welding process. It also represents the zone along which fracture occurred during failure of the tank. There seemed to be a significant difference between the two weld regions, however. That from the failed weld appears to be thinner in width in the narrow, middle portion than that from the intact panel. Direct measurement from the samples with a lupe and graticule gave the width of the failed weld as about 0.6 mm, while the width of the intact weld is about 0.8 mm. It was concluded that the welding process was such as

Fig. 8. Close-up of weld section from an intact panel. The section has been finally polished with 1600 grade emery paper and exposed to boiling xylene vapour. The weld appears wider at the outer and inner surfaces of the panel (arrows), and the darker central line represents the original join of the sheets. The weld section from the failed panel showed a slightly thinner central zone.

to give some variability in the size of the heat-affected zone (HAZ), and that there was probably a direct connection between size of the HAZ and the liability of the weld to fail.

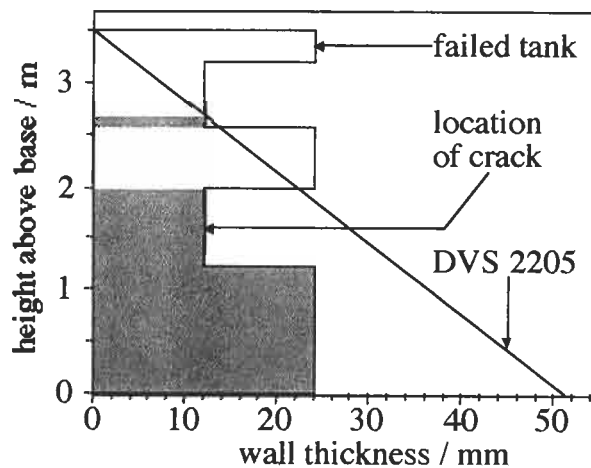
The line marked DVS 2205 in Fig. 3 shows eqn (3) plotted in terms of height from the base (i.e.  $(h_{\max} - h)$ ), rather than hydrostatic head  $h$ . Also shown is the outline of the wall thickness variation as shown in Fig. 1 for the failed tank. The shading indicates the regions of the tank wall where the thickness is less than that obtained from the DVS 2205 design code. It is clear that there are serious discrepancies between the thicknesses of the failed tank wall and those derived from the design code.

Fig. 3. Variation of wall thickness,  $s$ , of failed tank with height,  $h_{\max} - h$ , from its base compared with that specified by DVS 2205 design code (shaded areas are less than the code's thicknesses).
