# ***FAILURE ANALYSIS CASE STUDIES II***

A sourcebook of case studies selected from the pages of  
*Engineering Failure Analysis* 1997-1999

**D.R.H. JONES**

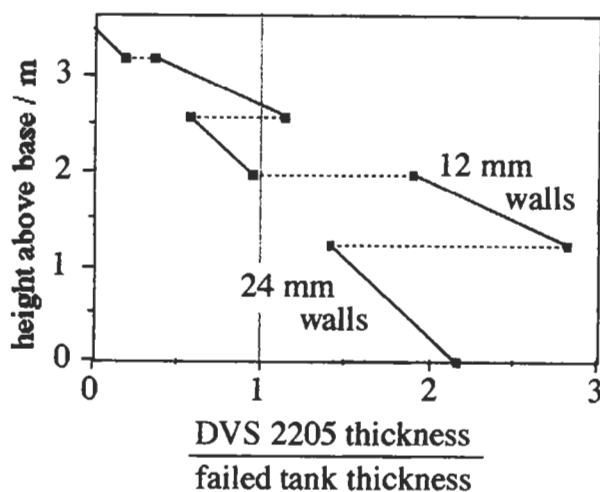
Fig. 4. Ratio of DVS 2205 wall thickness to that used in the failed tank and its variation with height above the base of the tank.

ments is highlighted in Fig. 4. This plots the ratio of the wall thickness from eqn (3) to that of the failed tank as a function of height from the base. The largest discrepancy is found in the lower 12 mm thick section—just the section where the failure originated.

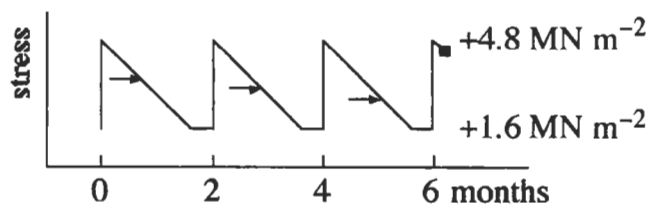
Fig. 8. Schematic of stress variation at outer surface in response to filling cycles of the tank: the arrows indicate schematically the critical stress for slow crack growth.

greater than those derived from DVS 2205 (see Section 4), the effect of an extra 50% stress cannot be anything but serious. Cracks tend to start at surface flaws, which is just where the tensile stresses are highest, and in Part 1 of this work it was found that this was indeed how the crack in the failed tank started (see Figs 3 and 6 in Part I). Two mitigating features, that delayed the failure of the failed tank, were, firstly, that there was a stress gradient through the thickness of wall material, so that any crack starting at the outer surface would propagate into a decreasing stress field, and, secondly, the loading of the tank was periodic. This meant that the maximum surface tensile stress at the site of failure varied between about  $4.8 \text{ MN m}^{-2}$  when the tank was full, to about  $1.6 \text{ MN m}^{-2}$  when the liquid level had sunk below the failure height. This is sketched schematically in Fig. 8 for the four loadings of the tank in its six or so months of service. (Bear in mind that this is a simplified schematic—the maximum stress should fall off slightly as the bending stresses relax. In addition, there is no information on the exact form of the loading cycle.) Also indicated (by the arrows) is the schematic behaviour of the critical stress for slow crack growth, showing how this stress would have fallen at each loading cycle, reflecting the crack growth in the preceding cycle.

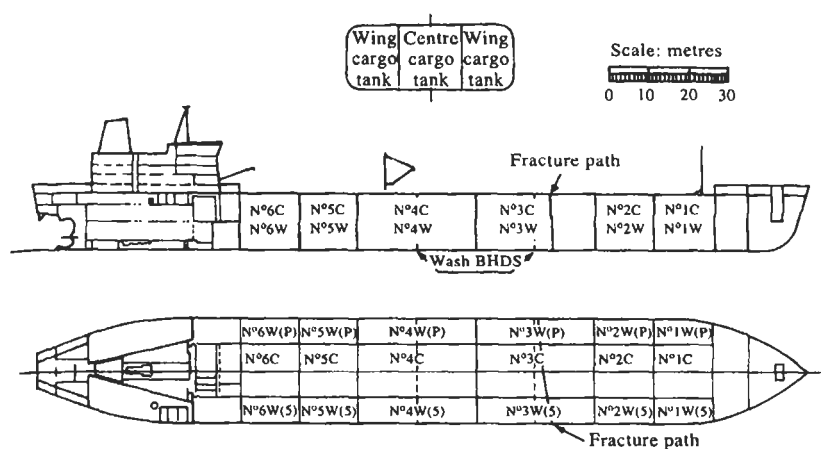
Fig. 2. General details of the MV *Kurdistan*.

Following this incident, two cracks were reported in the side shell in the vicinity of the No. 3 tank (Fig. 2). On the starboard side, a 6 in. (150 mm) crack was visible approximately 12 ft (~4 m) below the level of the deck, and 23 ft abaft of the bulkhead. On the port side, a vertical crack, starting ~12 ft, and ending ~18 ft (~5 m), below deck level, 37 ft (~11 m) abaft of the bulkhead, was apparent. Oil was seen to leak from both cracks, particularly the port side, which appeared to have opened up by ~0.5 in. (12 mm) in the centre. At this time, ullages (measurements of the tank levels) were taken of the No. 3 wing tanks, indicating a large drop in oil level. At 14.30, air was reported to be heard entering the No. 3 centre tank, and an ullage of 8 ft was recorded (the ullage should have been 4 ft). At this time, the wing tanks had an ullage of 10 ft. It was assumed that a longitudinal bulkhead had also cracked, and that oil was entering the wing tanks from the centre tank. To prevent further spillage, oil was pumped from the No. 3 to the No. 4 wing tank.

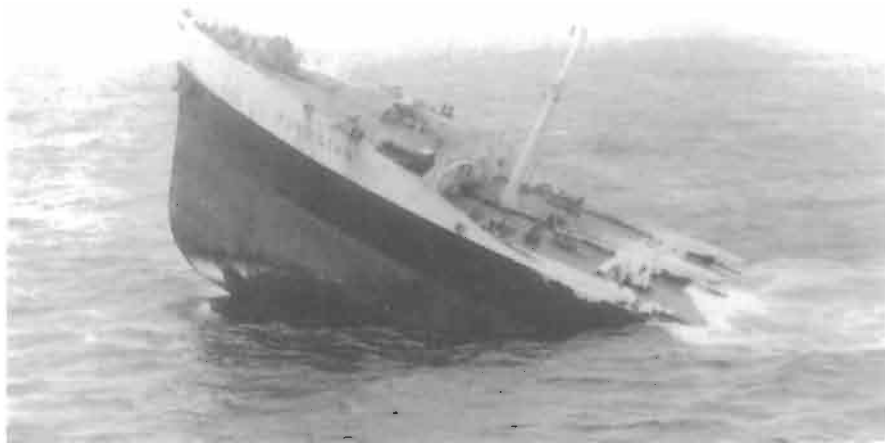
Fig. 3. Bow section of MV *Kurdistan* after breaking in two.

was reported. At 21.40, a third shudder was experienced, and  $\sim 150$  ft ( $\sim 46$  m) of the bow section lifted up, severely distorting the deck plates, and the bow broke away from the aft section of the ship (which was approximately two-thirds of the ship's length).

The ship would have been in a sagging condition in a calm sea, meaning that the keel would be in tension under these conditions. Hence, on breaking in two, the fractured ends of the two sections of the ship dipped into the sea, with the bow and stern rearing out of the water (Figs 3 and 4). At this point, the ship was abandoned. The 41 persons on board *Kurdistan* were all in the aft section of the vessel. With the exception of the chief officer, who remained on the vessel, the crew and their

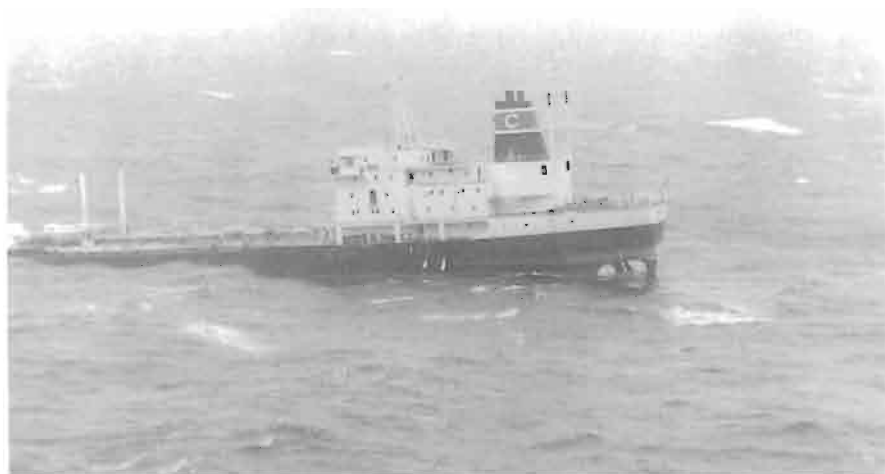
Fig. 4. Stern section of MV *Kurdistan* after breaking in two.

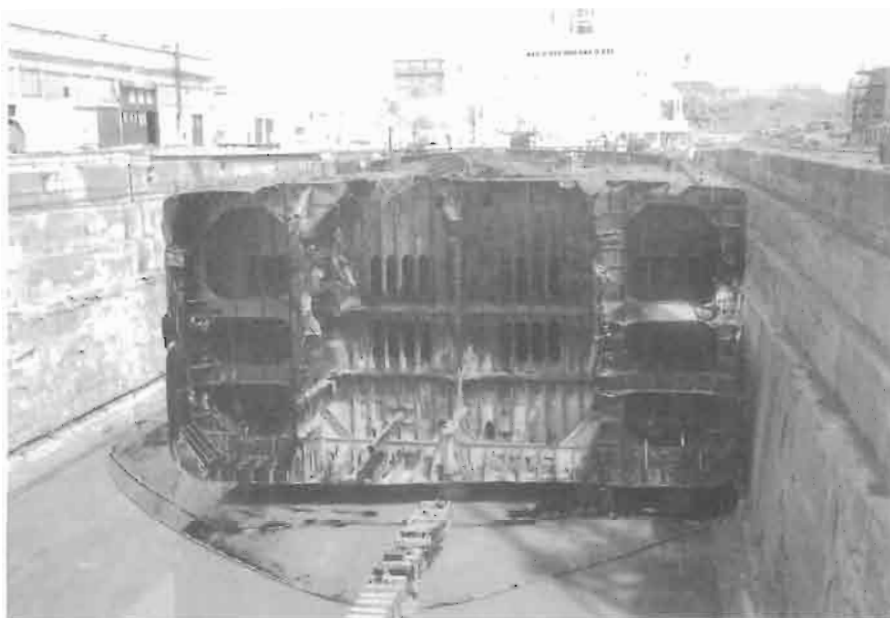
Fig. 5. General view of the stern section of the MV *Kurdistan*.

families were picked up from the two lifeboats launched. The chief officer was rescued by helicopter on 16 March. The stern section of the ship was subsequently salvaged and towed to dry dock at St John, New Brunswick, docking on 15 April, after the oil had been pumped out of the remaining tanks (Fig. 5). The bow section was sunk on 1 April to prevent further pollution. Over 5000 tons of bunker oil had been lost from the rupture of the No. 3 centre tank alone.

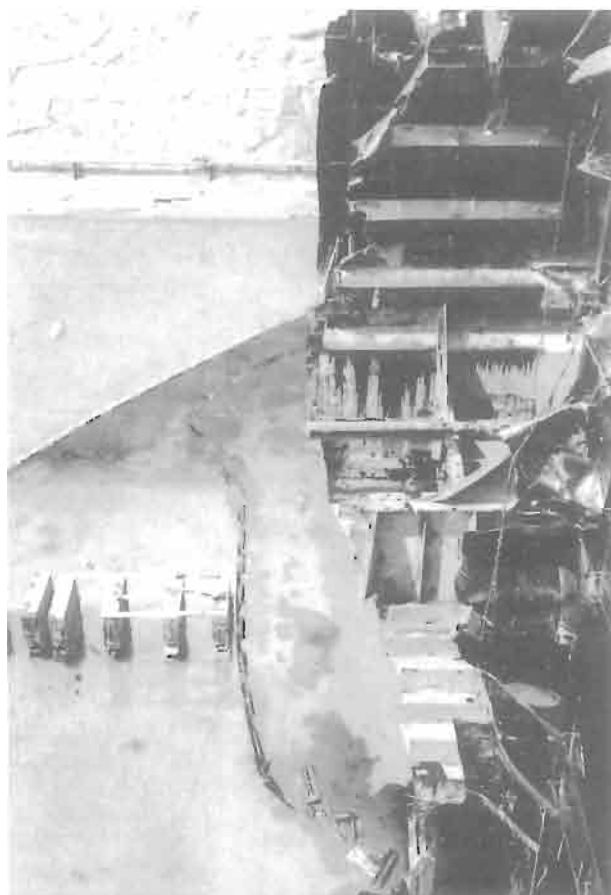
On 11 April, the Welding Institute (TWI) was called in by Mr T. Chorley, Chief Ship Surveyor of the U.K. Department of Trade (DoT), Sunley House, Holborn, London, to assist one of their senior ship inspectors in surveying the ship on docking. Dr Garwood of TWI accompanied Mr Hume of the DoT to Canada on 15 April to make the inspection. The inspection was carried out employing a platform controlled by a crane to inspect the ship's sides and check fracture surfaces, and, by wading along the dock floor, to inspect the fracture faces of the longitudinals, centre keel and bottom plate (Fig. 6).

Fig. 6. View of longitudinals, centre girder and bottom shell from port side of vessel.

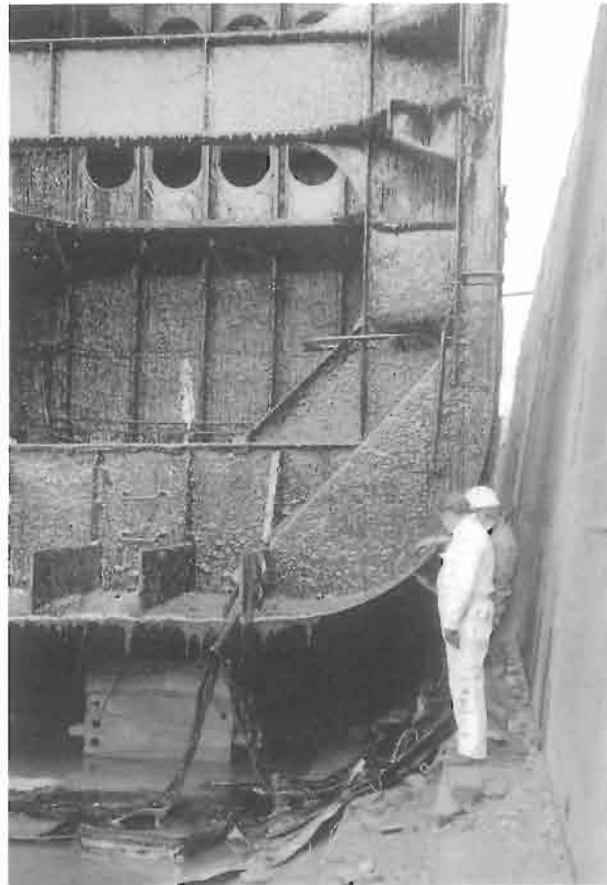
Figures 8 and 9 show the bilge keel and shell on the port side. The bilge bracket detail is also

Fig. 8. Port bilge keel and keel showing three longitudinals, bilge bracket and fracture face of hull plating.

clearly visible. The fracture in the shell occurred just aft of the forward bilge bracket, but there was no evidence that the crack was connected in any way with the bracket as the fracture of the shell appeared to be entirely in the plate material. After propagating from the bilge keel, the crack ran in a brittle manner up the port side shell plate (as shown in Fig. 8). Unfortunately, the exact point at which the crack arrested could not be ascertained as the brittle fracture continued into the heavily buckled and deformed region of the hull where all fracture characteristics had been completely destroyed. Due to the deformation incurred in this region, however, it would appear reasonable to assume that this was one of the last parts of the hull to fracture, and thus the initially brittle crack did arrest in this region.

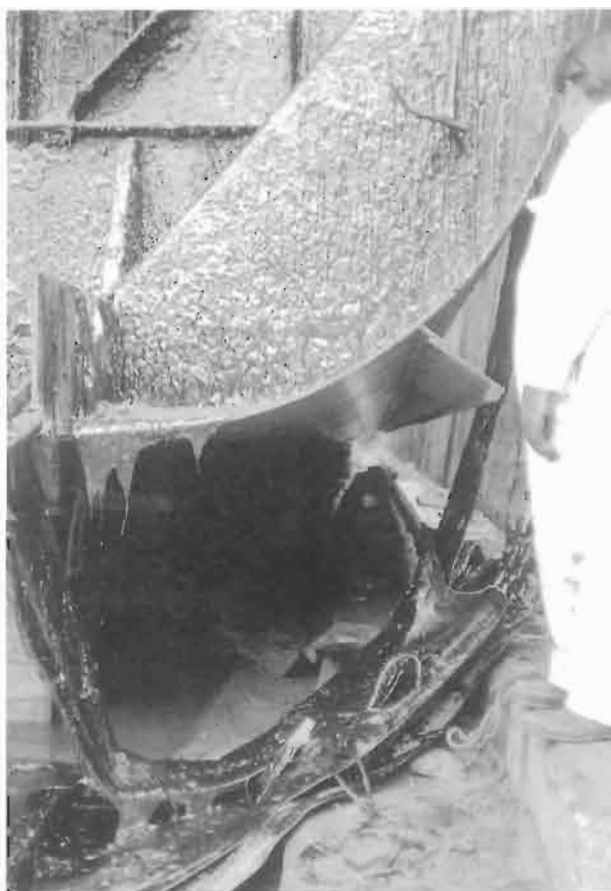
Fig. 9. Port bilge keel showing bilge bracket: also showing longitudinal.

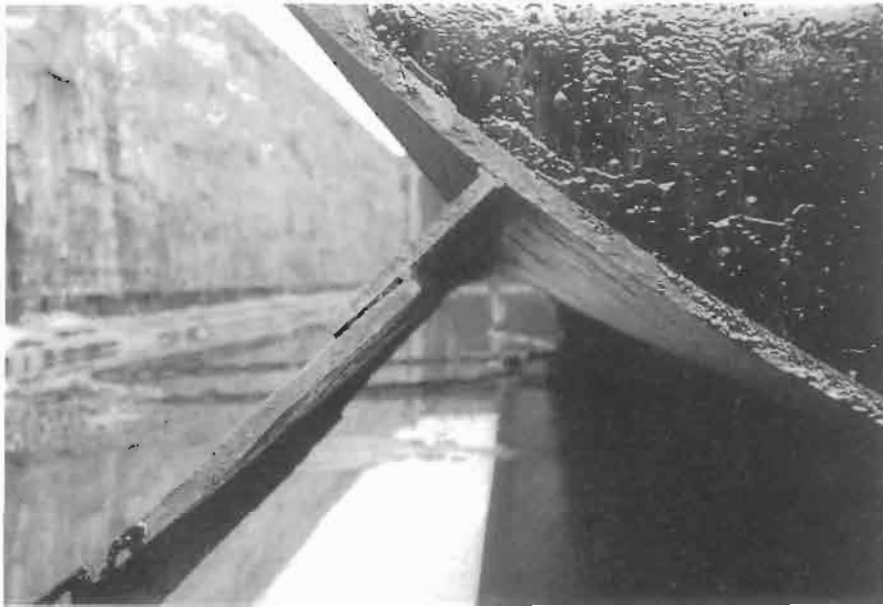
Fig. 14. Starboard bilge keel.

- 8 Brittle fracture
- 9 Brittle fracture [1 in. (25 mm) in centre ductile]
- 10 Brittle fracture [into drainhole 1 in. (25 mm) ductile, then brittle]
- 11 Brittle fracture
- 12 Brittle fracture
- 13 Ductile

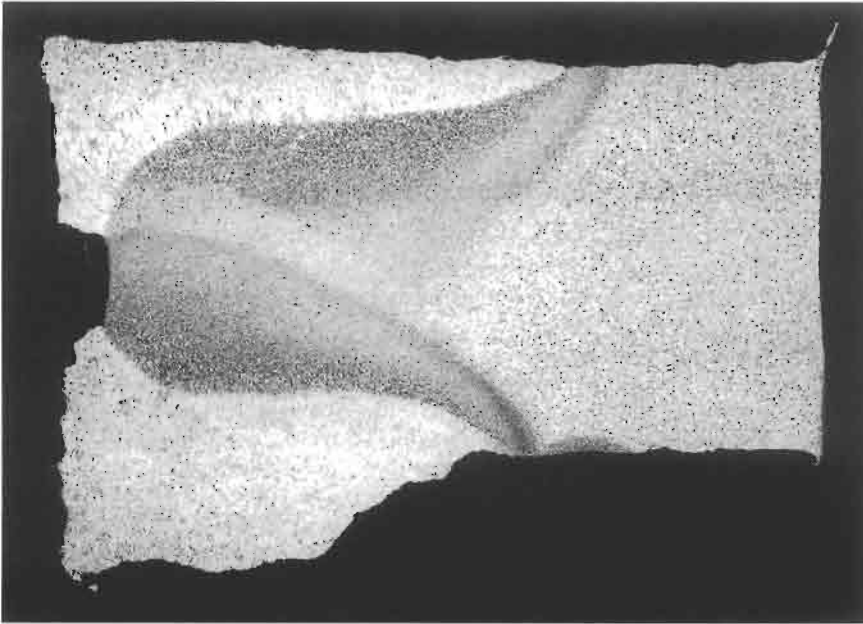
Fig. 15. Ground bar butt weld in double-sided region. Note incomplete penetration.  $\times 7$ .

Although the lack of penetration defect of the starboard sample must have seen comparable loading to that experienced by the detail which initiated in the port sample, this was not a critical defect. The presence of a complete double-sided weld was obviously sufficient to reduce the overall stress and local stress concentration effects experienced by this weld to levels below that at which any significant fatigue crack propagation had occurred. Because of the lower overall stress and local stress concentration levels, and the presence of a smaller and blunter defect in the starboard detail, fracture initiation from this site was much less likely. As noted in [1], if the ground bar weld detail

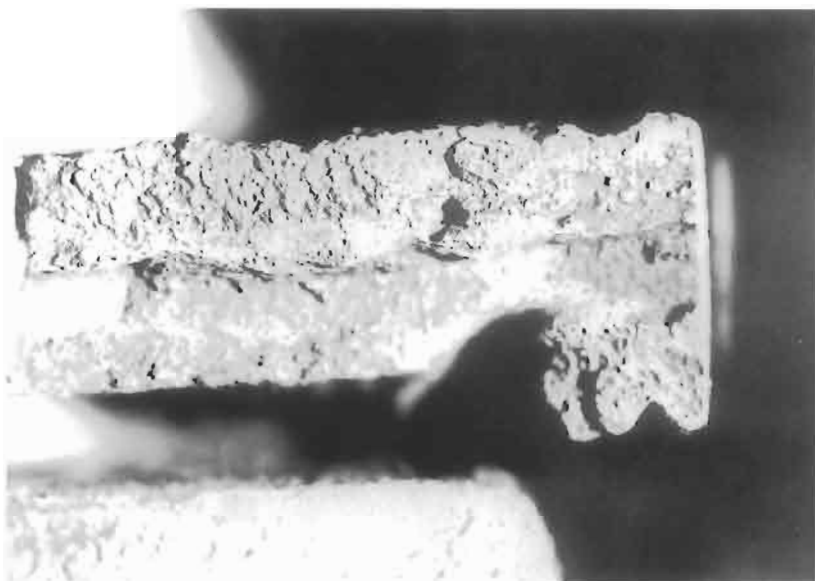
Fig. 18. Fracture surface of ground bar butt weld in sample 1 in single-sided region, close to inboard edge of bulb bar. Note smooth, featureless region in root of weld.  $\times 4$ .

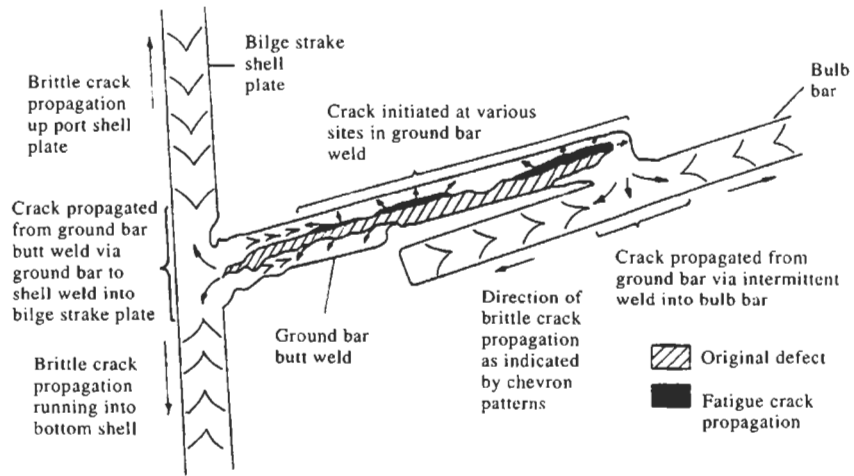
The directions of propagation from the initiation sites in the port sample are believed to have been as shown in Fig. 20.

Fig. 20. Crack initiation in ground bar weld and subsequent propagation into shell—port bilge keel detail.

The path of the fracture initiating from the primary sample is shown in Fig. 20.

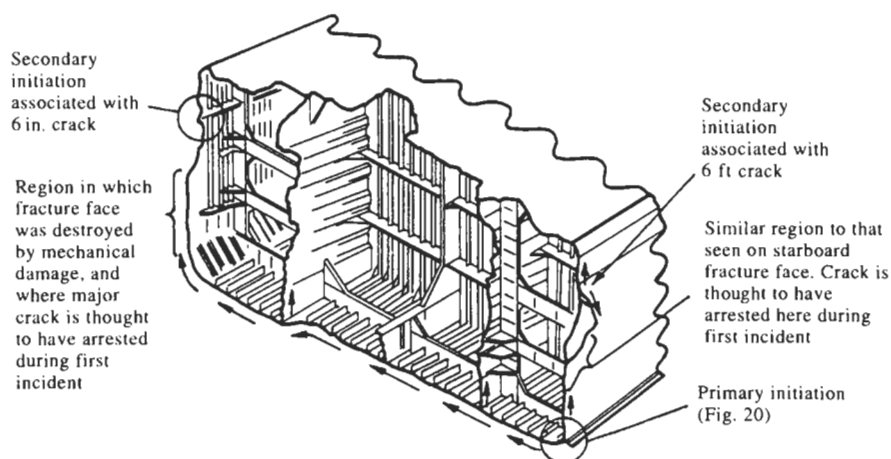
Fig. 22. Extent of crack propagation after the first reported incident. General view.

As the crack propagated along the bottom shell, it entered the longitudinal girders and bulkheads to the degree shown in Figs 22–25. In several of these, especially the bulkheads, the crack was arrested, due to higher temperatures of the shell caused by the heated cargo, and to the thinner plate in the bulkhead material.

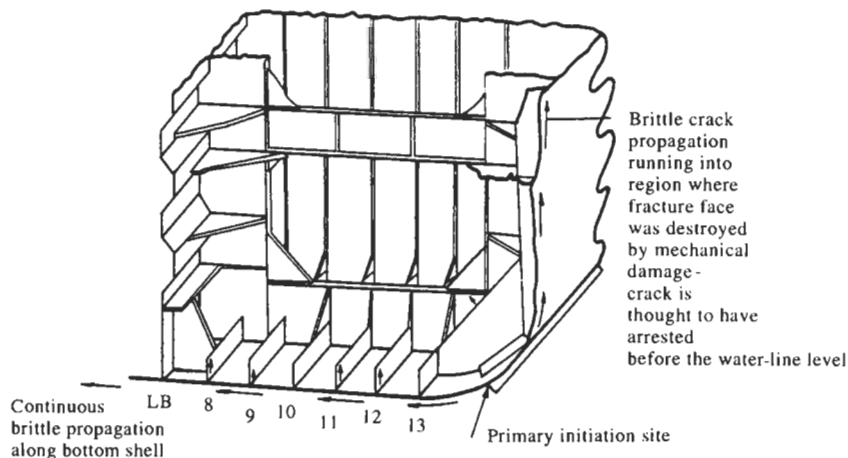
Fig. 23. Crack propagation—port bilge keel region during the first incident.

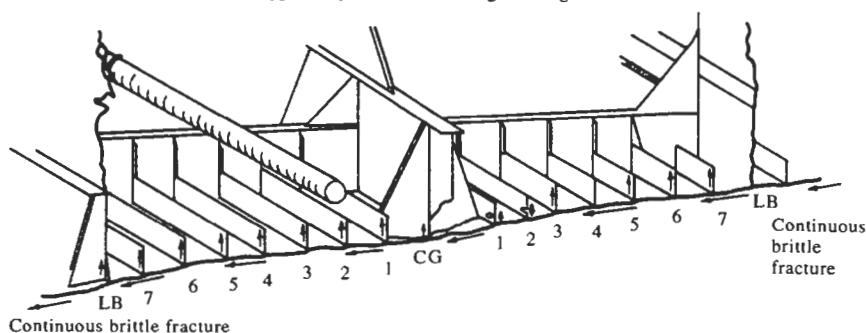
Fig. 24. Crack propagation during the first incident—bottom shell fracture.

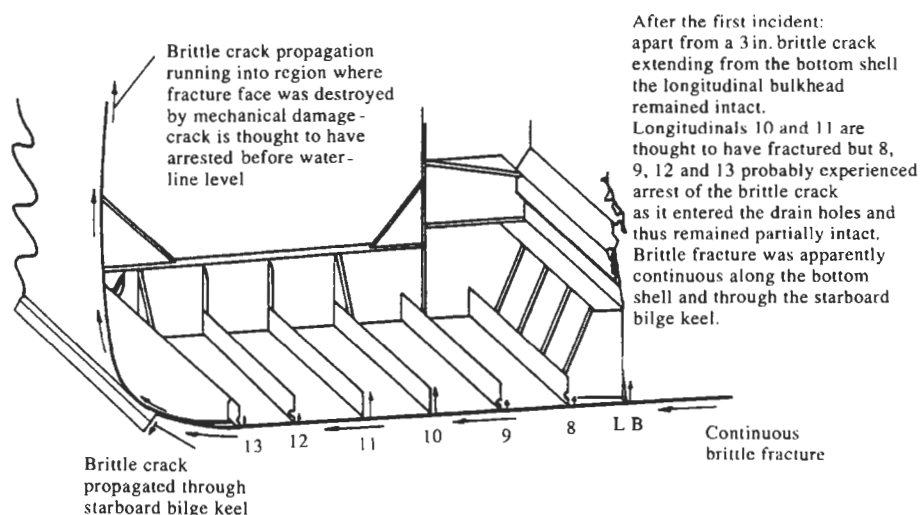
Fig. 25. Crack propagation during the first incident—starboard bilge keel region.

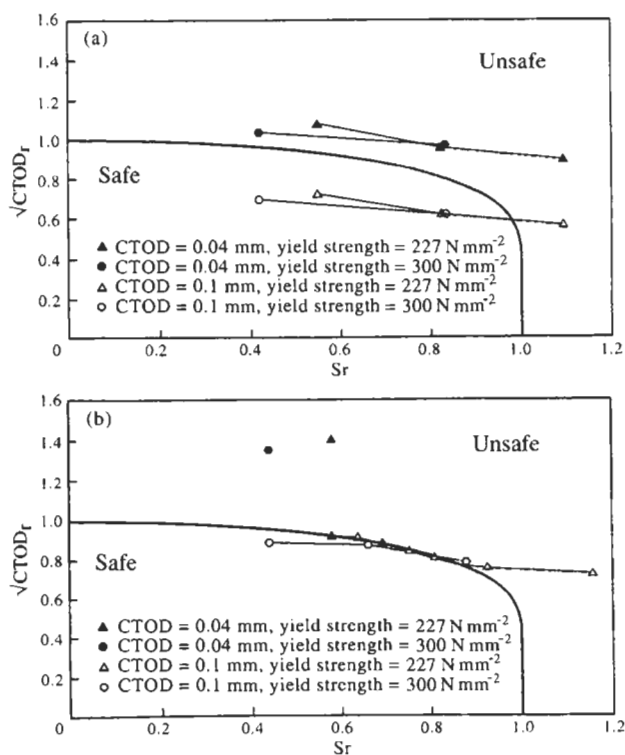
The reanalysis is illustrated in Fig. 26 using the level 2 procedure of BSI PD6493: 1991 with weld metal CTOD values relating to the low and medium strain rates. Assessment points are drawn for stress inputs of 100, 150 and 200  $\text{N mm}^{-2}$ , assuming a yield strength of 227 and 300  $\text{N mm}^{-2}$ , relating to plate and weld metal, respectively. The reanalysis indicates that failure (indicated by points outside the failure locus) would, in fact, have been possible at low strain rates as the higher load level is approached. For the intermediate rate, CTOD toughness failure is predicted for the still-water condition of 100  $\text{N mm}^{-2}$ . This reanalysis confirms the criticality of the combination of high applied stresses (due to the combination of cargo loads, wave loads and hot cargo in cold seas), high residual stresses, the presence of a significant weld defect, and low toughness.

Fig. 26. (a) MV *Kurdistan* level 2 assessments—embedded defect assumption. (b) MV *Kurdistan* level 2 assessments—surface defect assumption.

by the strain rate induced by the wave loading as the vessel exited the ice field. The reanalysis indicates that a marginally higher rate than the low strain rate would have been just sufficient to reduce the toughness below a CTOD of 0.1 mm, and would have caused a brittle initiation under the prevailing loading conditions.

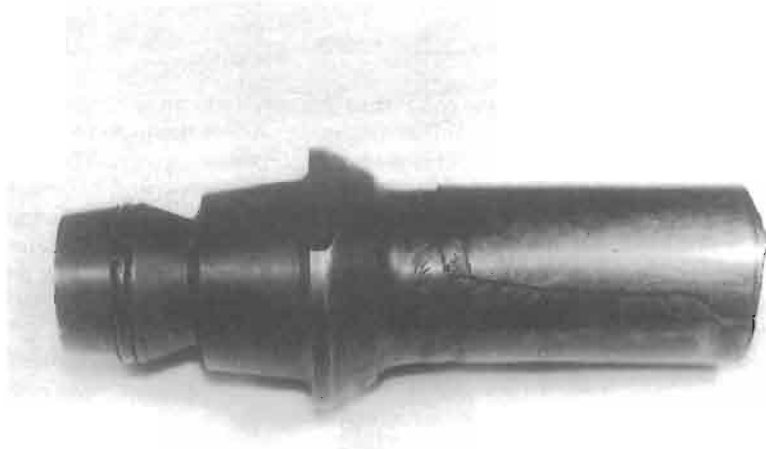
Fig. 1. Typical failed actuator piston rod showing the adapter, the circumferential weld and a large crack.

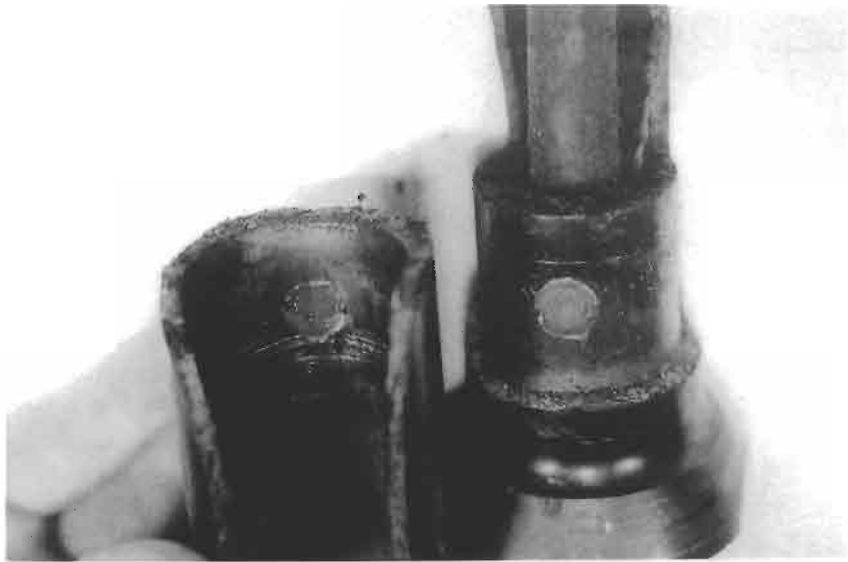
Fig. 2. Typical fracture through the centre of the weld and along the piston rod. The location of one of the rosette welds can be seen.

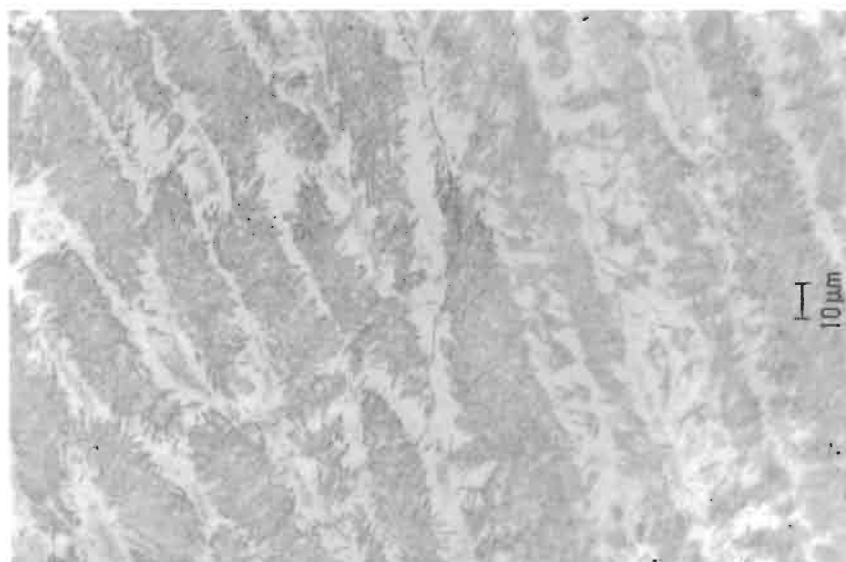
Fig. 3. Optical micrograph of one of the E312 welds showing austenite/ferrite duplex structure and a hairline crack (centre of photograph) (etchant: Vilella's etch).

place, the former composition was more likely. Indeed, the microstructure of the E312 weld consisted mainly of austenite and ferrite (Fig. 3), but a large degree of grain boundary and intragranular carbide precipitation, probably chromium carbides, was also observed. The carbide precipitation probably took place during nitriding, resulting in the high hardness of the weld and weakening of the grain boundaries.

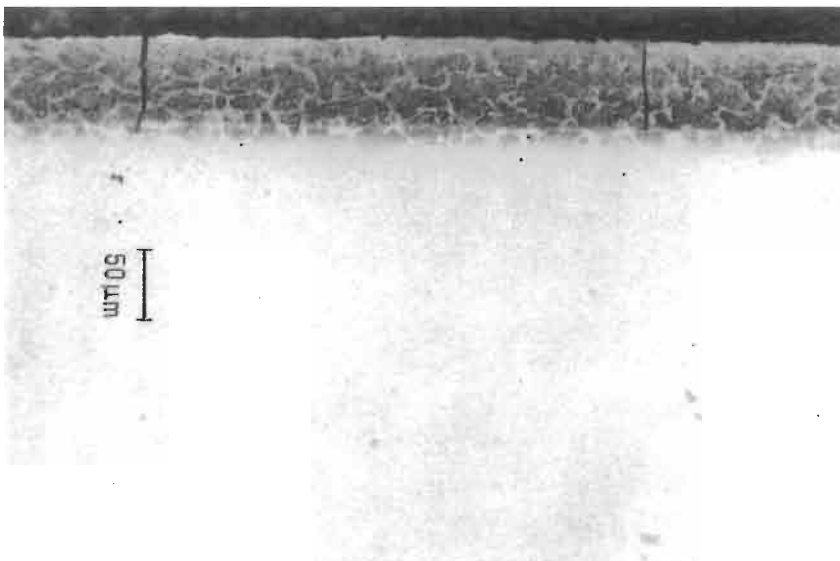
The surface of the weld showed a nitrided layer which was cracked at regular intervals (Fig. 5). Sections of the surface adjacent to the weld bead clearly showed the white layer from the nitriding process. Surface cracks were visible. Since the white layer was not present in the crack (Fig. 6), these cracks probably originated after the nitriding process.

Fig. 5. Optical micrograph of the E312 weld showing cracks that originated after the nitriding (etchant: 2% Nital).

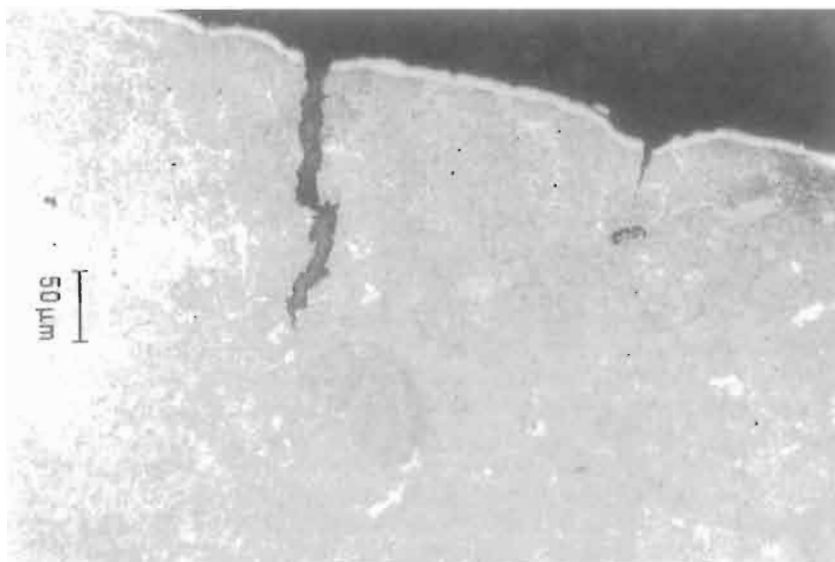
Fig. 6. Optical micrograph of the En32 steel immediately adjacent to the weld showing cracks that originated after the nitriding (etchant: 2% Nital).

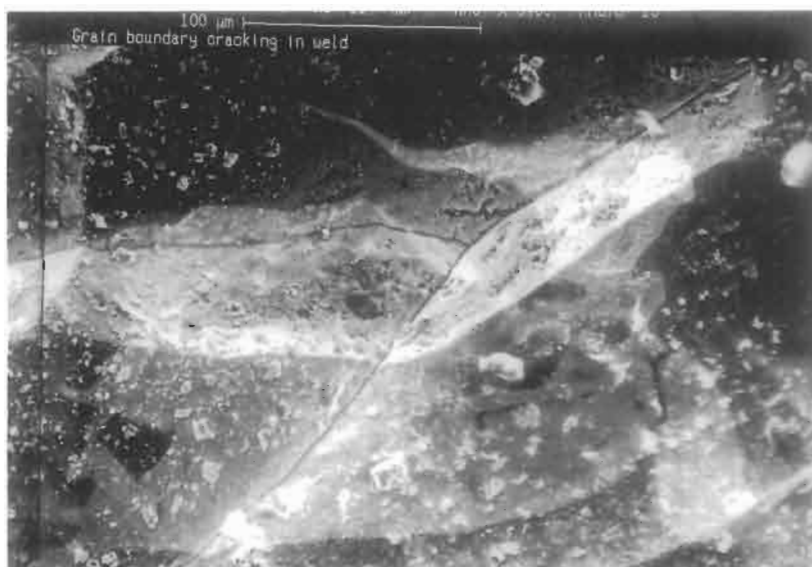
The fracture surfaces showed no signs of fatigue. Fracture was intergranular and numerous intergranular cracks were visible on the fracture surfaces (Fig. 7).

Fig. 7. SEM fractograph of the fracture surface as received. The intergranular nature of the fracture and secondary cracks can be seen.

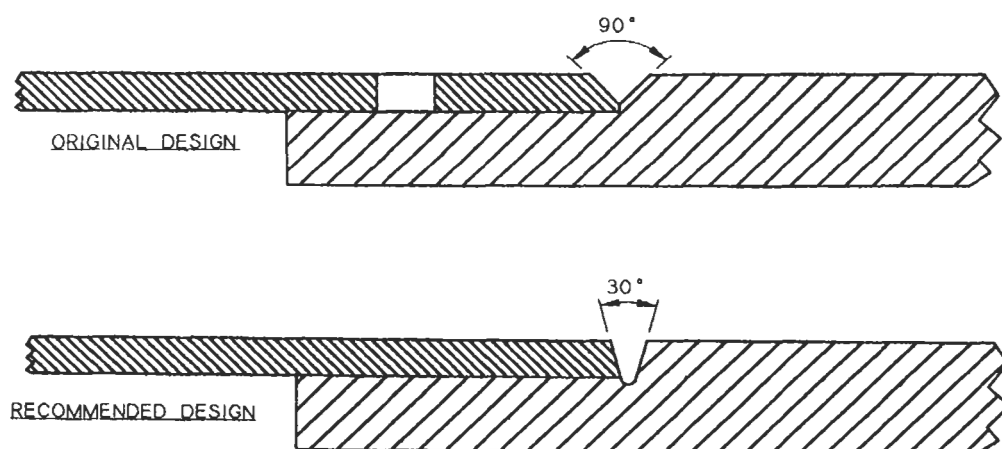
The weld bead was very wide and relatively shallow (Fig. 8), and in some cases insufficient penetration resulted in a circumferential stress concentrator in line with the centreline of the weld. Ideally, where two components are only welded along a part of their contact surface, the un-fused plane should be off-centre and not parallel to the weld centreline.

Fig. 8. Schematic drawings of the original and recommended weld preparations.

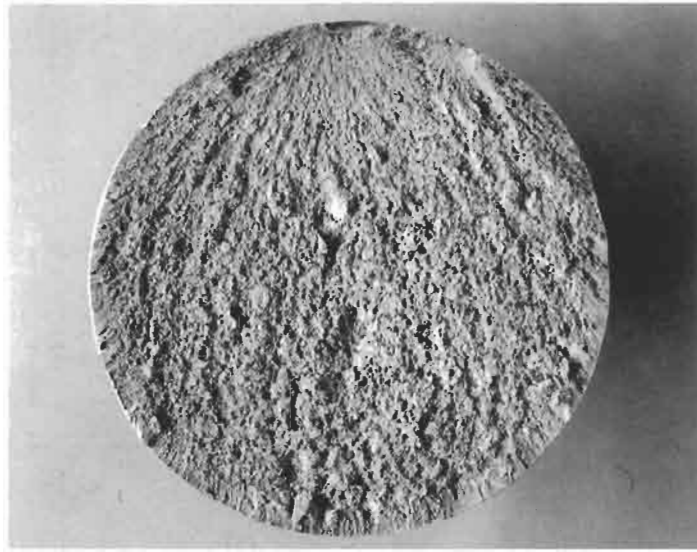
Examination of the fracture surfaces revealed that in both cases the fracture was triggered by a small surface crack. The morphology of the fracture surfaces was very similar in the two bars; a representative picture is shown in Fig. 2. Observation by scanning electron microscopy revealed a quasi-cleavage morphology.

Fig. 2. Fracture surface of a broken bar.

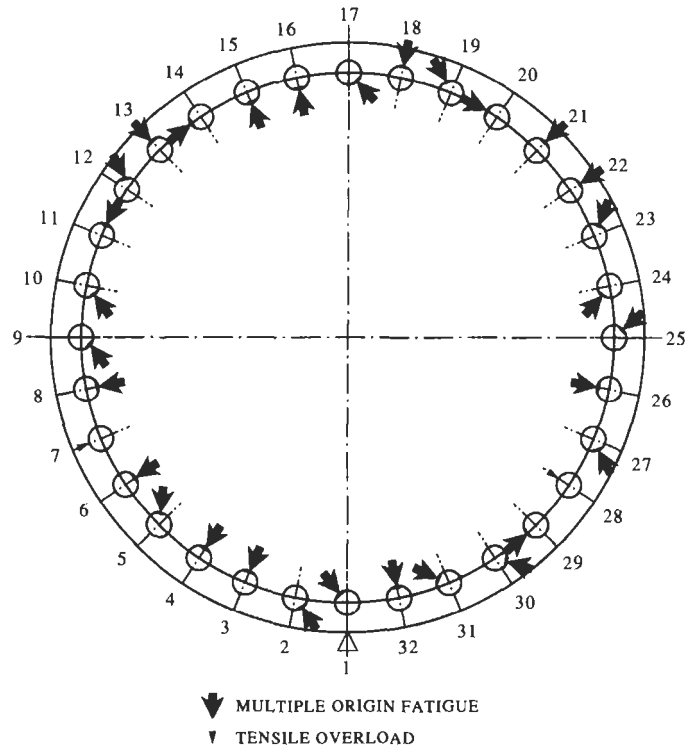
Fig. 7. Plan view of the cover, showing the positions of the fractured bolts and the corresponding fracture origins.

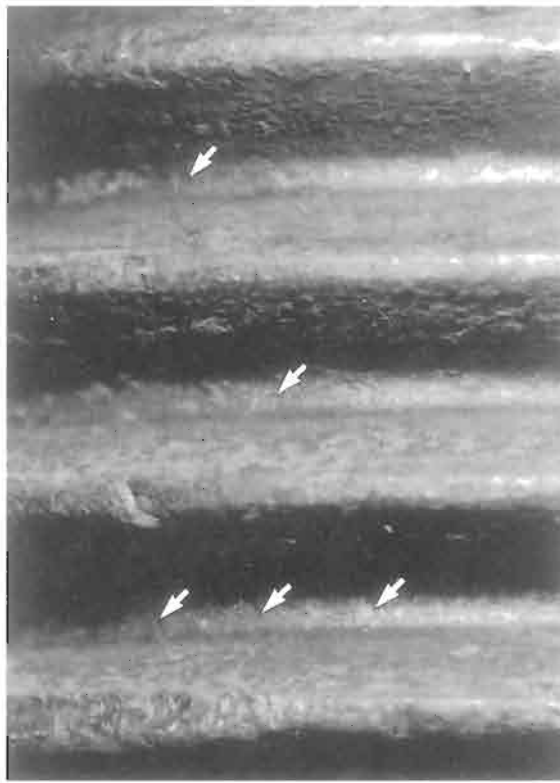
Fig. 8. General surface condition of the bolt threads, showing evidence of pitting corrosion (arrowed).

A water additive is used for its lubricating and hole cleaning properties, but only if the system is a closed loop. In addition, the additive would have no corrosion-inhibiting effect on the water. A medium such as an oil-based red lead primer should be used at the connection joint between the cover and the body in order to prevent water from reaching the drive head bolts. The torque tightening of the 32 bolts will cause the compound to "spread" and allow satisfactory sealing of the mating surfaces.

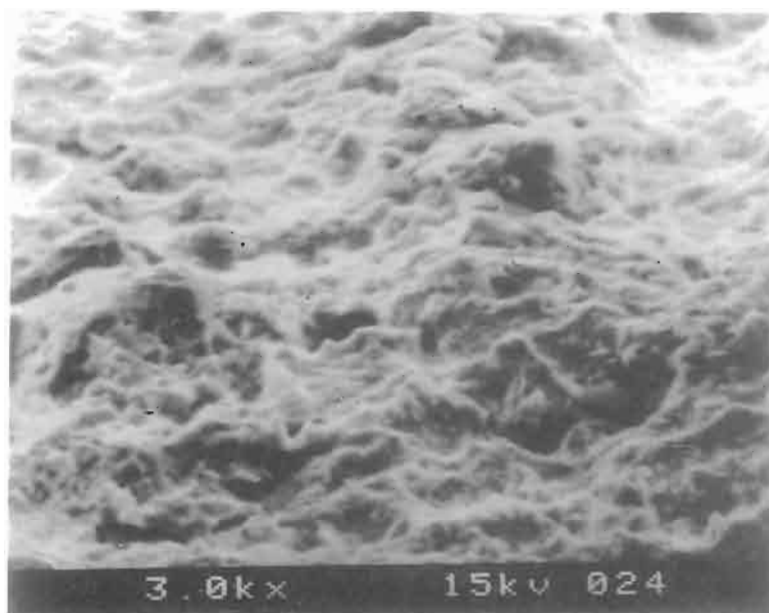
Fig. 9. Scanning electron fractograph showing features characteristic of fatigue.  $\times 3600$ .

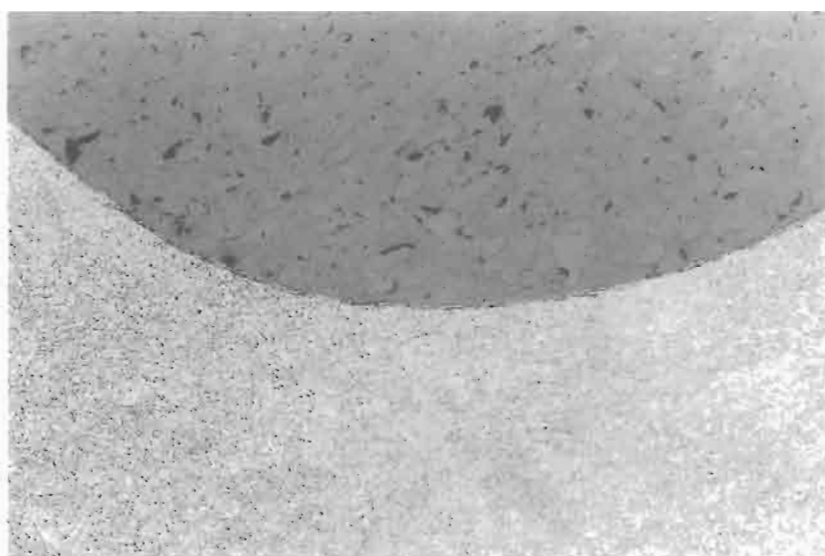
Fig. 10. Longitudinal section of a bolt thread root showing fine tempered martensite, and no material or manufacturing defects. Etched in 2% nital.  $\times 285$ .

The metallurgical examination of the bolts showed that the failure was not associated with any material or manufacturing defects. The bolts conformed to the specification requirements in all respects.

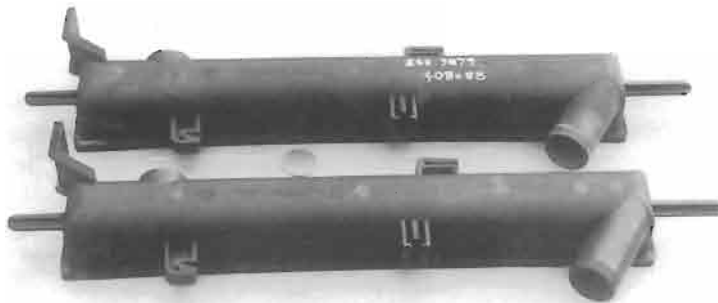
Fig. 1. Failed and new radiator boxes compared. The upper, failed sample cracked after 500 miles in service.

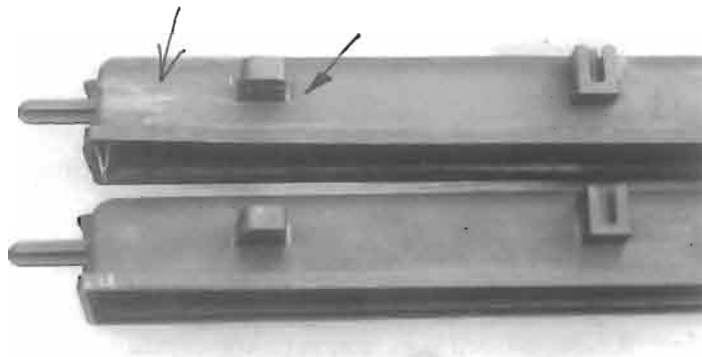
Fig. 2. Comparison of lower ends of upper, failed box and new box below. Closed arrow shows brittle crack which ran along inner corner of adjoining fan buttress. Open arrow shows contamination from leaking cooling water when tank was in situ.

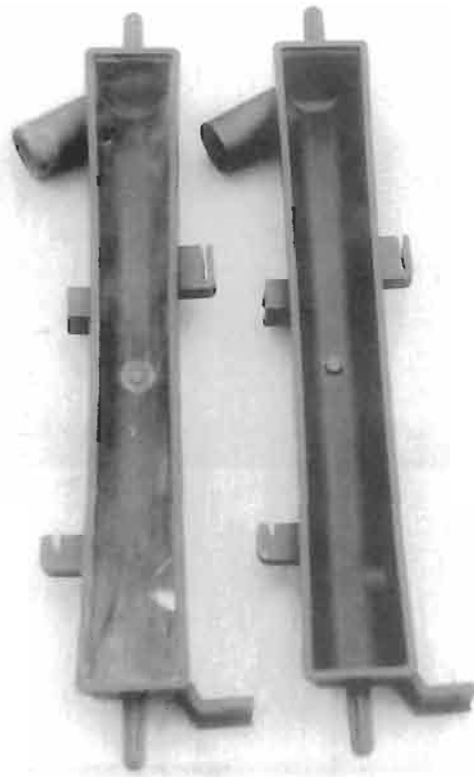
Fig. 3. Comparison of dimensions of failed (LHS) and new radiator boxes. Note longitudinal distortion of failed box.

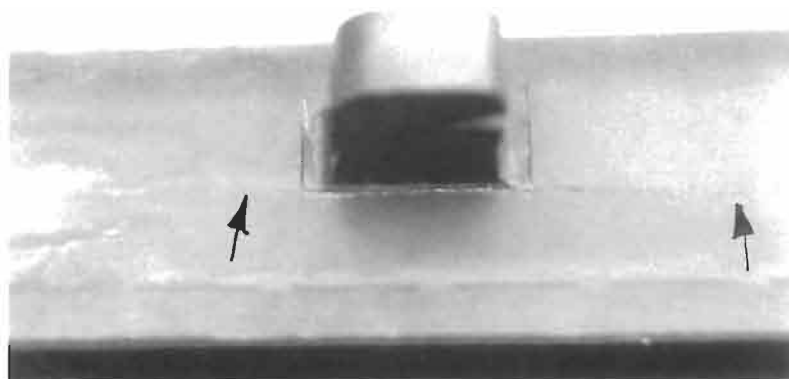
Fig. 4. Macrograph of brittle crack, running along stress concentration of buttress corner, and ending at points shown by closed arrows.

upright position when in use on the car. The crack was brittle in nature, and extending ca 6.3 cm internally and almost the same distance externally (Figs 4 and 5).

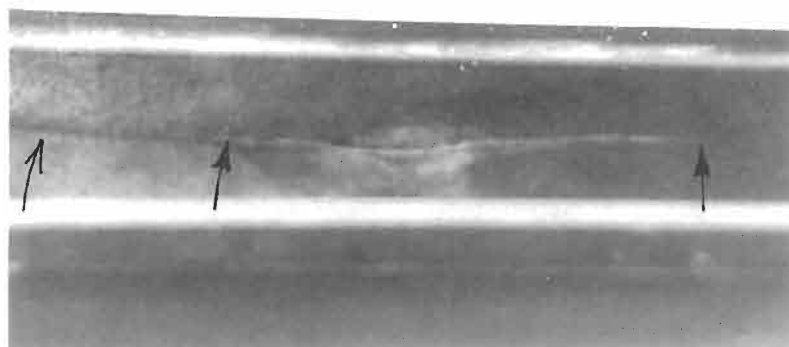
Fig. 5. Macrograph of brittle crack on inner surface, with ends shown by closed arrows. Weld line at left (open arrow) co-linear with crack, and surrounded by extensive flow line pattern.

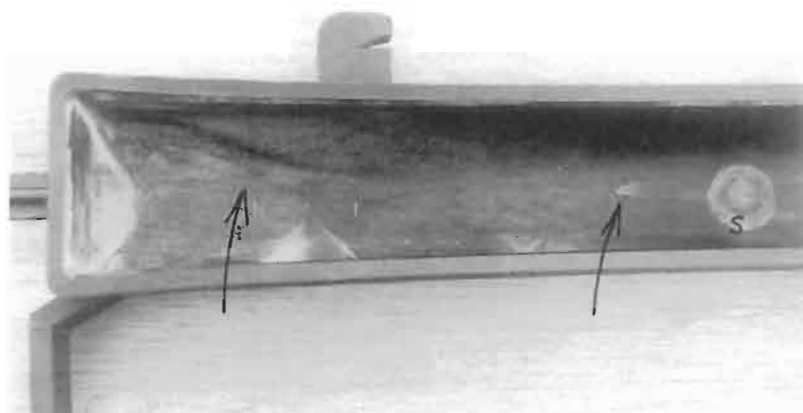
Fig. 6. Close-up of top inner surface of failed box showing complex flow lines (open arrow, left) and sprue (S). Cold slug near sprue at centre (open arrow, right).

The flow pattern could also be traced further away from the crack (Fig. 6). It appeared to emanate from the sprue, and was aligned towards one of the far corners of the box. A defect found close to the sprue, comprised a deep, short irregular weld line often known as a 'cold slug'. Such defects are generally caused by incomplete melting of the moulding pellets, whose external shape is thus partly preserved in the melt (Fig. 6).

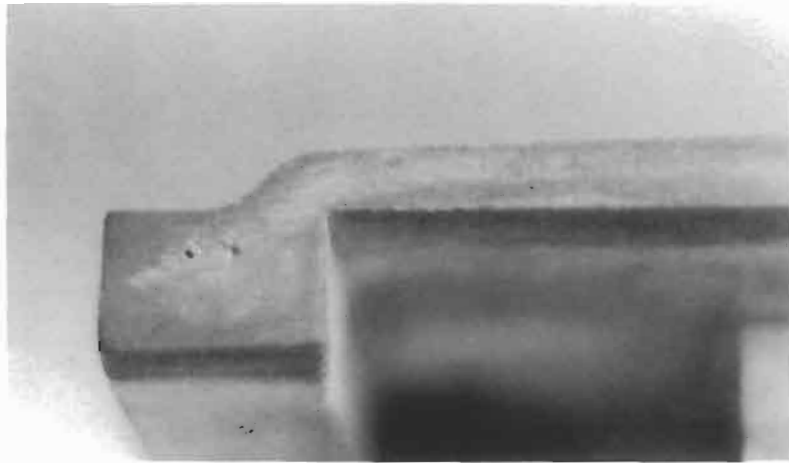
Fig. 7. Macrograph of abraded and polished section through edge of new radiator box, after light etching with chromic acid. Voids are present in the thick edge section, and change in fibre orientation is shown along the thinner section by shading.

There were several types of defect seen in the fracture surface here, including a large weld line, cold slug fragments and voids. The latter are especially likely to form at or near a thickening of the tank wall (e.g. Fig. 7). Judging by the several white stains observed on the buttress surface immediately above the lateral corner, it is likely that there were several very slow leaks before the final, catastrophic failure when the cracks propagated catastrophically. The bead would have formed during this phase of the failure. It was possible to quantify the effect of the several weakening mechanisms at work in the failure. The initiating mechanisms are:

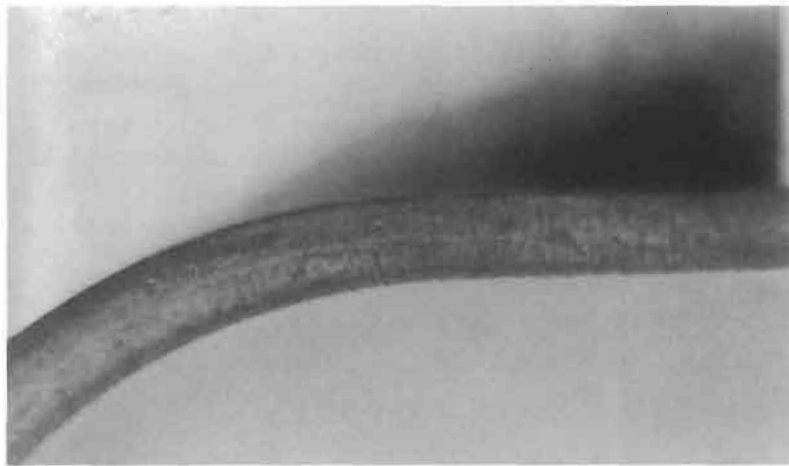
Fig. 8. Macrograph of curved thin section of new radiator box after abrasion, polishing and chromic acid etching. Change in fibre orientation can be clearly seen at the left (arrows), with a skin/core effect, and microvoids are present in the interior.

Unfortunately, the ideal tends to break down when real moulding sections are examined in detail. The skin/core effect was seen at its best, ideal form at the left-hand part of the thinner section (Fig. 8). Here, there was a clear skin approximately 0.5 mm thick on both inside and outer

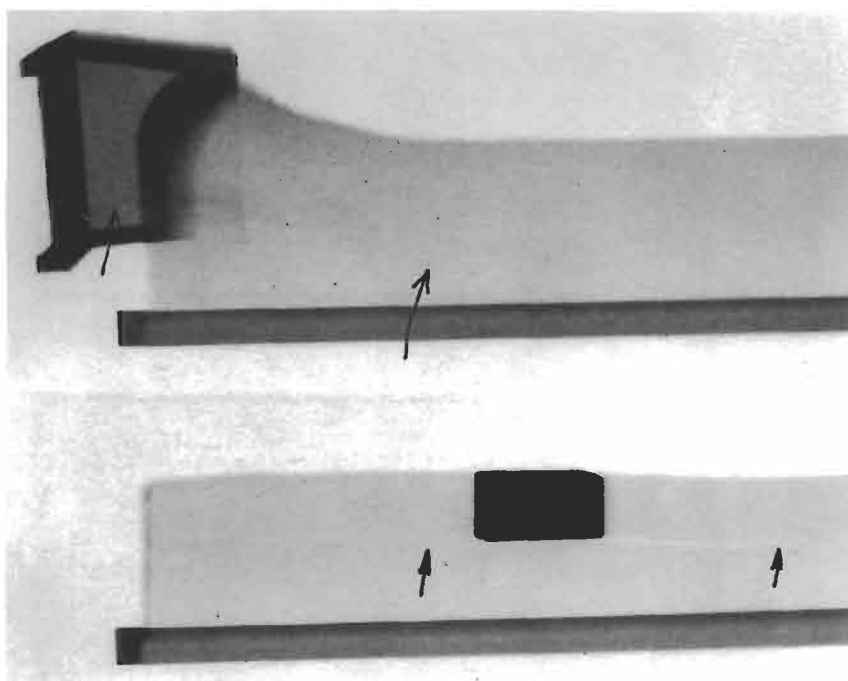
Fig. 9. X-radiograph of side of new tank (top) and part of failed tank (bottom). Trace of flow lines can be seen in the upper radiograph (between the open arrows). The crack is well shown in the lower section (solid arrows). The thick lower edges of both radiographs show variable density along their length due to internal voids.

Some of the sections were radiographed using soft X-rays provided by a medical source [3, 4]. They showed the critical crack in excellent detail, and also provided evidence of the flow lines and clumping of fibres seen in the etched sections (Fig. 9). One shot from the failed tank, showed the faint trace of a 'cold slug' near the sprue. It reinforced an earlier observation (Fig. 6), giving an important clue to the cause of failure, because it indicates incomplete melting of the granules used to feed the injection moulding machine.

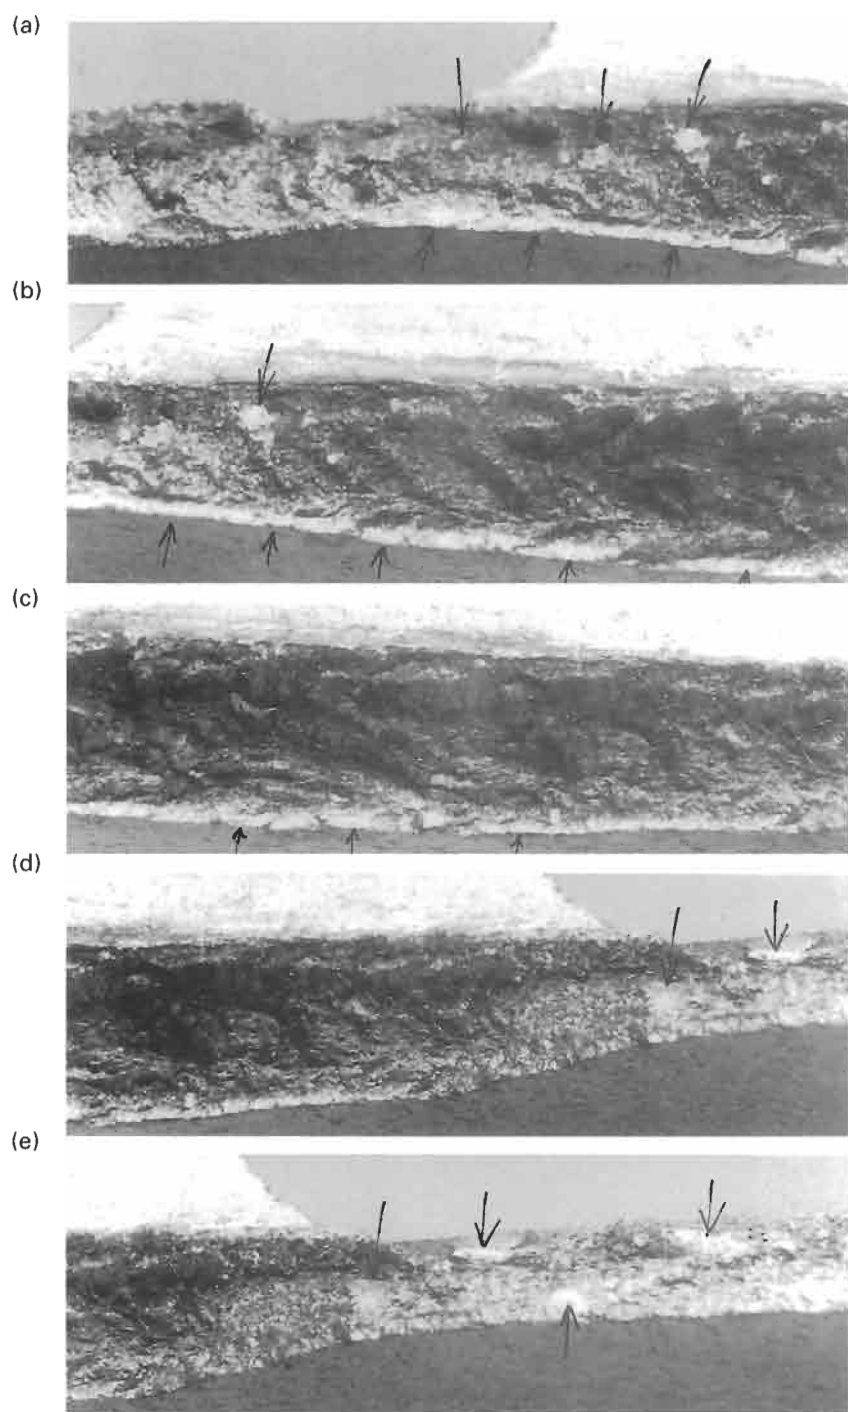
Fig. 12. Panoramic sequence of gold-plated fracture surface, left to right across crack from top to bottom. Remnants of cold slugs and lower weld line shown by open arrows.

So what defects were visible on the fracture surface? One feature was the several smooth, irregular zones, most clearly seen in the optical macrographs of Fig. 12. There were several areas where such features occurred: a smaller cluster under the first buttress corner; a group near the second buttress corner and a linear, shallow zone on the underside of the fracture surface. The irregular form of the first two groups suggested that they may represent fragments of the original pellets used in the moulding process which have not fused together, and thus represent lines of weakness within the solid material. They could thus be most closely related to the cold slug defect found on the inner surface of the moulding, near to the sprue (Fig. 6) and one of the radiographs. The linear zone was the clearest indication of a 'true' weld line, which would be formed when the pellets have lost their original shape due to melting, but then two streams of molten plastic have impinged without fusing. The smooth areas in the interior could also represent internal weld zones.
