# ***FAILURE ANALYSIS CASE STUDIES II***

A sourcebook of case studies selected from the pages of  
*Engineering Failure Analysis* 1997-1999

**D.R.H. JONES**

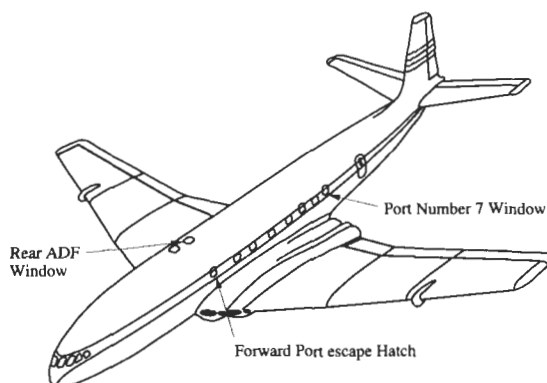
Fig. 3. The main failure sites on Comets G-ALYP and G-ALYU.

Cracks were known to be present in the aircraft upon manufacture, and there was an approved technique for identifying such defects and "locating" them by drilling the end of the crack with a  $\frac{1}{16}$  in. (1.6 mm) drill [1]. In most cases, the crack was seen not to extend beyond the location hole, and this was assumed to be adequate security against further crack growth. In fact, there was a "located" crack near the forward port corner of the rear ADF (automatic direction finding) window (Fig. 3) on Yoke Peter, which did not grow beyond the locating hole until the final failure of the cabin.

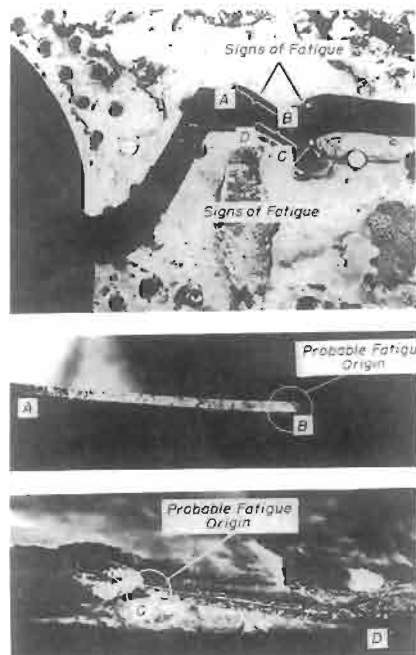
The failure of Yoke Peter was deduced to be a fatigue crack near the starboard rear corner of the rear ADF window (Fig. 4). This crack emanated from a 10 mm diameter bolthole, and propagated to failure after unexpectedly few pressure cycles of the cabin. This bolthole in such a highly stressed

Fig. 4. Close-up views of the failure in the skin of Comet G-ALYP. Crown Copyright. Reproduced with the permission of the Controller of HMSO.

area was recognized as a prime site for fatigue failure initiation, and de Havilland subsequently redesigned the windows and increased the thickness of the skin in these areas to prevent this occurring on later Comet aircraft. The stress around a cut-out was shown to be over 3 times the remote stress due to cabin pressurization both experimentally [2] and theoretically [3]. Using the  $S-N$  data available at the time, it was possible to explain the shortened fatigue life.

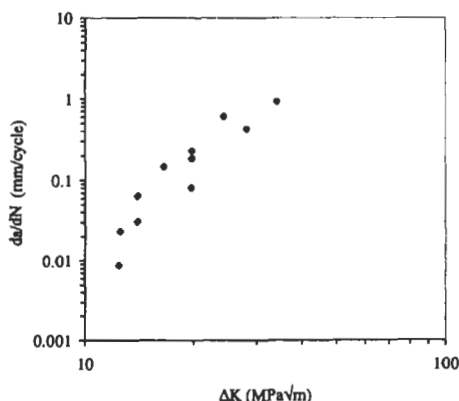
Yoke Robert underwent 11,313 cycles, and cracks were prevented from further growth at a length of 165 mm, as this was felt to be the length at which cracks would propagate to failure within a few more cycles. This gives a fracture toughness of around  $35 \text{ MPa m}^{1/2}$ . Using the strain gauge measurements made on the same fuselage, it is possible to construct a plot of  $da/dN$  against  $\Delta K$  for the Comet I skin (Fig. 5).

Fig. 5. Fatigue crack growth of the Comet I fuselage.

$m$ , of 4.0. The crack growth rate is much faster than for subsequent aluminium alloys, but it is unclear whether this is due to the alloy itself, the application, or the water environment of the test. The consequences of the water environment of the tank test were addressed by Atkinson *et al.* [5] at the time of the tests, and it was felt that a cabin skin would be cycled through wet and dry periods during service (outside due to the weather and inside due to condensation), and this cycling may be more damaging than the environment of a tank test. The degraded environmental performance in aluminium alloys in aerospace applications has also been noted by Barter *et al.* [6].

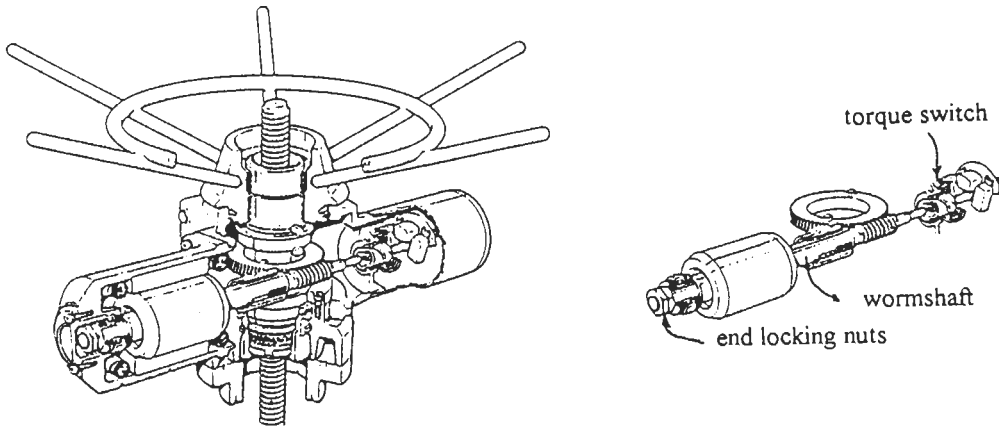
Fig. 1. Schematic diagram of a conventional Rotork actuator. The recessed locking nut (failure site) and wormshaft are clearly visible.

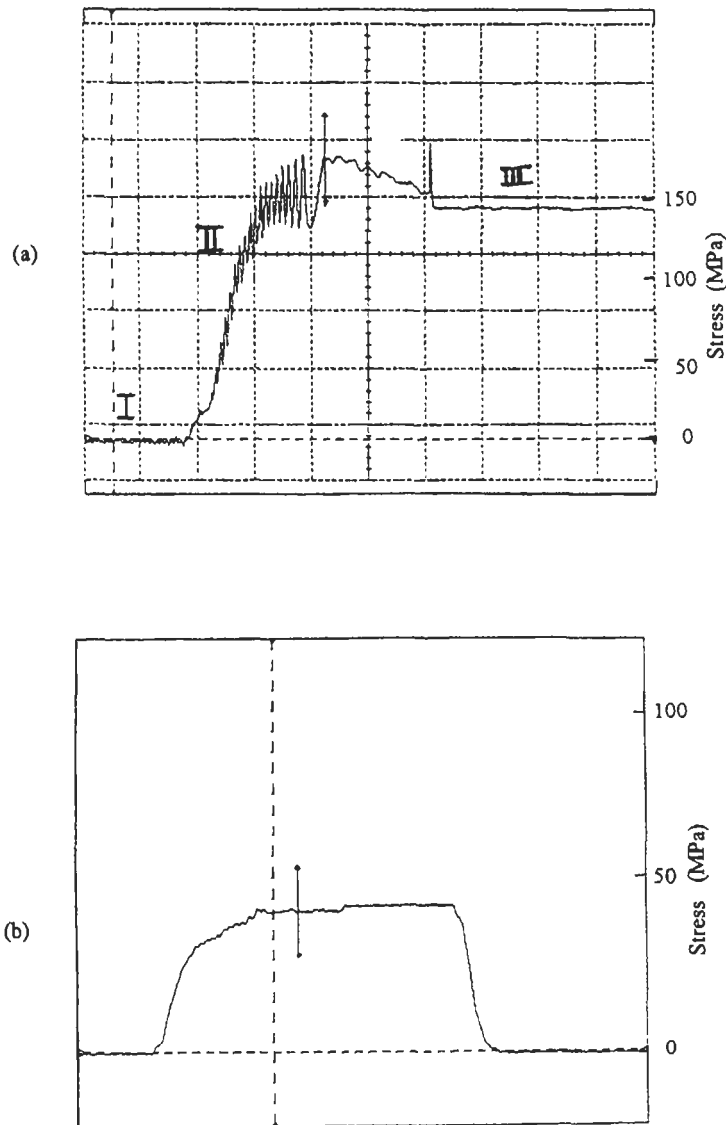
The strain gauges were now connected to the strain gauge amplifier using the TW leads in a “tension bridge” configuration as opposed to a “bending bridge” configuration. The loading tests against the disc brake torque limiter with the limit switch disconnected, just as in the bending test series, were repeated. A typical strain time trace result is shown in Fig. 4(b) from which, it is clear that the cyclic stresses were very low as the disc brake engaged but the wormshaft, once arrested or stalled, showed a net tensile stress, as might be expected. The magnitude of this tensile stress, however, was not excessive, typically  $45 \pm 5$  MPa.

Fig. 4. Strain time traces for the strain gauged shaft on the Koeberg Rotork test bench for (a) bending and arrest against the disc brake, (b) tension and arrest against the disc brake. Note the significant offset.

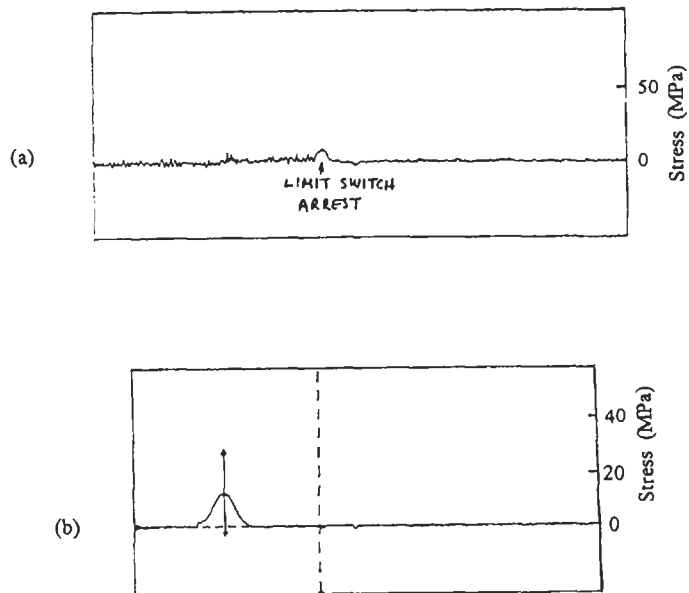
Again for completeness a tension test was conducted where the limit switch detector was employed (so that the disc brake torque limiter did not come into operation) and the measured tensile stress was low ( $< 12$  MPa) (Fig. 5(b)). Thus under safe operation of the limit switch the wormshaft tensile stresses were low and the performance quite satisfactory.

Fig. 5. Strain time traces for limit switch operation and arrest for (a) bending and (b) tension. In both cases the resultant stresses are small.

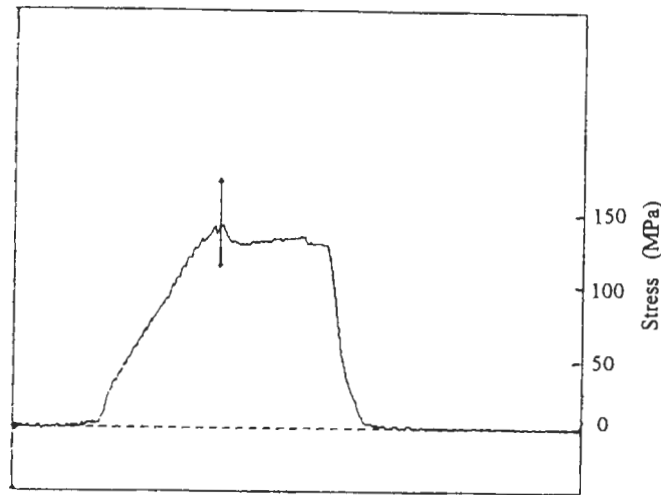
Fig. 7. Strain time trace in the bending configuration under so called "stall" conditions, with the disc brake completely removed. Far from exhibiting minimal stresses the trace shows substantial offset bending strains imposed through the Belvel washers and recessed nut assembly.

The strain time traces, were, however, remarkable. Rather than a small ripple about the  $x$  axis, a significant offset strain (and hence stress) was observed (Fig. 7). The offset strains were large (Table 2), with typical direct bending peak and offset stresses of approximately 133 and 118 MPa respectively. These are not trivial, and, when considered with SCF effects, would easily cause fatigue cracking.

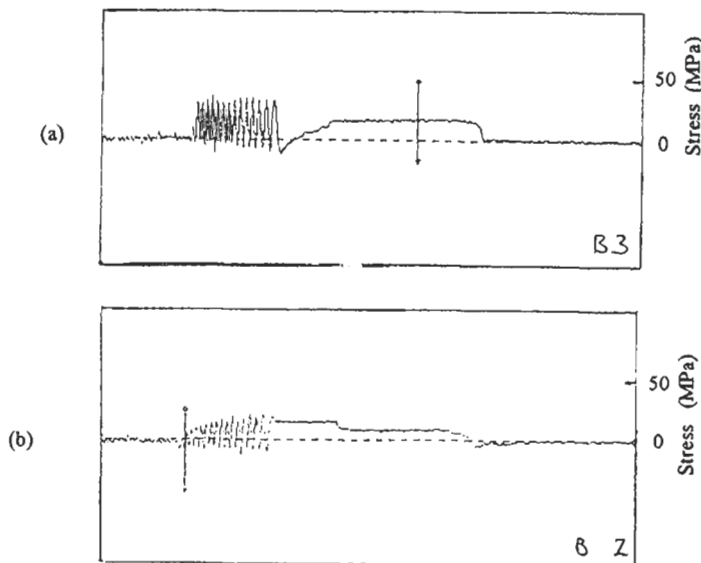
Bending tests for both disc brake arrest and so-called “stall” tests at comparable torques (to Figs 4 and 7) using the square faced long nut are shown in Fig. 8(a) and (b). These strain time traces show substantially reduced offset bending stresses, reduced from typically  $124 \pm 6$  MPa to approximately  $24 \pm 3$  MPa for “normal” stall conditions. With the long nut but  $2^\circ$  oblique face under stall conditions high offset stresses of typically  $172 \pm 3$  MPa, were obtained. Tension stresses were less ( $15.5 \pm 3$  MPa) and under trip switch arrest conditions the stress levels were even lower. The use of the square longer nut assembly to reduce the offset stress appears vindicated and subsequent to making the manufacturers aware of this finding, they undertook to redesign this “thin” lock nut system. The final design incorporated a system not unlike the above long nut solution in that the recessed nut did not exhibit any canting over. The fatigue cracking problem of these actuator shafts has been overcome, and the problem effectively solved. What is of special interest here is the observation that, as a result of the tolerance of the nut in an ordinary “nut and

Fig. 8. Strain time traces for the long nut in bending configuration for arrest from (a) the disc brake and (b) under “stall” conditions with the disc brake removed (comparable to Figs 4 and 7). The large offset stress has effectively been removed.

In view of this somewhat unexpected finding, it was decided to test the concept (i.e. that the high bending stresses in the shaft were caused by the seating of the Belvel washer/thin nut combination), by replacing the thin nut with one very much longer. The tolerance and thread details were still the same, but with a recessed nut of length 28 mm and engaged thread length of 8 threads (as opposed to approximately 4 mm long and nearly 2 engaged threads), the capacity for the long nut not sitting squarely on the shaft was substantially reduced. In addition, a further 28 mm long nut was manufactured, but with a deliberate oblique face (2 degree offset) to simulate the thin nut under non axisymmetric location.

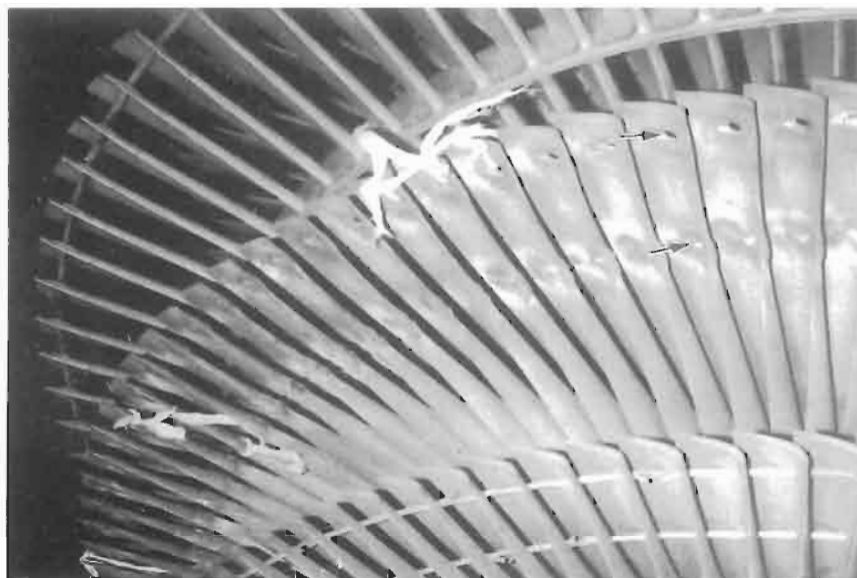
Fig. 1. Photograph showing the assembly of the blade without the lacing wire which has been removed by debrazing. Arrows indicate the position of lacing holes from where crack initiation occurred.

outer lacing holes but without lacing rods is shown in Fig. 1. The locations of the fracture i.e., at inner and outer lacing holes are indicated by arrows (Fig. 1). The lacing rods attached to the blades were fractured and some of the fractured portion could not be identified inside the casing. Distortions due to impact from the broken blade and lacing rod piece were found at the leading and trailing edges of many blades. The brazed joints between the lacing rods and the edges of the lacing holes were found disjoined at many places. Holes, cavities and several other physical discontinuities were observed in the brazed material attached to the lacing hole. It was obvious that decohesion of the brazing joint had occurred at many places. It is important to note that many brazed joints were found failed and developed defects which were revealed by nondestructive examination such as dye penetrant testing during the last overhauling period. The broken and damaged braze joints were removed and braze repairing was carried out in those areas. The colour of the blade was black indicating  $\text{Fe}_3\text{O}_4$  (magnetite) scale of varying thickness.

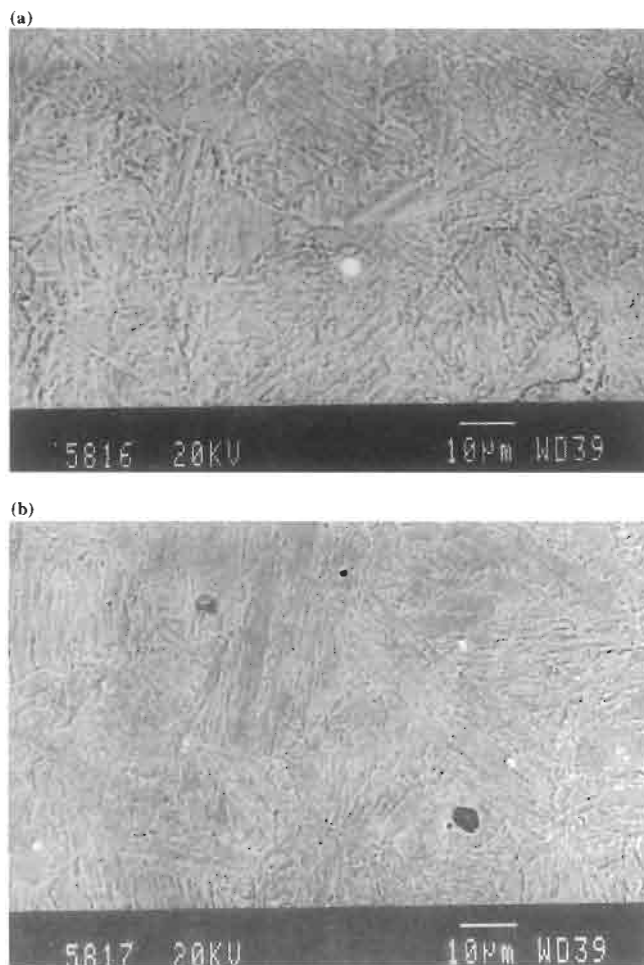
Fig. 2. (a) Tempered martensitic microstructure of the blade material; (b) tempered bainitic microstructure of lacing rod.

the normally expected microstructures. The same reproducible microstructures were observed in randomly selected places, indicating the homogeneous nature of microstructure. No indication of microstructural degradation was thus observed in either blade or lacing rod structures [3].

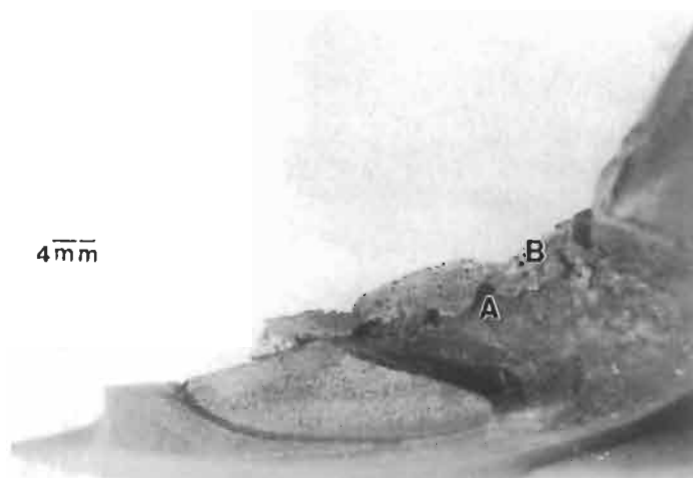
A low magnification fractograph is shown in Fig. 3. The holes, discontinuities and pores of various sizes were observed in the area associated with the lacing holes/braze interface. These discontinuities marked 'A' in Fig. 3 indicate poor wetting with the blade surface during the brazing operation. The small holes marked 'B' might have been generated due to galvanic corrosion. The EDX was carried out for composition analysis near the microvoids and holes. It was found that the Zn content in the remnant brazing material had decreased whereas Fe, although not present in the original braze material, was detected. The elemental redistribution of the alloying elements, mainly Zn, is indicating galvanic corrosion. Because of high electronegativity compared to Ag, Cu and Fe, the anodic dissolution of Zn from the braze material in wet steam is possible. Ammonia present in wet steam may also enhance corrosion of the brazing material. It was apparent that corrosion had decreased the strength of brazed joint rendering the interface weak, leading to decohesion.

Fig. 3. Low magnification image of the fractured surface of the blade showing physical discontinuities (marked as A) and holes (marked as B) in the braze joint.

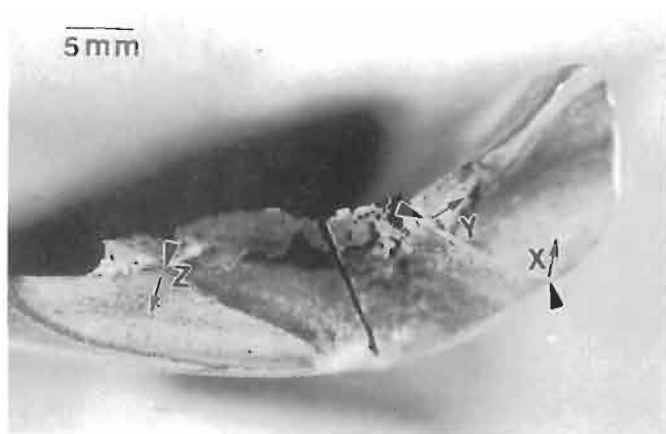
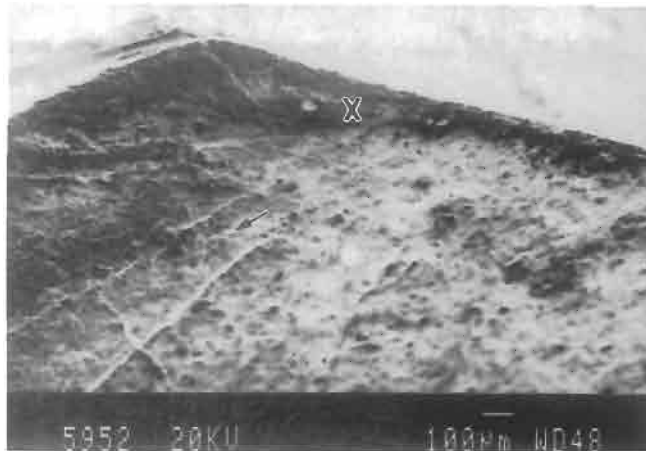
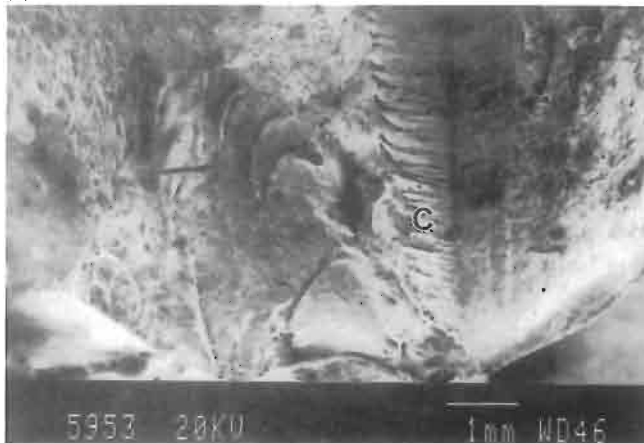
A high magnification fractograph of the fractured surface on the thicker section of the blade is presented in Fig. 4(a). The crack initiation point is identified at 'X'. The enlarged view of region 'X'

is shown in Fig. 4(b). Another initiation point at 'Y' (Fig. 4(c)) indicates multiple crack origin sites along a plane inclined to the radial direction (centrifugal axis) of the blade. The fretting mechanism due to rubbing or low amplitude impact collision between blade and loosened lacing rod appears to be the controlling factor for crack initiation. The stage II of crack growth due to fatigue has been established from the presence of striations and ratchet marks (Fig. 5(a) and (b)). The last stage of the crack propagation associated with overload has been identified from the presence of ductile features. The fracture surface of the thinner side of the blade (the other side of the lacing hole) showed a distinct transition from intergranular/quasicleavage to a ductile fracture mode from the inner surface to the outer surface. The crack initiation point was at the corner which was diagonally opposite point 'X' (marked as 'Z' in Fig. 4(a)). Though there are no striations present in the fracture surfaces, it may be interpreted as fatigue crack growth with high stress intensity range and mean stress. These types of features under fatigue load in thinner sections (i.e., plane stress condition) have been reported in the literature [5]. It can also be surmised that the presence of quasicleavage features was due to superimposed static or steady load (in this case mainly centrifugal load) during fatigue crack growth. Figure 6 shows intergranular features and cracking from point 'Z' in Fig. 4(a)). Figure 7 shows decohesion at the braze-blade interface.

Fig. 4. (a) Crack initiation points marked by arrow head in optical micrograph; (b) SEM fractograph taken from area marked as 'X' in Fig. 4(a); (c) SEM fractograph from area marked as 'Y' in Fig. 4(a). Arrows indicate crack growth directions (dark line at the centre indicates the cut-mark along which fracture surface was cut into two pieces for SEM observation).

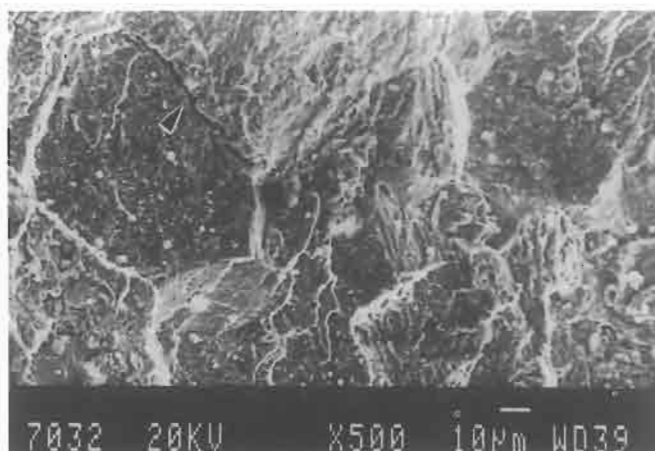
Fig. 6. Fractograph from the site marked as 'Z' in Fig. 4(a) showing the presence of intergranular features. Intergranular crack is indicated by the arrow head.

galvanic corrosion of the steel parts is indicated; the latter is accelerated by the loss of chromium, especially of the blade, by the mechanism suggested by Kawakatsu [8]. The loss in chromium is also reflected in the occurrence of some grain boundary cracks as shown in Fig. 6. There is no evidence that stress corrosion cracking was the cause of failure of blades. Interfacial corrosion of the type observed resulted in significant weakening of the braze joint (Fig. 7) and detachment of the lacing wire leading to fretting fatigue for crack initiation.

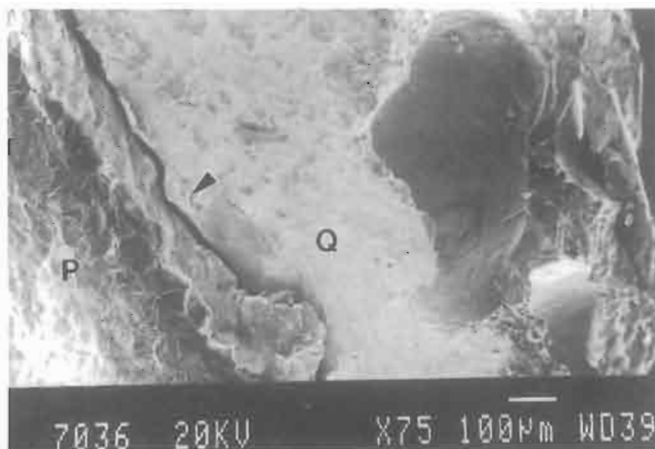
Fig. 7. Decohesion at the braze-blade interface (marked by arrow head). P: blade; Q: corroded portion of the braze.

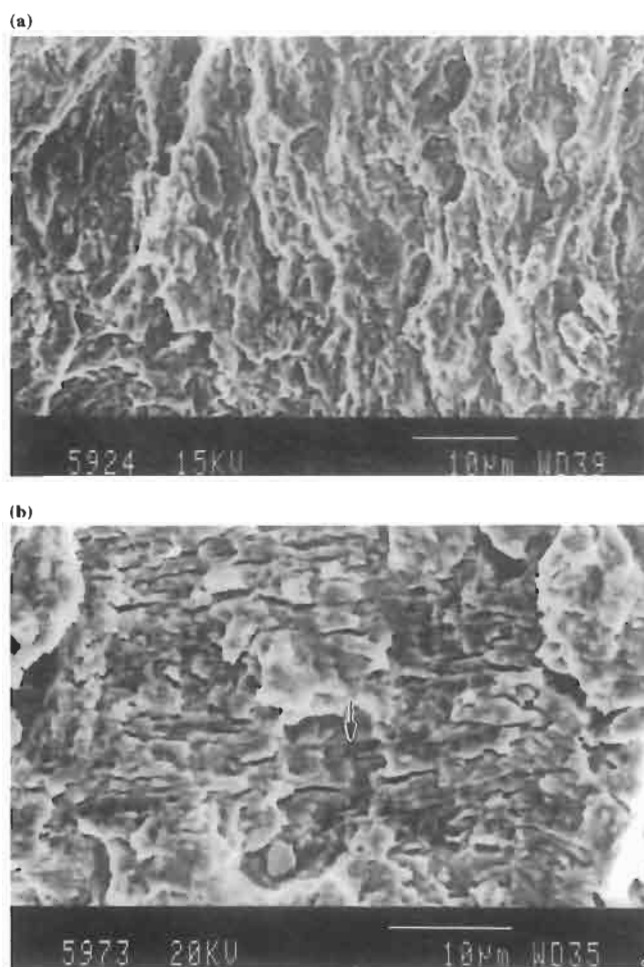
half of the yield stress with this specimen geometry. In the specimen with 0.7 kN static load and 0.5 kN dynamic load a crack was detected after  $10^4$  cycles followed by rapid failure. The fracture surfaces examined by SEM did not exhibit any striations or beach marks (Fig. 8(a)). The presence of a large number of secondary cracks in the fracture surface indicates a high amount of work hardening during crack propagation which is in conformity with the literature of fatigue failure. In the case of the second specimen no cracks were observed until  $13 \times 10^5$  cycles. The test was then interrupted and loads were increased to a static load of 0.6 kN and a dynamic load of 0.5 kN. Cracks were observed after  $2 \times 10^5$  cycles and the specimen failed immediately. Fatigue striations were observed in the fracture surface which was roughly 2 mm away from the notch root (Fig. 8(b)). It is concluded from the second test that the damage accumulation during the initial loading facilitated the crack initiation within a short time at the higher stress level. The simulation, thus, indicates that depending on the level of mean stress and amplitude of the alternating stress, one can

Fig. 8. Fractograph from simulated HCF test 1(a) and test 2(b). Fatigue striations can be noted in (b).

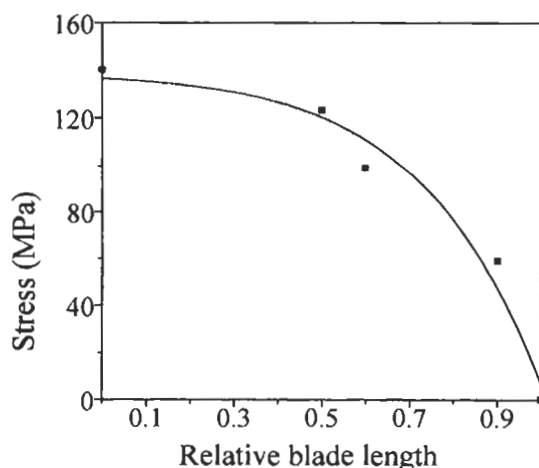
Fig. 9. Pattern of centrifugal stresses in an LP blade during operation at 50 Hz frequency.

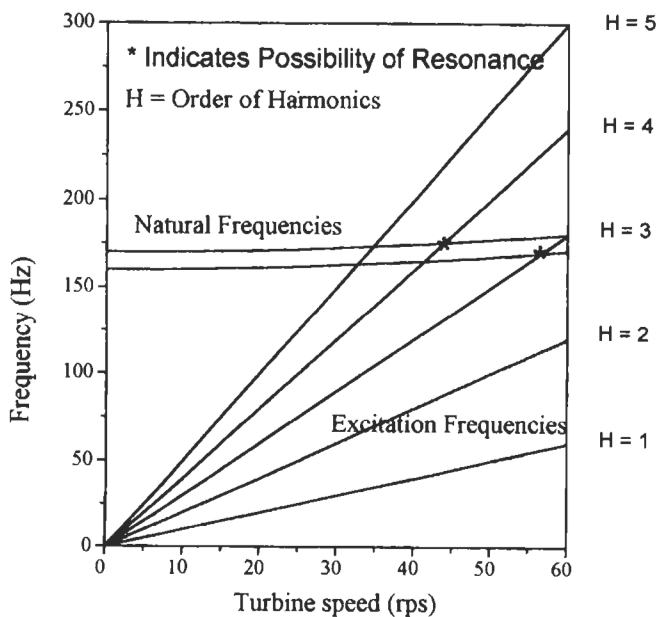
When the turbine rotates with  $\sim 3000$  rpm, which is required for 50 Hz line frequency, the third harmonic of the excitation frequency is 150 Hz and the fourth harmonic of the excitation frequency is 200 Hz which will not match with the natural frequency of the blade (170–180 Hz) and, therefore, the possibility of resonance is ruled out during the operation of stipulated frequency. For resonance to occur, it requires a minimum over-frequency of 56.5 Hz as well as maximum under-frequency of 45 Hz.

It is important to note that before the day of failure the operating frequency from the plant data was found to be at 45.5 Hz for 13 s. It is also found that nearly 10% of operating life was above a

Fig. 11. Campbell diagram for understanding the possibility of resonance.

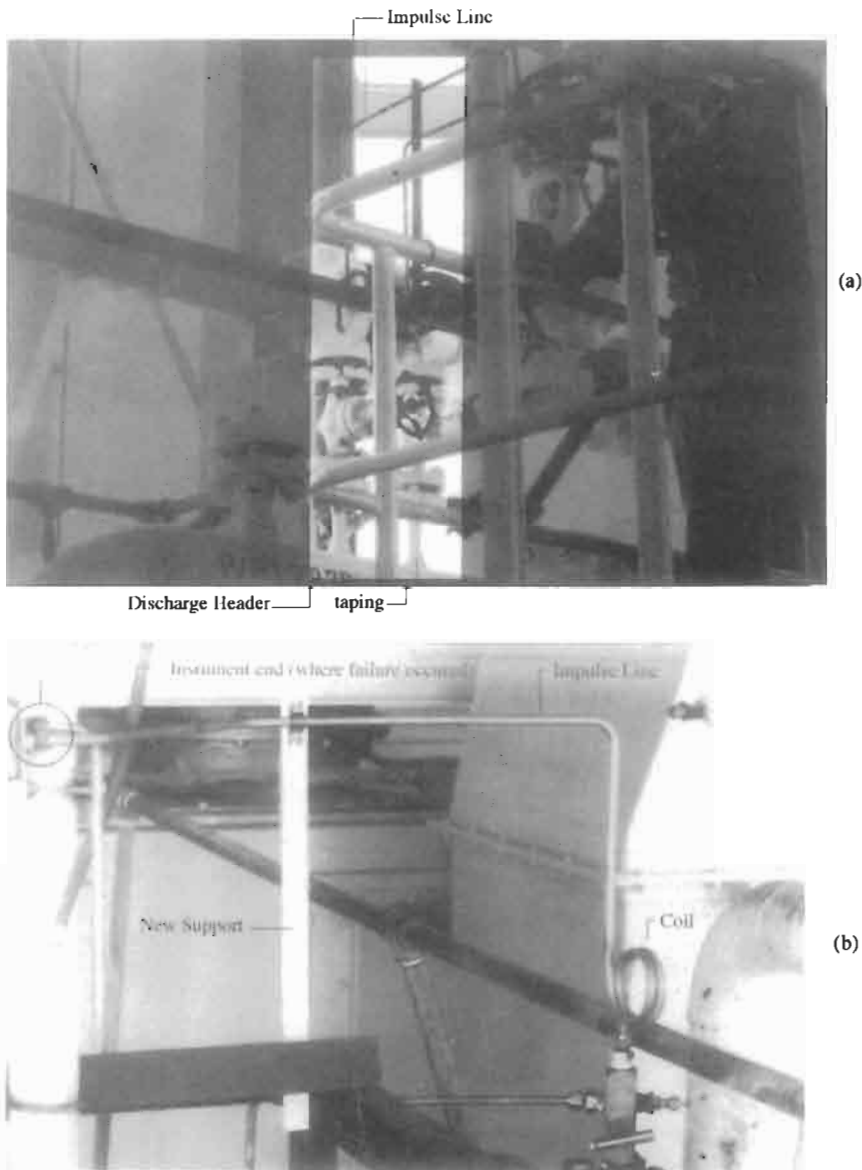
Fig. 1. A general view of the discharge header: (a) shows three pressure taps, two are connected, one is flanged-off. (b) shows a close-up of the impulse line, depicting the connection-type, coil, and support.

The failed line fractured at the root of the mounting collar, at the instrument side (see Fig. 1). Visual examination showed that the fractured piece was jammed inside the nut (Fig. 3). It was noted that the broken piece was excessively off centred, indicating possible misalignment of the tubing during original mounting. A sample cut from the failed line was subjected to chemical analysis which confirmed that the tubing material was stainless steel type 316, as originally specified.

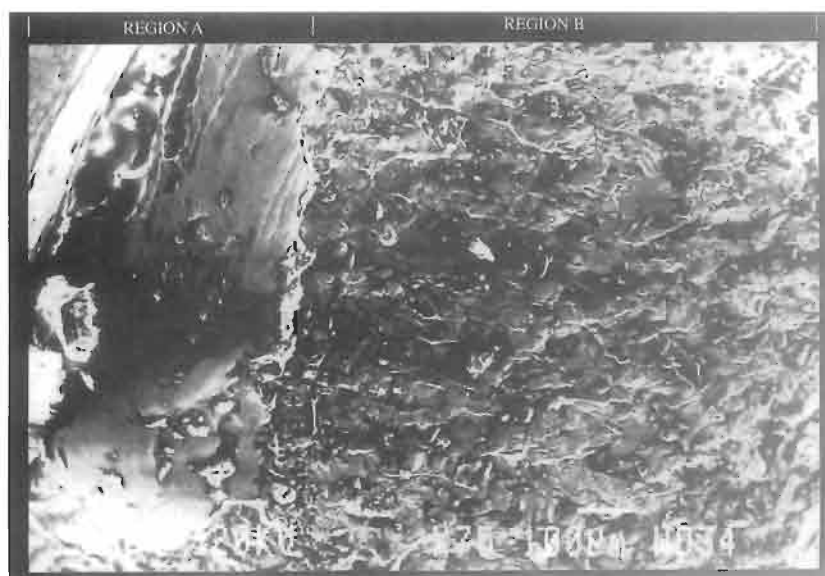
Samples of the fracture piece were examined using SEM (Scanning Electron Microscopy). The examination showed that the mode of failure was predominantly fatigue. Figures 4–7 show SEM photographs. Figure 4 shows the fracture surface, taken close to the outer layers of the tubing. A

Fig. 4. Fracture surface taken close to the outer layer of the tubing.

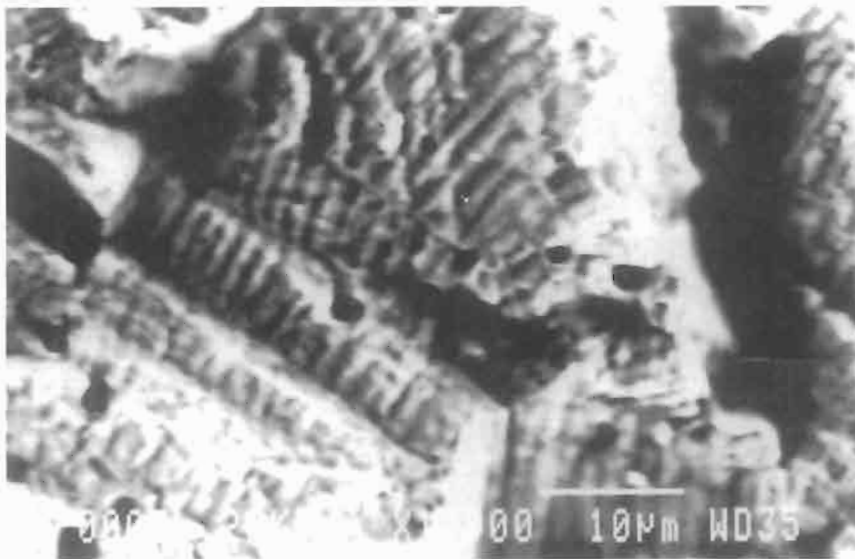
Fig. 7. Close-up view of the highlighted area in Fig. 6.

The microscopic examination showed that the impulse line failed through high-cycle fatigue. This is confirmed by FE analysis in that peak vibration (in the tubing) occur at low frequencies, with maximum stress points localised at the failure point. The root cause of failure is excessive vibration emanating from the connecting flange at the discharge pipe. It is believed that a significant amount of this vibration is induced by the dynamics of the flow within the discharge manifold. Without decoupling this motion, it is probable that similar failure will occur in the future. The following measures were recommended:

- (1) The over-hung mass on the flange connection and its cantilever effect should be minimised. This can be achieved by using smaller flanges with short connections.
- (2) The tubing length should be kept to a minimum to avoid resonance at low frequencies.
- (3) The instrument end should be as far as possible decoupled from the pipe end. This can be achieved more effectively by using axial-coil configuration with larger coil diameter and/or increased number of turns. A sensitivity analysis is needed to determine the exact dimensions.
- (4) The installation procedures on site be reviewed to ensure that tubing connections are properly aligned, as per manufacturer's recommendations.

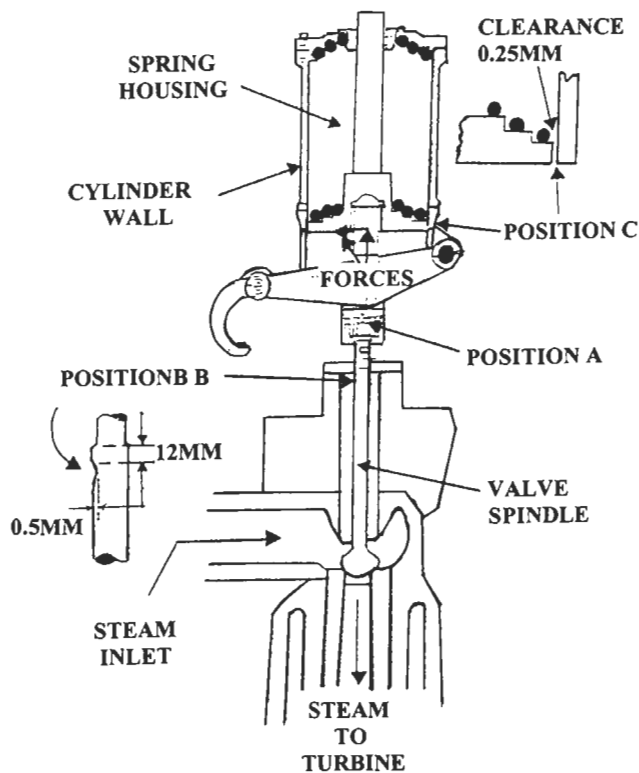
A detailed view of the valve spindle arrangement is shown in Fig. 1 and in this instance the valve was in the closed position. All failures occurred at position A at the root of a spindle thread while the spindle bending problem was observed at position B. At these positions the working temperature was assessed at about 300°C. Also, the forces acting on the valve spindle are illustrated in Fig. 1 between piston C and the actuating lever where the vertical force is the result of steam pressure and the angular force was caused by the angle of the actuating or lifting lever. The resultant force is a sideways bending force on the valve spindle and it was calculated that the relationship between the bending stress  $\sigma_B$ , and value of spindle deflection  $\lambda$ , at position A could be expressed as follows:

Fig. 1. Valve spindle system.

At position B an area of wear, around 0.5 mm deep (see Fig. 1) was observed on one side of the valve spindle surface indicating the presence of a significant bending action or stress. This bending stress could have been the result of:

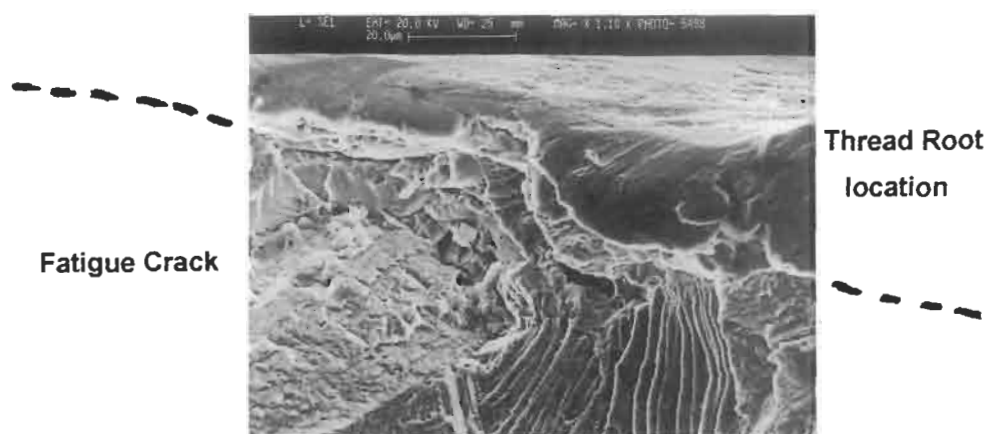
From a detailed examination of the broken spindle fracture surfaces it was assessed that failure was the result of a ductile fatigue crack extension process which was initiated at the thread root

Fig. 2. Fatigue initiation site at thread root location.

location (see Fig. 2) and propagated by ductile striated crack growth (see Fig. 3). In three of the four failures surface crack initiation was helped by the presence of near surface titanium based non-metallic inclusions. The coarse nature of the striation spacing (see Fig. 3) suggested a high stress, low cycle fatigue situation. Indeed the short service lives of the four broken spindles, viz., 33, 136, 167 and 316 days added credence to this suggestion.

Such a recurring failure in a critical plant component needed to be urgently addressed in an effort to obviate or at least mitigate the problem. In the present instance it was suggested that the high stress situation at the spindle threaded location be reduced by two actions; firstly, changing the thread profile to a rounded thread (e.g. NF000-032 type thread) which had an associated stress concentration factor which was about 25% lower than the present square ISO thread and secondly by introducing significant compressive stresses (which need to be overcome before fatigue can occur) by shot peening. The influence of these actions on the valve spindle deflection-time to fatigue failure relationship is illustrated in Fig. 7. From Fig. 7 it can be seen that both shot peening and re-profiling the thread significantly increased the valve spindle life at spindle deflection levels of around 1 mm. Indeed at 0.9 mm spindle deflection the spindle service life was increased from less than one year to around 8 years. The service temperature in the region of valve spindle failure was estimated to be around 300°C and it is known that thermal relaxation of the compressive stresses can occur at high temperature. However, recently Gauchet *et al.* [2] have reported encouraging results where significant

Finally, it has been shown that thread re-profiling and shot peening can mitigate fatigue failure in valve spindles. Also regular checks of actuating system out-of-alignment should be carried out together with good insulation at key locations which should help minimise thermal distortions.

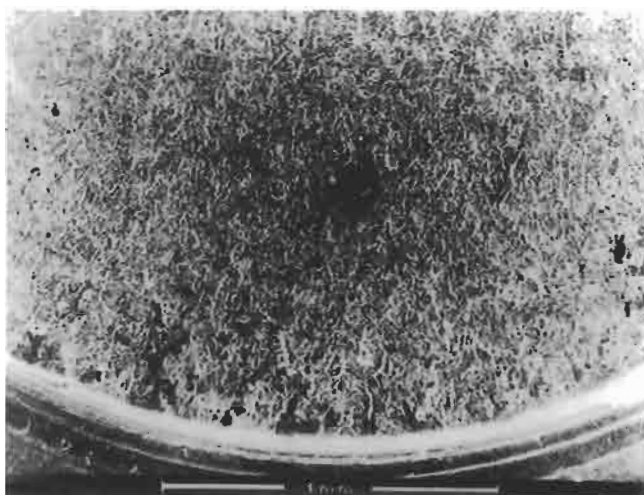
The fracture surface (Fig. 2(a)) of the 3# bolt was characteristic of a typical fatigue fracture, i.e. there was a crack initiation zone, a fatigue crack propagation zone and a final ductile fracture zone. The fatigue crack initiated at one position in the thread root at a machining mark. The crack propagated towards the far edge of the thread. The origin zone was rough (Fig. 3) and had many radial lines. The propagation zone was smooth and there were distinct fatigue striations (Fig. 4). In comparison with the fatigue surface, the final ductile zone was smaller and was around 20% of the total cross sectional area. According to the above-mentioned features, the fracture surface is characteristic of fatigue. The final ductile fracture zone was typically dimpled. No material defects were found in the fatigue origin zone.

Fig. 3. Fatigue origin zone of 3# bolt.

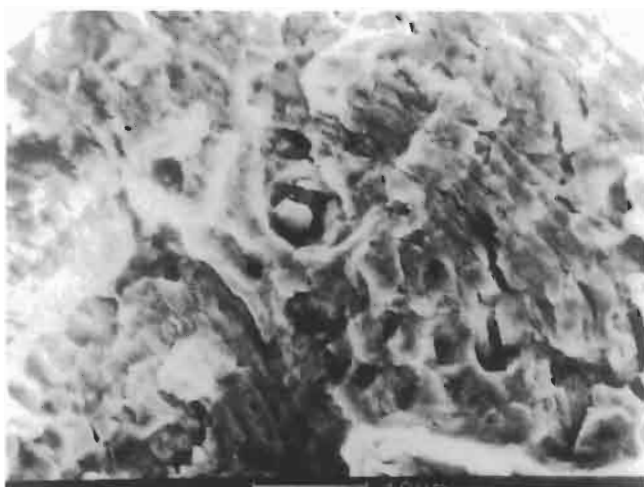
Fig. 4. Fatigue striations in fatigue propagation zone of 3# bolt.

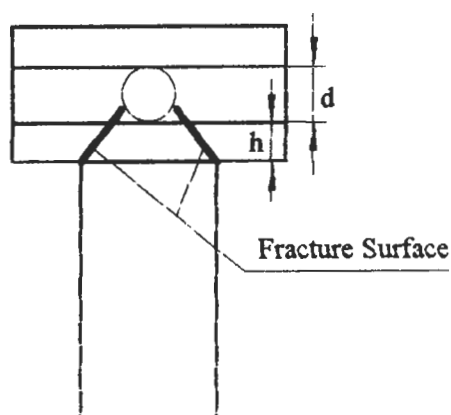
The fracture surfaces of the 1# and 2# bolts initiated at the edges of the assembly holes, as shown in Fig. 2(b) and Fig. 2(c). A schematic of the fatigue fracture sites is shown in Fig. 5. The cracks obviously propagated towards the root of the bolt until the remaining cross section became unable to support the load and failed by fast fracture. In comparison with the macro-fracture surface of 3#

Fig. 5. Schematic of fracture position of 1# and 2# bolts.

It is known from Fig. 5 that 1# and 2# bolts fractured at the location between the assembly holes and the bolt root. Assume that the fracture surfaces were circular cones and were acted on by a uniform tensile stress  $\sigma$  (Fig. 8).

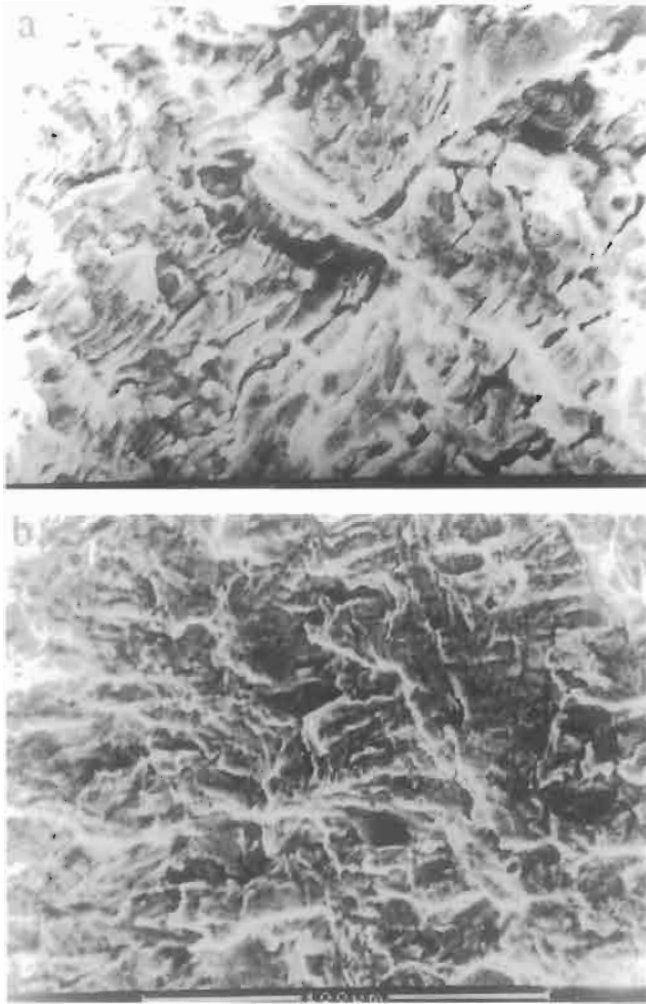
bolt, the fracture surfaces of bolts 1# and 2# were rather rough with propagation radial lines, but no fatigue beach marks. However, the photographs of the fracture surfaces taken in the SEM at high magnification showed that there were fatigue striations (Fig. 6). Mixed zones between the dimples and the fatigue striations existed in the fracture surfaces of bolts 1# and 2#.

Fig. 6. Photographs of the fracture surfaces taken in the SEM. (a) 1#; (b) 2#.

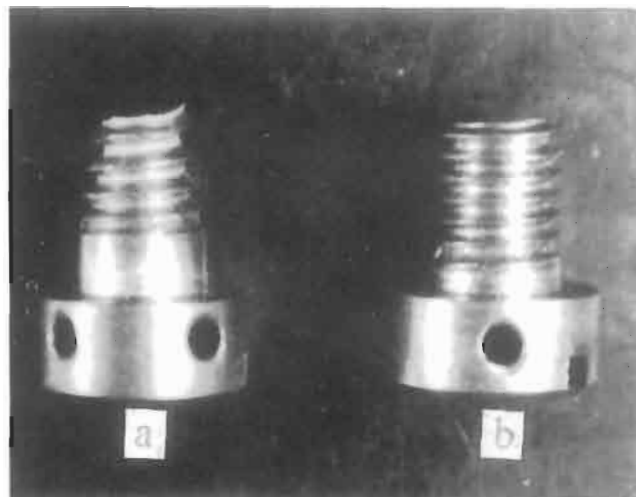
Fig. 9. Comparison of fracture surfaces for (a) tensile fracture, and (b) 3# bolt fatigue fracture.

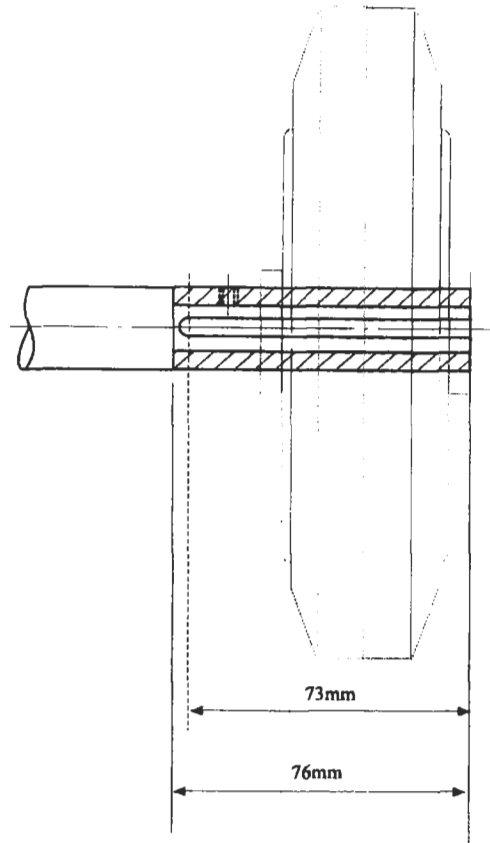
The failed wheel shaft had broken in two, having separated close to the end of the keyway slot on one of the 12 mm diameter hubs—approximately 73 mm from one end, as shown in Fig. 2. A fatigue crack is clearly evident for about half of the broken sectional area (that nearest to the keyway groove) as the characteristic circular lines radiating outwards from the corner of the keyway are clearly visible. The remaining section failed through static fracture—being insufficient to support the loads. From observation of the failed shaft it is not evident whether shaft bending or torsion is the primary cause or whether it is a combination of the two and so analysis is necessary.

Fig. 2. Drive shaft detail design.

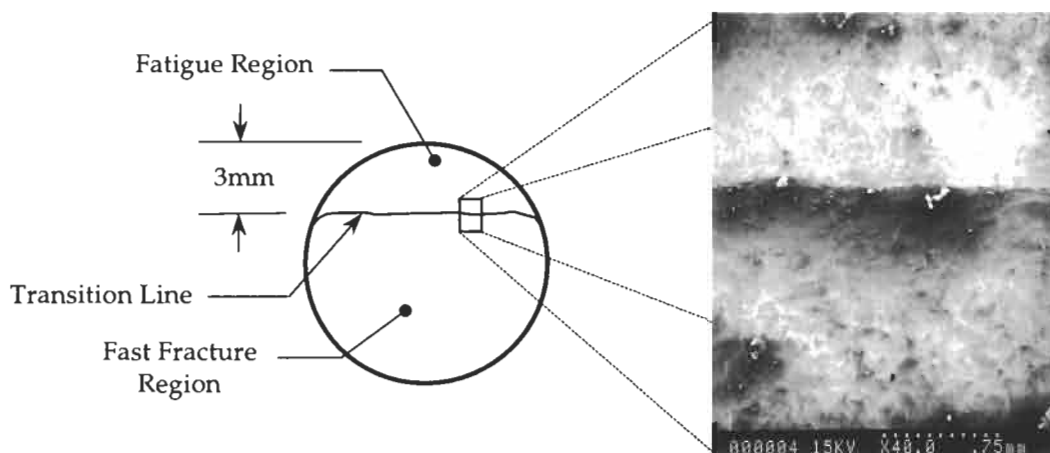
The pin was in service for approximately  $1\frac{1}{2}$  years before failure occurred. At that time, the machine was disassembled to reveal the fractured adjustment pin, Fig. 5. Upon close inspection of the pin, two distinct regions on the fracture surface were seen. One region is indicative of fatigue crack growth and the other of fast fracture. Once the fatigue crack reached a critical size of approximately 3 mm, the pin failed completely due to fast fracture, Fig. 6. A micrograph of the fracture surface clearly shows the transition line from the fatigue driven crack growth to fast fracture as well as a micrograph of the transition region. It was at this transition line that the crack reached a critical length and the pin failed completely due to fast fracture, Fig. 6. In Fig. 6, the upper portion of the micrograph shows a relatively smooth (smeared) surface consistent with fatigue crack growth. The surface smearing was caused by crack closure and surface contact. The lower portion of the picture in Fig. 6 shows a region of ductile tearing with less smearing evident at the point of crack instability and the region of fast fracture. The transition line from fatigue

Fig. 6. SEM picture of the transition region from fatigue to fast fracture.

One way to improve the design to avoid fatigue failure would be to redesign the machine to add support at the end of the pin. This would reduce the bending stresses by half since the pin could be modeled as a simply supported beam instead of a cantilever beam. Another method of changing the design would be to increase the pin diameter and/or use a stronger grade of steel. However, this would probably increase material and manufacturing costs. It has also been shown that the addition of a relief groove behind the shoulder causes a reduction in the stress concentration, Figure 10.

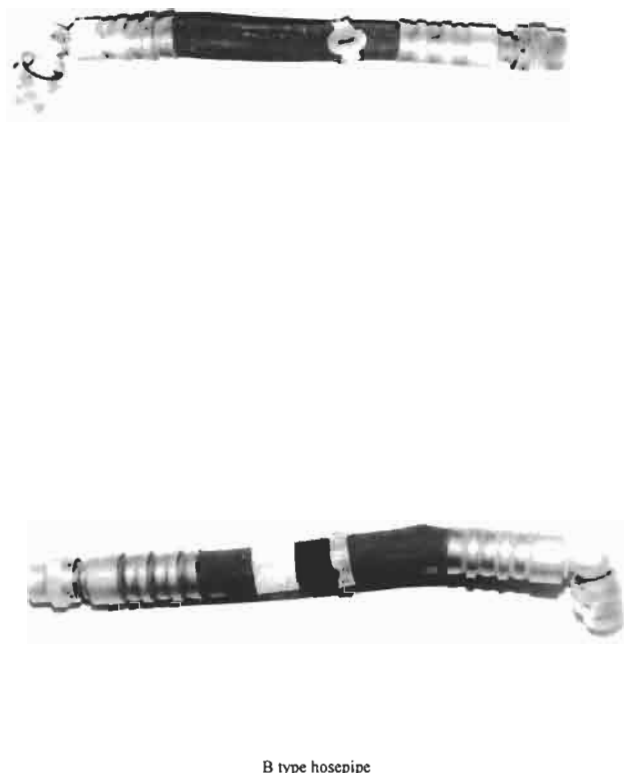
B type hosepipe

- (1) There were, to some extent bending deformations in both ends of the hosepipes, with more deformation taking place near the end of the elbow pipe (see Fig. 1).
- (2) For most hosepipes only one opening existed in the exterior of the rubber at the bending position near the end of the metal elbow adapter, but two openings were observed in one A type hosepipe.
- (3) The distance from the bursting position to the end of the adapter housing was 0–15 mm.
- (4) The bursting shape of the outer rubber was irregular and there with axial, circumferential and branched cracking.

Fig. 1. Appearance of bursting hosepipes (arrowheads aim at openings).

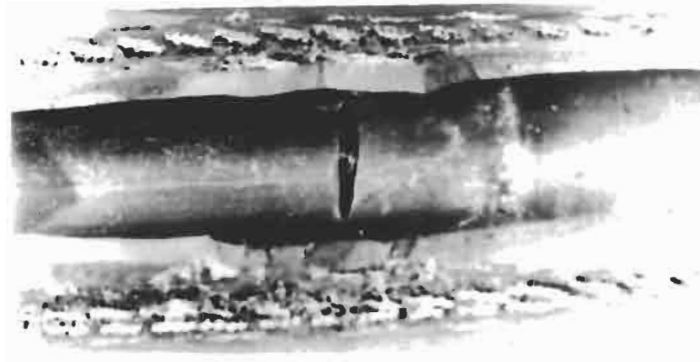
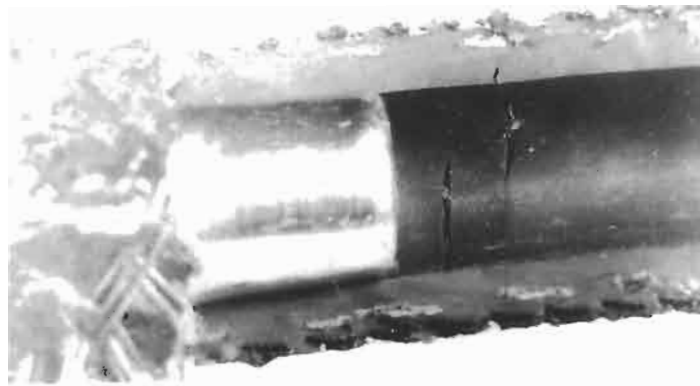
- (1) The steel wire layer was intact.
- (2) In all A type hosepipes, there was only one opening in the inner rubber layer. Similar results were obtained for most B type hosepipes except two, where two openings were observed.
- (3) The opening in the inner rubber layer was situated in the outside of the bend near the metal elbow adapter. The distance between the opening and the metal core is about 2.0–12.5 mm (see Fig. 2).
- (4) The openings in the inner rubber layer are circumferential, as shown in Fig. 2.
- (5) No other defects were observed in the inner layers of the hosepipes.

Fig. 2. The openings in the inner rubber layer.

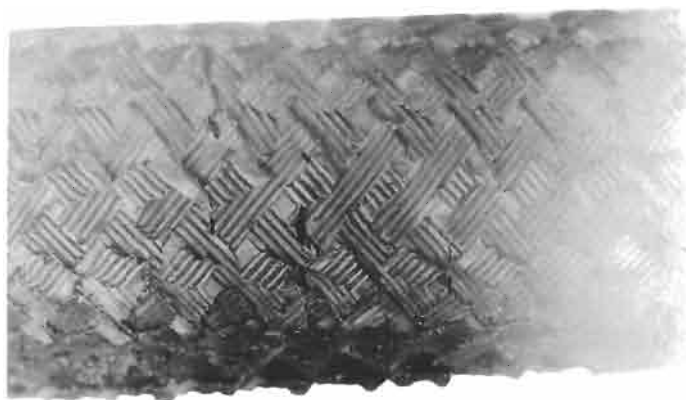
Fig. 3. The openings in the outer surface of the inside middle layer.

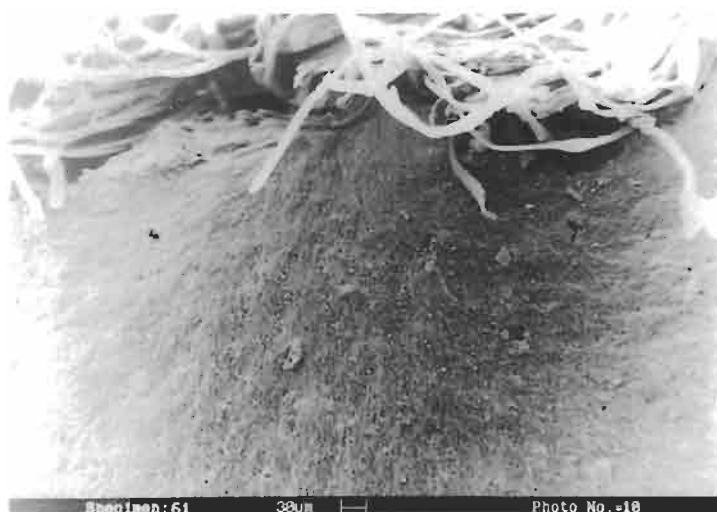
Opening the fracture and inspecting by SEM, it was found that the fracture surfaces in both A and B type hosepipes have the same characteristics, showing flats and radiating ridges (see Figs 4 and 5). Fatigue markings in the later period of propagation could be clearly observed (Fig. 6). The

Fig. 4. The fracture appearance of an A type hospipe.
