# ***FAILURE ANALYSIS CASE STUDIES II***

A sourcebook of case studies selected from the pages of  
*Engineering Failure Analysis* 1997-1999

**D.R.H. JONES**

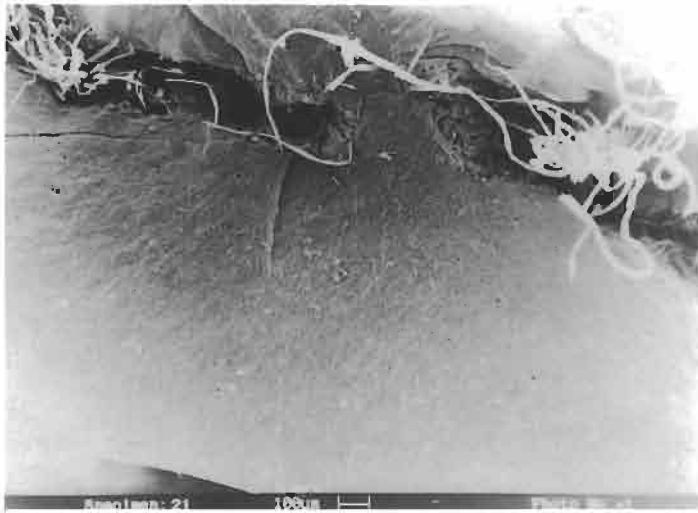
fatigue cracks were possibly initiated at the interface between the cotton thread and the inner layer. Finally, there were no obvious defects in the fatigue initiation zone (Fig. 5).

Fig. 5. The fracture appearance of a B type hosepipe.

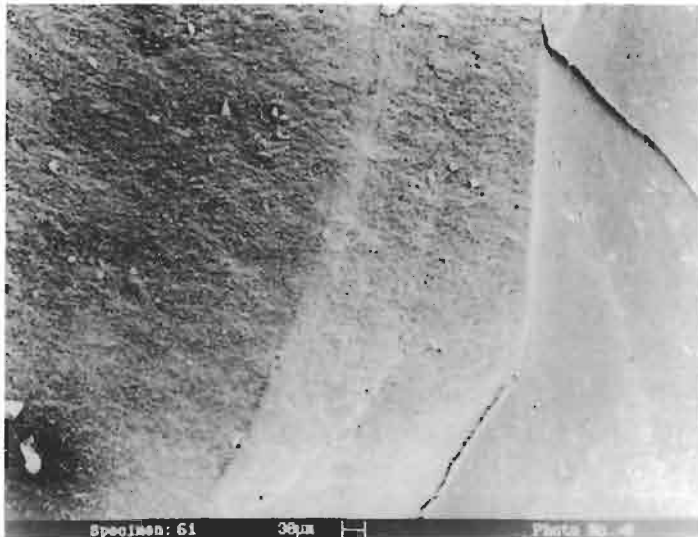
Opening the fracture and inspecting by SEM, it was found that the fracture surfaces in both A and B type hosepipes have the same characteristics, showing flats and radiating ridges (see Figs 4 and 5). Fatigue markings in the later period of propagation could be clearly observed (Fig. 6). The

Fig. 6. Fatigue beach marks.

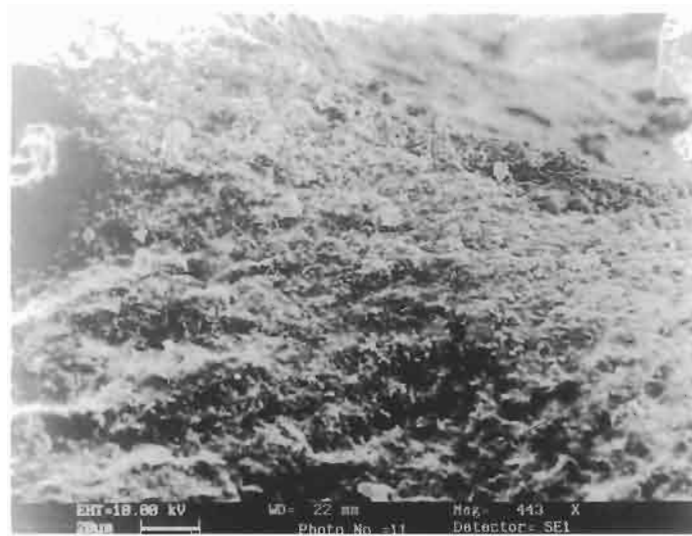
Smaller cracks had similar fatigue characteristics (Fig. 7).

Fig. 7. The fracture appearance of small cracks.

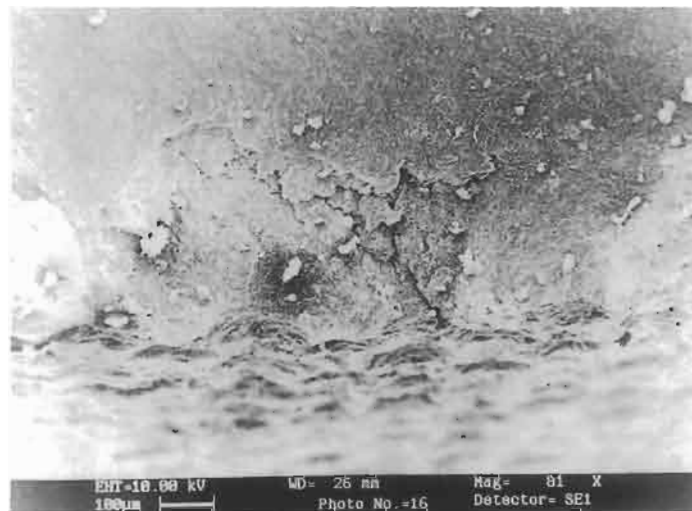
Opening the outer layer fractures and observing by SEM, it was concluded that cracks initiated from the outer surface and propagated towards the inner surface. Multiple initiation sites and some fatigue striations were observed (Fig. 8).

Fig. 8. The fracture appearance of the outer layer.

alternating stress caused by pressure variations. The outer layer bears stress and bursts after the inner layer bursts. When kerosene has penetrated the inner and middle layers as well as the steel wire layer, kerosene gathered between the steel wire and the outer layer. Large fatigue cracks initiated in the most highly bent position of the outer layer and formed the multiple fatigue crack sources.

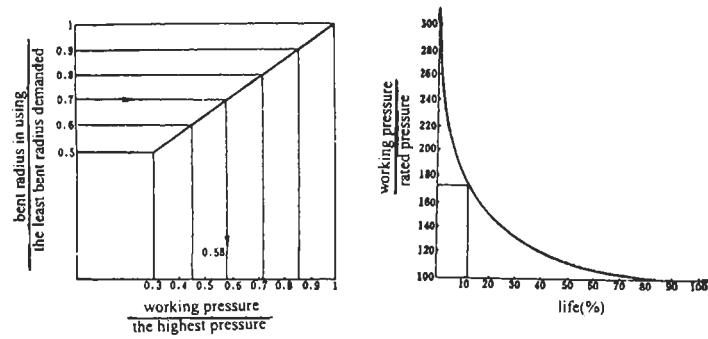
Serious bending deformation in mounting is another important reason for hosepipe bursting. Limited by the space, bending deformation could not have been avoided in mounting the hosepipes. It was reported that the minimum bending radius in a high pressure hosepipe is about 6–7 times the external diameter [1]. The pressure capacity of the hosepipe will drop rapidly if the radius is too small. When the hosepipe works in normal conditions the working life will drop. For example, the service pressure of A style hosepipes is 700 MPa. When the bending radius is 70% of the minimum required in mounting only 58% of the rated working pressure of the hosepipe can be applied in service, i.e., 406 MPa (Fig. 10). If the working pressure is kept at 700 MPa, the working life is shortened to 12% (Fig. 10).

Fig. 10. Relation between bent radius, pressure capacity and working life of hosepipe.

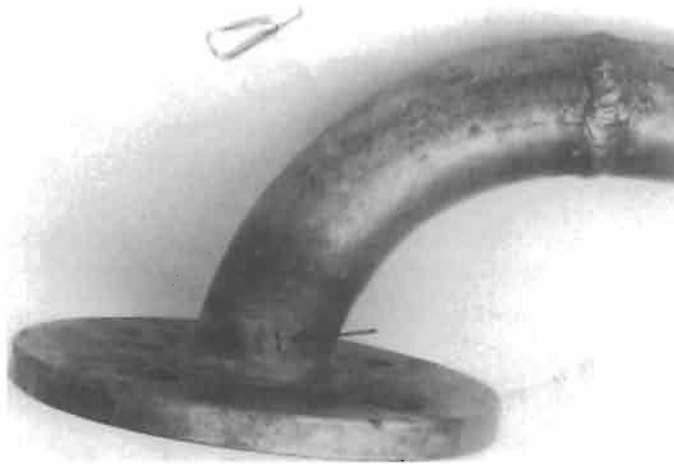
The joint consists of a tube (25 mm ID and 32 mm OD) made of AISI 304 L grade stainless steel welded to a flange made of the same steel (Fig. 1) The joint is used to transfer  $HNO_3$  from a storage tank to an NO reactor. A leak was noticed in the pipe portion of the joint.

Fig. 1. Photograph of the pipe-to-flange joint (arrow shows the leaking portion).

Cold working and welding processes used for component fabrication introduced stresses. Welding of dissimilar metal compositions introduced electrode potential differences. This combination created conditions conducive to preferential corrosion attack. Sensitization may also have been a factor owing to the high carbon content of the pipe, and the high heat input which may have been required to make the pipe-to-flange weld.

- (1) Components should be given an annealing treatment after fabrication processes like bending, welding etc.
- (2) Joining by welding of dissimilar materials should be avoided.
- (3) Possible sensitization can be avoided by using the L grade of stainless steel.

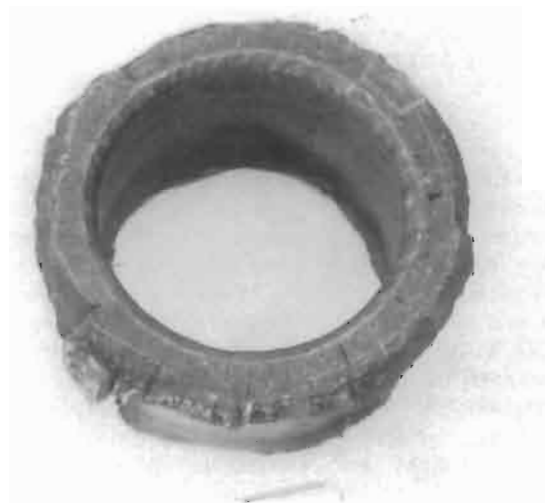
Figure 4 shows a photograph of the failed component. The failure was in the flange portion 7 mm away from the pipe-to-flange weld zone. During the operation of the plant, there was a leak in one portion of the flange, and, while tightening, it crumbled. The material in this component is exposed

Fig. 4. Photograph of failed sight port flange.

Usage of incompatible materials for different components has resulted in the failure of the component.

- (1) Joining by welding of dissimilar materials should be avoided.
- (2) Chrome plating of components enhances the resistance to corrosion attack.
- (3) In oxidizing atmospheres like  $\text{HNO}_3$ , care should be exercised to avoid moisture while using Teflon as the gasket material in combination with austenitic stainless steels.

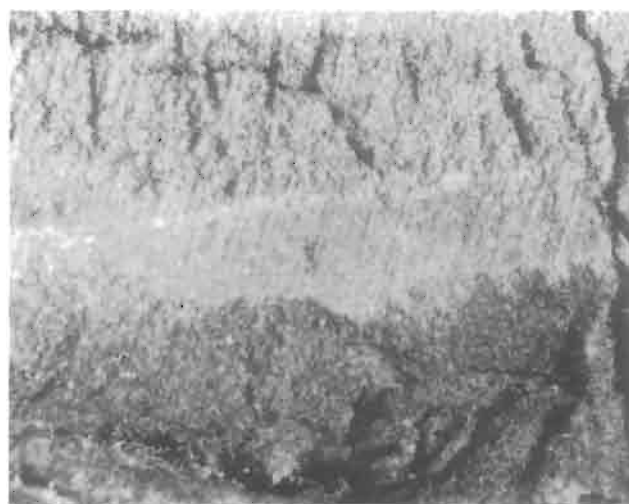
Fig. 5. Stereomicrograph of the cracked portion of the sight port flange.  $\times 16$

have started at the flange–pipe interface, and propagated along the radial direction in the flange. The pipe portion, however, did not reveal any cracks. The grain boundary thickening in the flange portion is due to sensitization of the microstructure during welding of the flange to the pipe. The sensitized microstructure contains  $\text{Cr}_{23}\text{C}_6$ -type carbides precipitated along the grain boundaries in a fine network. The area adjacent to the grain boundaries becomes depleted of chromium, and the corrosion resistance in this area deteriorates. Two dissimilar metal compositions are in contact, and a large unfavorable area ratio is present. The net effect is rapid attack in the impoverished areas, resulting in intergranular fracture [3]. The use of Teflon as gasket material can also enhance the corrosion attack. It is reported [4] that, in the system consisting of austenitic stainless steel,  $\text{N}_2\text{O}_4$  and Teflon, the latter can enhance the corrosion rate if any moisture is present in the system.

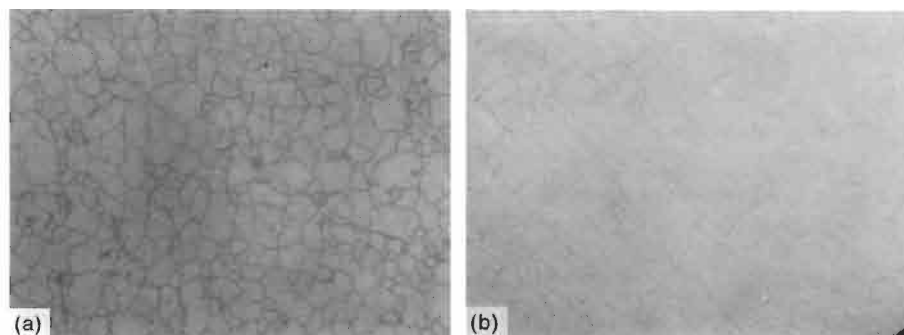
Figure 5 shows a stereomicrograph of the cracked region of the component. Figure 6(a) and (b) shows the microstructure of the component in the flange and pipe portion, respectively. The microstructure of the flange portion does not correspond to AISI 304 L type steel, whereas the microstructure of the pipe portion is typical of AISI 304 L type steel, which agrees with the chemical analysis results. Figure 7(a) shows the microstructure in the interface region of the pipe and flange, revealing the corrosion attack on the interface, and its propagation intergranularly into the flange portion with grain dissolution [Fig. 7(b)]. However, the pipe portion and the weld region do not show any such corrosion attack [Fig. 7(c)]. The microstructure in the flange portion shows grain boundary thickening at and near the interface and intergranular cracking. Figure 8(a)–(d) is SEM fractographs of the failed flange, which show the completely intergranular nature of cracking and grain dissolution. The preferential attack of the corrosive medium along slip bands is shown in Fig. 8(b) and (c). Figure 8(d) shows the corrosion product (tar-colored powder) observed on the fracture surface, and found to be  $\text{Fe}_2\text{O}_3$  by XRD analysis (Fig. 9).

Fig. 6. Optical micrographs of sight port flange. (a) Flange portion (does not correspond to AISI 304 type). (b) Pipe portion (typical of AISI 304 microstructure). Both  $\times 80$ .

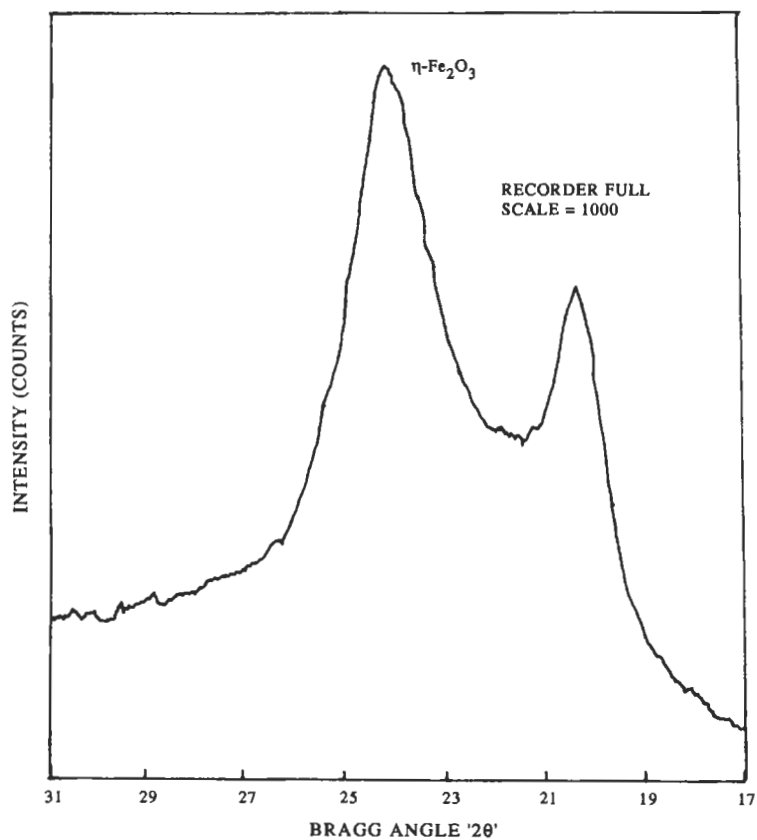
Fig. 9. XRD pattern of corrosion product ( $\text{Fe}_2\text{O}_3$ ) on sight port flange.

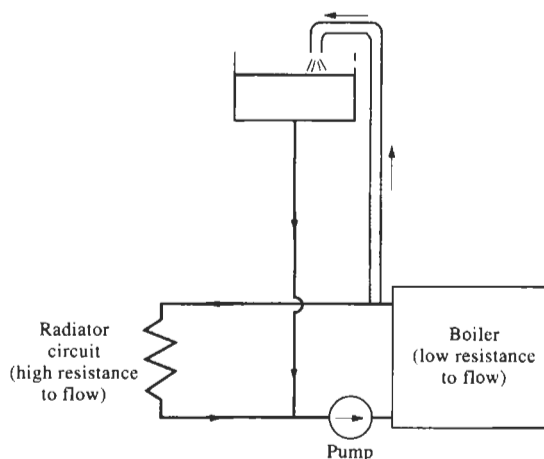
Fig. 4. Design fault 1—pumping water through the expansion tank.

A typical fault is shown in Fig. 4 [4]. If the flow resistance of the radiator circuit is large compared to that of the boiler, then, depending on the location of the pump, water can be forced up the vent and discharged into the expansion tank. A particularly bad location for the pump is shown in Fig. 4—in the return line between the cold feed and the boiler. It is easy to see that, when a large pressure drop is needed to get the water to flow around the radiator circuit, then the water will tend to take the easier route, and there will be a circulation loop between the boiler and the expansion tank. Naturally, as the water pours out of the vent it continually picks up air. This “pumping over” would not have happened if the pump had been positioned to the *left* of the cold feed instead of to the right. Figure 1 shows the standard position for the pump in a modern installation—in the flow line after the vent. When the pump is put in this position pumping over cannot occur.

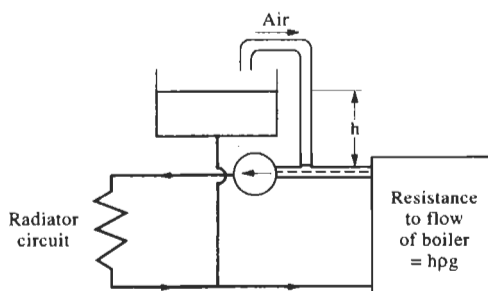
Figure 5 shows another fault—when air is drawn in down the vent pipe [4]. In order to pull water through the boiler the pump must generate a low pressure in the flow line from the boiler. This low pressure depresses the head of water in the vent pipe. If the expansion tank is not high enough, the surface of the water in the vent pipe will be pulled down to the level of the flow line, and bubbles of air will be swept into the circuit. Oxygen concentrations of  $\approx 5$  ppm have been found in systems

Fig. 5. Design fault 2—drawing air in through the vent.

suffering from this defect [4]. To avoid air intake, the static head  $h$  must be greater than the flow resistance of the boiler by a suitable safety margin; a typical value for  $h$  is 1.5 m.

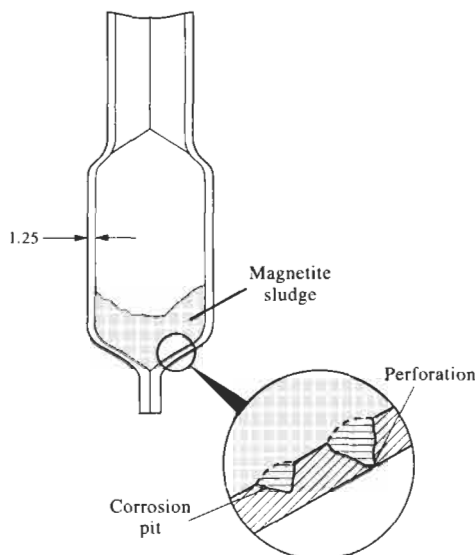
Fig. 10. A layer of magnetite sludge had formed in the water space at the bottom of the radiator. Pitting corrosion had occurred where the sludge covered the steel. Dimensions in mm.

until the concentration of sodium nitrite in the water was 1300 ppm (parts per million, or  $\text{mg l}^{-1}$ ). The sodium nitrite was the active ingredient in the inhibitor package; the sodium borate was added as a buffer to keep the pH of the water at about 9. However, after only 2 years the new radiators started leaking. The offending radiators were removed, and one was cut open. As shown in Fig. 10, a layer of black sludge had formed in the water space at the bottom of the radiator. The corrosion had originated beneath this deposit, and had developed into deep pits. One of these had penetrated right through to the outside surface. However, there was no evidence of any pitting above the sludge.

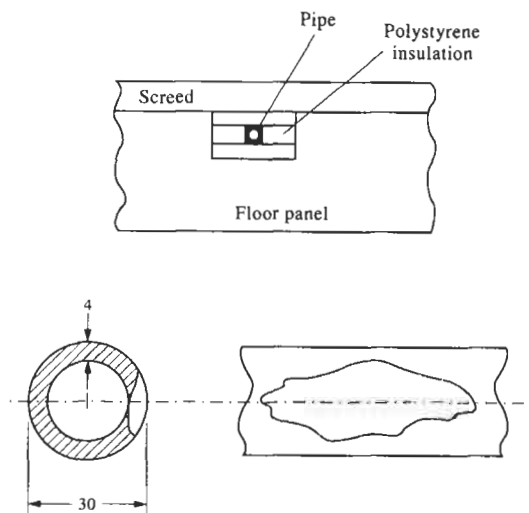
Fig. 14. The corroded steel pipe. Dimensions in mm.

were laid in the concrete during the construction. By 1985, the pipes had started to leak. A typical failure is shown in Fig. 14. The pipe had an outside diameter of  $\approx 30$  mm, and a wall thickness of  $\approx 4$  mm. It had been cast into the floor panel of one of the student rooms, and was insulated with slabs of expanded polystyrene. When the floor was dug up, it was found that the pipe had rusted from the outside. The wall of the pipe had perforated, and the water inside the heating system had started to leak out. The corrosion deposits were reddish-brown in colour.

The roof of the building consisted of a series of horizontal pre-cast concrete slabs. These had started to take in rain-water at the joints. The structure of the building was complex, and the rain-water travelled large distances before leaking into the rooms or the public areas. It was concluded that the most likely explanation for the corrosion was that the pipes had come into contact with the leaking rain-water. The horizontal runs of piping on each floor were connected by vertical runs laid in open ducts, and it was thought that these could have channelled the rain-water from one floor to another.

Since air was able to get to the surface of the pipe, the cathodic oxygen-reduction reaction would have taken place easily. In addition, the incoming rain-water would have been saturated with oxygen. The corrosion product was presumably red rust (hydrated  $\text{Fe}_2\text{O}_3$ ). The Pourbaix diagram for iron (see Appendix A) shows that this oxide is produced when the oxygen content is high. Rain-water is also saturated with carbon dioxide: it contains  $\approx 1300 \text{ mg l}^{-1}$  of the gas [3]. The carbon dioxide converts to carbonic acid, and the pH falls to  $\approx 4.5$  as a result [2]. As can be seen from the Pourbaix diagram, rain-water is aggressive to mild steel: iron cannot start to produce an oxide film at a pH of 4.5 unless the potential is taken up to  $+0.4 \text{ V}$ . A strong oxidizing agent would be needed to get the potential this high.

Mild steel typically corrodes at the rate of  $0.05\text{--}0.15 \text{ mm/year}$  in slowly moving soft water saturated with air at  $15^\circ\text{C}$  [16]. However, the pipes were not always at  $15^\circ\text{C}$ : when the heating system was operating they were closer to  $70^\circ\text{C}$ . Figure 6 shows that the corrosion rate should go up by  $\approx 2.7$  times over this temperature interval. The heating system was generally used only for 6 months out of each year; on average the corrosion rate was probably  $\approx 1.8$  times greater than it would have been at  $20^\circ\text{C}$ . This would give a corrosion rate of  $\approx 0.09\text{--}0.27 \text{ mm/year}$ . If it is assumed that rain-water had been leaking into the building for  $\approx 7$  years, the depth of attack would be  $\approx 0.6\text{--}1.9 \text{ mm}$ . If the steel develops pitting corrosion, the rate of attack in the pit can be up to 10 times the rate of general corrosion [16]. In this case, the pits would easily be capable of perforating the wall

Many central heating installations function perfectly well without corrosion inhibitors. But what must be done to avoid corrosion when inhibitors are not used? The first requirement is to make sure that a uniform, stable film of oxide forms on the metal to act as a barrier to corrosion. The pH of the water must be in the range where a passive layer is thermodynamically possible. pH ranges can be estimated from the Pourbaix diagrams (see Appendix A): they are 7–12.5 and 9–14 for copper and iron, respectively. Hard water ( $\text{pH} \approx 8$ ) is less aggressive to copper and steel than soft water ( $\text{pH} \approx 6.5$ ). The initial condition of the system has an important influence on the state of the protective films. It is bad to test a system with water and then leave it drained down. Corrosion will occur in the aerated pool of water at the bottom of each radiator, and the film may be penetrated by corrosion pits. It is best to put the system into working order straight away, and to keep it filled with water. Because chloride and sulphate ions attack the oxide films, the water should be as free from them as possible. Copper pipes are sometimes attacked by residues of soldering flux or graphite, and these, too, should be avoided.

Once a stable film has formed, the rate of corrosion depends on the cathodic reaction. The oxygen-reduction reaction can be prevented by keeping the oxygen content of the water as low as possible. Pumps should be placed so they do not pump water through an open expansion tank or draw air into the system. The water in an open expansion tank should be kept cold to minimize evaporation. It is preferable to use a sealed air cushion expansion tank instead of an open expansion tank. Obviously, the system should not be drained if this can be avoided. The hydrogen-reduction reaction can be minimized by keeping the pH high, and the temperature low.

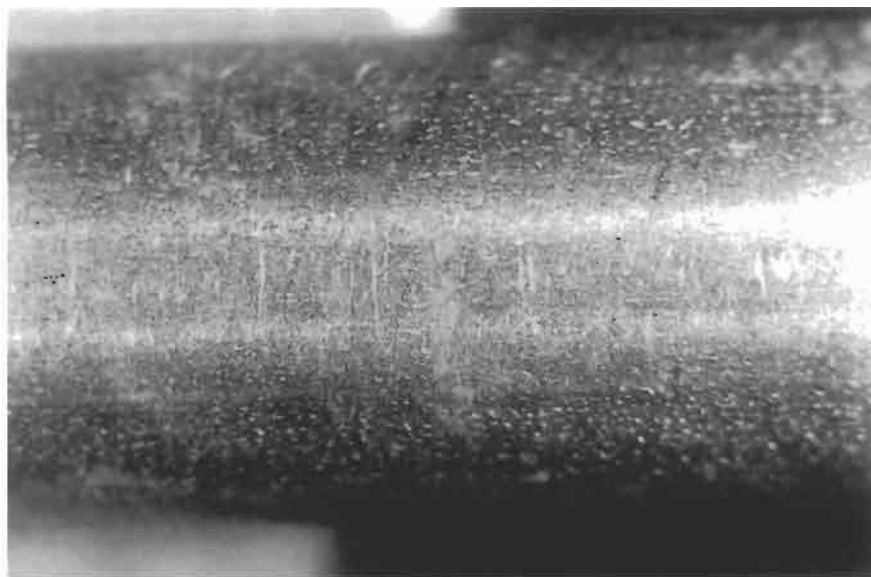
After 12 days of exposure at 25 °C, a pale yellow discolouration of the originally clear water-rich phase was observed, and a light ring of rust began to appear at the edge of the o-ring immersed in this phase (Fig. 3). Neither discolouration of the solutions nor rings of rust at the o-rings were

Fig. 3. Light ring of rust which appeared at the o-ring immersed in the water-rich phase after 12 days of exposure at 25 °C ( $\times 16$ )

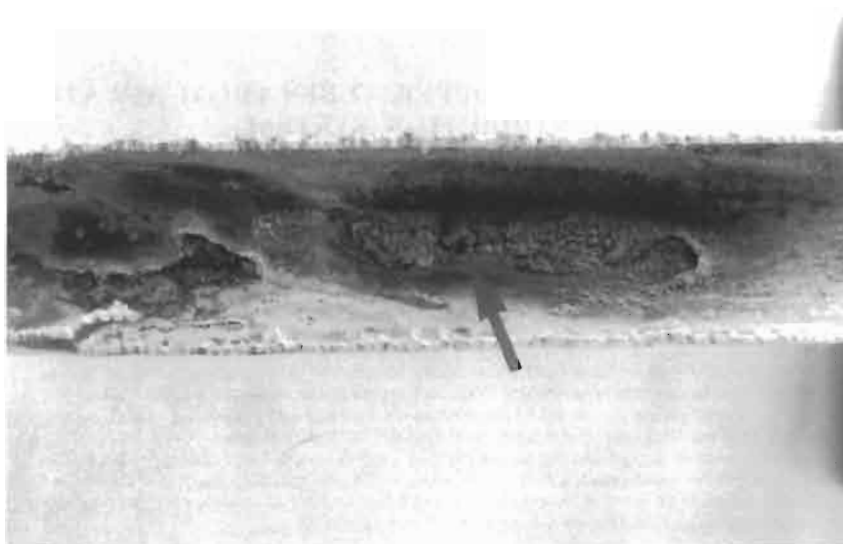
Fig. 1. The internal surface of a tube ( $\times 2$ ). The arrow indicates the presence of a tubercle of corrosion product.

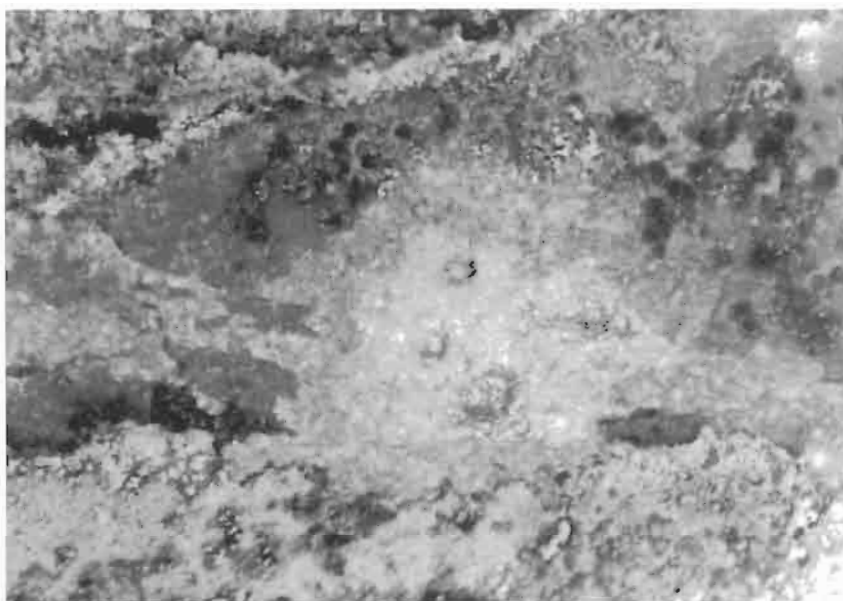
Fig. 2. A high magnification photograph of the region beneath a corrosion tubercle ( $\approx \times 50$ ). Note the presence of the greenish-white scale, the underlying black layer and the corrosion pit.

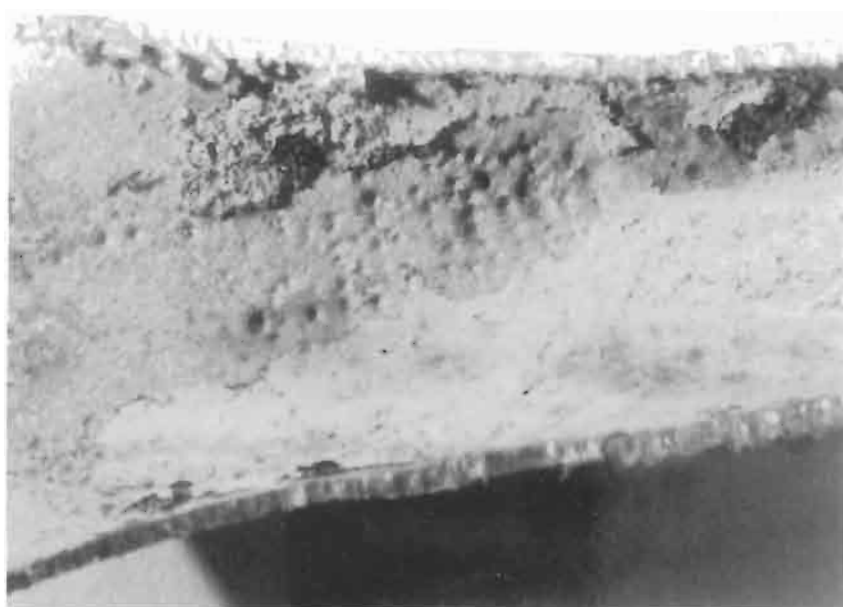
Fig. 3. The internal surface of a tube showing extensive pitting ( $\times 3$ ).

It was concluded that the failure of the copper tubes was due to Type I pitting attack. It is not clear at this stage what the exact cause of pitting failure was, particularly given the fact that pitting only became evident after 12 years' service. It is highly unlikely that it may be due to the presence of foreign matter deposits introduced during installation of the system. The introduction of foreign matter in the water is, however, a possibility, particularly if the water is not filtered. A change in water quality or content (e.g. resulting from mixing of the water with borehole or well waters) could also be responsible for pitting.

suggested that such treatment would be both unsuccessful and unfeasible. It was therefore recommended that the copper tubes be replaced. Careful attention should be given to the usual causes of Type I pitting. In particular, it should be ensured that all tubes be thoroughly cleaned and freed of any carbonaceous deposits prior to installation. The tubes should also be cleaned to ensure complete removal of any foreign matter deposits and solder pastes after installation. The use of water filters could also be considered to prevent the introduction of foreign matter in the water. Furthermore, the quality and content of the water should be determined and its potential to cause pitting assessed. The extent of replacement or modifications to the water distribution system would, to some degree, depend on the results of such water analyses.

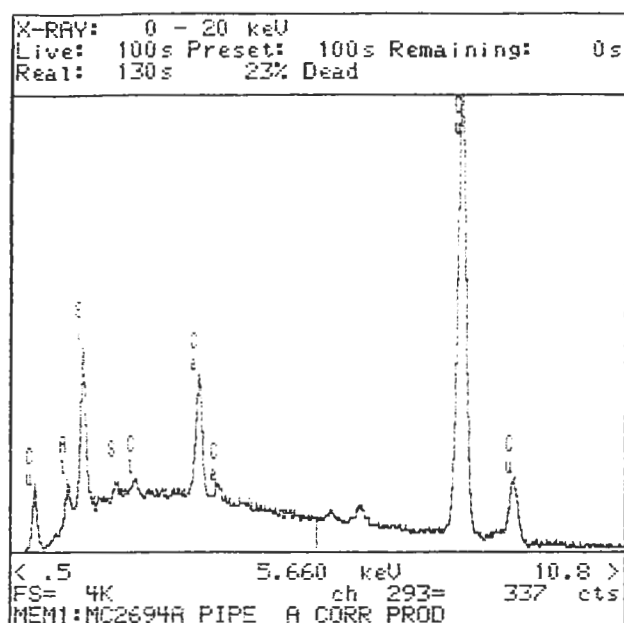
peak originates from the base metal. The large silicon and calcium peaks, and the smaller aluminium peak are due to the presence of these elements in the scale. These elements are readily oxidised and are therefore frequently detected in scale deposits. A minor chloride peak was also detected. This ion is usually associated with pitting attack but the quantity of chloride in this case does not appear to be large.

Fig. 4. The EDS results of the greenish-white deposits found on the internal surfaces of the tubes.

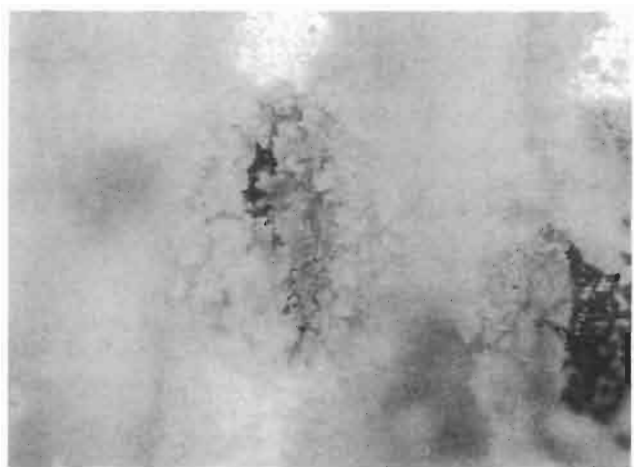
Fig. 3. Debris on waveguide surface. Copper hydroxy nitrate corrosion along corrugations in waveguide.

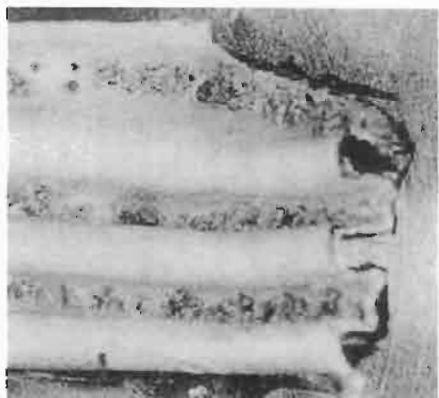
Fig. 4. Corrosion product along corrugations in the waveguide.

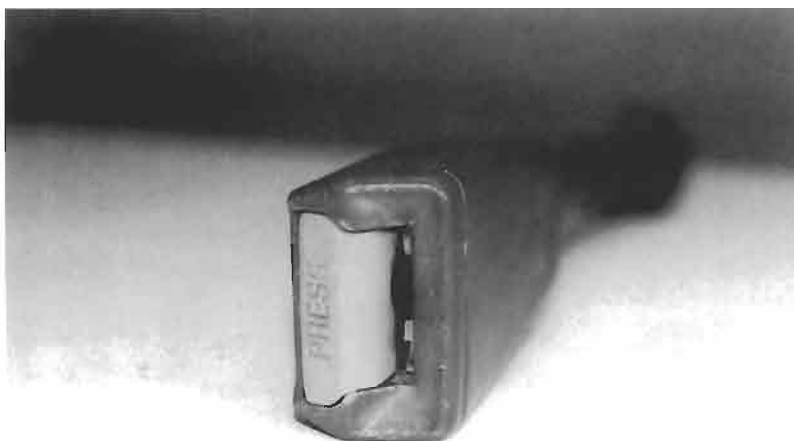
Fig. 1. Typical Takata seat belt receptacle of one of the affected designs. This receptacle was removed from a 1989 Honda Accord. Note impact damage especially to the plastic housing.

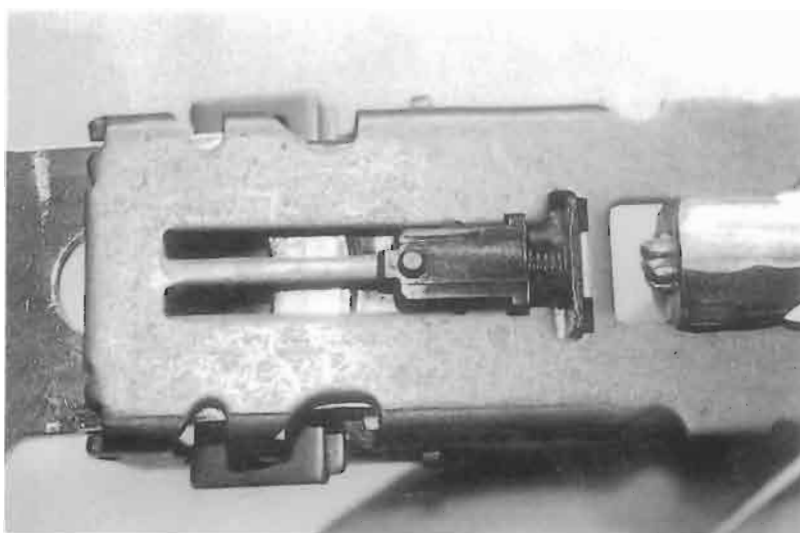
Fig. 5. 'Mode one' failure, showing a bottom view of the receptacle housing. The clasp, at left, is attempting to completely enter the receptacle, but it cannot, because of the button fragment lodged behind the slider.

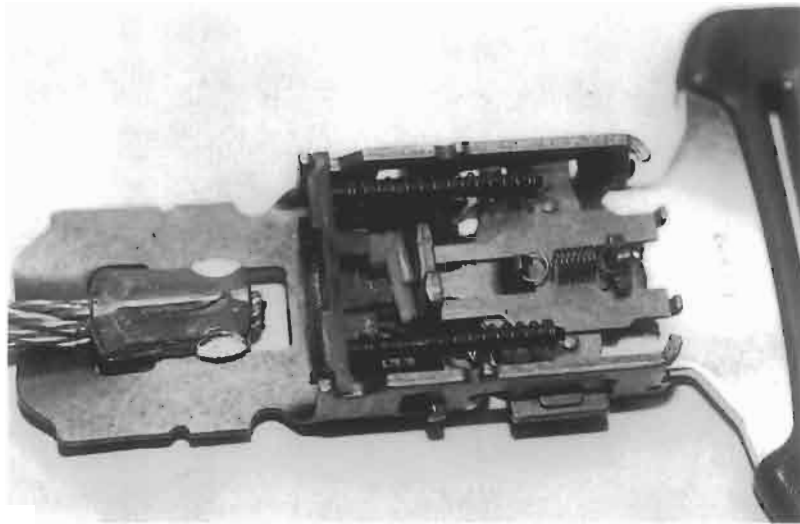
Fig. 6. 'Mode two' failure, showing a fragment of the release button lodged just to the left of the locking slider. In this case, the fragment keeps the locking slider from sliding to the unlocked position when the release button (not shown) is pressed.

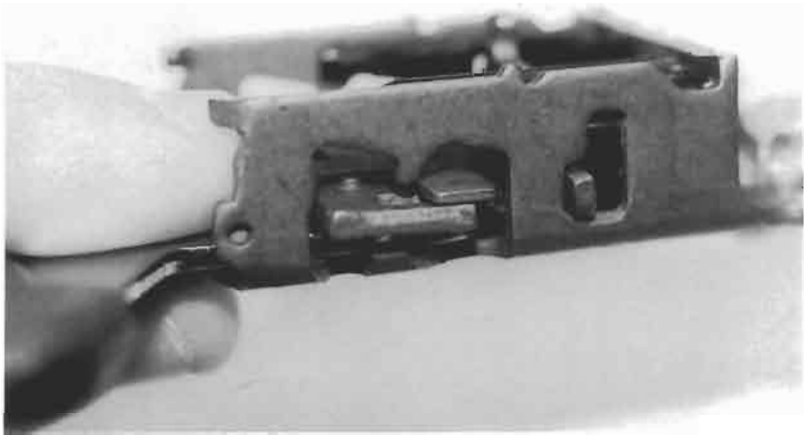
The third failure mechanism results when a small piece of plastic from the release button becomes lodged in such a way the locking slider cannot quite slide to its fully locked position (Fig. 7). Thus, while the clasp can be inserted into the receptacle, seemingly latching the belt, in reality the clasp can be removed by pulling on the belt with relatively little force.

Fig. 7. 'Mode three' failure. In this case the button fragment (not shown) does not allow the locking slider to slide all the way to the latched position (compare to Fig. 3) giving the appearance that the buckle is latched when it is not.

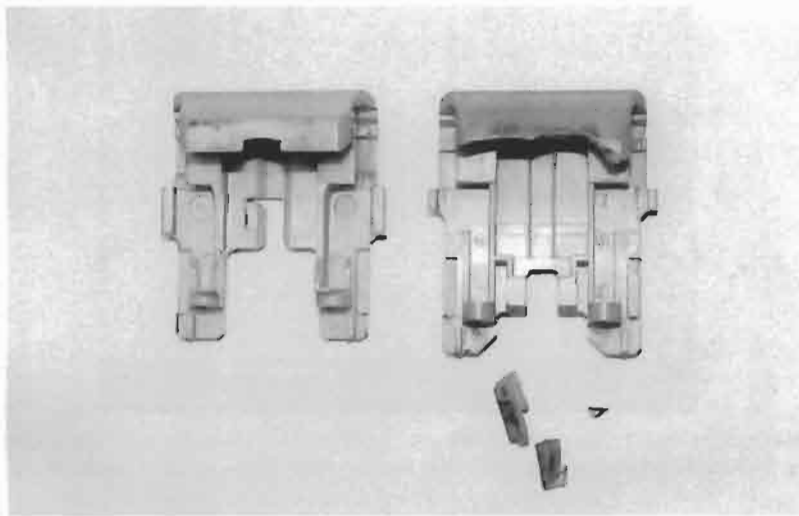
Figure 8 shows a release button along with several fragments. This figure also shows (at left) a release button that is still intact. Both buttons came from Honda Accords, although from different model years, which accounts for small differences in the designs. A closeup of the fracture surface of the button from Fig. 8 is shown in Fig. 9.

Fig. 8. Two release buttons from Honda Accords. The button at right has degraded and fractured, while the one at left is in better condition.

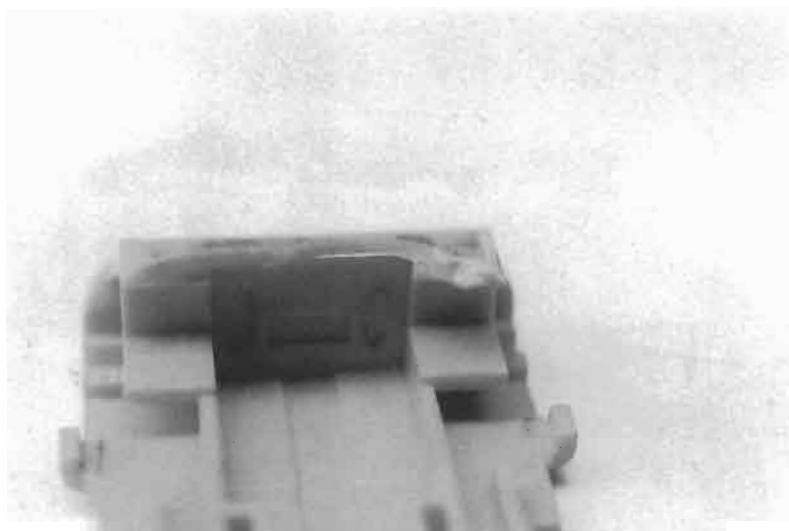
Fig. 9. Close up of the fracture surface of the button on the right in Fig. 8.

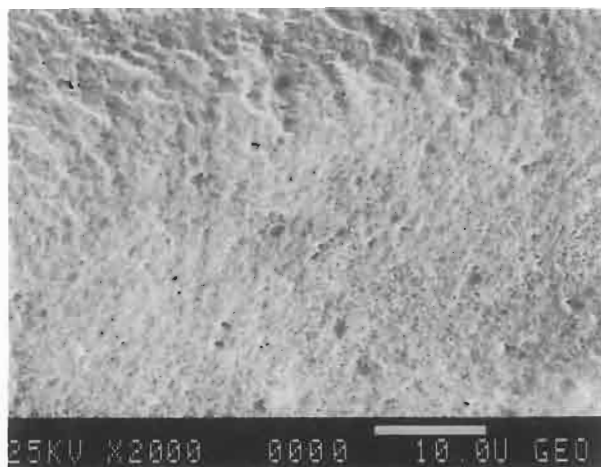
Fig. 10. Scanning electron micrograph of a fracture surface of a degraded release button. The presence of a discontinuous phase (typical of a rubber-modified polymer) is indicated by the round holes on the fracture surface.

combined with the SEM appearance of the fracture surface, led to the conclusion that the release buttons are molded from ABS.

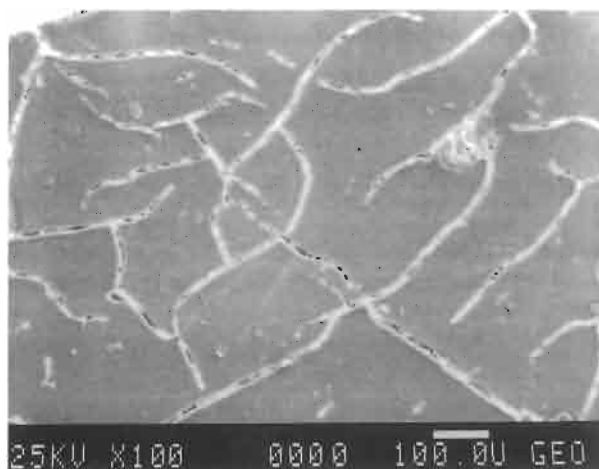
Figure 11 shows a closeup of the 'Press' surface of a release button. The surface of the button has faded (become discolored) and is criss-crossed with crazing. Further magnification, as shown in Figs 12 and 13, confirms the presence of a network of crazing cracks extending into the button.

Fig. 13. Scanning electron micrograph of the button in Fig. 12. The crazing cracks are seen to extend through the surface of the material.

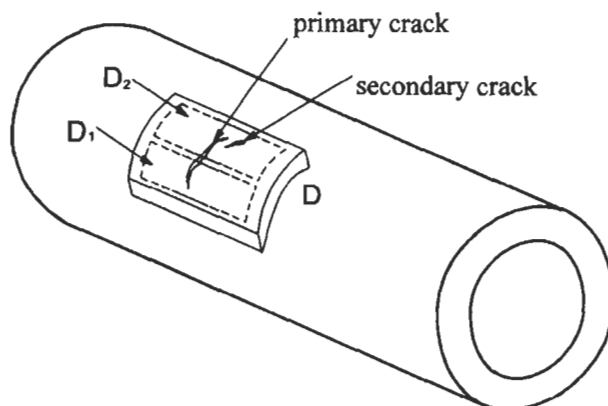
Fig. 2. Samples of a cracked radiant tube for failure analysis.

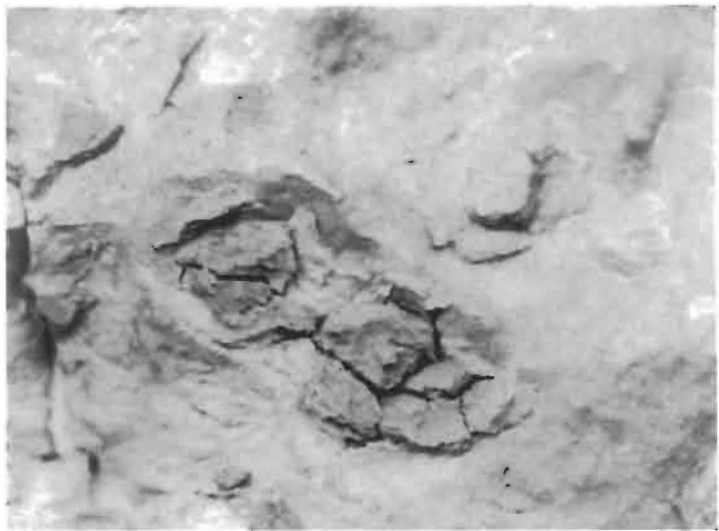
Fig. 4. Enlarged view of a cracked oxide scale located in thinned area.

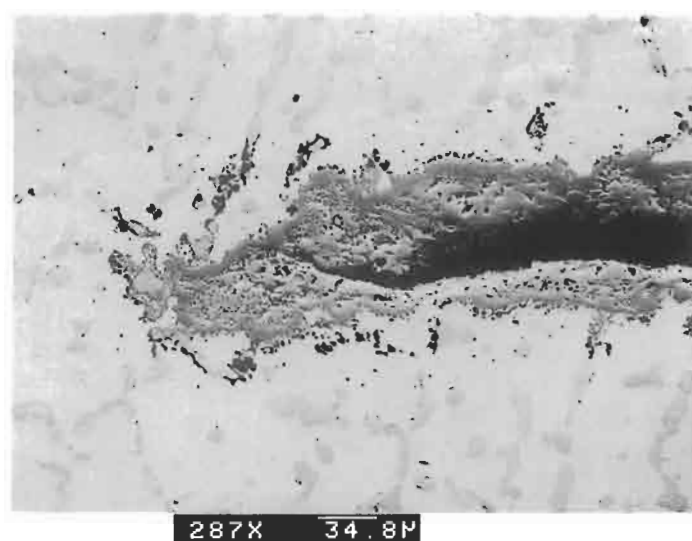
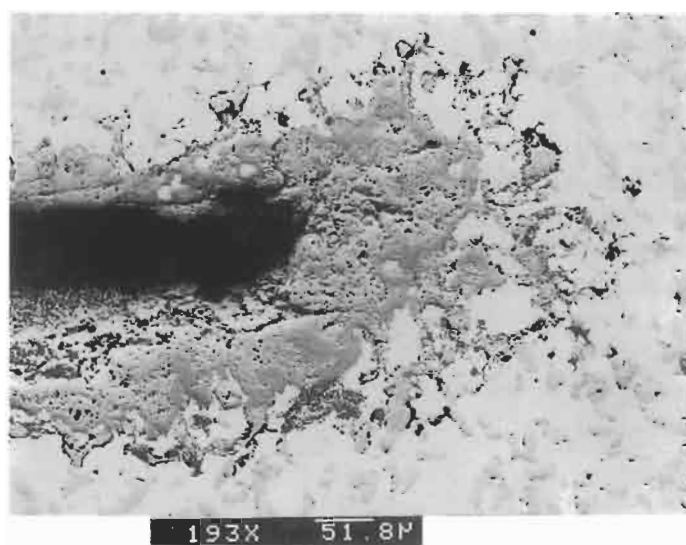
Fig. 6. Crack tip morphology.

in Fig. 6. Thus, it can be argued that the main cause for the formation of cracks in the tube is oxidation.

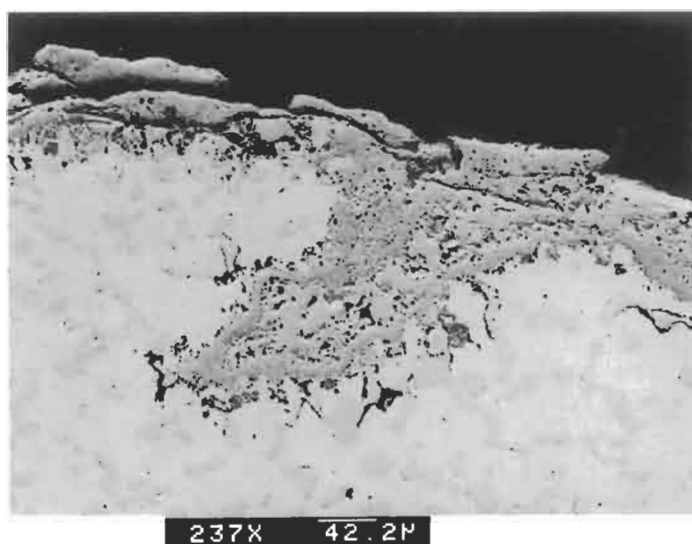
The primary crack in the specimen D<sub>1</sub> which was opened to fracture is illustrated in Fig. 7. The top line of the specimen represents a fracture surface of the primary crack where a deep oxide layer is present. Beneath the primary crack, the formation of a secondary crack with a shallow oxide layer is observed. It is evident that the characteristics of the crack are similar to the crack shown

Fig. 7. Oxide spike under the fractured surface of primary crack.

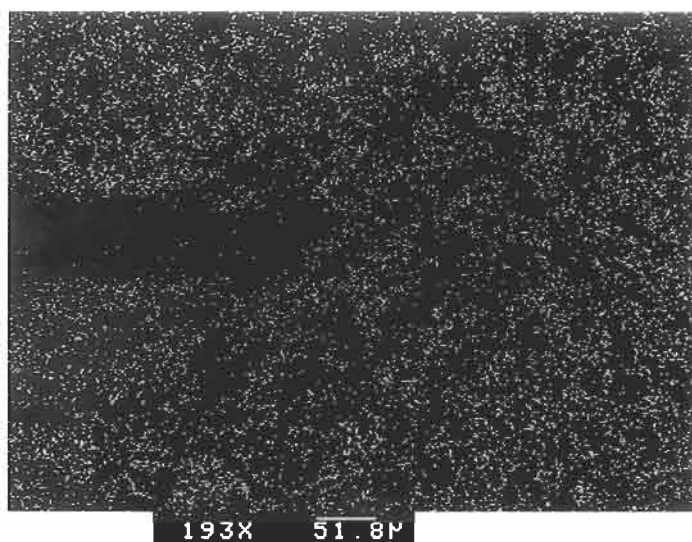
Fig. 8. Ni distribution map of crack tip region (same location as shown in Fig. 6(b))

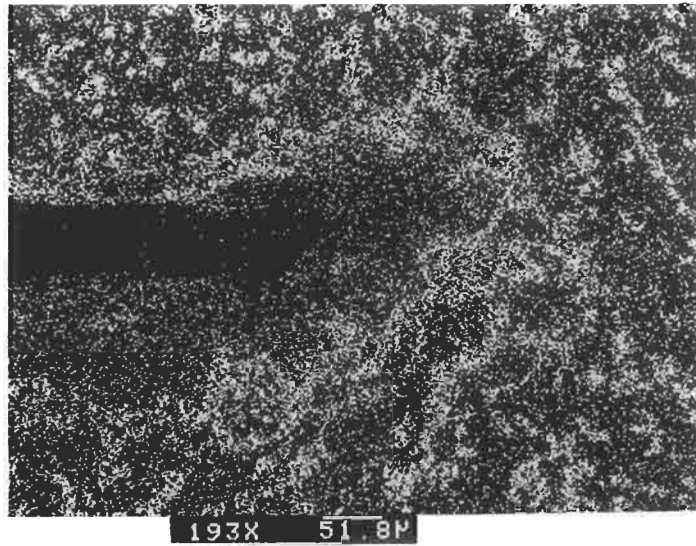
Fig. 9. Cr distribution map of crack tip region (same location as shown in Fig. 6(b))

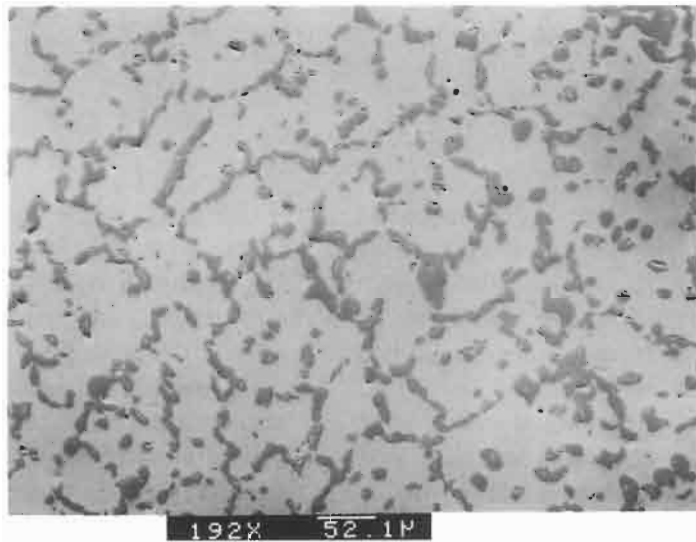
Fig. 10. Microstructure of uncracked region of the tested radiant tube.

Referring to the known reference microstructures of HK tubes degraded at high temperature [3], the microstructure shown in Fig. 10 corresponds to the microstructure similar to one aged at 950–1000°C for 60,000 h. Since the service period of the failed tube was only 15,000 h which is much less than the 60,000 h of the corresponding microstructure, it can be predicted that the service temperature of the tube was above 1000°C. Figure 11 shows a microstructure near the cracked area which shows internal void formation. Voids of this kind were reported to be formed when the service temperature reaches 1090–1230°C in the case of Ni–Cr steel [4]. Hence, it can be argued that the local metal temperature during the service must go up to this high temperature. This overheating can be induced by touching of the flame to the tubes near the supporting guide A in Fig. 1. Therefore, to prevent radiant tube failures methods should be sought to lower the tube metal temperature below 1000°C, particularly in the vicinity of supporting guide A. Modification of burner tips or improving combustion systems can be considered.

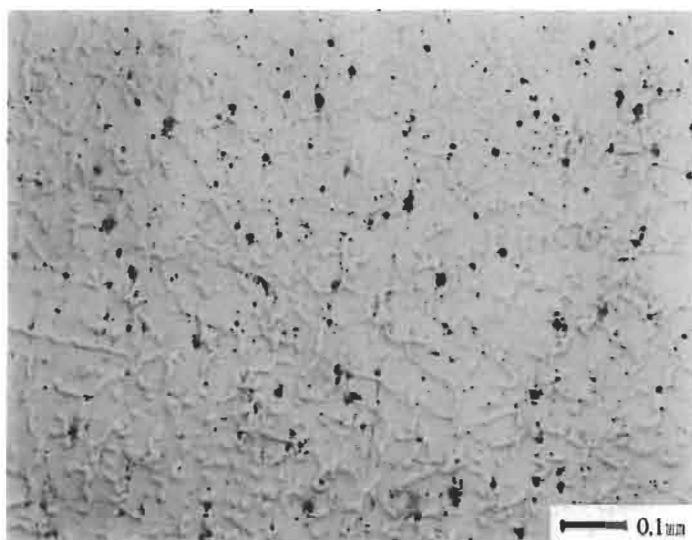
Fig. 11. Microstructure of cracked region of the tested radiant tube showing void formation

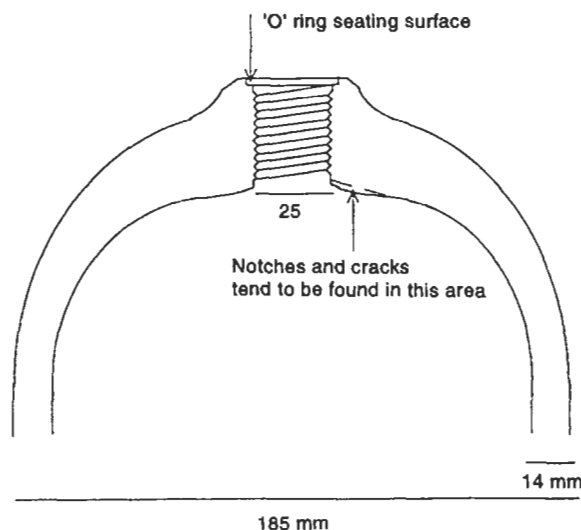
Fig. 1. The top of an aluminium gas cylinder with the area of crack initiation and growth indicated.

To determine the crack driving stress intensity, the stresses presented for an aluminium cylinder in Price *et al.* [11] were used.  $K_I$  was estimated made using British Standards PD 6493: 1990 Level 2 for a crack of 4 mm depth by 20 mm long in the position shown on Fig. 1. If there is no residual stress,  $K_I$  is 5.54 MPa  $\sqrt{\text{m}}$ .

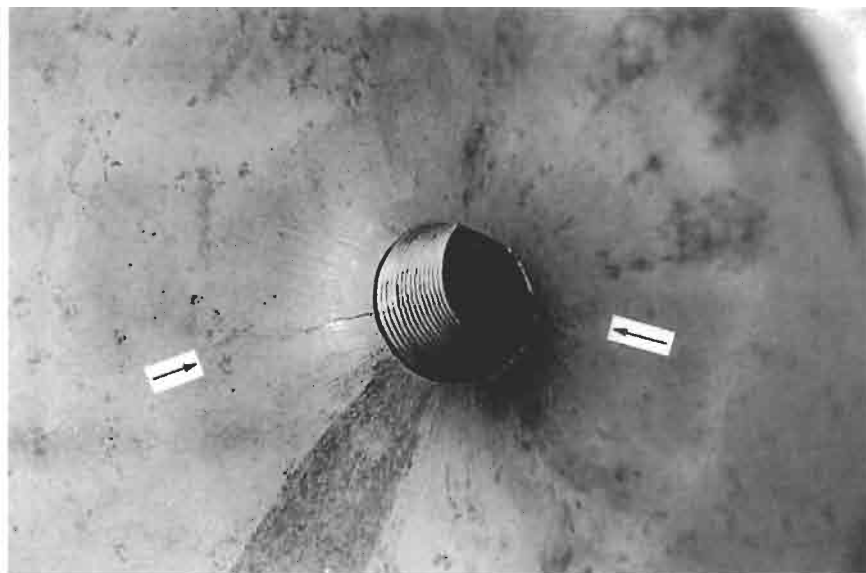
Fig. 2. Inside the top of cylinder A. Two large cracks almost opposite each other are marked. This specimen has been broken open and crack growth was found to proceed under the surface further than detectable using dye penetrant on the surface. The defect appearance conforms to the intergranular growth mechanism.

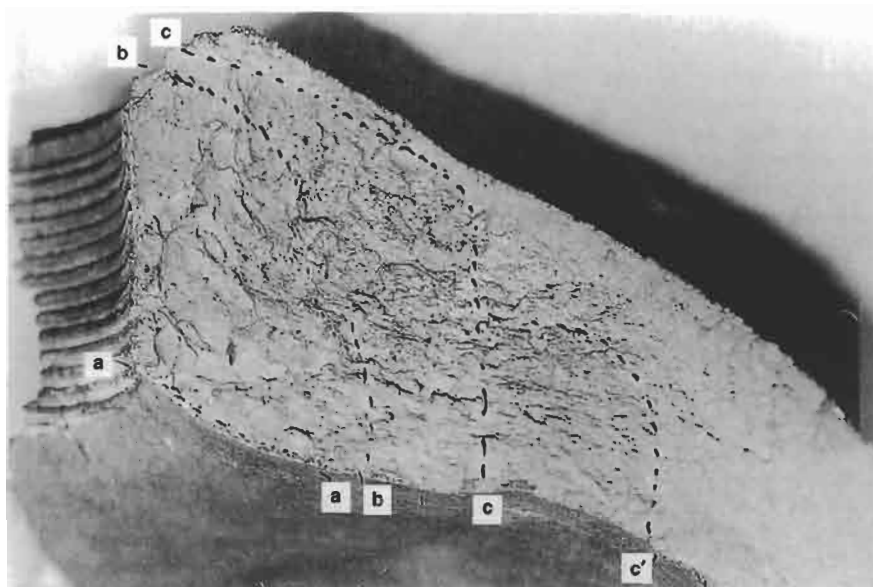
Fig. 3. The fracture surface of one of the four fractures of cylinder B. The photograph has been marked to highlight beachmarks caused either by damage during hydrotests of the cylinder or indicating changes to the crack growth mechanism. Some growth stages might leave no clear beachmark.

- a Area of different morphology indicating initial defect.
- a-b Area of growth which is mainly intergranular which is consistent with SMIE. Note that in this region some grains are very large because of recrystallisation during the heat treatment cycle
- b-c, c-c' Faster area of growth, plastic areas mixed with SMIE.
- After c, c' Plastic rupture, surface approaches 45° to other fracture plane.

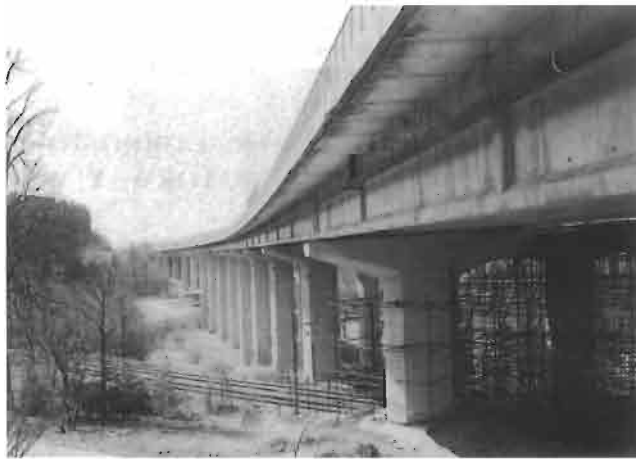
Fig. 1. Prestressed concrete construction of the viaduct.

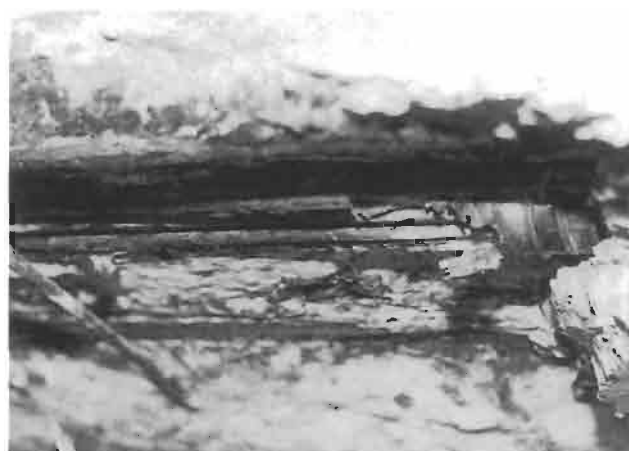
Fig. 3. Corrosion damage of cables.
