# ***FAILURE ANALYSIS CASE STUDIES II***

A sourcebook of case studies selected from the pages of  
*Engineering Failure Analysis* 1997-1999

**D.R.H. JONES**

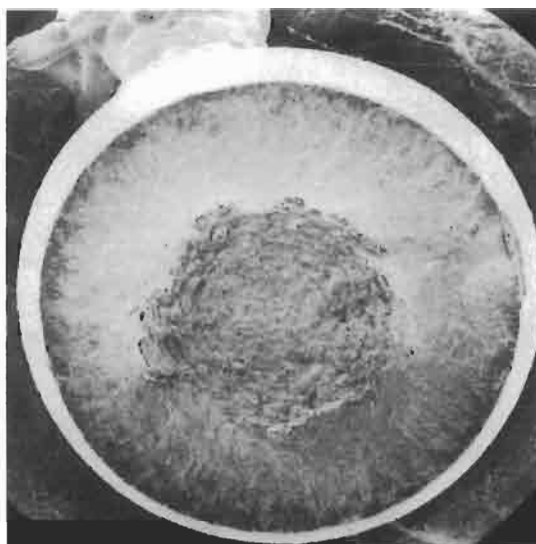
The (SEM) fractographic analyses of the fractured surfaces of the test specimens, after the mechanical testing, agree well with the results shown in Table 1. The material defined by Corr. d. = 0 is tough (Fig. 4). In the middle a so-called fibrous zone can be seen, where the crack is only progressing slowly. This means that for the crack to progress during the tension test in a stable manner, a relatively large amount of energy is needed. In the shear-lip zone (the ring area surrounding the fibrous zone) a change in the rate of progress of the crack can be observed. In this area its spreading is unstable and quicker. In the fibrous zone the fracture surface with typical relatively large dimples (Fig. 5) appears tough. A tough fracture can also be observed in the shear zone, but, as the material in the tension test slips at an angle of  $45^\circ$ , characteristic shears occur which make the characteristic dimples more or less invisible.

Fig. 4. SEM photograph of the fracture surface of a specimen with Corr. d. = 0.  $\times 13$ .

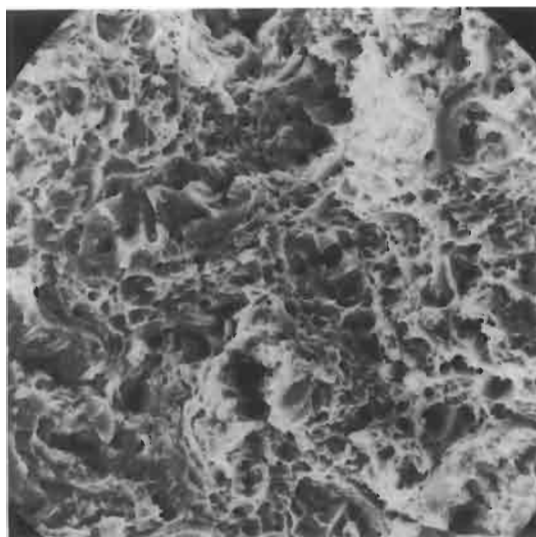
Fig. 5. SEM photograph of a specimen with Corr. d. = 0, showing the tough fibrous zone.  $\times 2000$ .

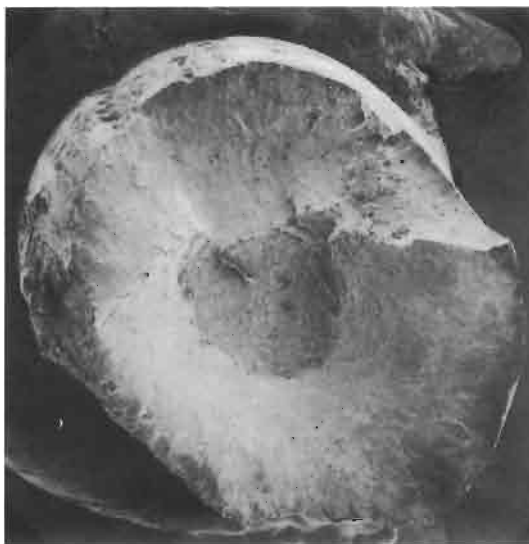
It is quite clear that stress corrosion and hydrogen embrittlement reduce the size of the fibrous and shear-lip zones (Figs 6 and 7), and the proportions in both of brittle locations increases. It is a fact that the nucleation and propagation of microcracks, their coalescence into larger cracks together

Fig. 6. SEM photograph of a specimen with Corr. d. = 2, with a reduced fibrous zone, and increased brittleness of the shear-lip zone.  $\times 13$ .

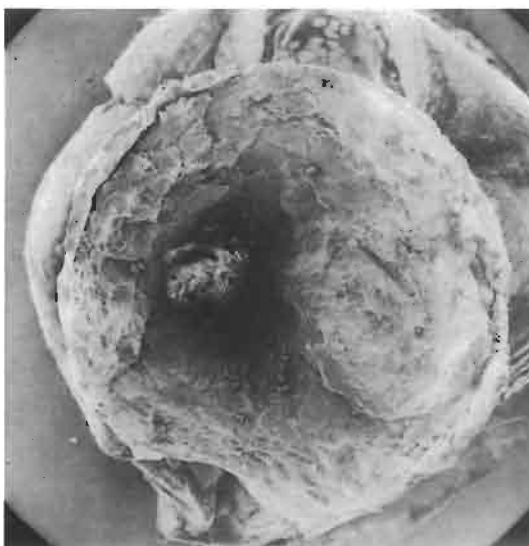
Fig. 7. SEM photograph of a specimen with Corr. d. = 5, showing the very brittle nature of the fracture surface.  $\times 10$ .

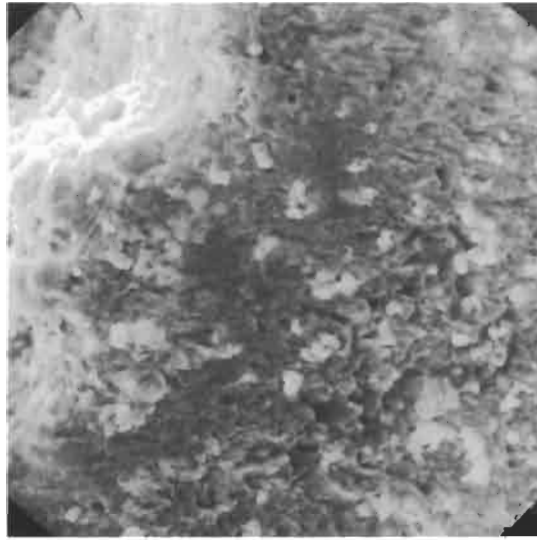
Fig. 8. SEM photograph of a specimen with Corr. d. = 2, showing the shallow dimples.  $\times 1000$ .

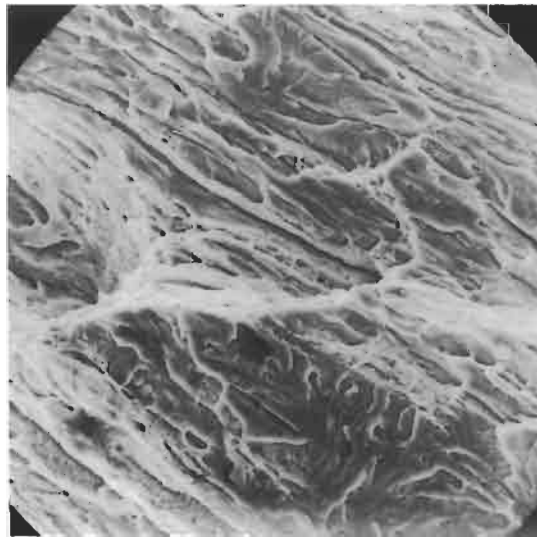
Fig. 9. SEM photograph of a specimen with Corr. d. = 5, showing the brittle nature of the fracture surface.  $\times 1000$ .

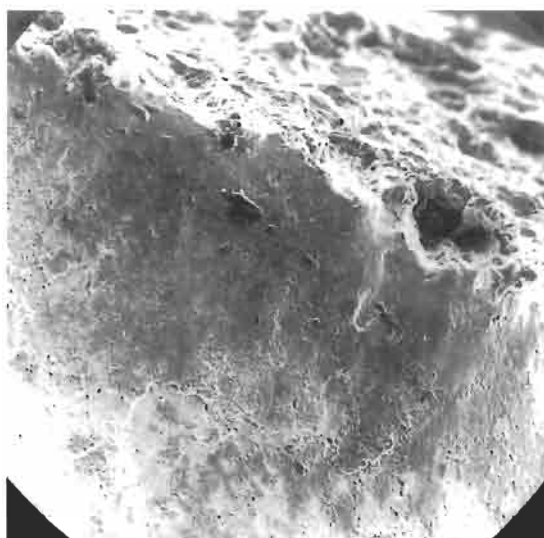
Fig. 10. SEM photograph of a specimen with Corr. d. = 5, with corroded (black) and uncorroded (white) regions.  $\times 100$ .

of corroded areas in the stress corrosion crack (Fig. 10). Such uncorroded areas only occur due to transcrystalline slips at those locations where the hydrogen has reduced the cohesive force between the atoms of the metal at the crack tip or, for example, by the pressure mechanism in which molecular hydrogen occurs with the recombination of atomic hydrogen. As the molecules of hydrogen occur, high pressures of up to  $10^6$  bar are released, resulting in the occurrence of local microcracks which join together into macrocracks thereby leading to failure of the wire. The final result of all these mechanisms of cracking is the occurrence of the already mentioned brittle regions, with the cleavage appearance of the fracture surfaces.

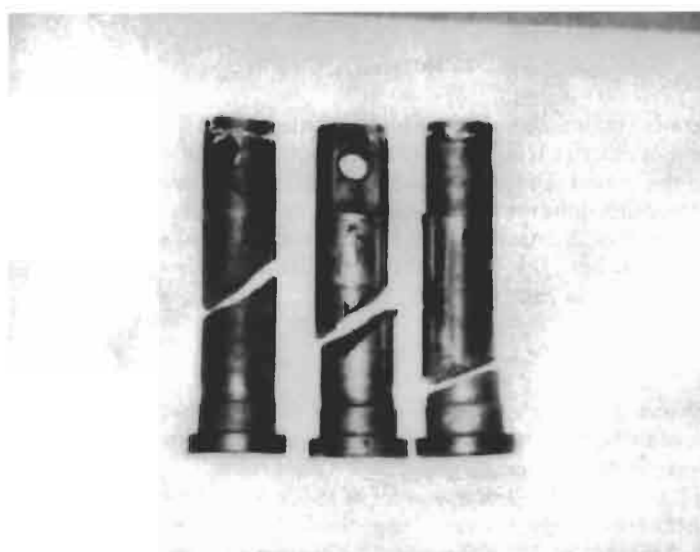
Twelve pins were examined, three of which had fractured. All the pins examined had been in operation in the conveyor for about six weeks. The three failed pins had fractured at an angle of approximately 45° (Fig. 1). Although pin C failed close to the bottom of the pin, plant personnel reported that the majority of fractures were in the middle portion of the pin.

Fig. 1. Three fractured pins showing the position and angle of the fractures.

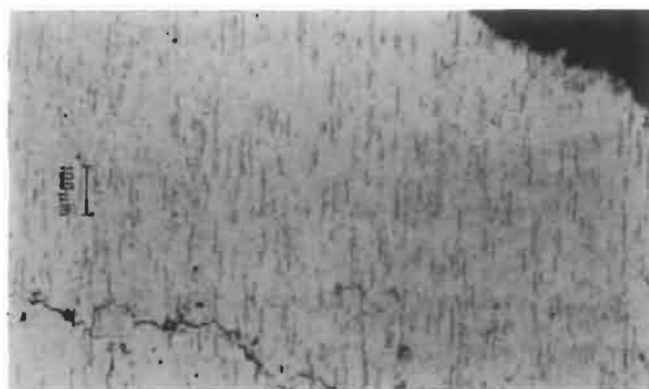
Fig. 2. Fractured pin C. Note the intergranular nature of the fracture surface on the bottom left, and the crack running parallel to the main fracture. The ferrite stringers can also be seen.

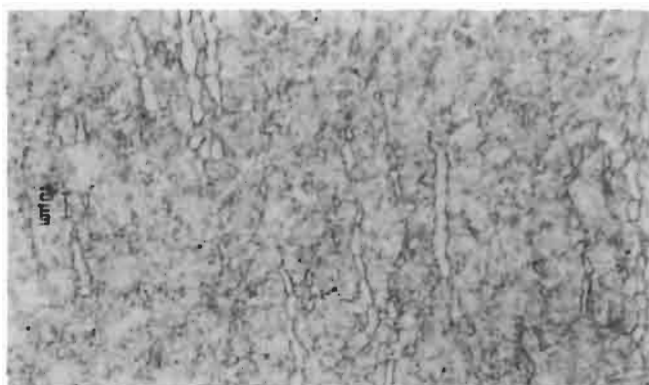
Fig. 3. A high magnification of the structure shown in Fig. 2, showing the tempered martensite and ferrite stringers of pin C.

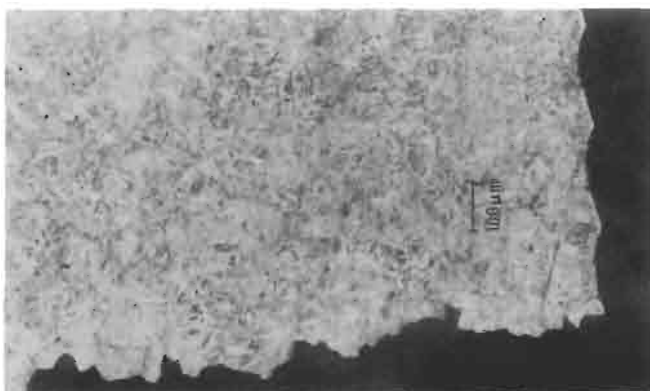
All of the fractures, of which the example in Fig. 4 is typical, are intergranular. They exhibit features, including yawning grain boundaries, micropores and no grain boundary corrosion, which indicate that they were caused by hydrogen embrittlement (HE) (Fig. 5) [2]. A small section of a fracture surface can be seen at the bottom of both Figs 2 and 4. In Fig. 2, the intergranular nature of the fracture, as well as the crack running parallel to the main fracture surface, confirms that the ferrite stringers did not contribute to the propagation of the crack, and thus the failure of the pins.

The surface on the right-hand side of the pin in Fig. 4 shows the original machining marks on the outside of the pin. This confirms that little corrosion had taken place on the pin.

Fig. 4. The tempered martensite matrix as found in all the pins, except pin C, whose structure is shown in Figs 2 and 3. Note the intergranular nature of the fracture surface on the bottom as well as the machining marks on the right.

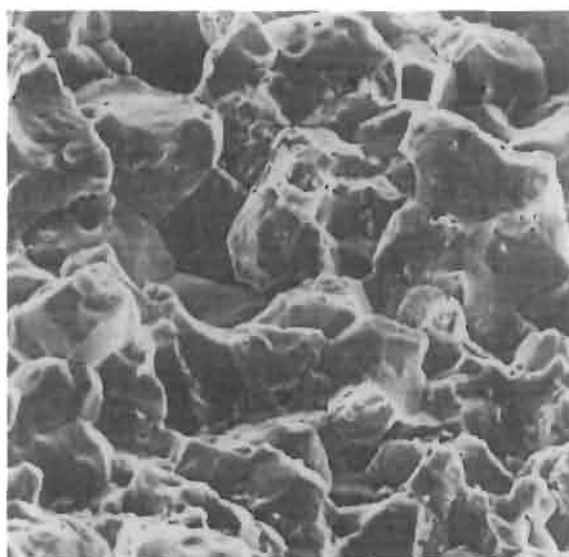
Fig. 5. An SEM picture of the fracture surface of a pin showing the intergranular nature of the fracture. Micropores, yawning grains, and the absence of grain boundary corrosion, characteristic features of HE, are shown.

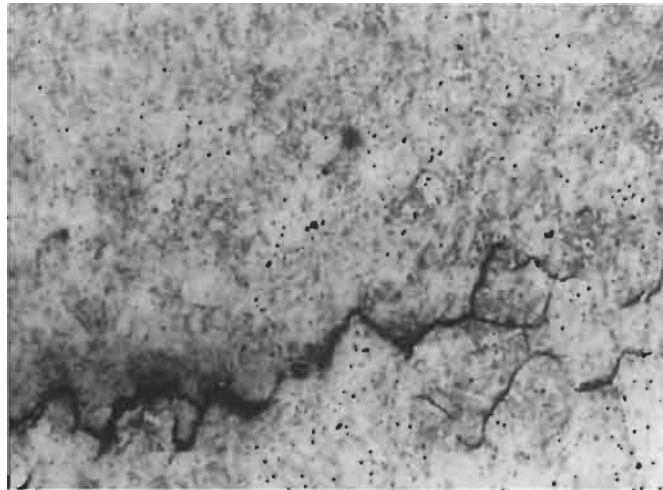
Fig. 3. Replicated micrograph of reheat crack showing bainitic microstructure and crack path following weld heat affected zone (magnification  $\times 50$ ).

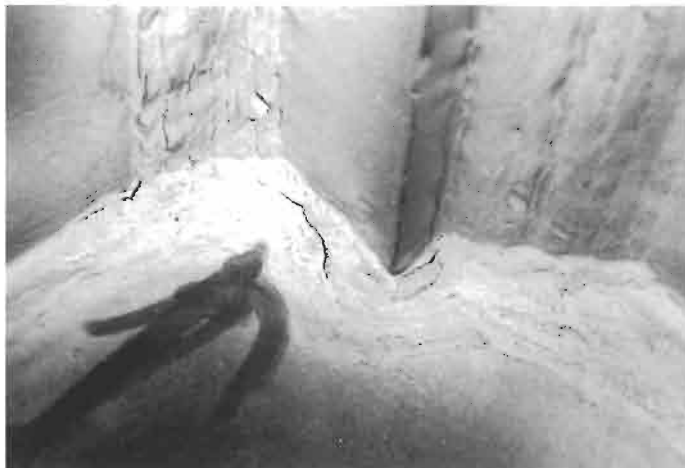
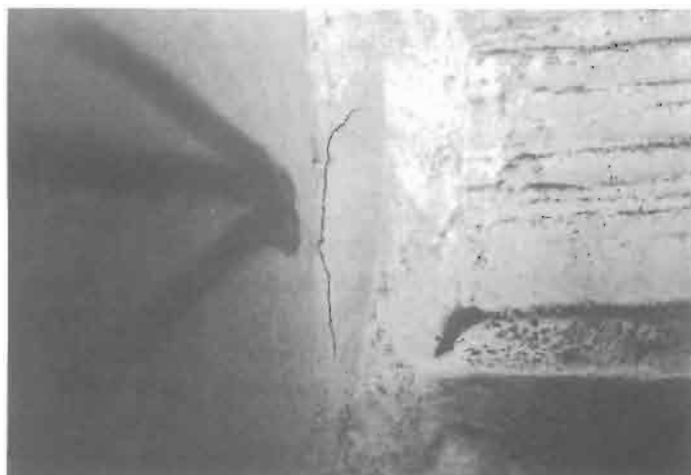
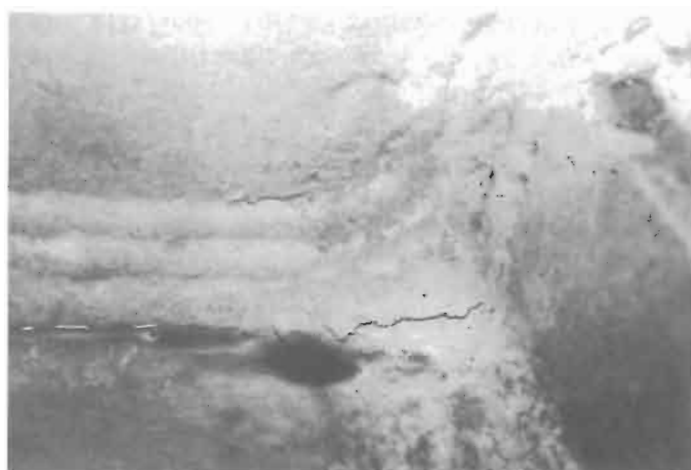
Cracking in the 1Cr–1/2Mo external supports fabricated from SA387 GR 12 cl 2 was detected by magnetic particle testing. All eight of the support legs contained cracks which were associated with the gusset-to-ring weld or the gusset-to-shell weld. Some were relatively short, transverse cracks, typically 30–40 mm in length, and some were relatively long 300–400 mm cracks running longitudinally along the toe of the weld. Figures 4–6 are typical of many of the cracks observed.

Fig. 4. Typical cracks found at external support welds.

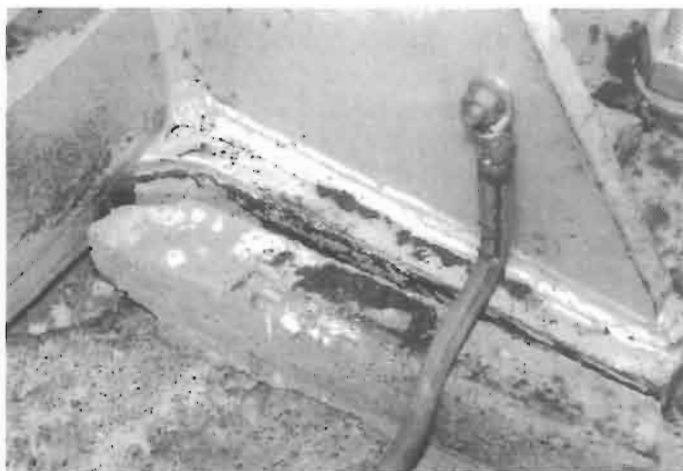
It was noted that much of the welding contour and weld surface finish was rather rough, as evidenced in the photographs. Particularly noteworthy, however, was the complete absence of any “rat holes” at the tri-axial joints between gussets, shell and horizontal ring (Fig. 7 shows typical detail of this area). The presence of “rat holes” at such intersections is considered to be normal, good fabrication practice in order to reduce or eliminate the complex tri-axial stresses that are otherwise imposed on these members. It was ascertained that this detail had indeed been clearly specified on the relevant fabrication drawings.

Fig. 7. Typical detail of gusset welds showing complete absence of “rat hole” at the junction of the three members.

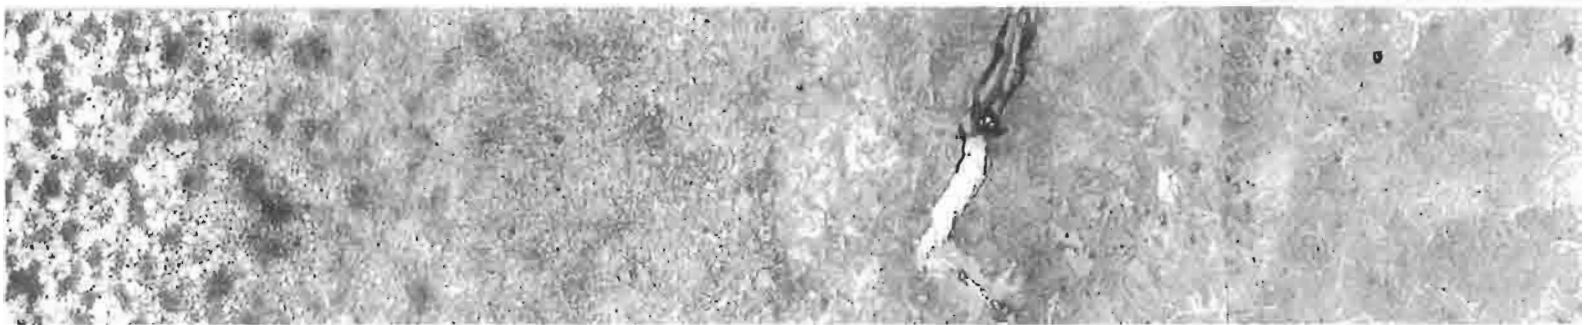
Fig. 8. "Panoramic" section of crack location in support F1 (magnification  $\times 100$ ).

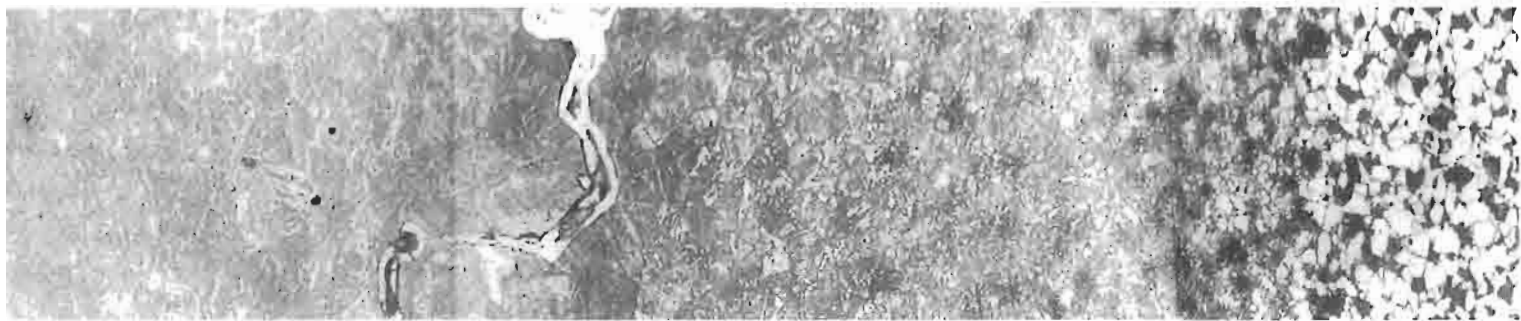
Fig. 9. "Panoramic" section of crack location in support G1 (magnification  $\times 100$ ).

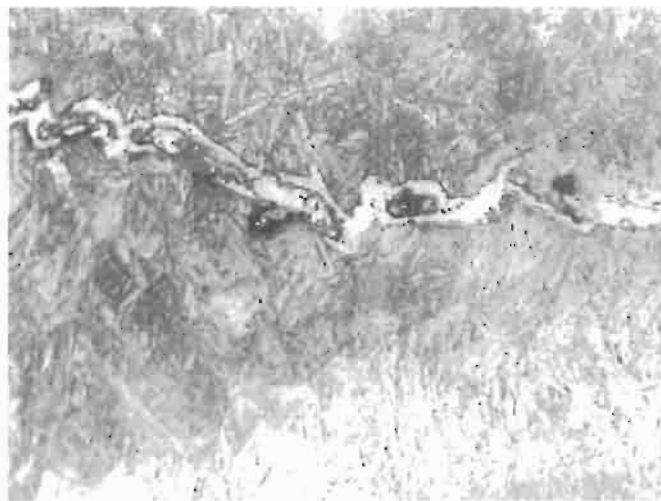
Fig. 10. Detail of oxide filled crack in martensite area of HAZ, support G1 (magnification  $\times 100$ ).

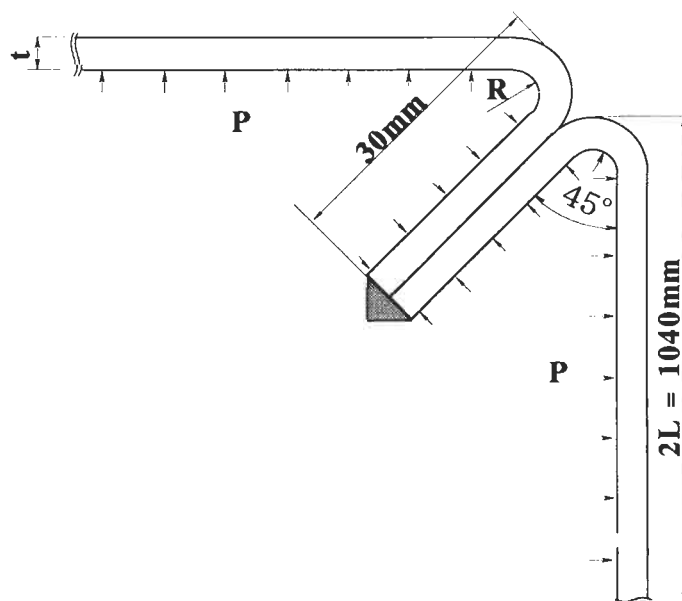
Cold working becomes more pronounced as the inner radius of the corner portion shown in Fig. 2 becomes smaller and, consequently, hydrogen embrittlement susceptibility is thought to increase. Further, it is conceivable that the amount of tensile strain occurring on the inside surface during water proof testing also increases with smaller inner radii.

Fig. 2. Enlarged sketch of corner of thermal storage tank panel.

The damage occurring at the cold-bent corner portions of thermal storage tanks made of ferritic stainless steel (SUS436L) is believed to be due to hydrogen embrittlement cracking brought on by tensile strain which developed during water proof tests performed after the stainless steel had been charged with hydrogen by galvanic corrosion during acid washing at the fabrication stage. The corner portions were analyzed by the finite element method and the dependency, on bending radius, of the strain developing at the corner portion during water proof tests was clarified. Additionally, the dependency of magnitudes of cold working on fracture elongation of tensile test specimens hydrogen-precharged was ascertained. Based on these results, it was clarified that, from the mechanical standpoint, inner radius/thickness ( $R/t$ ) must exceed approximately 2.

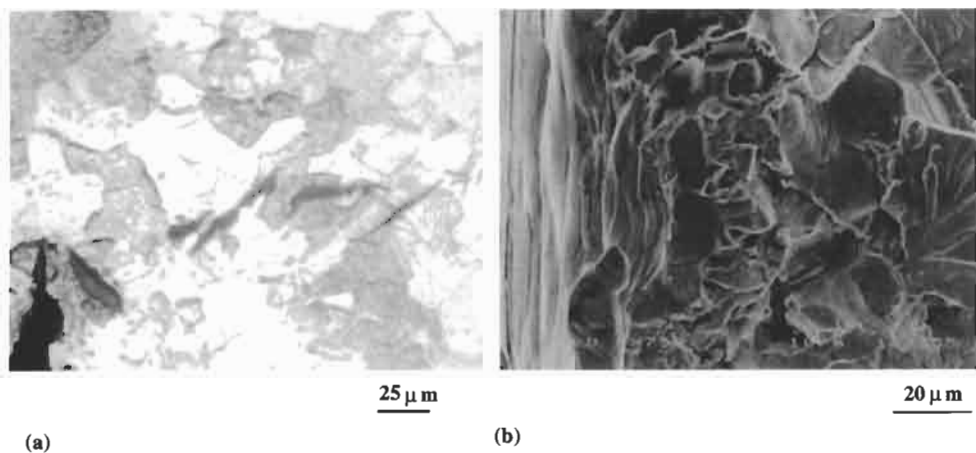
Fig. 4. Microstructure of cracks and SEM micrographs of fracture surface in panel corner.

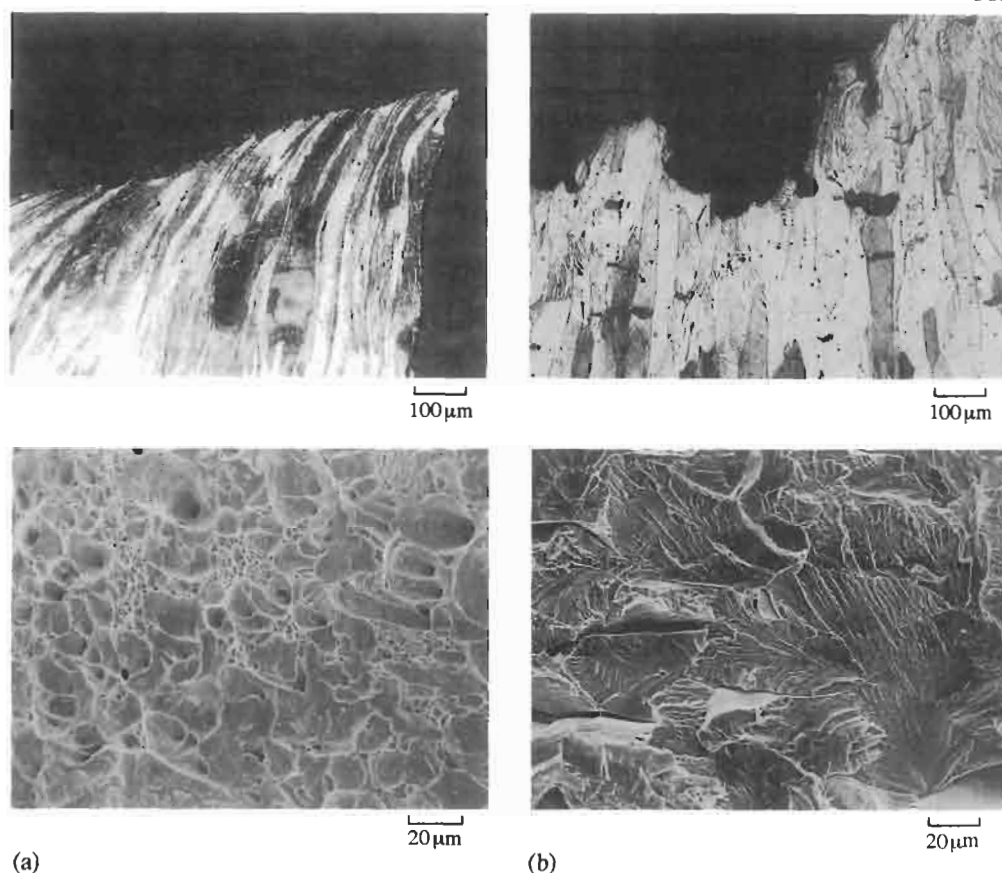
A chart showing the stress-strain relationship in the case of a reduction ratio of 30% is given in Fig. 8. From this, it can be seen that the rupture elongation of hydrogen-charged specimens is very markedly reduced. The results of observations of the cross sectional microscopic structure in the vicinity of ruptures in a 30% reduction ratio specimen and related scanning electron micrographs are shown in Fig. 9. The hydrogen-uncharged specimen had ruptured in a ductile manner and the entire surface of the fracture is dimpled (Fig. 9(a)). On the other hand, cleavage fractures had occurred in the hydrogen-charged specimen (Fig. 9(b)), indicating the large influence of hydrogen.

Fig. 9. Microscopic structures and SEM micrographs of fracture surfaces of tensile test specimens for 30% reduction ratio. (a) Hydrogen-uncharged; (b) hydrogen-charged.

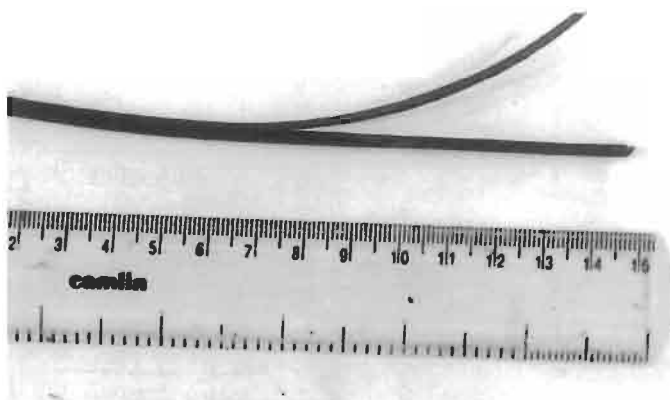
The wire rods, which have failed at various stages during spooling and stranding, typically show a split along the drawing direction (Fig. 1). The longitudinal splitting into layers during the rolling

Fig. 1. Wire rod showing a typical split failure.

operation, termed delamination, is one of the qualitative indication of the decrease in ductility. The fresh fracture surfaces were observed to be shiny, indicating the possibility of HE. No other distinctive features were observed on the surfaces of failed wire rods.

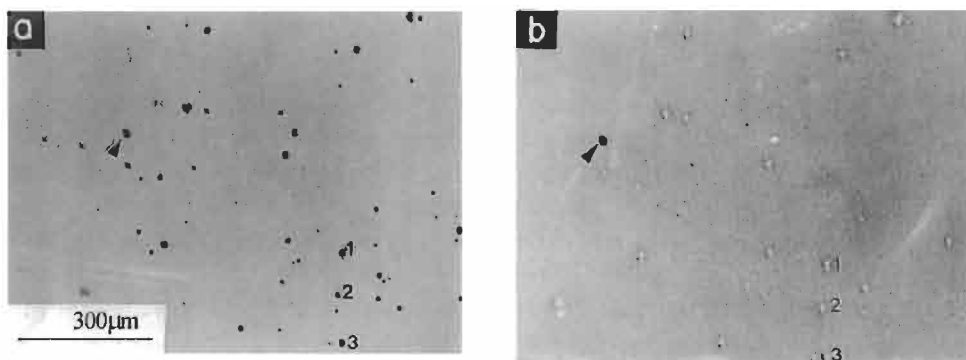
Microscopic examination was conducted to observe both the inclusions and the microstructural features. Typical features are shown in Fig. 3(a and b). In addition to the few inclusions that are observed, a number of pores approximating to 1–2% volume fraction were present in most of the areas that were examined. It may be noted that the inclusions and the pores could be distinguished from each other by varying the focusing plane, as their planes of foci are different, and this has been demonstrated in Fig. 3(a and b). It is also observed that some of the pores have coalesced to form crack like defects. Figure 4(a and b) presents the typical features that are expected in a cold drawn steel wire rod, viz., a fibrous appearance comprising elongated ferrite and cementite lamella (pearlite). A crack along the drawing direction has been marked in Fig. 4(a).

Fig. 3. Optical micrographs of unetched wire drawn sample. (a) Transverse section shows abundance of pores in focused condition. (b) Over-focused condition showing pores as illuminated spots and inclusions as dark spots. The correspondence between (a) and (b) can be noted.

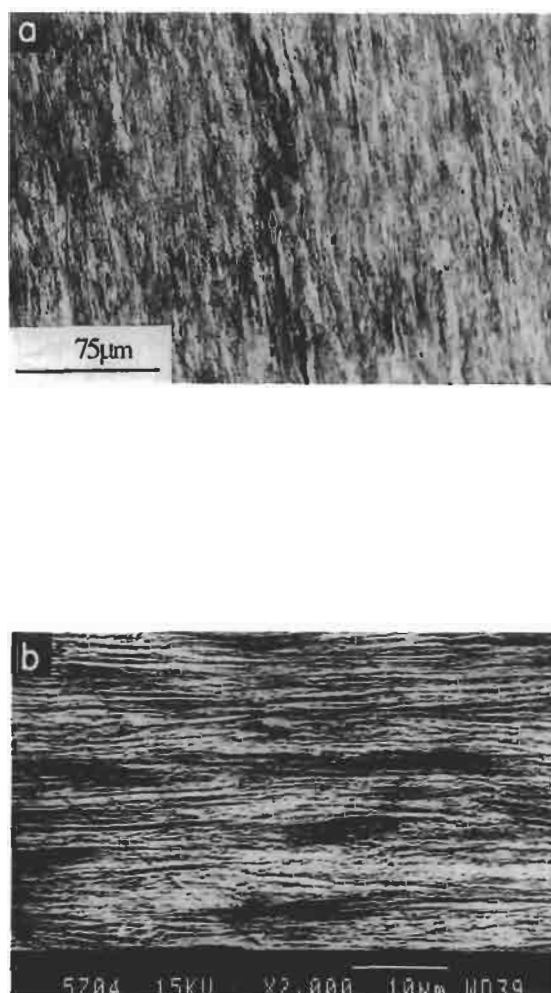
Fig. 4. (a) Optical micrograph and (b) SEM photograph showing microstructures featuring typical fibrous nature comprising elongated ferrite and cementite lamella. The cracks along the drawing direction can be observed in (a).

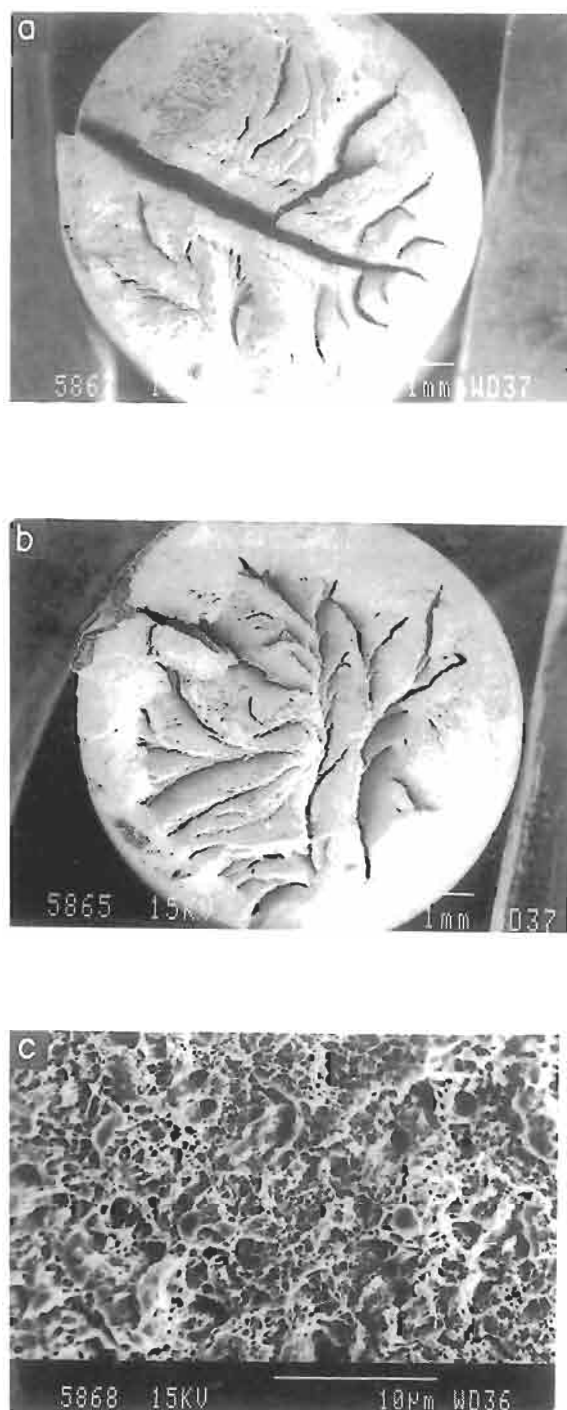
diffuse during the specimen preparation stage itself. The fracture surfaces of the tensile test specimens were also observed under the SEM and are reported in Fig. 7(a, b and c). Figure 7(c) shows the dimple network in the centre of the fracture surface of the as-received sample. Similar features were observed on the fracture surfaces of the baked samples.

Fig. 7. SEM fractographs of (a) as-received specimen; (b) baked specimen; (c) dimple fracture observed at higher magnification, location as at (a).

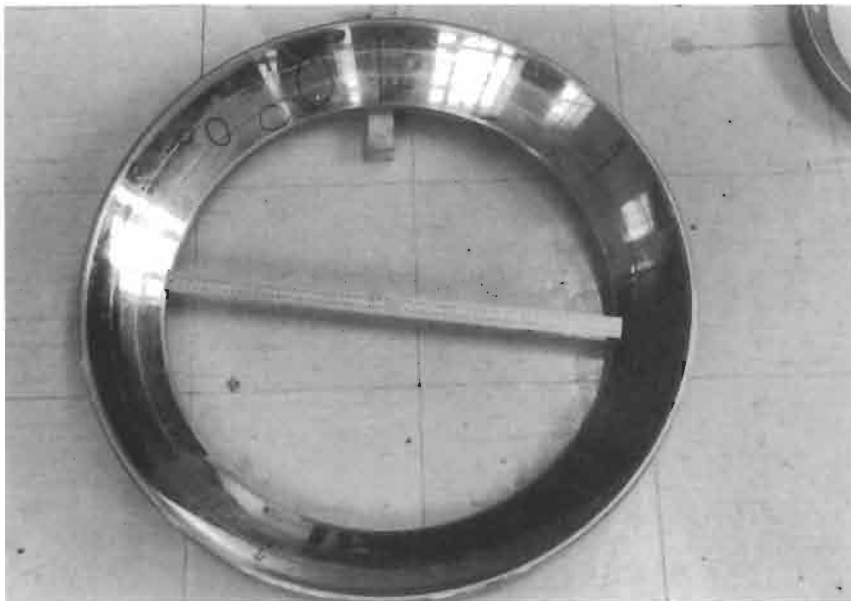
bearing (Fig. 2) [4] Under repeated loading, cracks ultimately initiate at the point of maximum stress, and propagate parallel to the surface. At some stage, these cracks deviate and grow towards the contact surface, resulting in the formation of steep-sided pits. These pits are usually microscopic, but may, with continued bearing operation, act as stress concentration sites for further damage.

Fig. 2. Thrust bearing cup showing highly polished surfaces typical of the initial stages of rolling contact fatigue.

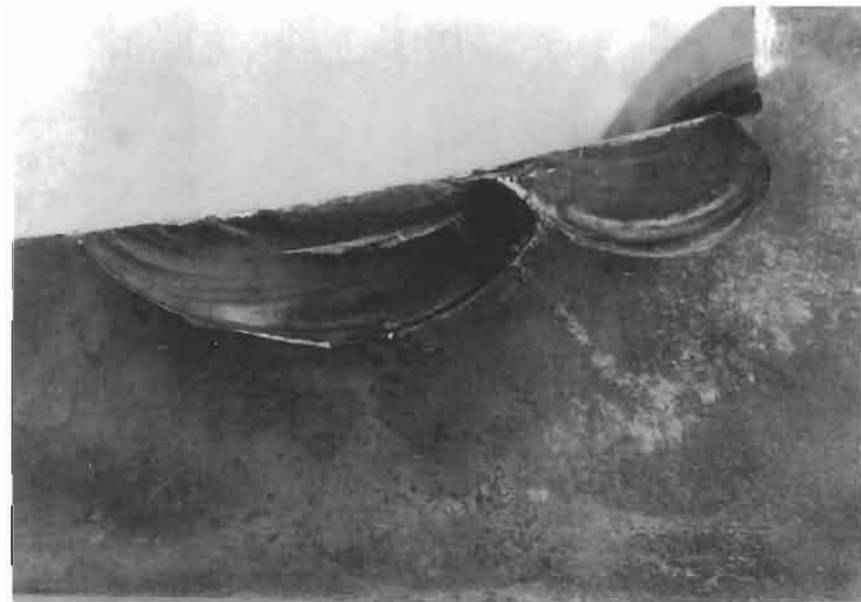
Fig. 4. Crack face in the vicinity of the region marked with an arrow in Fig. 3.

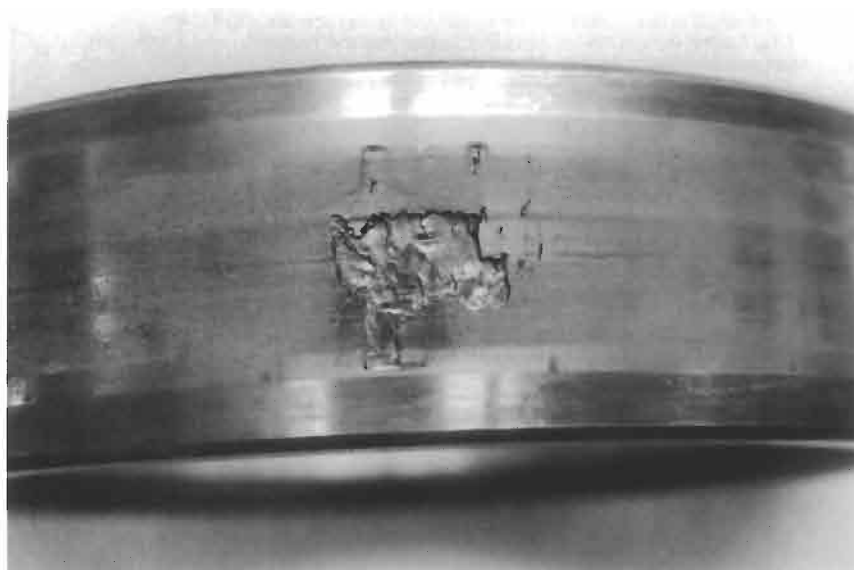
Fig. 7. Severe spalling on the inner ring of a thrust bearing.

or as a result of cracking at the case–core interface in case-hardened components. The damage in this case results in the formation of large, deep pits with sharp edges, steep sides, and flat bases. A good example of this is given in Fig. 7, which shows the inner raceway of the failed thrust bearing [6].

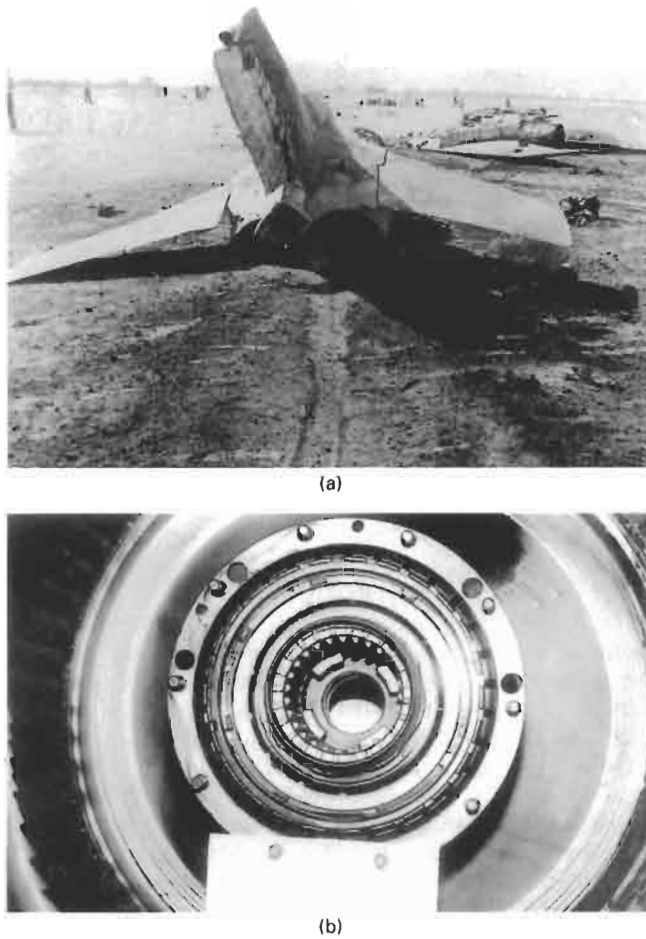
Fig. 1. (a) The plane after the accident. (b) Bearing components on the compressor shaft after the accident.

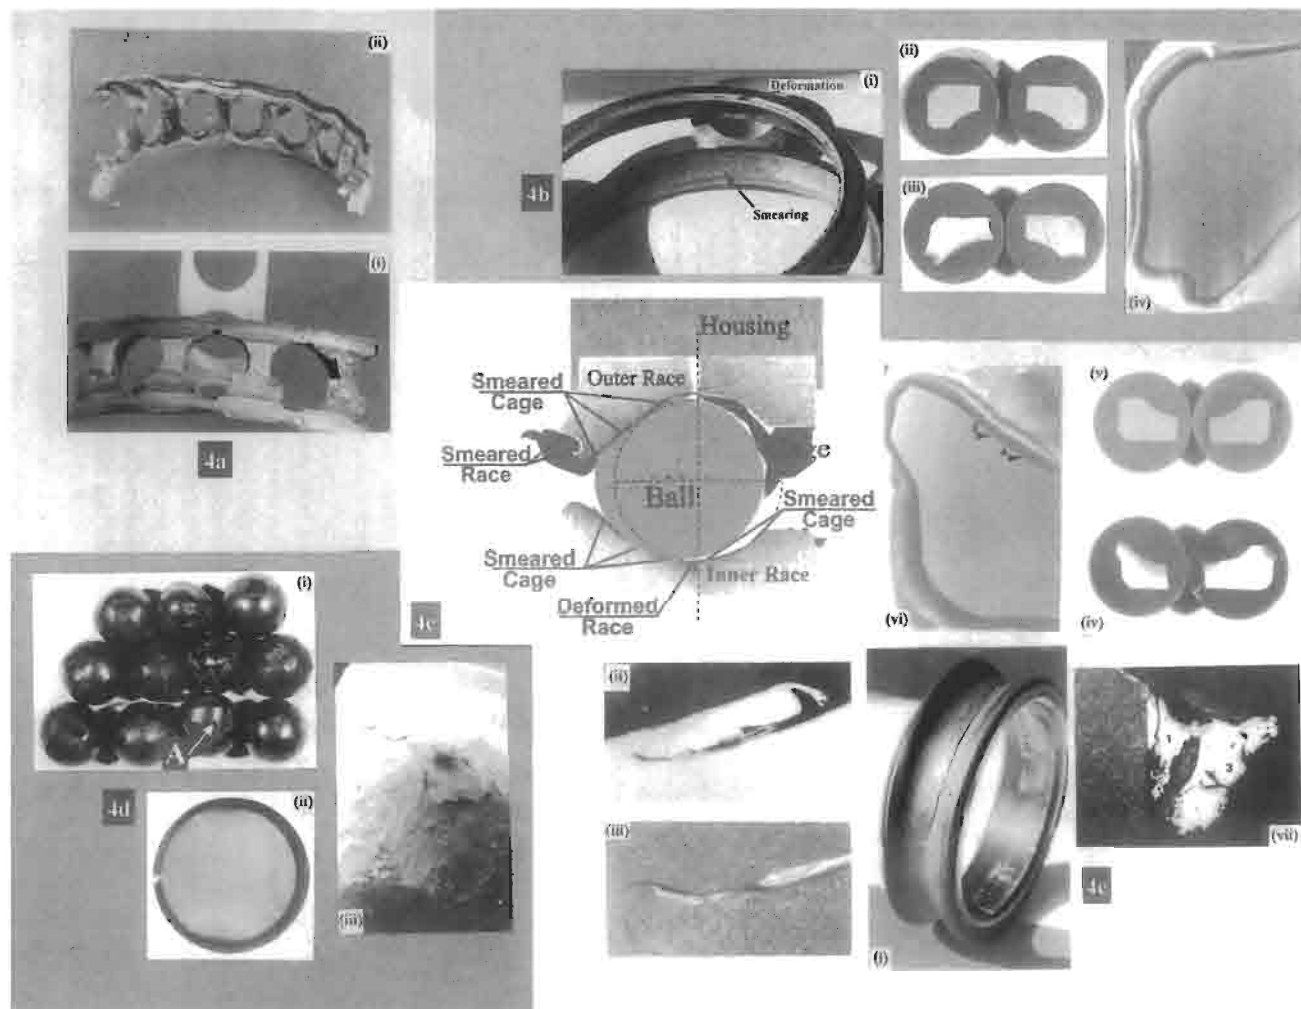
of bearing components after mishap is shown in Fig. 3a. The compressor and then the CMB components were disassembled; the latter were retrieved in a severely distressed condition. The condition of the retrieved components was compared with ones which were in normal use in another engine. The retrieved cage compared with a new one is shown in Fig. 3b. A detailed study of the retrieved components was conducted using stereo, optical and electron microscopes to establish the mechanism of damage. Detailed views of the sections of interest of each component are discussed in the following with the help of the micrographs in Fig. 4.

Fig. 4. (a-d) Deformation in the components just before the accident. (e) Hypothetical sketch based on observations in Figs 4a -d.

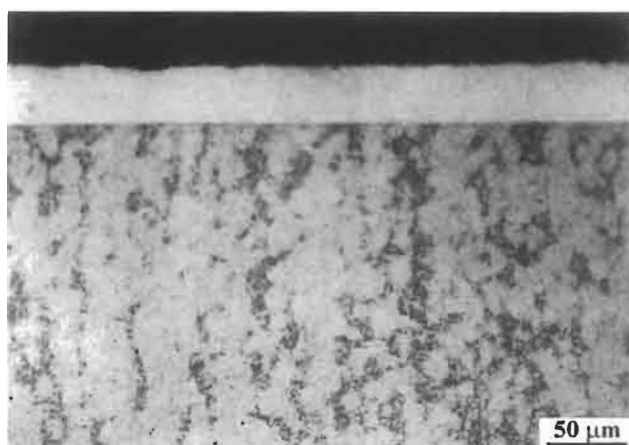
Fig. 5. Optical micrograph of the cage and the silver coating.

Optical microscopy of the cage shows a dual phase structure of the material (Fig. 5). The cage is most probably cast and has a  $\sim 38 \mu\text{m}$  thick silver coating. Silver coating provides good resistance to fretting and improves the bedding-in and running properties of harder bearing materials [2]. Microscopic study revealed that there were darkly etched spherical inclusions in the cage material; the inclusions are up to  $\sim 8 \mu\text{m}$  in diameter and are Al-rich.

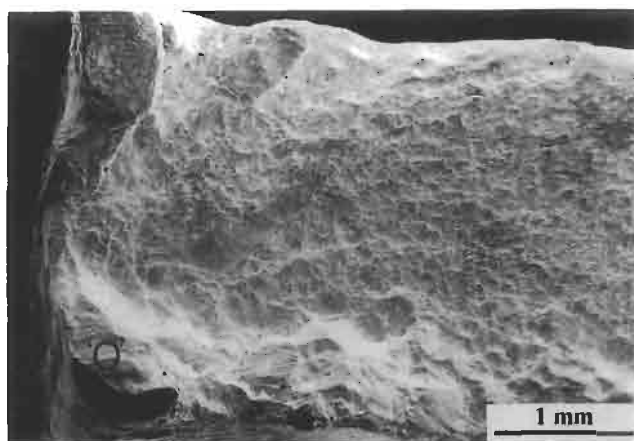
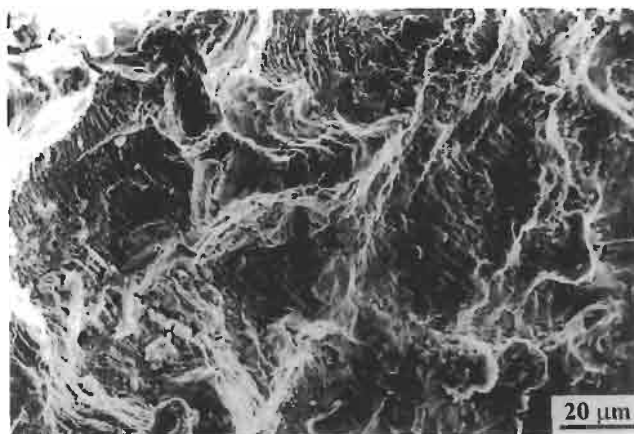
Fig. 7. SEM photographs of the fractured surface of the retrieved cage: (a) general view; (b) fatigue striations.

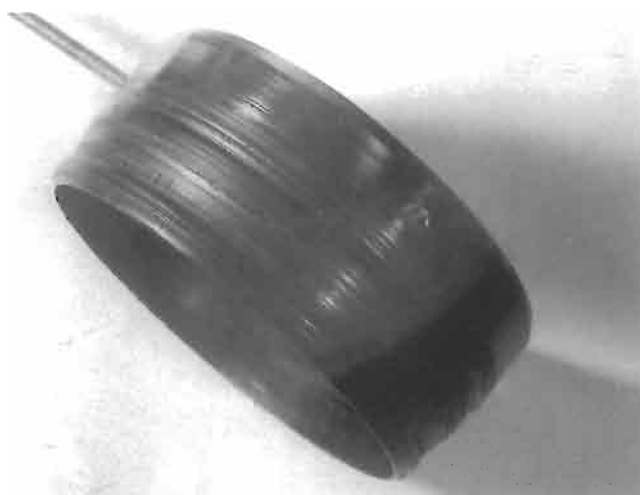
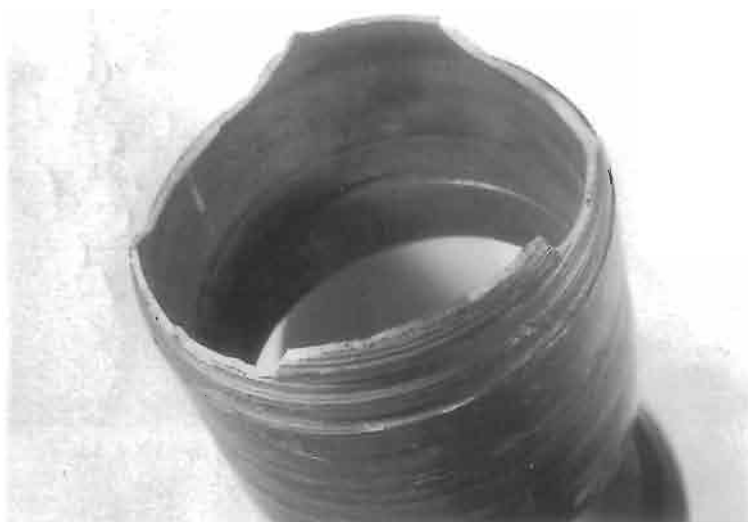
Fig. 3. Photographs of the failed chromium-plated sleeve after separation from the shaft.

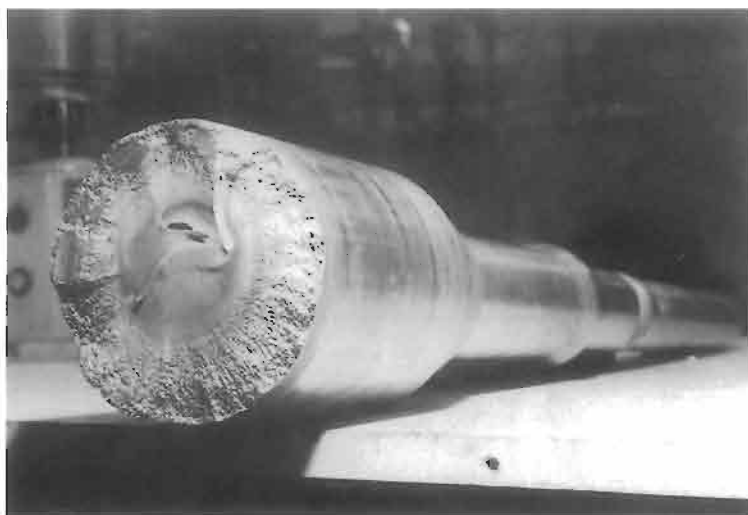
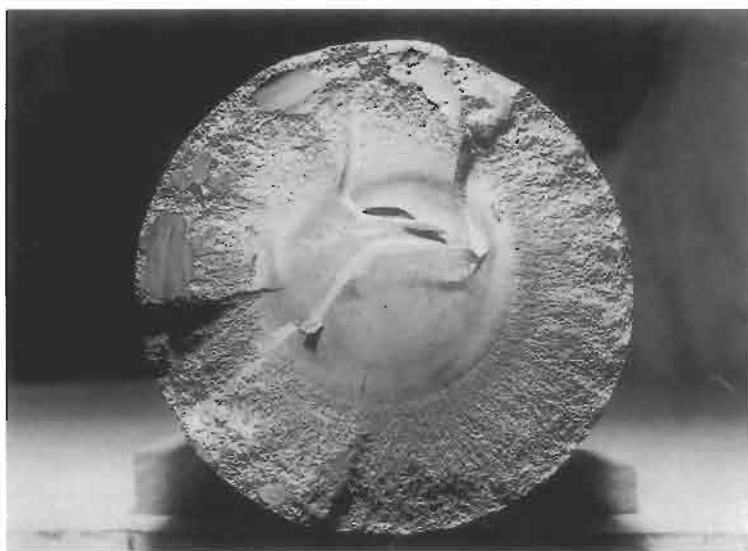
Figure 4 shows the fracture surface of the shaft. The appearance and topography is different in the outer part and in the inner part. In the outer part, the fracture is rough and bright, and it becomes smoother and more matte towards the center of the shaft. It is possible to differentiate

Fig. 4. Photographs of the failed shaft.

two zones: one external zone, rough and bright, as a symmetrical ring up to approximately half of the radius, and one internal zone, flat and matte, wherein can also be seen some ligaments. The shape and appearance of these ligaments suggest that they have been originated by torsion in the final fracture of the shaft.

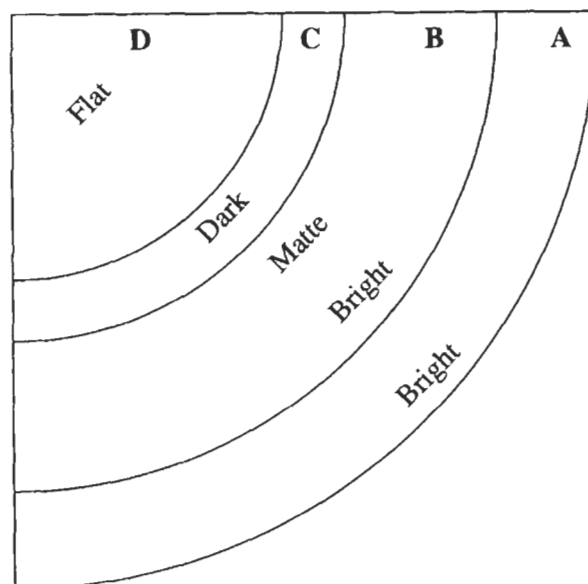
Fig. 5. Schematic illustration of the shaft fracture surface.

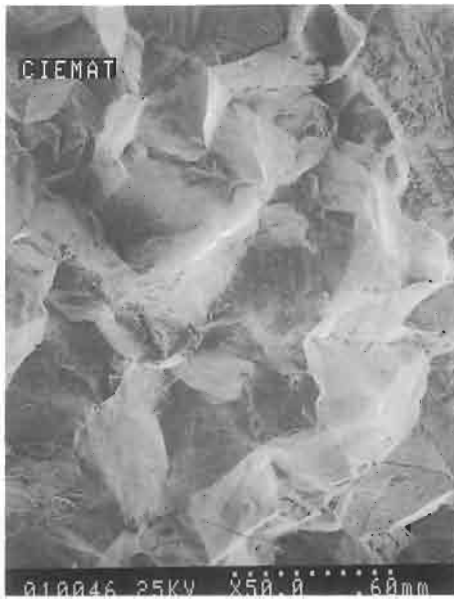
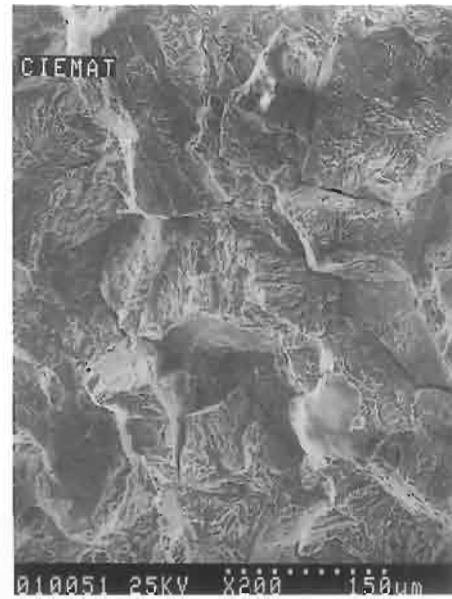
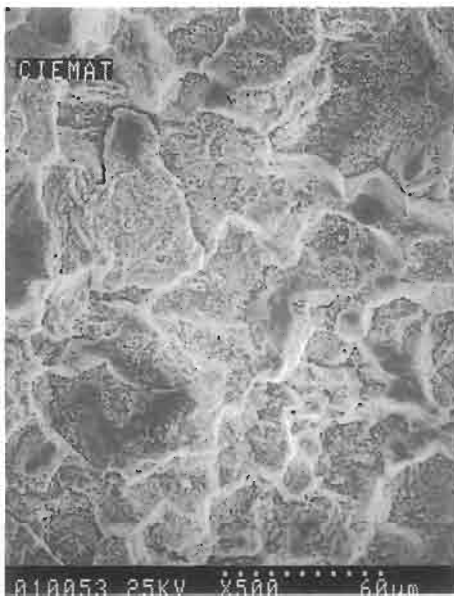
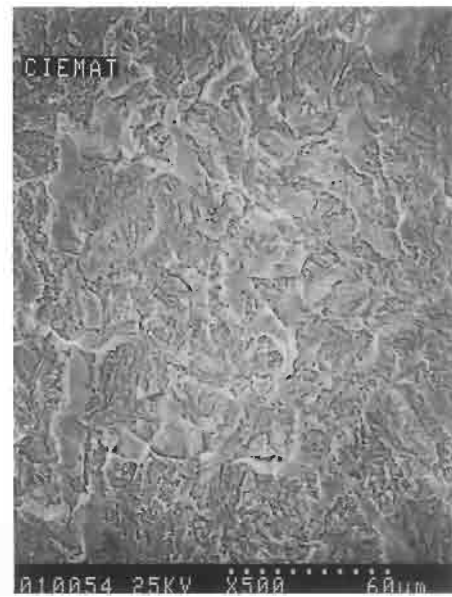
In the outer part, zone A (Fig. 6a), which is approximately 10 mm wide, the fracture morphology is mainly intergranular, with grains up to 600  $\mu\text{m}$  in diameter, but showing also some small areas with transgranular fracture. This morphology is constant in all the zone A, but the grain size decreases considerably from the external diameter towards zone B. In zone B (Fig. 6b), approximately 15 mm wide, progressively from zones A to C, the grain size decreases and the proportion of transgranular fracture increases. Close to zone C the fracture is almost transgranular, although some grain boundaries are still visible. Zone C (Fig. 6c), of  $\sim 5$  mm width, shows a dark coloration due to the presence of deposits. Under the deposits there are mainly transgranular areas but also some intergranular facets. Grains  $\sim 20$   $\mu\text{m}$  in diameter can be measured in this zone. Finally, the morphology of zone D (Fig. 6d) is typical of fatigue and torsion processes.

Fig. 6. Fractography of the shaft fracture surface: (a) zone A (OD) of Fig. 5; (b) zone B of Fig. 5; (c) zone C of Fig. 5; (d) zone D of Fig. 5.

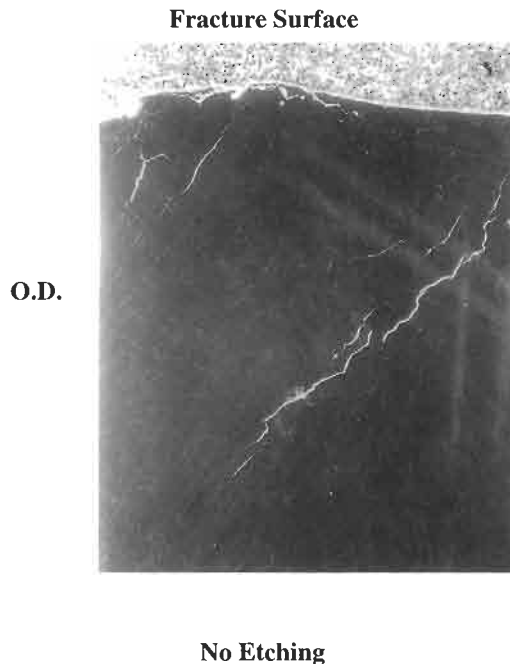
Fig. 7. Metallographic section close to shaft fracture surface.

photograph taken without etching the metallographic sample, while Fig. 8 consists of a micrographic montage performed after etching the sample. In both cases it can be observed that there are many subsurface cracks under the fracture surface. The cracks are parallel within them, and they have a defined orientation. As regards the grain size, this gets large close to the external diameter and close to the fracture surface, in accordance with the fractographic observations.
