# ***FAILURE ANALYSIS CASE STUDIES II***

A sourcebook of case studies selected from the pages of  
*Engineering Failure Analysis* 1997-1999

**D.R.H. JONES**

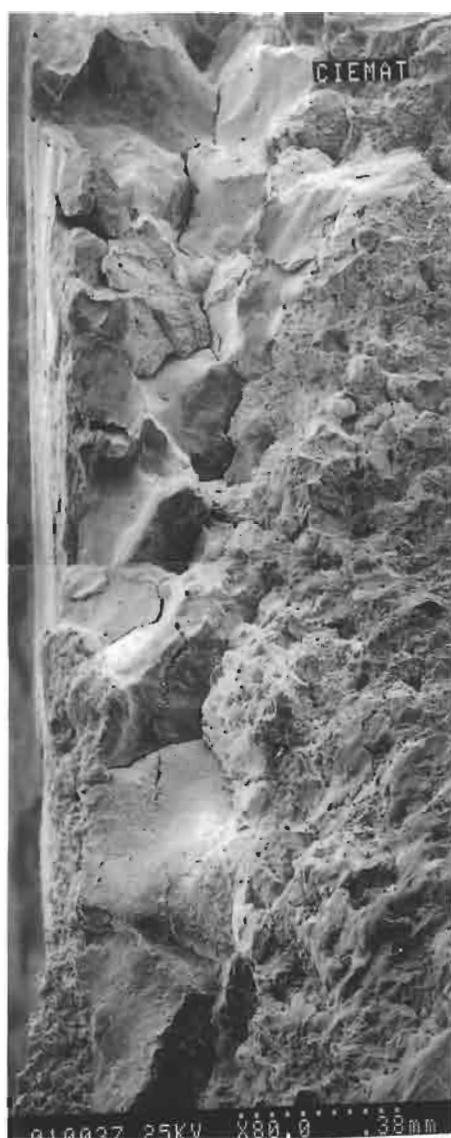
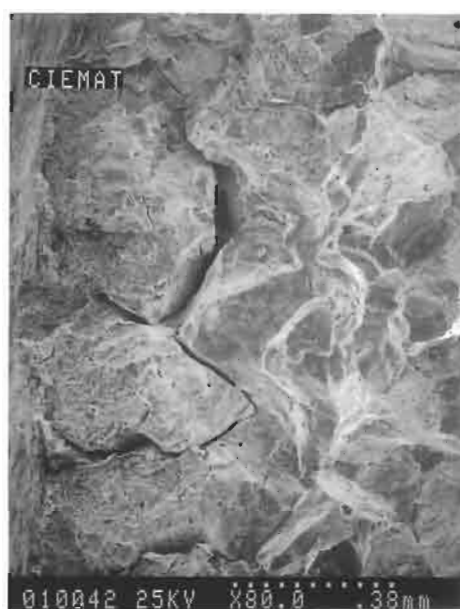
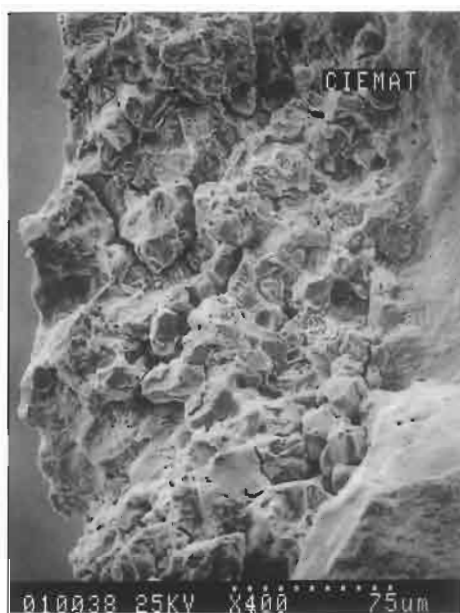
with big grains (up to  $\sim 400\ \mu\text{m}$  in diameter); intergranular but with small grains ( $\sim 20\ \mu\text{m}$  in diameter); and mixed modes of fracture, transgranular and intergranular with large grains (see Fig. 9).

Fig. 9. Fracture surface of the failed chromium-plated sleeve (OD).

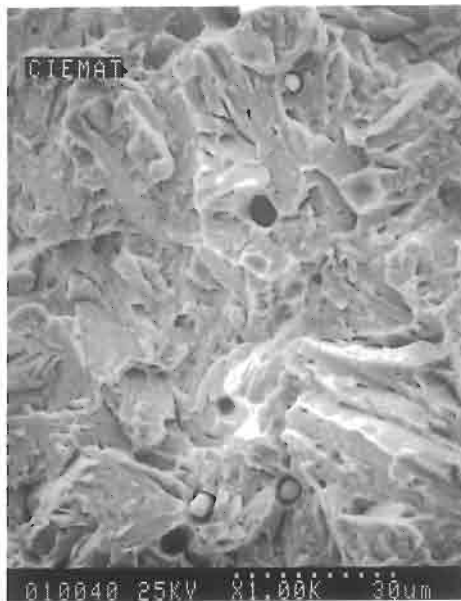
In the center of the sleeve thickness, the fracture morphology was brittle cleavage (Fig. 10), and at the inner diameter (ID) the fracture was ductile by nucleation and coalescence of microvoids, indicating that the final fracture of the sleeve was produced in this zone.

Fig. 10. Fracture surface of the failed chromium-plated sleeve (center).

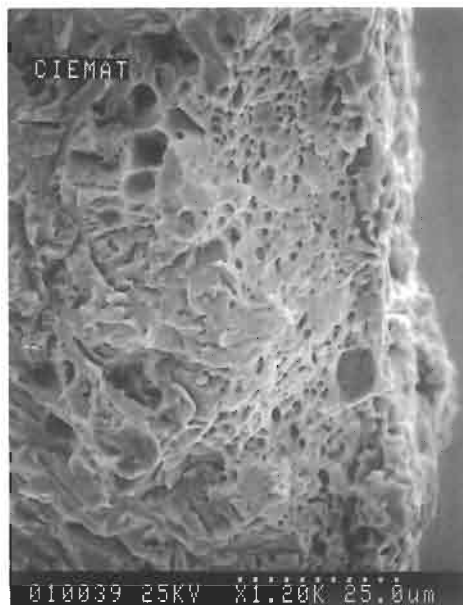
Fig. 11. Fracture surface of the failed chromium-plated sleeve (I.D.).

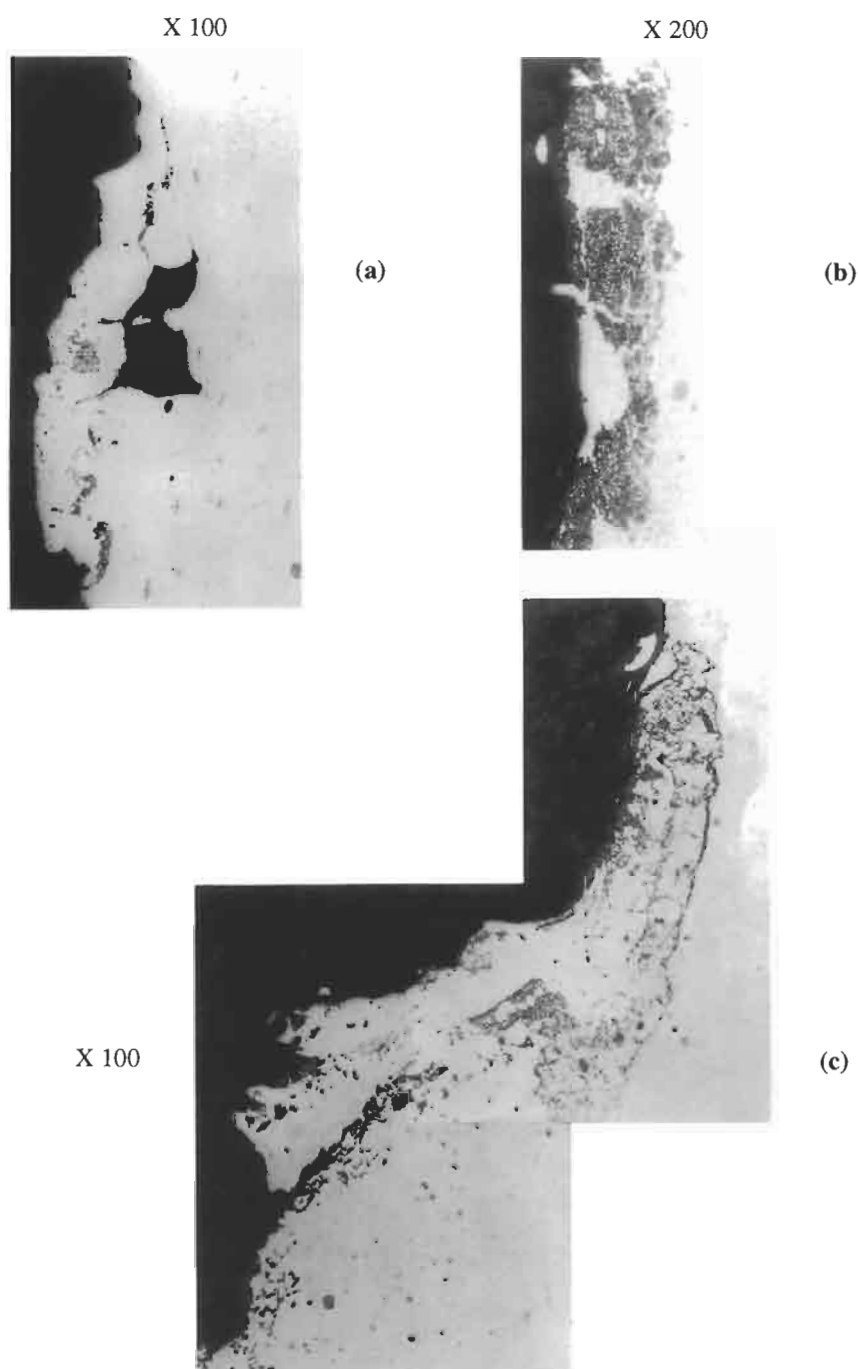
Fig. 12. Metallographic sections, not etched, close to the fracture surface of the chromium-plated sleeve (OD).
