# Failures Related to Hot Forming Processes

Dick Douglas, Forging Consultant  
Charles V. White, Kettering University  
Tim McHenry, Collins Aerospace

## Introduction to Failures Related to Hot Forming Processes

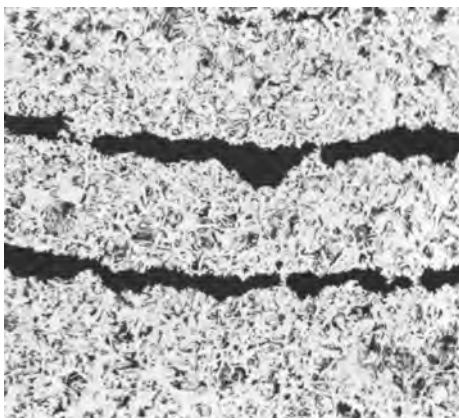
**Fig. 6** 1038 steel bar, as-forged. Longitudinal section displays secondary pipe (black areas) that was carried along from the original bar stock into the forged piece. Gray areas are pearlite; white areas, ferrite. 2% nital etch. Original magnification: 50×

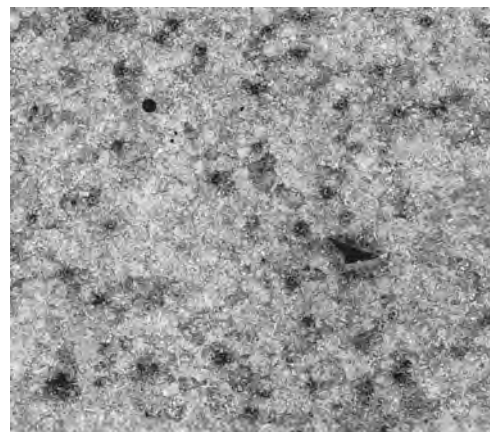
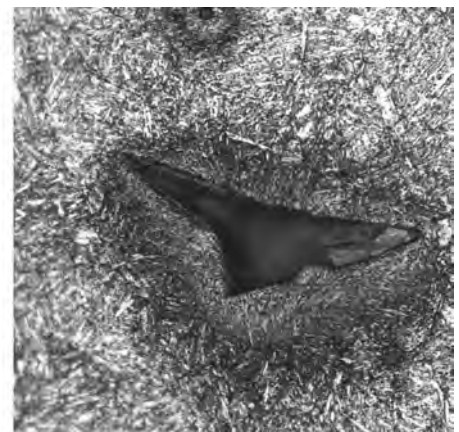
**Fig. 7** Inclusions and a pipelike cavity in tempered martensite of AISI E4340 steel. (a) Original magnification: 100×. (b) Original magnification: 600×. Courtesy of Mohan Chaudhari, Columbus Metallurgical Services

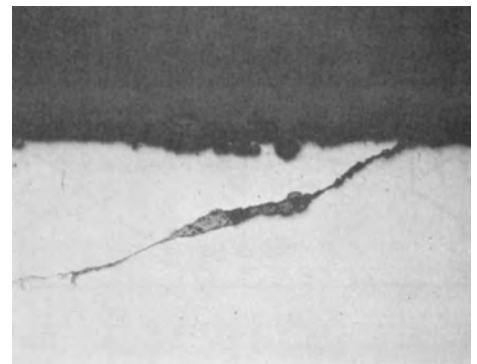
Laps are surface irregularities that appear as linear defects and are caused by the folding over of hot metal at the surface. These folds are forged into the surface but are not metallurgically bonded (fused) because of the oxide present between the surfaces (Fig. 10). Thus, a discontinuity having a sharp notch is created.

**Fig. 10** Micrograph of a forging lap. Note the included oxide material in the lap. Original magnification: 20×

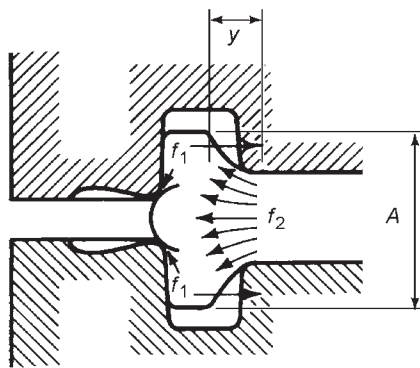
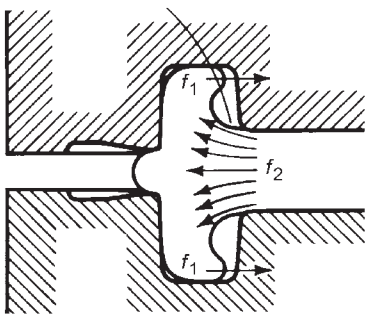
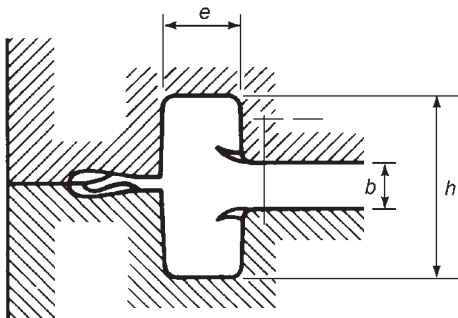
A lap or fold results from an improper progression in fill sequence. Normally, a lap or fold is associated with flow around a die corner, as in the case of an upper rib or lower rib, or with a reversal in metal-flow direction. A general rule of thumb is to keep metal moving in the same direction. The die corner radius is a critical tool dimension, and it should be as generous as possible. In progressing through a forging sequence, the die corners should become tighter with each step. Thus, the workpiece fillets are initially large and progressively become smaller as the forging steps are completed. Figure 11 shows schematically a lap forming as metal flows around a die corner.

**Fig. 11** Lap formation in a rib-web forging caused by improper radius in the preform die

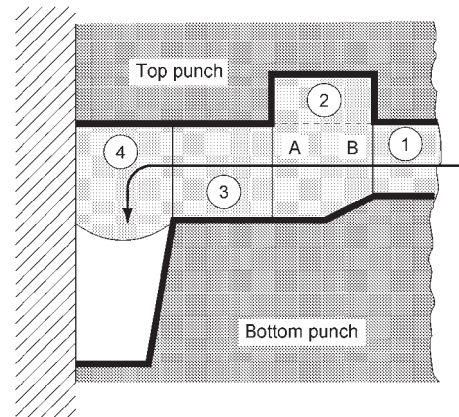
from excessive metal flow past a filled detail of the part. Flow-through defects form when metal is forced to flow past a recess after the recess has filled or when material in the recess has ceased to deform because of chilling. An example of this is shown in Fig. 12 for a trapped-die forging that has a rib on the top surface. The rib denoted by "2" is filled early in the forging sequence, and significant mass must flow past the rib in order to fill the inner hub, zone "4." The result can be a complete shearing-off of the rib in the worst case, with a lesser case being the formation of a shear-type crack.

**Fig. 12** Schematic of a flow-through crack at the base of a rib in a trapped-die forging. Excessive metal flow past region 2 causes a shear crack to form at A and propagate toward B.

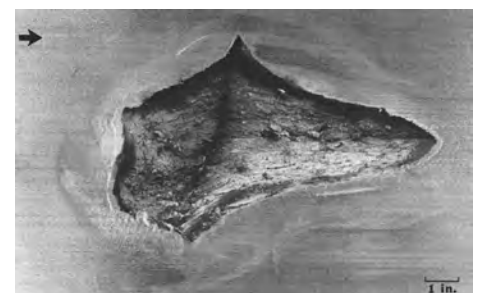
Macroetching and ultrasonic inspection methods are the most widely used for identifying regions of internal unsoundness. Bursts usually display a distinct pattern of cracks, are readily detected by macroetching, and do not show spongy areas—thus, distinguishing them from pipes. Figure 16 shows a large burst

**Fig. 16** Cross section of a forged bar showing a forging burst. The burst is located approximately at the centerline of the workpiece. Arrow indicates the direction of working.

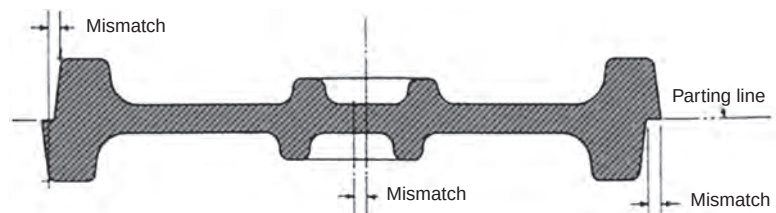
Mismatch occurs when the die alignment is offset horizontally, as illustrated in Fig. 17. While some mismatch is expected due to the nature of the forging process, the mismatch may become exaggerated when the alignment guides on the forging machine are poorly maintained. Mismatch may also occur if the operators have done a poor job of aligning the dies during the initial setup.

**Fig. 17** Illustration of mismatch in a forging due to poor die alignment

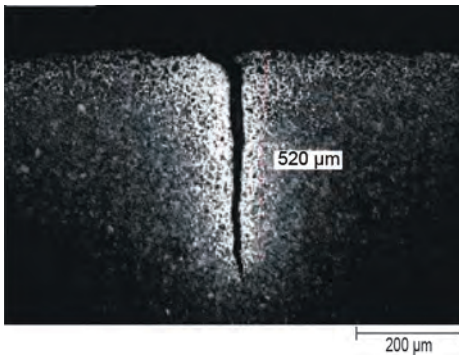
**Fig. 4** A preexisting hot mill rolling crack along the outside surface of the steel. Note the white indications of decarburization along the crack

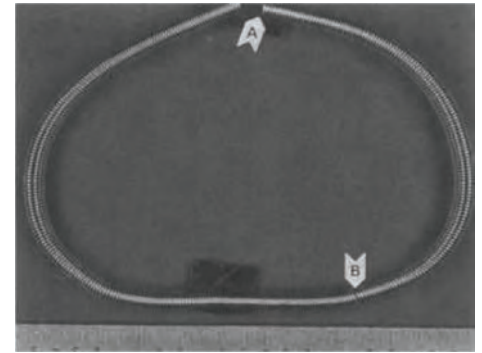
The springs were made from AISI type 302 stainless steel, work hardened by drawing to 2140 to 2240 MPa (310 to 325 ksi). The two ends of a single length of spring were wound together to make a loop used in the lip seal. Therefore, mating fracture faces were located on opposite ends of each broken spring (Fig. 5). Parts similar to these had been used successfully in this application for 16 years. These seals were from newly manufactured units, thus failing very early in the product life cycle.

**Fig. 5** Optical photograph of a failed spring showing the relation between the fracture (arrow A) and the joint (arrow B)

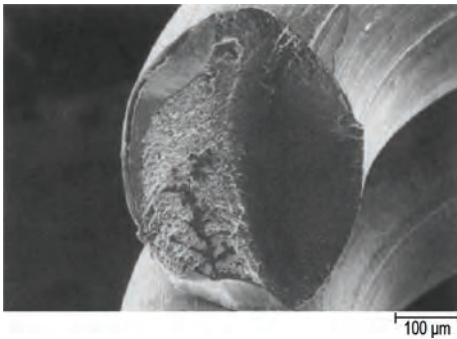
**Fig. 6.** SEM image showing the fatigue crack on the right and overload area on the left

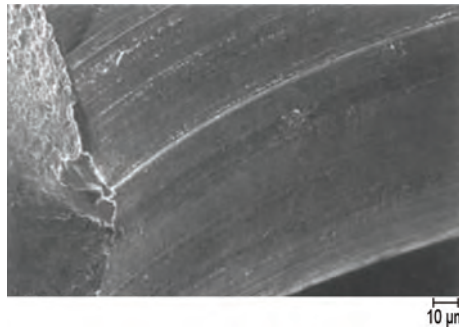
**Fig. 7** SEM image showing the drawing defect line at the initiation site of the fatigue crack in Fig. 6, magnification 400×

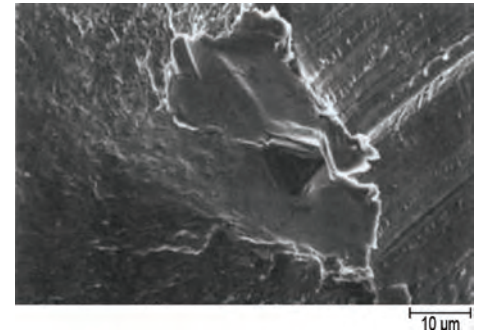
**Fig. 8** SEM image showing the initiation site in Fig. 7 at higher magnification. Magnification 1500×

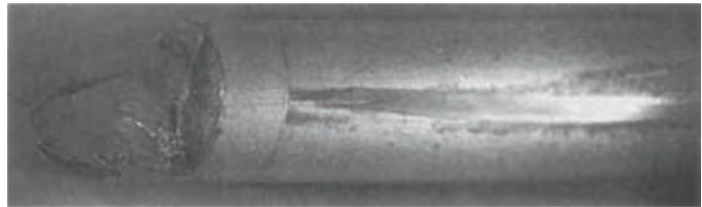
Figure 9 shows a helical spring that completely fractured, and Fig. 10 shows a second helical spring with a fatigue crack at a similar location as the fractured spring. A complete metallurgical analysis for microstructure and hardness did not find any significant issues. SEM imaging was performed (Fig. 11), and some evidence of corrosion was found; however, this was attributed to the harsh service environment and determined to not be a cause of the fatigue fracture. One of the fractured samples was evaluated with x-ray diffraction to determine the residual stresses along the inside diameter and outside diameter. The inside diameter had residual tensile stresses that ranged from 480 to 690 MPa (70 to 100 ksi), and the outside diameter had residual compressive stresses that ranged from -230 to -350 MPa (-33 to -50 ksi). If the springs had high residual stresses from the coiling operation, then the coil inside diameter would probably be in tension; the center of the spring, in a neutral condition; and the outside diameter, in compression. Residual tensile stress at the coil inside diameter could cause a crack to propagate perpendicular to the axis of the wire until the intact cross section was reduced enough for final propagation by

**Fig. 9** A fracture surface (left) on a helical spring

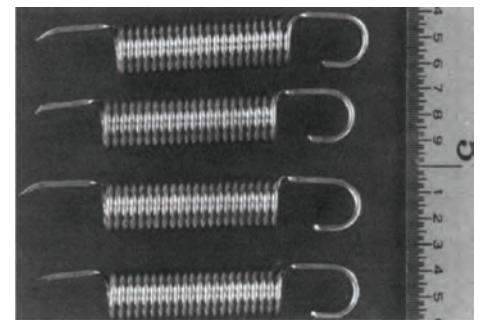
**Fig. 19** Optical photograph of several of the spring failures; the typical failure locations are shown on the left

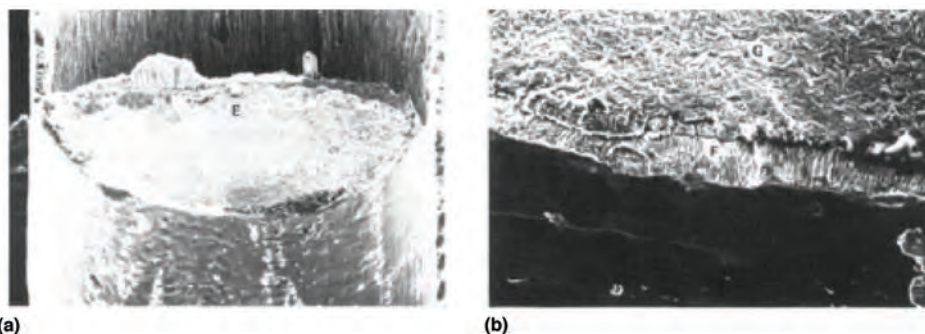
rather a small, nonmetallic inclusion at the origin of the fatigue fracture (Fig. 21). The average fatigue striation spacing was approximately  $0.6\text{ }\mu\text{m}$  near the overload fracture, indicating that at least 500 load cycles were associated with the fatigue crack progression (Fig. 22). The overload portion of the fracture followed the elongated grains (a “woody” fracture) (Fig. 23) and should not be confused with intergranular fracture. Because the springs had been zinc plated, hydrogen embrittlement, which normally produces an intergranular fracture, was a specific concern. However, this did not occur; all of the spring fractures initiated in a fatigue mode.

Fig. 21 SEM micrographs showing an inclusion at the origin

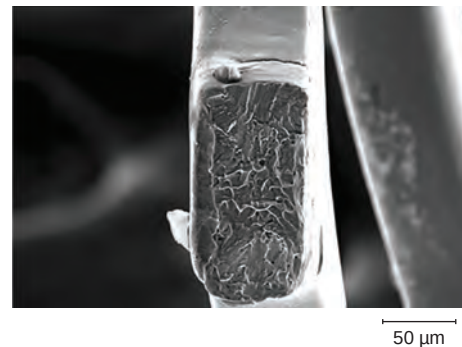
**Fig. 27** SEM image of fractured nitinol stent

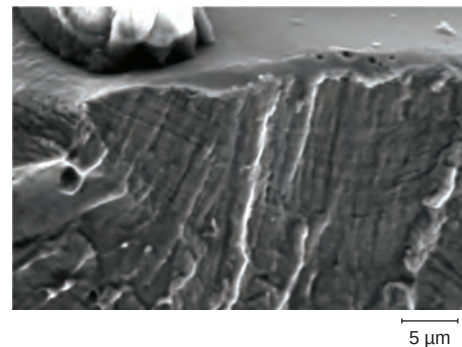
**Fig. 28** SEM image of striations on fractured nitinol stent

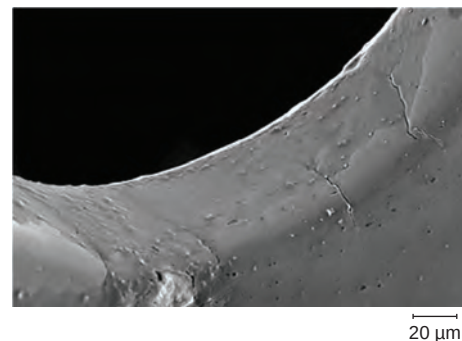
**Fig. 29** SEM image of cracks from other locations on the nitinol stent

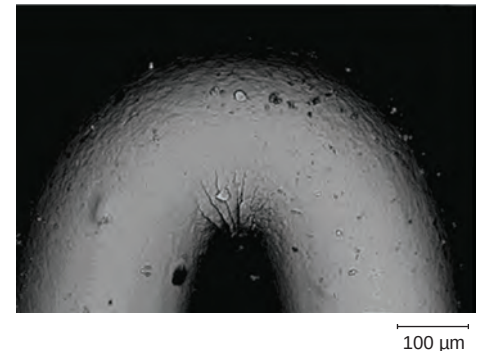
**Fig. 30** SEM image showing a nitinol wire in compression with cracks at the intrados and no cracking at the extrados

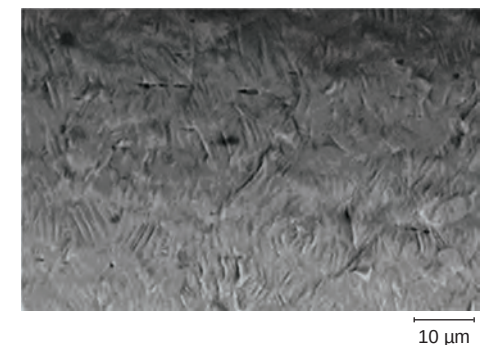
**Fig. 31** SEM image of slip lines and small cracks in a compression-damaged sample subjected to 27% strain

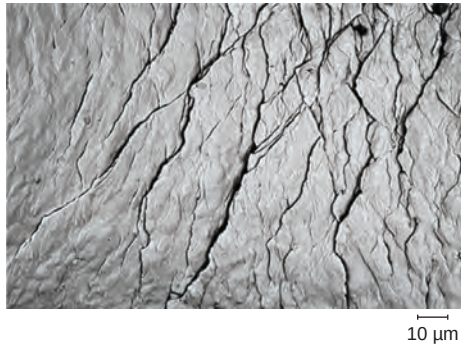
**Fig. 32** SEM image of compression-induced cracks in a nitinol wire sample subjected to 50% strain

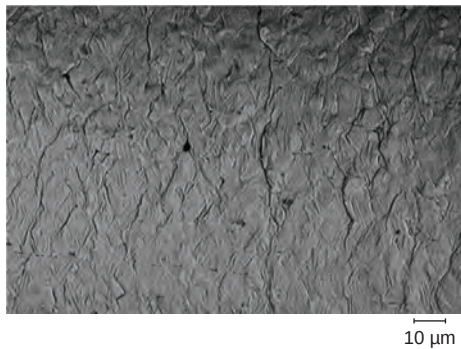
**Fig. 33** SEM image of slip lines and cracks in a compression-damaged nitinol wire sample subjected to 31% strain

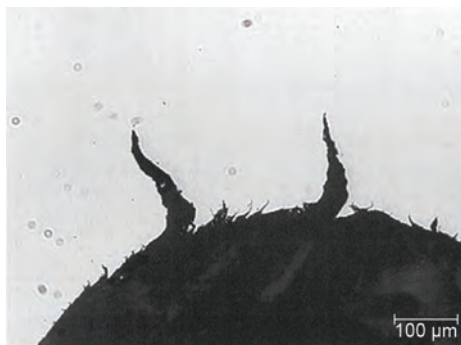
**Fig. 34** Metallographic image of intrados cracks in compressed and released nitinol wire sample. Cracks initiate in shear during compression and grow in tension upon release

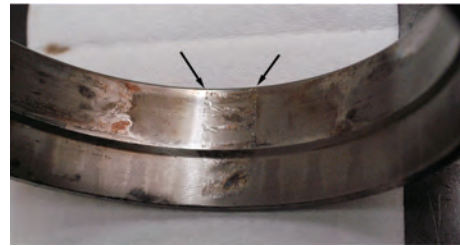
After disassembly, it was noted that the surface of the journals had been heavily scored, and the inside of the inner seal wear ring contained unique wear patterns (Fig. 7, 8). In one case, the seal wear ring had cracked (Fig. 8).

**Fig. 7** Black arrows indicate galling damage. Note the fretting discoloration at right and left

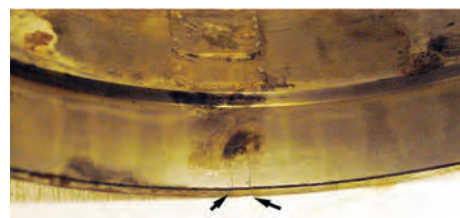
**Fig. 8** Cracking present on seal wear ring due to excessive hoop stress

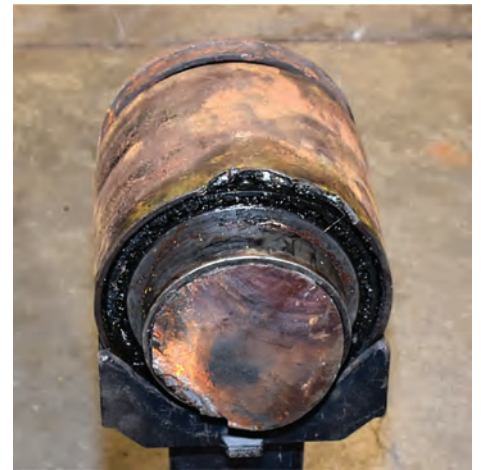
Fig. 10 As-received axle stub with bearing in place

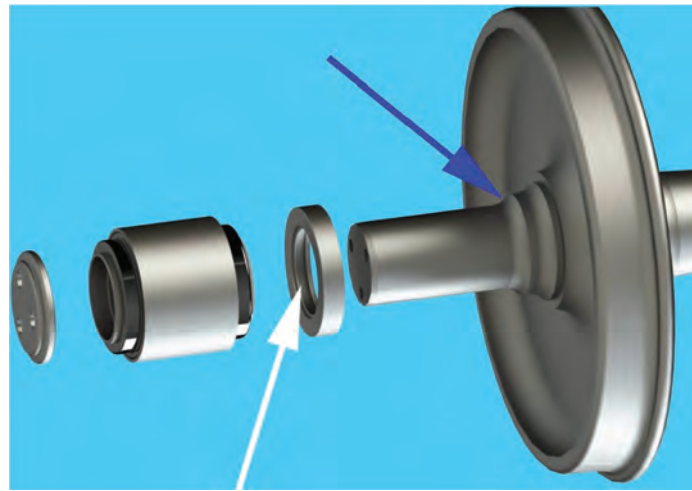
**Fig. 12** One-half of wheelset showing journal fillet (blue arrow), backing ring blend radius (white arrow), cartridge bearing, and end cap (at left)

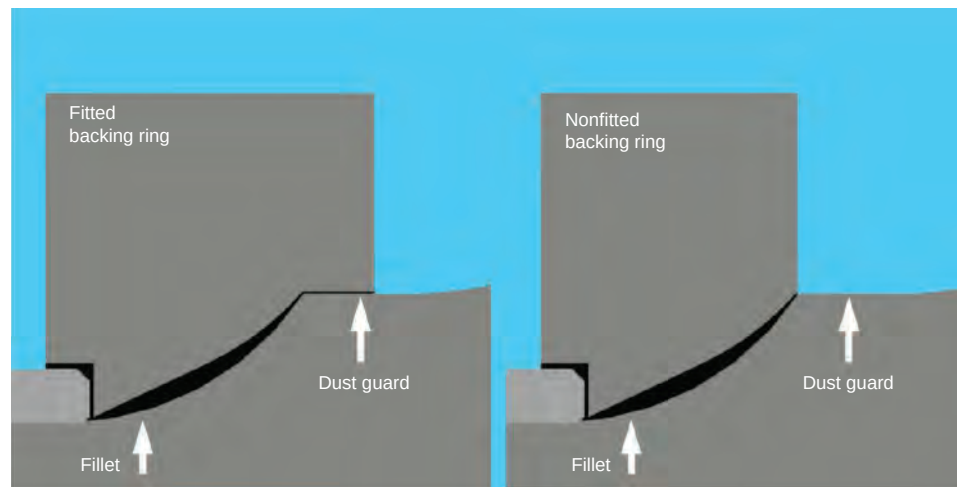
Since the adoption of the 286,000 lb gross rail load (GRL) freight cars, all wheelsets must be assembled with fitted backing rings on fitted axles. This means that the backing ring must have an interference press-fit onto the axle. Figure 13 compares a fitted backing ring with a nonfitted backing ring arrangement. This axle was found to have a fitted backing ring. (For non-286,000 lb GRL axles, it is possible that fitted backing rings could be applied to nonfitted axles. The backing ring would cover the dust guard of the axle; however, the axle dust guard would be too small in diameter to provide a press fit.)

**Fig. 13** Cross-sectional view of fitted backing ring on a fitted axle versus a nonfitted backing ring on a nonfitted axle

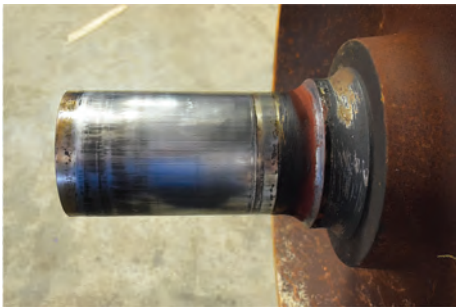
The mate journal after bearing removal is shown in Fig. 16 and 17. Pitting is present along the Tectyl application interface. Both journals were cleaned using a solvent to remove the Tectyl from the surface of the journals. Figures 18 and 19 depict the failed

**Fig. 16** Overall view of mate journal after bearing removal

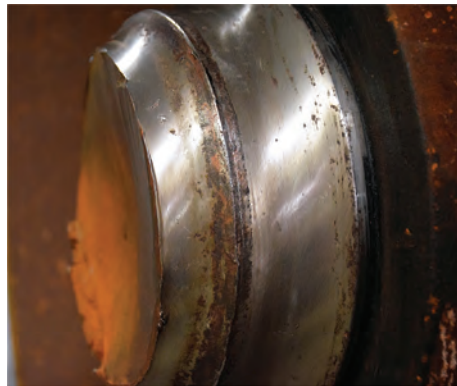
**Fig. 18** Failed journal after cleaning at initiation site, with mechanical damage present

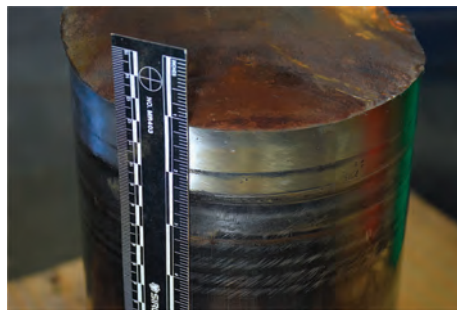
**Fig. 19** Failed journal after cleaning. Pitting is visibly present near the initiation region

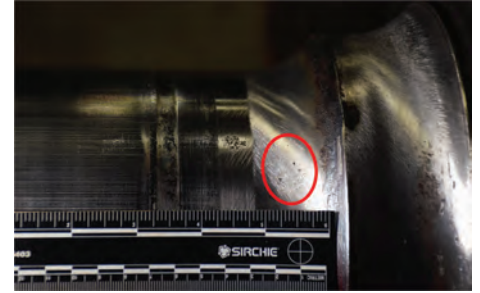
journal outer diameter (OD) after cleaning, with pitting present on the OD near the initiation site. Figure 20 shows the area with the most severe pitting density on the OD of the mate journal fillet.

**Fig. 20** Mate journal after cleaning, with pitting present in the fillet region

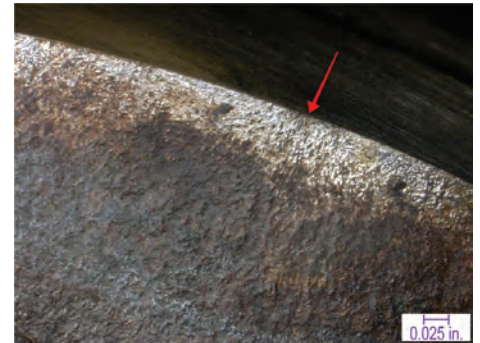
**Fig. 21** Fracture-initiation location indicated by arrow

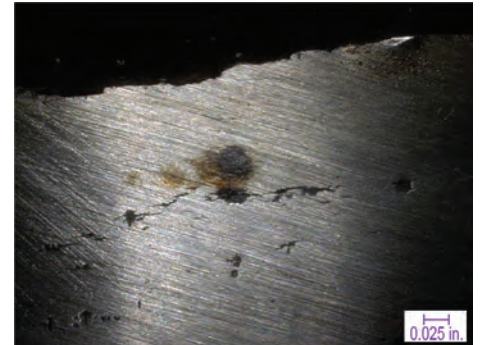
The journals, along with the fillets, were inspected using a Keyence digital microscope. Figure 21 is a magnified view of the fracture-initiation location. Figures 22 and 23 show secondary cracking emanating from the pitting present on the OD of the fillet journal. The sanding marks bisect the corrosion product within the pit. The mate journal was inspected, and it was noted that pits were present, with the grinding marks also bisecting the corrosion product contained within the pit (Fig. 24). Figures 25 and 26 show pits found on the mate journal fillet where grinding marks follow the edge contours of the bare metal pit walls. Not all of the pits contained debris.

**Fig. 22** Secondary cracking emanating from pitting on the failed journal

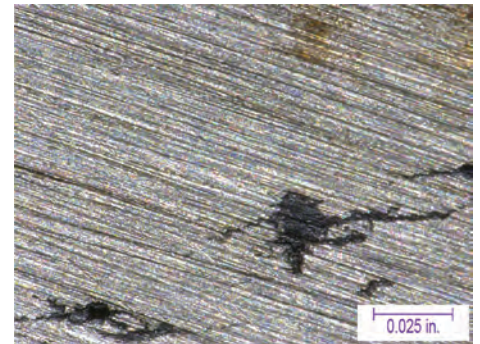
**Fig. 23** Failed stub secondary cracking. Grinding marks bisect the corrosion product

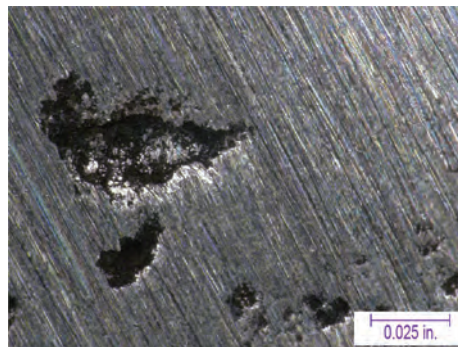
A reconditioned axle will have abrasion marks present along the fillet from the cleaning process. What is unusual is the presence of corrosion pits within the cleaned zone, because all pits are to be removed during axle reconditioning (Ref 6). The presence of abrasion marks within the pit walls (Fig. 25, 26) is a

sign that the pit was present at the time of reconditioning. The effect of pits on the localized stress state of the axle causes localized stresses to exceed the material fatigue (endurance) limit, because progressive fatigue crack propagation morphology was identified on the axle. This is the reason for the AAR MSRP requiring all pitting to be removed.

The grinding and machining marks present in the debris-filled pits are evidence that some of the corrosion pitting was not fully removed during the axle-reconditioning procedure. The fact that bidirectional machining marks are present suggests that the pitting was sufficiently severe that multiple angles of the belt or disk were attempted to eliminate the existing pits from the fillet. This is evident in Fig. 25 and 26, where the radial marks left by the grinding operation change direction when the pit is encountered.

**Fig. 25** Mate journal pitting with grinding marks present in the bare metal of the pit

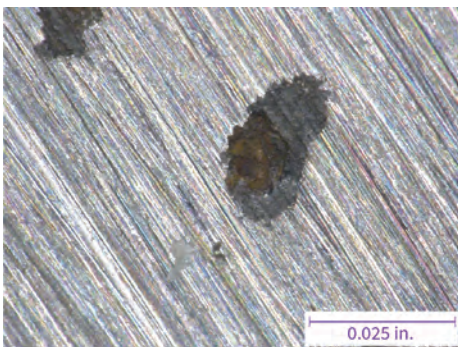
**Fig. 24** Mate axle with pitting corrosion product bisected by grinding marks

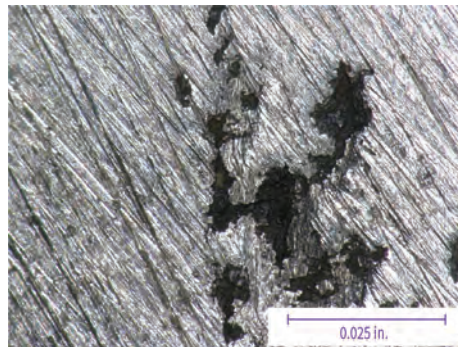
**Fig. 26** Mate journal pit with grinding marks following the contours of the pit walls

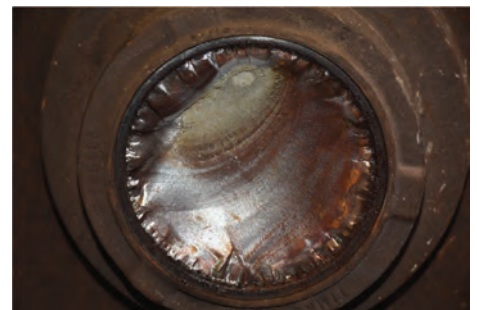
**Fig. 28** Fracture surface on axle side. Note that the backing ring remains in place on the axle due to the fitted backing ring

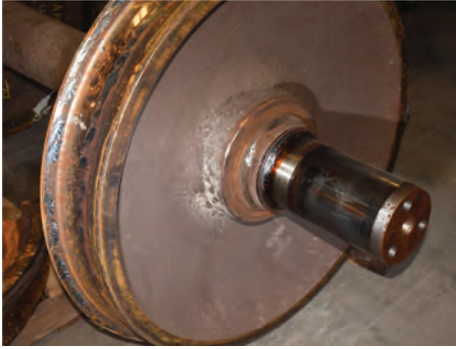
**Fig. 29** Mating side of axle with bearing removed. The failed journal was still within the bearing assembly, as seen in Fig. 30. A distinct population of ratchet marks is observable around the circumference of the fracture surface. The ratchet marks indicate the combination of crack planes

The failed journal was still within the bearing assembly (Fig. 30). Nearest to the fracture surface are the inner seal wear ring, the seal housing, and the chipped bearing cup. The seal wear ring would have been pressed into the back side of the backing ring (Fig. 28). A distinct population of ratchet marks is observable around the circumference of the fracture surfaces. The ratchet marks indicate the combination of cracking planes. The fracture surfaces showed fracture initiation from multiple locations around the circumference of the journal.

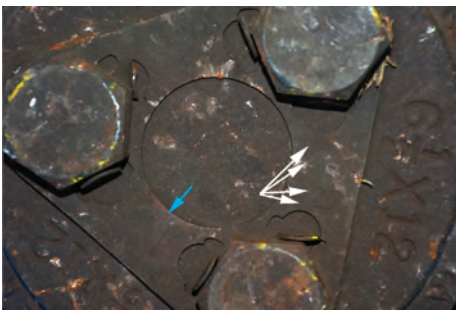
**Fig. 31** Cap screw locking plate. Blue arrow indicates "N" for new, while white arrows indicate month and year (December 1990)

installer as to whether the bearing is new or reconditioned, including the month and year of installation. In this case, it was found that the bearing had been installed in new condition in December 1990 by Trinity 54 in Dallas, Texas. These notations are shown in Fig. 31.

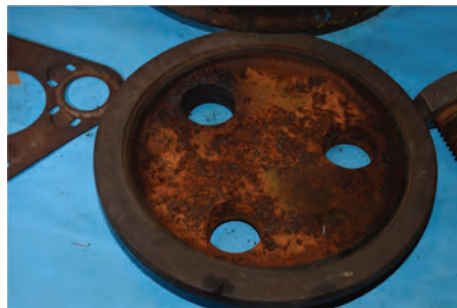
The end cap was removed from the failed side. A noticeable amount of red rust was present on the interior of the end cap (Fig. 32). The journal stub was pressed out of the bearing. Present on the end of the journal was the axle fabrication data (Fig. 33). The axle was manufactured by Standard Forged Products, McKees Rocks Forgings of McKees Rocks, Pennsylvania, in June 1990.

**Fig. 32** Inside of subject bearing end cap

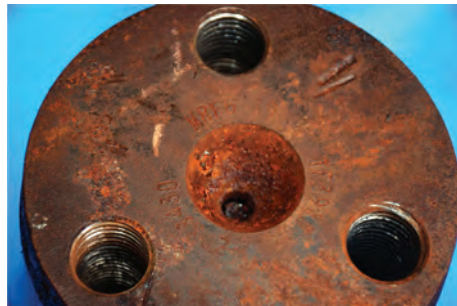
**Fig. 33** Axle journal end stampings. Clockwise: manufacturer's marks (MRF, McKees Rocks Forgings; date of manufacture, June 1990), heat number, and serial number. The bearing components were degreased and cleaned in solvent. Beyond typical fretting wear seen in the ridges worn into the inner cone (race), as seen in Fig. 34, no negative conditions were noted within the components of either bearing

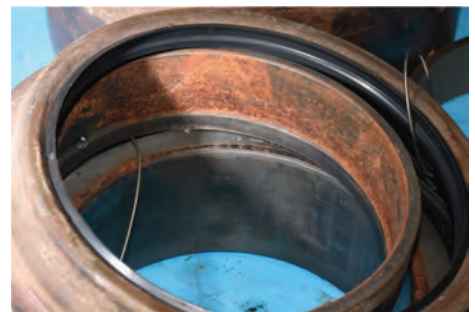
wear seen in the ridges worn into the inner cone (race) (Fig. 34), no negative conditions were noted within the components of either bearing.

**Fig. 34** Seal wear ring (inverted) below seal housing. Fretting wear can be seen on the inner cone at the bottom of the stack. The fractured journal was also cleaned in mineral spirits and then cut approximately 25 mm (1 in.) from the fracture surface. This was performed to enable the area adjacent to the fracture to be inspected. Prior to inspection with a digital light microscope, the section was soaked in Evapo-Rust to remove the tightly adhering red rust adjacent to the fracture surface, as seen in Fig. 35. An example of the surface condition of the axle is shown in Fig. 36. The fracture is to the viewer's left, and the concentric lathe tool cutting marks can be seen as vertical parallel grooves farther to the right of the pitting

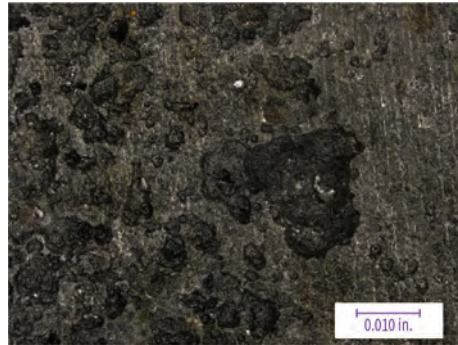
Increased magnification inspection of the surface revealed sharp-edged pits with well-defined edges and, to a greater extent, circular pits on the axle (Fig. 37). Note that the lathe tool markings are intersected by the corrosion pits. This is logical because the axle was first machined and then, during operation, corrosion occurred that intersected the groove marks. This observation is obvious, knowing a priori that the axle had never been reconditioned.

**Fig. 37** General pitting present in the axle. Note parallel lathe tooling marks interrupted by corrosion pits

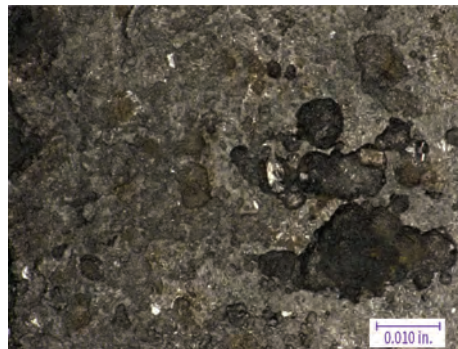
the pits (Fig. 38, 39). It is noteworthy that there are no abrasion marks present in the embedded debris. In reconditioned bearings, it has been observed that the embedded debris contains abrasion markings due to the abrasion that occurs during the reconditioning process. Of course, if properly reconditioned, there should be no pitting present in the fillet area of the journal.

**Fig. 38** Pronounced pitting present on journal surface. Note the corrosion material embedded in some of the pits

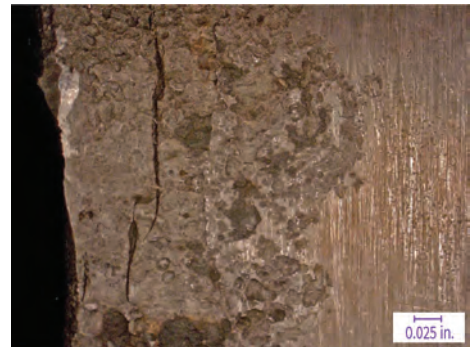
Greater magnification inspection around the circumference of the axle revealed additional fatigue cracks (secondary) near the fracture surface (Fig. 39).

**Fig. 39** Secondary fatigue cracks present near primary fracture surface

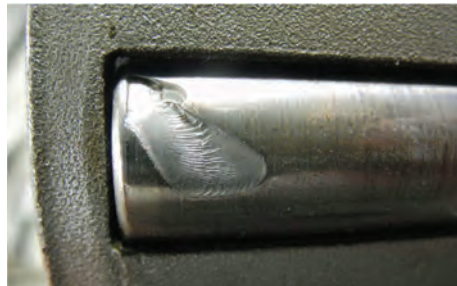
rollers are end loaded, the ends of the bearings will spall and fail (Fig. 43).

**Fig. 43** Tapered roller bearing fracture from end loading due to loss of lateral clamp force

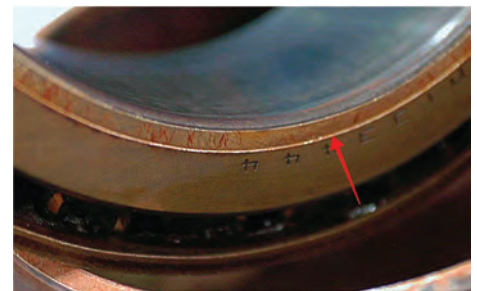
**Fig. 44** Back face wear of a bearing cone. Arrow indicates the step present from wear against the seal wear ring

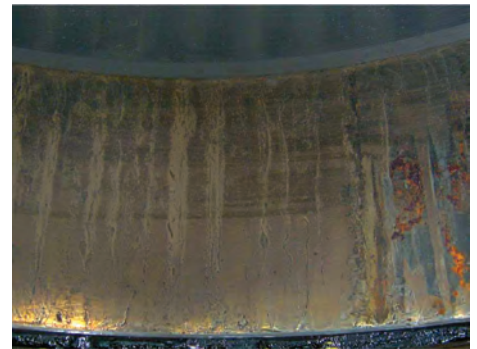
**Fig. 49** Water etching with microcracking present on the cup of a bearing

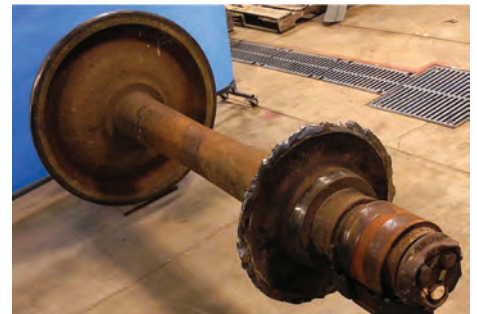
**Fig. 50** As-received wheelset with portion missing

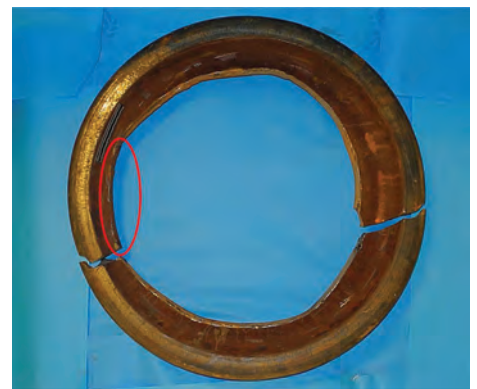
**Fig. 51** As-received rim sections viewed from the back rim face. Circled area indicates initiation region

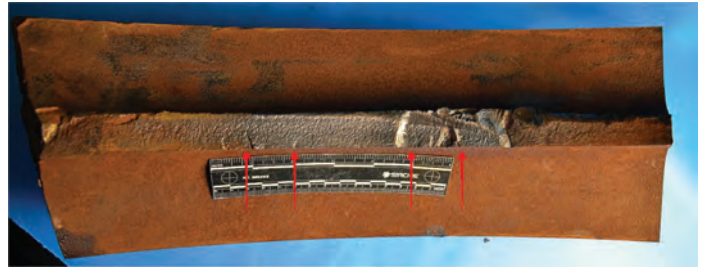
**Fig. 53** Overall view of fracture surface sectioned from rim shown in Fig. 51. Arrows indicate fracture-initiation locations

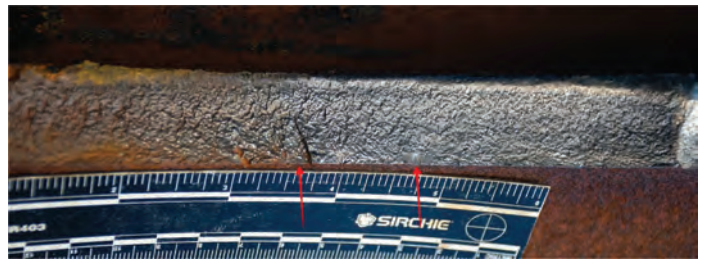
**Fig. 54** Closeup of the two fracture-initiation locations at the left in Fig. 53

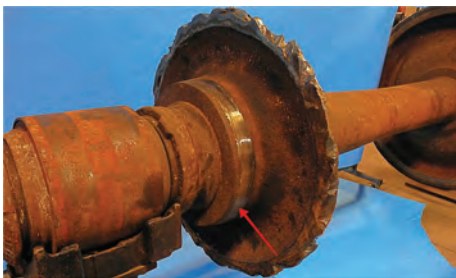
**Fig. 52** Hub and partial plate section of failed wheel. Arrow shows the wear from riding on the rail

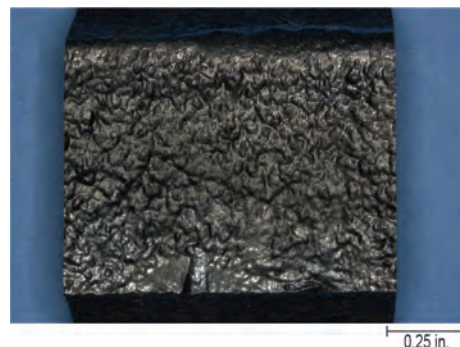
**Fig. 56** Closeup of fracture-initiation location

plate to flex. The flexing causes one surface of the wheel plate to experience tension when the opposite side experiences compression. This is within expected performance; however, wheel plates that contain pronounced corrosion pitting have been found to experience plate-initiated fatigue cracking. Thus, the wheel failed due to a fatigue crack that initiated from a corrosion pit on the back plate face of the

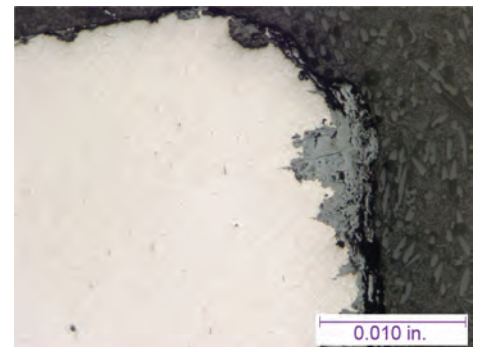
**Fig. 57** Secondary cracking present within pits. Fracture surface is toward the top of the image

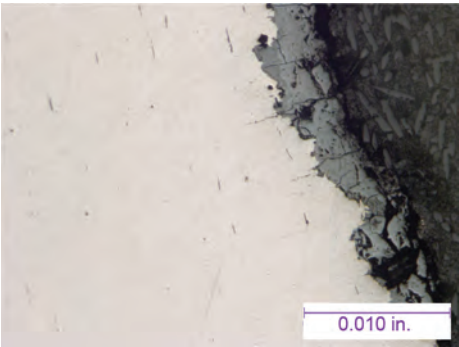
Fig. 58 More secondary cracking from an area with surface corrosion

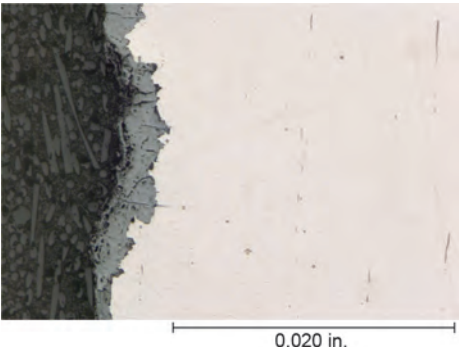
Fig. 59 Secondary cracking present within corrosion pits

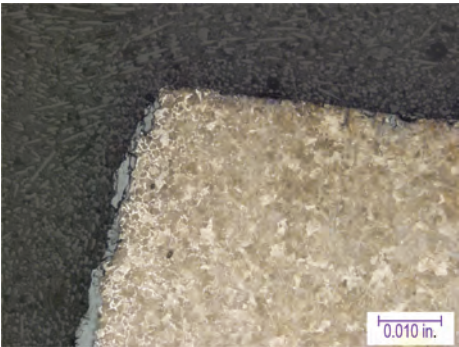
noted that the surfaces had some decarburization present. The amount of decarburization present on the fracture-initiation side was less than that on the opposite side of the wheel (Fig. 60, 61).

Fig. 60 Fracture initiation is toward the top of the image. Some decarburization is present along the forging surface

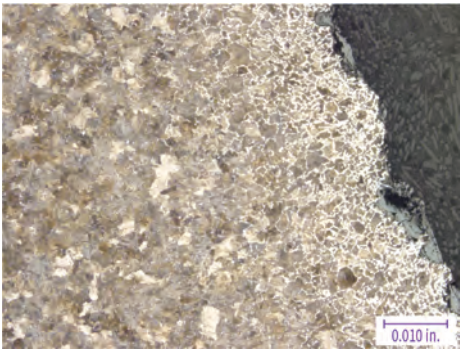
Fig. 61 Opposite side of plate to initiation. More decarburization is present along the forging surface

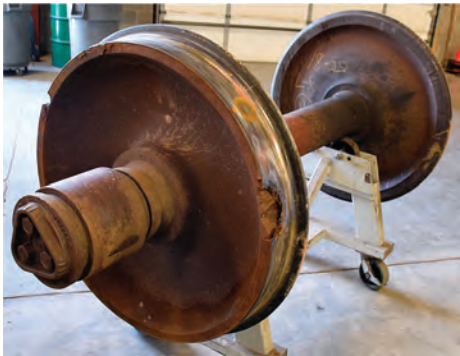
Fig. 62 As-received wheelset with damage present to the running surface

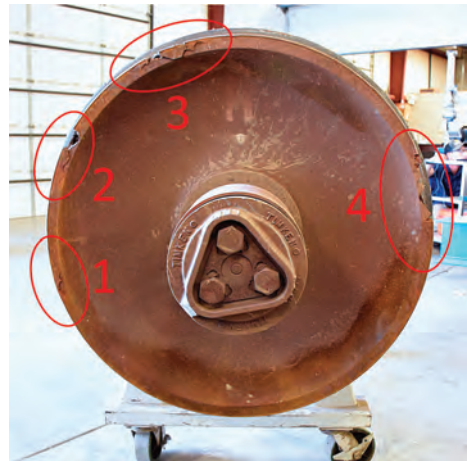
Visual inspection of the wheel showed cracking within the tread in four areas (Fig. 63). The cracking was similar to a shattered rim; however, the fatigue cracking progressed in a stepped manner. Close-up views of the fractures from the front rim face and the running surface are shown in Fig. 64 to 70.

Fig. 63 End view of the wheelset. Fracture locations are numbered and indicated by ovals

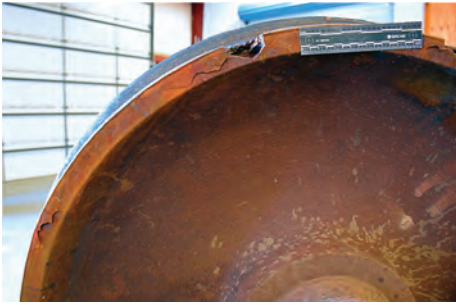
**Fig. 64** Close-up end view of areas 1 and 2 from Fig. 63

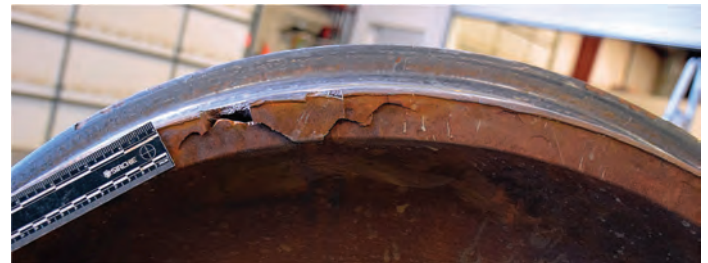
**Fig. 67** Close-up end view of area 3 from Fig. 63

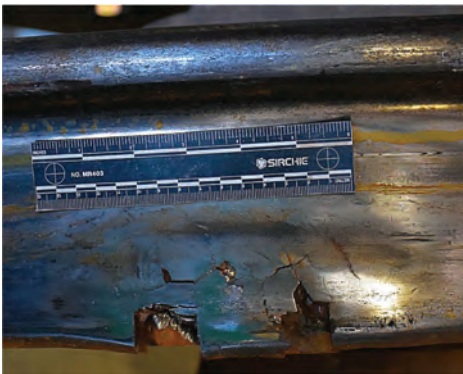
**Fig. 68** Top view of damage to area 3 from Fig. 63

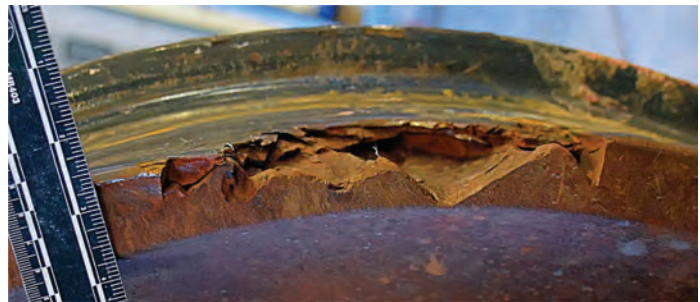
**Fig. 69** Close-up end view of area 4 from Fig. 63

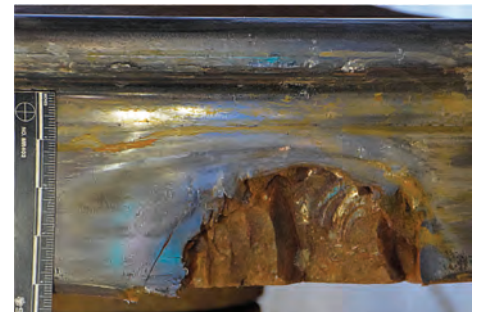
**Fig. 70** Top view of damage to area 4 from Fig. 63

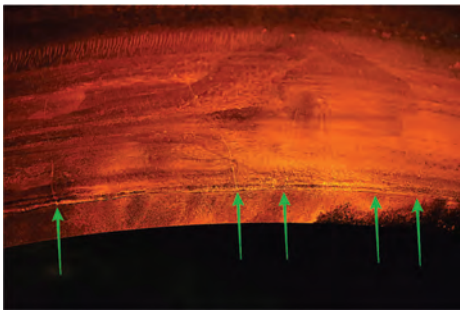
Some of the cracks were quite visible to the naked eye; however, there were subtle indications that warranted ultraviolet magnetic-particle inspection to be performed on the wheel. Widespread cracking was identified over the circumference of the wheel tread. The cracks were similar to thermal cracks but extended farther into the running surface and, frequently, at an angle up to  $20^\circ$  with respect to the tread surface. The cracking is indicated by arrows in Fig. 71 to 73.

Fig. 71 Magnetic-particle testing results from near fracture area 1. Arrows indicate crack locations

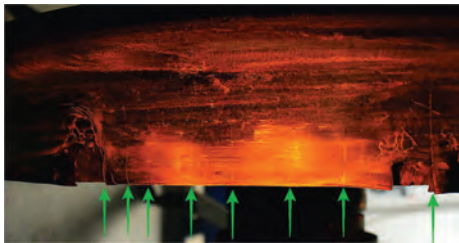
Fig. 72 Magnetic-particle testing results from between fracture areas 2 and 3. Arrows indicate crack locations

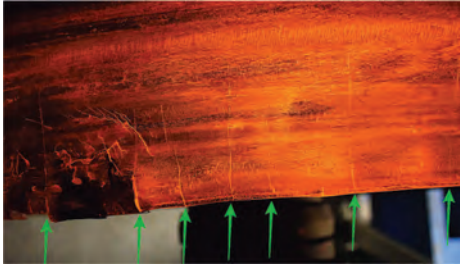
Fig. 73 Magnetic-particle testing results from near fracture area 3. Arrows indicate crack locations

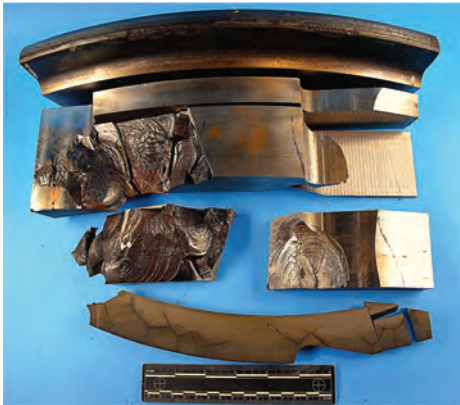
After examining the fracture and crack locations, a section of the rim between fracture areas 2 and 4 was removed from the wheel. The wheel section was further thinned to allow the cracks to be opened. Figure 74 shows the results of sectioning: opened fracture surfaces in addition to a hot macroetched section of wheel tread approximately 9.5 mm ( $3/8$  in.) from the front rim face. The macroetch was performed when difficulties arose in opening the running surface cracks; the macroetch sample is shown in Fig. 75. A close-up view of the branched cracking present in the macroetch is shown in Fig. 76.

Fig. 74 Analyzed rim section showing fracture locations and macroetch performed on a section

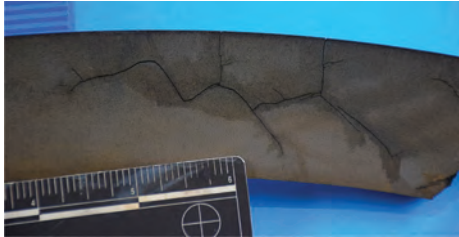
Fig. 76 Closeup of branched cracking present in the macroetch sample

Further sectioning of the rim sample was performed, and additional fracture surfaces were revealed. An extensive fatigue crack network, with typical beach marks originating from peaks or one of the triple points, is shown in the macroetch in Fig. 76. One of the fracture surfaces had been open to the atmosphere, and some surface rust was present (Fig. 77). The opposing fracture surface was still bare metal, indicating that the fractures had not been exposed to the atmosphere (Fig. 78).

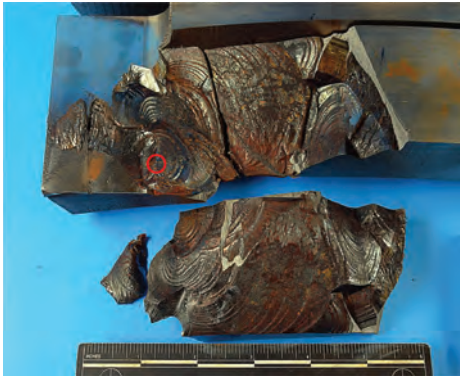
Fig. 77 Circle indicates initiation location on fracture surfaces

The fracture surfaces revealed in Fig. 77 and 78 were subsurface cracks and were not the cracks found on the running surface from the magnetic-particle inspection. Further sectioning exposed a section of one of the cracks found on the surface (Fig. 79). The dark surfaces are indicative of a thermal crack.

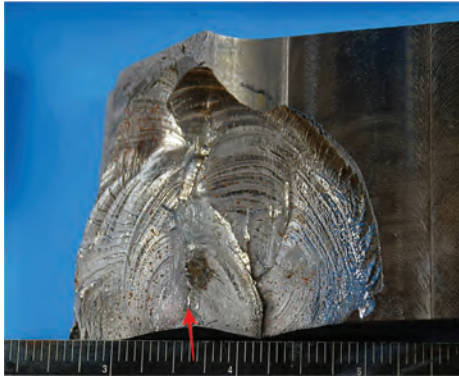
Fig. 78 Opposite fracture surface. Arrow indicates initiation location

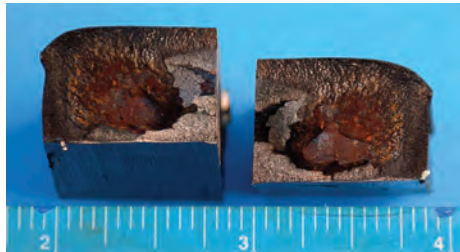
Fig. 79 Thermal crack revealed from further sectioning of the wheel tread sections

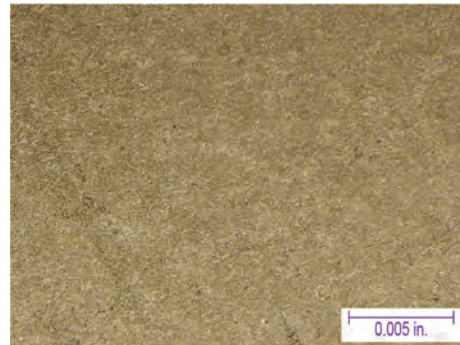
Two sections were removed from the left side of the macroetch sample (Fig. 75). These samples were mounted, polished, and etched with 2% nital in accordance with standard metallographic procedures. The samples were examined, and it was noted that the texture of the steel was more columnar toward the running surface and became more equiaxed where the branched cracks were farther from the running surface. This observation is best seen in Fig. 80 and 81; both images are overall photomerges of the metallographic samples. The texture is likely the result of solidification of the steel during casting of the wheel. The microstructure observed at the surface of both samples consisted of tempered martensite (Fig. 82). Martensite is not permitted in freight car wheels; the core microstructure was consistent with pearlite (Fig. 83).

**Fig. 82** Representative surface microstructure consisting of tempered martensite

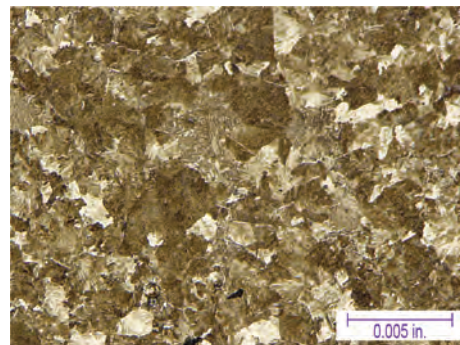
**Fig. 83** Representative core microstructure consisting of pearlite

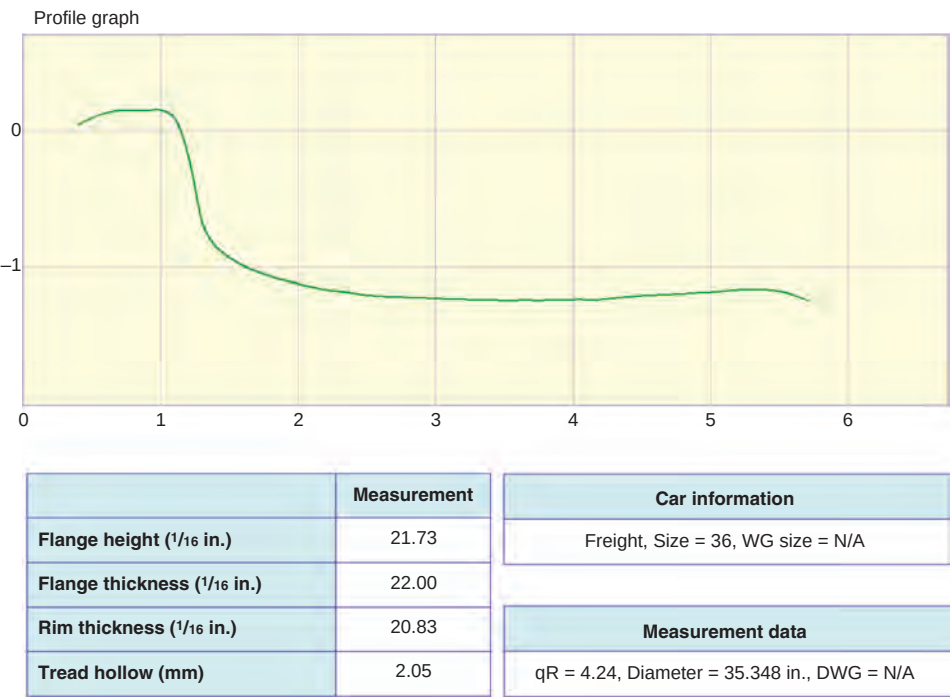
The wheel profiles were measured using a digital wheel profilometer and are shown in Fig. 85 and 86. No exceptions were taken with the failed wheel profile. The mate wheel profile was approaching the hollow tread limit as well as the high flange limit.

Fig. 85 Wheel profile for failed wheel NORX 2811 R1

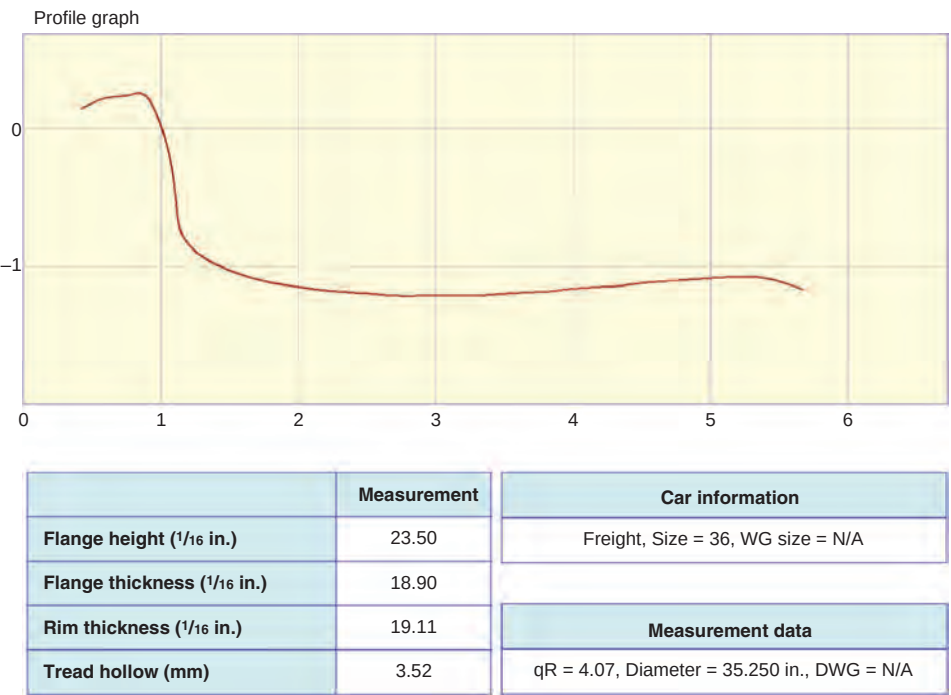
Fig. 86 Wheel profile for mate wheel NORX 2811 L1

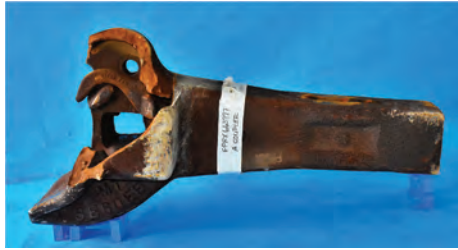
2569, is consistent with a model number SE60EE. A section of the coupler that included the date of manufacture was missing. The coupler body was deformed, which resulted in the thrower becoming trapped within the coupler (Fig. 87).

Fig. 87 As-received failed coupler

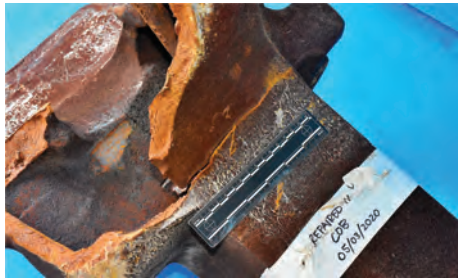
Visual inspection of the coupler revealed a large crack behind the head (Fig. 88). The

large crack allowed the coupler body to be deformed and resulted in the thrower becoming trapped within the coupler. Figure 89 shows the coupler from a different angle, and the deformation is indicated by an arrow.

Fig. 88 View of cracking, which caused the thrower to be trapped

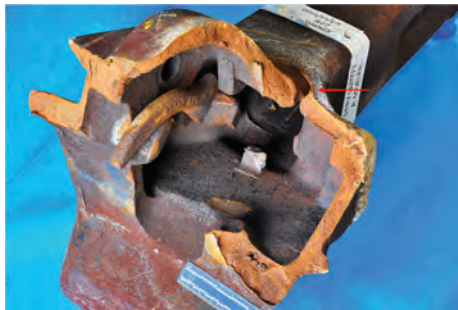
Figure 89 also shows the fracture surface, which is comprised of overload fracture with

Fig. 89 Overall view of the fracture face. Arrow indicates deformation at crack shown in Fig. 88

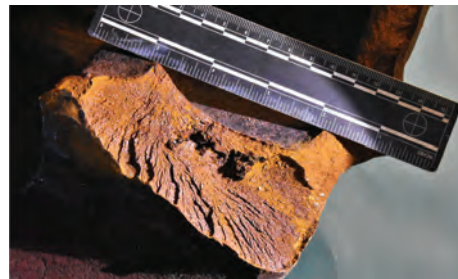
the presence of some porosity. Figure 90 shows an initiation location that contains some porosity. Figure 91 shows the other side of the fracture surface and another initiation site. No fatigue cracking was noted on any of the fracture surfaces.

Fig. 90 Fracture surface at the bottom of Fig. 89. Some porosity is present in the fracture

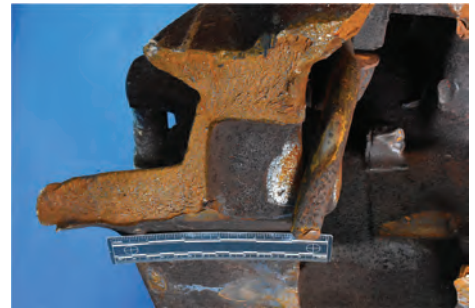
Fig. 91 Fracture surface to the left in Fig. 89. Overload failure
