# Failures Related to Hot Forming Processes

Dick Douglas, Forging Consultant  
Charles V. White, Kettering University  
Tim McHenry, Collins Aerospace

## Introduction to Failures Related to Hot Forming Processes

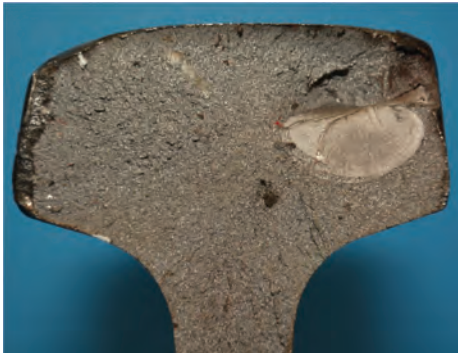
Three sections of rail were supplied. Two sections (Fig. 93) share a common fracture surface, which shows evidence of a subsurface fatigue-initiation site on the field side of the rail head (Fig. 94, 95). Although this fatigue site would have weakened the rail head, it is not the cause of the derailment, because no wheel leaving or receiving batter is associated with it. The rail fractured at this location as a result of the derailment, due in part to the weakened state due to the fatigue crack, referred to as a detail fracture in the rail industry. The third section of supplied rail contains a fracture that initiated at a weld in the rail (Fig. 96). Wheel impact damage at the fracture site is also visible in Fig. 96 and indicates that the rail was in a fractured state as freight car wheels continued passing over it. The fracture continued to grow at this site and eventually ejected the recovered fractured

Fig. 94 Subsurface fatigue fracture surface initiating from field side of rail head. No discoloration indicates the crack was not open to the atmosphere

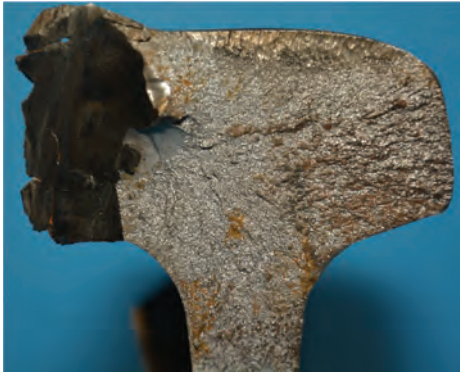
Fig. 95 Mating fracture surface of Fig. 94. Note the damage caused by postfracture wheel impact

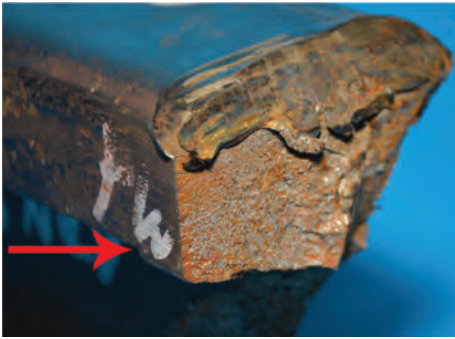
The fracture in the rail sections shown in Fig. 93 is a result of the derailment and not the cause of the derailment, despite the presence of a detail (subsurface fatigue) crack. The rail section shown in Fig. 96 fractured at the location of an in-track weld and shows evidence of wheel traffic following the fracture initiation. The rail section shown in Fig. 96 was the cause of the derailment. Based on the materials provided, the rail fractured at or near a weld during the passing of wheels, causing the derailment. While the components provided did not include the “smoking gun” section, the evidence present in Fig. 96 is consistent with a broken-rail-caused derailment.

**Fig. 96** Fracture surface and wheel impact damage. Red arrow indicates weld material and grinding marks

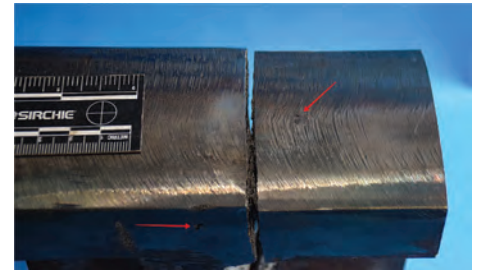
The rail and included weld were visually examined in the as-received state. It was noted that voids were present in the head of the rail (Fig. 98, 99). Figure 100 shows the fracture surfaces, with the initiation location circled and a void in the corner of the base indicated by an arrow.

**Fig. 98** Head of rail. Arrows indicate the voids present

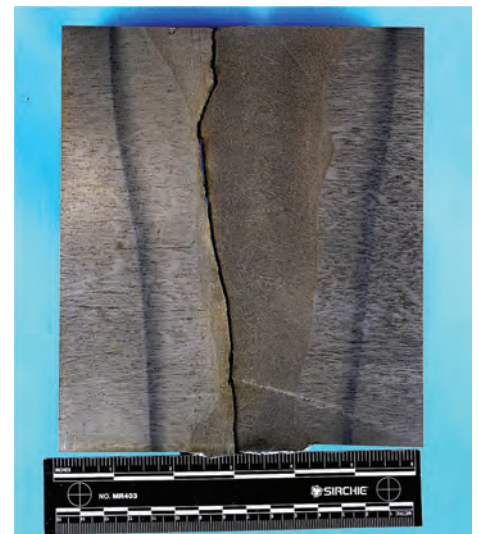
Figure 101 shows the results of the macroetch. The fracture-initiation region was within the weld metal. It was noted that the heat-affected zone was approximately 12 cm (4.75 in.) wide in the head of the rail and 8 cm (3.25 in.) wide in the base of the rail. The weld metal region was also asymmetrical (Fig. 101).

**Fig. 101** Macroetch results of failed weld

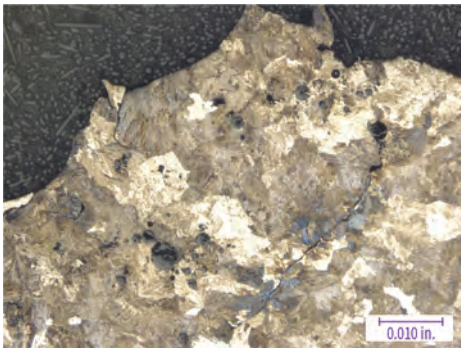
**Fig. 103** Micrograph showing inclusions and cracking near the fracture surface (top of image)

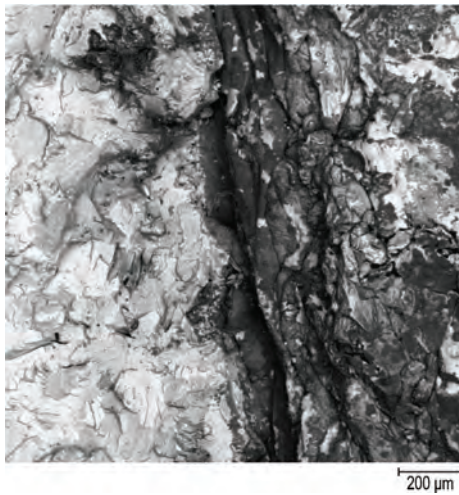
**Fig. 107** Backscatter image. Left side of image is base metal; right side is the defect area. Original magnification: 116×

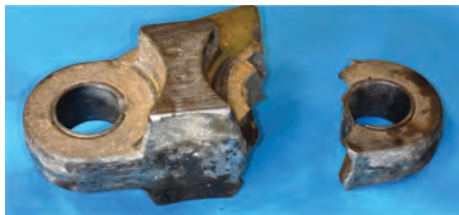
An average Brinell hardness of 285 was measured on the link section surface of the piece at right in Fig. 109. The measured hardness converts to an ultimate tensile strength of approximately 972 MPa (141,000 psi). The links were

**Fig. 109** Fractured undercutter chain link in the as-received condition

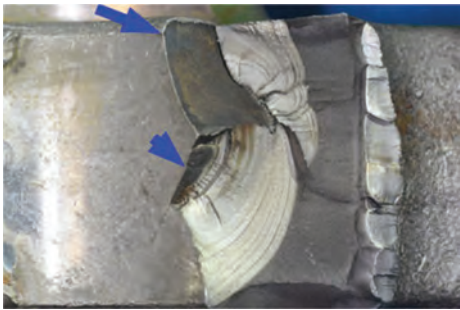
A heavy layer of oxidation was present on a portion of the fracture surface (Fig. 110). The

**Fig. 110** Multiple fatigue cracks in chain link. Arrows indicate fracture surfaces with heavy oxide

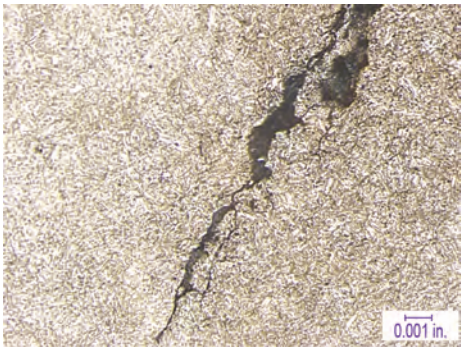
quench cracks had developed during heat treating (Fig. 111).

**Fig. 111** Microstructure of chain with intergranular surface crack. Nital etch. Original magnification: 1000×

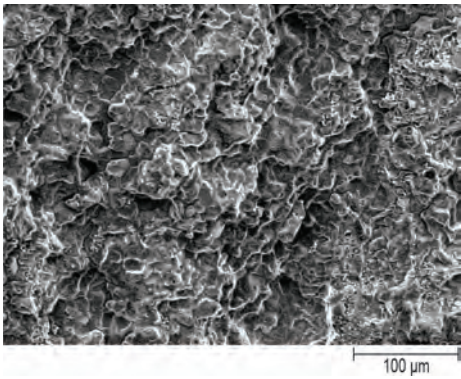
oxide surface prevented inspection of the fracture surface and was therefore removed, using an inhibited hydrochloric and dibutyl thiourea solution. Examination of the surface cracking by SEM verified the presence of intergranular fracture (Fig. 112).

**Fig. 112** Scanning electron microscope image of surface crack indicating intergranular fracture. Original magnification: 350×

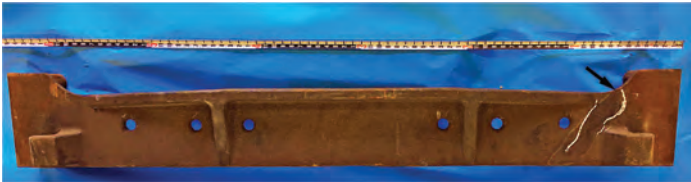
A retarder beam was removed from service due to an observed crack during daily inspection. A retarder is used as an external brake applied to the front and back rim faces of a wheel to slow railcars in hump yards, while using gravity to sort individual cars down a hill through switches to one of many tracks during train assembly. A metallurgical failure analysis was requested to determine if the cracking occurred due to a manufacturing defect or if improper repair processes had been employed. In Fig. 113 and 114, the beam is shown in the as-received condition, with a crack outlined in chalk.

**Fig. 113** Overall view of as-received beam. Crack location is indicated by chalk and arrow on right side of image

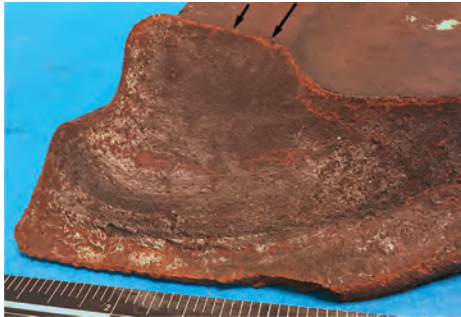
surfaces were exposed (Fig. 115). The morphology of the fracture surfaces was interpreted as typical fatigue fracture, as indicated by the beach marks present. The arrows are oriented toward the crack-initiation location (Fig. 116).

**Fig. 116** Close-up view of fatigue fracture surface with beach marks. Arrows indicate the initiation-site areas

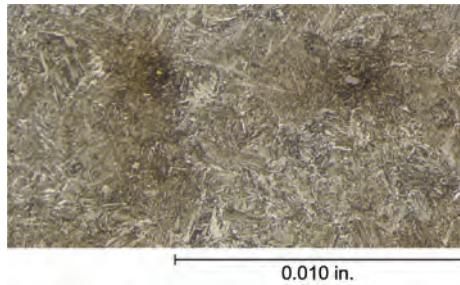
The microstructure sample was mounted and polished according to standard metallographic procedures. The sample was etched with a 2% nital reagent and inspected using a digital microscope. The microstructure was consistent with tempered martensite, which is expected for a quenched-and-tempered steel (Fig. 118).

Fig. 118 Microstructure is tempered martensite
