# **METALLURGICAL FAILURE ANALYSIS**

Techniques and Case Studies

KANNADI PALANKEEZHE BALAN

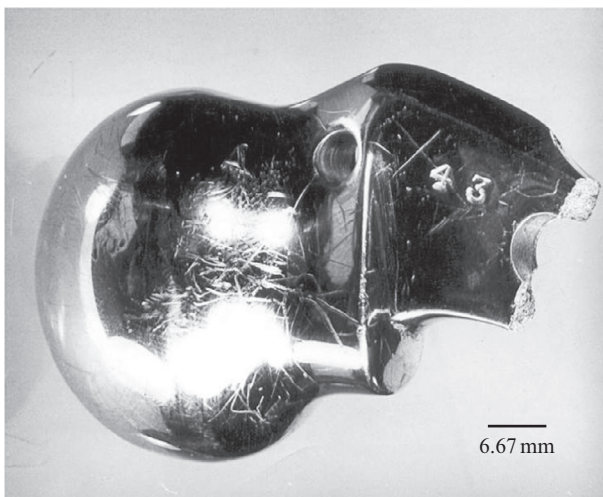
*Visual Examination:* The hip joint prosthesis had broken into two parts across a hole as shown in Fig. 4.1.1. The fracture surface was coarse and crystalline (Fig. 4.1.2). Two punch marks were noticed on either side of the hole, which were joined by a crack on the surface of the implant (Fig. 4.1.3).

**Fig. 4.1.1** Broken part of the hip joint prosthesis in the as-received condition.

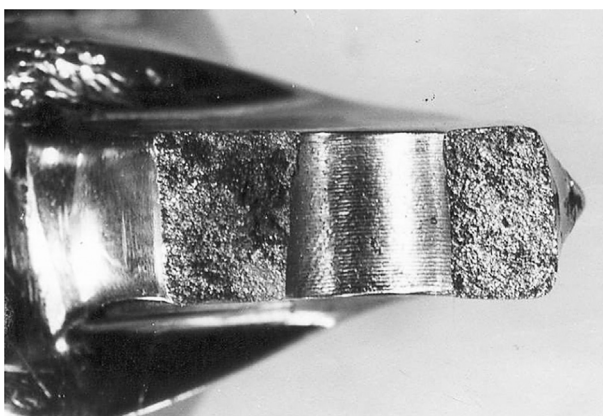
**Fig. 4.1.2** Fracture surface showing a coarse and crystalline fracture.

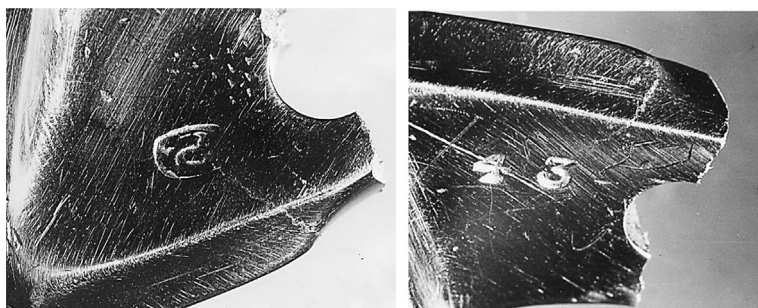
**Fig. 4.1.3** Punch marks joined by a crack on the surface as seen on either side of the hole.

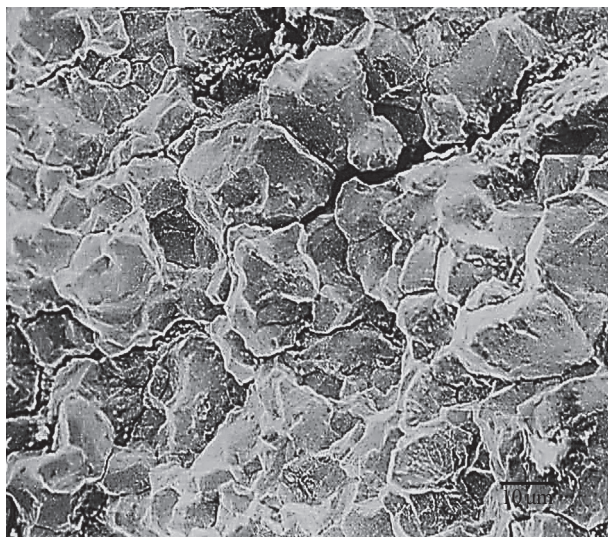
*Fractographic Examination:* Examination of the cleaned fracture surface under SEM revealed intergranular fracture features with secondary cracks (Fig. 4.1.4).

**Fig. 4.1.4** SEM fractograph showing intergranular fracture with secondary cracks.

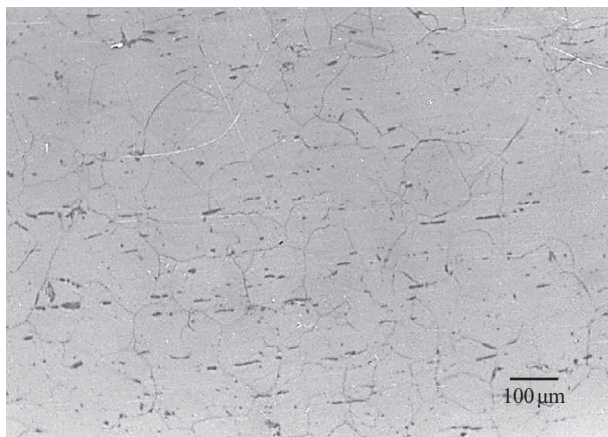
*Metallographic Examination:* Longitudinal section adjacent to the fracture was prepared for metallography. In the unetched condition, the sample showed a large population of elongated sulfide and globular oxide inclusions (Fig. 4.1.5). On etching with aqua regia, the sample revealed equiaxed grains of austenite with annealing twins and intergranular corrosion (Fig. 4.1.6).

**Fig. 4.1.5** Micrograph showing a large number of elongated sulfide and globular oxide inclusions. Unetched.

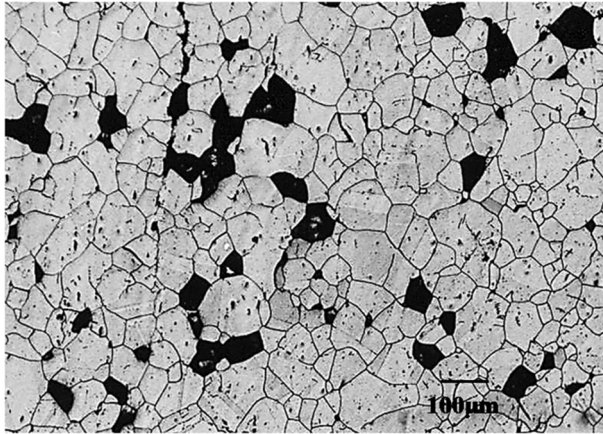
**Fig. 4.1.6** Micrograph of longitudinal section adjacent to fracture revealing equiaxed grains of austenite with annealing twins and intergranular corrosion as evidenced by removal of polygonal grains in the microstructure. Etchant: Aqua regia.

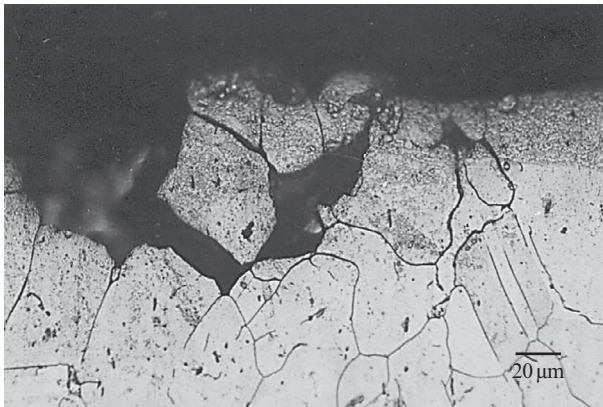
Sample a little away from failure was subjected to a test for evaluating whether it was sensitized. For this purpose, the sample was boiled with 65% nitric acid for 30 min [1]. Examination of the sample after polishing and etching revealed intergranular corrosion (Fig. 4.1.7).

**Fig. 4.1.7** Micrograph of a section of the sample that was subjected to test for sensitization showing intergranular corrosion. Etchant: Aqua regia.

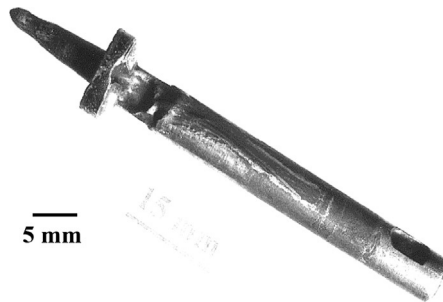
*Visual Examination:* The failed part of the firing pin in the as-received condition is shown in Fig. 4.2.1. The neck region was found to have been deformed.

Fig. 4.2.1 The failed firing pin in the as-received condition.

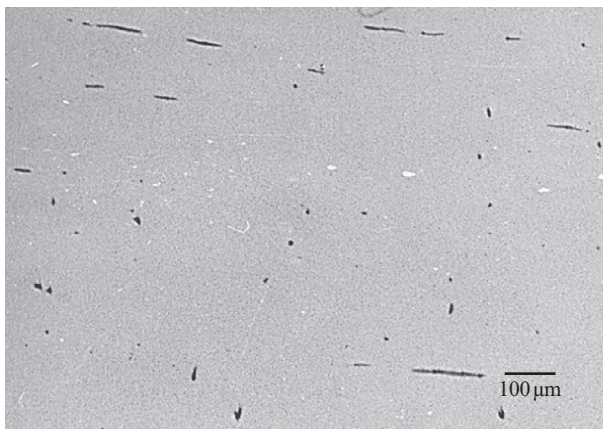
Fig. 4.2.2 Micrograph of the longitudinal section of the sample showing a large number of globular oxide and elongated sulfide inclusions. Unetched.

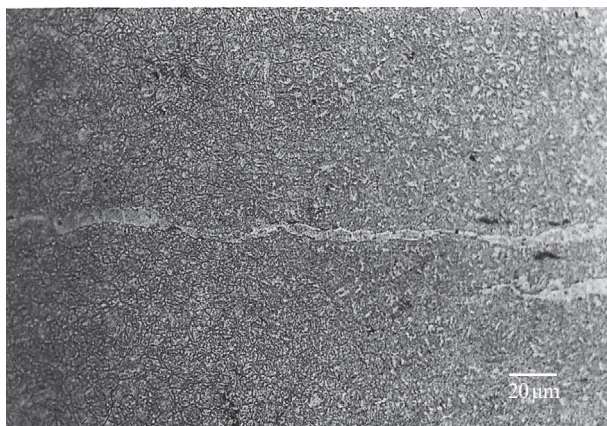
**Fig. 4.2.3** Micrograph of the longitudinal section of the sample showing martensite and reverted austenite. Etchant: 2% nital.

On etching with 2% nital, the sample revealed martensite and reverted austenite (Fig. 4.2.3).

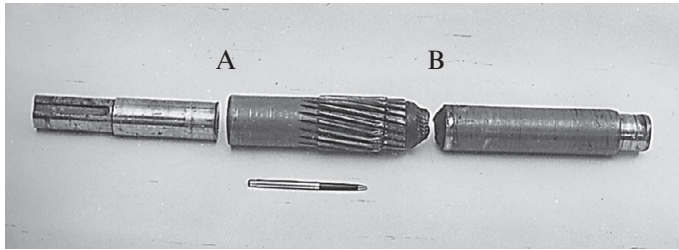
*Visual Examination:* The failed shaft in the as-received condition is shown in Fig. 4.3.1. Fracture at position ‘A’ was found to be completely rubbed, while fracture at position ‘B’ was relatively intact. The fracture at position ‘B’ showed a cup and cone type of fracture, whereas the fracture at position ‘A’ showed negligible deformation.

**Fig. 4.3.1** Failed shaft in the as-received condition.

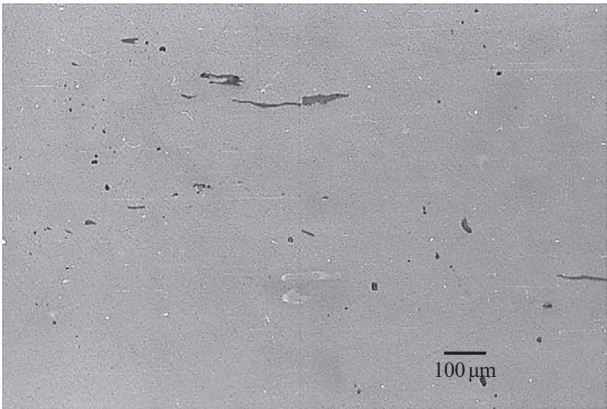
**Fig. 4.3.3** Micrograph of the sample showing a number of elongated sulfide and globular oxide inclusions. Unetched.

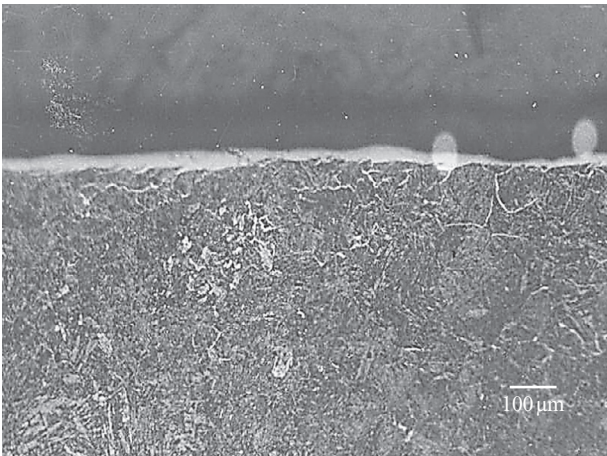
**Fig. 4.3.4** Micrograph of the sample showing nitrided layer with a white etching layer of iron nitride on the surface. Etchant: 2% nital.

*Hardness:* The average Vickers micro hardness of the nitrided case was 650HV at 100g load and the average Vickers hardness of the core was 312HV at 10kg load.

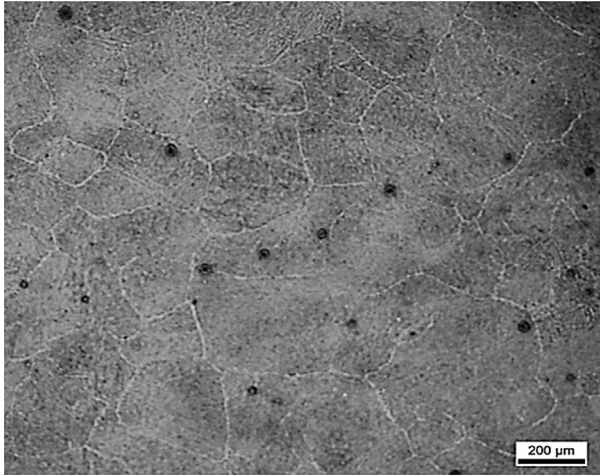
**Fig. 4.3.5** Micrograph of the sample showing proeutectoid ferrite along prior austenite grain boundaries in a matrix of tempered martensite. Etchant: 2% nital.

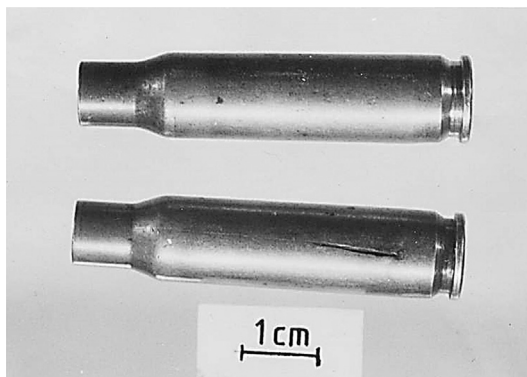
*Visual Examination:* Cartridge cases, a failed one along with a good one in the as-received condition, are shown in Fig. 4.4.1. A crack of about 15 mm length at a distance of about 8 mm from the base can be seen in the failed cartridge case (Fig. 4.4.1). There was no significant thinning of the wall near the crack.

**Fig. 4.4.1** Cartridge cases, a failed one along with a good one in the as-received condition.

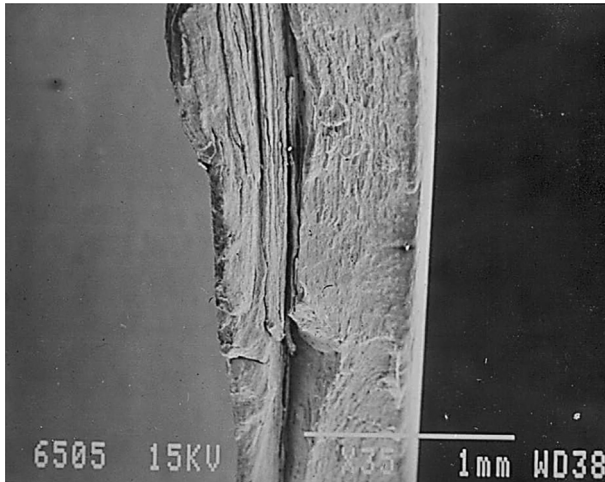
*Fractographic Examination:* The crack was cut open and the fracture surface was cleaned and examined under SEM. Up to the mid thickness, the fracture appeared like lamellar tear followed by ductile fracture (Fig. 4.4.2). Extensive tear-like features with their longitudinal axis parallel to the direction of

**Fig. 4.4.2** SEM fractograph showing lamellar tear followed by ductile fracture.

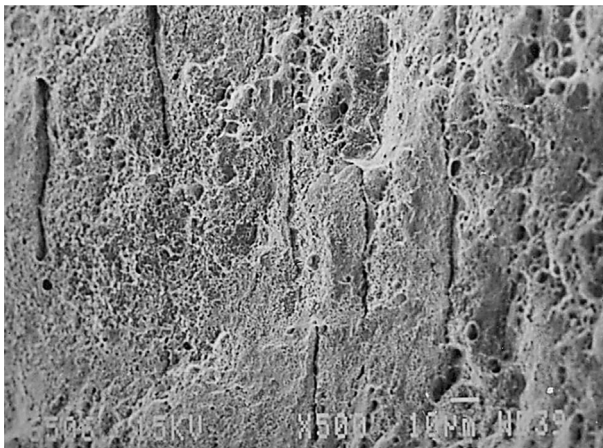
**Fig. 4.4.3** SEM fractograph showing tear-like features with their longitudinal axis parallel to the direction of drawing near the origin.

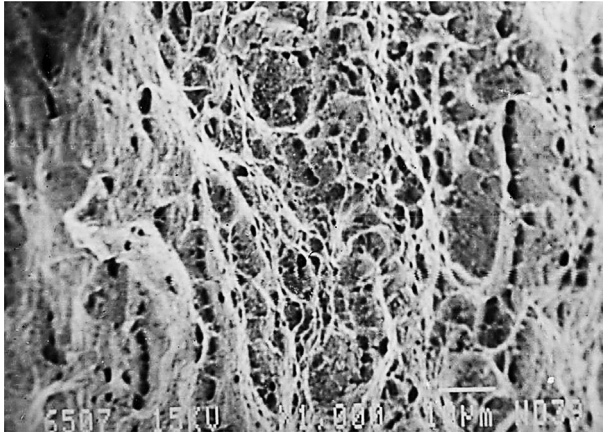
**Fig. 4.4.4** SEM fractograph showing predominantly a dimpled rupture.

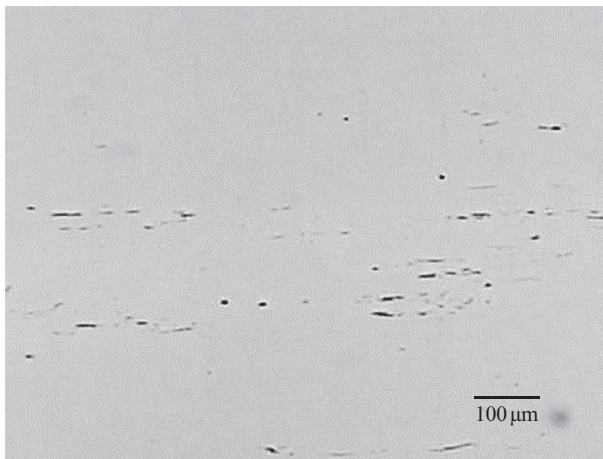
*Metallographic Examination:* Sections of both failed as well as good cartridge cases were prepared and examined under optical microscope. In the unetched condition, stringers of inclusions were seen both in failed as well as good cartridge samples (Fig. 4.4.5). The length of the stringers varied between 50  $\mu\text{m}$  and 200  $\mu\text{m}$ . On etching with acidified potassium

**Fig. 4.4.5** Micrograph of longitudinal section of the sample showing stringers of inclusions. Unetched.

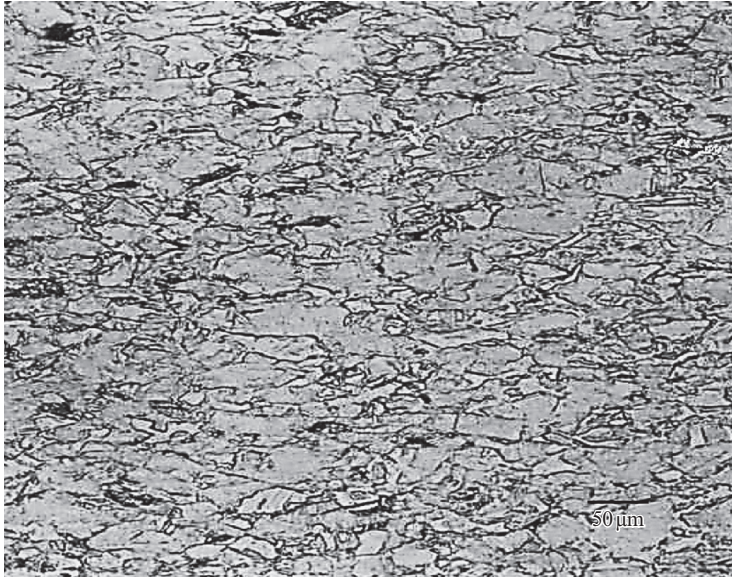
dichromate solution, the sample revealed deformed fine alpha grains, the extent of deformation increasing with increasing distance from the base. A typical microstructure at the mid-length of the cartridge case is shown in [Fig. 4.4.6](#). On analyzing the stringers by EDAX, the inclusions were found to contain sulfur, zinc, and copper ([Fig. 4.4.7](#)).

**Fig. 4.4.6** Micrograph of longitudinal section of the sample showing deformed fine alpha grains. Etchant: Acidified potassium dichromate.

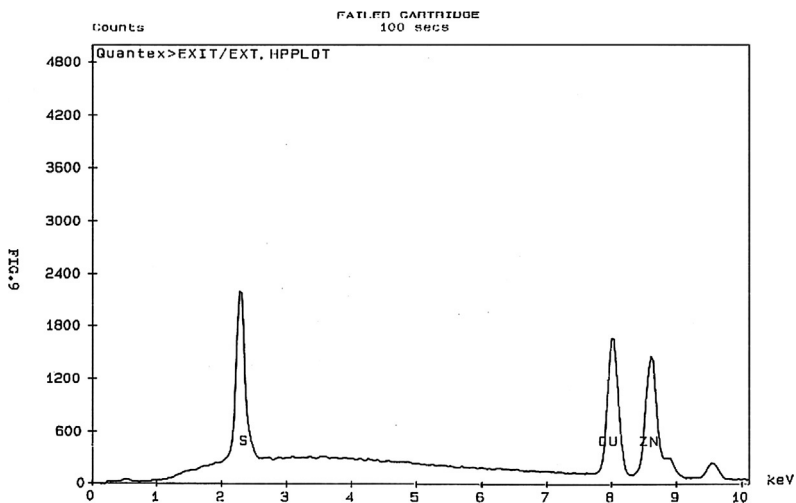
**Fig. 4.4.7** EDAX of the inclusion showing presence of S, Cu, and Zn.

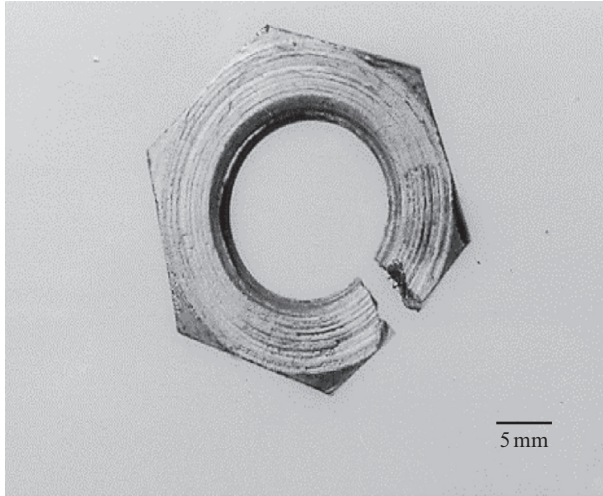
*Visual Examination:* The failed nut in the as-received condition is shown in Fig. 4.5.1. The nut has fractured along the longitudinal axis.

**Fig. 4.5.1** Failed nut in the as-received condition.

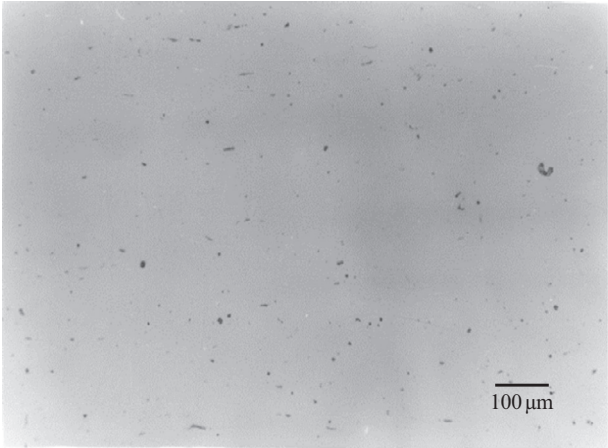
nonmetallic inclusions and also some large slag pockets (Figs. 4.5.3 and 4.5.4). On etching with 2% nital, the sample revealed a tempered martensite structure (Fig. 4.5.5).

**Fig. 4.5.3** Micrograph of the sample showing a large number of elongated sulfides and globular oxide inclusions. Unetched.

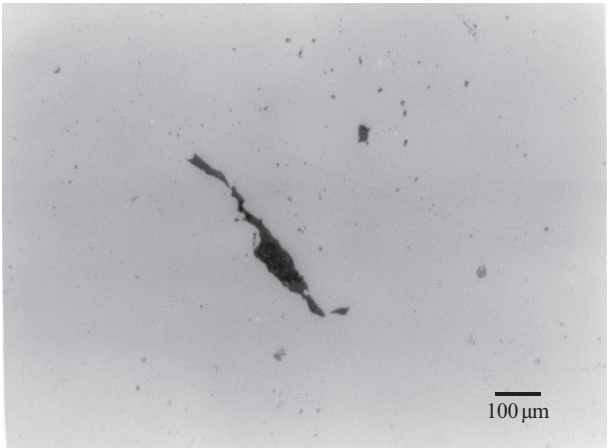
**Fig. 4.5.4** Micrograph of the sample showing a large slag pocket. Unetched.

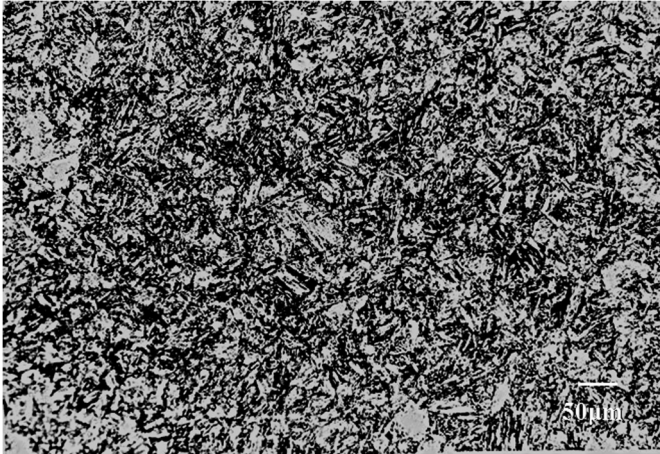
**Fig. 4.5.5** Micrograph of the sample showing a tempered martensite structure. Etchant: 2% nital.

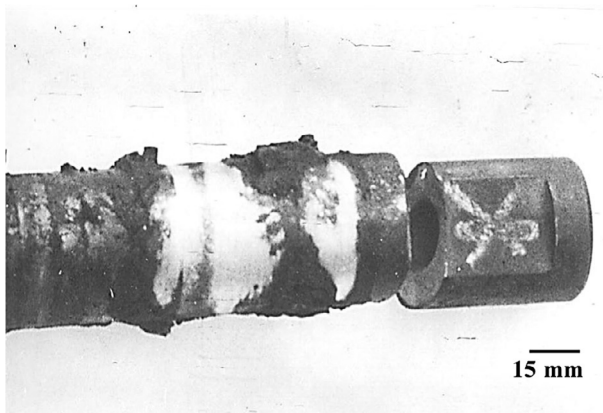
*Visual Examination:* The failed track pin sample in the as-received condition is shown in Fig. 5.1.1. The pin was found to have broken at the edge of a rectangular slot on the surface at one end. Broken parts of the rubber bush were seen sticking to surface of the pin. Fracture surface showed chevron marks converging at the central portion of the edge of the slot (Fig. 5.1.2).

Fig. 5.1.1 The failed track pin sample in the as-received condition.

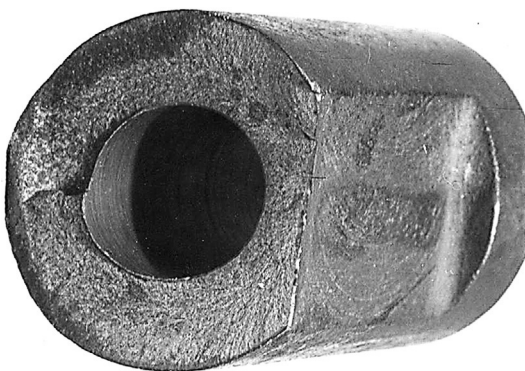
**Fig. 5.1.2** Fracture surface showing chevron marks converging at the central portion of the edge of the slot

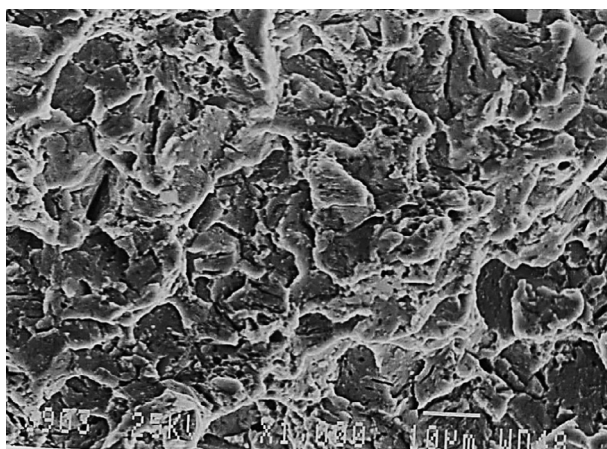
*Fractographic Examination:* On examining the cleaned fracture surface under SEM it showed quasi-cleavage fracture features with secondary cracks (Fig. 5.1.3).

**Fig. 5.1.3** SEM fractograph showing quasi-cleavage fracture features with secondary cracks

The chemical composition suggested that the failed track pins were nearly conforming to En24 grade steel. The quasi-cleavage fracture was indicative of the fact that the failure had occurred at relatively high strain rate, which is possible under the influence of a stress raiser. Here insufficient fillet radius at the edge of the slot could act as the requisite stress raiser. The persistence of cast structure indicated insufficient reduction from stages of cast ingot to the rolled pin. Chemical inhomogeneity due to the cast structure was responsible for banded microstructure varying from carbides and ferrite to tempered martensite after the heat treatment of the pins. Higher hardness of the pins as compared to the specification again indicated improper heat treatment or the initial microstructure not responding to the specified heat treatment.

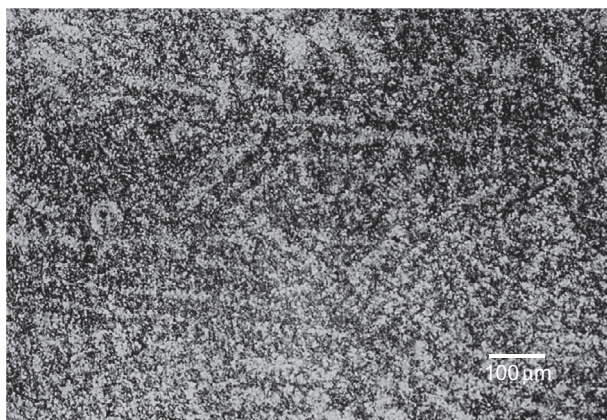
**Fig. 5.1.4** Micrograph of the transverse section revealing a typical cast structure with fine dendrites. Etchant: 2% nital.

The presence of cast structure, chemical inhomogeneity, and high hardness resulted in inadequate ductility. The radius provided at the edge of the slot would probably be insufficient for the altered condition of the steel.

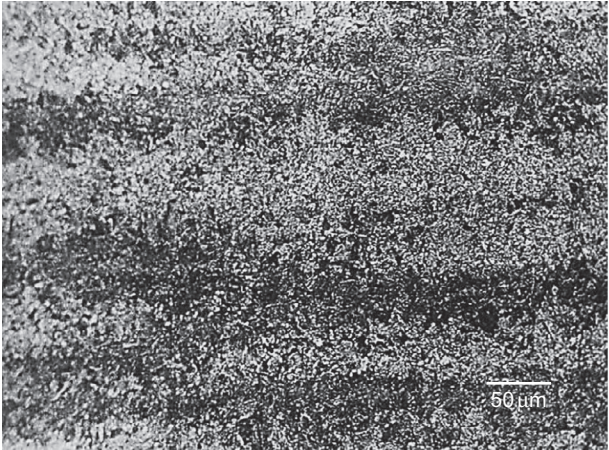
**Fig. 5.1.5** Micrograph of the longitudinal section showing spheroidized carbides and ferrite in the bright band and tempered martensite in the dark band. Etchant: 2% nital.

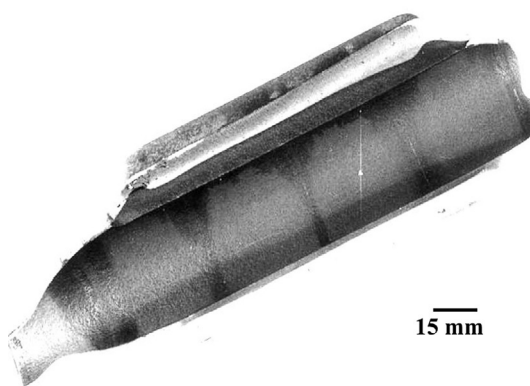
*Visual Examination:* A part of the failed track shoe is shown in Fig. 5.2.1. The fracture surface was found to be dark along the length to a depth of 2mm

Fig. 5.2.1 Part of the failed track shoe in the as-received condition.

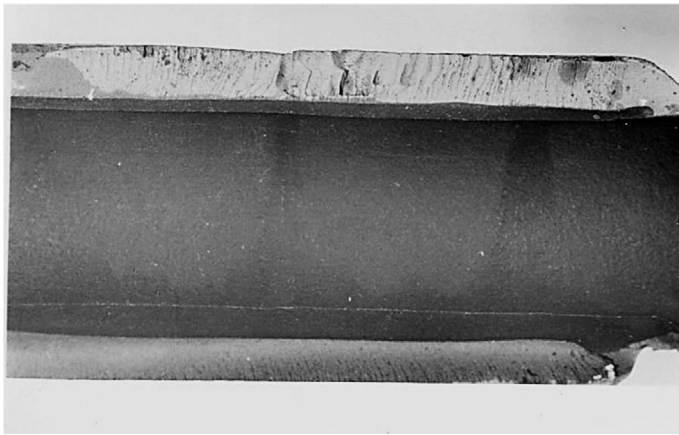
**Fig. 5.2.2** Fracture surface of the failed component showing dark color to a depth of 2mm near the inner surface.

The dark adherent oxide on the fracture surface near the inner surface masking intergranular fracture features indicated that this was a preexisting crack in the component that was inherited from a stage prior to heat treatment. Oxidation and consequent decarburization of the regions adjacent to the fracture surface suggest that the preexisting intergranular crack was exposed to the furnace atmosphere during austenitization. The evidences thus point out that the most probable stage of development of the crack in the track shoe was during material processing.

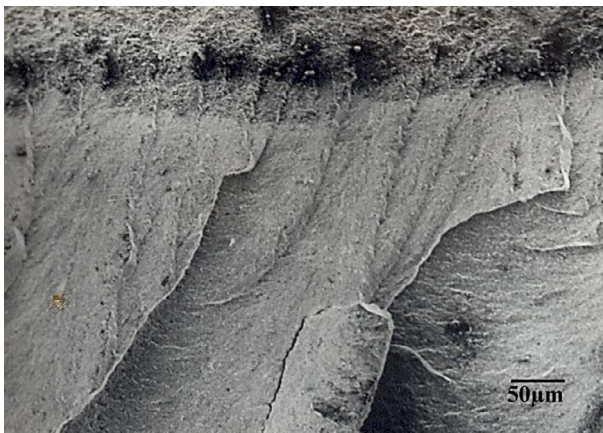
**Fig. 5.2.3** SEM fractograph showing fracture initiating from the inner surface.

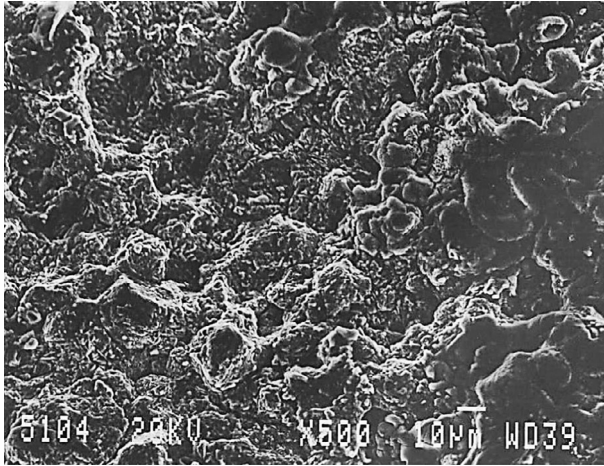
**Fig. 5.2.4** SEM fractograph showing adherent oxide layer on the dark region of the fracture surface.

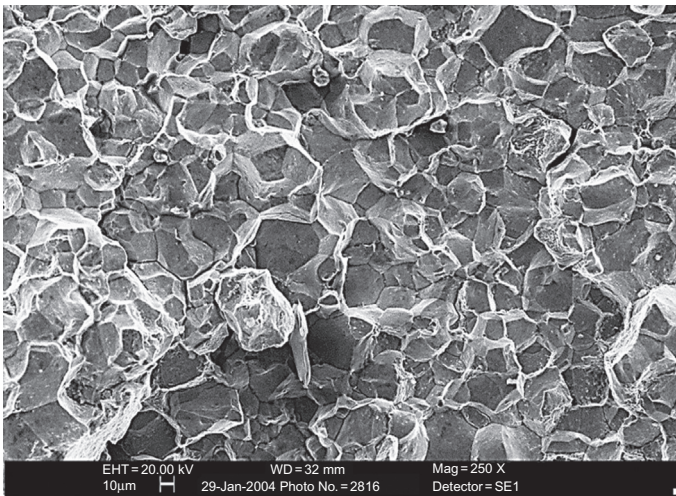
**Fig. 5.2.5** SEM fractograph showing intergranular fracture with secondary intergranular cracks.

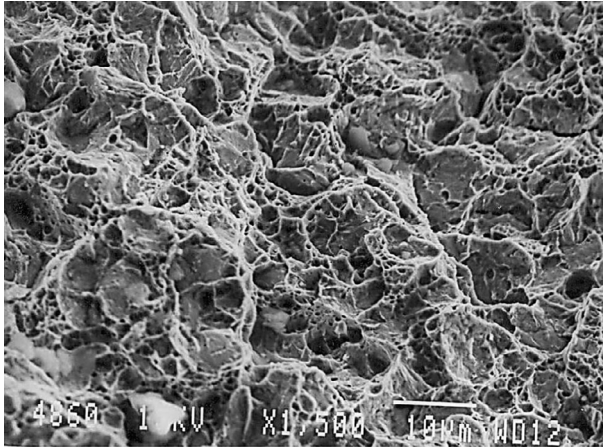
**Fig. 5.2.6** SEM fractograph showing quasi-cleavage fracture on the remaining fracture surface.

The final failure of the component has occurred due to high strain rate under the stress-raising influence of the preexisting crack in a brittle mode. The higher hardness and lower ductility of the changed steel has aided in the brittle failure of the component by lowering its brittle fracture energy.

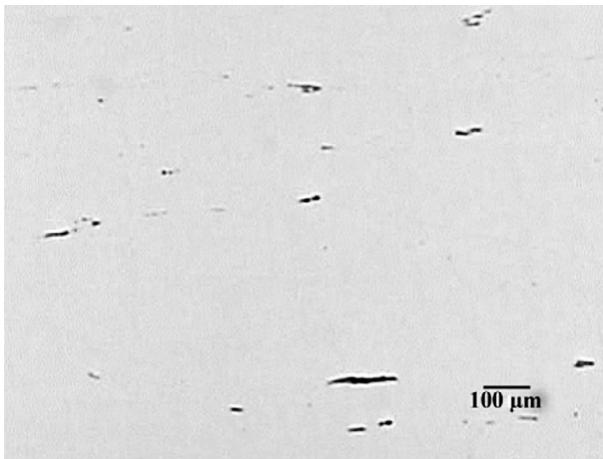
**Fig. 5.2.7** Micrograph of the longitudinal section of the sample showing elongated sulfide and globular oxide inclusions. Unetched.

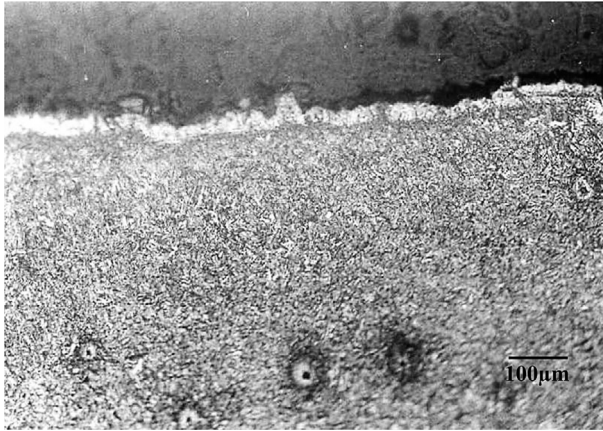
**Fig. 5.2.8** Micrograph of transverse section of the sample showing decarburized layer and intergranular cracks near the surface. Etchant: 2% nital.

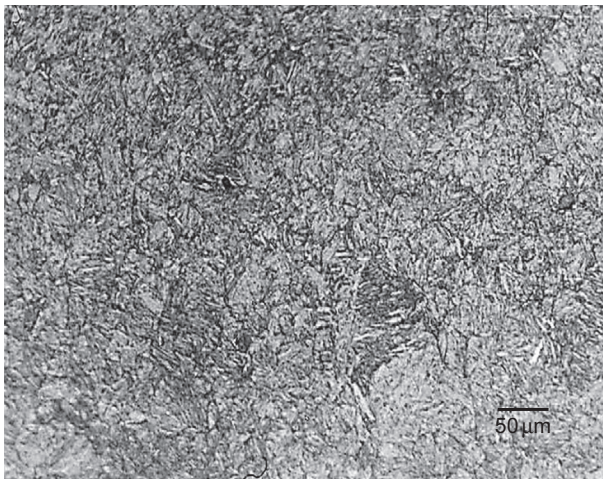
**Fig. 5.2.9** Micrograph of the longitudinal section of the sample showing a tempered martensite structure. Etchant: 2% nital.

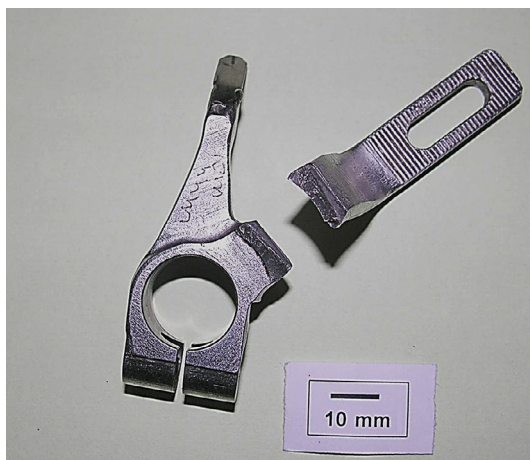
*Visual Examination:* The failed component in the as-received condition is shown in Fig. 5.3.1. The fracture surface showed two distinct planes. One fracture surface showed dark layer of grease and dust smeared on it and other was brighter and relatively smooth.

**Fig. 5.3.1** The broken control lever in the as-received condition. The two distinct fracture surfaces with a prominent demarcation of change in plane are seen.

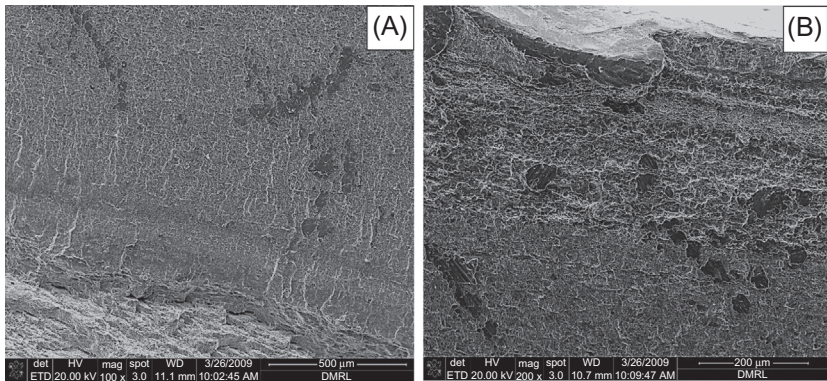
*Fractographic Examination:* The fracture surface was cleaned with dilute oxide remover followed by cleaning in acetone ultrasonically and examined under SEM. The fracture surface showed three distinct regions. The originally dark region of the fracture surface appeared granular, brighter region appeared smooth and the shear lip region appeared fibrous (Fig. 5.3.2A and B). At higher magnification, the granular part of the fracture surface revealed a predominantly transgranular cleavage fracture (Fig. 5.3.3), the smooth fracture surface revealed a quasi-cleavage fracture (Fig. 5.3.4) and the final failure region of about 500  $\mu\text{m}$  width showed dimpled rupture (Figs. 5.3.5).

**Fig. 5.3.2** (A) SEM fractograph of the fracture surface showing granular feature in the dark region and smooth fracture in the bright region. (B) SEM fractograph of the final failure region showing fibrous fracture.

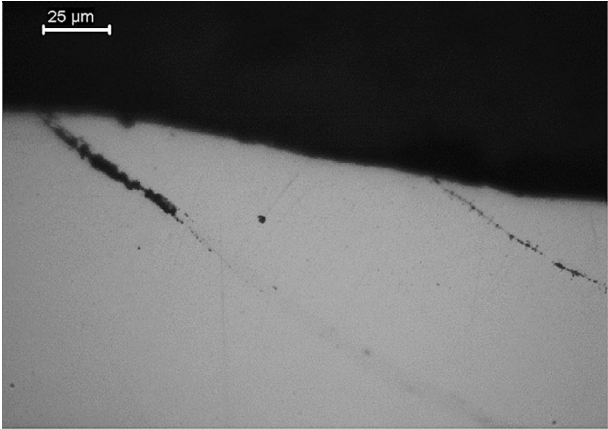
*Metallographic Examination:* Longitudinal section of the failed component taken from the elbow portion of the component was prepared for metallographic examination. In the unetched condition, the sample showed a few preexisting cracks filled with oxides near the surface (Fig. 5.3.6). On etching with aqua-regia decarburized layer was seen around one of the cracks (Fig. 5.3.7). The cracks were found to be propagating along the interface

**Fig. 5.3.6** Micrograph of a sample away from fracture showing preexisting Oxide-filled cracks near the surface. Unetched.

The microstructure revealed grain flow tracing the contours of the profile of the component, indicating that the component was a forged product. The presence of surface cracks with oxides suggested that they were formed during forging. The decarburized layer around the crack also suggested that the cracks were existing in the material prior to austenitization treatment. The presence of grease and dust on one part of the fracture surface indicated that it was a preexisting part of the crack that was exposed to the environment when the lever was operational.

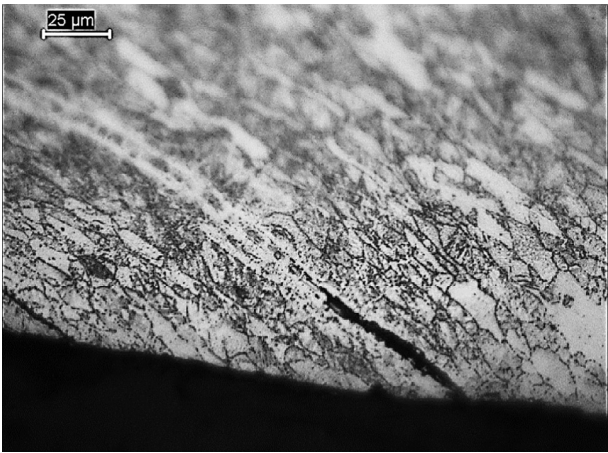
**Fig. 5.3.7** Micrograph of the sample showing decarburization around the preexisting wide crack. Etchant: aqua regia.

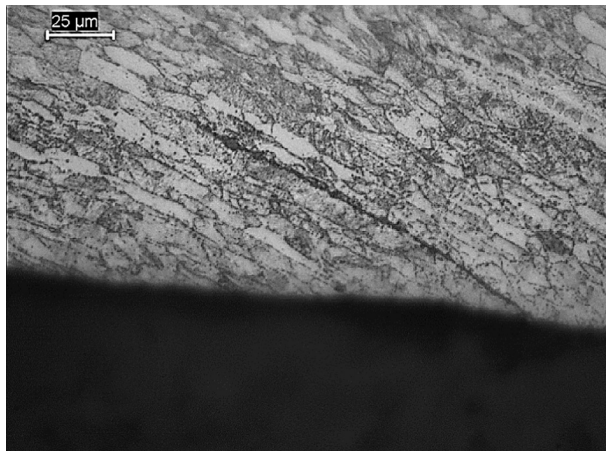
**Fig. 5.3.8** Micrograph of the sample showing preexisting transgranular crack propagating along the interface of martensite and  $\delta$ -ferrite. Etchant: aqua regia.

The evidences revealed that at the region of failure there preexisted a forging crack. The stress-raising influence of the preexisting crack caused its propagation under operational load ultimately resulting in its failure. The high chromium and tungsten content in the  $\delta$ -ferrite makes it a brittle phase in martensitic stainless steel [2]. The cleavage mode of failure is due to the presence of  $\delta$ -ferrite in the microstructure and brittleness caused due to tri-axial state of stress at the preexisting crack.

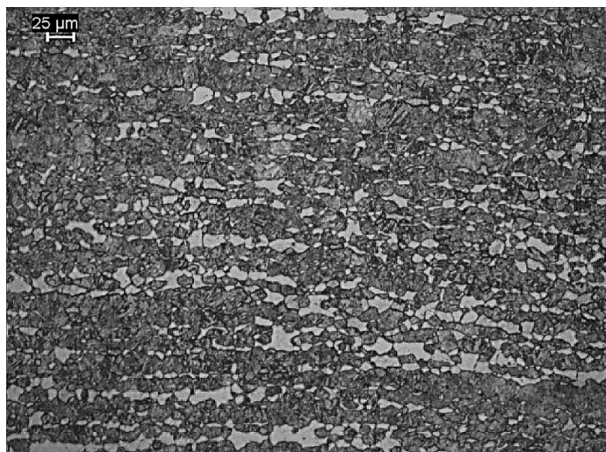
of martensite and  $\delta$ -ferrite, the two major phases observed in the microstructure (Fig. 5.3.8). The microstructure showed grains tracing the contour of the profile of the component. The microstructure revealed tempered martensite and  $\delta$ -ferrite (Fig. 5.3.9). The volume fraction of  $\delta$ -ferrite was nearly 15%–20%.

**Fig. 5.3.9** Micrograph of a section of the sample showing aligned  $\delta$ -ferrite in a matrix of tempered martensite. Etchant: aqua regia.

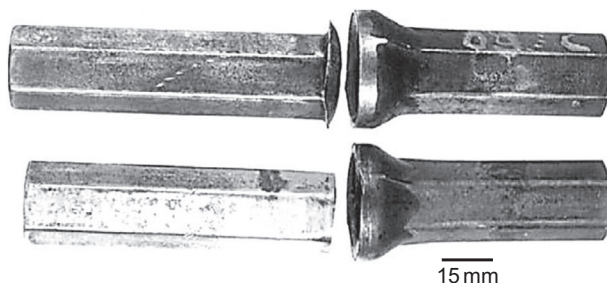
*Visual Examination:* Two failed drill rods in the as-received condition are shown in Fig. 5.4.1, and an unused one from the same batch of manufacture is shown in Fig. 5.4.2. On visual examination it was observed that in all the samples received for failure analysis the collar-shank fillet was sharp and the surface at this junction was quite rough (Fig. 5.4.2). From Fig. 5.4.1 it can be seen that the failure had occurred near the collar-shank junction in all the samples. The fracture surfaces were found rubbed, damaged, and rusted in all the samples (Fig. 5.4.3).

Fig. 5.4.1 Failed drill rods in the as-received condition.

- (i) Exercise proper control over collar forging operation in order to avoid formation of cracks.
- (ii) Render higher fillet radius and proper surface finish at the collar-shank junction.
- (iii) Impart hardening and tempering treatment to the collar region instead of normalizing in order to obtain the specified hardness level.

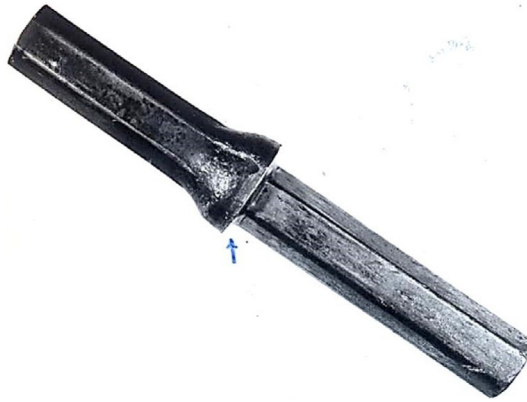
**Fig. 5.4.2** An unused drill rod from the same batch of manufacture in the as-received condition.

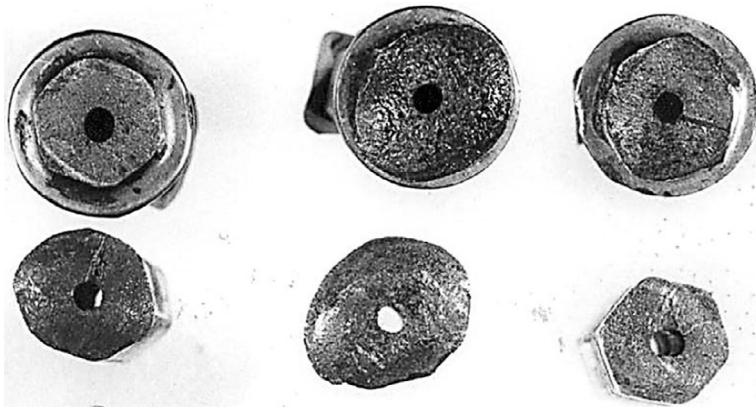
**Fig. 5.4.3** Fracture surfaces showing rubbed, damaged, and rusted surfaces.

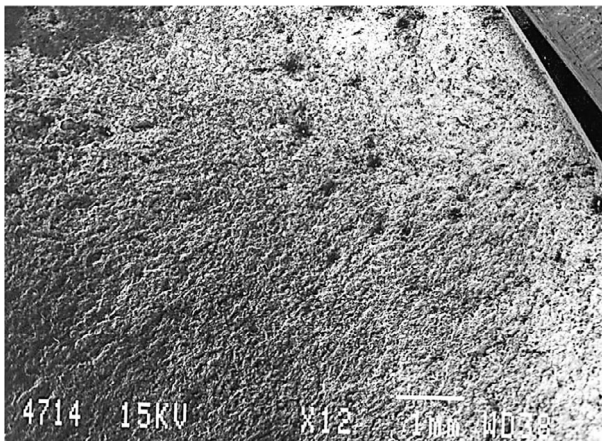
**Fig. 5.4.4** SEM fractograph of the fracture surface showing a typical crack origin at the collar-shank junction.

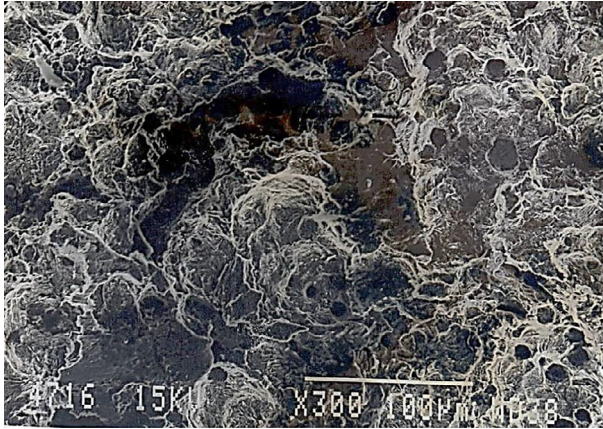
**Fig. 5.4.5** SEM fractograph of the fracture surface near the crack origin showing some adherent oxides and pits.

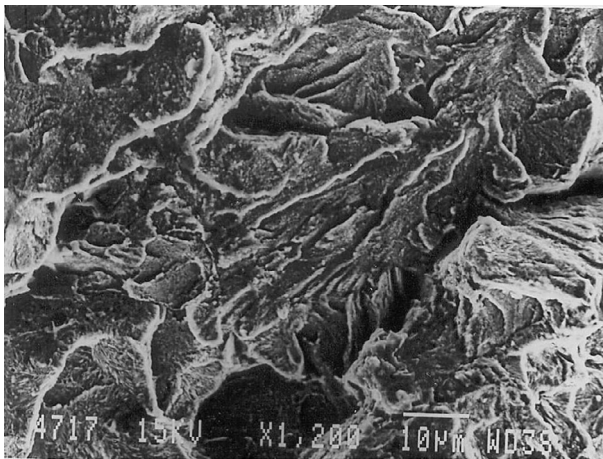
**Fig. 5.4.6** SEM fractograph of the fracture surface showing transgranular cleavage fracture.

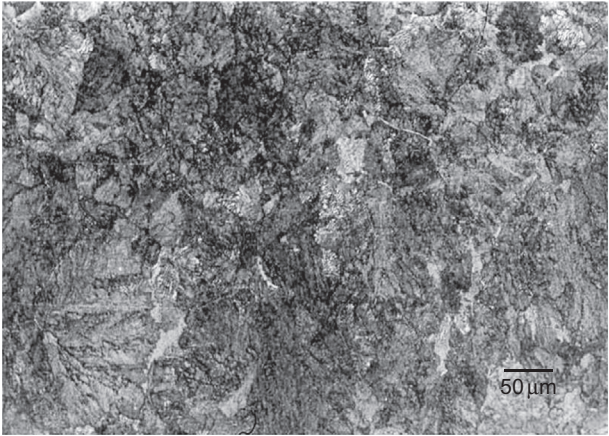
*Metallographic Examination:* Longitudinal sections from near the failed region were prepared from all the drill rod samples and examined under optical microscope. On etching with 2% nital, the samples revealed ferrite and lamellar pearlite structure. A representative microstructure is shown in [Fig. 5.4.7](#). The unused drill rod sample was also examined under optical microscope after preparing a longitudinal section of the sample from a similar area as that of the failed samples. The fillet contour at the collar-shank junction showed sharp nicks ([Fig. 5.4.8](#)). A crack was also observed to have initiated from one of the nicks and propagated in a transgranular mode

**Fig. 5.4.7** Micrograph of longitudinal section of the failed drill rod sample showing ferrite and lamellar pearlite structure. Etchant: 2% nital.

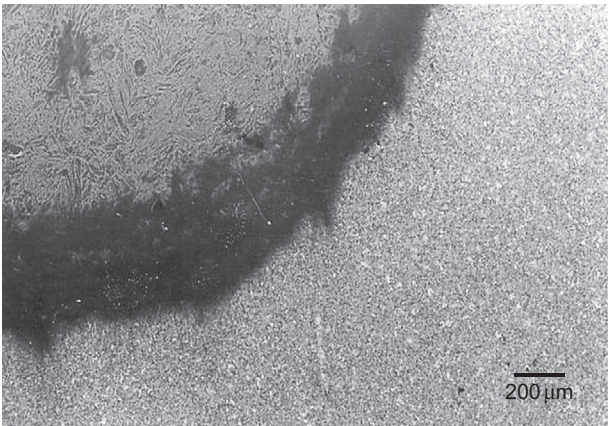
**Fig. 5.4.8** Micrograph of a section of the unused drill rod sample showing sharp nicks on fillet contour at the collar-shank junction. Etchant: 2% nital.

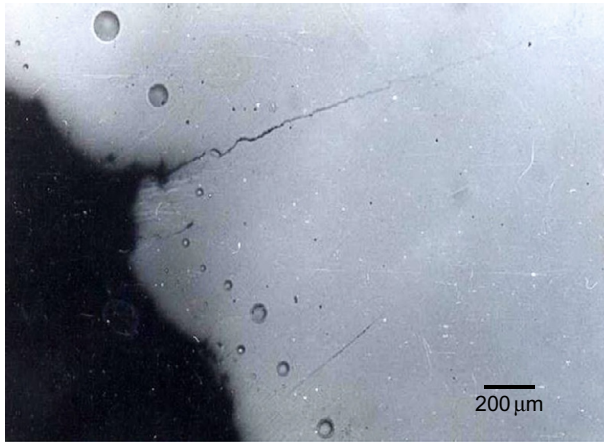
**Fig. 5.4.9** Micrograph of a section of the unused drill rod sample showing transgranular crack propagating from one of the sharp nicks.

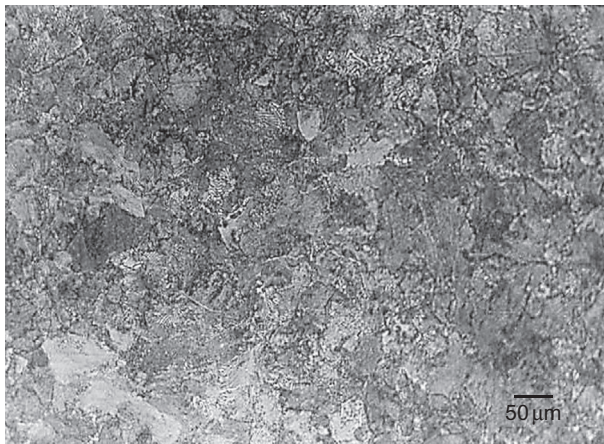
**Fig. 5.4.10** Micrograph of a section of the unused drill rod sample showing ferrite and lamellar pearlite. Etchant: 2% nital.

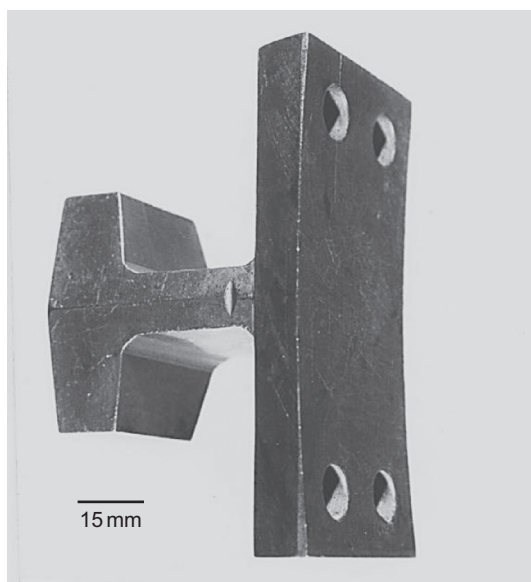
*Visual Examination:* A cracked lug in the as-received condition is shown in Fig. 5.5.1. The lug showed deep grooves, steps, and severe roughness on the machined surface. The crack was forced open. The fracture surface showed dark color and rust across the stem and at least on half the section of the base (Fig. 5.5.2). Bright yellow color was also seen on one-third of the thickness on all four sides of the fracture surface at the base.

Fig. 5.5.1 A cracked lug in the as-received condition.

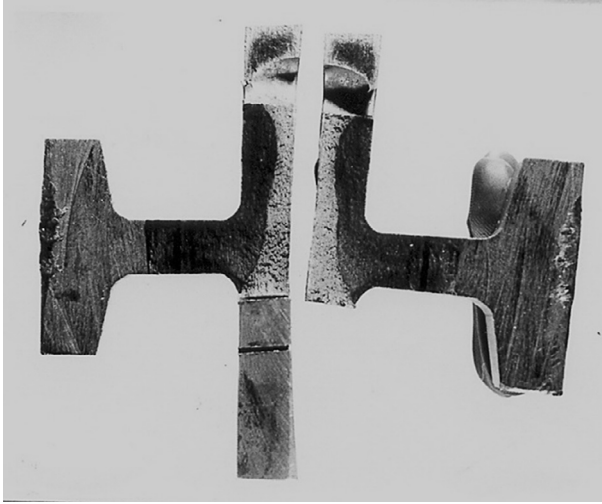
**Fig. 5.5.2** The fracture surface showing dark color and rust across the stem and at least on half the section of the base.

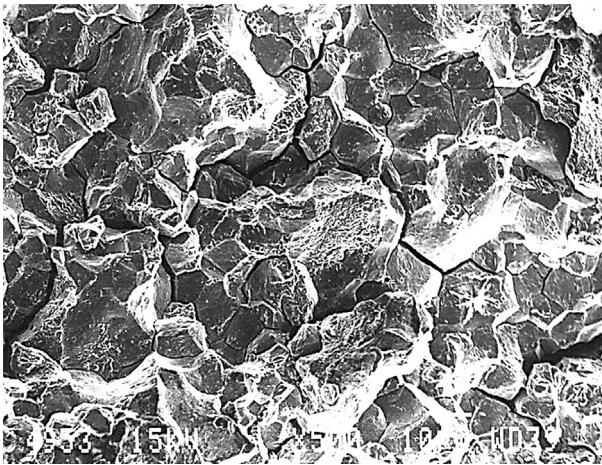
**Fig. 5.5.3** SEM fractograph of the dark region of the fracture surface showing an intergranular fracture with secondary cracks.

It is confirmed that the crack existed before cadmium plating and since hydrogen embrittlement often results after cadmium plating, this reason for cracking can be ruled out. Considering the significant variation in section thickness and poor surface finish after machining, the susceptibility of the lug to quench cracking is highly probable as these act as stress raisers.

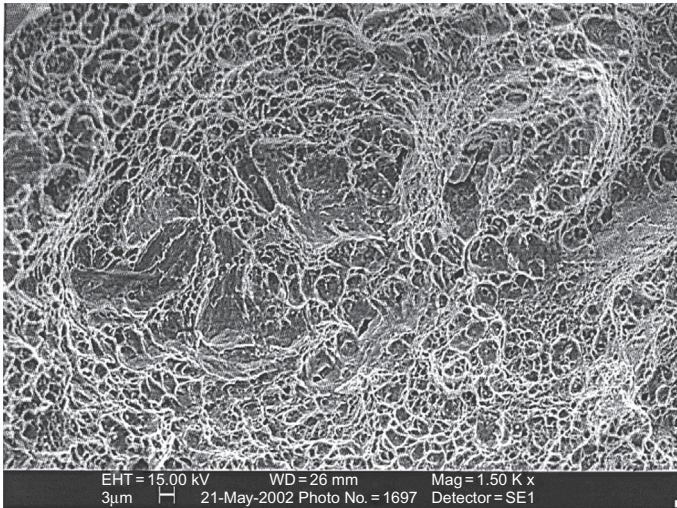
**Fig. 5.5.4** SEM fractograph of the remaining part of the fracture surface showing fine equiaxed dimpled rupture.

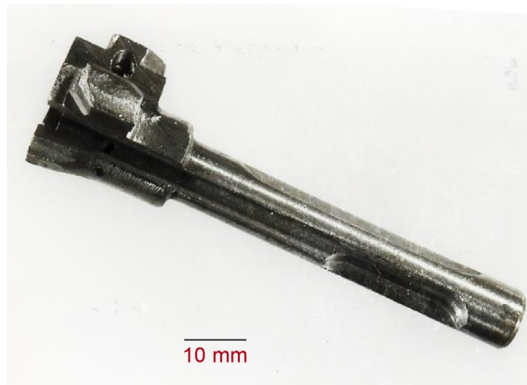
*Visual Examination:* One of the breech blocks showing a typical failure in the as-received condition is shown in Fig. 5.6.1. The breech block showed wide variation in section thickness. The failure was found to have occurred at the ejector chamber where the section thickness was the lowest. Cracks were also observed around the firing pin retainer hole adjacent to the extractor recess (Fig. 5.6.2).

**Fig. 5.6.1** Failed breech block in the as-received condition.

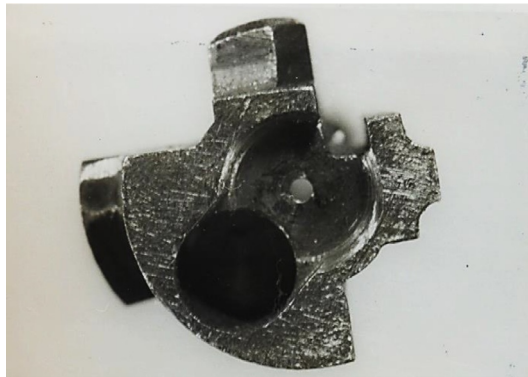
**Fig. 5.6.2** Close-up view of the failed component showing cracks around the firing pin retainer hole adjacent to the extractor recess.

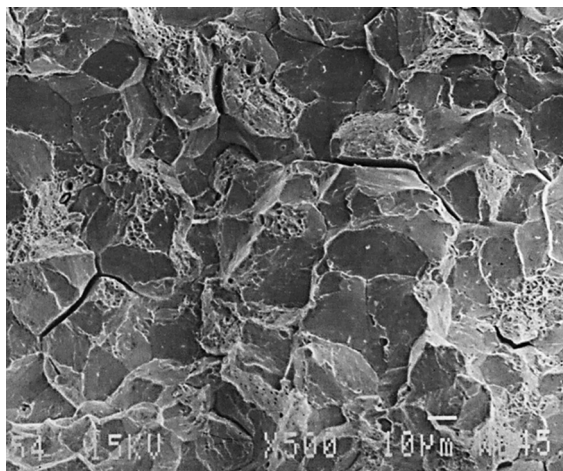
**Fig. 5.6.3** SEM fractograph at the crack origin showing intergranular fracture with secondary cracks.

The fracture origin was located at the surface, which incidentally was case hardened and finish ground. Intergranular cracks had developed on the surface either during grinding of the case or during operation of the weapon. Under the influence of the stress-raising effect of the intergranular crack at the surface, the remaining crack had propagated in a mixed quasi-cleavage and dimple mode due to overload at a high strain rate.

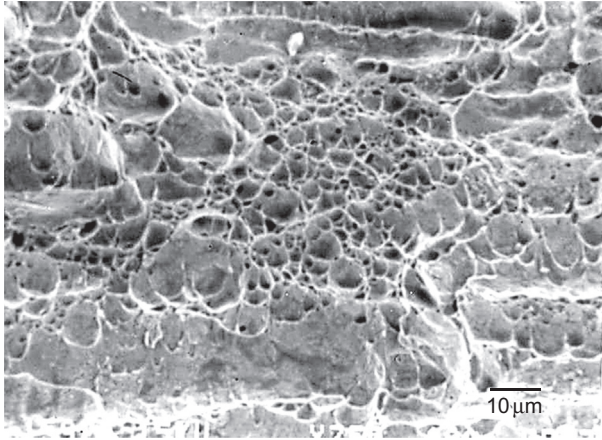
**Fig. 5.6.4** SEM fractograph of the remaining fracture surface showing a mixed mode of quasi-cleavage and dimpled rupture.

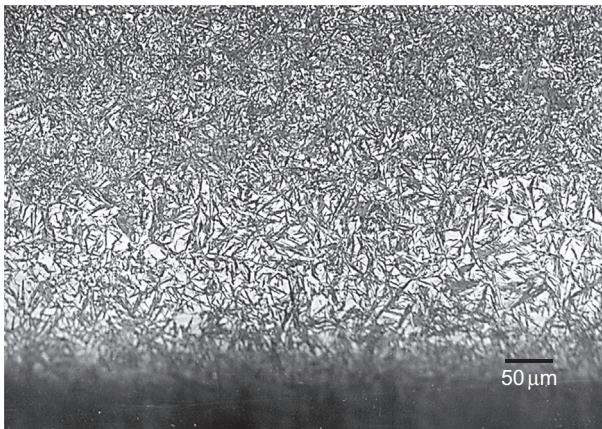
surface leaving about an average of 0.40 mm thick core in the failed region (Fig. 5.6.5). Near the hole at one location, the entire section thickness showed a case (Fig. 5.6.6). The case showed acicular martensite and retained austenite (Figs. 5.6.5 and 5.6.6). The core of the sample showed a tempered martensite structure (Fig. 5.6.7).

**Fig. 5.6.5** Micrograph showing a deep case carburized layer near the failed region. Etchant: 2% nital.
