# **METALLURGICAL FAILURE ANALYSIS**

Techniques and Case Studies

KANNADI PALANKEEZHE BALAN

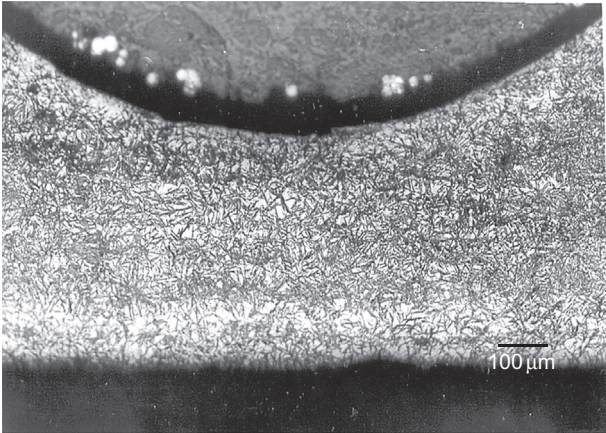
**Fig. 5.6.6** Micrograph showing case carburized layer across the thickness near a hole. Etchant: 2% nital.

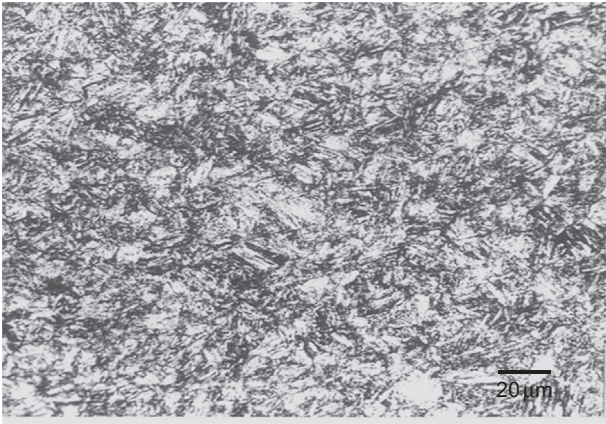
**Fig. 5.6.7** Micrograph showing a tempered martensite structure at the core of the sample in the thick section. Etchant: 2% nital.

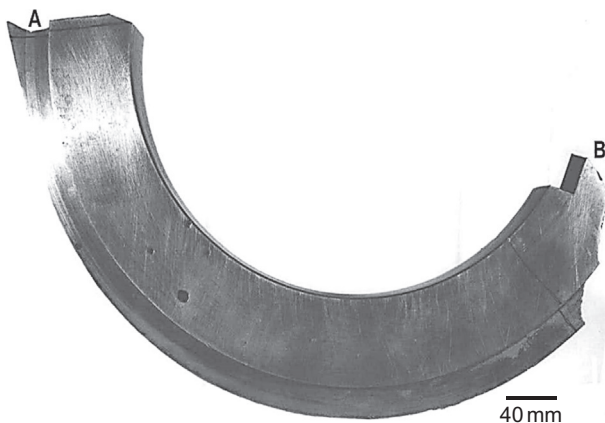
*Visual Examination:* Broken part of one of the pieces of the ring in the as-received condition is shown in Fig. 5.7.1. The cutter ring was found to have broken from two portions that are almost diametrically opposite (A and B in Fig. 5.7.1). Fracture at location 'A' had initiated from the corner of the keyway and propagated radially outward at an angle of  $\sim 0^\circ$  up to the section where the thickness decreases (Fig. 5.7.2). The fracture surface showed a coarse and crystalline fracture under stereomicroscope. Location 'A' showed

Fig. 5.7.1 The broken cutter ring in the as-received condition.

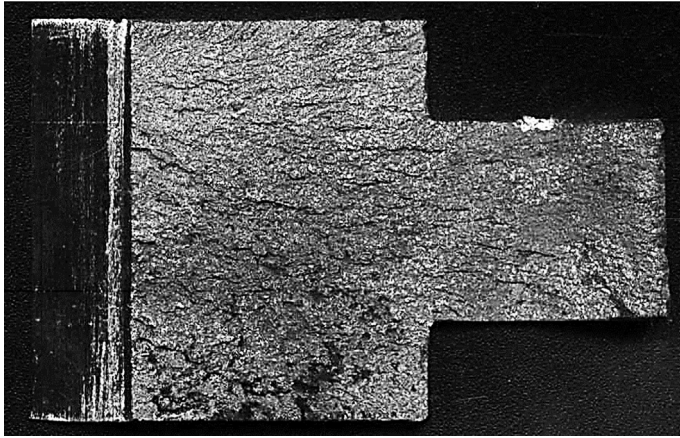
**Fig. 5.7.2** Fracture surface at location 'A' showing a brittle fracture.

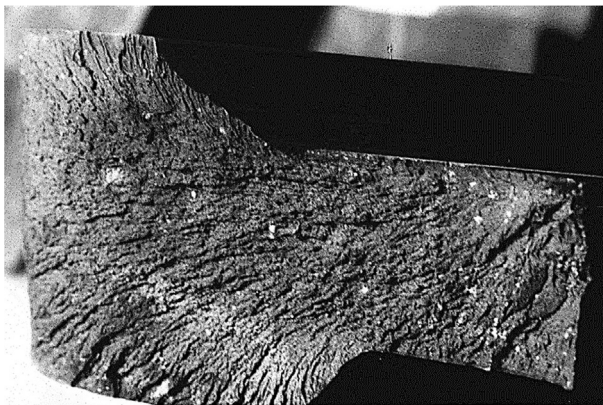
a fracture without any deformation except for a small shear lip at the final failure zone. Fracture at location 'B', on the other hand, revealed a shear at  $45^\circ$  originating at a corner of the cutting tool and propagating radially inward as seen by the chevron pattern on the fracture surface (Fig. 5.7.3). The fracture surface showed a fibrous fracture when examined under stereomicroscope.

**Fig. 5.7.3** Fracture surface at location 'B' showing chevron marks.

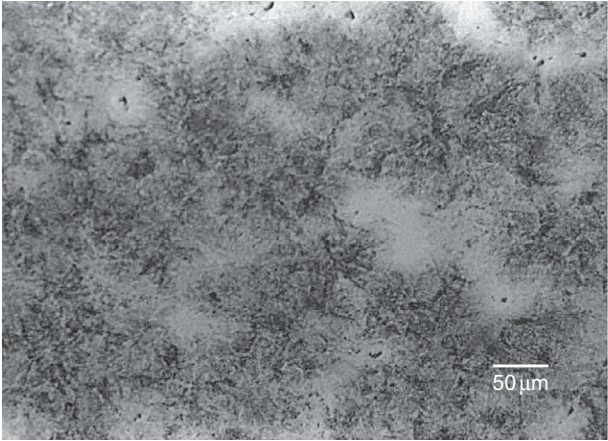
*Metallographic Examination:* A section of the ring was prepared and examined under optical microscope. On etching with 2% nital, the sample revealed a cored structure of tempered martensite (Fig. 5.7.6).

**Fig. 5.7.6** Micrograph of a section of the cutter ring showing a cored structure of tempered martensite. Etchant: 2% nital.

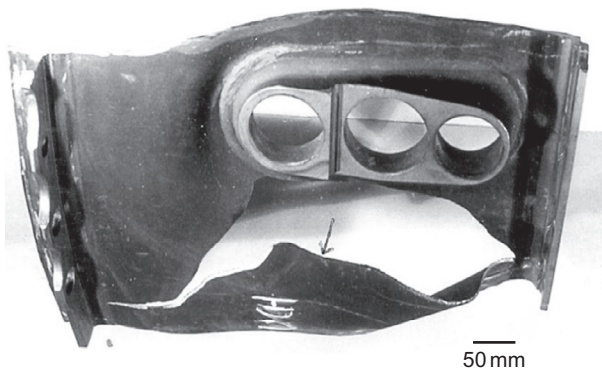
*Visual Examination:* The combustion chamber outer casing (C.C.O. casing) was observed to have failed along the weld between the elliptical area containing the three hollow cylindrical portions and the C.C.O casing sheet (Fig. 5.8.1). The fracture surface of a length of about 50 mm (arrow in Fig. 5.8.1) in the sheet was found to be smooth and dark with no noticeable deformation. The rest of the fracture surface was bright and fibrous with a 45° shear failure.

Fig. 5.8.1 The failed part of CCO casing in the as-received condition.

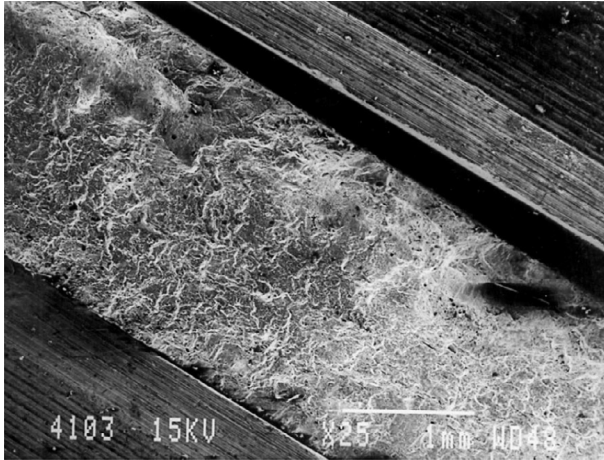
**Fig. 5.8.2** SEM fractograph of the fracture surface showing a number of cavities near the inner surface of the casing.

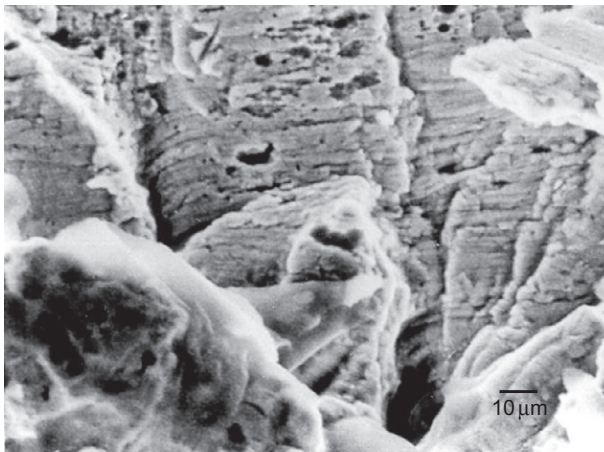
**Fig. 5.8.3** SEM fractograph of the fracture surface showing cleave-like step originating from large cavities near the inner surface of the casing.

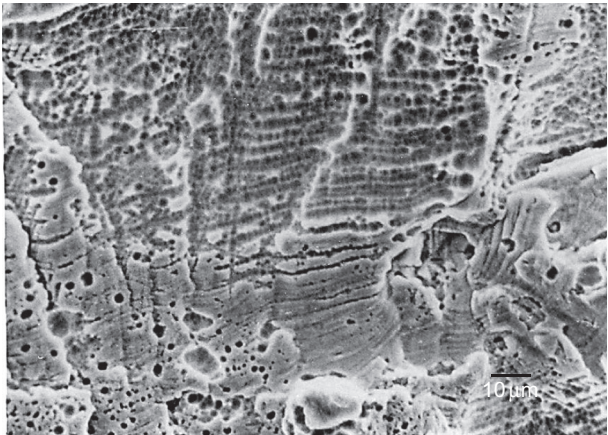
**Fig. 5.8.4** SEM fractograph of the fracture surface showing characteristic fatigue striations masked by globular pits.

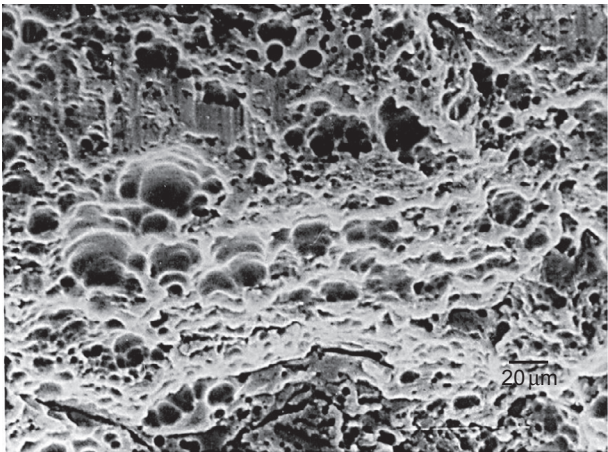
**Fig. 5.8.5** SEM fractograph of the fracture surface showing dimpled rupture in the final failure zone.

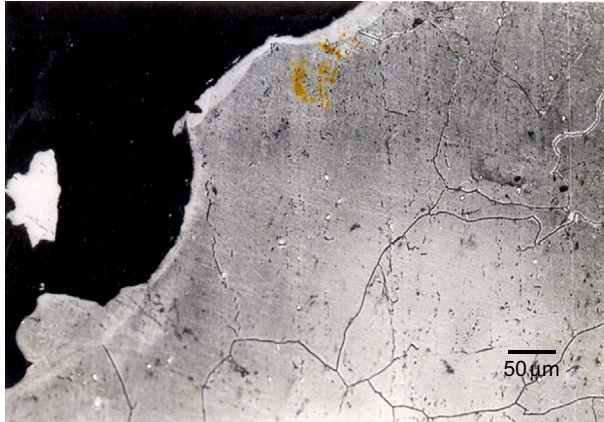
In the unetched condition, the sample showed a number of oxide and nitride inclusions. On etching with acidified ferric chloride the sample revealed failure along the weld (Fig. 5.8.6). The sheet sample showed coarse equiaxed grains of austenite with annealing twins containing carbides and nitrides (Fig. 5.8.7)

**Fig. 5.8.6** Micrograph of a section of the sample showing primary cracking along the weld. Etchant: Acidified ferric chloride.

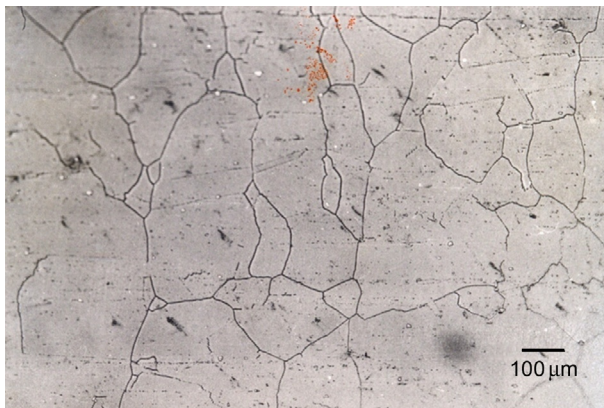
**Fig. 5.8.7** Micrograph of a section of the sample showing coarse equiaxed grains of austenite with annealing twins containing carbides and nitrides. Etchant: Acidified ferric chloride.

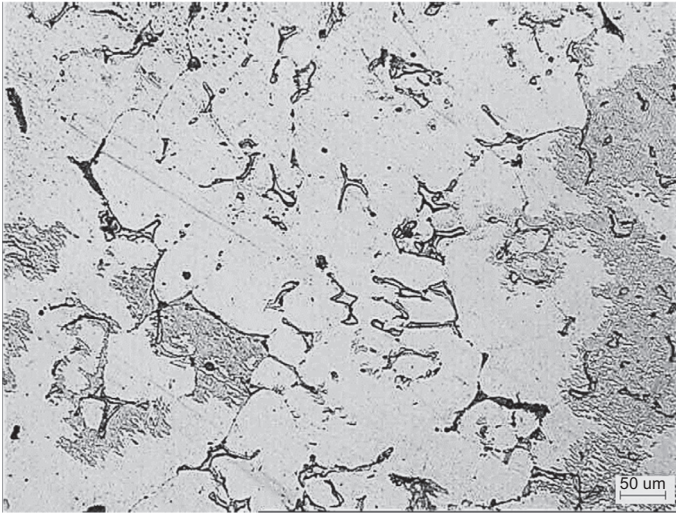
**Fig. 6.1.8** Micrograph of the flange sample showing a dendritic microstructure and interdendritic microcavities. Etchant: Aqua regia.

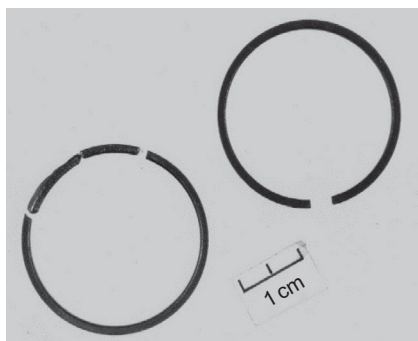
*Visual Examination:* The sealing rings in the as-received condition are shown in Fig. 6.2.1. The fracture surface when examined under stereomicroscope was seen to be coarse and crystalline.

Fig. 6.2.1 Failed sealing rings in the as-received condition.

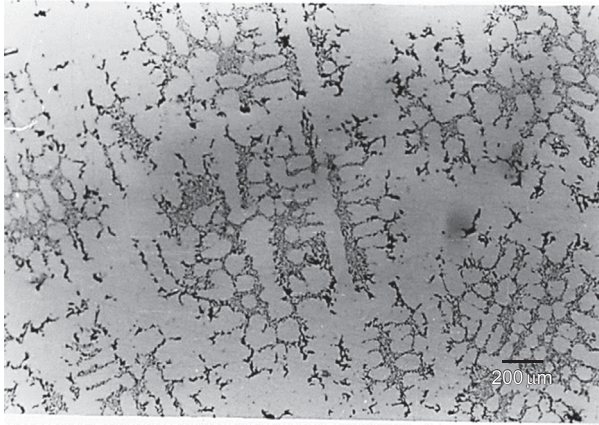
**Fig. 6.2.4** A typical micrograph showing E-type graphite distribution in a section of sample A. Unetched.

*Metallographic Examination:* Sections of the two failed samples were prepared for metallographic examination. In the unetched condition, sample (A) showed interdendritic segregation of fine graphite flakes having preferred orientation i.e., E-type distribution as per ASTM A247 (Fig. 6.2.4) [1]. In the unetched condition, sample (B) showed random distribution of graphite flakes and rosette grouping, i.e., a mixed A-B type distribution (Fig. 6.2.5) [1]. On etching with 2% nital, the failed sample (A) revealed interdendritic segregation of finer graphite flakes with preferred orientation in a matrix of lamellar pearlite with free cementite (Fig. 6.2.6). On etching

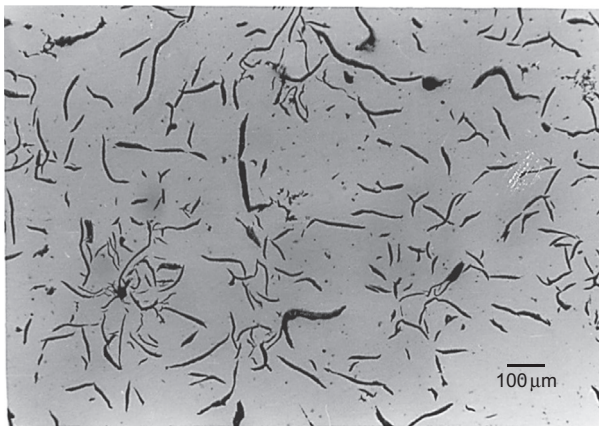
**Fig. 6.2.5** A typical micrograph showing mixed A-B type graphite distribution in a section of sample B. Unetched.

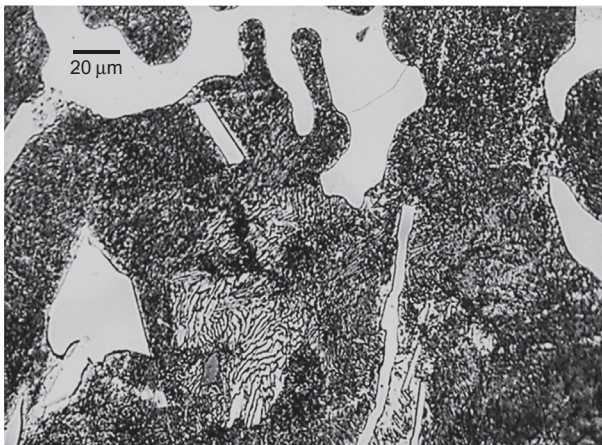
**Fig. 6.3.4** Same as [Fig. 6.3.3](#) at higher magnification. Note the lamellar nature of pearlite phase. Etchant: 2% nital.

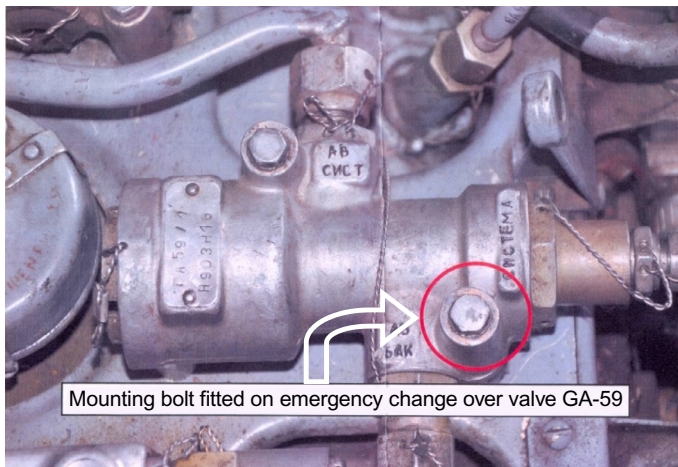
**Fig. 7.1.1** Close-up view showing the mounting bolt fitted on the emergency change over valve.

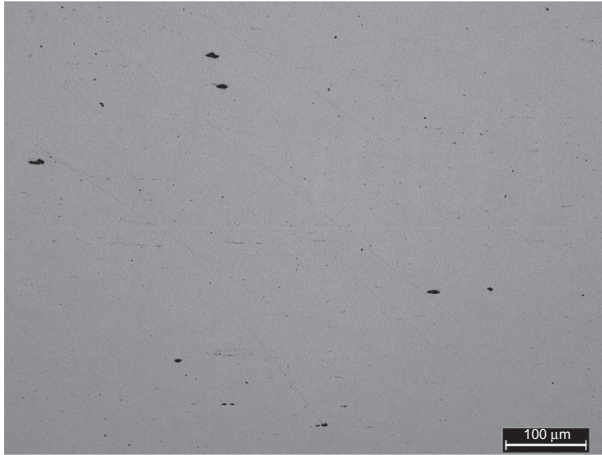
**Fig. 7.1.7** Micrograph of the longitudinal section of the failed bolt showing elongated sulfide and globular oxide inclusions. Unetched.

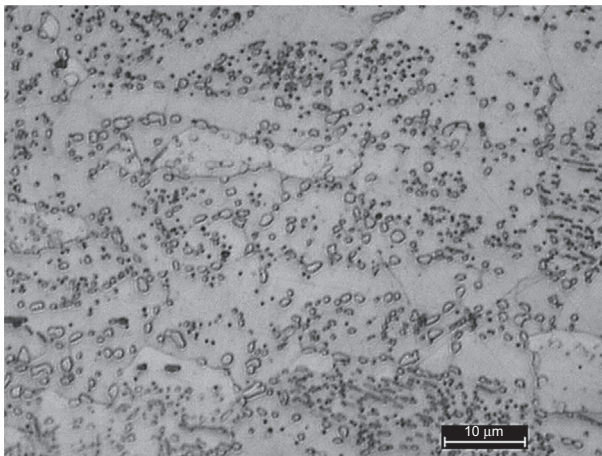
**Fig. 7.1.8** Micrograph of the longitudinal section of the failed bolt showing spheroidized carbides in a matrix of ferrite. Etchant: 2% nital.

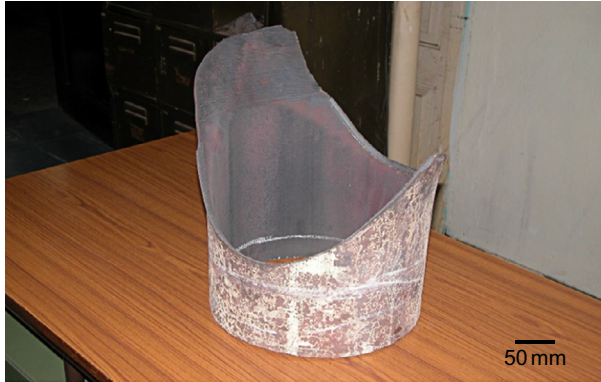
*Visual Examination:* The burst pipe in the as-received condition is shown in Fig. 7.2.1. The pipe was found to have flared and deformed near the fracture. One side of the inner surface of the pipe showed machined grooves which

**Fig. 7.2.1** The burst pipe in the as-received condition.

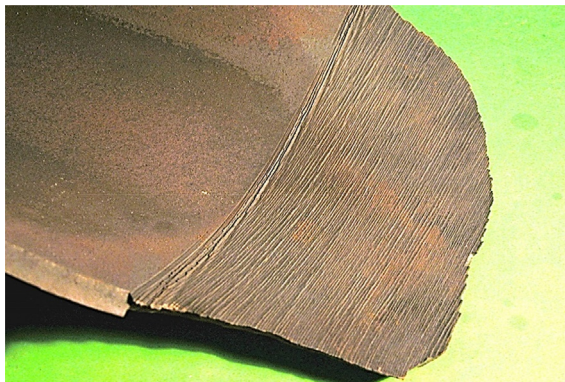
**Fig. 7.2.2** Close up of the inner side of the failed part of the pipe showing deep-machined grooves especially at the junction of the grooving and the smooth region.

was very deep at the junction of the grooved region and the smooth region below (Fig. 7.2.2). The pipe had burst with a  $45^\circ$  shear all along the fracture surface (Fig. 7.2.3). The fracture surface was examined using a magnifying glass. It did not show any origin of failure. Therefore, a number of samples of the fracture surface were taken for further examination by scanning electron microscope (SEM). The dimensions of the burst pipe were as given here.

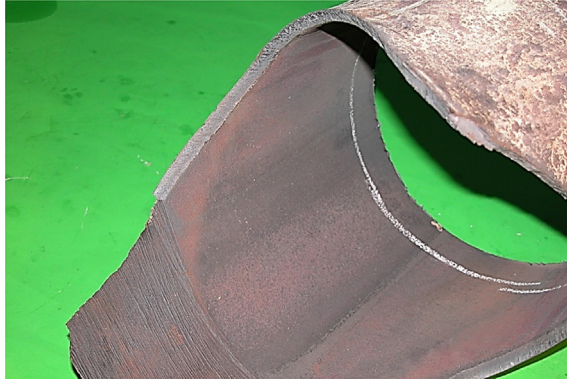
**Fig. 7.2.3** A large portion of the fracture surface of the burst pipe showing a 45° shear.

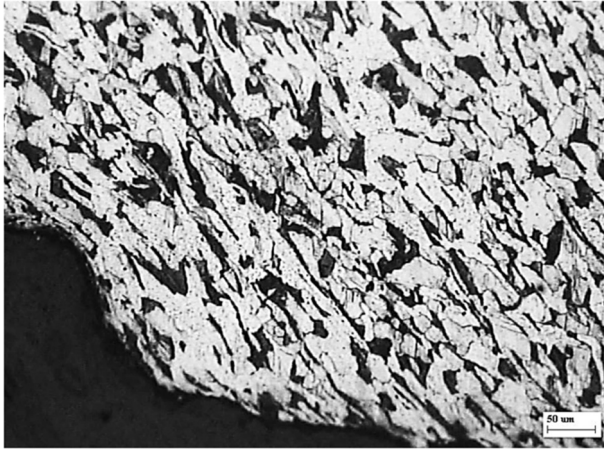
**Fig. 7.2.5** Micrograph of a section of the sample taken from a region near the fracture showing elongated grains of ferrite and pearlite. Etchant: 2% nital.

the sample taken from an area near the fracture showed slip bands and elongated grains of ferrite and pearlite ([Fig. 7.2.5](#)). On observing the section at higher magnification it revealed spheroidized carbides within the ferrite phase and colonies of pearlite ([Fig. 7.2.6](#)). The carbides were found to be segregated more near the pearlite colony as though they were formed out of pearlite phase. The sample away from the fracture showed equiaxed grains of ferrite and colonies of pearlite ([Fig. 7.2.7](#)). The pearlite colony showed lamellar structure.

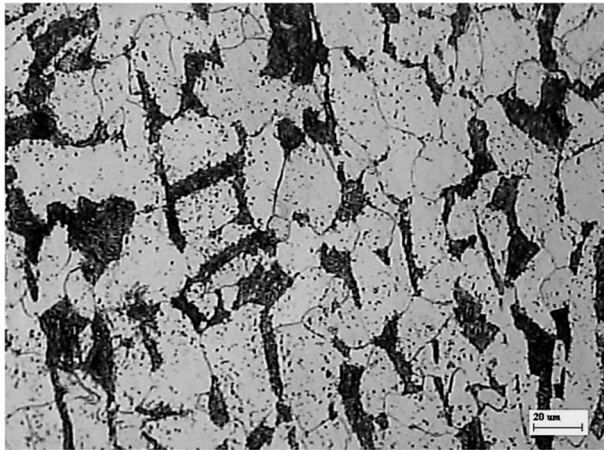
**Fig. 7.2.6** Micrograph of the sample as described in [Fig. 7.2.5](#) showing pearlite (dark) and spheroidized carbides within the ferrite phase. Etchant: 2% nital.

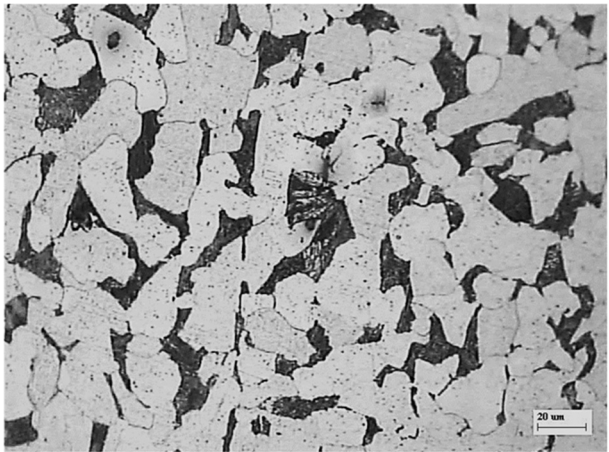
**Fig. 7.2.7** Micrograph of a section of the sample taken from a region away from the fracture showing equiaxed grains of ferrite and colonies of pearlite. Etchant: 2 % nital.

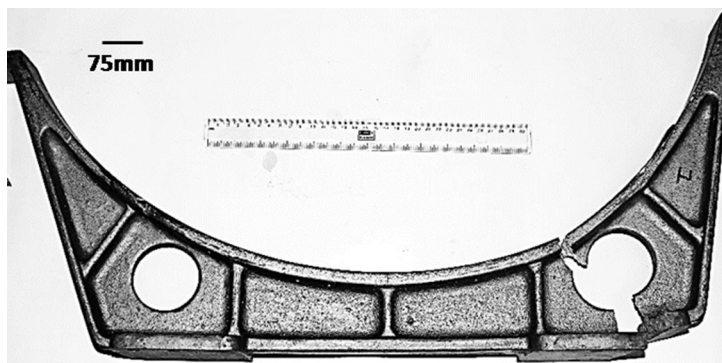
Fig. 7.3.1 Failed body of the saddle in the as-received condition.

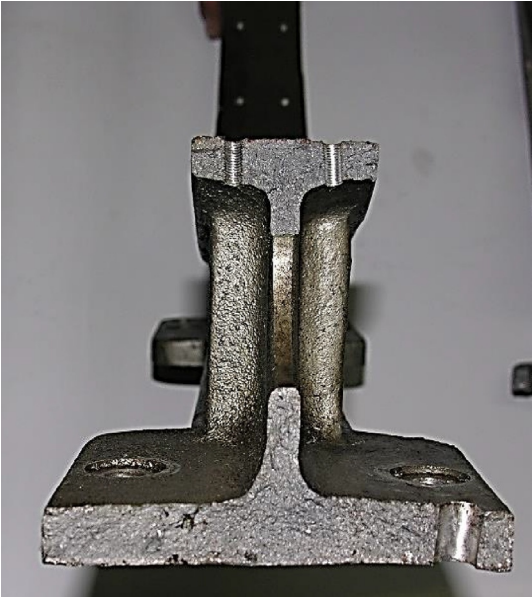
*Visual Examination:* The failed component in the as-received condition is shown in Fig. 7.3.1. The fracture surfaced did not show any probable crack origin. The fracture surfaces showed a mixed mode fracture i.e. a mixture of fibrous and granular fracture (Fig. 7.3.2).

**Fig. 7.3.2** Fracture surface of the failed component showing a mixed mode of granular and fibrous fracture feature.

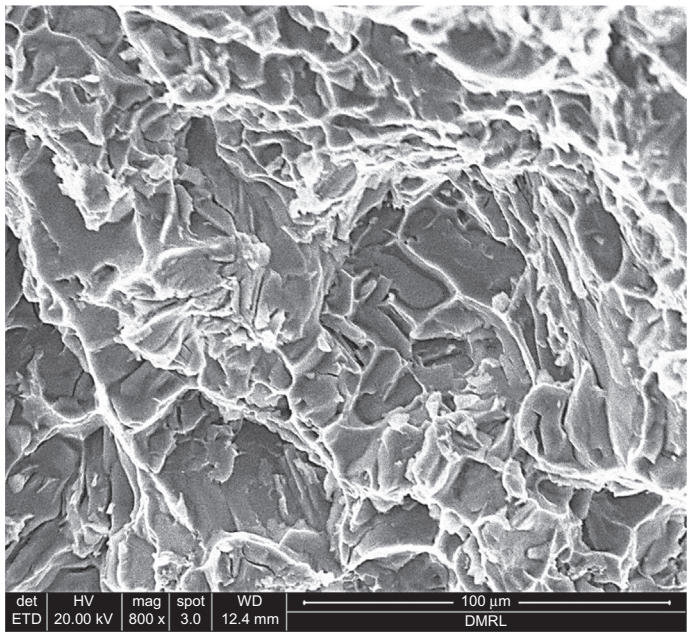
**Fig. 7.3.3** SEM fractograph of the fracture surface showing region of quasi-cleavage fracture.

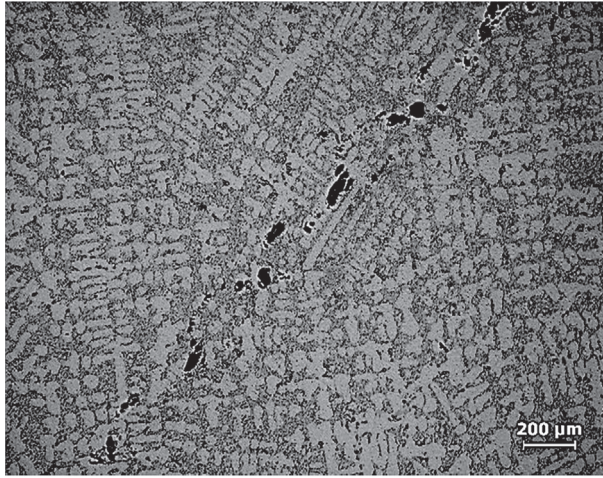
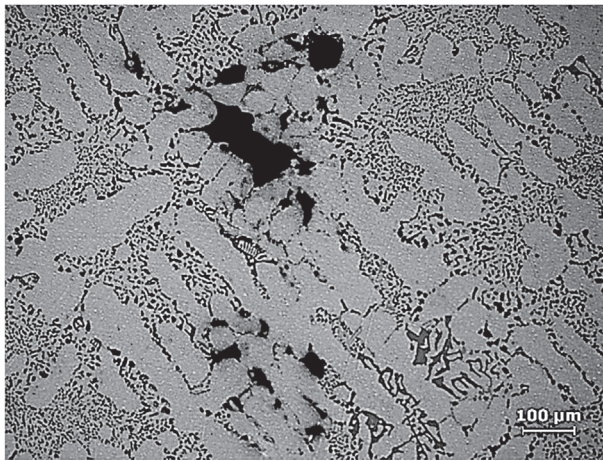
*Metallographic Examination:* Sections in all the three directions of the components were prepared for metallographic examination. In the unetched condition, the sample showed a few interdendritic cavities and gas porosities (Fig. 7.3.5). On etching with Keller's reagent the samples revealed a cast structure consisting of an interdendritic network of eutectic silicon (gray) and some particles of  $Mg_2Si$  (black) with dendrites of aluminum solid solution (Fig. 7.3.6).

**Fig. 7.3.5** Micrograph of longitudinal and transverse sections of the casting showing (A) aligned gas porosities as a stringer and (B) as pockets. Unetched.

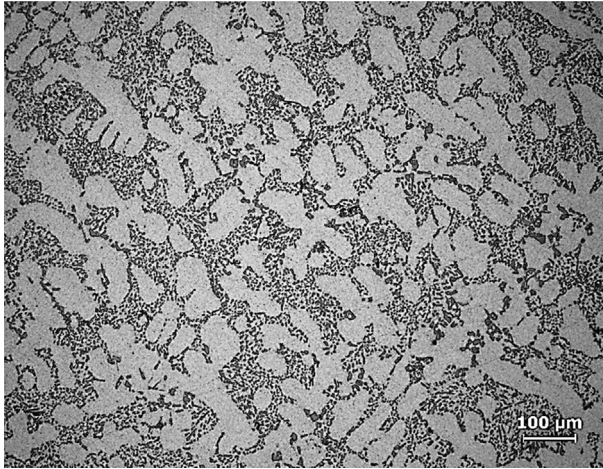
**Fig. 7.3.6** Micrograph of a section of the casting showing dendrites of aluminum solid solution, some particles of  $\text{Mg}_2\text{Si}$  (black), and interdendritic network of eutectic silicon (gray). Etchant: Keller's reagent.

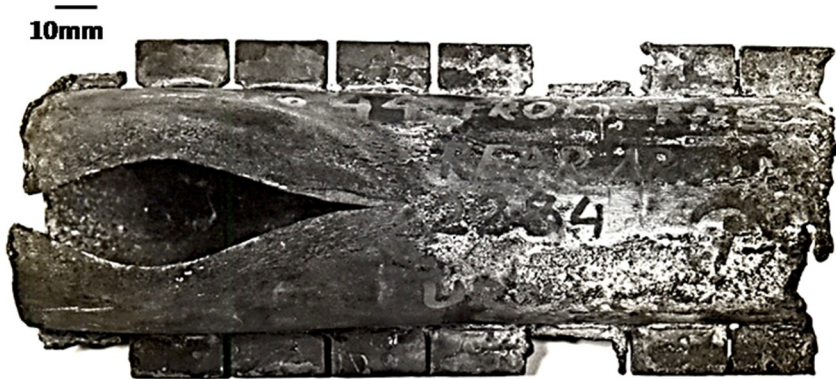
*Visual Examination:* The failure appeared to have originated on the fire side of the tube and propagated longitudinally. The fracture appeared to be a characteristic 'thin lip' rupture. The tube had bulged considerably near the failed region and the wall thickness of the tube was found to have reduced from 8mm to nearly 2.5mm. A photograph of the failed tube is presented in [Fig. 7.4.1](#).

**Fig. 7.4.1** Failed water wall tube in the as-received condition.

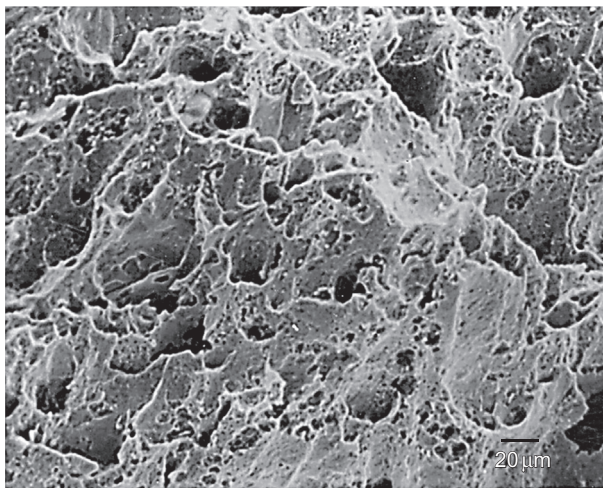
under SEM. Slightly elongated dimples of different sizes were noticed on the fracture surface (Fig. 7.4.2).

**Fig. 7.4.2** SEM fractograph of the fracture surface showing a dimpled rupture.

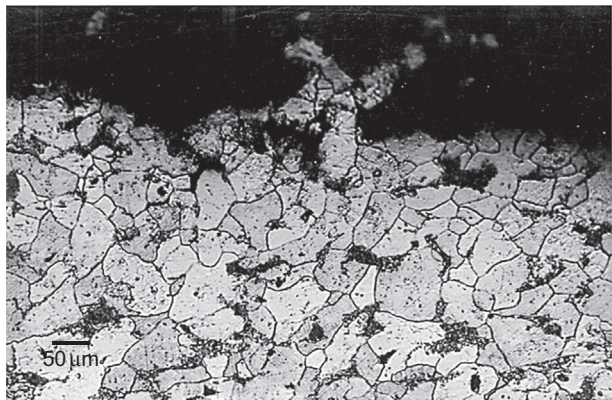
*Metallographic Examination:* A tangential section containing the crack tip and fracture edges was prepared for the metallographic examination. On etching with 2% nital, the sample revealed globular carbides in a ferrite matrix (Fig. 7.4.3). A 10 mm long transverse section near the region of maximum deformation containing the fracture surface was prepared for metallographic examination. On etching with 2% nital, the sample revealed elongated grains of ferrite and globular carbides near the fracture surface

**Fig. 7.4.3** Micrograph of a tangential section of the sample showing globular carbides and nearly equiaxed ferrite. Etchant: 2% nital.

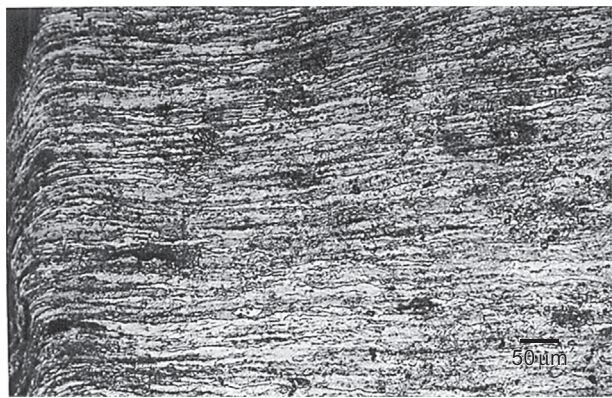
**Fig. 7.4.4** Micrograph of a transverse section of the sample near the region of maximum deformation showing severely deformed ferrite and globular carbides. Etchant: 2% nital.

620°C. It is reasonable to conclude that the tube was operated at such a high temperature as indicated by the changes in microstructure.

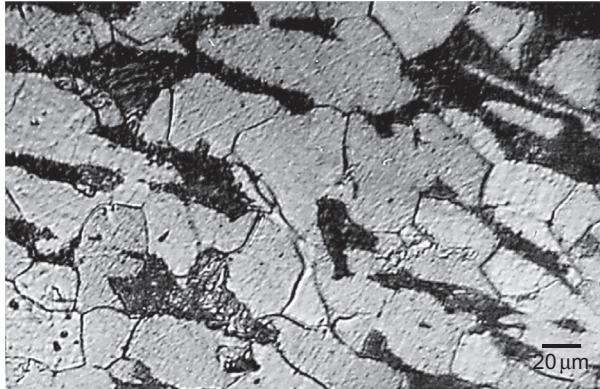
(Fig. 7.4.4). Metallographic examination of a transverse section taken from the rear side of the tube revealed equiaxed ferrite and lamellar pearlite structure (Fig. 7.4.5).

**Fig. 7.4.5** Micrograph of a transverse section of the sample from rear side of the tube showing equiaxed ferrite and lamellar pearlite. Etchant: 2% nital.

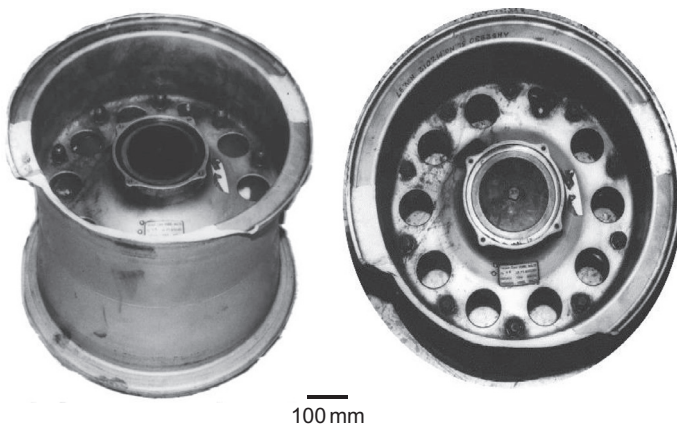
*Visual Examination:* The wheel hub in the as-received condition is shown in Fig. 8.1.1. Careful examination showed that the fracture was initiated at the junction of the rim and hub on the outer surface of the wheel. On examination under stereomicroscope, the fracture surface showed

**Fig. 8.1.1** Failed wheel hub in the as-received condition (two views).

The wheel hub had failed due to fatigue initiated at two slag pockets entrapped at the junction of the rim and hub on the outer surface of the wheel.

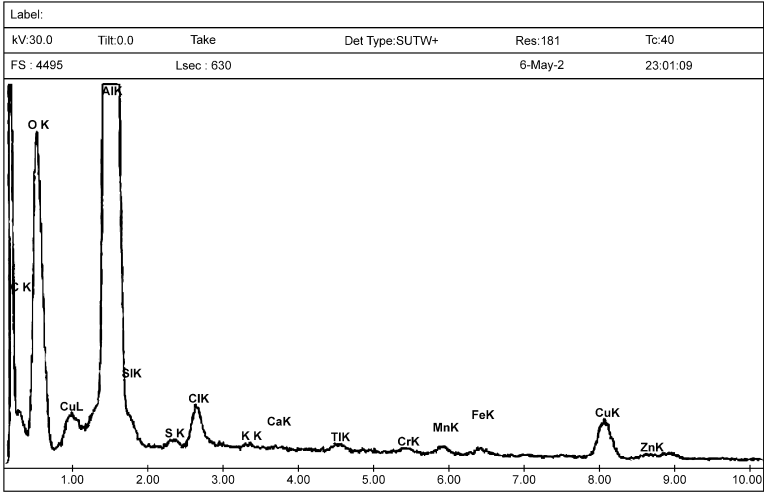
Fig. 8.1.4 EDAX of the inclusion at the origin.

the inclusion cluster at the fracture origin indicated that it was a slag entrapment in the alloy. The slag inclusion caused the initiation of fatigue crack that propagated under cyclic loading condition, which remained concealed under the tire and was not detected during the previous stages of examination. The final failure was due to overload.

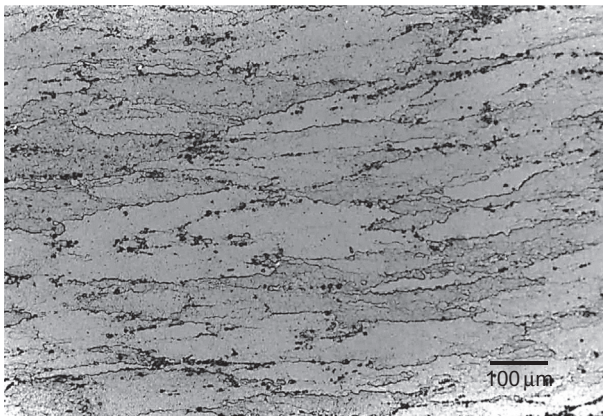
*Metallographic Examination:* Sections of the wheel hub were prepared for metallographic examination. On etching with Keller's reagent elongated grains of aluminum solid solution with undissolved precipitates were revealed (Fig. 8.1.7).

**Fig. 8.1.7** Micrograph of the wheel hub sample showing elongated grains of aluminum solid solution with undissolved precipitates. Etchant: Keller's reagent.

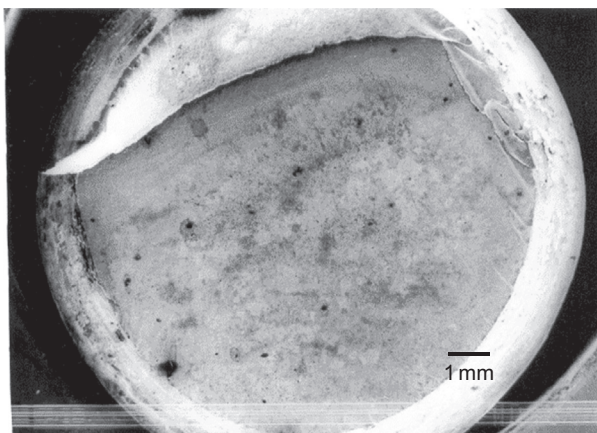
*Visual Examination:* On cleaning rust and grease from the fracture surfaces they revealed beach marks (Fig. 8.2.1).

Fig. 8.2.1 Fracture surface of one of the bolts showing beach marks.

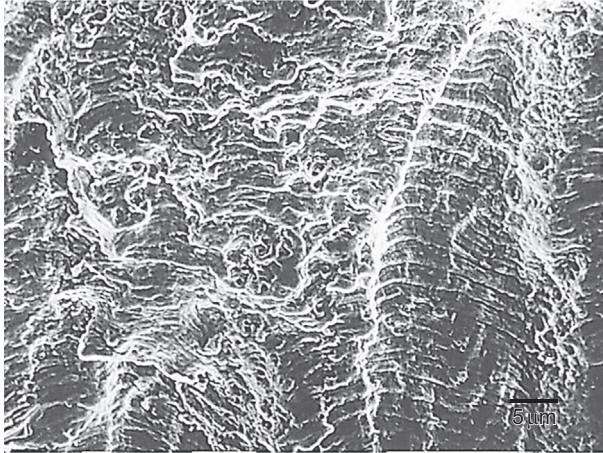
*Fractographic Examination:* When examined under SEM the fracture was found to have originated from the thread root and propagated across the section. The smooth fracture occupying two-third of the fracture section revealed beach marks at lower magnification and fatigue striations at higher magnification (Fig. 8.2.2). The remaining fracture surface revealed equiaxed dimples (Fig. 8.2.3).

**Fig. 8.2.2** SEM fractograph of the region containing beach marks showing fatigue striations at higher magnification.

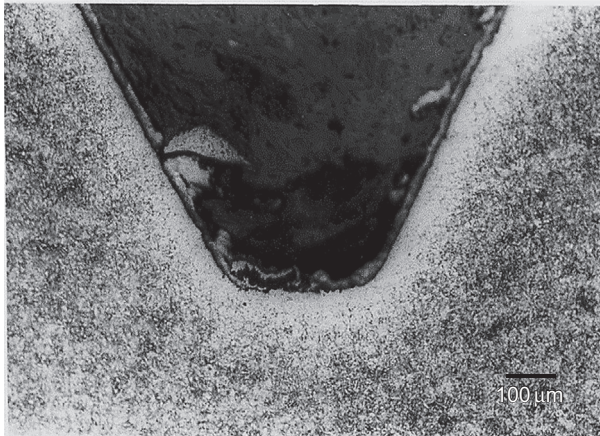
*Metallographic Examination:* Longitudinal section of the bolt samples showed decarburized layer to a depth of 0.15 mm all over below the threads (Fig. 8.2.4). The microstructure revealed tempered martensite (Fig. 8.2.5).

**Fig. 8.2.4** Micrograph of the bolt sample showing decarburized layer all-along the threaded region. Etchant: 2% nital.

The bolts of the flapjack-mounting bracket had failed due to fatigue initiating at the decarburized layer below the thread root.

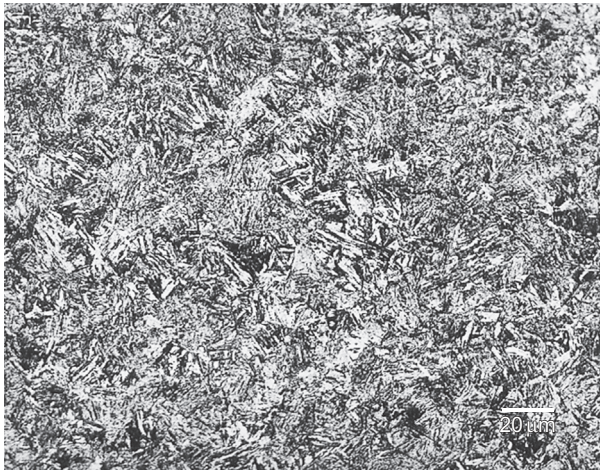
**Fig. 8.2.5** Micrograph of a section of the bolt sample showing a tempered martensite structure. Etchant: 2% nital.

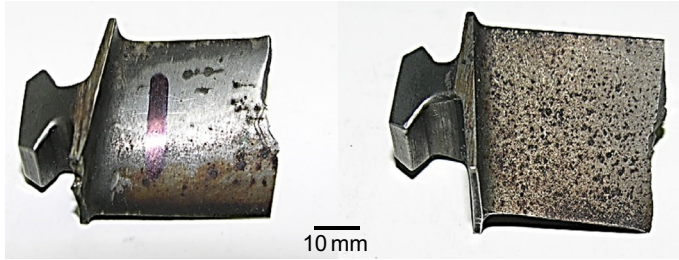
*Visual Examination:* The failed fourth stage compressor rotor blade in the as-received condition is shown in [Fig. 8.3.1](#). Convex surface of the aerofoil region showed dark brown deposits near the leading edge and a few pits.

**Fig. 8.3.1** Compressor rotor blade in the as-received condition showing the convex and the concave surface of the aerofoil containing a large number of corrosion pits and brown deposits near the leading edge.

Concave surface of the aerofoil region showed a large number of pits and brown deposits. The fracture surface showed smooth fracture containing beach marks to a length of two-third from the leading edge. The final one-third of the fracture surface showed fibrous fracture features.

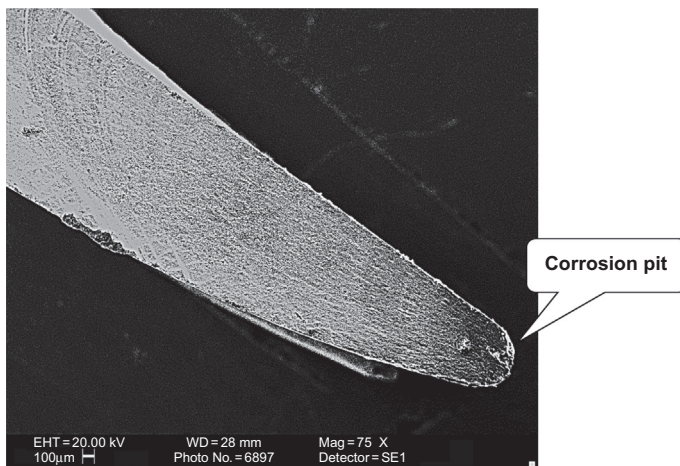
*Fractographic Examination:* The fracture surface was cleaned ultrasonically in acetone and examined under scanning electron microscope (SEM). The fracture surface showed corrosion pit at the leading edge and smooth fracture with beach marks (Figs. 8.3.2 and 8.3.3). The debris within the corrosion pit was analyzed by energy dispersive X-ray analysis (EDAX). Presence of chlorine, sulfur, and bromine was found in the pitted region besides

**Fig. 8.3.2** SEM fractograph of the fracture surface showing corrosion pit at the leading edge and smooth fracture surface with beach marks.

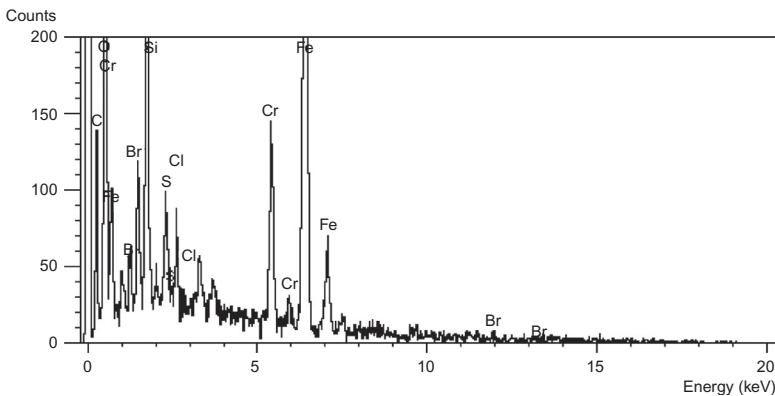
**Fig. 8.3.4** EDAX spectrum of the debris within the corrosion pit at the leading edge showing the presence of sulfur, chlorine, and bromine besides the alloying elements of the blade.

chromium and iron (Fig. 8.3.4). From near the pit beach marks were found initiating and propagating toward the trailing edge (Fig. 8.3.5). Fatigue striations were revealed in the area showing beach marks (Fig. 8.3.6). The final fracture region revealed equiaxed dimples (Fig. 8.3.7).

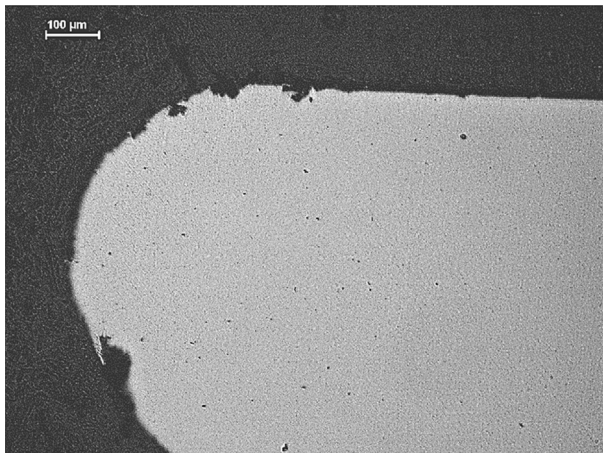
*Metallographic Examination:* Section across the aerofoil parallel to the fracture surface was prepared for metallographic examination. In the unetched condition, the sample showed a number of pits on the concave surface of the aerofoil near the leading edge and a few pits on the convex surface of the

**Fig. 8.3.8** Micrograph of transverse section of the aerofoil showing pitting corrosion near the leading edge. Unetched.

The fourth-stage compressor rotor blade had failed due to fatigue that was initiated at corrosion pits at the leading edge.

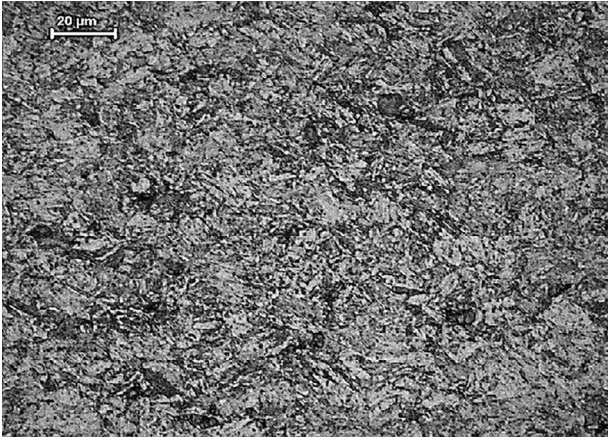
aerofoil near the trailing edge (Fig. 8.3.8). On etching with aqua regia, the sample revealed a tempered martensite structure (Fig. 8.3.9).

**Fig. 8.3.9** Micrograph of transverse section of the aerofoil showing a tempered martensite structure. Etchant: Aqua regia.

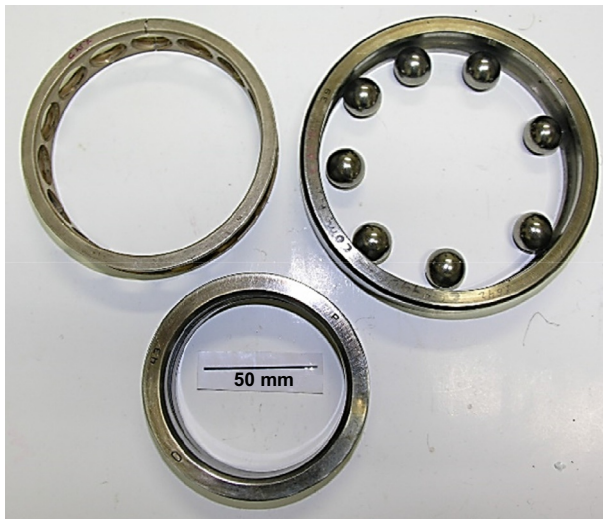
*Visual Examination:* The failed ball bearing showing the inner race, the outer race, the balls, and the cage in the as-received condition are shown in Fig. 8.4.1. The cage showed breakage at two locations: one parallel and the other inclined at  $45^\circ$  to the axis of shaft (Fig. 8.4.2). The fracture surfaces at the straight crack showed smooth fracture, while the crack inclined at  $45^\circ$  showed fibrous fracture.

**Fig. 8.4.1** The failed ball bearing showing the inner race, the outer race, the balls, and the cage in the as-received condition.

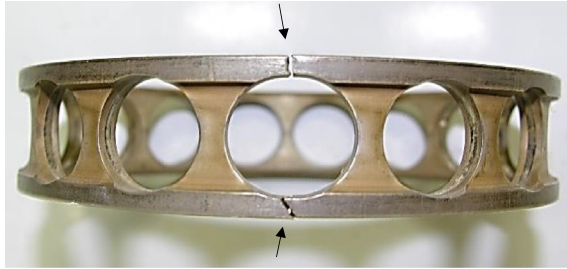
**Fig. 8.4.2** The broken cage in the as-received condition showing one of the breakage parallel and the other inclined at  $45^\circ$  to the axis of shaft.

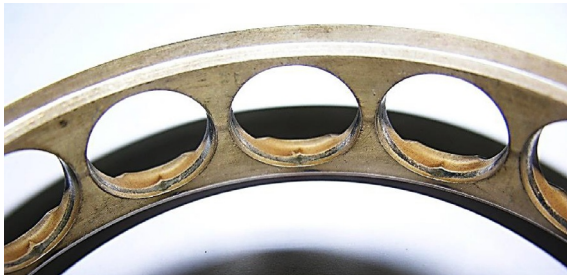
The circular slots where the balls are seated within the cage showed the path traced by the balls while in motion. This path was visibly off-center in all the circular slots (Fig. 8.4.3). Moreover, the path also showed two dent marks at 3 and 9'O clock positions with respect to shaft axis (Fig. 8.4.4).

**Fig. 8.4.3** The broken cage in the as-received condition showing the eroded track marks of the ball within each circular slot and the dent marks at two opposite locations.

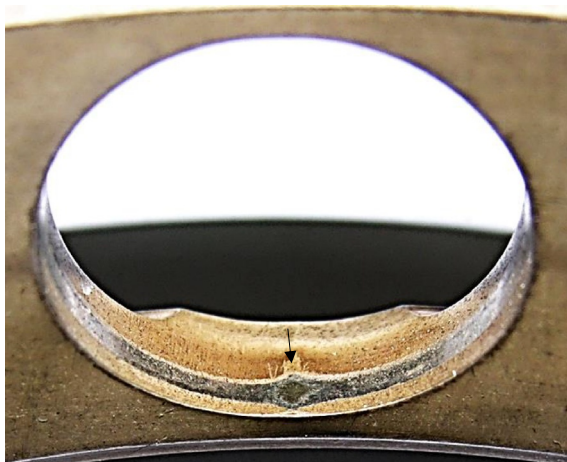
**Fig. 8.4.4** Magnified image of the track mark and the dent mark with pointed ends.

The smooth crack is observed to have initiated at the dent marks from inner surface and propagated to the outer surface of the circular slot.

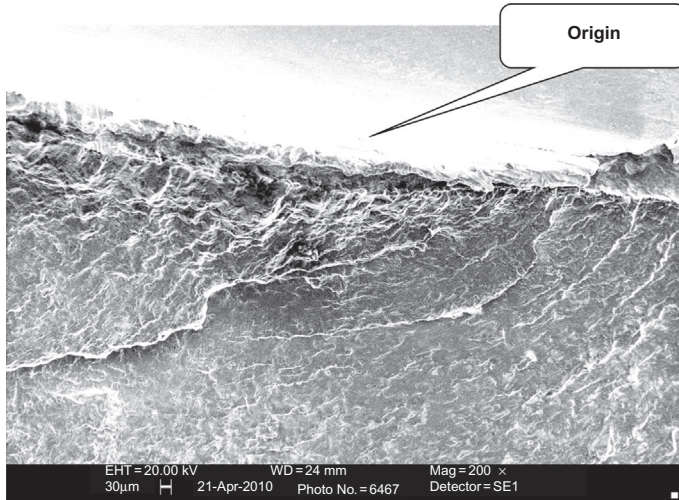
**Fig. 8.4.6** SEM fractograph of the fracture surface of the cage showing crack origin and beach marks diverging from the origin.

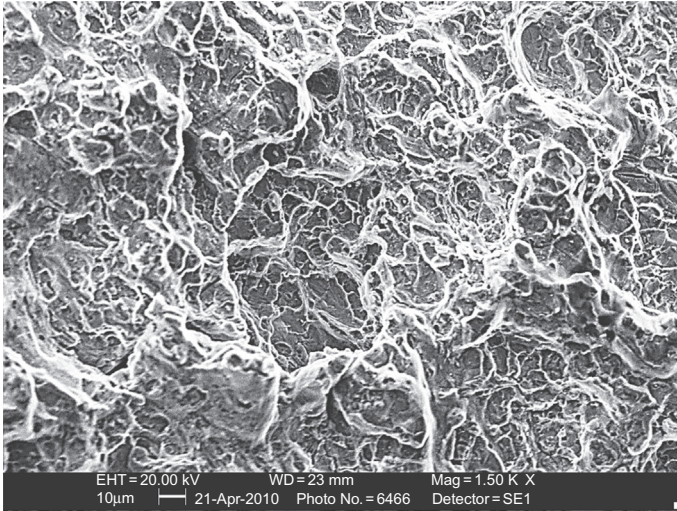
**Fig. 8.4.8** SEM fractograph of the fibrous region of the straight fracture surface revealing dimples.

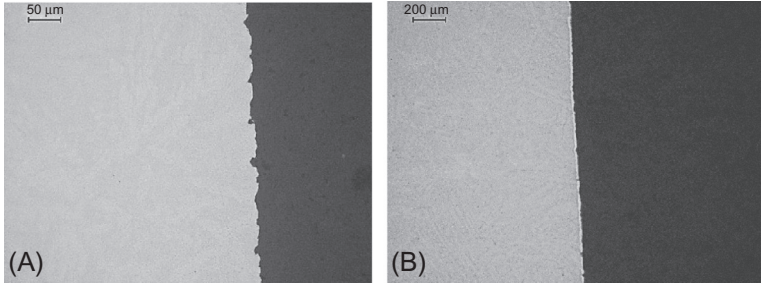
**Fig. 8.4.10** Micrograph of a section of the cage showing (A) erosion and pitting on the inner surface and (B) relatively intact outer surface. Unetched.

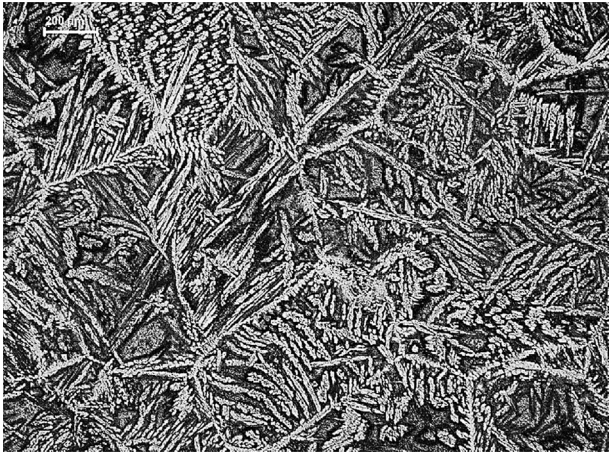
revealed a cast structure having alpha grains in a matrix of eutectoid decomposed beta phase and retained beta phase (Fig. 8.4.11).

**Fig. 8.4.11** Micrograph of a section of the cage showing cast structure having alpha grains in a matrix of eutectoid decomposed beta phase and retained beta phase. Etchant: Acidified potassium dichromate.

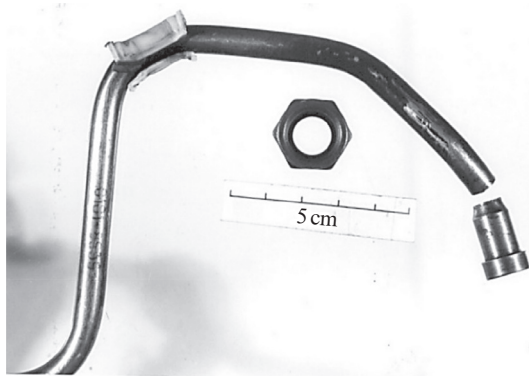
*Visual Examination:* A fine circumferential crack of about 5 mm length was observed at about 8 mm from the weld region (Fig. 9.1.1). The crack was forced open and the fracture surface was observed to have been rusted.

**Fig. 9.1.1** The segment of the failed fuel pipe in the as-received condition.

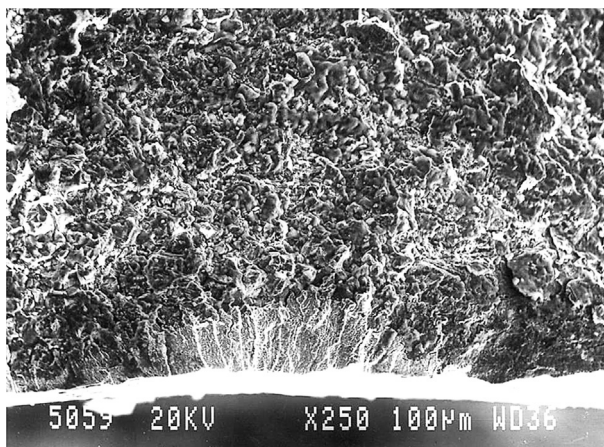
*Fractographic Examination:* The fracture surface was cleaned with acetone ultrasonically and examined under SEM. The sample showed chevron marking over a small lens shaped region near the inner surface (Fig. 9.1.2). The fracture surface contained adherent corrosion debris evidenced by mud cracks (Fig. 9.1.3). EDAX of the corrosion debris revealed the presence of chlorine (Fig. 9.1.4). The rust was cleaned with an oxide remover followed by cleaning with acetone and re-examined. The sample revealed transgranular fracture at the lens shaped region followed by intergranular fracture all through the remaining section thickness (Fig. 9.1.5).

**Fig. 9.1.2** SEM fractograph of the fracture near the inner surface showing chevron marking over a small lens shaped region.

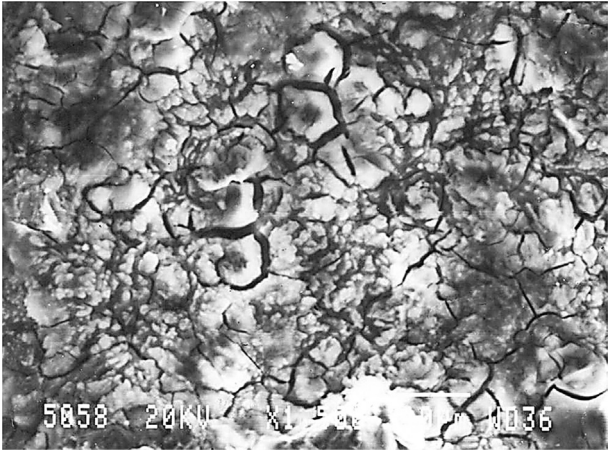
**Fig. 9.1.3** SEM fractograph of the fracture surface showing adherent corrosion debris evidenced by mud cracks.

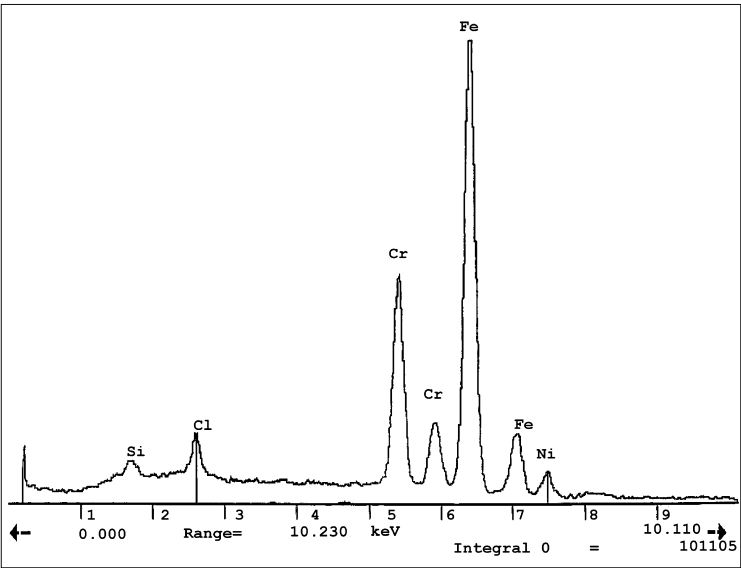
**Fig. 9.1.4** EDAX spectrum of the corrosion debris.

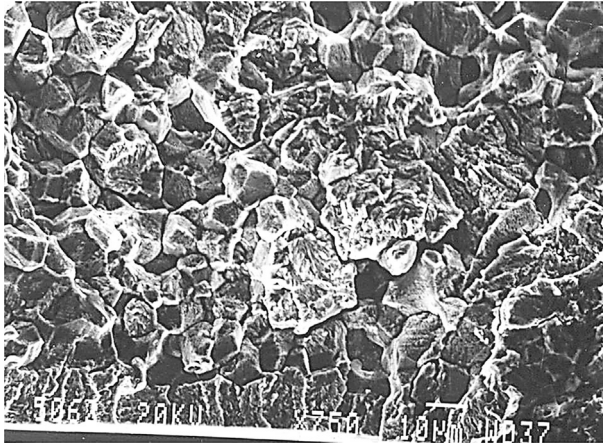
**Fig. 9.1.5** SEM fractograph of the larger area of the fracture surface showing intergranular fracture.
