# **METALLURGICAL FAILURE ANALYSIS**

Techniques and Case Studies

KANNADI PALANKEEZHE BALAN

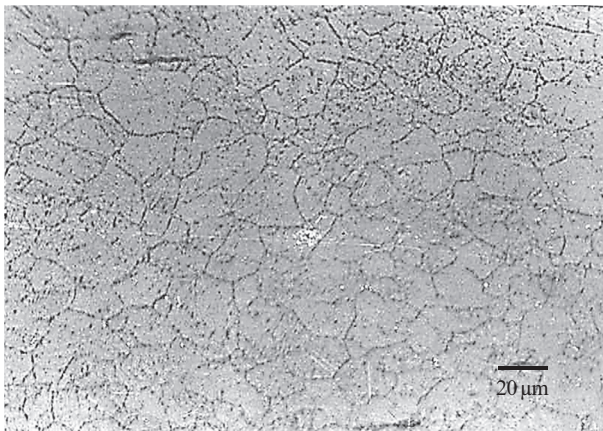
**Fig. 9.1.6** Micrograph of longitudinal section of the pipe sample showing equiaxed grains of austenite with annealing twins and chromium carbide precipitates at the grain boundaries. Etchant: Aqua regia.

chromium carbide precipitates at the grain boundaries (Fig. 9.1.6). Mixed trans- and intergranular secondary cracks were observed near the inner surface of the sample (Fig. 9.1.7).

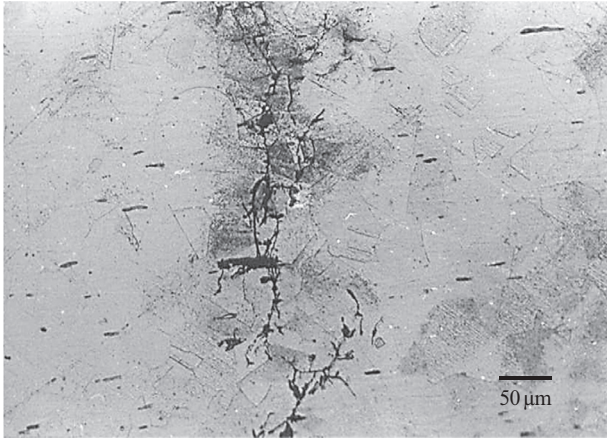
**Fig. 9.1.7** Micrograph of longitudinal section of the pipe sample showing a large number of sulfide inclusions and mixed trans- and intergranular secondary cracks near the inner surface of the sample. Etchant: Aqua regia.

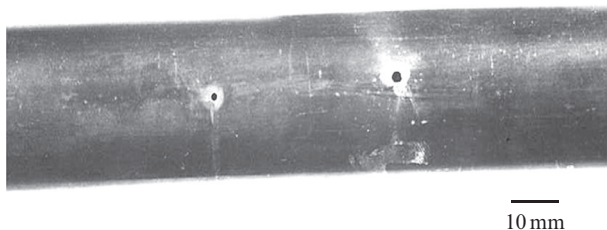
*Visual Examination:* A number of small holes of 1–2 mm diameter were observed on the condenser tubes (Fig. 9.2.1). The holes, in general, were found on the bottom half of the tubes. A sample tube was sectioned longitudinally to observe the condition of the inner surface. At a number of locations isolated small pockets of green colored corrosion debris were observed. There were no evidences of erosion ripples.

Fig. 9.2.1 A portion of failed condenser tube in the as-received condition.

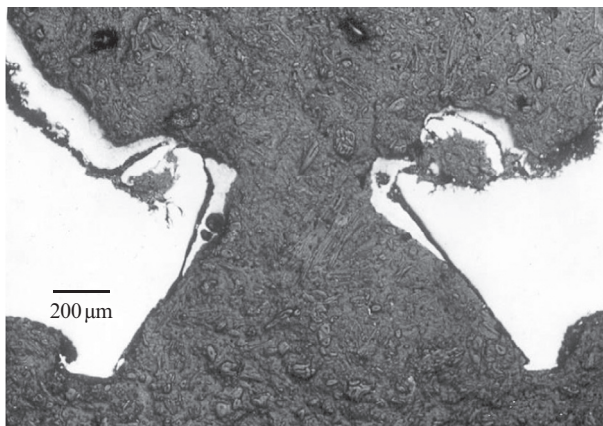
*Metallographic Examination:* A longitudinal section containing a hole was prepared for metallography. Silver paint was applied on the inner surface in order to retain the corrosion products. The hole containing the pit at which it originated is shown in Fig. 9.2.2. The pit, which had later developed into a hole, contained dark gray colored corrosion debris (Fig. 9.2.3). On etching, the sample revealed equiaxed grains of alpha and strain markings (Fig. 9.2.4).

**Fig. 9.2.2** Micrograph of the tube sample across the hole. Unetched.

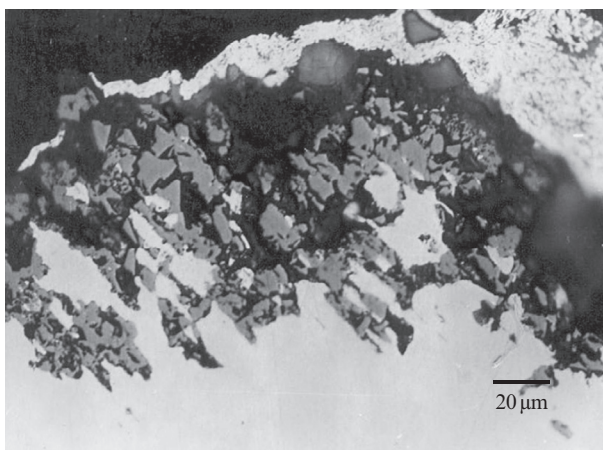
**Fig. 9.2.3** Micrograph of the tube sample showing corrosion debris at a pit. Unetched.

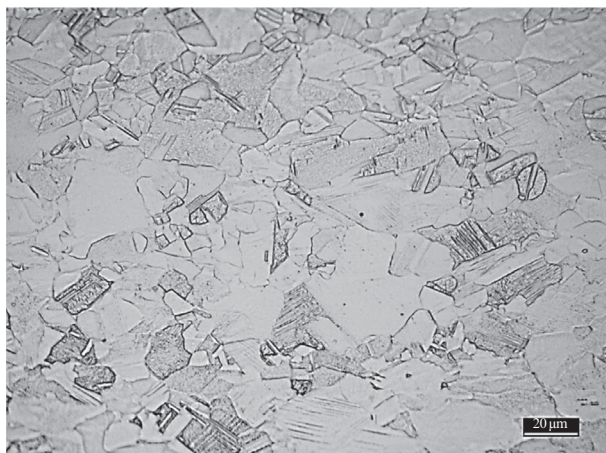
**Fig. 9.2.4** Micrograph of longitudinal section of the sample showing equiaxed grains of alpha and strain markings. Etchant: Acidified potassium dichromate.

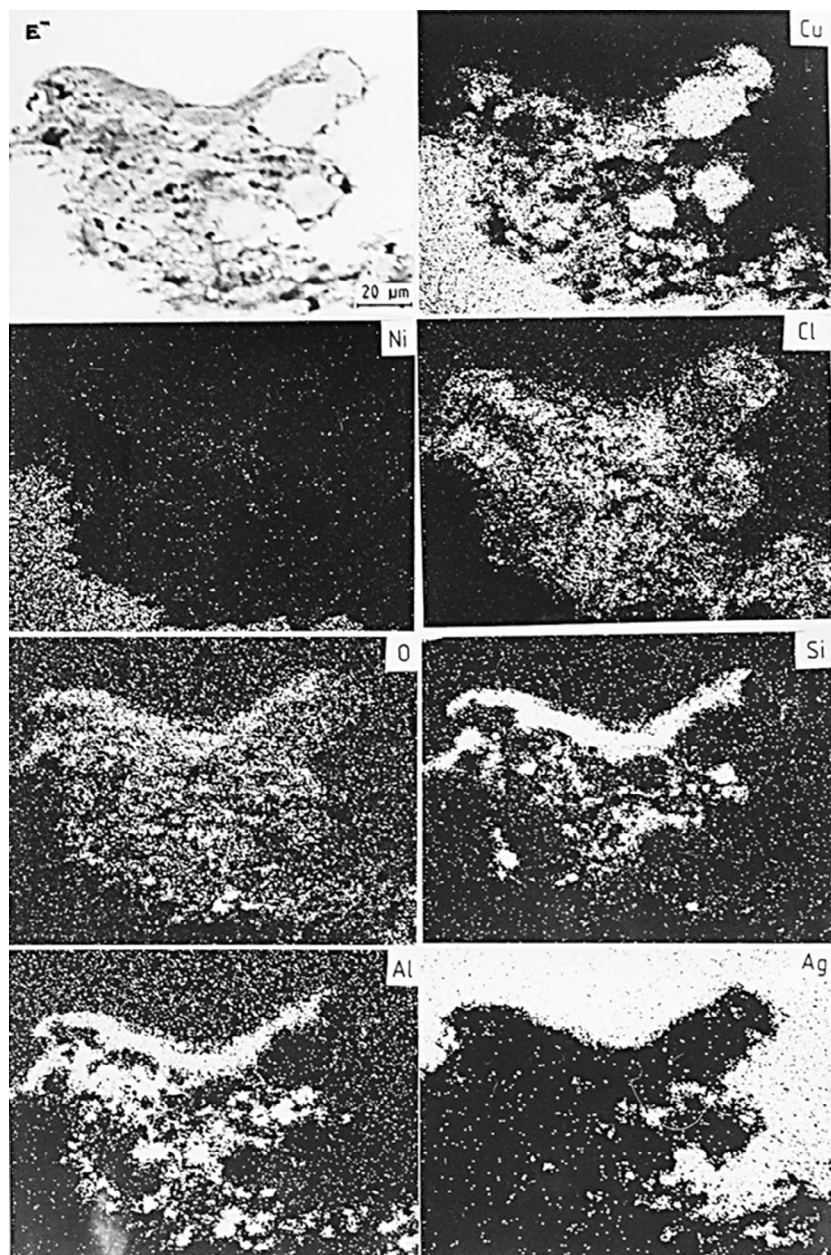
*Electron Probe Micro Analysis (EPMA):* The corrosion debris at the pit shown in Fig. 9.2.3 was analyzed by EPMA. The BSE image along with elemental X-ray mapping for Cu, Ni, Cl, O, Si, Al, and Ag are presented in Fig. 9.2.5. It is evident from the figure that there is depletion of nickel and enrichment of chlorine, oxygen, silicon, and aluminum in the corroded region. Corrosion debris in the Fig. 9.2.5 is below the silver paint.

The chemical composition and hardness conformed to the specified grade of cupro-nickel alloy in annealed condition. Metallographic examination indicated that the tubes had suffered pitting corrosion ultimately resulting in perforation. EPMA revealed that the corrosion was caused by the presence of chloride in the coolant water leading to denickelification. The fact that the tubes were in good condition at the time of shut down and such large number of them developed leaks in a day after recommissioning suggested that the corrosion damage had occurred during the idle period which was about 6 months in this case. Though the users did not mention the conditions of the condenser tubes during the overhaul period, the extent of damage suggested stagnant conditions leading to pitting corrosion.

**Fig. 9.2.5** The BSE image along with elemental X-ray mapping for Cu, Ni, Cl, O, Si, Al, and Ag.

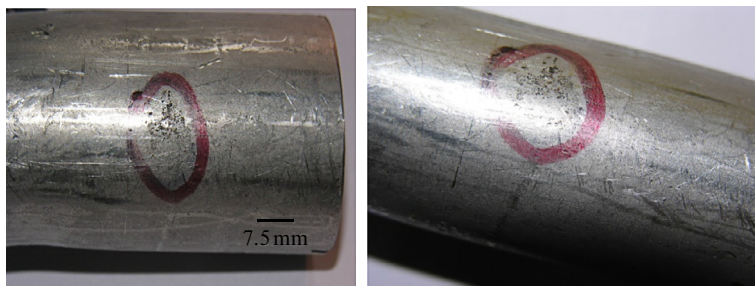
*Visual Examination:* The failed pipe sample in the as-received condition is shown in Fig. 9.3.1. The pipes showed high density of pitting on their outer surfaces, while the inner surfaces of all the pipe samples were free from pitting. The localized pits were aggregated into pockets rather than seen uniformly over the surface.

Fig. 9.3.1 Failed pipe samples in the as-received condition

- (i) Use AISI 316L or AISI 316T (based on the strength required) that are more pitting corrosion-resistant stainless steels as compared to AISI 321.
- (ii) Do not paint stainless steel pipes as localized damages of painted surface can be sites prone to pitting corrosion.

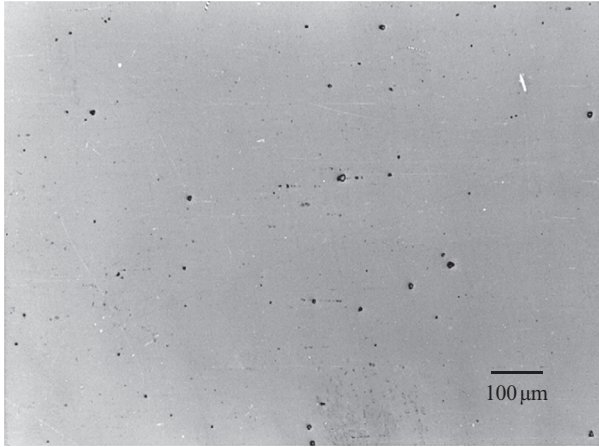
**Fig. 9.3.2** Micrograph of longitudinal section of the sample showing a large number of globular oxide and nitride inclusions. Unetched.

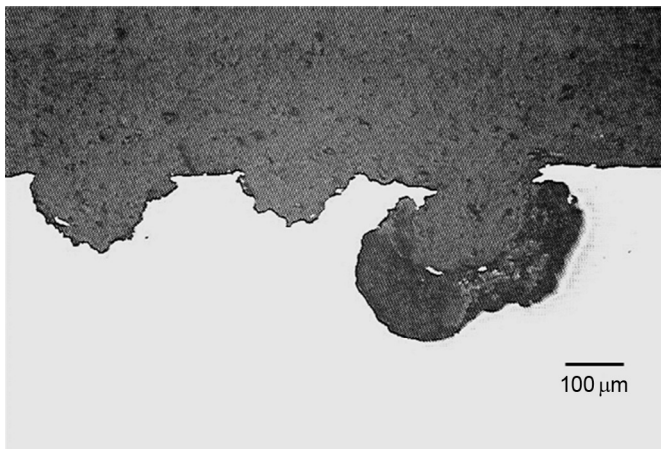
*Metallographic Examination:* Longitudinal sections of the pipe samples were prepared for metallographic examination. In the unetched condition, the samples showed a large number of globular oxide and nitride inclusions (Fig. 9.3.2). The outer surface showed a number of surface and subsurface pits (Fig. 9.3.3). The depth of the largest pit observed was  $400 \mu\text{m}$ . The inner

**Fig. 9.3.3** Micrograph of longitudinal section of the sample showing a number of pits on the outer surface. Unetched.

The failure of H.P. air and hydraulic pipes during re-pressurization test was caused by extensive pitting corrosion.

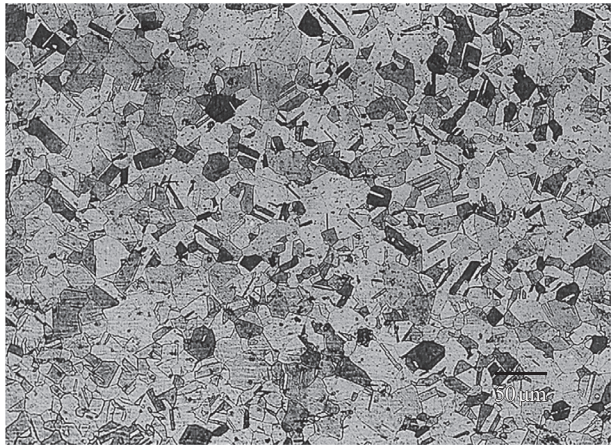
**Fig. 9.3.4** Micrograph of longitudinal section of the sample showing equiaxed grains of austenite with annealing twins.

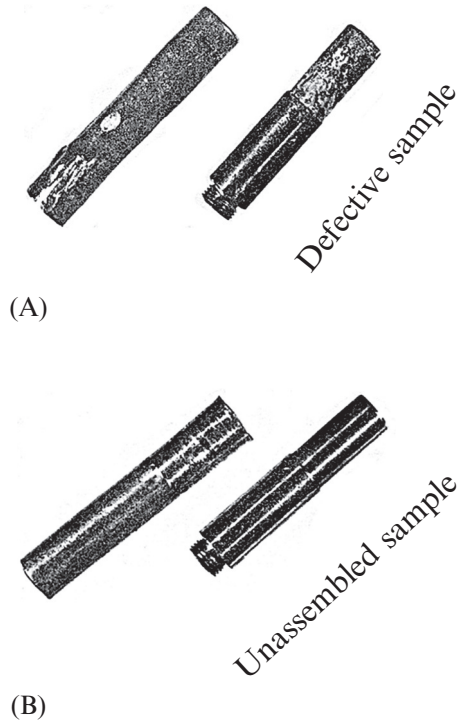
*Visual Examination:* The delay tube along with the capsule, of both assembled (defective) as well as unassembled, is shown in Fig. 9.4.1A and B, respectively. The defective tube samples showed thick adherent grayish white colored corrosion debris on the outer surface. On cutting the sample longitudinally into two halves the inner surface also showed thick adherent gray colored corrosion debris. The machined outer and inner surfaces of the unassembled tube sample showed metallic luster. The capsule of the failed tube was slightly bulged and showed loosely held grayish green deposit on its inner surface.

**Fig. 9.4.1** Delay tube and capsule samples in the as-received condition. (A) Defective sample showing corroded surface of the delay tube and tool marks on the capsule, (B) Unassembled sample showing machined bright surface.

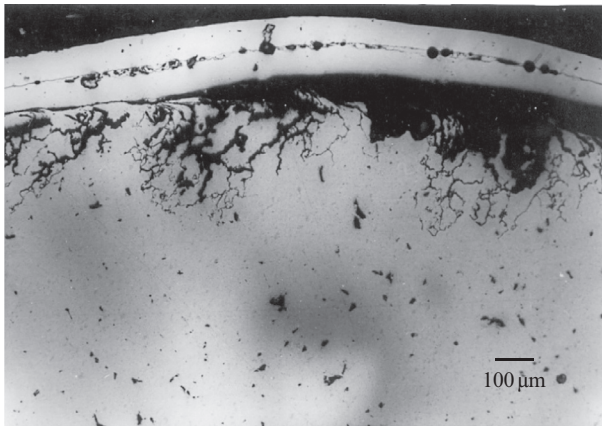
**Fig. 9.4.2** Micrograph of transverse section of the defective sample showing pitting and intergranular corrosion on the outer surface. Copper strip was wrapped to protect the outer surface for sample preparation. Unetched.

The delay tubes had suffered intergranular corrosion of their surfaces due to improper heat treatment of the material used, rendering them susceptible to corrosion.

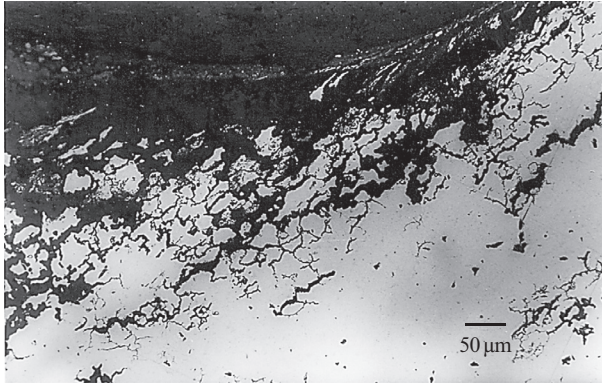
**Fig. 9.4.3** Micrograph of transverse section of the defective sample showing intergranular corrosion of the inner surface. Unetched.

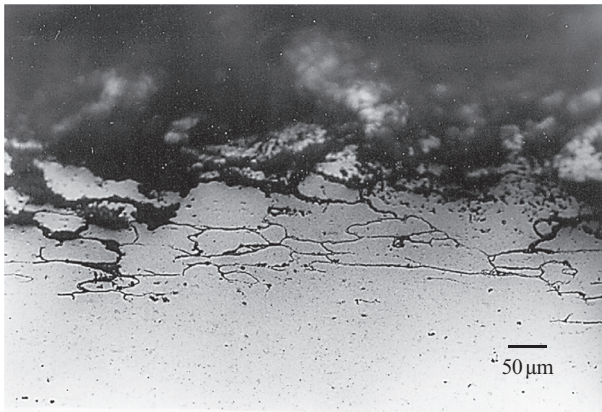
**Fig. 9.4.4** Micrograph of longitudinal section of the defective sample showing intergranular corrosion of the outer surface. Unetched.

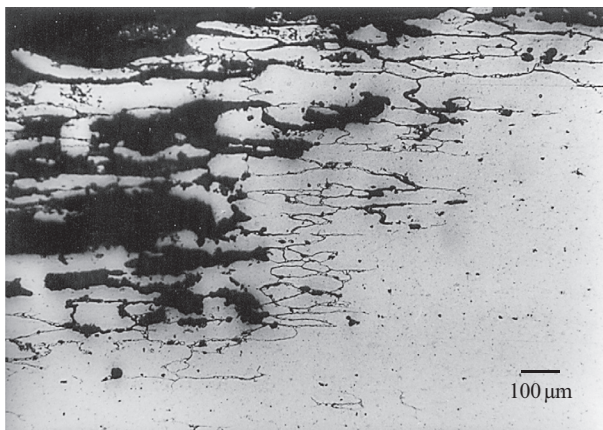
**Fig. 9.4.5** Micrograph of longitudinal section of the defective sample showing intergranular corrosion of the inner surface. Unetched.

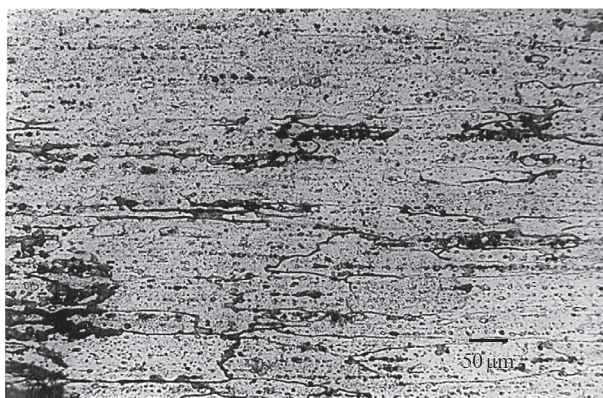
**Fig. 9.4.6** Micrograph of longitudinal section of the defective tube sample showing large number of undissolved particles and grain boundary precipitation of  $\text{CuAl}_2$  near the corroded surface. Etchant: Keller's reagent.

delay caused during quenching or low rate of cooling during quenching has allowed precipitation of  $\text{CuAl}_2$  particles along the grain boundaries resulting in impoverishment of copper from the vicinity of the grain boundaries rendering the alloy susceptible to intergranular corrosion.

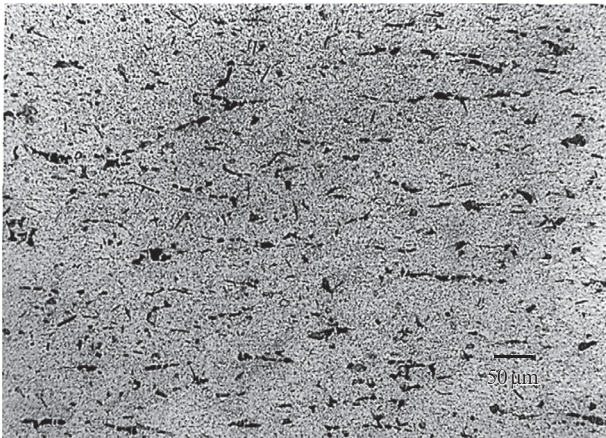
**Fig. 9.4.7** Micrograph of the longitudinal section of the defective tube sample showing large number of undissolved particles and grain boundary precipitation of CuAl<sub>2</sub> away from the corroded surface. Etchant: Keller’s reagent.

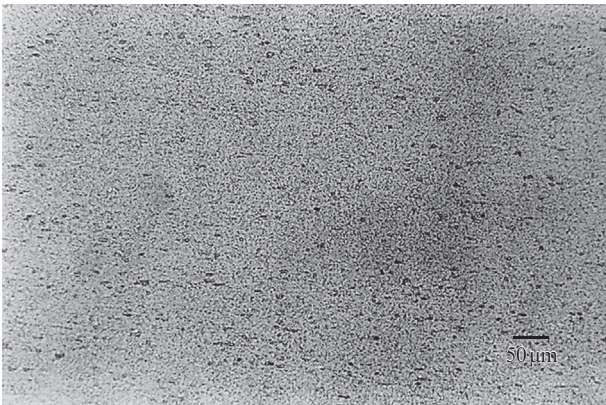
**Fig. 9.4.8** Micrograph of longitudinal section of the unassembled tube sample showing relatively finer undissolved particles in a matrix of aluminum solid solution. Etchant: Keller’s reagent.

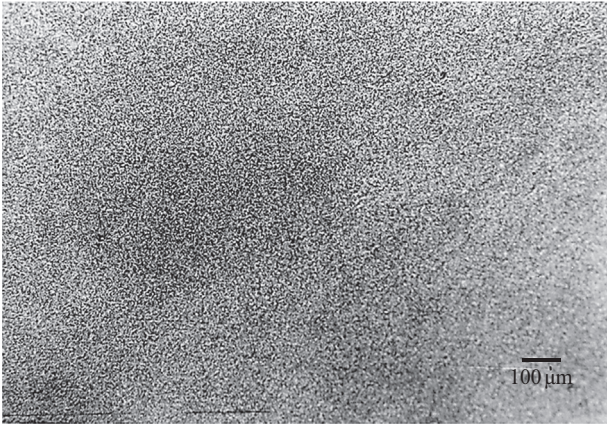
**Fig. 9.4.9** Micrograph of longitudinal section of the capsule sample showing fine undissolved particles in a matrix of aluminum. Etchant: Keller’s reagent.

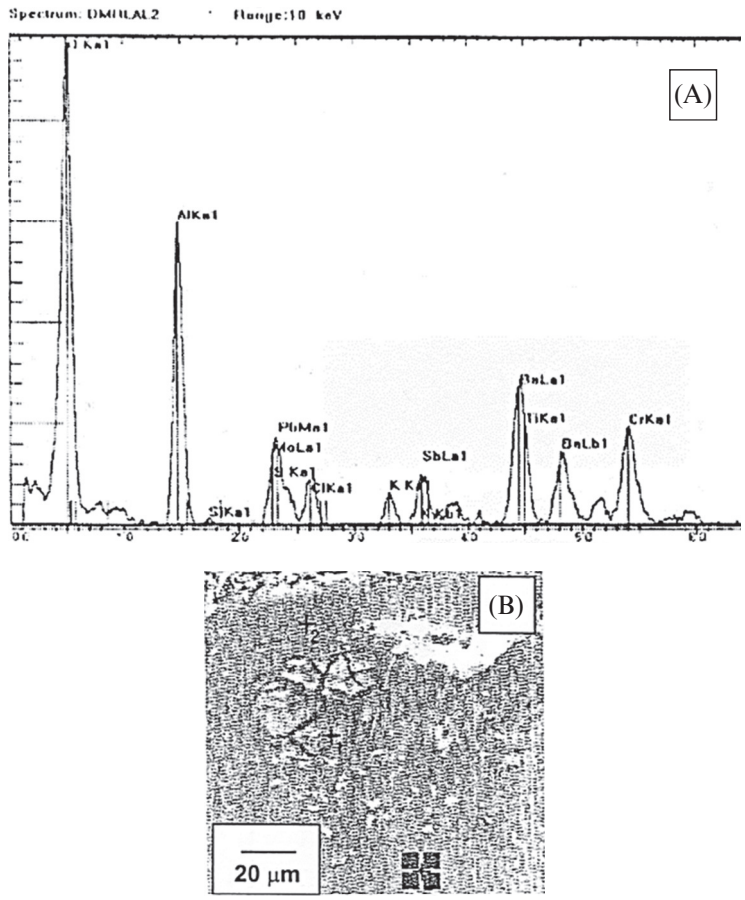
(EDS) analysis. The overall and the point analysis of the corrosion debris on the defective delay tube sample showed the presence of oxygen in addition to the constituent elements of the parent material and the explosive filling. EDS spectrum, SEM micrograph of the analyzed region, and the results of point analysis of the defective delay tube sample are shown in [Fig. 9.4.11](#).

**Fig. 9.4.11** EDS analysis of the corrosion debris on the inner surface of the defective delay tube.

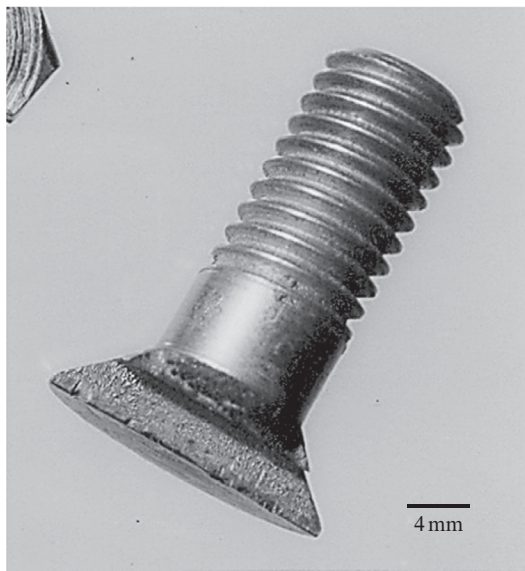
*Visual Examination:* The failed screw in the as-received condition is shown in Fig. 10.1.1. The screw was found to have broken along the edge of the central slot. The fracture surface was coarse and crystalline.

Fig. 10.1.1 The failed screw in the as-received condition.

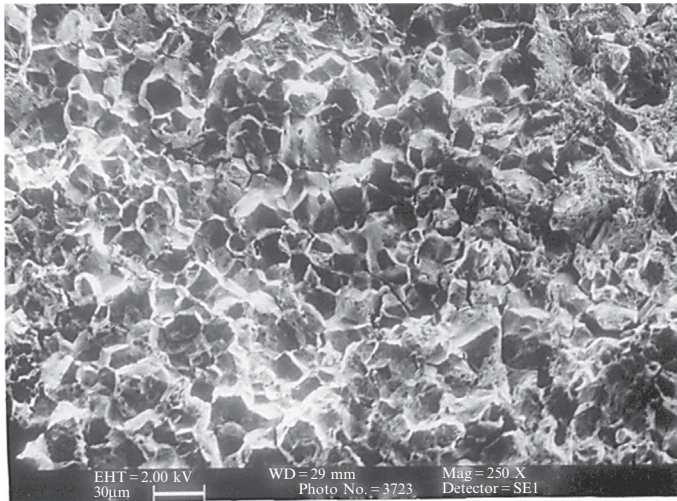
*Fractographic Examination:* The fracture surface was cleaned ultrasonically in acetone and examined under scanning electron microscope (SEM). The fracture surface revealed essentially intergranular fracture (Fig. 10.1.2).

Fig. 10.1.2 SEM fractograph of the fracture surface showing intergranular fracture.

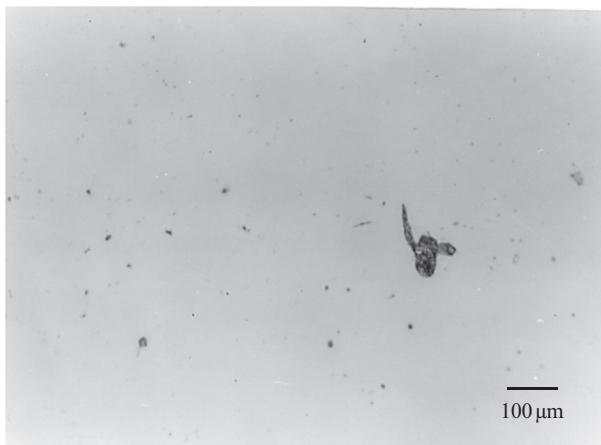
Fig. 10.1.3 Micrograph of longitudinal section of the screw showing large population of globular oxide and slag-like coarse inclusions. Unetched.

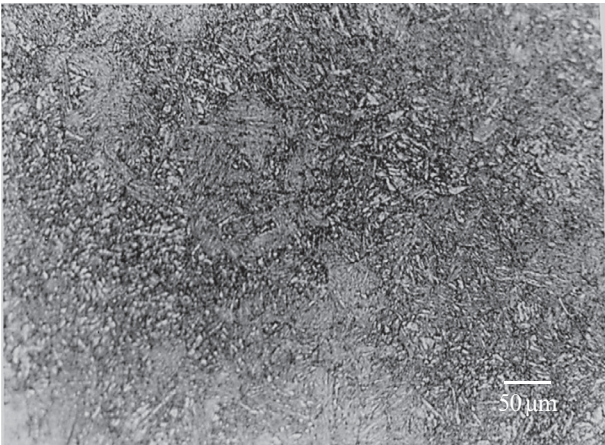
**Fig. 10.1.4** Micrograph of longitudinal section of the screw showing a tempered martensite structure. Etchant: 2% nital.

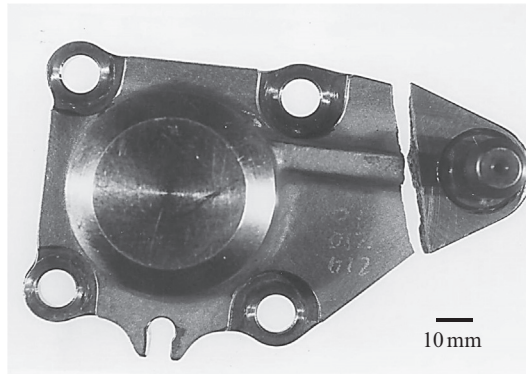
*Visual Examination:* The broken differential valve cover/bracket in the as-received condition is shown in [Fig. 10.2.1](#). The component is found to have broken from an area, near the pin. The area near the failure did not show any plastic deformation. The fracture surface was cleaned and observed under stereo microscope. The surface showed a coarse and crystalline fracture. Photograph of the close-up view of the mating fracture surfaces is shown in [Fig. 10.2.2](#).

**Fig. 10.2.1** Broken differential valve cover in the as-received condition.

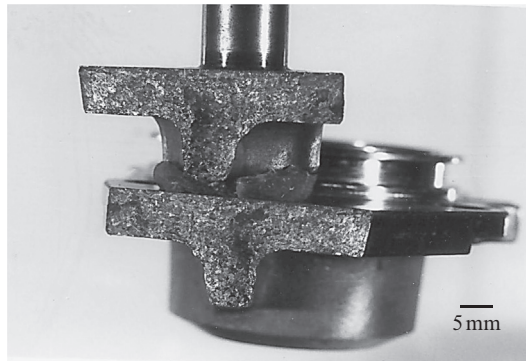
**Fig. 10.2.2** Fracture surfaces of the component showing coarse and crystalline fracture.

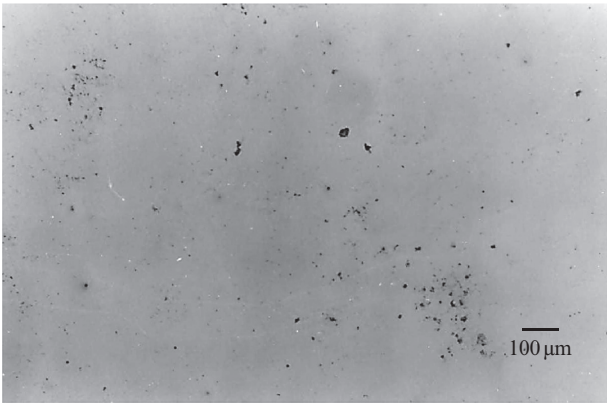
**Fig. 10.2.4** Micrograph showing microporosities in the sample. Unetched.

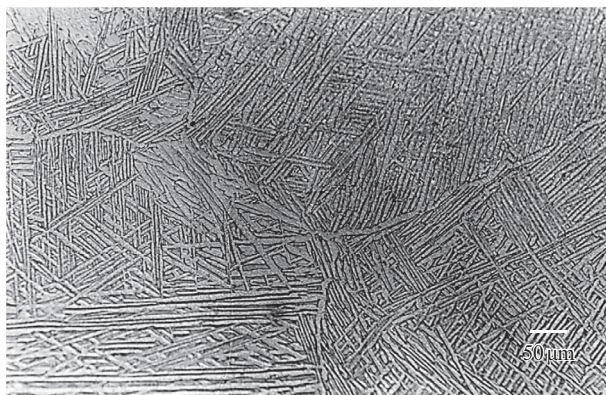
**Fig. 10.2.5** Micrograph of the sample showing a transformed beta structure containing acicular plates of alpha and thin plates of beta. Grain boundaries are showing plates and film of alpha. Etchant: Kroll's reagent.

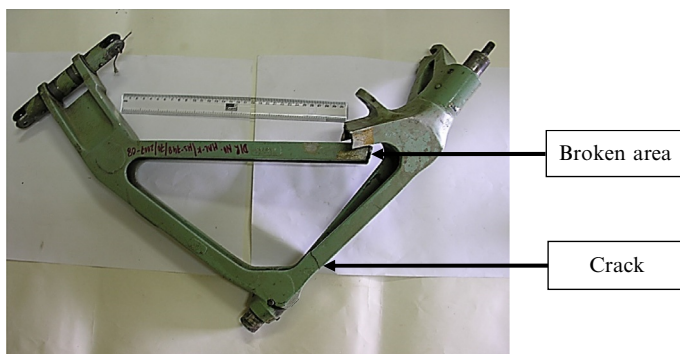
*Visual Examination:* The failed lever assembly in the as-received condition is shown in Fig. 10.3.1. The component was an integral piece of three arms with steel inserts at all the three ends which were secured in position with rivets. The component was found to have been painted. The component

Fig. 10.3.1 The failed lever assembly in the as-received condition.

showed a breakage on one of the arms and a crack on another arm. A close-up view of the crack is shown in [Fig. 10.3.2](#). The inner surface of the component was found to be rough and soiled and showed pits and deep grooves. The fracture surface was coarse and crystalline.

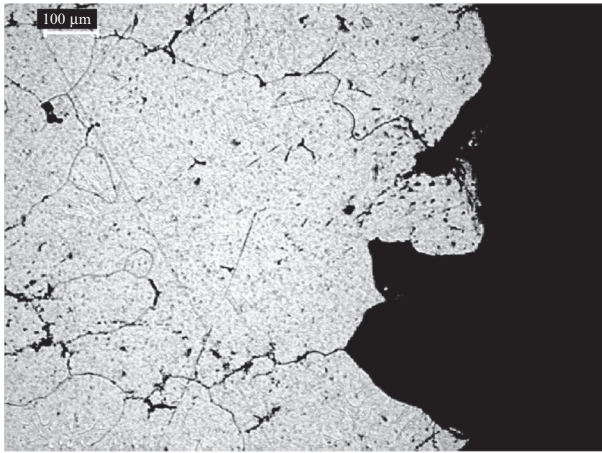
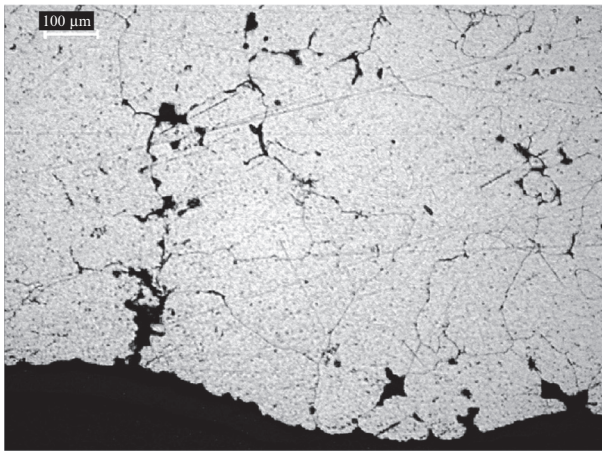
**Fig. 10.3.6** Micrograph of the sample showing secondary intergranular branching cracks perpendicular to the primary fracture. Etchant: Keller's reagent.

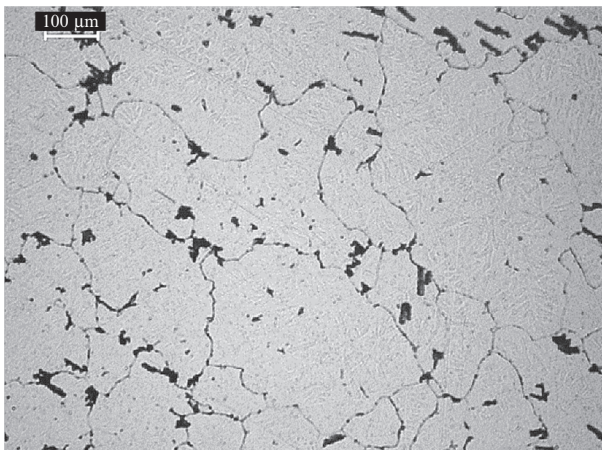
**Fig. 10.3.7** Micrograph of the sample showing coarse grains of aluminum solid solution and interdendritic network of  $Mg_2Al_3$  phase (dark). Etchant: Keller's reagent.

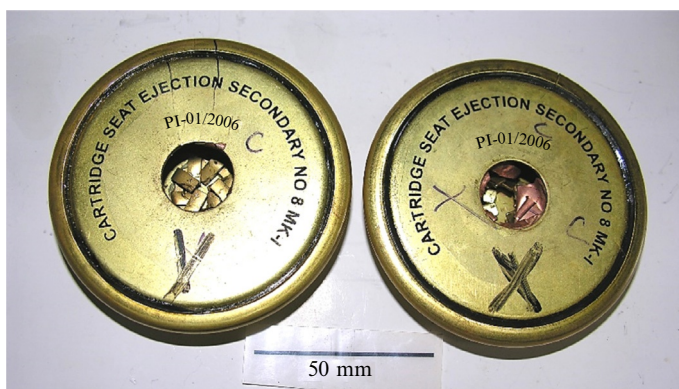
Fig. 10.4.1 Failed cartridges in the as-received condition.

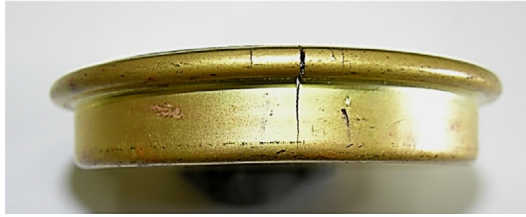
*Visual Examination:* The cracked cartridges in the as-received condition are shown in Fig. 10.4.1. The cracked portion of one of the cartridges is shown in Fig. 10.4.2. The wider part of the crack was found on the top U-bend of the cup. The crack was found to have propagated on either side of the U-bend. On opening the crack, the fracture surface showed tarnished regions at the U-bend and on the side wall (Fig. 10.4.3). Cup portion of

**Fig. 10.4.2** Side view of a sample of the failed cartridge showing the crack.

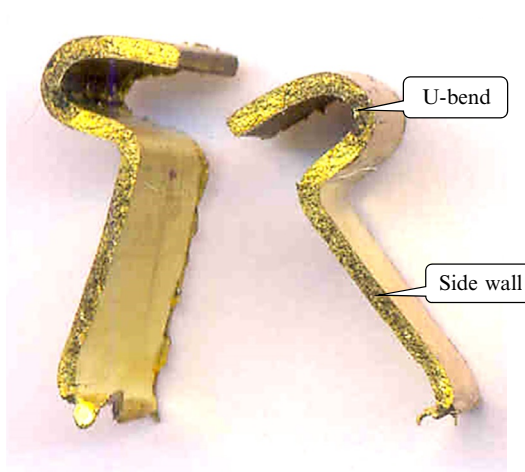
**Fig. 10.4.3** Mating fracture surfaces of one of the cracks showing tarnished regions on the U-bend and side wall of the cup.

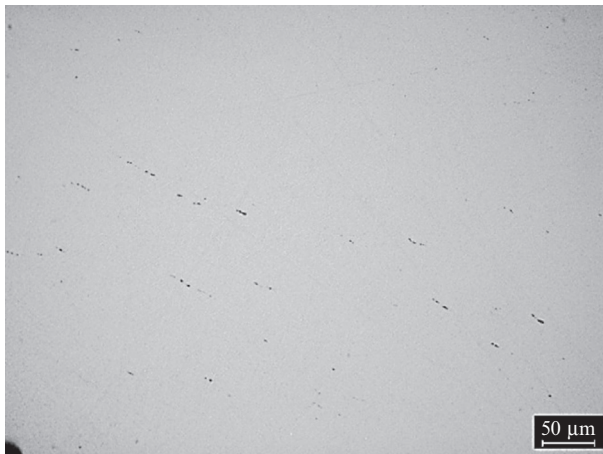
**Fig. 10.4.10** Micrograph of a section from the cartridge sample showing strings of zinc sulfide inclusions. Unetched.

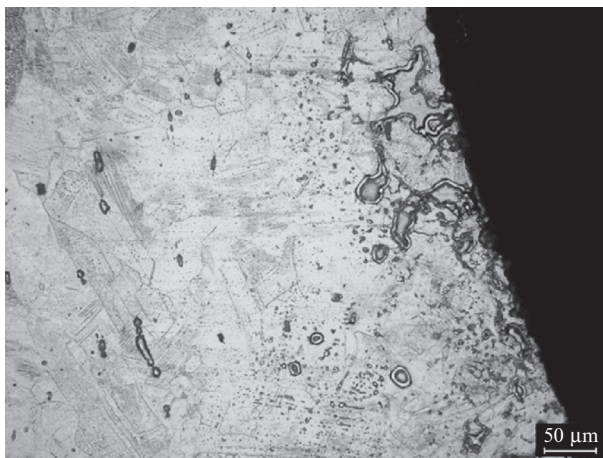
**Fig. 10.4.11** Micrograph of a section showing corrosion near the inner surface of the U-bend. Etchant: Acidified potassium dichromate.

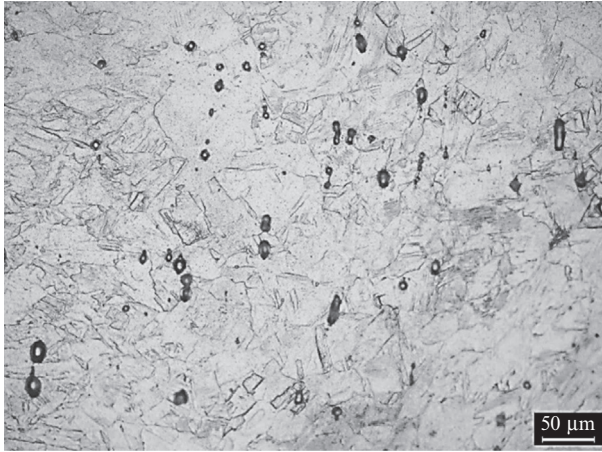
**Fig. 10.4.12** Micrograph of a section from the U-bend of the cartridge sample showing equiaxed alpha grains with some strain markings and zinc sulfide inclusions. Etchant: Acidified potassium dichromate.

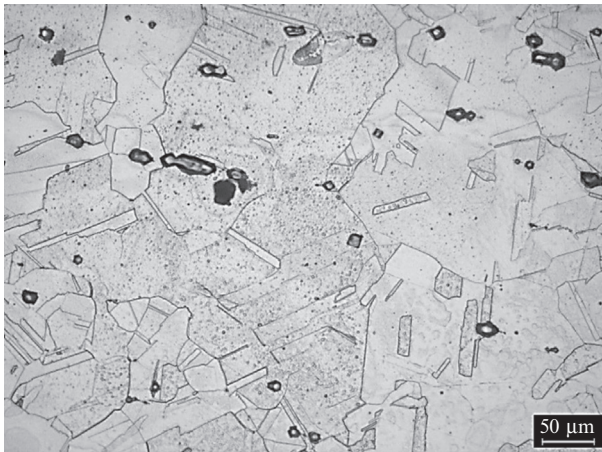
**Fig. 10.4.13** Micrograph of a section from the lid of the cartridge sample showing equiaxed alpha grains with annealing twins and zinc sulfide inclusions. Etchant: Acidified potassium dichromate.

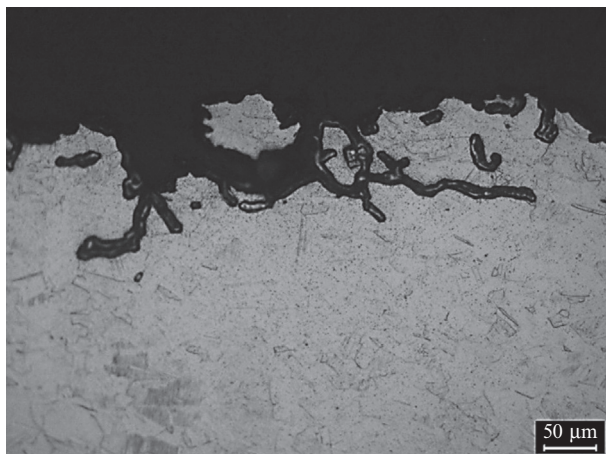
(Fig. 10.4.13). A section perpendicular to the fracture surface showed a number of secondary intergranular branching cracks (Fig. 10.4.14).

**Fig. 10.4.14** Micrograph of a section perpendicular to the fracture surface of the cartridge sample showing a number of secondary intergranular branching cracks. Etchant: Acidified potassium dichromate.

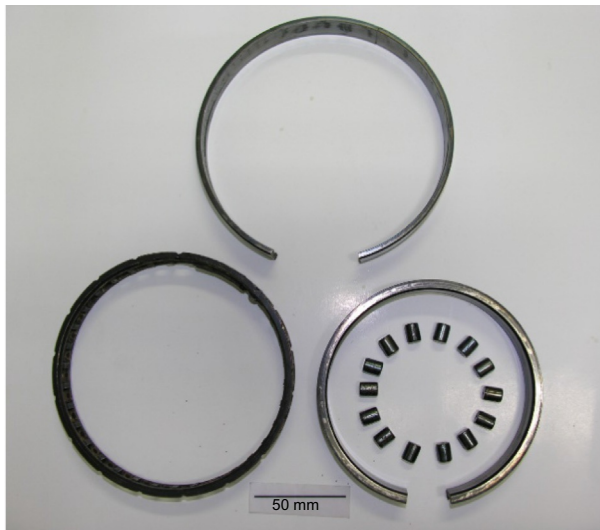
*Visual Examination:* The failed bearing in the as-received condition is shown in Fig. 11.1.1. The inner surface of the outer race showed pitting and grooving of the surface on one side (Fig. 11.1.2). The outer surface of the inner race showed score marks (Fig. 11.1.3). The rollers were badly worn out and a few showed flattened surfaces (Fig. 11.1.4). The outer and inner surfaces of the cage showed severe wear and breakage (Fig. 11.1.5).

**Fig. 11.1.1** Failed bearing showing the outer race, the inner race, the rollers, and the cage in the as-received condition.

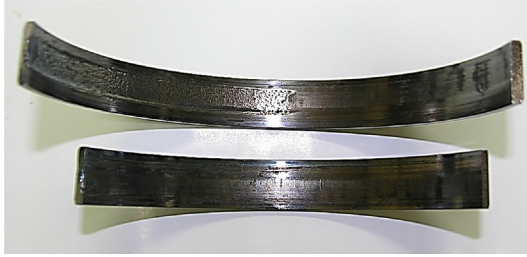
**Fig. 11.1.2** Inner surface of the outer race showing the damage concentrated to one side

The outer race showed pitting and grooving on the inner surface a little off-center. This happens when the radial load exceeds the axial load and when the bearing is overloaded. The outer race also revealed surface and subsurface cracks and spalling of the inner surface, which is indicative of rolling contact fatigue.

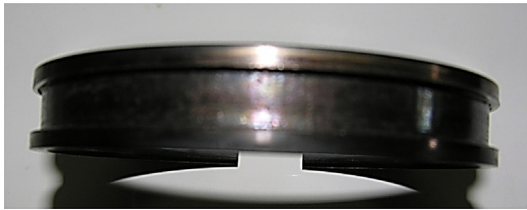
**Fig. 11.1.3** Outer surface of the inner race showing score marks.

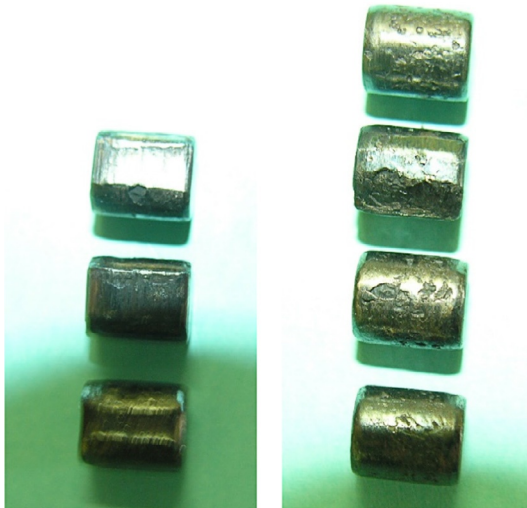
**Fig. 11.1.4** Rollers showing severe wear and flattening of the surfaces.

Surface wear of rollers by pitting has resulted due to rattling movement of the rollers while sliding/skidding over damaged raceways causing friction and heating. The roller surfaces were deformed due to rubbing action at high temperature as evidenced by their flat surfaces and lower hardness.

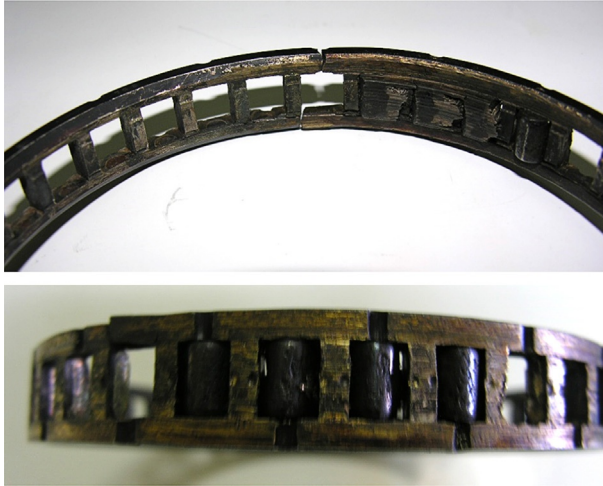
**Fig. 11.1.5** Outer and inner surfaces of the cage showing surface wear and breakage.

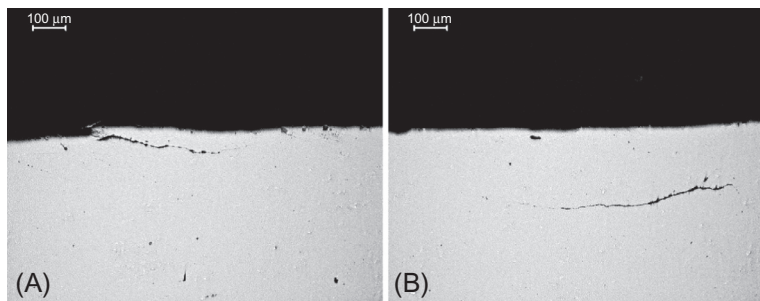
*Outer Race:* In the unetched condition the inner surface of the outer race showed a number of surface and subsurface cracks parallel to the surface (Fig. 11.1.7). The inner surface of the outer race also showed surface spalling

**Fig. 11.1.7** Micrograph of the inner surface of the outer race showing crack near the (A) surface and (B) subsurface crack almost parallel to the surface. Unetched.

Fatigue cracks are initiated at or very near the contact surfaces of bearing components as a result of stress concentrations. High stresses in localized regions are caused due to improper contact configurations, misalignment, or distortion. Eventually, such situation can lead to surface deterioration, crack initiation, and spalling. Alternating shear stresses reach maximum values at a distance below the surface initiating subsurface cracks. Subsurface-initiated fatigue cracks propagate parallel to the surface and eventually result in dish-shaped spall.

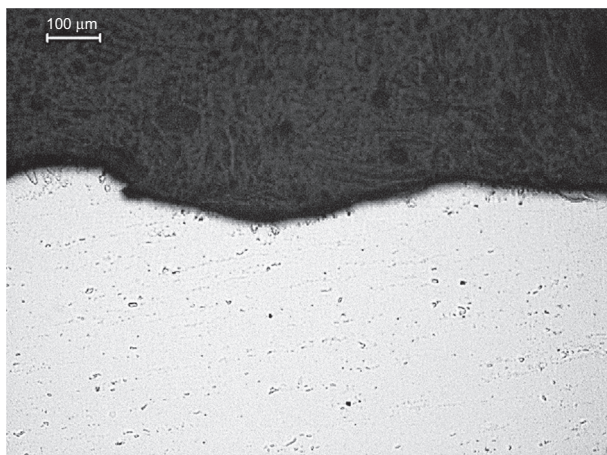
**Fig. 11.1.8** Micrograph of the inner surface of the outer race showing spalling and removal of material from the surface. Unetched.

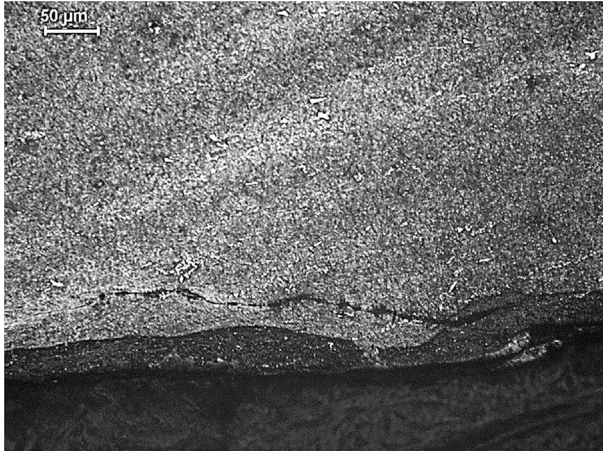
**Fig. 11.1.9** Micrograph of the inner surface of the outer race showing cracking and spalling near the surface. Etchant: 2% nital.

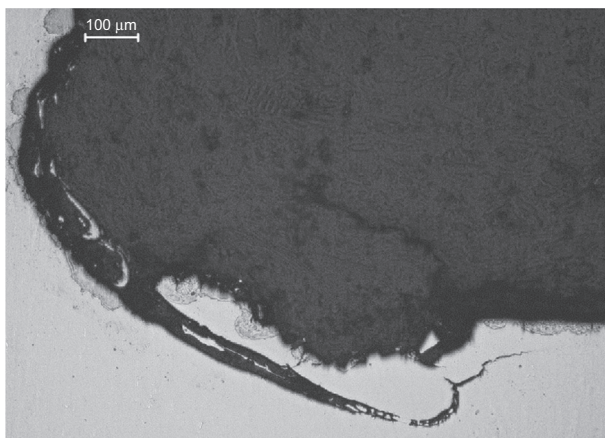
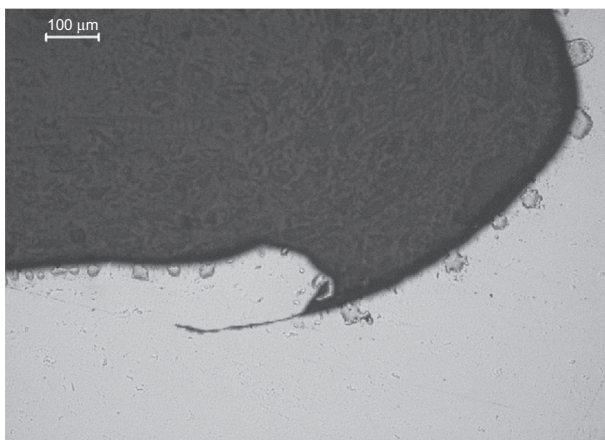
*Inner Race:* In the unetched condition, the outer surface of the inner race showed cracking and spalling at the corners of the groove (Fig. 11.1.11). The flat surface at the center showed micro-pitting and cracks (Fig. 11.1.12). On etching with 2% nital the sample revealed undissolved (coarse) and reprecipitated (fine) carbides in a matrix of tempered martensite (Fig. 11.1.13).

**Fig. 11.1.11** Micrograph of the outer surface of the inner race showing cracking and spalling of the material from the corners of the grooves. Unetched.

The outer surface of the inner race revealed cracks and spalling at the corners of grooves. Small micro-pitting and cracking were also observed at the polished contact surface. These are again evidences of rolling contact fatigue.

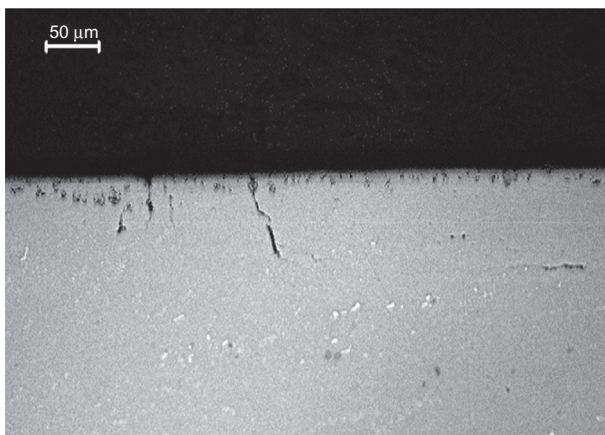
**Fig. 11.1.12** Micrograph of the outer surface of the inner race showing micro-pitting and cracking near the surface. Unetched.

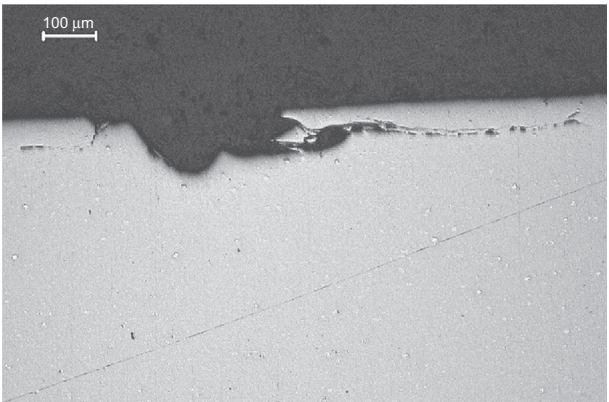
*Rollers:* In the unetched condition, longitudinal section of the rollers showed surface wear, cracks, and removal of material (Fig. 11.1.14). On

**Fig. 11.1.14** Micrograph of horizontal section of a roller showing surface erosion and removal of material. Unetched.

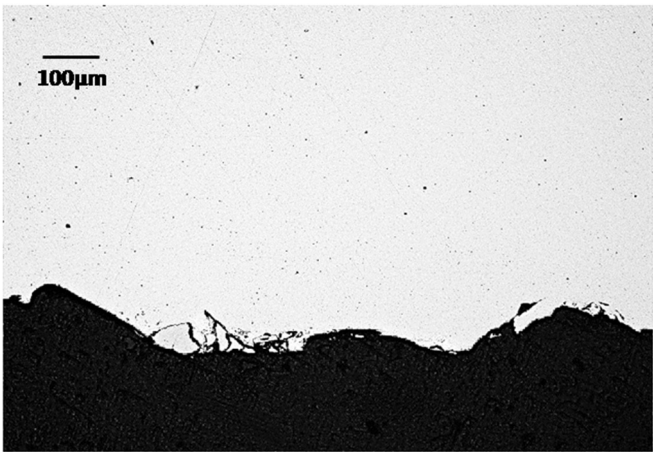
*Cage:* In the unetched condition the cage sample showed surface wear, cracks, and removal of material (Fig. 11.1.16). On etching with acidified potassium dichromate solution, the sample revealed alpha grains in a matrix of transformed eutectoid beta (Fig. 11.1.17).

**Fig. 11.1.16** Micrograph of the cage sample showing surface erosion and removal of material. Unetched.

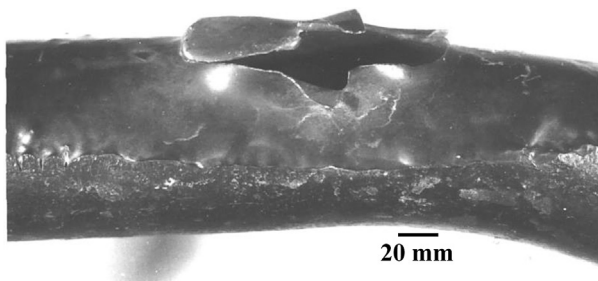
**Fig. 11.2.1** The failed LTSH tube in the as-received condition.

The LTSH tube had failed primarily due to hot erosion of the outer surface probably due to impingement of hot flew gases focused at the bend. The thinning of the tube due to hot erosion and low yield strength caused by high temperature resulted in final failure of the tube by overload.

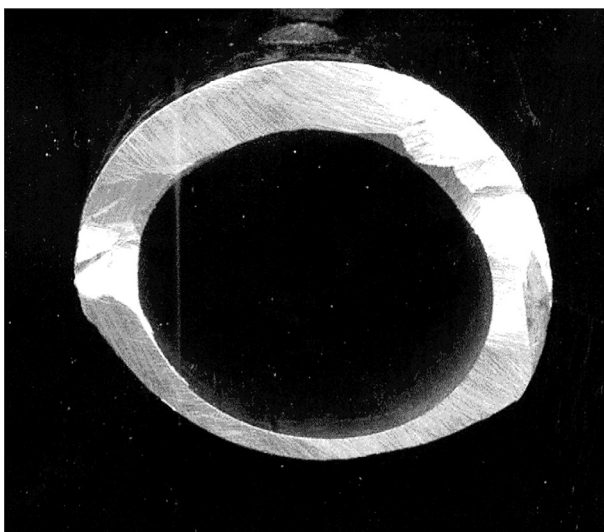
**Fig. 11.2.2** Cross section near the failed portion of the tube showing severe surface erosion evidenced by reduction in thickness.

that the tube was used in annealed condition. The tube showed severe blistering and erosion on the outer surface leading to considerable thinning of the tube section from 5 mm to <2 mm. The surface erosion could have been caused by flew gas impingement on the bend portion of the tube as evidenced by maximum material removal in that region. Blistering and material removal coupled with discoloration in the area suggested hot

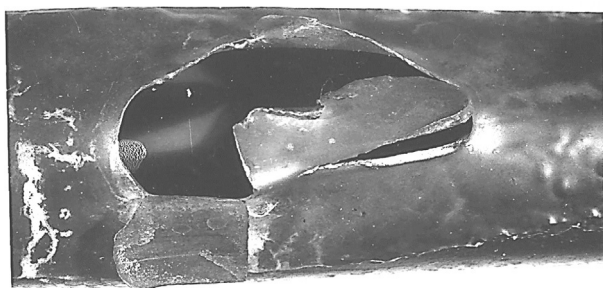
**Fig. 11.2.3** Thinning of the failed region seen on the tube.

erosion to be the primary cause of failure. The erosion had caused the thinning of the tube to such an extent that it could no longer withstand the applied load at the prevailing temperature. High temperature of flue gas ( $600^{\circ}\text{C}$ ) on the outer surface and super-heated steam ( $450^{\circ}\text{C}$ ) on the inner surface caused lowering of the yield strength of the steel. However, metallography confirmed that the overheating of the tube has not taken place beyond  $\text{AC}_1$  as evidenced by cold worked structure and higher hardness of the failed region as compared to equiaxed structure and lower hardness of an area away from failure. Lower yield strength due to prevailing temperature conditions coupled with thinning of the tube section due to hot erosion could no longer permit the LTSH tube to withstand the applied load causing overload failure of the tube as evidenced by dimpled rupture.

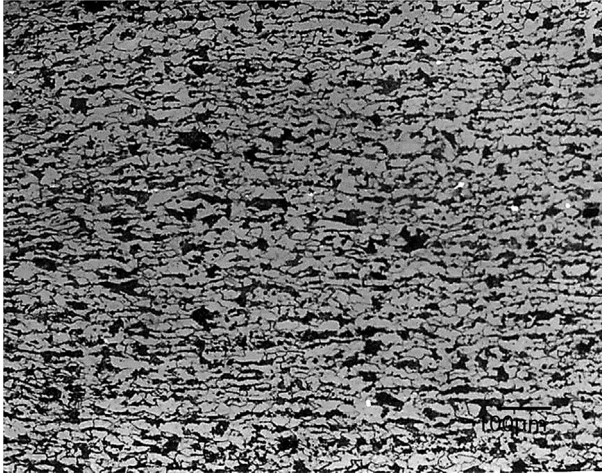
**Fig. 11.2.5** Micrograph of a section of the tube showing elongated grains of ferrite and pearlite near the failure. Etchant: 2% nital.

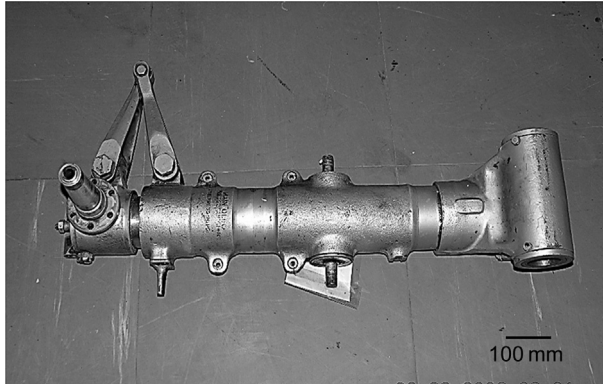
*Visual Examination:* The wheel hub did not show any sign of failure. The brake unit was badly rubbed and worn out. The axle was found broken at the threaded portion (Fig. 11.3.1). Close-up of the broken portion of the axle is shown in Fig. 11.3.2. The mating fracture portion of the axle was inside the axle nut. The outer bearing in the as-received condition is

**Fig. 11.3.1** Oleo in the as-received condition showing the broken axle.

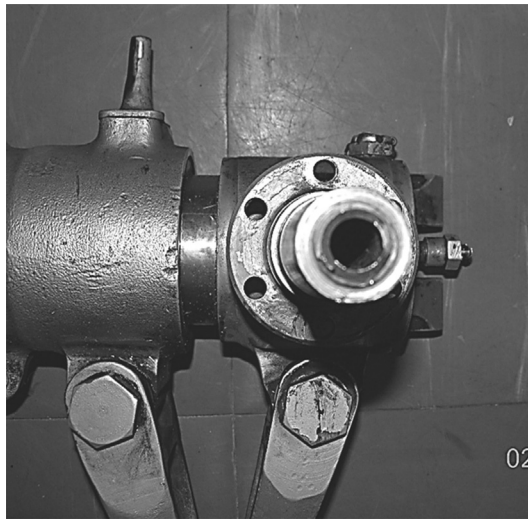
**Fig. 11.3.2** Close-up of the fractured portion of the axle.

The fracture surface of the axle showed a  $45^\circ$  shear with one half showing a cup portion and the other half a cone portion. The junction of the two portions showed a twist. The fracture had originated from the first thread root.

Chemical analysis of the axle suggested that it was made of a low alloy steel conforming to SAE 4130. Microstructure and hardness indicated that it was used in a hardened and tempered condition. Fibrous fracture and dimpled rupture pointed to the fact that the axle had suffered an overload failure.

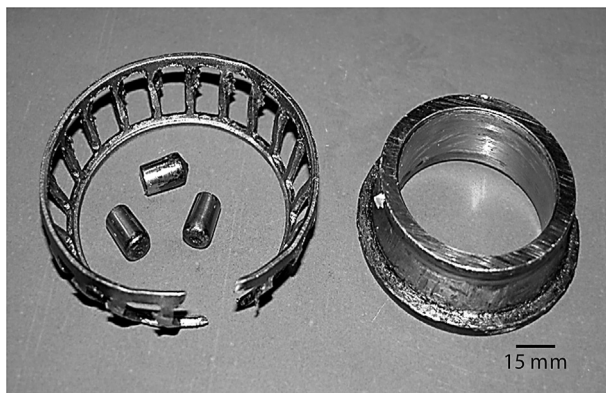
shown in [Fig. 11.3.3](#). The outer surface of the inner race of the bearing showed dent marks on at least half of the circumference at locations corresponding to the rollers ([Fig. 11.3.4](#)). The inner surface revealed scoring marks and bluing. Only three rollers were found which were worn out badly and showed evidences of bluing. The cage was badly rubbed, deformed, and broken. The split pin which locks the axle nut to the axle at the thread was found missing. Since the axle was broken and the bearing showed evidences of failure, the two components were taken up for further examination.

**Fig. 11.3.3** The outer bearing in the as-received condition showing the inner race, the cage, and the rollers.

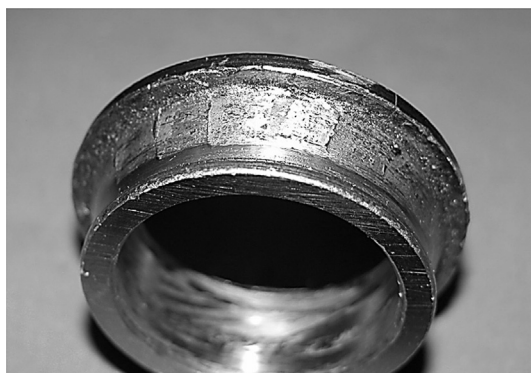
**Fig. 11.3.4** The outer surface of the inner race showing dent marks corresponding to the locations of the rollers.

Frictional overheating could be the result of dry running conditions of the bearing. This has led to bearing seizure causing score marks and micro-cracks on the inner and outer surfaces of the inner race. The circumstances prevailing in the wheel assembly have caused failure of the bearing. Failure of the bearing has caused overload of the axle resulting in breakage of axle at the thread region.
