# **METALLURGICAL FAILURE ANALYSIS**

Techniques and Case Studies

KANNADI PALANKEEZHE BALAN

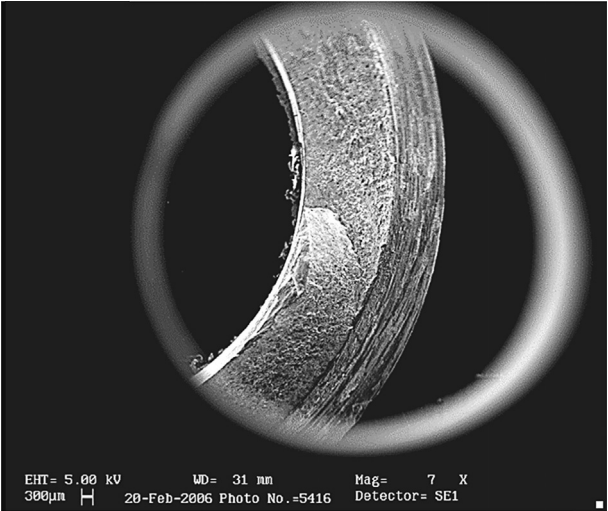
*Fractographic Examination:* The portion of the axle remaining within the axle nut was unscrewed, cleaned with acetone ultrasonically, and the fracture surface was examined under scanning electron microscope. The fracture surface showed a fibrous fracture originating from the first thread root (Fig. 11.3.5). The fracture surface revealed equiaxed dimples all over it (Fig. 11.3.6).

**Fig. 11.3.5** SEM fractograph of the fracture surface of the axle showing a fibrous fracture.

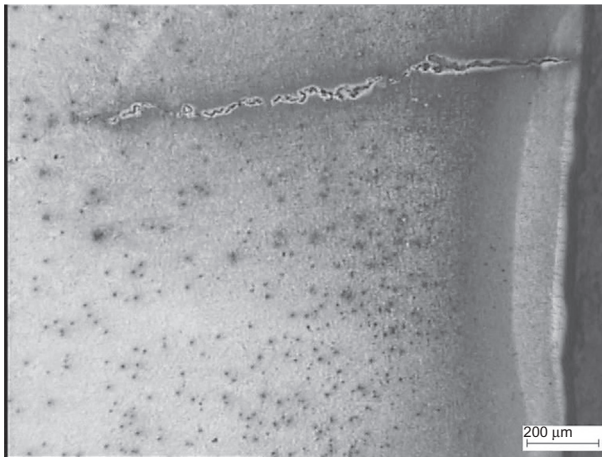
**Fig. 11.3.9** Micrograph of the transverse section of the inner race showing white etching layer of untempered martensite and crack on the inner surface. Etchant: 2 % Nital.

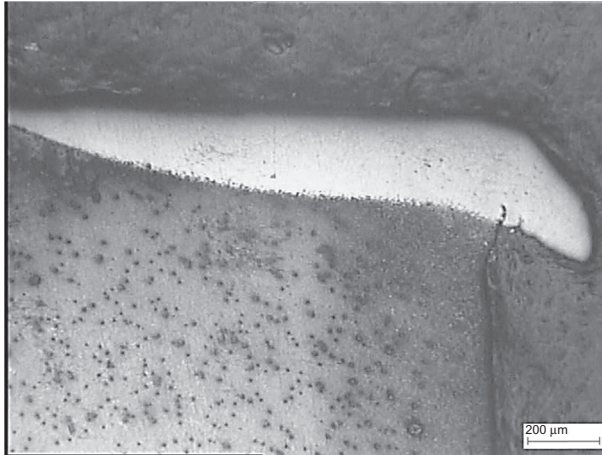
**Fig. 11.3.10** Micrograph of the transverse section of the inner race showing white etching layer of untempered martensite on the outer surface. Etchant: 2 % Nital.

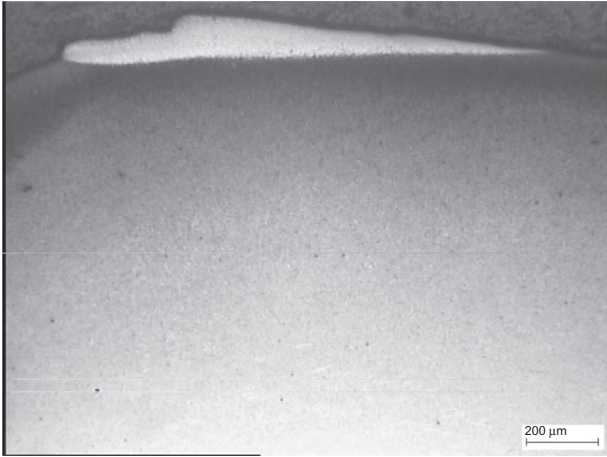
**Fig. 11.3.12** Micrograph of the transverse section of the roller sample showing white etching layer of untempered martensite on the surface. Etchant: 2% Nital.

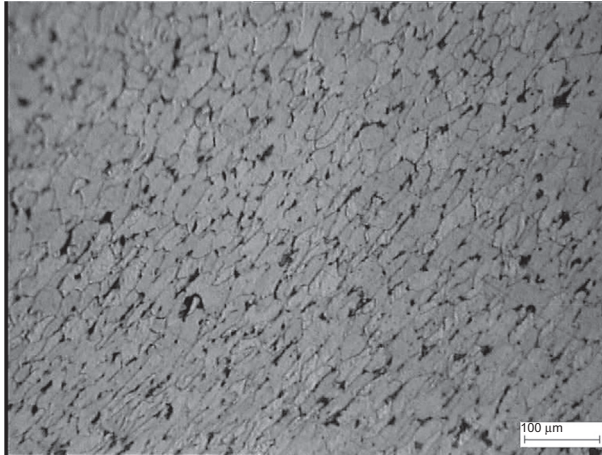
**Fig. 11.3.14** Micrograph of the transverse section of the cage sample showing deformed grains of ferrite and pearlite. Etchant: 2% Nital.

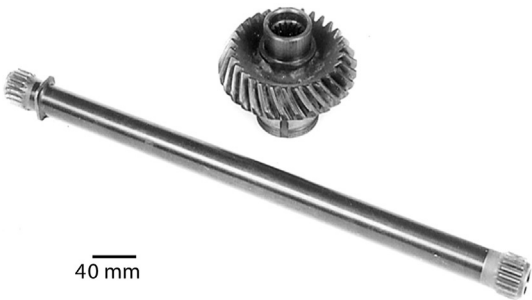
**Fig. 11.4.1** The worn out coupling shaft and bevel gear in the as-received condition.

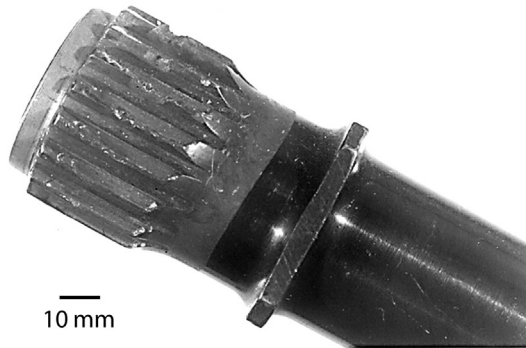
*Visual Examination:* The worn out bevel gear and coupling shaft in the as-received condition are shown in Figure 11.4.1. One of the splined ends of the shaft and the spline cut within the gear was observed to have been badly worn out (Fig. 11.4.2). The other end of the shaft was found to be intact.

**Fig. 11.4.2** The spline end of the coupling shaft showing the extent of wear and spalling.

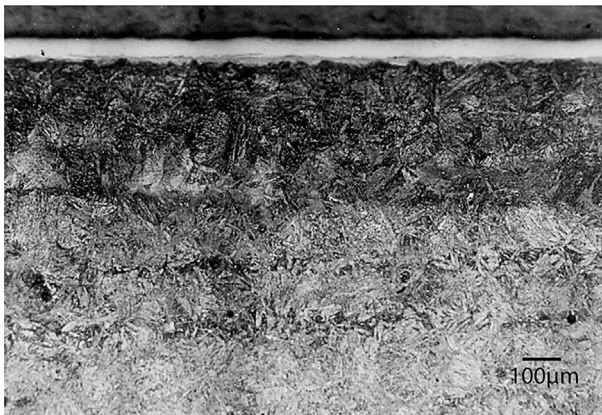
**Fig. 11.4.3** Micrograph of longitudinal section of the coupling shaft showing a nitride case at the spline region. A white etching layer of about 20–30  $\mu\text{m}$  at the surface is observed just below the nickel plating. Etchant: 2% nital.

the nickel plating (Fig. 11.4.3). A nitride case of about 300  $\mu\text{m}$  depth was observed below the white etching layer as shown in Figure 11.4.3. The case showed a nitrided martensitic microstructure with prominent acicularity and a white film along the grain boundaries. The core of the sample showed a tempered martensite microstructure (Fig. 11.4.4).

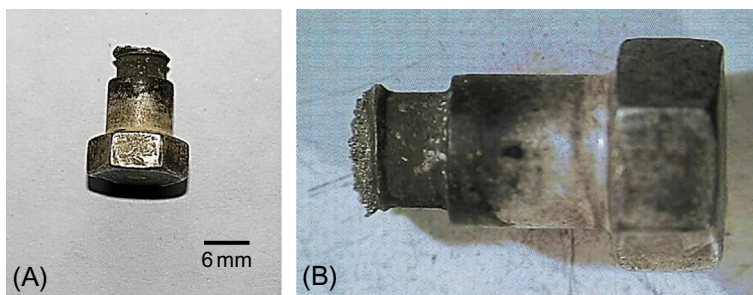
*Visual Examination:* The failed bolt in the as-received condition is shown in Fig. 12.1.1. The failure had taken place from the first thread root in the shank. The fracture surface was found to be coarse and crystalline.

**Fig. 12.1.1** Photograph showing the failed bolt in the as-received condition. (A) General view and (B) close-up showing coarse and crystalline fracture.

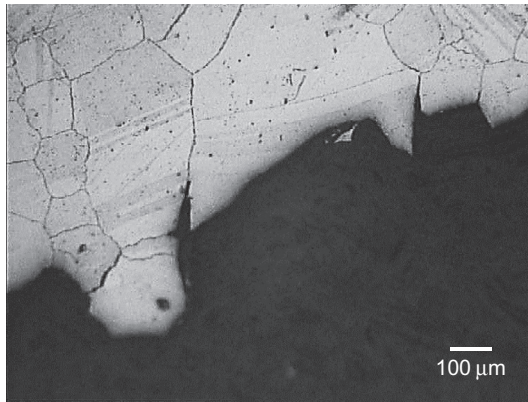
*Metallographic Examination:* Longitudinal section of the bolt containing the fracture surface was mounted and prepared for metallography. In the unetched condition, the sample showed a number of oxide and titanium carbo-nitride inclusions. On etching with Kalling's reagent the sample revealed primary cracking along the grain boundaries with secondary intergranular cracks (Fig. 12.1.4). The sample revealed equiaxed grains of gamma solid solution with annealing twins and carbides ( $M_{23}C_6$ ) along the grain boundaries (Fig. 12.1.5). Grain coarsening was also observed

**Fig. 12.1.4** Micrograph revealing primary cracking along the grain boundaries with secondary intergranular cracks. Etchant: Kalling's reagent

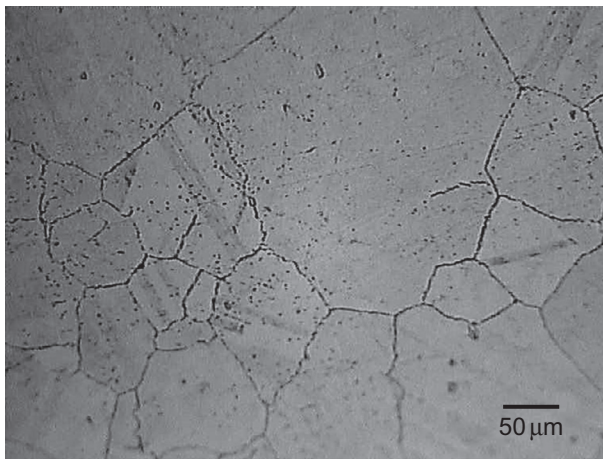
**Fig. 12.1.5** Micrograph showing equiaxed and nonuniform grains of gamma solid solution with annealing twins and carbides ( $M_{23}C_6$ ) along the grain boundaries. Etchant: Kalling's reagent.

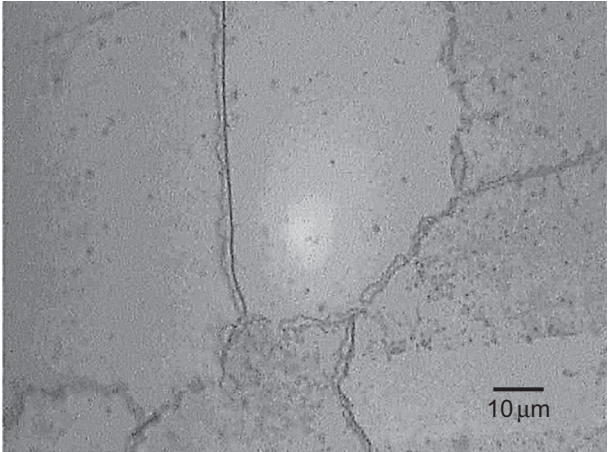
**Fig. 12.1.6** Micrograph revealing continuous films of carbide ( $M_{23}C_6$ ) along the grain boundaries. Etchant: Kalling's reagent.

following the process of Ostwald ripening. At higher magnification, a large number of grains revealed continuous films of carbide ( $M_{23}C_6$ ) along the grain boundaries (Fig. 12.1.6). Gamma prime ( $\gamma'$ ) was not visible under optical microscope.

The microstructure revealed the presence of grain boundary films of carbides which must have formed either during heat treatment or during service at elevated temperature. The grain boundary film of carbides is detrimental to stress rupture life of nickel base alloys. It is known that the

This data indicates that at temperatures above 800°C the rupture life is only 100 h at a stress as low as 185 MPa. Service at elevated temperature, presence of grain boundary carbide films, and intergranular mode of fracture point to the fact that the bolt had suffered stress rupture.

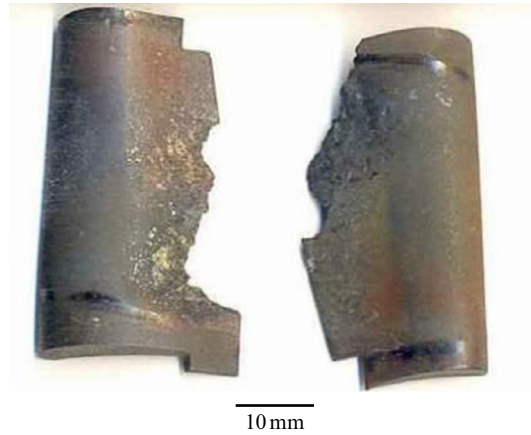
*Visual Examination:* The damaged vanes in the as-received condition are shown in [Fig. 12.2.1](#). The breakage was observed on one-half to three-fourths of the distance from the upper end on the trailing edge of the vanes.

**Fig. 12.2.1** Damaged vanes showing degradation and roughness on the surface of the convex side.

The fracture surface was seen to be coarse and crystalline. The convex side of the vanes showed surface degradation similar to corrosion damage, surface roughness, and cracks (Fig. 12.2.1). Brown scale and some cracks also appeared on the concave side of the vanes (Fig. 12.2.2).

Impingement of hot blow of gases from combustion chamber at about 925°C which is probably focused on the trailing edge and convex side of the vanes has caused localized cracking and partial spalling of the surface coating resulting in overheating, hot corrosion, and oxidation of the basic material. This damage process has ultimately caused stress rupture of the vanes removing a considerable portion of the trailing edge.

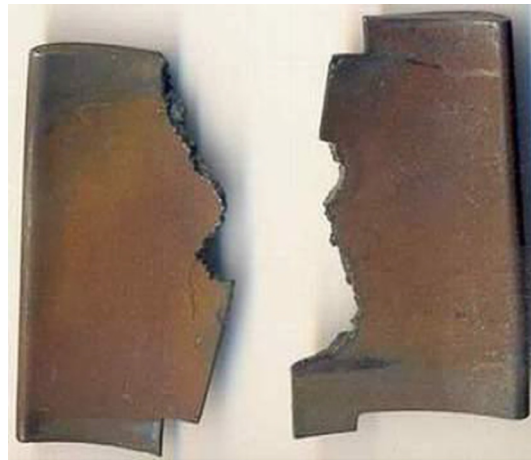
**Fig. 12.2.2** Damaged vanes showing cracks and oxidation on the surface of the concave side.

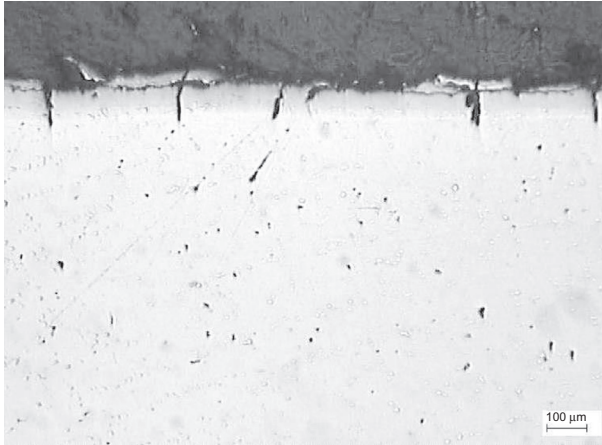
**Fig. 12.2.4** Micrograph of the vane sample showing cracks on the surface coating on the convex side near the trailing edge of the aerofoil. Unetched.

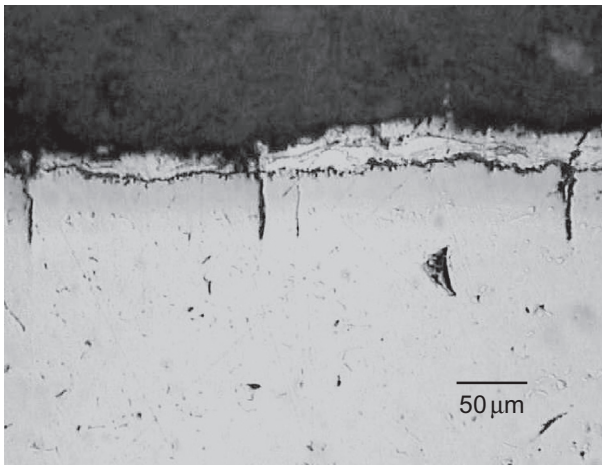
**Fig. 12.2.5** Micrograph of the vane sample showing the process of peeling off of the surface coating on the convex side of the aerofoil. Unetched.

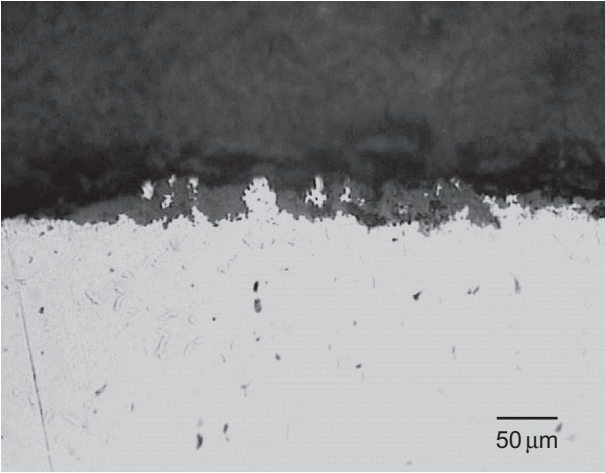
**Fig. 12.2.6** Micrograph of the vane sample showing surface oxide scale on the concave side of the aerofoil. Unetched.

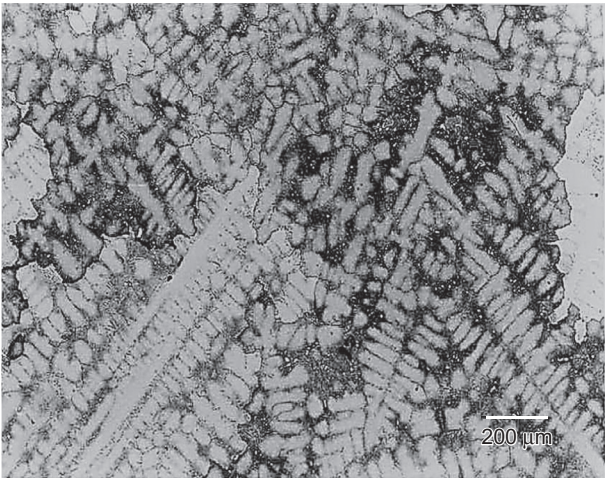
**Fig. 12.2.7** Micrograph of the vane sample showing a cast (dendritic) microstructure in the aerofoil. Etchant: Kalling's reagent.

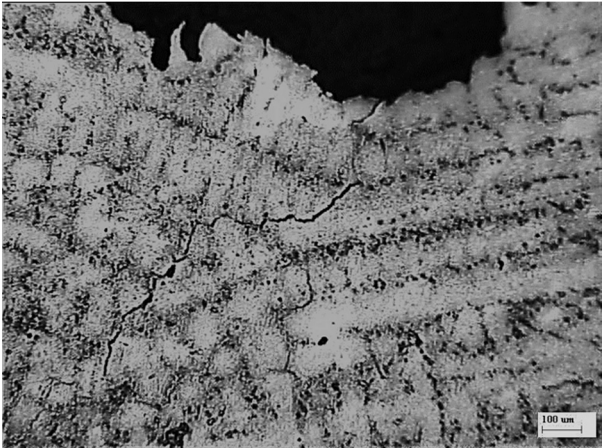
**Fig. 12.2.8** Micrograph of the vane sample showing a zig-zag fracture surface and intergranular secondary crack in a cast microstructure. Etchant: Kalling's reagent.

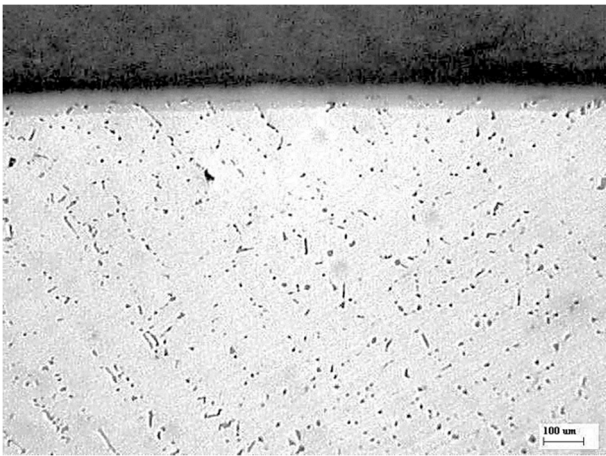
**Fig. 12.2.9** Micrograph of the vane sample showing surface coating remaining intact near the root region. Unetched.

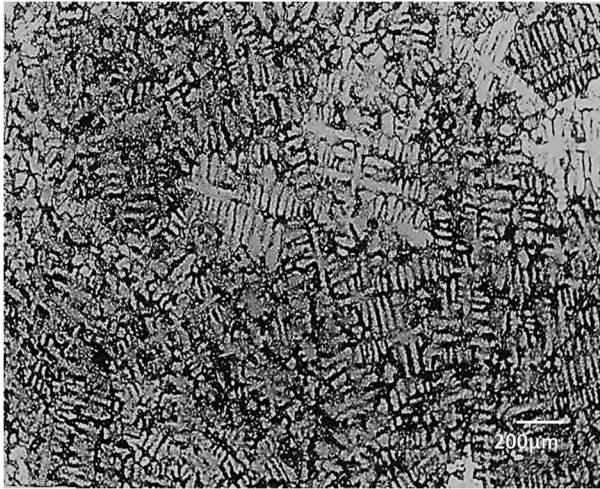
*Metallographic Examination:* Samples were sectioned perpendicular to the long axis of a vane from three regions viz. the top aerofoil, the central aerofoil containing the fracture surface, and the root. The samples were prepared for metallography. The convex surface of the aerofoil region showed a surface coating of about 60  $\mu\text{m}$  and a number of cracks in the coating propagating to the substrate (Fig. 12.2.4). The vertical cracks were observed to be joined by horizontal cracks and at places where the coating was found to be getting peeled off from the cracked portion (Fig. 12.2.5). At a number of locations on the concave side oxidation of the surface was seen (Fig. 12.2.6). On etching with Kalling's reagent the sample showed a cast (dendritic) microstructure (Fig. 12.2.7). The aerofoil region near the center of the vane showed zig-zag fracture surface and intergranular secondary crack in a cast structure (Fig. 12.2.8). The sample from near the root region showed the surface coating to be intact (Fig. 12.2.9). On etching, the sample revealed a cast microstructure with dendrites (Fig. 12.2.10).

**Fig. 12.2.10** Micrograph of the vane sample showing a cast dendritic microstructure in the root region. Etchant: Kalling's reagent.

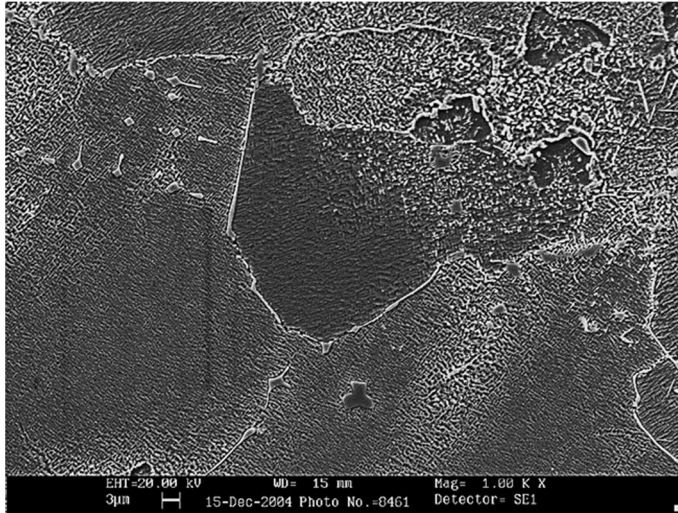
The samples were observed under scanning electron microscope. Both the aerofoil and the root region showed predominately continuous films and at places discrete carbides along the grain boundaries (Figs. 12.2.11 and 12.2.12). At higher magnification the aerofoil region showed cuboidal

**Fig. 12.2.12** SEM micrograph of the vane sample showing similar microstructure as in Fig. 12.2.11 in the root region. Etchant: Kalling's reagent.

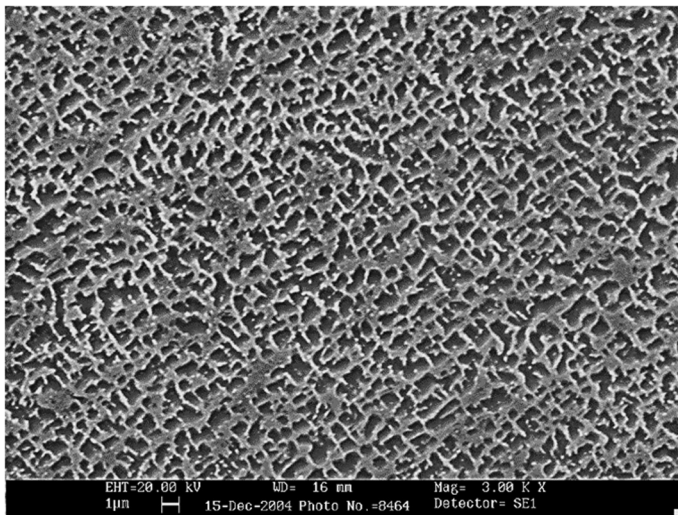
gamma prime in a gamma matrix (Fig. 12.2.13). The root region also revealed a similar microstructure but the gamma prime was considerably finer (Fig. 12.2.14).

**Fig. 12.2.13** SEM micrograph of the vane sample showing cuboidal gamma prime ( $\gamma'$ ) precipitates in a gamma ( $\gamma$ ) matrix in the aerofoil. Etchant: Kalling's reagent.

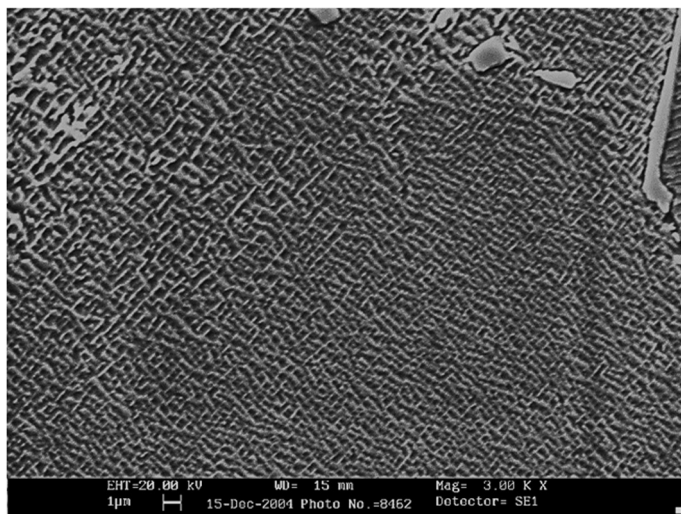
aerofoil and root regions could most probably be due to (a) the difference in section thickness and consequently differential cooling rates after casting, and (b) overheating of the aerofoil region. The higher hardness observed in the root region as compared to the aerofoil was also due to the finer grain

**Fig. 12.2.14** SEM micrograph of the vane sample showing cuboidal gamma prime ( $\gamma'$ ) precipitates in a gamma ( $\gamma$ ) matrix in the root region. Observe the finer size  $\gamma'$  precipitates as compared to [Fig. 12.2.13](#). Etchant: Kalling's reagent.

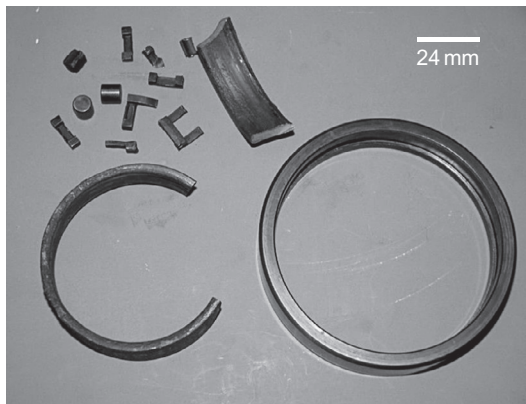
*Visual Examination:* The failed component in the as-received condition contained the bearing races, broken pieces of retainer, and severely worn out rollers (Fig. 12.3.1). The bearing race showed a large number of radial cracks of varying lengths. On opening the cracks, the fracture surfaces were found to be severely oxidized.

Fig. 12.3.1 Bearing components in the as-received condition.

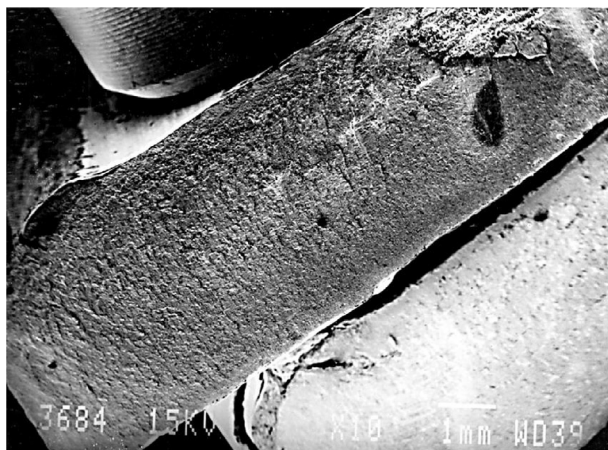
*Fractographic Examination:* Fracture surface of a few freshly opened cracks from the bearing race was cleaned ultrasonically in acetone and examined under scanning electron microscope (SEM). The fracture surface showed a crystalline fracture having a number of radial secondary cracks (Fig. 12.3.2). The fracture surface revealed intergranular fracture with secondary cracks (Fig. 12.3.3). At higher magnification, the grain facets showed evidences of melting and resolidification (Fig. 12.3.4).

**Fig. 12.3.2** SEM fractograph of the fracture surface of the bearing race showing a crystalline fracture having a number of radial secondary cracks.

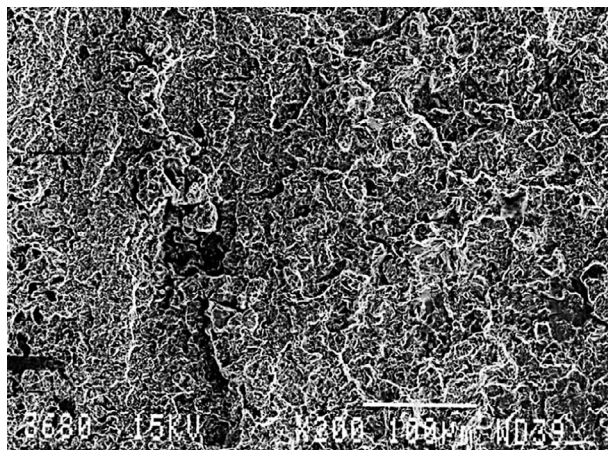
**Fig. 12.3.3** SEM fractograph of the fracture surface of the bearing race showing intergranular fracture with secondary cracks.

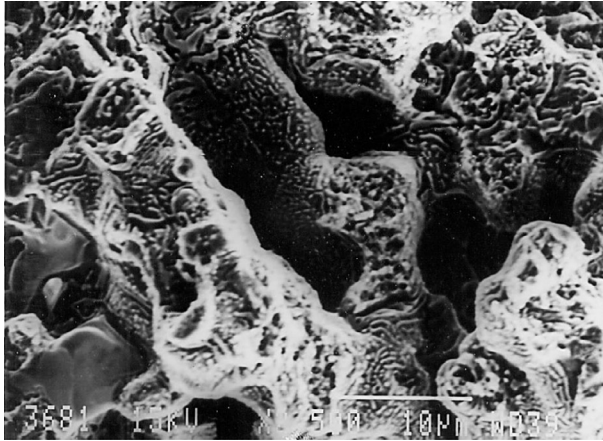
**Fig. 12.3.4** SEM fractograph of the fracture surface of the bearing race showing dendrites.

crackings in the race. The heat generated due to frictional heat has raised the race temperature to melting temperature of the steel at localized regions as evidenced by formation of dendrites as a result of melting and resolidification.

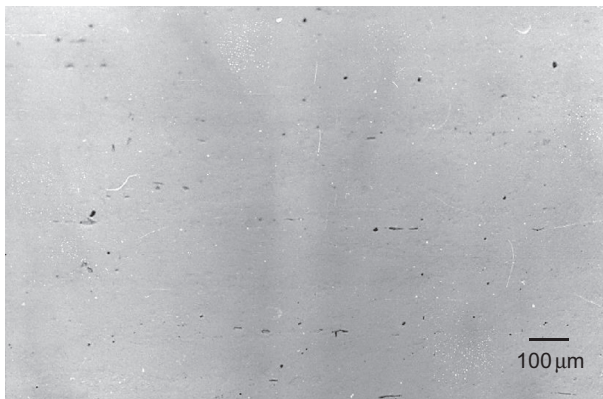
**Fig. 12.3.5** Micrograph of longitudinal section of the race sample showing a number of nonmetallic inclusions. Unetched.

*Metallographic Examination:* Longitudinal and transverse sections of the sample from the bearing race were prepared for metallographic examination. In the unetched condition, the race sample showed a large population of nonmetallic inclusions (Fig. 12.3.5). Race sample near the fracture surface showed voids and fissures connected by intergranular cracks (Fig. 12.3.6). Intergranular cracks were also found deep inside the sample (Fig. 12.3.7). Wedge-shaped micro-cavities were also noticed in many parts of the sample (Fig. 12.3.8). On etching with 2% nital, the race sample revealed evidences

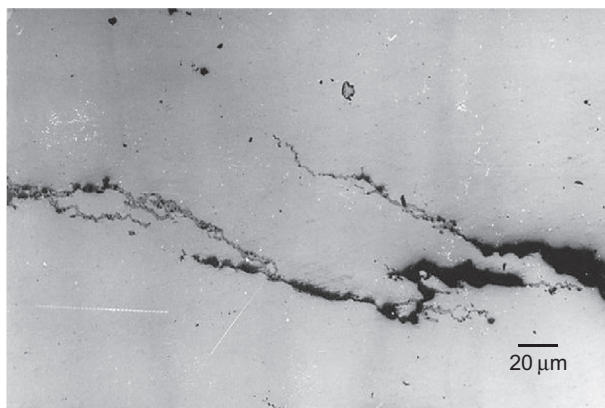
**Fig. 12.3.6** Micrograph of longitudinal section of the race sample near the fracture region showing voids and fissures connected by cracks. Unetched.

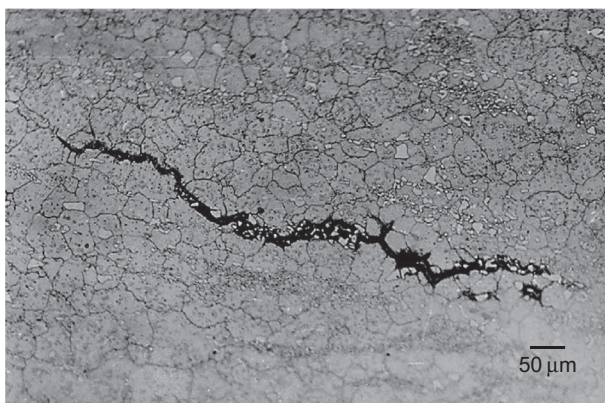
**Fig. 12.3.7** Micrograph of a section of the race sample away from the fracture region showing intergranular cracks inside the material. Etchant: 2% nital.

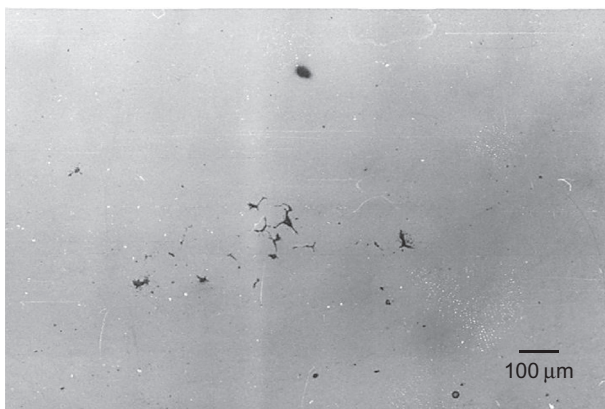
**Fig. 12.3.8** Micrograph of a section of the race sample showing wedge-shaped microcavities. Unetched.

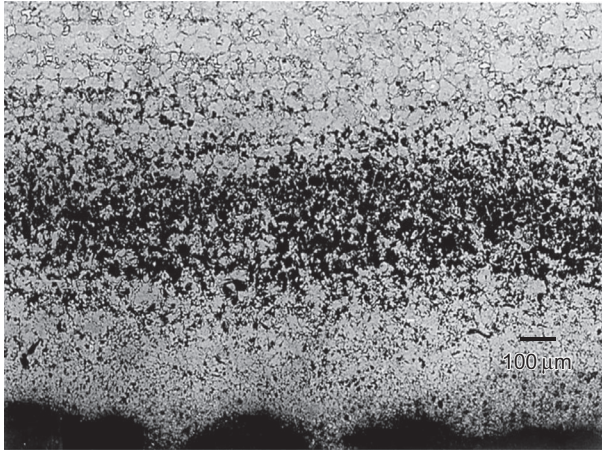
**Fig. 12.3.9** Micrograph of a section of the race sample near the inner surface showing pitting and oxidation. Etchant: 2% nital.

of pitting and oxidation near the inner surface (Fig. 12.3.9). Longitudinal section of the race sample showed intergranular cavities and undissolved carbides in a matrix of tempered martensite (Fig. 12.3.10). Transverse section revealed carbide precipitation along the grain boundaries (Fig. 12.3.11).

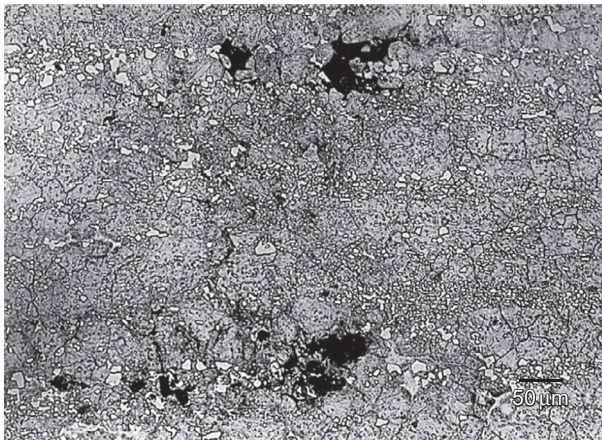
**Fig. 12.3.10** Micrograph of longitudinal section of the race sample showing intergranular cavities and undissolved carbides in a matrix of tempered martensite. Etchant: 2% nital.

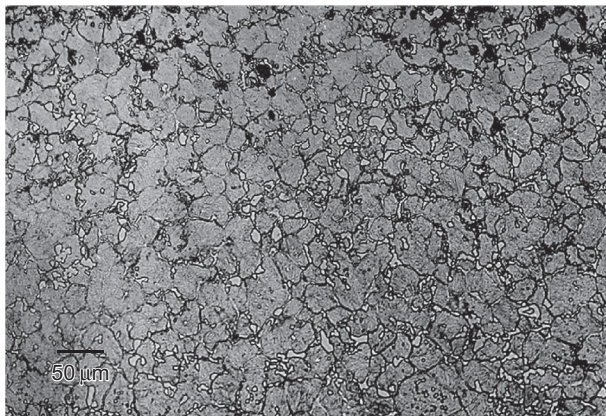
**Fig. 12.3.11** Micrograph of transverse section of the race sample showing carbide precipitation along the grain boundaries. Etchant: 2% nital.

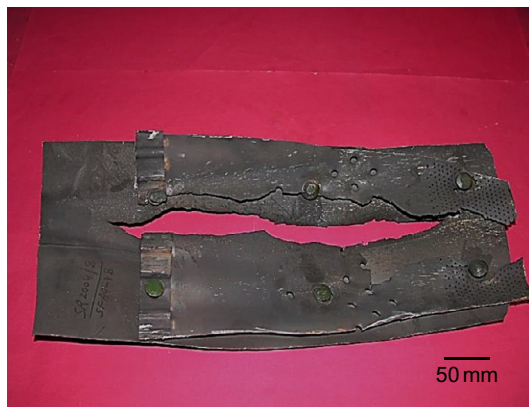
*Visual Examination:* The jet nozzle casing in the as-received condition is shown in Fig. 12.4.1. The component was observed to have suffered a

Fig. 12.4.1 Failed jet nozzle casing in the as-received condition.

longitudinal rupture of size about 400 mm. The fracture surface was found to have been badly oxidized and the scale was not easily removable even by chemical cleaning.

Cracking of the jet nozzle casing was a result of hot corrosion of the component.

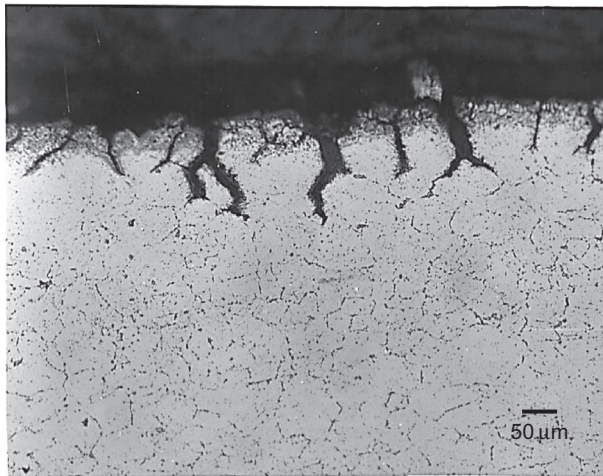
*Metallographic Examination:* Sections of the samples near and away from the fracture were prepared for metallographic examination. In the unetched condition, the jet nozzle casing sample near the fracture showed severe grain boundary oxidation and cracks. On etching with aqua regia, the sample revealed intergranular oxidation and cracks near the surface and equiaxed grains (Fig. 12.4.2). Section away from fracture also revealed grain boundary oxidation and cracks near the surface and equiaxed grains (Fig. 12.4.3).

**Fig. 12.4.2** Micrograph of a section of the sample from failed region showing grain boundary oxidation and cracks near the surface and equiaxed grains. Etchant: Aqua regia.

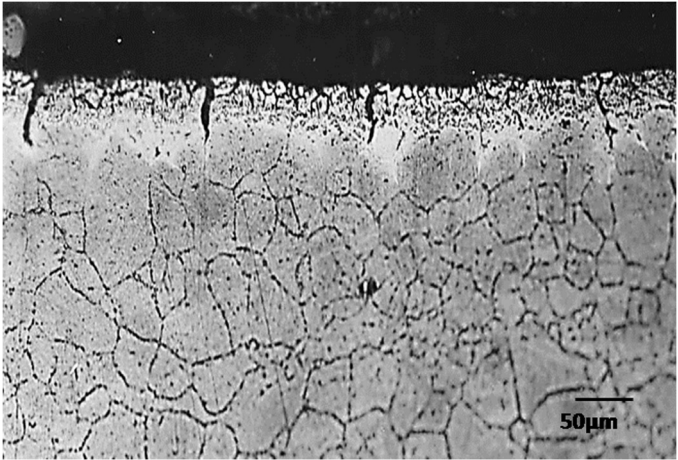
**Fig. 12.4.3** Micrograph of a section of the sample away from failed region showing grain boundary oxidation and cracks near the surface and equiaxed grains. Etchant: Aqua regia.

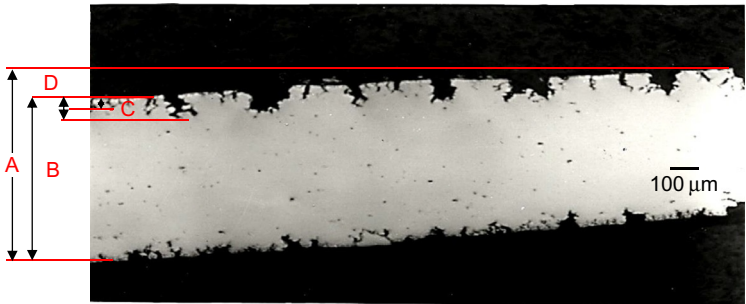
*Evaluation of Hot Corrosion:* The hot corrosion damage is evaluated from the micrograph as shown in [Fig. 12.4.4](#). [1]

**Fig. 12.4.4** Micrograph of a section showing hot corrosion damage near the surface. Unetched.

Metal loss per side  $= (A - B)/2 = (800 - 700)/2 = 50 \text{ } \mu\text{m}$

The deterioration indicated that the casing was subjected to hot corrosion, resulting in considerable loss of material and failure of the component in intergranular mode. Lower hardness of the material near failure could be due to localized grain coarsening.

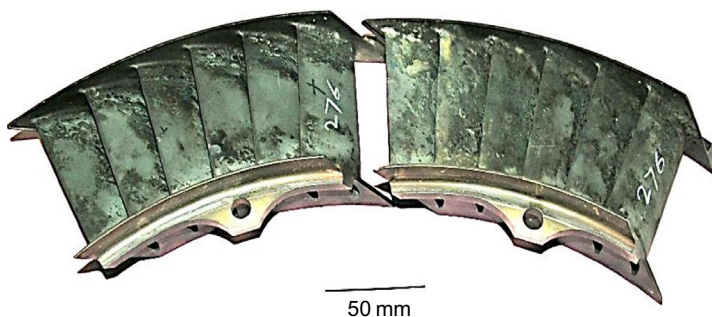
*Visual Examination:* The turbine stator vanes in the as-received condition are shown in Fig. 12.5.1. Each segment contained six hollow vanes. Three vanes on one segment and two vanes on another segment showed cracks near its trailing edges (Figs. 12.5.2 and 12.5.3). The cracks were 6–10 mm long. The surfaces of the vanes were found to be rough. The cracked portions of the vanes were sectioned using an EDM wire cut machine and removed. On opening the cracks, the fracture surfaces were found to contain dark adherent oxide.

Fig. 12.5.1 Two segments of failed vanes in the as-received condition.

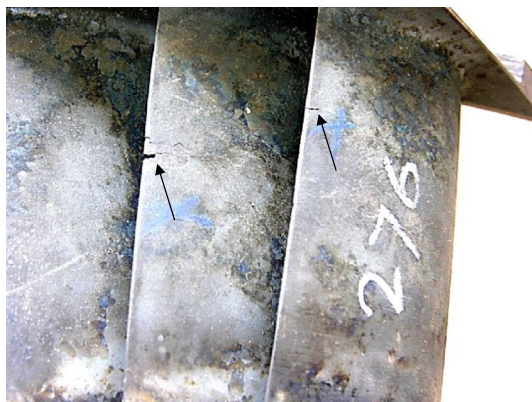
**Fig. 12.5.2** Close-up view of one segment of the vanes showing cracks near the trailing edge on the convex side of the aerofoil.

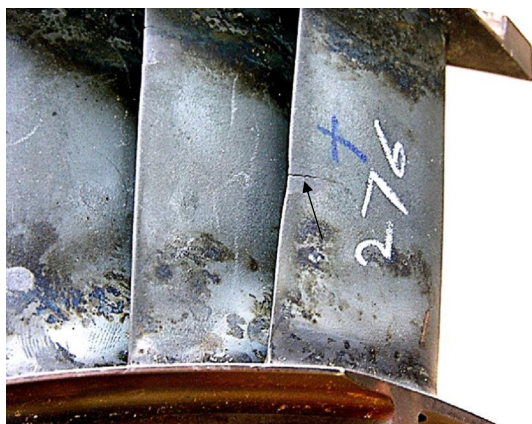
**Fig. 12.5.3** Close-up view of another segment of the vanes showing cracks near the trailing edge on the convex side.

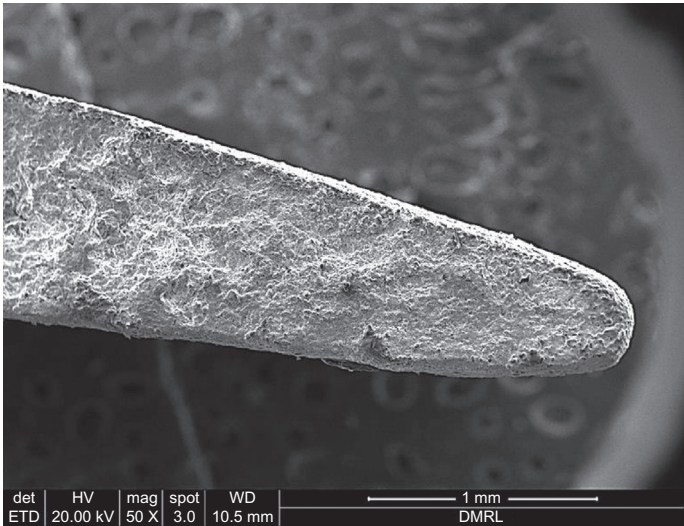
*Fractographic Examination:* The fracture surfaces were cleaned using an oxide removing solution, followed by cleaning in acetone ultrasonically. On examining under SEM, the fracture surfaces showed thick adherent oxide scale, which probably was not removed by cleaning (Figs. 12.5.4 and 12.5.5). A typical energy dispersive X-ray spectroscopy (EDAX) of the fracture surface is shown in Fig. 12.5.6.

**Fig. 12.5.4** SEM fractograph of one of the typical fracture surfaces at the trailing edge of the aerofoil.

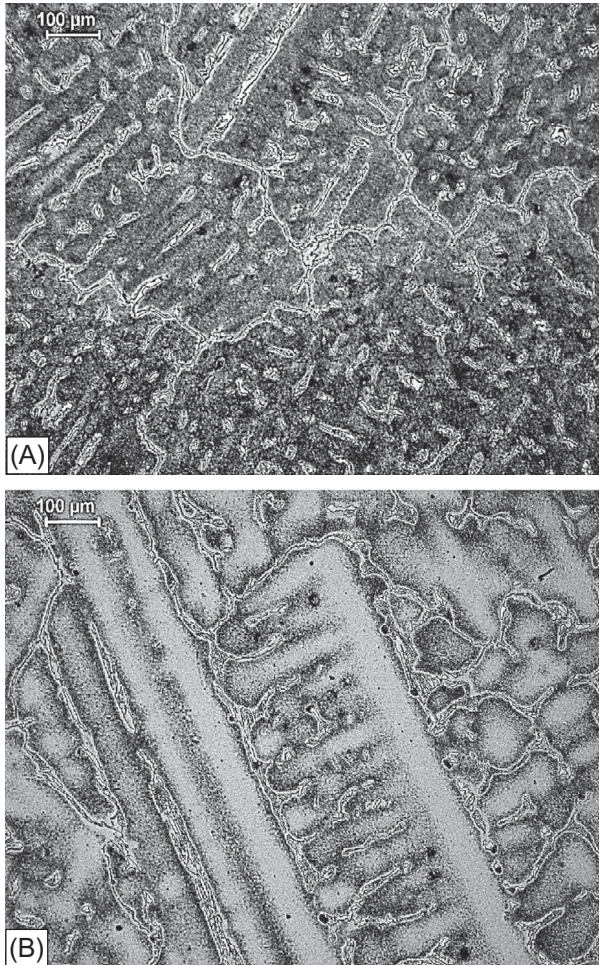
In the unetched condition, the longitudinal section of the aerofoil of the vane samples showed oxide-filled cracks near the surface (Fig. 12.5.7A). On etching with Kalling's reagent, the sample revealed that the oxide-filled surface cracks predominantly propagated through interdendritic/grain boundary regions (Fig. 12.5.7B). Sections of the sample taken from both aerofoil and the root regions showed dendritic structure (Fig. 12.5.8). The structure revealed primary eutectic carbides ( $M_7C_3$ ) along the interdendritic regions and mottled (fine spotted) chromium-rich ( $M_{23}C_6$ ) carbides in a matrix of solid solution of cobalt on both aerofoil as well as root regions (Fig. 12.5.9).

**Fig. 12.5.8** Micrographs of the vane sample showing a dendritic structure. (A) Aerofoil and (B) root. Etchant: Kalling's reagent.
