# METALLURGY OF FAILURE ANALYSIS

# Metallurgy of Failure Analysis

Formerly Manager (Design) Aircraft  
Design Bureau, Hindustan Aeronautics Limited  
Bangalore

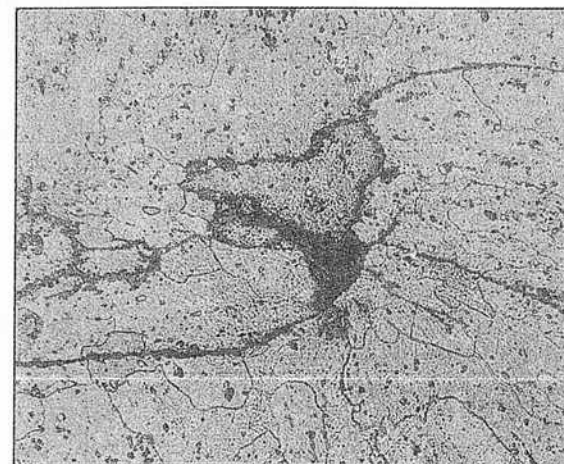
**Microstructural Analysis** Micro-examination of the sections across the defect revealed intergranular cracks tracing the path of round segregated particles and oxide film discontinuities (Fig. 7.3). In addition, the structure showed pockets of gas voids in chain

Fig. 7.3 Black segregated particles along the path of intergranular cracks ( $\times 250$ )

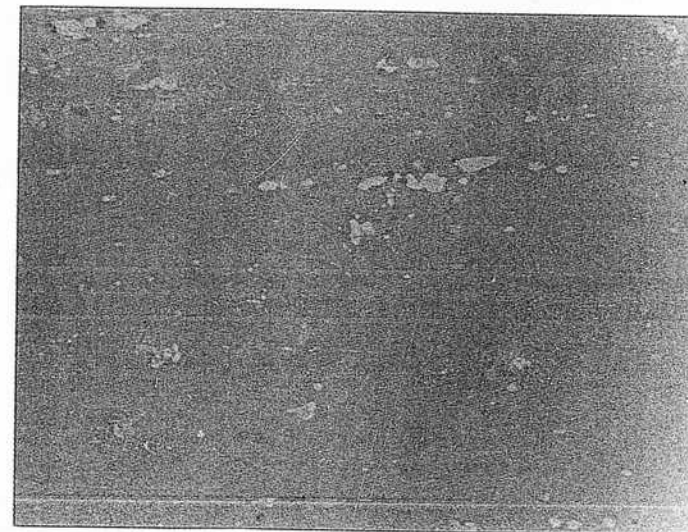
Fig. 7.6 The microstructure of a satisfactory heat-treated aluminium-4% copper alloy with no evidence of segregation, under the scanning electron microscope ( $\times 450$ )

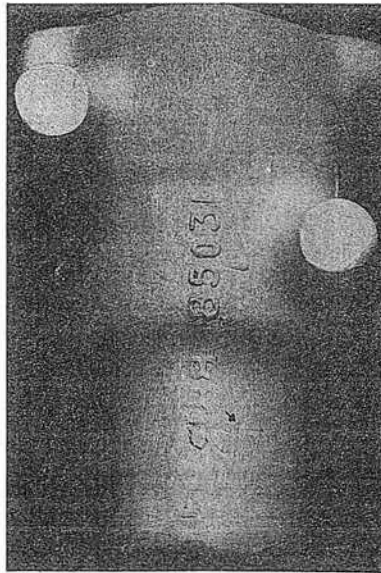
Fig. 7.8 Dark brown lines on the surface of the part ( $\times 1$ )

Examination of the anodised parts showed numerous dark brown (parallel) line indications all over the surface of the body, in varying magnitudes (Fig. 7.8).

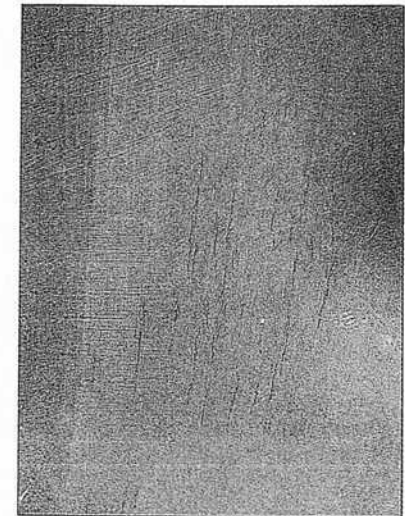
Examination of the line defects at a magnification of  $\times 3.5$  revealed them as deep furrow type linear surface tears (Fig. 7.9).

Fig. 7.9 Linear surface tears at close up magnification ( $\times 2$ )

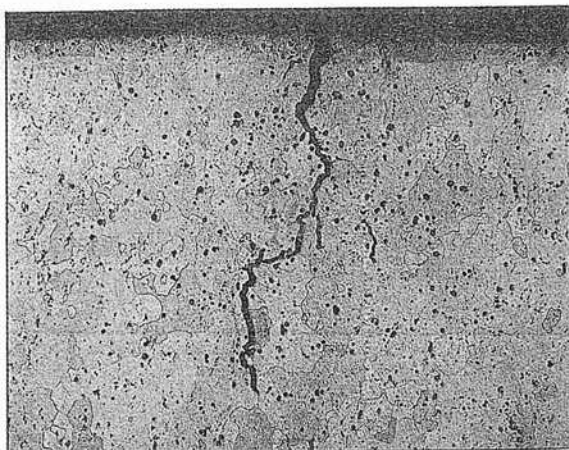
**Microstructural Analysis** Micro-examination of the sections taken across the defects revealed numerous grain boundary cracks emanating from the surface (Fig. 7.10). At higher magnification, numerous zones of grain boundary cracks and eutectic melting (Fig. 7.11) were observed, indicating severe heat deterioration effect. However, examination of the microstructure of the forging stock was found free from any structural inhomogenities or defects.

**Fig. 7.10** Grain boundary cracking in the microstructure at the defect zone ( $\times 50$ )

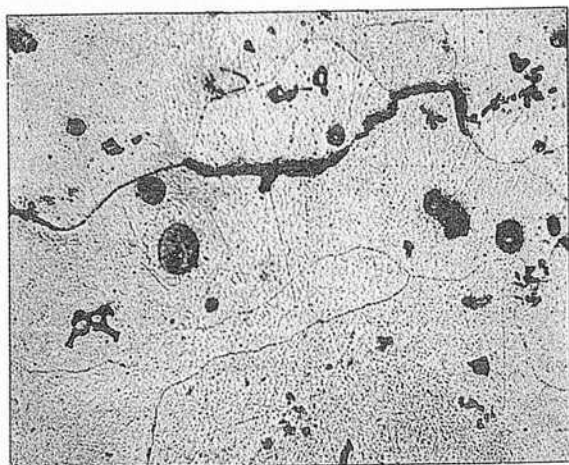
**Fig. 7.11** Severe heat deterioration effects in the core structure ( $\times 400$ )

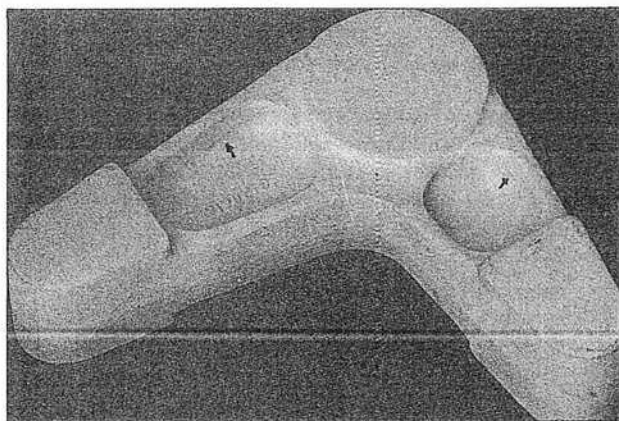
All the forged parts on subsequent anodising showed linear discontinuities in single at location of the concave fillet radii portions (Fig. 7.12).

Fig. 7.12 Linear discontinuity along the fillet radius ( $\times 1$ )

On visual examination, the as-forged bell crank parts showed linear discontinuities in single along the fillet radii at two locations (marked in Fig. 7.12).

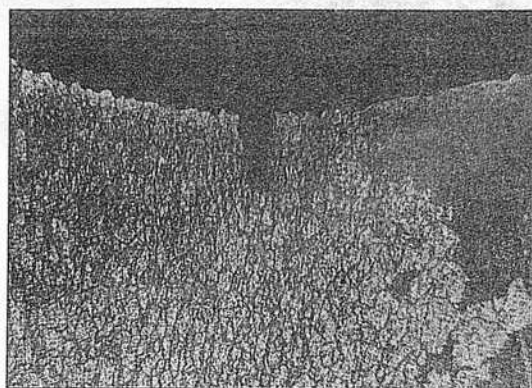
**Microstructural Analysis** Micro-examination of the same section used for macro-examination revealed a 'U' shaped cavity (Fig. 7.14) in the defective zone, indicating the presence of a fold/lap to a maximum depth of 0.50 mm in the section examined.

**Fig. 7.14** The presence of a fold in the form of 'U' shaped cavity in the defective zone (× 12)

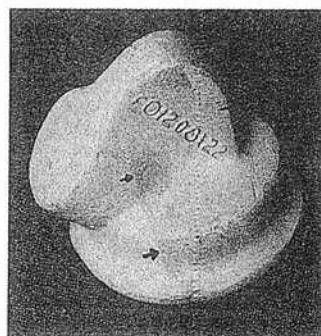
Examination of the forgings revealed identical black patches, either single or numerous but discontinuous, confined mostly to the base area of the forging (Fig. 7.15).

Fig. 7.15 Black patches (× 1)

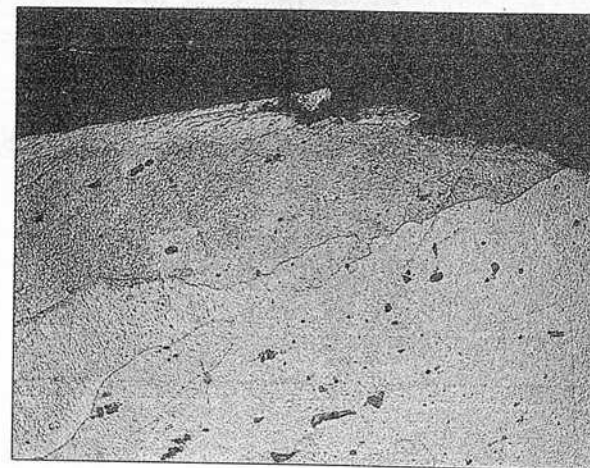
**Microstructural Analysis** Micro-examination of the sections across the defect zone revealed a thin black oxide layer (Fig. 7.16) ingressed beneath the surface (possibly during forging), forming a distinct discontinuity up to a maximum depth of 0.02 mm. However, no anodised layer was noticed in the zone containing the oxide layer. Micro-structure of another defective part showed grain boundary thickening (Fig. 7.17) in places very close to the surface in the black patch area.

Fig. 7.16 Black oxide layer beneath the surface (× 400)

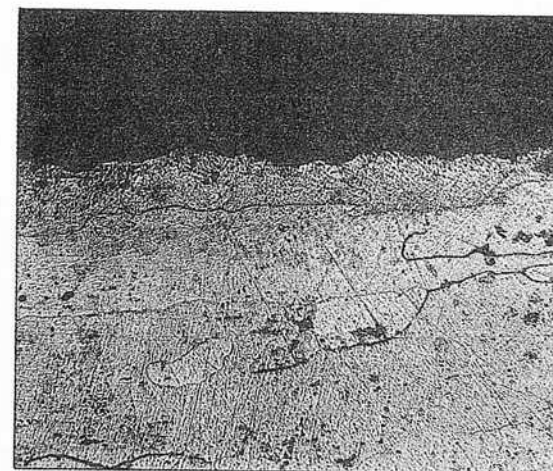
Fig. 7.17 Grain boundary thickening (× 400)

treatment of the batch was quite satisfactory. The development of grain boundary thickening, as observed in the microstructure (Fig. 7.17), could be due to the fact that the base surface areas of the forging were locally overheated. It possibly occurred during critical deformation in the forging operation itself and before heat treatment. It is important to note that grain boundary thickening was confined only to the surface of the black patch area and its core structure was free from any abnormality. It is also well-known that aluminium-copper alloys containing more than 2% of copper have a greater tendency to burning during the high current density anodising treatment.

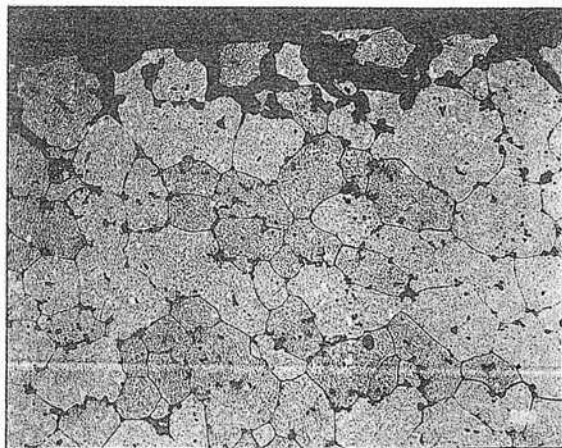
**Fig. 7.18** Grain boundary cracking and eutectic melting ( $\times 400$ )

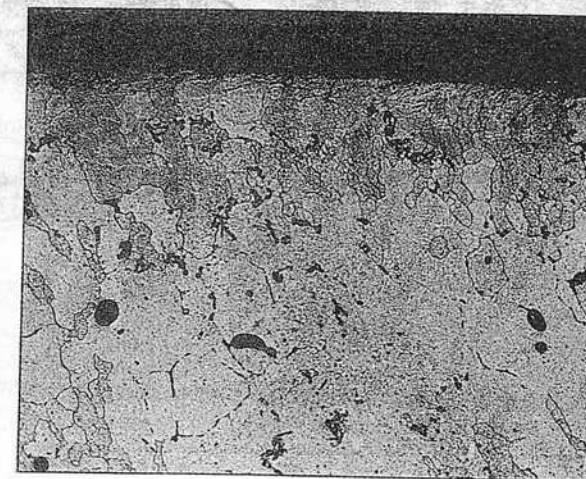
**Fig. 7.19** Rounding off of constituents ( $\times 400$ )

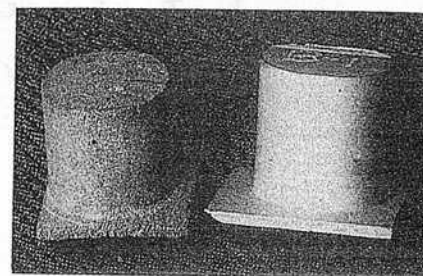
matrix without any overheating effects, respectively. These parts were anodised after etching in the same bath used for the above defective batch quantity. The severely overheated part showed uniform black patch throughout the entire surface, whereas, the other two were found free from any blackening effect (Fig. 7.20).

**Fig. 7.20** Blackening effects all over in the severely heat treated part (left) and no perceptible effect in the slightly overheated part (right) ( $\times 1$ )

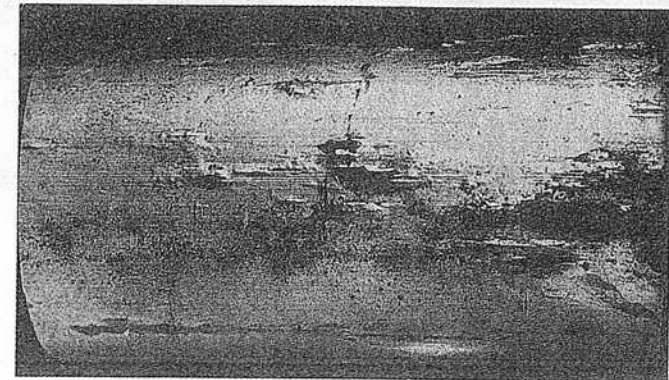
Several bars were showing surface blisters and corrosion products (Fig. 7.21), on inspection after a period of storage time.

Fig. 7.21 Surface blisters and corrosion products (× 1)

Examination of the defective zones visually (and also under a low power stereoscopic microscope) revealed occasional blisters, accompanied with voluminous white corrosion products (Fig. 7.21).

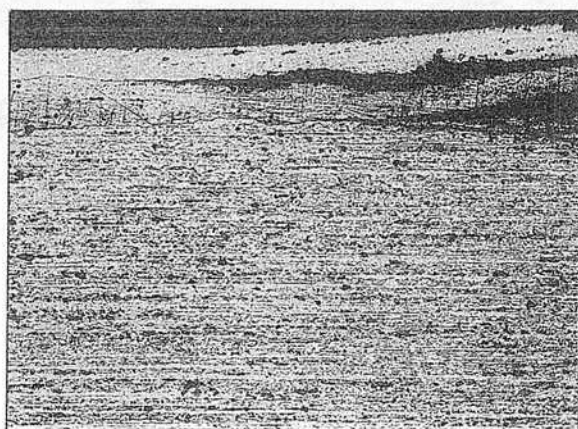
**Microstructural Analysis** Micro-examination of the cross-section in the longitudinal direction revealed surface corrosion to a depth of 0.5 mm from the section, resulting from a rapid layeral attack along the grain boundaries. The layeral separations were found parallel to the metal surface with a characteristic leafing action (Fig. 7.22). These features positively indicated the presence of a corrosion mechanism similar to that of an exfoliation type. Microstructure was otherwise found to be satisfactorily heat treated.

Fig. 7.22 Layeral corrosion and leafing action ( $\times 50$ )

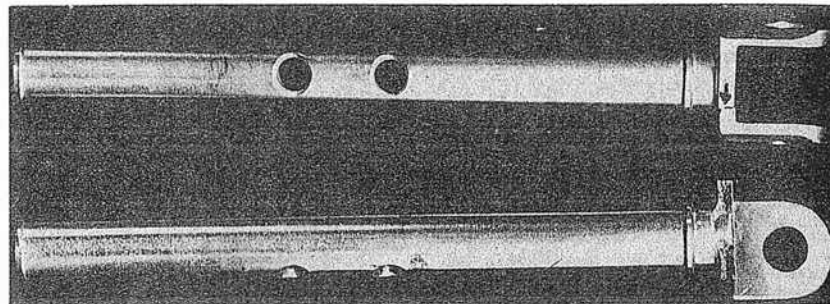
A few piston rods from different production batches were found cracked in the eye end portion, after the chrome plating and baking treatment. One of them cracked in the plating operation itself instantly broke on slight tapping (Fig. 7.23).

Fig. 7.23 Cracks in the eye end portion of the piston rods ( $\times 1$ )

Examination of the piston rods showed identically straight cracks along the outer radii, i.e. 0.5 mm away from one of the two forked eye ends (Fig. 7.23).

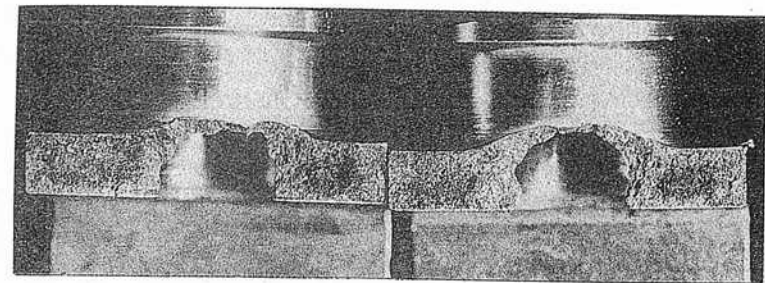
**Macrofractography** Fractography examination of the broken surfaces of the eye ends showed identical fractures, i.e. coarse, irregular and crystalline features, typical of a brittle inter-crystalline failure (Fig. 7.24).

Fig. 7.24 Coarse crystalline features in the fracture after the cracks were opened out ( $\times 6$ )

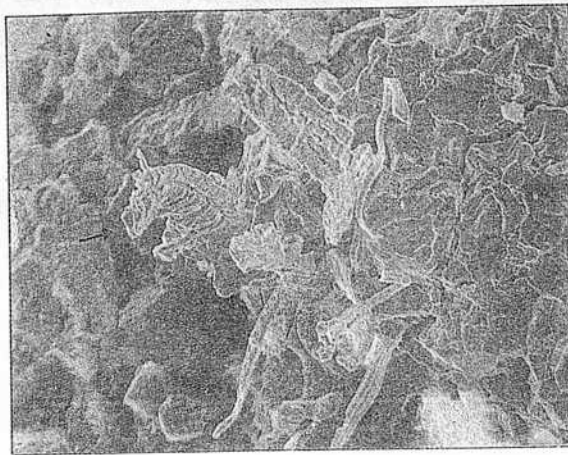
**Scanning Electron Microscopy Fractography** Examination of the fracture by the scanning electron microscope at  $\times 450$  magnification revealed a curved botanical leaf (Figs 7.25 and 7.26) like structure (a rare form that occasionally characterises the hydrogen embrittlement phenomenon) and transgranular cracks in the quasi cleavage matrix of the predominantly intergranular (Fig. 7.26) fracture. These fracture features were a clear indication of failure due to hydrogen embrittlement.

**Fig. 7.25** Curved botanical leaf-like structure under scanning electron microscope ( $\times 450$ )

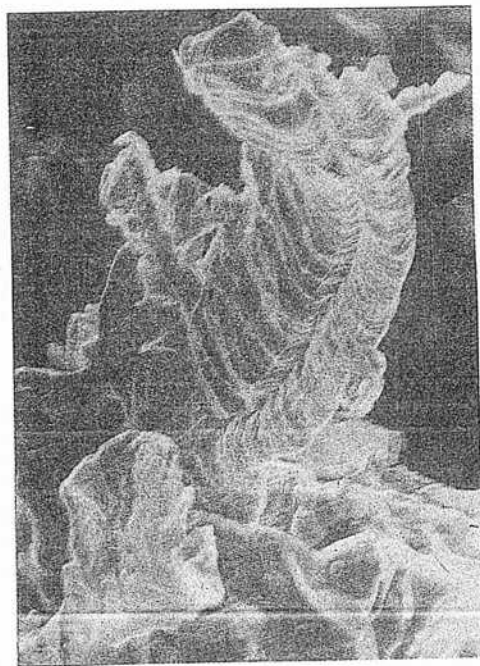
**Fig. 7.26** Enlarged view of the botanical leaf as in Fig. 7.25 ( $\times 1200$ )

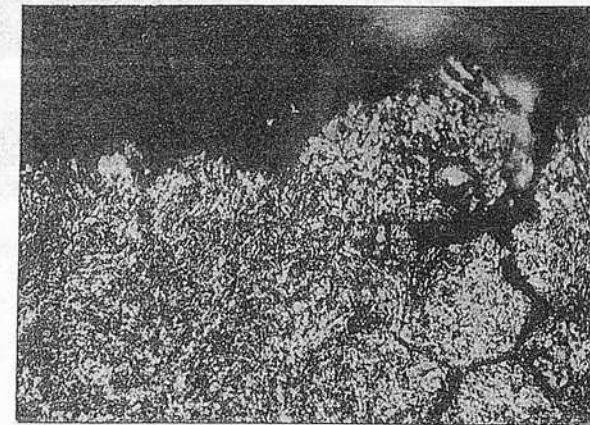
**Microstructural Analysis** Micro-examination of a section across the fracture revealed intergranular cracking in the tempered martensitic structure with occasional lifting up of crystals (Fig. 7.27). The feature of lifting up of crystals was indicative of a sudden intergranular mode of failure.

**Fig. 7.27** Intergranular cracking with lifting of crystals ( $\times 100$ )

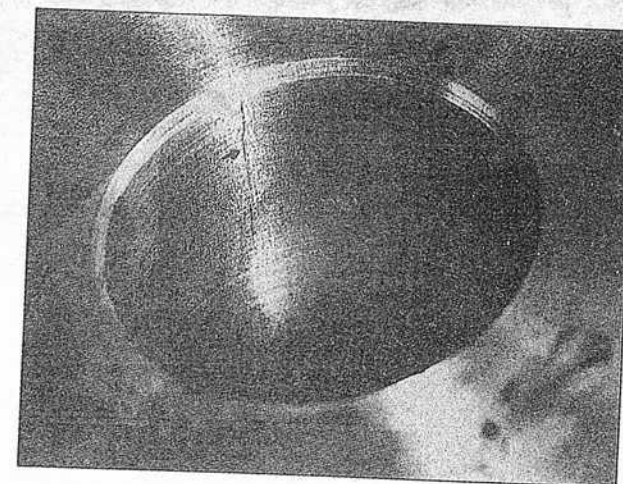
**Fig. 7.29** The presence of sub-surface cracks as indicated by magnafluxing in the 50 mm dia machined hole surface of the rolled bar stock used for fabrication of the part ( $\times 1$ )

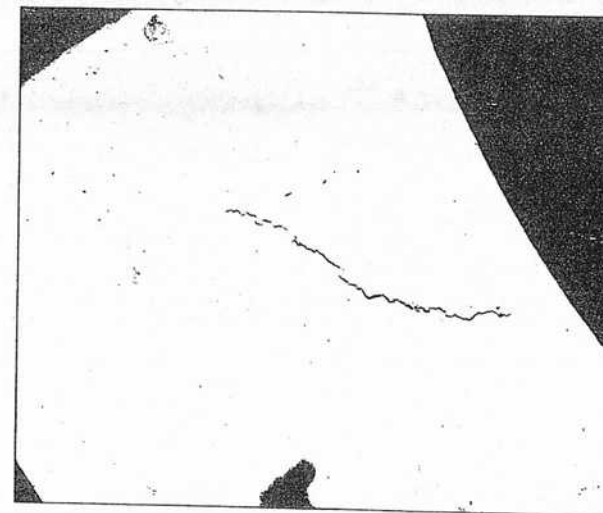
**Microstructural Analysis** Macro-examination of the sections taken across the defect indications in both the discs revealed sub-surface discontinuous hairline (zig-zag) cracks (Fig. 7.32), which were intergranular in nature without any evidence of branching. Microstructure of the defective part at higher magnification also showed discontinuous intergranular cracks with typical manganese-sulphide inclusions along the path of cracking (Fig. 7.33).

**Fig. 7.32** The presence of sub-surface cracks in the zone across the crack indications (as polished) ( $\times 12$ )

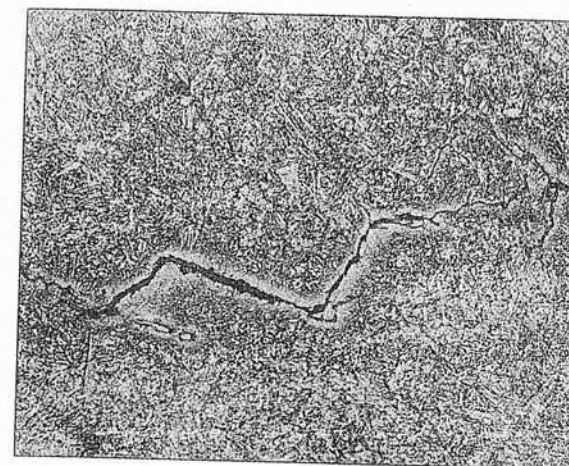
**Fig. 7.33** Intergranular cracks with manganese (grey) and oxide (dark) inclusions in the crack path of a section across the radial cracks of the heat-treated part ( $\times 100$ )

The scanning electron fractography clearly established that random occurrence of the tiny cracks was due to hydrogen embrittlement phenomenon. This is also supported by the presence of high hydrogen content in the material prior to heat treatment.

**Remedial Action** In the absence of records on manufacturing history of the supplied raw material, the major source of hydrogen absorption was suspected to have come from improper pickling operations of the hot rolled bars. It was suggested to control the acid pickling operation strictly within the specified process parameters in future supplies. Also, quality control was advised to check the level of hydrogen gas in the rolled bars before acceptance for forging.

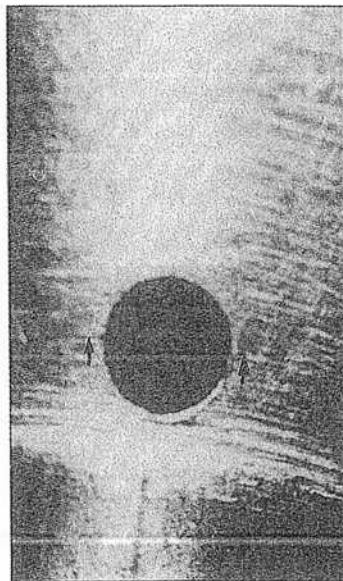
**Fig. 7.35** Cracks on either side of the inspection hole (x10)

Visual examination of both the failed link rods (using magnifying lens) showed feeble indication of tiny cracks emanating from either side of the inspection hole edge (Fig. 7.35). Further the hole edges were found very sharply cut, without any deburring and elongated towards the swaged portion.

**Magnetic Particle** Based on the above indications, both the link rods were subjected to magnetic particle inspection. The test showed distinct crack like indications (Fig. 7.35) at the hole edge.

**Visual** Examination of the magnetic particle inspected rod confirmed the cracks and were found extending to a length of 2 mm in a circumferential direction (Fig. 7.35). On close observation, the swaging was found to have been carried out to within 1 mm from the hole edge.

**Remedial Action** In view of the development of fatigue cracks, the limit of swaging was recommended to be at least 3 mm off the hole edge. This is because the hole edge serves as a very sensitive notch by virtue of its closeness to the highly worked region. Further it was suggested to debur the hole edges to avoid unnecessary stress concentration effects.

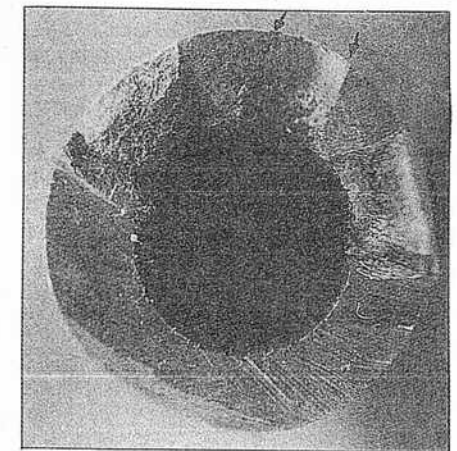
**Macrofractography** Fractographic examination of the cracked regions, at  $\times 25$  magnification, under the stereoscopic microscope revealed a distinct smooth zone with widely spaced but faint beach markings (Fig. 7.36). This is typical of failure under a low

**Fig. 7.36** Fatigue zones with trace beach marks (x6)

cycle fatigue phenomenon. The fatigue cracks were found to have originated at the sharply cut and undeformed hole edge. The fatigue zones on either side of the hole edge were found identical and diametrically opposite to each other, covering 1/15th of the cross-sectional area. The remainder showed over-stressed fracture characteristics, which occurred during forced opening of the crack.

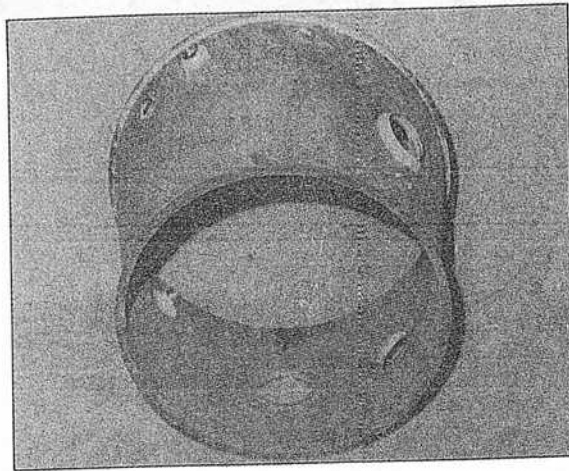
Fig. 7.37 The by-pass duct assembly ( $\times 1/10$ )

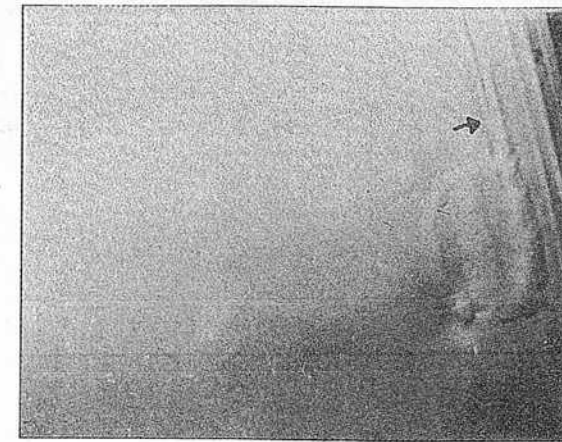
Fig. 7.38 Weld patch and pronounced undulation on the skin, away from the weld area ( $\times 1/2$ )

fracture studies under the stereoscope as well as scanning electron microscopes. The fracture was ultrasonically cleaned prior to scanning electron microscopic examination.

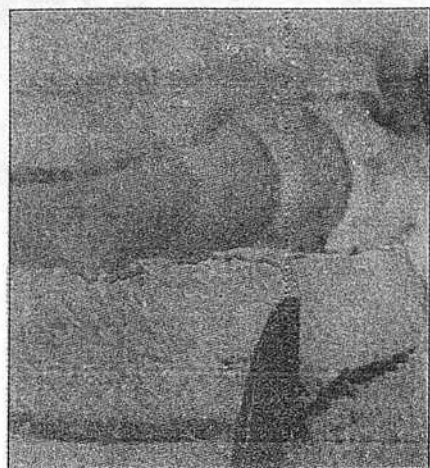
Fig. 7.39 Zig-zag type crack/rupture ( $\times 1$ )

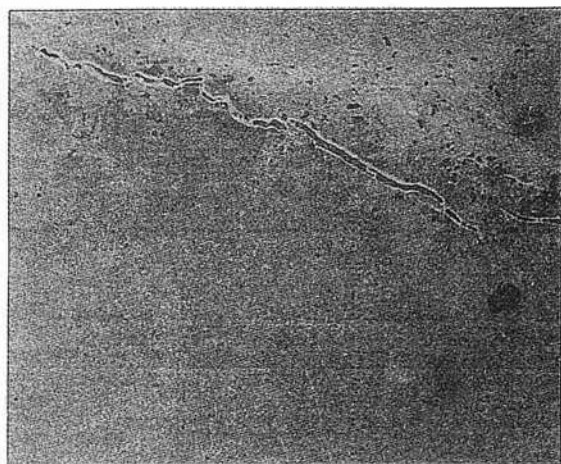
Fig. 7.40 A close-up of the zig-zag crack ( $\times 3$ )

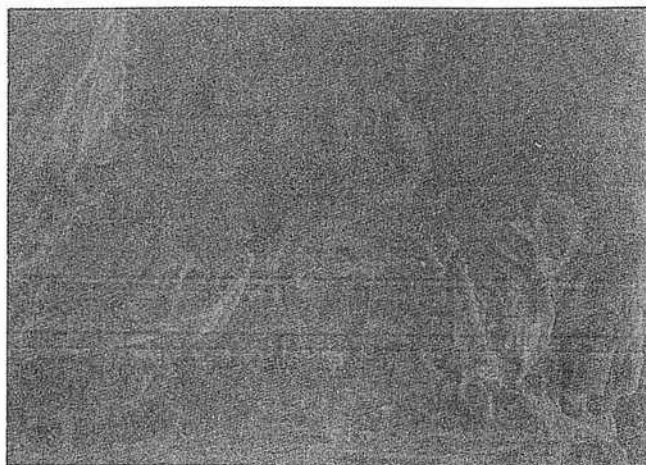
**Fig. 7.42** Brittle flat faceted cleavage under the scanning electron microscope ( $\times 450$ )

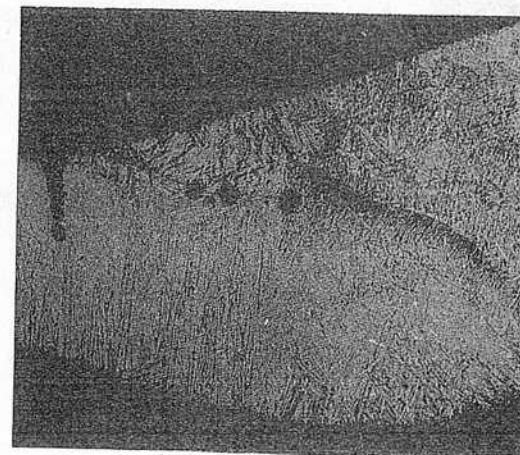
**Microstructural Analysis** A section across the defect was examined under the optical microscope (at  $\times 50$ ). It showed a short transverse crack to a max. depth of 0.32 mm (Fig. 7.44), starting at the apex of the 'V' profile in the vicinity of the fusion line (i.e. between the edge of the weld bead and heat affected zone). The defect zone also showed the clear presence of an oxide entrapment in the microstructure, along with a few gas pores in the weld fusion line. The microstructure predominantly consisted of acicular alpha phase, coarse in the heat affected zone (HAZ) and finer in weld bead (Fig. 7.45 and 7.46). However, the microstructure in HAZ, away from the defect, was found to be fairly homogeneous (Fig. 7.47).

**Fig. 7.44** Transverse crack, oxide entrapment and gas pores ( $\times 50$ )

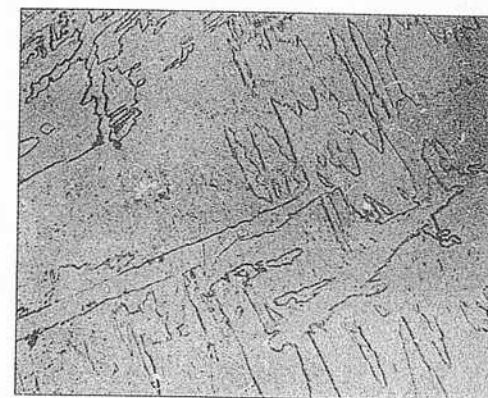
**Fig. 7.45** Acicular alpha phase in HAZ ( $\times 200$ )

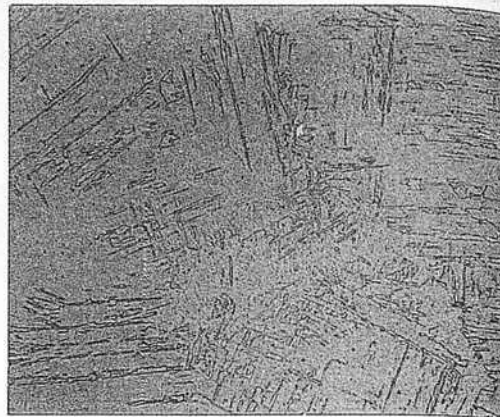
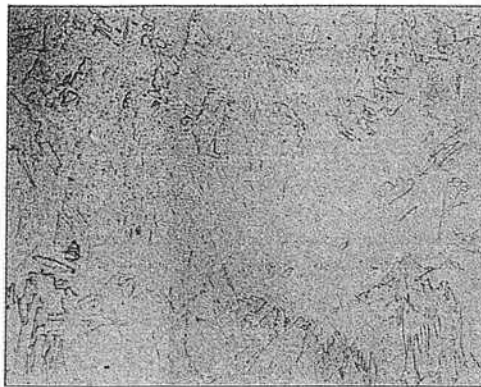
**Fig. 7.46** Fine acicular alpha phase in the weldbead ( $\times 200$ )

**Fig. 7.47** Homogeneous microstructure in HAZ away from the defect ( $\times 200$ )

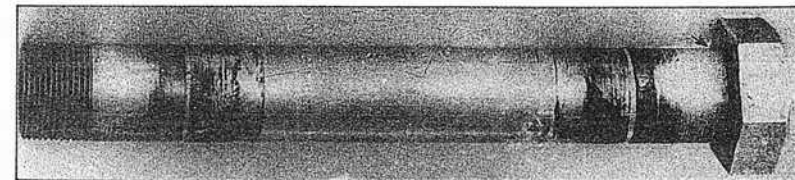
Fig. 8.1 Attachment bolt showing the location of failure and wear marks (x 3/4)

Examination of the bolt shank and the broken off head portion revealed that the failure was circumferential and all along the shoulder radius. On placing the broken head on to the shank, it was observed that the shoulder radius was too sharp (0.25 mm) for the bolt size. The shank surface showed uneven wear marks (Fig. 8.1) all around, but confined to areas of contact with the bore surface of the component through which it was engaged. Presence of such wear marks is not an unusual phenomenon in used bolts of this type.

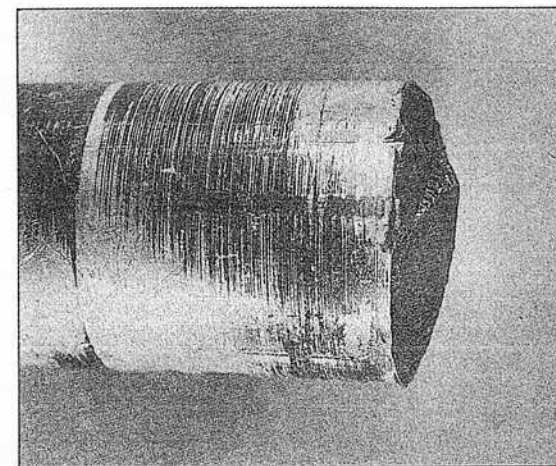
**Visual** A close study of the broken ends of the bolt (Fig. 8.3) indicated that the fracture was basically a 'cup and cone' type.

Fig. 8.3 Side view of the shank near the fracture showing uneven wear marks in the surface and "Cup and Cone" type fracture ( $\times 2.5$ )

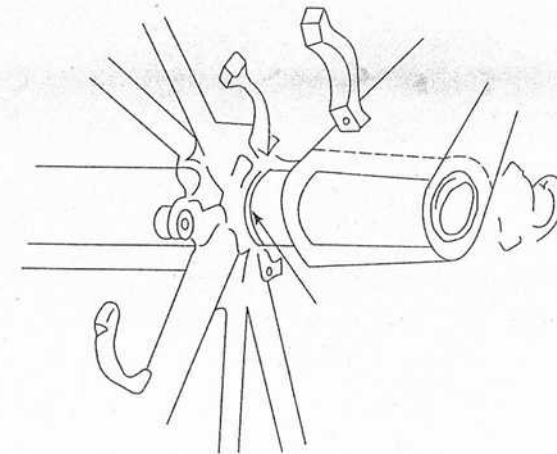
Bending of the cross tube reportedly occurred during landing. Bending was only on one side at a location just inboard of the in-board ball bearing and out-board of the body structure mounting (Fig. 8.6). On disassembly, the tube was found broken in two halves.

Fig. 8.6 Enlarged view of Fig. 8.5 at the circled zone showing the location of the bent portion

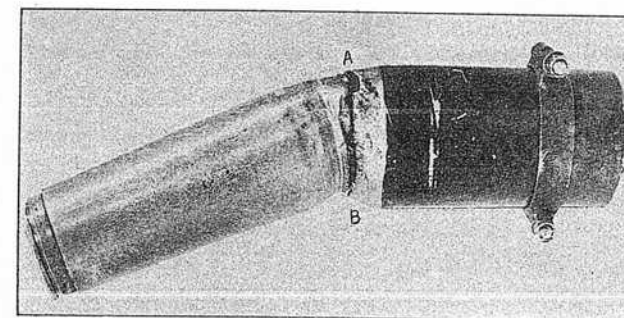
On matching the broken ends together, it was found that the swaged end portion of the cross tube had severed transversely just inboard of the in-board ball bearing set area. The tip of the cross tube was found lifted up (angle of bend about 20°), and the tube wall was buckled down (Fig. 8.7). The circular cross-section of the tube at section 'AB' (Fig. 8.7) had become oval in shape (Fig. 8.8).

Fig. 8.7 The failed swaged end of the cross tube with the severed pieces matched together. The bright end portion was housed in the main landing gear assembly ( $\times 1/4$ )

**Macrofractography** On fractographic examination at  $\times 10$  magnification, the bottom half of the tube cross-section at 'AB' (Fig. 8.7) showed a flat-faced fracture confined to half the wall thickness from the outer diameter, the remainder being shear lips.

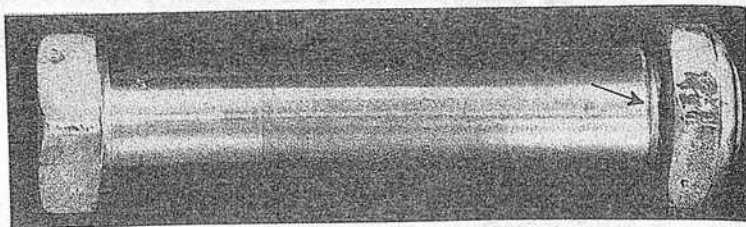
Fig. 8.9 Breakage along the stress-relief groove exposed under the nut ( $\times 1$ )

**Macrofractography** Evaluation of the broken surface under a low-powered stereoscopic microscope at  $\times 10$  magnification, revealed a clear surface fracture flow and shear lips at the end of the fracture (Fig. 8.11). This was indicative of a typical shear overload failure. The origin of the crack, from the lines of surface flow, was traced to a location in the stress-relief groove indicated by the arrow (Fig. 8.9).

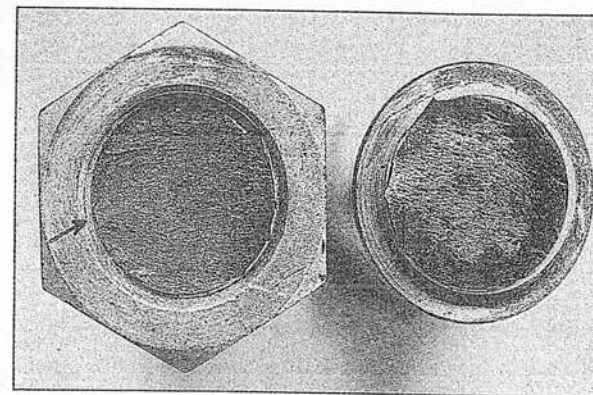
Visual examination of the bolt and nut revealed that the failure was circumferential, along the stress-relief groove between the threaded end and the shank, in a plane at right angles to the axis of the bolt (Fig. 8.11). No damage was observed in the bolt and nut, except for spanner-slippage marks at the nut hexagon corners.

Fig. 8.11 Fracture flow lines (broken ends kept side by side) with shear lips ( $\times 1$ )

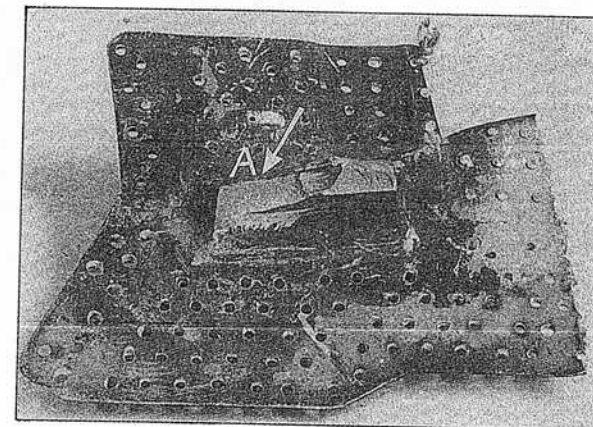
Breakage of the root rib and cracking of the centre fitting were reported after the crash of the aircraft (Figs 8.12 and 8.13).

**Fig. 8.12** Root rib piece showing the fracture through the large bolt hole (x 2/5)

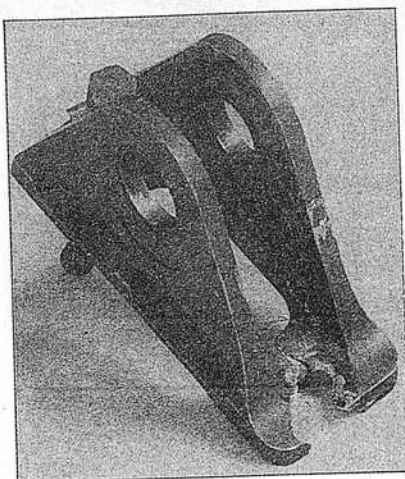
**Fig. 8.13** Centre fitting showing location of crack through the small bolt hole in the mid-web ( $\times 1/4$ )

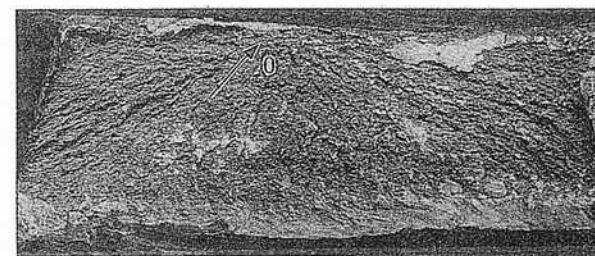
**Macrofractography** Fractographic examination of both the fractures under a low-powered stereoscopic microscope at  $\times 10$  magnification, showed basically brittle features with shear lips. The well defined 'Chevron' pattern in the fracture pointed towards the clear origin of the crack (Figs 8.14 and 8.15). No trace of any progressive type of failure, such as fatigue or stress corrosion was noticed.

**Fig. 8.14** Enlarged view of fracture 'A' in Fig. 8.12 showing 'Chevron' pattern of high velocity brittle fracture with its origin at 'O' ( $\times 2$ )

Fractographic examination established the fact that the breakage of the root rib and the cracking of the centre fitting were a clear case of brittle failure under high velocity impact. Any high velocity impact failure is normally associated with 'Chevron' markings in the ensuing fracture, with the origin clearly defined as the convergence point of the emanating fracture lines (Figs 8.14 and 8.15).

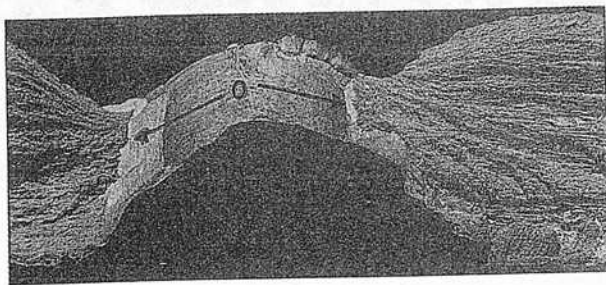
**Fig. 8.15** Enlarged view of fracture in Fig. 8.13 showing typical 'Chevron' pattern of high velocity brittle fracture with its origin at 'O' ( $\times 2$ )

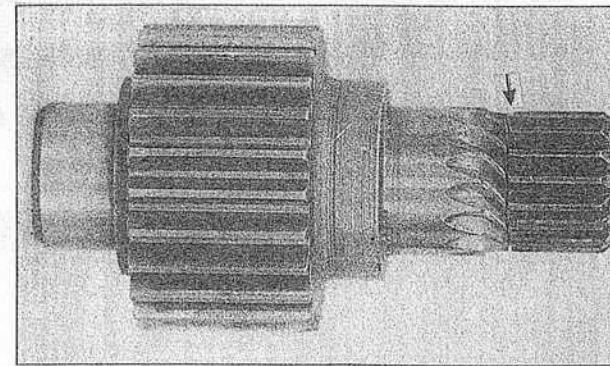
**Fig. 8.16** The broken pieces of the pinion matched together showing helical deformation of the splines towards failure ( $\times 3$ )

The pinion was reported deformed and broken off across the small splined end portion during service (Fig. 8.16).

Visual examination of the broken pinion pieces on matching together revealed that the smaller pinion end had fractured transversely in a plane perpendicular to the axis of the pinion, about 1 cm off the end-face. Also the straight splines from the shank had deformed uniformly in a helical pattern (Fig. 8.16).

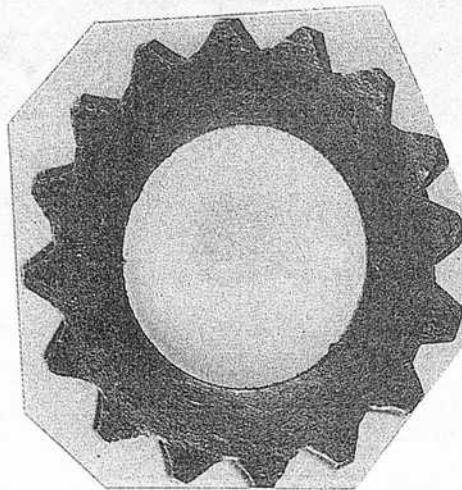
**Macrofractography** Fractographic examination of the fracture surface of the pinion under a low powered stereoscopic microscope at  $\times 10$  magnification, revealed that the entire surface was having a smooth texture of rotary metal smearing (Fig. 8.17).

Fractographic analysis of the broken surface of the small splined portion established the type and nature of the failure as torsional overload, by the characteristic deformatory condition of the straight splines and rotary metal smearing on the fracture.

**Fig. 8.17** Fractured surface of the pinion showing smooth texture and rotary metal smearing (x8)

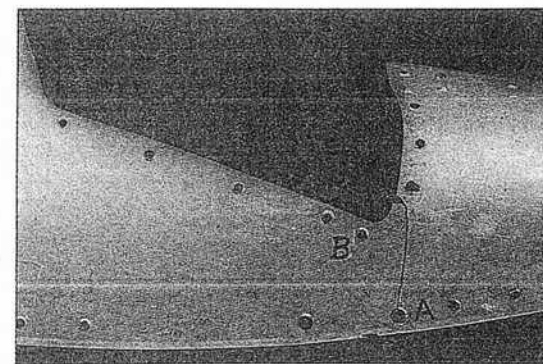
The fairing skin was found cracked (Fig. 8.18) after it had served a simulated service cyclic loading for a period equivalent to 6500 flying hours.

**Fig. 8.18** Cracked fairing skin (x 1/5)

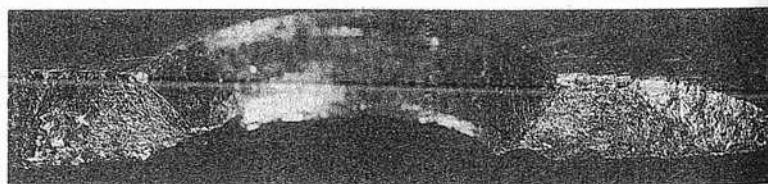
**Macrofractography** Examination of the fractured surfaces revealed that the plane of cracking was at right angles to the skin surface and 'shell' markings in the smooth fracture, typical of fatigue failure. The origins of fatigue were traced to the bottom corner surface on either side of the rivet hole (Figs 8.19 and 8.20).

Fig. 8.20 Fractured surface at 'B' marked in Fig. 8.18 ( $\times 7$ )

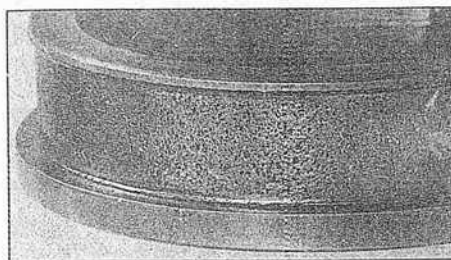
Examination showed that the cam reduction drive gear was broken angularly with two teeth off in one zone (Fig. 8.21) along the root radius. It also revealed that the adjacent tooth root radius from one side of the broken portion was cracked. Examination of the race way of the inner race of the bearing showed severe spalling all over (8.22).

Fig. 8.22 Close up view of the raceway with severe spalling ( $\times 1$ )

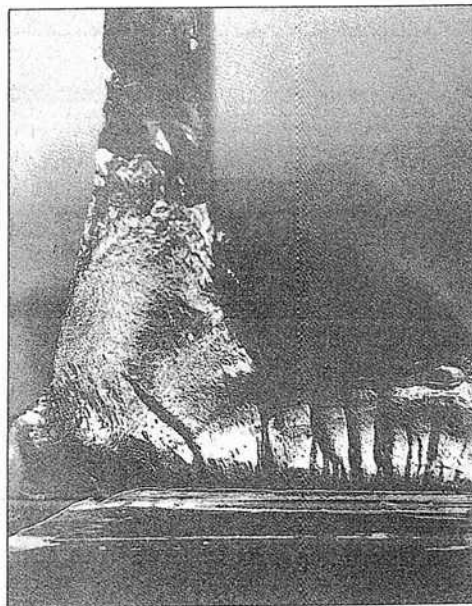
**Macrofractography** On close examination under the stereoscopic microscope at  $\times 25$  magnification, both driving as well as non-driving faces of all the teeth showed wear marks. Tooth root radius portions also showed original deep machining tool marks (Fig. 8.23). Examination of the fracture of both the broken teeth revealed closely spaced

Fig. 8.23 Fatigue zones originating from the deep tool marks at the tooth radius ( $\times 6$ )

and distinct 'beach' marks in the smooth surface which covered the entire thickness (Figs 8.23 and 8.24) of the tooth radius portion. Origin of the fatigue fracture was located at the deep machining tool marks along the root radius.

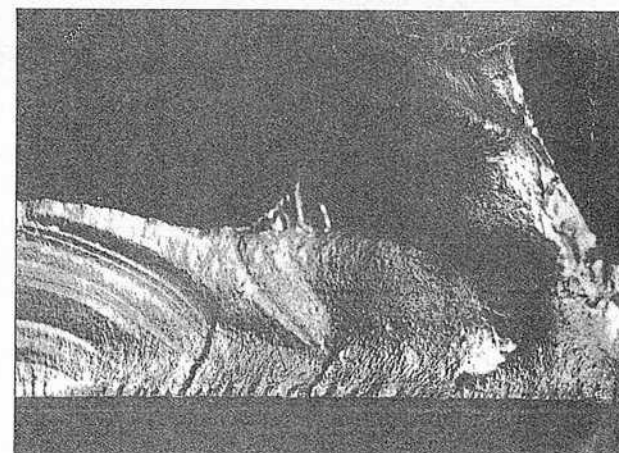
Fig. 8.24 Fatigue zones also originating from the tooth radius ( $\times 8$ )

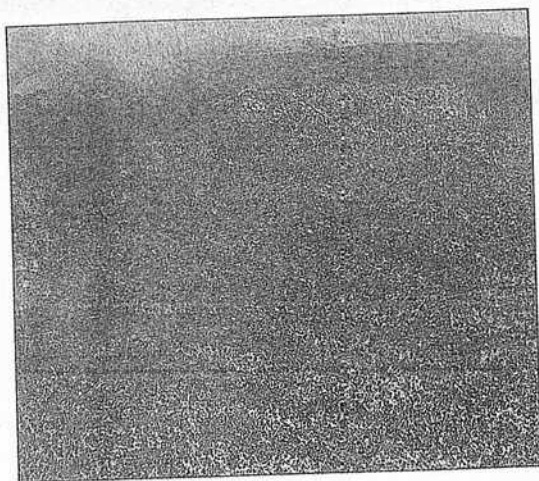
**Fig. 8.25** Severe carbide bandings in the bearing material ( $\times 50$ )

In the case of failure of the inner race of the bearing assembly, it was established that the spalling was due to the development of fatigue cracks in service. The reported shorter life of the bearing was attributed to the presence of carbide bands, rendering the high hardness ball bearing material inhomogeneous. This facilitated the process of spalling by fatigue faster due to reduced fatigue resistance.

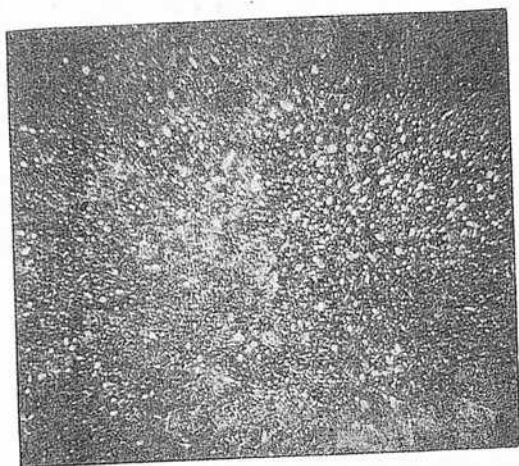
**Microstructural Analysis** Micro-examination of the section of the steel gear material across the zone of fatigue revealed satisfactory case-carburised (hardened and tempered) structure in the tooth portion. In the case of inner race material the microstructure was found in satisfactory hardened and tempered condition with numerous tiny carbides interspersed in the matrix. But, however on low magnification examination at  $\times 50$ , severe banding of carbides oriented towards the inner race surface was clearly discernible (Fig. 8.25). These bands, on higher magnification at  $\times 800$ , were found to be a congregation of tiny carbides (Fig. 8.26).

**Fig. 8.26** Agglomeration of numerous tiny carbides in the banded zone at higher magnification ( $\times 800$ )

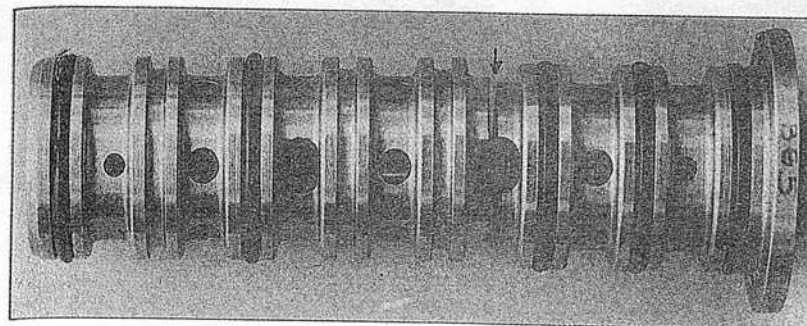
The valve broke into two after it had served only 26 hours of service (Fig. 8.27) during flight. The valve was operating at a working load of 3000 psi at the time of failure.

Fig. 8.27 The relay valve guide separated across an elongated hole ( $\times 1$ )

Examination revealed that the valve had separated transversely into two through one of the two sets of elongated holes, and the hole bore surface was found irregular and discoloured.

It was recommended to inspect the remaining parts using the stereoscopic microscope and/or the boroscope, for detection of surface defects of a similar nature in the bore region and if present, to reject them.

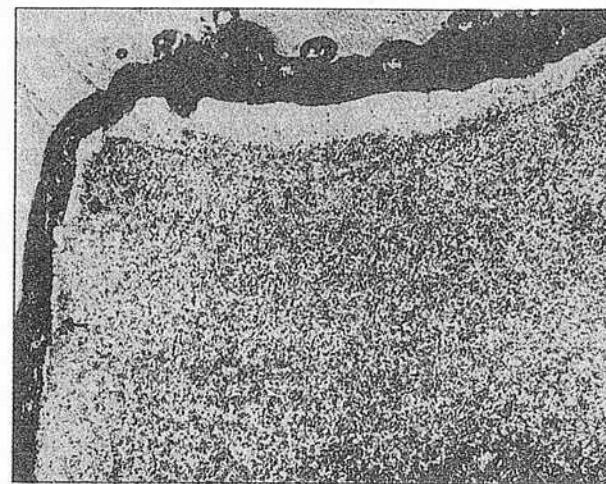
Obviously, these features pointed out that the brittle separation of the valve guide across the elongated hole had occurred due to pre-existence of a crack in the outer corner of the bore, out of an unduly overheated (hard white layer) structure formed during the machining stage.

**Microstructural Analysis** Micro-examination of a section across the zone of origin, revealed a conspicuous white layer (remelted) in the outer surface of the bore, to a maximum depth of 0.035 mm. Microstructure also revealed a 0.35 mm deep overtempered zone just beneath the white layer (Fig. 8.29). Otherwise, the core structure

**Fig. 8.29** White layer and underlying overtempered layer with a trace of white layer penetrating to a considerable depth ( $\times 100$ )

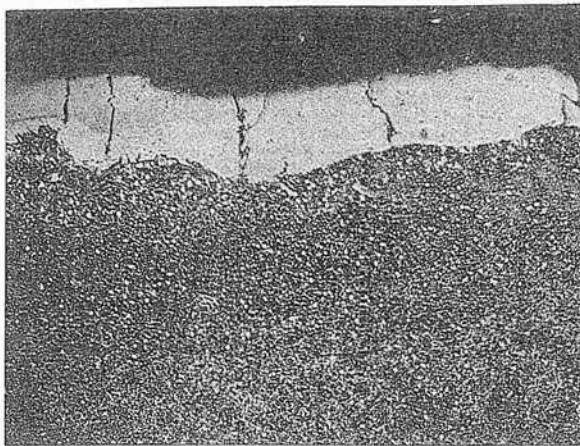
Fig. 8.30 Numerous transverse cracks in the white layer ( $\times 400$ )

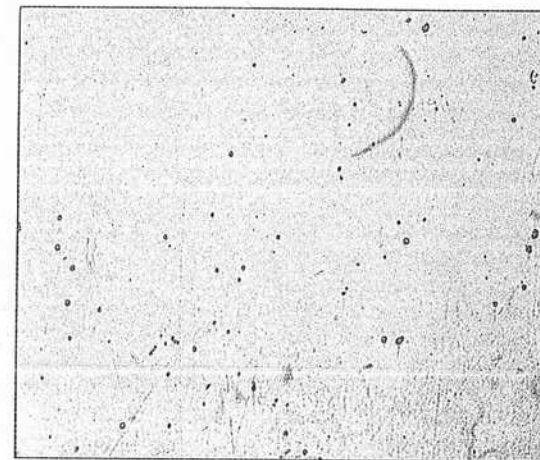
**Microstructural Analysis** Micro-examination of a section across the fracture, in the region very close to the sub-surface defect, revealed the material rather unclean with numerous globular non-metallic oxide inclusions (Fig. 8.35) conforming to D5 thin series at  $\times 100$  magnification. Otherwise, the microstructure consisted of satisfactory fine grained tempered martensite.

**Fig. 8.35** Numerous globular non-metallic oxide inclusion in the material ( $\times 100$ )

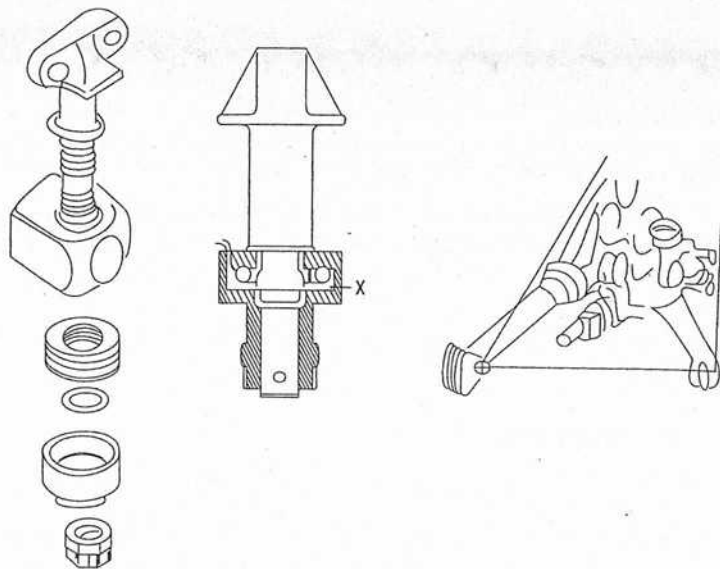
The race which was in contact with the larger dia base (marked 'X' in Fig. 8.36) was found broken during inspection of the blade spacing system.

**Fig. 8.36** Break up view of the trunion and bearing assembly of the blade spacing system with the type of bearing under investigation marked 'X'

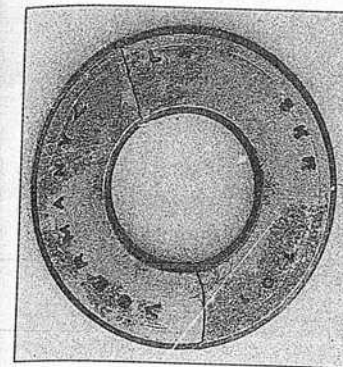
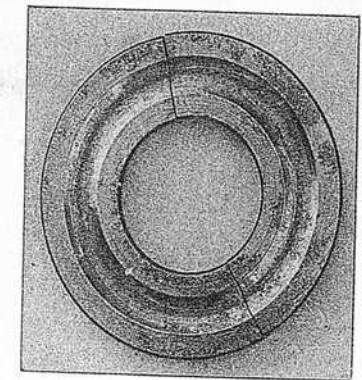
Examination revealed that the breakage of the bearing race had taken place almost diametrically (Figs 8.37 and 8.38). Deep indentation marks observed on the flat surface were found incidentally outside the line of fracture (normally which act as weak/stress concentration points for sudden breakage or progressive failures). On close observation it showed annual uneven wear marks on the flat surface adjoining both the ID as well as OD but there were no brinelling marks in the race way groove (Fig. 8.38). The failed thrust bearing was found consisting of two identical races with a groove and a ring of caged balls in the groove. However, slight corrosion patches seen on the flat outer surface had developed subsequent to breakage.

**Fig. 8.37** Flat outside of the broken bearing race ( $\times 1\frac{1}{2}$ )

**Fig. 8.38** Inner grooved side of the broken bearing race ( $\times 1\frac{1}{2}$ )

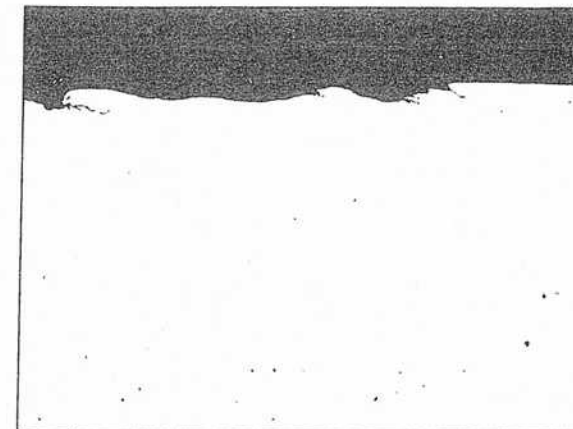
up the carburised layer (Figs 8.44 and 8.45). Further, tempered martensitic structure of the case was found free from any carbides, either in the form of network or isolated particles, whereas structure of the case in the imported gear revealed carbides in network form at the grain boundaries as well as in isolation.

Fig. 8.44 Sub-surface crack ( $\times 50$ )

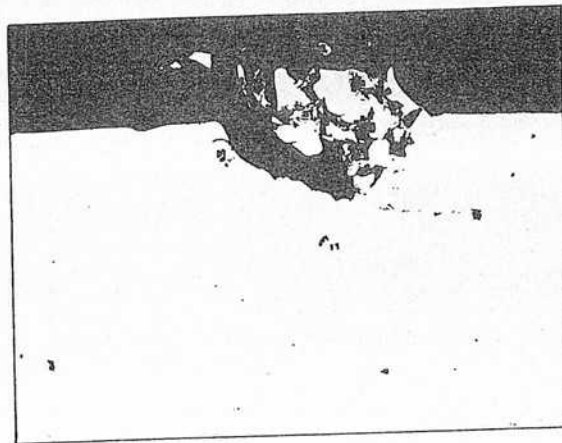
Fig. 8.45 Angular cracks and lifting up of the spalled piece ( $\times 100$ )

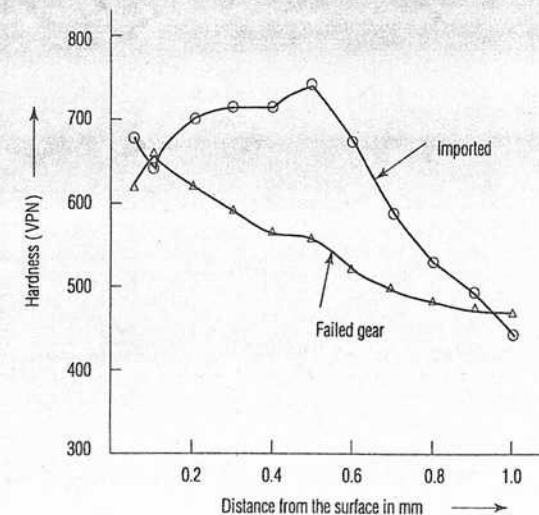
Fig. 8.46 Comparative hardness survey of failed gear with imported gear

tester at 500 gms. The results indicated a lower hardness in the case hardened layer compared to that of the imported one.

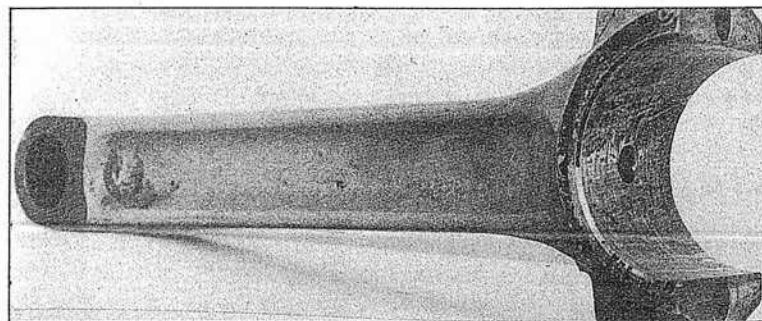
Fig. 8.47 Pre-mod connecting rod showing the dowel pin hole ( $\times 1/2$ )

the dowel pin hole due to change of bearing locking system, it was reported that pre-mod connecting rods were permitted for use.
