# METALLURGY OF FAILURE ANALYSIS

# Metallurgy of Failure Analysis

Formerly Manager (Design) Aircraft  
Design Bureau, Hindustan Aeronautics Limited  
Bangalore

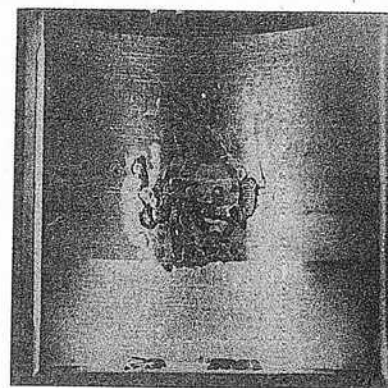
One bottom bearing (Fig. 8.48) was found deteriorated after 400 hours of service since installation.

Fig. 8.48 Bottom half bearing showing cracking and spalling ( $\times 1$ )

Visual examination of the bearing half revealed cracking and spalling of the bearing overlay (chunks of bearing metal flaked off in a few zones, exposing the original deep turning marks in the copper back plate) confined to the central portion only (Fig. 8.48). Also a circular discolouration (heat affected) was observed on the outside of the back plate in the same central portion, which was found coinciding with the dowel pin hole location of the pre-mod connecting rod housing.

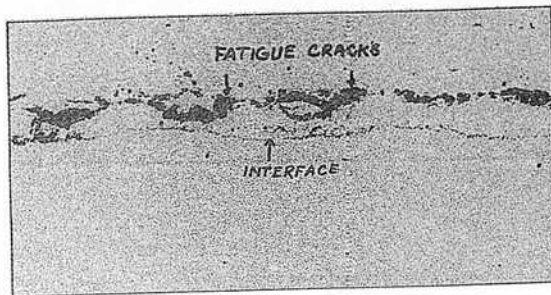
Micro-examination of sections of the deteriorated bearing metal together with copper back plate revealed satisfactory adhesion of the bearing metal to the back plate. Numerous cracks, some parallel to the back plate and others at right angles to it, were observed in the bearing layer-microstructure (Fig. 8.49). Such features were typical of thermal fatigue cracks in bonded bearings.

Fig. 8.49 Fatigue cracks in the interface zone ( $\times 100$ )

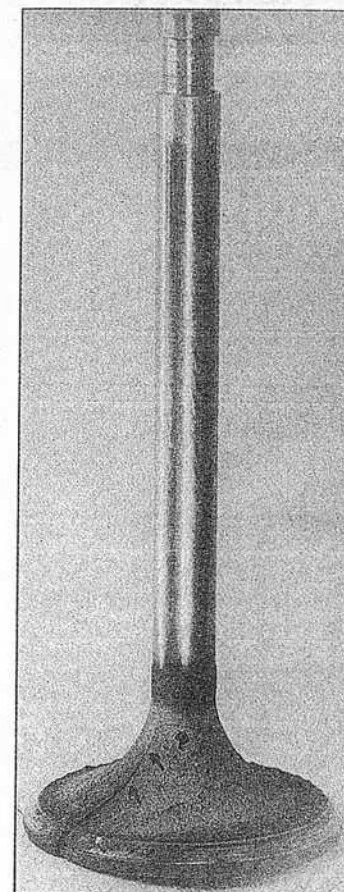
During a routine inspection of the engine, one intake valve was found cracked (Fig. 8.51), after 107 hours of service since the previous overhaul (total period of service was not known).

The intake valve was found cracked radially in the seat region, starting from the rim and extending deep into the neck portion (Fig. 8.52). Heavy deposits of oxide/corrosion products were noticed, particularly towards the rim surface.

**Fig. 8.51** Intake valve showing radial crack in the seat portion ( $\times 3/4$ )

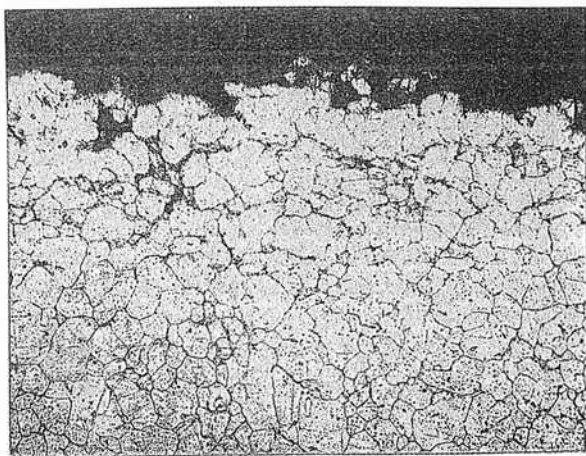
**Microstructural Analysis** Micro-examination of a section of the intake valve in the seat region adjoining the fracture as well as the tapered rim end, revealed numerous deep corrosion pits along the outer periphery of the rim (Fig. 8.53) and secondary cracks (on the surface) running parallel to the main crack (Fig. 8.54) of thermal fatigue nature. Otherwise, the austenitic structures were found satisfactory.

**Fig. 8.53** Deep corrosion pits in the outer periphery of the rim (x50)

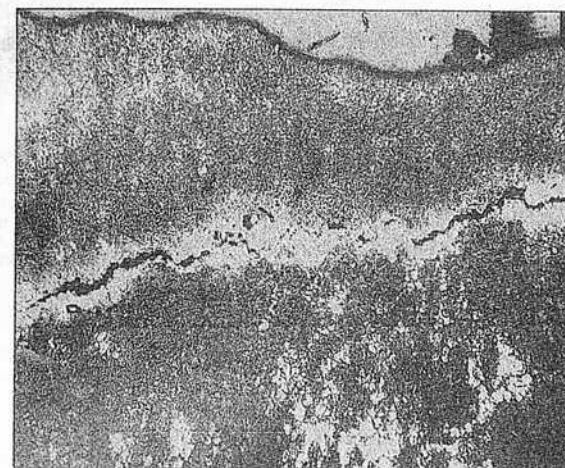
**Fig. 8.54** Shows secondary cracks parallel to the main fracture (x5)

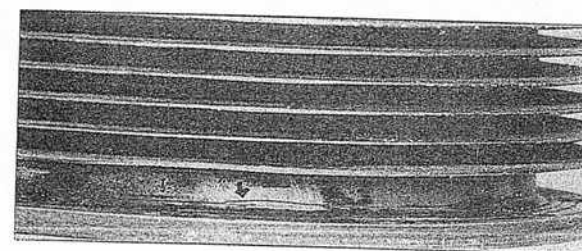
During a major overhaul of the aircraft, one of the four cylinders was found circumferentially cracked in the flange radius portion of the barrel (Figs 8.55 and 8.56).

Fig. 8.56 A close-up of the cracked portion ( $\times 2$ )

Examination of the failed barrel revealed cracking along the bottom radius of the thick flange for about one fourth of the circumference (Figs 8.55 and 8.56).

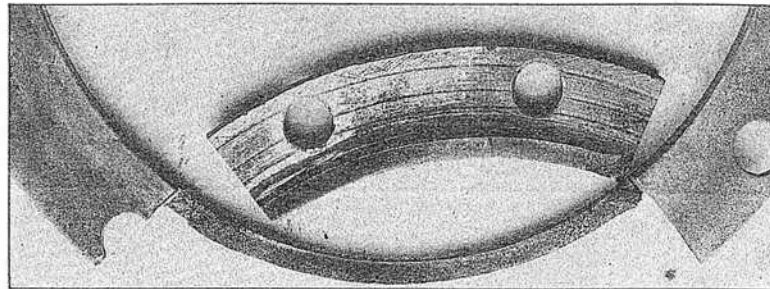
On close examination, it was found that the machining of the barrel was poorly finished, leaving deep tool marks and an improper flange fillet radius (Fig. 8.57).

Fig. 8.57 A distinct circular impression mark around the bolt hole with a severe bite at the flange radius ( $\times 1\frac{1}{2}$ )

**Visual Examination** Examination under a magnifying lens further revealed a distinct circular impression corresponding to that of the steel washer used for bolting the barrel. The impression was around a bolt hole, with a prominent deep bite at the flange radius (Fig. 8.57). Other holes were found free from such dents impressions.

**Macrofractography** Examination of the fracture surface revealed faint but clearly discernible beach marks of fatigue failure type under bending loads, with the origin at the fouled radius zone (Figs 8.57 and 8.58).

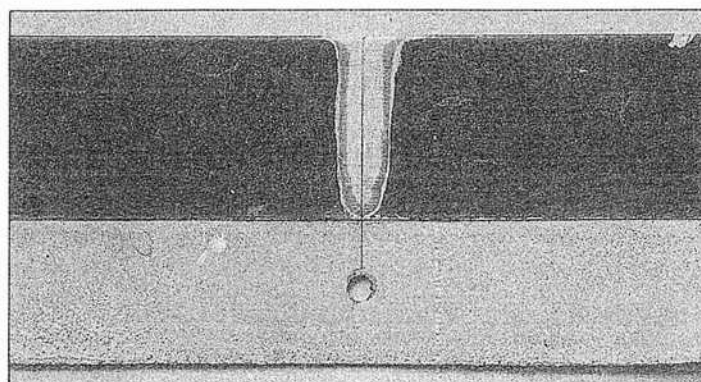
During inspection, after 1000 hours of flight, the trailing edge strip of one of the three rotor blades was found transversely cracked through the rivet hole (Fig. 8.61).

Fig. 8.61 Straight transverse crack in the trailing edge through the first rivet hole ( $\times \frac{1}{2}$ )

The skin was peeled off at the cracked trailing edge strip section and a transverse crack was observed to have emanated from the first drilled hole, from the root end of the blade (Fig. 8.61). The bucked rivet did not show any abnormalities in the bucking process. Further, the rivet hole was found elliptical due to offset drilling with the bottom basement below the rivet shank, filled with araldite (Fig. 8.62). This indicated that there existed a discontinuity just below the rivet shank (Figs 8.61 and 8.63).

**Remedial Action** Since a number of cases of such cracking have been reported in the main rotor blades, the process of drilling operation of the trailing edge as well as the skin were recommended to be modified, so as to avoid offset drilling.

Also, it was recommended to ensure freedom from such offset drilling after completion of rivetting operation by suitable NDT methods such as the X-ray.

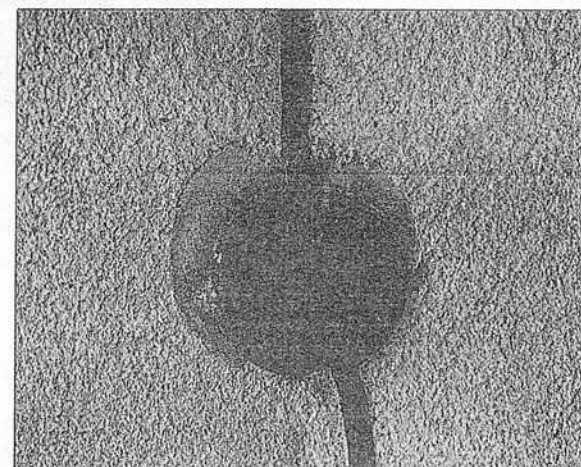
Fig. 8.62 Offset drilling at first rivet hole (i.e. space outside the rivet filled with araldite) ( $\times 10$ )

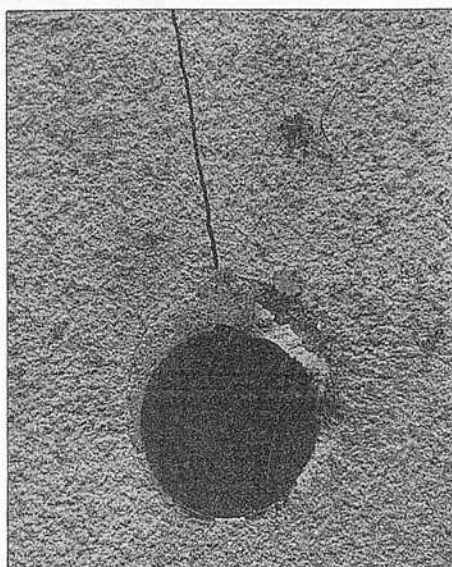
Fig. 8.63 Offset drilling in the second rivet hole ( $\times 10$ )

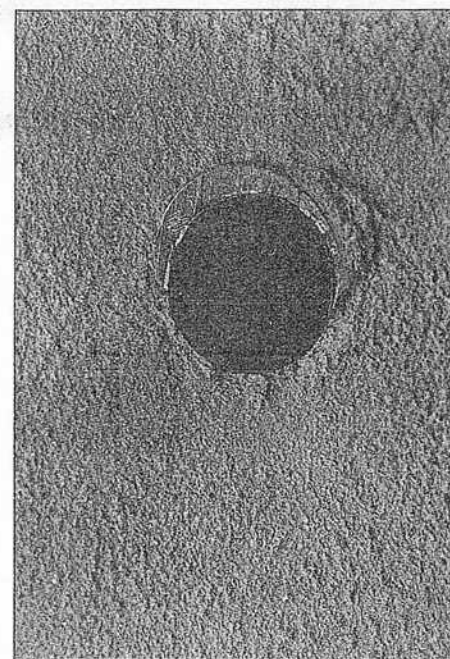
Fig. 8.64 Offset drilling in the third rivet hole ( $\times 10$ )

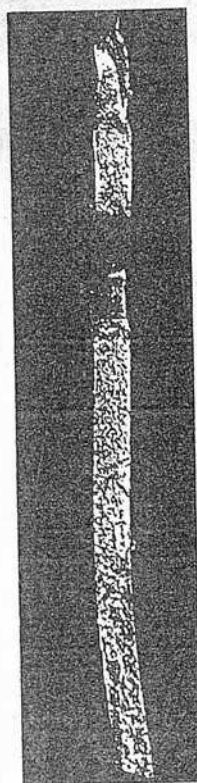
**Most Probable Cause** The basic cause of the premature failure of the main rotor blade was due to fatigue under complex combination of bending and centrifugal stresses with offset drilled hole areas (filled with soft araldite) as stress raisers.

**Fig 8.65** Fatigue zones on either side of the first rivet hole ( $\times 6$ )

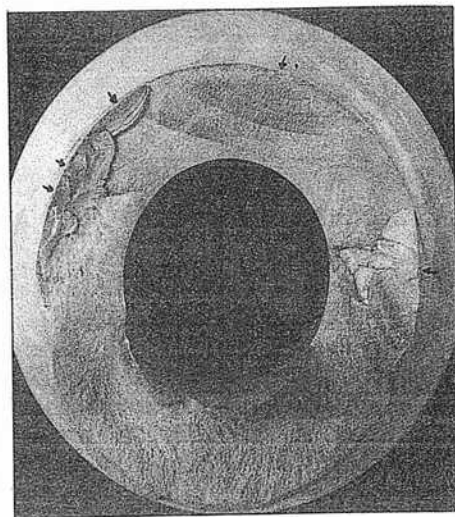
Visual examination revealed that the breakage had occurred circumferentially along the radius portion of the hub, in the region of minimum OD (Fig. 8.67). The surface in the region of the fracture showed no apparent defect or abnormality. However, examination under the stereoscopic microscope showed numerous corrosion pits all around the hub radius. On cleaning them, deep pittings were found in places with interconnecting fine cracks (Fig. 8.68).

Fig. 8.67 Distinct fatigue zones at several places marked by arrows ( $\times 3/4$ )

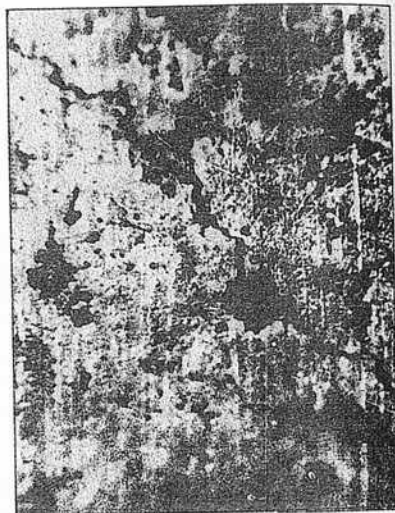
Fig. 8.68 Deep pittings and connecting cracks ( $\times 6$ )

**Microstructural Analysis** Micro examination of the section across the main fatigue zone revealed the crack path as transgranular. Transgranular mode of cracking also confirmed that the failure was due to fatigue. Otherwise, the aluminium copper alloy material was found satisfactorily heat treated with no structural abnormalities. However, corrosion attack on the surface in the radius portion was found intergranular, forming deep fissures up to a maximum size of 1.5 mm dia and 1 mm depth in the section examined.

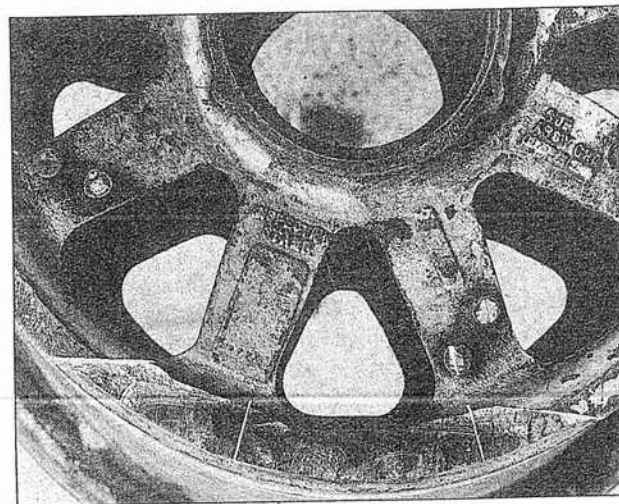
**Macrofractography** The crack along the rim was carefully opened out and the fractured surface covering the entire section thickness was found smooth in a plane square to the zone of cracking in the groove surface and showing distinct 'shell' markings, typical of fatigue failure (Figs 8.70 and 8.71). Origins of fatigue were traced to the several deep corrosion pits on the groove surface, constituting parallel ratchet type fatigue zones (Fig. 8.71) at different places in the initial stages of crack propagation.

Fig. 8.71 Zones of fatigue and their origins in the groove ( $\times 2/5$ )

Fractographic examination clearly established the fact that the cracking along the rim had occurred due to corrosion fatigue. It is known that magnesium-10% aluminium cast alloy material is resistant to corrosion with chromate coating. In this case occurrence of corrosion indicated that the effectiveness of the chromate protective coating was lost due to prolonged usage. Based on this suspicion an enquiry was made and it was learnt that during maintenance, the tubular rim was often removed and put back and in the process the protective coating on the groove got abraded off at places. This facilitated corrosion attack by the water droplets/moisture from the changing atmospheric conditions to which the wheel assembly is always exposed. It was also ascertained that in many cases, prompt protection of the bare abraded surface was not resorted to by the maintenance crew.

**Most Probable Cause** The basic cause of the cracking of the rim portion was due to corrosion fatigue (the corrosion attack arising from the atmospheric conditions of the extremely corrosion prone bare magnesium alloy portions and the fatigue due to repeated loadings during landing and take off).

**Remedial Action** Prompt protection of the abraded regions before insertion of the ring, and periodic check for deep corrosion pits as well as fatigue cracking were recommended.

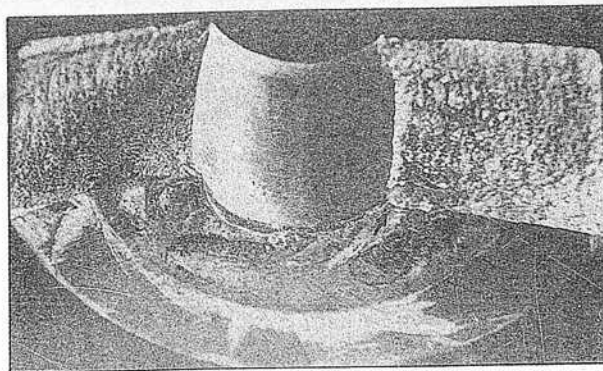
Macroscopic studies revealed severe fretting marks on the inner surface of the lug around the bush hole. The crack was opened out and the fracture surface showed clear signs of a fatigue crack, originating from the severely fretted zones at the hole edge. Micro-examination further confirmed the fretted zone as the origin of fatigue with numerous strain lines in the vicinity of cracking as an evidence of severe cold working effect. This phenomenon indicated the presence of a relative motion between the mating lugs during flight, operating under complex torsional cum bending stresses. Based on these observations, the failure was attributed to fretting fatigue.

**Macrofractography** Examination of the fracture surface revealed a smooth, conspicuous zone of 'shell' markings (typical of fatigue), covering half the cross-section diagonally on either side of the bush hole (Fig. 8.73). The rather concentric shell markings pointed the origins of fatigue in the fretted zones of the inner surface of the lug. The remainder was found rough and fibrous, suggestive of a final fracture when being opened out.

**Fig. 8.73** The fatigue cracks originating from the fretted zones (marked by arrow) ( $\times 3$ )

It was recommended to provide adequate shimming between the mating lugs in order to minimise the relative motion.

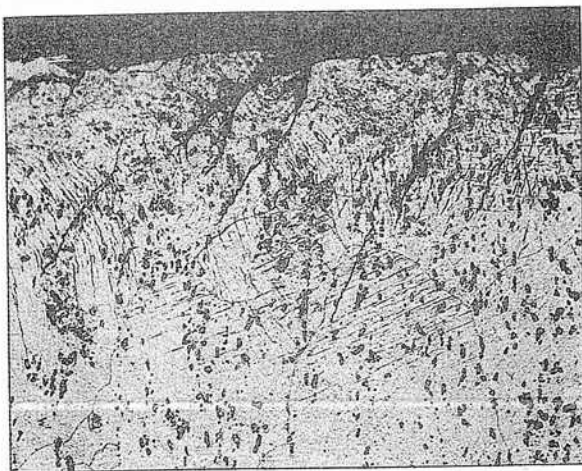
**Microstructural Analysis** Micro-examination of the aluminium alloy forged lug material across the zone of cracking revealed numerous parallel transgranular cracks, emanating from the fretted surface together with several strain lines in the close vicinity of fatigue origin (Fig. 8.74). Zones away from the fatigue origin showed a satisfactory heat treated structure with no abnormalities.

**Fig. 8.74** The microstructure with strain lines and transgranular cracks at the zone of failure ( $\times 100$ )

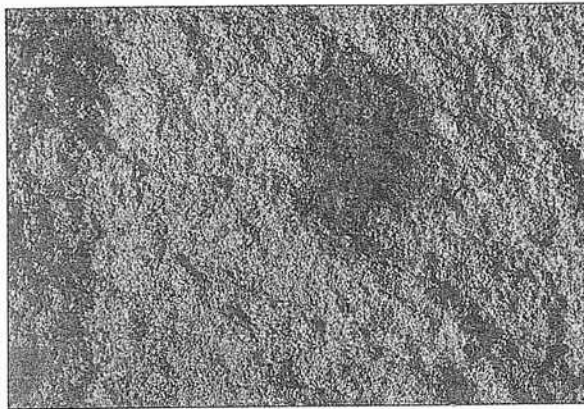
**Simulation Tests** Suspecting, from the nature of corrosion pits and its powdery deposits, that the corrosion was a product of an internal chemical reaction, a texture examination was carried out on the cut-out strips after breaking them off under bending overload. Although immediately on fracturing no abnormalities were noticed, after a day of exposure to the atmosphere the fresh fracture started developing black patches (Fig. 8.76). These black patches were also found increasing in area with exposure time. These characteristics were typical of corrosion due to flux inclusion.

Fig. 8.76 Black zones developed in fractured surface when exposed to atmosphere, due to the presence of flux inclusions ( $\times 1$ )

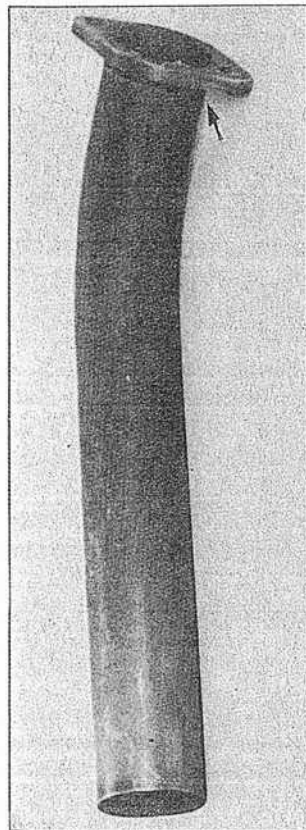
The exhaust pipe is an arc-welded assembly of tubular pipe and collar, made of austenitic stainless steel (Fig. 8.77) and is used as an outlet for hot gases from the engine. The collar end of the pipe assembly is attached to the engine bay area by bolts and is left hanging outside the aircraft.

Fig. 8.77 The failed exhaust pipe assembly showing the location of the crack ( $\times 1/3$ )

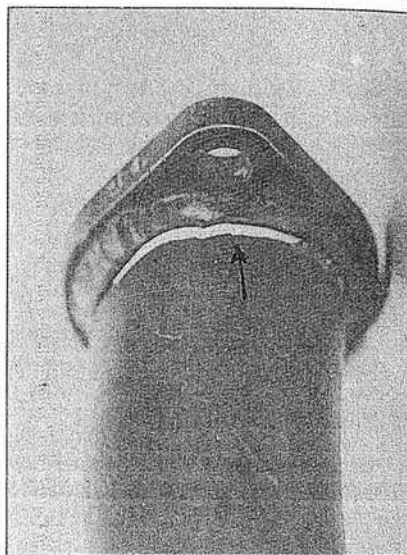
During routine inspection of the aircraft, the exhaust pipe assembly was found to have cracked along the toe of the welded joint (Fig. 8.78). The total period of service that the part had undergone prior to failure was not available.

Fig. 8.78 Close up view of the cracked area at the weld toe ( $\times 2/3$ )

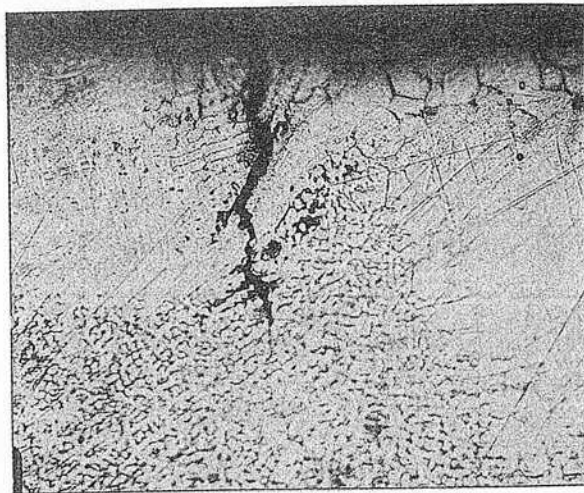
**Metallography** Micro-examination of the section across the failed region of the pipe at  $\times 400$  magnification, revealed numerous intergranular corrosion cracks with few of them propagating extensively into the heat affected zone (Fig. 8.80). However, on

**Fig. 8.80** Several intergranular corrosion cracks with some of them penetrating deep ( $\times 400$ )

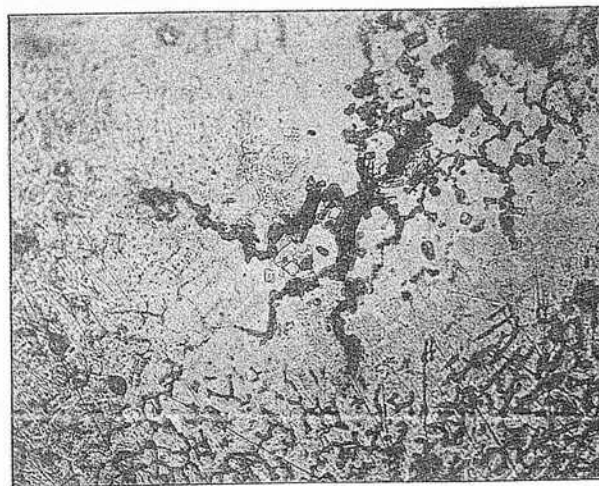
examination of the same area at  $\times 1600$  magnification, chromium carbide particles were observed precipitating along the grain boundaries (Fig. 8.81). The welding characteristics, such as fusion and penetration were found satisfactory.

**Fig. 8.81** Massive chromium carbide precipitation along the grain boundaries at HAZ ( $\times 1600$ )

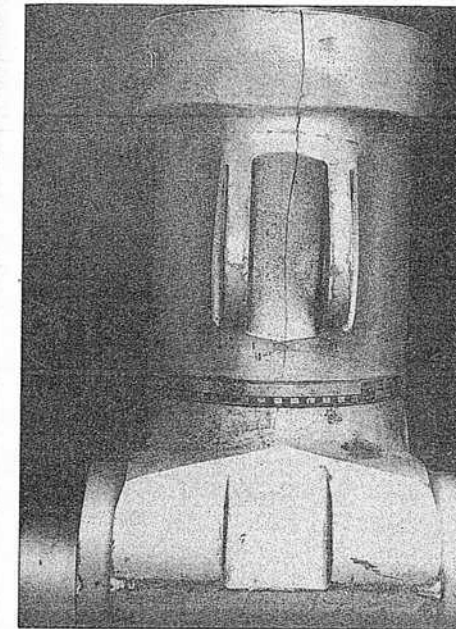
Examination of the fitting attachment revealed a linear crack emanating from the top rim of the hollow body, tracing vertically through the mid-zone of the attachment lugs down to the bottom radius of the housing and then turning side ways (Fig. 8.82). The

Fig. 8.82 Main fitting attachment and location of the straight longitudinal crack ( $\times 3/4$ )

fracture path was found in the longitudinal direction of the forged component covering the entire wall thickness of the body.

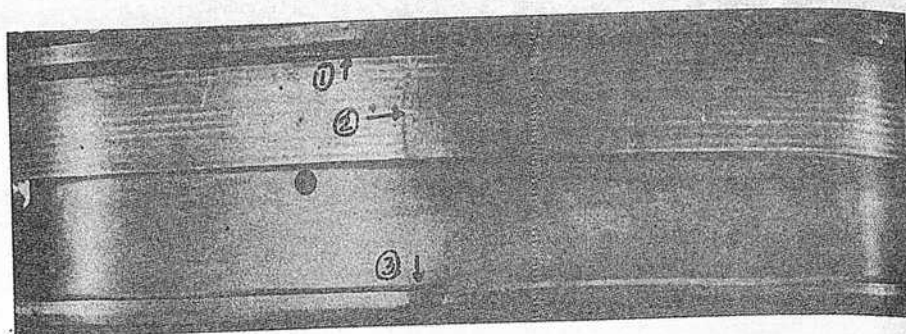
At this stage, it was felt pertinent to examine the copper alloy bush insert (Fig. 8.83) for any damages it might have suffered at the inner surface of the hollow body (i.e., at the location of the insert where maximum straining is expected due to service load). On close examination, evidence of longitudinal damages such as waviness in the top land, deep ingression (appearing as if caused by any hit) on the border land below and a nick and bulge in the bottom raised rim portion (marked as 3-1 respectively in Fig. 8.83) were observed on the outer surface of the bush in the location corresponding to that of the crack.

**Fig. 8.83** Bush insert showing longitudinal damages on the outer surface ( $\times 1$ )

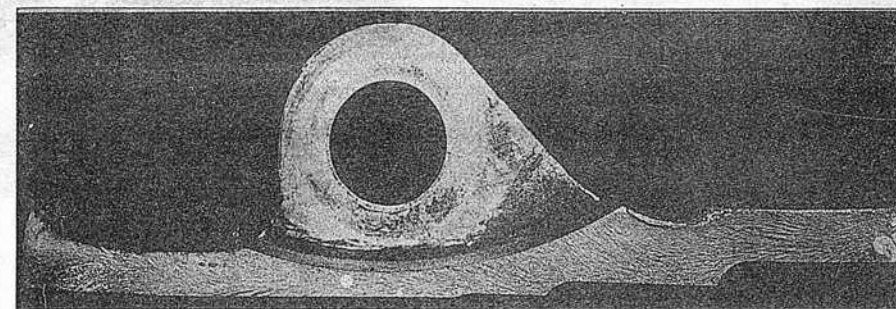
**Macrofractography** Fractographic examination of the cracked surface at  $\times 35$  magnification, revealed a distinct bright 'half moon' zone at the inner corner of the cylinder wall and brittle layer surface (Fig. 8.85).

**Fig. 8.85** A distinct bright half moon zone and brittle layer surface in the fracture ( $\times 1/4$ )

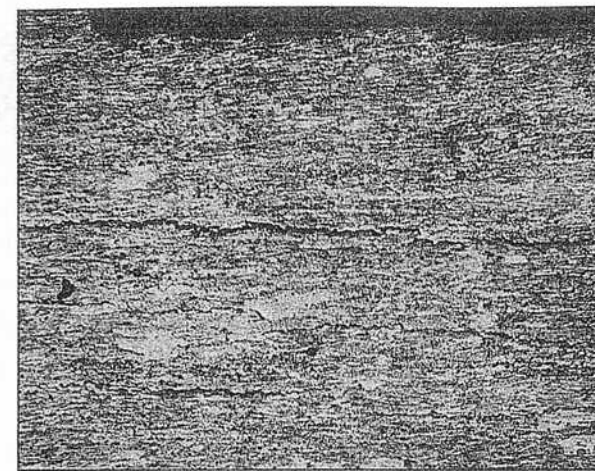
**Microstructural analysis** Micro-examination of a section parallel to the zone of fracture initiation revealed that the main fracture was intergranular along with numerous discontinuous intergranular cracks, also running parallel to the main crack (Fig. 8.86). This was a positive indication of cracking under the stress corrosion phenomenon. Other than this the microstructure did not reveal any abnormalities.

**Fig. 8.86** Microstructure showing parallel intergranular cracks ( $\times 100$ )

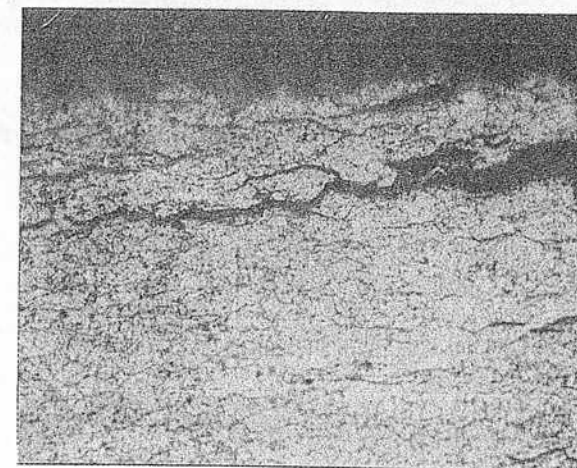
intergranular mode with multiple secondary cracks running parallel to the main crack (Figs. 8.90 and 8.91). These structural features gave a positive indication of stress corrosion. As seen from the microstructure of the adjoining area of the rivet head, cracks were found emanating from the severely cold worked regions (Fig. 8.91) in the shoulder radius zone between the head and the shank.

**Fig. 8.90** Intergranular mode of fracture with multiple secondary cracks running parallel to the main crack ( $\times 200$ )

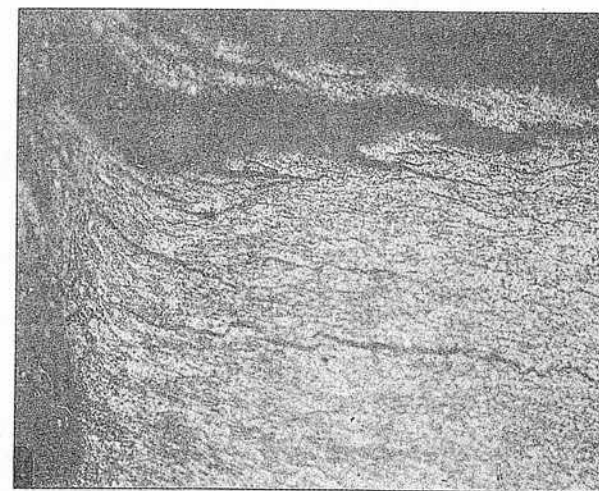
**Fig. 8.91** Cracks emanating from the severely cold worked region of the rivet head shoulder radius ( $\times 200$ )

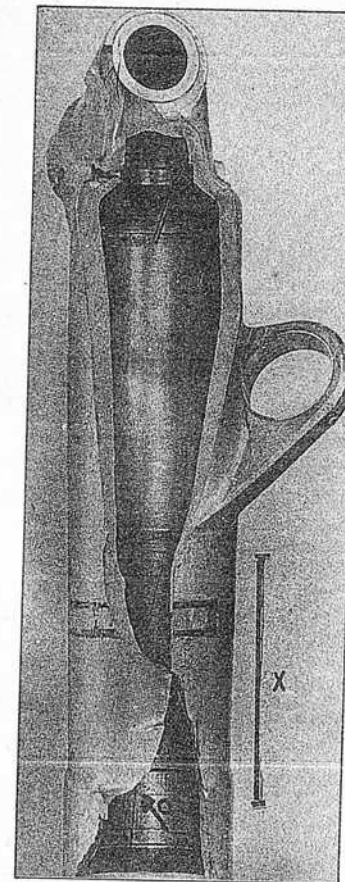
**Fig. 8.92** The oleo head after bursting ( $\times 1/6$ )

Examination showed that the bottom end of the oleo cylinder had broken off with three longitudinal cracks emanating from the open end (Fig. 8.92). It also revealed numerous corrosion pits all over the lower half of the bore surface (Fig. 8.93). Further, presence of very conspicuous bright 'half moon' zones at five places (Fig. 8.94) covering almost the entire wall thickness were observed on the fracture, in the region marked 'X' (Fig. 8.92).

**Macrofractography** The long middle crack (marked 'O' in Fig. 8.92) was carefully opened and the entire fracture surface studied under a stereoscopic microscope at  $\times 10$  magnification. Fracture lines and chevron markings indicated that the tear had initiated from the bright moon zones, which were found brittle with laceral cracks (Fig. 8.95). Further, the radial fracture lines were found to have their nuclei at the corrosion pits on the bore surface (Fig. 8.96).

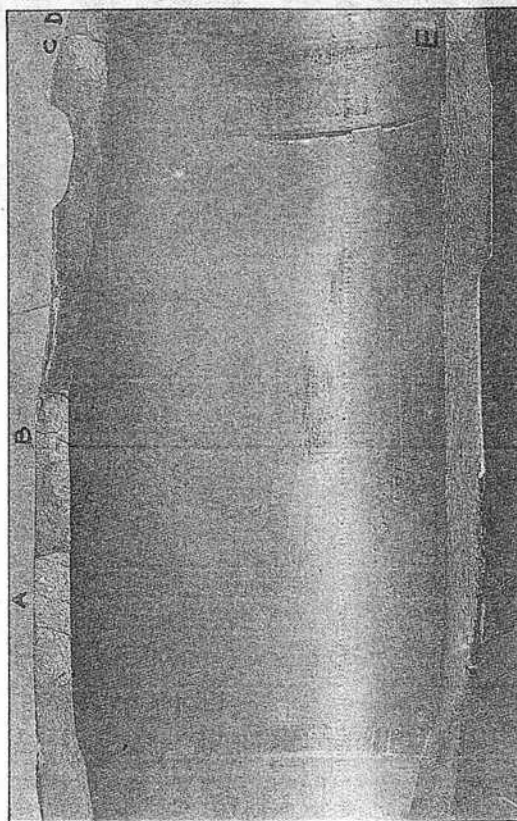
Fig. 8.94 Location of five bright 'half moon' zones marked by A, B, C, D and E ( $\times 1/2$ )

Fractographic as well macro and micro-examination clearly established the fact that the premature failure of the oleo leg had occurred due to stress corrosion attack. Further, examination revealed that the multiple cracks had originated from the bore surface instead of the normal outer surface zone of the cylinder, where applied tensile stresses tend to concentrate maximum for any progressive type of failure to occur.

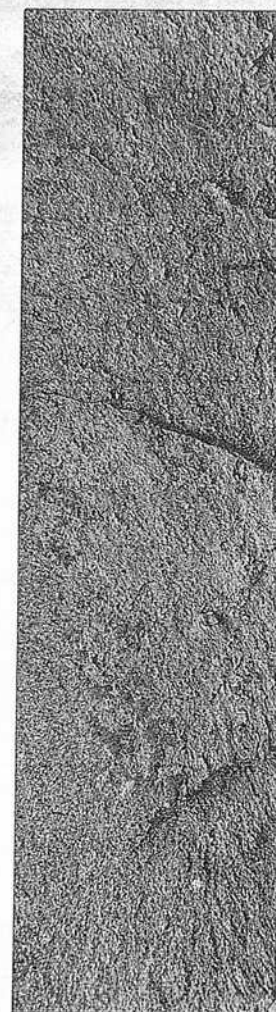
Fig. 8.95 Brittle layeral cracks at location 'A' in Fig. 8.94 ( $\times 2\frac{1}{2}$ )

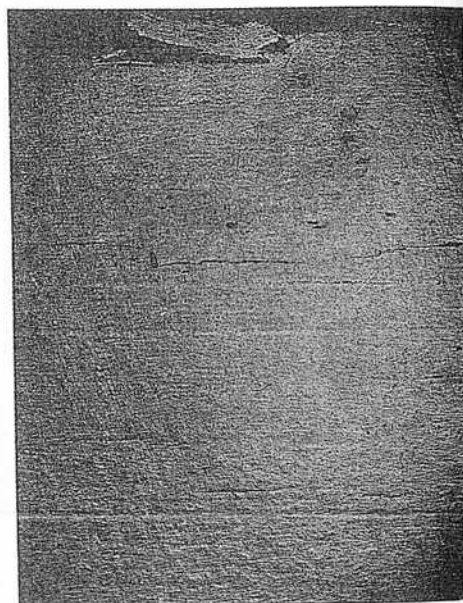
cracks (Fig. 8.97). Micro-examination of the same section, on polishing and etching, showed that the fracture was intergranular in nature, with numerous secondary intergranular cracks running parallel to the main crack (Fig. 8.98). These microstructural characteristics positively indicated the occurrence of a stress corrosion phenomenon.

**Fig. 8.97** Parallel cracks on the bore surface adjoining the fracture, on etching ( $\times 10$ )

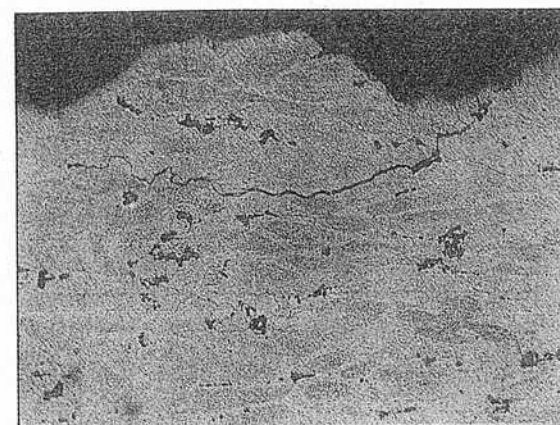
**Fig. 8.98** Intergranular fracture and secondary cracks ( $\times 100$ )

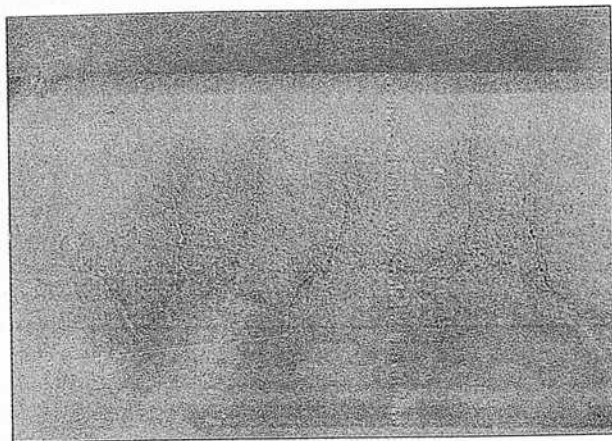
surface. Also, a number of irregular hair line cracks were noticed in a criss-cross manner on the loaded flank as well as on the outer surface of all the gear teeth (Fig. 8.100). Even a few of the non-driving tooth faces showed similar cracks. Some of the flanks showed severe flaked off regions with a transition from unbranched cracks to branched cracking (Fig. 8.101).

**Fig. 8.100** Criss-cross hair line cracks on the outer surface of gear tooth (×9)

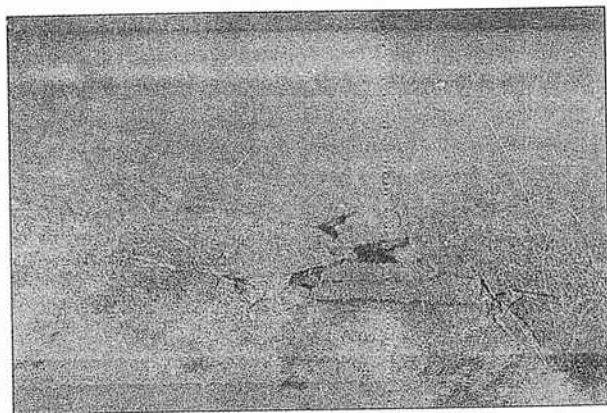
**Fig. 8.101** Severe flaking on the surface of a gear tooth (×9)

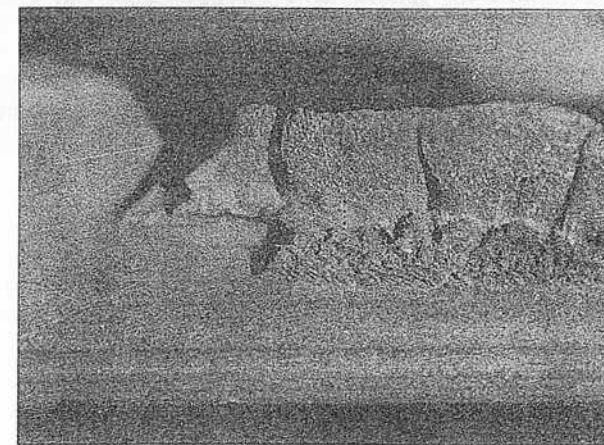
**Macrofractography** Examinations of the fractured surface under the stereoscopic microscope at  $\times 10$  magnification, revealed that the cracks were restricted to the depth of the hardened case and had originated from the internal surface. Further, nature of the fracture was found to be coarse crystalline with Neumann bands, typical of a brittle fracture under hydrogen embrittlement (Fig. 8.102).

**Fig. 8.102** Coarse crystalline fracture surface with 'neumann bands' (×9)

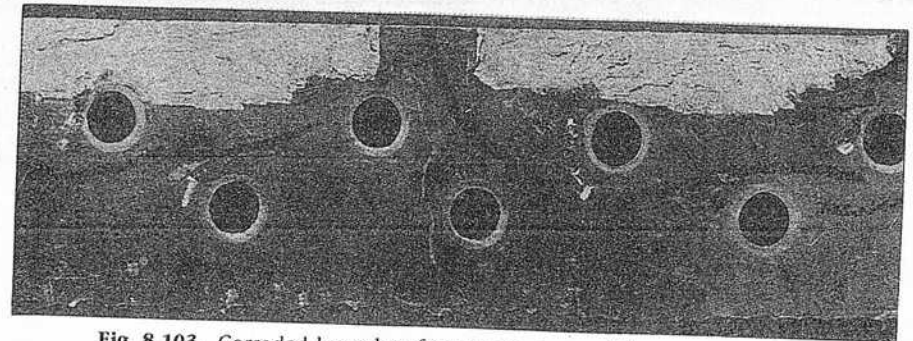
Corrosion patches were detected at two places of the spar cap during routine inspection (Fig. 8.103).

Fig. 8.103 Corroded layeral surface at two zones of the spar cap ( $\times 1$ )

Examination of the cut piece showed severe corrosion patches in two adjacent zones, extending to an identical area of 6 cm  $\times$  1 cm with voluminous corrosion products in the powdery form. On removal of the powder, corroded zones were found intact with no evidence of defects such as corrosion pits, etc. However, the corroded surface showed characteristics of a brittle feature (Fig. 8.103).

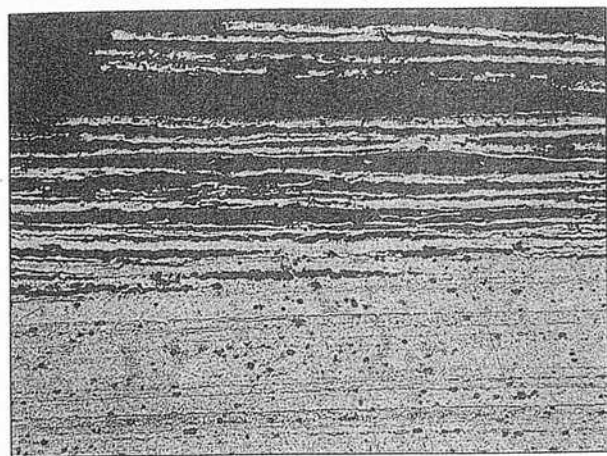
**Microstructural Analysis** Micro-examination of the sections both in the longitudinal and transverse directions of the corroded zone revealed numerous thin, long and parallel surface layers, flaking off along the extrusion grain fibres. These directional attacks resulted in a pronounced leafing action (Figs 8.104 and 8.105). The leafing action was

**Fig. 8.104** Long parallel surface layers flaked off along the extrusion grain fibres in the microstructure of the corroded zone ( $\times 100$ )

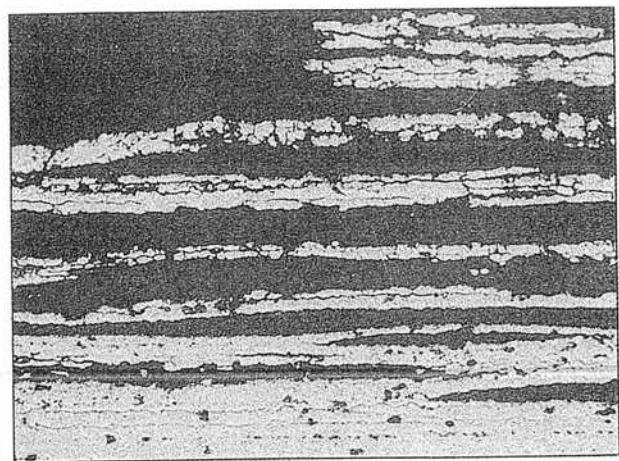
**Fig. 8.105** Enlarged view of the layeral cracking ( $\times 200$ )

found extending to a maximum depth of 1.1 mm in the sections examined. All these features were well indicative of an exfoliation corrosion phenomenon.

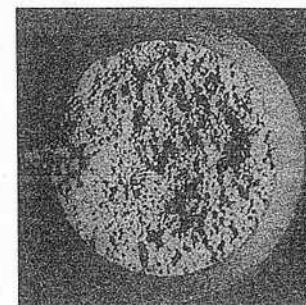
**Macrofractography** Examination of the fractured surfaces of all the failed bolts at  $\times 10$  magnification showed identical fibrous type of fracture of a ductile material (Fig. 8.107).

Fig. 8.107 Fibrous fracture ( $\times 10$ )

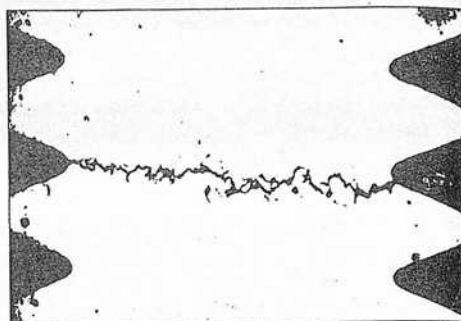
**Microstructural Analysis** Micro-examination of the failed bolt in the longitudinal section revealed a multiplicity of cracks originating at the thread roots and propagating throughout the section thickness in an intergranular manner (Fig. 8.108). Micro-examination of the same section showed voids and formation of intercrystalline fissures with

**Fig. 8.108** Intergranular cracks across the thread root ( $\times 12$ )

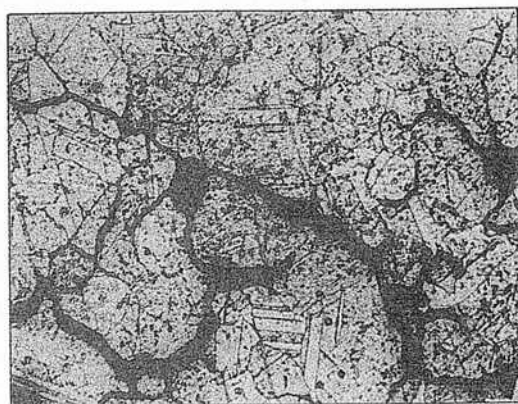
loosening of the grain boundaries (Fig. 8.109), all typical of a creep failure. The structure was otherwise found satisfactory.

**Fig. 8.109** Voids and intercrystalline fissures ( $\times 100$ )

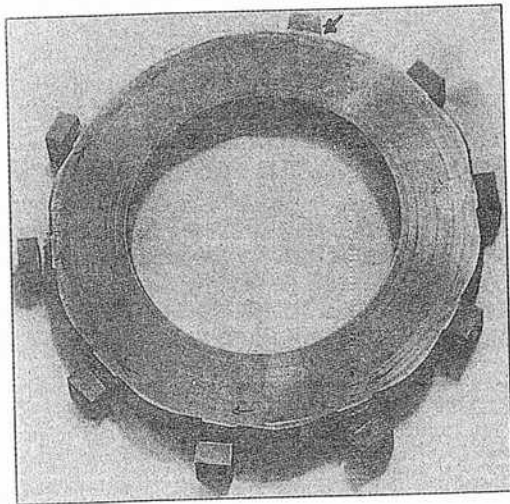
Fig. 8.110 Failed friction plate showing the location of cracks of six tenons ( $\times 1/3$ )

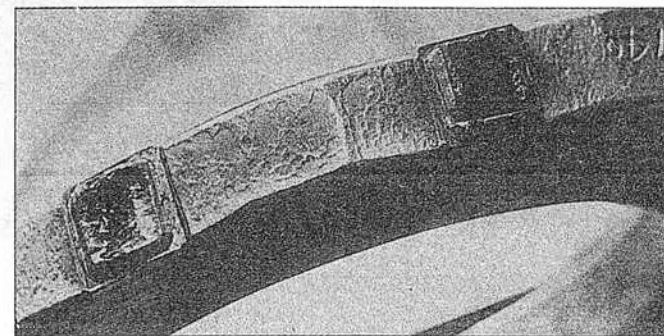
On visual and macro-examination, the surfaces of all the broken tenons were found totally covered with heavy black soot, including discolouration on the top surface between the tenons. This was indicative of a high frictional temperature effect. All the fractures were found almost identical in nature, and were in an angular plane with the initiation zone at the radius marked in Fig. 8.111. However, the fracture surface were

Fig. 8.111 Close-up view of fracture of the tenons showing the origin sites ( $\times 1/2$ )

found almost rubbed. Further, a close examination under the stereoscopic microscope at  $\times 10$  magnification revealed stepwise damages/pressed marks around the base portion of the tenons, due to improper (forced) insertion of the tenon sleeve.

**Remedial Action** It was recommended to avoid undue stresses caused by the improper insertion of the tenon sleeves.

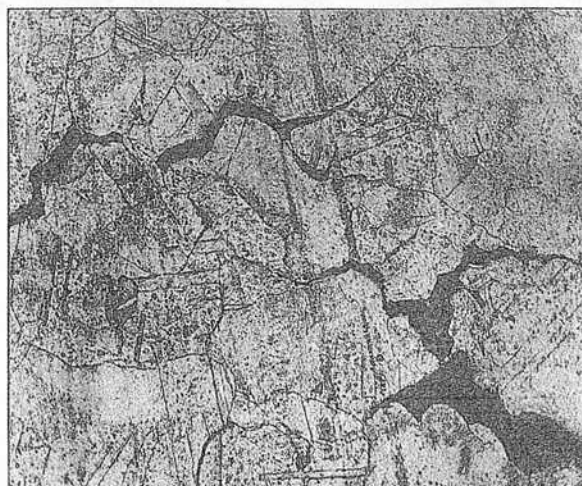
**Microstructural Analysis** Micro-examination of a section across one of the broken tenons showed a fracture predominantly of the intergranular mode, with a few zones in and around the fracture revealing a wide opened intergranular crack, i.e. by joining the voids along the grain boundary path and having originated at a triple point (Figs 8.112 and 8.113). All these features indicated a failure by creep.

Fig. 8.112 Triple point cracks and creep voids ( $\times 400$ )

Microstructural features clearly established the fact that the failure of the tenons was due to creep. The copper-chromium alloy friction plate is subjected to high friction temperature (around  $600^{\circ}\text{C}$ ) during each landing, and over a period of time and a number of landings, creep phenomenon is usually expected to occur at the critical radius zones of the tenons under service stresses. It is pertinent to mention here that presence of stepwise mechanical damages/pressed marks around the base portion of the broken tenons indicated an additional imposed stress besides the service stress. The combined effect of temperature and stress had accelerated the creep phenomenon.

**Most Probable Cause** The basic cause of the breakage of the tenons of the friction plate was attributed to creep phenomenon.
