AGARDograph No. 278

## AGARD Corrosion Handbook Volume 1 Aircraft Corrosion: Causes and Case Histories

W.Wallace  
Head, Structures and Materials Laboratory  
National Aeronautical Establishment  
National Research Council Canada  
Ottawa, Ontario, Canada

D.W.Hoeppner  
Cockburn Professor of Engineering Design  
Department of Mechanical Engineering  
University of Toronto  
Toronto, Ontario, Canada

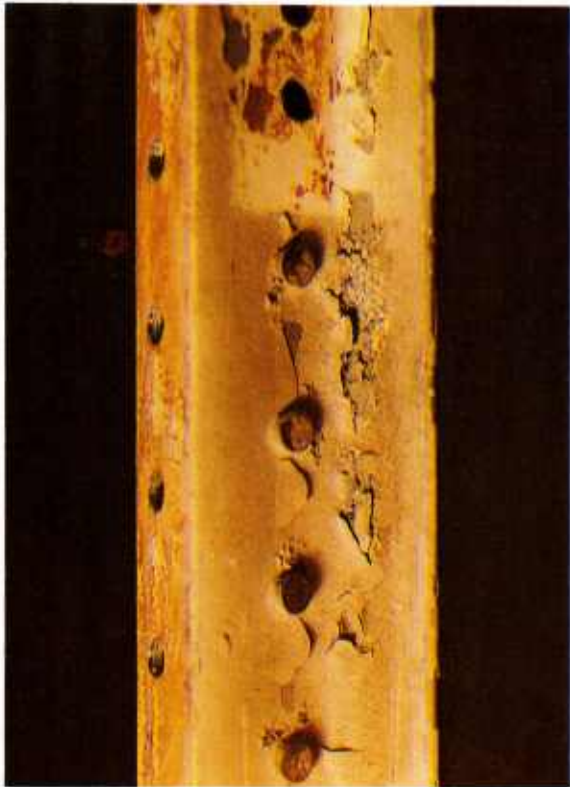
The corrosion products of aluminium and magnesium alloys are evident as white to grey powdery deposits, the latter are often of a fluffy or granular nature. Figure 7-3 shows the surface corrosion damage to an aluminium alloy stringer, where the chromate pre-treatment and primer coat had failed, probably through aging and exposure to moisture. Early identification of aluminium or magnesium corrosion is essential, and frequently the first indications are flaking or blistering of the surface finish. Figure 7-4 shows an area of general surface corrosion on a magnesium alloy skin of a helicopter on which the chromate pre-treatment had locally failed.

Fig. 7-3 Flaking of the chromate pre-treatment and primer on an aluminium alloy stringer and corrosion of the exposed metal

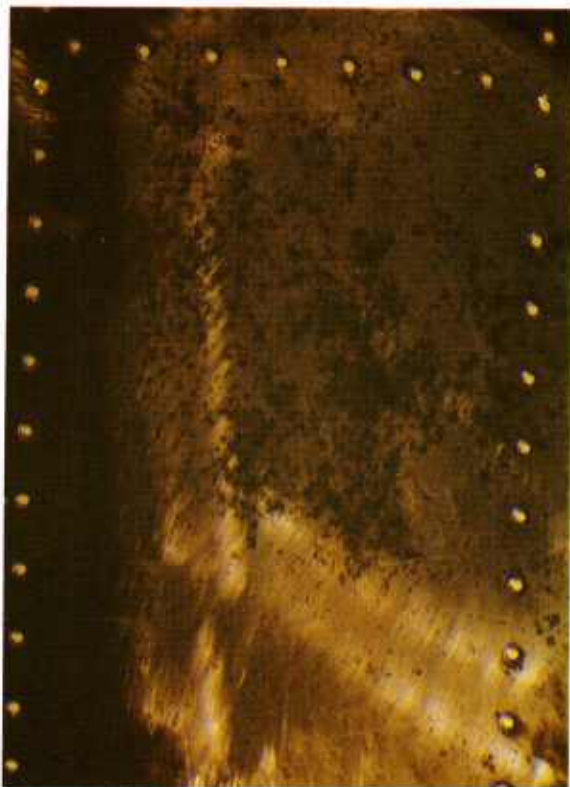
Fig. 7-4 Uniform corrosion in a magnesium alloy helicopter skin after damage to the chromate pre-treatment

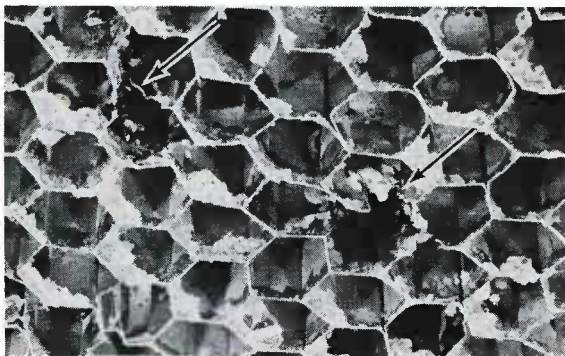
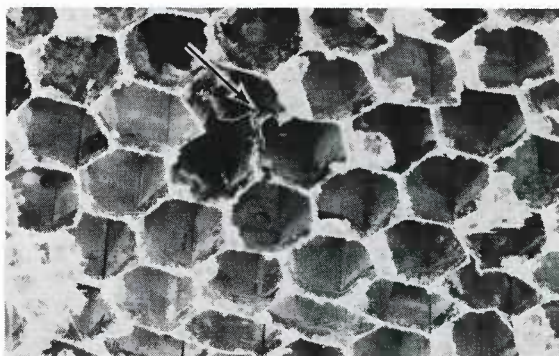
Fig. 7-5 Corrosion damage in an aluminium alloy honeycomb structure from a fighter aircraft  
(a) Inner surface of the aluminium skin showing perforations.  
(b) Foam rubber filler material.  
(c) and (d) Arrows point out areas of severe corrosion damage in the honeycomb.

Early attention to uniform corrosion damage is particularly important where the metal skin is used as an outer layer of a honeycomb sandwich structure, or closed box structure. Failure to do so may lead to penetration of the skin by corrosion, and the entry of water or other corrodents into the internal structure. Figure 7-5 shows the corrosion damage to an aluminium honeycomb structure from a fighter aircraft. Figure 7-5(a) shows heavy corrosion on the inner surface of the aluminium skin, with holes which allowed the ingress of water. Figures 7-5(c) and 7-5(d) show areas of corrosion damage to the aluminium honeycomb, which are indicated by arrows. Figure 7-5(b) shows a sample of foam rubber filler material which formed a layer between the skin and the honeycomb. It is uncertain whether the rubber in this case contributed to the corrosion reactions, but the operators of this particular aircraft did note that the rubber was usually not present. This simply serves to point out that all material combinations should be evaluated with respect to corrosion before a design is finalized, since one material may contribute to the corrosive environment of another.

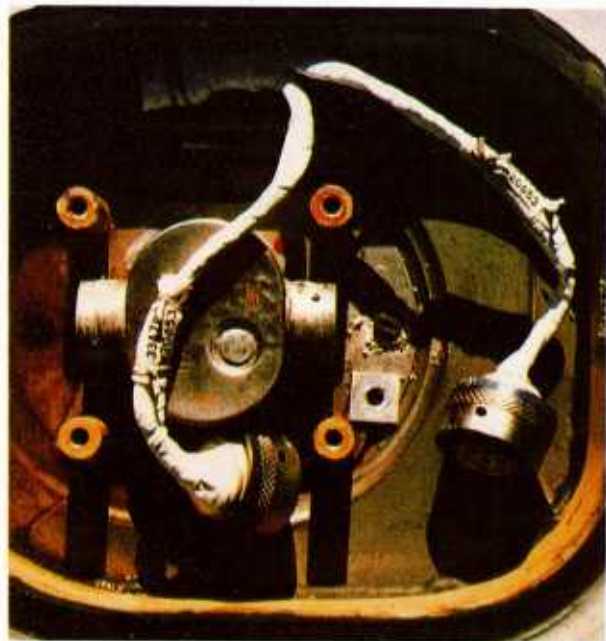
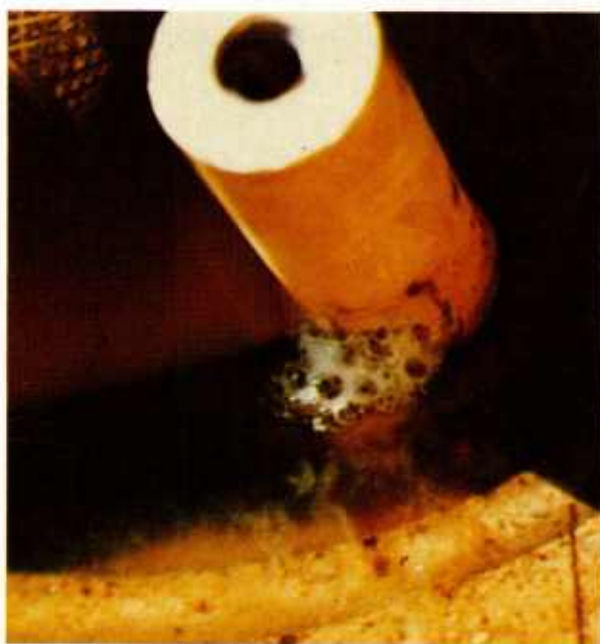
The need to prevent the ingress of water and other corrodents to internal structure and equipment is nowhere more important than with electrical and avionics equipment. In the interests of obtaining specific electrical characteristics, the materials used are often inferior in terms of corrosion resistance, and serious corrosion problems and often malfunction of equipment can occur if the equipment is not properly sealed. Figure 7-6(a-c) shows examples of corrosion of electrical equipment in a military aircraft due to water intrusion around the access door. The general reddish-orange discolouration of the compartment walls and floor, in Figure 7-6(a), indicates that uniform corrosion has occurred in these areas. The close-up photographs of Figure 7-6(b) and -6(c) show local eruptions of corrosion products around a screw and binding post, which are probably examples of galvanic corrosion and crevice corrosion.

Fig. 7-6 Corrosion in a container used to house electrical equipment

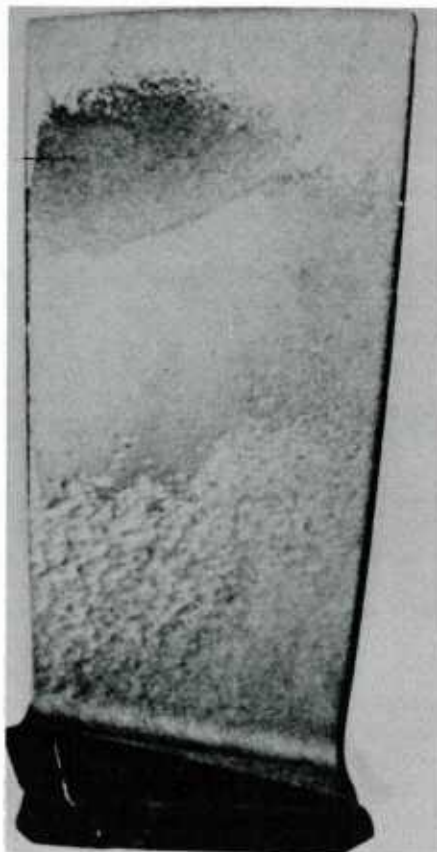
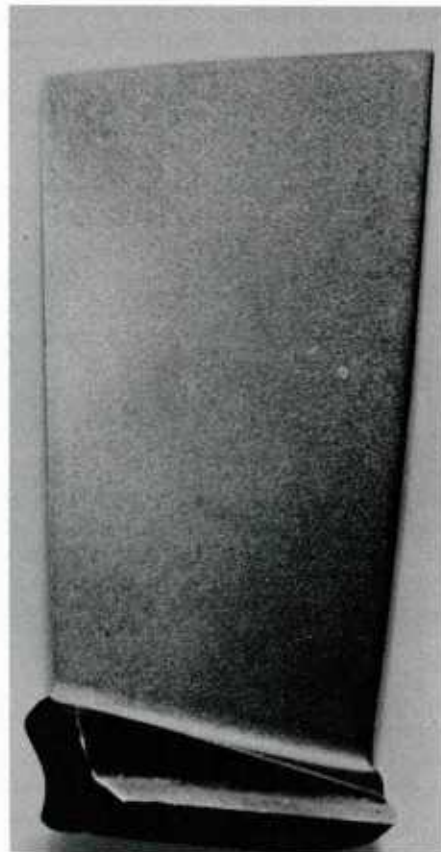
Erosion-corrosion is a common form of damage to aircraft propellers and turbine engine components operating either in the intake air stream, or in the hot gas path. Components such as impellers, compressor blades, turbine blades, nozzles and guide vanes are particularly prone to damage. Figure 7-8(a) shows erosion-corrosion damage on the concave surface of a compressor blade from a fighter aircraft engine after 16.5 hours in an erosion test cell. This particular blade was protected by a proprietary protective coating, applied by a vapour deposition process. Figure 7-8(b) shows a similar blade protected with a bias sputtered TiCrC coating after a similar 16.5 hour exposure in the test cell. A great number of hard, erosion resistant coatings are available for protection of engine coatings, and a great deal of research and development on new coatings continues.

T-58 COMPRESSOR BLADES AFTER 16-1/2 HOURS EROSION TEST (CONCAVE SURFACE)

Fig. 7-8 Erosion-corrosion damage on the airfoil of a fighter aircraft compressor blade

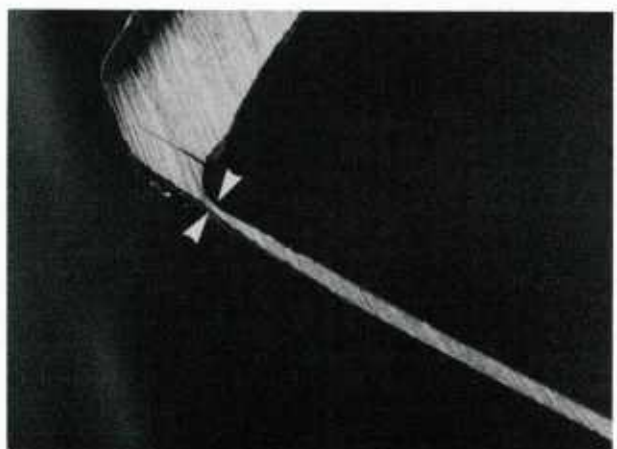
The brake disc assemblies were removed from both main wheels of a light single engine aircraft (Fig. 7-9(a)). Both brake disc assemblies were severely corroded in the fillet radius area between the disc and the sidewall, and there was a 12-15 mm band of corrosion around the outside surface of the wall as shown in Figure 7-9(a).

Fig. 7-9 Corrosion failure of a brake disc assembly

The brake disc assembly number 2 had failed around the sidewall circumference adjacent to the disc; this area was severely weakened due to corrosion to the extent that the wall thickness at the failed section was reduced to approximately one-quarter of the original thickness. Figure 7-9(b) shows the corresponding section through the disc and sidewall of the unfailed assembly, number 1. Even though this particular unit had not failed, a serious loss of material had occurred leading to a reduction of sidewall section thickness, as indicated by the arrows in Figure 7-9(b).

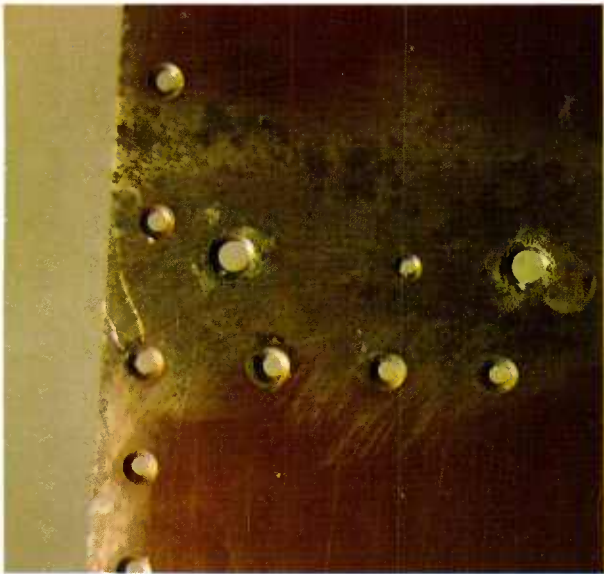
The example of Figure 8-2 shows dissimilar metal, or galvanic corrosion damage at fastener holes where steel bolts fastened through a magnesium alloy skin. The positions of these two materials in the electrochemical series, or galvanic series indicates that a high electrochemical potential would exist between them when in contact, and severe galvanic corrosion could be expected to occur.

Fig. 8-2 Galvanic corrosion around fastener holes used to locate steel fasteners in a magnesium alloy skin

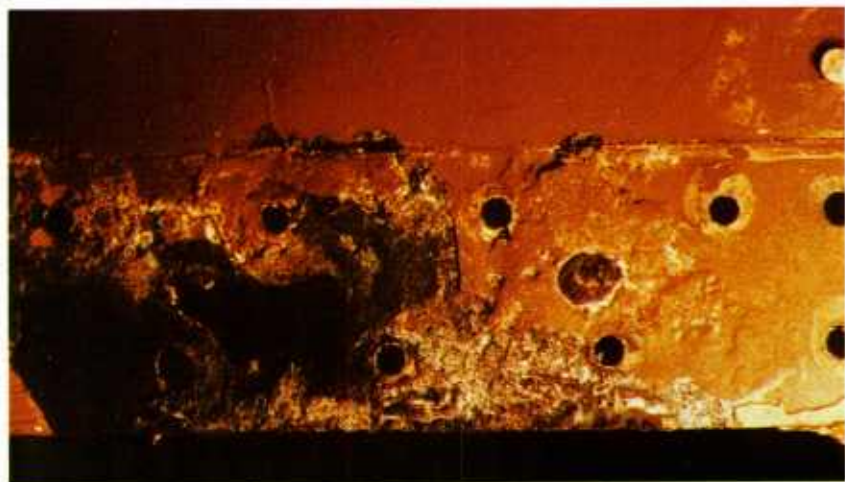
(a) Dismantled joint in a magnesium alloy panel.

Some examples of crevice corrosion are shown in Figures 9-2(a), 9-2(b) and 9-2(c). Figure 9-2(a) shows a corroded and perforated magnesium panel in a dismantled joint area from a transport aircraft structure. The corrosion damage was due to inadequate sealing. Figure 9-2(b) presents a similar case of crevice corrosion at the interface of a magnesium alloy skin joint, which was also due to inadequate sealing. In both examples the most severe damage is away from the edges of the fastener holes which suggests that galvanic corrosion was not the major factor. Figure 9-2(c) shows a situation where both galvanic corrosion and crevice corrosion contributed to the damage. The corrosion damage has occurred at the junction between a magnesium alloy floor panel and aluminium alloy frames and angle plates. This problem was probably aggravated by poor drainage conditions, and inadequate sealing and surface protection.

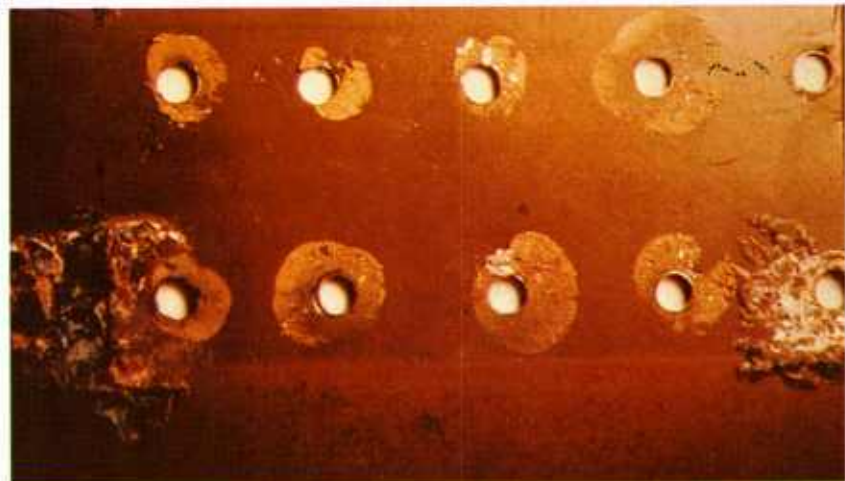
(b) Crevice corrosion in a magnesium alloy skin joint due to inadequate sealing.

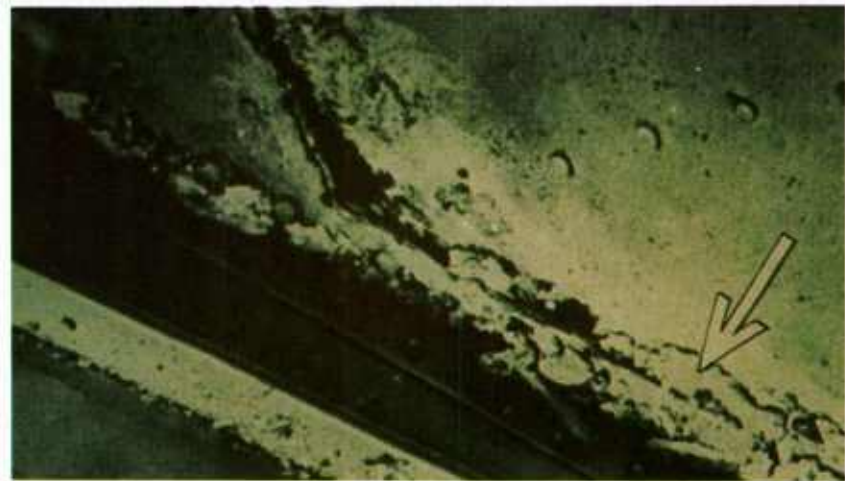
(c) Crevice and galvanic corrosion between a magnesium alloy floor panel and aluminium alloy frame member.

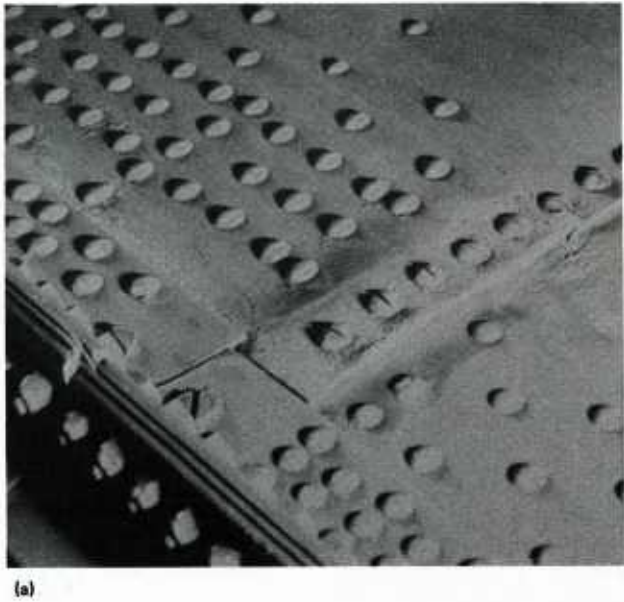
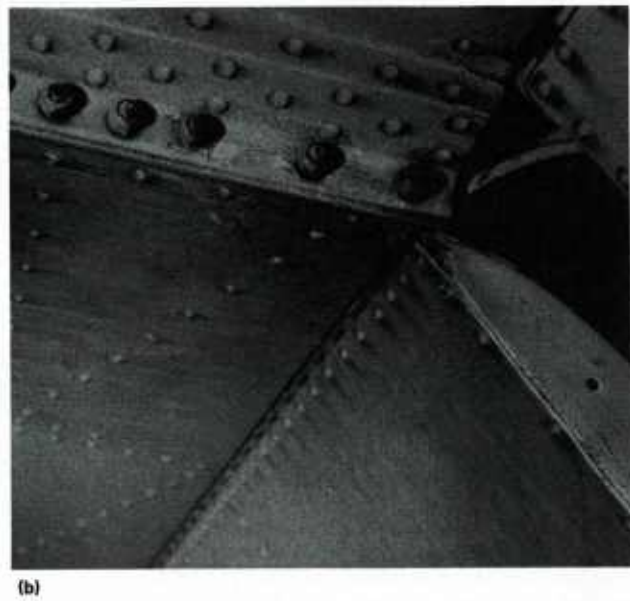
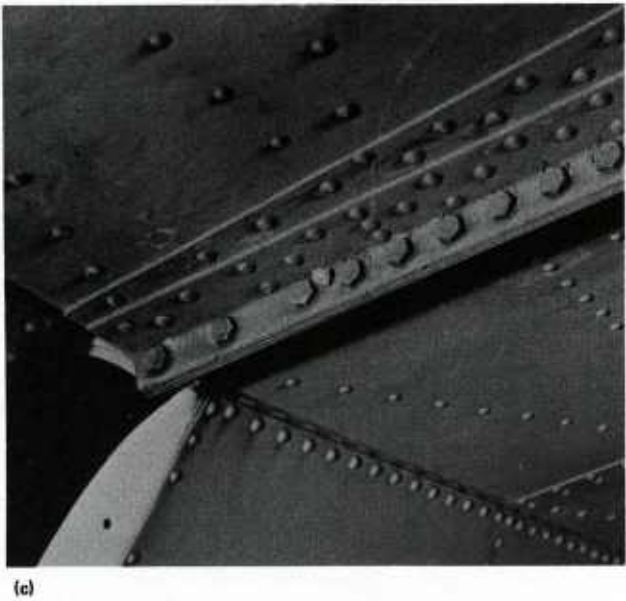
Fig. 9-3 Crevice corrosion in the outer wing coupling flange of a transport aircraft

- (a) Crevice corrosion in aluminium lap joint.
- (b) and (c) Corrosion around bolts and under nuts in the under wing structure.

Crevice corrosion may be particularly severe with magnesium alloys since they are the most anodic of the common airframe structural alloys, however similar problems also exist with aluminium alloys. Figures 9-3(a), 9-3(b) and 9-3(c) show examples of crevice corrosion in the outer wing coupling flange of an older type small transport aircraft which had been operating in the Mediterranean region. The damage was observed during routine visual inspection, and subsequently x-ray inspection was used to measure the depth of corrosion in the different areas of structure. The structure was predominantly aluminium alloy sheet and flanges, with steel fasteners, and the structure was protected by a titanium dioxide ( $\text{TiO}_2$ ) pigmented paint finish. Crevice corrosion is evident between the aluminium alloy flanges and sheet, and at the aluminium lap joints (Fig. 9-3(a)). Corrosion cavities were also observed under the bolts and nuts (Figs. 9-3(b) and 9-3(c)), and the corrosion can be seen to extend beyond the area of contact of the fasteners. Measurements of the depth of corrosion showed that this was greatest under the heads of the bolts and nuts, rather than at the immediate edges of the fastener holes. This suggests that the crevice effect was probably at least as significant as the galvanic effect in this case. The corrosion repair work led to this aircraft being out of commission for a reported "long period", although the precise details were not available. The repair work involved the use of a pigmented zinc chromate primer and top coat, in place of the  $\text{TiO}_2$  finish used originally.

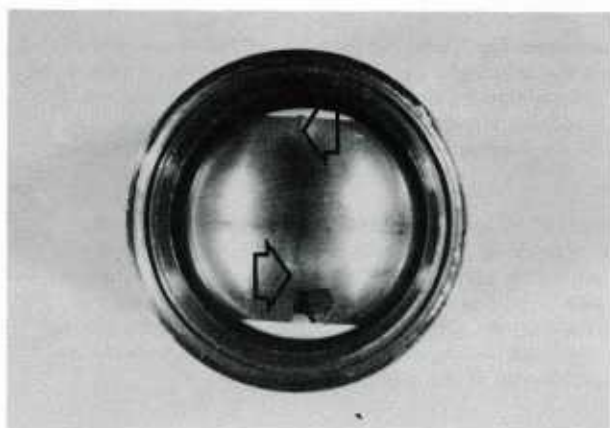
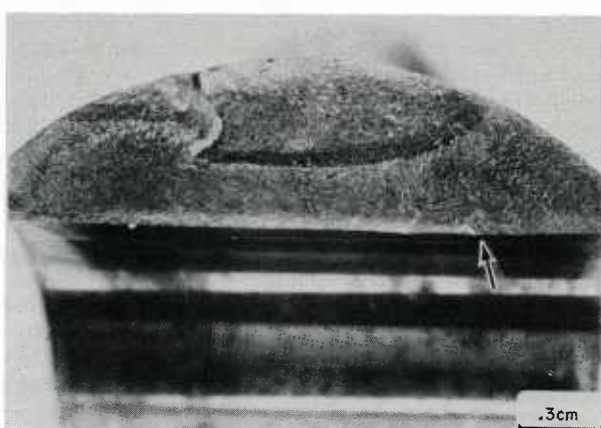
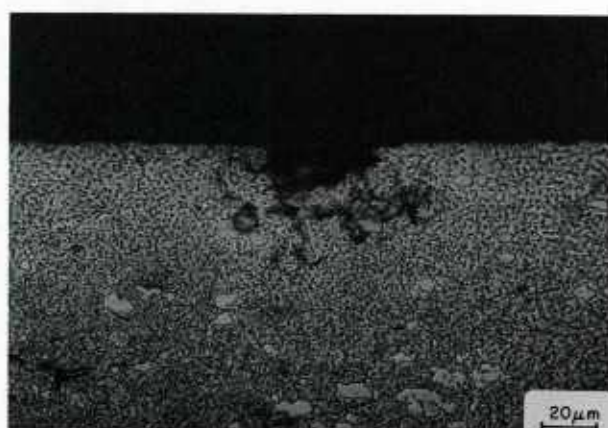
**Fig. 9-9 Pitting induced failure of some 440C stainless steel hinge bearings**

Visual inspections led to the discovery of cracking in several chromium plated type 440C martensitic stainless steel wing flap hinge bearings. Three of the suspect parts were submitted for laboratory examination, and these are shown in Figure 9-9(a).

Bearings 1 and 2 were found to be cracked, while bearing 3 was found to be uncracked. In bearing No. 1, two separate cracks were found; one crack took the path shown in Figure 9-9(b), while the second crack, which is not shown, ran straight across the bearing cross-section. Bearing No. 2 showed the crack path seen in Figure 9-9(c). Further visual examination of the bearing crack fractures showed the cracks were flat and slightly fibrous, as indicated in Figure 9-9(d). The fracture face of bearing No. 2 differed slightly from the two fractures seen on bearing No. 1 in that there was a chip missing on the outer edge of the bearing.

Optical examination revealed numerous corrosion pits on the inner diameter of the failed bearings, and also on bearing No. 3 which had not failed. A typical example is shown in Figure 9-9(e). Figure 9-9(f) shows a cross-section through one of the corrosion pits, and a network of fine intergranular cracks can be seen emanating from the base of the pit.

- (a) Three hinge bearings from a fighter aircraft.
- (b) Bearing number 1, showing crack configuration.
- (c) Bearing number 2, showing crack pattern and fragment missing at end of crack.
- (d) Fracture face of second crack in bearing number 1. Arrow shows probable crack initiation area. (Mag.  $\times 5$ )
- (e) Corrosion pits on the inner diameter of a bearing which are typical of all three bearings submitted. (Mag.  $\times 20$ )
- (f) Cross-section of corrosion pit found on bearing showing intergranular cracking at the base of the pit. Picric acid etch. (Mag.  $\times 500$ )

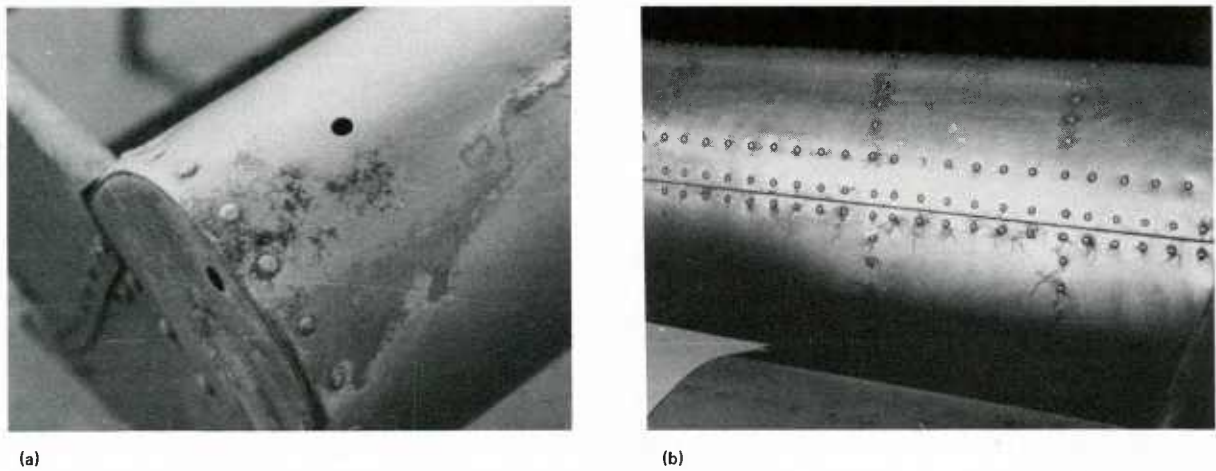
This aircraft had also been operating in the Mediterranean region, and the corrosion damage was again detected during visual inspection. The structure in this case was made from 2024 aluminium and had been protected by a nitro-alkyd resin paint system. Areas of corrosion damage are shown in Figure 9-14(a), and in Figure 9-14(b) after removal of the paint system. The corrosion was largely superficial, although penetration had occurred in one area. The surface corrosion showed the thread-like meanderings of filiform corrosion, and appeared to have originated in the fastener holes, as indicated in Figure 9-14(b).

Fig. 9-14 Filiform corrosion in some 2024 ailerons and flaps

- (a) General appearance of the corrosion showing blistering of the paint.
- (c) Filiform appearance of the corrosion tracks radiating away from fastener holes.

A strontium chromate epoxy primer and polyurethane finish were recommended to replace the nitro-alkyd protection system used previously.

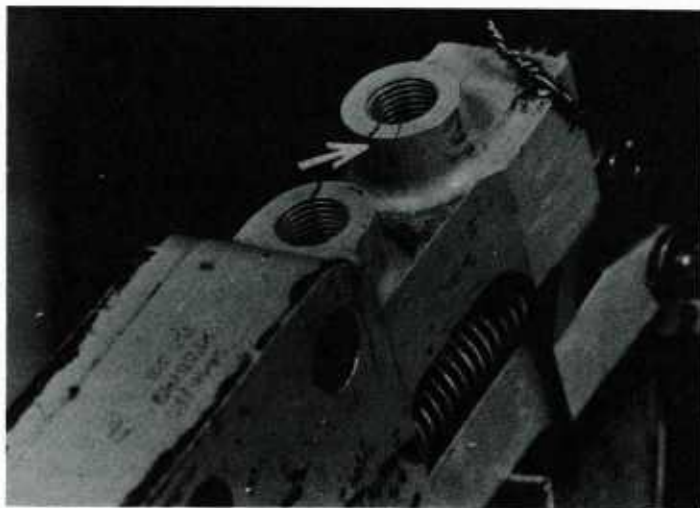
Stress corrosion is a particularly insidious form of corrosion since it will often occur with little or no visual evidence of surface corrosion such as discolouration or the build up of noticeable corrosion products. This is illustrated in Figure 13-1(a), which shows stress corrosion cracking in the bosses of a forged aluminium alloy component. The cracks can travel over long distances with time, as indicated in Figure 13-1(b), and as they propagate they lower the residual strength of the affected part. Figure 13-1(b) shows stress corrosion cracking which initiated at corrosion pits in the flat lower surface of an undercarriage leg, the corrosion pits having served as local stress raisers. Stress corrosion cracks may propagate deeply into thick section parts, as indicated in Figure 13-1(c), while the visible surface crack length may often be quite small. The banded appearance of the fracture surface in Figure 13-1(c) is an indication that crack growth occurred in a slow, time dependent manner, and macroscopically the fracture surface may resemble

- (a) Cracks in the bosses of a forging.  
 (b) SCC in an undercarriage leg.  
 (c) Stress corrosion fracture surface in an aluminium forging.

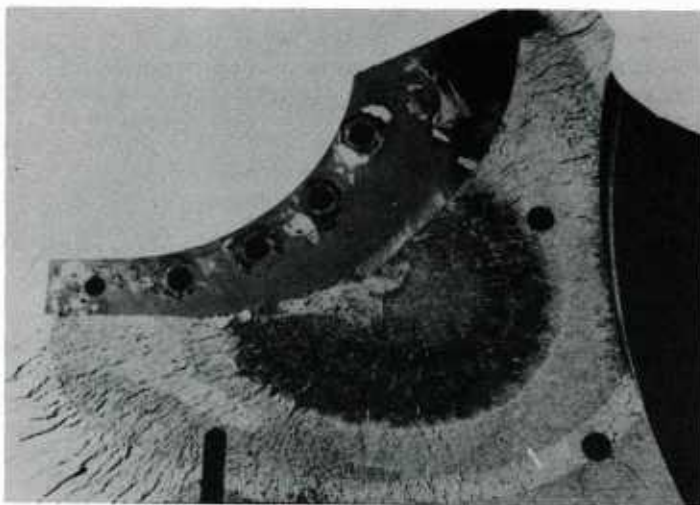
(c)

fatigue. The part shown in Figure 13-1(c) was a high strength aluminium-zinc alloy forging and the stress corrosion cracking was attributed to poor forging and heat treatment practice which produced a microstructure susceptible to SCC. The part was also thought to have contained high residual stresses as a result of poor machining practices, and the corrosive environment experienced in service was the final parameter leading to SCC.

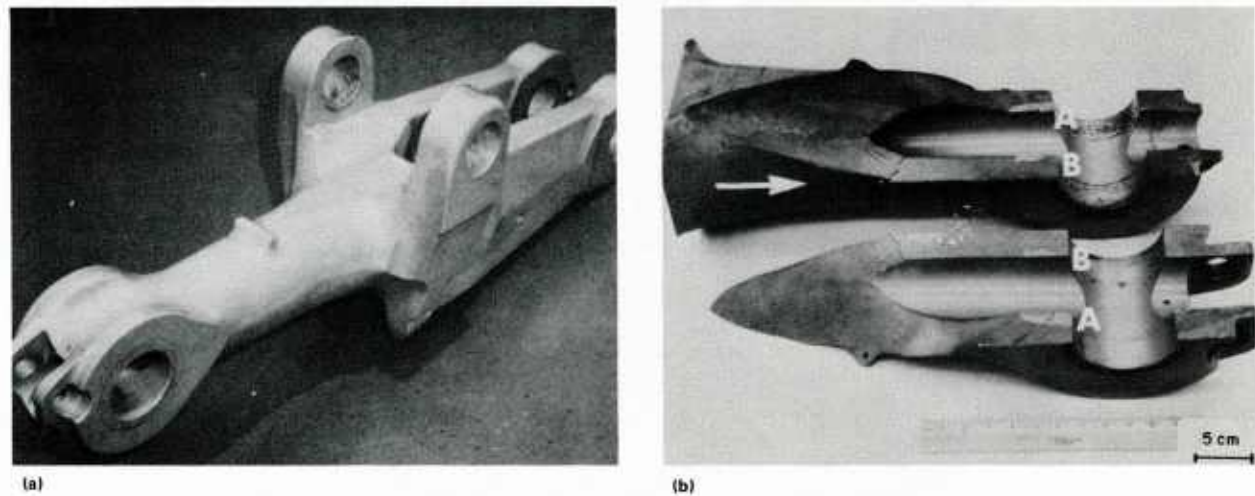
The main landing gear bogie of a large turboprop transport aircraft failed on touchdown, fortunately without causing a serious accident. The part was found to be made from a 7075-T6 forging of the type shown in Figure 13-30(a), and was found to have split along the forging parting plane as indicated in Figure 13-30(b). The tip of the white arrow in Figure 13-30(b) indicates the position of the crack tip in the parting plane, and therefore indicates the maximum extent of cracking in the parting plane. The longest crack was nearly 30 cm long at failure, but since the forging surface had been fully shot peened, the surface residual compressive stresses had prevented the growing cracks from breaking through to the surface and hence revealing themselves to surface inspection. Cracking initiated at the main axle bore, where the most susceptible end grain boundaries on the forging parting plane were exposed by the machining process. Cadmium plated steel bushings were mounted in the main axle bore by interference fit, and corrosion pits were found in the aluminium forging underneath the bushings. Thus even though cadmium plating was used, there appears to have been a sufficiently high galvanic potential in the presence of moisture to initiate pitting attack which led in turn to stress corrosion cracking. The stresses driving SCC in this part were due to the interference fit bushings and residual stress resulting from the post-forge heat treatment operations.

Fig. 13-30 Stress corrosion cracking in a 7075-T6 main landing gear bogie, case history 13-4.

- (a) New and unused bogie.
- (b) Failed bogie beam showing the crack initiation sites (A and B) underneath the shrunk-in steel bushings for the main axle bearings. The arrow tip indicates the maximum extent of the crack in the parting plane.

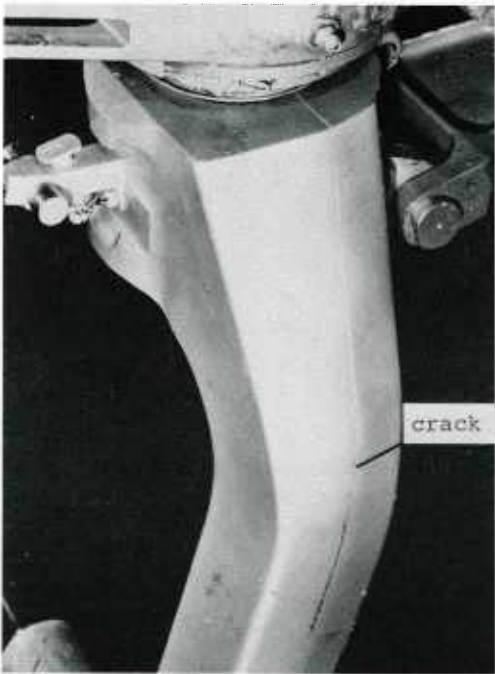
- (a) Complete landing gear assembly.
- (b) Close-up of the fork outer surface showing the crack.
- (c) Close-up of the fork inner surface showing the crack.

The crack was found to extend through the thickness of the fork, as indicated in Figures 13-32(b) and 13-32(c), and when the crack was opened up it was found to extend over about three quarters of the longitudinal cross section of the fork, as indicated in Figure 13-33. Figure 13-34(a) shows the fracture surface and reveals a dull fibrous fracture typical of stress corrosion cracking, where the crack appears to have started in the upper bore for the nose-landing gear leg attachment and the adjacent bore hole, which was introduced as a weight saving measure. However while the bores may have been effective in respect to weight savings, they provided natural traps for moisture. Figure 13-34(a) also reveals a narrow ribbon of material along both external surfaces which appear to have a lighter appearance than the area affected by SCC, and this suggests that the stress corrosion crack may have propagated over a substantial distance through the NLG-fork before breaking through to the external surfaces. Thus the crack may have been hidden for a substantial period of time prior to visual detection. Figure 13-34(b) shows a metallographic section through the crack tip and demonstrates quite clearly that the crack had propagated along grain boundaries, as expected for SCC in this type of alloy. The intergranular fracture mode was confirmed by scanning electron microscopy.

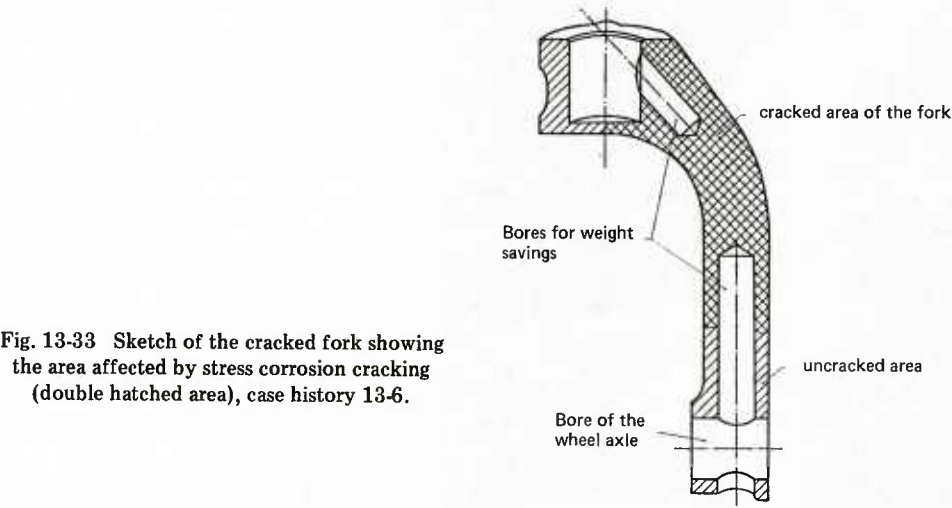
Fig. 13-33 Sketch of the cracked fork showing the area affected by stress corrosion cracking (double hatched area), case history 13-6.

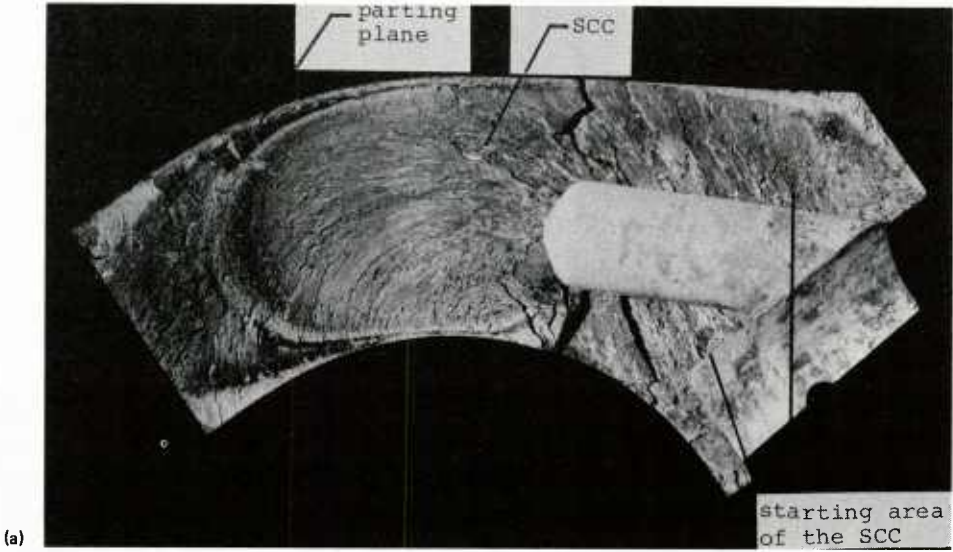
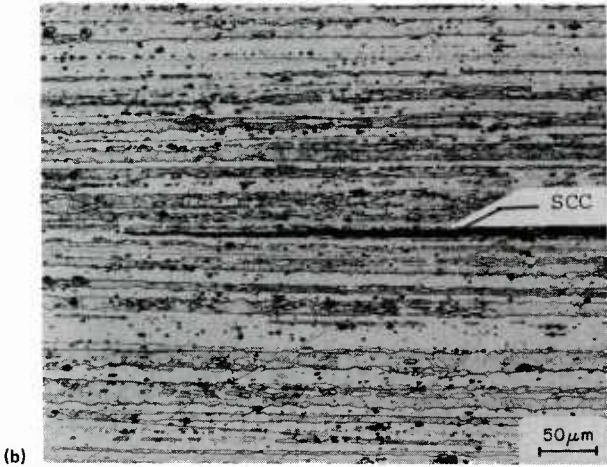
Fig. 13-34 Stress corrosion cracking in a 7075-T6 NLG fork, case history 13-6.

- (a) Macroscopic view of the SC crack in the fork.
- (b) Section through the tip of the crack showing the intergranular crack path.

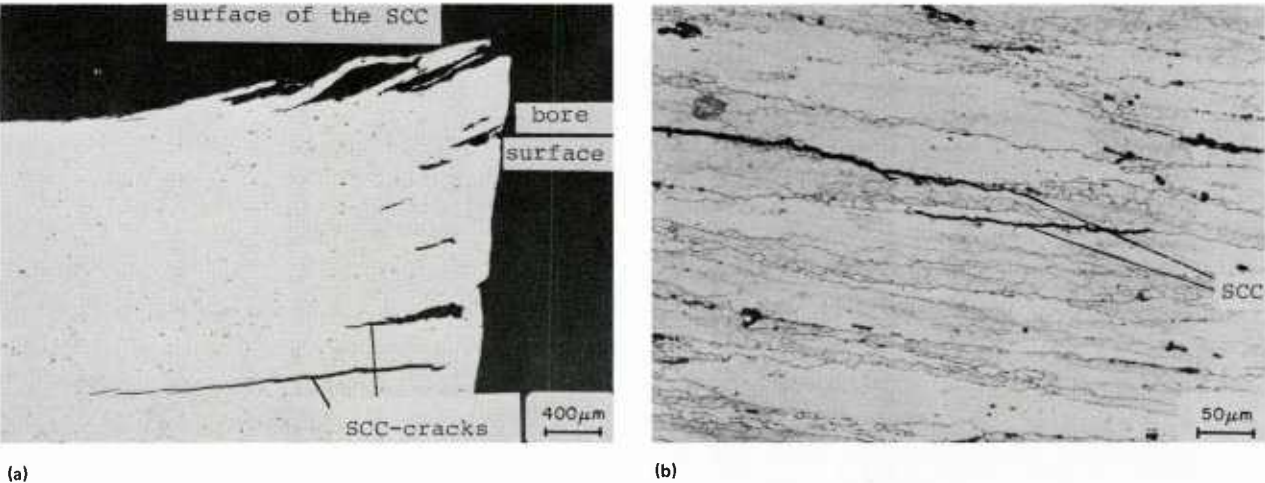
Metallographic examinations showed that a series of cracks was present in the landing gear strut, lying in planes between the axis of the cylinder bore and the axis of the securing bolt hole (Fig. 13-37(a)). Figure 13-37(b) shows the tip of the longest crack of Figure 13-37(a), and this etched micrograph shows that the cracks follow the grain boundaries of the large pancake shaped grains. Some fine recrystallized grains lie around the perimeters of these larger grains.

Fig. 13-37 Cross sections through the nose landing gear strut adjacent to the retraction cylinder bore and bolt hole, case history 13-7.

- (a) Showing multiple stress corrosion cracks.
- (b) Shows the tip of the lower crack in (a) above and indicates that the crack path is intergranular.

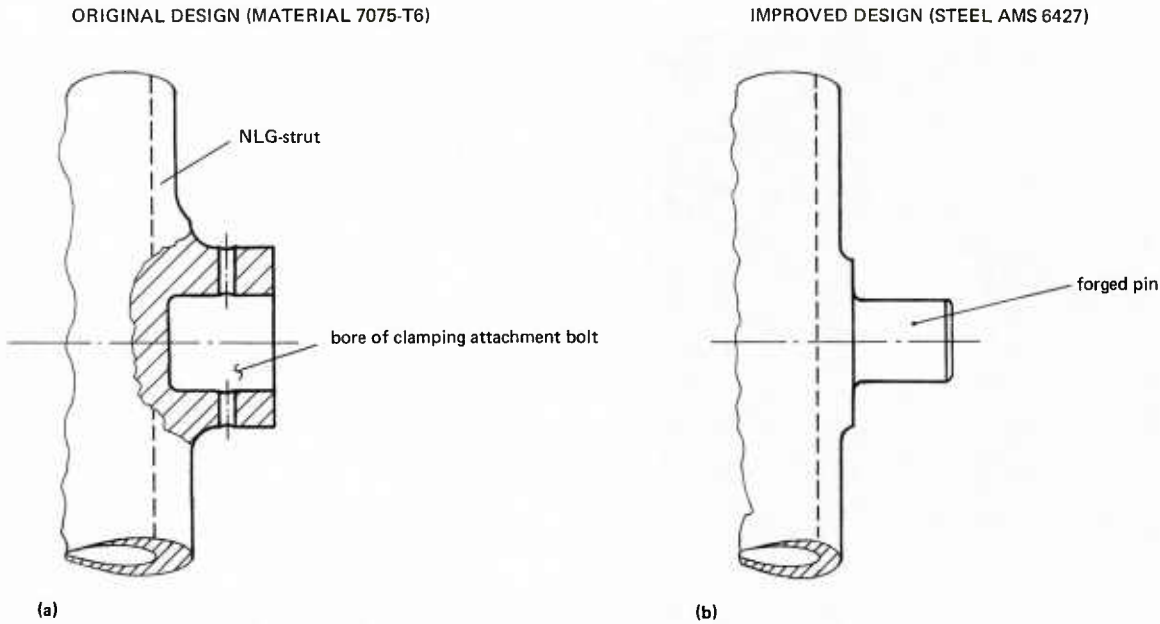
Fig. 13-38 Design details of the nose landing gear strut, case history 13-7.

- (a) Original design.
- (b) Modified design.

A number of alternative designs were considered to resolve this problem including the use of one of the newer high strength, stress corrosion resistant forging alloys such as 7050-T73. However, it was decided to change to a high strength low alloy steel, AMS-6427 (0.3% C, 0.9% Cr, 0.2% Cu, 0.9% Mn, 0.42% Mo, 1.9% Ni) which provides higher strength together with good stress corrosion resistance. The design was also changed, replacing the clamping attachment bore with a forged steel pin, as indicated in Figure 13-38. The steel forging was protected by a vacuum deposited layer of cadmium plating followed by a layer of epoxy primer and a single coat of polyurethane paint.

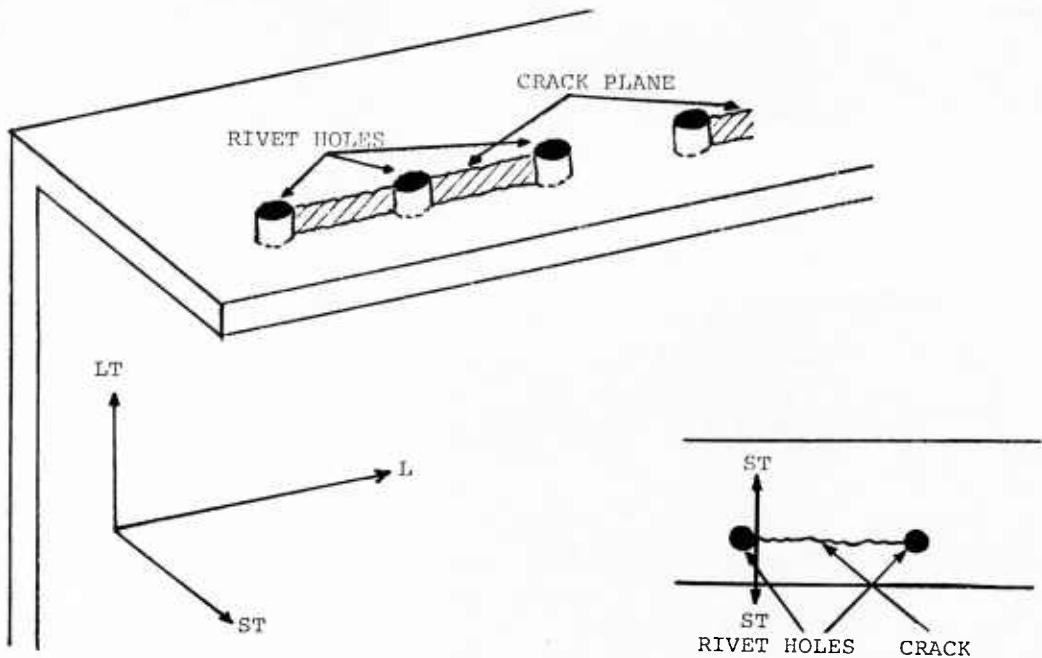
A spectrographic analysis showed the alloy contained 3% Mg, 5.1% Zn, 1.8% Cu, 0.18% Cr and lesser amounts of Fe, Si and Mn. The alloy concentrations were consistent with specifications for 7075 and the alloy hardness indicated the material was in a T6 strength condition. A microstructural evaluation of the grain structure showed a heavily wrought structure of pancake shaped grains, where the crack plane was coincident with the plane containing the longitudinal-long transverse directions, and the short transverse direction was normal to the crack plane as indicated in Figure 13-40.

Fig. 13-40 Orientation of the crack plane with respect to the principal directions in the fuselage frame, case history 13-8.

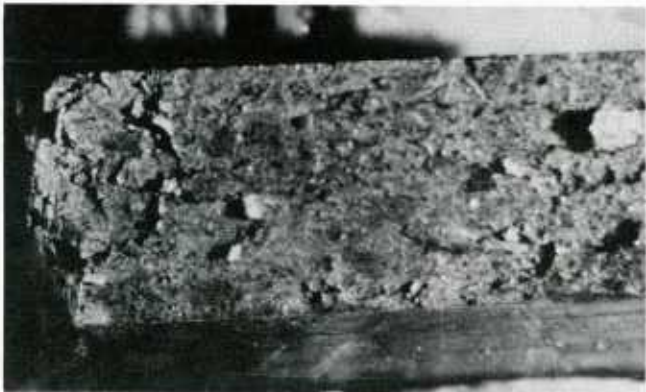
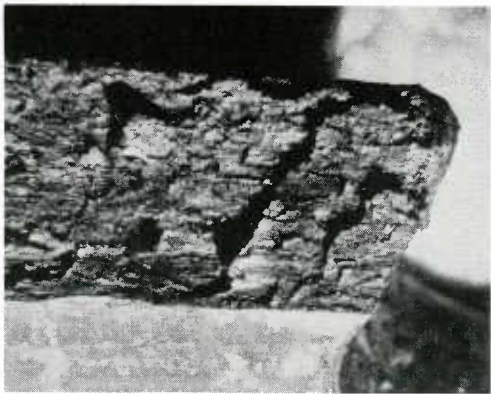
Fig. 13-42 Fracture surface topography extending between two adjacent fastener holes, case history 13-8.

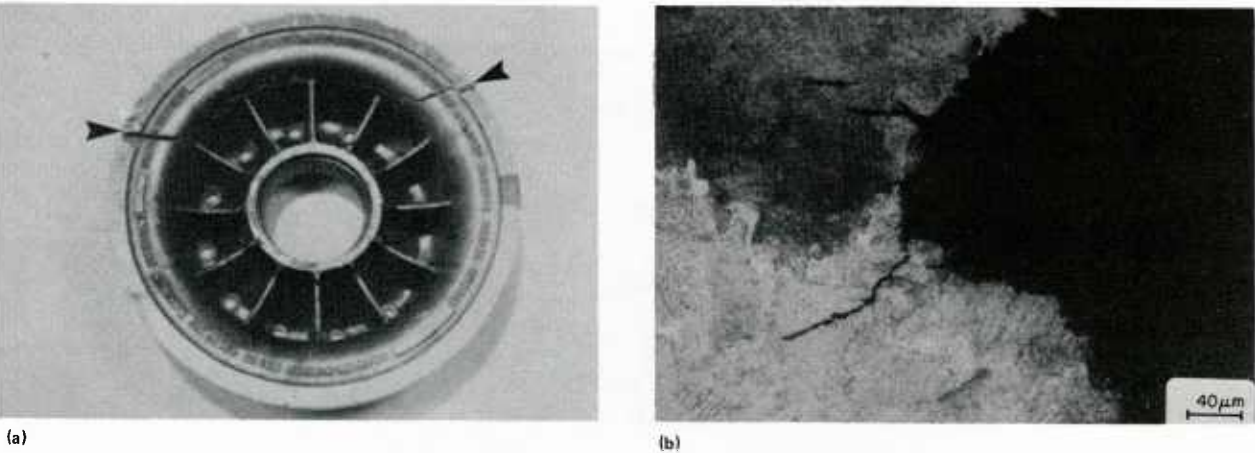
A large rim section was found broken from the rim of a STOL transport aircraft main wheel after landing (Fig. 14-8(a)). The cause of fracture was found to be corrosion fatigue cracking which had grown completely through the rim section. Cracking initiated from the tyre bead seat radius, and the corrosion products were typical of a marine environment.

Fig. 14-8 Corrosion fatigue of a magnesium alloy (AZ-91C) main landing gear wheel  
(a) General view of the failed wheel and the crack indicated by arrows.  
(b) Section through a typical pit showing multiple corrosion fatigue cracks.  
Nital etch. (Mag.  $\times 250$ )

These experimental low pressure tyre wheels allowed salt moisture to penetrate the tyre bead seat area between tyre and rim, aided by frequent tyre changes. The wheel was a magnesium alloy casting (AZ-91C) and fatigue crack initiation occurred at the base of deep corrosion pits. Figure 14-8(b) shows a typical pit with multiple crack origins.

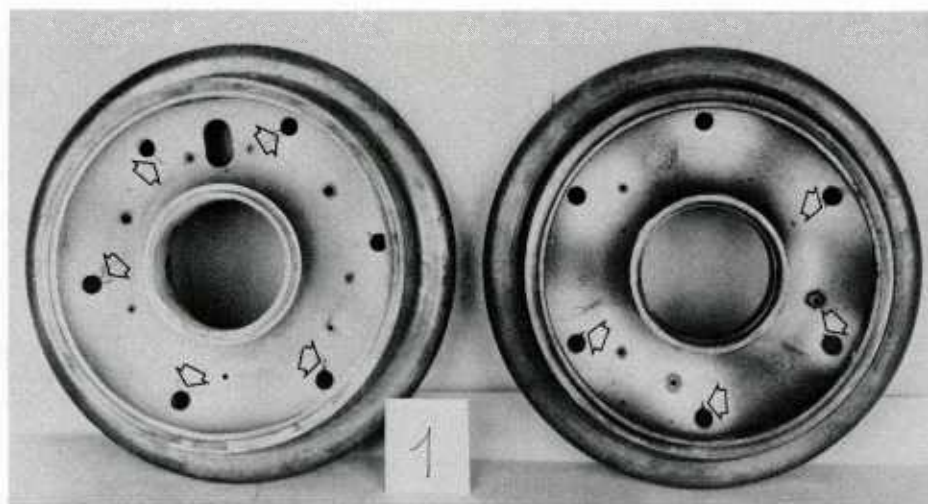
(a)

Multiple cracks were found propagating out of bolt housings during a visual and liquid penetrant inspection of the nose wheels of a fleet of fighter aircraft. Many wheels were found to be affected, and typical cracks are indicated by the arrows shown in Figure 14-10(a).

**Fig. 14-10 Corrosion fatigue of a magnesium alloy (AZ-91C) nose wheel**

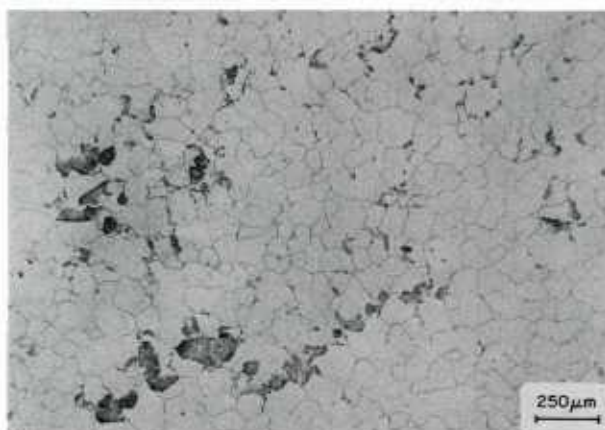
(b)

Metallurgical analysis showed that the wheels were made of a magnesium alloy casting, AZ-91C, with a nominal composition Mg-9% Al-0.7% Zn. The microstructure (Fig. 14-10(b)) consisted of equiaxed grains with fine precipitates of an intermetallic compound along grain boundaries. Brinell hardness determined with a 500 kg load and a 10 mm diameter ball indenter was found to be BHN-51 to 59, which is typical of materials in the T4 heat treatment condition.

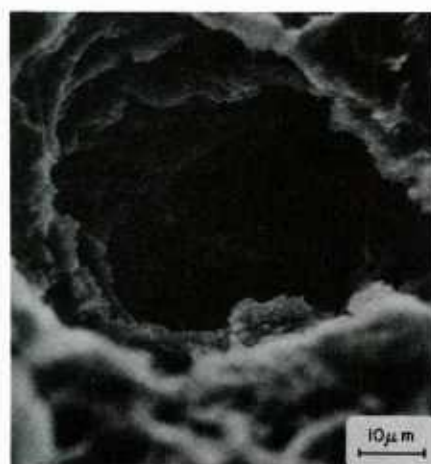
(d)

Several cracks were opened in the laboratory, and these showed a dark zone, covered by corrosion products, which extended up to the bright overload zone produced during opening (Fig. 14-10(c)). The inner surfaces of the bolt holes were also examined. These were found to contain deep corrosion pits of the type shown in Figure 14-10(d). Examination of the fracture surfaces using a scanning electron microscope showed that intergranular cracking had occurred in the initiation regions (Fig. 14-10(e)), while transgranular fracture had occurred at longer crack lengths (Fig. 14-10(f)). Both the intergranular and transgranular zones were badly corroded, but fatigue striations were clearly visible in the transgranular areas (Fig. 14-10(f)).

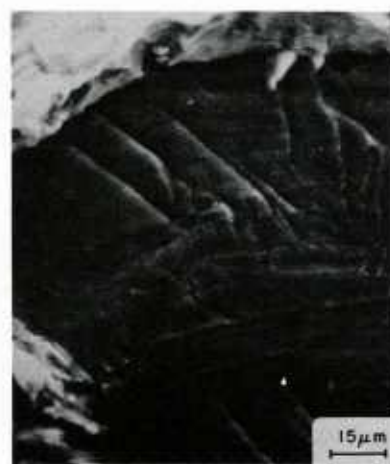
(f)

Pitting attack in the bolt holes may have been influenced by galvanic effects, or by crevice conditions existing between the wheel and the steel bolts. However, the presence of heavy corrosion across the fracture faces and the clear evidence of striations suggests that corrosion fatigue was responsible for at least the later stages of crack propagation. This aircraft had operated in the Mediterranean region which is also a significant factor. This, and the two preceding case histories, suggest that magnesium alloy castings are not good choices for aircraft wheels.

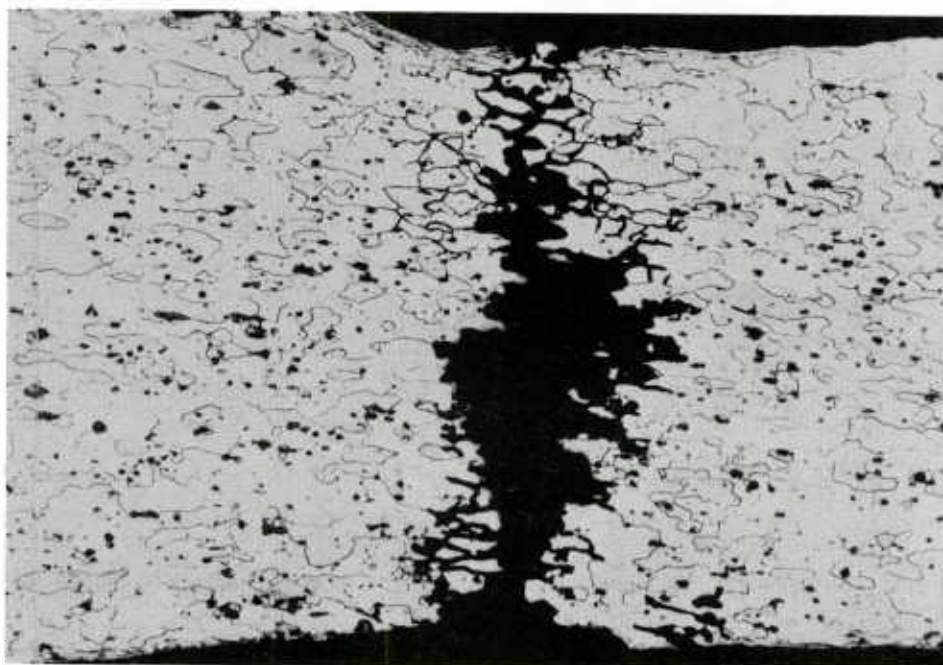
Fig. 15-6 Typical perforation corrosion caused by micro-organisms. Alloy: 2024 (Al-Cu-Mg)

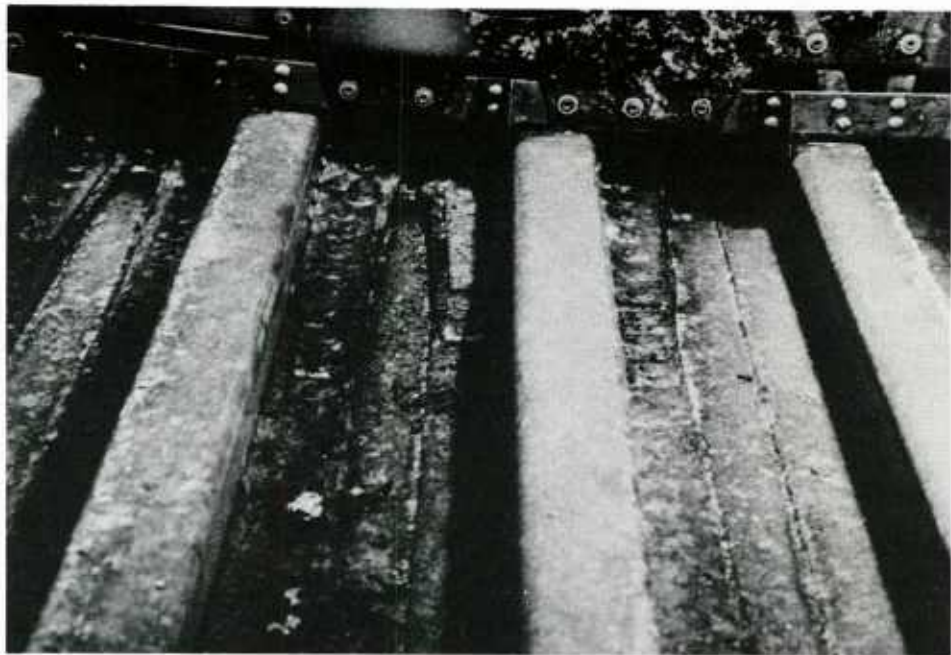
Fig. 15-8(b) Typical view of integral fuel tanks with microbiological corrosion
