**RELIANCE INDUSTRIES LIMITED**  
**HAZIRA**

## **TRAINING MODULE**

## **MECHANICAL SEALS** In Centrifugal Pumps

**Based On Failure Analysis Reports**

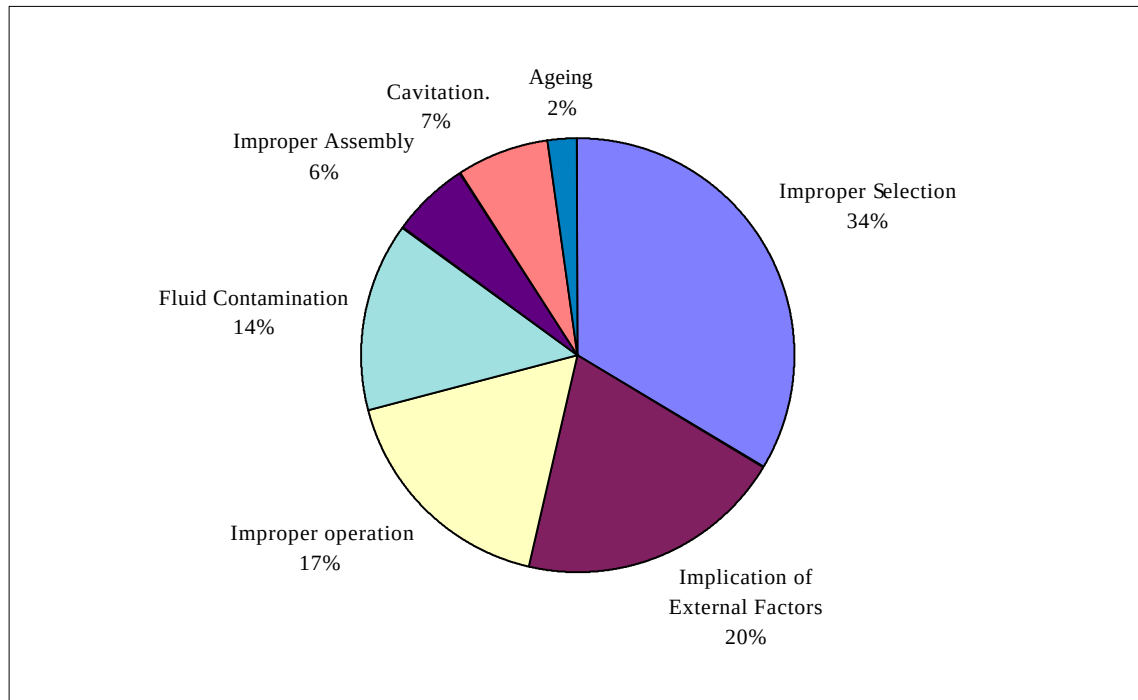
The failure of a mechanical seal can be due to many reasons as it was observed in the failure analysis reports. Of the total 86 no. failures analysed the “mechanical seal failure modes” in the complex can be broadly summarised as given below. The failure can be due to any one or combination of these modes.

1. Improper Selection of Seals Design/Seal component/Flushing Plan = **29** Failures
2. Implication of External Factors  
(like bearing failure, high vibration, Shaft eccentricity etc.,) = **17** Failures
3. Improper start up and Improper Operation conditions / Procedures. = **15** Failures
4. Fluid contamination / Seal flush oil degradation. = **12** Failures
5. Cavitation. = **06** Failures
6. Improper Installation / Assembly / Poor Workmanship = **05** Failures
7. Ageing - Seal have completed a satisfactory life cycle. = **02** Failures.
