COMPENDIUM OF POST-FAILURE ANALYSIS TECHNIQUES  
FOR COMPOSITE MATERIALS

RAY GROVE, BRIAN SMITH  
BOEING MILITARY AIRPLANE COMPANY  
P. O. BOX 3707  
M/S 73-43  
SEATTLE, WASHINGTON 98124

JANUARY 1987

INTERIM REPORT FOR PERIOD JULY 1984 - NOVEMBER 1986

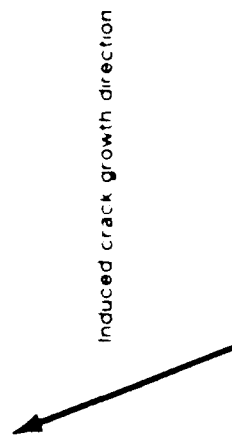
30-deg tilt

0-deg tilt

Figure 3-61. SEM Photomicrographs of Effect of Tilt on Striation Resolution

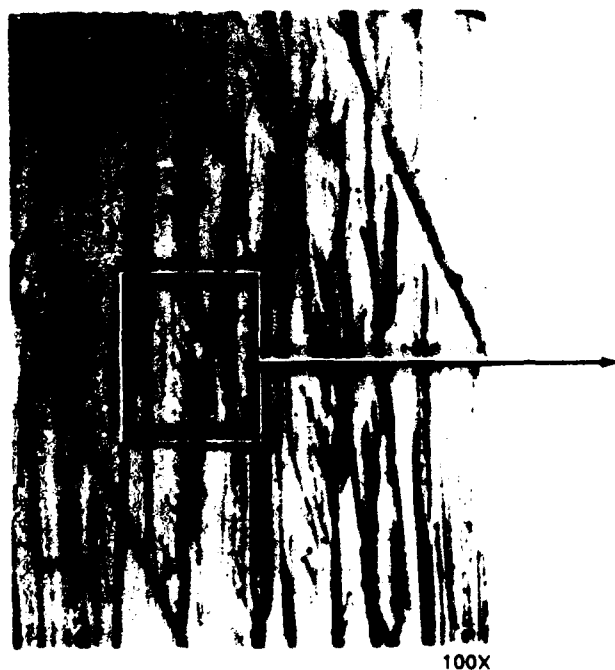
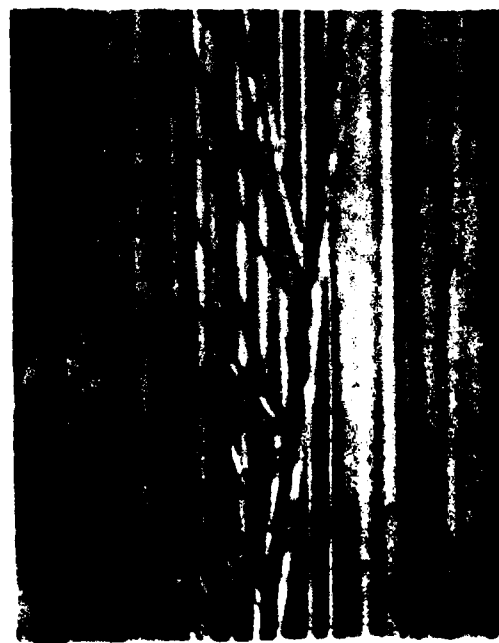
Crack propagation direction

Figure 4-11. Optical Photomicrographs of Intended Fracture Plane Between 0/0-deg Plies, DCB 21°C (70°F) Specimen

High magnification optical photomicrographs of interlaminar tension fractures which delaminated in the direction of fiber orientation are illustrated in Figure 4-11. The surface reveals a reflective appearance with flat areas of resin fracture between the regions of fiber/matrix separation. Inspection reveals branching lines (river marks) in these flat resin fracture areas, along with an extremely fine texture or feathering (resin microflow); the direction of river mark coalescence corresponds with the direction of overall crack growth. These photomicrographs are taken from a region between plies that

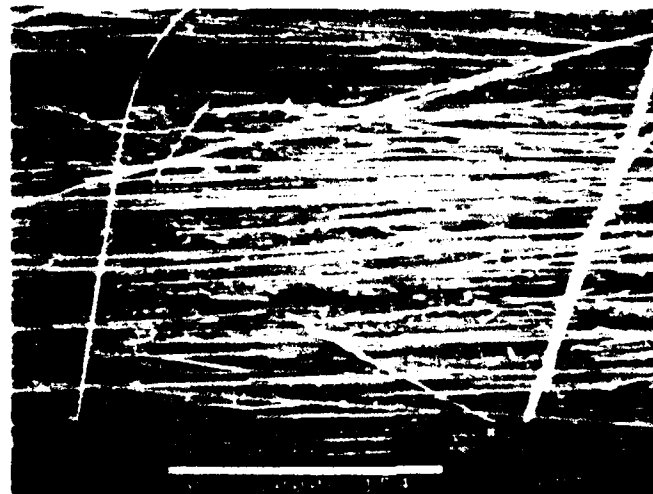
Figure 6-12. -65°F Dry, 70°F Dry, and 270°F Dry Conditions (SEM 50X)

←  
Mechanically Induced crack direction

-65°F. dry

70°F. dry

270°F. dry

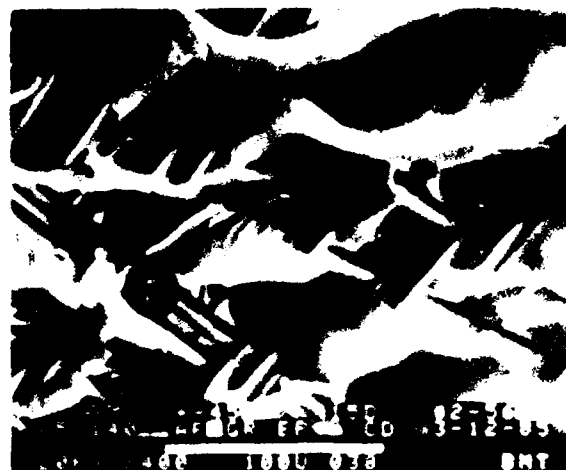
Figure 6-15. +45/-45 Plies With Matrix Fracture, Fiber Separation, River Marks, and Textured Microflow

| • Fracture between | +45/-45 plies |

- F Fiber matrix separation
- M Matrix fracture
- R River markings
- T Textured microflow

Mechanically induced crack direction

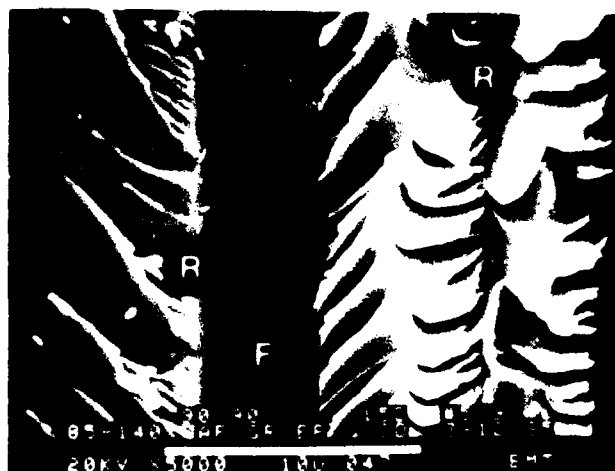
| • Test conditions | 21°C. dry |
| • Fracture between | 0/90 plies |
| Material | Hercules 3501-6/177°C cure<br>AS4 fibers |

- F Fiber matrix separation
- M Matrix fracture
- R River markings

Figure 6-28. 0/90 Plies at 21°C Dry Condition With Matrix Fracture, Fiber Separation, and River Marks

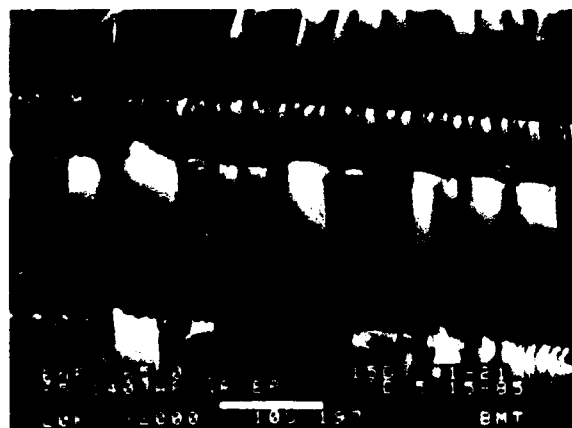
| • Test conditions | Dry |
| • Fracture between | 0/0 plies |
| Material | Hercules 3501-6/177°C cure<br>AS4 fibers |

Figure 6-36. 0/0 Plies at -65°F Dry, 70°F Dry, and 270°F Dry Conditions With Fiber Separation and Hackles

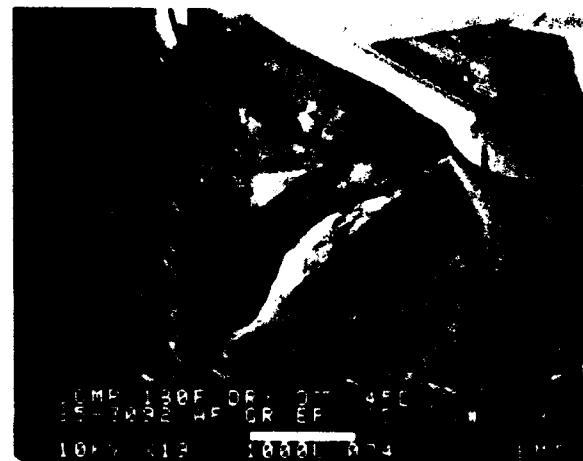
Figure 6-70. 0 (32) Ply at -65°F Dry, 180°F Dry, 270°F Dry Conditions (SEM Low Magnification)

| Material | Hercules 3501-6/177°C cure<br>AS4 fibers |

← Mechanically induced crack direction

The reader should note that the low-magnification SEM photomicrographs reveal both compression fracture (flat) and tension fracture (fibers protruding). This is because the flexural nature of the test specimen, where cracking is initiated at the notch in compression. The high magnification photographs are from the compression fracture region.

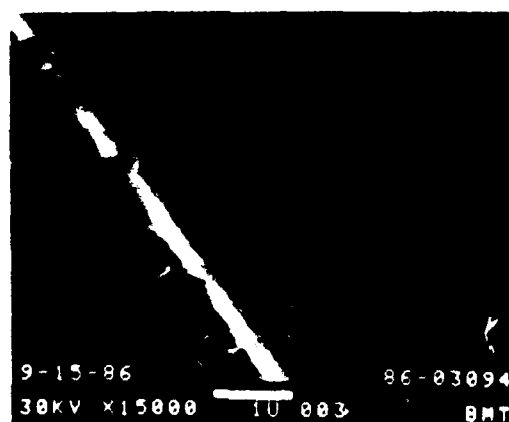
| Fracture type | Interlaminar fatigue mode II shear |
| Material | Hercules 3501-6/177°C cure<br>AS4 fibers |

Figure 6-108. 0/0 Plies at 21°C Dry Condition (Fatigue CLS Mode II, 40% to 80% Static)

See Figures 6-103 through 6-109.
