AFWAL-TR-82-4085

SEM/TEM FRACTOGRAPHY OF COMPOSITE MATERIALS

General Dynamics  
Fort Worth Division  
P.O. Box 748  
Fort Worth, Texas 76101

SEPTEMBER 1982

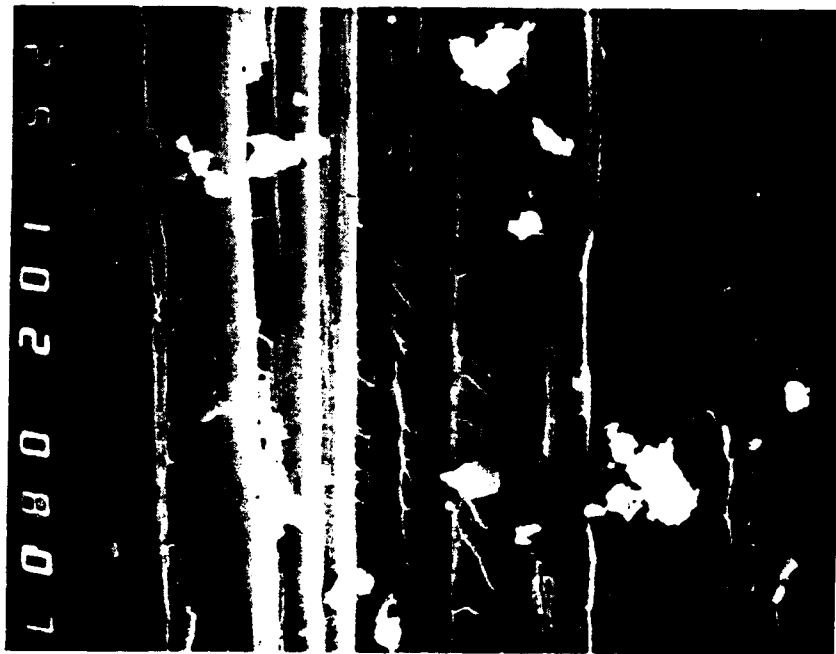
Figure 15 River Pattern in Resin Material Between Fibers in Mode I Specimen , 1000X

River patterns are evident at magnifications of 500X or higher in the resin material between fibers and in resin-rich regions (i.e., resin pockets which form when plies are butted together or at flaws in prepreg tape). The proposed explanation for their formation is that separate cleavage crack segments develop on parallel planes within the matrix regions. As the segments run through the resin, they grow in width and approach each other. Eventually, the crack segments join together fracturing thin ligaments of material and forming steps between the parallel cleavage planes. These steps converge in the direction of local crack propagation. Figures 14 and 15 illustrate typical river patterns found on Mode I type specimens. The pattern in Fig. 14 developed at a resin-rich region within the lamina while the pattern in Fig. 15 illustrates the cleavage of matrix material between fibers.

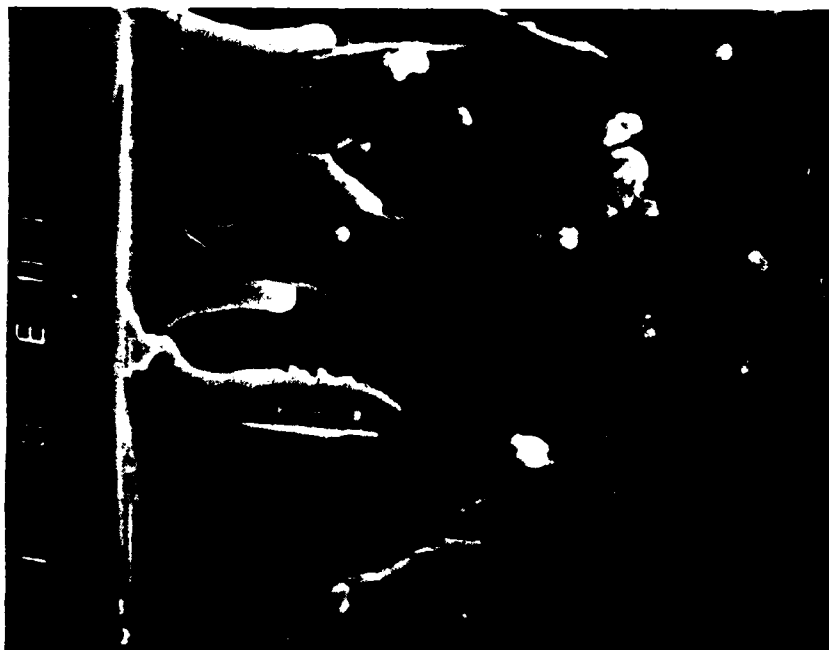
Figure 16 Photomicrograph of Feather Pattern on Mode I Specimen , 10,000X

Another distinct cleavage-fracture feature, the feather pattern or feather mark, was also evident in the failed matrix material. Compared to river patterns, feather marks are more difficult to detect; they have a finer texture and are seen at 3000X or more. They are chevron shaped surface marks which point back in the direction of local crack origin. Figure 16 is a 10000X photomicrograph of the surface of a Mode I specimen in which both river patterns and feather patterns are evident. Complex feather patterns were also found on Mode II specimens. Figure 17 is an example of such a pattern.

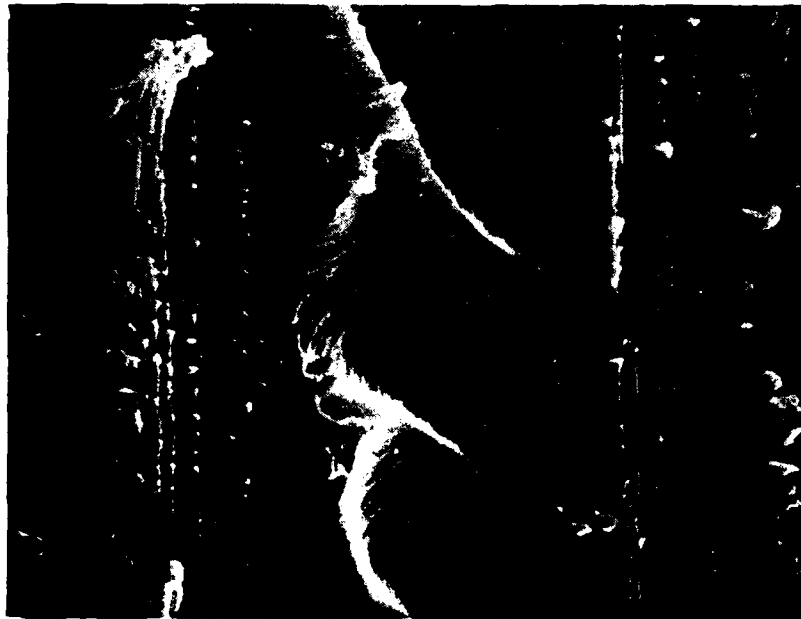
Figure 17 Photomicrograph of Feather Pattern on Mode II Specimen , 5000X

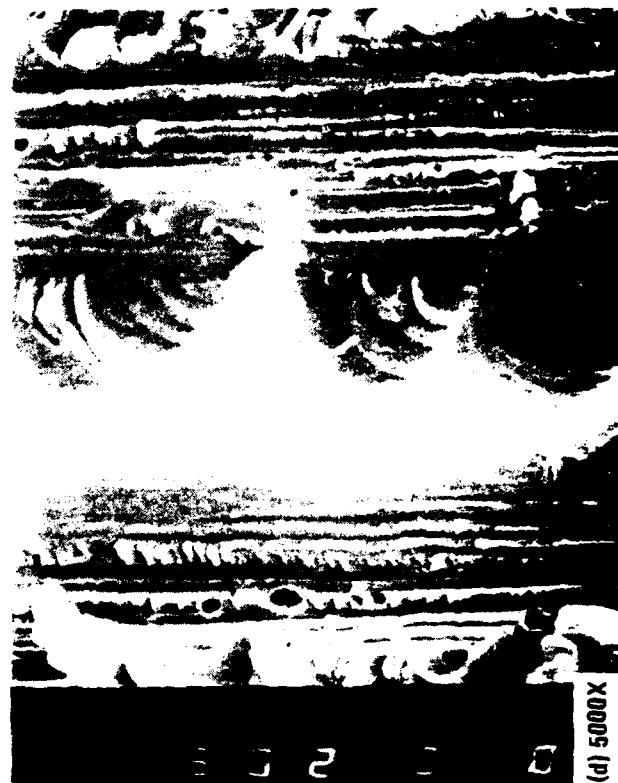
Figures 19b, c, and d Photomicrographs of G12 Shear Specimen Surface

Figure 19b, c, d are SEM photomicrographs of the fracture surface. Relatively few fiber breaks were observed over the specimen. The key surface features were hackle patterns in the epoxy resin between the fibers. These raised patterns showed consistent orientation over each fracture surface. Although the angle of inclination varied in regions, the general tilt direction was constant.

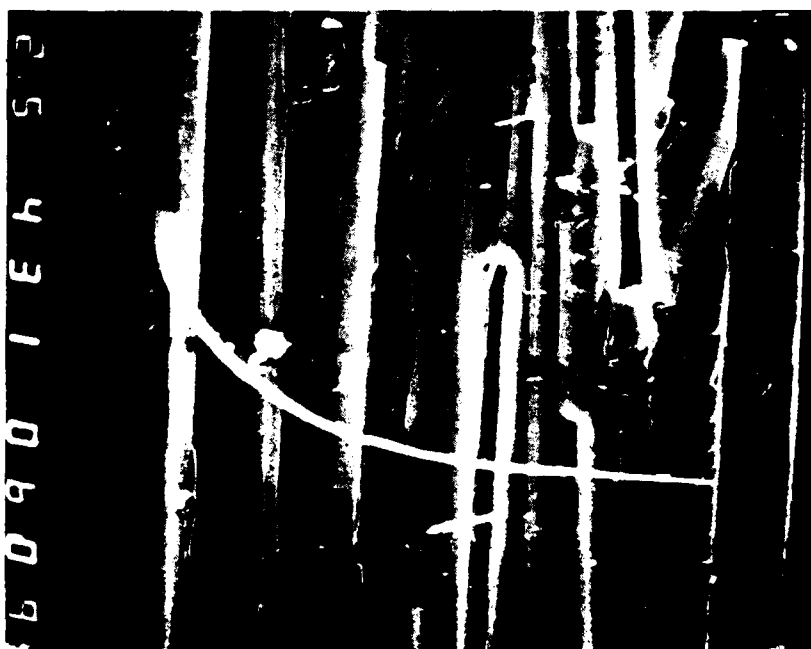
**Figure 21d Photomicrograph of G<sub>23</sub> Shear Specimen Surface, 430x**

The G<sub>23</sub> specimens also differed from the G<sub>12</sub> and G<sub>31</sub> specimens on the microscopic level. Investigation showed that none of the characteristic hackle features developed on the specimens. Instead, matrix artifacts consisted of cleavage features (i.e., river patterns). Figure 21c is a 100X photomicrograph of a typical specimen section. Several cavities which once contained fibers are evident on the specimen surface. The resin material which surrounds these voids appears to be relatively undisturbed. (This observation is verified in Fig. 21d). The bright curved feature which appears in the upper right corner of the photograph is a sliver of matrix material which has been partially stripped away from the adjacent fiber. These stringers were found throughout the failed surface. Figure 21d is a micrograph of that same stringer. The figure also demonstrates the development of river patterns in the matrix material between fibers. These cleavage features were also evident throughout the specimen. The river patterns and the position of the matrix stringer indicate that, at least locally, the crack front progressed from left to right.

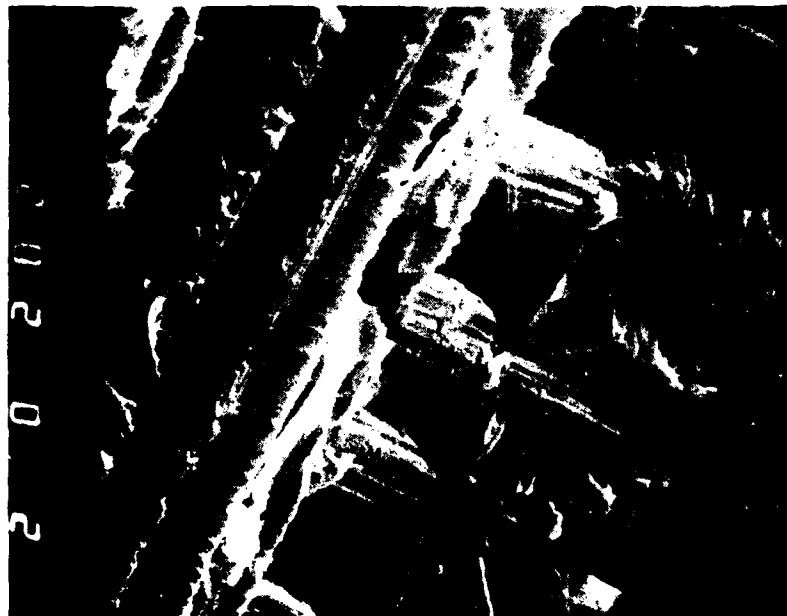
Figure 31f Mixture of Mode I & Mode II Features in  $\pm 45^\circ$  Laminae Under Compression, 2000X

At 2000X magnification (Figure 31f), a mixture of Mode I and Mode II features are evident.
