# Corrosion Under Insulation and Fireproofing

API RECOMMENDED PRACTICE 583  
FIRST EDITION, MAY 2014

AMERICAN PETROLEUM INSTITUTE

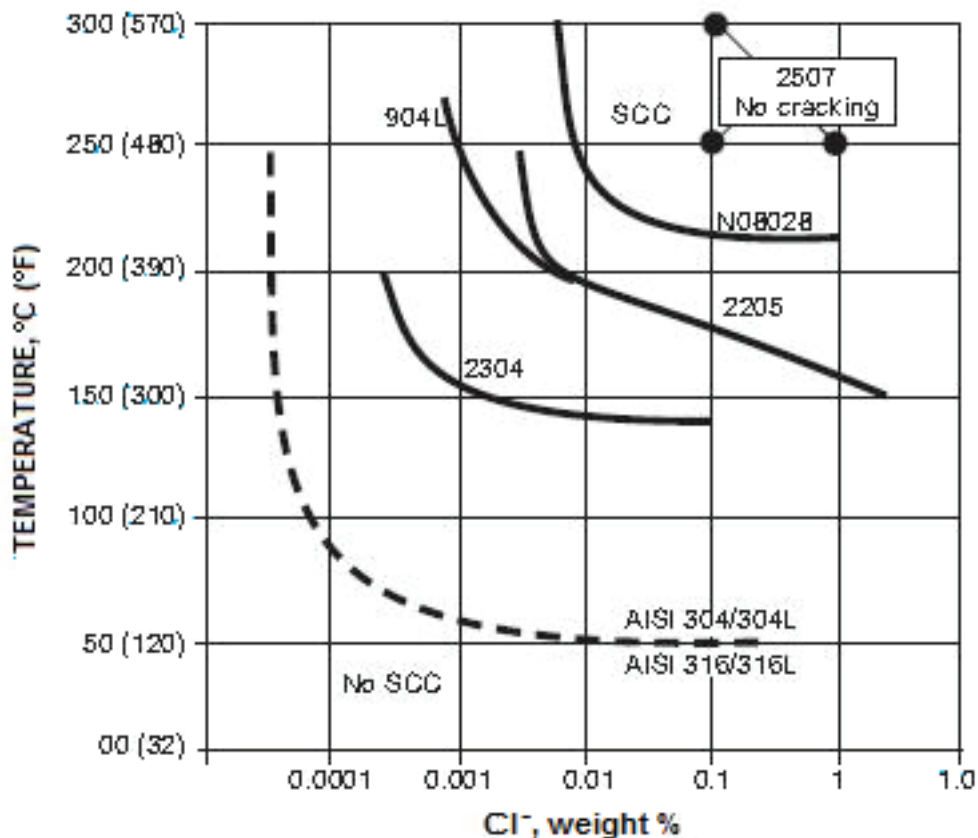
Figure 1—SCC Tendency of Austenitic and Duplex Alloys

CUI damage in duplex stainless steels occurs at higher temperatures than observed for austenitic stainless steels. Figure 1 shows the results of SCC tests conducted on austenitic and duplex stainless steels. As can be seen from these results, SCC of duplex stainless steels does not occur until about 285 °F (140 °C) at very high chloride concentration levels. In general, there have been few reported cases of cracking in the industry, but those that have been reported were under severe conditions where SCC could be predicted. Some of the failures reported have been on offshore facilities and were attributed to ECSCC on relatively hot equipment. API 938-C discusses the use of duplex stainless steels in the refining industry.

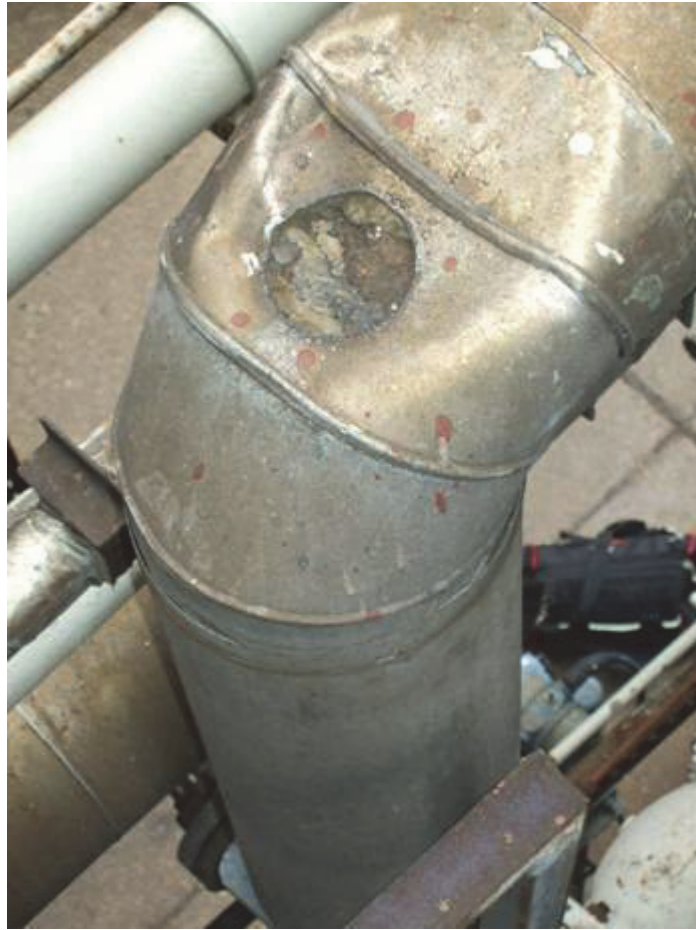
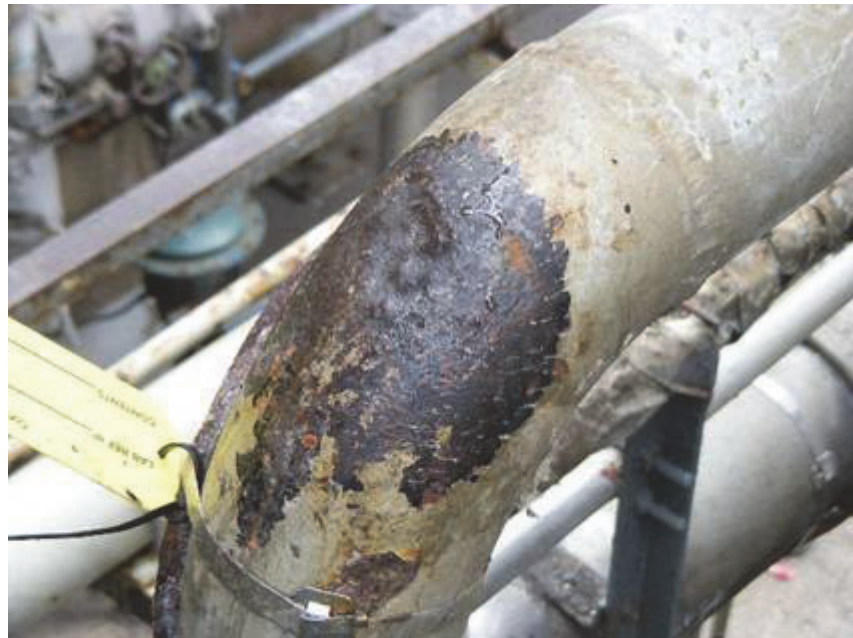
**Figure 2—Jacketed piping with missing insulation plug (top photo) allowing water ingress and subsequently corrosion on piping elbow (bottom photo).**

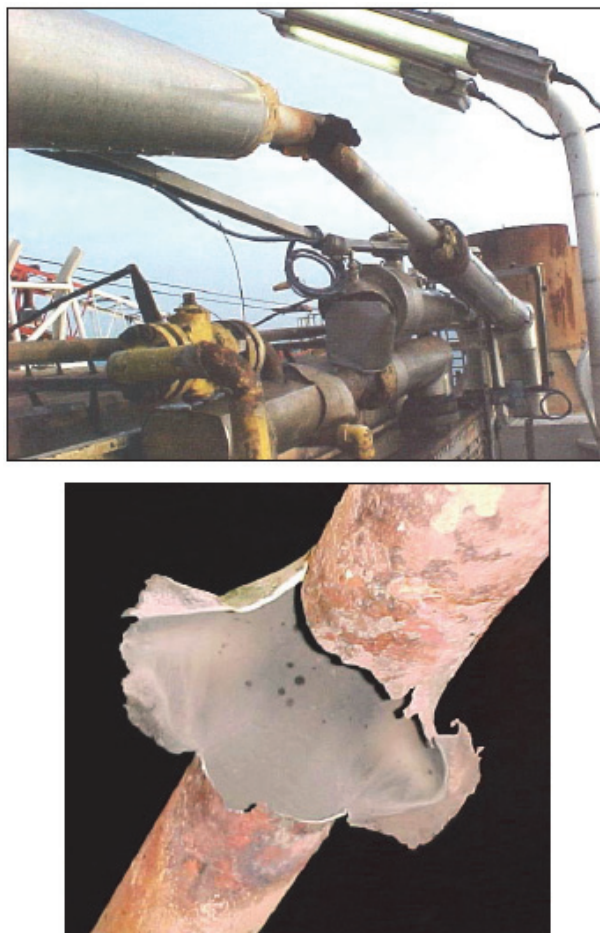
**Figure 3—CUI Failure of 4-in. Gas Compressor Recycle Line**

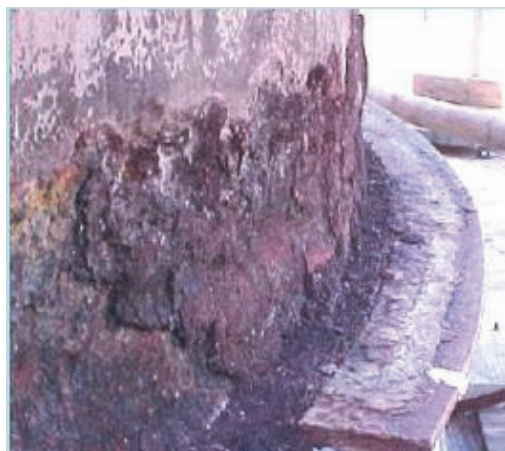
**Figure 4—CUI at an Insulation Support Ring**

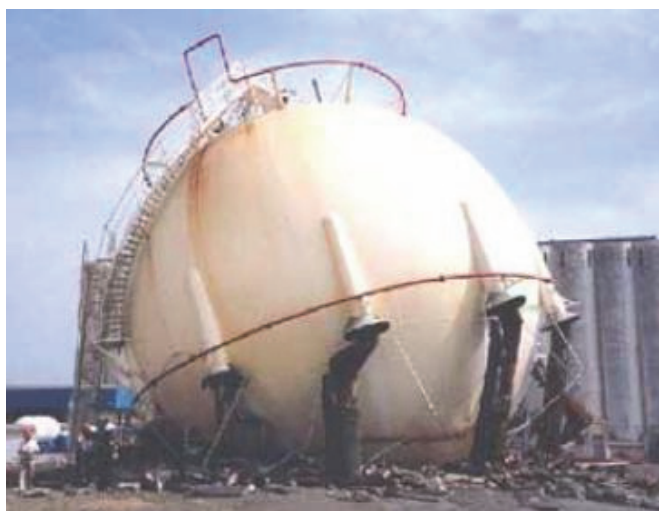
**Figure 5—Failure of Sphere Legs Due to CUF**

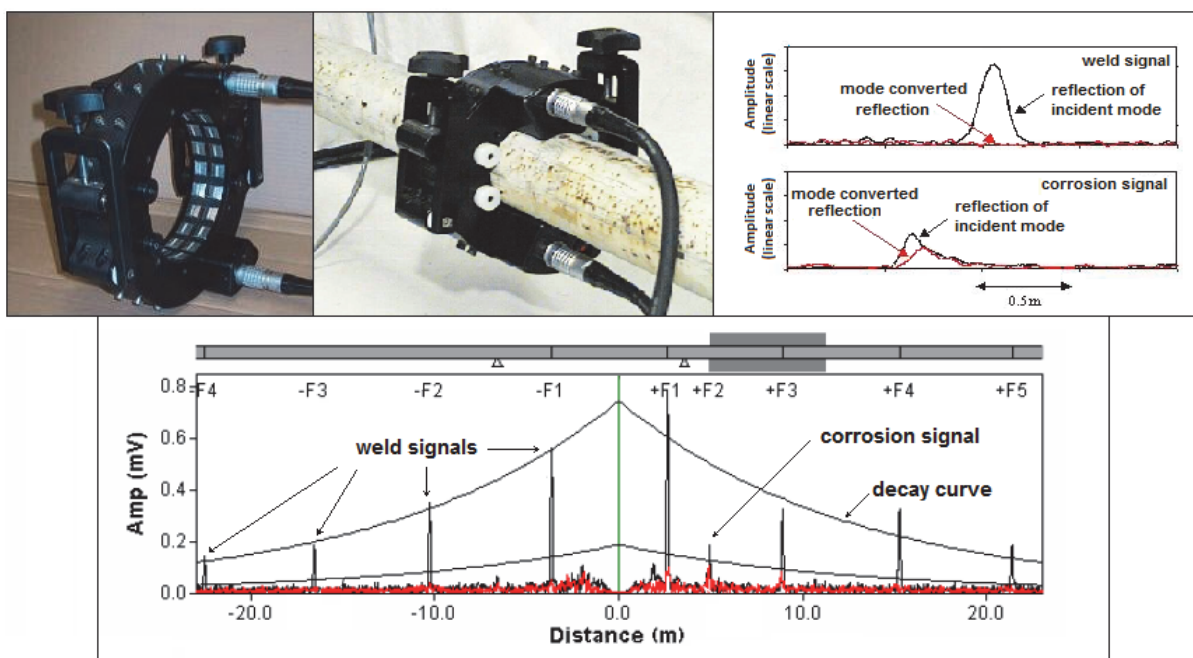
**Figure 6—Guided Wave Transducer Arrays, Signal Representation, and Results**

The torsional wave mode is the transmission mode most commonly used. The equipment operates in a pulse-echo configuration where the array of transducers is used for both the excitation and detection of the signals.

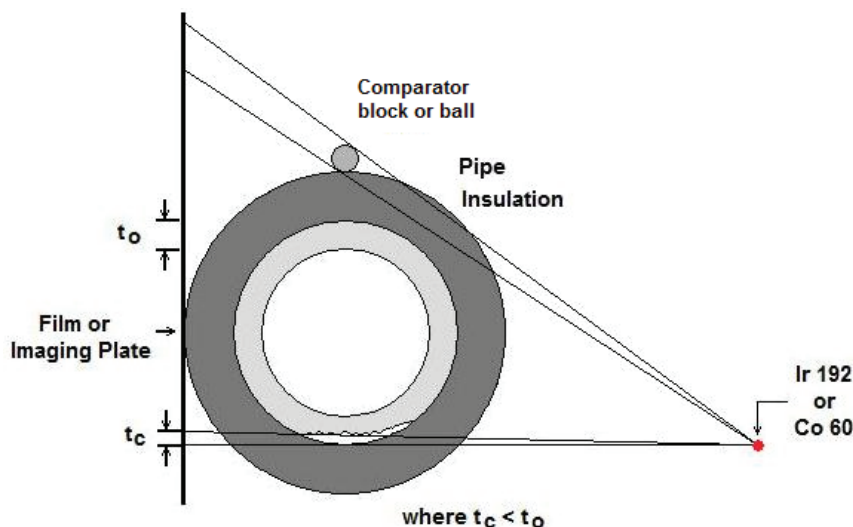
Figure 7—Schematic of Profile Radiography Setup

- a) *Profile Radiography*—Profile radiography is used to radiograph a small section of the pipe wall. A comparator ball is used to assess the remaining wall thickness of the pipe (see Figure 7). The exposure source is usually iridium 192, with cobalt 60 being used for heavier wall piping. Alternately, profile radiography can also be done using X-ray sources. Profile radiography is an effective evaluation method but becomes technically challenging in piping systems over 10 in. (25.4 cm) in diameter and only offers the limited luxury of verifying relatively small areas. Profile radiographs can be taken using either a tangential or double-wall radiographic technique.

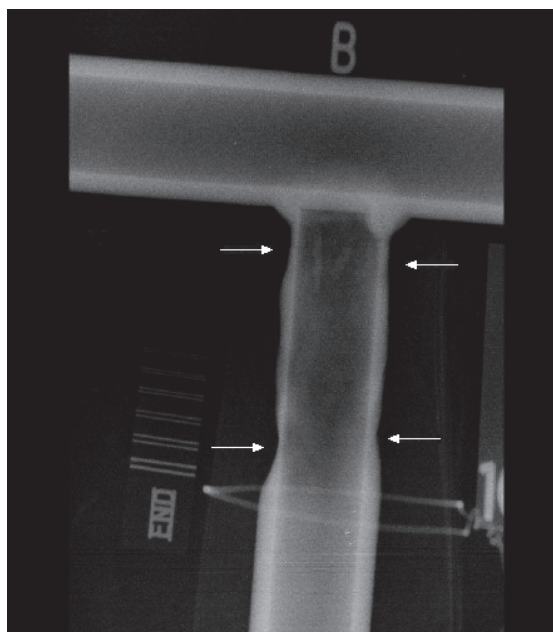
**Figure 8—Profile Radiograph of CUI Damage on an Insulated Small Diameter Pipe**

This technique is not capable of detecting ECSCC on austenitic or duplex stainless steels. In addition, radiation safety can be a real concern. The need to cordon off a large area for radiographic examination can result in downtime and personnel scheduling conflicts. Profile radiography is usually preferred to assess insulated piping for uniform corrosion damage. Figure 8 shows a profile radiograph image made using a digital imaging plate.

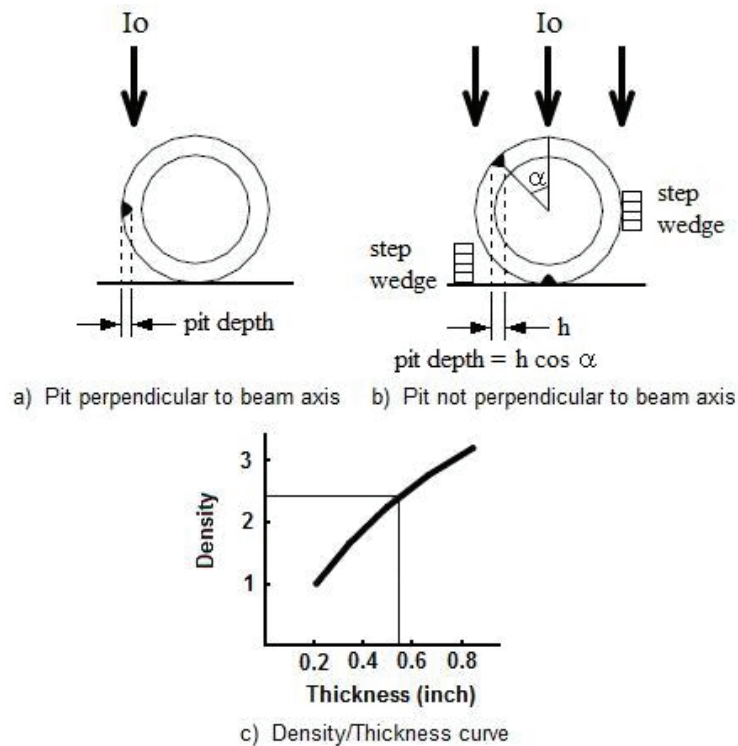
Figure 9—Pit Depth Measurement Techniques

When pitting damage is perpendicular to the axis of the radiographic beam, the pit depth measurement can be measured directly off the radiograph [see Figure 9 a)]. When the pitting is located at some angle to the axis of the radiographic beam, the projected pit depth ( $h$ ) needs to be corrected for the geometry [see Figure 9 b)]. Guidelines on the application limits for profile radiography are shown in Figure 10.

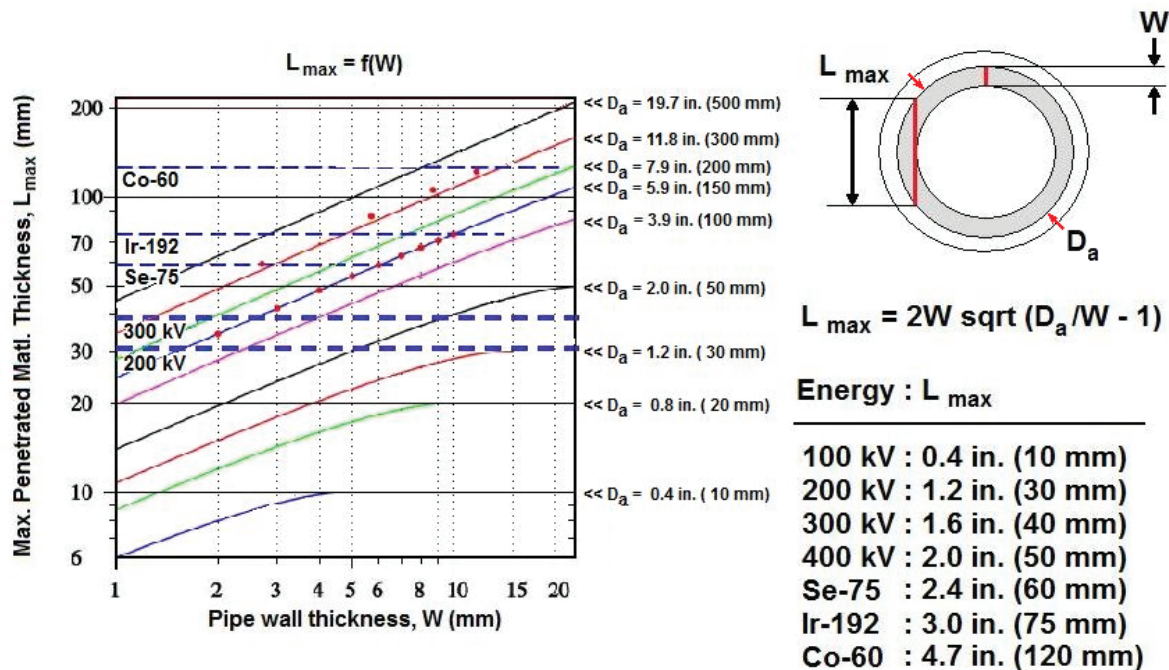
Figure 10—Application Limits for Tangential and Film Density Radiography

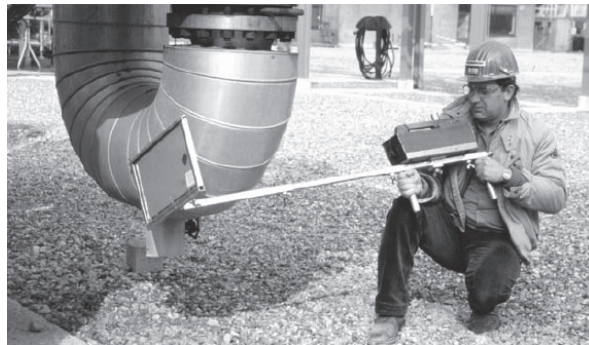
**Figure 11—Photo of a Flash Radiography System for Pipe Profiling to Detect Wall Thinning Due to Corrosion**

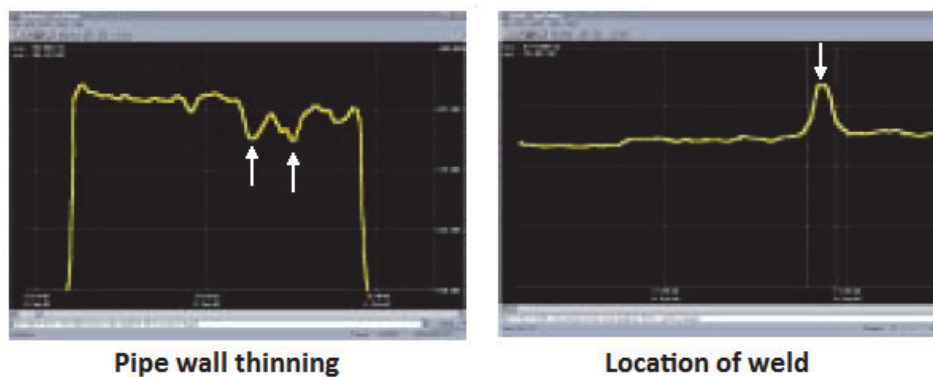
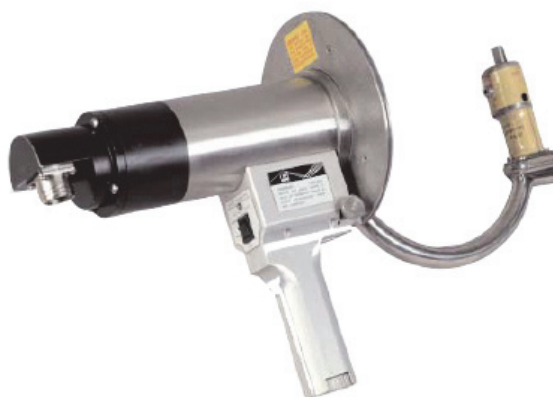
a) Display Showing Double-wall Thickness

b) Photo of a Radiometric Profiling System

**Figure 12—Radiometric Profiling Display and System**

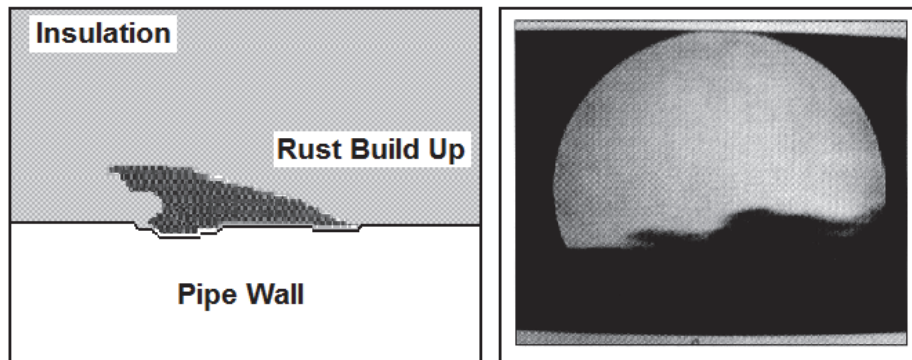
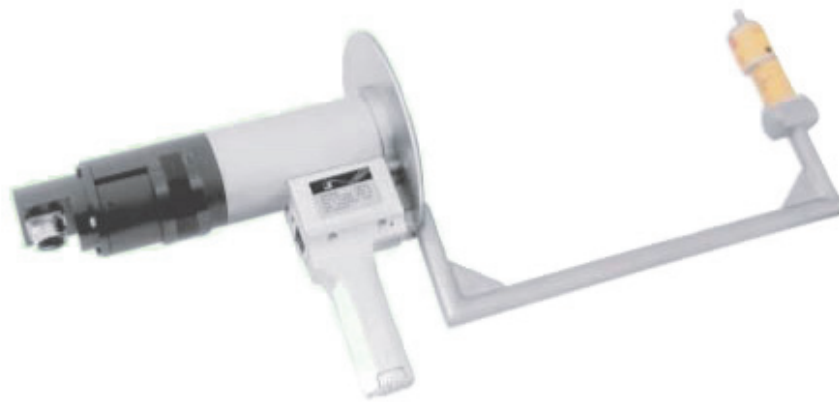
a) Representation of CUI (left) and a Silhouette Display of CUI (right)

b) Photo of a Real-time Radiography System

**Figure 13—RTR Display and System**

Most of the fluoroscopy systems come with a heads-up video display. A helmet-mounted, visor-type video display frees the system operator's hands to maneuver the C-arm while keeping the image before the operator at all times. The heads-up display also improves interpretation by shielding the screen from the sun. The video images can be printed on site using a video printer or recorded for evaluation at a later date.

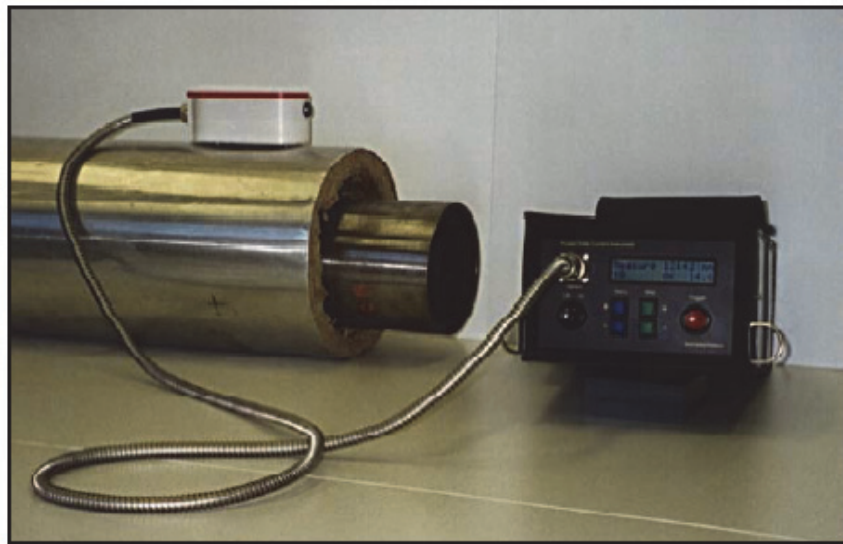
**Figure 14—A Pulsed Eddy Current Instrument with Probe**

PEC has been used in recent years to detect areas of wall thinning on insulated piping through aluminum or stainless steel jacketing. It is also used to inspect fireproofed legs on storage spheres. It is a noncontact, electromagnetic examination method used to detect the average wall loss of carbon and low alloy steel materials. A photo of a pulsed eddy current system is shown in Figure 14.

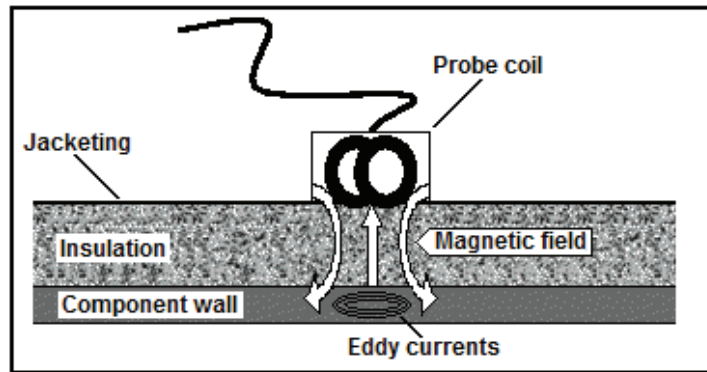
Figure 15—Principle of Operation the Pulsed Eddy Current Technique

A magnetic field, created by an electrical current in the probe coil, penetrates the jacketing and magnetizes the pipe wall. Current, in the probe coil, is then switched off to cause a sudden drop in the magnetic field. As a result of the change in the magnetic field, eddy currents are generated in the pipe wall. These eddy currents diffuse inward and decrease in strength. This decrease in the strength of the generated eddy currents is monitored by the probe coil. The thickness of the component is related to the length of time it takes for the eddy currents to show a change of the decay rate when eddy currents reach the back wall of the metal. The greater the wall thickness of the component, the longer it takes for the eddy currents to reach the backwall. Figure 15 and Figure 16 show a representation of the pulsed eddy current technique and a pulsed eddy current display.

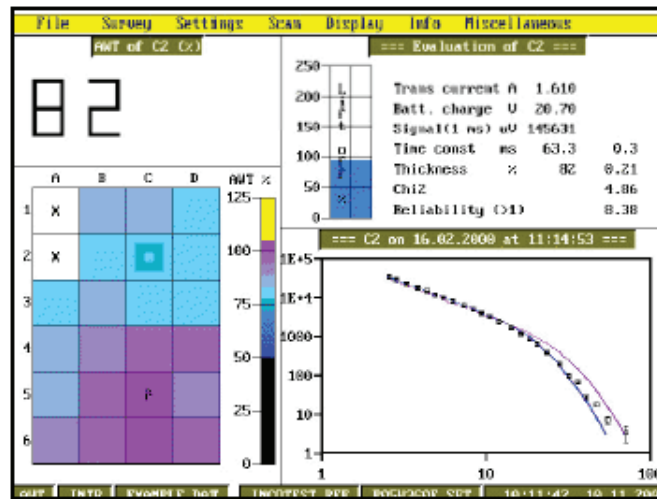
Figure 16—A PEC Display Showing AWT Reading (top left), Logged Inspection Grid (bottom left), and the Decay of the Eddy Currents (bottom right)

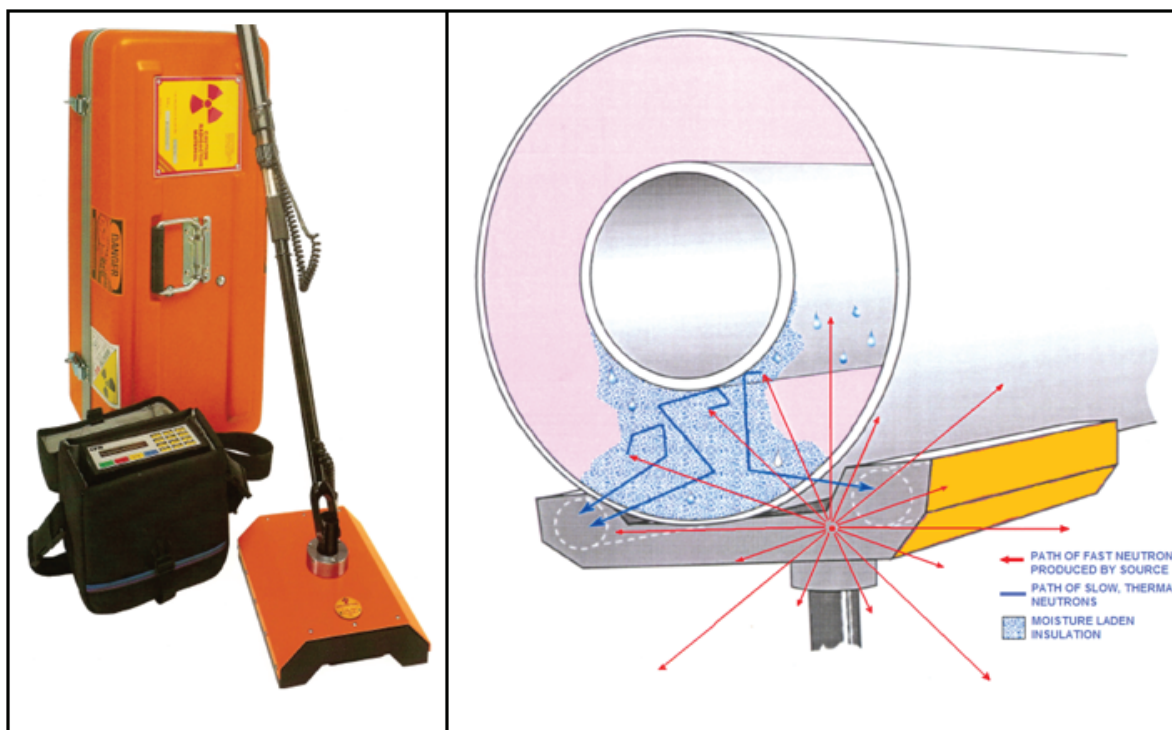
**Figure 18—A Photo of a Neutron Backscatter System**

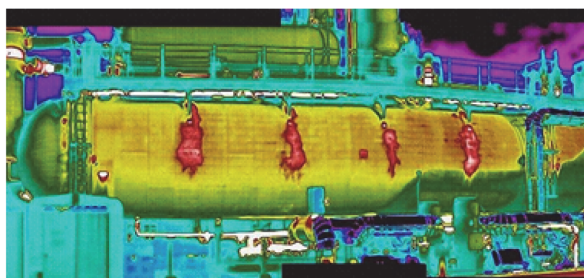
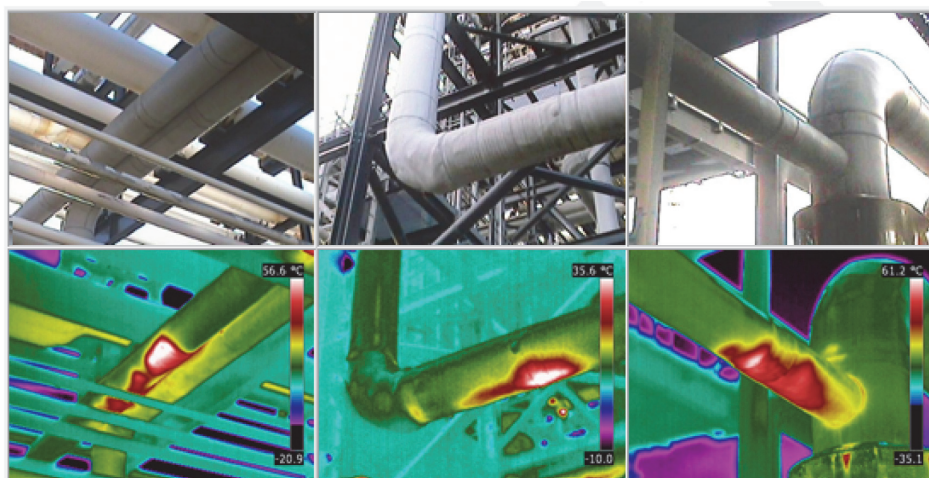
a) Desalter Vessel Showing Water Intrusion Under the Insulation

b) Saturated Insulation on Piping

Figure 19—Thermographs Showing Areas with Wet Insulation (in Red)

conductivity in the component. Thermography is often carried out from as far away as 65 ft (20 m). Full inspection coverage can at times be difficult because of site obstructions such as existing piping or equipment during IR photo shooting. Figure 19 shows examples of IR thermographs.

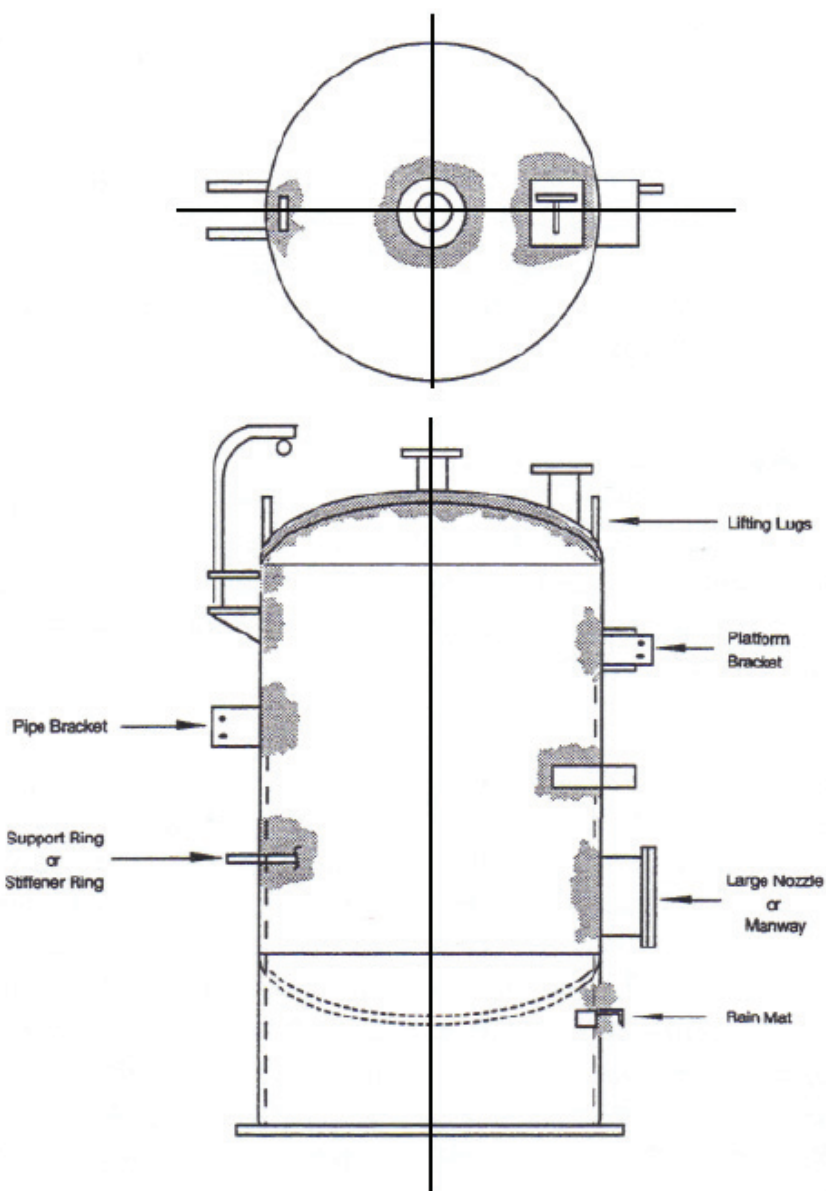
**Figure 20—Areas of Concern for CUI in a Vertical Vessel**

The areas of concern on an insulated, vertical vessel are illustrated in Figure 20. As indicated, the top head especially where nozzles, lifting lugs, etc. project through the insulation can be at greatest risk from CUI. Similarly the vertical walls are at risk at positions where horizontal attachments (support brackets, stiffener and/insulation rings, nozzles) pierce the insulation. Such attachments can provide paths for water to short circuit the weatherproofing/insulation and contact the walls.

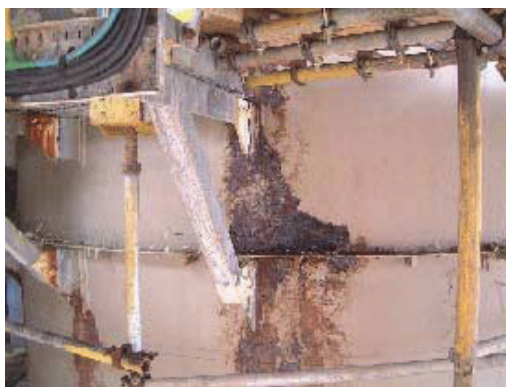
**Figure 21—Example of a Design/Layout That is Difficult to Insulate**

As a general rule of thumb, complicated designs are difficult to insulate and should be avoided. Figure 21 is an example of a design layout that is difficult to insulate and weatherproof and therefore had from the outset a high potential for CUI.

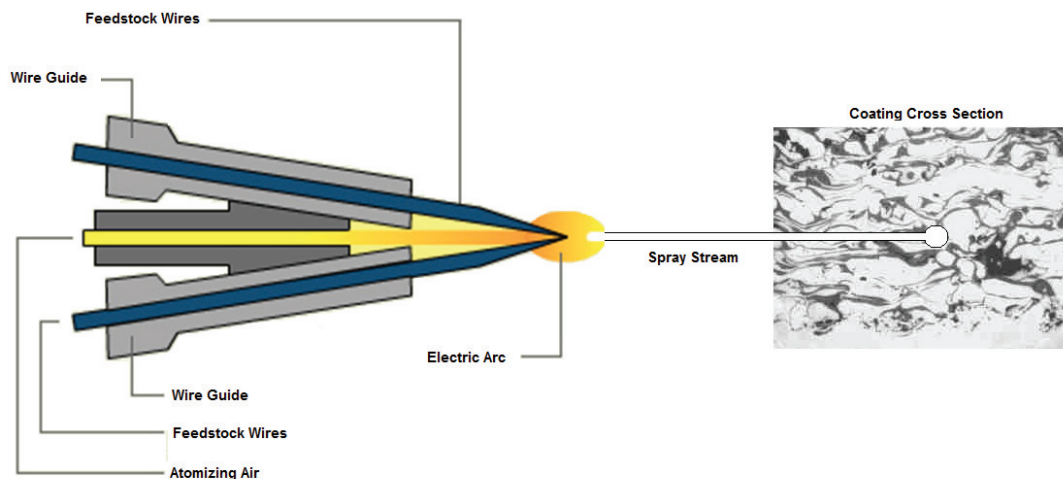
**Figure 23—Schematic of Two-wire Electric Spray Processes and Deposit Microstructure**

Thermally sprayed aluminum coatings are applied by either the electric arc spraying (also referred to as metallizing) or oxy-fuel wire spraying (also referred to as flame spraying) process (see Figure 23 and Figure 24).

In the electric spray process (Figure 23), the two aluminum wires are continuously fed toward each other to the gun tip at a uniform speed. A low-voltage direct current power supply is used, with one wire serving as the cathode and the other as the anode. As the wires leave the wire guides, they produce an electric arc at the point just before the wires meet. The high-temperature arc [ $>9000^{\circ}\text{F}$  ( $>5500^{\circ}\text{C}$ )] that is produced melts the wires. High-pressure compressed air, injected into the gun, produces a fine spray of aluminum droplets. As the spherical droplets impact the surface, they flatten to produce a platelet-like structure that is a mixture of coating, oxides, and porosity. A high magnification view of the deposit cross section is shown in Figure 23. The particles are mechanically bonded to the metal substrate.

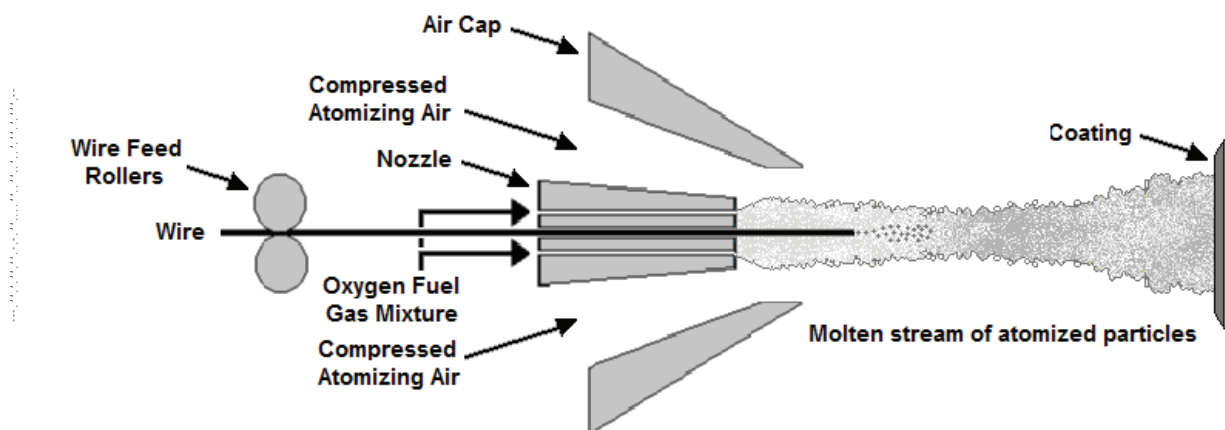
**Figure 24—Schematic of Oxy-fuel Wire Spray Processes**

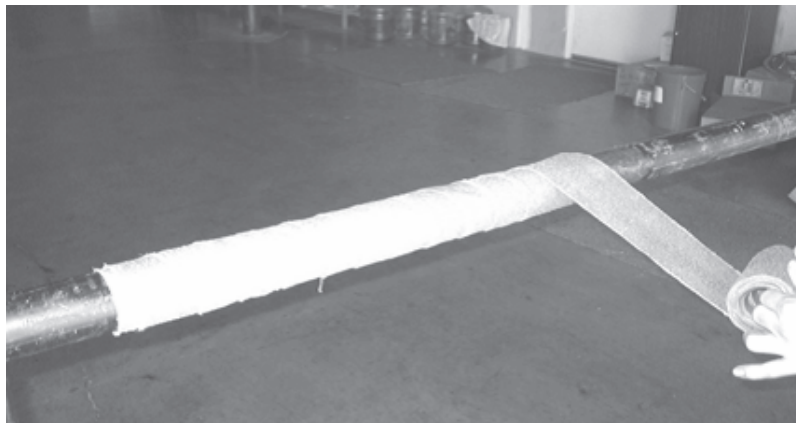
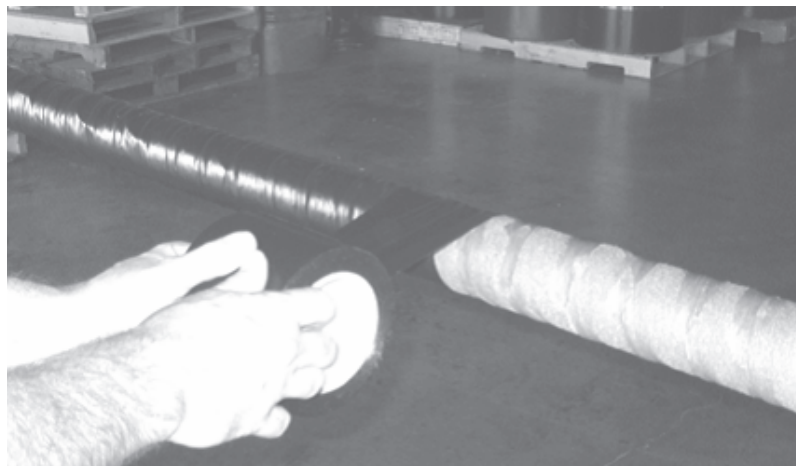
**a) Nonwoven Bonded Synthetic Fabric Impregnated with Natural Petroleum Being Applied to a Mastic Coated Surface**

**b) PVC Film Being Applied Over a Petroleum-based Tape Wrap**

**Figure 25—Example of a Petroleum-based Tape Wrap System**

- 1) a surface priming paste to displace surface moisture, passivate surface oxides, and fill in small irregularities in the substrate;
- 2) a mastic filler to ease contours around irregular shapes such as pipe joints, flanges, valves, bolts, and other irregular shapes; and
- 3) a nonwoven bonded synthetic fabric, fully impregnated, and coated with natural petroleum.

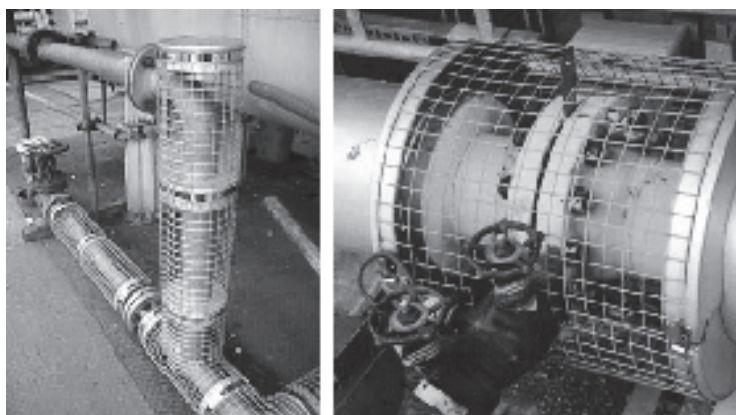
**Figure 26—Photograph of a Personnel Protective Cage on a Vertical and Elbow Section of Piping (left) and a Removable Personnel Protective Cage on a Valve (right)**

Equipment or piping operating above 140 °F (60 °C) poses a risk to personnel when skin comes in contact with the hot metal surface. In many instances, these surfaces are insulated for the sole purpose of personnel protection from the hot metal surface. The unnecessary use of thermal insulation creates a location for potential corrosion. In these cases, the insulation should be removed and wire “standoff” cages should be used instead. These cages are simple in design, low in cost, and eliminate CUI concerns and costs associated with maintenance of the insulation system. Examples of different types of personnel protective cages are shown in Figure 26.

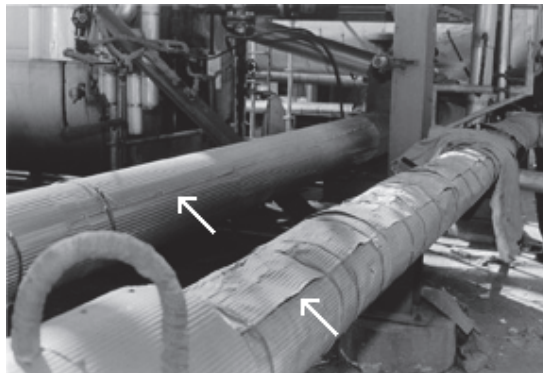
**Figure 27—Photo Showing Piping with and Without Damage to the Insulation System**

Figure 27 shows one of the piping segments (i.e. left arrow) with newly jacketed insulation system. The lap and butt joints of the jacketing are effectively sealed with caulk piping to prevent moisture ingress. However, when temperatures change, materials expand and contract causing cracks in the caulking, allowing moisture to penetrate the insulation system. Damage to the caulk seal may not be detected until the jacketing is removed. If undetected, CUI of the piping can occur. The only effective solution for this issue is to periodically dismantle a section, inspect the sealants, and determine whether the entire system needs to be resealed.

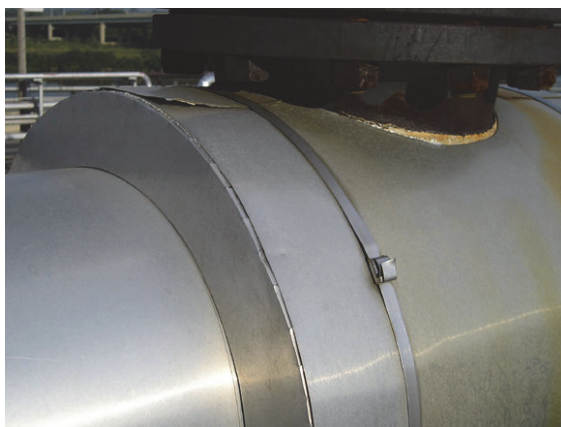
**Figure 28—Example of Jacketing Joint with Missing Caulking**

Smoothing the sealant is often done to provide a more attractive finished appearance but may result in a large amount of the sealant material being removed. This can potentially reduce the life of the sealant and increase the chance of a leak.

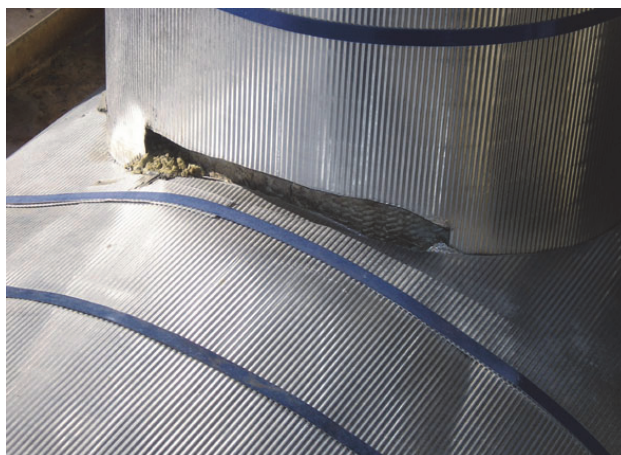
**Figure 29—Example of Poor Jacketing Fit-up**

Jacket materials installed with improper “fit and finish” provide easy path for water access (see Figure 29). Gaps between jacket components larger than 0.125 in. (3.2 mm) cannot be successfully sealed with caulking and sealants. Stresses and natural movement between these parts can cause the sealants to fail prematurely, letting in moisture and contaminating the insulation.

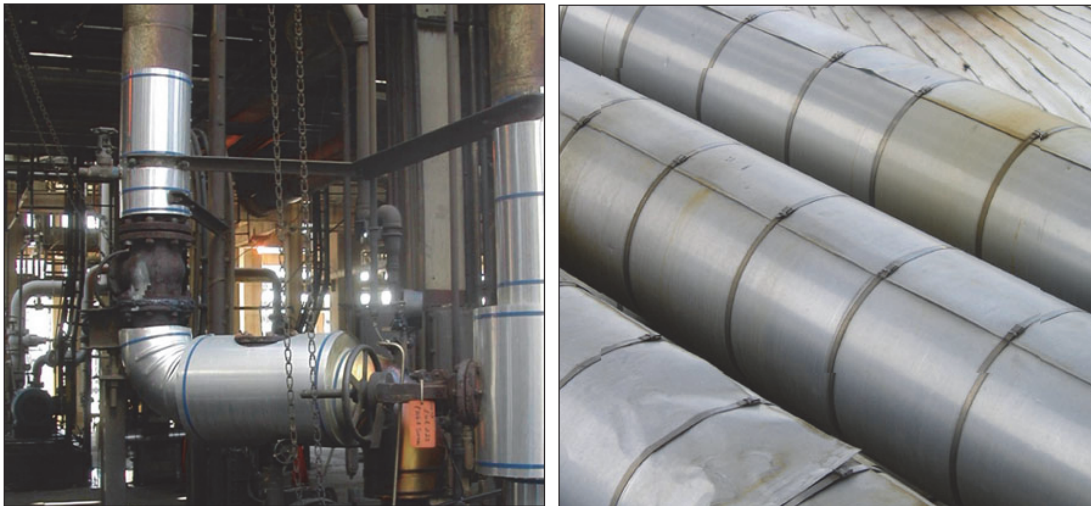
**Figure 30—Examples of Joints with Poor Ability to Shed Water**

Jacketing or weather barriers can also be installed improperly by not providing the proper ability to shed rain (see Figure 30). On vertical sections, this happens when lower sections of the jacketing material are installed over the top of the upper sections. On horizontal sections, it happens when the lap section is installed close to the top or bottom of piping rather than to the sides. It can also happen when a section of jacketing is wrapped around the insulation such that the upper section of the jacket horizontal lap is overlapped by the lower section. All of these installation errors allow water into the insulation system.

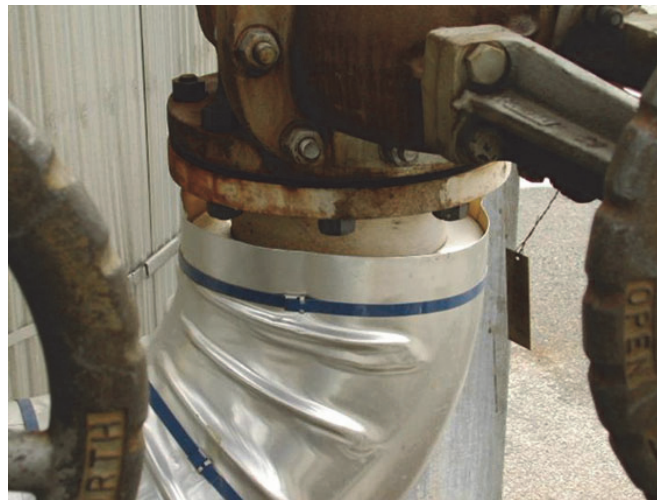
**Figure 31—Example of Missing End Cap**

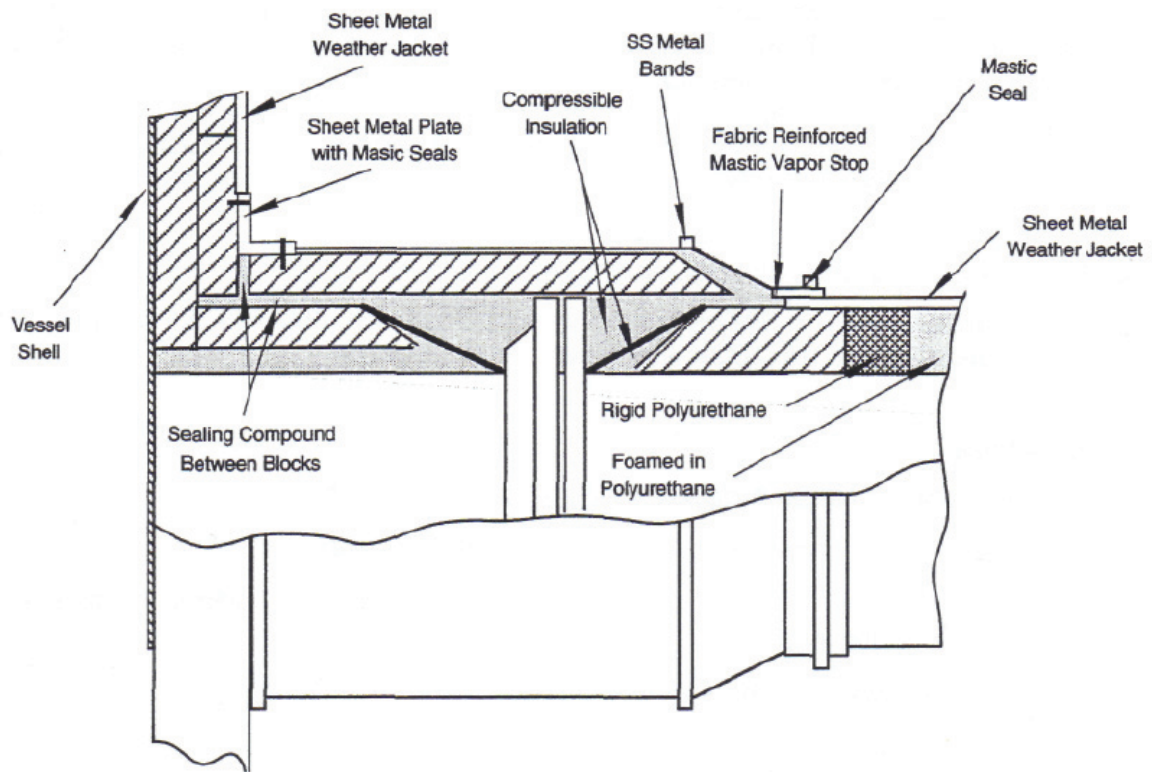
Figure B.1—Method of Insulating Nozzles and Manways

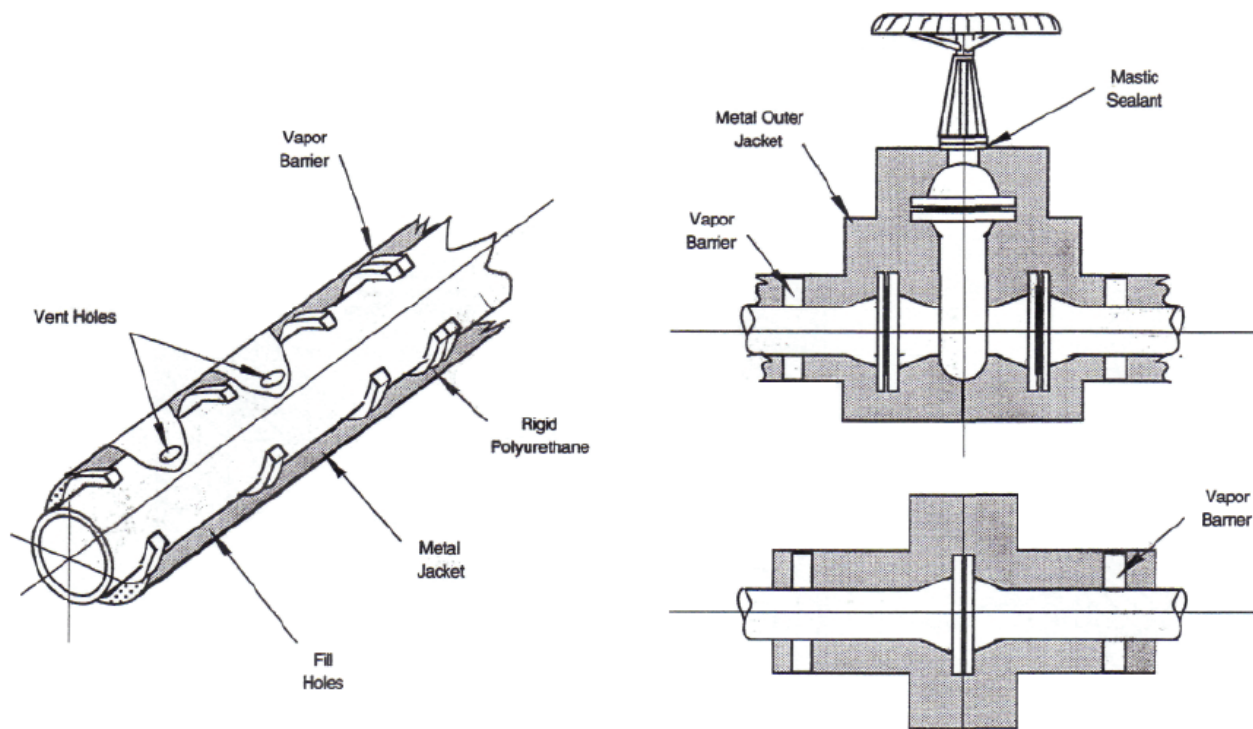
**Figure B.2—Method for In Situ Polyurethane Foaming of Straight Pipe and Valve/Flange Boxes**

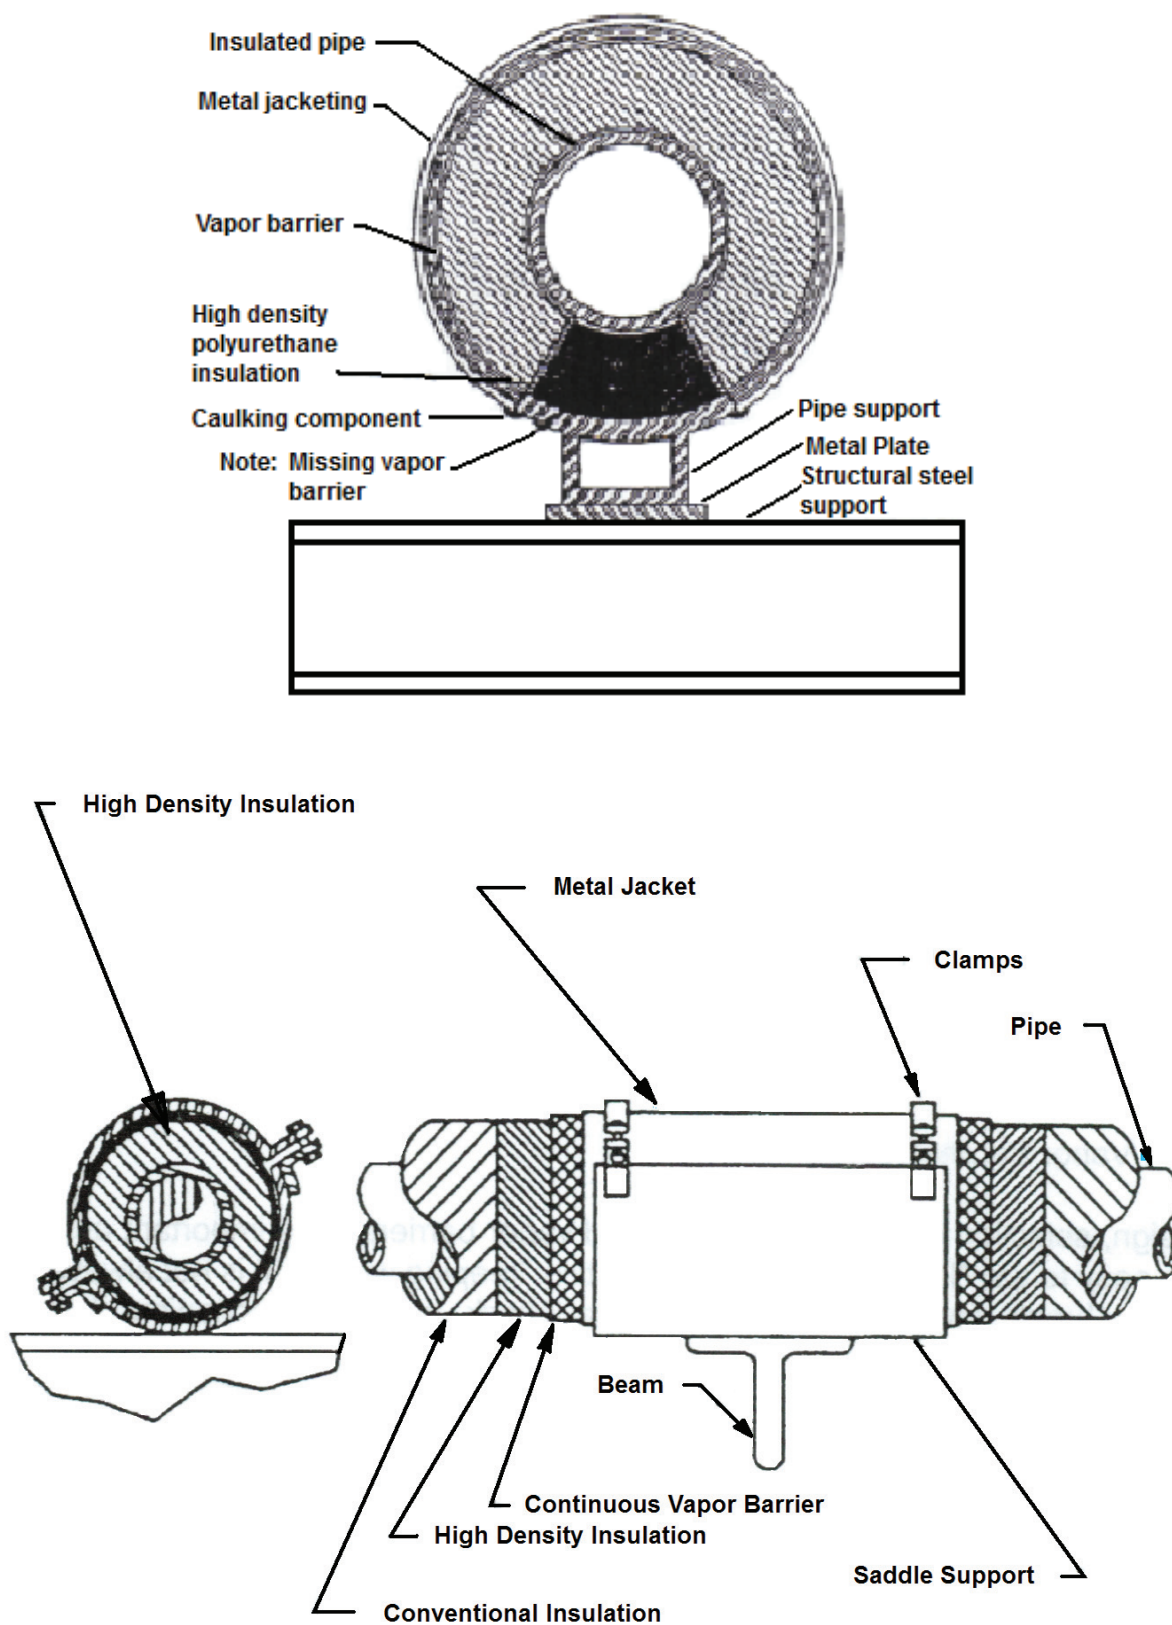
**Figure B.3—Method for Insulating Pipe Support with and Without Continuous Vapor Barrier**

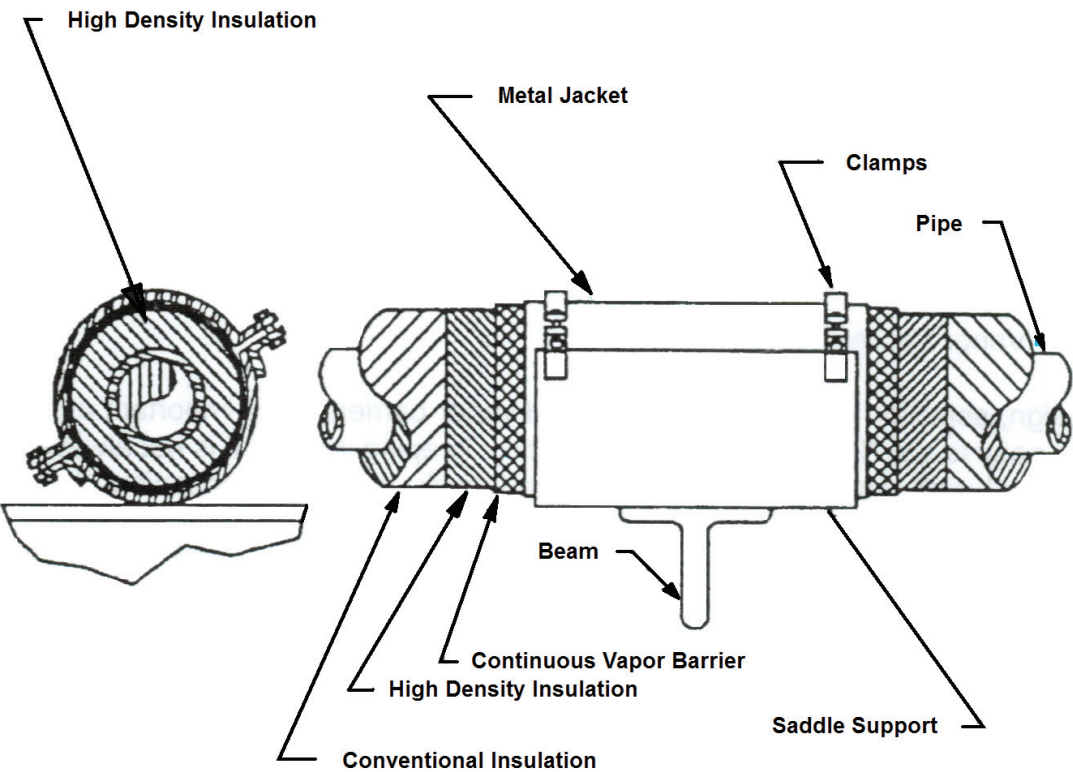
Figure B.4—Method for Insulating Miscellaneous Attachments
