# Corrosion Under Insulation and Fireproofing

API RECOMMENDED PRACTICE 583  
FIRST EDITION, MAY 2014

AMERICAN PETROLEUM INSTITUTE

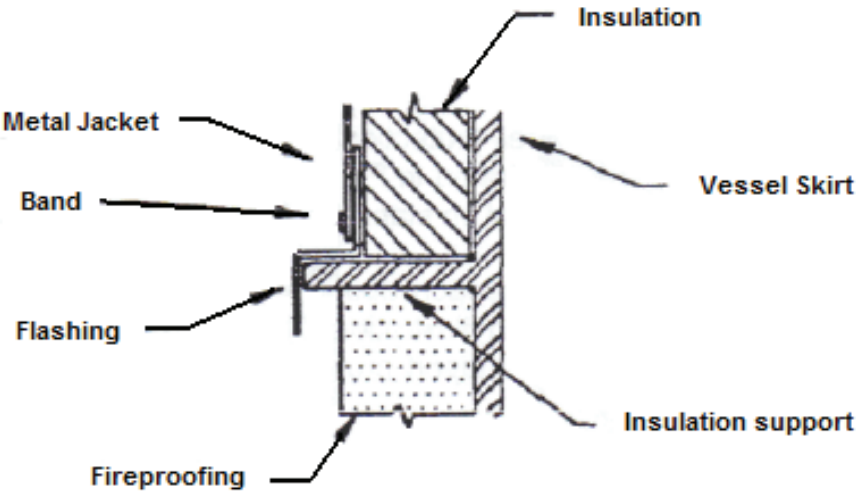
Figure B.5—Method for Insulating Vertical Vessel Bottom Support Ring

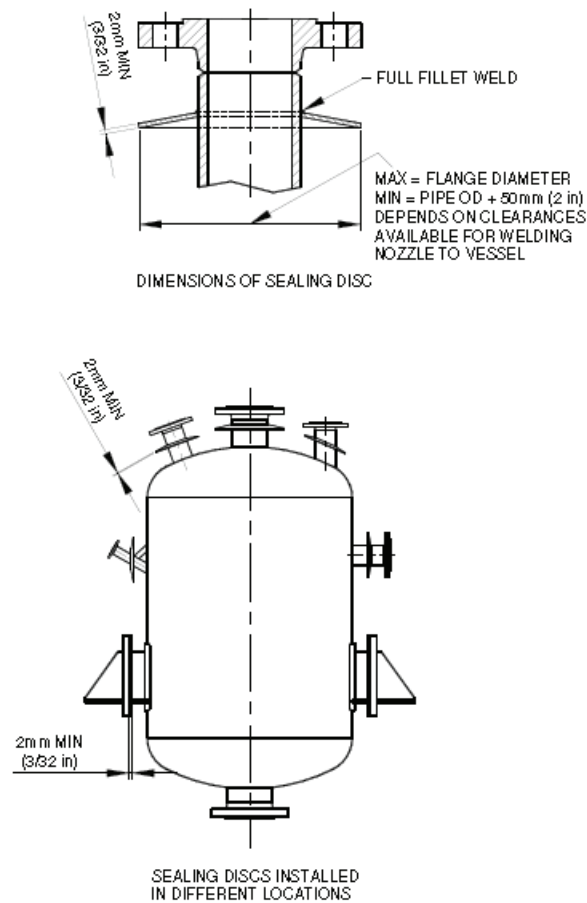
**Figure B.6—Method of Diverting Water Away from Critical Locations**

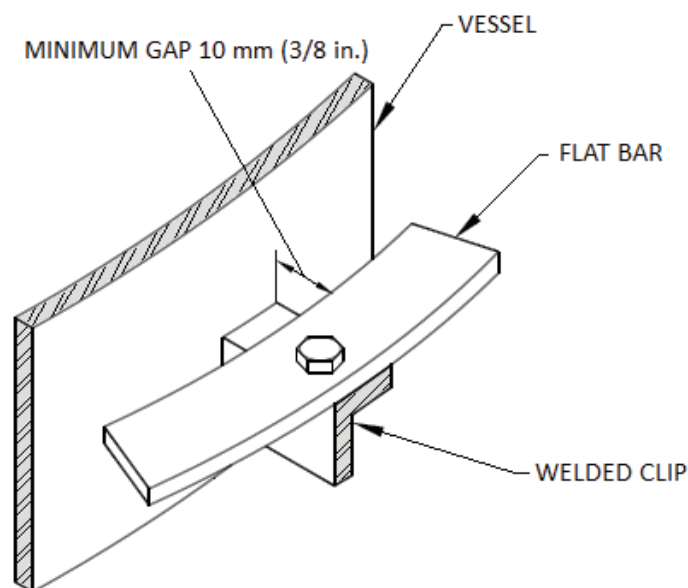
**Figure B.7—Method of Avoiding Water Buildup at Insulation Supports**

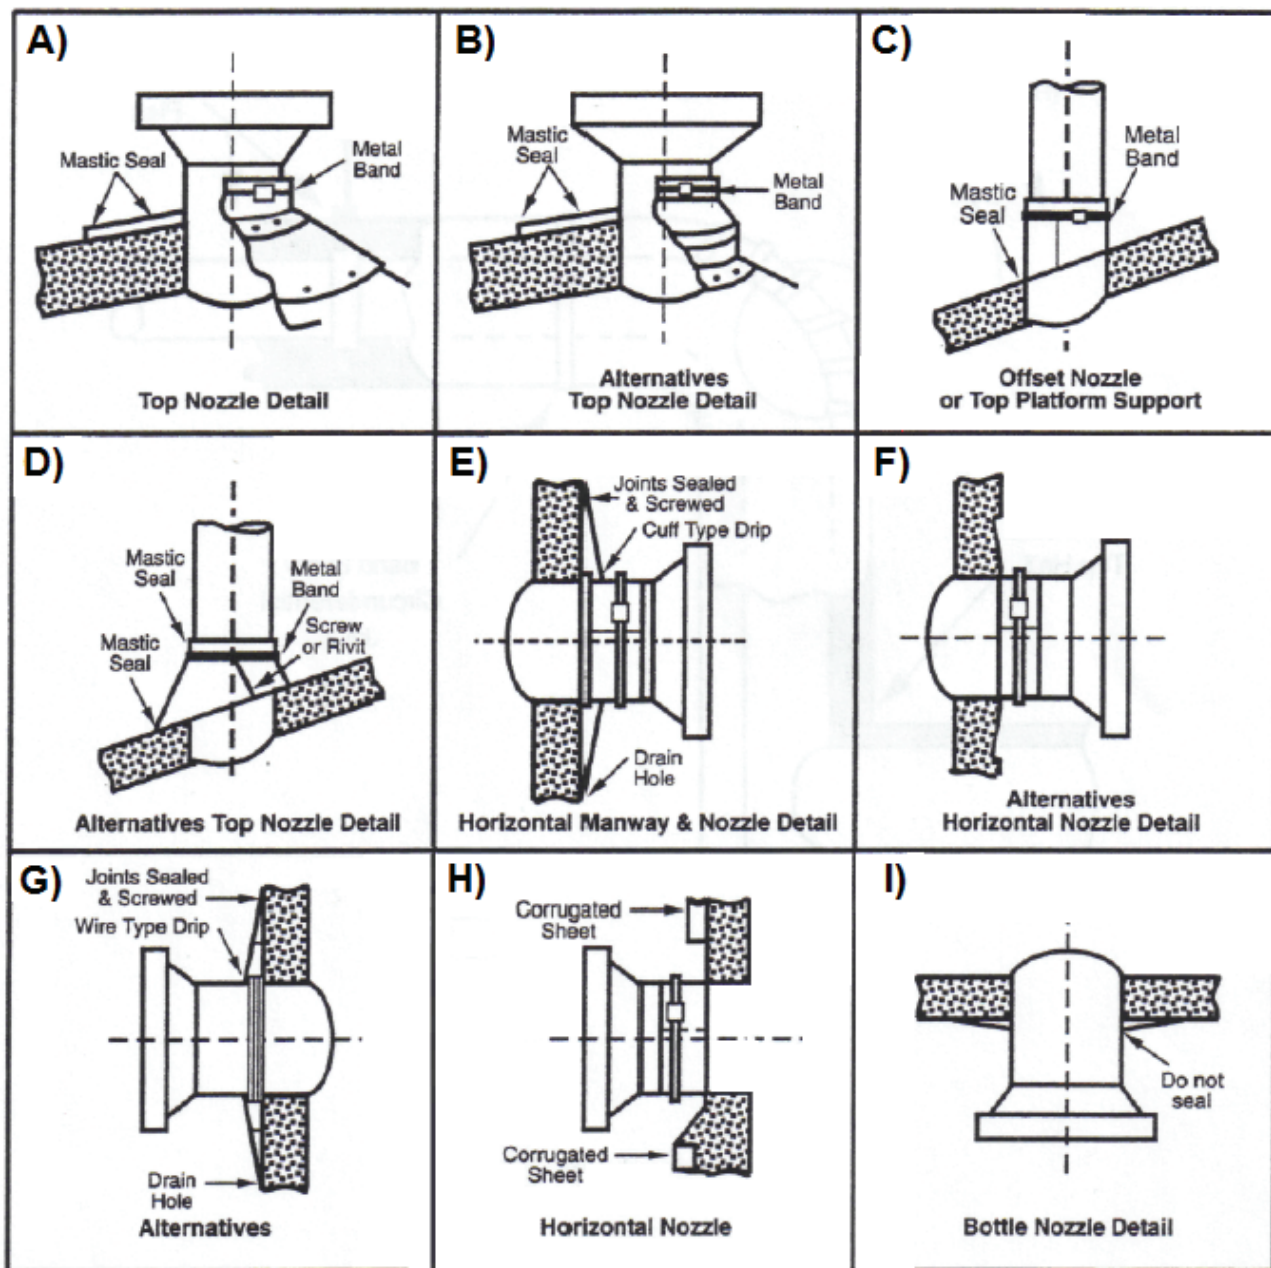
Figure B.8—Method of Avoiding Water Buildup for Vessel Nozzles and Attachments

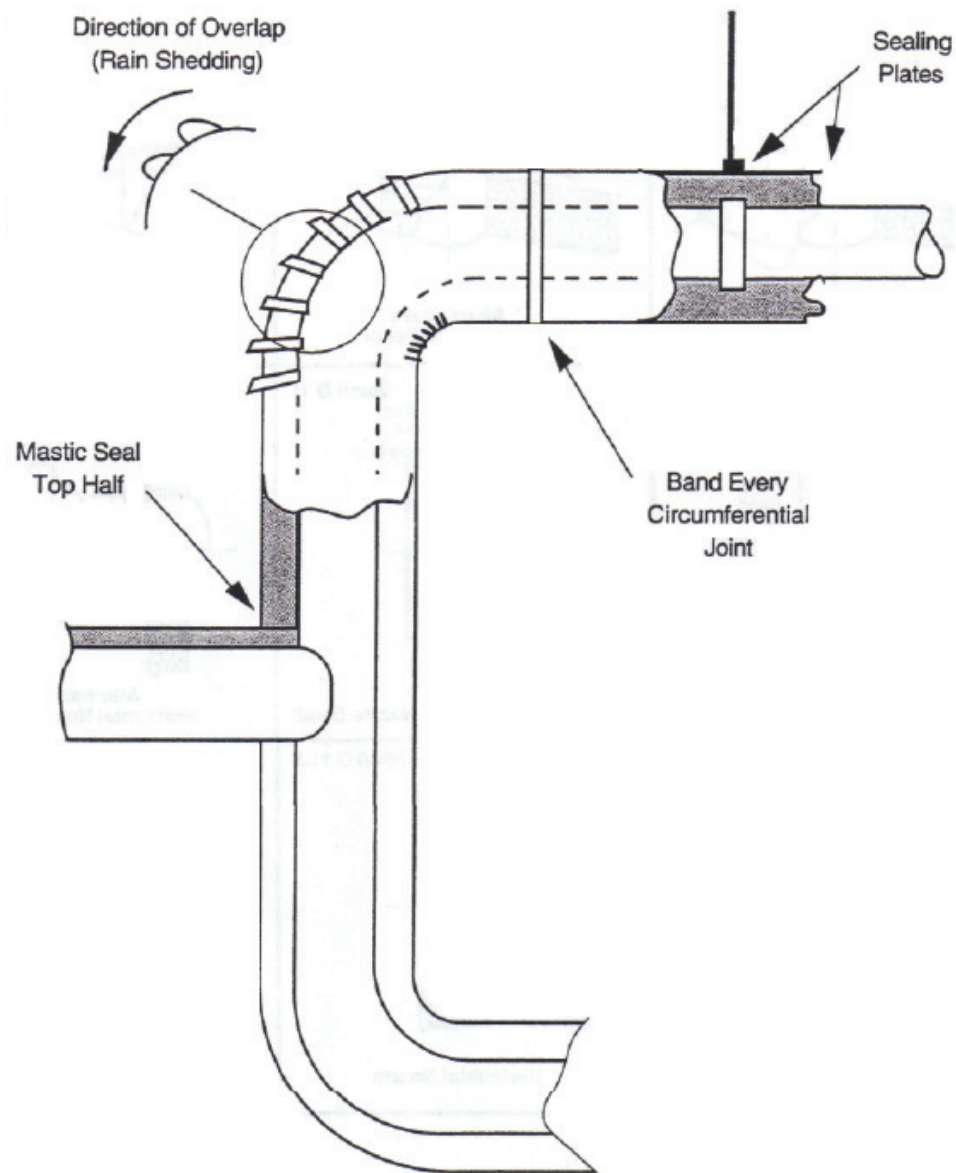
**Figure B.9—Method of Avoiding Water Buildup for Piping**

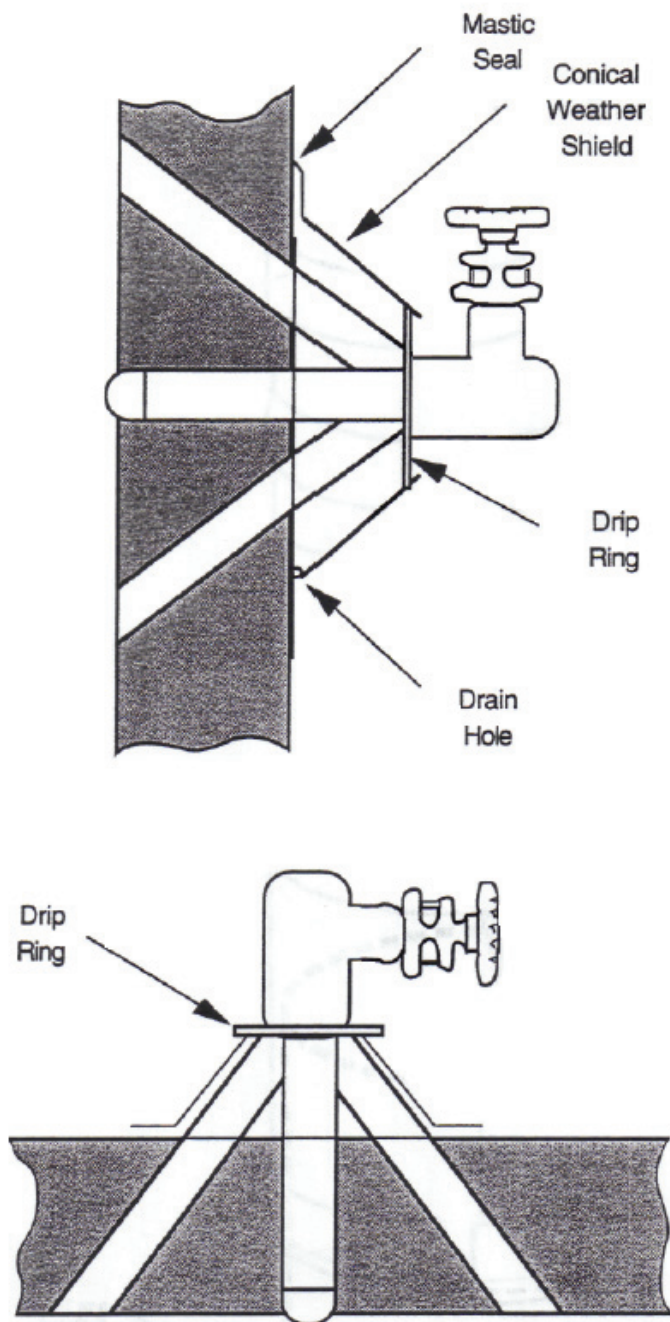
**Figure B.10—Method of Avoiding Water Buildup for Horizontal and Vertical Gussets**
